## ASIA TURBOMACHINERY & PUMP SYMPOSIUM

# PITTING CORROSION LED TO CATASTROPHIC GAS TURBINE COMPRESSOR BLADE LIBERATION

FADLIL HAFEEZ – PETRONAS  
MOHD FAIZAL – PETRONAS

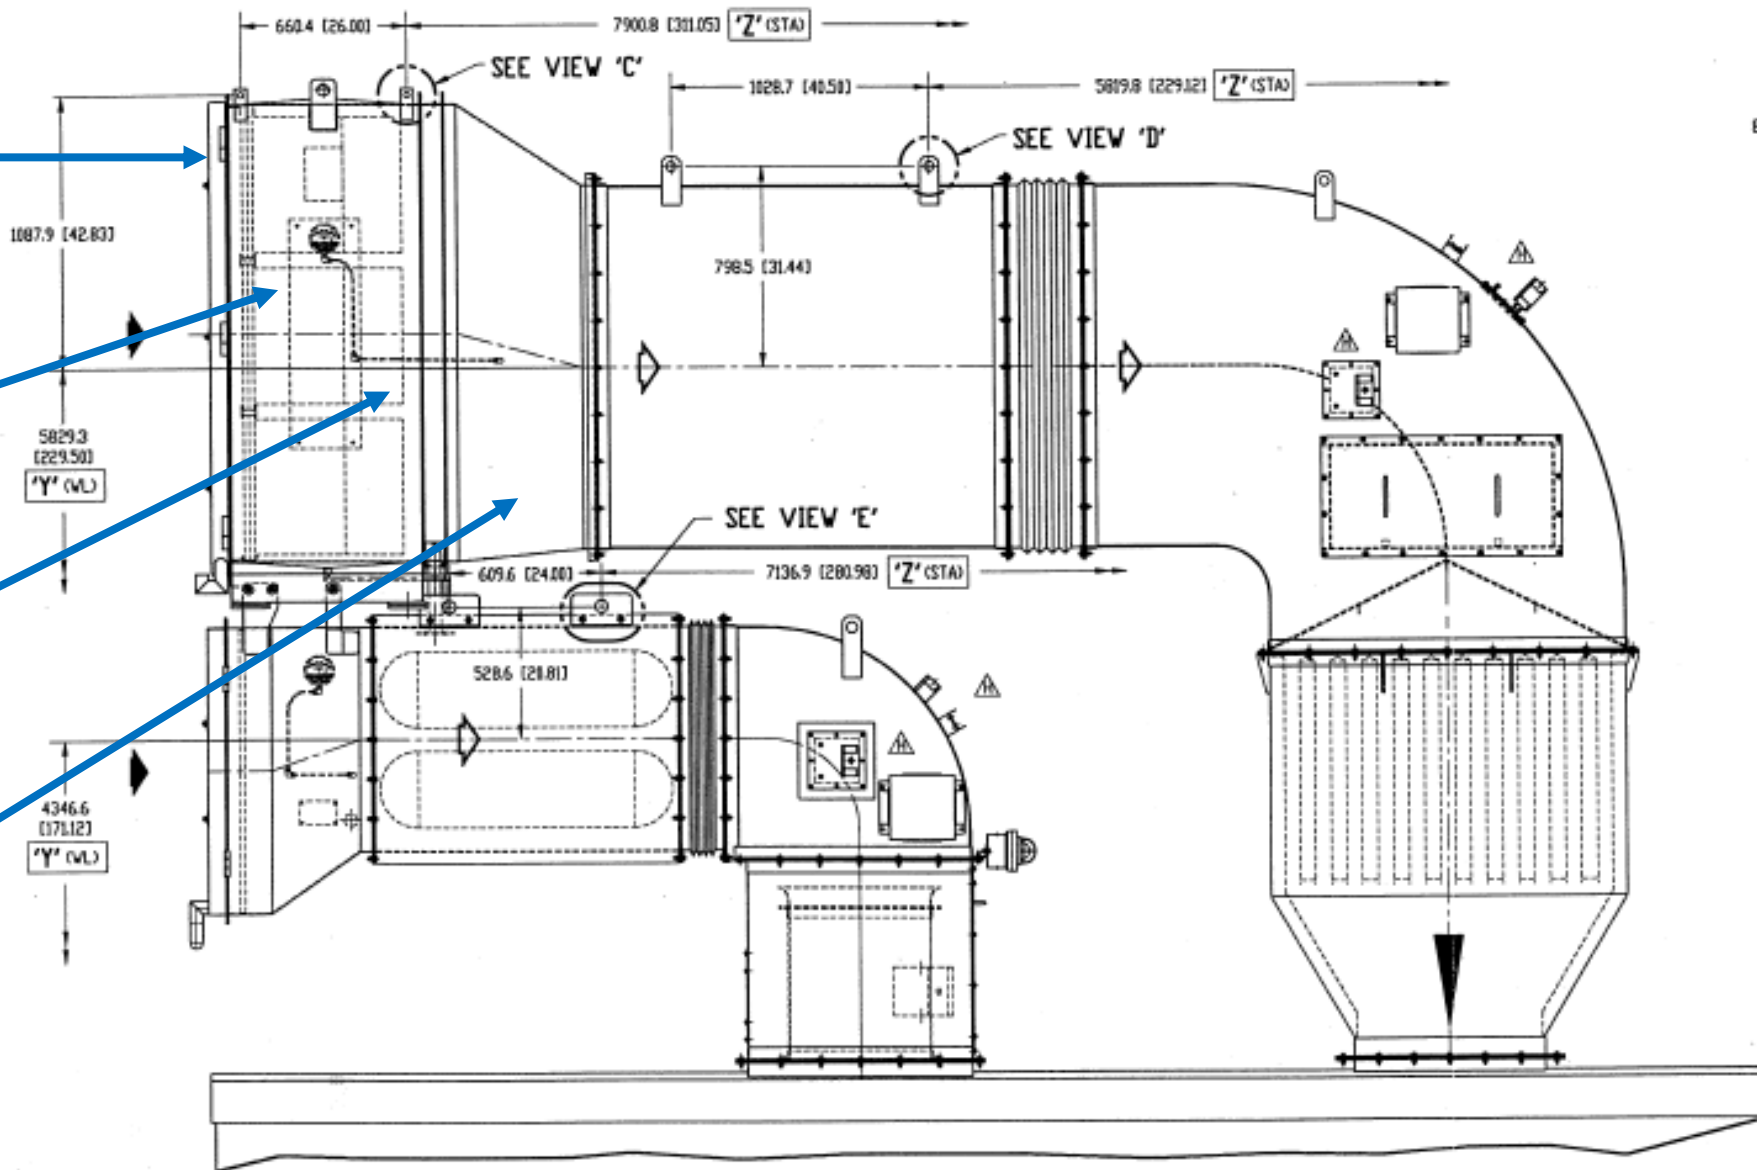
# AIR INTAKE SYSTEM OVERVIEW

Stage 1: Marine Vane Separator (MVS)

Stage 2: G4 single pocket

Stage 3: F7 10 pocket

Stage 4: Marine Vane Separator (MVS).

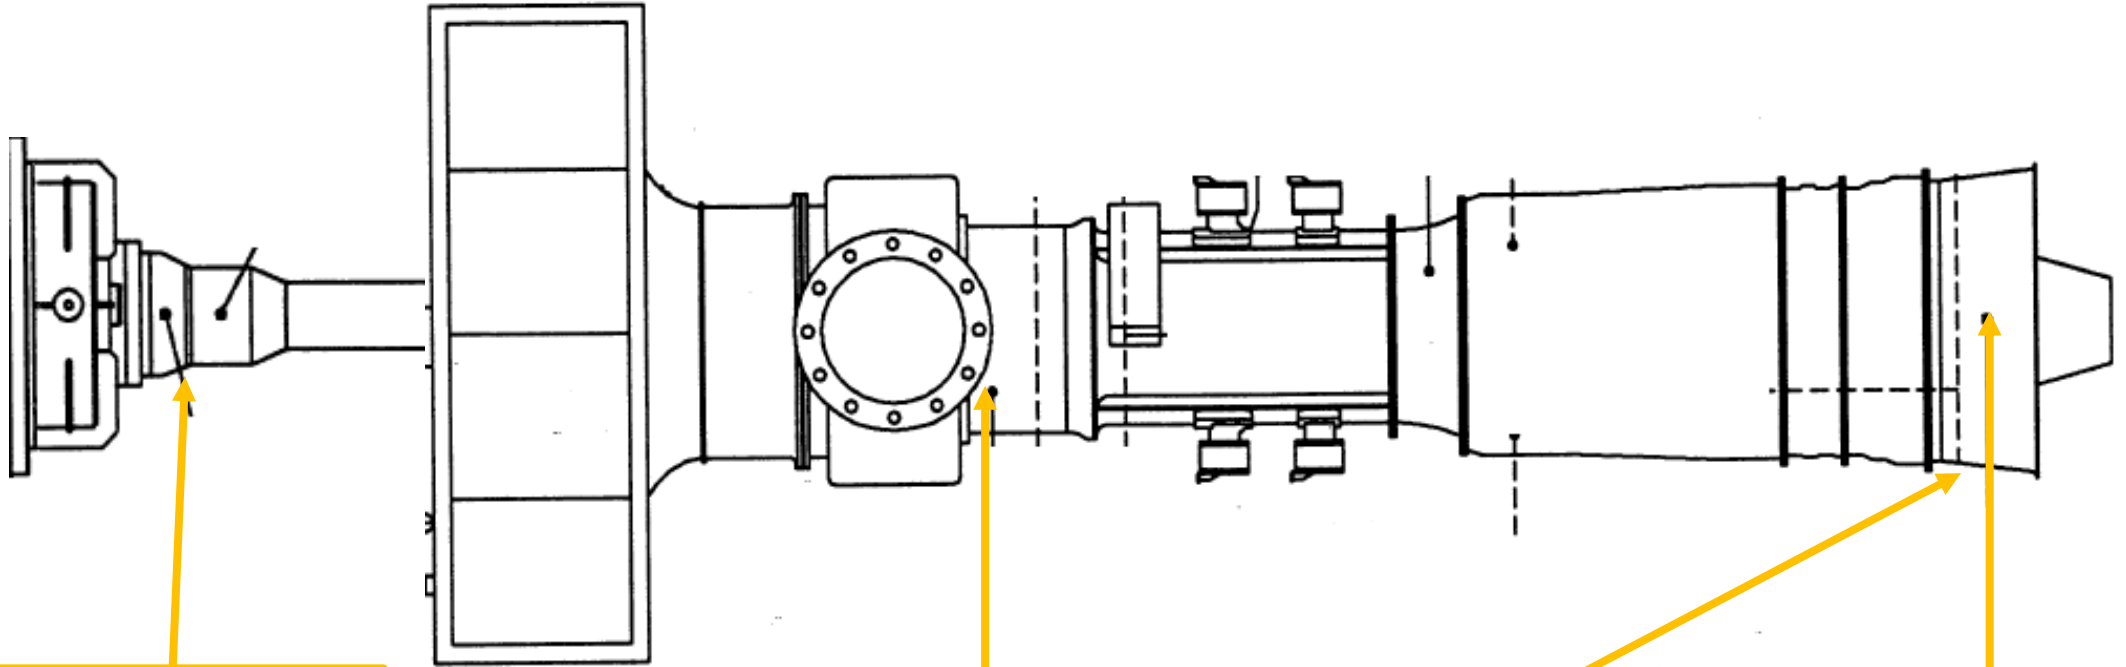
# MAIN INSTRUMENTATION OVERVIEW

Power Take Off  
(PTO) Vibration  
– VE65

Compressor Case  
Vibration – VE67

Turbine Outlet  
Temperature  
(TOT) – TE60

Turbine Case  
Vibration – VE66
