ASIA TURBOMACHINERY & PUMP SYMPOSIUM

Gas Turbine Load Limited due to High Exhaust Temperature Deviation

ExxonMobil

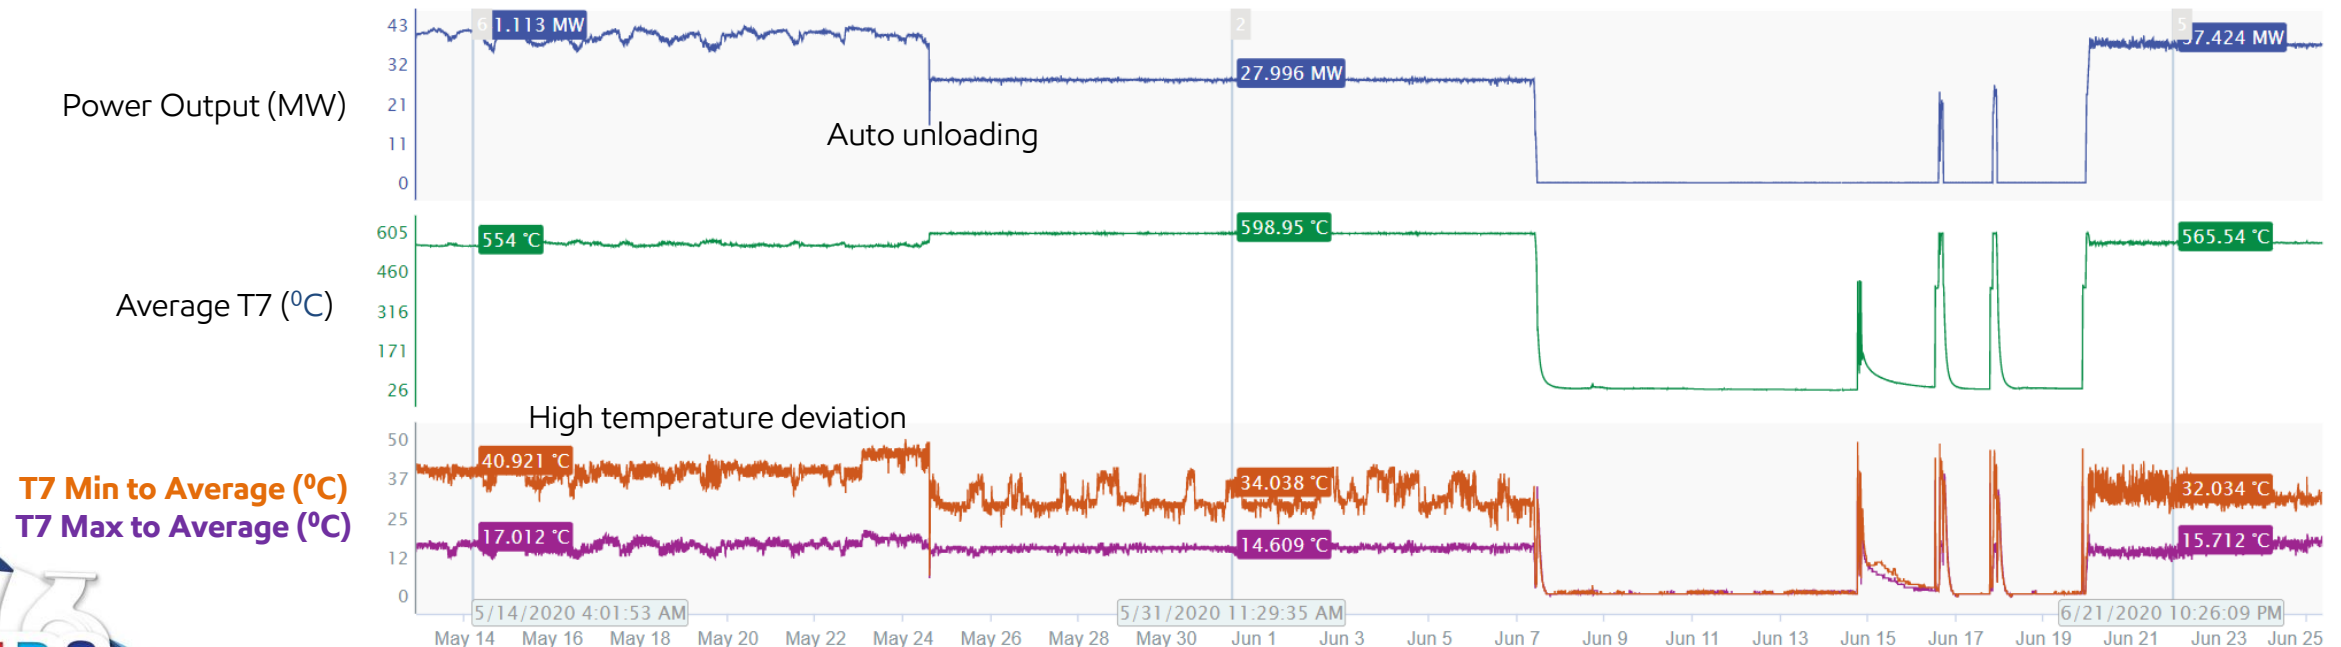
The GTG was shutdown for planned maintenance (PM). During GTG restart, Turbine Exhaust Temperature (T7, Min to Avg) increased instantaneously from ~10°C to ~40°C but the GTG was capable of delivering up to full load for ~1 month until hitting alarm.

That triggered protection logic to auto unload the machine to part load due to cold spot. GTG power was then kept at part load 30MW to control the exhaust temperature deviation.

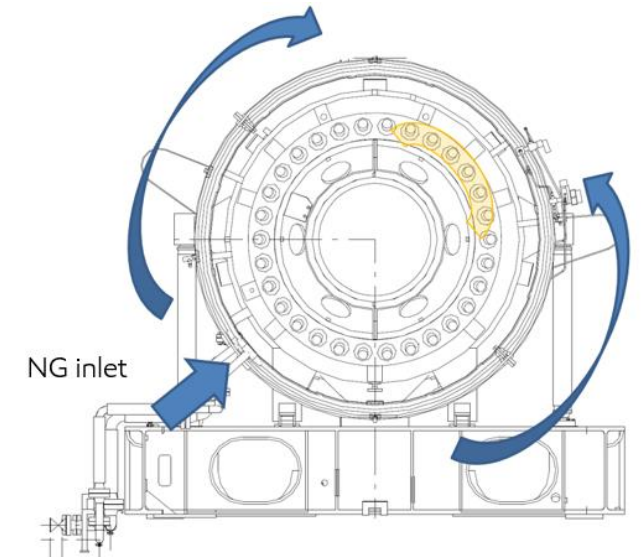
Findings

During PM window, the following observations were made:

1. At the fuel gas manifold, residue dirt was observed sticking to wall.
2. A number of burners orifice plates were found plugged with particles
3. Sample collected and sent for EXD testing which revealed presence of rust particles.
