Relation between wear ring clearances & non-synchronous vibrations in BFW centrifugal pump

Waqar Ahmad-Engro Fertilizers

A de-superheating boiler feed water pump was facing high vibration issue for last 19 years.

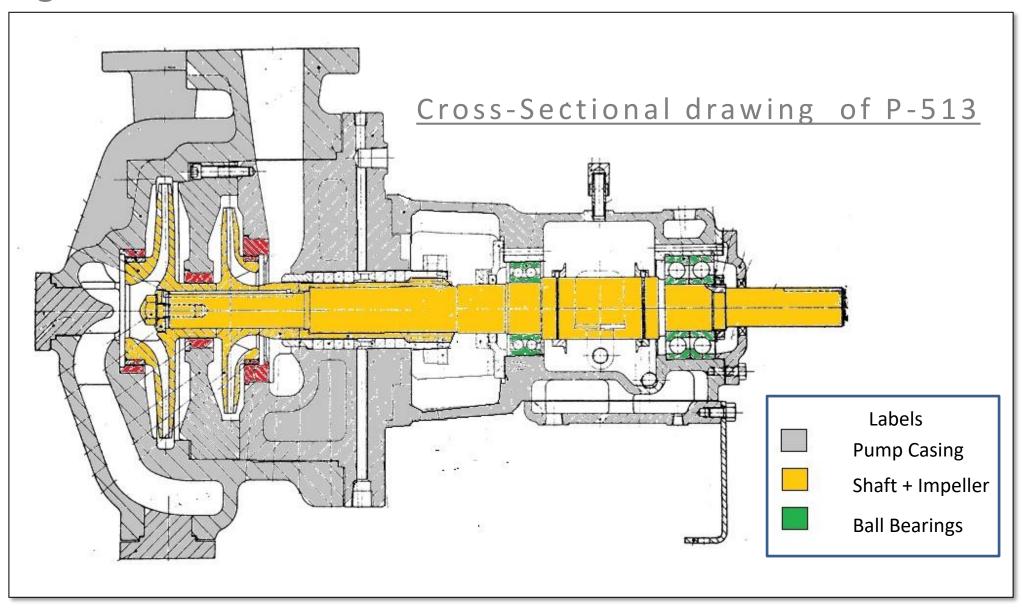
This pump takes suction from this de-aerator drum. Afterward, It has 2 applications. First, it supplies quenching water to the de-superheating stations. Second, it is utilized in the initial filling of BFW for steam generation during power black-out emergency situation.

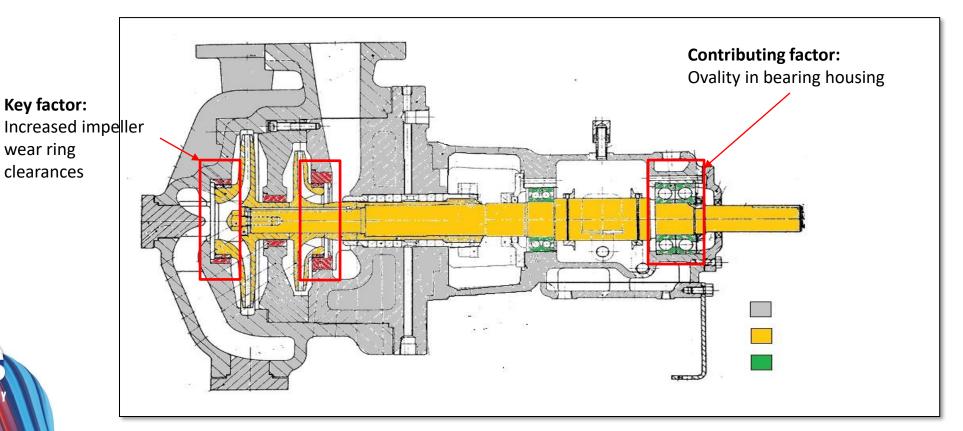
Method of rule of elimination was utilized to identify the cause of the problem. Based on analysis, it revealed that dominant frequency 1.58X was appearing in vibration spectrum, due to increased impeller wear ring(both) clearances (key factor) & issue of comparatively high vibration at pump I/B end (vs O/B end) was caused by ovality in bearing housing (contributing factor).

Machine was started on 16 Feb-2021, after performing corrective actions. Vibration values of pump were reduced from 1.1 inch/sec to 0.10 inch/sec pk at same operating parameters. Dominant frequency of 1.58x order present in previous spectrums was completely vanished. Currently, vibrations of machine are running normal.

- 1. Wear ring clearances were newly fabricated to maintain correct clearances. Moreover, wear ring were additionally fabricated and introduced in warehouse as spare item.
- 2. Machining of I/B bearing housing and installation of sleeve ring was done, to address ovality issue. Moreover, I/B bearing was modified with steel caged ball bearing.
