ASIA TURBOMACHINERY & PUMP SYMPOSIUM

Vibration Diagnostic of Steam Turbine Intermittent Rubbing

KER PIN JUN – EXXONMOBIL
NG WEI SING - EXXONMOBIL

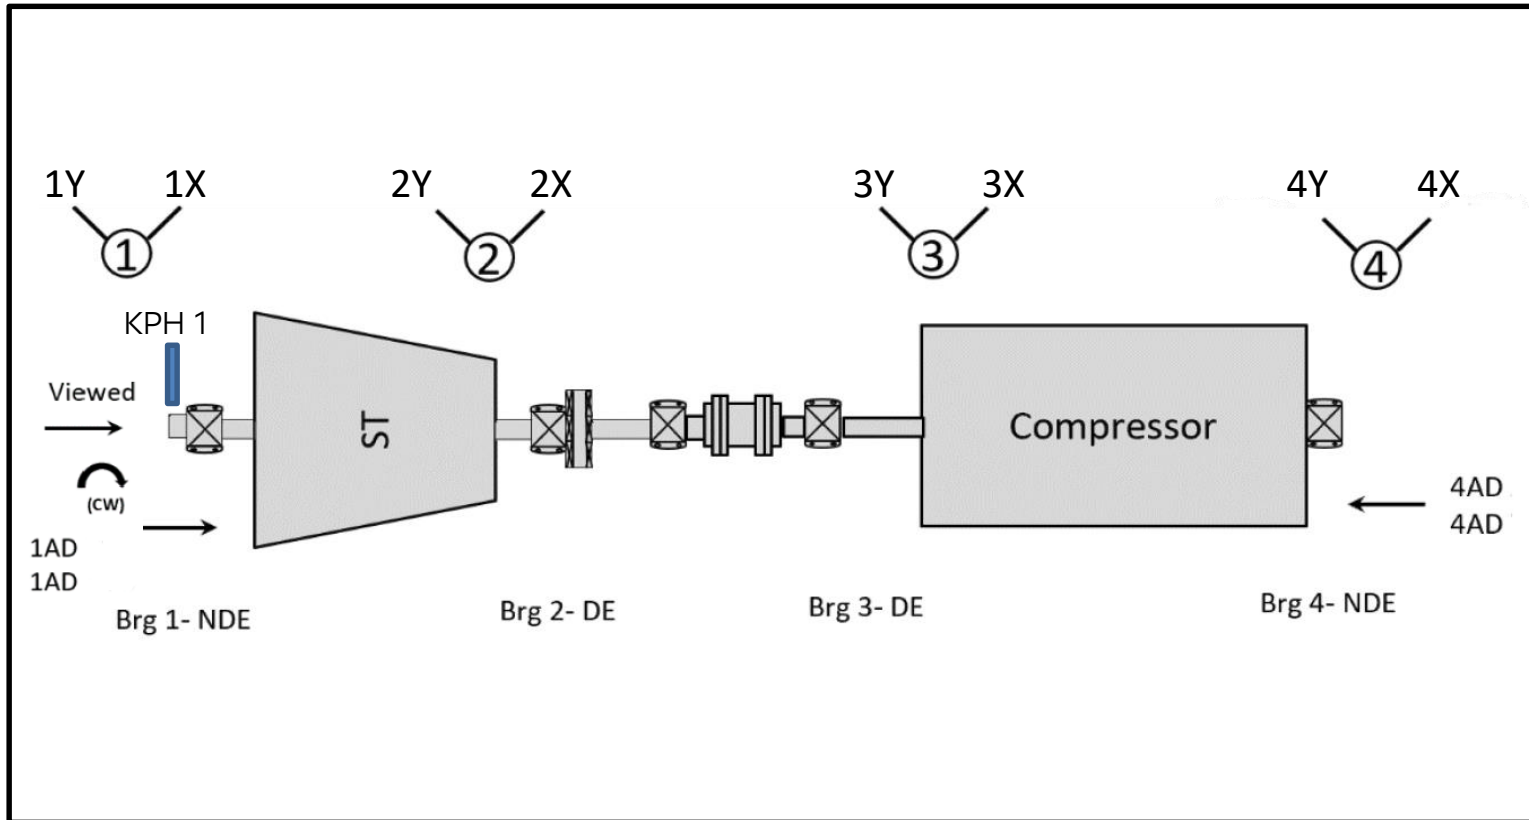
Steam Turbine Probe Orientation

Probe Orientation				
Tag#	Equipment	Bearing	X/Y	Key Phasor
1Y	Turbine NDE	1	45° Left	KPH 1
1X	Turbine NDE	1	45° Right	
2Y	Turbine DE	2	45° Left	
2X	Turbine DE	2	45° Right	
3Y	Comp DE	3	45° Left	
3X	Comp DE	3	45° Right	
4Y	Comp NDE	4	45° Left	
4X	Comp NDE	4	45° Right

Alarm set point: 30 μm

Trip set point: 48 μm

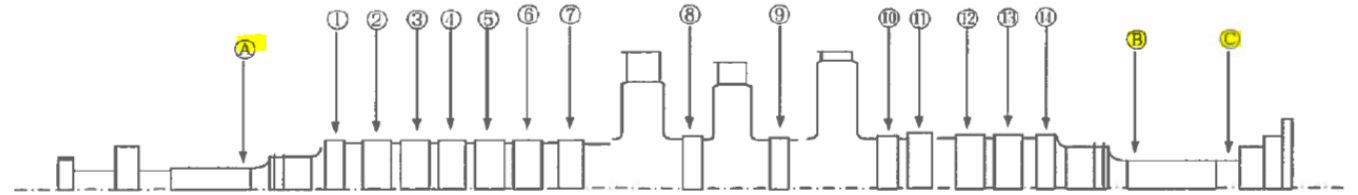
Internal Labyrinth Clearance (*W)

- Base on vibration data analysis, it is highly suspected the cause of intermittent vibration spike is due to **light or partial rubbing** of rotor.
- Rubbing is not a machinery malfunction; but rather a secondary indicator that there are other primary cause(s) that led to the rub.
- Last overhaul QA/QC record indicates the location of tightest clearances is at the bearing housing oil baffle (A, B and C with design clearance of 0.001" – 0.003")
- Site check revealed that the sealing air supply to oil baffle was not commissioned post turbine restart in 2019.
- *Lack of sealing air => Oil migration to oil baffle => Oil carbonization (high temp.) => Smaller clearances => Rotor rubbing*

Position	Design	As Found	As Left (Final)		Position	Design	As Found	As Left (Final)
A	Oil Baffle	0.025-0.076	0.09	0.0254	8	2 nd stage Laby		Damaged	0.5330
1	Outer Laby	0.483-0.584	0.62	0.5330	9	3 rd stage Laby		Damaged	0.5330
2	Mid Laby		0.60	0.5330	10	Inner Laby	0.483-0.584	0.60	0.5330
3	Mid Laby		0.65	0.5330	11	Inner Laby		0.58	0.5330
4	Inner Laby		Damaged	0.5330	12	Mid Laby		0.58	0.5330
5	Inner Laby		Damaged	0.5330	13	Mid Laby		0.55	0.5330
6	Inner Laby		Damaged	0.5330	14	Outer Laby		0.55	0.5330
7	Inner Laby		Damaged	0.5330	B	Oil Baffle		0.025-0.076	0.09
				C	Oil Baffle	0.025-0.076	0.09	0.0254
