ASIA **TURBOMACHINERY** & **PUMP** SYMPOSIUM  
APRIL 2020 | KUALA LUMPUR CONVENTION CENTRE

# Identification and Mitigation of H<sub>2</sub> Recycle Gas Compressor Blade Pass Resonance

Machinery Engineer  
ExxonMobil, Singapore

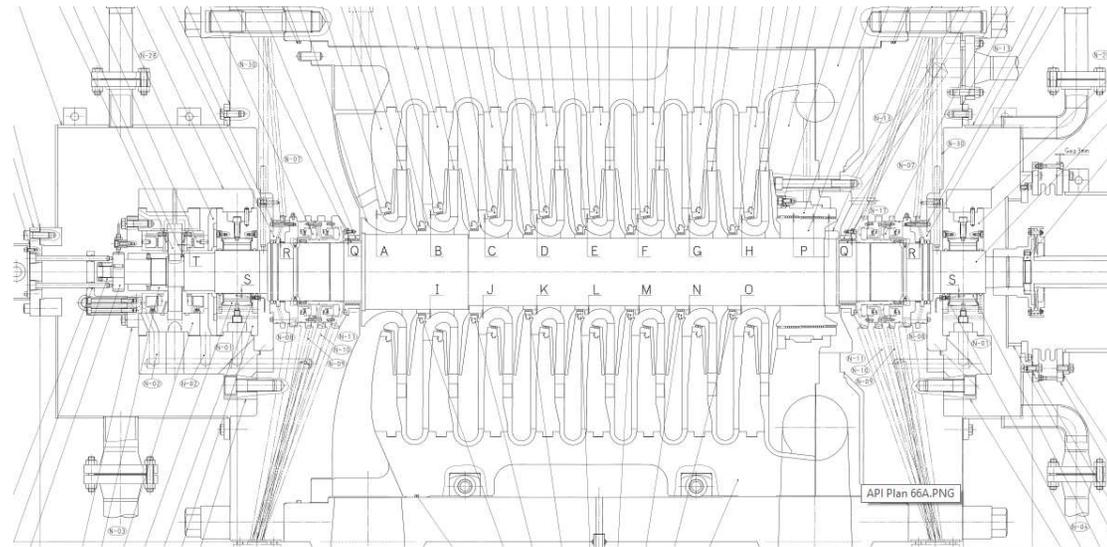
- H2 recycle gas 8 stage centrifugal compressor
- Motor (VFD) + step up gearbox drive.
- Operating speed range: 5170-10800 rpm
- Resonance range: 8800-9150 rpm
- No. of blades in impeller: 11
- No. of vanes in diffuser: 12
- Speed range in which vibration occurs: 8800-9150 rpm
