ASIA **TURBOMACHINERY** & **PUMP** SYMPOSIUM
APRIL 2020 | KUALA LUMPUR CONVENTION CENTRE

Resolution of Steam Turbine High Vibration Due to Rotor Rub

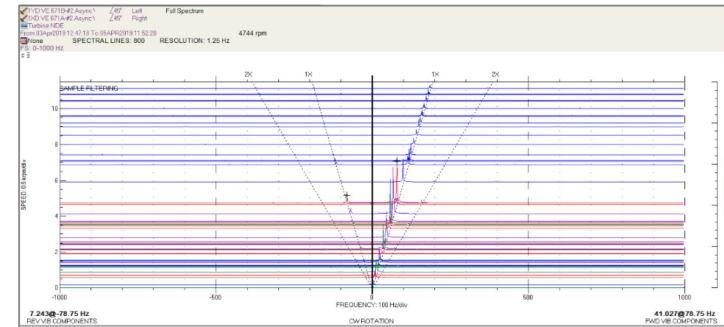
Y: 7.42 μm pp
X: 11.07 μm pp

- High vibration occurred at steam turbine, especially Bearing-1.
- All frequency spectrum indicates sign of dominant 1x vibration.
- Initial suspect: tight internal clearance between labyrinth seals and rotor.

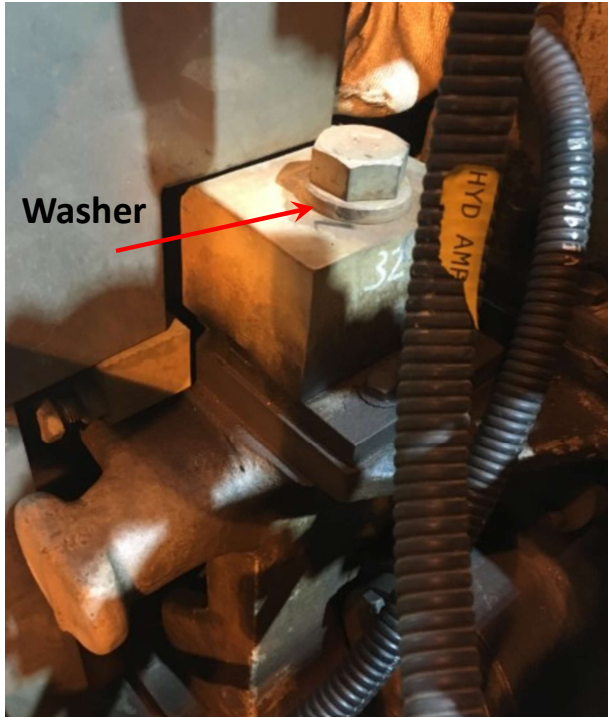
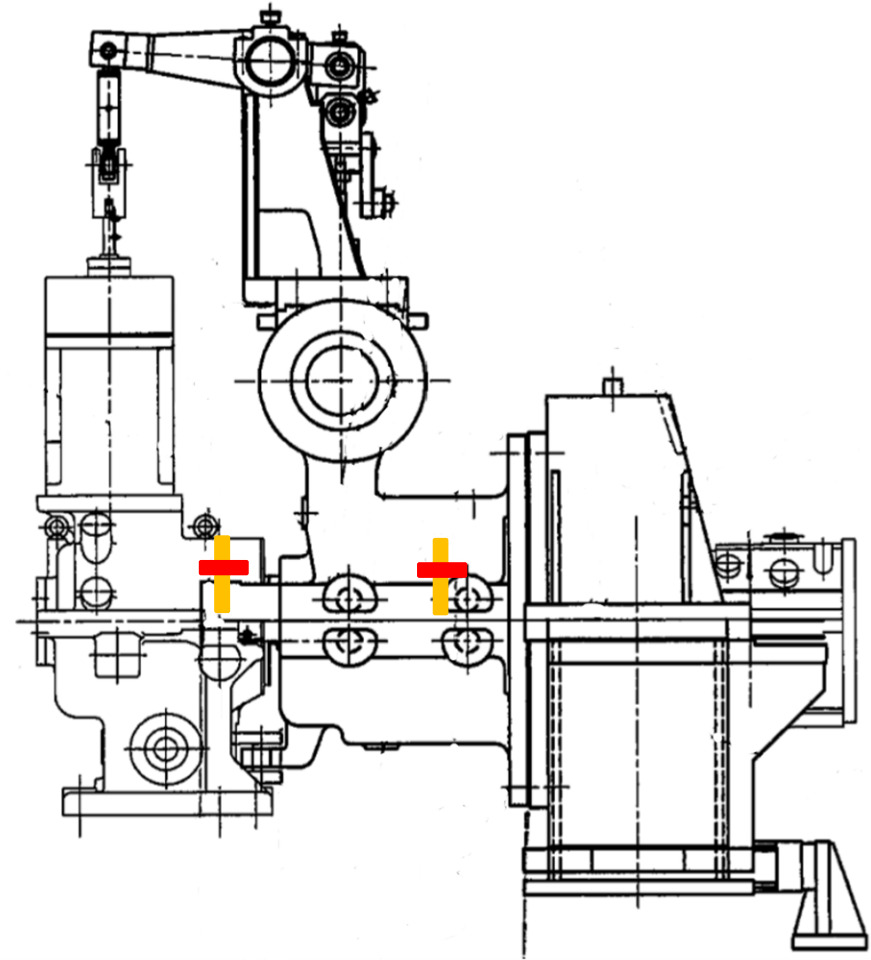
Direct Cause Assessment

During turbine overhaul, the top casing was lifted to extract the rotor assembly for inspection. Most probably the as-found clearance was not checked by OEM rep prior to removal.

One of the hold down bolts at the turbine NDE was found tight.

The issue was resolved by adding shims to the hold down bolts to allow clearance between the bolt and washer and hence allow casing to grow without restraints. The turbine was successfully restarted after the minor modification with very minimum vibration
