ASIA **TURBOMACHINERY** & **PUMP** SYMPOSIUM
APRIL 2020 | KUALA LUMPUR CONVENTION CENTRE

Online Mitigation of Gearbox Bearing High Temperature due to Oil Varnishing

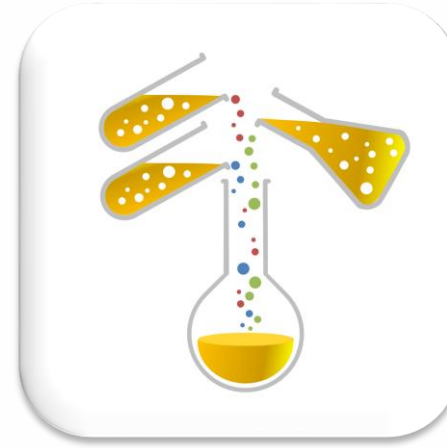
- No change in viscosity and flash point
- More samples for detailed laboratory test.

High MPC >40
(Critical)

Deplete of
ZDDP & Phenols

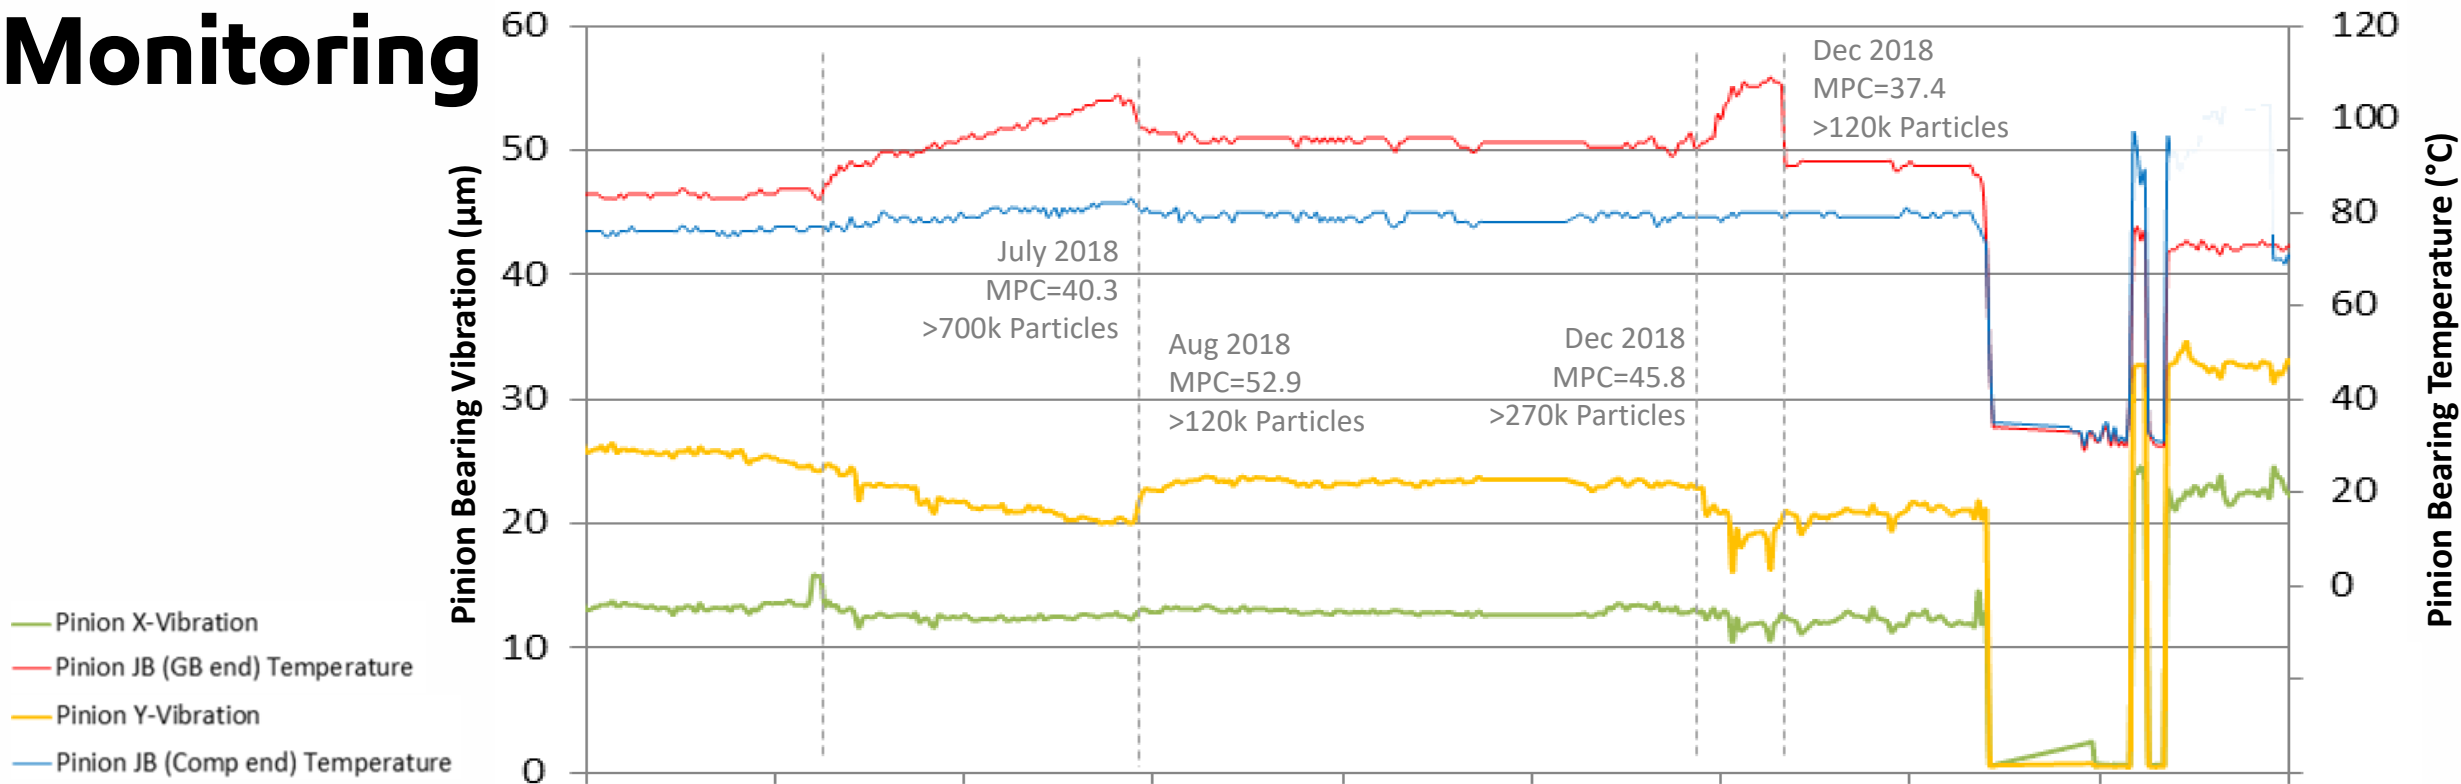
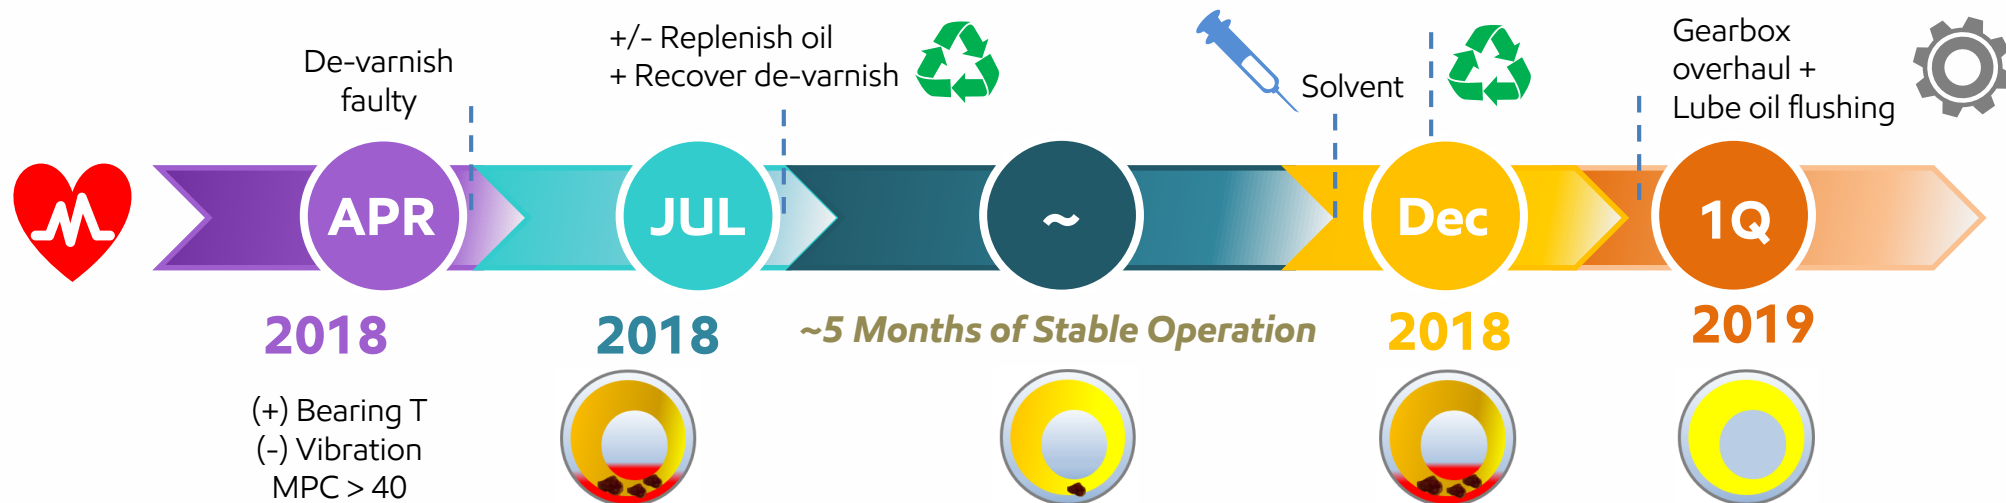
Monitoring

- Recovering of pinion bearing vibration close to normal level
- Reduced in pinion bearing temperature to 92°C
- Particle counts (5 to $15\mu\text{m}$) reduced by $\sim 60\%$
- MPC remained high >40
