Test set-up contribution into a Generator Mounted Epicyclic Gear mechanical running test performance

Authors: Nick Glover, Gaspare Maragioglio

Scope of this Case Study: Highlight the importance of system integration analysis

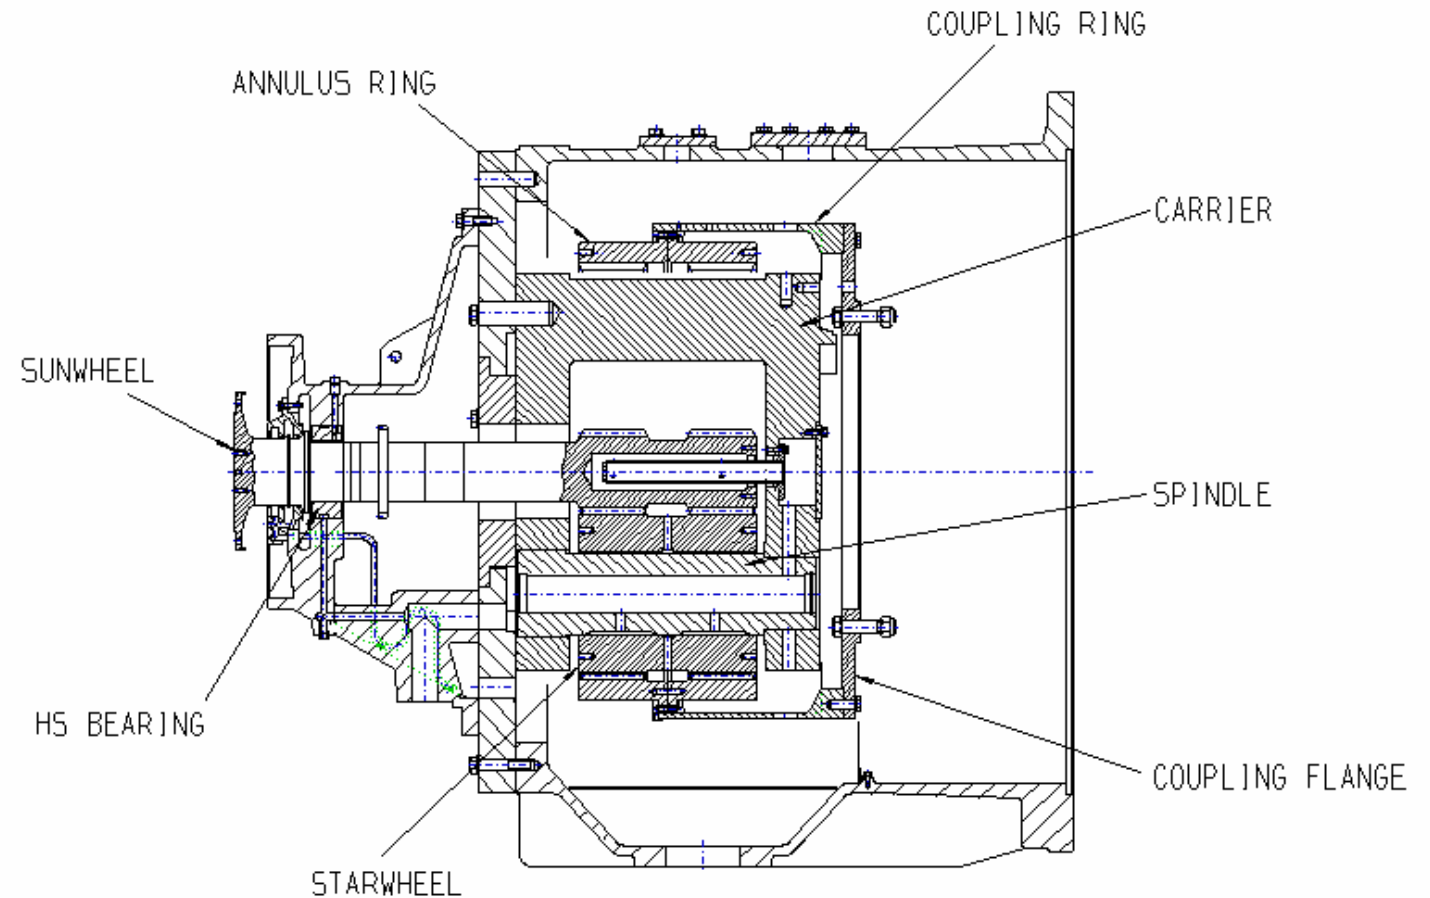
- Rated Power 16600 kW
- Input speed 9514 rpm
- Output speed 1800 rpm
- AGMA SF 1.3
- Driver Gas Turbine
- Driven 60Hz Generator

- Single Bearing Sunwheel
- Star Epicyclic Gear.

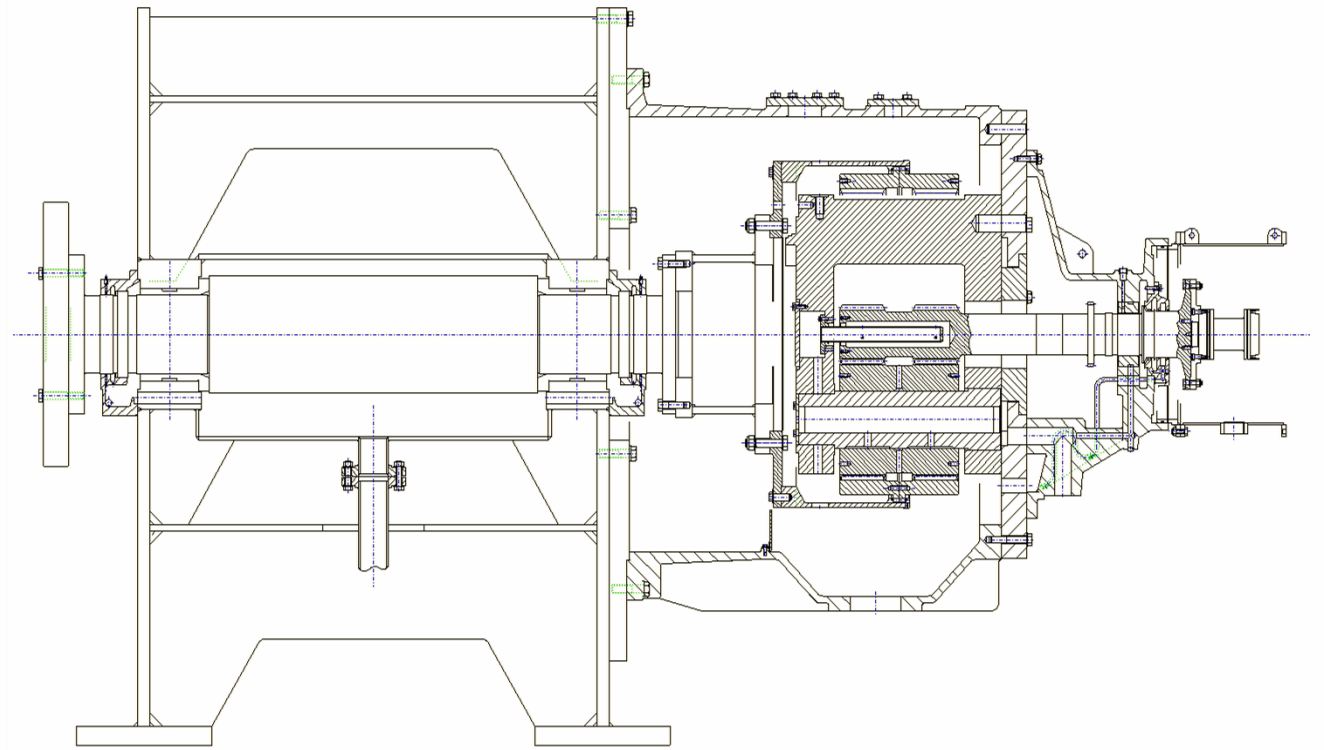
The specific Epicyclic Gearbox is installed overhang on the Generator casing, so the MRT arrangement is such that the gearbox is installed on a dedicated pedestal system, to replicate the package configuration.

The pedestal consists of a casing and a shaft rotating in two journal fluid dynamic bearings. The shaft is bolted directly to the Gear low speed shaft assembly.

The pedestal structure is then bolted to the test bench floor through several foundation bolts.
