# Mitigation of perennial seizure of boiler feed water pumps during commissioning of refinery unit

Mantosh Bhattacharya

## **Problem statement –**

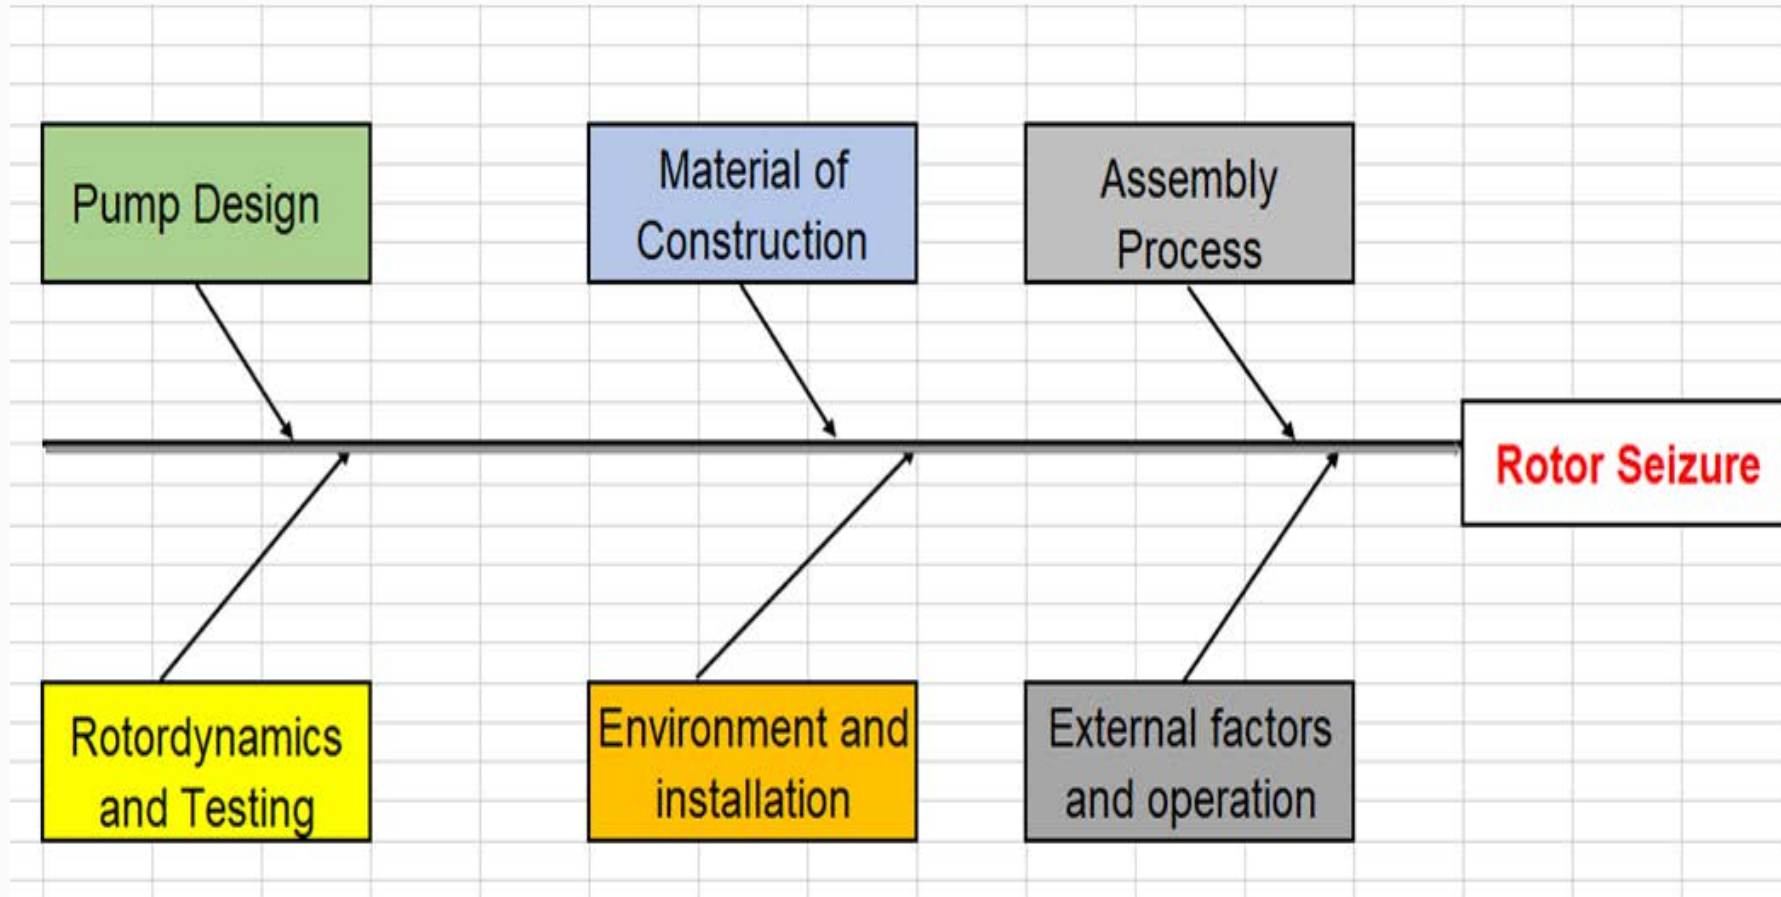
## Root cause Analysis – Fishbone (Ishikawa ) diagram

Several start-up attempts made against a partially jammed pump unit, led to extensive overheating of the rotor, caused mechanical stress in the rotor . This caused lamination damage that resulted in a significant unbalance with the bearing damage.

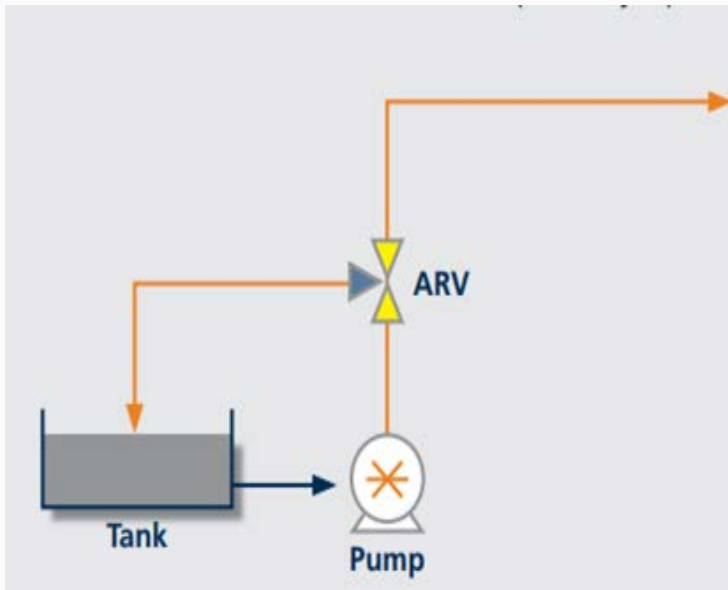
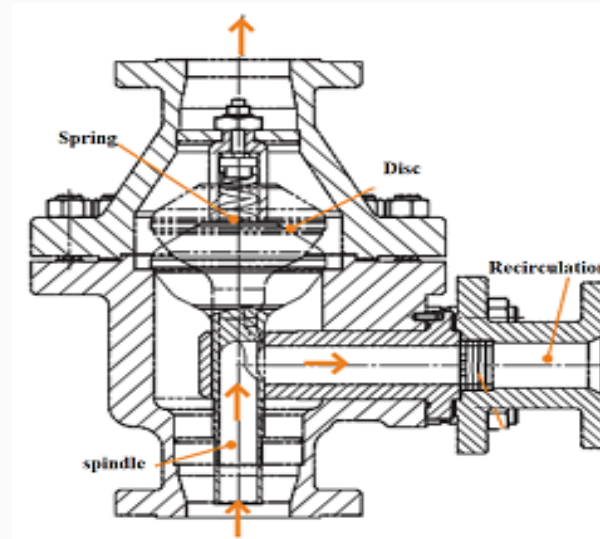
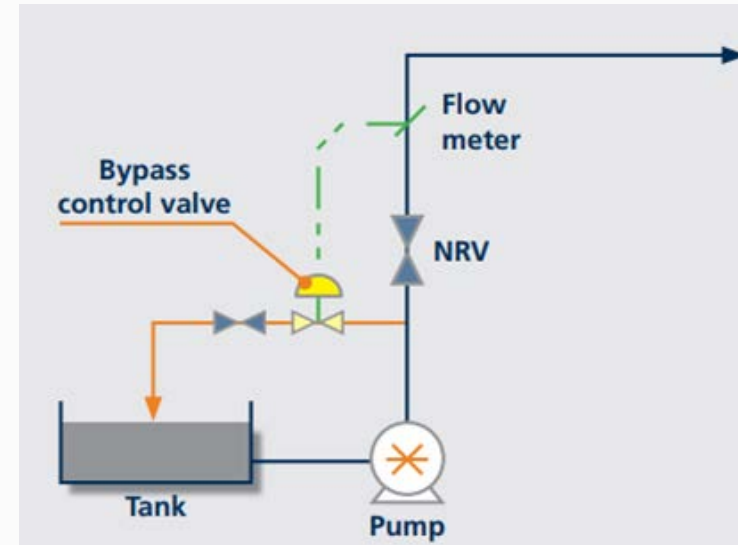
7G.Lack of lubrication at close clearance parts leading to encroachment of clearance parts during start up – It was observed by careful analyzing the trend plots that before pump started to pick up full speed , flow fell down and downfall of flow was continuous and never recovered causing a situation of no flow.

ARV (automatic recirculation valve – Mechanical type ) –(shown below left) is the common application is to protect pumps which handle hot water for boiler feeding where partial evaporation of the water content might cause the pump to run dry. The modification of the on-off recirculation system ( ARV ) is the modulating system (bypass type flow control valve) which was installed in system right from beginning . NRV is the check valve. The bypass control valve was modulating based on flow meter feedback.

Generic Pump loop with ARV , internals of recirculation valve and bypass type flow control valve

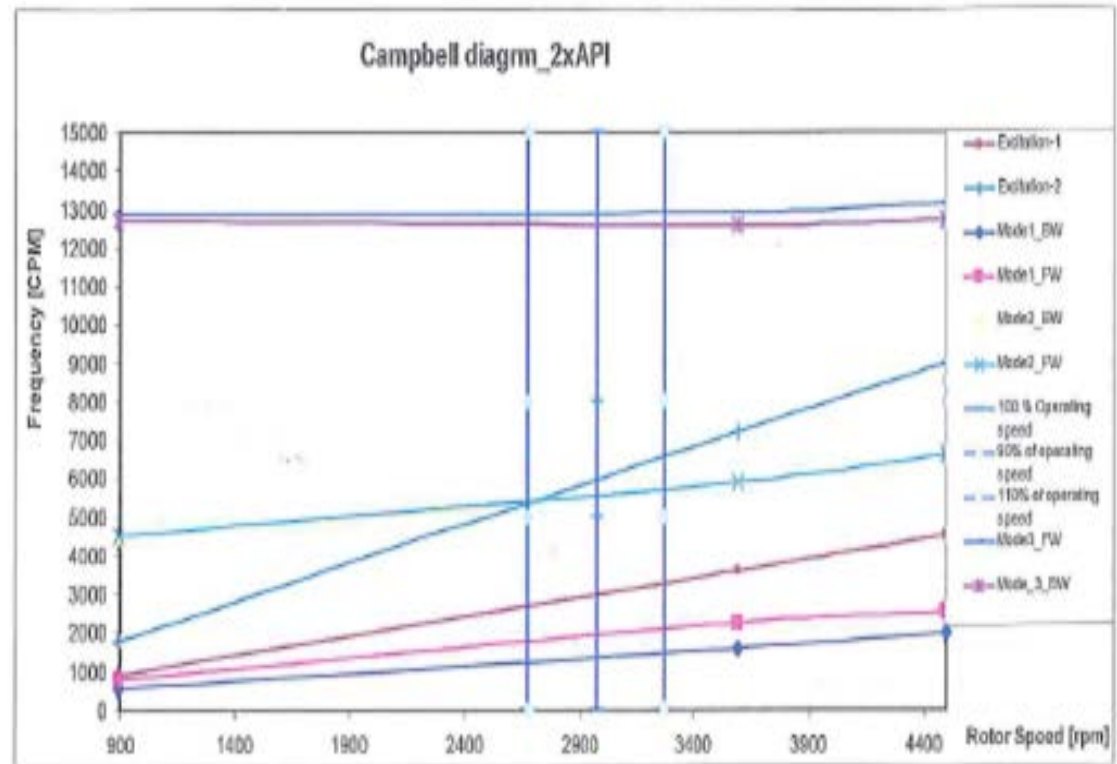
4.4.3 Field condition\_2x new clearance:

Inter-stage location where clearances were increased
