ASIA **TURBOMACHINERY** & **PUMP** SYMPOSIUM
22-26 FEBRUARY 2021 | NOW VIRTUAL!

Inappropriate Operation During Mechanical Running Test of a High-Pressure Compressor Equipped With an Hole Pattern Seal

Yves Bidaut , MAN Energy Solutions Schweiz AG

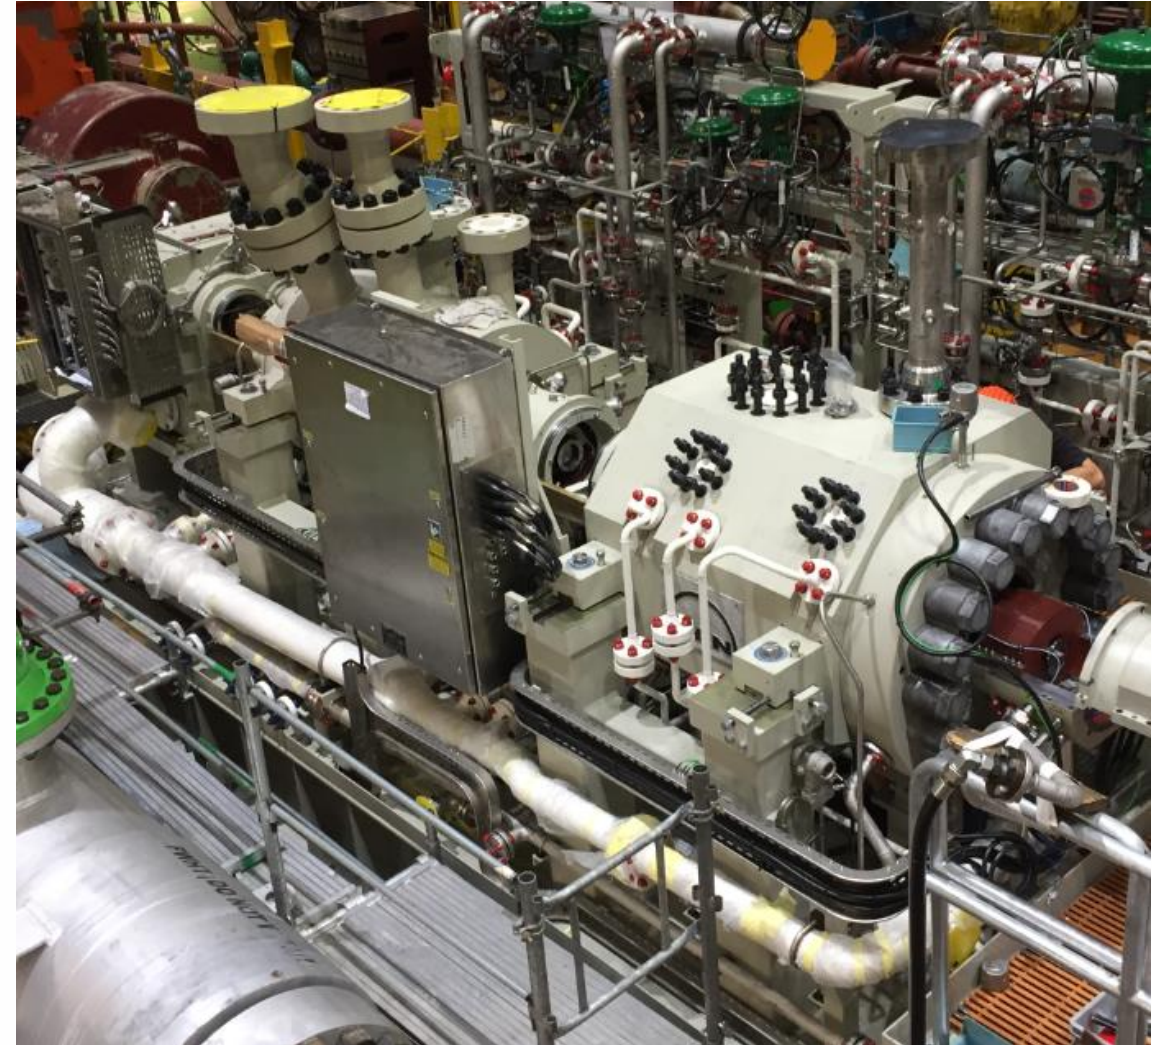
- In house mechanical test in facility test
- Sudden increase of radial vibrations on bearing probes → shut-down
- During shut-down
 - Trip
 - Vibrations up to 100 μm

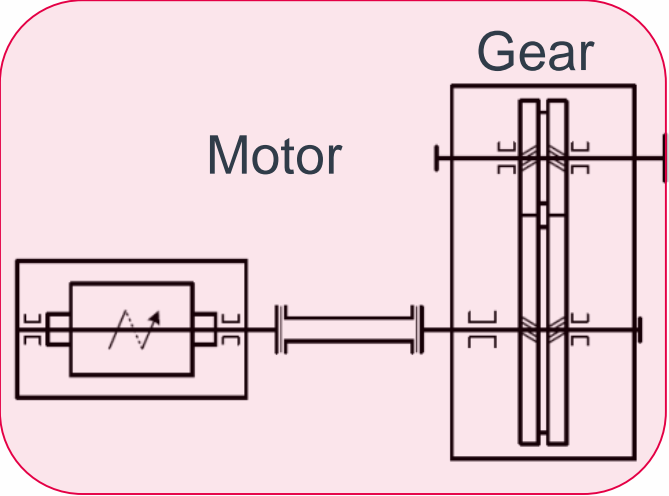
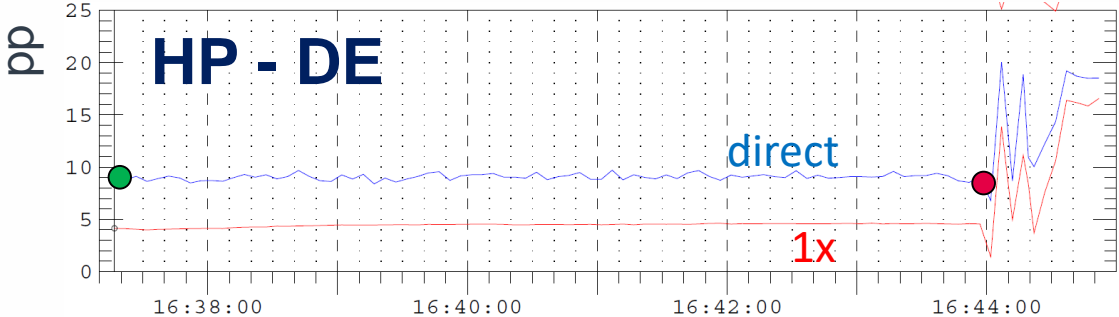
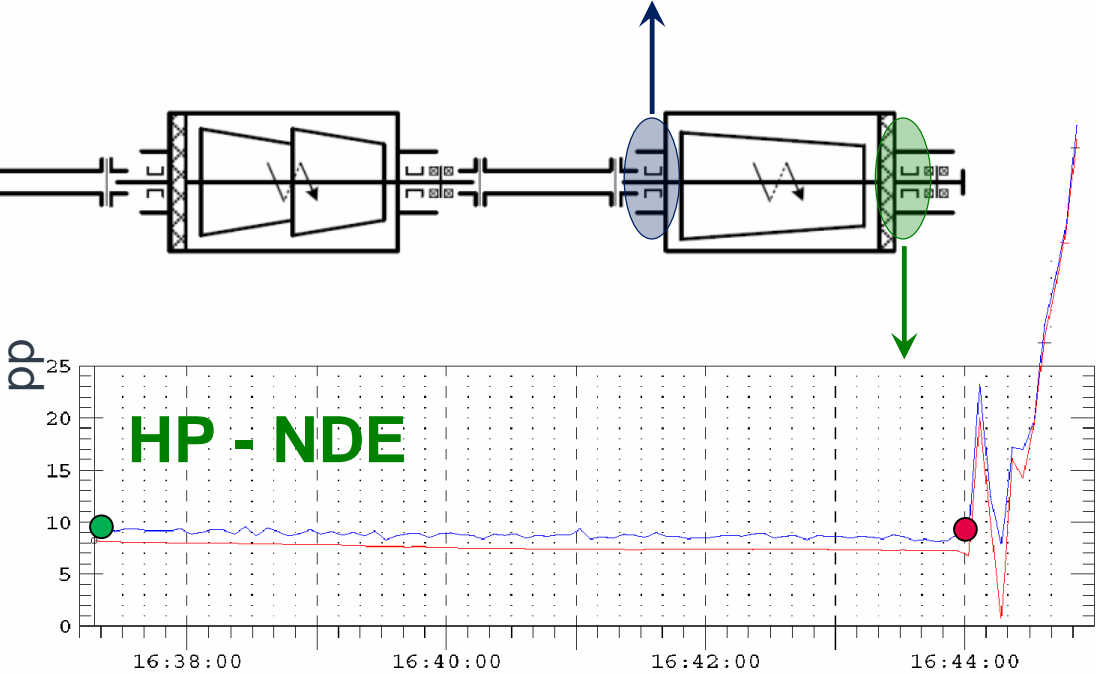
Testbed equipment

→ Sudden increase of vibrations at DE (20 μm) and NDE ($> 100 \mu\text{m}$)

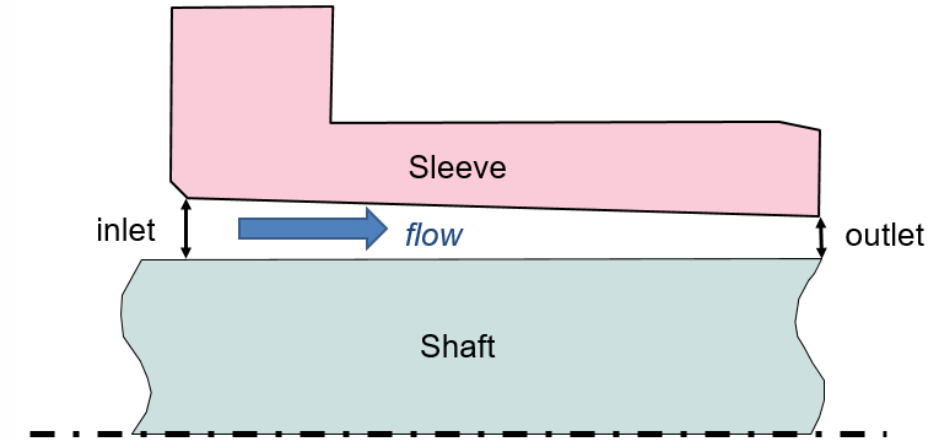
- In order to ensure the rotordynamic stability
 - Clearance of seal must be kept convergent at all operating conditions
 - Convergent conical clearance (inlet larger than exit) already manufactured
- Loads which determine the clearance in operation (considered in the FEA)
 - Pressure (casing, sleeve)
 - Temperature (casing, sleeve)
 - Centrifugal forces (shaft)

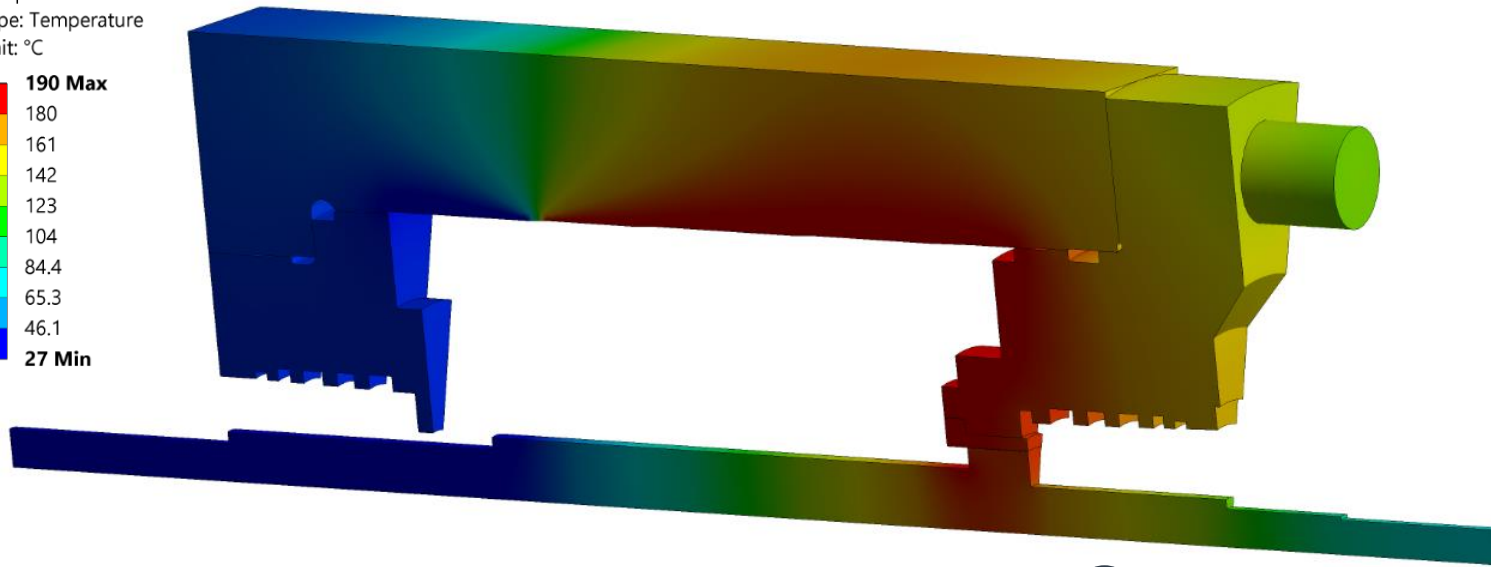
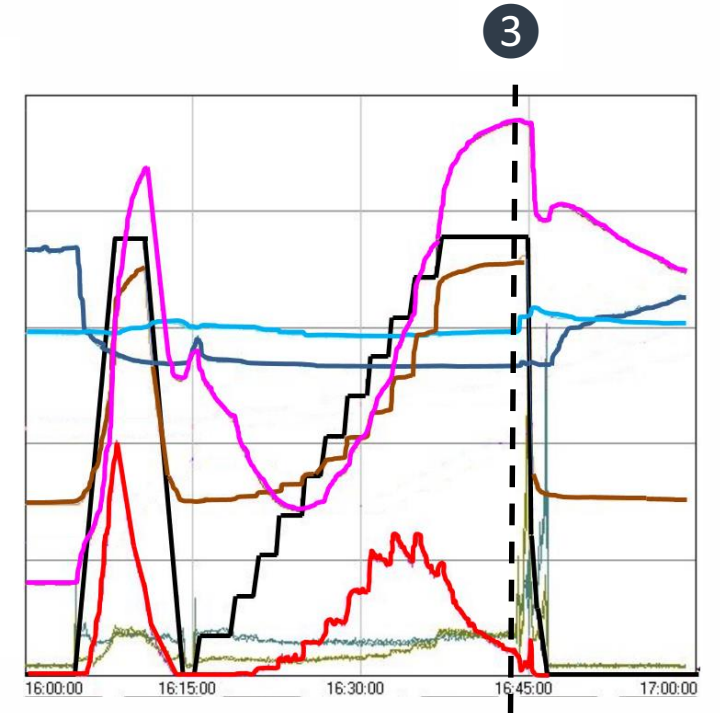
Temperature Distribution at ③

- Boundary Conditions at ③ : $p_{in} = 30 \text{ bar}$, $T_{in} = 27^\circ\text{C}$, $p_{out} = 71 \text{ bar}$, $T_{out} = 190^\circ\text{C}$, $n = 15'090 \text{ rpm}$

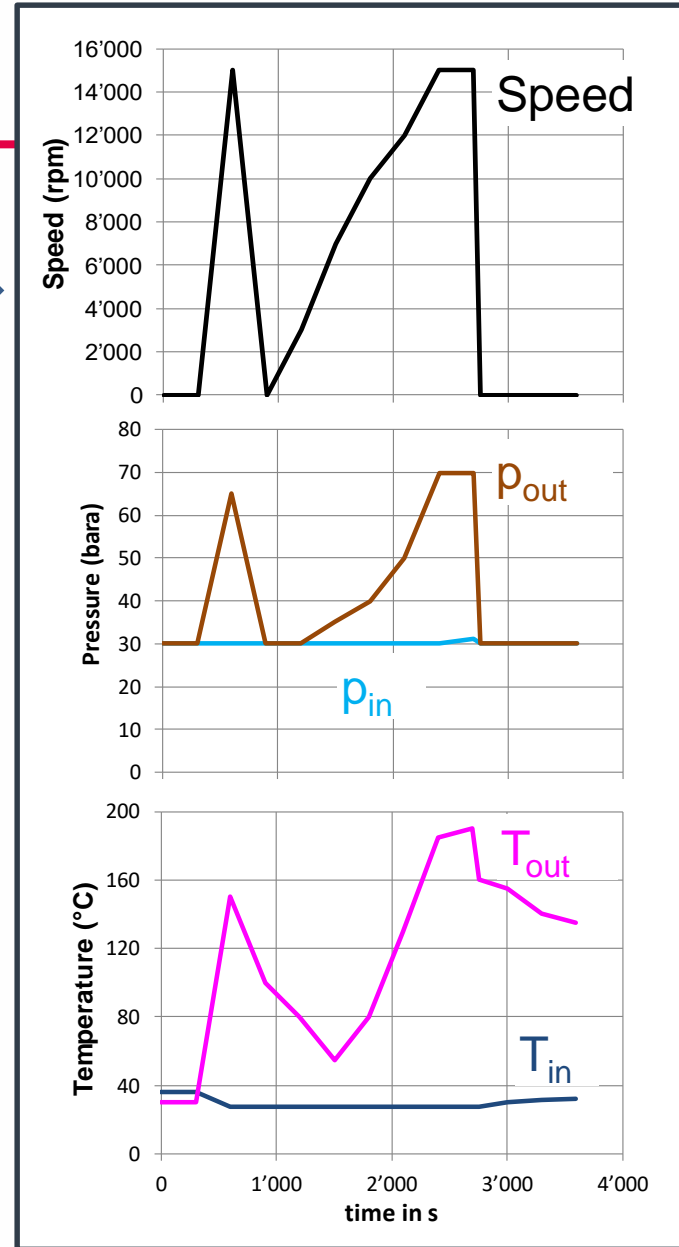
Simulation of operation (16:00 – 16:45 : 2'700 s)

- Hole Pattern Seal and Shaft warm up much quicker than Casing and Cover → High Temperature Difference !
