51ST TURBOMACHINERY & 38TH PUMP SYMPOSIA

Case Study on Coupling Crack on a Centrifugal Pump

Train consists of 5000KW/60HZ (3588 RPM) induction electric motor driving a centrifugal pump through a flexible shim-pack coupling.

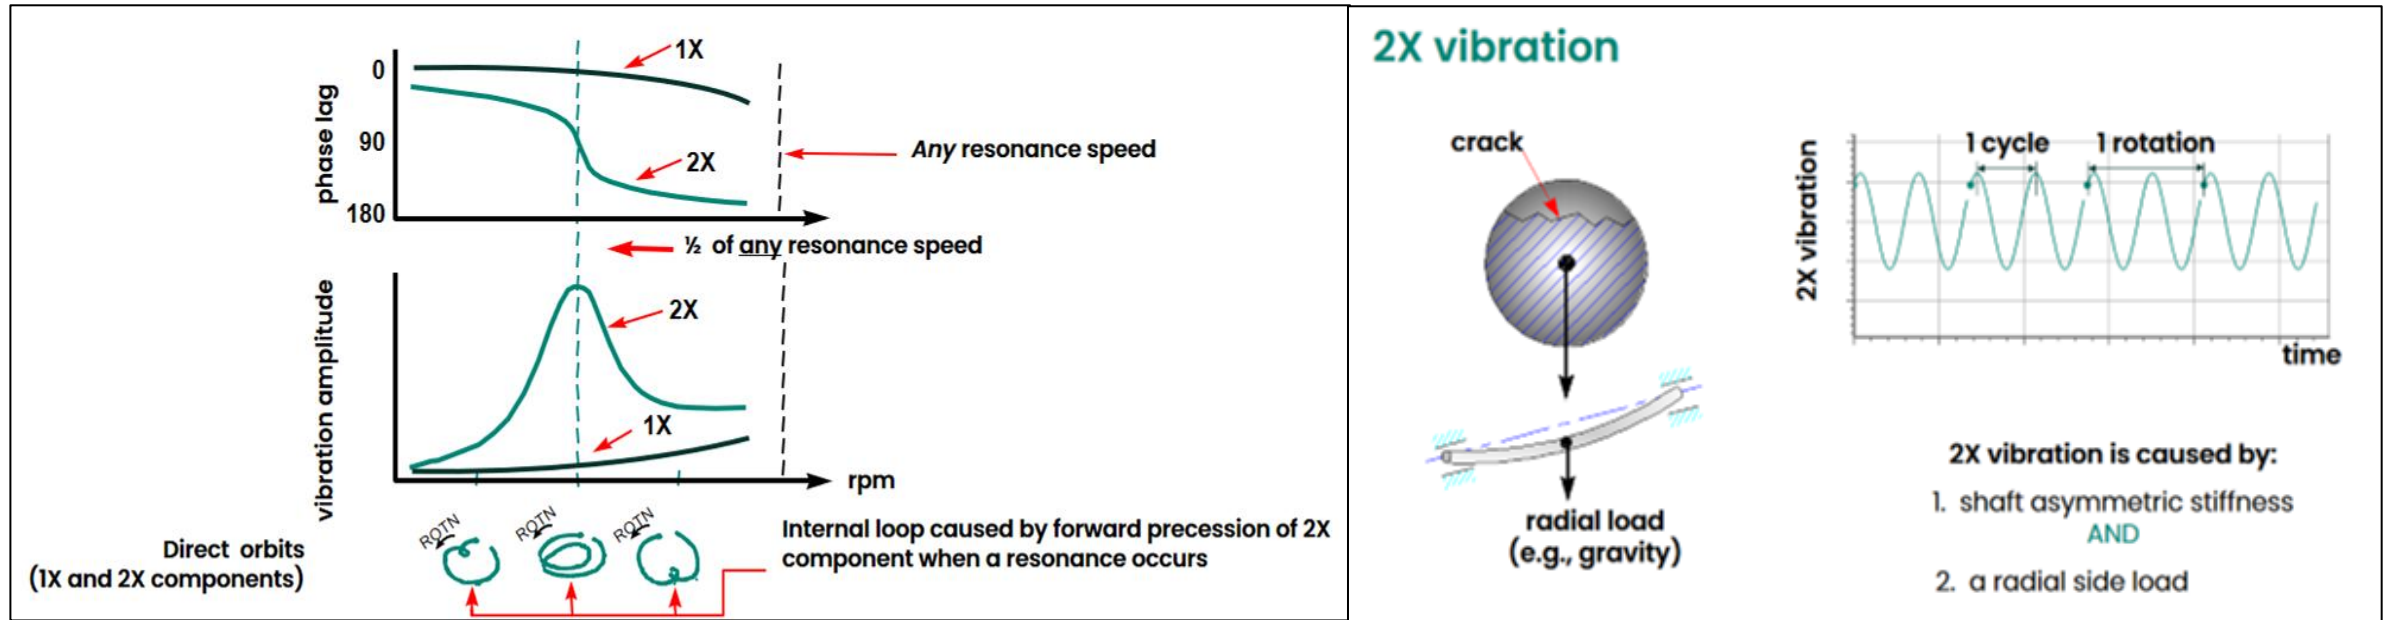
Back to Basics: Shaft Crack Detection Rule

- A rotor system with an asymmetric shaft and a radial side load force, rotating at a speed near half “ $\frac{1}{2}$ ” of any resonant frequency, may experience high 2X vibration amplitude and 2X phase shift.
- Other 2X vibration effects on a cracked shaft will result in a more rapid growth of the crack. This includes increased reversal stresses & low or high cycle fatigue.

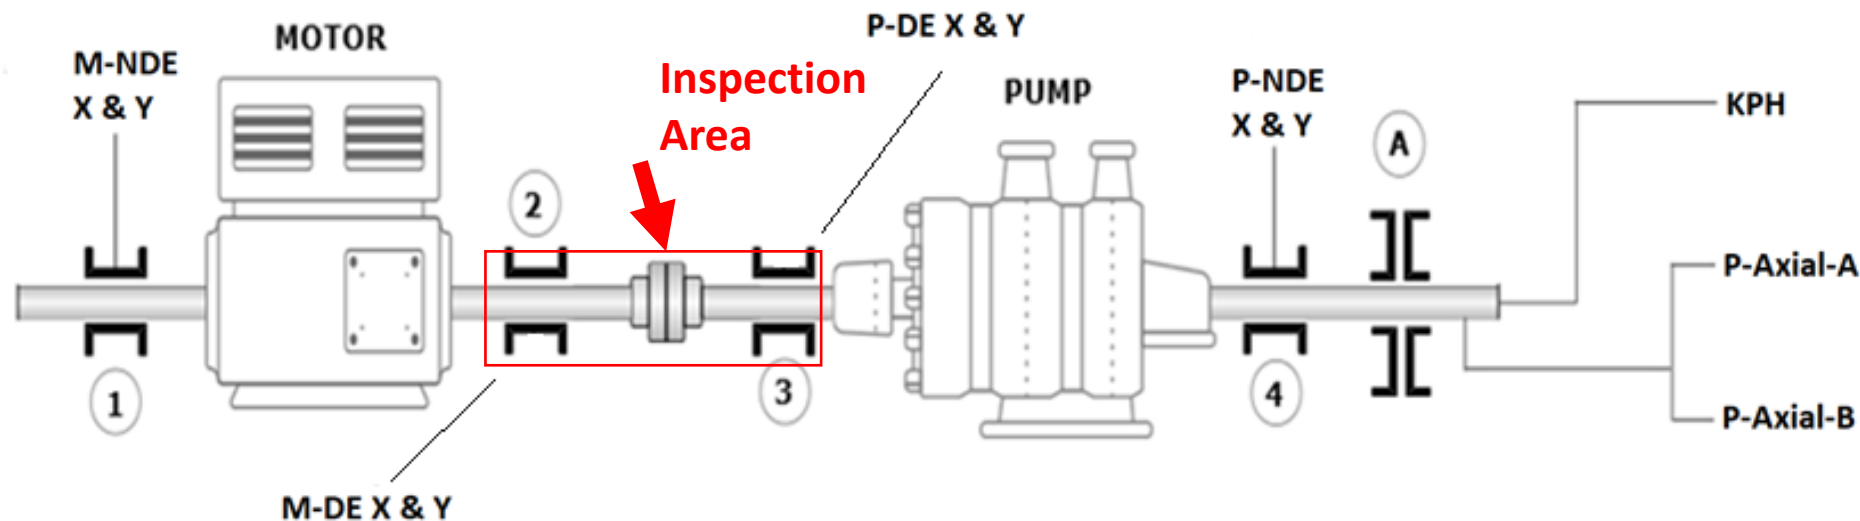
Findings

- ✓ Upon our recommendation, the site team inspected the coupling and found the shims (membrane) are bent and broken, as shown in the photos and inline with what was recommended.

- Historically these units are found in a highly corrosive environment in addition to corrosive foundations (another case from other sister machine) which could lead to this damage.
- The high dynamic forces coming from the motor each startup and frequently due to multiple process upsets could also contribute to experiencing this type of failure. This has been observed historically which also led to multiple pump trip events during startup.
- Minimum flow setpoint for one or two pump operation was found set incorrectly and rectified accordingly.
- Based of the findings above, asset team is working through the list of causes and eliminating them.

- It was concluded that the rotor is experiencing crack symptoms; hence it was recommended to:
 - Inspect the coupling between motor and pump for any sign of coupling shims damage or shaft crack.

- Coupling was replaced and the unit started again with acceptable and normal vibration levels.
