51ST TURBOMACHINERY & 38TH PUMP SYMPOSIA

Reciprocating Compressor Motor Vibration During Initial Start-up

Robert C. Eisenmann, Jr – bp Rotating Systems Advisor
Yasser Nasef – bp Rotating Equipment Engineer – North Africa

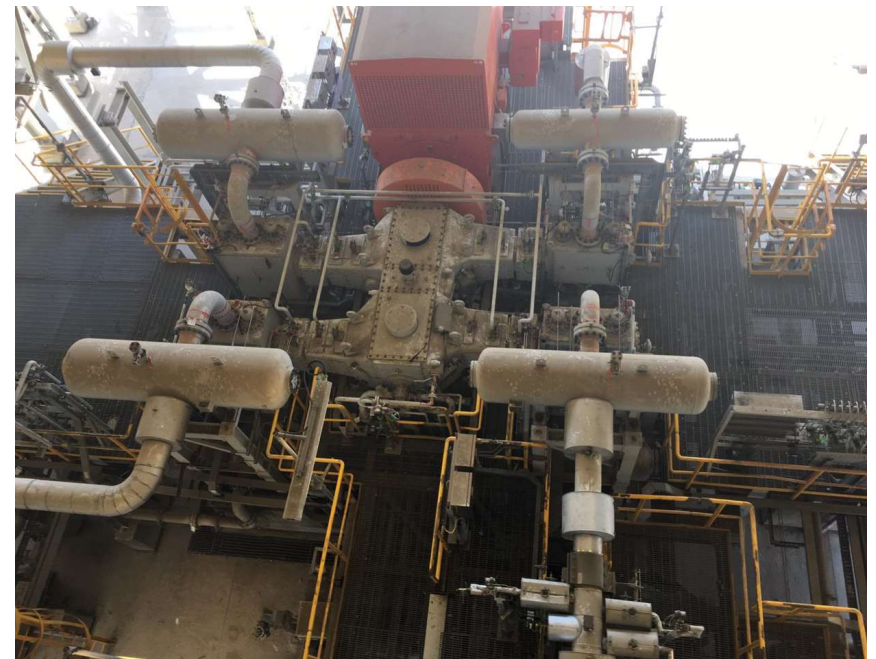
Flash Gas Compressors

- Commissioning of 2 new reciprocating compressors in Flash Gas Service
- 4 Throw/ 3 Stage – 2/1/1
- Motor
 - Induction Motor
 - 425 rpm
 - 1300 kW (1750 Hp)
 - Single Bearing/rigid coupling
- Monitoring and Protection System Aligned with API 670 5th Edition Annex P
 - Including X/Y displacement probes on motor bearing
