School Conditions Will Continue to Earn Failing Grades

ABSTRACT

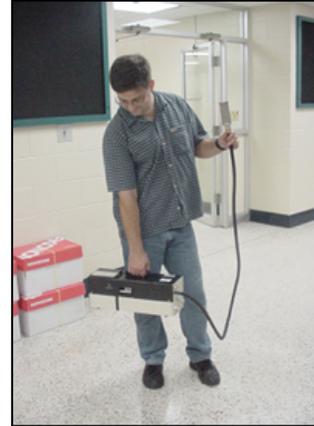
Figure 4. Tracer Gas Ventilation Rate Testing at a Florida School

- zone pressure mapping (measuring pressure differences between different areas in the school and between the school building and outdoors)
- a blower door building airtightness test
- tracer gas decay ventilation rate test (designed to test how much outside air is brought into the building under normal operating conditions)
- sampling and monitoring of indoor conditions (typically including temperature, relative humidity and CO₂ measurements).

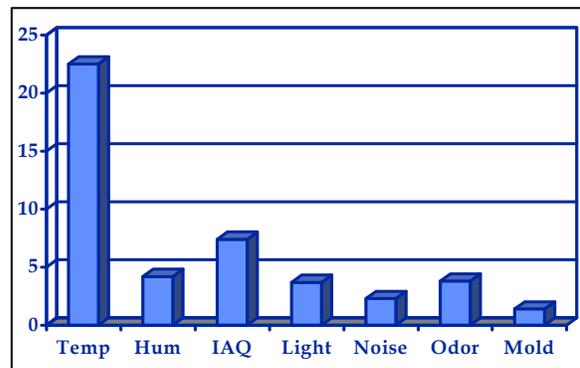
Figure 5. Chronic Complaints by Category

At 22.5% of respondents, temperature was by far the greatest cause of chronic complaints, followed by IAQ, humidity and odors (see Figure 5 – top of the next page). Only 1.4% of respondents reported chronic mold problems, while 68.7% reported no mold problems. Conversely, only 2% of respondents reported no temperature problems at their school. Twenty-nine percent (29%) of respondents thought most or all the classroom temperature complaints were likely caused by not having enough thermostats or zones, while 37% % thought none of the temperature complaints were due to those factors.
