Estimation the performance of solar fiber optic lighting system after repairing the glass Fiber Cables in a South Korean Residential Building

Kwang-Seok Cha
 Renewable Team Leader
 Hyundai Engineering and
 Construction, Ltd.
 Seoul, South Korea

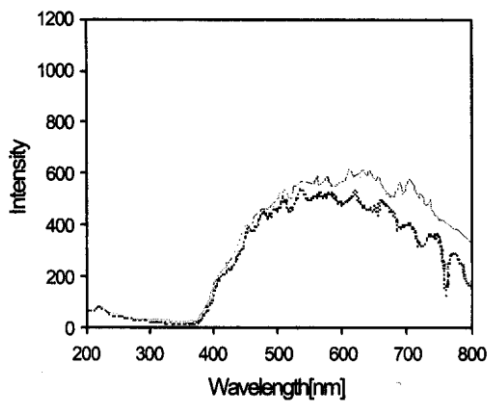
Fig. 15 Results of spectrum analysis

Fig. 15 is a before and after graph of the wavelength distribution of the light emitted. The dark line on the graph indicates the wavelength following the repair. Initially, the wavelength shows a spectrum ranging from white to red. The visible rays are subdivided, according to wavelength, into red (750-620nm), orange (620-585nm), yellow (585-575nm), green (575-

500nm), blue (500-445nm), dark blue (445-425nm), and violet (425-390nm). We find that light from the emission point falls mainly within the red spectrum; this is due to an improper focal distance at the concentration part. Fig. 16 displays, for one particular apartment, the distribution of luminous intensity from mid-morning to mid-afternoon. The left axis indicates the indoor luminous intensity while the right axis indicates that for outdoors.

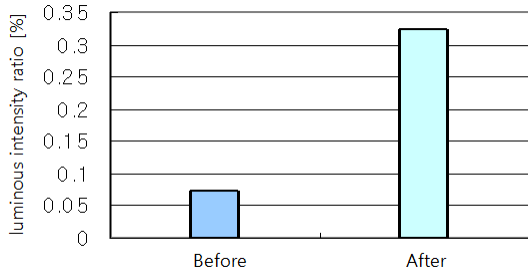
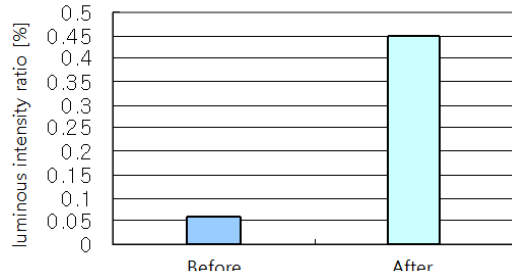
Fig. 17 Comparisons of luminous intensity ratio in winter season

shifted from red to white. Fig. 17 shows that the luminous intensity ratio before the repairs was between 0.06 and 0.07%; after repairs the value rose to between 0.323 and 0.447%. This is to say, the luminous intensity ratio increased at least seven-fold.

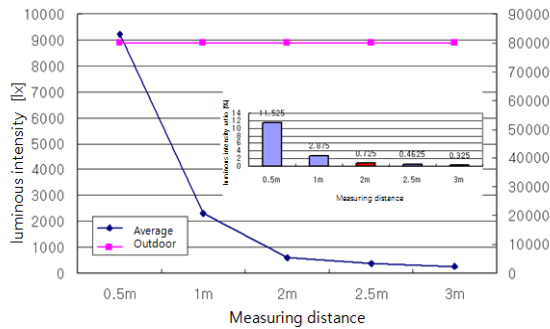
Fig. 18 Average luminous intensity guideline when outdoor luminous intensity is 80000lx

After repairs were made, the measured value of luminous intensity ratio, at 3 meters from the light source, fell short of the recommended guideline of 0.725%. The repairs, however, enabled a 55% increase in luminous intensity. By adjusting the sun-tracking apparatus

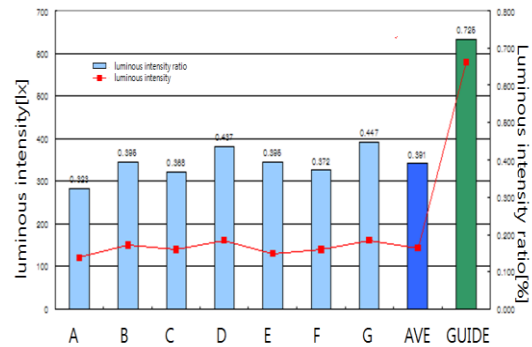
Fig. 19 Comparisons of luminous intensity ratio at sample house in winter season

the focal point on the cable terminal was 96% more accurate. Fig. 19 shows the average luminous intensity ratio of all rooms that were measured; the average of which was 0.391% compared to the recommended guideline of 0.725%.
