ASIA TURBOMACHINERY & PUMP SYMPOSIUM
SINGAPORE | 22 - 25 FEBRUARY 2016
M A R I N A B A Y S A N D S

2 Case Studies on Unique Machinery Repair Techniques:

- Brush Plating Repair of Eroded Compressor Diaphragm
- Combining 2 Failed Gearboxes into 1 Functional and Reliable Gearbox

ExxonMobil Exploration and Production Malaysia Inc.

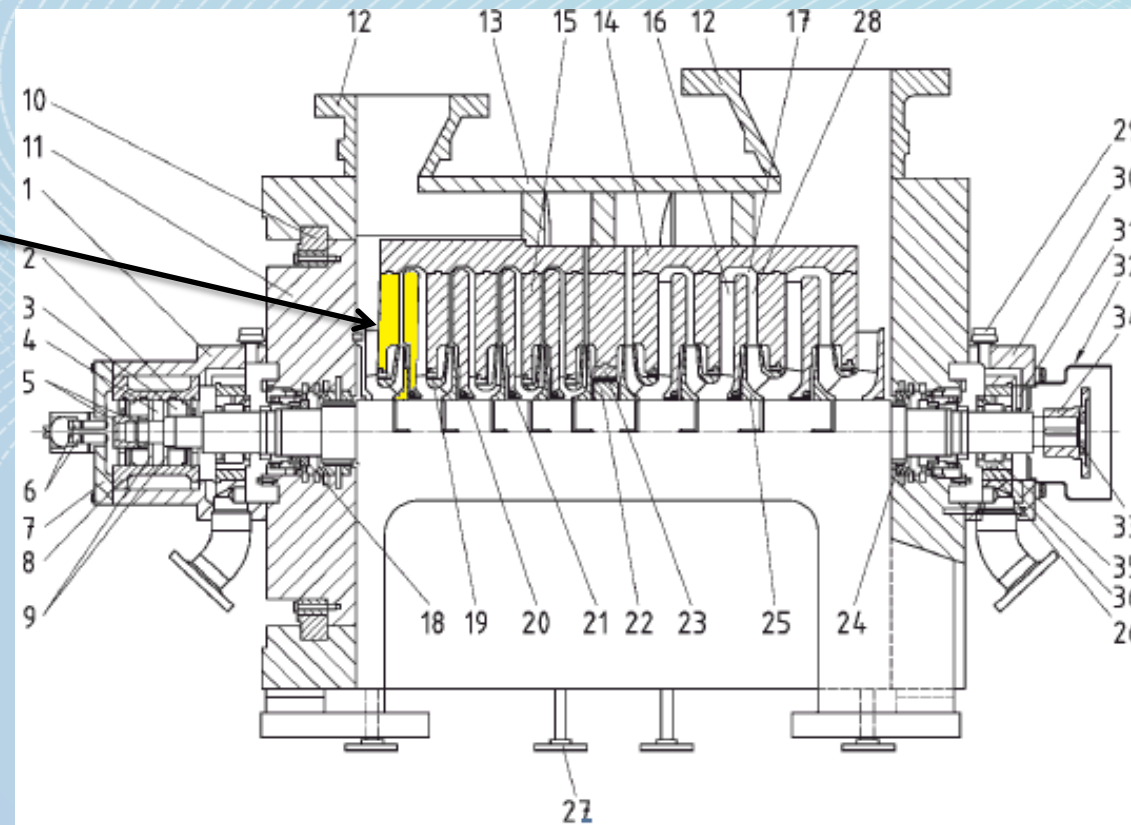
Compressor Assembly Cross Section

*Inlet
Diaphragm
highlighted
in yellow*

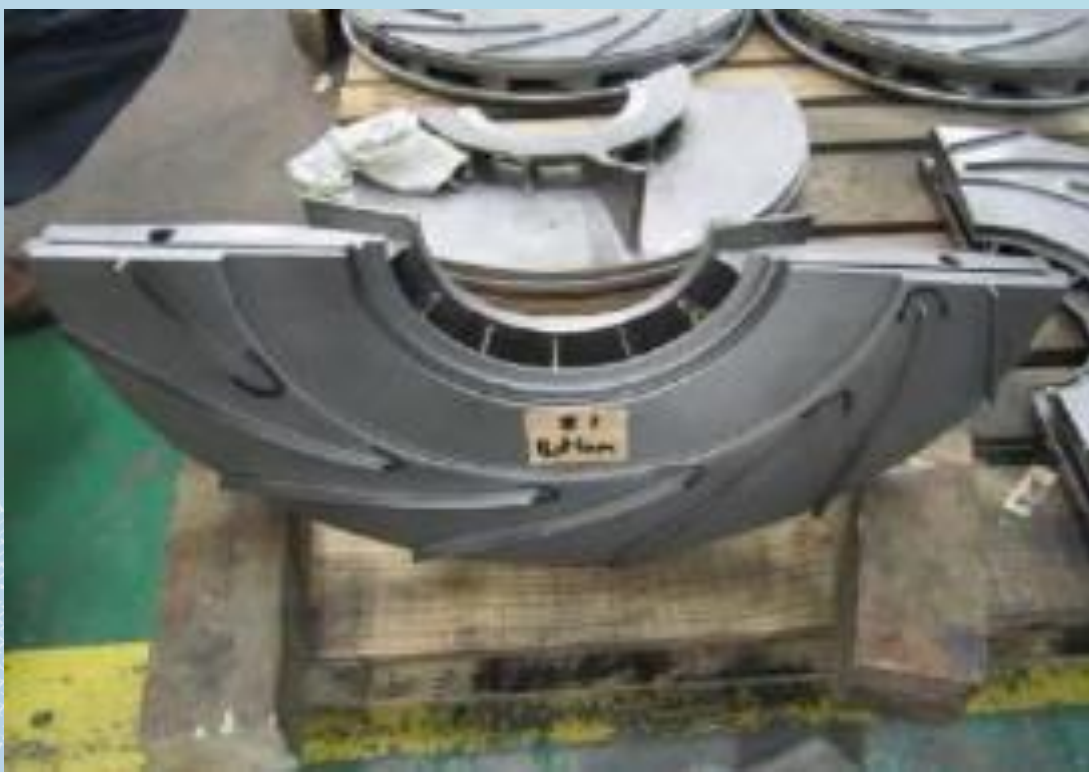
HP Inlet Diaphragm (bottom)

- A compressor train removed for overhaul in June 2011 due to loss of compressor efficiency
- HP inlet diaphragm vanes found eroded (70% material loss) due to liquid carryover
- >6 months of lead delivery time for new diaphragm

- Able to perform electroplating repair at localized damaged areas (eg. diaphragm vanes)
- Faster lead time (repair completed in approximately 6 weeks)
- Repair conducted at regional one-stop comprehensive engineering service provider shop

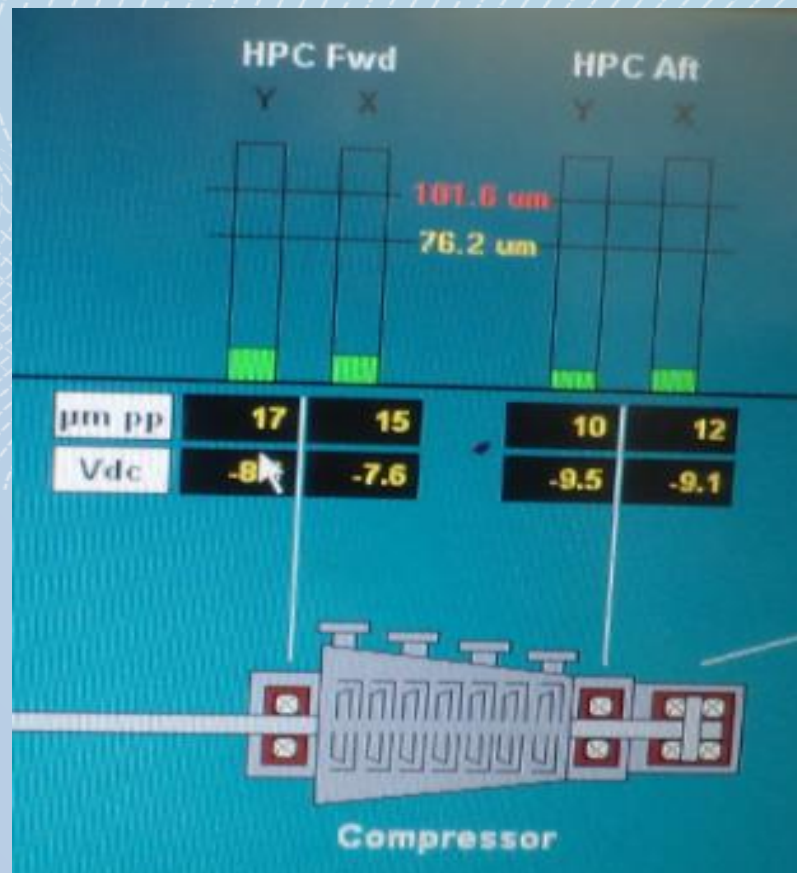
Screenshot of TCP HMI for compressor vibration channels

- Concerns that nickel copper plating may debond under normal operating conditions (high pressure + temperature)
- Potential to obstruct flow which may affect compressor efficiency or worst case subjected as FOD which may result in elevated vibration and potential premature compressor overhaul
- Consistent monitoring of compressor vibration channels trending for early signs of bonding failure
- Temporary solution until new diaphragms arrived

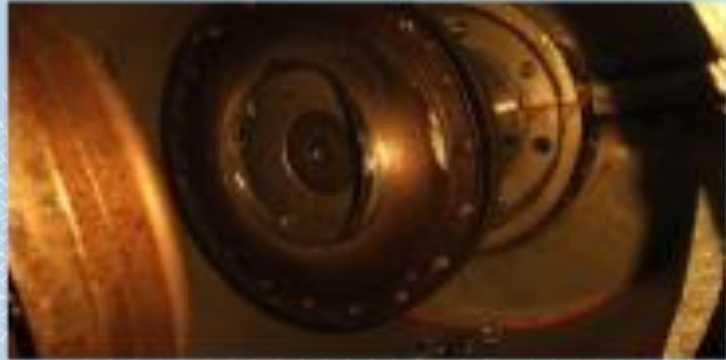
View inside the cover

Location of debris

Location of August 15 MB Coupling Failure

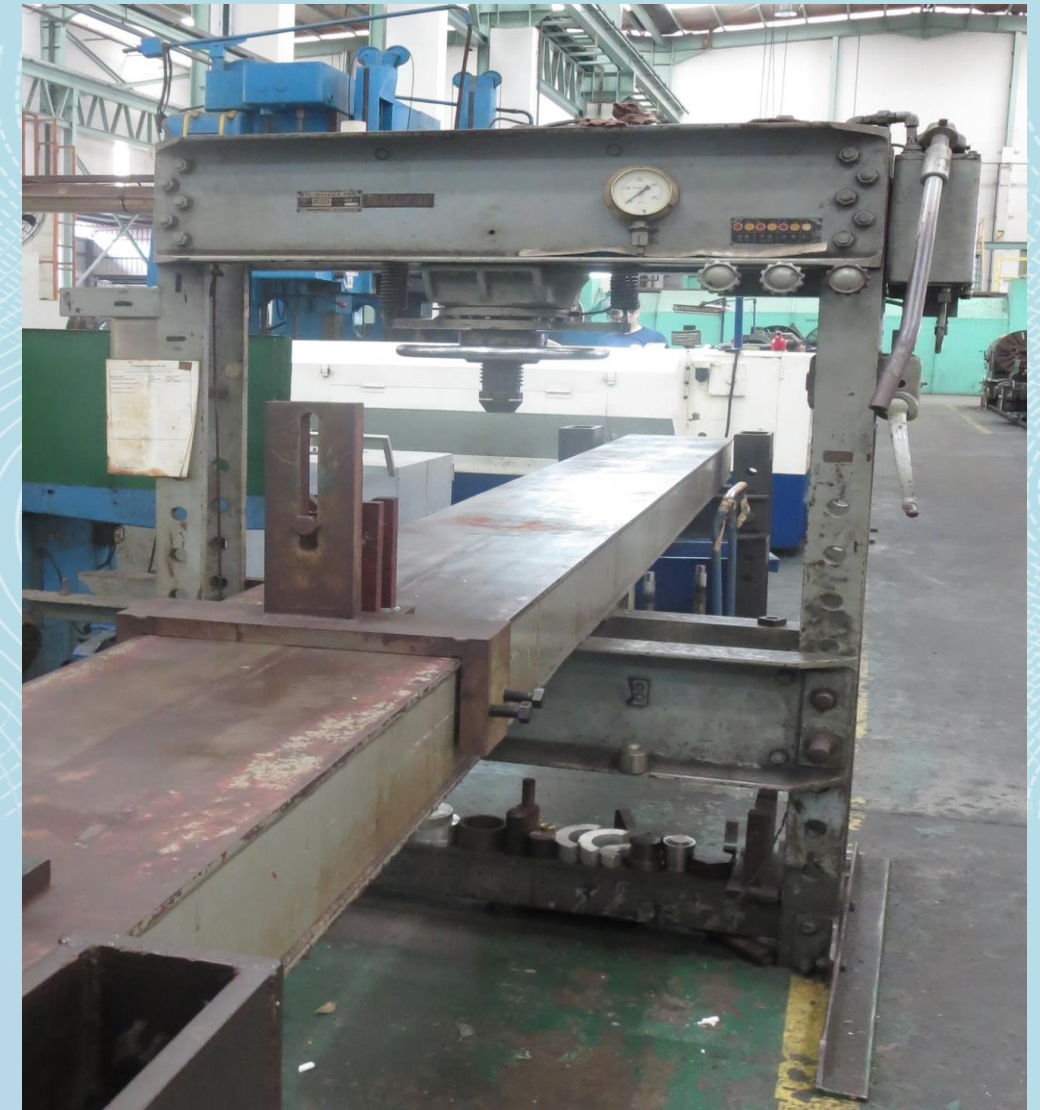
60 Ton Hydraulic Press

- Workshop run-out readings were almost identical to those at site (TIR approximately 0.2 mm)
- Balancing checks verified tapered shaft eccentricity
- Magnetic Particle Imaging (MPI) and Ultrasonic testing (UT) demonstrated no subsurface cracks or defects
- Rockwell Hardness to confirm material identity and yield stress
- **ASSESSMENT:** Rotor damage was confined to eccentricity thus repair options could be pursued

1. Hydraulic press to correct gross eccentricity
2. Surface grinding of shaft taper to restore 1:20 taper profile to coupling hub area
3. Full inspection to confirm no damage sustained in Steps 1 & 2
