EQPETGVG'O CUQPT['Y CNN'TGVTQH'U UVGO UHQ'T'DNCUV'RTQVGEVKP "

A Dissertation

CAROL FC[G JOHNSON

Major Subject: Civil Engineering

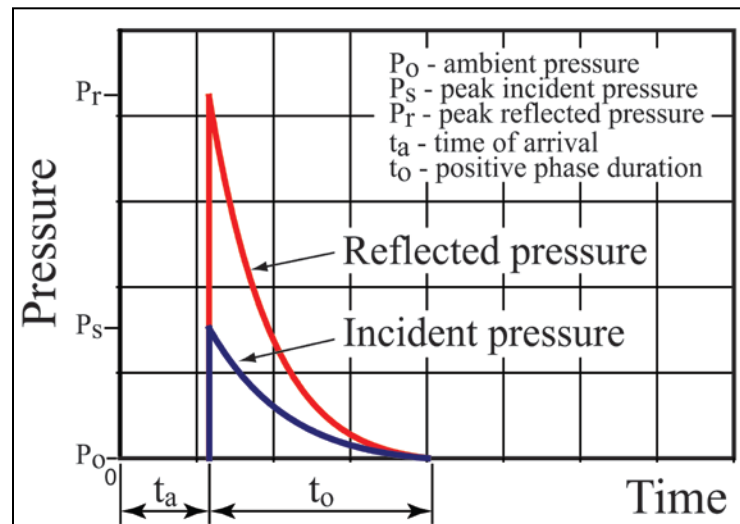
Figure 1.1. Blast loading. (Johnson, DiPaolo, and Woodson 2011)

Explosions produce a shock wave or high-pressure front that propagates outward from the “point” of detonation. The length of time that it takes for the shock front to propagate to a specific point of interest is defined as the time of arrival, t_a . The shock front depicts an almost instantaneous rise in pressure (Figure 1.1). The peak incident pressure, P_s , is at the end of this initial phase. The

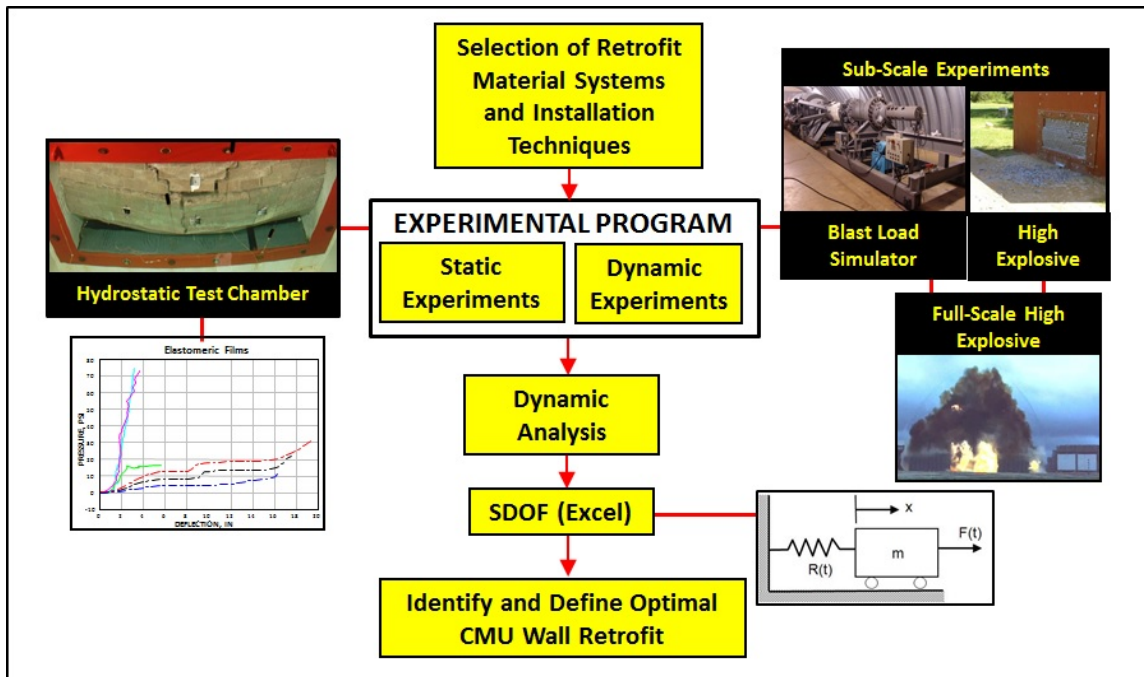
Figure 2.3. Research plan.

The plan used to achieve the two research objectives is illustrated in Figure 2.3. The retrofit material systems and installation techniques for evaluation as retrofit systems for unreinforced CMU infill walls were selected first. The systems were evaluated in an experimental program divided into two parts. Part 1 consisted of a series of subscale static experiments to characterize the material properties and application techniques. Part 2 consisted of a set of subscale and full-scale dynamic experiments used to evaluate the retrofitted CMU walls' response to blast loads. Once the experimental program was completed, the dynamic analysis of the CMU walls began. An SDOF model developed in Excel was used to predict the mid-span deflection of the retrofitted CMU walls under blast load. The resistance functions created from the static experiments conducted in Part 1 of the experimental program were used in the dynamic analysis. The resistance

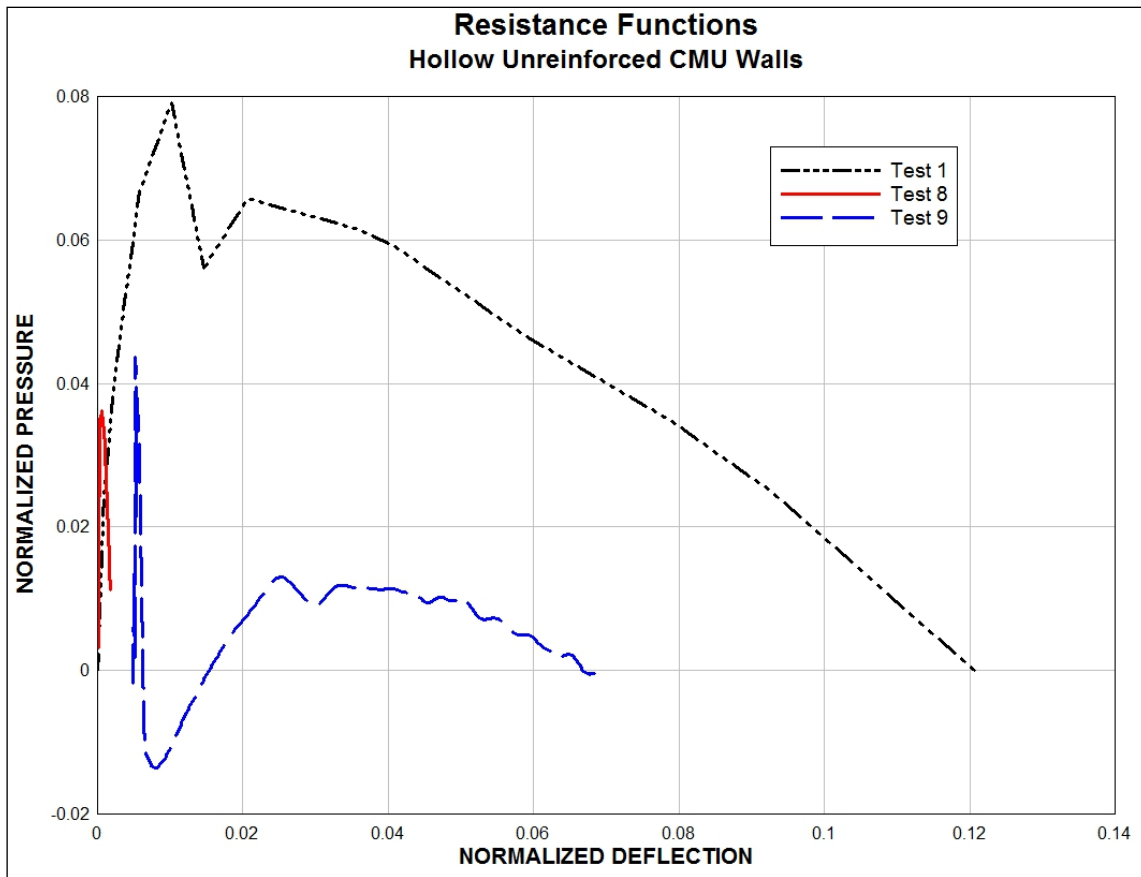
Figure 3.2. Resistance functions for hollow and unreinforced CMU walls.

Three hollow and unreinforced CMU walls were evaluated in the Hydrostatic Test Chamber (HTC). The corners on the first CMU wall evaluated in the chamber became bound in the top corners, and the high resistance observed in the data is considered to be unrealistic. The diagonal cracking observed in the photos also indicated that the wall was unable to deform freely (Figure 3.1a). The CMU wall in Test 8 failed one course above the midline at approximately 0.0396 (Figure 3.1b). In Test 9, the CMU wall cracked below the top 1/4 span, and the bottom section of the wall fell into the chamber (Figure 3.1c). The resistance functions created from the original pressure and deflection data for each of the experiments were normalized and are provided in Figure 3.2.

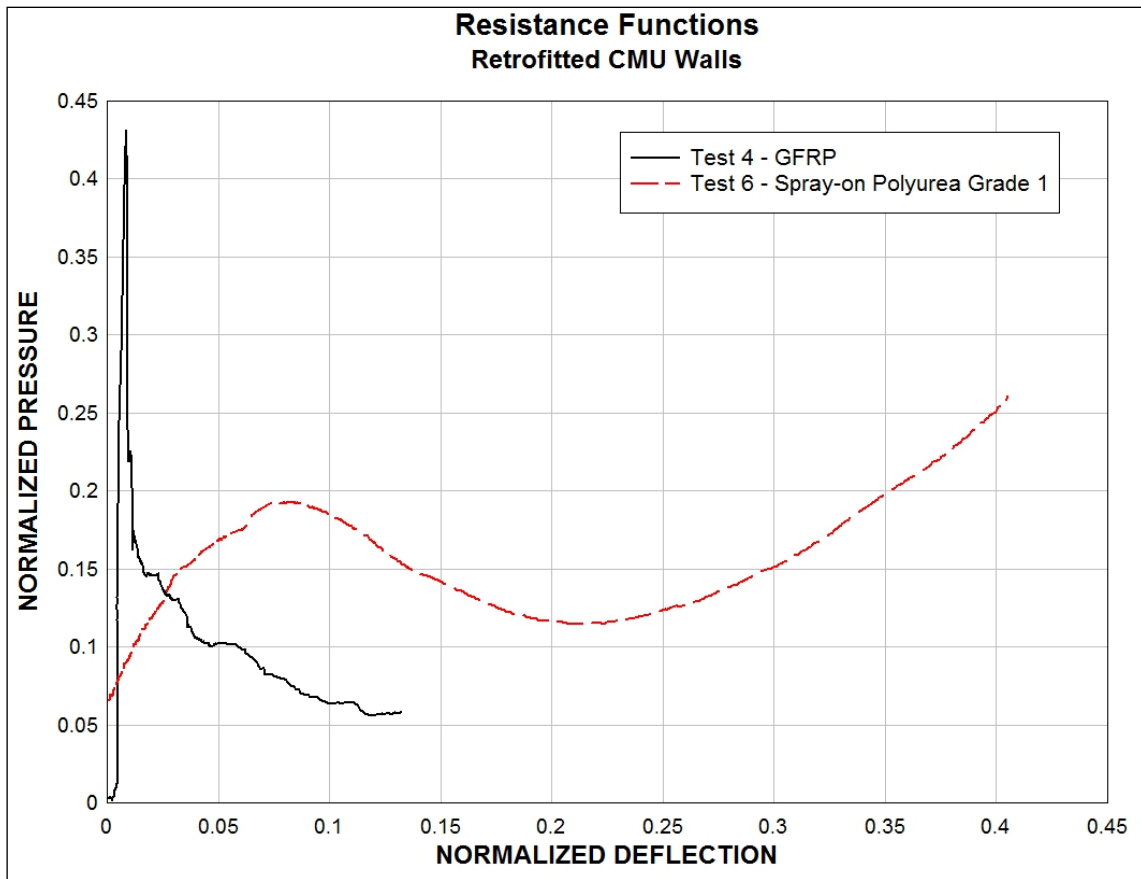
Figure 3.4. Resistance functions for the retrofitted CMU walls.

The hollow unreinforced CMU wall retrofitted with the GFRP (Test 4) failed when the material that overlapped the top support peeled off (Figure 3.3b). The resistance function created from the original pressure and deflection data was normalized and provided in Figure 3.4. The ultimate flexural resistance of the CMU wall occurred at a deflection of 0.0086 and a pressure of 0.426 (Figure 3.4).

The hollow and unreinforced CMU wall retrofitted with the spray-on polyurea (Test 6) failed when the 2-in. overlap peeled off the top support (Figures 3.5a and b). The ultimate flexural resistance of the CMU wall occurred at a deflection of 0.0776 and a pressure of 0.193 (Figure 3.4). The ultimate tensile membrane resistance of the retrofit system occurred at a deflection of 0.405 and pressure of 0.263.

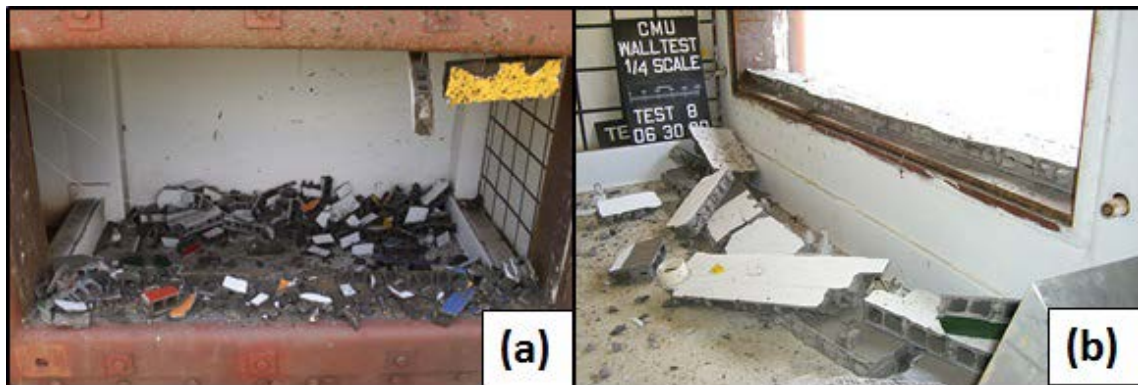
Figure 3.7. Unreinforced, hollow, unretrofitted CMU walls. (a) Test 3. (b) Test 8.

destroyed, and the debris entered the structure at a normalized velocity of 1. Marks scattered across the back wall indicated that the debris impacted the wall along the centerline. In Test 3, the CMU debris impacted the rear wall of the structure at a velocity of 0.577. The largest pieces of debris were two to four blocks wide, and the majority of the debris was located inside the reaction structure (Figure 3.7a). A portion of the wall collapsed in Test 8, but the debris fell into the reaction structure. A 1-ft section of the CMU wall wedged into the side walls of the frame, a second section of the wall fell onto the bottom support of the frame, and the third section of the wall fell into the front of the reaction structure at a negligible velocity (Figure 3.7b).

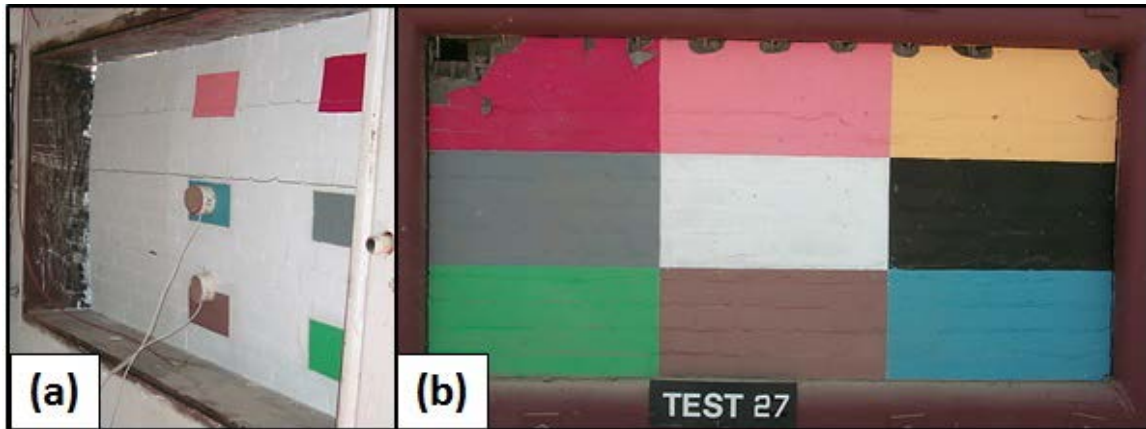
**Figure 3.9. Hollow, unreinforced, and unretrofitted CMU wall – Test 27.
(a) Interior. (b) Exterior.**

The CMU walls in Tests 4 and 27 were damaged, but neither wall became a debris hazard (Figures 3.8a and b and Figures 3.9a and b, respectively). “Damage to the CMU wall in Test 4 consisted of some spalling along the top of the wall, a crack in the mortar bed that extended the full length of the wall, several hairline cracks were visible in the mortar joints on the exterior and interior face of the CMU wall, and a yield line was

visible across the wall 18 in. above the bottom support.” (Woodson, Bullock, and Baylot 2001) There was enough damage to require the wall to be rebuilt. The accelerometers mounted to the wall indicated a 0.112 deflection into the structure at the mid-span and 0.0646 at the quarter point. The wall in Test 27 was also heavily damaged but did not collapse into the structure. The wall had a permanent 0.0862 deflection into the reaction structure at two yield line locations 18 and 24 in. above the bottom support of the frame. The top of the wall permanently deflected 0.0646 into the reaction structure, and a crack was found in the mortar bed that extended the full length of the wall. A few of the blocks along the top support lost a portion of their faceshells, and half of a CMU block in the top corner fell into the reaction structure. The accelerometers indicated a maximum deflection at the mid-span of 0.112 and 0.043 at the quarter point.

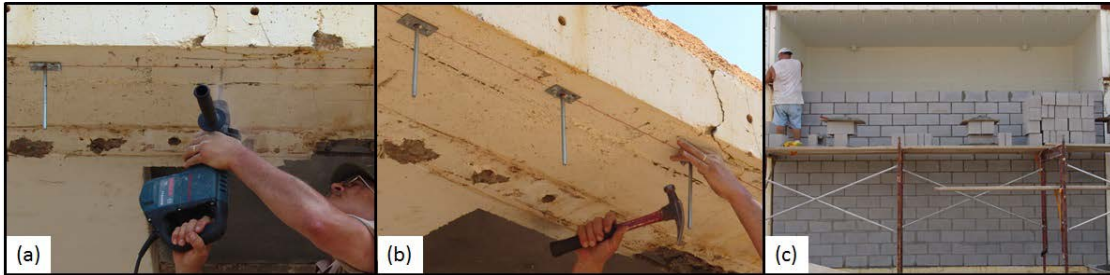
Figure 4.5. Full-scale construction. (a) Concrete hammer drill. (b) Installing anchor bolts to mount slip dowels. (c) CMU stacked in running bond.

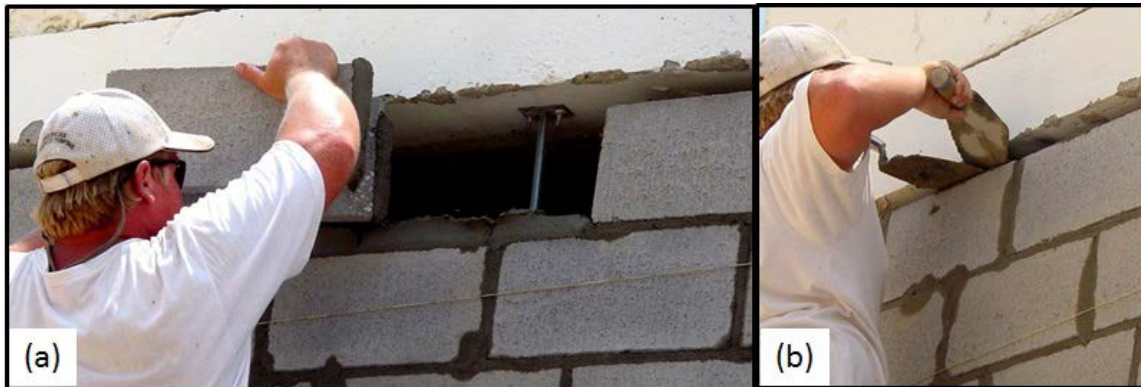
Figure 4.6. Wall construction. (a) Mason placing top course of blocks with slip dowels. (b) CMU cells with slip dowels fully grouted.

(25.4-mm) gap and slip dowels (PTA Series #420 Anchors) provided lateral support without adding additional restraint. The slip dowels, equivalent to a #4 bar, were used in every third cell (every 16 in. or 406 mm). The PTA Series Anchors (#420) permitted vertical deflection without transferring compressive loads to the CMU wall. A concrete hammer drill, anchor bolts, hammer, and wrench were required to install the slip dowels (Figures 4.5a, b, and c). Horizontal ladder mesh reinforcement (#220) was placed in every other course. Only the CMU cells that contained slip dowels were fully grouted (Figure 4.6a and b).

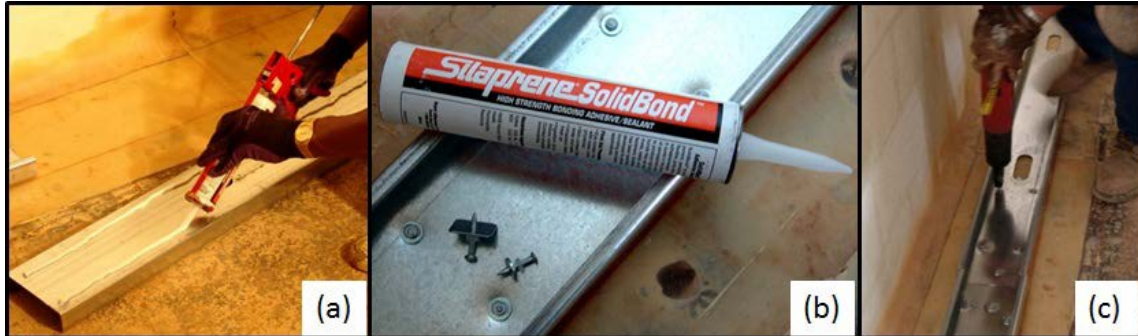
Figure 4.16. Anchor System 8. (a) Steel stud member. (b) Adhesive. (c) Ramset and nails required for installation.

used the same fasteners as System 5, but the steel angle and structural tube were replaced by a thin-walled steel stud member (Figure 4.15a). Systems 7 and 8 used the same thin-walled steel stud member used in System 6, but the robust anchor sleeves and bolts were replaced with smaller Red Head concrete anchors (Figure 4.15b) and a ramset actuator and fastener system, respectively (Figure 4.16a, b, and c). To prevent

the retrofit materials from sliding between the interface of the mechanical fasteners and the elastomeric materials (Figure 4.16b), extra adhesive was applied to the bottom of all the steel elements used as anchor plates.

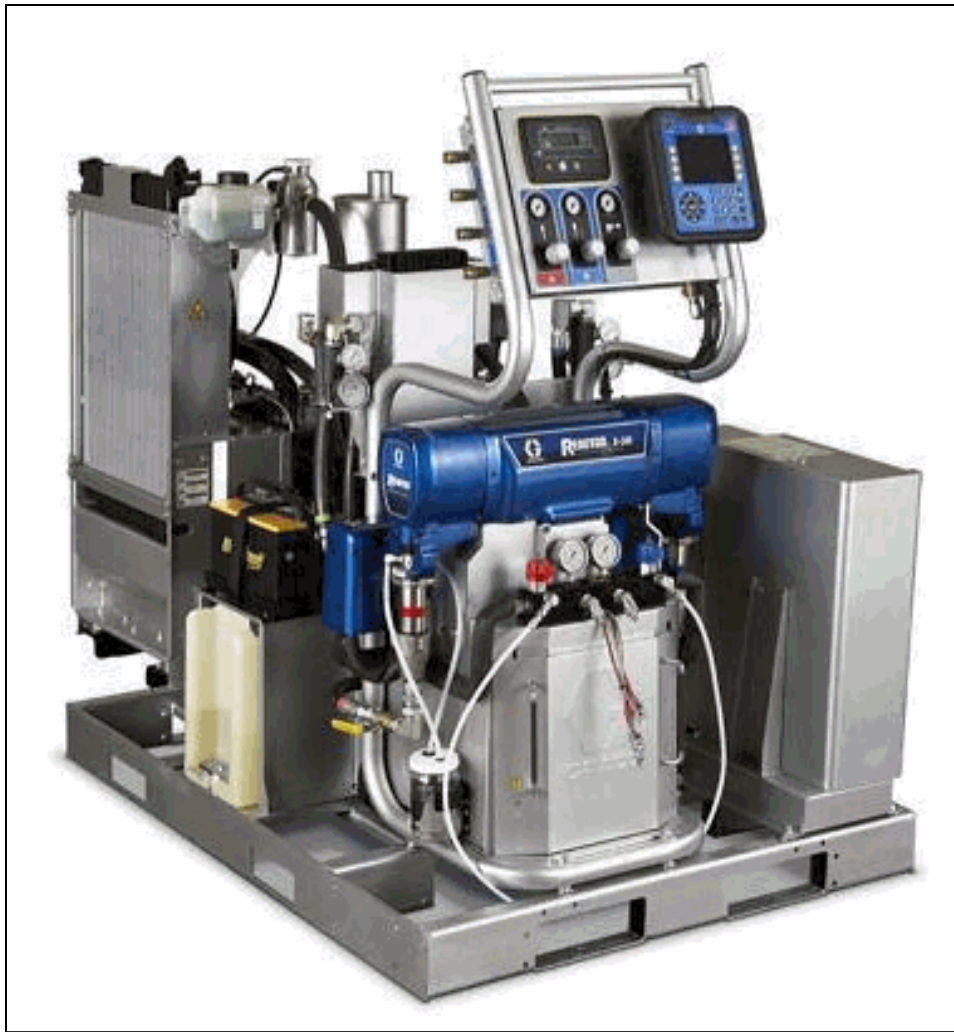
Figure 4.18. Graco Reactor E-XP2i Unit. (Graco Inc. 2012)

The Glas-Craft MX systems are no longer manufactured. The recommended dispensing system in 2012 was the Graco Reactor E-XP2i, which was a self-contained turnkey model consisting of the electric Reactor, a diesel generator, and integrated air compressor as one unit that sold for \$75,000. The unit was mounted on a skid that could be loaded by forklift onto a trailer or truck as required (Figure 4.18). The Grade 2 spray-on polyurea used in this research was sold in 925-lb sets of the A and B components. On average, one 925-lb set covered 617 sq ft of surface area at a thickness of 250 mils. The cost of each set ranged from \$3,136 to \$3,275, depending on the number of sets purchased. As additional sets were purchased, the cost per set decreased. Additional information on the new Graco E-XP2i Integrated Reactor is found at <http://www.graco.com/content/dam/graco/aftd/literature/brochures/348500/348500EN-B.pdf>.

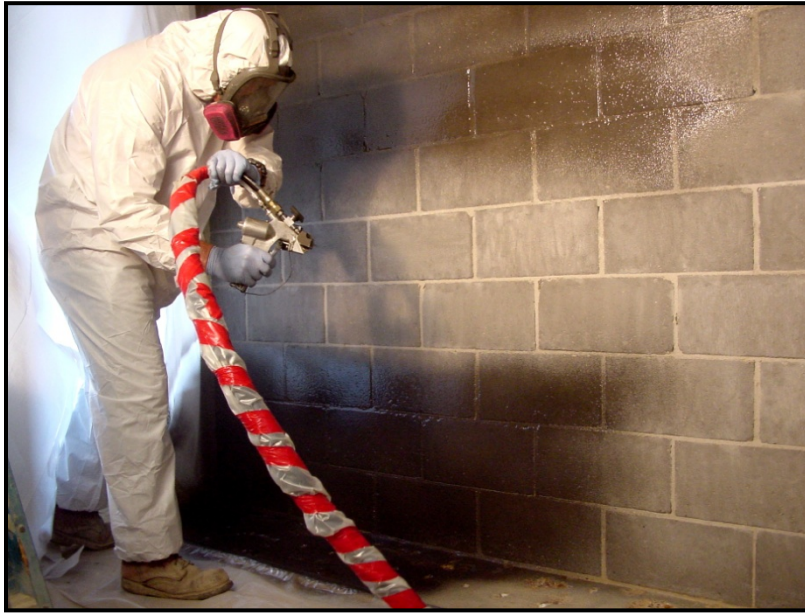
Figure 4.19. Safety equipment required for polyurea application.

The two-part spray-on polyurea material required the following safety products during application, i.e., gloves, Tyvek disposable protective coveralls with hood, and respirators with full face shields and fresh air supply pump (Figure 4.19). Safety glasses, gloves, and a respirator were required during application of the primer (Primer 1 or Primer 4) and during the operation of a wire wheel brush or grinder. If a sand blaster was

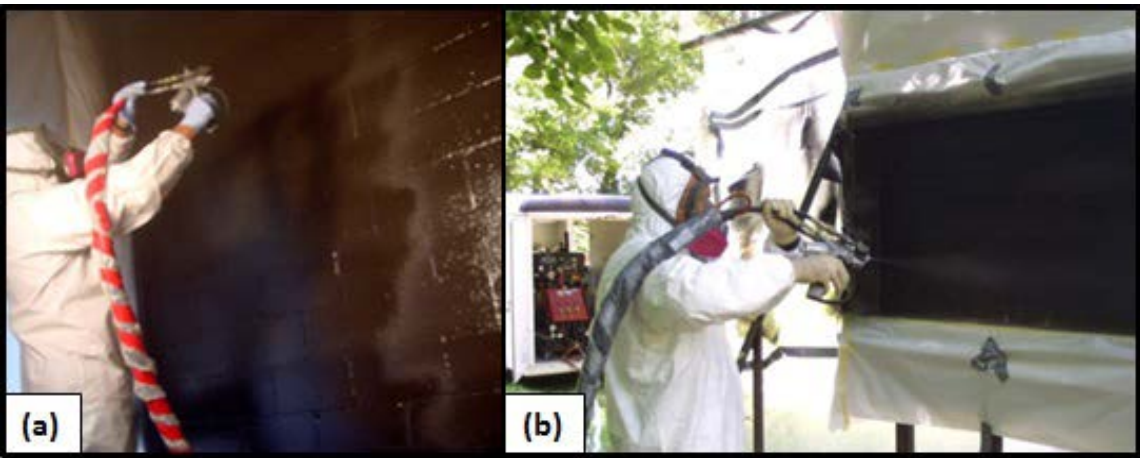
Figure 4.27. Spray-on polyurea. (a) Spray wall surface in a continuous manner until desired thickness achieved. (b) Application of spray-on polyurea to subscale specimen.

(Figures 4.26b and 4.27). If any moisture was on the wall or supports, the polyurea did not adhere well, and bubbles formed in the material layer. If the bubbles were large, they were cut out, and new material was sprayed over the hole until it was the required thickness. The polyurea had very good adhesion to itself; so once the first layer was completed, the remaining application procedure was completed with minimal delays until the final thickness desired was achieved (Figures 4.27a and b). However, if the wall

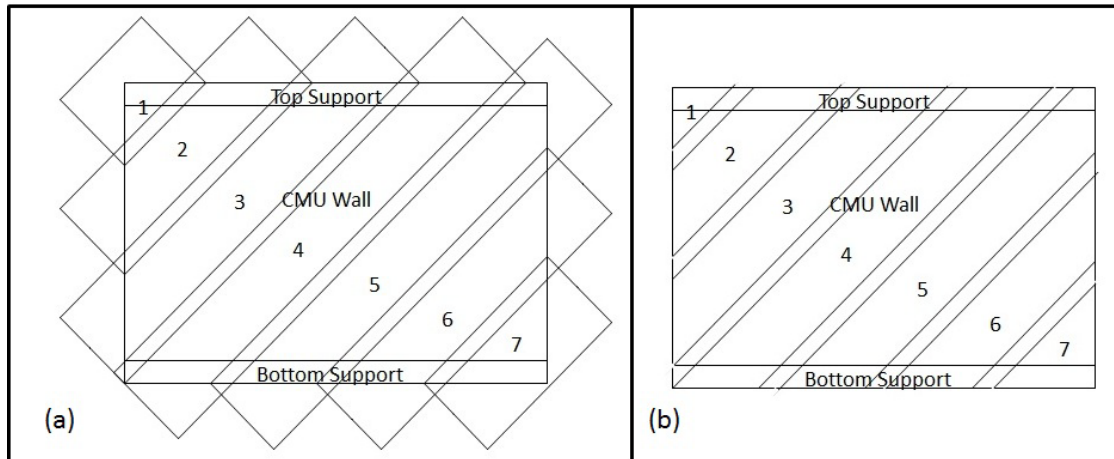
Figure 4.28. Fabric orientation. (a) The fiber reinforcement layout. (b) Fabric coverage after sheets were trimmed to fit wall.

The fiber reinforcing fabric was designed and cut to length before the spray-on process began. The material must cover the entire wall surface and a section of the top and bottom supports. The only fiber reinforcement available for researchers when the reinforced spray-on polyurea experiments began had fiber bundles oriented at 0/90 deg. To facilitate a ± 45 -deg orientation on the wall, pieces were cut and trimmed to the lengths required to cover the entire surface and applied diagonally onto the wall surface

(Figures 4.28a and b). The sheet layout was designed so that the two longest pieces would be used to cover the wall surface from one corner to the opposite corner, and the sheets would be secured or anchored at both the top and bottom supports. The fibers

Application of the fabric reinforcement began in the top left corner and moved down the wall as shown in Figures 4.28a and b and as the numbers 1 to 7 indicate on Figures 4.28a and b. The reinforcement was also applied to the supports. The area to be adhered to the support was folded and creased prior to placement on the wall, to create as tight a corner as possible (Figures 4.30a and b). The reinforcement was applied by removing the backing paper revealing the PSA. In the full-scale experiments, the reinforcement was too heavy to stick to the wall without additional assistance, so the spray-on polyurea was sprayed at sporadic locations to anchor the reinforcement to the wall (Figures 4.31a and b). Each successive sheet overlapped the previous sheet of reinforcement by a minimum length of 8-in. on the full-scale walls to create a continuous mat of reinforcement across the entire surface of the wall and supports (Figures 4.32a and b). After the reinforcement was placed on the wall, the entire surface area was rubbed down to remove all of the excess glue/adhesive that remained on the wall between the fiber bundles. As much of the excess glue as possible was removed to provide a contaminate-free surface for the second layer of spray-on polyurea. If glue remained on the wall surface, a good bond would not be formed between the first layer of spray-on polyurea and the second. The objective was to fully encapsulate the reinforcement between the two coats of spray-on polyurea.

researchers cut the pieces at angled lengths and applied them diagonally onto the wall surface (Figure 4.60a). The layout of the sheets was designed first, so that the appropriate lengths and forms of the film could be prepared, as illustrated in Figure 4.28. The material covered the entire wall surface and the top and bottom supports. The sheet layout was designed so that the longest piece would cross the wall surface from one corner to the other and be secured or mechanically anchored at both the top and bottom supports. The remaining sheets were only mechanically anchored at one support. Installers allowed a designated width of material to overlap 12 in. on the top and bottom supports to anchor the fabric, and each successive sheet of film overlapped the previous sheet by at least 8 in. Each fabric sheet was labeled to ensure proper placement on the wall.

as illustrated in Figures 4.28 a and b in Section 4.5.2. The weight of the film and the lack of adhesion between the film and epoxy required temporary bracing during the application process (Figure 4.61). The overlap/seam dimensions along the length of the sheets were not uniform due to unexpected difficulties during the application process. To prevent a failure along the compromised seams, an additional 1-ft strip of reinforced film was added over these areas (Figure 4.62). Mechanical anchorage System 3 was used to secure the retrofit system to the reaction structure at the top and bottom supports. FS12 was evaluated at dynamic load level 1.

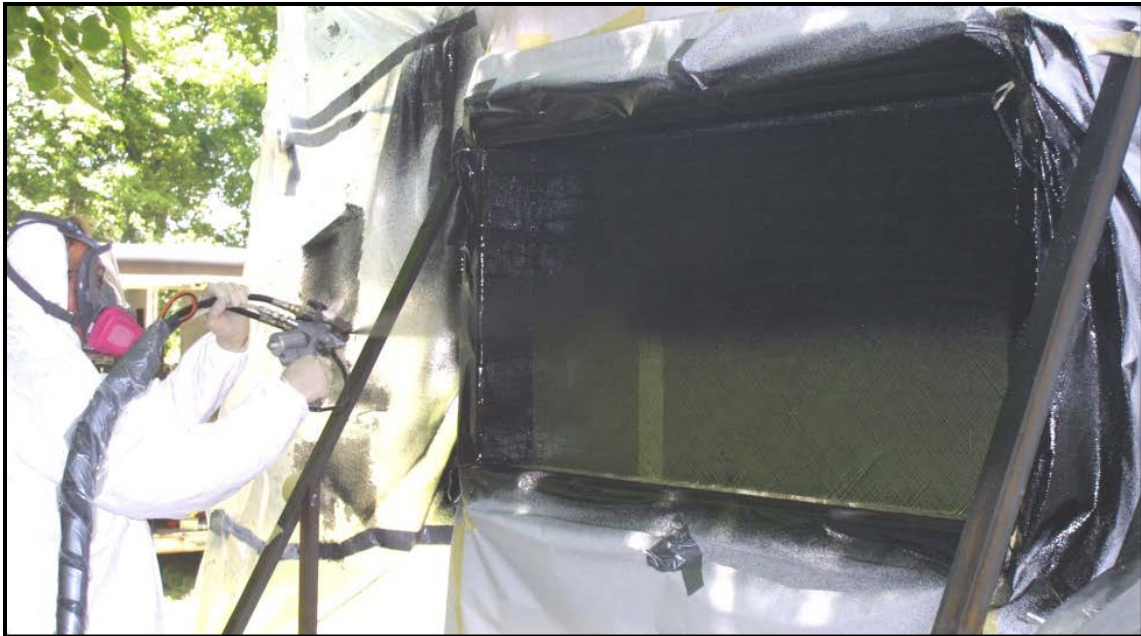
Figure 4.35. Application of second coat to subscale specimen.

The second layer of spray-on polyurea was used to encapsulate the reinforcement on the wall (Figures 4.34a and b and Figure 4.35). The spray-on polyurea bonds very well to itself, so the open weave in the fiber reinforcement allowed the new material to bond to the previous layer. The technique used to apply the first coat of spray-on polyurea was repeated for the second layer. Once the desired thickness of the second layer of spray-on polyurea was achieved, the plastic sheeting, wire tape, and trim materials were removed.

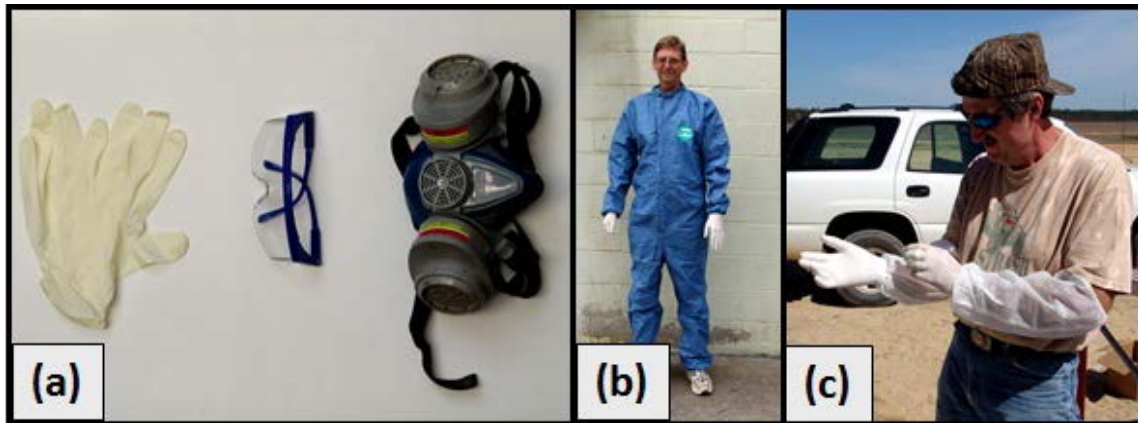
Figure 4.37. Safety equipment. (a) Mandatory: latex gloves, safety glasses, and respirator. (b) Protective clothing disposable paint suit. (c) Latex gloves and sleeves.

The application of the trowel-on thermoset retrofit required two safety products, i.e., gloves and safety glasses (Figures 4.37a through c). Safety glasses and gloves were worn at all times. Latex gloves were worn while priming the substrate, mixing materials, and applying the trowel-on material. A respirator was mandatory during the application of the primer (Primer 1 or Primer 4) and during the operation of a sand blaster, wire wheel brush, or grinder. However, a respirator was not required during the application of the trowel-on material. Wearing protective clothing was not mandatory but was highly recommended during the application of the trowel-on material. While applying the

material, dropping some of the material on one's arms, head, and clothing was not unusual, so as a protective measure, a hat and a paint suit or sleeves were worn to avoid this nuisance (Figures 4.37b and c).

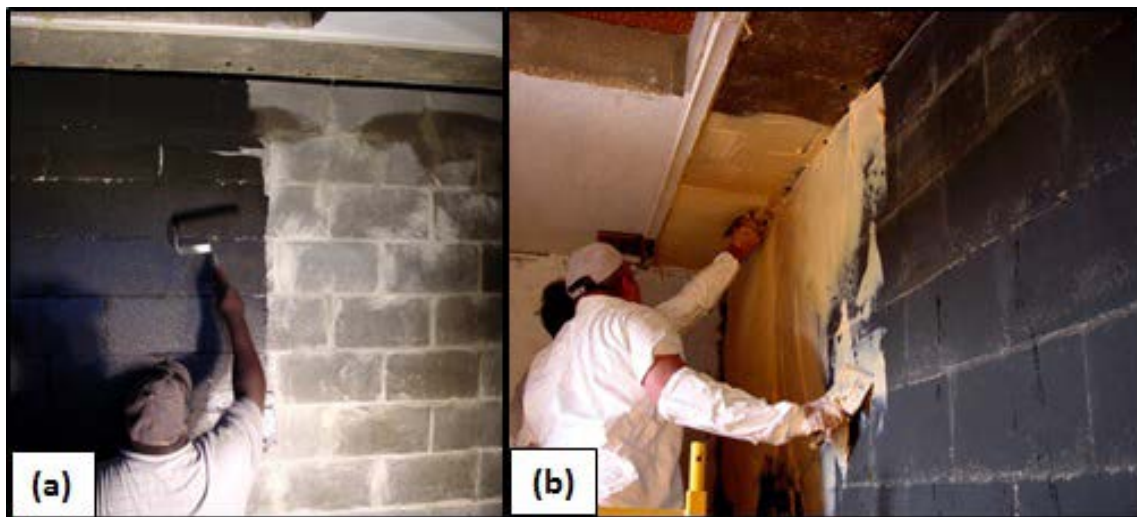
Figure 4.38. Quality control. (a) CMU wall surface is painted black; no paint applied to concrete supports. (b) Trowel-on material applied to the clean support and painted CMU wall.

they were painted to replicate the full-scale wall surface and not as a quality control method. The wall and paint had to be dry prior to application of the trowel-on polymer (Figure 4.38b). Paint was not applied to the surface of the supports. The bond between the support surface and the trowel-on thermoset had to be as strong as possible to prevent a peel-back failure, and a layer of paint would have diminished the bond strength at the supports. The wire tape and plastic sheeting used to remove excess material after

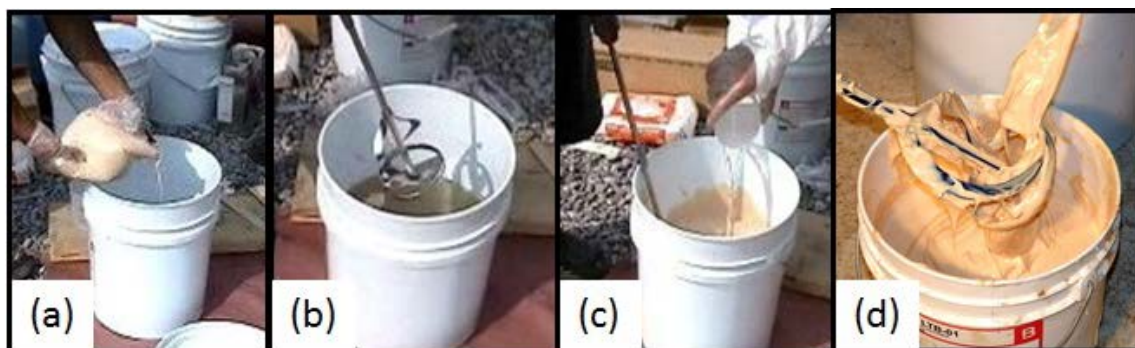
Figure 4.39. Mixing process. (a) Part B is added to Part A. (b) First two components are mixed with a paddle wheel attachment on the drill mixer. (c) Addition of Part C while mixing the material. (d) Material is ready to be applied to the wall.

The three trowel-on components were packed in containers pre-measured for a particular area of coverage. The mixing process began by adding the entire contents of Part B into the bucket containing Part A (Figure 4.39a). When any amount less than a full container was required, Part A and B were mixed at a 3:1 ratio by weight. The two

components were mixed using a paddle wheel attachment on a standard drill (Figure 4.39b). The mixing process was stopped intermittently, and a paint stick was used to scrape the sides, corners, and bottom of the container to ensure that the material was mixed thoroughly. Part C, the “Build Agent” (Figure 4.39c), was added to the bucket last. Once Part C was added and mixed with the other materials, the mix began to thicken. The entire bottle of Part C did not have to be used. The amount of build agent used was dependent on the applicator’s ability and environmental conditions. As larger quantities of Part C were added, the material thickened and became harder to apply to the wall. The mixing process was complete when the material became a thick, sticky paste as shown in Figure 4.39d.

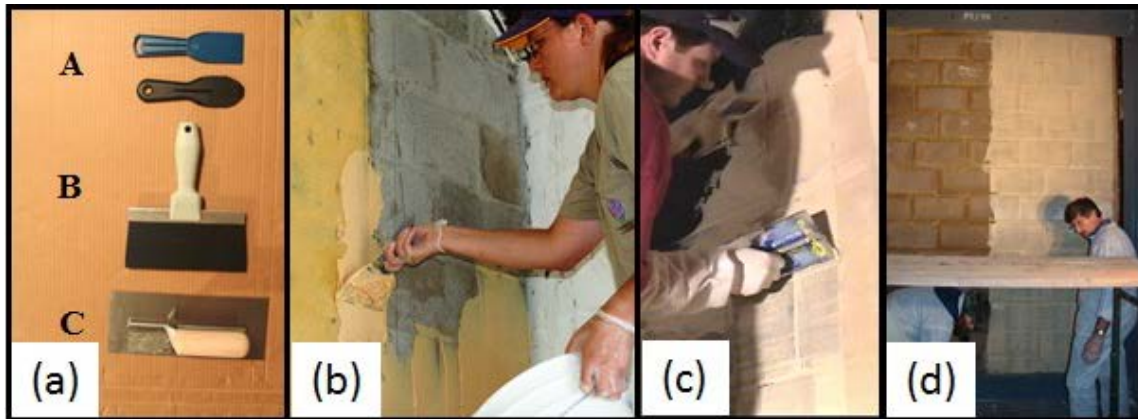
Figure 4.50. Trowel-on material application. (a) Trowels used to apply the thermoset. (b) Flat trowel used to apply material to wall. (c) Notched trowel used to control thickness. (d) One section of trowel-on material is completed and ready for film application.

the width of the thermoplastic film using a flat or straight trowel (Figure 4.50b) normally used in plaster or stucco finishes. The third person immediately followed the second person with a notched trowel (Figure 4.50c) held against the CMU wall's surface at an angle slightly less than perpendicular (90 deg). The notched trowel selected for application should be larger than the desired thickness of the trowel-on polymer. For example, in this experiment, the target thickness was 0.06 in. (1.5 mm), so a notch trowel with a 0.175-in. (4.8-mm) groove was selected. A notched trowel with a 0.1875-in. (4.8-mm) depth applied at an angle to the wall's surface produces a groove of material with a depth of 0.125 in. (3.2 mm). The application of the thermoplastic film redistributed the trowel-on material to a thickness approximately half of the groove depth. Once the trowel-on/film retrofit procedure was completed, the layer of trowel-on material was reduced by half to a depth of 0.06 in. (1.5 mm) with a 0.06-in.- (1.5-mm-) thick film for a total retrofit thickness of 0.12 in. (3.1 mm). The primary purpose of the

The procedure used to apply the trowel-on polymer to the CMU wall (Figures 4.51b and c) was also used at the supports (floor and roof slabs.) The only difference in the procedure was at the corners. A small 3-in. (7.62-cm) plastic putty knife trimmed into an elliptical shape was used to apply a continuous and thick layer of material at the corners (Figure 4.51c). Modifications to the plastic putty knife are shown in Figure 4.50a.

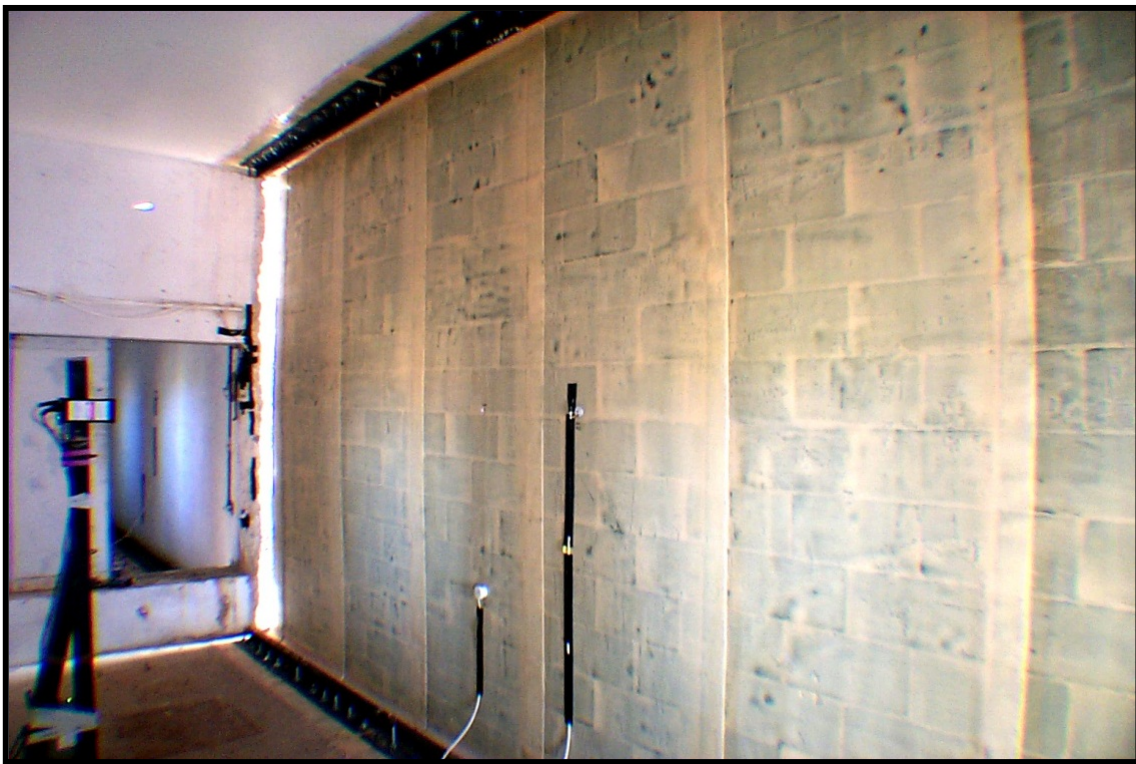
Figure 4.55. Each successive sheet overlapped the previous sheet.

a weak zone in the retrofit system. The flat trowel used in the application process was also used to scrape off the excess trowel-on material. The overlap area, a 4-in.- (10.2-cm-) wide vertical strip on the edge of the previous sheet of film was cleaned with MEK, denatured alcohol, or acetone and allowed to dry before the next batch of trowel-on material was applied (Figure 4.54b). The trowel-on material was applied to a 4-in. strip of the previous sheet of film to bond each successive sheet into one continuous system (Figure 4.54c). The application procedure was repeated until the CMU wall was completely covered (Figure 4.55).

One of the four full-scale mechanical anchorage systems described in Section 4.3.3 was used to secure the retrofit system to the top and bottom supports. System 5 was used on the retrofitted wall shown in Figure 4.55. The anchorage system used for each experiment is discussed in the appropriate experimental results section.

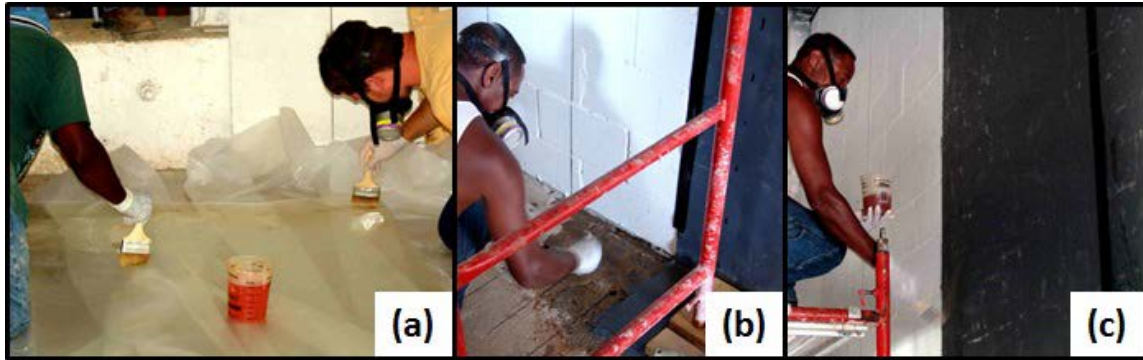
Figure 4.56. Primer application. (a) Prime the film. (b) Prime the support. (c) Prime the 4-in. area on the previous sheet of film that will be overlapped by new sheet.

The film sheets were cut before the retrofit process began. The height of the wall to be retrofitted was measured, and 2 ft were added to the overall length required to allow 1 ft of material to be used at each support. The elastomeric film used with the epoxy had to be primed to enhance the adhesion between the materials. A full coat of the primer was mixed and applied to the surface of the elastomeric film with a paint brush (Figures 4.56a through c). Multiple sheets of film were required to cover the wall surface, so the 4-in. strip to be covered by each successive sheet was primed (Figure 4.56c). Each successive sheet and overlap area on the previous sheet was primed by the second and third installers, while the first installer began mixing the epoxy. The film surfaces should be primed as needed, but not all at one time. Notice in Figures 4.56b and c that the support and overlap areas were primed in sections before

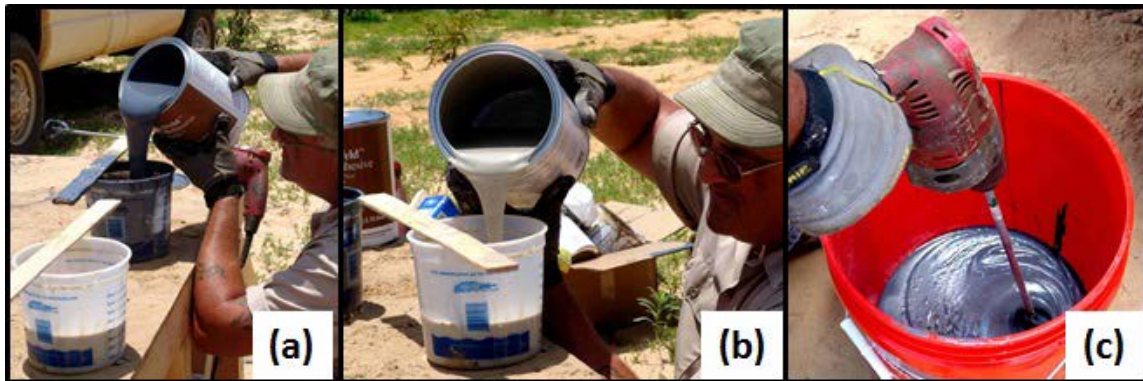
Figure 4.57. Mixing process. (a) Measure component A. (b) Measure component B. (c) Mix component A and B.

The base and accelerator components were measured in separate buckets at a 2:3 (Base:Accelerator) mix ratio by volume or 5:7 mix ratio by weight (Figures 4.57a and b). Each smaller bucket was poured into a 5-gal bucket and mixed with a paddle wheel attached to a drill (Figure 4.57c). Once a uniform color was obtained, the material was mixed for an additional 15 sec. Once mixed, the epoxy had a maximum window of application of 90 min. The material's window of application was reduced at higher temperatures and with large quantities of mixture. As in the trowel-on thermoset, the quicker the mixed epoxy was removed from the bucket and applied to the wall, the longer the window of application.

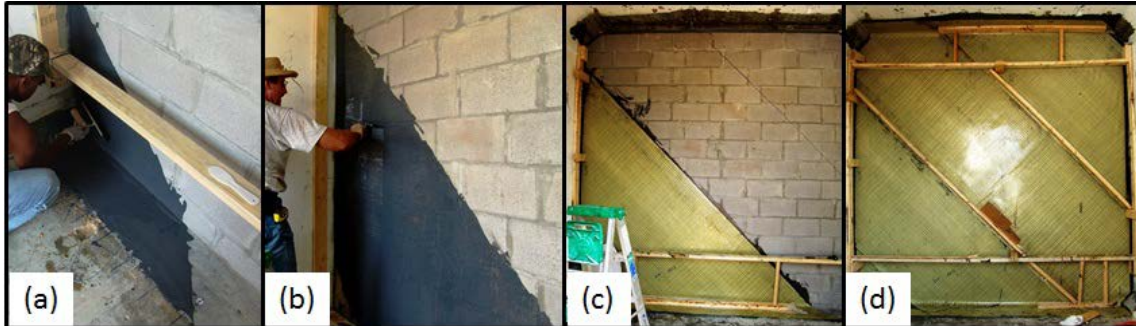
Figure 4.61. Retrofit application. (a) Trowel-on material applied in triangular sections. (b) Applying trowel-on material for film sheet two. (c) Sheet 2 applied to wall. (d) Temporary bracing applying pressure to film until epoxy cured.

The same procedure and tools discussed in Step 6 of Section 4.7.3.5 were repeated. The only difference between the two procedures was the shape of the area covered. In Section 4.7.3.6, the film was applied in vertical strips, so rectangular sections of the wall were covered with each epoxy mix. For this system, triangular sections that mimic the shape of the fiber-reinforced sheets of film were coated with the epoxy (Figures 4.61a and b).

The epoxy had a very short pot life, so the application process had to move quickly to leave adequate time for film application. To prevent the trowel-on material from curing before the application of the film, only mixing and applying enough epoxy for each individual sheet was important (Figure 4.61b). The primed side of the film was placed against the trowel-on material. The film was applied starting at the bottom corner support and moved up the wall (Figure 4.61c). The trowel-on epoxy took longer to cure, so temporary braces were used to keep the film in place until the bond was strong enough to maintain contact between the support surface and the film (Figure 4.61d). The temporary supports were removed once the epoxy cured (Figure 4.62a). Two people

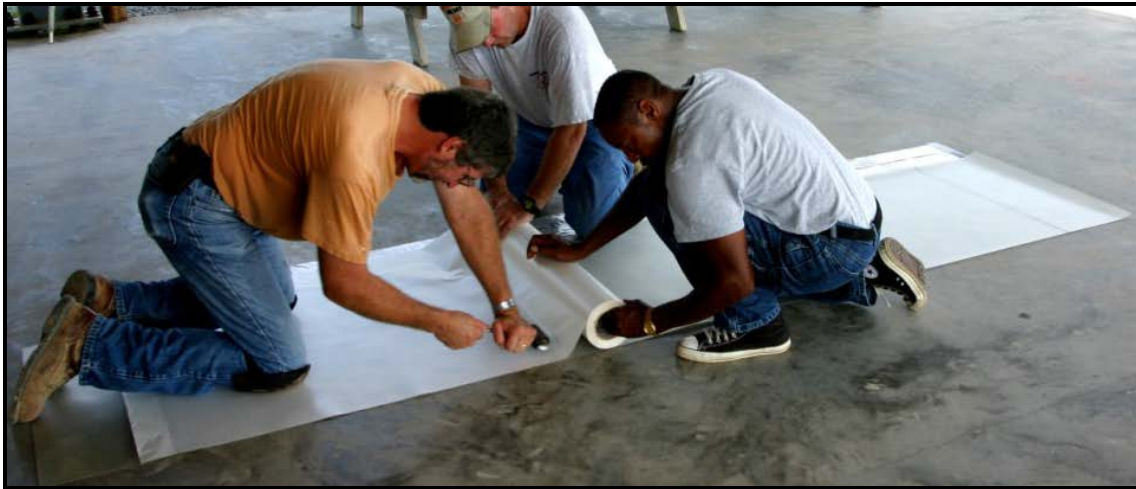
Figure 4.64. Acrylic adhesive applied to the elastomeric film in the field.

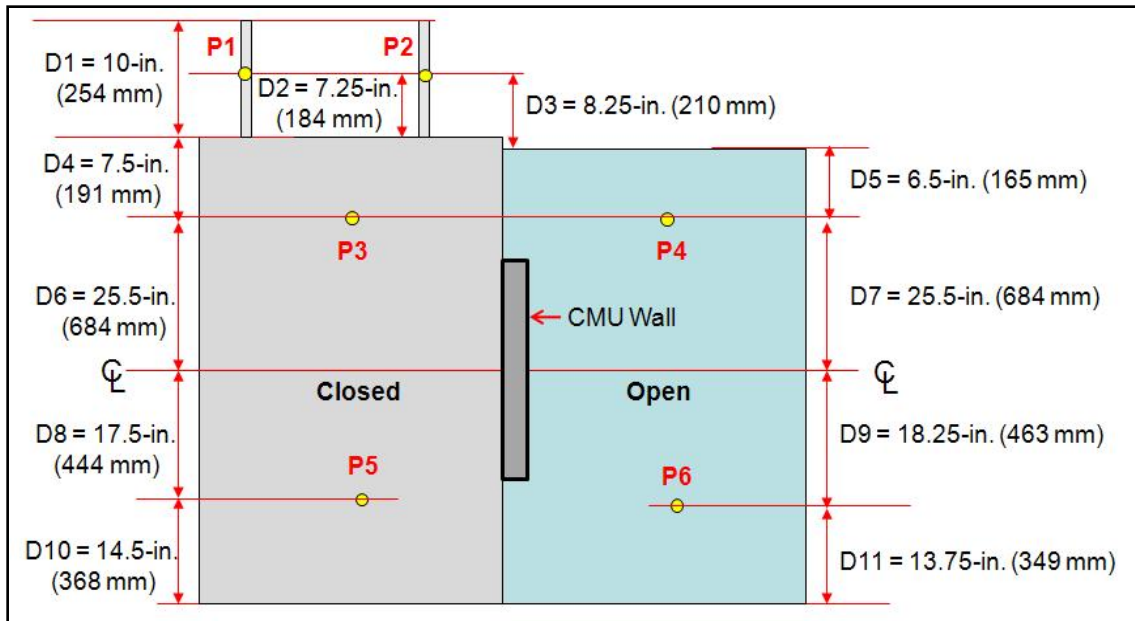
Figure 5.3. HTC: pressure gauge locations.

The instrumentation plan for the static experiments, as shown in Figures 5.2 and 5.3, consisted of five deflection gauges (D1-D5), three to six pressure gauges (P1-P6), still photography, and a normal-speed video camera above and below the water line.

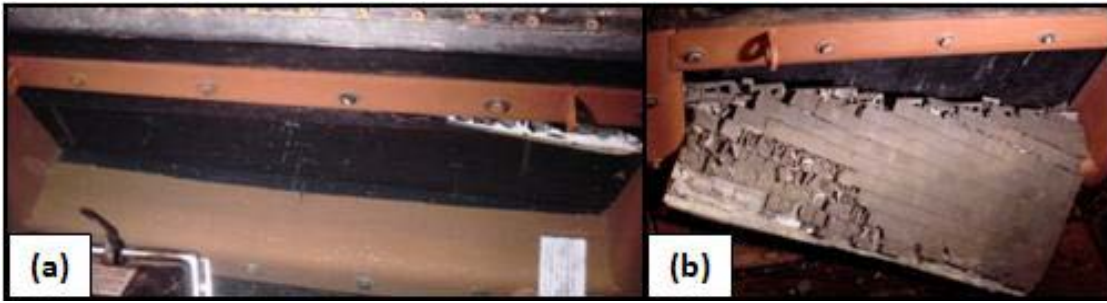
Figure 5.5. Trial 1. (a) Failure began at top support. (b) Complete failure of the retrofit material at the top support.

The wall failed very early in the loading process. When the wall reached a deflection of 2 in., the retrofit layer peeled away from the top support moving from right to left (Figures 5.5a and b). Based upon the results from this trial experiment, several procedures were changed. First, the aerosol spray adhesive was no longer used to adhere the reinforcement to the wall and to prevent a peel back failure; the area of overlap on the top and bottom supports was increased from 2 to 12 in. Additional information regarding the mechanical anchorage systems used was provided in Section 4.3.3.

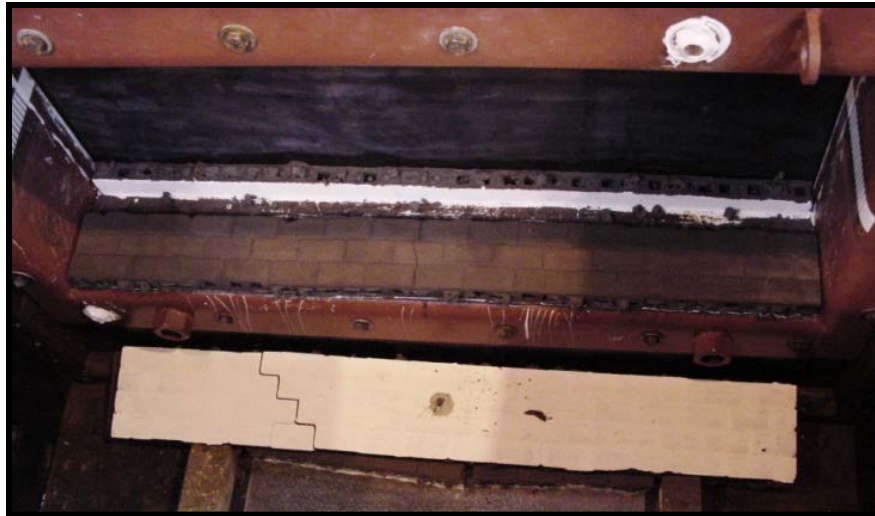
Figure 5.6. Posttest view of wall debris in chamber.

The first baseline or hollow, unreinforced, and unretrofitted CMU wall tested in the HTC was so weak that the wall failed before the relief valves could be closed and the data acquisition system started. The water in the two chambers reached the top of the open chamber before the wall failed; so, the hydrostatic pressure applied to cause failure of the wall was created within the 11-in. height difference between the top of the open chamber and the top of the relief valves. The maximum hydrostatic pressure at the point the relief valves are closed is equal to 0.4 psi, which implies that the Base 1 wall failed at a pressure between 0 and 0.4 psi. When the wall failed, it broke into four sections. The bottom course constructed in a mortar bed remained in the test frame (Figure 5.6) and the top section of the wall, where the blocks were grouted in around the dowels, lodged in the top of the steel reaction frame. One section of blocks fell onto the bottom flange of the steel frame and the remaining section of blocks fell onto the floor of the open test chamber.
