EQPETGVG'O CUQPT['Y CNN'TGVTQH'U UVGO UHQ'T'DNCUV'RTQVGEVKP "

A Dissertation

CAROL FC[G JOHNSON

Major Subject: Civil Engineering

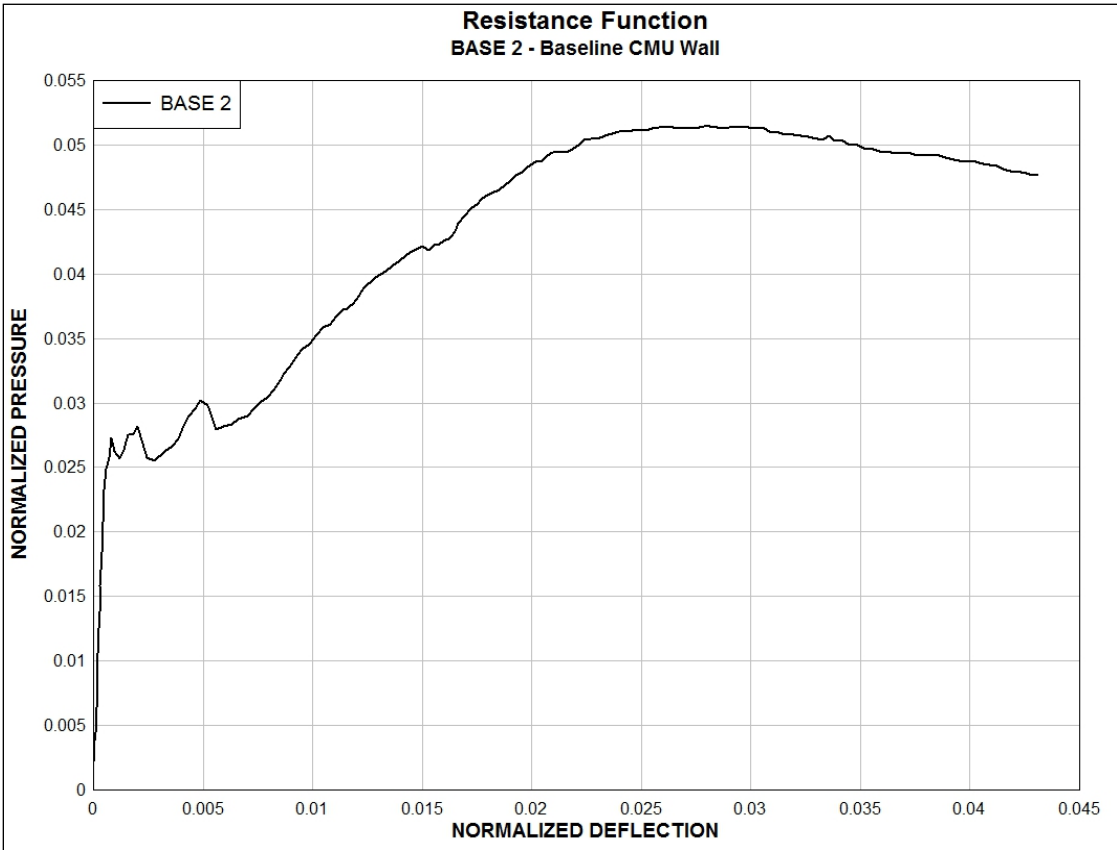
Figure 5.7. Resistance function for baseline CMU wall, Base 2.

The baseline CMU wall once again failed very early during the experiment; however, due to the changes in the test procedure data was collected. Once the wall cracked the blocks begin to deflect and rotate at the mortar joints and the wall continued to resist pressure up to a maximum pressure of 0.035 and a deflection of 0.0276 (Figure 5.7).

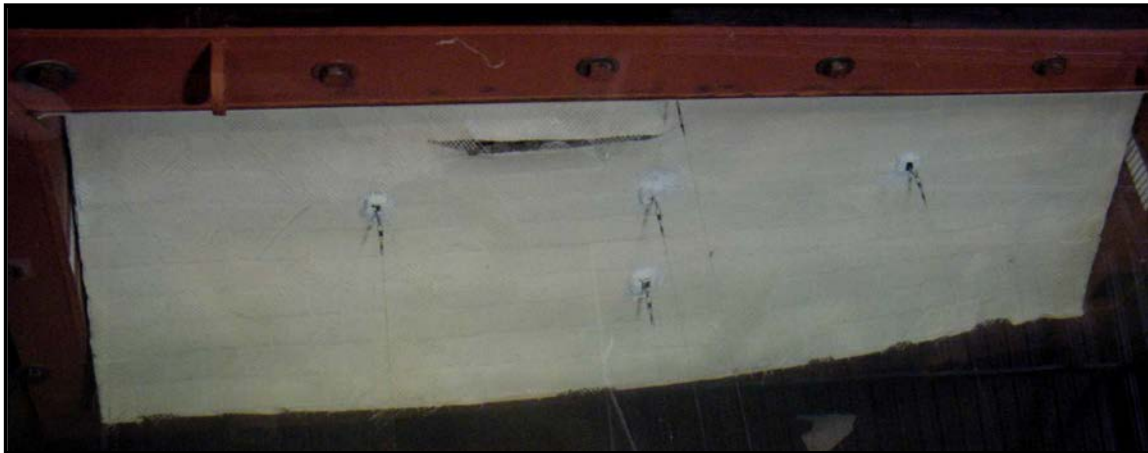
Figure 5.23. Ultimate failure of the retrofit occurred when the materials tore along the bottom anchor plate.

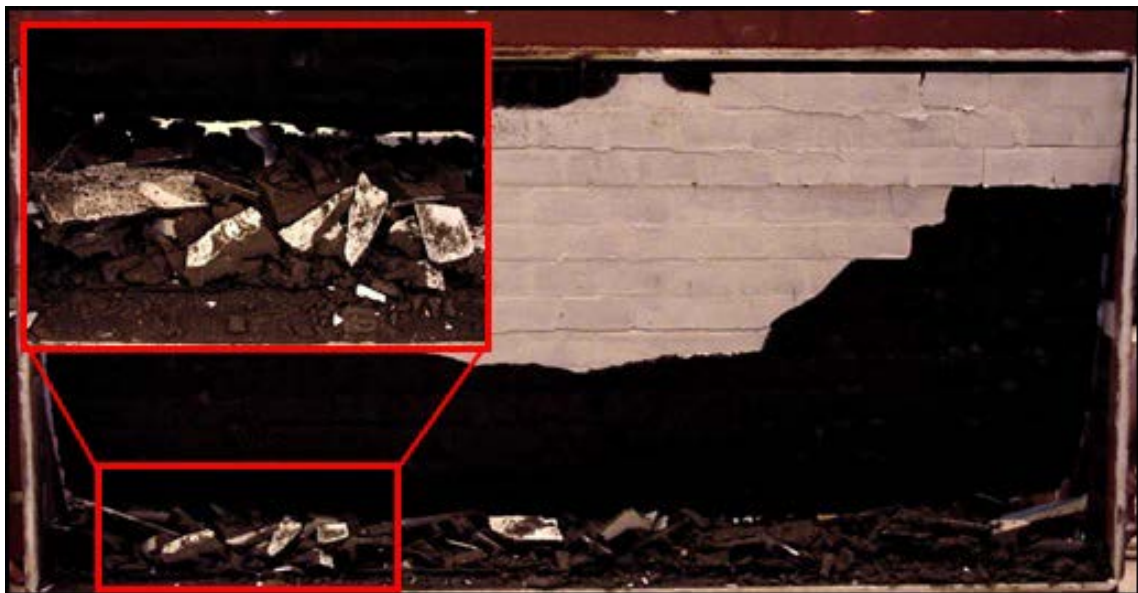
Figure 5.29. Accumulation of CMU debris on bottom flange of frame.

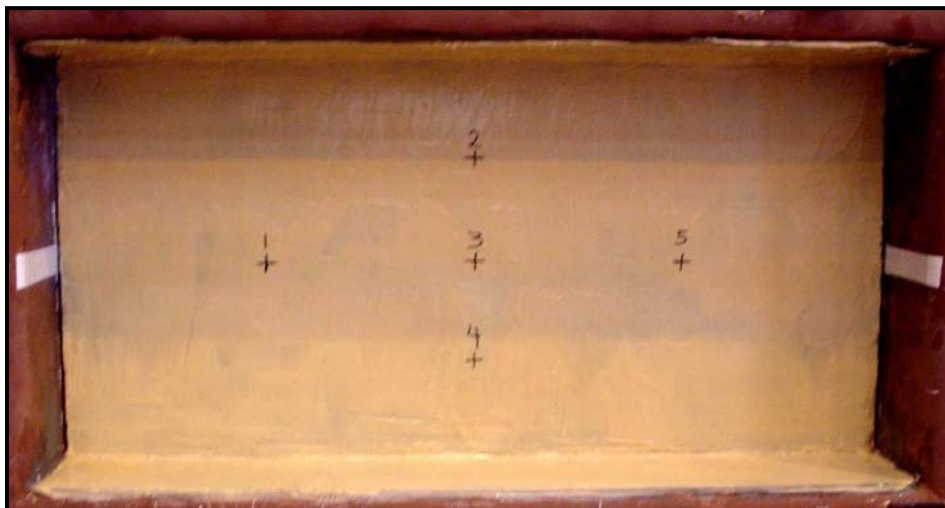
Figure 5.35. SW10 retrofitted with trowel-on thermoset.

Wall SW10 was retrofitted with a trowel-on thermoset material using the procedure detailed in Section 4.6. First, a layer of thermoset was applied to the wall and to the top and bottom supports using a notched trowel. A second layer of material was applied to the same area using a flat trowel to fill in the grooves until the desired retrofit thickness was achieved on the CMU wall and steel supports (Figure 5.35). No mechanical anchorage was used to secure the retrofit material. The retrofitted wall failed when the trowel-on material sheared along the top support. The ultimate flexural resistance occurred at a pressure of 0.0889 and a deflection of 0.0568. (Figure 5.36). The membrane continued to deform until final failure occurred at a pressure of 0.536 and a deflection of 0.744.

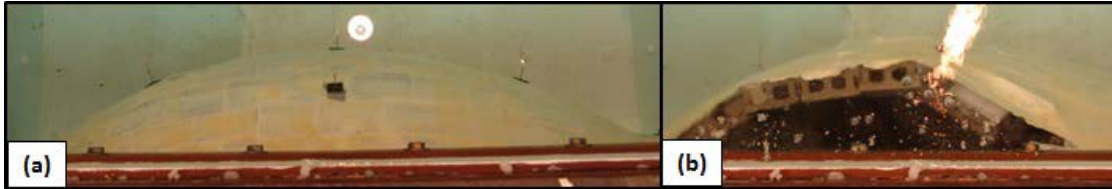
Figure 5.44. SW13. (a) Deformation extends past the reaction structure frame. (b) Failure of the film occurred when the material sheared at the top support.

The retrofitted wall exhibited a toughness not observed on any of the previous experiments. The wall deformation began along the mid-span of the wall (Figure 5.43b) and continued to be the area of maximum deformation until the elastomeric film sheared along the anchor plate at the top support (Figure 5.44b). The deformation in the retrofit was consistent across the mid-span of the wall until the deformation exceeded the 8-in. mark (Figures 5.45a and b). This appeared to be a limitation of the membrane separating the two chambers of water. Because the membrane is bolted on all four sides, it could not continue to deform uniformly with the wall, which is why the deflection of the film continued to increase at the center of the wall as illustrated in Figures 5.44a and b,

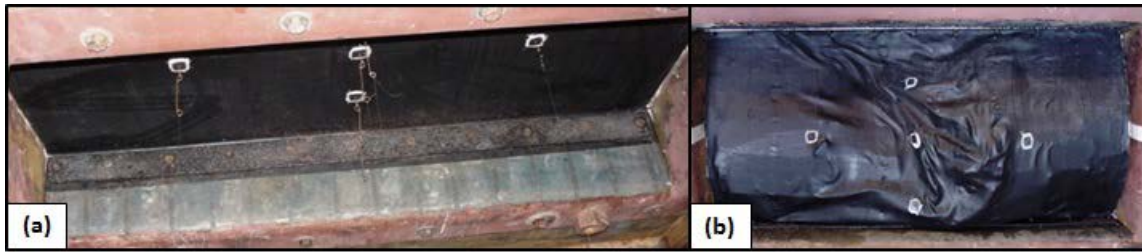
Figure 5.62. SW17. (a) Pretest view. (b) Posttest view of the retrofit system.

Wall SW17 was retrofitted with an unreinforced elastomeric film adhered to the wall and supports using a double sided tape (Figure 5.62a). A spray-on adhesive was used to

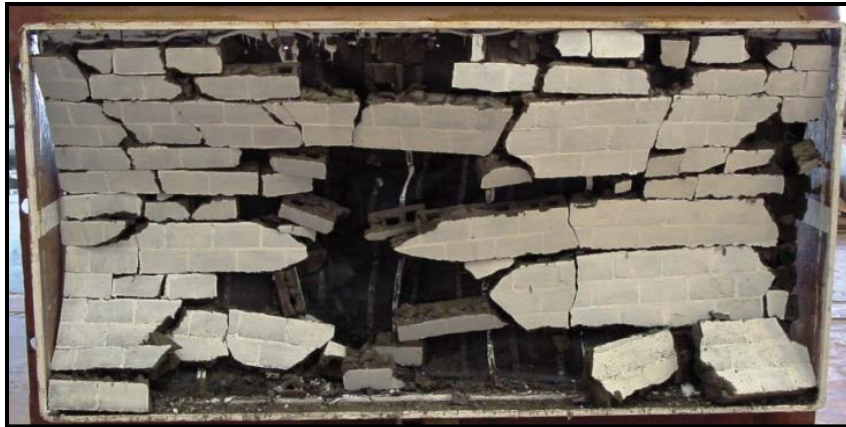
Figure 5.63. Damaged CMU blocks and area where the blocks lost adhesion.

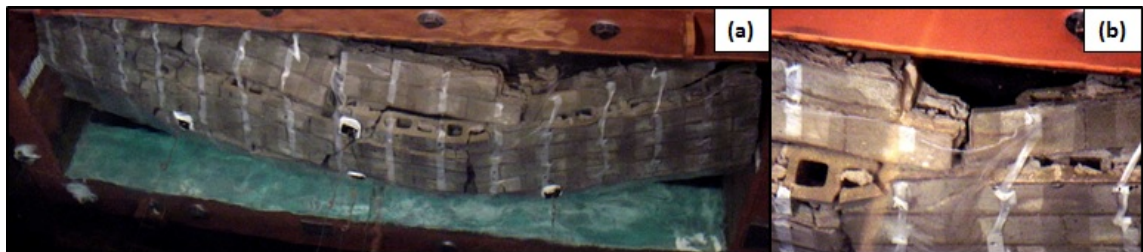
Figure 5.67. SW18. (a) Retrofit failure occurred when the film tore along the top support. (b) Tear in the elastomeric film.

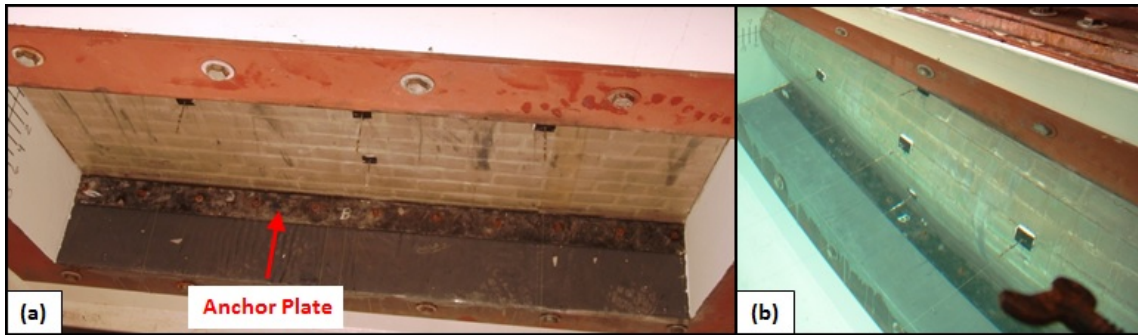
Figure 5.72. SW20. (a) Pretest view. (b) Deflection reaches 0.474. (Adapted from Johnson, Davis, Coltharp, Durst, and Smith 2010)

The application procedure used to retrofit SW19 was duplicated on wall SW20 (Figure 5.72a). The CMU wall failed at a pressure of 0.062 and a deflection of 0.0969. The retrofit system applied to SW20 was very ductile, allowing an overall deformation of 1.15 at a peak pressure of 0.367 before it sheared along the top support. The unreinforced and transparent film used to retrofit SW20 allowed witnesses to watch as the cracks formed during the loading process (Figure 5.732b).

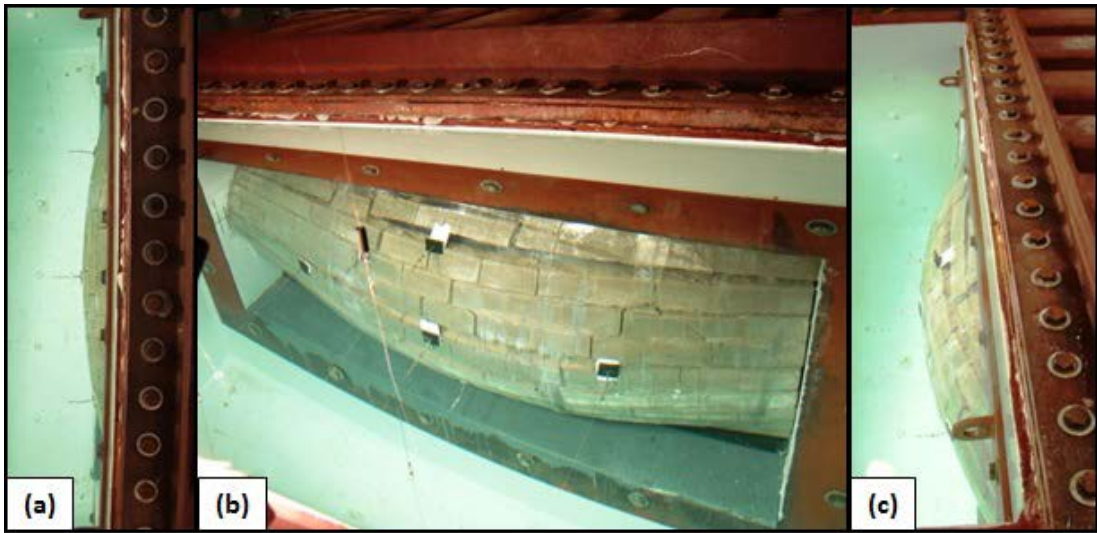
Figure 5.73. SW20. (a) Deformation passed the frame. (b) Vertical and horizontal cracks on wall continued to expand. (c) Gauge D1 disengaged from film surface. (Adapted from Johnson, Davis, Coltharp, Durst, and Smith 2010)

Witnesses watched as air bubbles trapped between the CMU wall surface and film traveled through the cracks formed in the CMU wall. As SW20 deformed, multiple cracks developed horizontally and vertically along the entire CMU wall surface. The ductility of the material is evident in Figures 5.73a and b as the wall extends past the steel frame surface. As the pressure continued to increase, the cracks in the wall continued to widen, and the PSA began to tear as the film stretched under the increasing deformation (Figure 5.74). As the PSA continued to tear, sections of the wall and film no longer carried any adhesion between the two surfaces. Deflection gauge, D1, was unable to maintain adhesion to the film during the deformation process and disengaged before complete failure occurred (Figures 5.73c and 5.74). Complete failure of the retrofit system occurred when the film tore along the top support. The resistance function developed from the pressure and deflection data for SW20 is plotted on Figure 5.71 (Johnson, Davis, Coltharp, Durst, and Smith 2010).

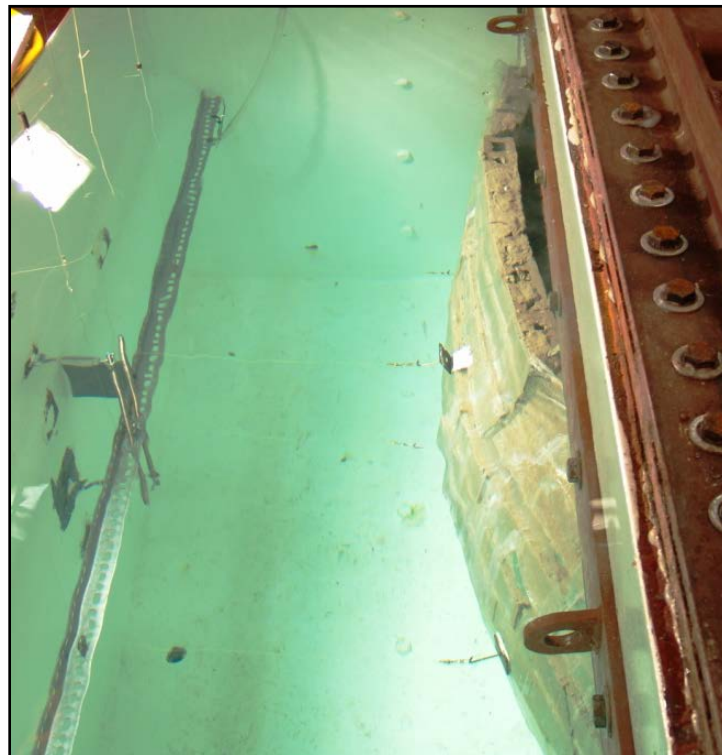
Figure 5.74. SW20– Final failure occurred as the film tore across the top support. (Johnson, Davis, Coltharp, Durst, and Smith 2010)

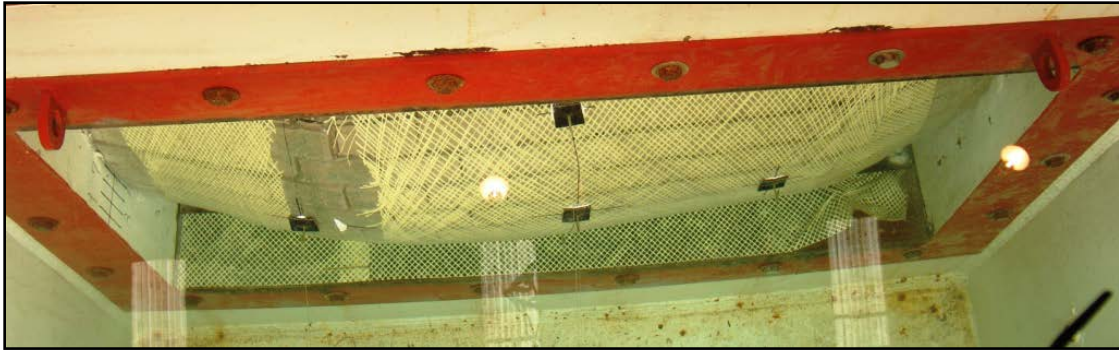
Figure 5.81. SW22 – maximum wall deformation transitioned from mid-height to the seam/overlap area. (Johnson, Davis, Coltharp, Durst, and Smith 2010)

which created a weak spot on the wall. The maximum wall deformation transitioned from the mid-height line to the seam/overlap area once the fibers shifted (Figure 5.81).” (Johnson, Davis, Coltharp, Durst, and Smith 2010) The PSA was not strong enough to maintain the adhesive bond along the supports and the film in the bottom right corner and the top left corner was pulled under the anchor plate (Figures 5.81, 5.82, and 5.83b). The CMU wall failed at a pressure of 0.0765 and a deflection of 0.137. The experiment was halted at a deflection of 0.831 at a peak pressure of 1.08 (Figure 5.84).

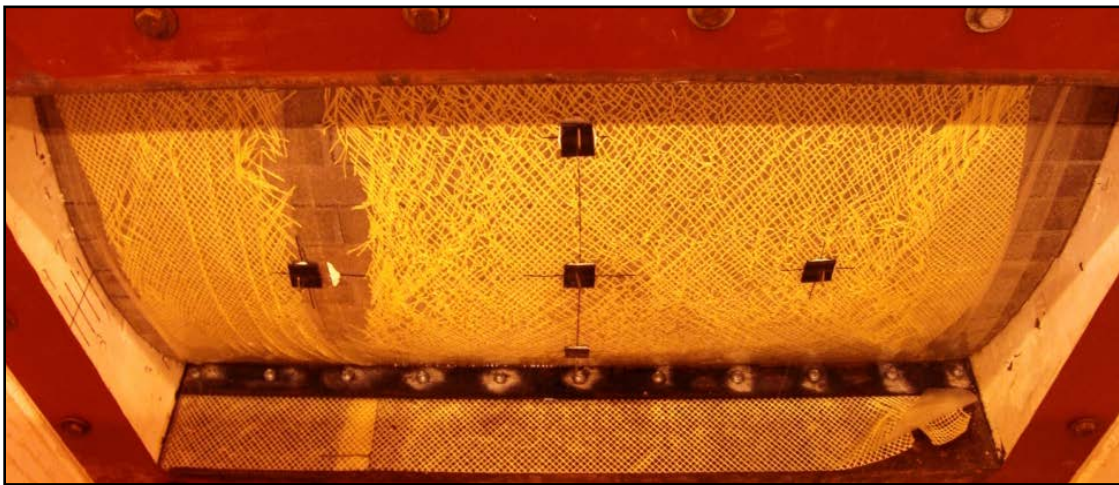
Figure 5.82. SW22 – Once pressure was relieved the fiber reinforcement was permanently deformed. (Johnson, Davis, Coltharp, Durst, and Smith 2010)

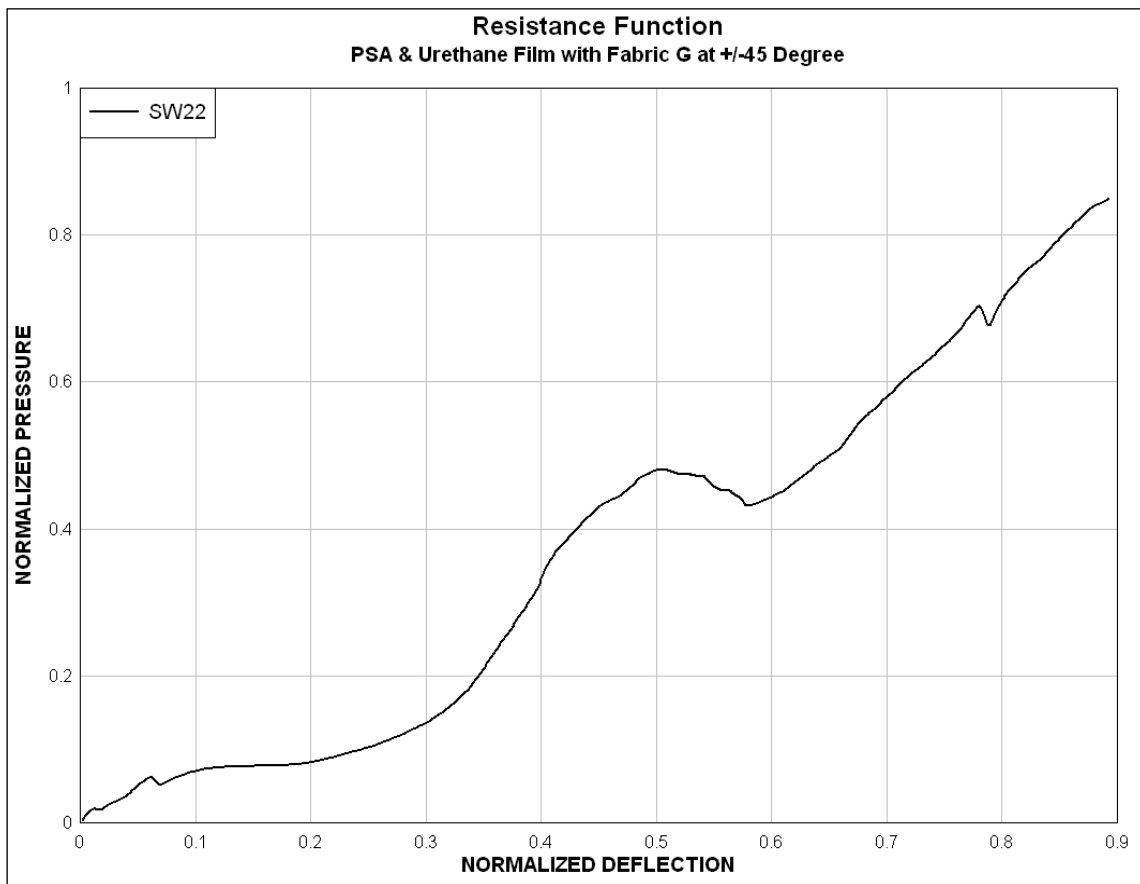
Figure 5.84. Resistance function for SW22.

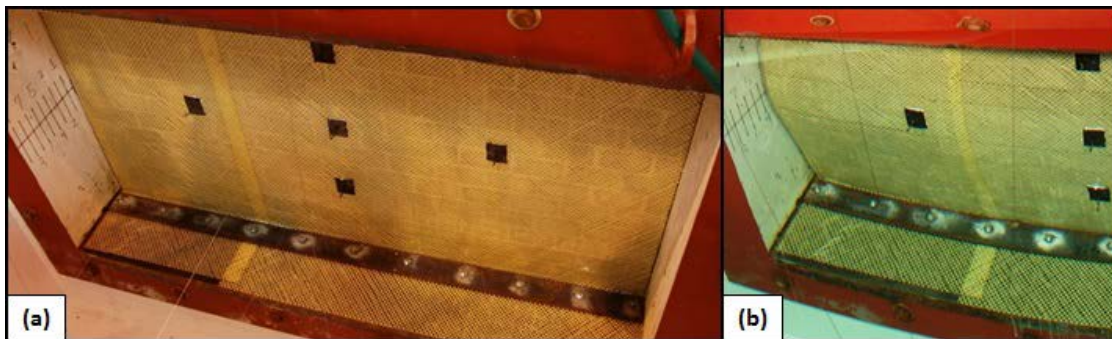
Figure 5.86. SW23. (a) Pretest view. (b) Deflection at 3 in.

The retrofit applied to SW23 also consisted of an elastomeric film that encapsulated an open-weave aramid fiber reinforcement (Figure 5.86a). The construction process between the two fiber reinforced films differed for SW22 and SW23. The film used on SW22 was laminated and the film used on SW23 was constructed by encapsulating the open weave fiber reinforcement with an elastomeric material through an extrusion

As the load on SW23 increased, the wall deformed along the mid-height of the wall (Figure 5.86b). However, as the wall deformation continued, the film began to stretch and deform along all of the edges of the film (Figures 5.87a and b). The seam became the weak spot and the deformation transitioned from the center of the wall to the seam/overlap region. As the elastomeric film continued to stretch, the film edges began to distort. In the previous experiment, SW22, the fibers shifted between the two sheets of film and the film maintained its integrity across the seam. However, in this experiment the bond between the film and fibers was strong, which prevented the fibers from distorting. This caused the entire film to recede from the seam (Figure 5.88). The extrusion process used to encapsulate the fibers in the film created a much stronger bond than the delamination process used in SW22. The experiment ended when the opening at the seam exposed an entire CMU. When the water was released from the pressurized chamber, the film exhibited permanent deformation as indicated by the wrinkles shown in Figure 5.88 (Johnson, Davis, Coltharp, Durst, and Smith 2010).

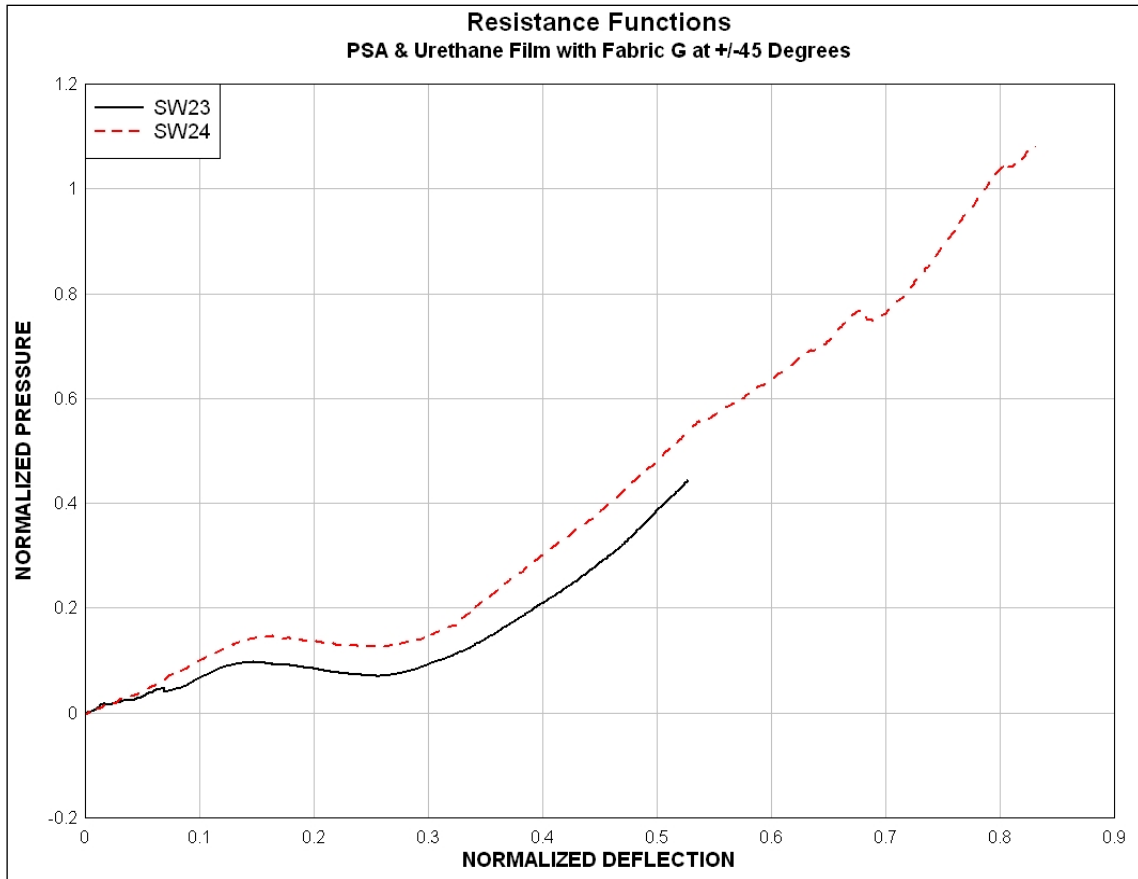
Figure 5.89. Resistance functions for SW23 and SW24.

The CMU wall failed at a pressure of 0.0972 and a deflection of 0.146. The experiment ended due to failure at the seam at a pressure of 0.443 and a deflection of 0.526 as seen on the resistance function in Figure 5.89.

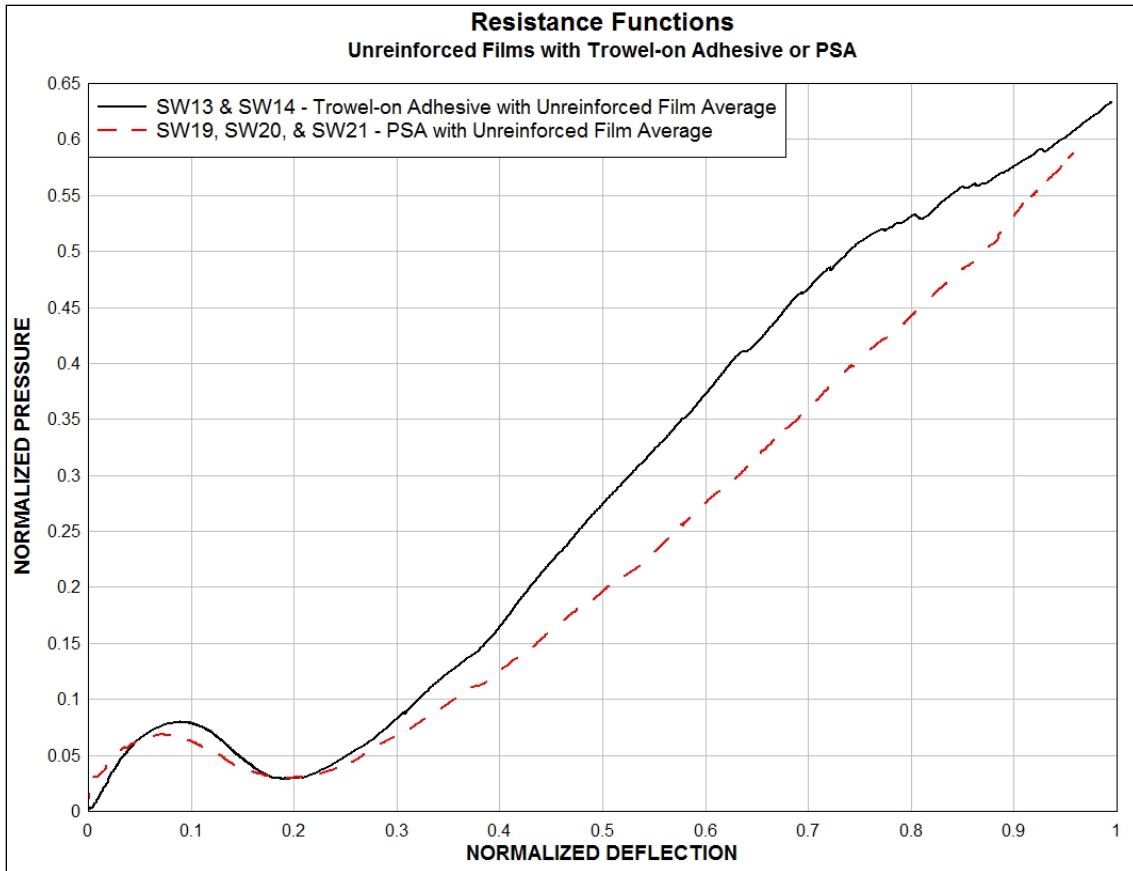
Figure 5.99. Comparison of unreinforced elastomeric films with trowel-on adhesive versus PSA.

The average resistance function created from the unreinforced elastomeric films adhesively applied to the walls using a trowel-on material (SW13 and SW14) was compared to the average resistance function developed from unreinforced elastomeric films applied to the wall using a PSA (SW19, SW20, and SW21) in Figure 5.99. The pressure and deflection at the point of ultimate flexural resistance was 0.0798 at a deflection of 0.0884 for the unreinforced elastomeric films with trowel-on adhesive, and 0.0689 at a deflection of 0.0723 for the unreinforced films with a PSA. The two retrofits failed within 0.0109 (16%) and 0.0161 (22%) from each other, which indicated that the ultimate failure of both retrofit systems was slightly effected by the method used to attach the films. The trowel-on adhesive added some additional stiffness to the films when one evaluates the slope of the lines past the point of ultimate flexural resistance to the point of retrofit failure. Both retrofit systems were selected for further evaluation. All

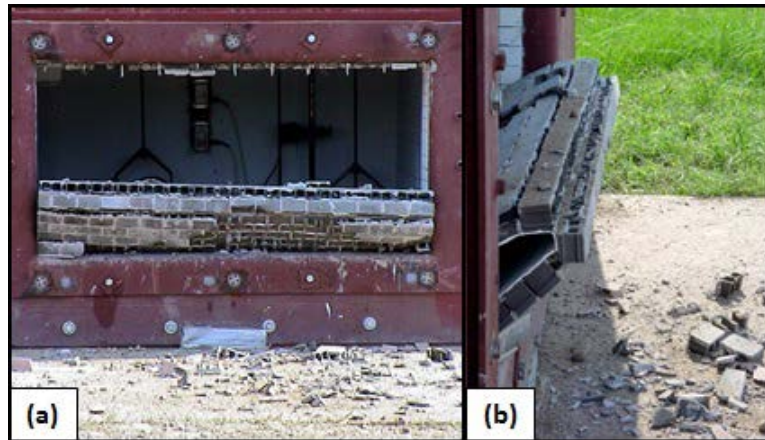
**Figure 6.14. DW4. (a) Exterior view.
(b) Exterior profile.**

Wall DW4 was retrofitted with a reinforced spray-on polyurea Grade 2. First, two passes of the spray-on polyurea were applied to the wall followed by a layer of Fabric A applied with the fibers oriented at 0/90 deg to the horizontal mortar joints of the wall. The fabric was encapsulated when two additional passes of the spray-on polyurea were applied over the fabric. DW4 was evaluated at dynamic load level 3. The retrofit sheared at the top support and folded over on itself (Figures 6.14a and b). The bottom support remained attached to the frame. High-speed video indicated that the wall deflected minimally before failure of the fiber reinforcement occurred at the top support (Figures 6.15a to d). While evaluating the high-speed camera footage, the wall appeared to transfer the load directly to the top support where the polyurea material and fibers failed along the top course of blocks. The wall failed during the initial deformation into

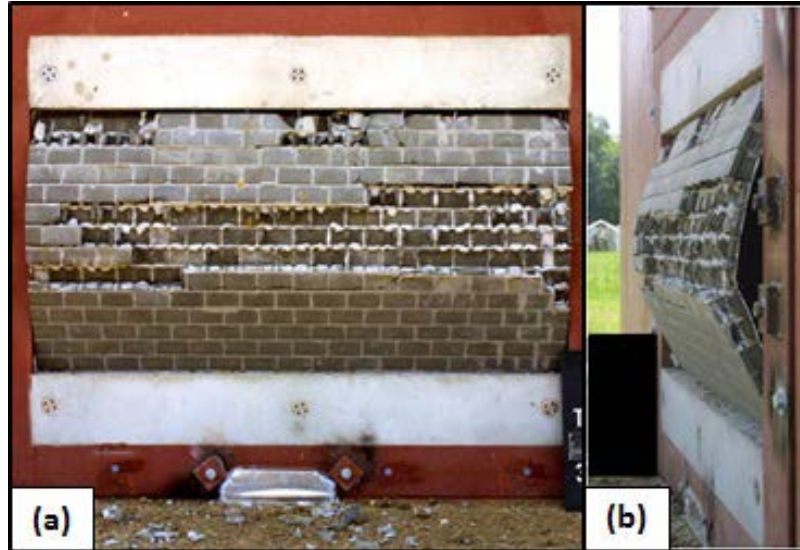
**Figure 6.17. DW5. (a) Exterior view.
(b) Permanent deflection.**

remained attached to the polyurea layer (Figures 6.17a and b). The center four courses of block were heavily damaged across the entire wall span, but again none of the debris was found in the reaction structure (Figure 6.18a). Approximately 30% of the CMU blocks were damaged during the experiment. The center of the retrofitted wall deflected 0.167 in. into the structure. The polyurea did peel back on the top and bottom supports, but the overlap was large enough to prevent failure. In Figure 6.18b one can see that some of the concrete pulled off the support when the spray-on material peeled back, indicating that the bond strength between the elastomer and concrete was very good. High-speed video footage showed that the peel back of the elastomeric material at the bottom and

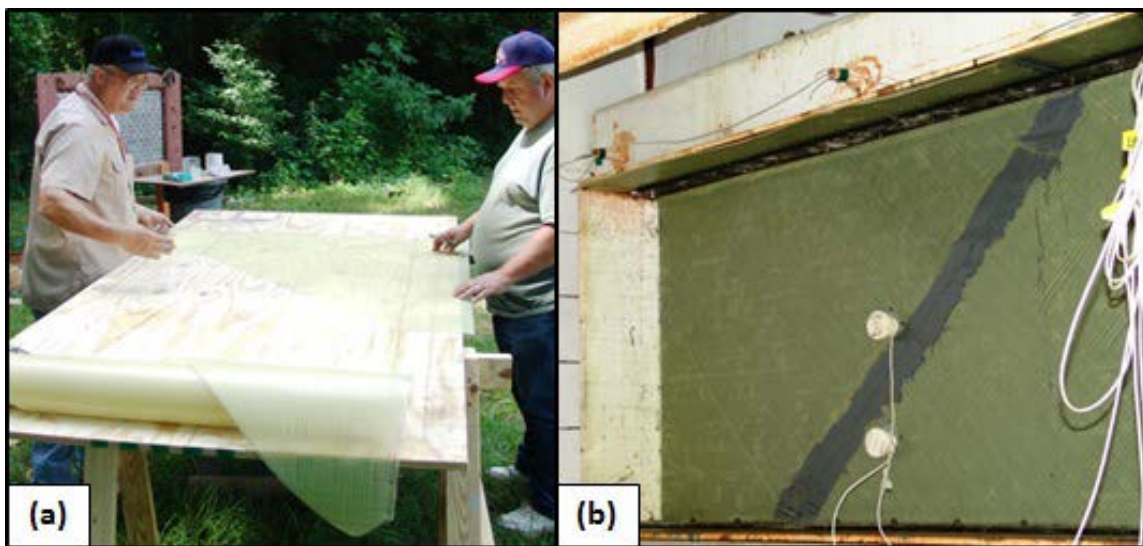
Figure 6.38. DW14. (a) Cutting film to orient fibers 45 deg to the horizontal mortar joints of the wall. (b) Two sheets of film used to cover CMU wall with epoxy seam along the center.

Wall DW14 was retrofitted using a two part trowel-on epoxy to adhere a fiber-reinforced film to the interior surface of the CMU wall. When this experiment was conducted, a fiber-reinforced film with fibers oriented at a 45-deg angle to the horizontal line across the film could not be manufactured. The fabric with fibers oriented at 0 and 90 deg was purchased from a supplier and sent to a manufacturer to create the fiber encapsulated film. The film was laid out and cut (Figure 6.38a), so that when the film was applied to the wall, the fibers would be oriented at + 45 and -45 deg to the horizontal support. Two pieces of film were needed to cover the wall surface, and one piece of material overlapped the previous sheet by 2 in. Extra epoxy was added at the seam to prevent the material from peeling back at the seam (Figure 6.38b). In addition to

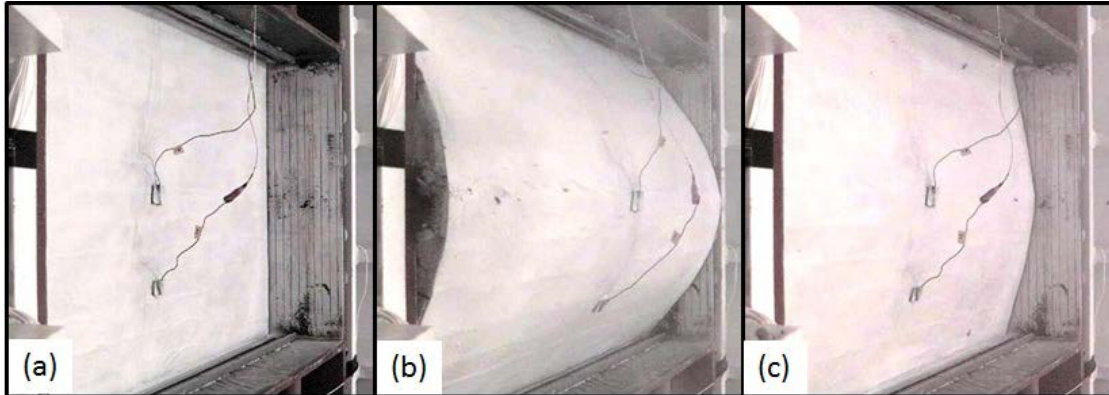
Figure 6.56. BLS5: Frames from high-speed video. (a) Pretest view before airblast arrives. (b) Point of maximum deflection. (c) Final wall position.

well at level 3, the reflected impulse load was raised to level 5 for BLS5. Figure 6.56a is a still frame of the interior retrofitted surface of the wall before impact of the airblast.

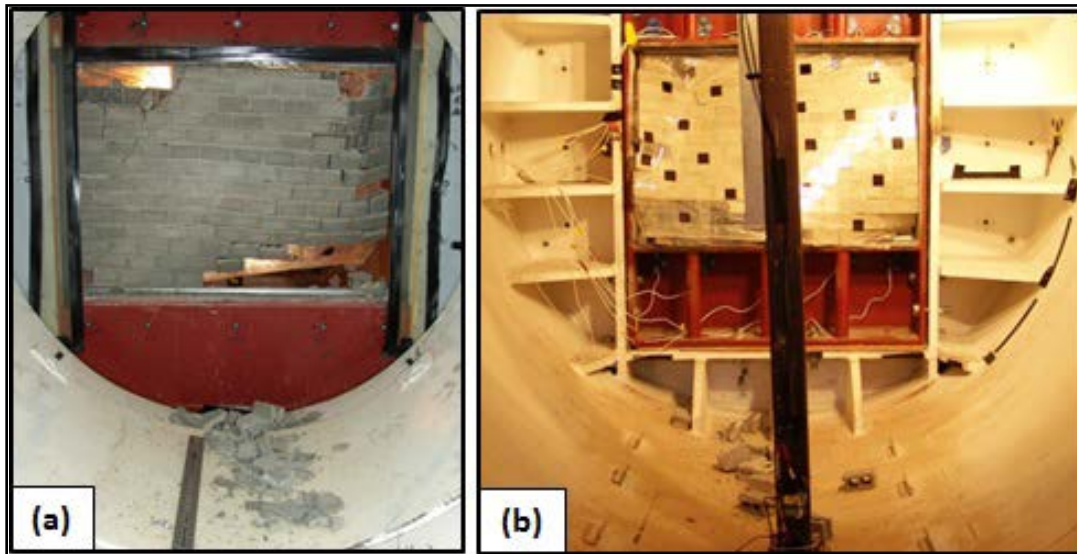
Figure 6.68. BLS7. (a) Damage to CMU wall. (b) Debris found in target vessel.

The retrofit system on BLS7 failed when 90% of the elastomeric film sheared along the edge of the anchor plate on the bottom support, and 22% of the film failed along the edge of the anchor plate on the top support (Figures 6.65a through e, 6.66 and 6.67). Although the elastomeric film tore, most of the blocks remained adhesively engaged to the film. Thirty percent of the blocks were missing from the film (Figure 6.68a), 21% were found in the BLS device, and 9% of the debris was found in the target vessel.

Almost 8% of the debris in the target vessel was found within 4 ft of the interior wall surface (Figure 6.68b). Two blocks were found 10 ft and 12 ft away from the original wall location.

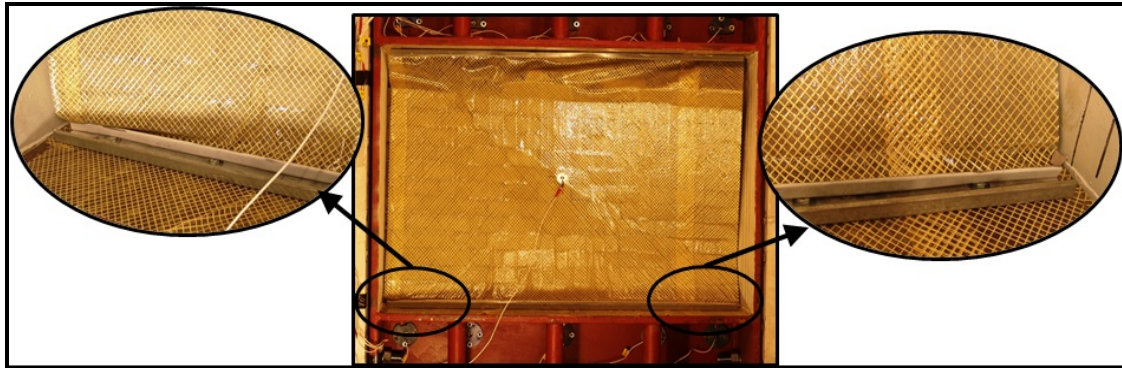
Figure 6.71. Interior view of retrofitted wall BLS8 and the damaged anchor plates.

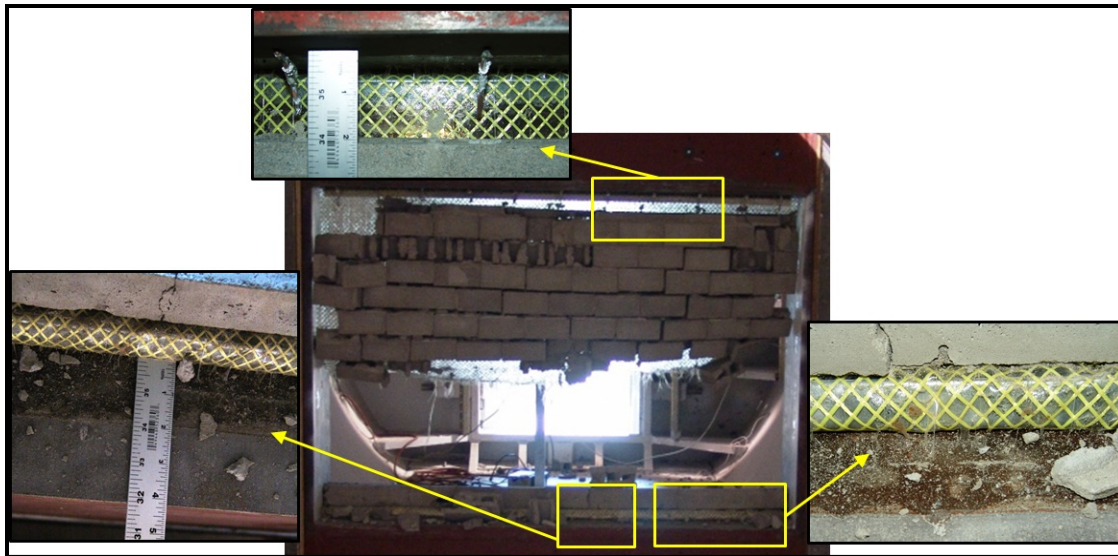
Figure 6.78. BLS9: Exterior view of anchor plates on the supports and damaged wall/retrofit materials. (Adapted from Johnson, Davis, Coltharp, Durst, and Smith 2010)

The anchor plates were not visible from the blast face before the experiment, but both anchor plates can be seen in the posttest pictures in Figure 6.78. The fibers that were pulled out of bundles from each half of the wall can be seen in Figure 6.79.

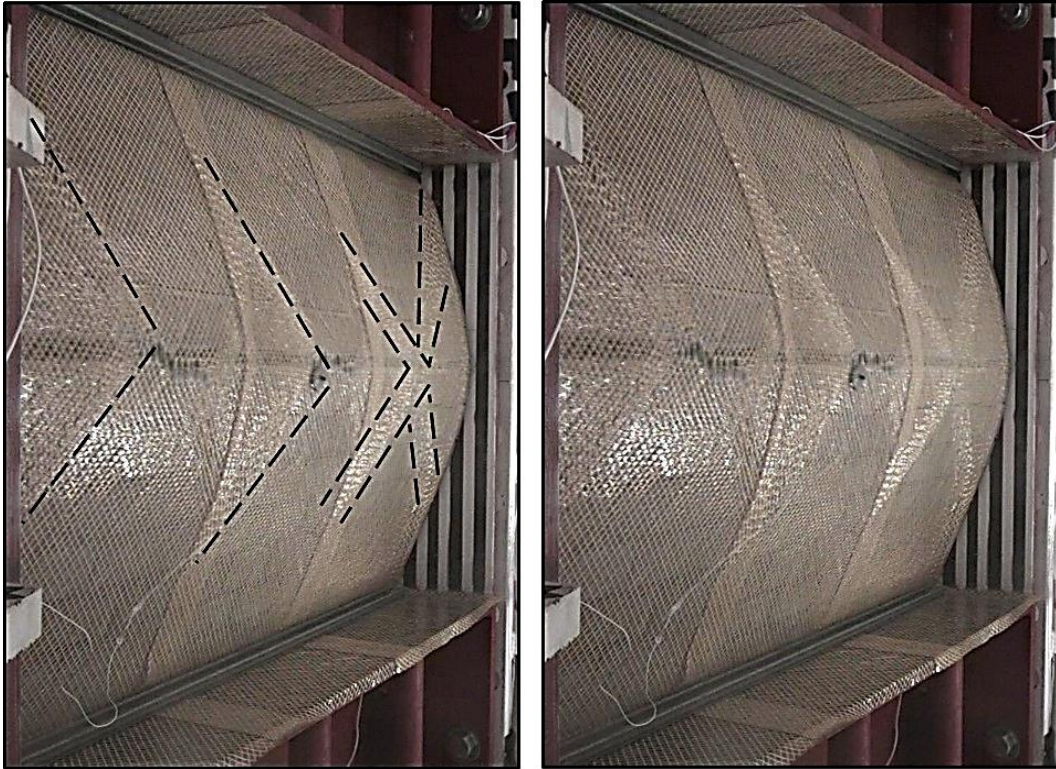
Figure 6.83. The two photos illustrate the pattern created in the elastomeric film at high stress and strain areas.

The high-speed camera located on the left side of the target vessel captured images of the wall's response that appeared to punctuate the high stress and strain areas in the elastomeric film. The lighting and camera angle appeared to highlight these areas in the

mid-section of the wall where the fibers were engaged during the wall's deformation.

One still frame from the video was chosen as an illustration (Figure 6.83). Dashed lines were added to the frame on the left to highlight the areas of interest on the frame to the right.

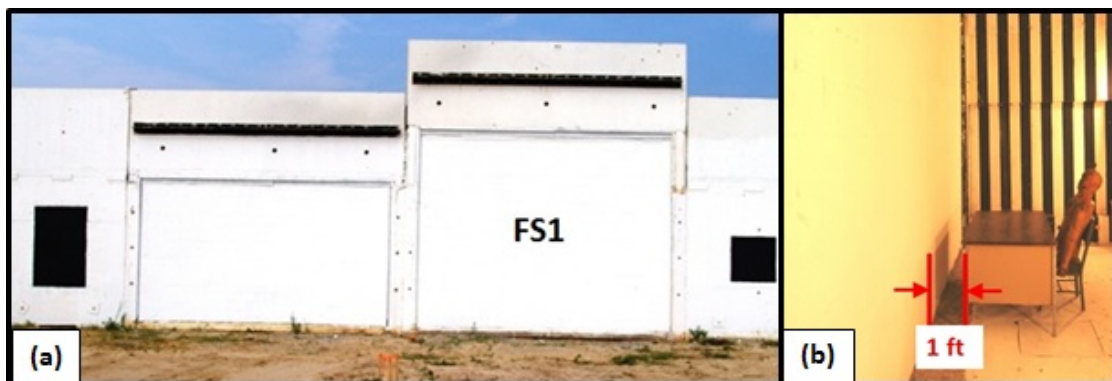
Figure 7.4. FS1. (a) Pretest view of exterior. (b) Interior view.

The first full-scale experiment evaluated at the AFB was an unretrofitted (baseline) CMU wall. The baseline wall was used to validate the secondary debris hazard associated with a blast load that was previously observed in the subscale HE and BLS experiments. The wall was constructed in the largest reaction structure available, Bay 2 with the extension (Figure 7.4a). A thin metal desk and a mannequin sitting in a steel chair were placed behind the test wall (Figure 7.4b).

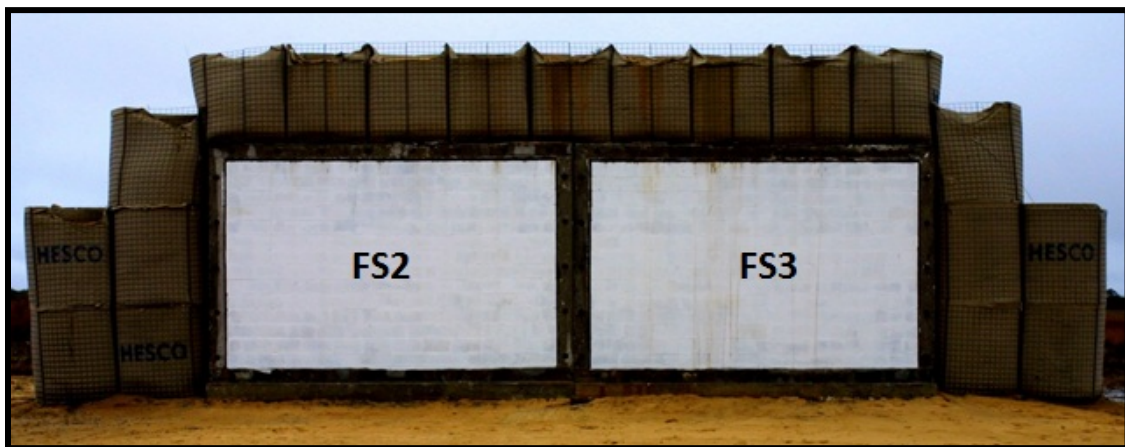
Figure 7.8. Pretest photograph of walls FS2 and FS3.

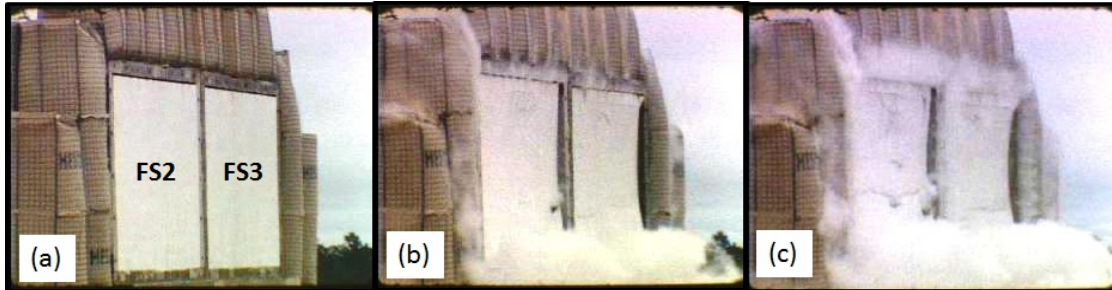
Figure 7.9. FS2 and FS3: High-speed video from exterior camera. (a) Pretest camera view. (b) Blast pressure impacts walls. (c) CMU blocks begin to disengage from retrofit.

Wall failure did not occur during the initial response. High-speed video indicated that the peel-back failure at the top support occurred after the initial loading and during the rebound of the wall (Figures 7.9a through c and Figures 7.10a through e). The adhesive bond was inadequate to maintain the retrofit integrity at the top support. The lack of adhesion could be attributed to the condition of the supports during the application of the retrofit. A 3-ft portion of the retrofit located at the bottom left corner support also peeled back. Although the retrofit system failed at the supports (Figure 7.10), no CMU wall debris was discovered inside the reaction structure. Posttest inspection of the material indicated that the liner had no visible damage and peeled off

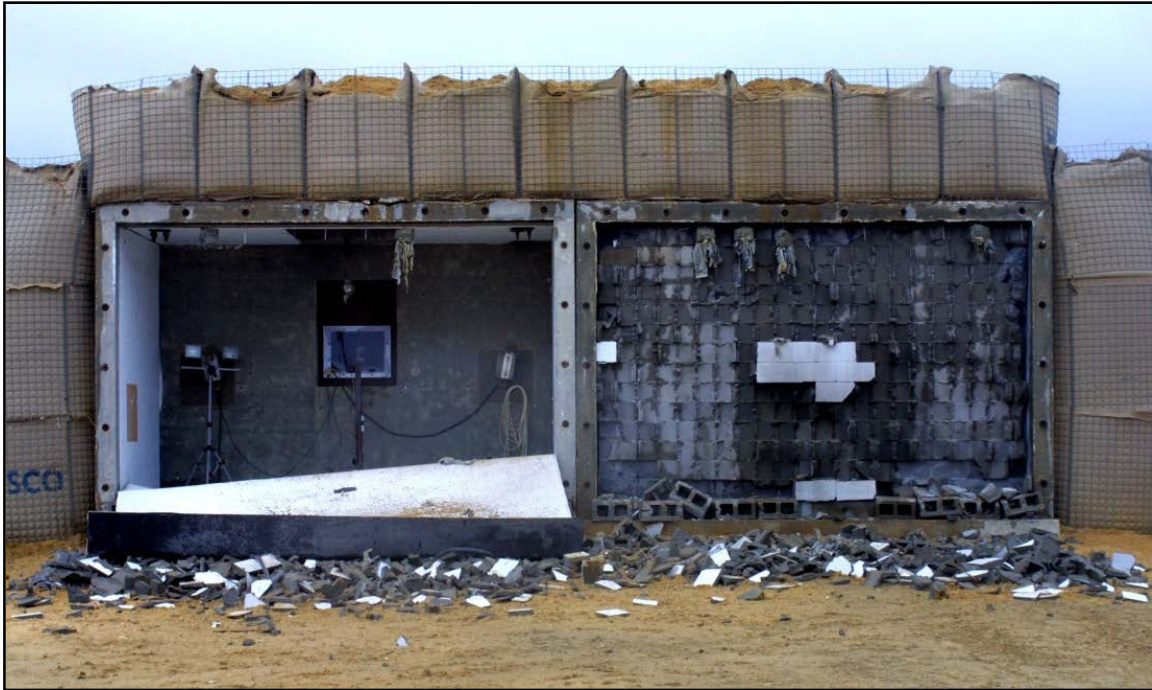
Figure 7.11. Posttest photograph of walls FS2 and FS3.

the reaction structure as one entity (Figures 7.11 and 7.12a and b). None of the CMU blocks remained adhered to the layer of polyurea.

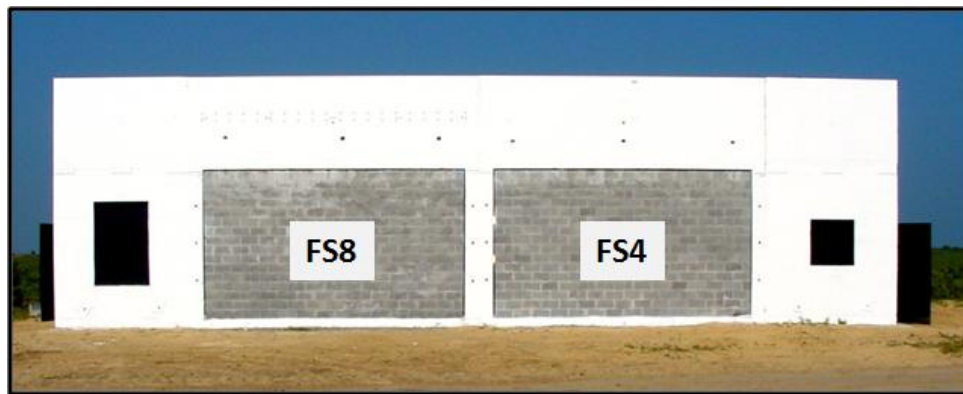
Figure 7.14. Pretest exterior view of retrofitted CMU walls FS4 and FS8.

Wall FS4 was constructed in Bay 2 and it was also retrofitted with a reinforced spray-on elastomer (Figure 7.14). First, eight passes of Grade 2 spray-on polyurea were applied to the wall, followed by a layer of Fabric E applied with the fibers oriented

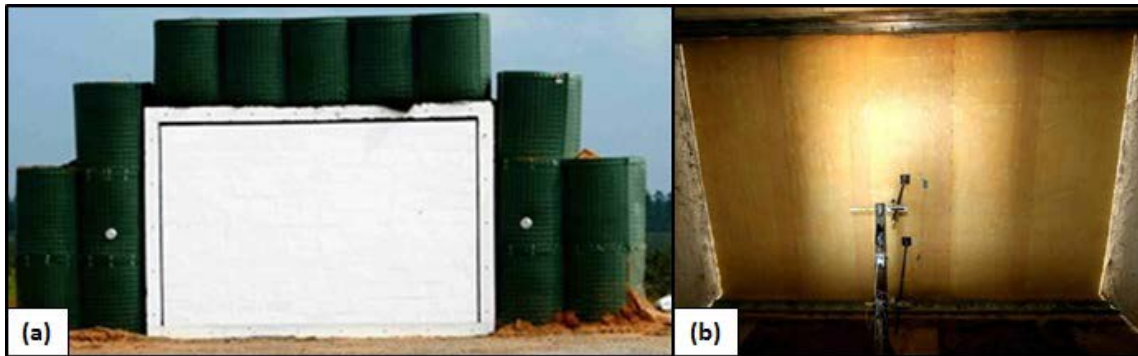
Figure 7.29. FS10. (a) Pretest exterior view of Bay 3. (b) Pretest interior view.

Wall FS10 was built in Bay 3, and the trowel-on thermoset and thermoplastic film materials and application procedure used in FS8 and FS9 were duplicated (Figures 7.29a and b). The mechanical connection used to secure the retrofit materials was changed from System 2 to System 3. A thin-wall steel stud member was used instead of the robust steel anchor plate, and the Hilti anchor bolts were replaced with Red Head concrete bolts (Figure 7.30a). A single continuous steel stud member was not installed;

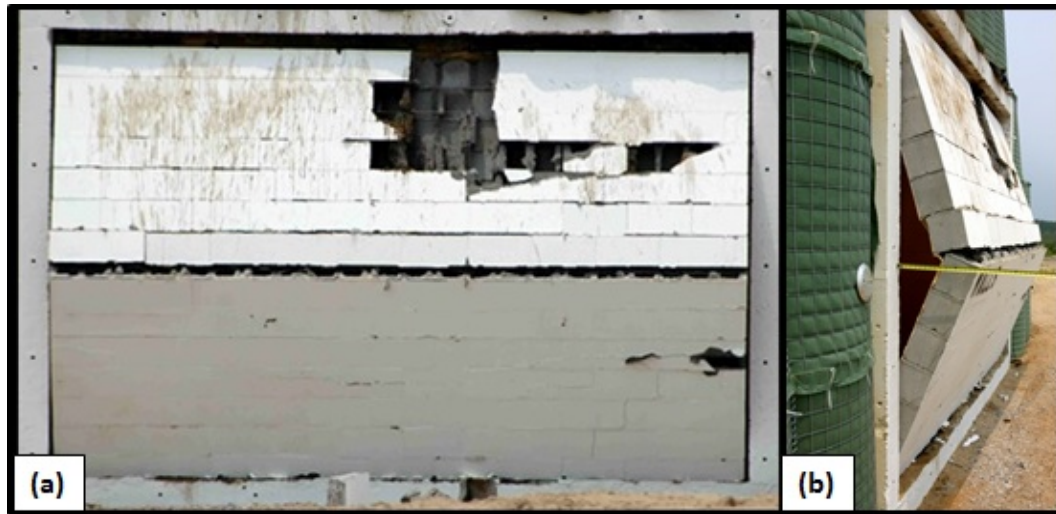
**Figure 7.33. FS10. (a) Posttest exterior view.
(b) View of permanent deformation.**

Eight of the blocks or 5% of the total blocks were damaged (Figure 7.33a). The wall had a peak deflection at mid-span of approximately 1 unit into the reaction structure and a permanent deflection of approximately 0.411 out of the structure (Figure 7.33b). The top and bottom anchors used to secure the retrofit were engaged during the wall's response, and the top anchor plate was deformed (Figure 7.31b). The side wall of the steel channel adjacent to the CMU wall on the bottom support was also deformed as shown in Figure 7.34a. Hours after the blast event, the weight of the blocks on the retrofit along the bottom half of the wall disengaged and fell to the ground (Figure 7.34b).
