EQPETGVG'O CUQPT['Y CNN'TGVTQH'U UVGO UHQ'T'DNCUV'RTQVGEVKP "

A Dissertation

CAROL FC[G JOHNSON

Major Subject: Civil Engineering

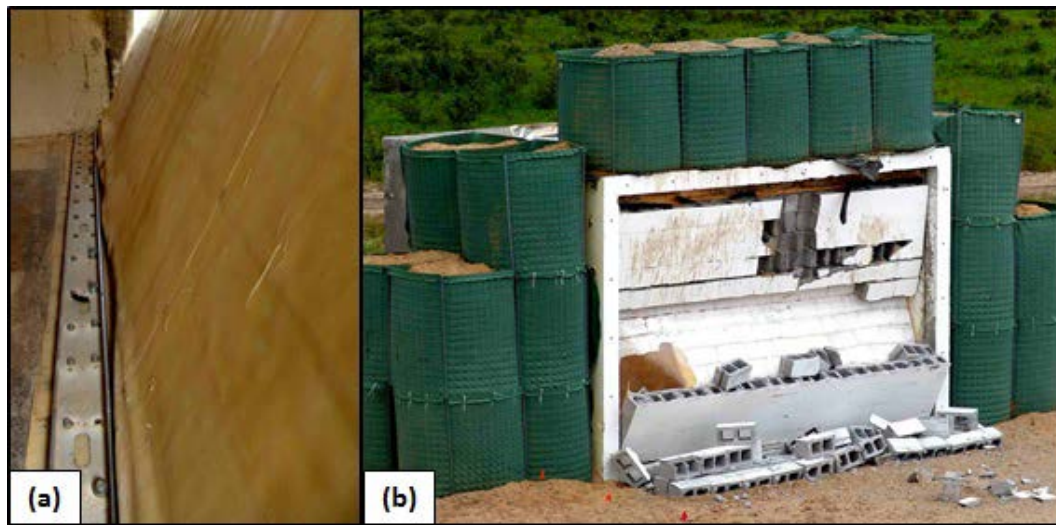
Figure 7.34. FS10. (a) Bottom support was engaged during wall response. (b) Hours after the blast event, the bottom section of the wall disengaged from the retrofit material.

Eight of the blocks or 5% of the total blocks were damaged (Figure 7.33a). The wall had a peak deflection at mid-span of approximately 1 unit into the reaction structure and a permanent deflection of approximately 0.411 out of the structure (Figure 7.33b). The top and bottom anchors used to secure the retrofit were engaged during the wall's response, and the top anchor plate was deformed (Figure 7.31b). The side wall of the steel channel adjacent to the CMU wall on the bottom support was also deformed as shown in Figure 7.34a. Hours after the blast event, the weight of the blocks on the retrofit along the bottom half of the wall disengaged and fell to the ground (Figure 7.34b).

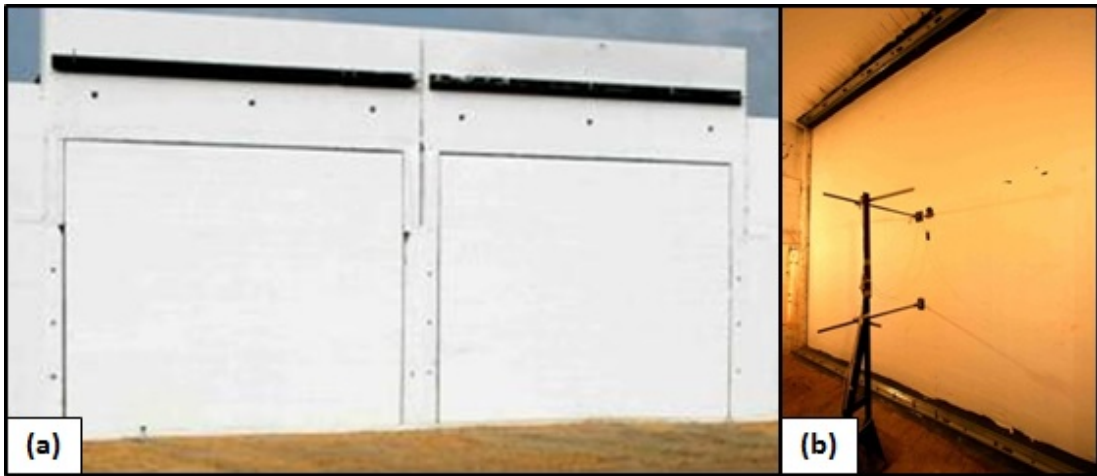
**Figure 7.35. FS11. (a) Pretest exterior view.
(b) Pretest interior view.**

Wall FS11 was built in Bay 1 with an extension to increase the wall height to 177 in., and the trowel-on epoxy and polyurethane film application process was similar to the procedure used in FS8-FS10 (Figures 7.35a and b). The epoxy/polyurethane combination did not bond as well as the thermoset/thermoplastic combination, so additional bracing was used at the top and bottom supports until the epoxy cured. The complete application procedure used to install the retrofit system was discussed in Section 4.7.3. Once the epoxy cured, the temporary braces were removed, and mechanical anchor System 2 was installed to secure the retrofit system. The polyurethane film was painted white to improve the quality of the video, since high-speed cameras require a significant amount of light to record at the speeds and resolution required for dynamic experiments. However, the white paint also provided an added benefit that was not planned. The white paint highlighted the high stress and strain areas on the wall. These high stress and strain areas located at the mortar joints in the central portion of the wall were identified when the paint deformed beyond its limit. As shown in Figures 7.36a, b, and c and Figures 7.37a and b, the paint failure along the mortar joints was very clear.

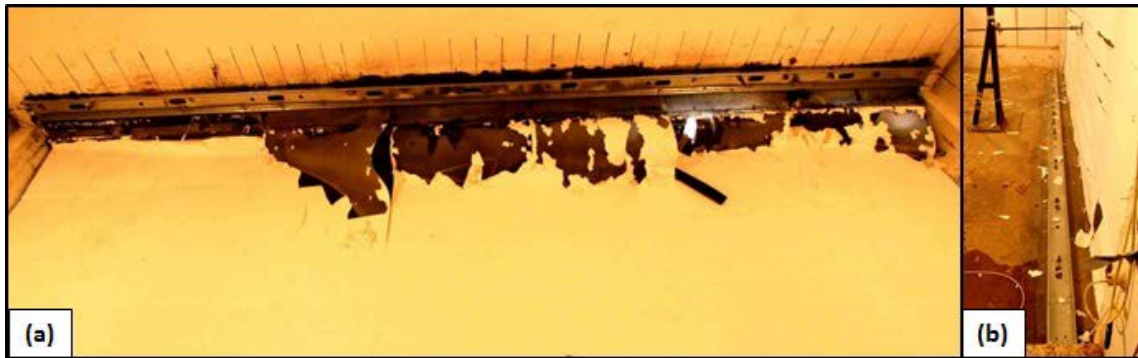
Figure 7.38. FS11. (a) Five of the seven sheets of film peeled off the top of the CMU wall. (b) Film at the bottom support did not appear to peel back.

The retrofit system on FS11 was subjected to the same dynamic load level (3) that FS10 survived. Five of the seven polyurethane sheets did peel down two to three blocks along the top of the CMU wall (Figures 7.37a and b and Figure 7.38a). The peel back of the film along the top support of the CMU wall could be contributed to the 1-in. gap at the top of the wall. Pipe foam was placed in the gap, but it did not completely fill the

void. The blast pressure may have jetted through the voids and applied a direct load to the adhesive between the film, epoxy, and CMU. No tears were found in the polyurethane film during the posttest inspection. The polyurethane film did not peel back at the bottom support (Figure 7.38b). The external high-speed video frames in Figure 7.39a, b and c show that the wall deflected at least 0.365 into the reaction

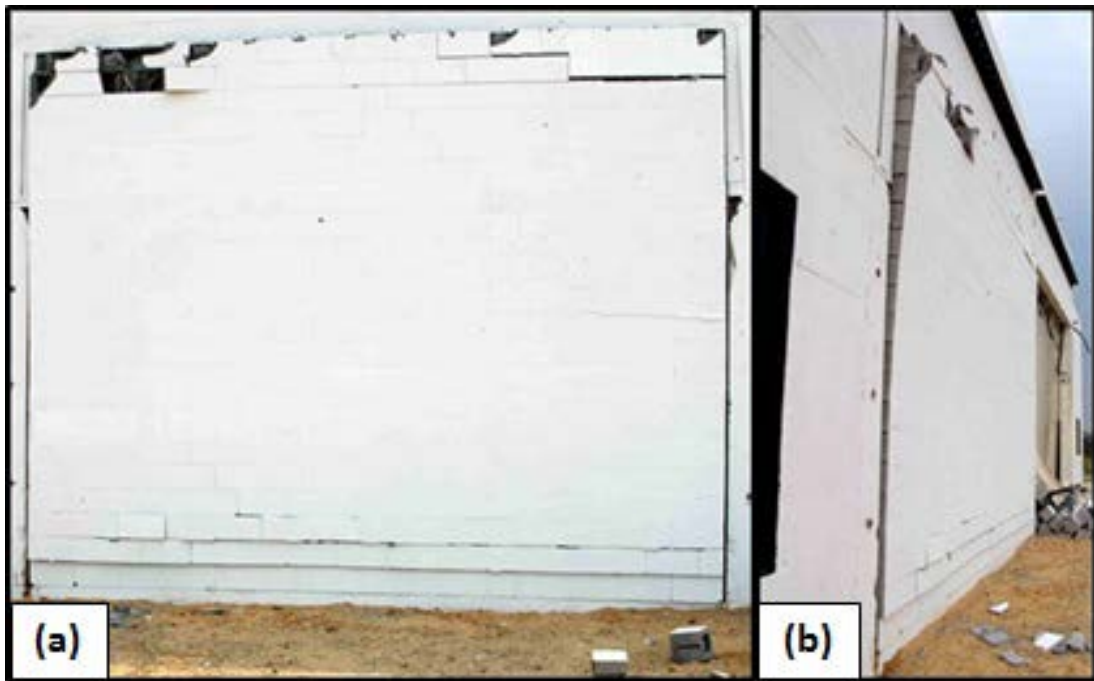
Figure 7.40. FS11. (a) Posttest view. (b) Posttest profile view.

structure. No debris was found inside the structure, and only four blocks lost their face shells (Figure 7.40a). Although the wall was compromised, it remained in the reaction structure. It appears that the wall was close to falling out of the reaction structure during the rebound phase because the wall was leaning out of the structure at the top course by $\frac{3}{4}$ of a block width (Figure 7.40b).

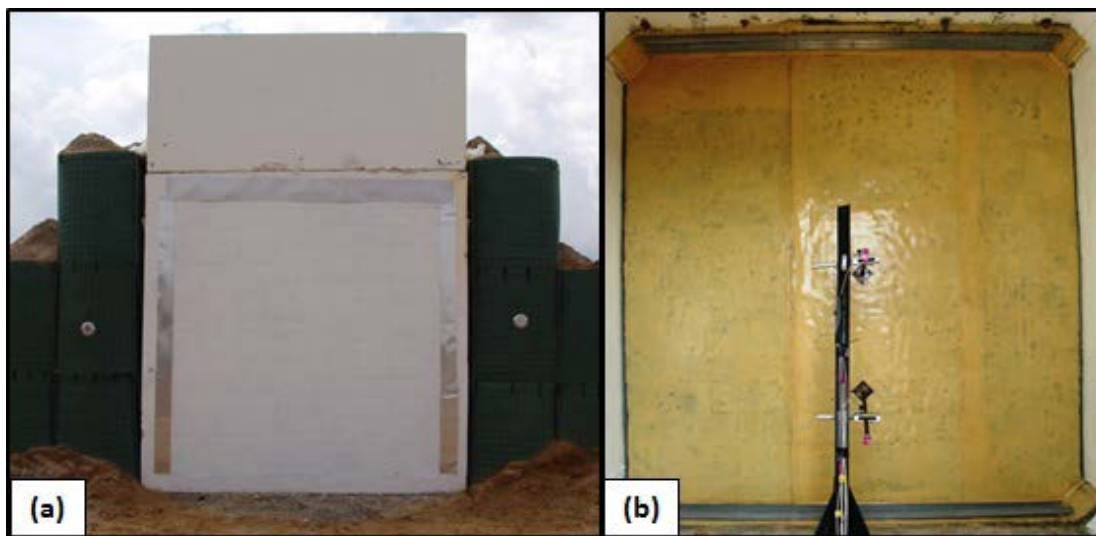
Figure 7.45. FS13. (a) Pretest exterior view with aluminum flashing covering the gaps. (b) Pretest interior view.

Wall FS13 was also constructed in Bay 5 and retrofitted with the trowel-on thermoset and an elastomeric film with Fabric F as the fiber reinforcement (Figures 7.45a and b). The elastomeric film was processed with the fiber reinforcement

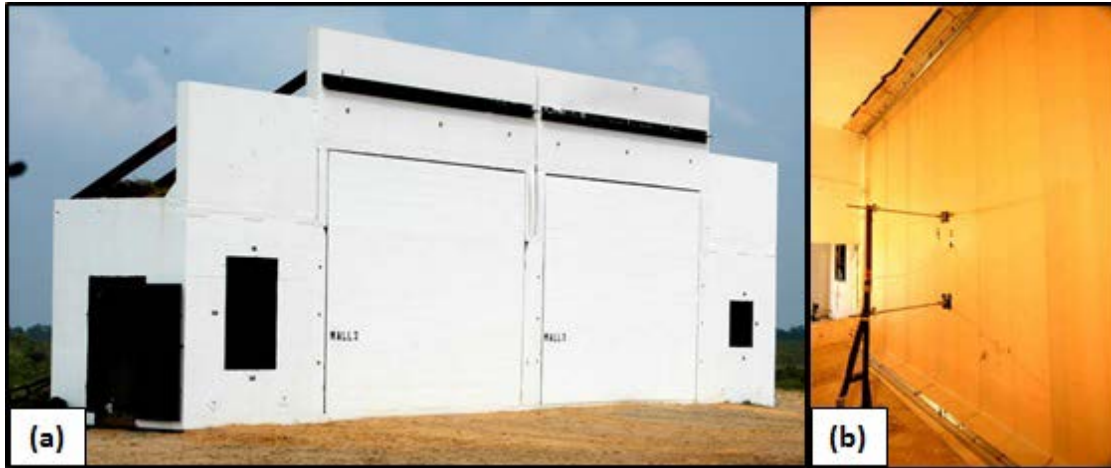
Wall FS14 was constructed in Bay 2 with an extension to increase the height to 177 in. and was retrofitted with a PSA and elastomeric film (Figures 7.48a and b). The PSA, a COTS carpet tape, was applied to the elastomeric film first. Then the film was cut to length and applied to the CMU wall. The concrete supports were primed (Primer 4), and the trowel-on epoxy used in previous experiments was used to adhere the film to the supports. A temporary support system was used until the epoxy cured, then the mechanical anchor System 2 was installed. Wall FS14 was evaluated at dynamic load level 3.

**Figure 7.48. FS14. (a) Pretest exterior view.
(b) Pretest interior view.**

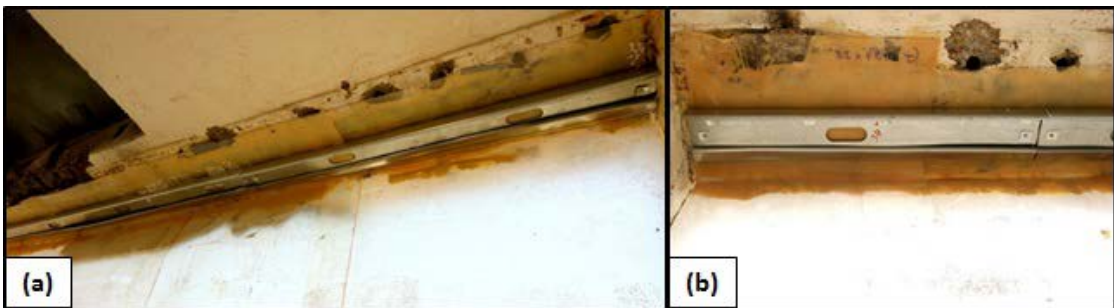
Figure 7.54. FS15. (a) Mechanical anchor at top support. (b) Close-up of deformed anchor.

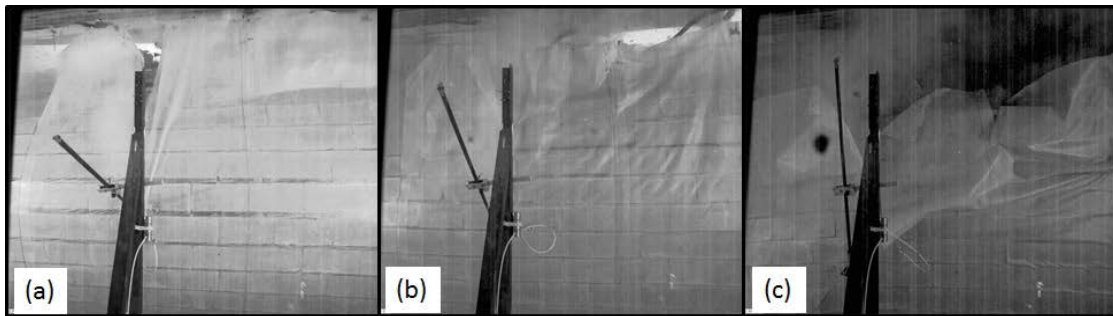
Figure 7.57. FS16: Frames from high-speed camera. (a) Blocks begin to disengage from the film. (b) Tear in film propagates the full length of the support. (c) Film and blocks fall into reaction structure.

The high-speed video showed the different phases of the retrofitted wall's response to the blast load as the wall deformed into the structure. First, cracks developed in the mortar joints, and then as the deformation continued, the film began to rip from left to right across the top support (Figures 7.56a, b, and c). The elastomeric film on the right half of the wall failed milliseconds later (Figures 7.57a, b, and c). The blocks and film

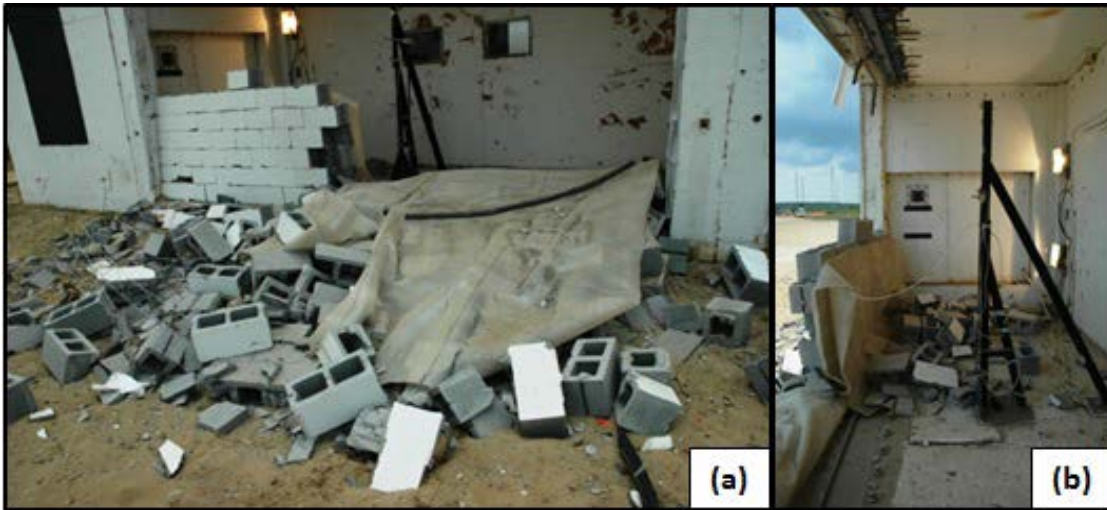
on the left half of the wall, which failed early in the wall response, fell outside the reaction structure (Figure 7.58a). The blocks from the top right half of the wall and the film both fell into the reaction structure (Figure 7.58b). In Figure 7.59a, the torn edge of the film is shown. The film failed before the steel stud member was deformed as shown in Figure 7.59b.

Figure 7.58. FS16. (a) Half of the wall fell out of the reaction structure. (b) Half of the wall fell into the reaction structure.

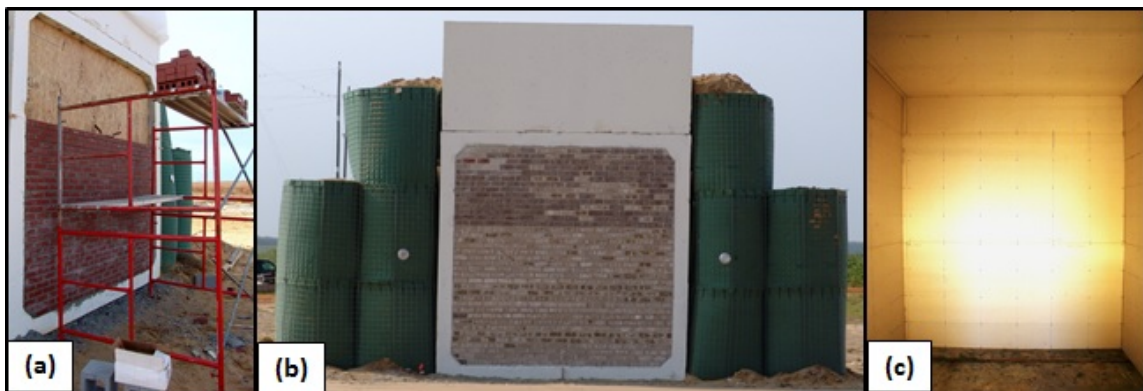
Figure 9.4. Brick façade. (a) Single wythe brick veneer. (b) Target exterior. (c) Target interior.

dimensional lumber, and standard sheetrock (gypsum board) was used on the interior walls and ceiling (Figures 9.3c and 9.4c). Veneers consisting of a single wythe of bricks were added to the front wall (Figures 9.4a and b) of each target. Unlike the CMU walls evaluated in the research program, a gap was not provided at the top or on the sides of the reaction structure to ensure a one-way response.

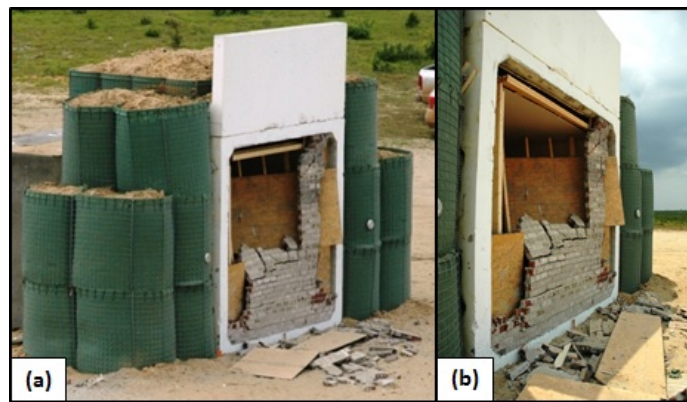
Figure 9.5. Unretrofitted wall response. (a) Posttest exterior view. (b) Debris outside of structure.

The unretrofitted target was heavily damaged during the HE event (Figure 9.5a). A majority of the brick veneer fell outside the reaction structure, but several large sections were propelled or fell into the reaction structure (Figure 9.5b, 9.6b, and 9.6c). The dimensional lumber and plywood used to frame the top half of the front wall were pulled away from the top support (Figure 9.6a). The bolts anchored the side walls and prevented the bottom plate from moving. This could be one reason that the primary

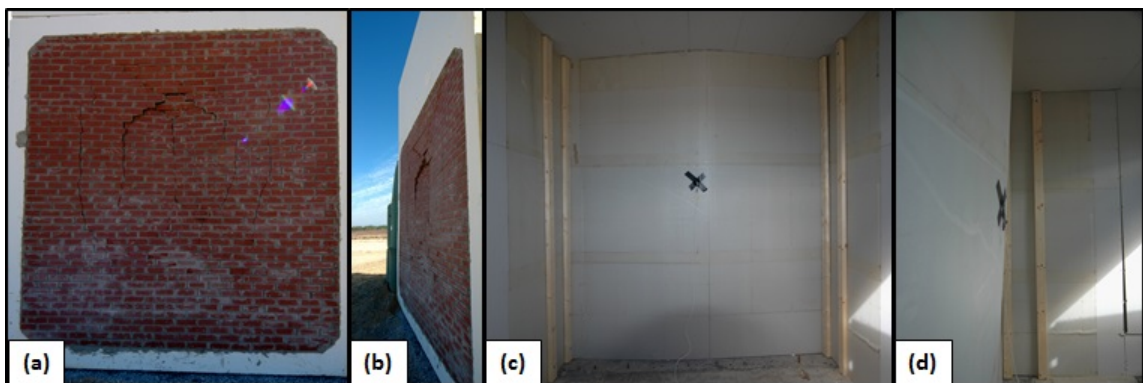
Figure 9.8. Retrofitting wall response. (a) Posttest exterior of retrofitted wall. (b) Profile view of wall. (c) Posttest interior view of wall. (d) Retrofitted wall deflected into structure, but no debris fragments were found inside protected space.

The retrofitted wall was damaged during the airblast, but no secondary debris was found inside the reaction structure. The brick veneer was cracked (Figure 9.8a), and the center of the wall deformed into the reaction structure (Figure 9.8d). The damage to the brick veneer implied that the wall developed a two-way response. As in the unretrofitted experiment, the largest amount of damage and deformation occurred in the top half of

the wall (Figure 9.8b). The accelerometer mounted on the center of the wall (Figure 9.8c) recorded a maximum deflection of 0.388.

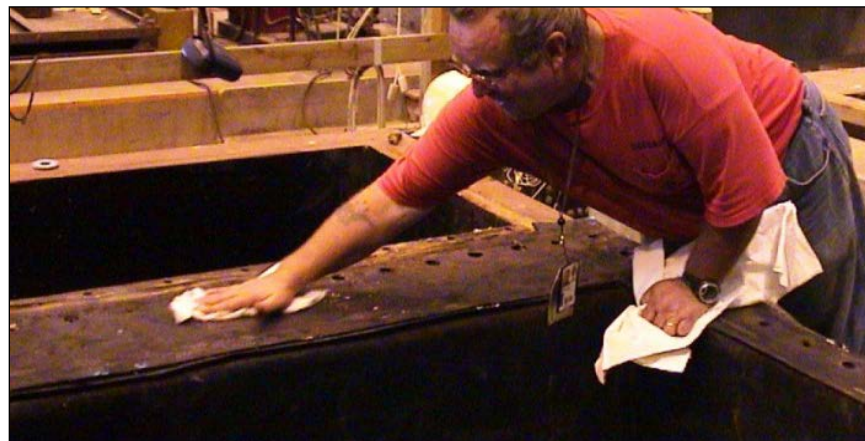
Figure C4. Neoprene seal is cleaned prior to application of new silicone.

the test. All of the old silicone used in previous experiments should be removed (Figure C4) before the setup process begins.

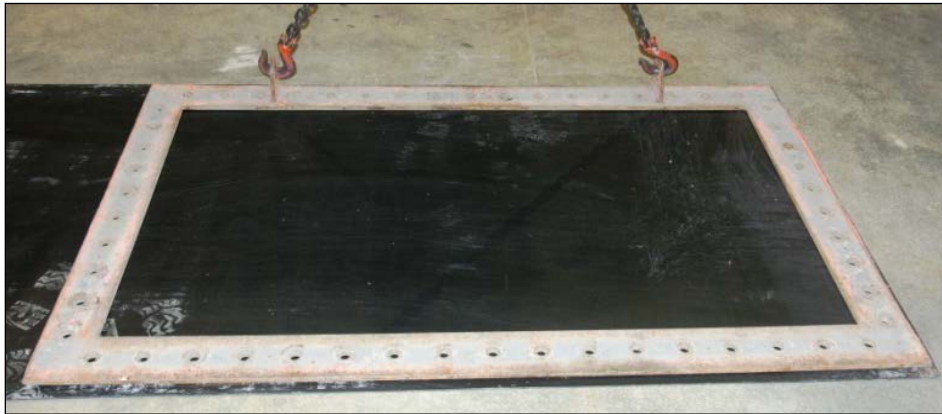
Figure C5. Steel ring and neoprene membrane.

Step 2: A neoprene membrane is used to seal the pressurized chamber and to apply the hydrostatic load on the test specimen. Unreinforced and one- and two-fiber-reinforced neoprene materials have been used, but the single-fiber-reinforced material performs the best. The unreinforced material was too weak to sustain higher loads on the test specimen, and the two-fiber material was not ductile enough to sustain large deformations. The material can be cut to 42 in. by 74-3/8 in. using a simple work knife (Figures C5 and C6).

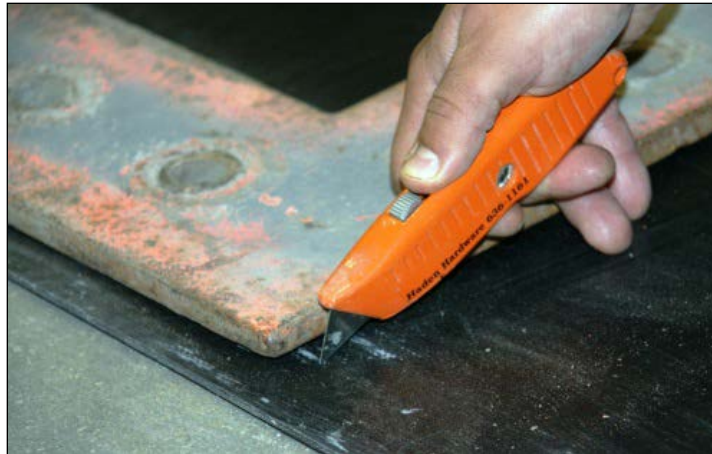
Figure C6. Simple work knife used to cut neoprene material to correct size.

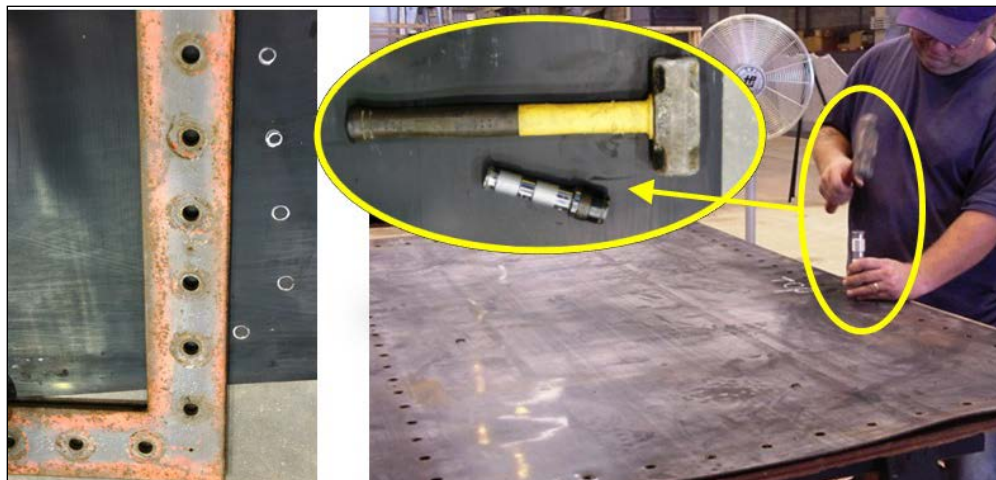
Figure C7. Use steel frame to layout bolt holes, then hammer and punch to create pass-through holes for bolts to secure the membrane to the HTC.

Step 3: Use the steel frame for the membrane to layout the proper bolt-hole placement in the neoprene. Use a punch and hammer to create pass through holes for the bolts that will be used to secure the membrane to the pressure vessel chamber (Figure C7).

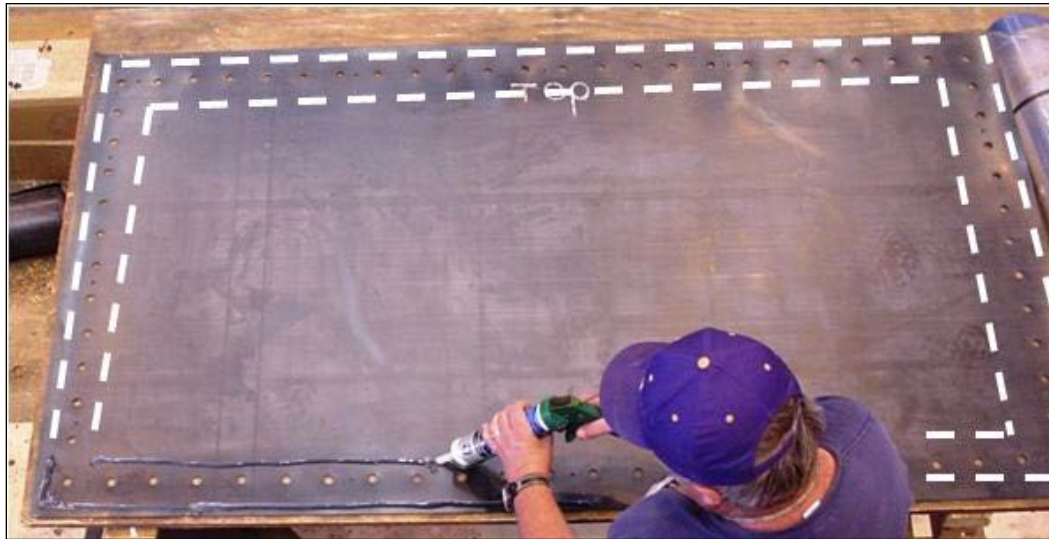
Figure C10. Apply two solid beads of silicone to membrane (one along perimeter and one just inside the bolt holes) before it is attached to pressure cavity.

Step 5: A solid bead of silicone should be placed along the perimeter of the membrane and on the interior line along the bolt holes. The full silicone bead should follow the dashed lines as shown in Figure C10. Use the crane to lift the membrane and lower it into the chamber on the pressure side (Figure C11).

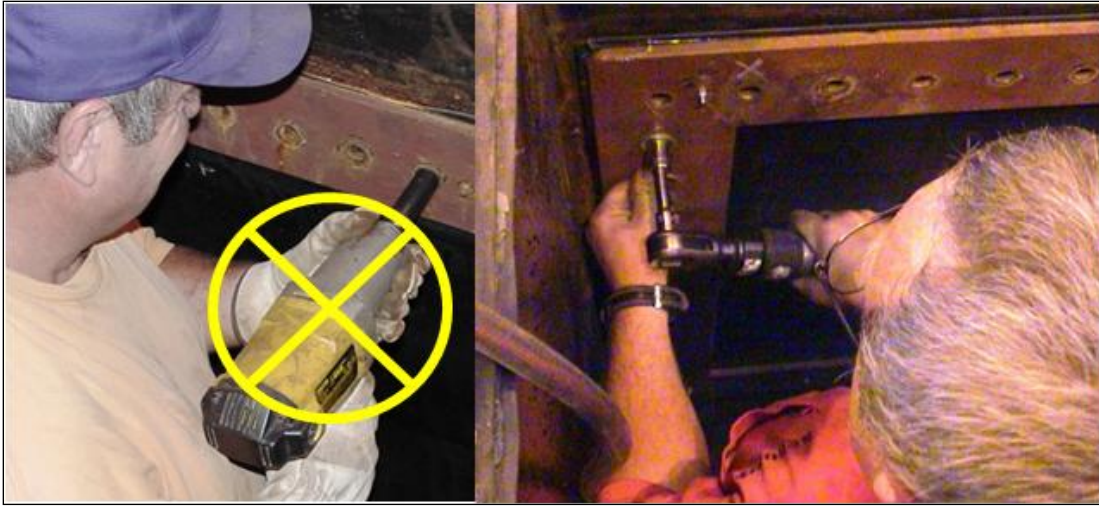
Figure C12. Bolt membrane steel frame to pressure cavity. Do not use an impact wrench; use an air or torque wrench.

Note: There will be multiple steps while setting up the HTC for an experiment that will require the user to bolt components to the walls of the HTC. When instructed to bolt a component to the HTC, DO NOT use an impact wrench (Figure C12). Use an air driven or socket (hand tool) wrench to tighten the bolts. The steel used to construct the HTC is thin, so an impact wrench will destroy the threads in the bolt holes.

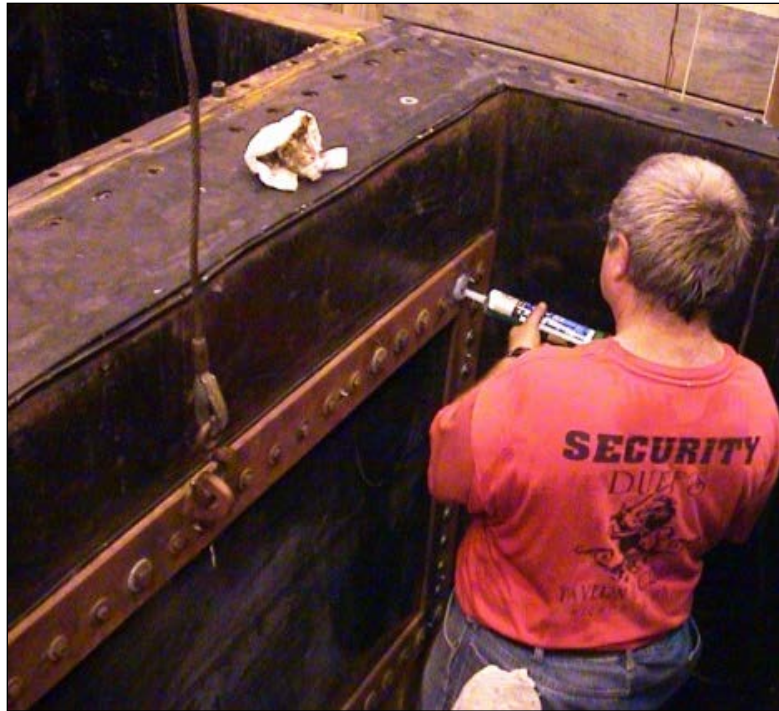
Figure C13. Silicone around bolts that may be stripped.

Step 6: Bolt the membrane into the pressure vessel. Check all the bolts used to secure the membrane before the top of the pressure chamber is attached. If a bolt is stripped and cannot be tightened, check to ensure the threads on the bolt are adequate. If the bolt threads look damaged, use another bolt. If the bolt is still loose and cannot be tightened, leave the bolt in place (as a plug) and silicone around the bolt to prevent any water leakage between the pressure and open chambers of the test apparatus (Figure C13).

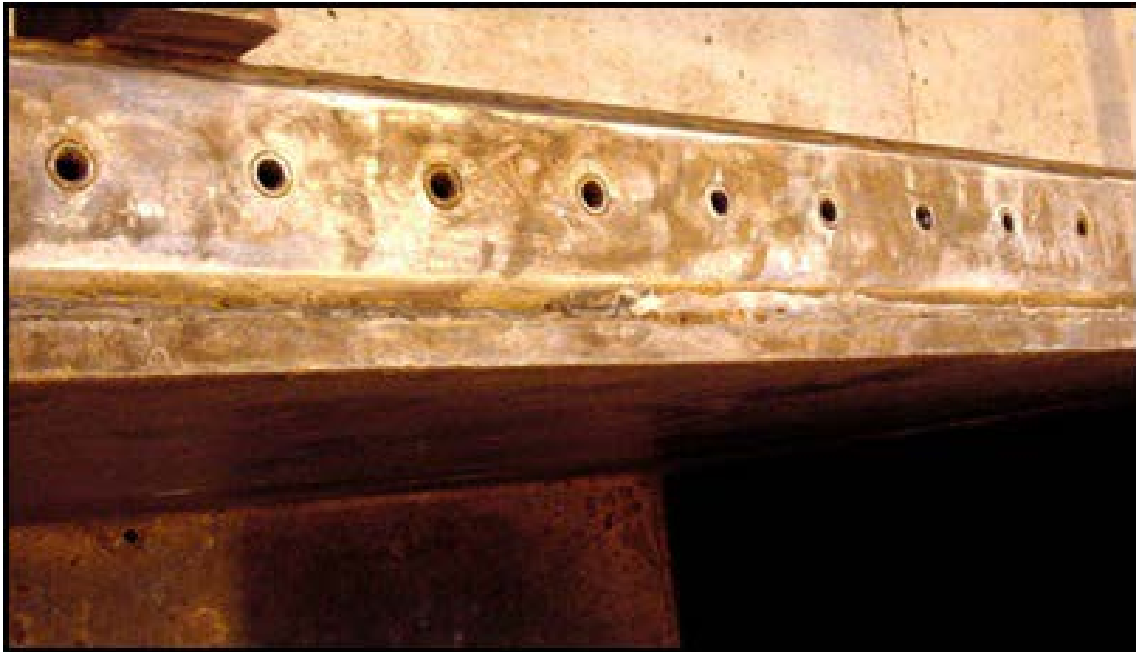
Figure C16. Cleaned side walls of pressure cavity.

Step 8: Remove all of the old silicone from the steel edges of the pressurized cavity using a wire brush or grinder with a cut-brush attachment (Figure C16). Inspect the previous neoprene layer; if the neoprene can be reused, simply clean the old silicone material off with a wire brush (Figure C17). If the neoprene cannot be reused, cut a new neoprene layer about 12 in. wide to fit along the edges of the chamber. Use the lid to layout the pass-through holes needed in the neoprene layer. Use the hammer and hole punch to create the pass-through holes. Note: To reduce the labor and time between experiments, it is recommended that an o-ring and a channel to house the o-ring be built into the top edges of the frame.

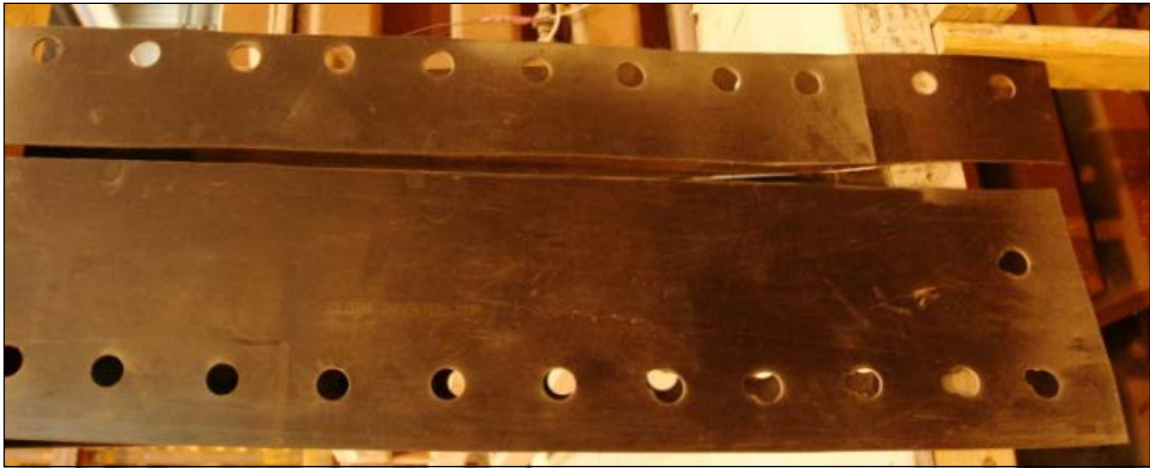
Figure C17. Neoprene seals used along side walls of pressure cavity.

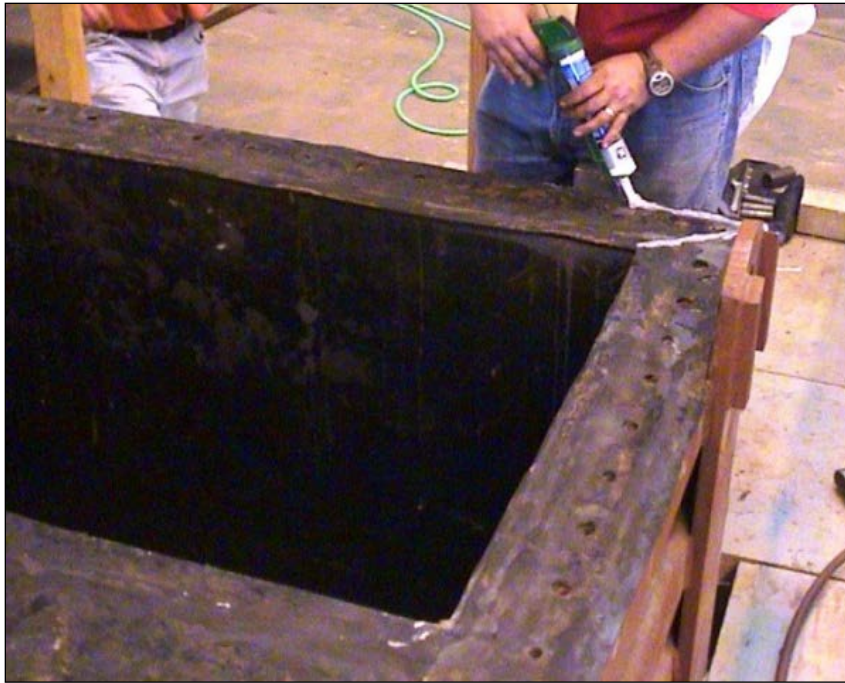
Figure C18. Apply silicone to steel edges of pressure vessel then apply neoprene seals.

Step 10: Place a bead of silicone along the perimeter of the pressure cavity (Figure C18). Make sure that a bead is along the interior and exterior edges of the steel cavity frame. Then place the precut and punched neoprene layer along the pressure vessel. Apply another bead along the interior and exterior perimeters of the neoprene before the lid is applied (Figure C19).

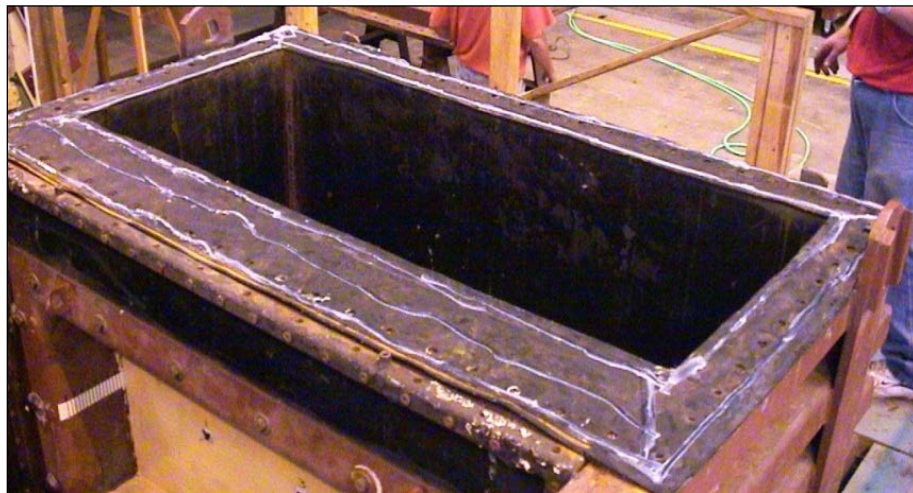
Figure C19. Apply another layer of silicone on neoprene seals before the lid is attached.

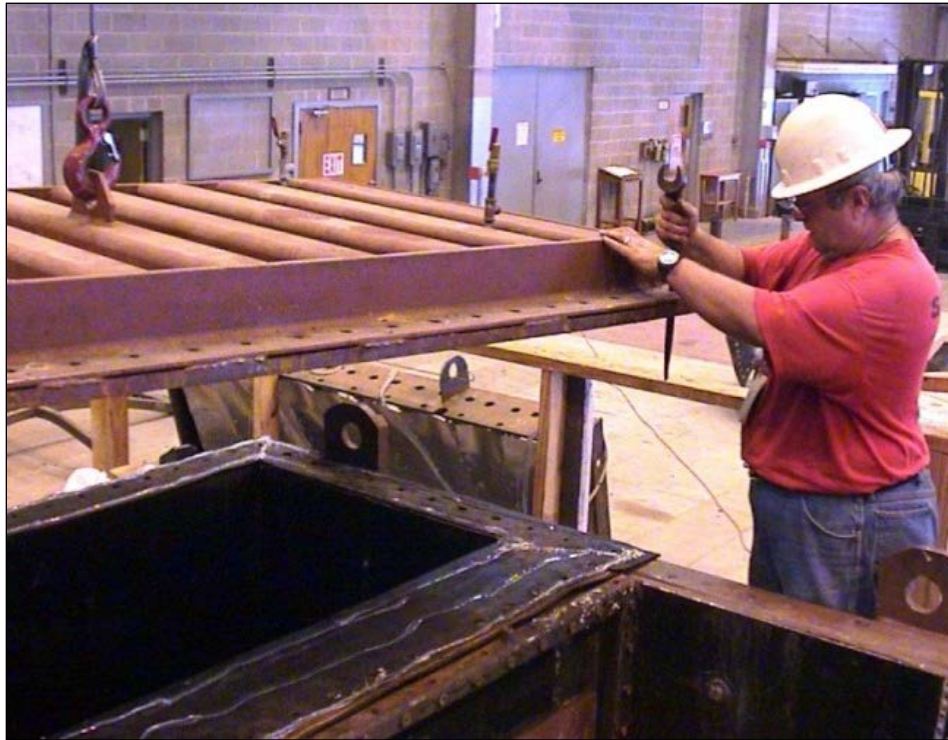
Figure C20. Attach lid to pressure vessel.

Step 11: Bolt the lid to the top of the pressure vessel (Figure C20). Use an air wrench or torque wrench to tighten the 64 3/4-in.-diam bolts (Figure C21). The lid and the pressure vessel will sandwich the neoprene layer (Figure C22). If a bolt hole is stripped or loose, leave the bolt in place and silicone around the bolt to prevent any water leakage. Mark or note the bolt hole that is loose or stripped so that it can be re-tapped before the next experiment. Because of the large number of bolts used to secure the top, a test can be conducted if one to six bolts are stripped as long as none of the stripped bolts are consecutive. The stripped bolts must have at least two good bolts between the stripped bolts. If more than six bolt holes are stripped, delay the experiment and re-tap the holes before proceeding.

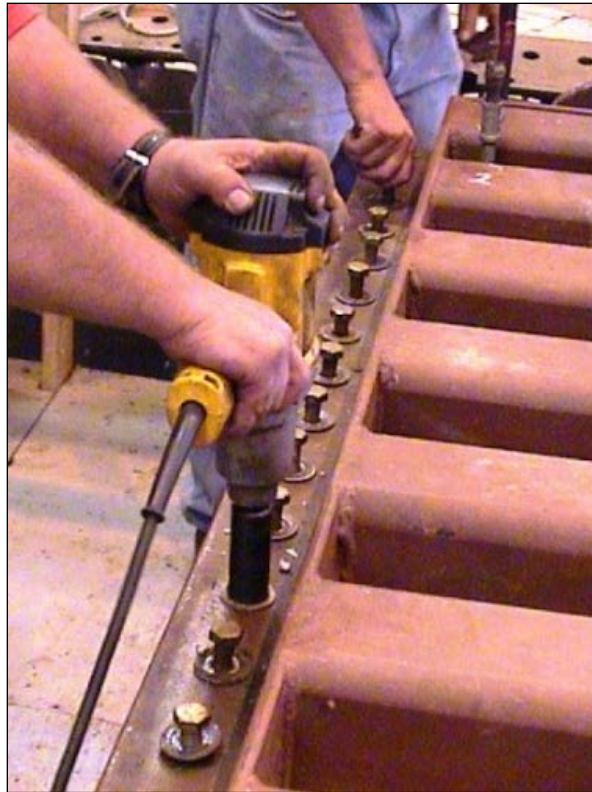
Figure C21. Bolt lid into place using air or socket wrench.

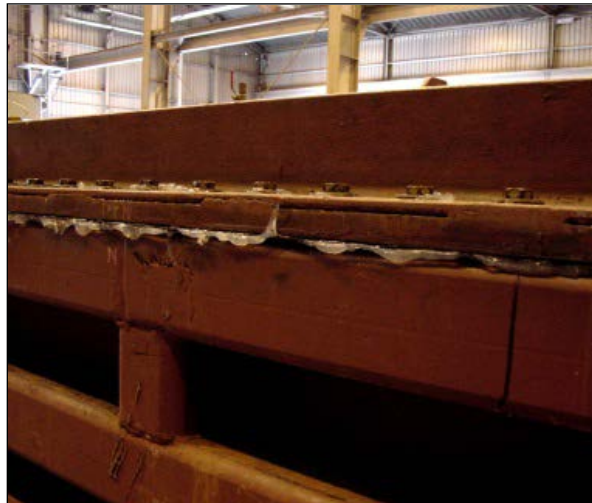
Figure C22. Neoprene seal between lid and HTC.

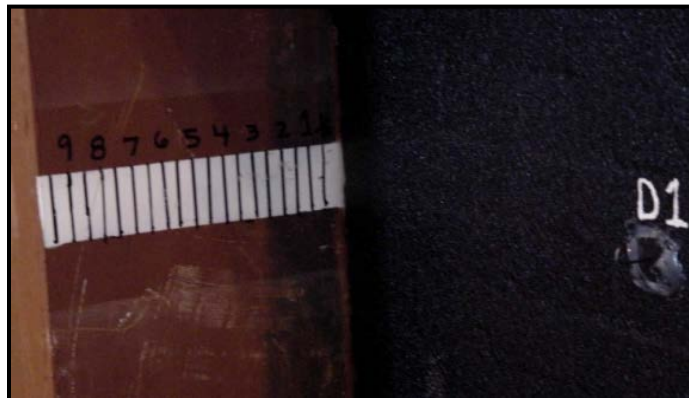
Figure C25. Paint deflection measurements on the side walls of the test frame.

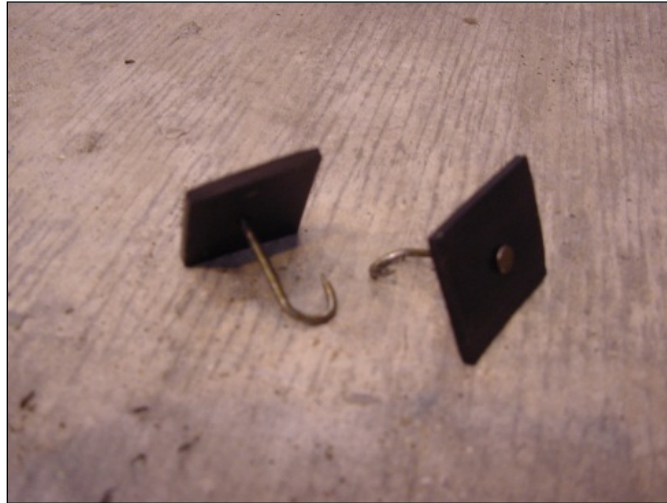
Figure C26. Deflection gauge mounts made from nails and neoprene squares.

Step 14: Make deflection gauge mounts. If large displacements are expected, ensure that a material is used that will adjust to the test specimen's deformation. For example, neoprene squares were used to make the gauge mounts in this test series (Figure C26). Nails were deformed to make hooks for the gauge wire attachment. The nail head

prevented the nail from pulling through the neoprene. Adhere gauge mounts to the wall using epoxy, silicone, or SolidBond 24 hr before the day of the experiment. Five deflection gauges were used in this test series (Figure C27).

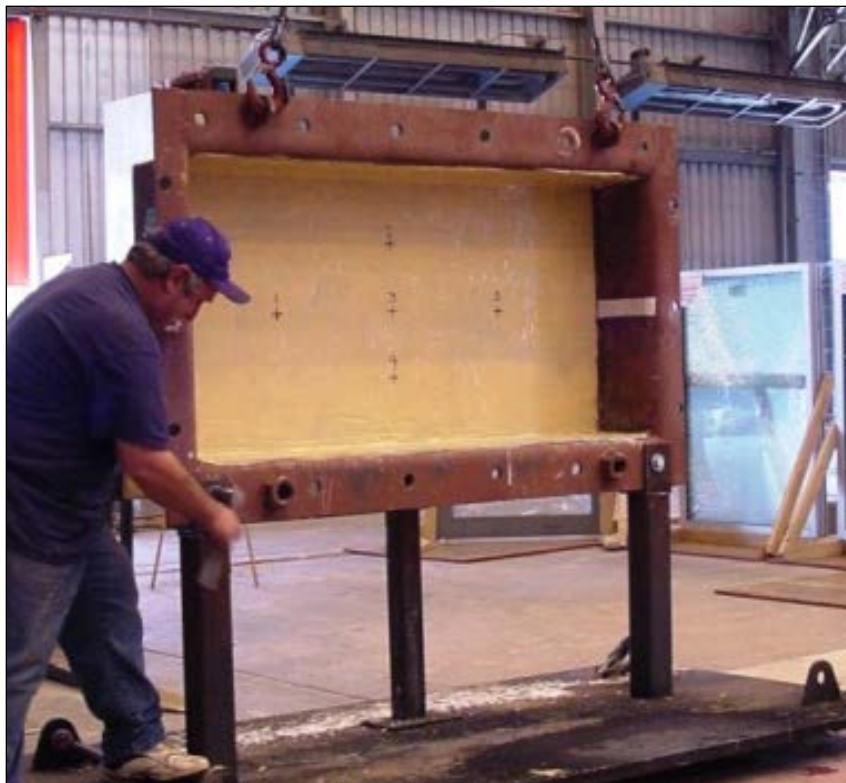
Figure C29. Hook crane to wall frame and unbolt frame from stand.

Step 15: Attach the crane to the wall frame and unbolt the frame from the stand (Figure C29). Ensure the crane is applying force to the frame before the frame is unbolted from the stand. Slowly move the wall into place and lower it into the open chamber (Figure C30). Load may need to be applied to the wall frame to position it in the vessel window (Figure C31).

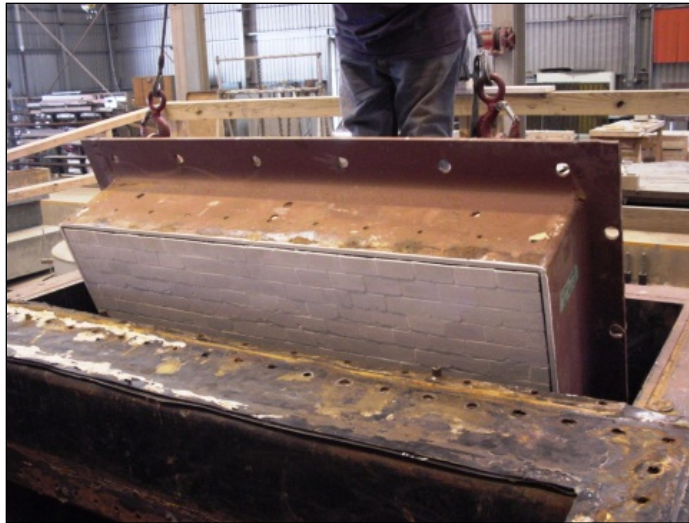
Figure C30. Lower wall frame into position.

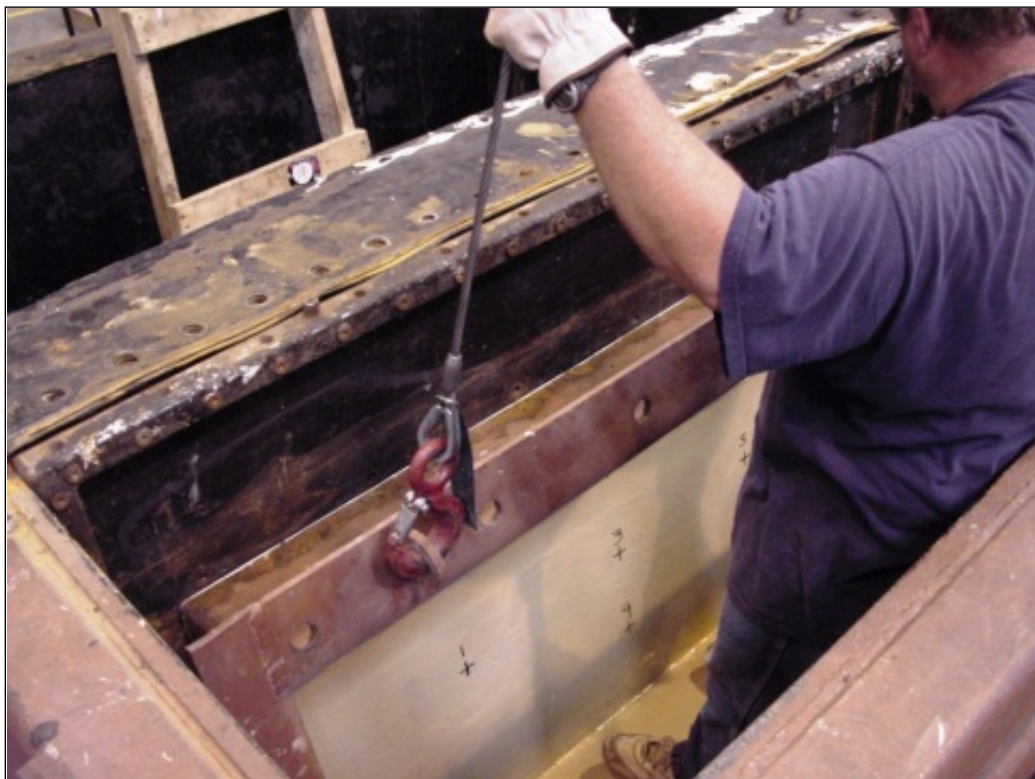
Figure C31. Technician counter balances frame to lower the wall into the chamber.

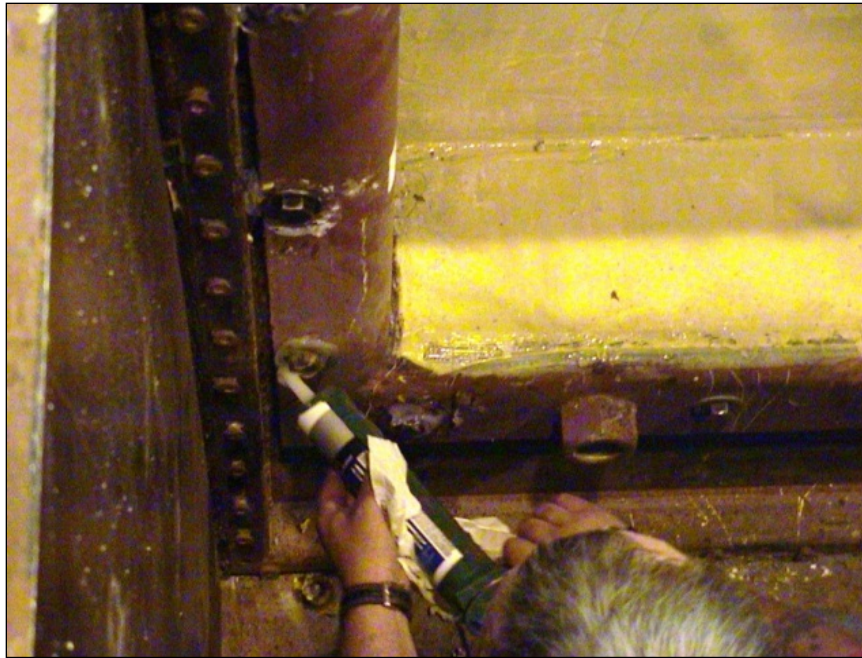
Figure C33. If a bolt appears to be stripped, then silicone bolts.

Step 16: Use an air wrench or torque wrench to tighten the 18 3/4-in.-diam bolts (Figure C32) used to attach the test specimen frame to the HTC. Check all bolts before the top of the pressure chamber is attached. If a bolt is stripped, silicone around the bolt to prevent any water leakage between the pressure and open chambers of the test apparatus (Figure C33). Mark or note the bolt hole that is stripped so that it can be re-tapped before the next experiment. A test can be conducted if one or two bolts are stripped, but if more than two bolt holes are stripped or if the two are consecutive, delay the experiment until repairs can be made.

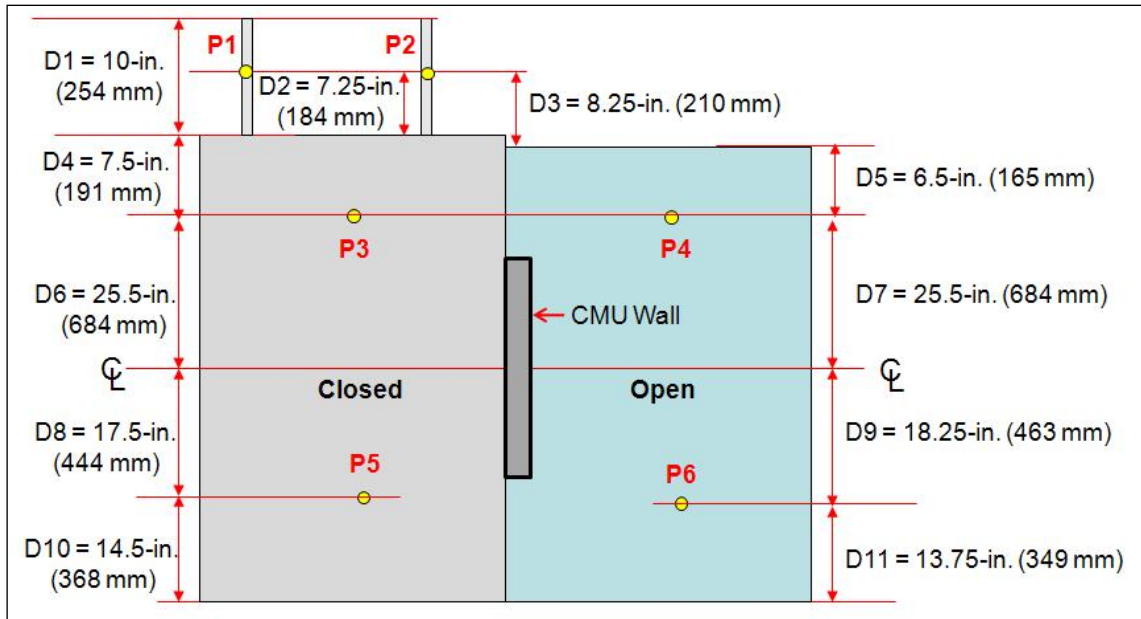
Figure C38. Locations of pressure gauge mounts on the HTC.

Step 18: Install pressure gauges in the mounts housed in the steel chambers and relief pipes (Figures C36 and C37). Six pressure gauge mounts are available for use on the HTC (Figure C38).

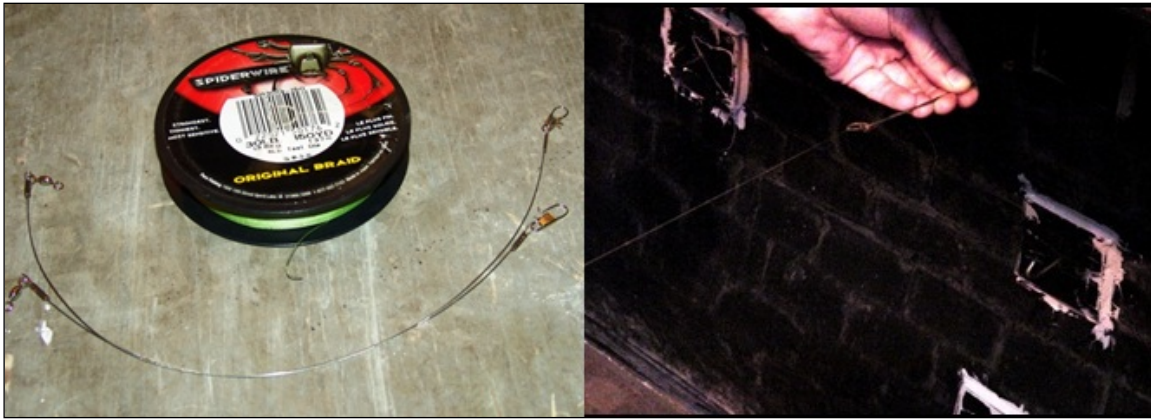
Figure C40. Fishing line used to create gauge wires and hook attachments.

Step 19: Install deformation rack (Figure C39) and attach gauge wires to the wall hooks. Fishing line and quick-release hook extensions are used to extend the length of the wire potentiometers (Figure C40). The deformation rack was constructed to allow the gauge locations to be relocated from test to test. The old deflection method required additional holes to be drilled in the chamber wall to move the deflection measurement points. A steel frame is pinned across the exterior wall of the open chamber, and eye hooks are used to direct the gauge wires to the wall hooks (Figure C41). The wire potentiometers are attached to a steel u-channel that is clamped directly above the open chamber of the HTC (Figure C42). A spacer plate is used to maintain a designated distance from the wall to the deflection rack. The hook-and-eye turnbuckles are used to

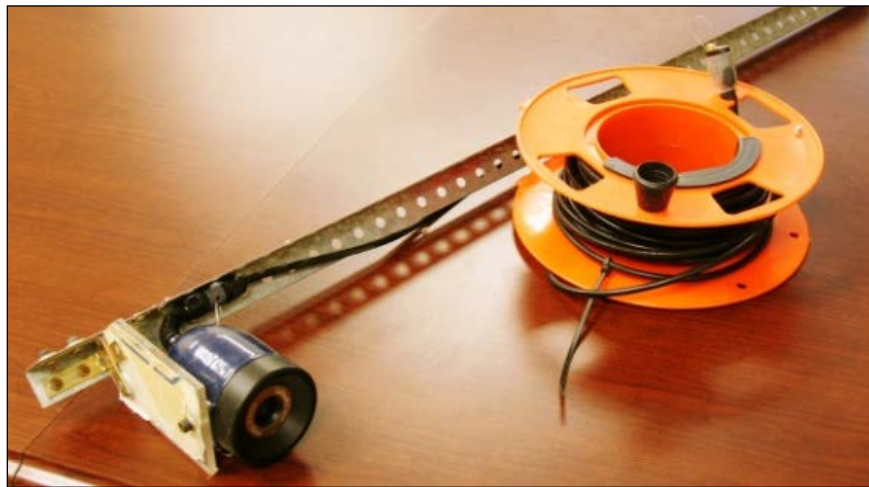
Figure C44. Underwater video camera.

Step 20: Place underwater video camera in chamber on steel post in the corner (Figure C43). The camera can be moved during the experiment to video specific points on the test specimen (Figure C44). Attach lights to steel post secured over the open chamber. Ensure that lights and power cords are secured so that these items will not get wet in order to prevent injury from electric shock.

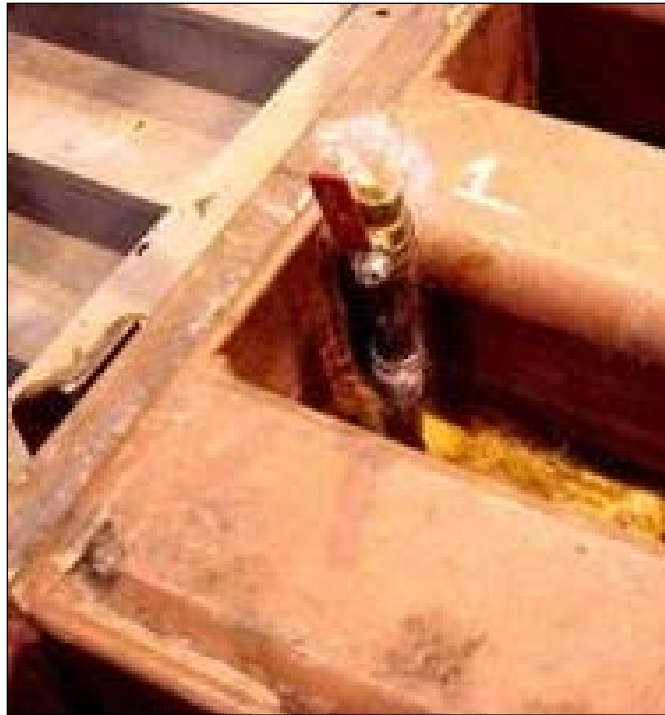
Figure C54. Close the relief valves when water begins to flow from relief valves.

Step 26: Continue to add water to the pressure chamber while the air trapped in the chamber escapes through the relief valves on the top of the pressure chamber lid. When water begins to spray out of the relief valves (Figure C54), close the valves beginning at the shortest pipe (labeled 1) to the tallest (labeled 4) as shown in Figure C55. Before the relief valves are closed, slow the water flow in the intake valves. If the water flow is not decreased, the test specimen will be loaded very quickly when the final relief valve is closed.
