EQPETGVG'O CUQPT['Y CNN'TGVTQH'U UVGO UHQ'T'DNCUV'RTQVGEVKP "

A Dissertation

CAROL FC[G JOHNSON

Major Subject: Civil Engineering

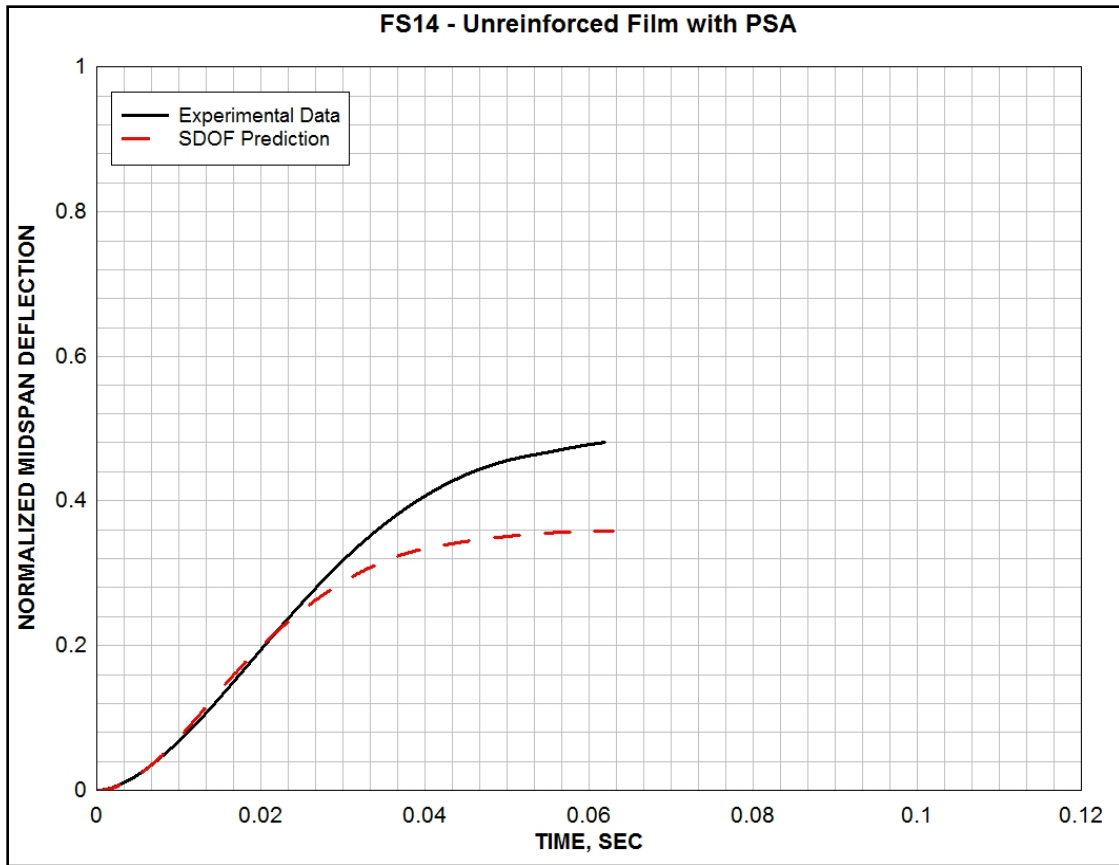
Figure F.7. Deflection for FS14 – Unreinforced Film with PSA.
