NON-DESTRUCTIVE EVALUATION OF BRIDGE STAY CABLE AND  
EXTERNAL POST-TENSIONING SYSTEMS

A Thesis

Major Subject: Civil Engineering

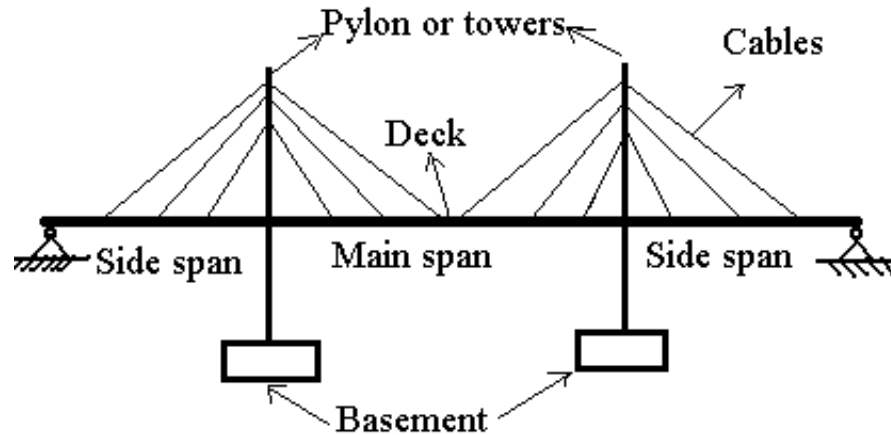
**Figure 2-1: Stay Cable Bridge (Vannemreddi 2010)**

A typical stay cable bridge is shown in Figure 2-1. The stay cables directly carry the loads on the bridge deck to the towers of the bridge, enabling longer span lengths dependent on the stay cable configuration. Both internal and external PT systems are often used in conjunction with stay cable systems to carry the loads of this long span bridge type. Over the years, four cable configurations have been implemented into cable-

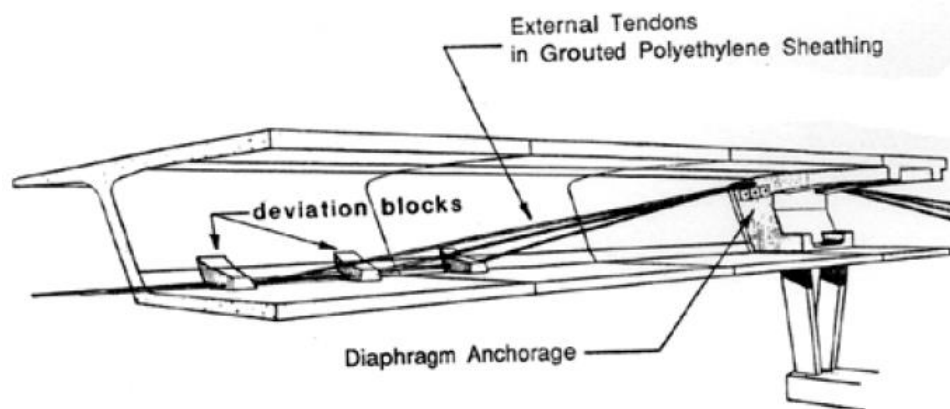
**Figure 2-2: Example of External Post-Tensioning System Setup (Lee 2007)**

Figure 2-2 shows an example of the setup of an external post-tensioning system within a bridge girder. The external tendons are in grouted polyethylene sheathing and their geometry is controlled by the deviation blocks and diaphragm anchorage within the girder.

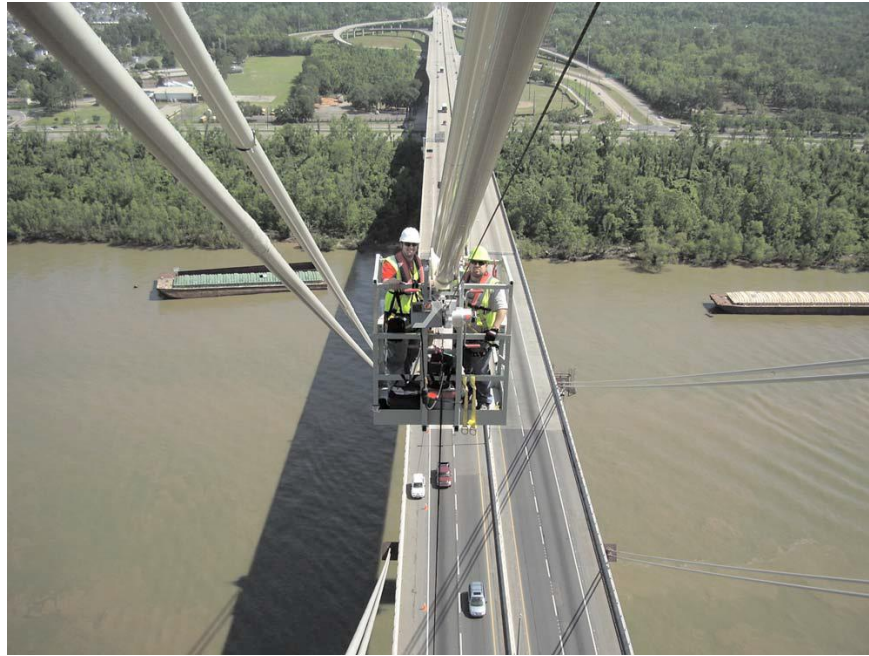
**Figure 2-4: Luling Bridge Stay Cable Inspection Basket (Mehrabi et al. 2010)**

cables, mostly as a result of poor handling by the contractor (Watson and Stafford 1988). Circa 1998, the Louisiana Department of Transportation and Development (LADOTD) devised a new method using two trolleys, shown in Figure 2-4, to inspect the unique Luling Bridge for damage and corrosion. One trolley, connected to four stay cables, is used to inspect the cables of the side bridge spans, while the other trolley is connected to only two cables in the main span and serves as a means to inspect two stay cables of the main span in close proximity (Elliott and Heymsfield 2003).

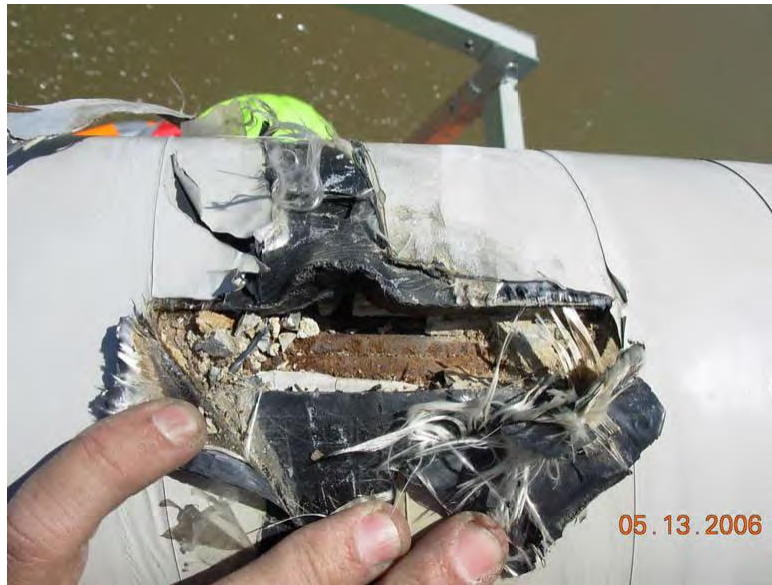
**Figure 2-5: Luling Bridge Corrosion and Sheathing Split (Mehrabi 2009)**

After cumulative problems with the stay cables of the Luling Bridge, a detailed evaluation program was carried out to identify the overall integrity of the stay cable system (Mehrabi et al. 2004). The bridge was found to have significant damage to the stay cable protective sheathing with complete exposure of some of the stay cables and corrosion playing a major role in their deterioration, shown in Figure 2-5 (Mehrabi et al. 2010).

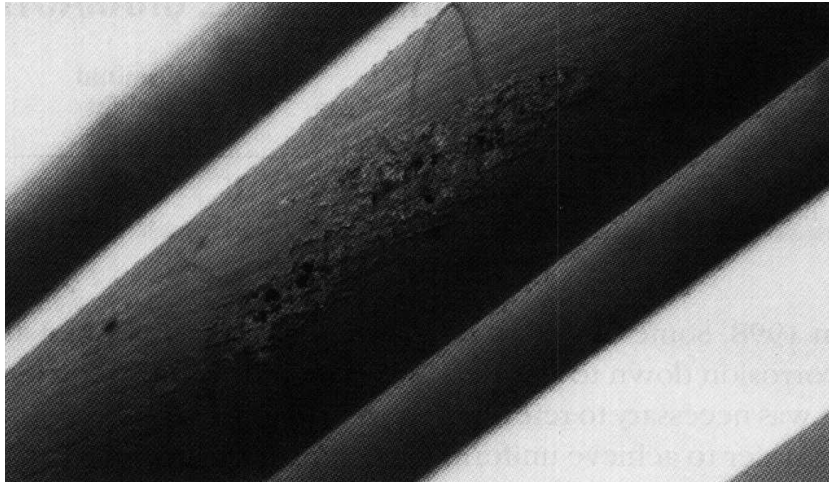
**Figure 2-7: Cable Corrosion in the General Rafael Urdaneta Bridge (De Rincon et al. 2001)**

Again, during inspection of the bridge in 1997-1998, significant cable corrosion and cable socket settling was discovered (Sarcos-Portillo et al. 2003). Typical localized corrosion is shown in Figure 2-7 and was especially prevalent in the stay cables on the north side of the bridge due to the wind patterns in the area.

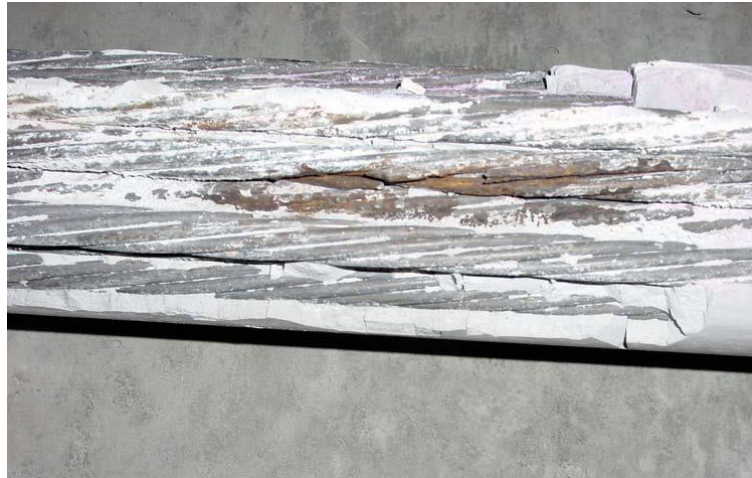
**Figure 2-9: Corrosion of the Mid-Bay Bridge (Corven 2001)**

Tendon deterioration conditions found included over 700 voids, corroded and broken tendons, and powdery, cementitious grout as shown in Figure 2-9 (Clark 2010, Corven 2001). These significant conditions were largely caused by poor grouting of the PT ducts. Notably at high points in the tendon profile, several of the external tendon anchorage regions were found only partially filled with grout (VSL 2002). It was clear during inspection that the external PT tendons had not been grouted to specifications (Hartt and Venugopalan 2002). Eleven out of a total of 846 tendons were replaced, with ten of these tendons located at expansion joints (Pereira 2003).

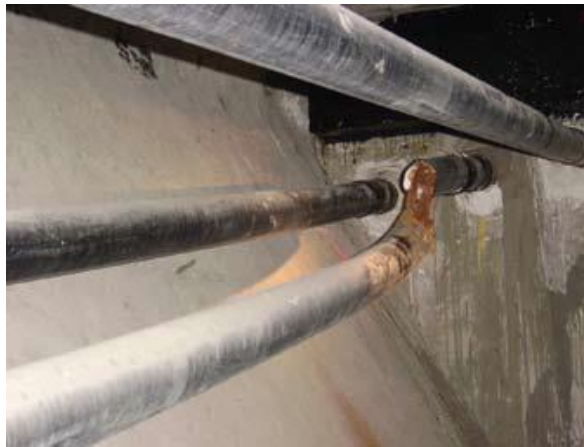
**Figure 2-11: Varina-Enon Bridge External Tendon Failure (Hansen 2007)**

In response, these voids were filled with a new high performance grout to mitigate the problem. However, in 2007, inspection of the Varina-Enon Bridge brought to light the failure of a severely corroded external tendon at a location where the cement grout met the high-performance grout. The tendon failure shown in Figure 2-11 and Figure 2-12 could have been caused by a corrosive interaction between the two grout types (Hansen 2007).

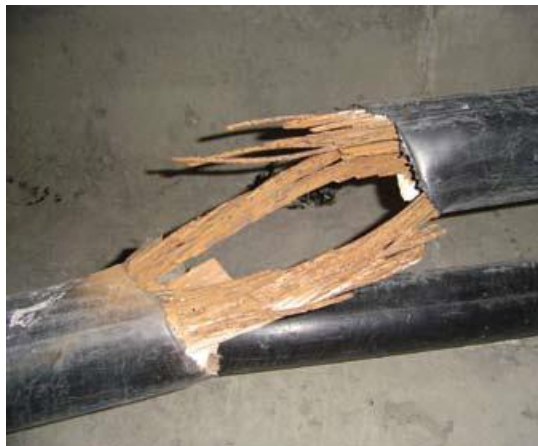
**Figure 2-12: Close-Up View of External Tendon Failure (Hansen 2007)**

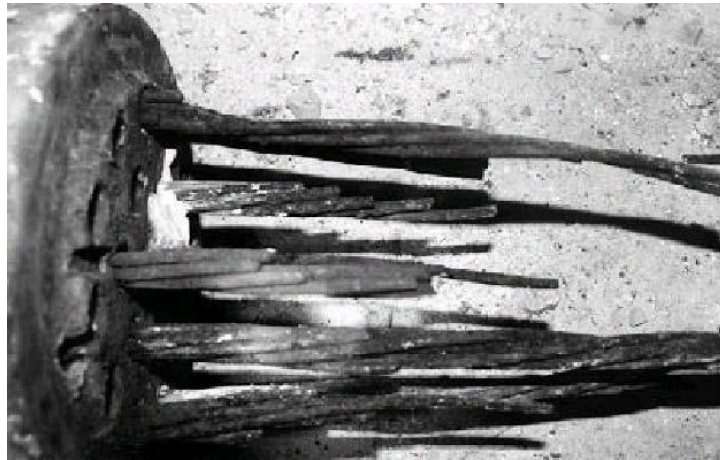
**Figure 2-13: Strand Corrosion of the Niles Channel Bridge (Powers et al. 2002)**

The Niles Channel Bridge had only been in service for 16 years when, in 1999, all 19 strands of an external tendon failed due to exposure and corrosion at an expansion joint (Tilly 2002). The failure was identified first by the significant displacement of a

tendon through one of the deviation saddles (Pereira 2003). This significant corrosion in the anchorage region of the tendon is shown in Figure 2-13.

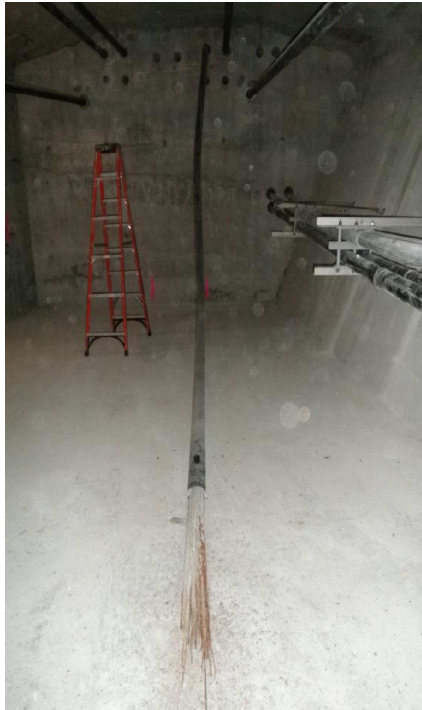
**Figure 2-16: External Tendon Failure of the Ringling Causeway Bridge (Paredes 2013)**

Two failed external tendons of the post-tensioned Ringling Causeway Bridge, seen in Figure 2-15, completed in 2003 in Florida required complete replacement after a bridge service life of only eight years (Paredes 2013). The first failed tendon, shown in Figure 2-16, was found on the floor during an electrical inspection and the second tendon failure was found during inspection a few months later. Both external tendon failures were attributed to corrosion in response to segregation of the grout and

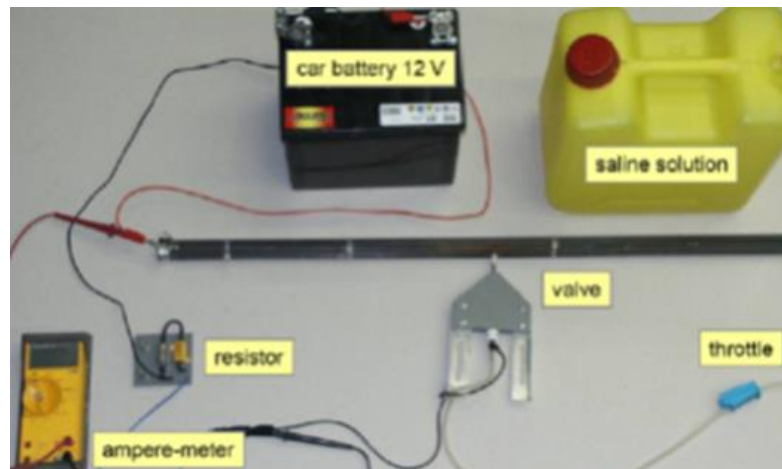
**Figure 2-17: Electrolytic Corrosion Cell Lab Setup (Fricker and Vogel 2007)**

A 12 V battery was used as the power supply to create a current through the strand to be corroded. This current was controlled by a resistor in the corrosion cell setup. A saline solution was gravity fed down a hose to create a corrosive environment at the desired corrosion location. The solution contained 50 g of sodium chloride and 1 mL of hydrochloric acid (2%) per liter of solution (Fricker and Vogel 2007).

Previously, an electrolytic corrosion cell was used to fabricate localized corrosion of wires in the PT of an existing bridge structure for testing (Fricker and Vogel 2007). Continuous acoustic monitoring was performed on the strands during corrosion to test the applicability of the monitoring system to detect the eventual wire breakage. The laboratory corrosion cell setup is seen in Figure 2-17 and the blind testing setup used in the field is shown in Figure 2-18.

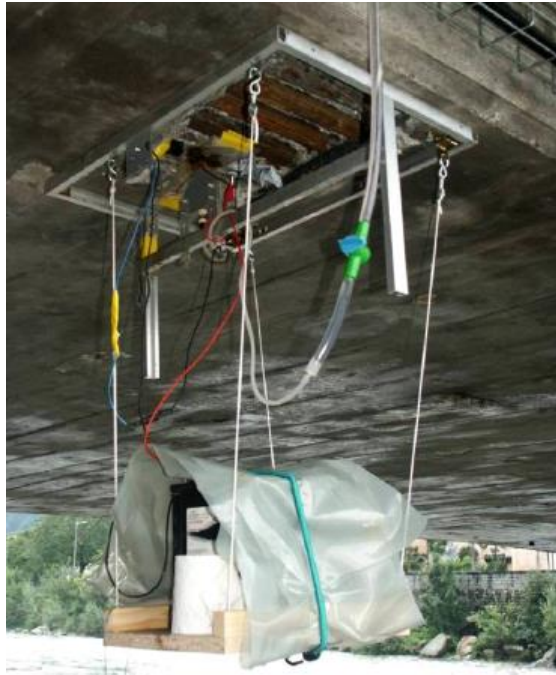
**Figure 2-18: Electrolytic Corrosion Cell Field Setup (Fricker and Vogel 2007)**

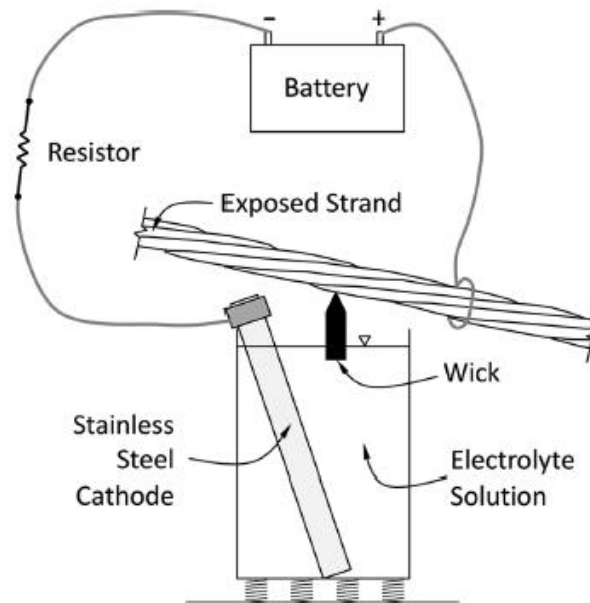
**Figure 2-19: Galvanic Corrosion Cell Setup (Wood et al. 2013)**

A similar corrosion cell setup was also used for fabricating localized corrosion on steel strands to be tested for residual tensile capacity (Wood et al. 2013). The galvanic corrosion cell used a solution of 20% hydrochloric acid and 10% sodium chloride by weight in which the exposed strand was immersed. A 12 V battery was also used in this localized corrosion setup seen in Figure 2-19.

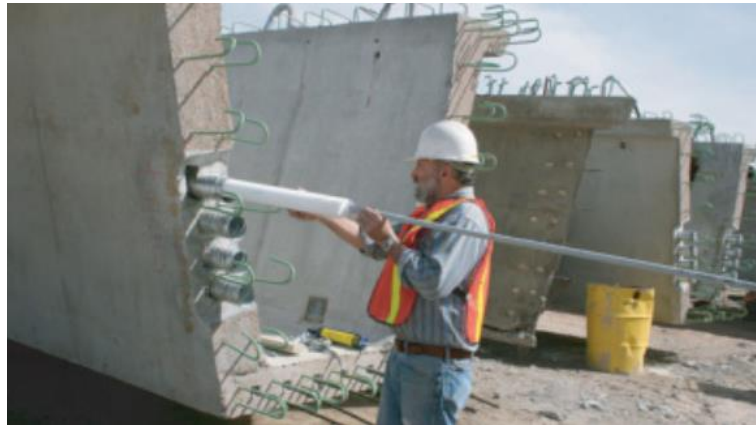
**Figure 2-20: Fabrication of Voids Using Polystyrene Foam (Tinkey and Olson 2007)**

Previously, voids have been fabricated in the grout of a girder PT system using stepped and tapered polystyrene foam rods (Tinkey and Olson 2007). The foam was inserted in the ducts prior to grouting as shown in Figure 2-20 in order to have predetermined locations where grout would not be placed in the ducts. The polystyrene foam was placed using wire rods to support the foam to be on the roof of the duct, representative of voids in the field. Smaller polystyrene foam pieces were also glued directly on to the duct (Tinkey and Olson 2007).

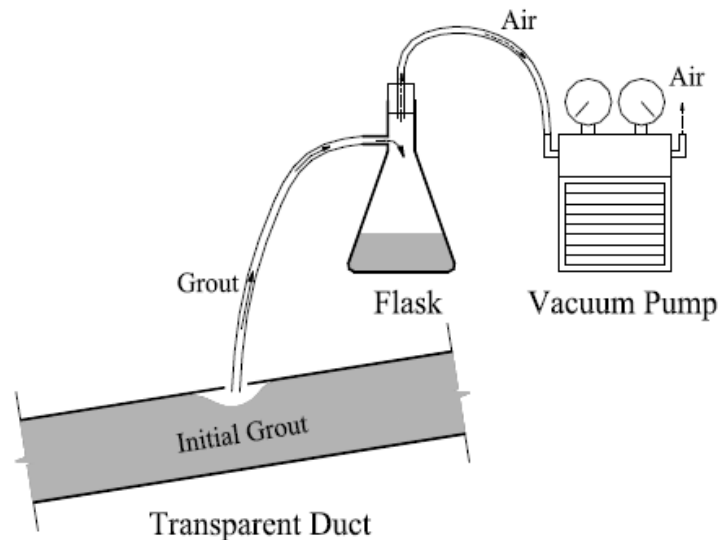
**Figure 2-21: Vacuum Pump Setup (Im 2009)**

To fabricate voids in several transparent external PT specimens, a vacuum pump configuration has been successfully used in the past (Im 2009). Trials concluded that the best time to extract grout from the specimens was two hours after grouting. As shown in Figure 2-21, the vacuum pump draws air out of a sealed flask, which in turn extracts grout from the specimen. The volume of grout extracted can be read on the flask, but the

drawback to this void fabrication methodology is that the shape of extracted grout left in the specimen is unknown without transparent ducts. To allow for the grout removal after grouting of the specimens, holes of one inch diameter were drilled into the duct at locations for later vacuum pumping and then temporarily sealed during the grouting process (Im 2009). This method has been proven to work for void fabrication, yet more research is needed on its usefulness with non-transparent ducts that hinder the view of the created air void shape.

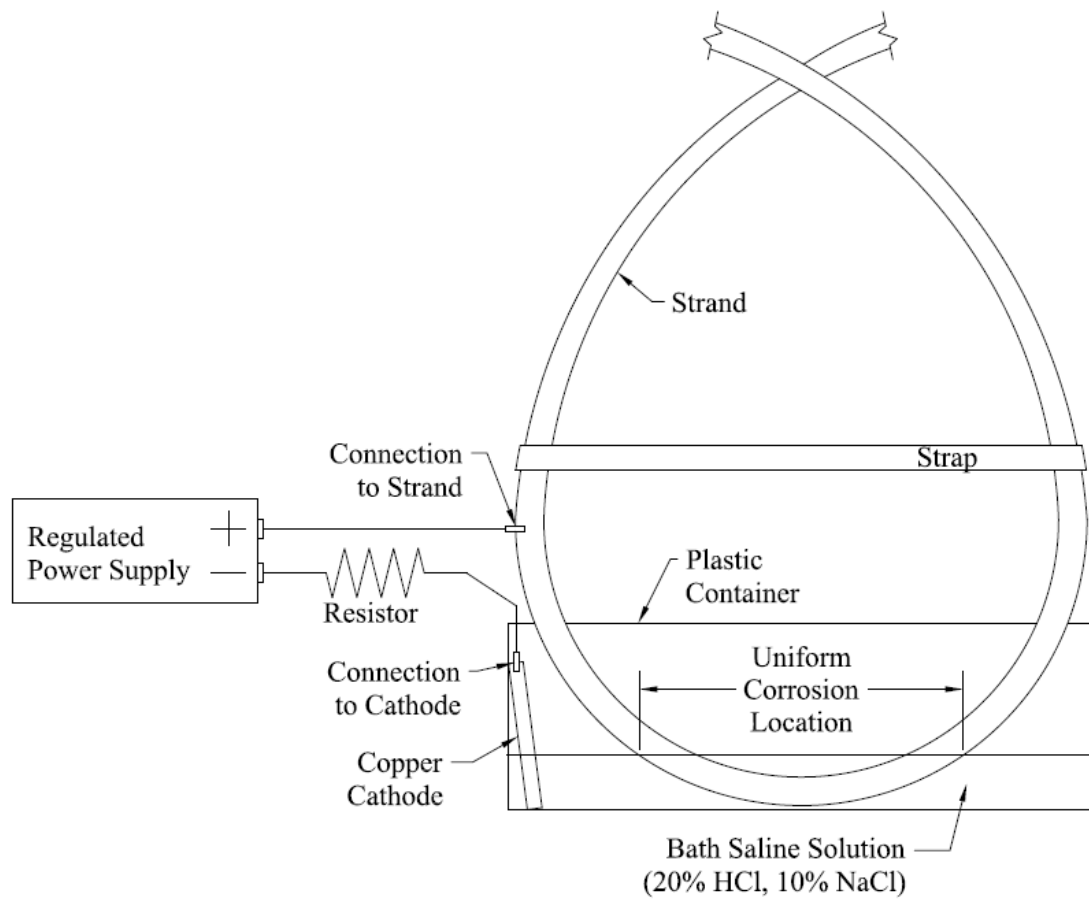
**Figure 3-1: Electrolytic Corrosion Cell Setup for Uniform Corrosion**

In Figure 3-1 and Figure 3-2, the electrolytic corrosion cell setup used in the laboratory for uniform corrosion is shown. A saline solution of 20% hydrochloric acid and 10% sodium chloride by weight was created and put into a plastic container. The total amount of saline solution was determined by the size of the container and the length of strand that needed to be immersed in the solution. The seven-wire strand was curved into a loop and held in place with a strap before being placed in the container. A copper rod was used as a cathode and partially submerged in the solution. A regulated power supply was used to conduct 1 Ampere of current through the circuit once it was connected and turned on. The power supply anode was directly connected to a location on the exposed steel strand and the power supply cathode went to a resistor and then extended to the end of the copper cathode outside of the solution to complete the current flow through the saline solution. The second rod shown in the plastic container is made up of non-conductive material and was simply used to stir the solution.

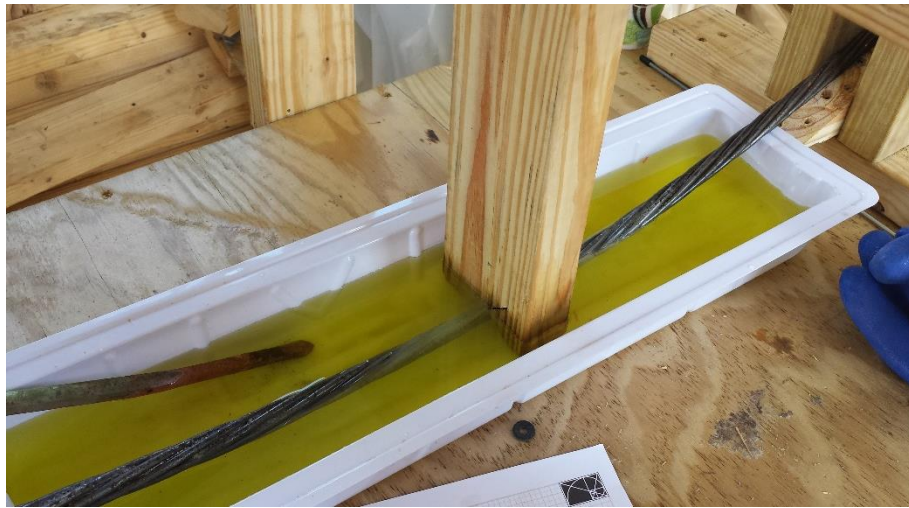
**Figure 3-3: Fabrication of Corrosion in the Field**

After completing multiple trials, the same overall electrolytic corrosion cell setup was used in the field except with a different strand configuration to keep the strand immersed in the solution. In the field, the actual strands to be used in the specimen were not held in a loop with a strap, instead a wooden support structure was built to hold the strand down as shown in Figure 3-3.

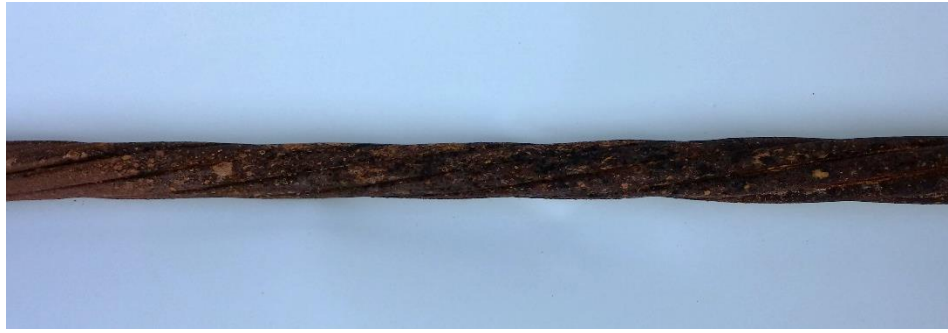
**Figure 3-4: Strand Corrosion**

A section of strand corroded by the electrolytic corrosion cell setup in the field is seen in Figure 3-4. In this case, the strand cross-section was reduced by 30% after fabrication of corrosion. The corroded strands were monitored for potential continuous corrosion before placement in the specimen in order to confirm the cross-sectional area loss had not changed. Also, multiple strand diameters were taken, including at every inch of immersed steel to verify that the length of immersed strand was uniformly corroded.

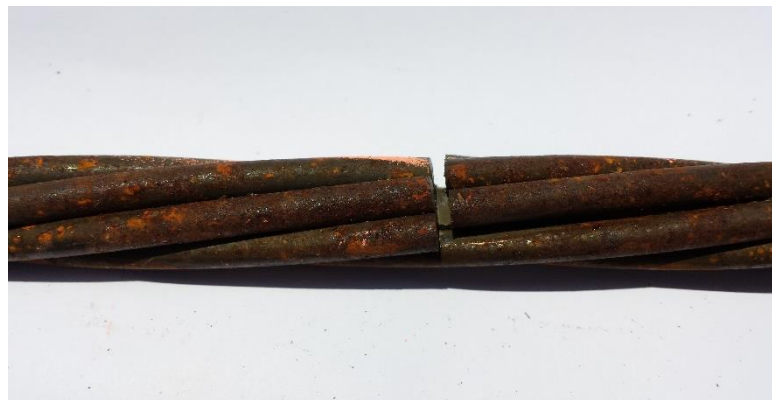
**Figure 3-5: Strand Breakage**

Breakage and section loss of the steel was implemented using a rotary grinder in two different ways. The breakage condition was replicated by using the grinder to cut a specified number of wires, whereas the section loss condition was fabricated by grinding the steel strands to remove material. The breakage condition on the strand in Figure 3-5 reduced the cross section by 50% by cutting a localized notch in the strand. In this case, three wires are completely severed, along with the center wire partially cut.

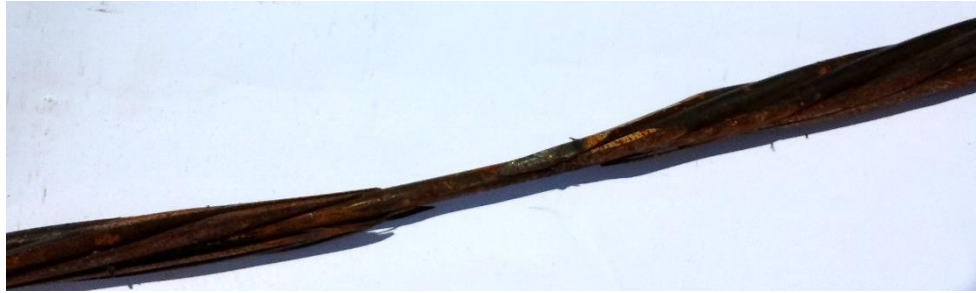
**Figure 3-6: Strand Section Loss**

In Figure 3-6, material was removed from the strand using a grinder to create a gradual loss of cross-section. In this case, with 86% strand cross-sectional area loss, six of the seven wires are completely severed, although varying levels of section loss are included in the specimen. As a means of quality assurance for both breakage and section loss, multiple strand diameters were taken to compute the most accurate cross-sectional area loss, as was done at the locations of corrosion. Also, the strands were cleaned after condition fabrication and before placement in the HDPE duct prior to grouting.

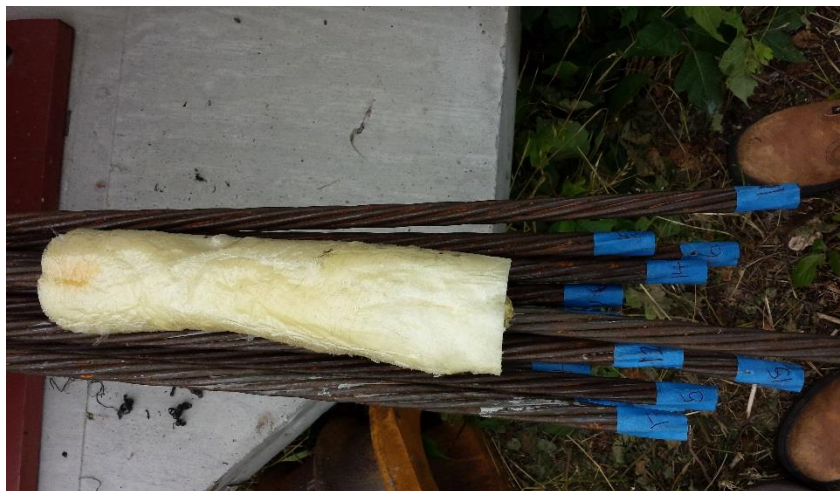
**Figure 3-7: Foam Void Attachment to Strand**

The artificial voids were appropriately sized by using an extra piece of HDPE duct as formwork. A two foot section of duct was cut in half lengthwise and then both pieces were individually lined with a plastic sheet. The polyurethane foam could then be sprayed into the form and easily separated after it had cured for 24 hours. The foam was then cut into the desired void shapes for the specimen.

After cutting each piece of polyurethane foam to the correct size for artificial void placement, the foam pieces could then be glued to the top strand at the desired location along its length before the strand was pushed through the duct. In Figure 3-7, the foam attached to the top strand is shown. In Figure 3-8, the fabricated foam void is seen sliding into the HDPE duct at the top of the duct interior. The strand was pushed farther into the duct until the foam voids were lined up in their correct locations prior to grouting.

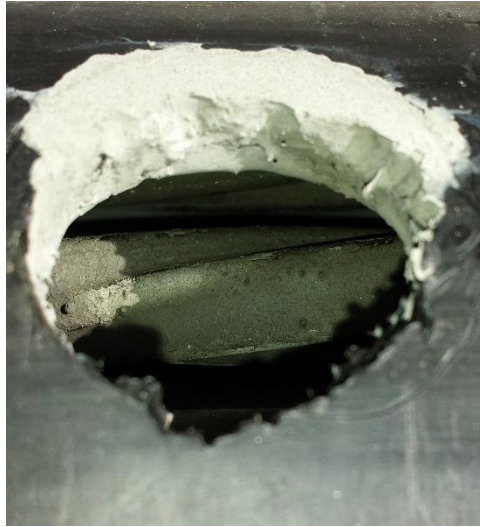
**Figure 3-9: Exposed Strand Visible Through Drilled Hole**

The fabrication method for air voids within the specimen was ultimately changed due to complications in the grouting process. The air voids were originally planned to be fabricated using a vacuum pump to extract a designated amount of grout at 2 hours after grouting. This protocol is still included for future reference, however at this point during the specimen construction, air voids were already found in the HDPE duct by visual inspection through the drilled holes as shown in Figure 3-9. Holes of 1.0 in. diameter had been drilled into the ducts for vacuum pump access and subsequently covered prior to grouting. With a large top void already present, the vacuum pump method was no longer executed. The top void was mapped out and included as a condition in the specimen for testing.

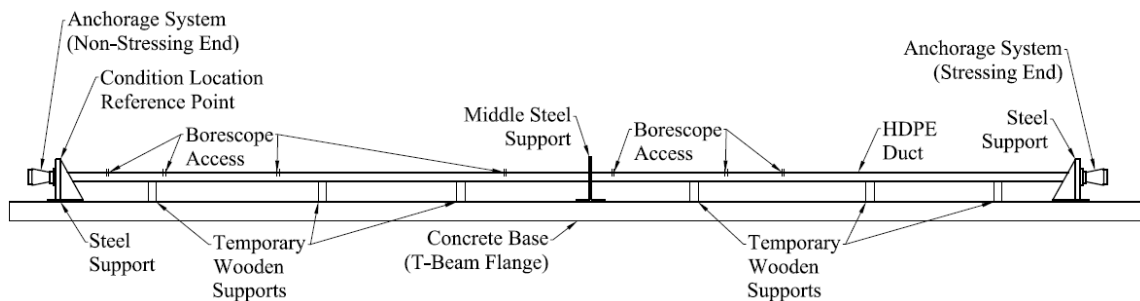
**Figure 4-1: Stay Cable and External PT Specimen Setup**

The specimen was designed to consist of an opaque, 4.0 in. diameter HDPE duct over 36 feet in length between two anchorage systems as shown in Figure 4-1. There are three steel duct support pieces bolted to eight inches of concrete below, one at each end and one at approximately mid-span of the duct length. The concrete used was a recycled 40 ft long T-beam flipped upside down on wooden supports. Wooden supports were also used temporarily throughout the specimen between the concrete base and the duct for support during grouting. Within the duct, the specimen design includes 19 grouted seven-wire strands of 0.6 in. diameter. Seven holes were drilled into the duct and covered prior to grouting. These drilled holes, originally planned for use in fabricating conditions with a vacuum pump, were used in reality as access points for the borescope inspection.

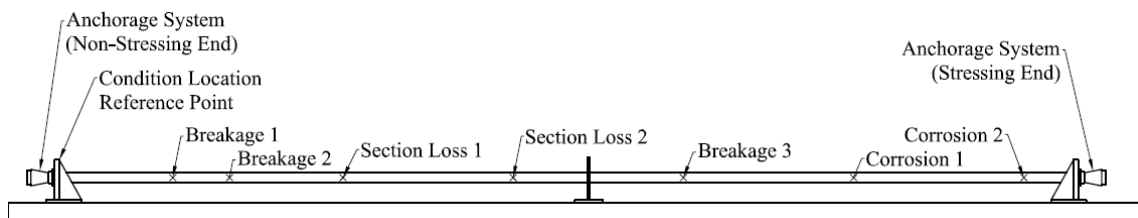
**Figure 4-2: Breakage, Section Loss, and Corrosion Placement**

Each of the two corroded segments were subject to the electrolytic corrosion cell with an immersed strand length of 6 inches. At the first corrosion location, two strands were corroded until 30% loss of cross-sectional area had occurred for each strand. At the other location of corrosion fabrication, only one strand was corroded until 50% cross-sectional area loss was fabricated. The corroded lengths of strand resulted in 3.2% and 2.6% tendon cross-sectional area losses, respectively. These steel deterioration conditions, along with their distance from the reference point at the first steel anchorage support piece are included in Table 4-1. Their locations along the stay cable and external PT specimen are illustrated in Figure 4-2.

Each of the steel conditions were fabricated at a designated length along the strands that were measured and cut from the strand spool. The condition locations were recorded as the distance from the inside face of the steel support at the non-stressing anchorage end, the condition location reference point in Figure 4-1. This distance was added to the length of strand needed to extend through the anchorage system in order to determine the total distance from the condition to the strand end before placement in the duct. These conditions include three breakage locations, two section loss locations, and two corrosion locations. Each condition location features a different loss in cross-sectional area of the tendon. At the breakage locations, the tendon cross-sectional area losses are 9.2%, 28.2%, and 4.1%, in order of closest to farthest from the steel support reference point. There is 18% cross-sectional area loss at the first section loss location and 13.5% cross-sectional area loss at the other section loss location. The breakage locations are considerably more localized than the section loss locations because wires were cut to fabricate breakage, whereas material was removed to form a gradual transition at section loss locations.

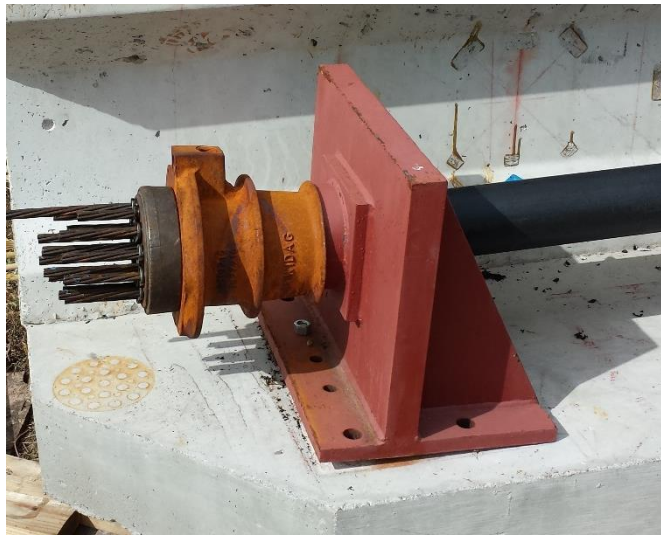
**Figure 4-4: Anchorage System under Construction**

Construction of the specimen began with connecting the three duct supports to the available concrete base at the TAMU Riverside Campus. Then, the wooden supports were set up, the duct was positioned, and the strands were pushed through and organized in the two anchorage systems. Before stressing, all of the strands were secured with wedges in the anchorage system at the non-stressing end. A stressing jack was used at the stressing anchorage end to pull the anchorage systems up into place and tension the strands enough to provide space between the strands and the bottom of the duct. After stressing, wedges were positioned at the stressing end to keep the strands tensioned enough to be straight throughout the duct. Figure 4-4 shows the non-stressing end anchorage system prior to cutting the stressed strand ends.

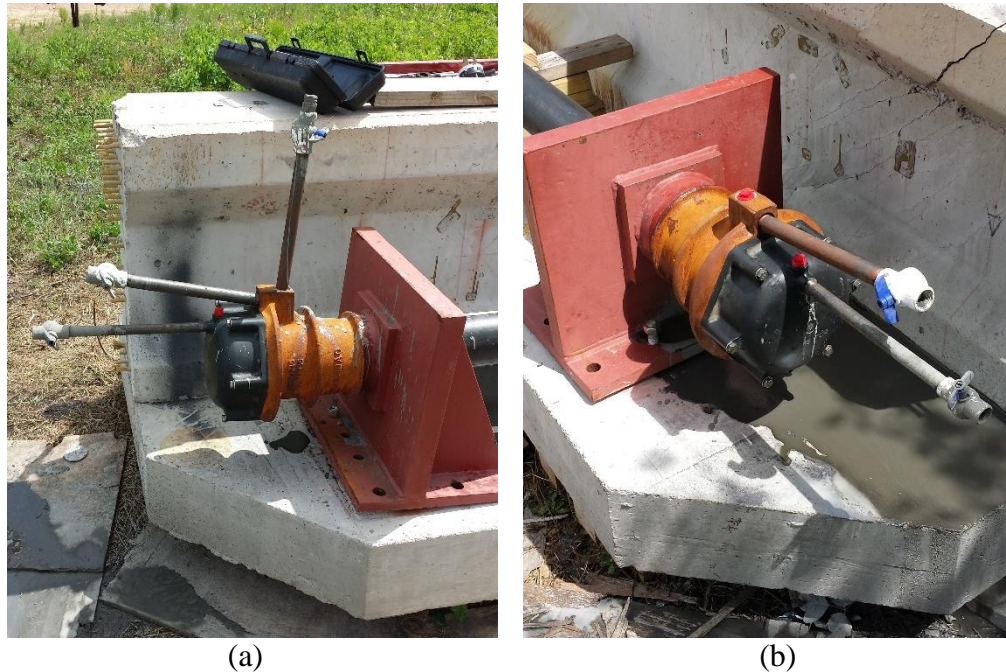
**Figure 4-5: Grout Ports at Anchorage: (a) Non-Stressing End, (b) Stressing End**

After the strands were cut, the anchorage caps were screwed on the anchorage system ends and the grout ports were connected prior to grouting. Each grout port included a steel pipe, which was screwed into the anchorage, and an end valve to close the grout port when required. These grout ports are visible in Figure 4-5. A waterproof silicone sealant was then applied between the duct and both faces of the steel support pieces in an effort to create an air tight attachment of the duct to the anchorage systems before grouting.

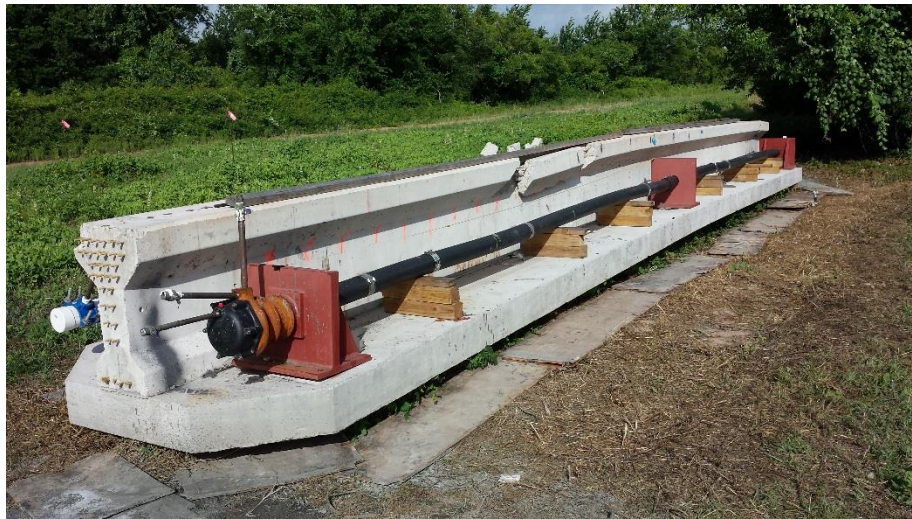
**Figure 4-6: Grouted Stay Cable and External PT Specimen**

site using a colloidal mixer and pumped into the specimen with a pneumatic pump. A generator was brought on site to power the mixer and an air compressor was likewise transported to the specimen location for connection to the pump. The grouted stay cable and external PT specimen is pictured in Figure 4-6.

Although taking every precaution to follow appropriate and necessary grouting procedures, there was ultimately low grouting pressure due to the pneumatic pump. The unplanned top air void extending the length of the specimen was most likely formed due to a combination of this inadequate grouting pressure and three identified grout leakage locations. The grout leakage that occurred after grouting is shown in Figure 4-7. Grout escaped out of each end anchorage setup where the duct was sealed to the steel anchorage support piece and also at one of the drilled hole locations. It is most likely that the sealant around the duct at the end supports was not given ample time to cure since

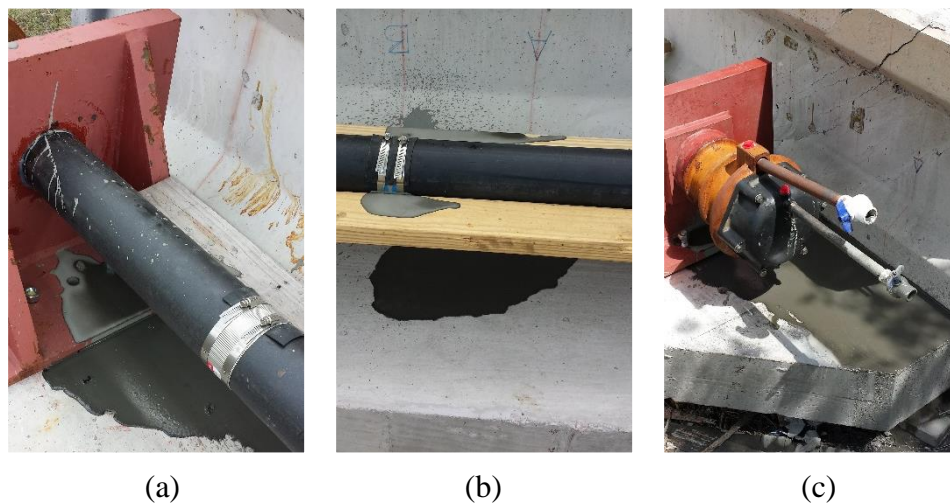
**Figure 4-7: Grout Leakage: (a) Anchorage, (b) Drilled Hole, (c) Anchorage**

there was a high temperature and high humidity environment present. At the drilled hole location, the grout leakage likely occurred due to inadequate coverage at a slight low point in the specimen. Although the specimen was designed to be completely horizontal, this was unrealistic due to unlevelled ground and sloping duct between supports after the grout weight was added.

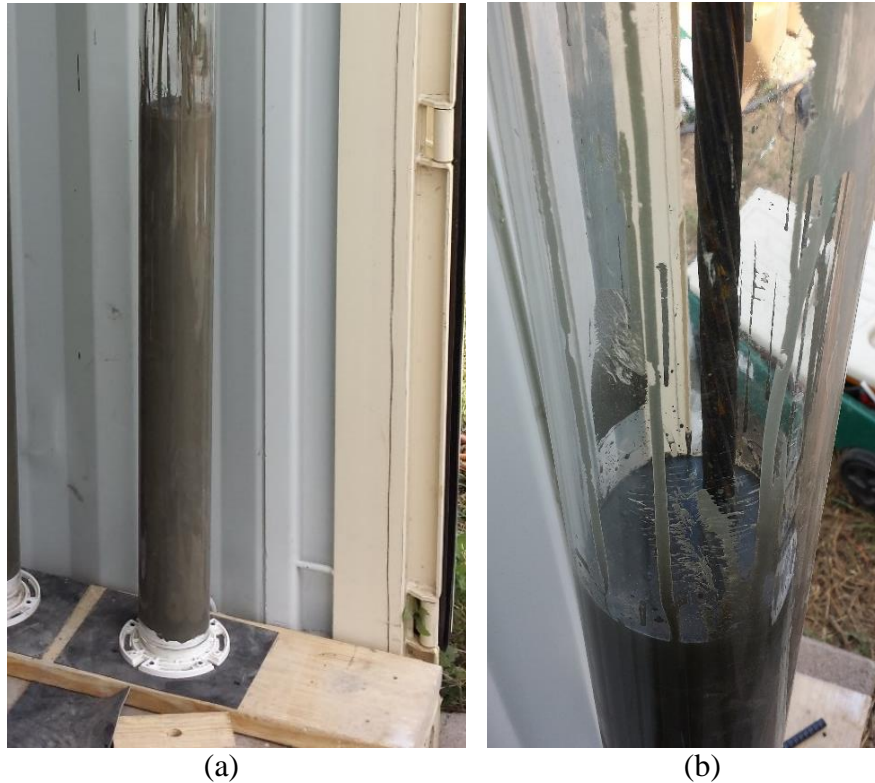
**Figure 4-8: Wick-Induced Bleed Test Setup: (a) Full View, (b) Close-Up**

Several material tests were performed on the freshly mixed grout. These tests include a wick-induced bleed test, wet density test, and flow cone test. Grout cubes were also formed for compressive strength testing. The wick-induced bleed test was performed according to ASTM C940-10A (ASTM 2010a). The setup consists of a clean strand inserted into a cylinder container filled with fresh grout to a height of 40 inches.

The grout used for the specimen passed the ASTM C940 standard for 0.0% bleed after 3 hours. One of the two wick-induced bleed test setups is seen in Figure 4-8.

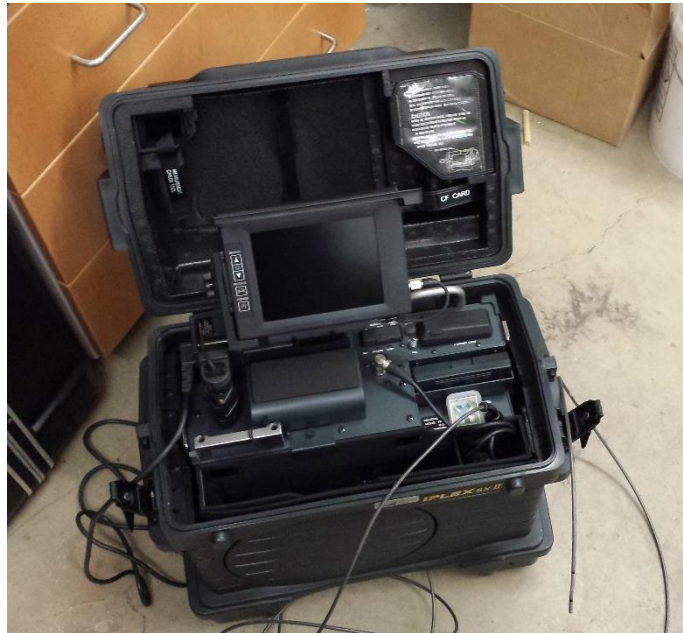
**Figure 5-1: Borescope Used on Specimen**

After discovery of the voided section in the duct that was unintentionally fabricated during construction, a borescope, seen in Figure 5-1, was used to map out the

extent of the air void. Access to the voided area was achieved through the seven drilled holes along the top of the duct. Upon uncovering the holes, the borescope could be maneuvered through the void space in either direction along the duct. Photos and videos were recorded with voice over to match the collected images with their location along the duct length. After removal of the grout ports at the system anchorages, the borescope could also be inserted in the grout caps and anchorages to determine the grout level throughout each anchorage region.

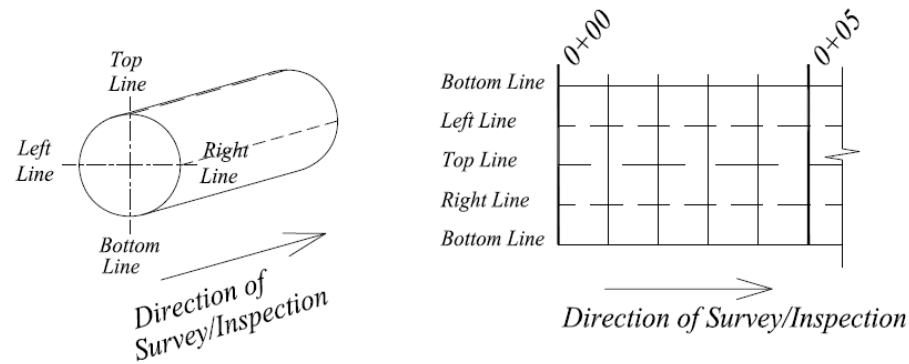
**Figure 5-2: Void Mapping Sheet (Im 2009)**

The collected borescope images inside the HDPE duct were used to map out the void shape created during grouting. The void mapping sheet shown in Figure 5-2, developed by Im (2009), was used to create a map of the borescope results for the full circumference and length of the duct shown in intervals of one foot. This void map was

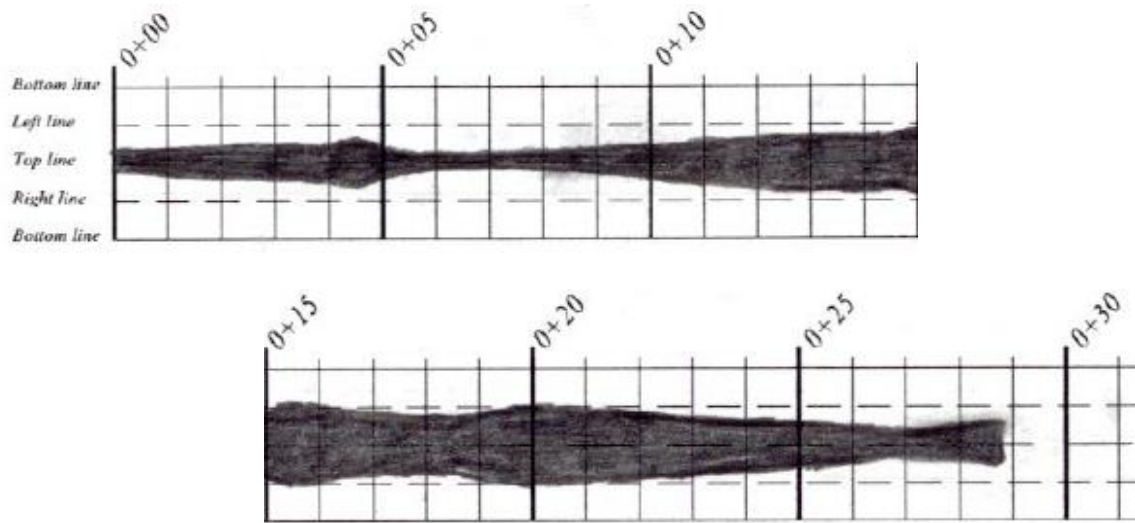
**Figure 5-3: Borescope Map of Voids**

As illustrated in Figure 5-3, the void extends across the entire top line of the duct from the void mapping starting point at the non-stressing anchorage end to the first foam

void. The first foam void is planted in the duct starting at 28 feet and 7 inches from the reference location. It is seen compressed in the middle right of Figure 5-4. Although the duct extends to over 35 feet, the range of duct from the first foam void to the second foam void into the stressing anchorage end was inaccessible by the borescope. No drilled holes lay between the artificial voids and at their locations the grout and strands blocked borescope access around them.

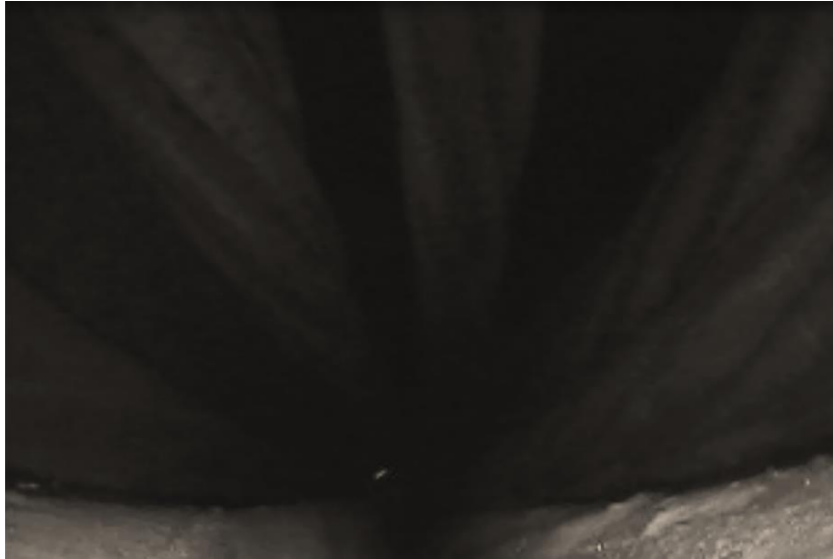
**Figure 5-5: Borescope View of Several Exposed Strands**

In the duct length that could be mapped out by the borescope, the greatest void extent over the duct cross section occurs between 13 feet and 21 feet, seen in Figure 5-5. Whereas, the smallest void area is seen at 0 feet and between 6 feet to 8 feet, shown in Figure 5-6. The change in air void size along the duct was likely caused by slight variations in the duct height due to unlevelled ground and the weight of the specimen

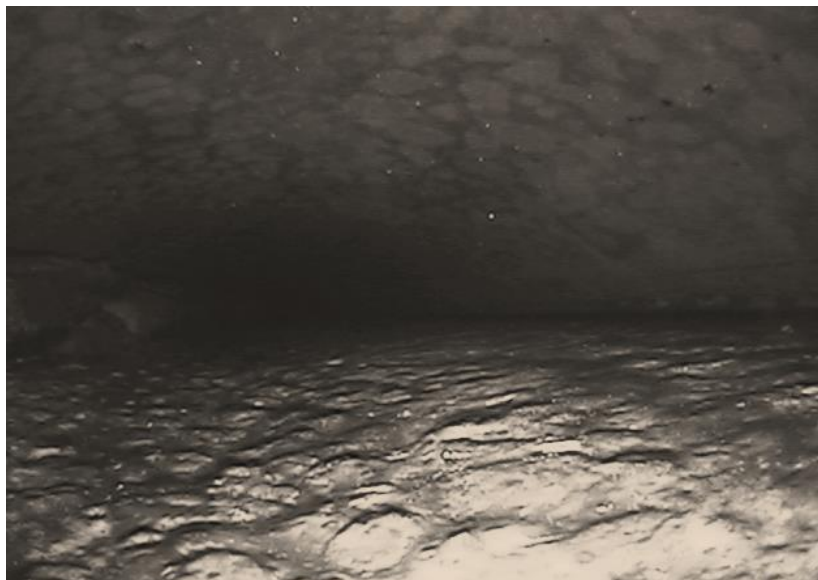
**Figure 5-6: Borescope View of Air Void**

between supports. These small slopes in the duct caused a varying amount of the cross section to be filled as the grout leveled out in a sloping duct.

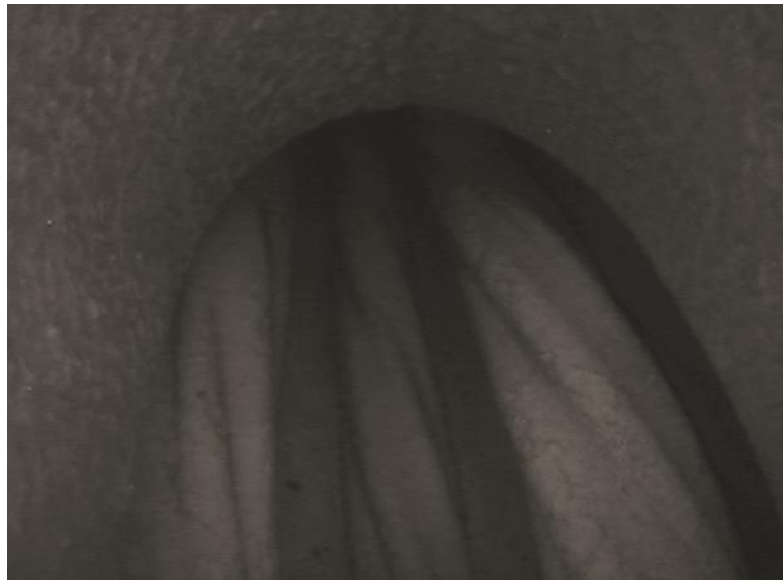
**Figure 5-7: Borescope View of Anchorage Region**

The borescope was also used in both anchorage regions, in both the anchorage system and grout cap. Exposed strands were visible at both ends of the specimen, although to a lesser extent in the non-stressing anchorage end, shown in Figure 5-7. The stressing anchorage end was less grouted throughout the anchorage region and grout cap at about half full of grout. The non-stressing anchorage end and grout cap, shown in Figure 5-8, ended up at approximately two thirds full of grout.

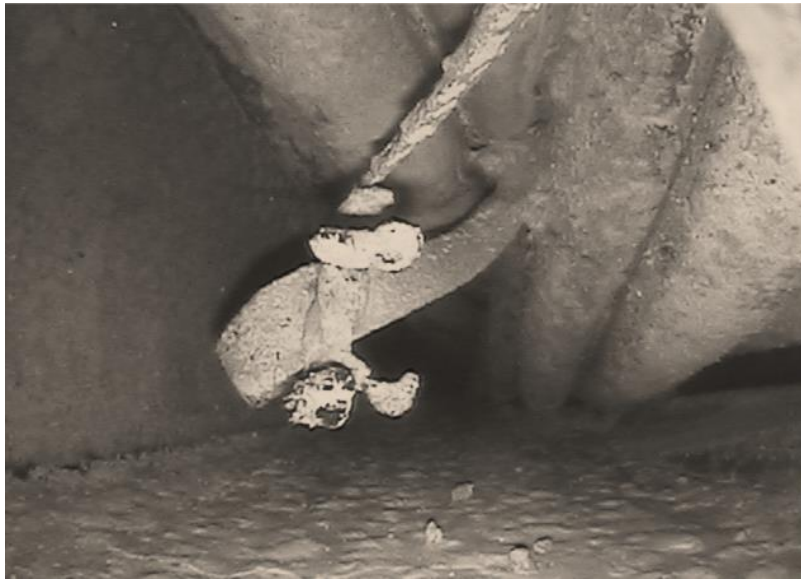
**Figure 5-9: Borescope View of Section Loss**

Although the borescope was primarily used to map the top air void, a location of section loss at 16 feet from the reference point was also seen during the specimen inspection. If exposed strands within the duct have been subject to corrosion, breakage, or section loss, it is possible that these conditions can be identified during borescope use in a voided section, although they need to be free from grout cover. At locations of breakage and section loss of the strands, the seven wires were held in place as much as possible to eliminate wires fraying from the bundle. However, as the strands were pushed through the anchorage systems and duct, it was difficult to prevent wires from fraying as seen in Figure 5-9.

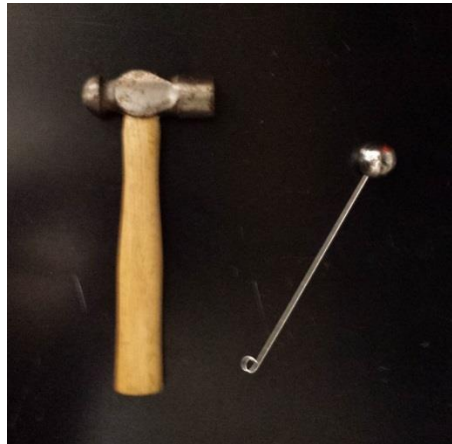
**Figure 5-10: Sounding Tools**

The non-destructive evaluation method of sounding was applied to the duct using the ball peen hammer shown in Figure 5-10. There are numerous impact tools that can be used to perform sounding on stay cables and external PT ducts, including the metal impactor also shown. During inspection, voids are identified by the acoustic response to tapping on the duct. Since these acoustic responses are interpreted by the inspector throughout sounding, it can be a very subjective method of condition evaluation. Tapping on an area of voided duct creates a different sound pitch than tapping on an area of fully grouted duct. Air voids produce a lower pitch response, whereas grouted duct creates a higher pitch response. By recording areas of lower pitch responses, a map of voided areas can be produced and these locations can be marked for further inspection.
