NON-DESTRUCTIVE EVALUATION OF BRIDGE STAY CABLE AND  
EXTERNAL POST-TENSIONING SYSTEMS

A Thesis

Major Subject: Civil Engineering

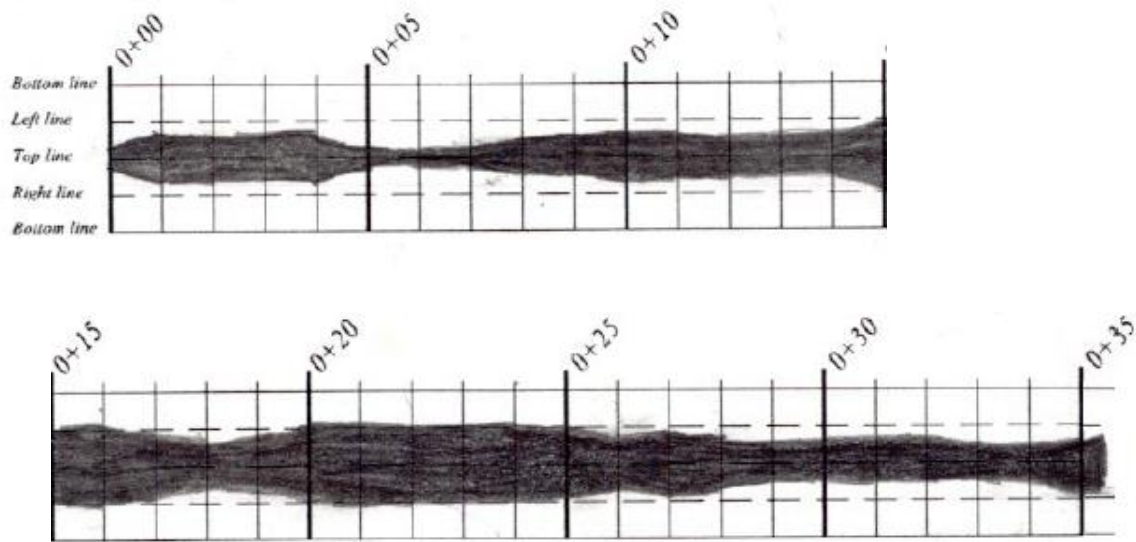
**Figure 5-11: Sounding Map of Voids**

The voids detected were recorded using the same void mapping sheet as used for the borescope inspection. The map is shown in Figure 5-11. After both the sounding method and the borescope inspection were carried out, the results were compared. The void map created by sounding is very similar to the void map produced from the borescope inspection. However, in occasional sections of duct length, the sounding method slightly overestimated the void size. This is likely due to the subjectivity involved in the evaluation method.

As seen in the sounding map, the two artificial voids, centered at 29 feet and 35 feet, created acoustic responses similar to that of air voids and were therefore recorded as voided duct. This result helps to validate the use of foam to replicate an air void in specimens subject to non-destructive evaluation, at least for use of the sounding method.

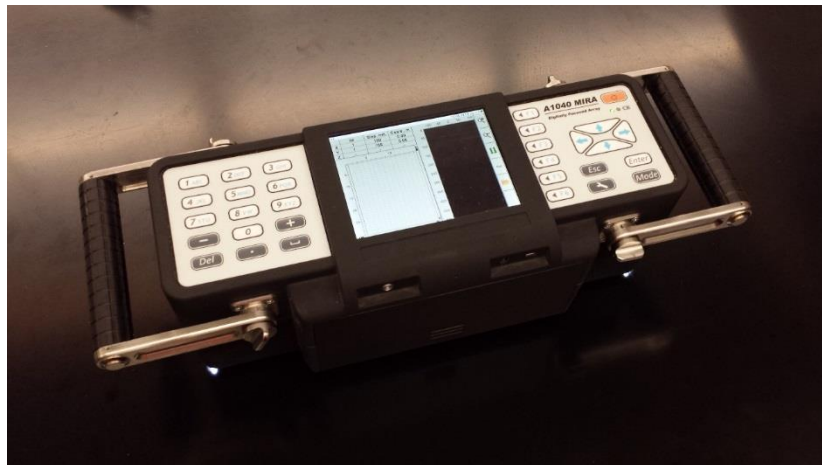
**Figure 5-12: Ultrasonic Tomograph**

Ultrasonic tomography was implemented on the specimen during both quality control and inspection time periods. The ultrasonic low-frequency tomograph used, shown in Figure 5-12, was the A1040 MIRA unit with operating frequencies of between 25 kHz and 85 kHz. This ultrasonic testing unit is intended for use on concrete, but was applied to the stay cable and external PT specimen to determine its applicability elsewhere. The underside of the tomograph is made up of an array of 48 total transducers

in a 4 by 12 configuration. The first row of four transducers sends shear waves into the material to be detected by all of the other rows of transducers. Once detected, the second row transmits another set of shear waves to be detected. This phased ultrasonic testing continues until the final row of transducers is reached. In this tomograph, dry point contact transducers are used, meaning no couplant is needed between the transducers and testing surface which makes testing both cleaner and faster. To test, the ultrasonic tomograph is pressed down on the material surface to depress the transducers and then a button is pressed to begin the phased array data collection.

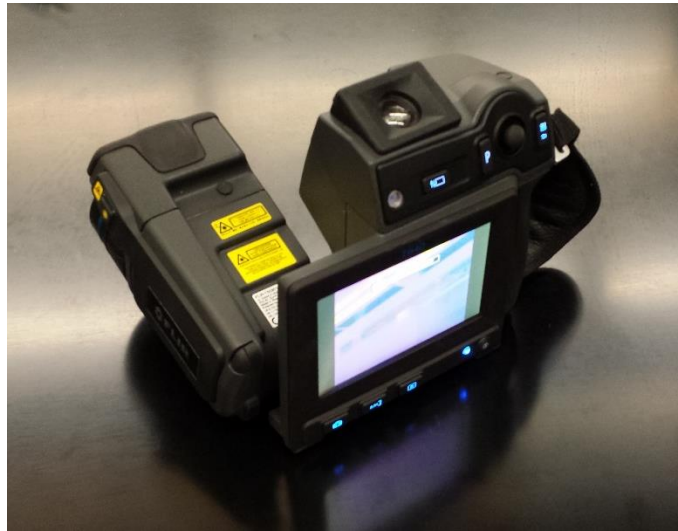
**Figure 5-14: Infrared Thermography Device**

The infrared thermography method was implemented by viewing the specimen with a FLIR (Forward Looking Infrared) device, shown in Figure 5-14, and capturing

thermal images as desired. The key to this non-destructive evaluation method was to perform testing on the specimen at the right time of day. Higher temperature differentials between the grout, air, and foam inside the duct produced infrared images of greater readability. These higher temperature differentials were found to occur during periods of time in which the specimen was either cooling down or warming up throughout the day. The rate at which different materials change temperature is a function of their specific heat value. With materials of varying specific heat values included in the specimen, the best time to capture thermal images was during temperature changes in the surrounding environment.

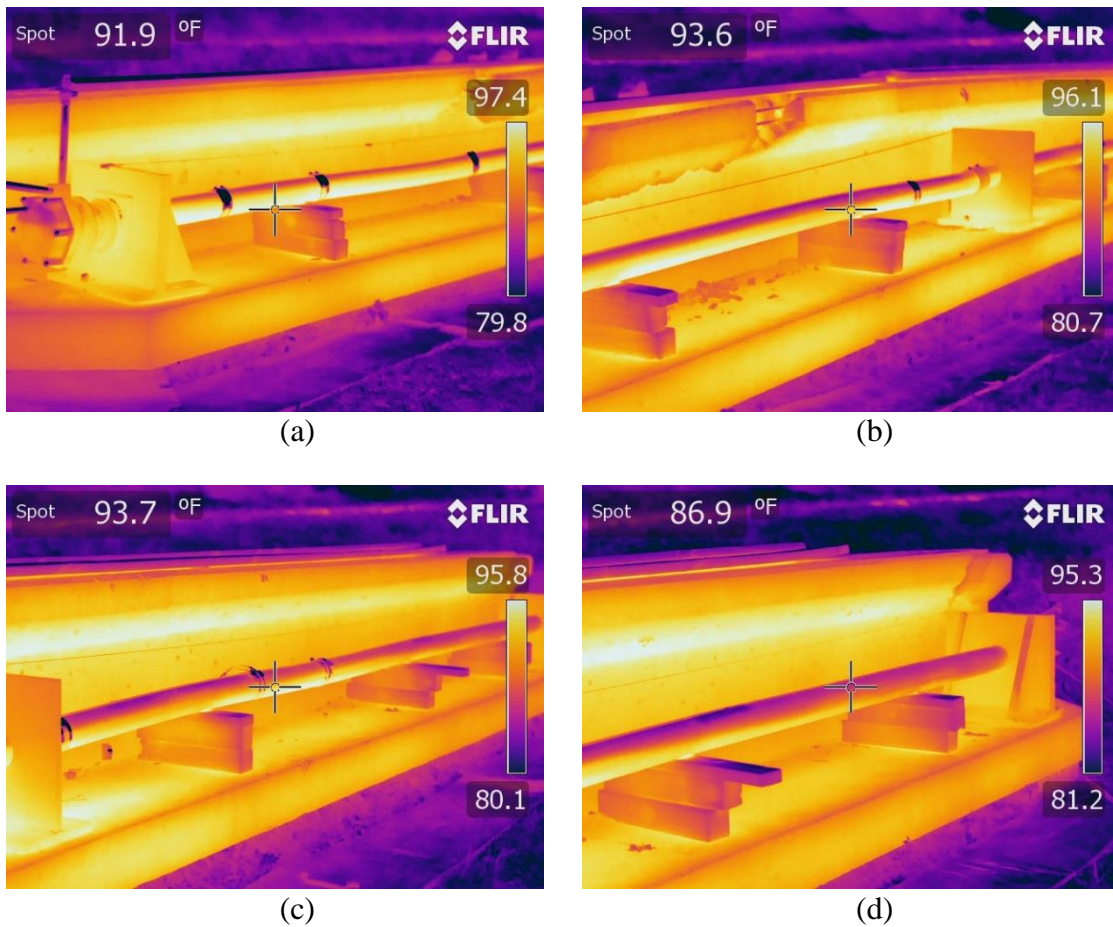
**Figure 5-15: (a-d) IRT QC of Duct Free Span during Cool Down**

In Figure 5-15 of images taken soon after grouting, the top void can be seen along the duct free span during a period of temperature cool down. During testing, it is important to take into consideration any portions of external PT that had been shaded from the sun for an extended period of time. In the bottom right image, more of the duct appears to be voided than is in reality due to that portion of duct being out of direct sunlight for some time. The other three images show a true representation of the voided duct area, seen by the purple color of cooler temperature in comparison to the orange and yellow colors of hotter temperatures.

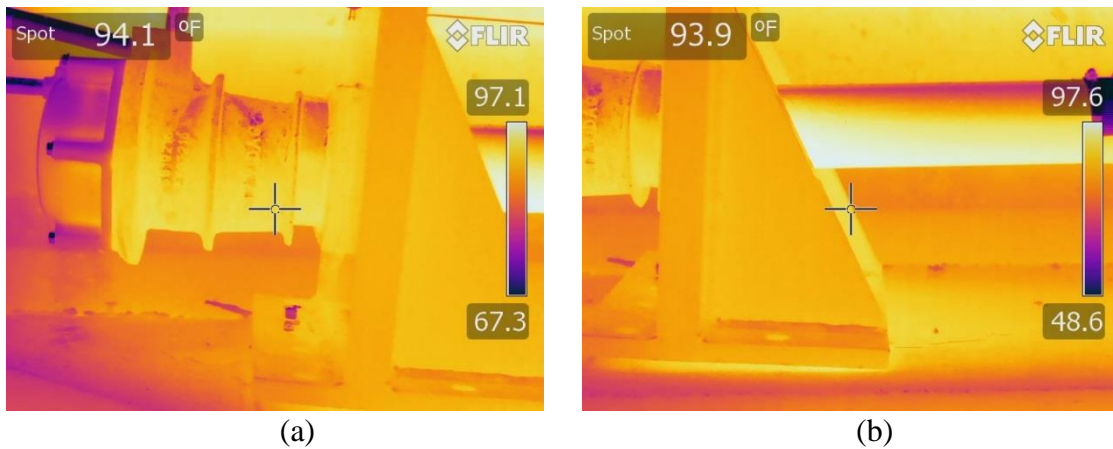
**Figure 5-16: (a-b) IRT QC of Top Void Variation during Cool Down**

On occasion, if the specimen was tested at the correct time during temperature change, images could be produced that matched closely with the ground truth borescope results. In Figure 5-16, the thermal views of the non-stressing anchorage region and the beginning of the free duct span align perfectly with the extent of the air void within the specimen during this quality control period of testing. The air void represented by the purple color in the images extends straight through the anchorage and once into the free duct, the void size begins to gradually expand through the first two feet of duct shown in the picture on the right. As the air within the specimen cools down faster than the grout,

the difference in temperature increases to make capturing these infrared thermal images possible.

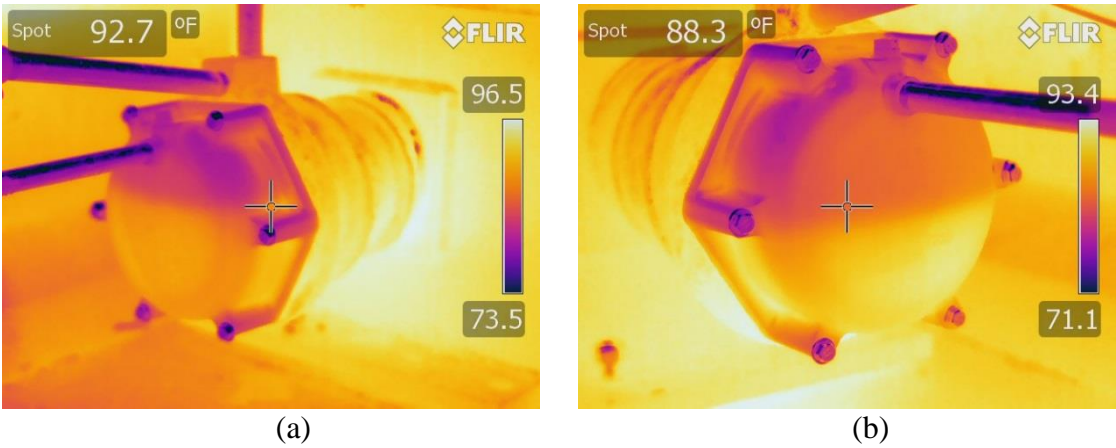
**Figure 5-17: (a-b) IRT QC of Anchorage Ends during Cool Down**

A significant finding during this non-destructive evaluation period was the quality of thermal images that could be taken of the grout caps at the specimen ends. The grout level is extremely evident both when the surrounding temperature is decreasing, as in Figure 5-17, and when the surrounding temperature is increasing, as in Figure 5-18. Being able to capture the dividing line between air and grout at the specimen ends soon after grouting makes this method of evaluation a strong candidate to be used as a quality control method specifically for external PT and even internal PT. During construction, a quick image can be taken of the grout caps at the right time of day to ensure that the duct is fully grouted through the anchorage regions. Anchorage regions are typically the most likely area of post-tensioning to include voids due to poor construction practices, especially with the use of harped tendons, either external or within concrete. By using

infrared thermography on the grout caps, the quality of grouting can in most cases be determined quickly and without having to remove the grout caps for inspection. If voids are detected, repair action can be planned and executed before the bridge structure even goes in to service.

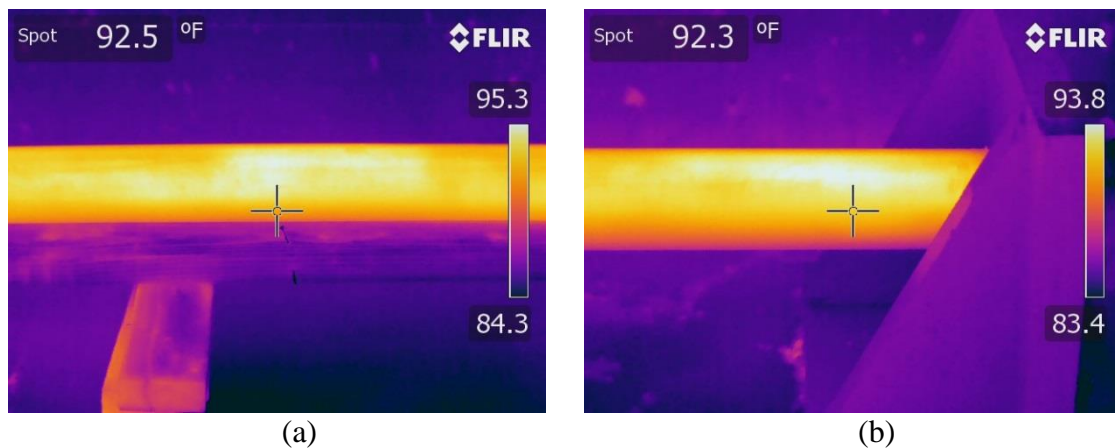
**Figure 5-19: (a-b) IRT QC of Foam Void Locations during Warm Up**

The foam void locations were evident in the thermal images, shown in Figure 5-19, even during quality control testing. Although the foam pieces were meant to be directly representative of air voids, the foam often stood out more than the air in the infrared thermography evaluation of the ducts. The first foam void shown in the left image and the second foam void shown in the right image were here seen to heat up faster than the assumed surrounding air during natural temperature increases. However, there is not ground truth data available from a borescope inspection for this portion of the duct for direct, valid comparison to the actual air void size.

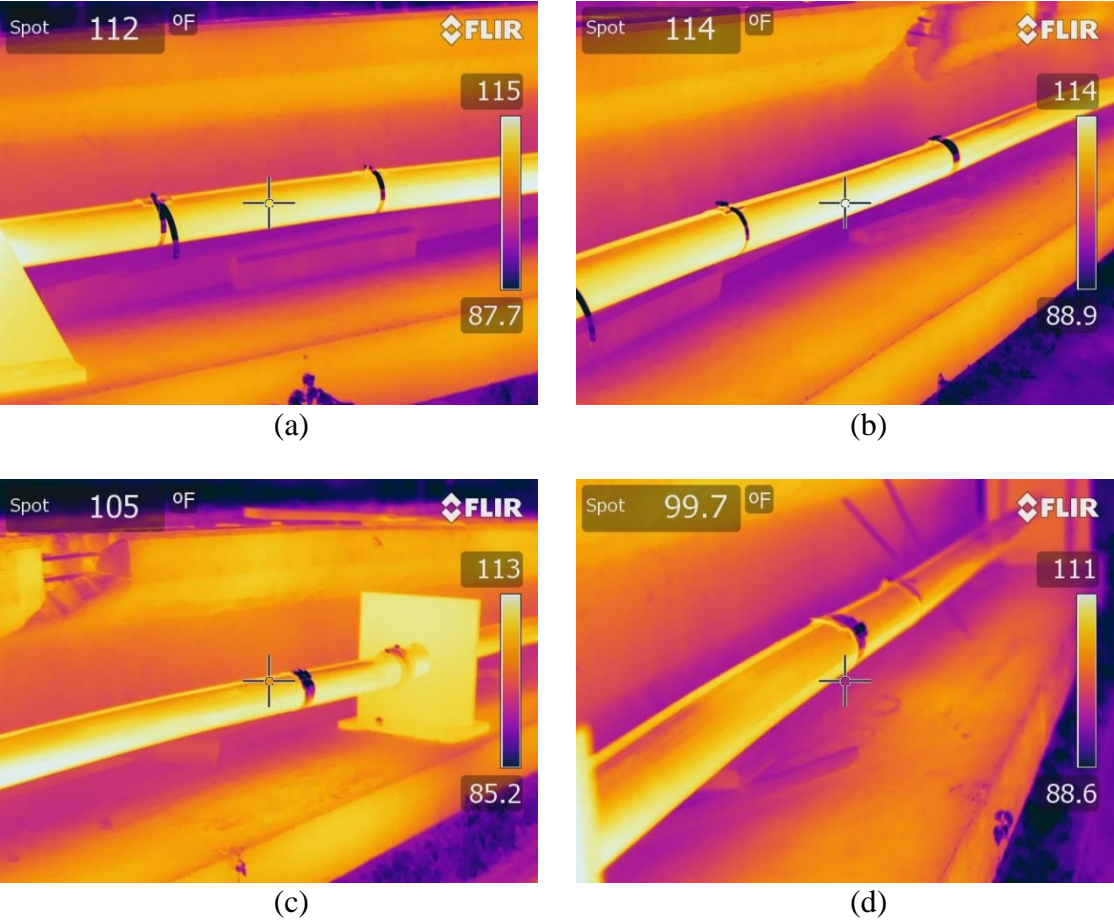
**Figure 5-20: (a-d) IRT Inspection of Duct Free Span during Cool Down**

After the grout had fully cured at 28 days, IRT evaluation of the specimen was carried out again to determine if the same results were achieved. Very similar thermal images of the specimen were captured during the inspection testing. In Figure 5-20, four images of the duct free span are shown as the specimen is cooling down. Again, the air

in the duct is decreasing in temperature more quickly than the grout due to the specific heats of air and grout. The void extent can be seen by the deeper orange coloring, while the hotter grout is represented by a light yellow, almost white coloring. In the top left image especially, at the beginning of the free span, it is evident that the amount of air at the top of the duct cross-section is increasing along the first few feet of free span and then decreases again at approximately 5 feet from the steel support, matching the borescope results.

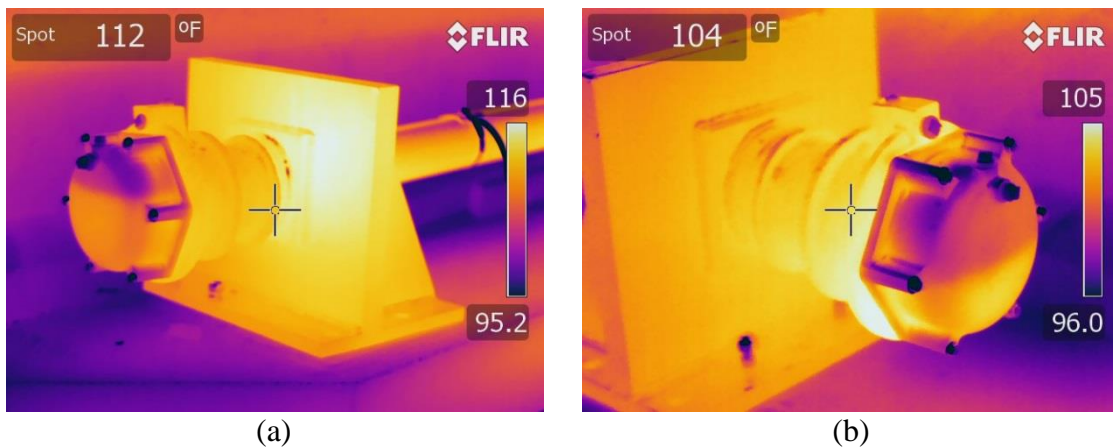
**Figure 5-21: (a-b) IRT Inspection of Anchorage Ends during Cool Down**

In Figure 5-21 and Figure 5-22, the grout cap thermal images are shown during cool down and warm up, respectively. Clear changes in temperature are seen at the interface between air and grout within the ends of the specimen, again with more grout filling the non-stressing anchorage end in the left side images. As an inspection method of in-service bridges, infrared thermography would be extremely valuable for quick non-destructive condition assessment of the anchorage systems.

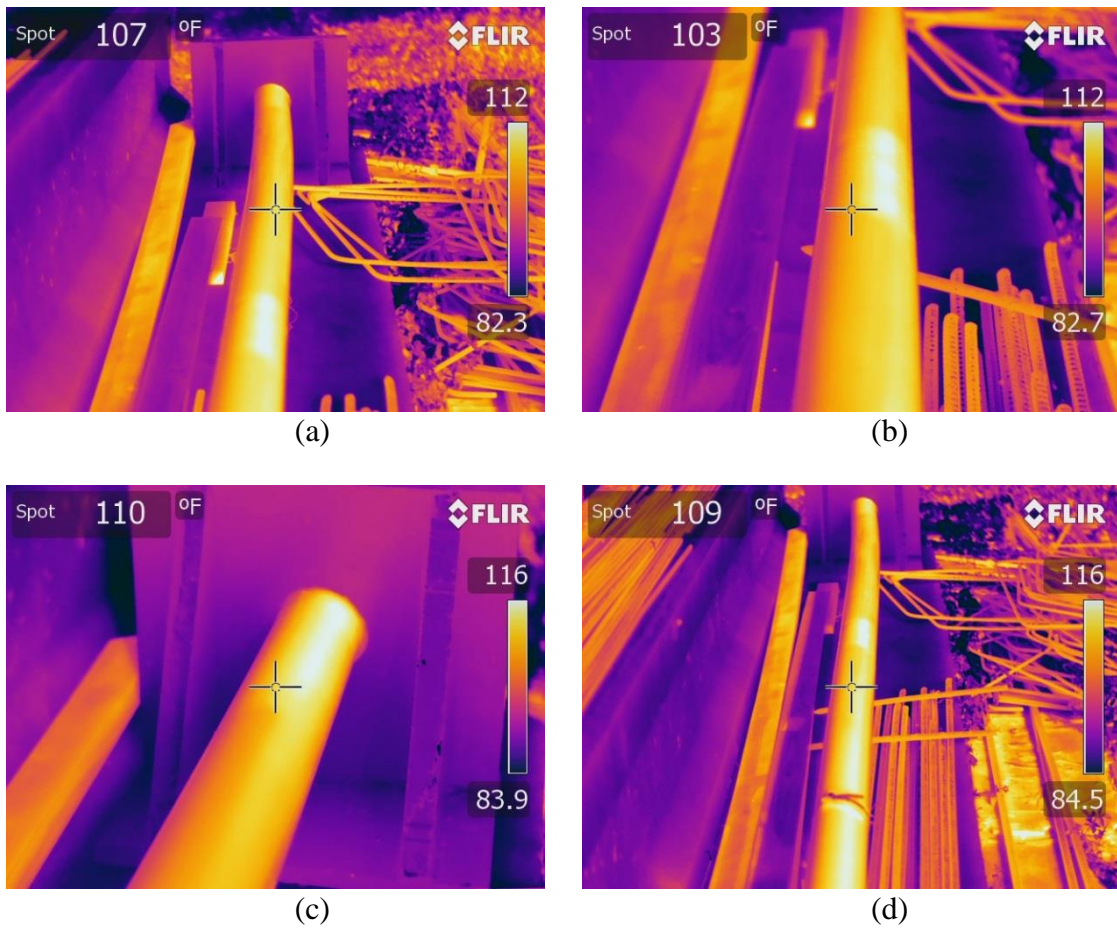
**Figure 5-23: (a-d) IRT Inspection of Foam Void Locations during Warm Up**

During the inspection phase, the foam void locations are once again easily and precisely detected with the use of thermal imaging. Seen both during warm up and cool down of the environment in Figure 5-23 and Figure 5-24 respectively, the foam voids are more apparent than the air voids within the duct. Although this makes locating voids easier during quality control and inspection testing, it creates a problem in that in certain circumstances foam voids may be detected whereas air voids would not be detected by infrared thermography. This means foam voids are not as representative of void conditions in the field as expected due to the different specific heat values of air and foam. Even though the specific heat of foam is closer to that of air than grout, in the future fabrication of conditions, the use of foam may not be desired in order to truly test infrared thermography equipment in the detection of voids representative of field conditions.

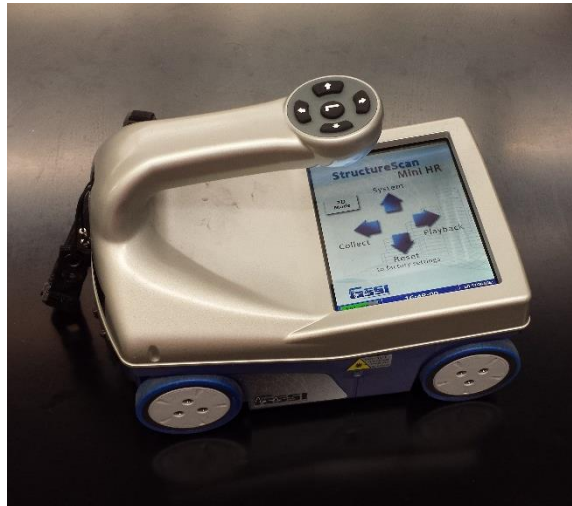
**Figure 5-25: Ground Penetrating Radar Unit**

Ground penetrating radar testing was conducted on the specimen during both the quality control and inspection time periods using the GSSI StructureScan Mini shown in Figure 5-25. As the GPR unit is wheeled across the material surface, it operates by sending and receiving electromagnetic waves that are altered by encountering materials of different dielectric properties. The detection of structural anomalies can then be concluded. Just as with the ultrasonic tomograph used, this GPR unit's intended use is for concrete, but it is included in this research to determine its applicability to stay cable and external PT systems.

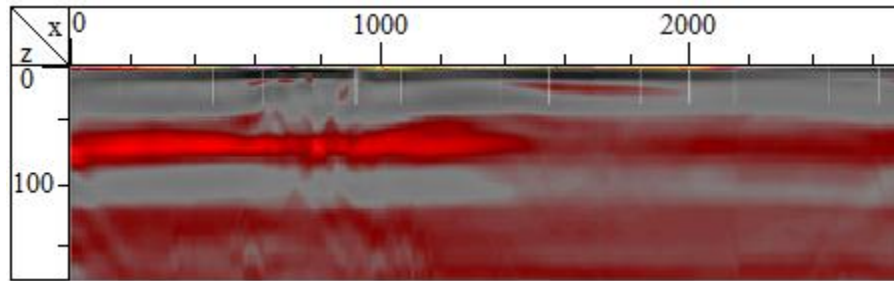
**Figure 5-27: GPR QC Test A1 at Small Air Void**

In Figure 5-27, the GPR scan is taken over Path 1 in Section A along the duct free span and in Figure 5-28, the scan is taken over Path 1 in Section C. The test A1 scan is located at the least voided section of duct, whereas the test C1 scan is within the largest air voided section of duct. The difference is clear in that the ground penetrating radar pulses were significantly affected by the amount of air present in the highly voided regions of duct. The air void size difference across the entire duct length is shown in images included in Appendix C.

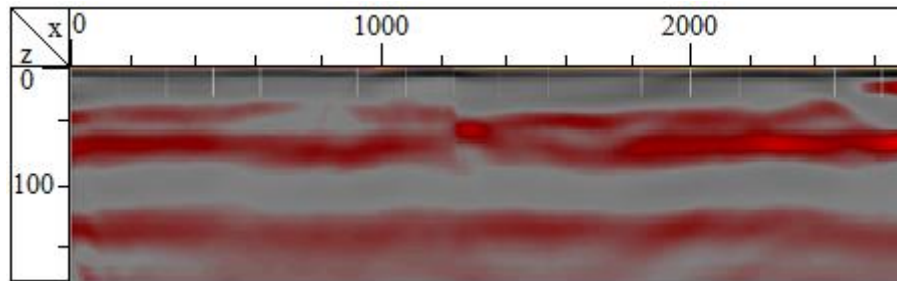
**Figure 5-29: GPR Inspection Test A2 at Small Air Void**

In Figure 5-29 and Figure 5-30, GPR results from after the grout had fully cured are shown. In Figure 5-29, the GPR scan is taken in Section A over Path 2 and in Figure 5-30, the scan is taken in Section C also over Path 2. Similar to the QC figures, the test A2 scan is located at the least voided section of duct, whereas the test C2 scan is within the largest air voided section of duct. Again, there is a significant difference in the results of a minimally voided section to a largely voided section.

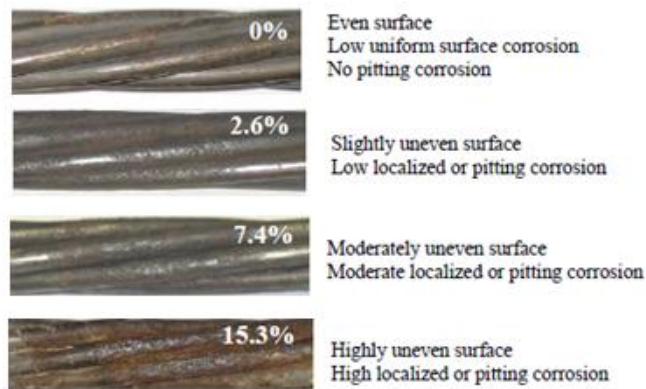
Sample of different corrosion levels with percentage of section loss (Trejo 2009)

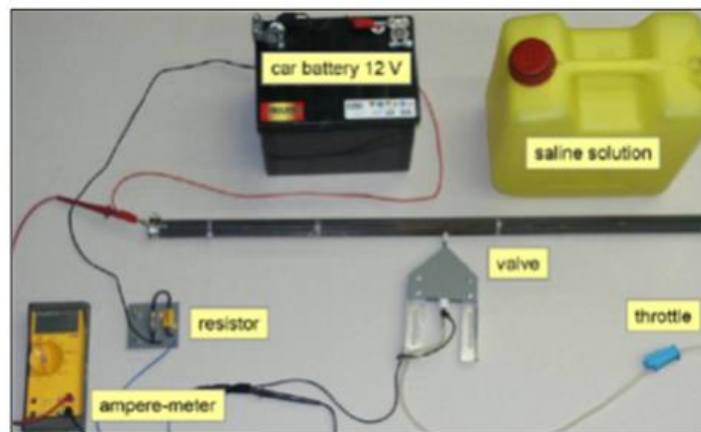
Components of electrolytic corrosion cell for localized corrosion (Fricker and Vogel 2007)

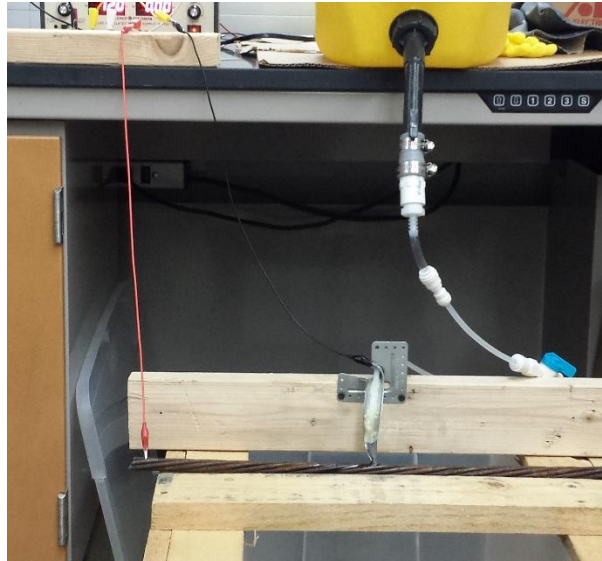
Sample set up of electrolytic corrosion cell for localized corrosion

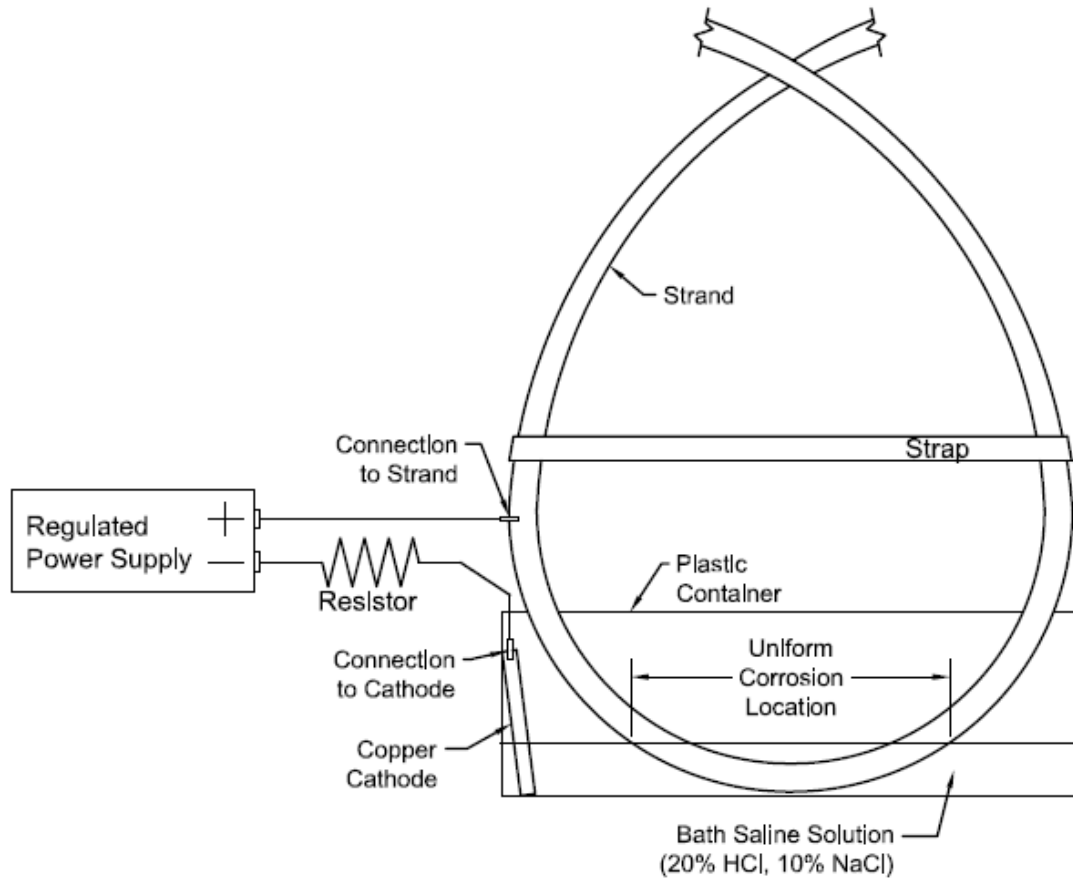
Set up of electrolytic corrosion cell for uniform corrosion

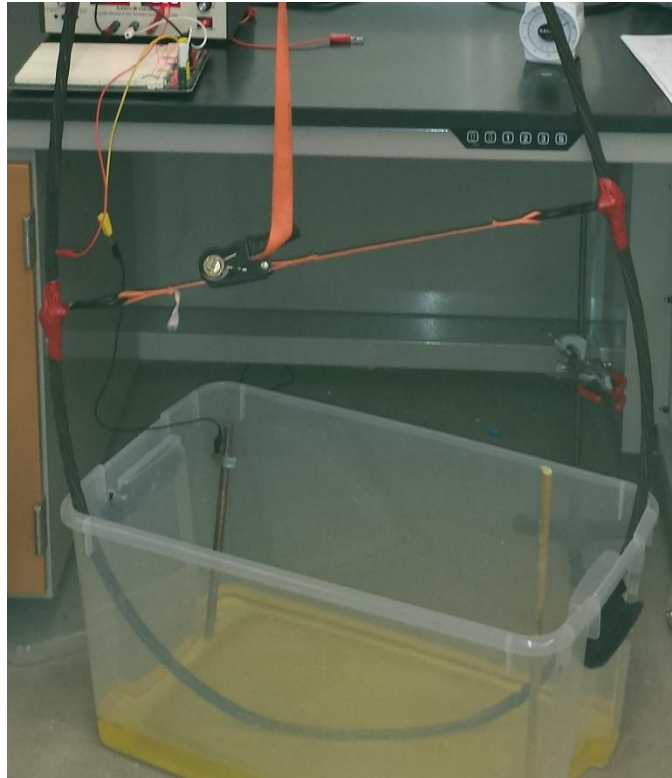
Sample set up of electrolytic corrosion cell for uniform corrosion

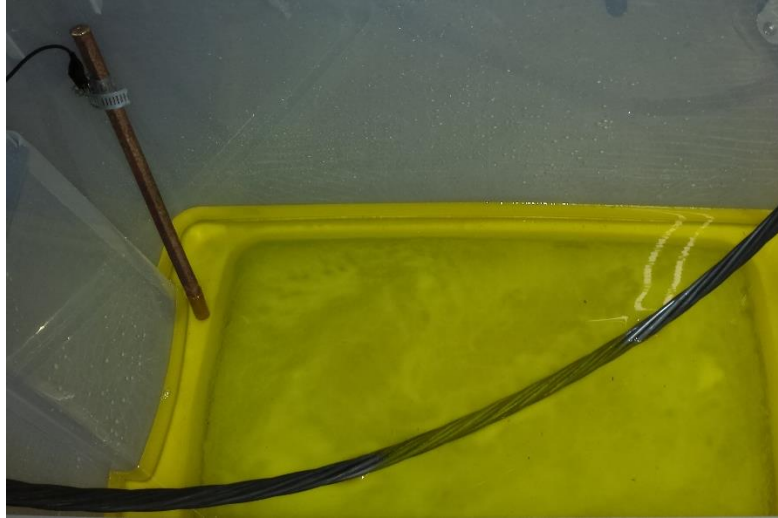
Strand and cathode in bath saline solution for uniform corrosion

Step 2 – Place the strand in the solution using the straps to keep the strand curved so that only the length to be corroded is immersed in the saline solution.

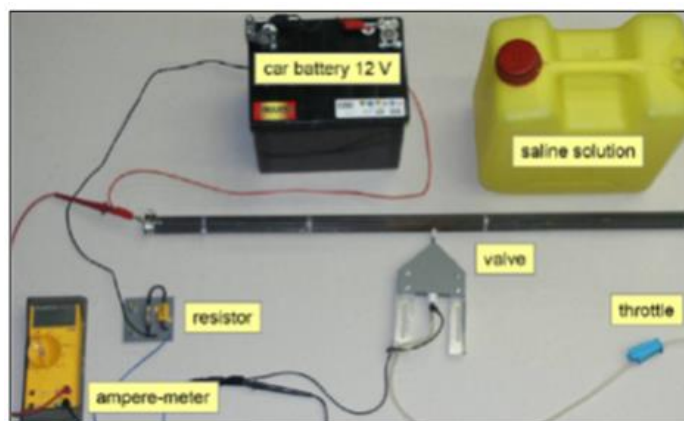
Components of electrolytic corrosion cell (Fricker and Vogel 2007)

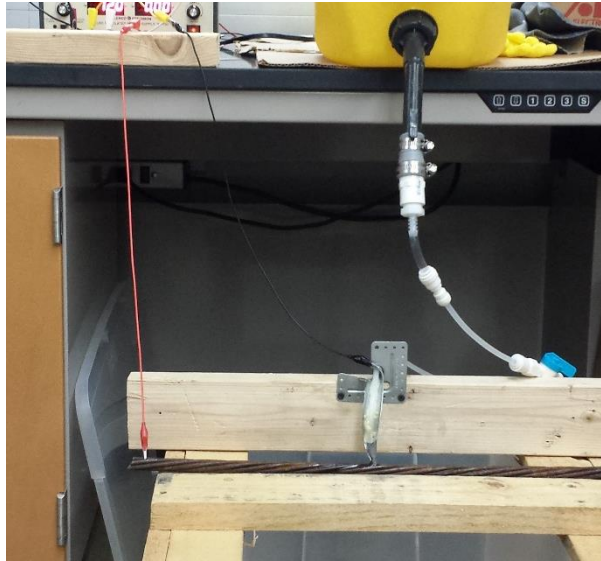
Sample set up of electrolytic corrosion cell for localized corrosion

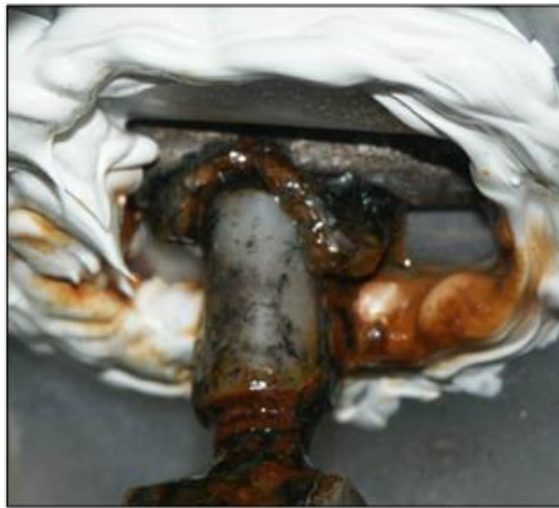
Sample application of corrosion cell (Fricker and Vogel 2007)

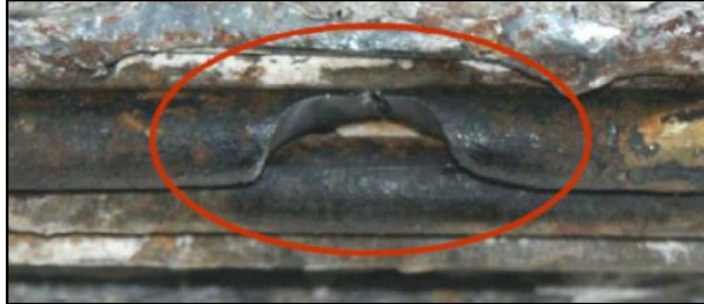
Sample of section loss condition due to corrosion cell (Fricker and Vogel 2007)

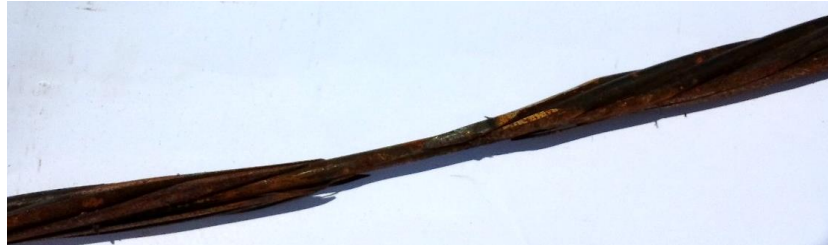
Strand Section Loss

The grinder will be applied to the designated amount of steel strands at each determined section loss location. These wires/strands with section loss are then pushed or pulled through the ducts of the specimen. Previously corroded or damaged strands that have already experienced section loss may also be used.

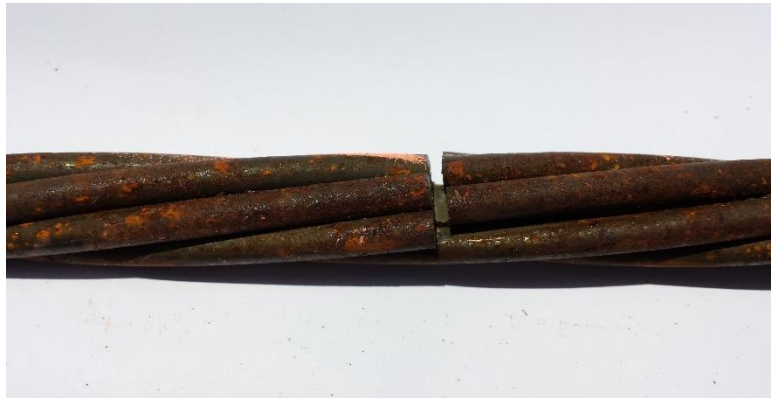
Broken wires of a steel tendon

The designated amount of steel wires or full strands will be cut at each determined breakage location. These cut wires/strands are then pushed or pulled through the ducts of the specimen. Corroded or damaged strands that have already experienced breakage may also be used.

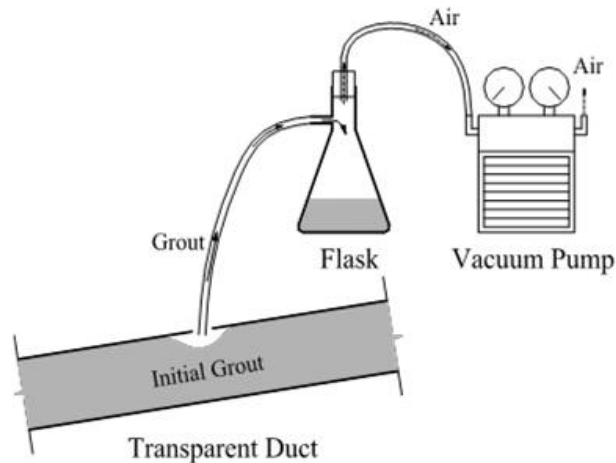
Schematic showing the set up for the vacuum pump (Im 2009)

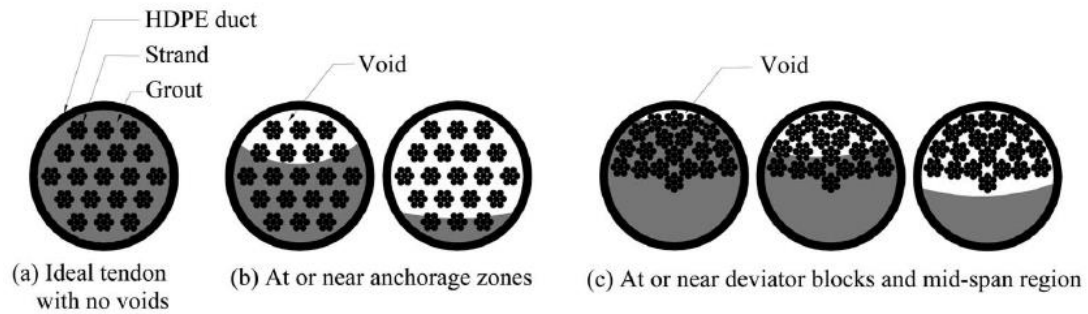
Cross sections of typical no-void and void conditions inside a PT duct (Trejo et al. 2009a)

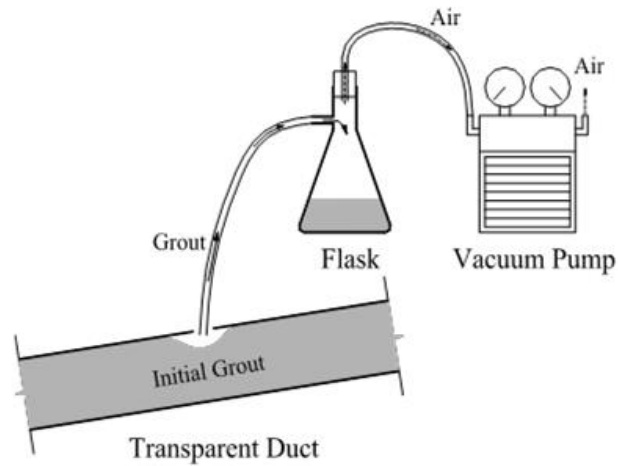
Schematic showing the set up for making artificial voids (Im 2009)

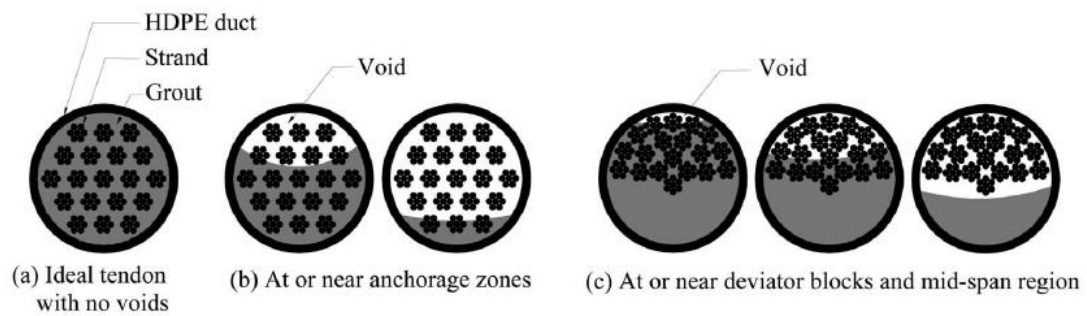
Cross sections of typical no-void and void conditions inside a PT duct (Trejo et al. 2009a)

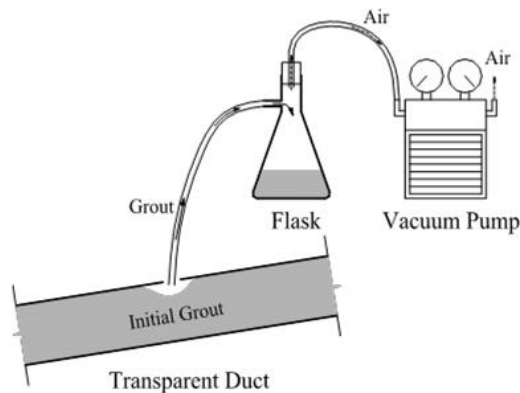
Schematic showing the set up for making artificial voids (Im 2009)

vent holes at the anchorage parts of the specimen. The water will infiltrate the ducts resulting in the water infiltration condition.
