Terrestrial Laser Scanning Survey of Haynes Engineering Building, Texas A&M University, College Station, Texas (November 24, 2019): Project Report

The following is a report on the terrestrial laser scanning survey of the Haynes Engineering Building at Texas A&M University in College Station, Texas, conducted by the Center for Heritage Conservation at Texas A&M University on November 24th, 2019.

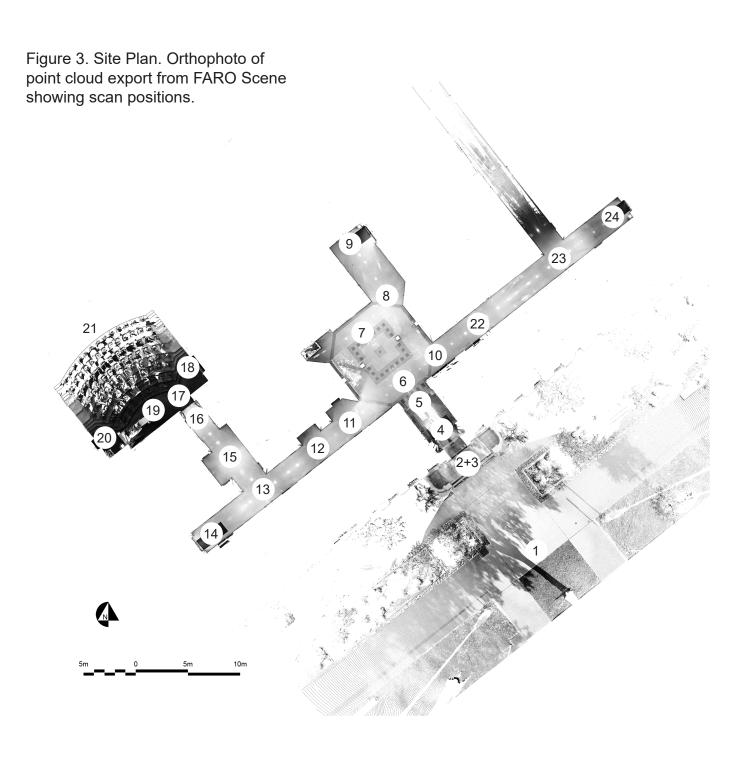
The team utilized a FARO Focus3D X330, a phase-based laser scanning system. The scan data were initially processed with FARO Scene 2019.0 software.

The scan project resulted in 24 usable scan positions, with each scan duration being around 8 minutes. A scan resolution of \(\frac{1}{4}\) was set; this results in an average point spacing of 6mm at a distance of 10m. The scan quality was set to 3x; this number pertains to the number of measurements of a collected data point. A full 360-degree capture was obtained at each scan position, with a vertical declination range of -60-degree to 90-degrees. Light metering was set to even-weighted and the high dynamic range (HDR) setting was not used for images.

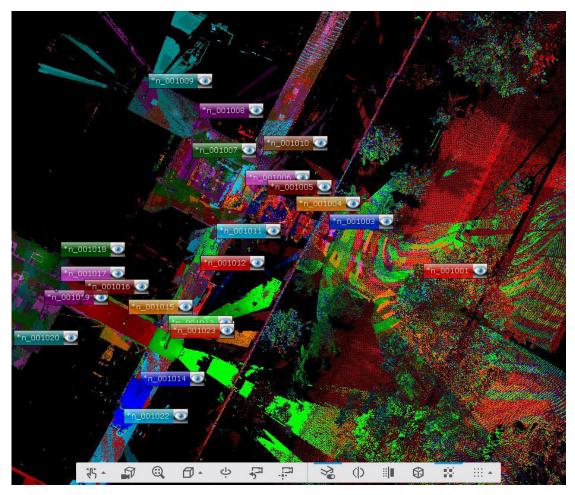
Figure 4: Plan view. Screenshot of point cloud in visual registration view from FARO Scene.

The most effective means of aligning adjacent scans correctly proved to be manual alignment using surface planes in the respective scenes. The resulting cluster was then optimized using cloud-to-cloud registration. Initial registration output (using topview and cloud-to-cloud automatic registration) yielded a mean point error of 2.9mm with a maximum point error of 44.6mm and a minimum overlap of 3.6%. Using manual registration and the fine registration capabilities of Scene, scan point statistics were improved. The mean point error was reduced to 1.2mm with a maximum point error of 3.8mm and a minimum overlap of 13.2%.

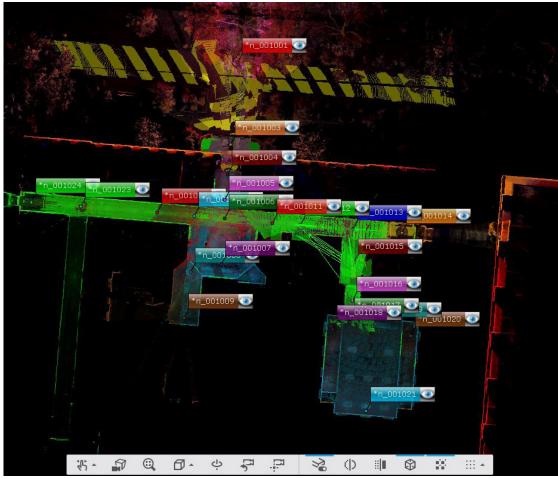
Figure 5: Plan view. Screenshot of point cloud in visual registration view from FARO Scene.

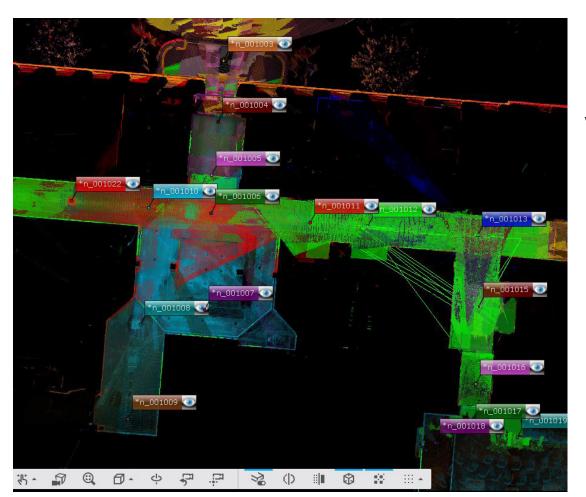
Figure 6: Plan view, Main Lobby Entrance. Screenshot of point cloud in visual registration view from FARO Scene.

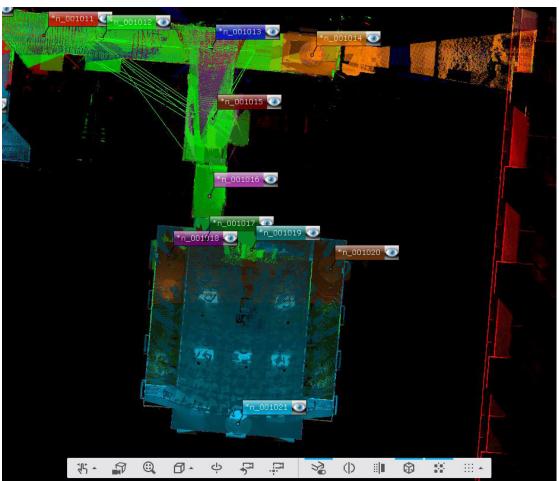
Figure 7: Plan view, Auditorium. Screenshot of point cloud in visual registration view from FARO Scene.

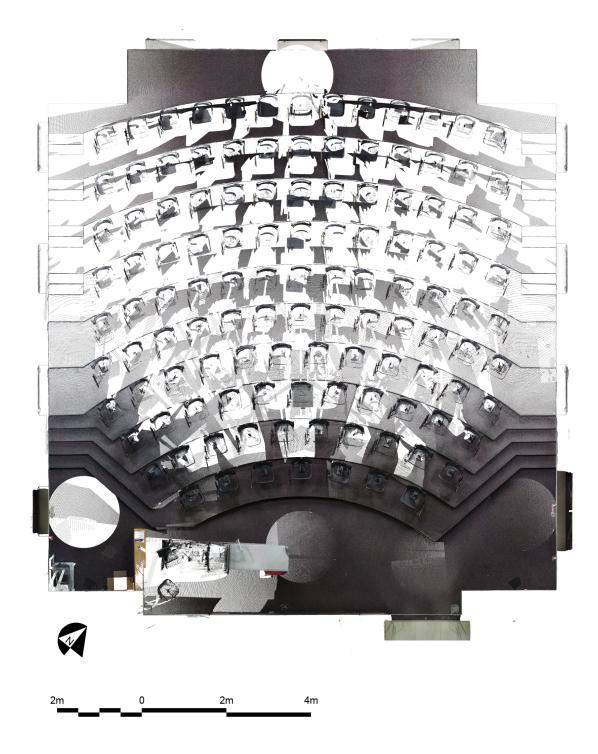
Figure 8. Auditorium, Floor Plan. Orthophoto of point cloud export from FARO Scene.

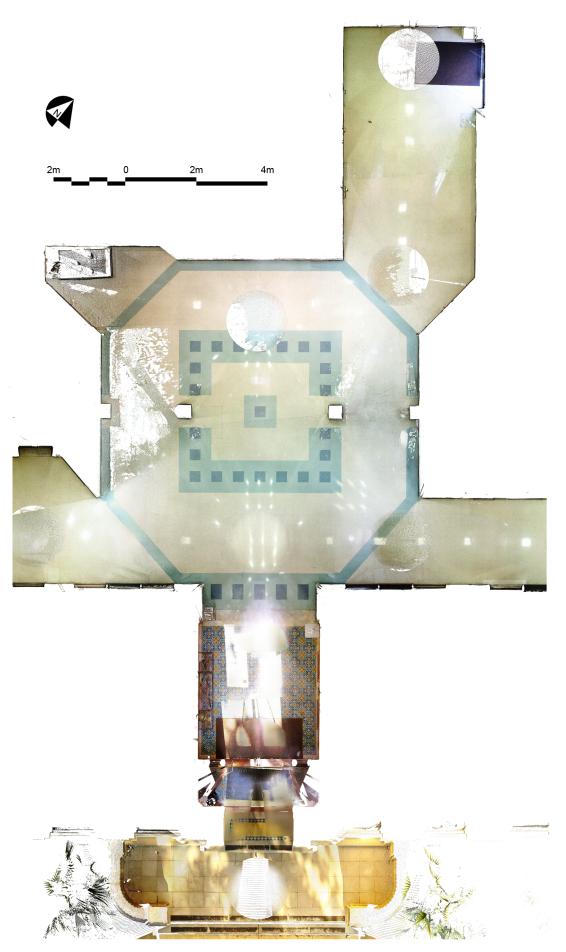
Figure 9. Main Lobby Entrance, Floor Plan. Orthophoto of point cloud export from FARO Scene.

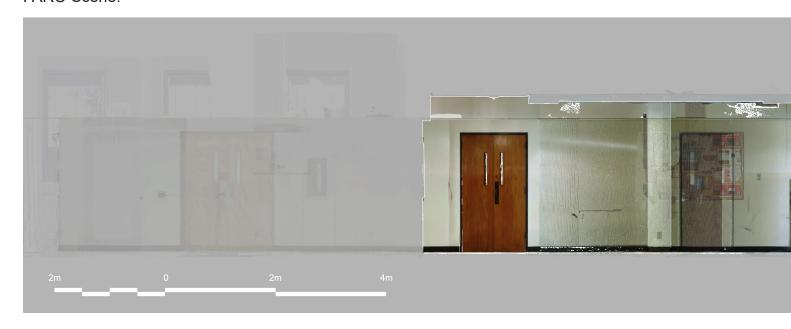
Figure 10. Transverse Section (Northwest-Southeast Axis, looking Northeast). Orthophoto of point cloud export from FARO Scene.

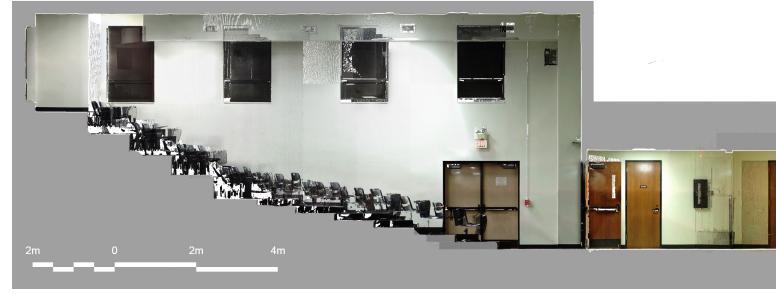
Figure 11. Transverse Section (Northwest-Southeast Axis, looking Northeast). Orthophoto of point cloud export from FARO Scene.

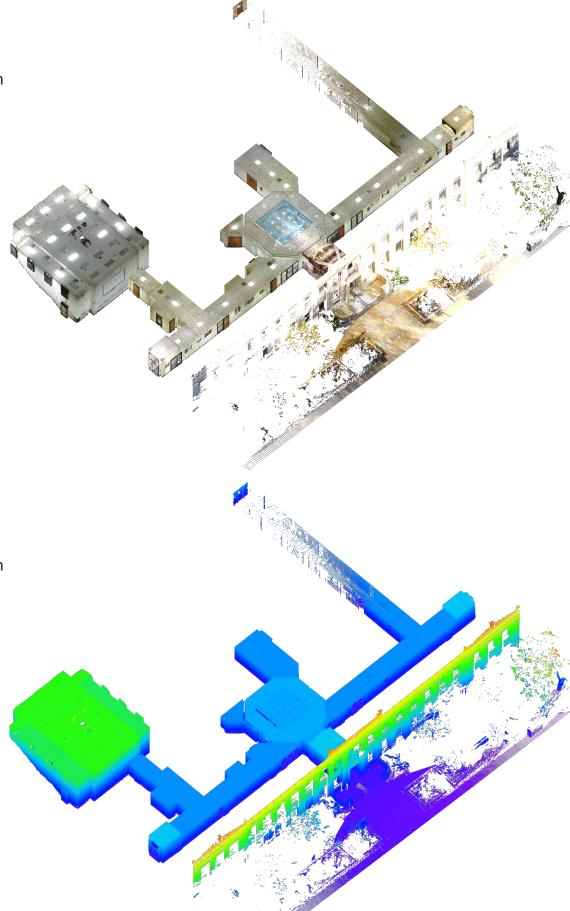
Figure 13. Isometric view (from South looking North). Image export from Autodesk ReCap ("heat map" filter showing topographic elevations: high [yellow/red] to low [violet/blue] elevations).

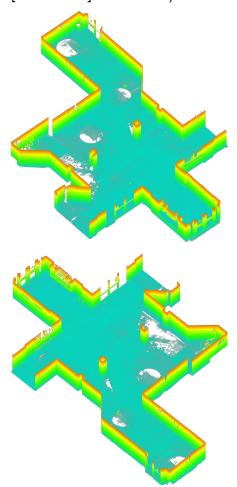
Figure 14. Main Lobby Entrance, Isometric view (from South looking North). Image export from Autodesk ReCap ("heat map" [below] filter showing topographic elevations: high [yellow/red] to low [violet/blue] elevations).

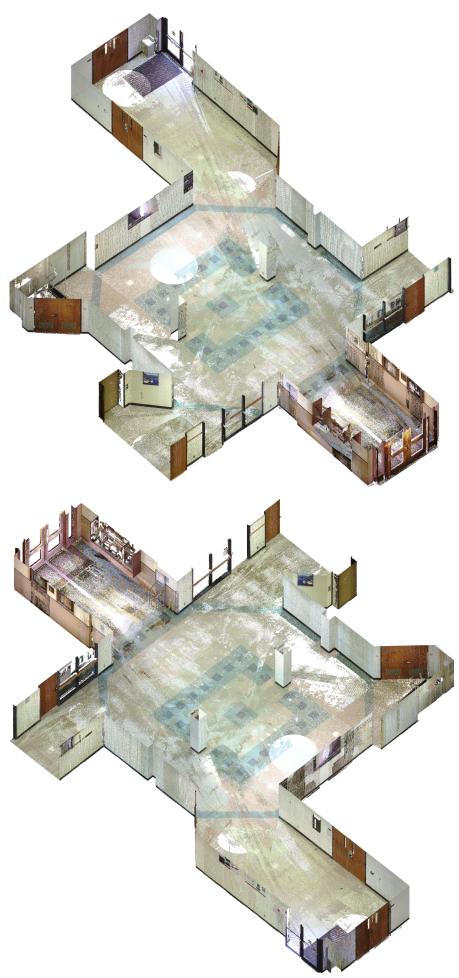
Figure 15. Main Lobby Entrance, Isometric view (from North looking South). Image export from Autodesk ReCap ("heat map" [above] filter showing topographic elevations: high [yellow/red] to low [violet/blue] elevations).
