**A RE-ASSEMBLY AND RECONSTRUCTION OF
THE 9TH-CENTURY AD VESSEL WRECKED OFF THE COAST OF
BOZBURUN, TURKEY**

A Dissertation

MATTHEW BENJAMIN HARPSTER

A Re-Assembly and Reconstruction of
the 9th-century AD Vessel Wrecked off the Coast of
Bozburun, Turkey. (August 2005)

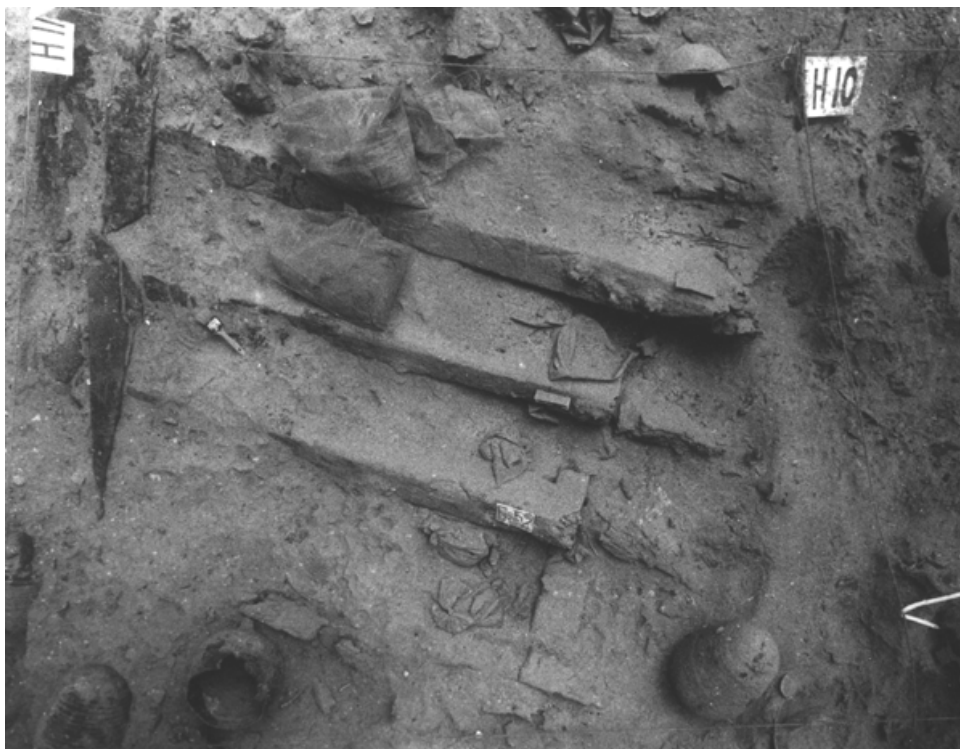
Figure 1-4: Hull remains found in square H11 (INA Archives).

The continuation of work in 1996 resulted in the further recovery of nearly 200 whole amphoras, fragments of 300 others, three coarse-ware pitchers, more lead fishing weights, a copper jug, encrusted carpenter's tools, and two fragments of a small blue-green glass goblet.⁸ Due to the large number of amphoras recovered, a basic typology was developed over the 1996 season that assigned the amphoras to three distinct classes.⁹ In addition to the creation of this typology, a number of the amphoras could also be grouped on the basis of graffiti inscribed on their surfaces.¹⁰ Work in 1996 also exposed the first signs of hull remains in situ. At this time, these remains were concentrated only at the upper end of the site and in excavation grid square H11, which was located approximately amidships.¹¹ While the wood exposed at the upper end of the site consisted primarily of disarticulated fragments with few original surfaces, that found in H11 comprised a section of the keel, four floor timbers, four planking strakes, two ceiling strakes, a section of a

stringer, and possibly a keelson (fig. 1-4).¹² These exposed hull remains also preserved evidence of iron nails, clear tool marks, clean edges and faces, and little damage from *Teredo navalis*.¹³

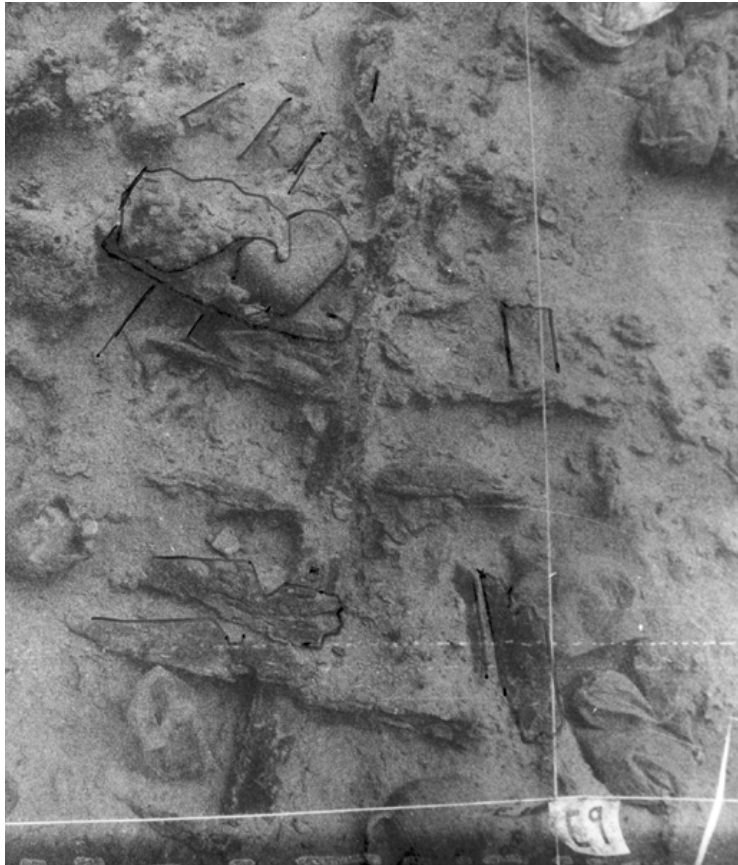
Figure 1-5: Hull remains found in square D10 (INA Archives).

The 1997 season consisted primarily of the further removal of amphoras as well as a refinement of their typology. More articulated hull material was exposed, including what was left of the stern, and the after 2 m of this material was mapped in place (fig. 1-5). Only a small percentage of the wood fragments found on site were brought to the surface and cataloged.

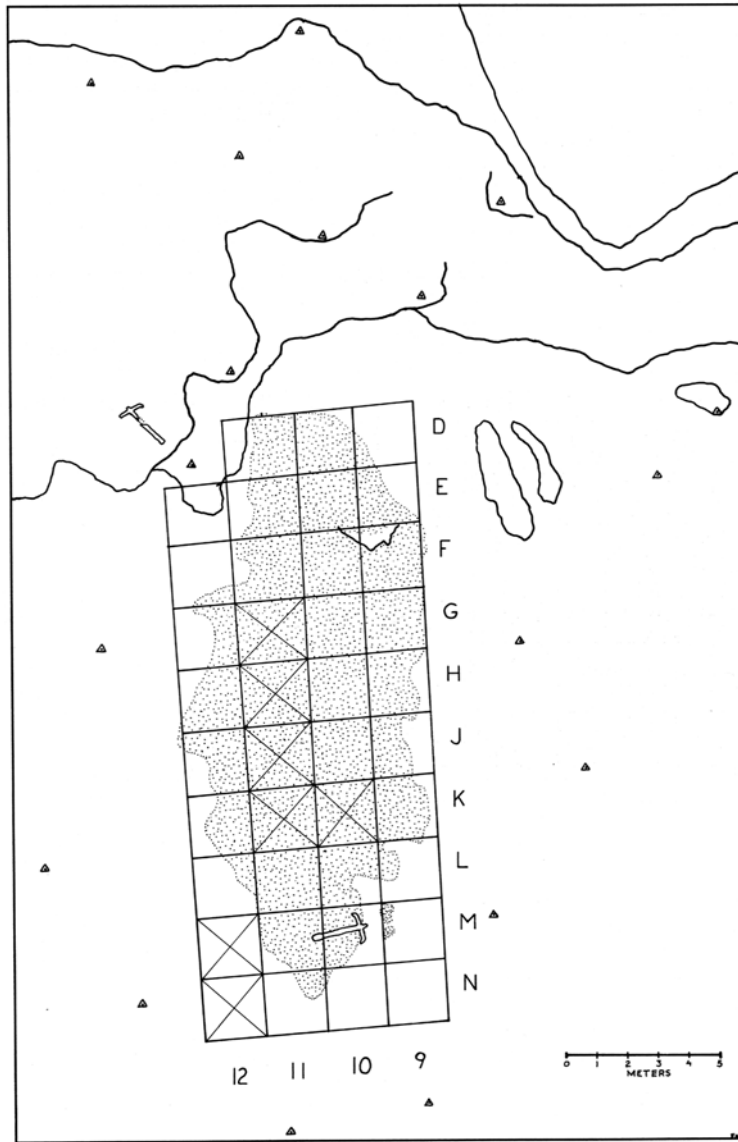
Figure 1-6: Plan of grid squares over site (INA Archives).

The amphoras, the most ubiquitous and numerous artifacts on site, were found in rows D through M (fig. 1-6). Their distribution and orientation on site tended to reflect their original arrangement stored in rows, and stacked in at least two layers, in the hull. The recovered galley ware, which consisted of eight cooking pots, seven coarseware pitchers,

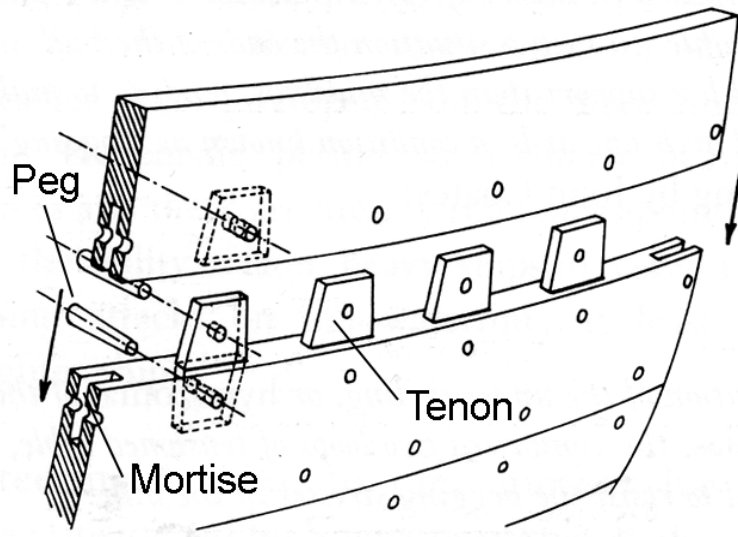
Figure 1-7: Schematic of the mortise-and-tenon method of hull assembly (after Coates 1995, 131).

A mortise is simply a slot cut into a piece of wood. The mortise may be on any face of a timber in question, but in the mortise-and-tenon method applied to hull planking, mortises are cut into the long edges of the planks. Tenons, on the other hand, are slips of wood that fit into the mortises. Usually, a tenon is of the same width and thickness as the mortise, but approximately twice as long as a single mortise is deep. With the mortise-and-tenon method, once the stem and sternpost are attached to the keel, mortises are cut into a rabbet or chamfer on either side of the keel, and tenons are then driven into each of the mortises (fig. 1-7). A matching set of mortises are cut into the lower edge of the first strake, and the entire strake is hammered into place, forcing the tenons into the mortises in strake one. The mortise-and-tenon joints may be further secured by drilling holes on either side of the seam through the planking and the tenons, and then driving wooden pegs into the holes.

This process is repeated along the edges of each strake. Thus, by using mortise-and-tenon joints to affix strakes together, it is possible to assembly most, if not all, of the exterior planking prior to attaching any or most of the internal framing. Using this method of construction, as the strakes of the ship are assembled prior to the frames, the planking determines the interior and exterior dimensions of the ship, and thus the general shape of the vessel. Presently, it is not entirely clear why the mortise-and-tenon method was adopted and used for such a long time throughout the Mediterranean. The hull produced is one that

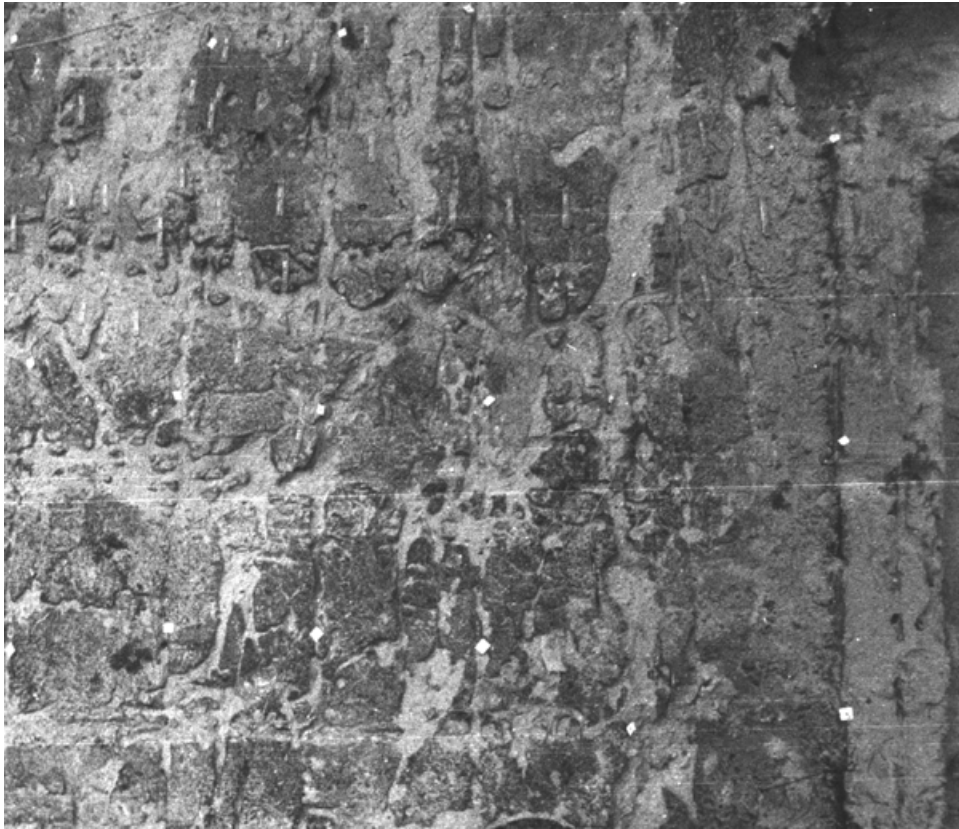
Figure 2-1: Detail of the *muşamba* squares on the hull remains while in situ (INA Archives).

The in-situ mapping of all the major hull components using the WEB program was similar to the mapping of the amphoras. To provide clear reference points on the preserved hull remains, small 1-cm squares of oilcloth (called *muşamba* in Turkish) were pinned to the upper surface of the timbers at the points to be mapped. These squares served two purposes. First, each square acted as an easily accessible reference point at which measurements were taken. Secondly, since each square stood out in photographs of the timbers in situ, they collectively enhanced the utility of the photographs when drawing the site plan (fig. 2-1). The affixing of the squares on the timbers was not arbitrary. In general, they were placed along one edge of a fragment to be mapped. In the case of the keel, they were placed along the starboard top edge. The WEB data, in conjunction with photography and measurements, was sufficient to produce a fairly accurate plan of the keel prior to its removal from the site.

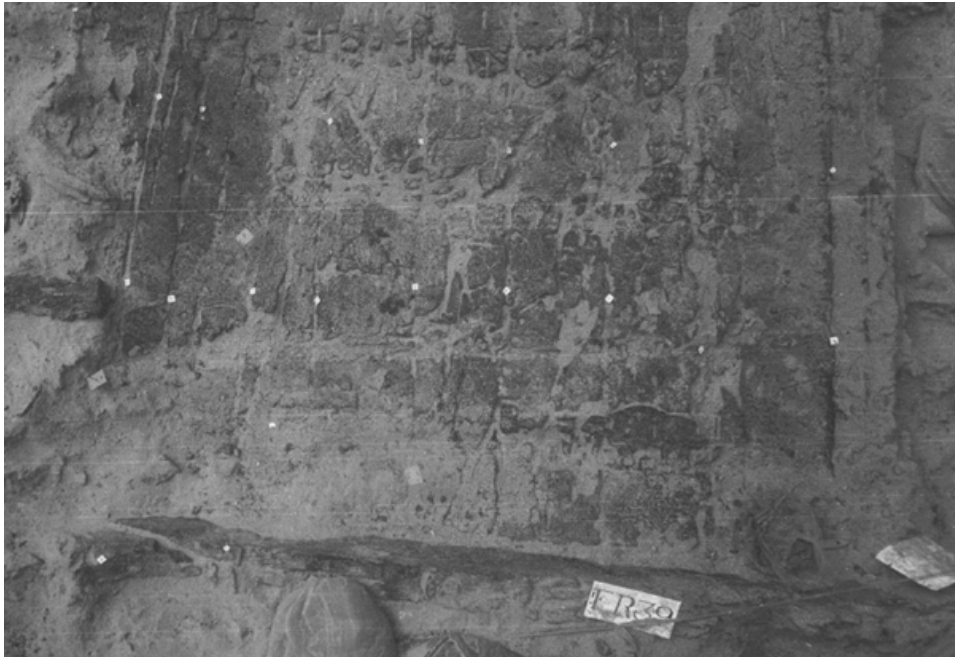
Figure 2-2: Detail of the *muşamba* squares demarcating the plank seams (INA Archives).

Similarly, the squares were attached to either the inboard or outboard edge of planking remnants, in locations where the seams between the strakes were easily distinguishable (fig. 2-2). By mapping the locations of the squares on a site plan, examining photographs and field notes, a preliminary site plan of the hull was developed by the Spring of 1999.

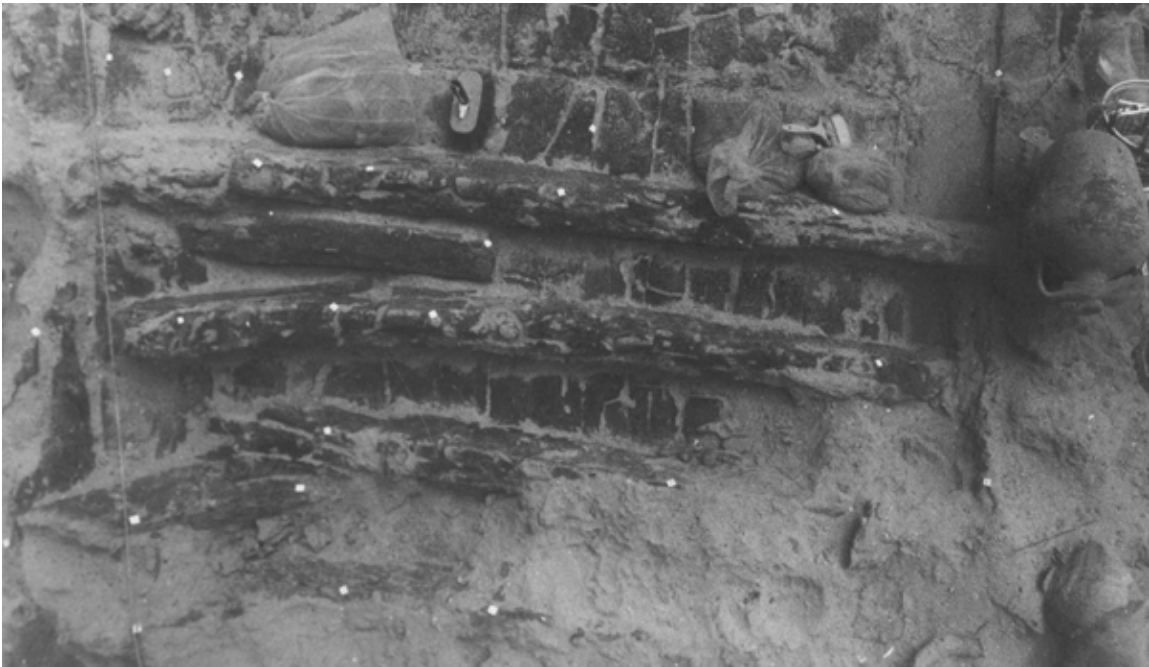
Figure 2-3: Detail of the *muşamba* squares along the after top edge of the floor timbers (INA Archives).

Determining where to attach the squares on the floor timbers was slightly more difficult. As the majority of the floor timbers, particularly those from FR 39 forward, had rolled downslope, they were either lying flat on their forward face, or had come to rest, tilted, on their forward bottom edge. In either case, the squares were placed in an effort to glean as much information from the WEB data as possible. Commonly, the squares were affixed to each floor timber along the top, after edge, chosen primarily because it maintained the original cross-sectional shape of the ship, and secondarily because that edge, as opposed to the top, forward or bottom edge, was easily accessible and visible in photographs (fig. 2-3). The resulting WEB data produced a rough sketch of the curve along the top face of the floor timber. That information, in conjunction with photography

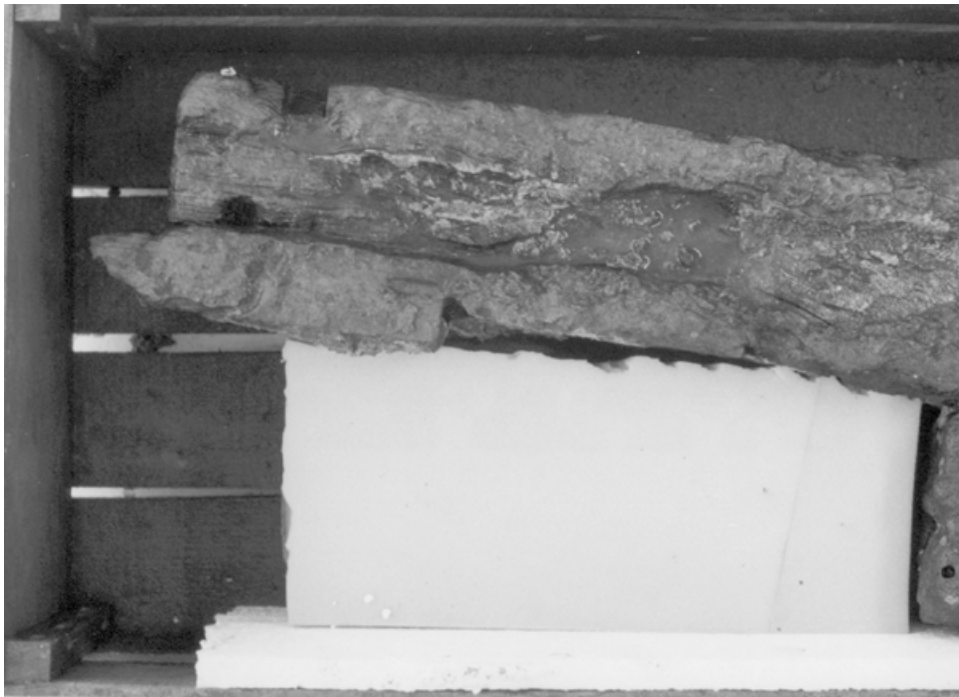
Figure 2-13: Foam blocking under the scarf in the stern.

rolled, and packed tightly against the sides of the tray (fig. 2-13). Next a padded cover for the tray was placed on top of the exposed keel face, and the sling was wrapped tight around this assembly. Using the sling for leverage, the entire assembly was slowly rolled 90 degrees, so that the keel fragment rested on the padding placed in the tray, then rotated another 90 degrees until the keel fragment rested on the padded cover (fig. 2-14). The sling was unwrapped, and the tray, now upside down, was removed (fig. 2-15). Once completed, the other three faces of the keel fragment were exposed for cataloging.

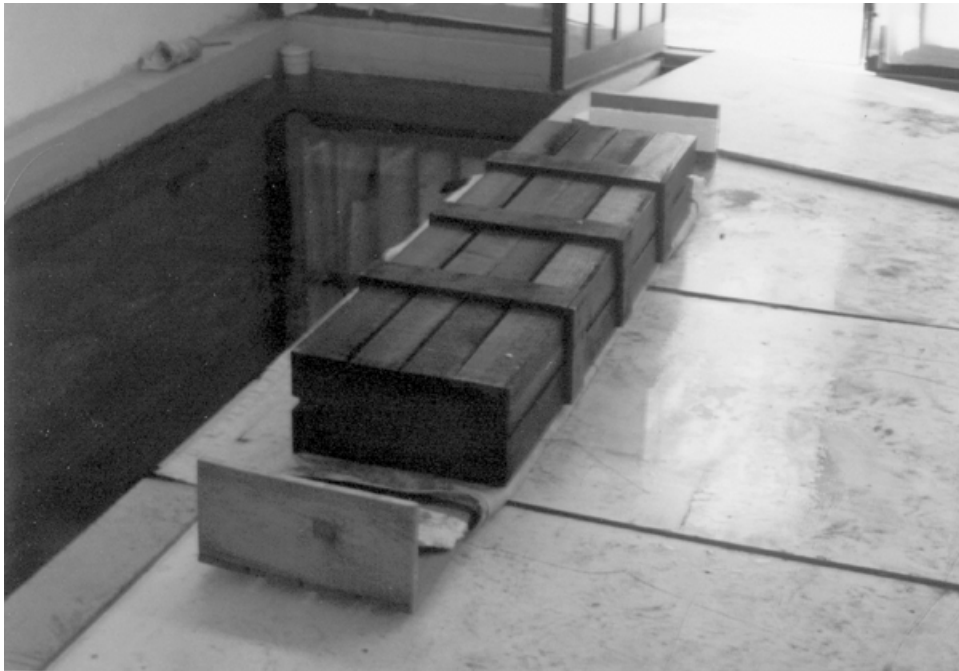
Figure 2-14: Rolling a keel fragment over for cataloging.

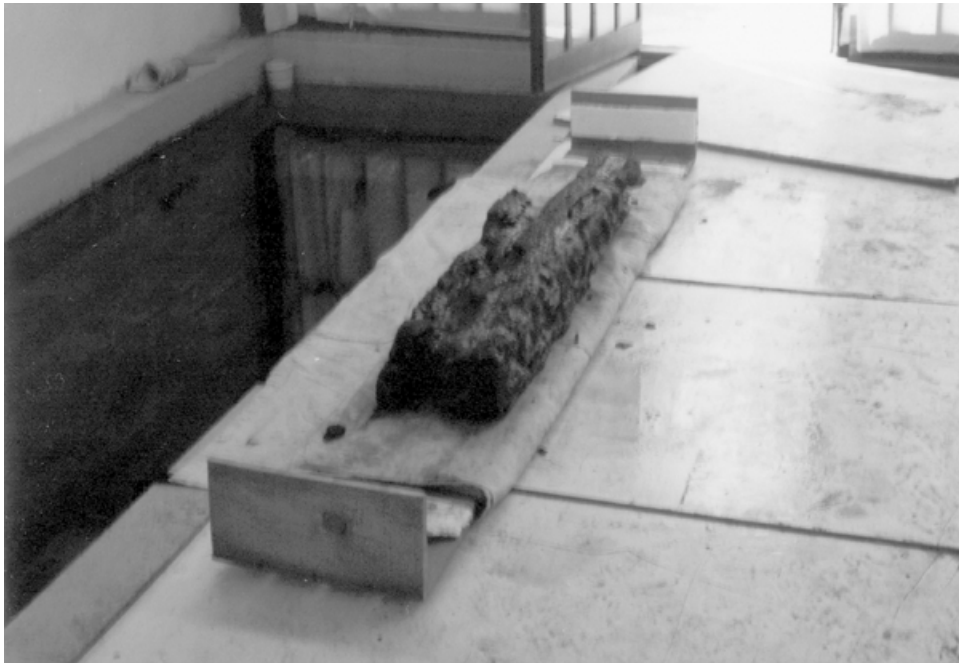
Figure 2-15: The carrying tray removed, exposing the keel fragment.

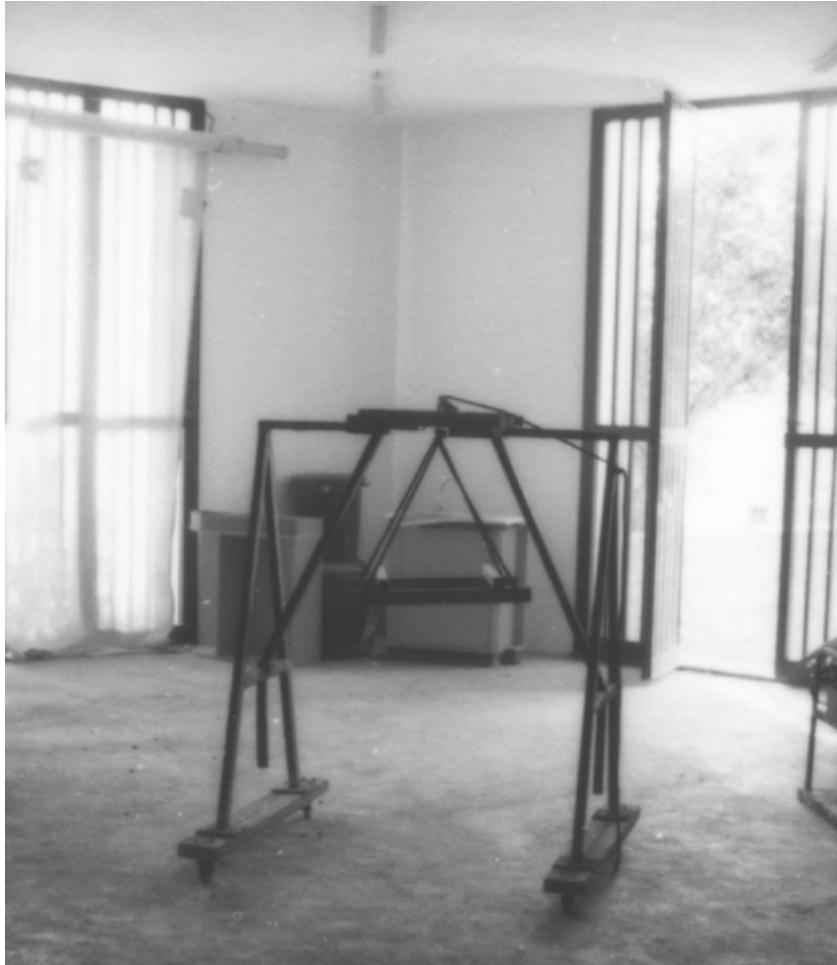
Figure 2-16: The A-frame used to carry wooden trays in the laboratory.

In comparison to the earlier temporary laboratory, moving the storage trays also tended to be more difficult in the deeper tanks of the Griffis laboratory. The greatest problem that had to be overcome was the inability for one person to both carry and lower the storage trays to the floor of the laboratory. Thus, a rolling dolly was built from a salvaged metal A-frame and scrap pieces of pine. The dolly's frame, which rested on two wooden struts with wheels, had a stationary pulley at its apex. A rope ran through the pulley to a suspended 50 cm x 50 cm platform on which the trays rested (fig. 2-16).

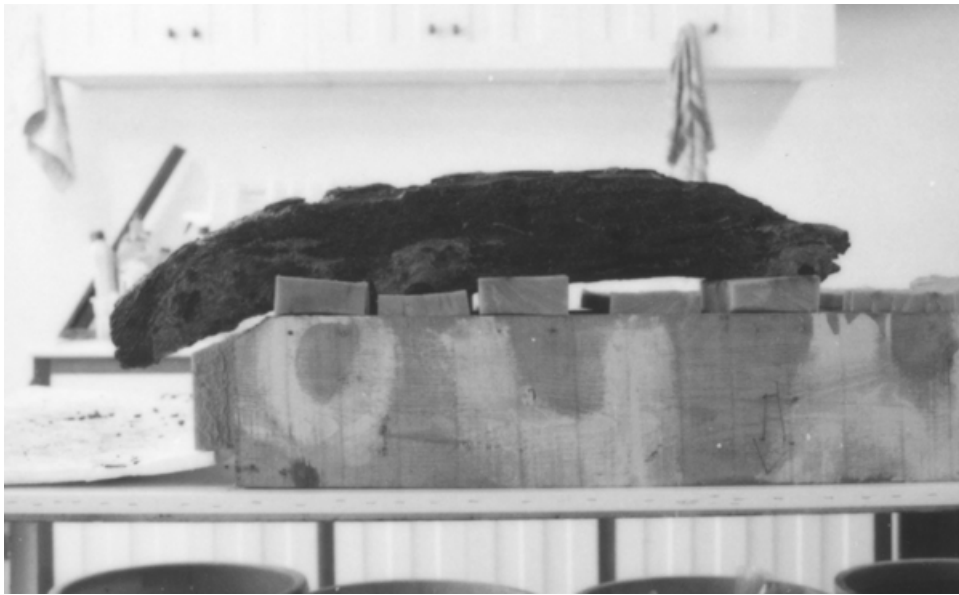
Figure 2-21: Using the frame stand to support a floor timber while cataloging.

To create a stable platform upon which the framing material could be supported, a wooden frame stand was built. This stand was padded with 5-cm thick foam and designed to support floor timbers in an upright or upside down manner, without placing undue stress on wood at the turn of the bilge of the hollow at the garboard (fig. 2-21). Another support

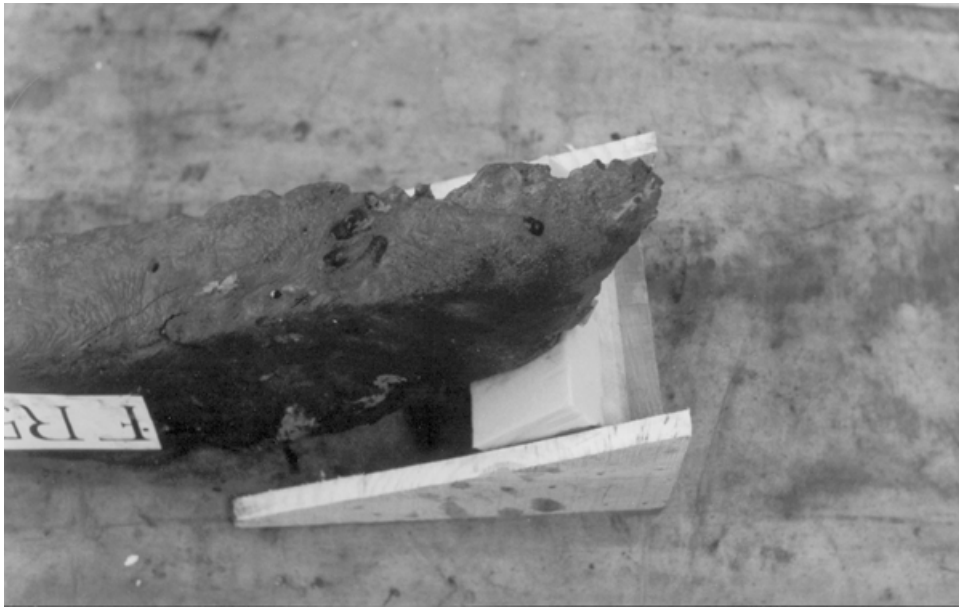
Figure 2-22: Using the small wedge to support a floor timber while cataloging.

was built for floor timbers that were preserved through the turn of the bilge but not at the hollow at the garboard. This latter stand was also built of pine, padded with .05-m thick foam, and was only a wedge designed to keep the floor timber upright when cataloging the top face (fig. 2-22).

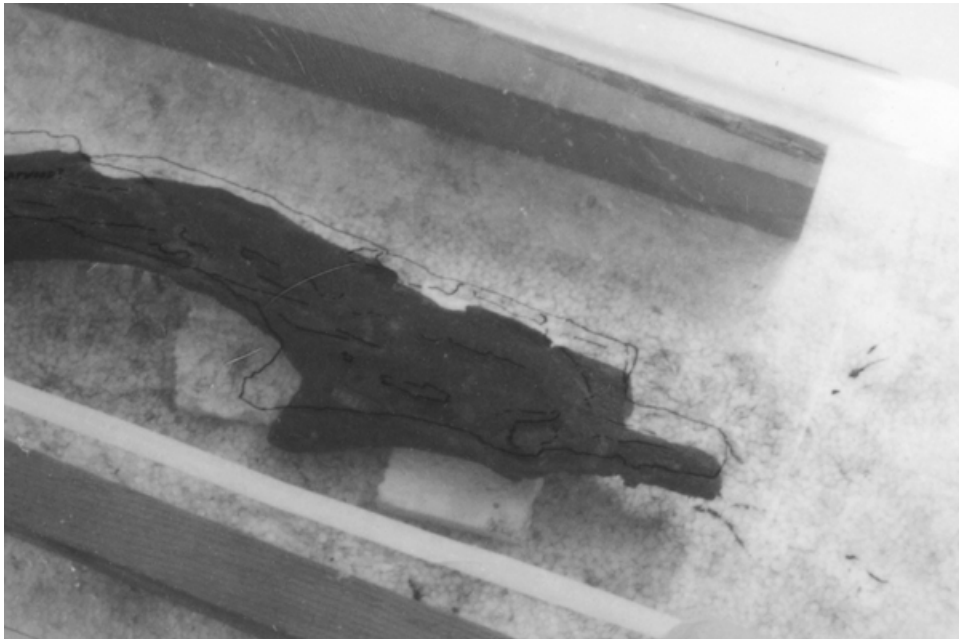
Figure 2-23: An ink drawing on clear acetate.

Bozburun timbers at 1:1 scale, the method of using a black marker on clear acetate or plastic was quickly adopted (fig. 2-23). When drawing the large flat faces of the keel fragments, and particularly the bow and stern faces of the floor timbers, the acetate was thumb-tacked directly to the fragment. For smaller, less distinct or fragmentary items, or all of the planking material, a pane of glass (1 to 2 m x .50 m w x .005 m) was supported over the item, and the acetate was affixed directly to the glass instead.

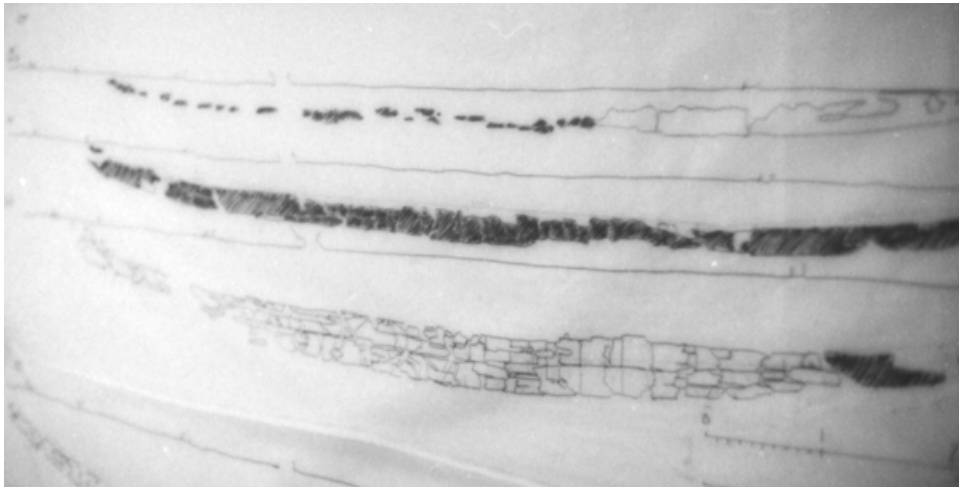
Figure 2-24: Drawings of various planks. The shaded fragments indicate that they have been cataloged.

marked as “completed” to maintain an up-to-date record of the material cataloged. Additionally, since the site plan retains the sweep of the strakes as found on the sea floor, this sweep may be recreated and recorded at scale during their re-assembly (fig. 2-24). To reproduce the sweep of a plank, a baseline was drawn on the site plan either between both ends of the plank, or (as the length of the cataloging table dictated) a 5.5 m section of the plank (fig. 2-25). A baseline, representing the site-plan baseline but at 1:1 scale, was drawn on the cataloging table. Measurements were then taken from the inboard or outboard edges of the plank to the baseline on the site plan and reproduced at scale on the cataloging table; the fragments could then be aligned appropriately. To draw the plank, one long edge of the glass was aligned with the baseline, as was one long edge of the acetate sheet itself. In this manner, although the glass might be moved three or four times during the drawing process, the glass, acetate, and drawing on the acetate have a number of reference points that were used to maintain the alignment of the drawing.

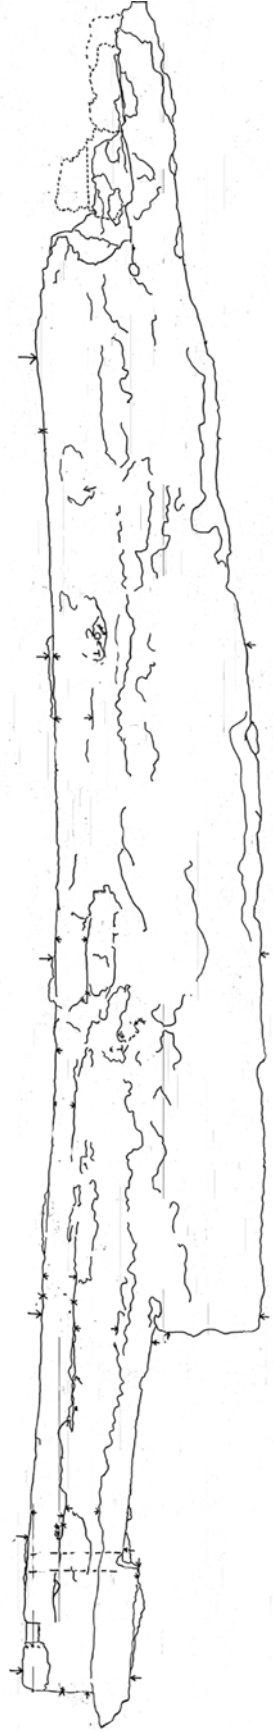
Figure 3-1: Drawing of the starboard side of the stem fragment (1:10 scale).

This fragment was recovered from the seafloor in one piece, representing all the remains of the stem (fig. 3-1). Some breakage has occurred during storage and cataloging, but the majority of the material broken or lost comes from the very forward end of this fragment, which is riddled with worm holes and preserves no original surfaces.

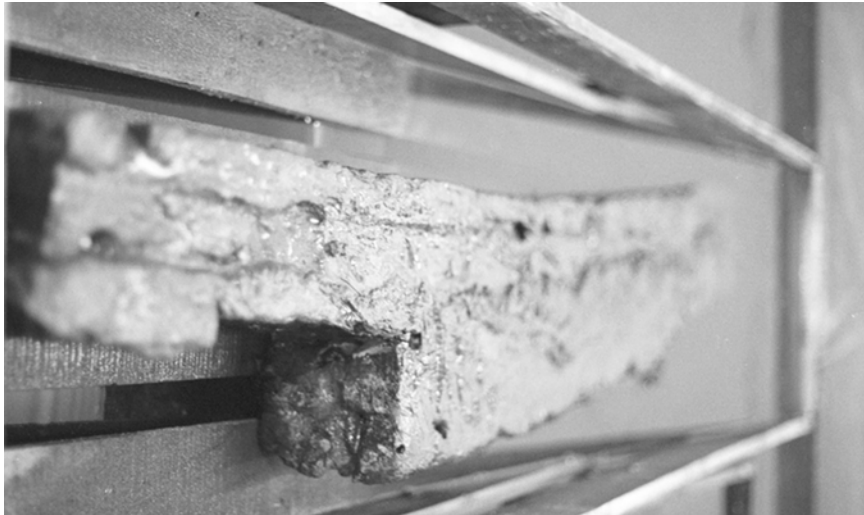
Figure 3-2: Photograph of the stem, illustrating its rise.

the scarf and all four faces of the stem are in fairly good condition. Enough of the stem is preserved to indicate the gradual rise of the stem's interior face from the keel's horizontal plane. For the fragment's preserved length of 2.285 m, the interior face rises approximately 8 cm to 12 cm (fig. 3-2). Each face also retains enough original surface to distinguish a cross sectional shape and demarcate the rabbet, which is evident on both sides. There is little or no surface pitting evident on the stem. Again, similar to the keel and the sternpost, the varying amounts of water penetrating the stem not only makes it difficult to handle, but will also cause difficulty during the conservation process.

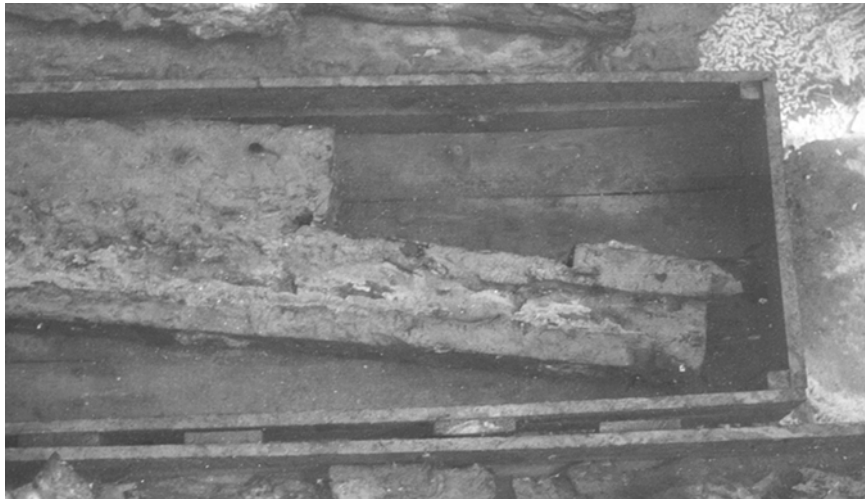
Figure 3-3: Photograph of the stem scarf.

The stem fragment also preserves the upper half of the 52 cm long box scarf present in the forward end of the keel (fig. 3-3). As this scarf mates to the box scarf in the forward end of the keel, it too has three vertical and two horizontal faces of similar dimensions and inclinations. For a detailed description of the design of this scarf, see the **Joinery** section in the following documentation of the keel. Because of the presence of the key between the two fragments, however, there is a 6 cm gap between the two short vertical faces demarcating the horizontal faces of each scarf. Distinctly absent in this half of the

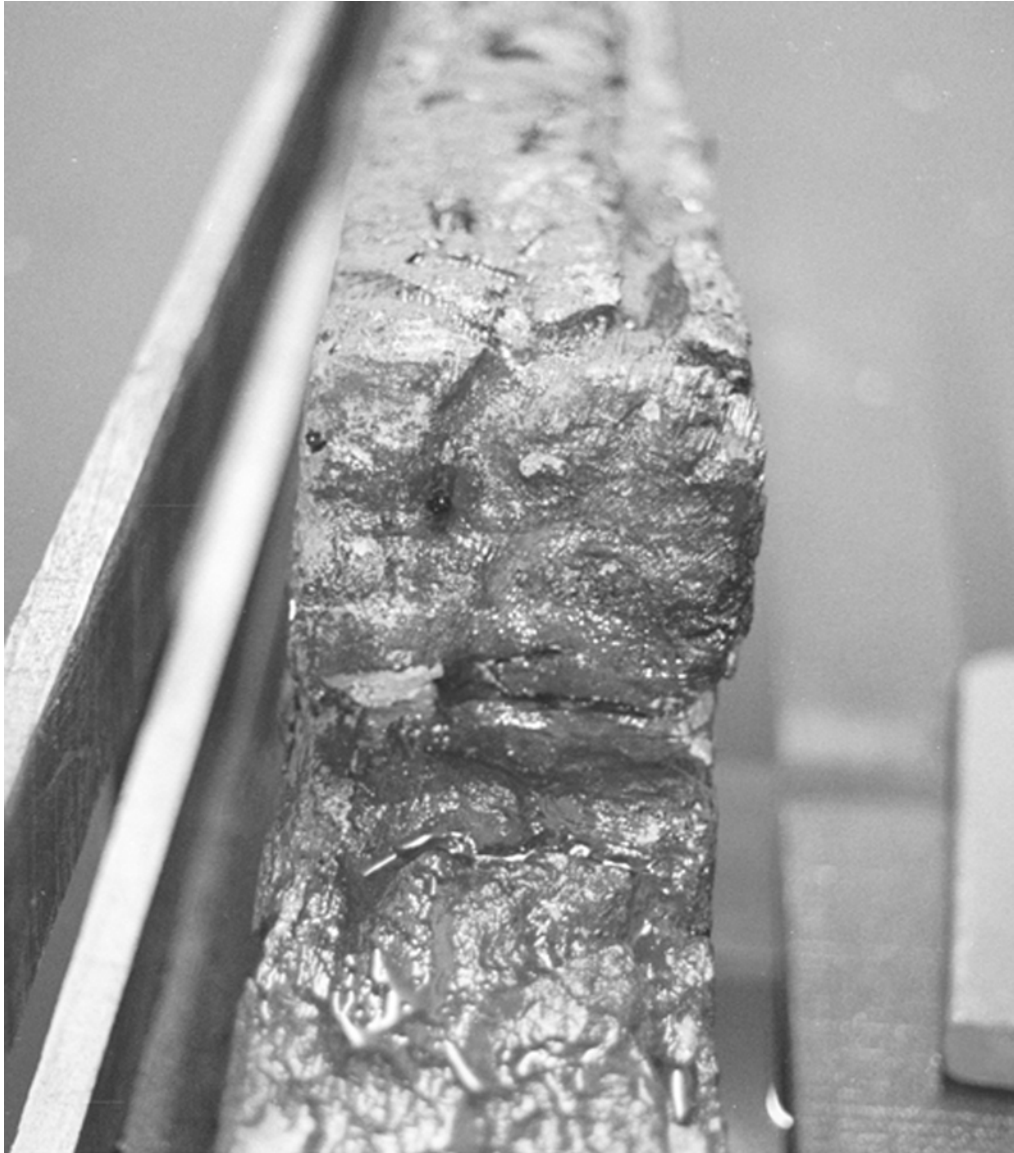
Figure 3-4: Photograph of the sawn face of the stem scarf.

scarf is a second pair of fixed tenons. As two pairs of mortises are in the lower half of the scarf in the keel, one pair in each of the two larger vertical faces, coordinating pairs of fixed tenons should be present in the upper half of the scarf as well. Only one pair, averaging 4.5 cm x 4.8 cm, is present, however. The lower vertical face is well preserved, as are portions of the horizontal face nearby, but neither face preserves evidence of the tenons' presence. The vertical face does retain numerous transverse ridges, however, which may represent eroded saw cuts, possibly indicating the purposeful removal of these fixed tenons (figs. 3-4, 3-5).

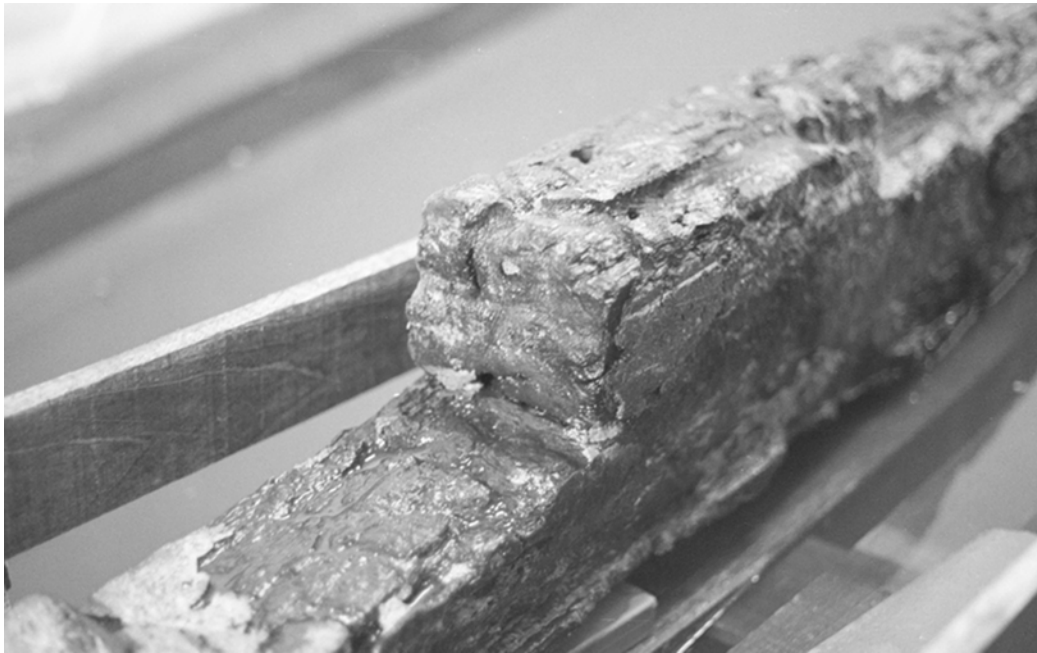
Figure 3-5: Another view of the sawn face on the stem scarf.

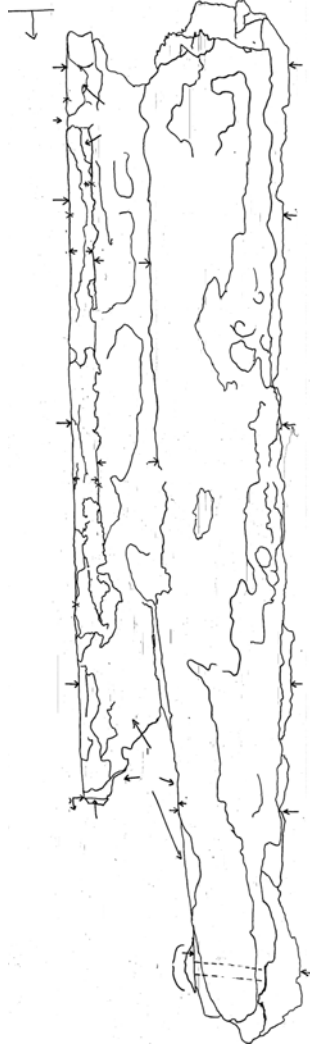
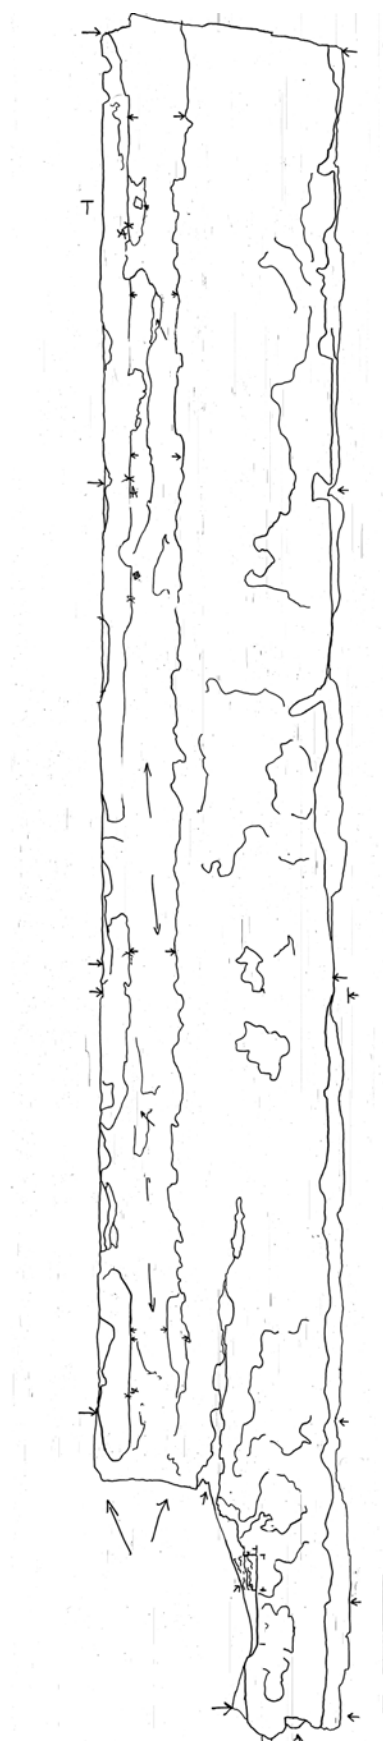
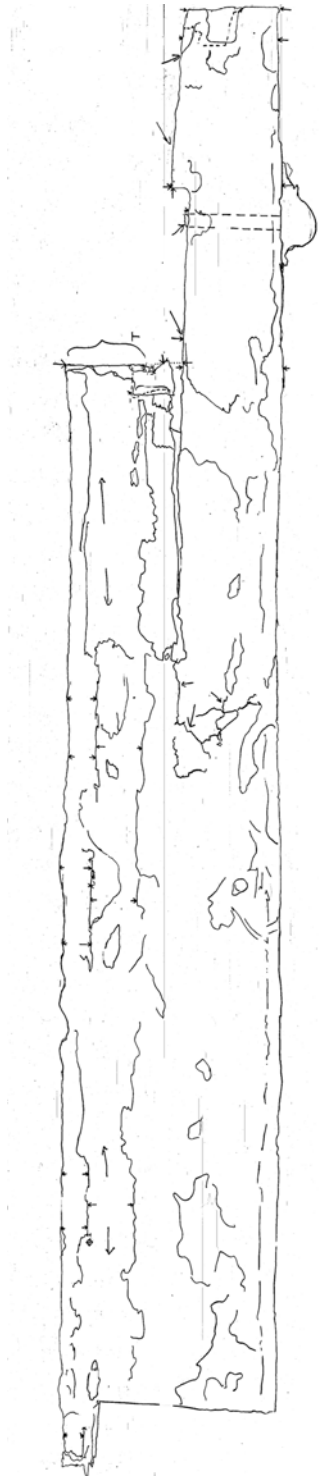
Figure 3-6: Drawing of the starboard side of the first fragment of the keel (1:10 scale)

Figure 3-7: Drawing of the starboard side of the second fragment of the keel (1:10 scale).

Figure 3-8: Drawing of the starboard side of the third fragment of the keel (1:10 scale).

The keel, although preserved and uncovered in one large and one small fragment, had to be divided into smaller pieces to ease the process of lifting it from the seafloor, transporting it back to camp and subsequently back to INA headquarters in Bodrum, Turkey (figs. 3-6 to 3-8). As such, fragment KK 2/3-30, which was the smaller of the two fragments (1.39 m long), was placed in a crate and lifted from the site, but fragment KK 31-39 was cut into three smaller pieces underwater with a handsaw. The three fragments were then crated individually and brought to the surface. The longest of the three pieces is 2.0 m

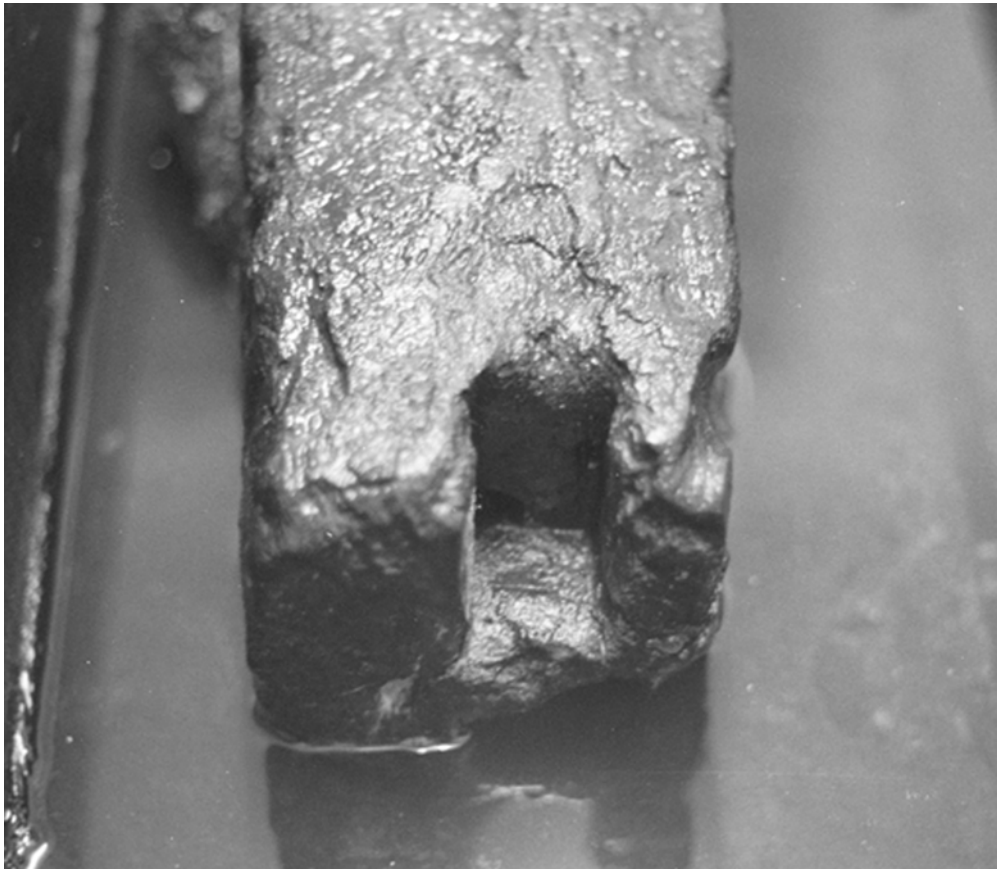
Figure 3-9: Photograph of the mortises in the keel's bow scarf.

The bow scarf in KK 37-39, which the better preserved of the two, is also the more complex. This scarf is composed of three vertical and two horizontal faces, as well as two pairs of mortises. The forward-most, vertical face of the keel is also the first vertical face of this scarf, and it contains the first pair of mortises as well (figs. 3-9, 3-10). This vertical face meets the bottom face at approximately 90 degrees, and then rises 12.5 cm before meeting the first horizontal face of the scarf at a second 90-degree angle. The two mortises in this vertical face, which average 6.5 x 5 x 4.1 cm, are placed side by side approximately 6 cm above the bottom face, and are 2 cm apart. Due to this separation, and their widths, the mortises do not possess exterior faces, but are instead open to either the port or starboard side. The first horizontal face of this scarf extends aft for 25 cm, gradually rising along its length until the thickness of this lower half of the keel is now 15 cm. At this point, this horizontal face meets the second vertical face, again at a 90 degree angle. This second

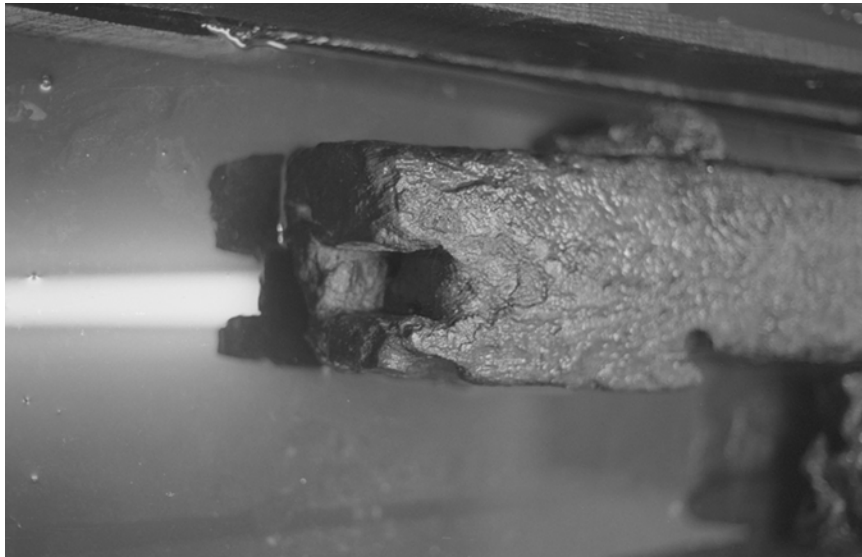
Figure 3-10: Another photograph of the mortises in the keel's bow scarf.

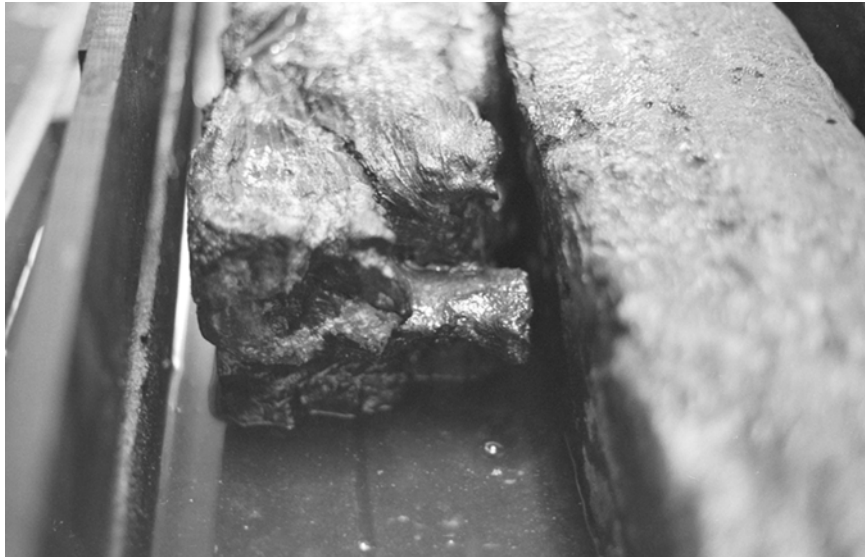
Figure 3-11: The second pair of mortises in the keel's bow scarf.

vertical face descends only 2.5 cm before terminating at the second horizontal face, meeting it at a 90 degree angle as well. The 2.8 cm diameter bolt was driven through this second horizontal face, 4.5 cm aft of the short, second vertical face. Approximately 24 cm aft of this short vertical face, the third, and tallest vertical face rises to meet the interior face of the keel, also at a 90 degree angle. It is in this last vertical face that the second pair of mortises were cut, in this case, at the junction between this vertical face and the second horizontal face (fig. 3-11). These mortises are larger than the first pair, averaging 5.8 x 4.5 x 8.2 cm, but similar to the first pair as they are also open along their exterior faces. Above these mortises, the remainder of the vertical face rises another 8 cm before terminating at the interior face of the keel. All in all, this scarf is 48 cm long.

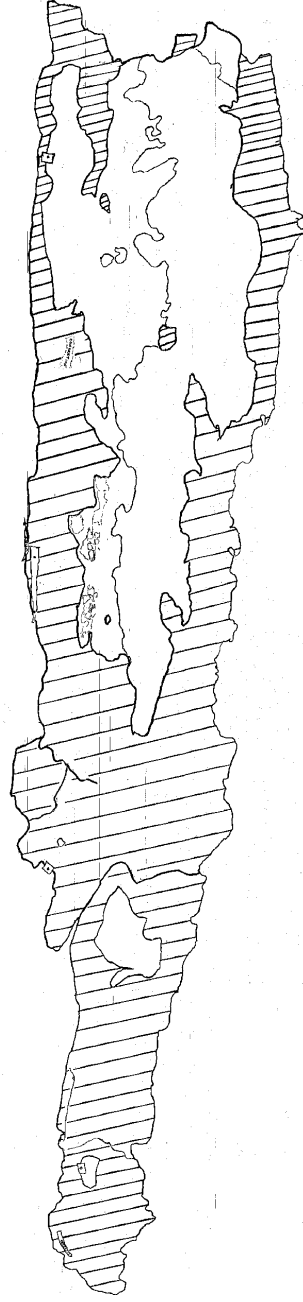
Figure 3-12: Drawing of the starboard side of the first fragment of the sternpost (1:10 scale).

The four recovered fragments of the sternpost, of which there are now more due to fresh breakage during storage, vary noticeably in their preservation (figs. 3-12, 3-13). The aft-most fragment of the sternpost, UM 222, preserves almost no original surface and is entirely riddled with worm holes. It has very little structural integrity, delicate surfaces and edges, and is fairly undiagnostic. Moving forward through the sternpost, however, the remaining fragments retain increasing levels of original surfaces and edges, as well as other diagnostic features.

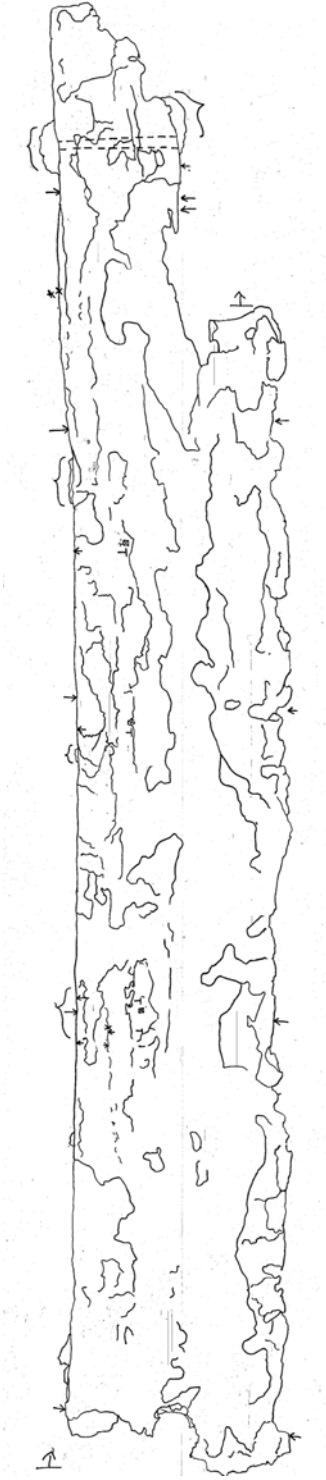
Figure 3-13: Drawing of the starboard side of the second fragment of the sternpost (1:10 scale).

The upper half of the scarf joining the sternpost to the keel is still preserved, in slightly better condition than the lower half in the keel, and retains enough material and original surfaces to determine some of its characteristics (fig. 3-13). This scarf, similar to the lower half of the scarf in the keel, is composed of two vertical faces and one inclined horizontal face approximately 40 cm long. The lower vertical face, which is approximately 13 cm high, contains two 5-cm deep mortises, which, like other examples, are separated horizontally and open on their exterior walls. This lower vertical face meets the inclined horizontal face, of which only 18 m is preserved around the bolt hole, at an angle of approximately 95 degrees. A 2.0 cm diameter bolt hole passes through this horizontal face
