**A RE-ASSEMBLY AND RECONSTRUCTION OF
THE 9TH-CENTURY AD VESSEL WRECKED OFF THE COAST OF
BOZBURUN, TURKEY**

A Dissertation

MATTHEW BENJAMIN HARPSTER

A Re-Assembly and Reconstruction of
the 9th-century AD Vessel Wrecked off the Coast of
Bozburun, Turkey. (August 2005)

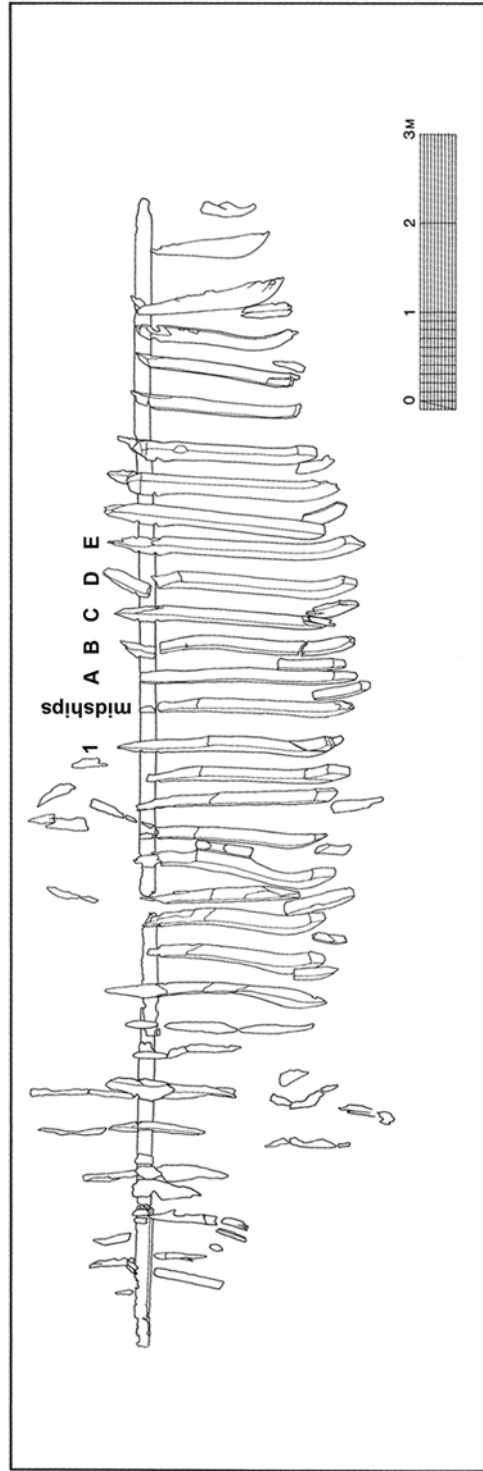
Figure 3-16: Site plan with oak floor timbers labeled.

Although many original surfaces are evident on the seven oak floor timbers, in comparison to the pine floor timbers, these seven are more fragmentary, delicate, and friable (figs. 3-16 to 3-23). All of them, in various degrees, are eroded and worn, and while *Teredo* damage is evident along the lengths of the timbers, it is particularly destructive at the distal ends of the fragments, beyond the sweep of the bilge. Due to the fragility and friable nature of these fragments, handling and cataloging them can be tedious, and can result in the loss of surface detail. None of the oak floor timbers were recovered in one fragment, and the number of cataloged fragments making up one oak floor timber varies from 3 (floor timber C) to 12 (floor timber D).¹ In general, all of the oak floor timbers are preserved, in either continuous or discontinuous fragments, from the vicinity of the keel to the sweep of the starboard bilge. Floor timber A, for example, has approximately 16 cm preserved over the keel, while floor timbers 1, B, C, D and E retain evidence of, or imply the presence of, port limber holes and the hollow at port strake one. The material preserved over or beyond the port edge of the keel, however, varies in condition. Floor timbers 1 and C preserve material over the keel, and evidence of both limber holes and port strake one's hollow in one large fragment each, while the same items are represented by the assembly of at least four fragments in floor timber E. Floor timber B retains one 35 cm long fragment which may have extended over the keel, and which may also preserve

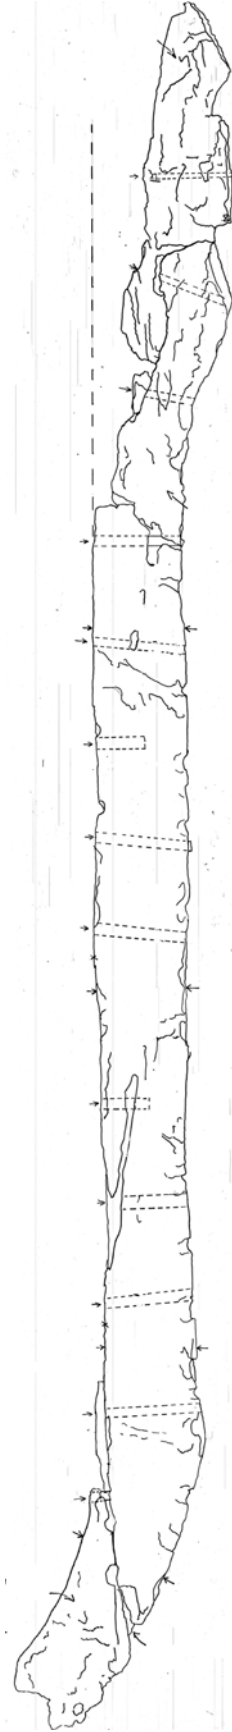
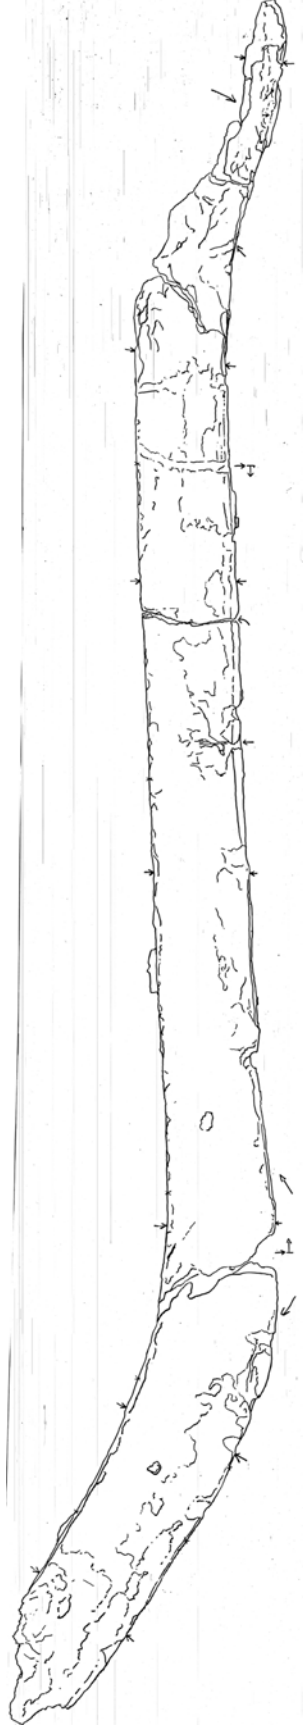
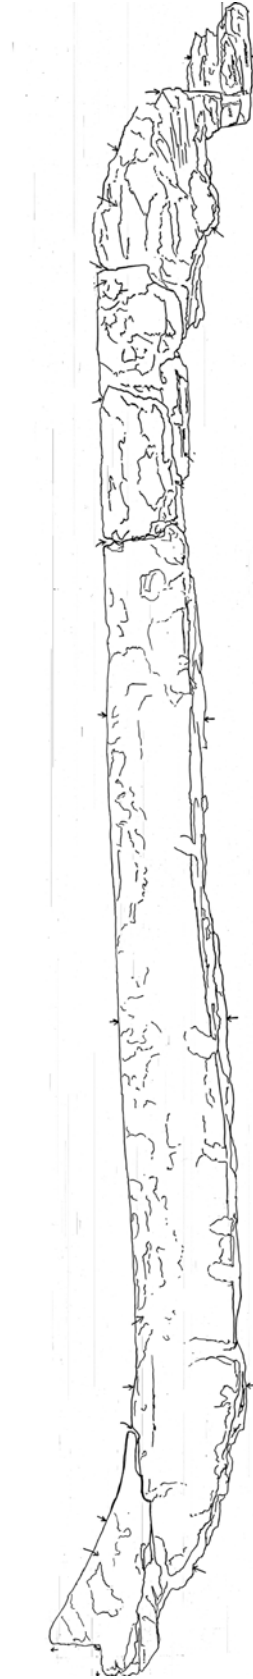
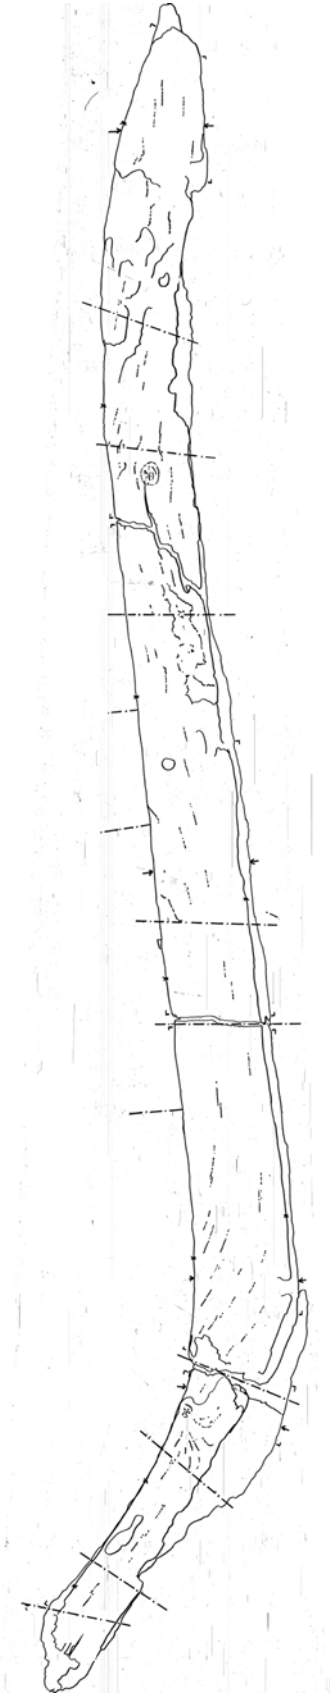
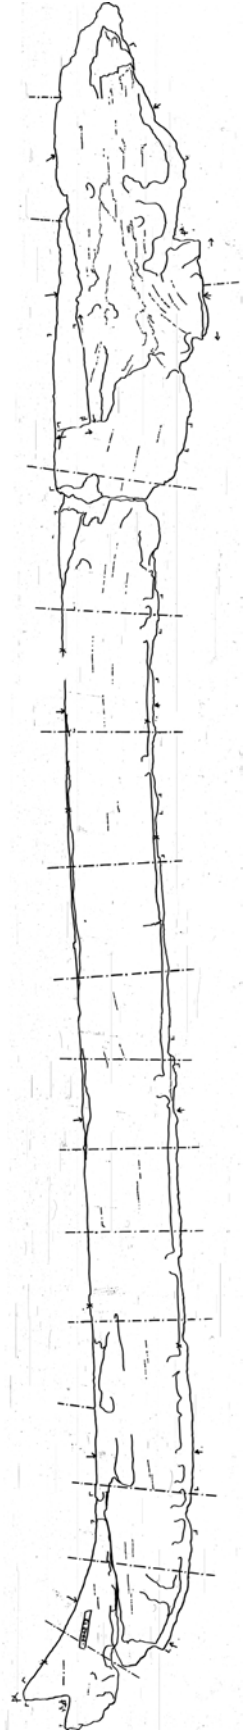
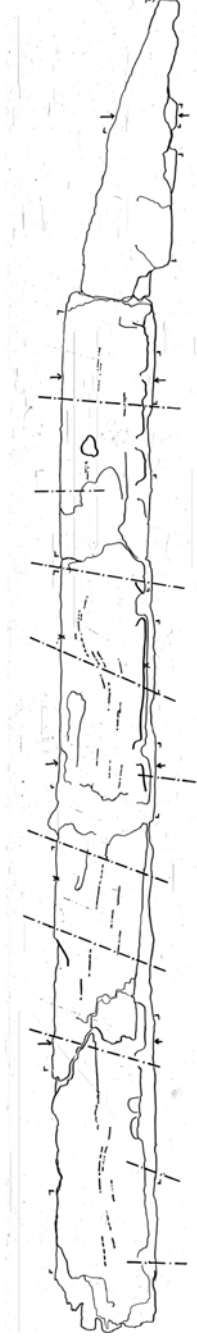
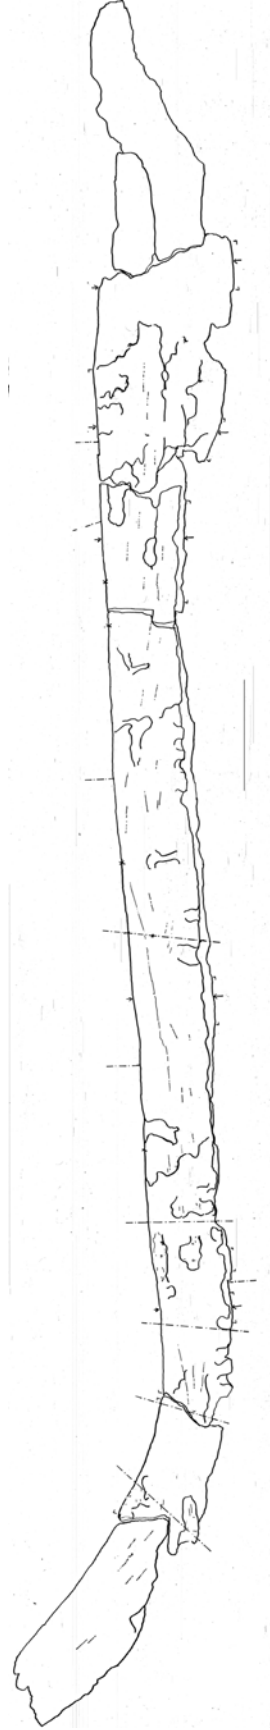
Figure 3-17: Drawing of the forward face of floor timber 1 (1:10 scale).

Figure 3-18: Drawing of the forward face of the midships floor timber (1:10 scale).

Figure 3-19: Drawing of the forward face of floor timber A (1:10 scale).

Figure 3-20: Drawing of the forward face of floor timber B (1:10 scale).

Figure 3-21: Drawing of the forward face of floor timber C (1:10 scale).

Figure 3-22: Drawing of the forward face of floor timber D (1:10 scale).

Figure 3-23: Drawing of the forward face of floor timber E (1:10 scale).

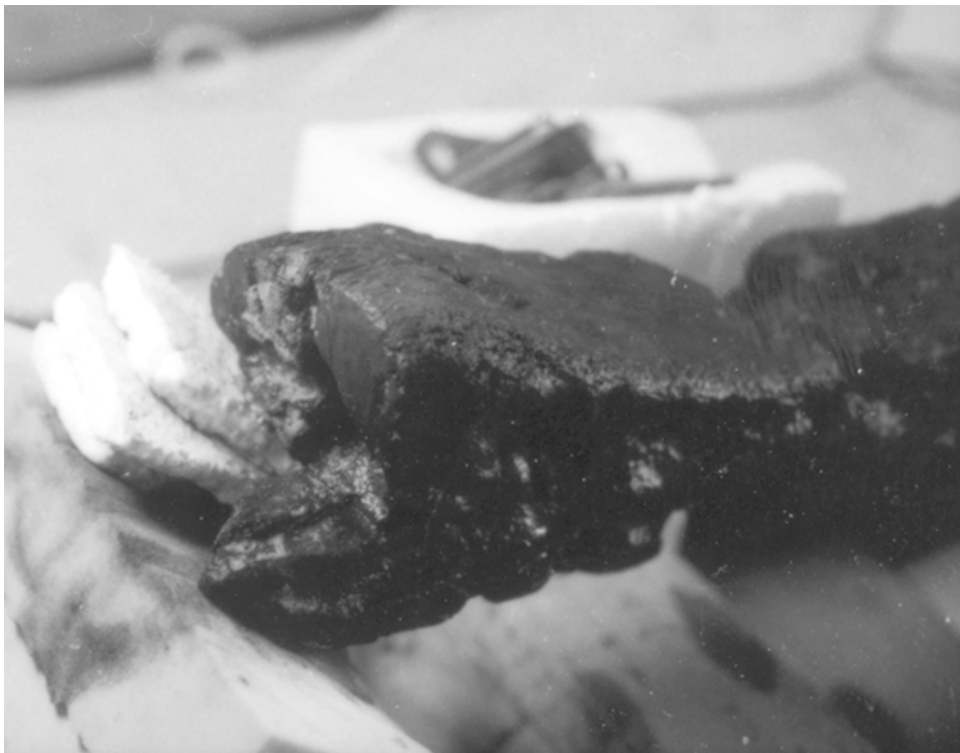
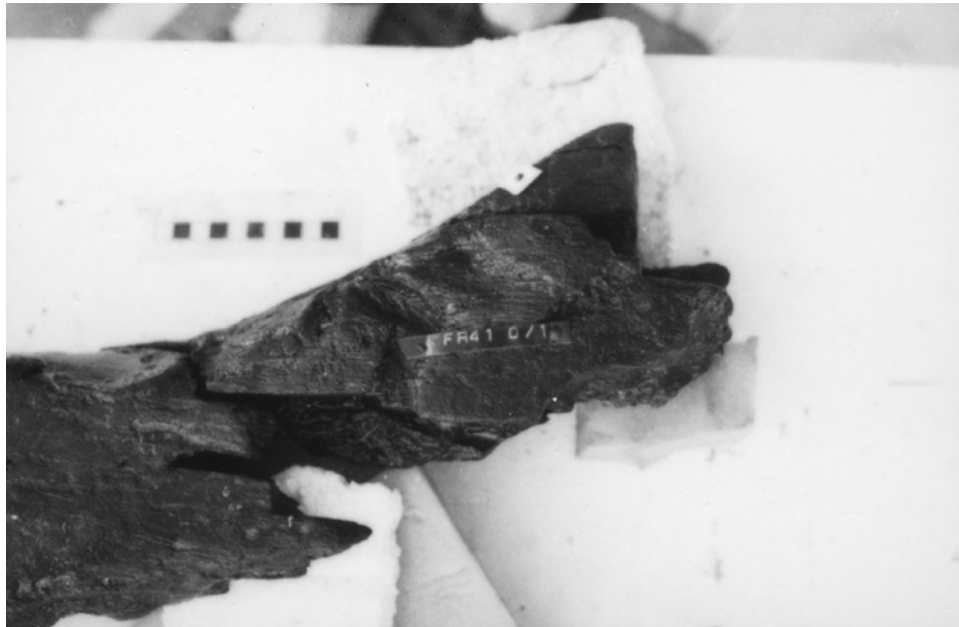
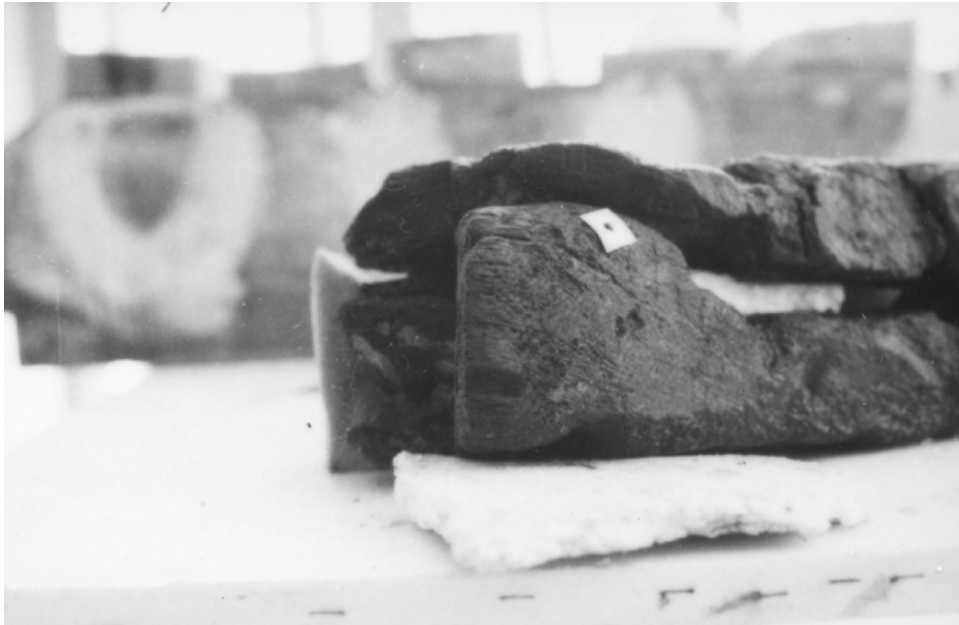
Figure 3-24: Photograph of the L-shaped scarf in floor timber A.

Figure 3-25: Another view of the L-shaped scarf in floor timber A.

Figure 3-26: The L-shaped scarf in floor timber A from above.

At the starboard bilges of the floor timbers 1, A, C and E, the remains of scarfs are present which aided the alignment of the futtocks with the floor timbers (figs. 3-24 to 3-31). Unlike the scarfs on the Serçe Limanı vessel, which are short, flat scarfs across the width of the floor timber, these four preserved scarfs consist of two faces that span the thickness of the floor timber. These two faces are fashioned into a rough L shape, commonly meeting each other at an angle between 70 and 95 degrees. The horizontal portion of the scarf is a flat surface, commonly preserved for a length of 4 cm to 5 cm, which extends outboard in alignment with the floor timber itself. The vertical face of the scarf is a flat face as well, commonly 5 cm to 7 cm high. Although these scarfs are located at the distal ends of the floor timbers, similar to Serçe Limanı, they are located specifically in the middle of the sweep through the bilge, not before or after the turn. In all cases, the junction of the two scarf faces is at least 30 cm outboard from the beginning of the upward sweep in the bilge evident in the lower face of the floor timber, and at least 12 cm higher than this point as well. Placing the scarfs in such a location means that the two faces of the scarfs meet the upper and lower faces of the floor timbers at acute angles, commonly between 40 and 60 degrees. It also means that the outboard end of the horizontal scarf face, in light of the open grain present at the distal ends of floor timbers 1, A, C and E, is very prone to post depositional damage and erosion. Taking such damage into account, it seems likely that the horizontal scarf faces were originally of an equal length to the vertical faces, about 5 cm to 7 cm long. These scarfs, however, were only fashioned in the starboard bilges of floor timbers 1, A, C and E. Material preserved at the starboard bilges of floor timbers B and D, and the floor timber at midships, not only indicates the absence of these scarfs, but that these three floor timbers extended farther up and around the turn of the bilge for an indeterminate distance (fig. 3-32).

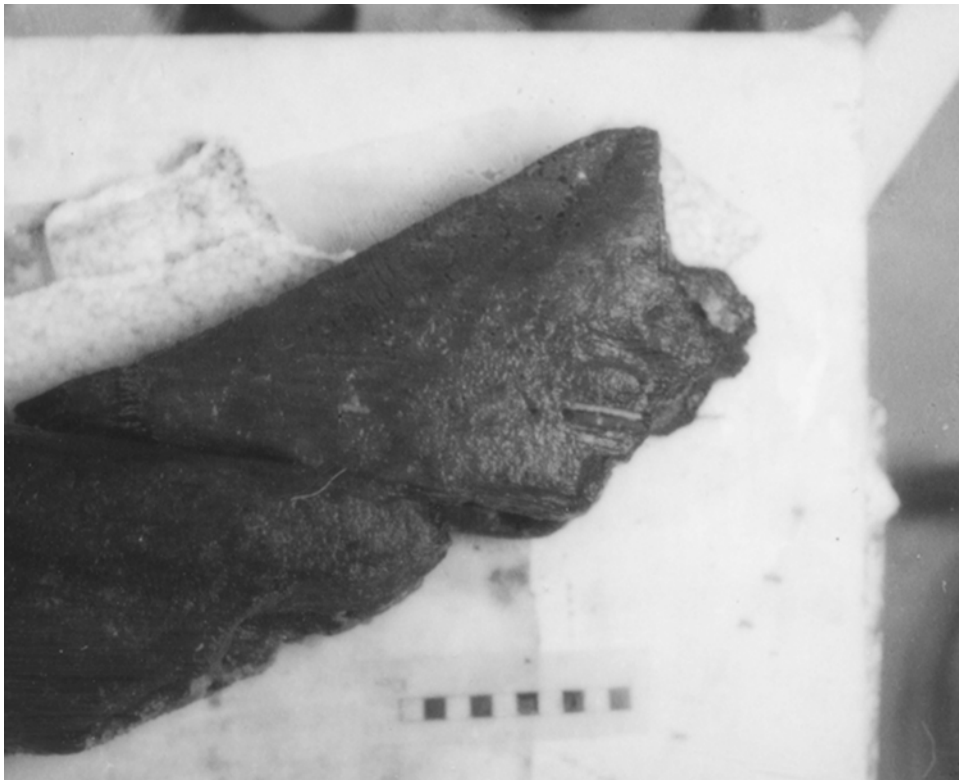
Figure 3-27: The L-shaped scarf in floor timber C.

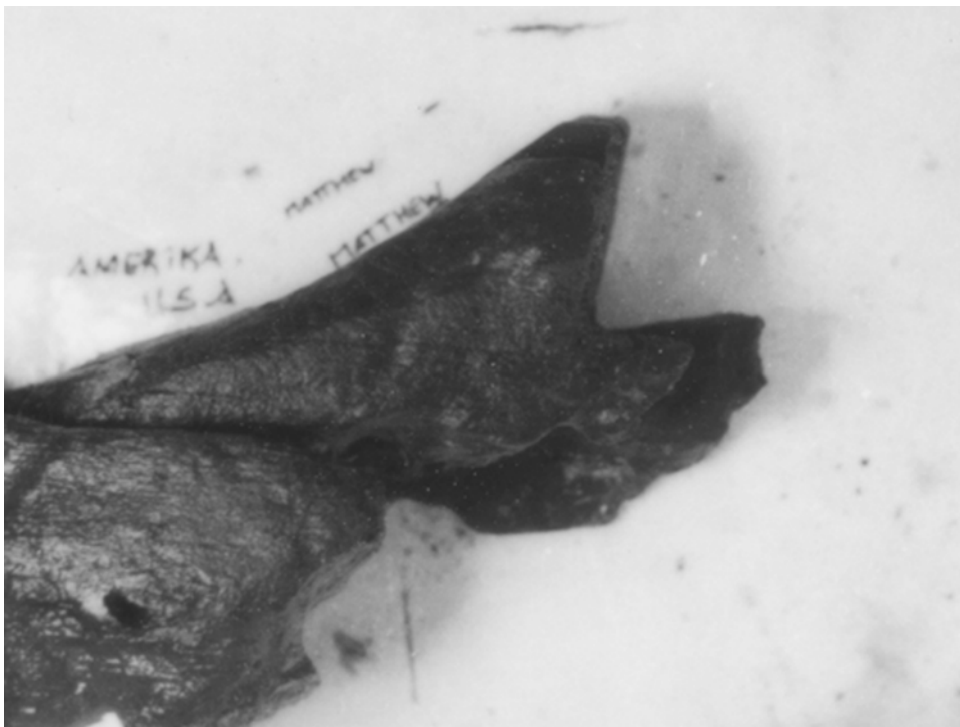
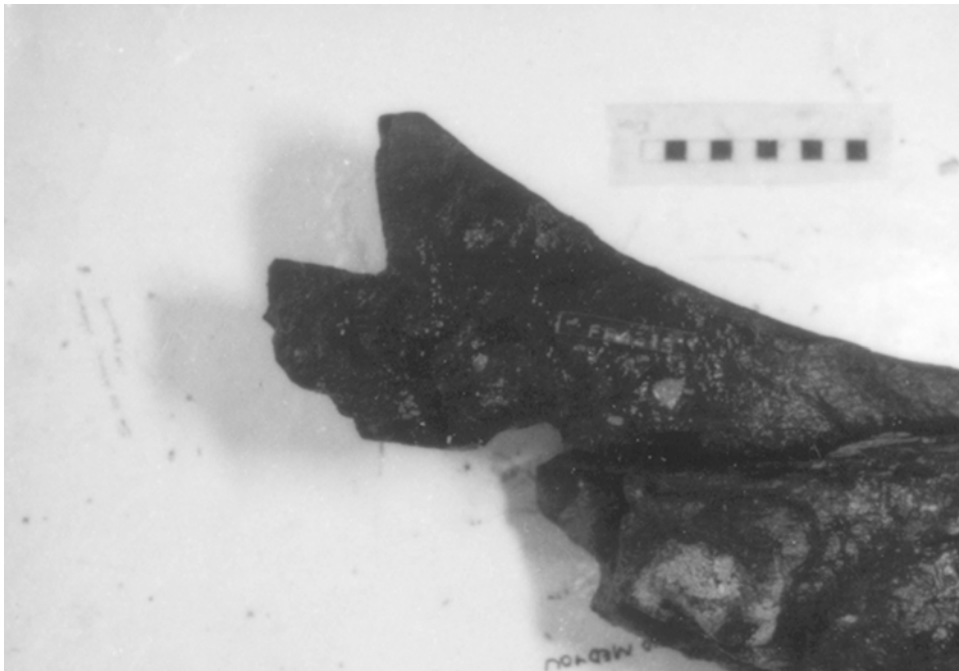
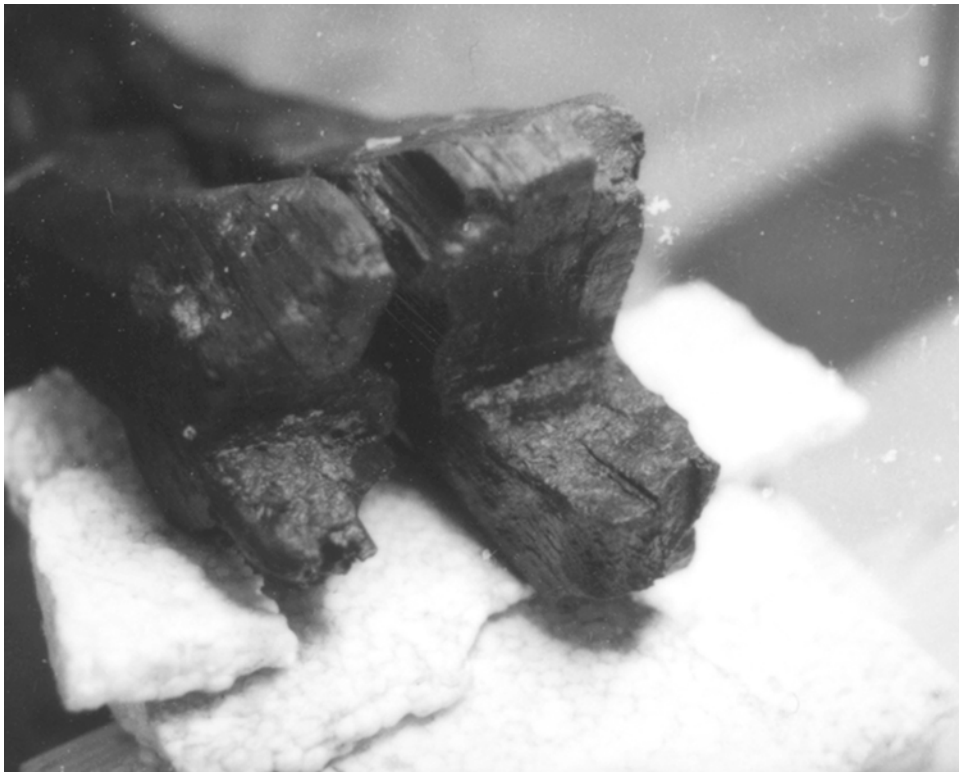
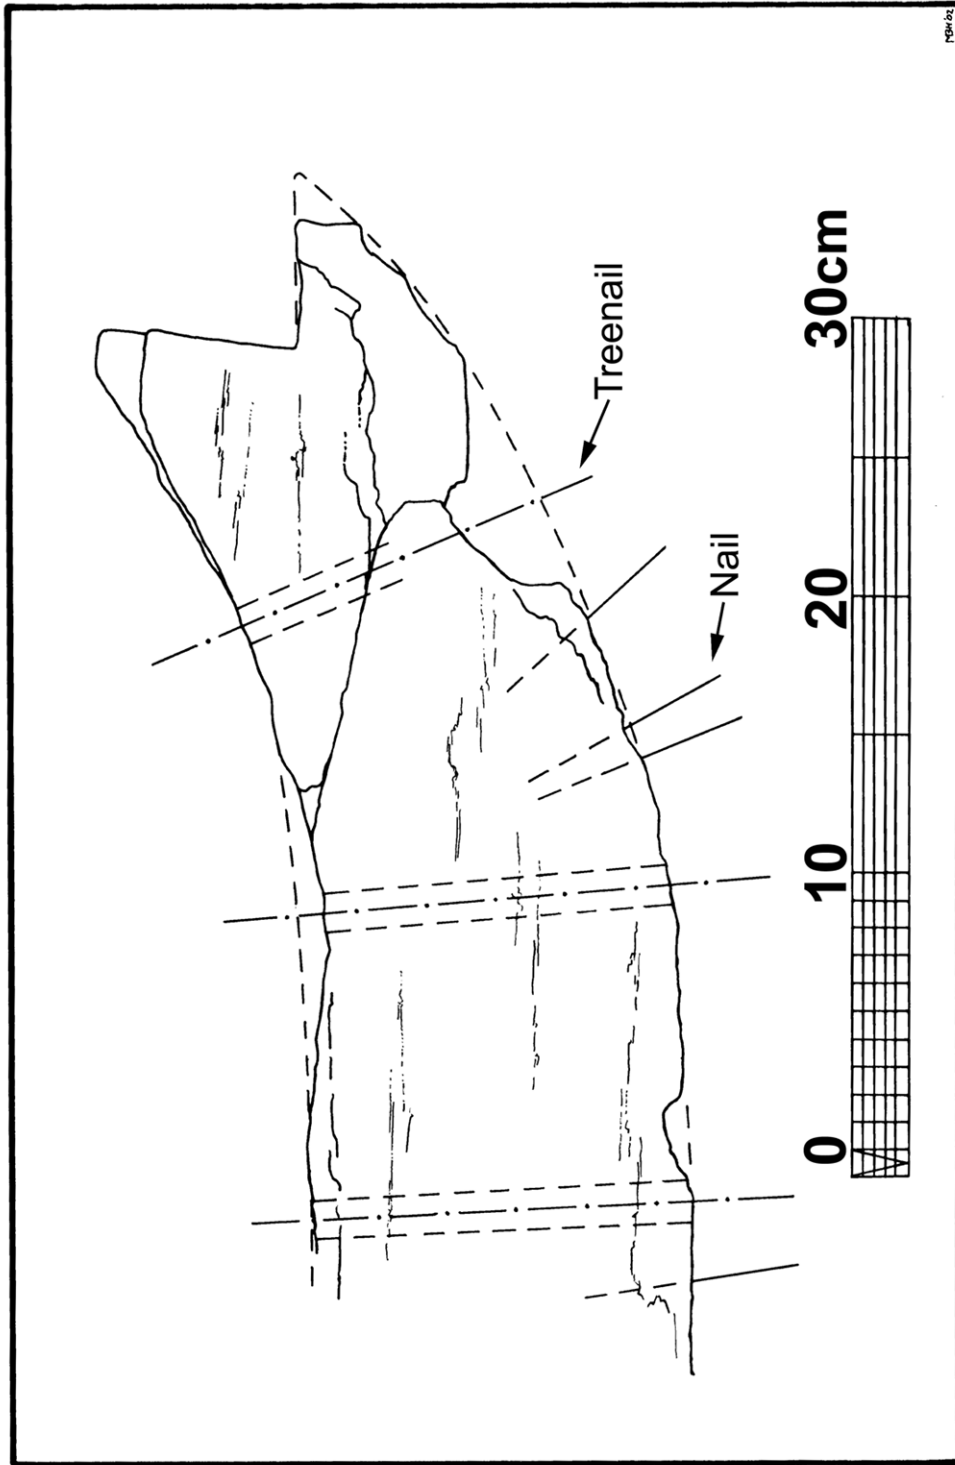
Figure 3-28: The L-shaped scarf in floor timber E.

Figure 3-29: Another view of the L-shaped scarf in floor timber E.

Figure 3-30: The L-shaped scarf in floor timber E from above.

Figure 3-31: Drawing of the L-shaped scarf in floor timber E.

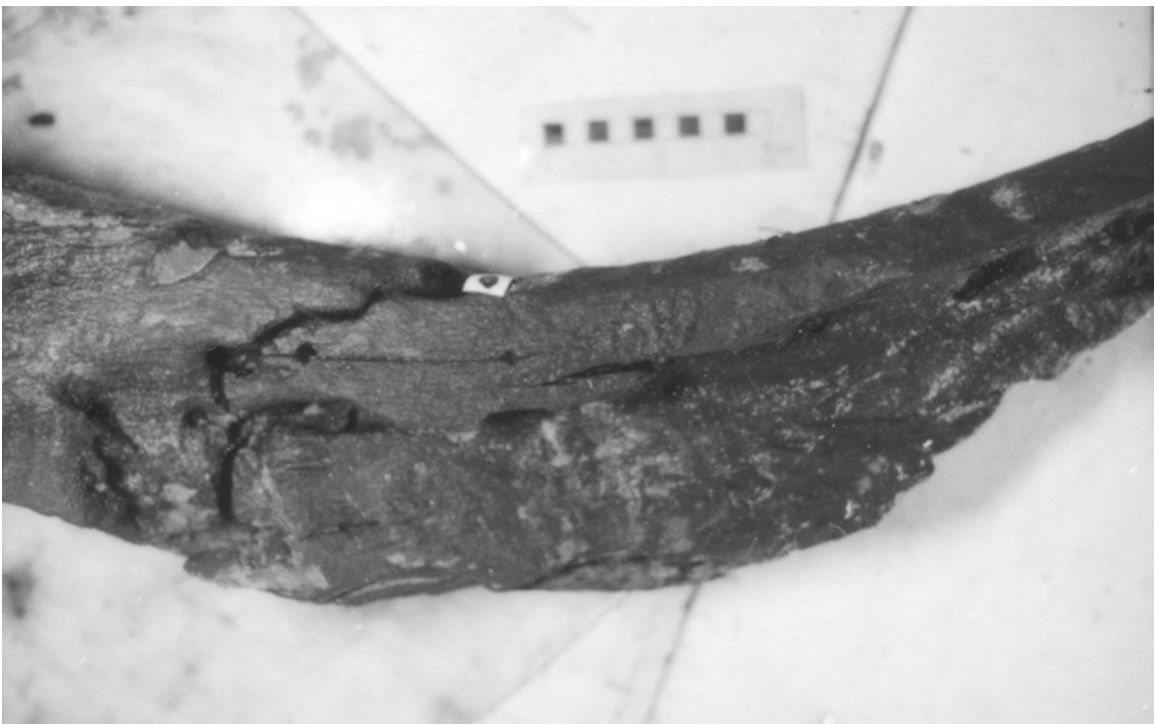
Figure 3-32: Photograph of the bilge curve in floor timber B. Note the grain curving up through the bilge.

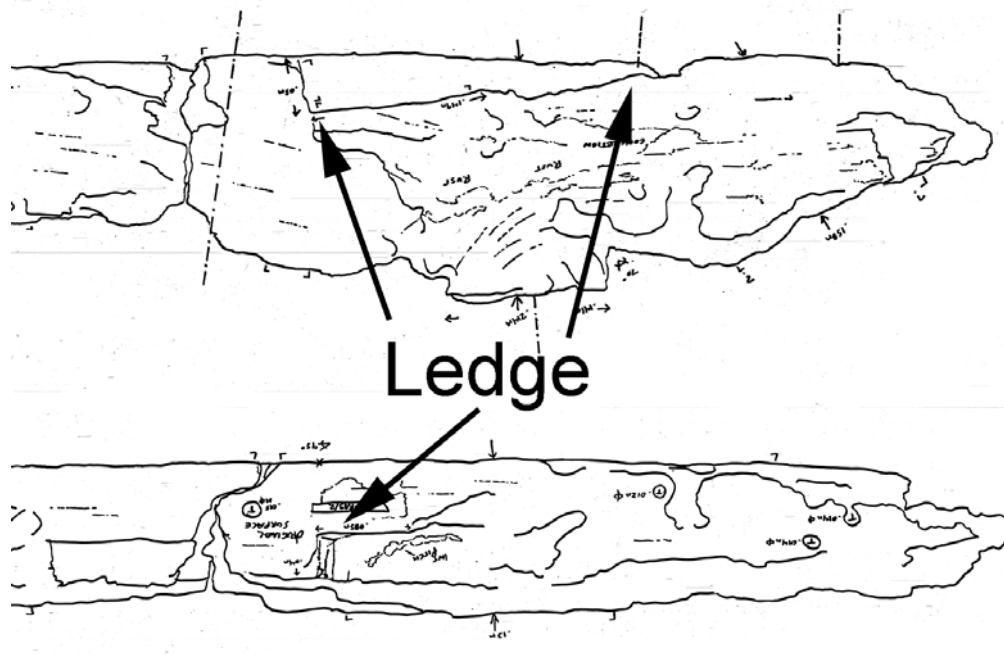
Figure 3-33: Drawing of the ledge cut into the top bow face of floor timber C (Not to scale).

Floor timber C, which among the oak floor timbers is best preserved over the keel, also preserves a shallow, inclined ledge on its bow face over the keel (fig. 3-33). This inclined ledge is approximately 4 x 33 cm. The inclined face, which comprises the ledge

itself, appears to begin approximately 8 cm outboard of the port edge of the keel, along the top face of the floor timber. At this point, this face declines into the floor timber at an angle of approximately 15 degrees, and continues across the midline of the floor timber to a point 13 cm outboard of the starboard side of the keel. A second, nearly vertical face, meets the inclined face of the ledge at this point at an angle of 100 degrees, and then extends upwards approximately 5 cm to meet the upper face of the floor timber. This ledge is best preserved along the starboard 14 cm of its extent. No treenails or metal fasteners are evident in any of its faces, nor does it appear to be a scarf of any kind.

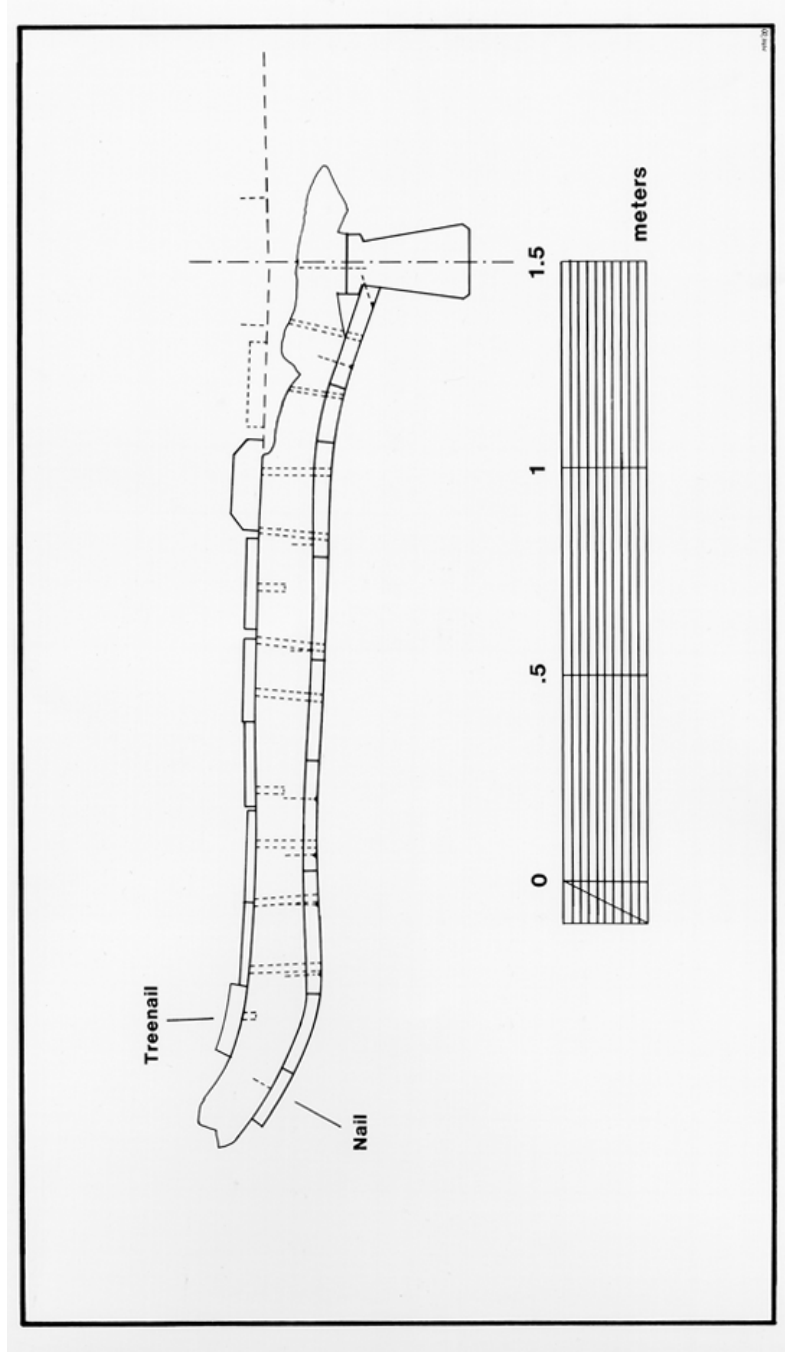
Figure 3-34: Drawing of the cross section of the hull at floor timber 1.

In addition to the treenails in the oak floor timbers, nails and bolts are present in the floor timbers as well (figs. 3-34, 3-35). In comparison, however, the placement of the treenails appears to be more methodical and regular than the placement of the nails, although both were employed to affix the planking to the floor timbers. Of the seven oak floor timbers, one has 10 preserved treenails, two have 11, three have 13, and one has 14.³ Moreover, the treenails' average spacing only varies between 14.4 and 18.14 cm. A total of 94 preserved treenails were recorded in the seven oak floor timbers, and of them, 89 are located on the starboard side of the keel. The majority of the preserved treenails are hexagonal in shape, 1.2 cm to 1.5 cm in breadth, but three examples, one each in floor timbers B, C and D, were square in cross section. Of the 89 treenails on the starboard side of the keel, only 76 pass through the floor timbers. Nine are only present on the top face of the floor timbers, while the remaining four are only evident on the bottom face of the floor timbers. Of those nine treenails only evident in the top face, however, one is located 17 cm from the turn of the bilge in floor timber D, while a second is located 16 cm from the preserved end of floor timber C. In light of the poor preservation of the bottom faces of

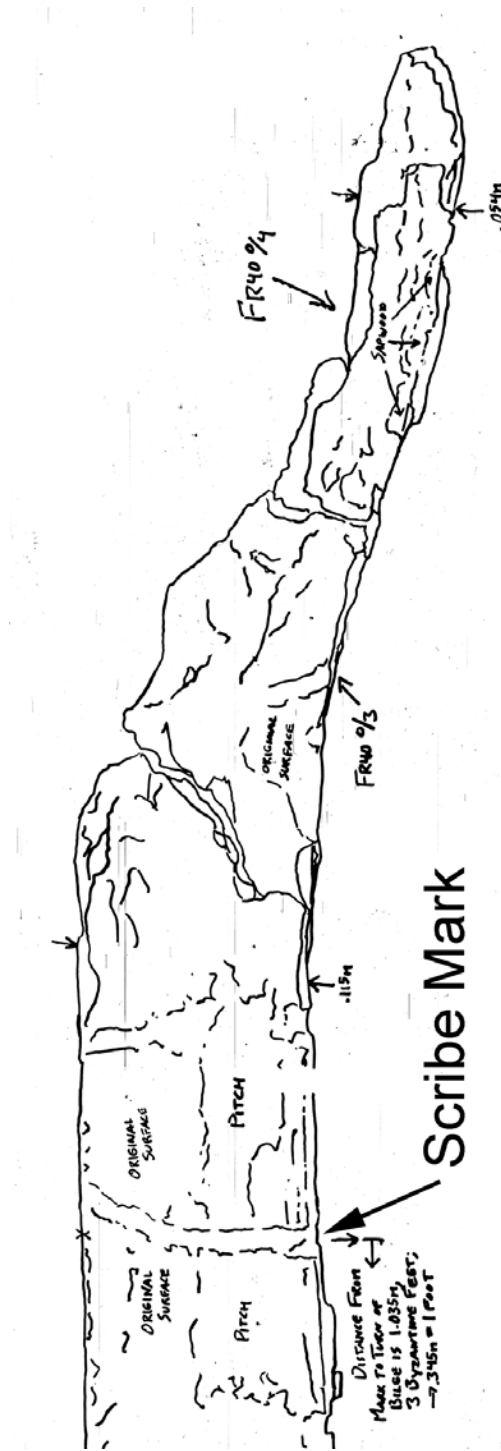
Figure 3-36: Detail of the scribe mark on the forward face of the midships floor timber (Not to scale).

In comparison to these tool marks, which were inadvertently left on the surfaces of the floor timbers, there is one, and perhaps a second, intentional mark evident on these timbers as well. The first mark, which appears to have been fashioned by scraping a blunt instrument approximately 1.0 cm wide down the bow face of the midships floor timber, extends over the molded depth of the floor timber from its upper to lower edge (fig. 3-36). This mark, which rises vertically approximately 8 cm prior to curving 25 degrees towards the keel, is located 61 cm from the preserved proximal end of the floor timber. It is the only such mark on the midships floor timber, and the only mark in such a location among the oak floor timbers. The second mark, found on the stern face of floor timber E, is more indefinite. This mark is similar in design to the first, although it appears to have been made with a much narrower and sharper instrument than that employed on the midships floor timber. It appears to span the molded depth of the floor timber as well as rising approximately 8 cm prior to bending abruptly towards the keel of the vessel, but the ends of the mark were either not cut, or not preserved. This latter mark is approximately 78.5 cm to the center of the keel, and 1.14 m to the preserved distal end of the floor timber.

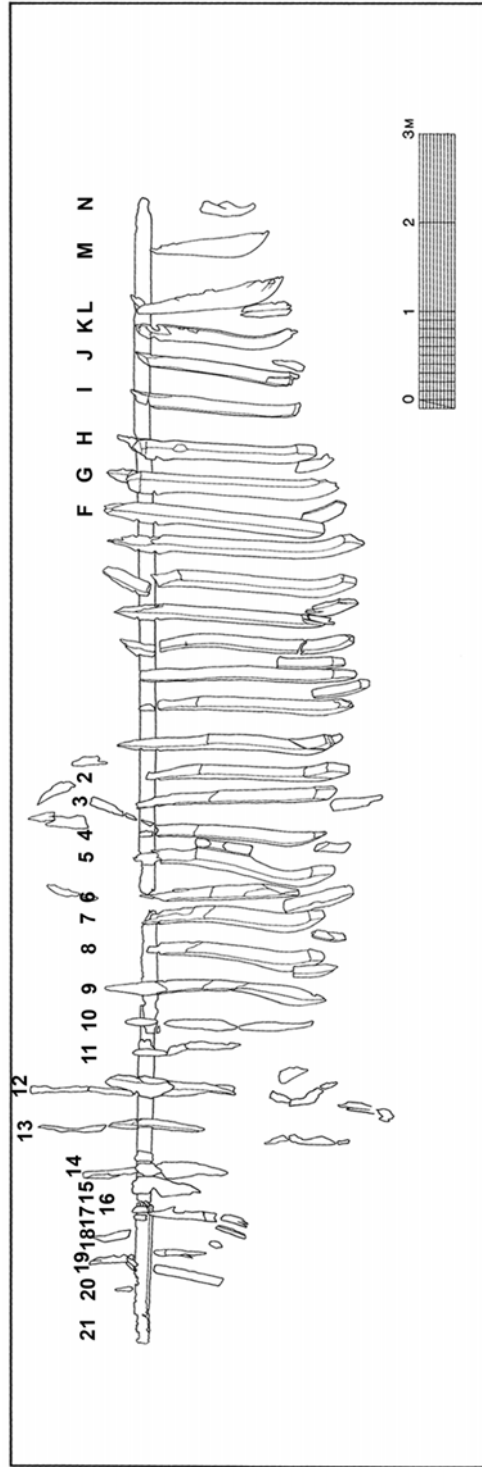
Figure 3-37: Site plan with the pine floor timbers labeled.

Of the 34 floor timbers cataloged in association with this vessel, seven are oak and the remaining 27 are pine (figs. 3-37 to 3-57). Unlike the oak floor timbers, as a whole, these pine floor timbers are stronger, apparently more durable, have suffered less wear and erosion, and tend to have crisper and cleaner edges and faces. The quality of this preservation, however, varies along the length of the vessel. Between the aft-most nine cataloged floor timbers, 19 through 11, and the pine floor timbers farther forward, there is a noticeable improvement in the quantity and quality of the material preserved. Floor timbers 18 through 14, for example, were so poorly preserved that they were not initially identified as floor timbers upon discovery. All five floor timbers suffer from a great deal of erosion on three of their four faces (only the bottom is somewhat preserved), and none could yield an accurate cross-sectional shape. As evident from the tables following this section, these five floor timbers are also composed of either a single, very eroded fragment, or numerous discontinuous fragments that cannot be re-assembled. Floor timber 13, of which approximately 65 cm is preserved, has original surfaces only on the inclined face of the starboard limber hole, and portions of the preserved aft face. While the angle between the bottom face and the inclined face of the limber hole is fairly distinct, other edges, and the top and bow faces, are rounded, eroded, and friable. The 37 cm long fragment of floor timber 12 preserves only portions of the bottom face, predominantly concreted areas around nail holes, while the rest of the fragment is severely eroded, friable and splintering. Floor timber 11, which is represented by five fragments, only two of which fit together, is slightly more substantial and solid. Original surfaces are evident on both the bottom and

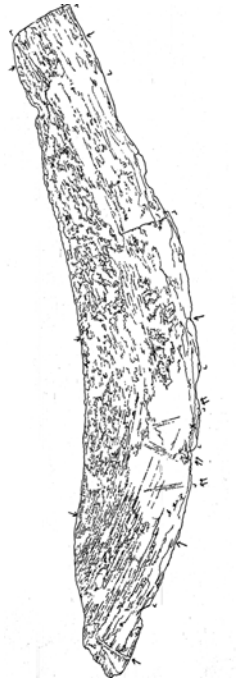
Figure 3-41: Drawing of the forward face of floor timber 10 (1:10 scale).

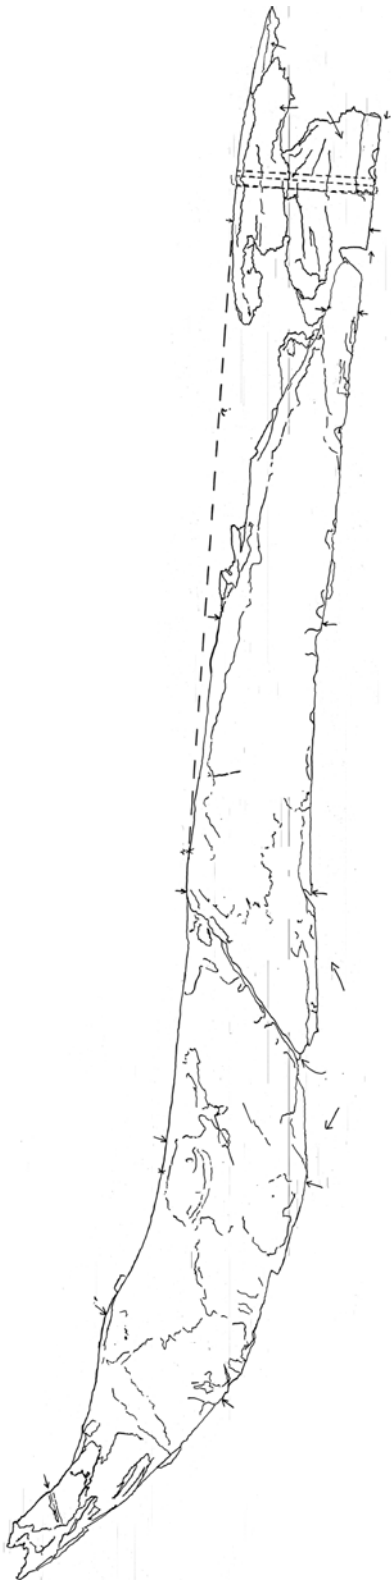
Figure 3-42: Drawing of the forward face of floor timber 9 (1:10 scale).

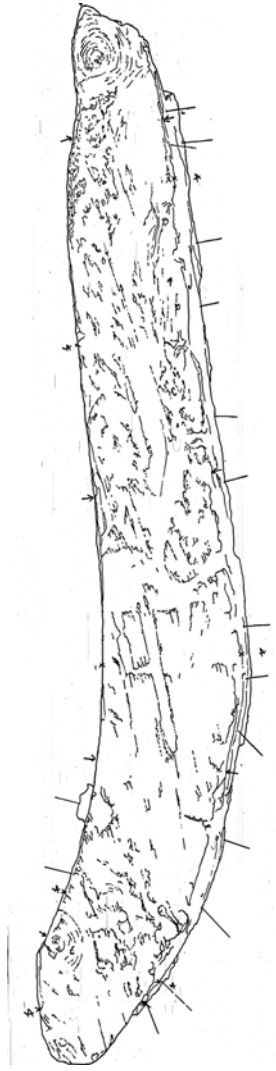
Figure 3-43: Drawing of the forward face of floor timber 8 (1:10 scale).

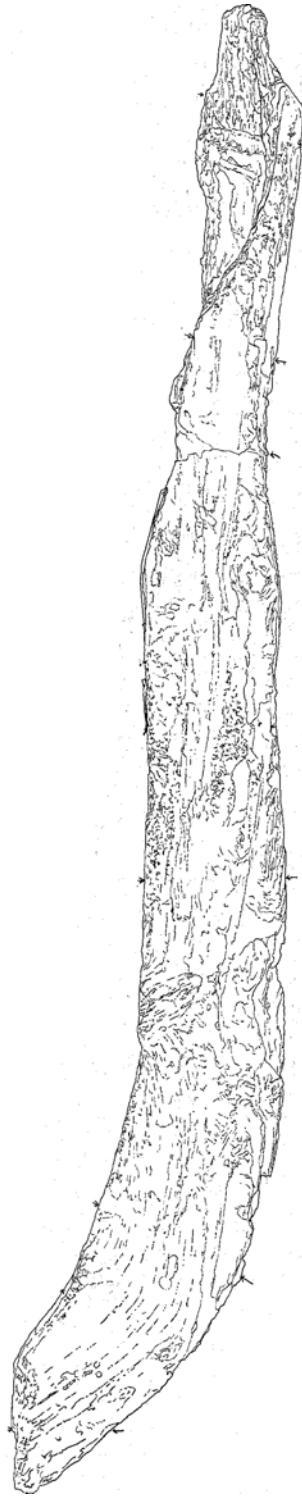
Figure 3-44: Drawing of the forward face of floor timber 7 (1:10 scale).

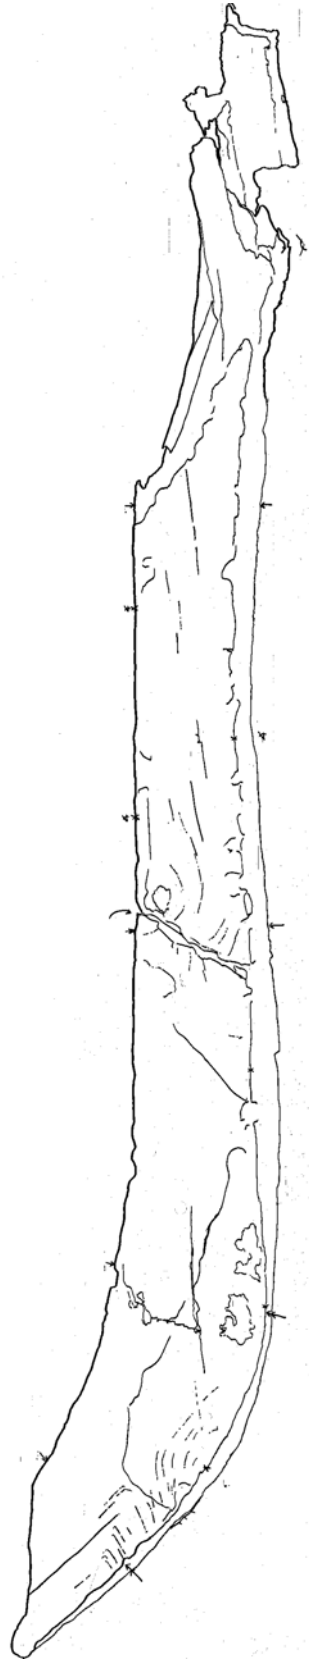
Figure 3-45: Drawing of the forward face of floor timber 5 (1:10 scale).

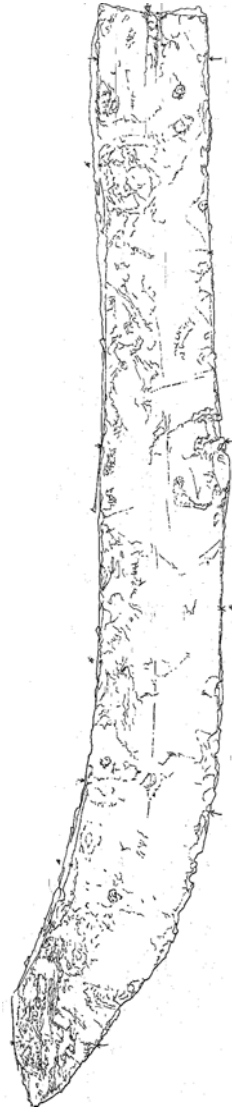
Figure 3-46: Drawing of the forward face of floor timber 4 (1:10 scale).

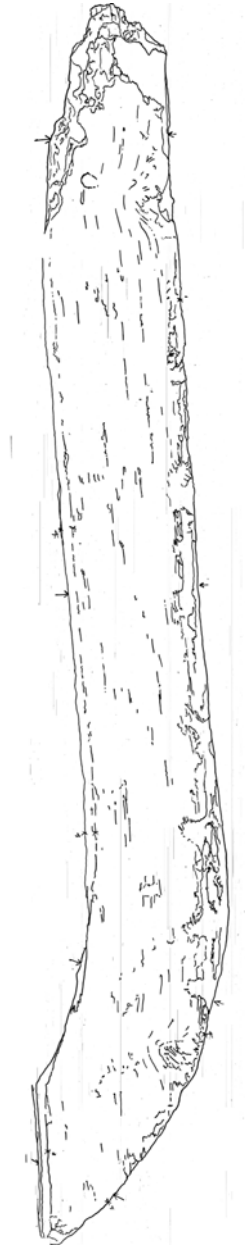
Figure 3-47: Drawing of the forward face of floor timber 3 (1:10 scale).

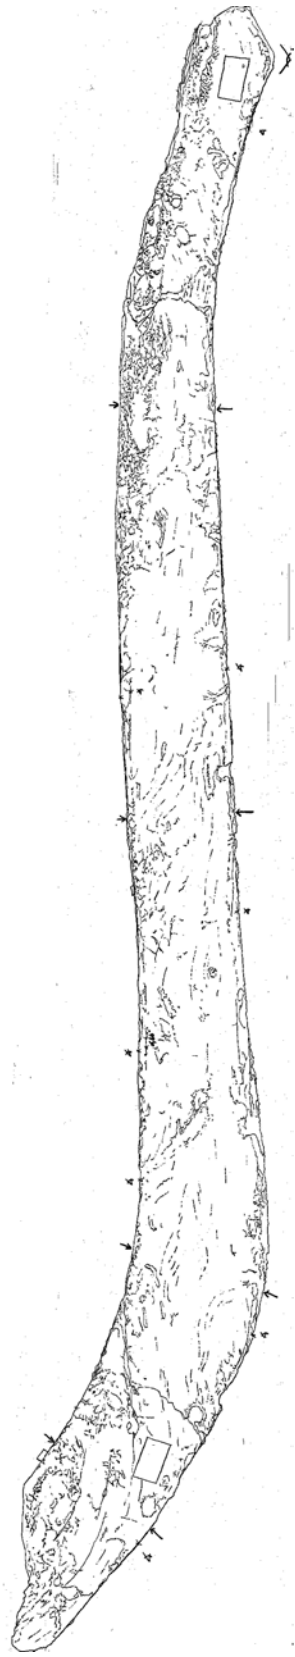
Figure 3-48: Drawing of the forward face of floor timber 2 (1:10 scale).

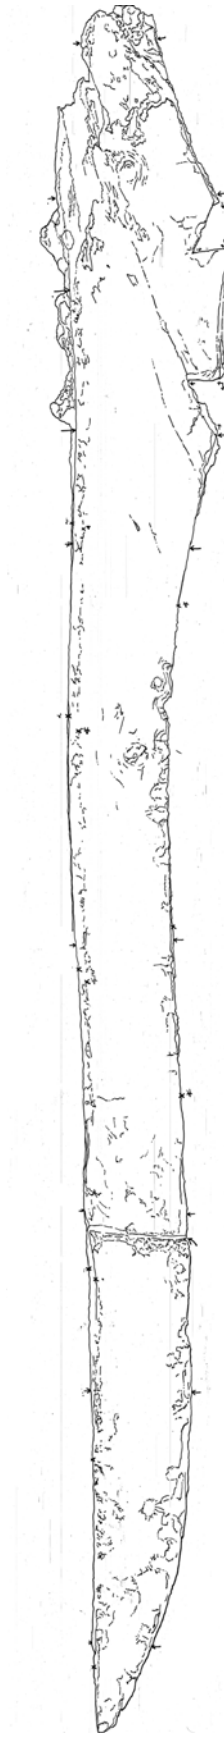
Figure 3-49: Drawing of the forward face of floor timber F (1:10 scale).

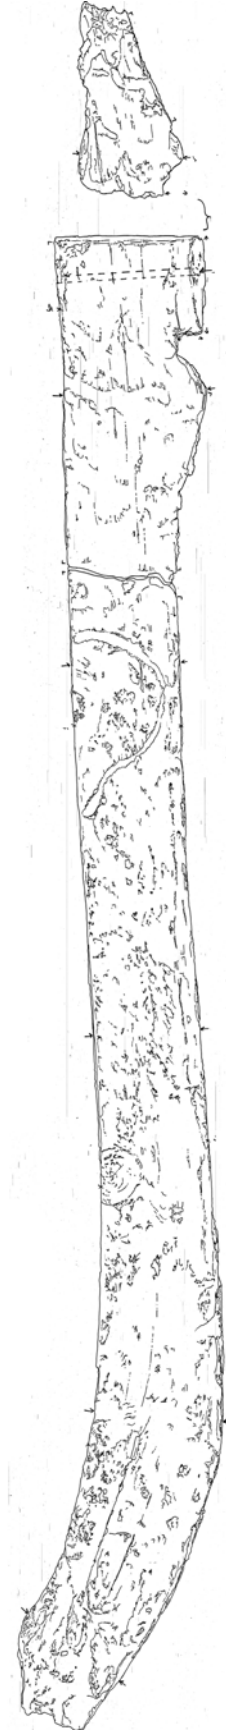
Figure 3-50: Drawing of the forward face of floor timber G (1:10 scale).

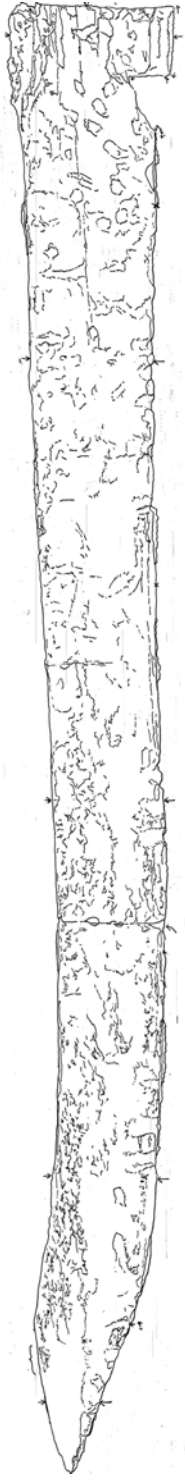
Figure 3-51: Drawing of the forward face of floor timber H (1:10 scale).

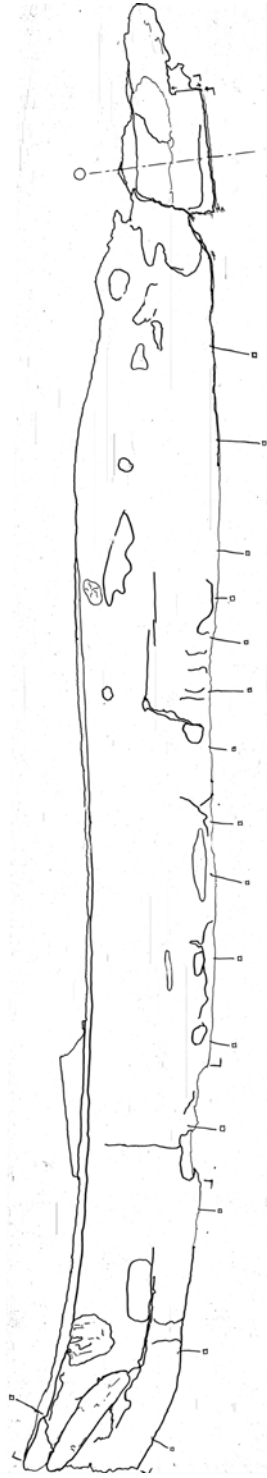
Figure 3-52: Drawing of the forward face of floor timber I (1:10 scale).

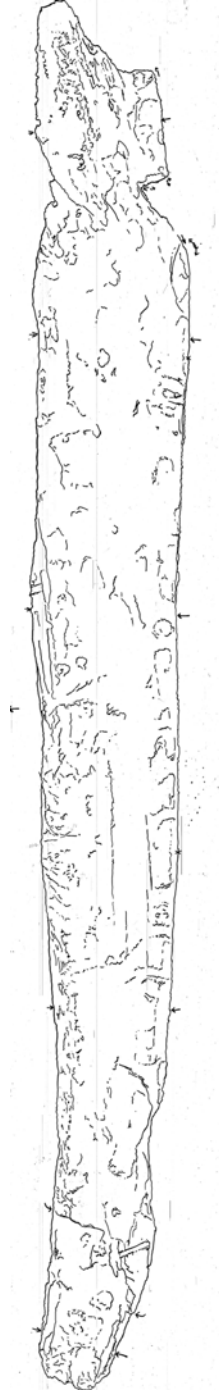
Figure 3-53: Drawing of the forward face of floor timber J (1:10 scale).

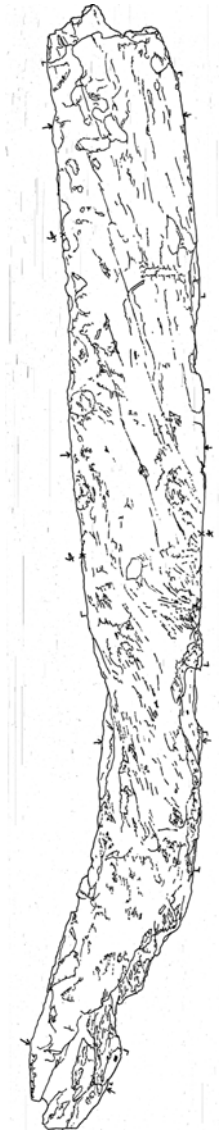
Figure 3-54: Drawing of the forward face of floor timber K (1:10 scale).

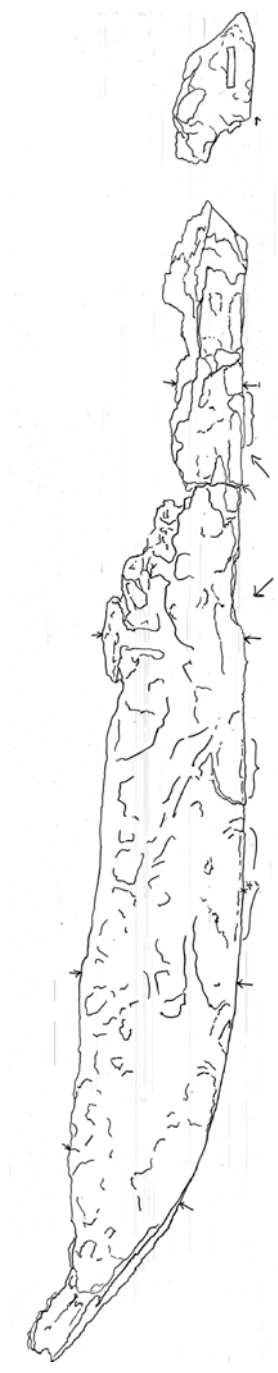
Figure 3-55: Drawing of the forward face of floor timber L (1:10 scale).

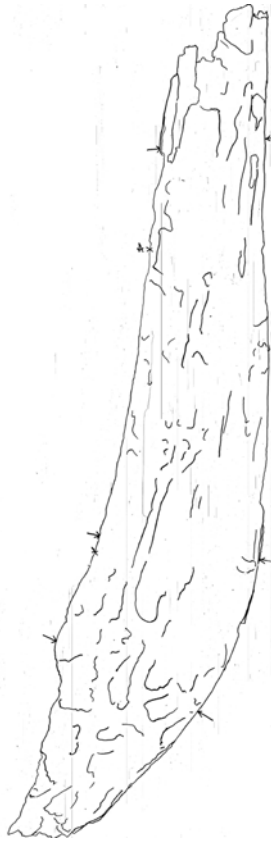
Figure 3-56: Drawing of the forward face of floor timber M (1:10 scale).
