**A RE-ASSEMBLY AND RECONSTRUCTION OF
THE 9TH-CENTURY AD VESSEL WRECKED OFF THE COAST OF
BOZBURUN, TURKEY**

A Dissertation

MATTHEW BENJAMIN HARPSTER

A Re-Assembly and Reconstruction of
the 9th-century AD Vessel Wrecked off the Coast of
Bozburun, Turkey. (August 2005)

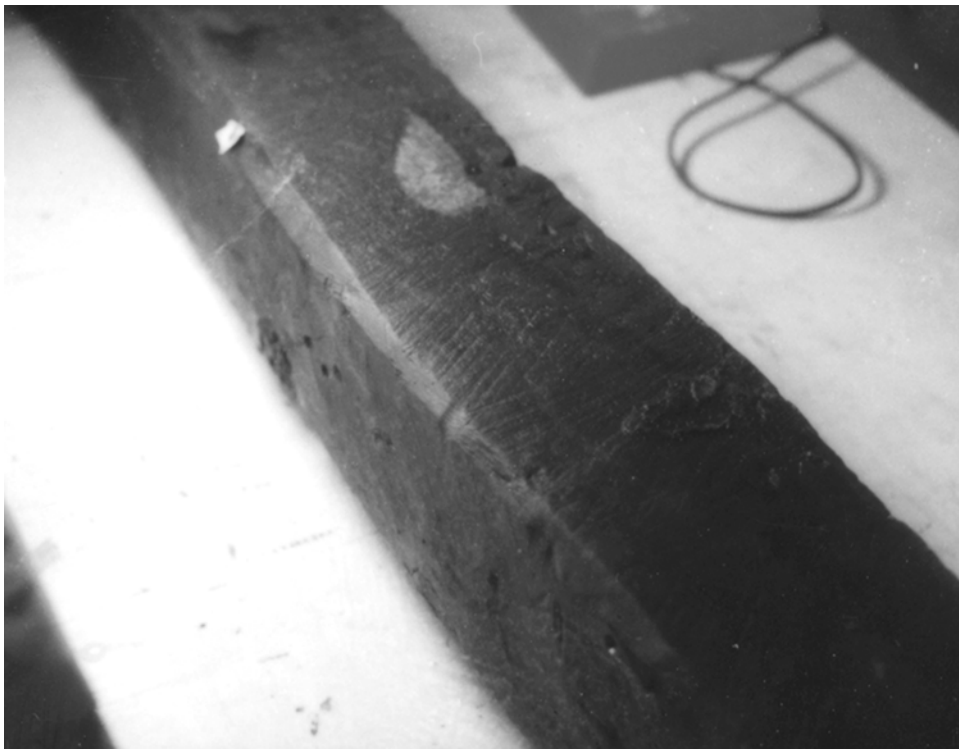
Figure 3-58: Photograph of a chamfer on a pine floor timber.

Similar to oak floor timber B, eight of the pine floor timbers preserved one or more chamfers along their top edges as well (figs. 3-58, 3-59). As each chamfer was produced by fashioning an intermediate face between, and diagonal to, the top face and either the bow or stern face, two intermediate angles were generated at the junctions between the face of the chamfer, and the horizontal and vertical faces of the floor timber. Among the nine chamfers preserved, the average upper angle of 137.8 degrees is slightly greater than the lower, of 132.8 degrees. Although collectively, these two averages add to 270.6 degrees, three-quarters of a circle, as they may be expected to, the angles associated with particular chamfers are not always as predictable. Only two of the nine preserved chamfers, on floor timbers 8 and 3, preserve matching angles of 135 degrees each. The remaining angles vary

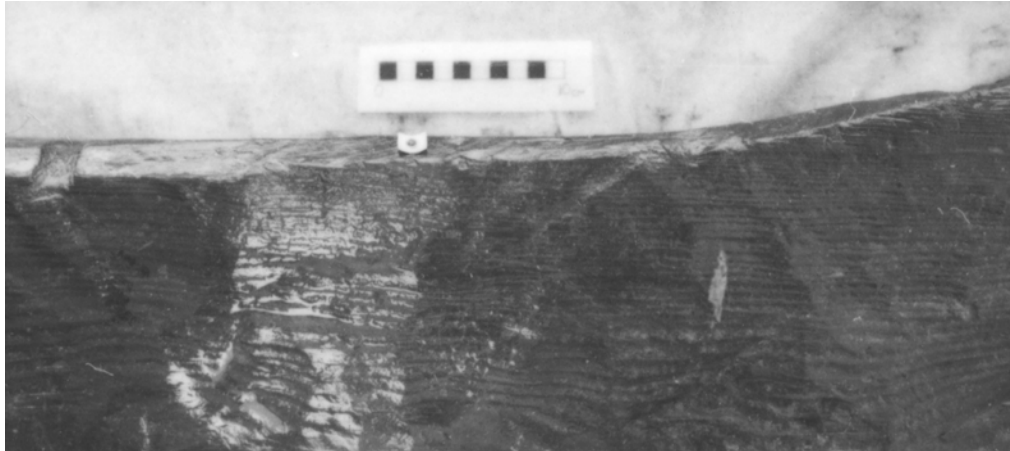
Figure 3-59: Another photograph of a chamfer on a pine floor timber.

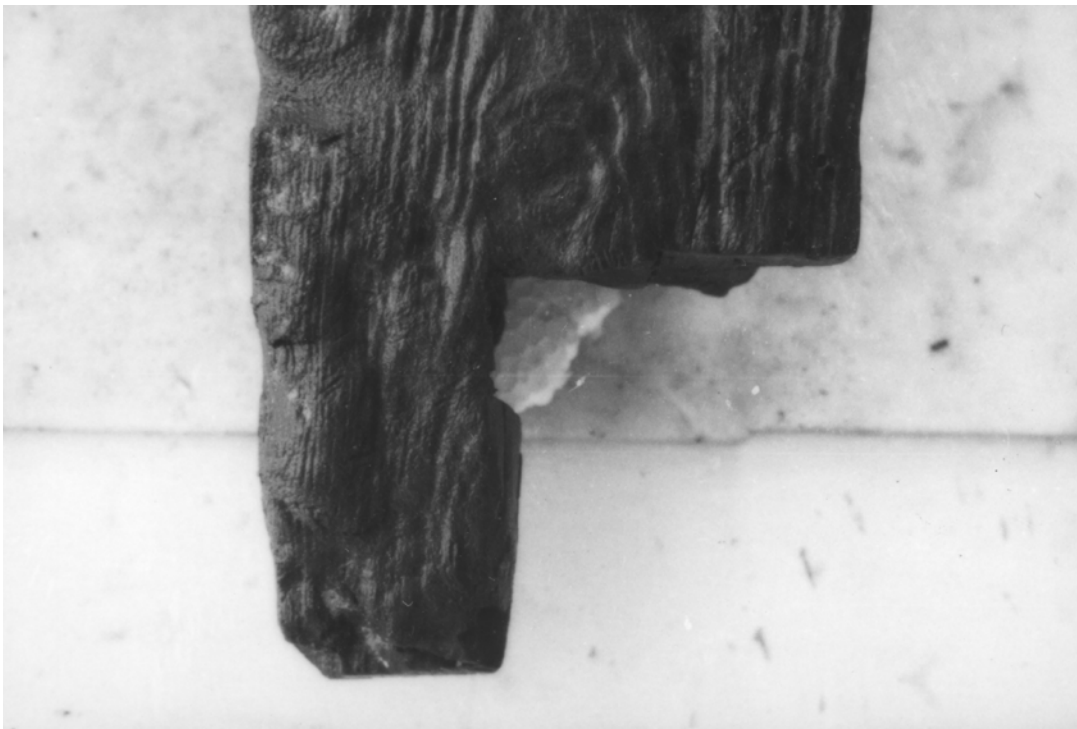
Figure 3-60: Photograph from above of the possible scarf in floor timber F.

There is one apparent scarf preserved among the pine floor timbers. Found at the distal end of floor timber F, its purpose, or original design, is not entirely clear. This apparent scarf is composed of two vertical faces roughly perpendicular to each other and to the top face of the floor timber (fig. 3-60). One face, approximately 9.4 cm long, is 6 cm from the bow face and parallel to the long axis of the floor timber, while the second face, perpendicular to the first, is 8.7 cm long. Original surfaces are evident in the areas adjacent to the junction of the two vertical faces, but outwards, the surfaces are questionable (figs. 3-61 to 3-63). It should be noted that outwards of this junction on the first vertical face, the rest of the face is not eroded or receded into the floor timber, but protrudes .8 cm more than the original material near the junction. On the one hand, this indicates that the material preserved on this face is original material, but on the other hand, this original material is not worked, it appears to be broken or split. Essentially, the extant material is a horizontal L shape, projecting the material along the bow face of the floor timber approximately 9.4 cm farther towards the turn of the bilge than the material on the stern face. Whether this horizontal L shape accurately reflects the original design of this material is unclear; this could have been a square hole chiseled through the distal end of the floor timber, around which the stern distal corner has broken away, or it may have been a narrow

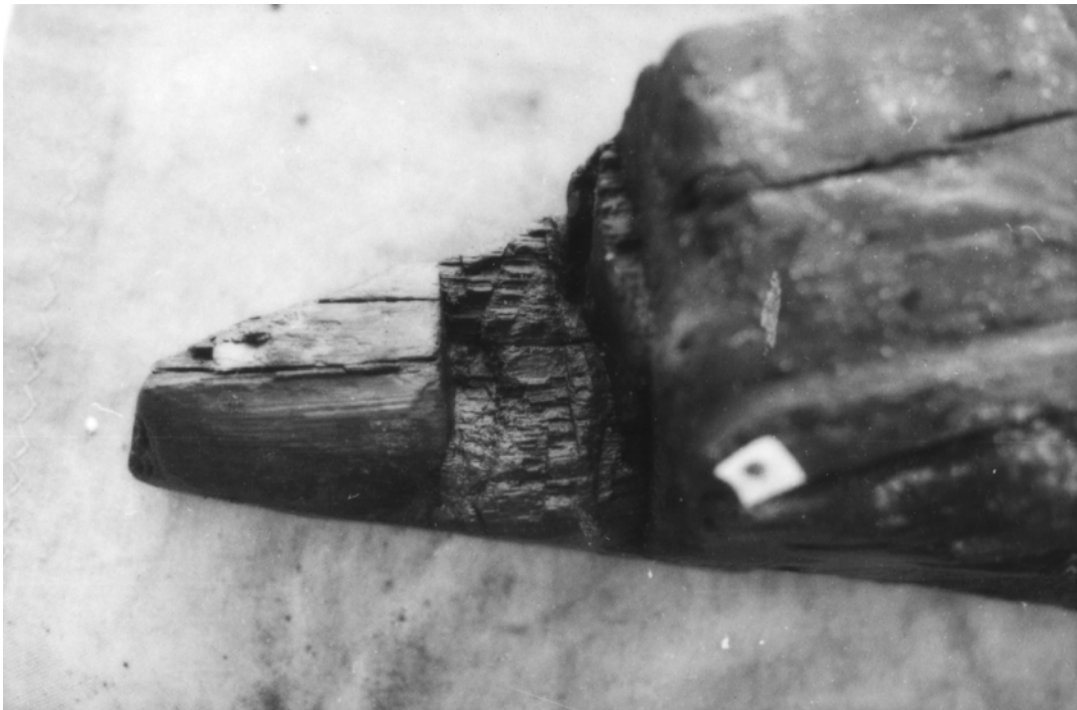
Figure 3-61: Photograph of the possible scarf in floor timber F from the after face.

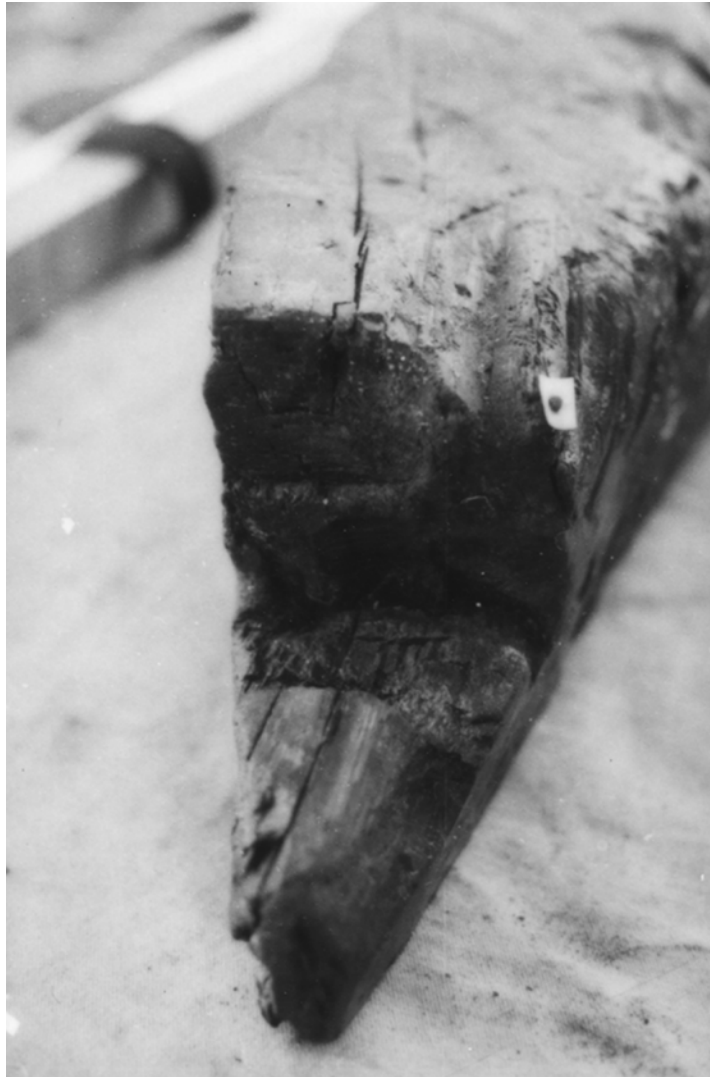
Figure 3-62: Photograph of the possible scarf in floor timber F from the bilge.

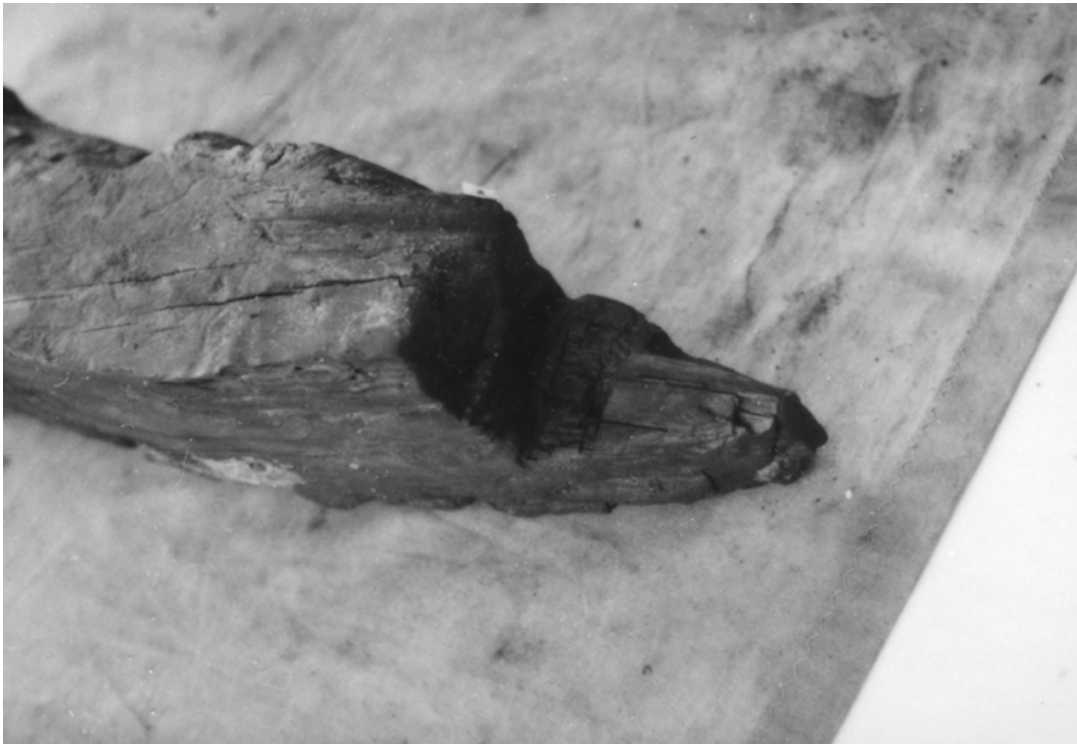
Figure 3-63: Photograph of the possible scarf in floor timber F from the bottom face.

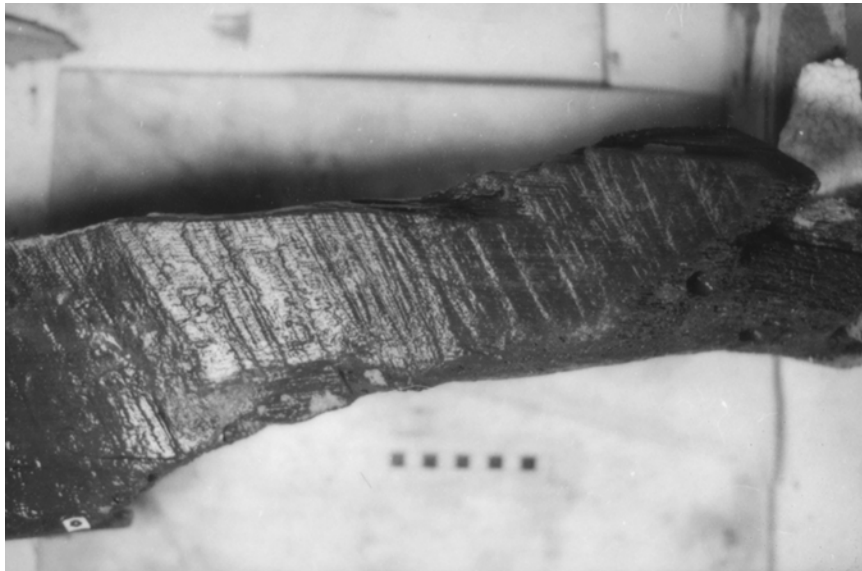
Figure 3-64: Photograph of saw marks on the after face of floor timber 5.

No hammer or axe marks are identified on the pine floor timbers, but this is not to imply that tool marks in general are rare or difficult to identify. The most predominant, and most informative, of the tool marks identified among the 21 pine floor timbers are collections of saw marks found on 12 of them (fig. 3-64). These marks are preserved in varying amounts, from a small patch 15 cm long on floor timber L, to a series spanning the preserved length of floor timber 2. Other than a dozen small marks on the top distal face of floor timber K, all of these marks are all found on the stern faces of these 12 floor timbers and moreover, in all cases where a cut direction may be discerned, the cutting proceeded from the starboard bilge towards the keel (figs. 3-65 to 3-67). Floor timbers 2 and G preserve scattered second sets of saw marks among the first set. These second sets are identifiable along the midbody of floor timber 2, and over the bilge of both, as they indicate a second trimming of the timber from the keel to the bilge. It has not been possible to gather information about either the saw's teeth, or its kerf. Although the actual

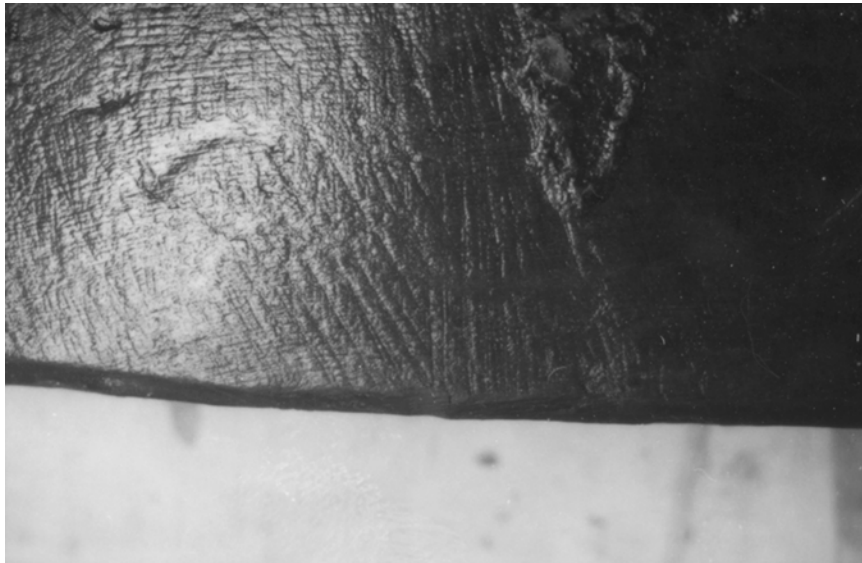
Figure 3-65: Photograph of more saw marks.

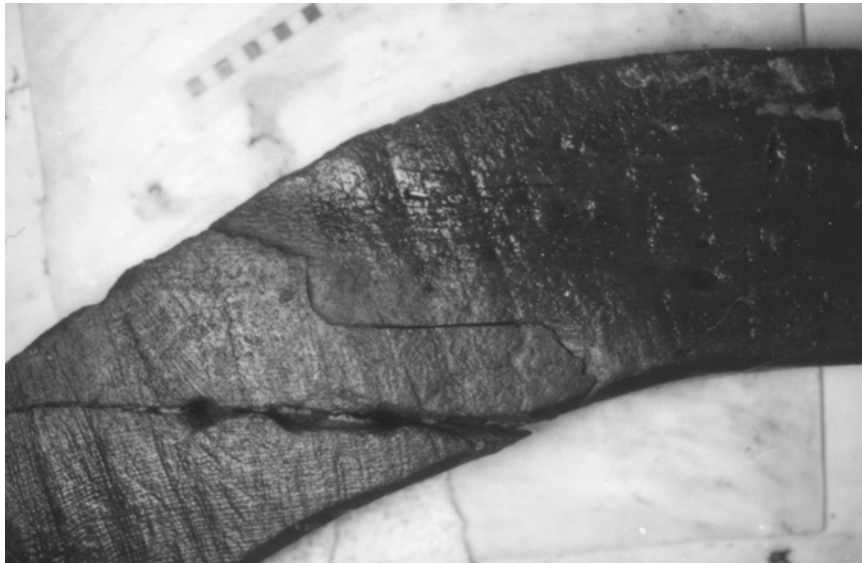
Figure 3-66: Photograph of the same marks.

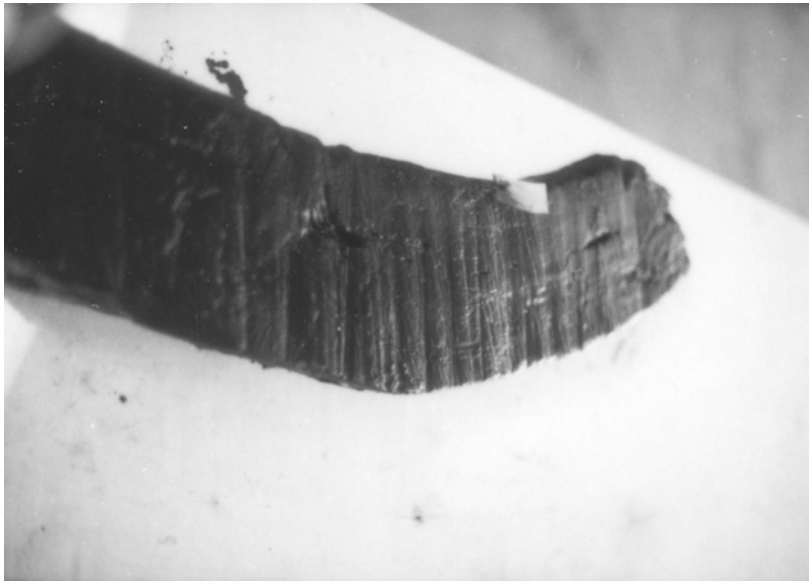
Figure 3-67: The varying angles of the saw marks on one floor timber.

angles of the saw marks varied between approximately 60 to 100 degrees to horizontal, on nine of the floor timbers, 9, 5, 2, G, I, J, K, L and M, the cut angles averaged less than 90 degrees and were all inclined towards the keel. Only on floor timbers 8, 4 and H are the saw marks inclined towards the bilge. On only one of the floor timbers, floor timber I, do the saw marks appear to retain a perpendicular orientation to the contour of the bottom face, thus changing their orientation relative to each other. The saw marks on the majority of the other floor timbers, 9, 5, 2, G, H, I, L and M, are relatively parallel to each other along the preserved length of the fragment, regardless of their location. Unfortunately, not enough saw marks are preserved on the stern faces of floor timbers 8, J and K to determine their alignment relative to each other, or the bottom face of the floor timber. On floor timbers 5, F, G and K, the saw marks become particularly close set and jumbled as the saw proceeded through knots in these timbers. Floor timber K preserves a second collection of similar saw marks 38 cm from the starboard edge of the keel with an alternating orientation, but in this case, there is no knot present. As such, it appears that the builders instead altered the saw's vertical orientation between 75 and 125 degrees on each cut, creating a series of isosceles triangles on the face of the floor timber (figs. 3-68, 3-69).

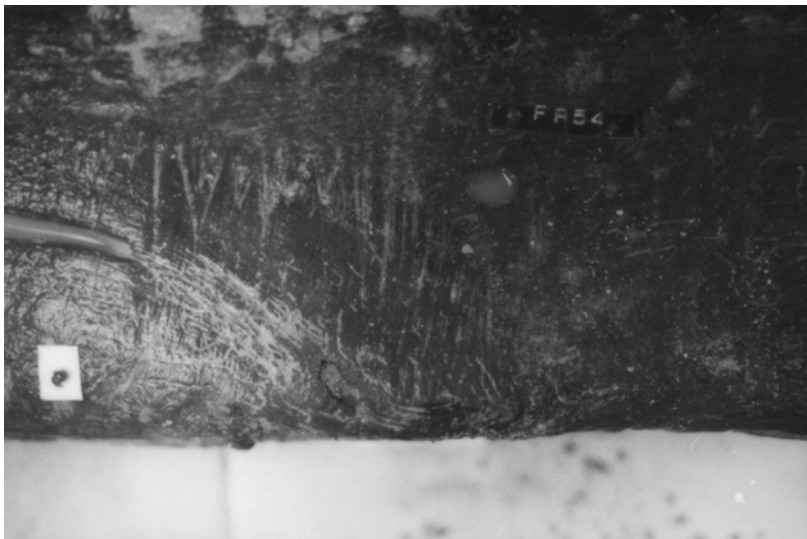
Figure 3-68: Photograph of the varied angles of saw cuts on floor timber K.

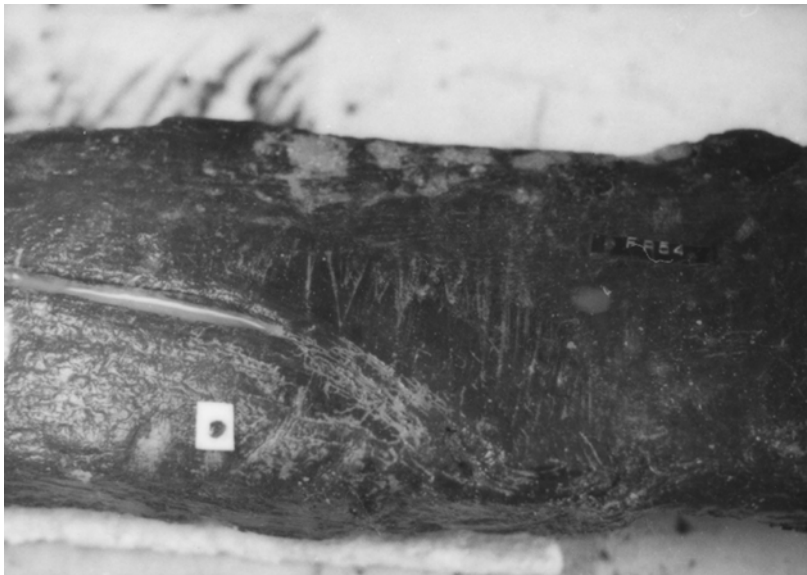
Figure 3-69: Another photograph of the same marks on floor timber K.

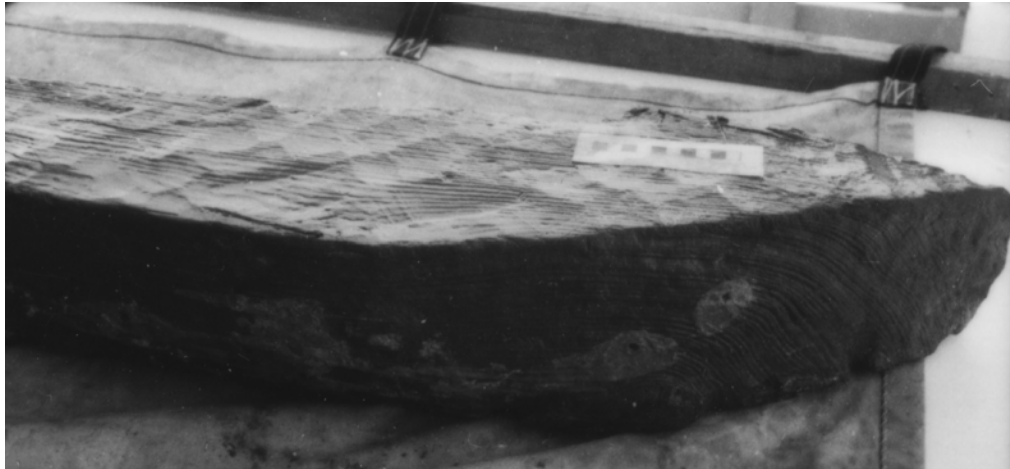
Figure 3-70: Adze dubbing evident on the after face of floor timber F.

Dubbing marks from an adze are evident on the pine floor timbers as well, and are evident on a greater number of preserved faces (figs. 3-70, 3-71). Significantly, the adze marks and saw marks are nearly exclusive in their distribution. Twelve pine floor timbers have adze marks preserved on their surfaces, but only one, floor timber 8, has both saw marks and adze marks on its stern face. These marks are only evident at the distal end of the floor timber, where it narrows from 15.8 cm to 12.1 cm. Adze work is evident on the stern faces of floor timbers 5 and F as well, but in these two cases, no saw marks are evident on these faces. Predominantly, the adze work is found on the top faces of nine of the 12 pine floor timbers, 8, 7, 5, 4, 3, 2, F, G and H. While floor timber 3 may be representative of the original state of these floor timbers, as dubbing marks are evident all along its preserved top face, these marks are now most commonly preserved only above the turn of the bilge. Dubbing marks are found on the bottom faces of five of the 12 floor timbers as well, on floor timbers 11, 8, 5, 4 and J, commonly scattered among the nail holes along the midbody of the floor timber. On the bow faces of the floor timbers, adze marks

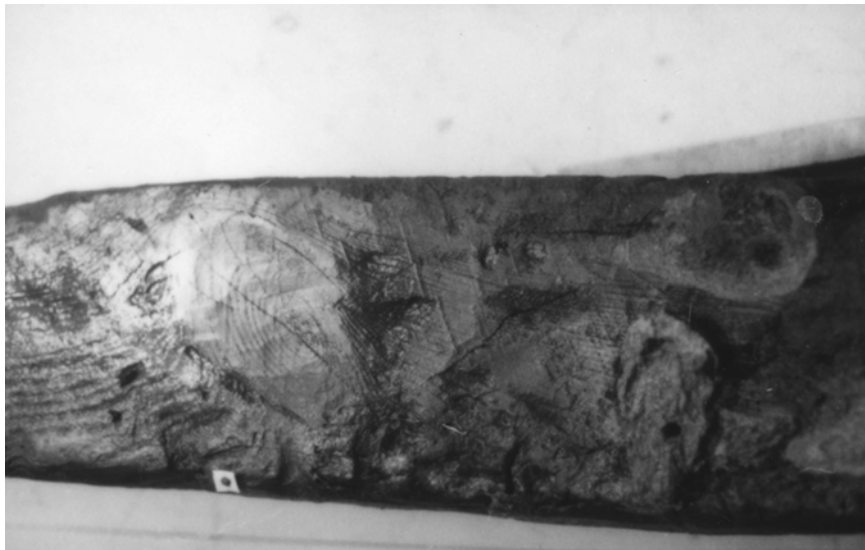
Figure 3-71: More adze work evident on the top face of a pine floor timber.

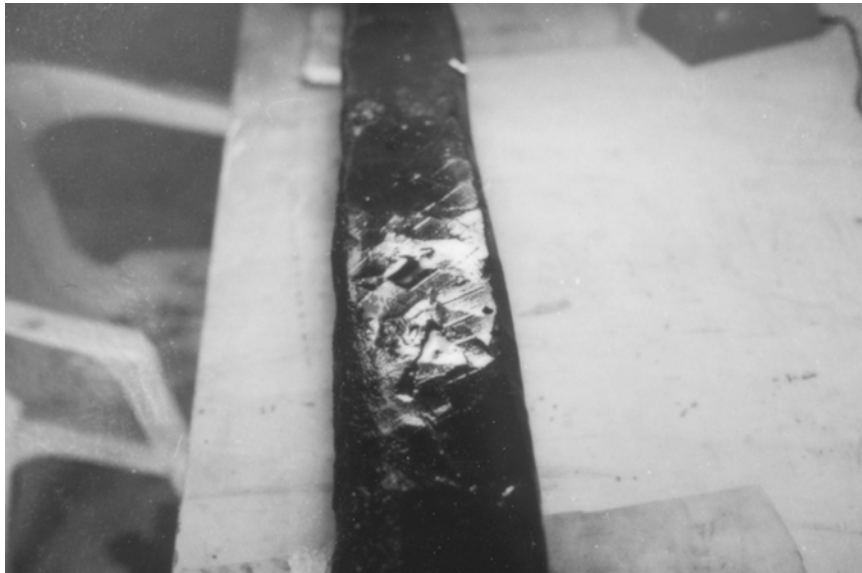
Figure 3-72: Note the ridge in the adze mark, indicating a nick in the blade of the adze.

are evident on 10-3, 4, 3 and 2, but they are most prominent on the latter two; only a handful of marks are evident on floor timbers 10-3 and 4. Similar to the adze work on six of the seven oak floor timbers, the dubbing marks on the top faces of the pine floor timbers also indicate a similar working pattern along the face. Over the bilge, the adze work again appears to proceed both across the face, from the stern to the bow edge, and towards the keel as well. As demonstrated on the top face of floor timber 2, however, this cutting pattern appears to be particular to the concave top face over the bilge, as farther inboard over the midbody, the cutting pattern is reversed. Along this section of floor timber 2, the dubbing proceeded across the top face from the bow to stern edge, and instead worked farther outboard, towards the bilge.⁷ The dubbing pattern on the bottom faces of these floor timbers also indicates that cuts were made across the width of the face, as opposed to along its length, but it is unclear if it proceeded from the bilge to the keel, or vice versa. Of the seven examples of dubbing marks on either the bow or stern faces of the pine floor timbers, all examples appear to indicate that the dubbing proceeded from the top to the bottom edges, although it is unclear if the proximal or distal end was worked first. It should also be noted that there may have been more than one adze in use during the fashioning of the floor timbers, as adze marks on the top faces of floor timbers 8 and G, and all the marks on floor timber 4, indicate that there was a nick in the blade of an adze being used (figs. 3-72 to 3-74). This nick is evident as a small ridge in the middle of the dubbing mark, parallel to the cut of the mark itself. The width of the adze blade cannot be determined.

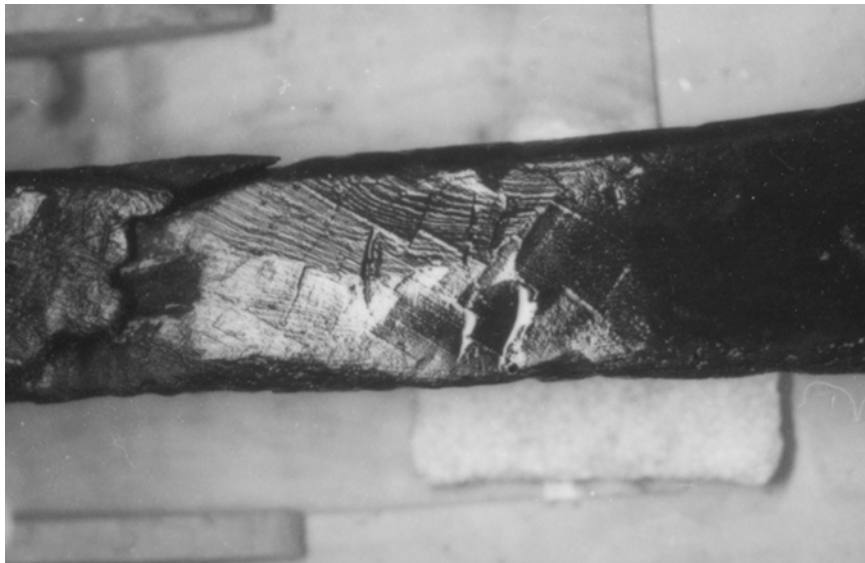
Figure 3-73: Photograph of similar ridges in adze marks.

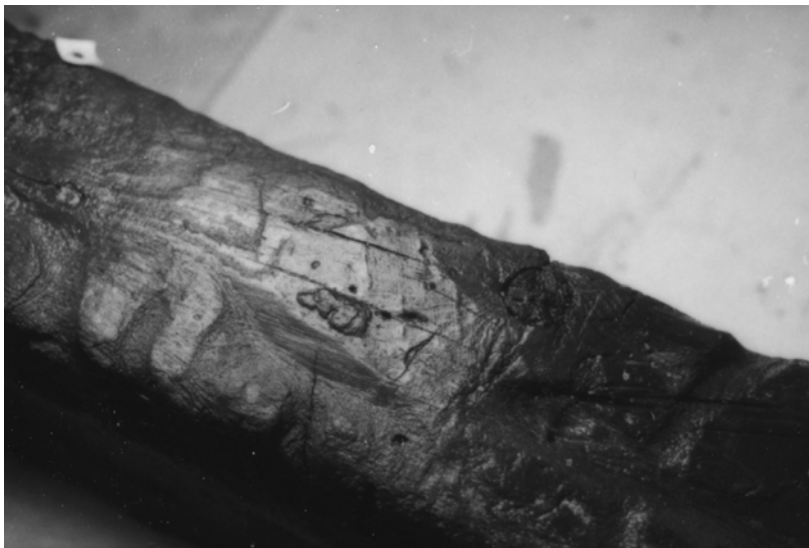
Figure 3-74: Another photograph of similar ridges in adze marks.

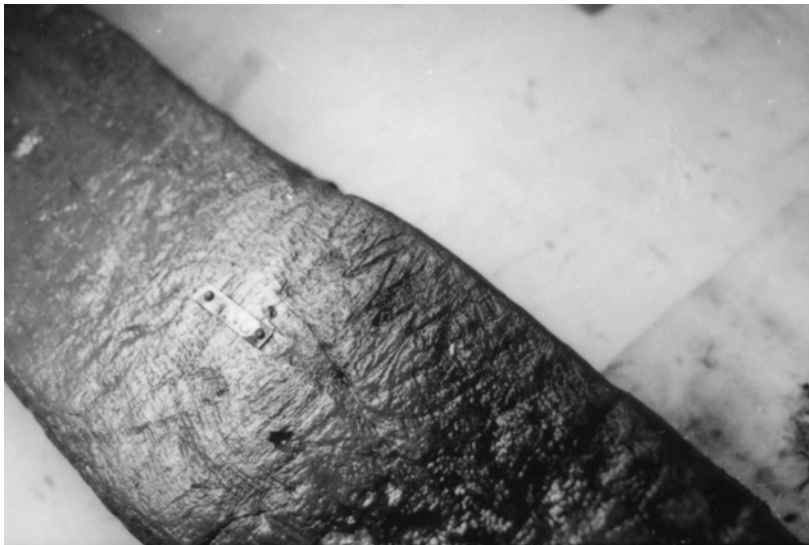
Figure 3-75: Unidentified tool marks in the after face of floor timber I.

Other tool marks, on the stern face of floor timber I, are evident, but unfortunately, their cause cannot be determined (figs. 3-75, 3-76). This a collection of gouges, 11 cm long and 6.5 cm high, which are in a pattern of isosceles triangles similar to the saw marks on floor timber J. In this case, however, they are not saw marks. Essentially, the interior of each triangle is depressed from the exterior, meaning that the border of each triangle is a slight ridge rising to the exterior of the cut area. This is not a significant depression, but if these were saw marks, then the ridges on the exterior of each triangle would not face each other, but be all oriented in one direction. It is impossible to tell, but if the interior of each triangle gouge is slightly convex, then these marks may be representative of a poor adzing technique in this small area back and forth across the stern face.

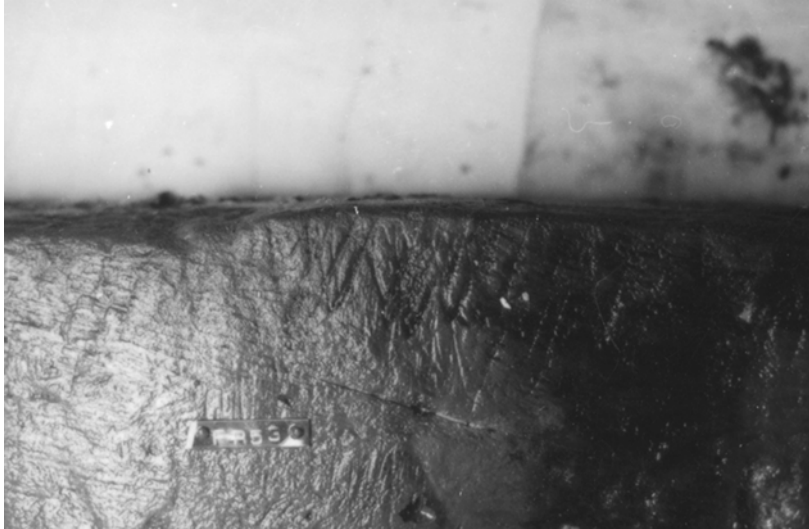
Figure 3-76: Another view of the unidentified tool marks on the after face of floor timber I.

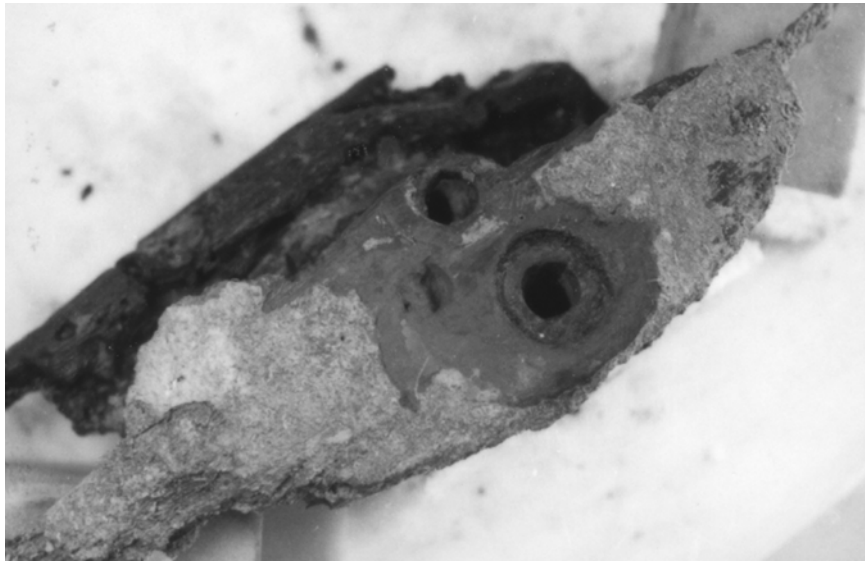
Figure 3-77: Photograph of the top face of floor timber 9 over the keel.

**A and B are round indentations
in the top face of floor timber 9.**

Of an indeterminate use are two round indentations, 1.5 cm in diameter, on the top face of floor timber 9 immediately over the keel (figs. 3-77 and A and B in 3-78). These two indentations, which are 4 cm apart, are slightly offset towards the starboard side of the floor timber, but are located in the immediate vicinity of the nail and bolt hole passing through to the keel. At the most these indentations are only .7 cm deep.

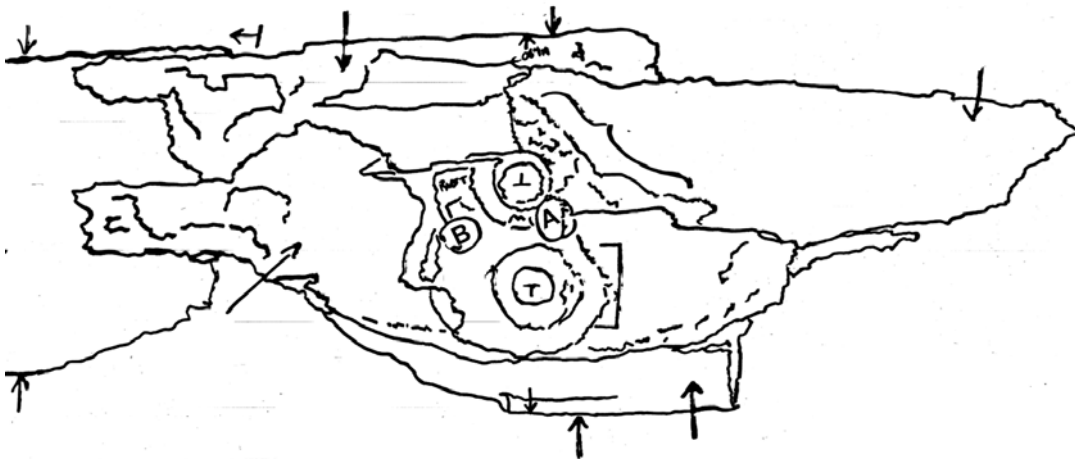
Figure 3-78: Drawing of the same face, note A and B.

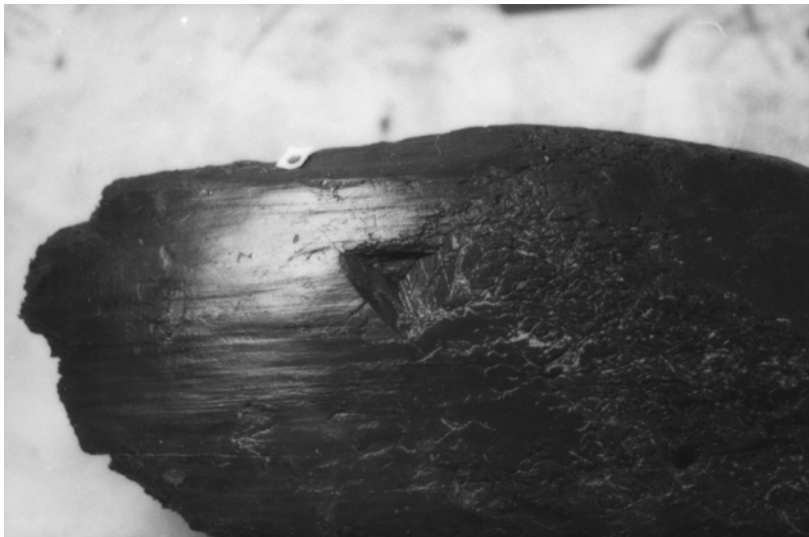
Figure 3-79: Photograph of the small triangle chopped out of floor timber H.

Lastly, chopped out of the waney face at the distal end of floor timber H is a small equilateral triangle approximately 4 cm on each side (fig. 3-79). It is 1 cm deep at the most, and as the center of the triangle is approximately 10 cm from the bow face, the triangle as a whole is slightly aft of the midline of the floor timber. The base of this triangle is roughly parallel with the long axis of the floor timber, so its apex points towards the bow of the vessel. As this mark or cut is in the waney face of the wood, and thus immediately below the layer of the bark, it is possible that it is the remnant of a larger cut in the bark itself that marked the tree for cutting.⁸

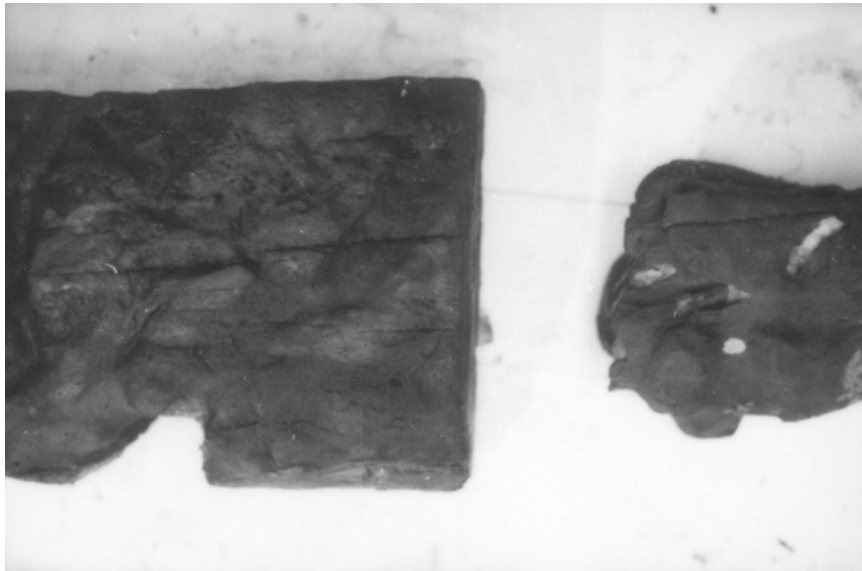
Figure 3-80: Photograph of the sawn face from dendrochronological sampling of floor timber G.

Five dendrochronology samples were gathered from the 21 pine floor timbers between 1996 and 2002. The two samples taken in 1996 are from floor timbers G and H, cut through the port limber holes, and were taken while the floor timbers were still in situ (figs. 3-80, 3-81). Floor timber 12, sample number 28, was sampled in 1999, and samples 64 and 66 were cut in 2002, from floor timbers 10 and N.

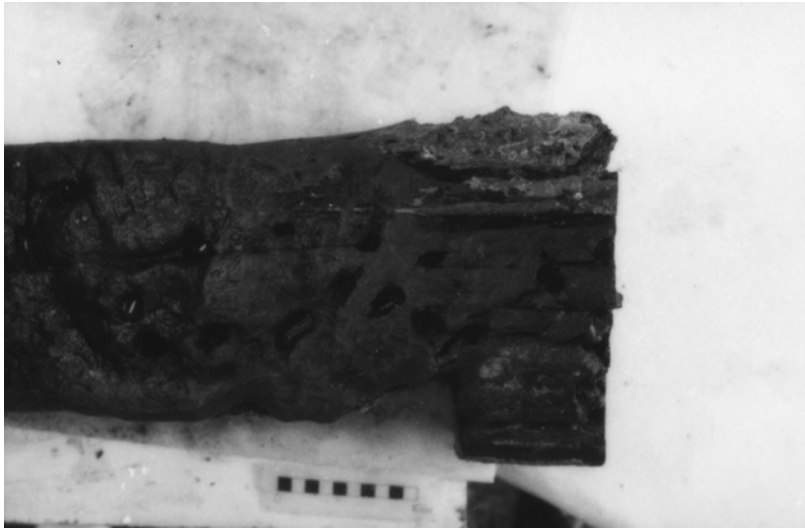
Figure 3-81: Photograph of the sawn face from dendrochronological sampling of floor timber H.

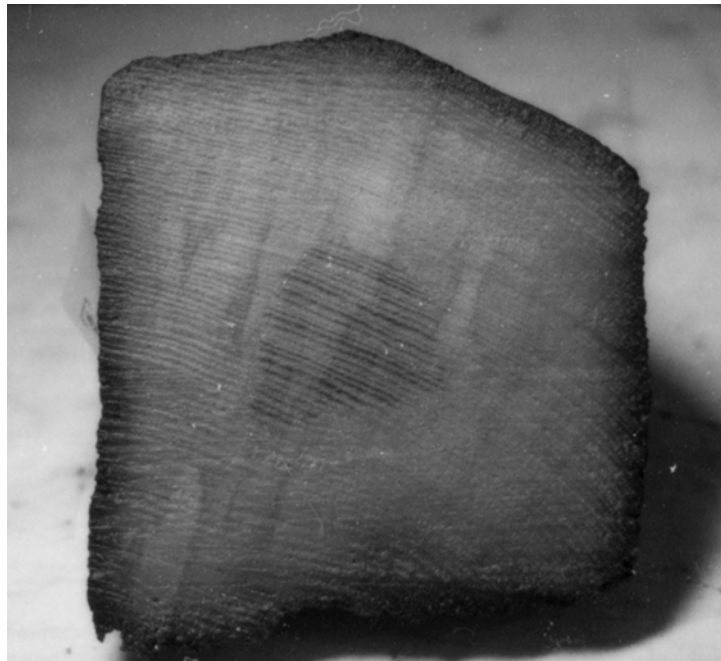
Figure 3-82: Photograph of the cross section of floor timber 4 after dendrochronological sampling. Note the growth rings.

Waney faces are much more prevalent on the pine floor timbers. Three definite waney faces, on floor timbers 4, 3, and H, as well as two very faint possible faces on floor timbers 7 and L, preserve the slightly undulating surface of the wood immediately below the bark (figs. 3-82 to 3-84). The waney faces on floor timbers 4, 3 and H, which are between 4 cm and 10.6 cm wide, are each preserved at the distal ends of the floor timbers over the bilge. As it is possible to estimate the location of the pith in these three floor timbers as well, rough diameters of the uncut timber may be approximated.

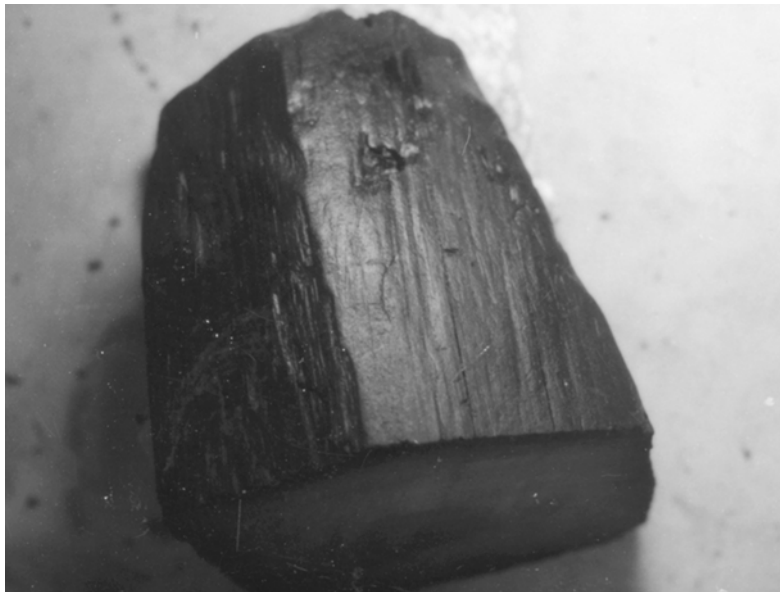
Figure 3-83: Photograph of the waxy face, after dendrochronological sampling.

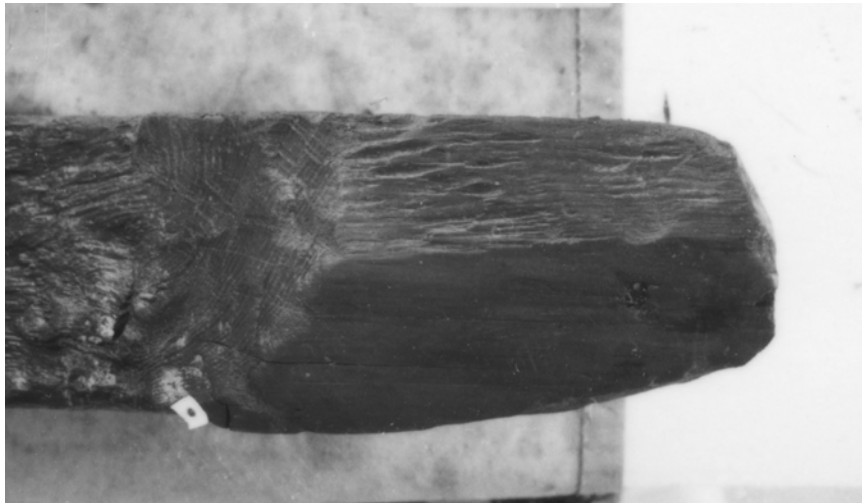
Figure 3-84: Photograph of the same wancy face on floor timber 4.

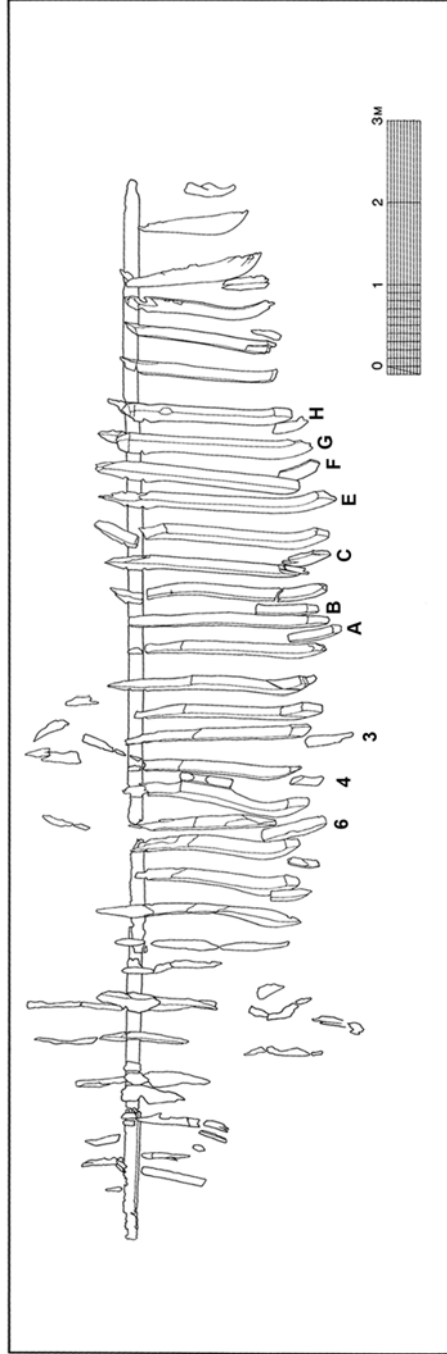
Figure 3-85: Site plan with the futtocks labeled.

There are a total of ten preserved futtocks among the preserved framing material, and of them, futtocks 4, A, B, C, E, F and G each have one associated fragment (Fig 3-85). Of the remaining three futtocks, futtock 6 has four associated fragments, futtock 3 has eight, and futtock H is composed of two fragments. Futtock H, however, is the only one of these three that possesses diagnostic information on all of its associated fragments; three of the fragments associated with futtock 6 and seven of the fragments associated with futtock 3 do not possess any diagnostic information. As such, although futtocks 6, 3 and H are associated with more than one fragment, futtock H is the only one that is represented by more than one piece of diagnostic material. Overall, since the futtocks are located over the starboard bilges, their preservation does not extend beyond the preservation of the floor timbers themselves. The longest preserved futtock is futtock A, 82 cm long, while the shortest, futtock 3, is only 29 cm long.

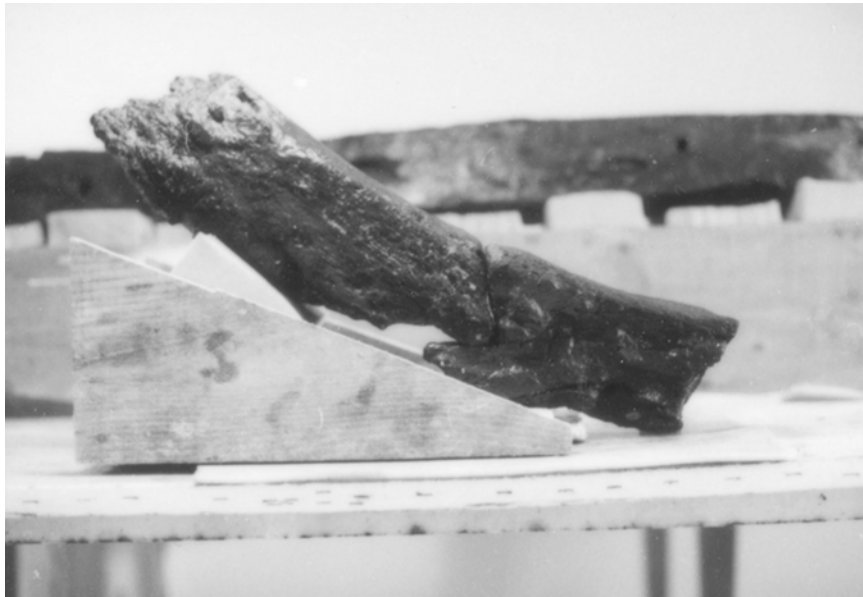
Figure 3-86: Photograph of mate between floor timber E and futtock.

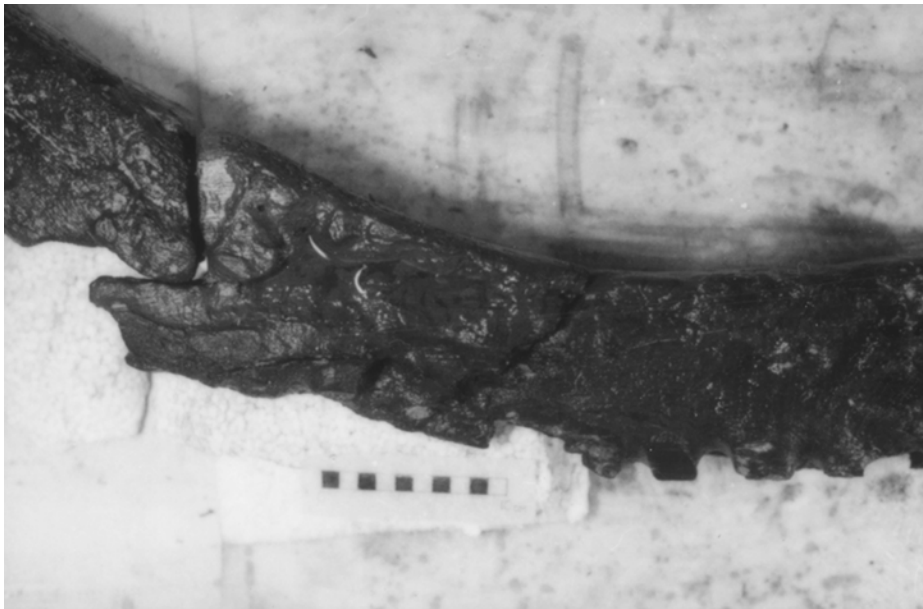
Figure 3-87: Another photograph of mold between floor timber E and futtock.

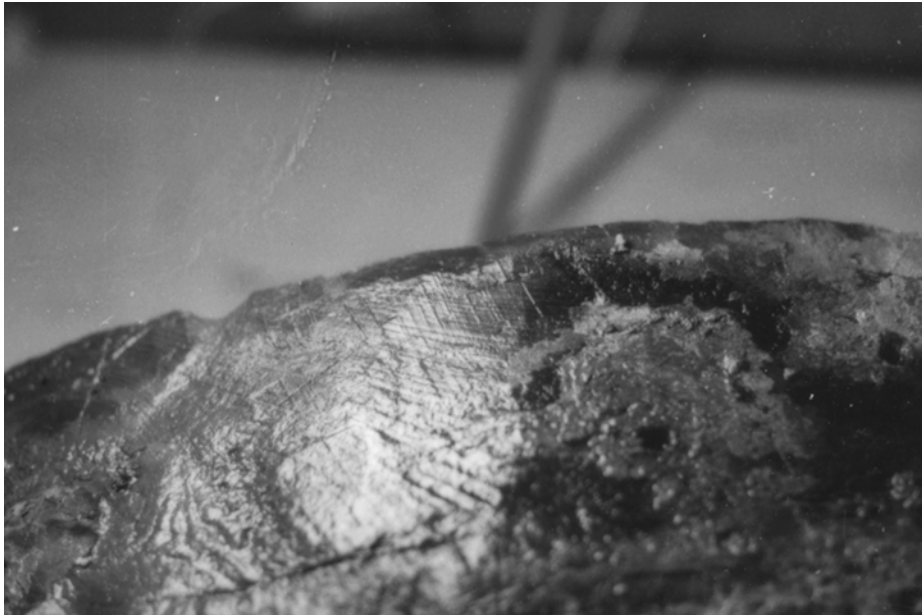
Figure 3-88: Photograph of futtock B illustrating dubbed faces.

The dubbing marks on the futtocks also indicate that they were fashioned in a similar manner to the pine floor timbers (figs. 3-88 to 3-91). Where possible, the adze work on the top faces of the futtocks indicates that they were generally dubbed either in a

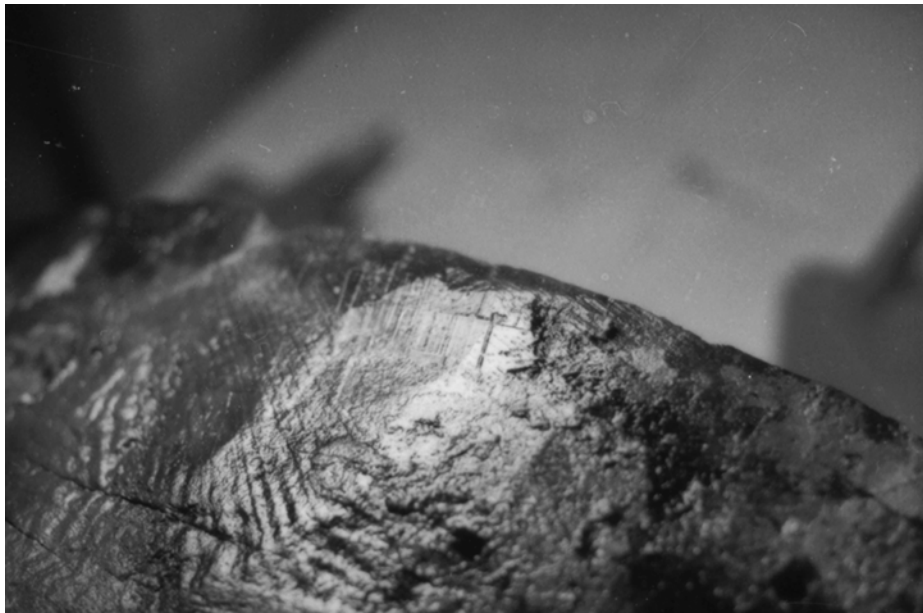
Figure 3-89: Another photograph of futtock B illustrating the dubbed faces.

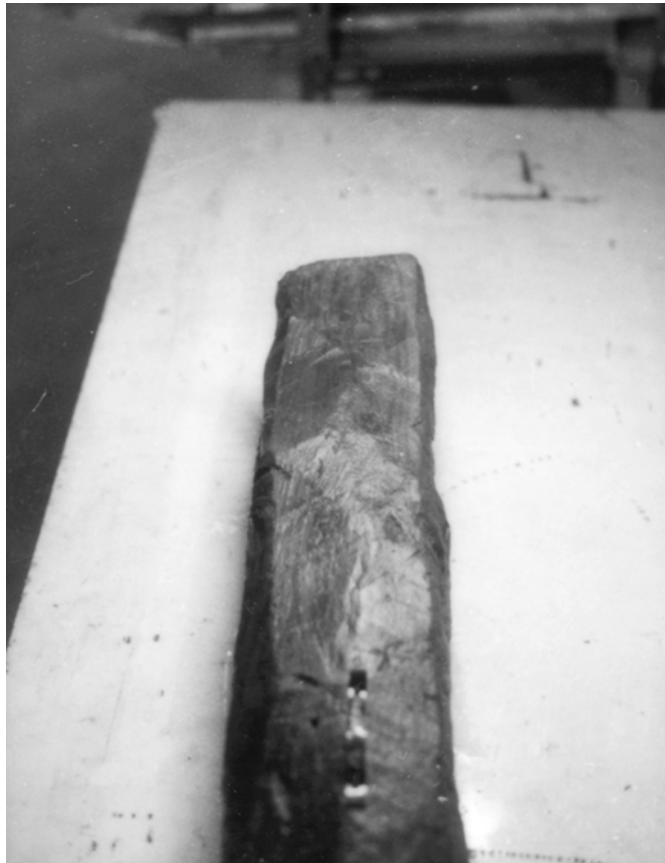
Figure 3-90: Photograph of dubbed faces on futtock 4.

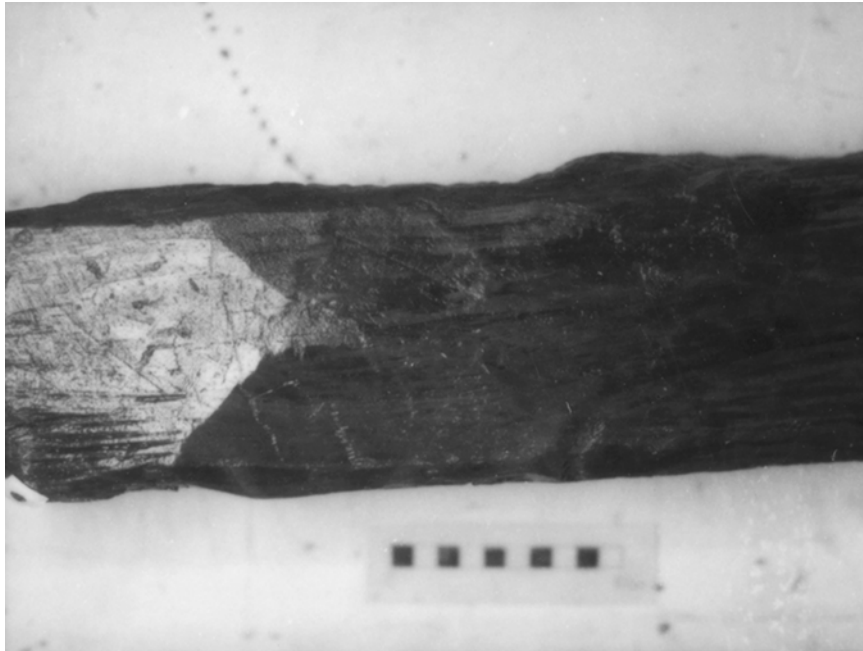
Figure 3-91: Photograph of dubbed faces on futtock 6.

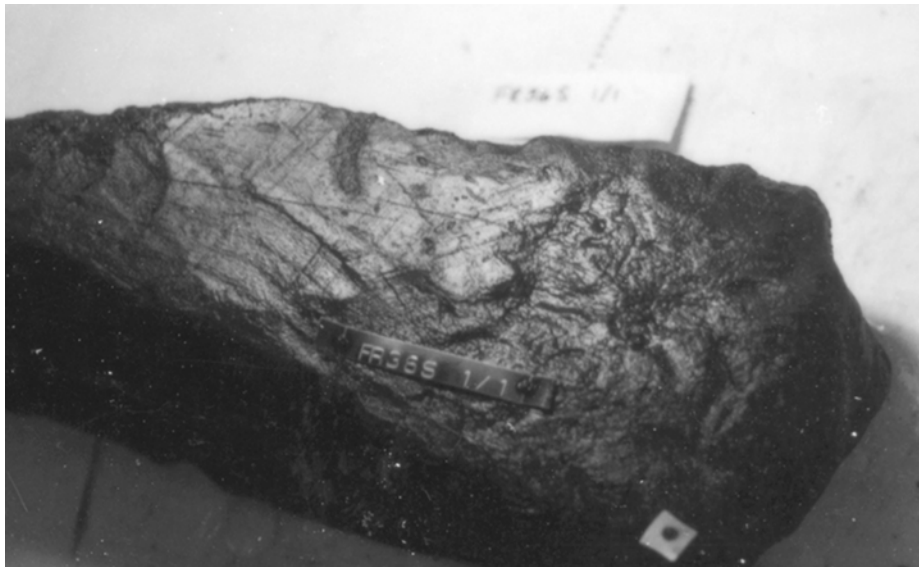
Figure 3-92: Photograph of dubbed faces on futtock C.
