**A RE-ASSEMBLY AND RECONSTRUCTION OF
THE 9TH-CENTURY AD VESSEL WRECKED OFF THE COAST OF
BOZBURUN, TURKEY**

A Dissertation

MATTHEW BENJAMIN HARPSTER

A Re-Assembly and Reconstruction of
the 9th-century AD Vessel Wrecked off the Coast of
Bozburun, Turkey. (August 2005)

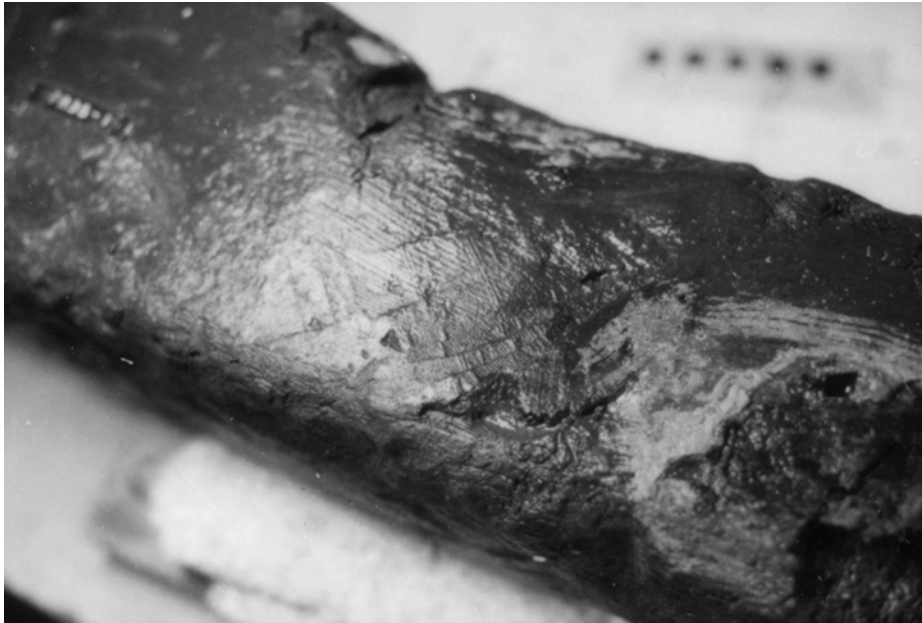
Figure 3-93: Another photograph of the dubbed faces on futtock C.

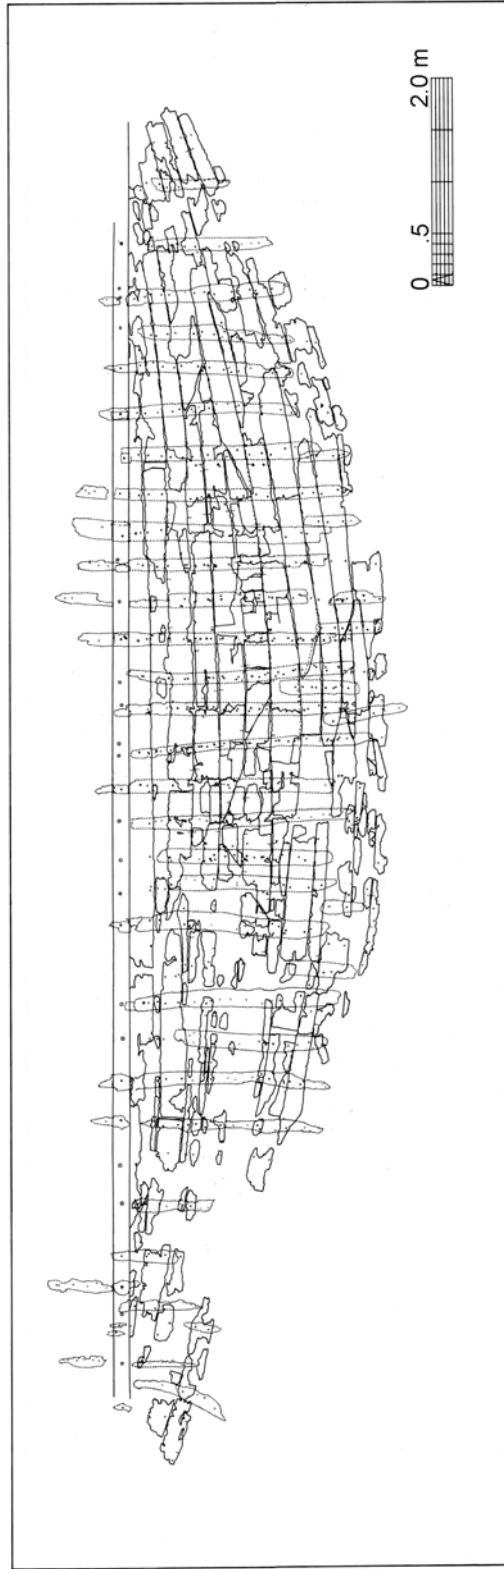
Figure 3-94: Drawing of the re-assembled starboard planking.

The locations, orientations and dimensions of planking fragments indicated in this catalog are based on their locations in figure 3-94, not as they were found in situ. Figures 3-94 and 3-95 indicates how the strakes were most likely aligned and affixed to the framing material prior to sinking; the locations of some fragments, as such, are not the same as those seen in the Methodology section, which has a site plan of the material during excavation.

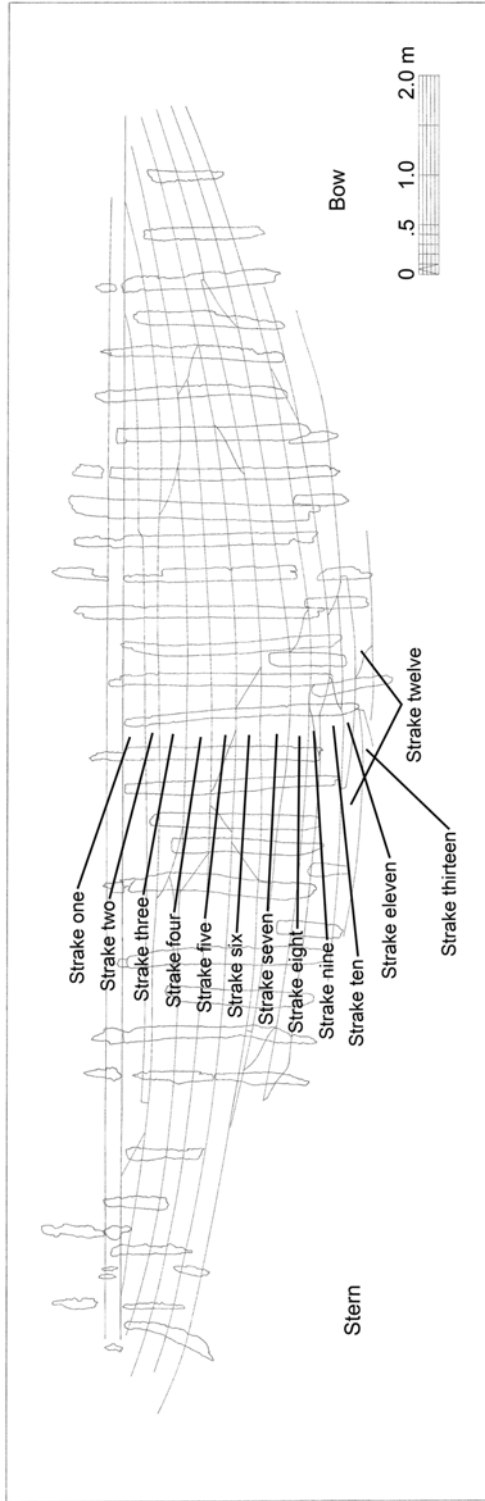
Figure 3-95: New strake numbers of the starboard planking.

Fragments SS9A 1/2 and 1/3 are missing and create a lacuna between SS9A 1/1 and 1/4. On drawing 175, the length of this space was unknown and indicated as such on the drawing. Once figure 3-95 was completed, it is now clear that these two missing fragments once represented approximately 65 cm of the strake's original length. Additionally, labels SS9A 1/4 and 1/9 are on the same fragment.

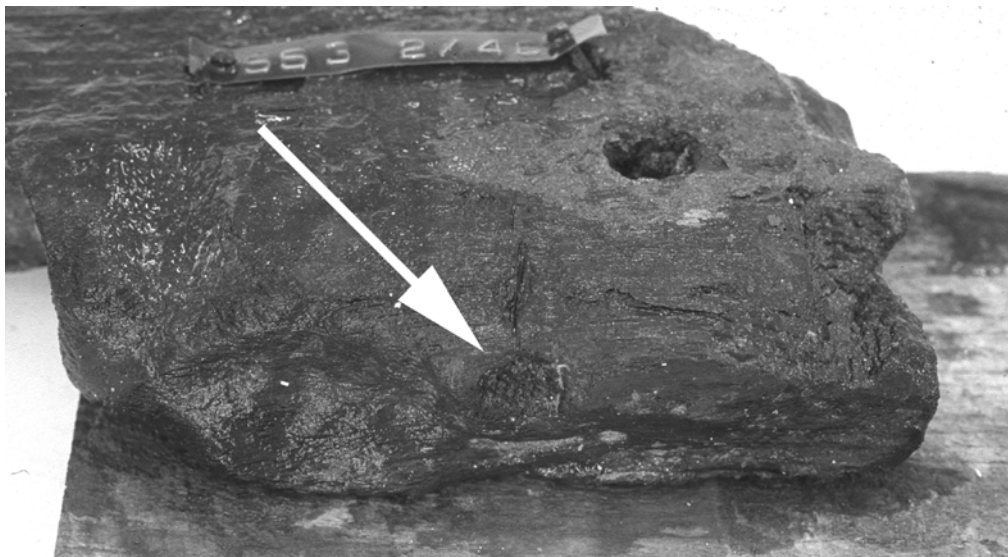
Figure 3-96: The arrow indicates the location of the exposed end of the edge dowel (From Harpster 2005, 89 fig. 3. Used with permission from the *International Journal of Nautical Archaeology*).

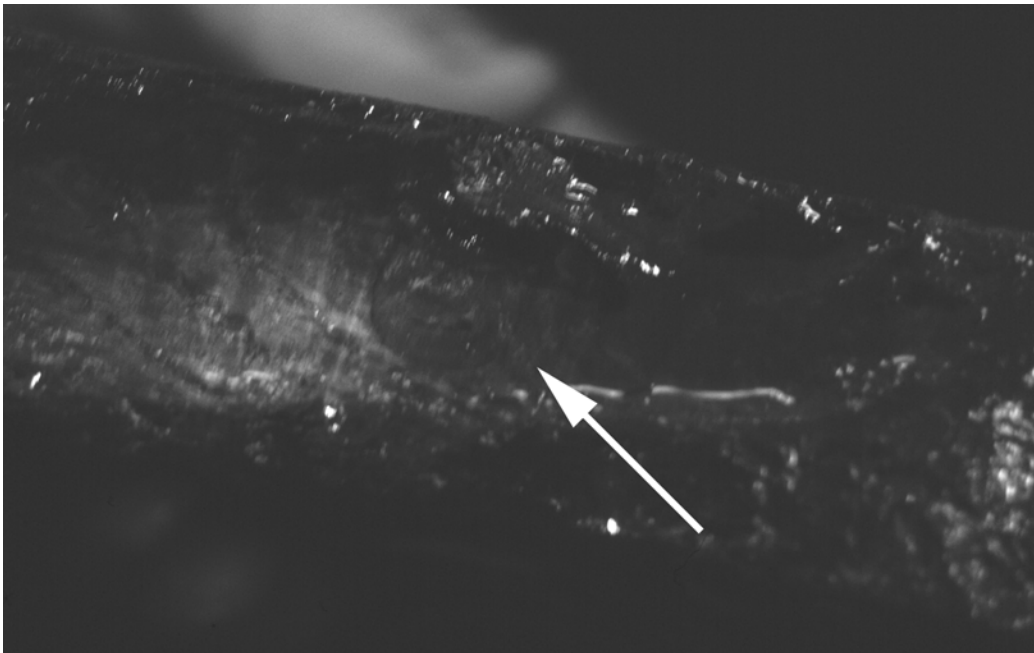
Figure 3-97: Note the dark circle in the edge of the planking (From Harpster 2005, 90 fig. 5. Used with permission from the *International Journal of Nautical Archaeology*).

revealed as dark circles along the edge of the fragment (fig. 3-97). As both the planking and the dowels of the Bozburun vessel are oak, this discoloration was often the only means of finding the dowels still in place. Presumably, if oak dowels were used on vessels with pine planking or vice versa, this technique may be unnecessary as the discoloration would already be evident.

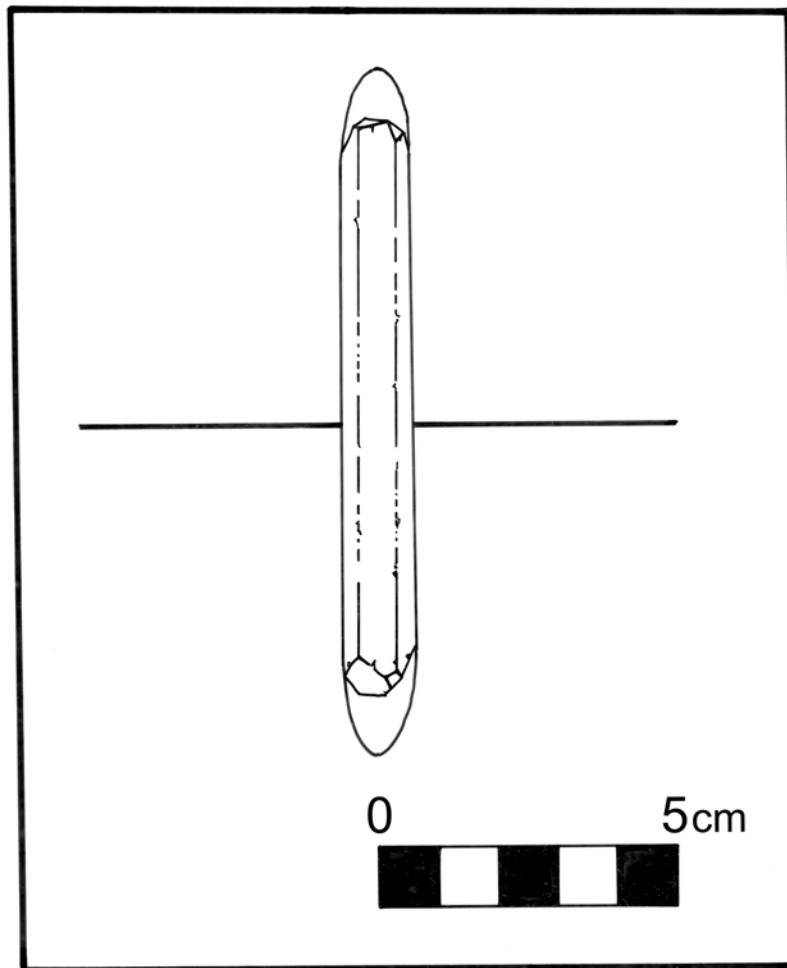
Figure 3-98: Cross section of a generic edge-dowel joint (From Harpster 2005, 91 fig. 7. Used with permission from the *International Journal of Nautical Archaeology*).

Overall, these dowels do not exhibit a great deal of variation in size and cross-sectional shape. The dowels averaged 1.2 cm in diameter and were driven, on average, 5 cm into the plank edges, where such a measurement could be taken (fig. 3-98). One dowel was driven only 2.8 cm into the inboard edge of strake four, while another, in the outboard edge of strake seven, was driven approximately 9 cm into that plank (fig. 3-99). Some dowels taper along their lengths, but this taper is so minimal - only 1 to 2 mm - it is unclear if it is purposeful.¹²

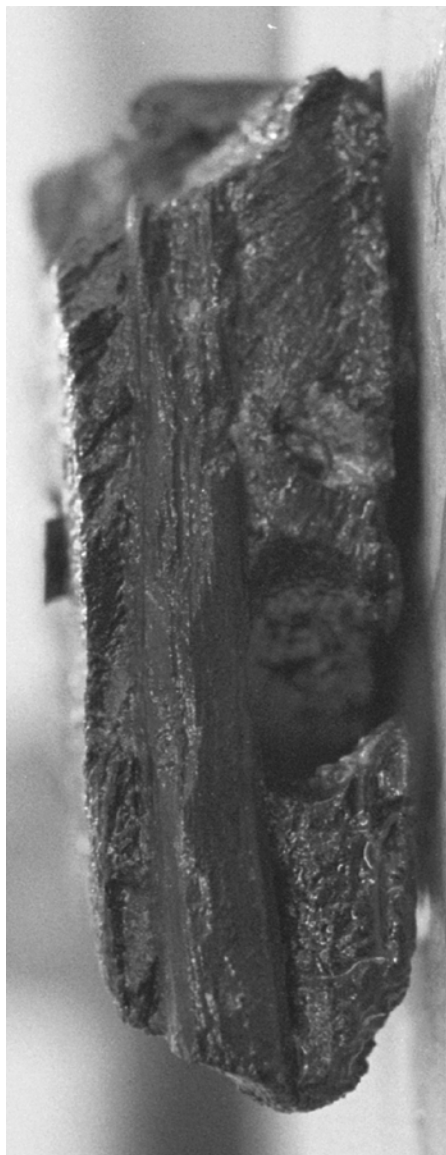
Figure 3-99: Photograph of the edge dowel driven c. 9 cm into the edge of strake seven (From Harpster 2005, 91 fig. 9. Used with permission from the *International Journal of Nautical Archaeology*).

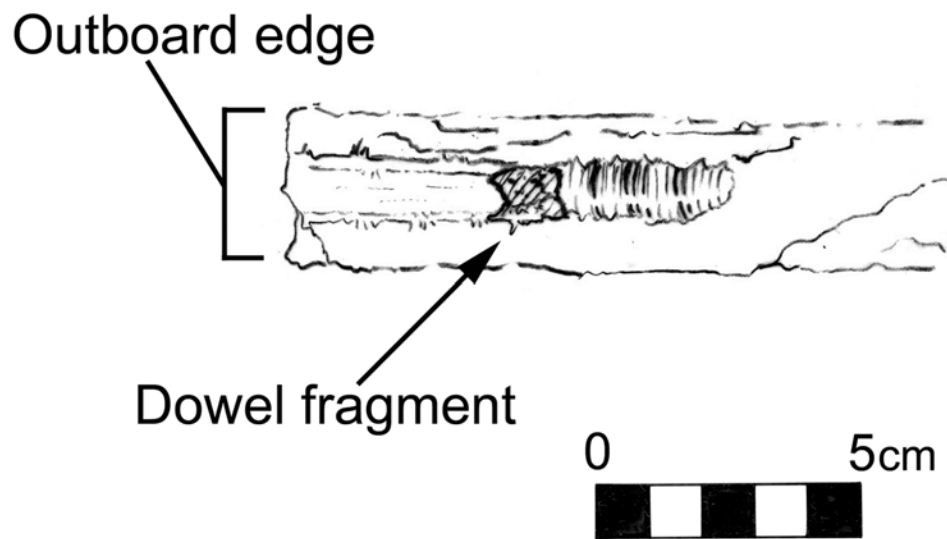
Figure 3-100: Cross section of the dowel joint in strake six (From Harpster 2005, 91 fig. 10. Used with permission from the *International Journal of Nautical Archaeology*).

place halfway along the hole's length. Between the dowel fragment and the bottom of the hole, the surface of the hole is still smooth and concave with faint striations perpendicular to its length (fig. 3-100). Between the dowel fragment and the plank edge the surface of the hole is indented into angled faces, reflecting half of the square shape of the dowel itself. The oak plank clearly swelled around this square dowel, indenting the concave surface of the hole to match the angled surface of the dowel. As the dowel was only driven 4.5 cm into a 7 cm-long hole, however, the remaining surface of the hole simply compressed around nothing and retained its original cross-sectional shape.

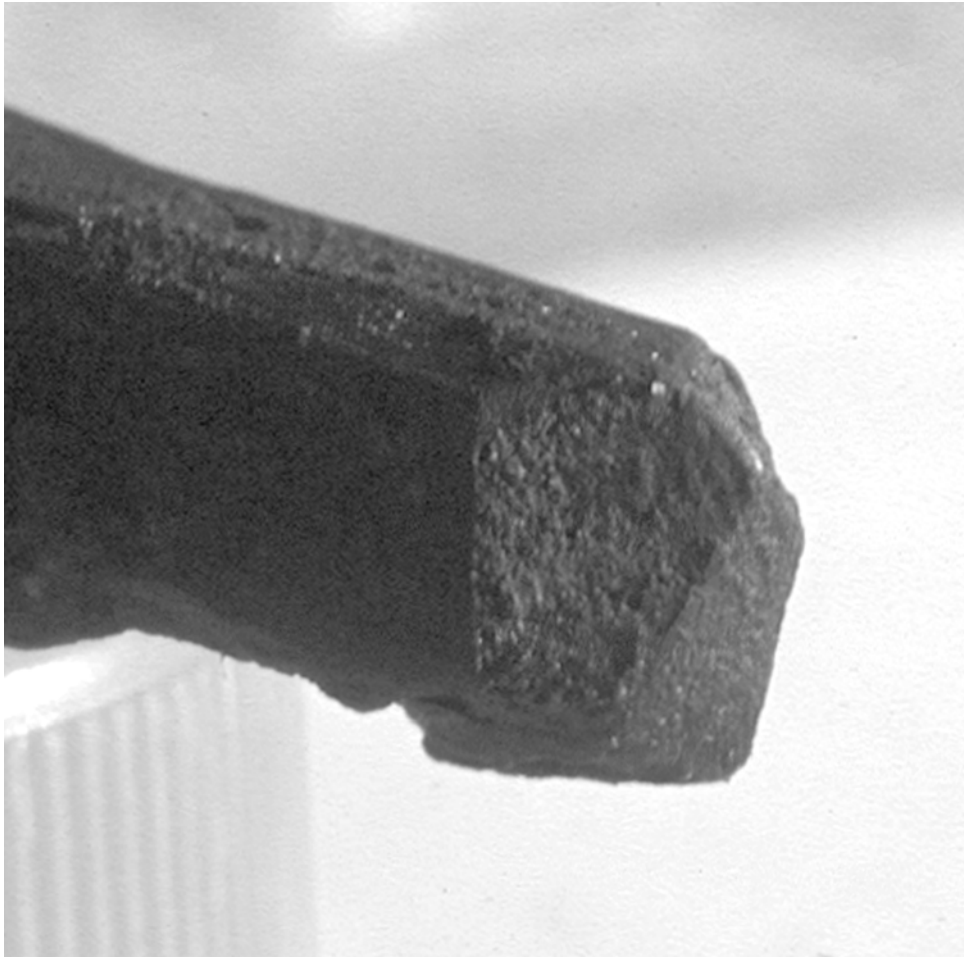
Figure 3-101: Photograph of the faceted end of an edge dowel (From Harpster 2005, 92 fig. 11. Used with permission from the *International Journal of Nautical Archaeology*).

Other evidence corroborates this pattern of assembly. These faint striations, preserved in at least three other holes, appear only where the holes' surfaces are still smooth and concave, and not angular, and so must be cuts or scrapes from a drill bit passing through the wood. Lastly, the crisp edges and clear, faceted faces on some of the dowels' ends indicate that they not only met little resistance while being driven into place, but they did not always impact with the bottom of the holes (fig. 3-101).

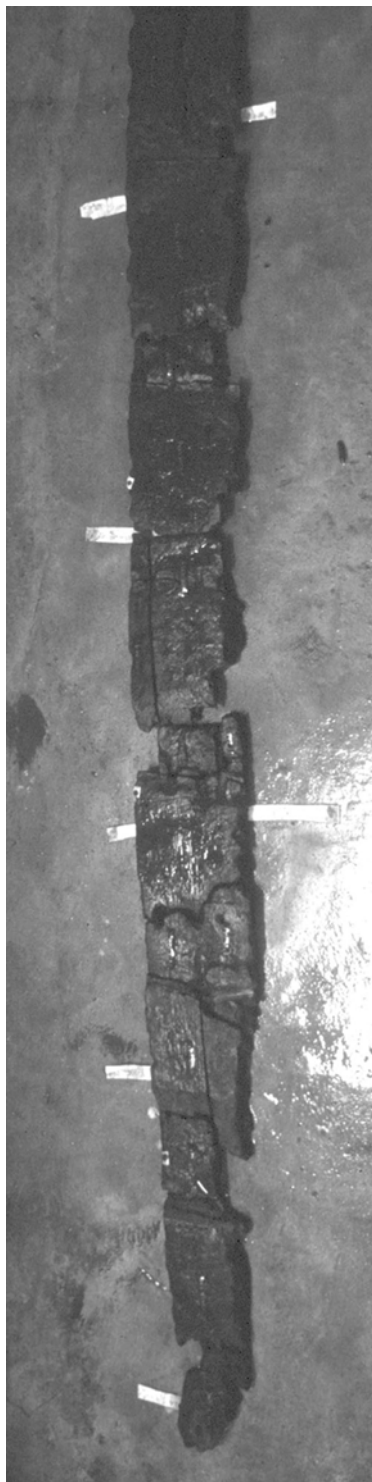
Figure 3-102: Photograph of locations of edge dowels mapped in the Griffis laboratory (From Harpster 2005, 92 fig. 12. Used with permission from the *International Journal of Nautical Archaeology*).

The average spacing between the dowel joints is 59 cm, but actual spacing values vary between 6.5 cm and 2.6 meters (figs. 3-102 to 3-105). It should also be noted that neither the holes, nor the dowels themselves, protrude to either the interior or exterior face of the planking. Moreover, the location of only one of these dowel joints is indicated by a scribe mark, on the interior face of strake eight. No other dowel joints are marked in such a manner.

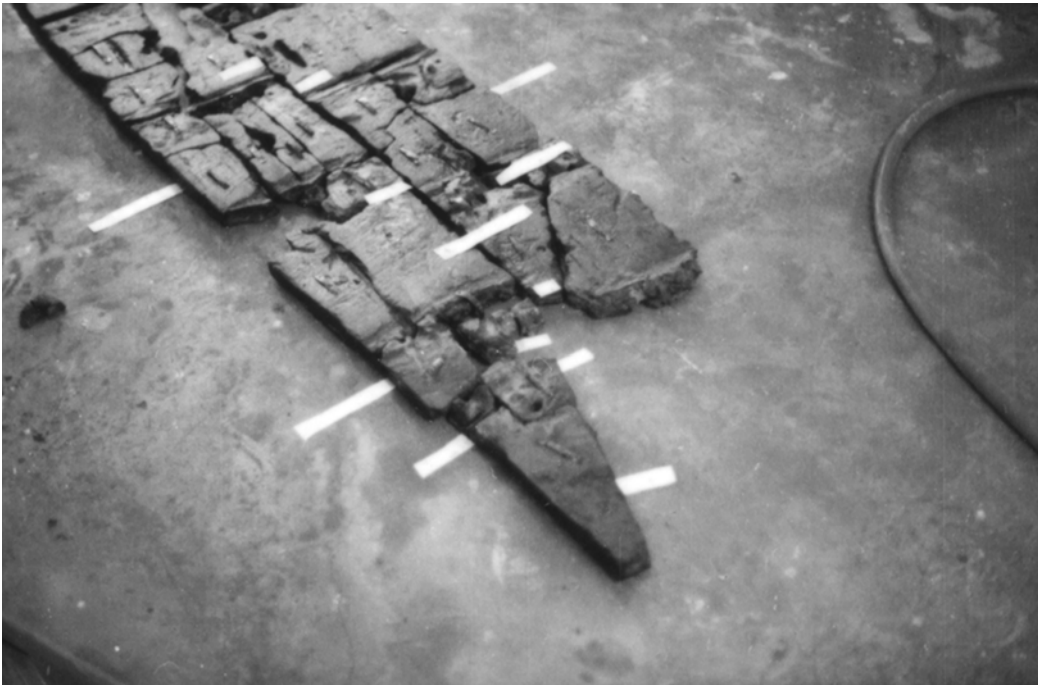
Figure 3-103: Another photograph of edge dowels mapped in the Griffis laboratory.

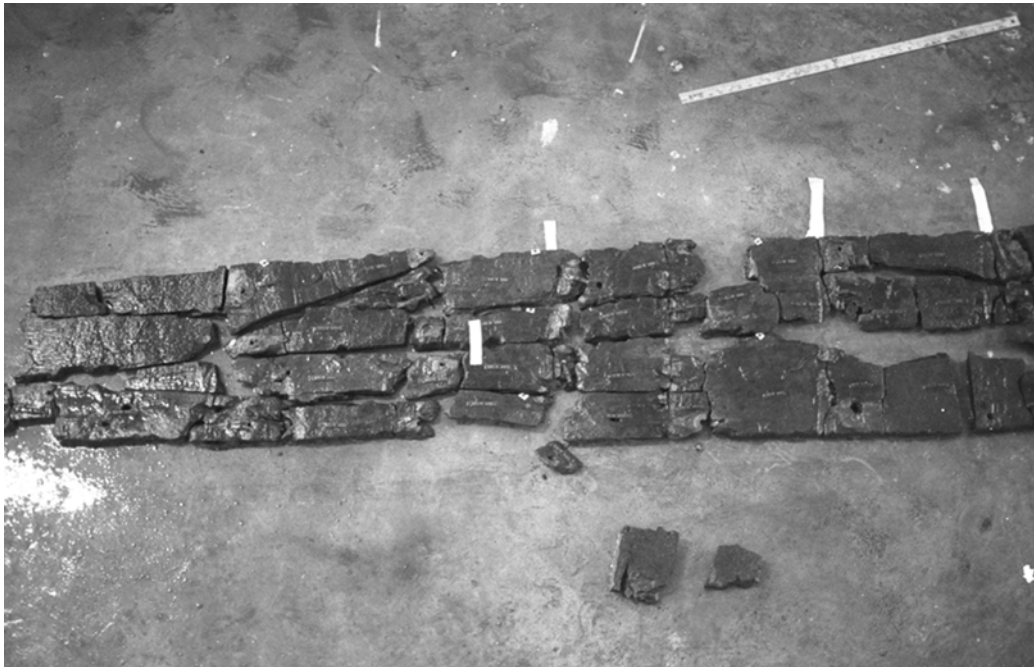
Figure 3-104: The white marks indicate the location of edge dowels in the preserved planking fragments.

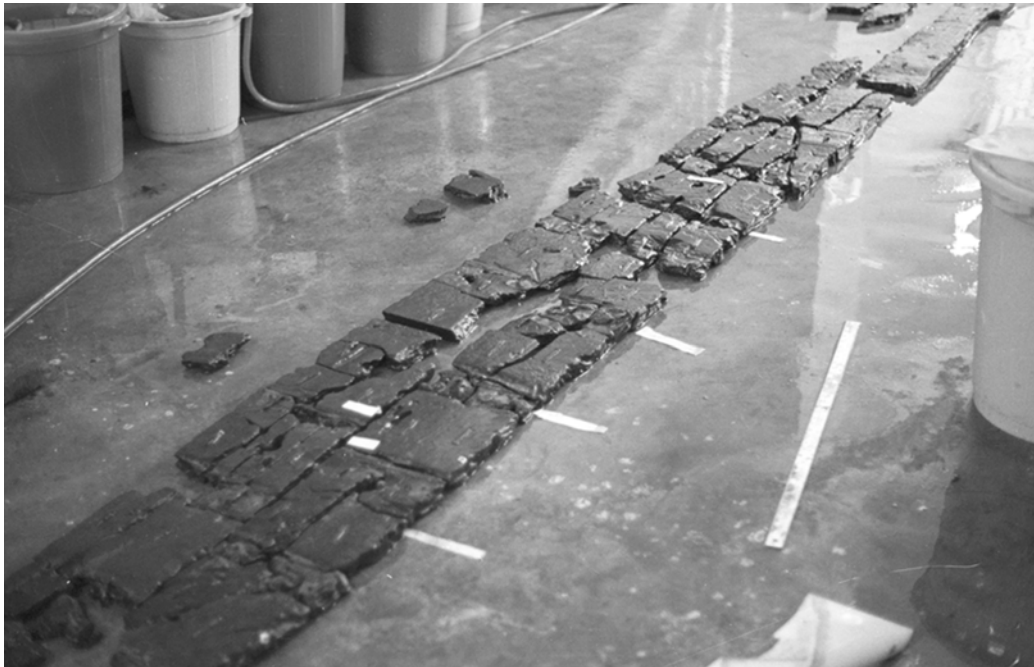
Figure 3-105: Another view of the locations of edge dowels along part of strake six.

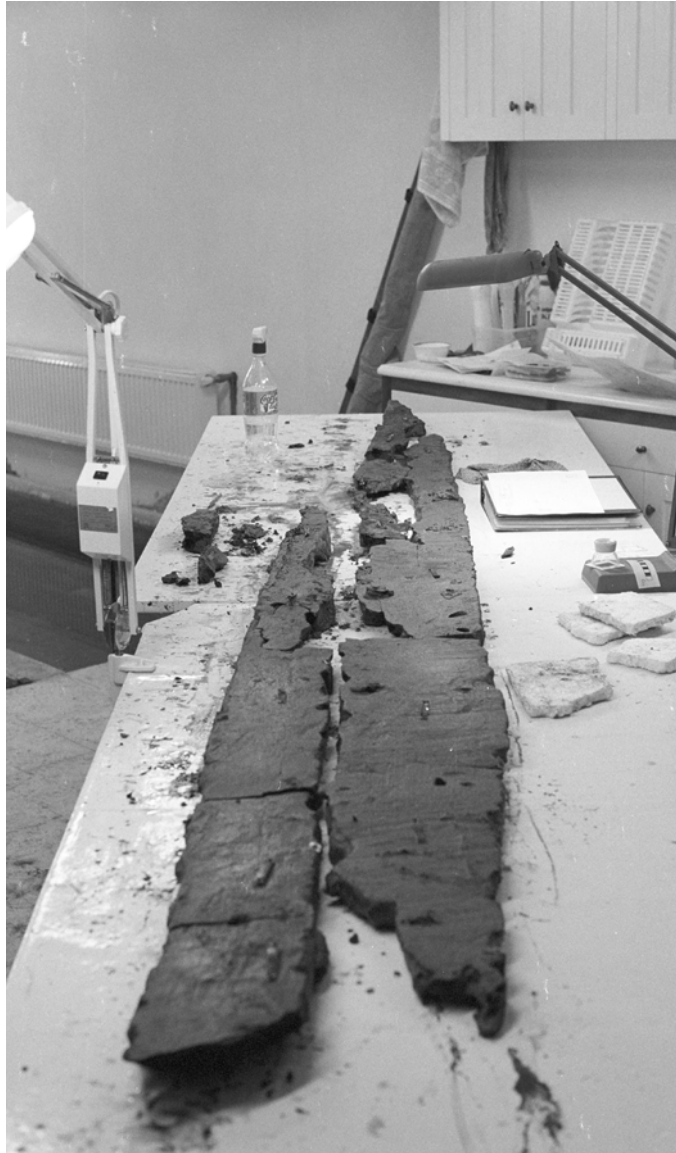
Figure 3-106: Photograph of the forward end of strake one, tapering to fit under strake two.

Although the combined length of the two planks in starboard strake one is nearly 9.5 m, there is little joinery or carpentry to distinguish this strake. The most significant item is its beveled rabbet edge, of which 8.66 m is preserved. As the exterior faces of fragments SS1 1/1 and 1/2 are slightly eroded, this edge is only 3.3 to 3.5 cm thick in the first plank, but it thickens to as much as 4 cm in the second plank, in fragment SS1 2/10. Along the larger plank, the angle of the rabbet edge to the plank's interior face varies between 115 degrees, in fragments SS1 2/3 and 2/47 at either extremity, and 105 degrees, in fragments SS1 2/12 and 2/16 near midships. As the exterior edge of this strake is approximately perpendicular to its interior face, the cross sectional shape of this plank is roughly rectangular, increasing in width from SS1 1/1, where it tapers into the sternpost, to 24 cm wide at fragment SS1 2/10. The plank width varies between 22.5 and 25.5 cm along 3.85 m of the length to fragment SS1 2/35, where the strake quickly tapers to 15.6 cm wide to mate with the interior edge of strake two (fig. 3-106). This latter width is maintained for the remaining 2.1 m of the strake's length, until the plank finishes 95 cm forward of the bow

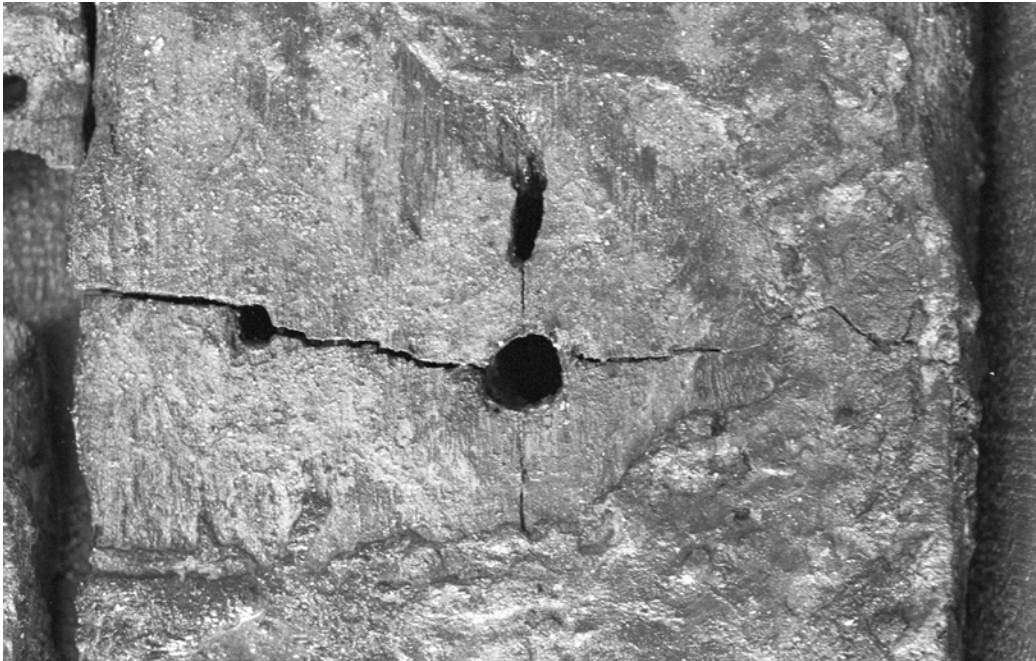
Figure 3-107: Photograph of the interior pitch coating strake one.

Of all the preserved strakes, this one is distinguished by the large amount of pitch preserved along its length. In addition to the nearly complete coverage of the exterior face with a fairly thick layer of exterior pitch, the interior face is substantially coated as well with interior pitch. This 3.1 m-long swath begins on fragment SS1 2/10, but increases to cover the full width of the plank 60 cm aft on fragment SS1 2/13 (fig. 3-107). This coverage ends abruptly at the midships floor timber, on fragment SS1 2/19. Through this area, the pitch is fairly solid and thick, with distinctive ridges and whorls indicating its flow and application. Generally, this pitch is thicker near the inboard edge of the strake, occasionally preserving a distinctive peaked boundary just outboard of a 1 to 2 cm-thick band of uncoated wood (fig. 3-108). Particularly noticeable are the uncoated areas on the interior face around the fasteners for the midships floor timber, as well as floor timbers 1 through 3. More interior pitch is preserved farther forward on fragments SS1 2/35 and 2/39, where the strake tapers to mate to strake two, and on fragment SS1 2/46-2/47, where the toe end of the strake is attached to the stem. The pitch in these areas is similar in appearance and composition to

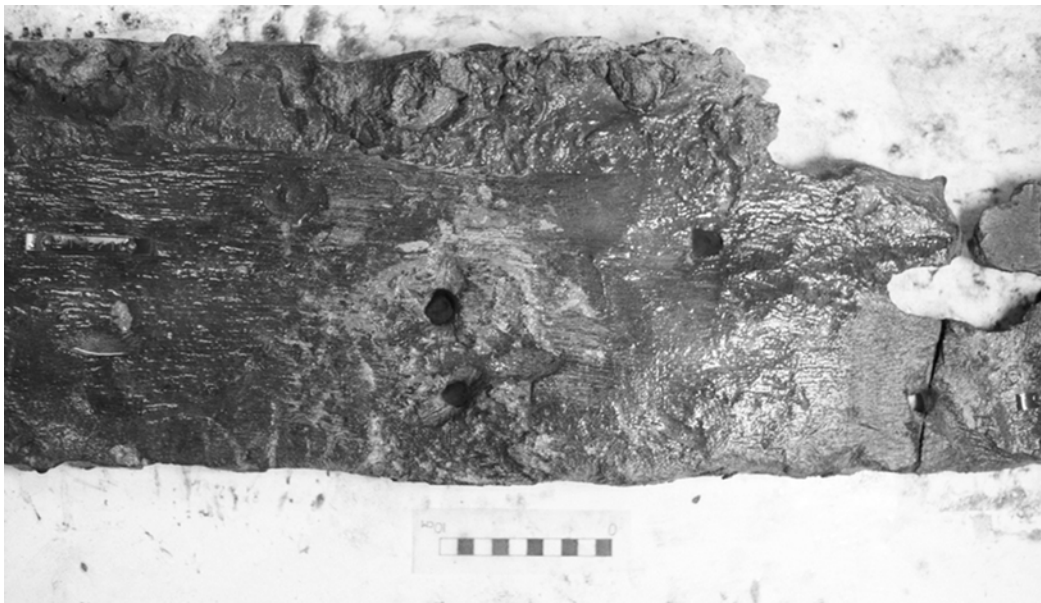
Figure 3-108: Photograph of the heavy coating of interior pitch on strake one. The inboard edge is to the top of the photograph.

that farther aft, preserving the same ridges, whorls, and a short section of the uncoated band of wood near the inboard edge.

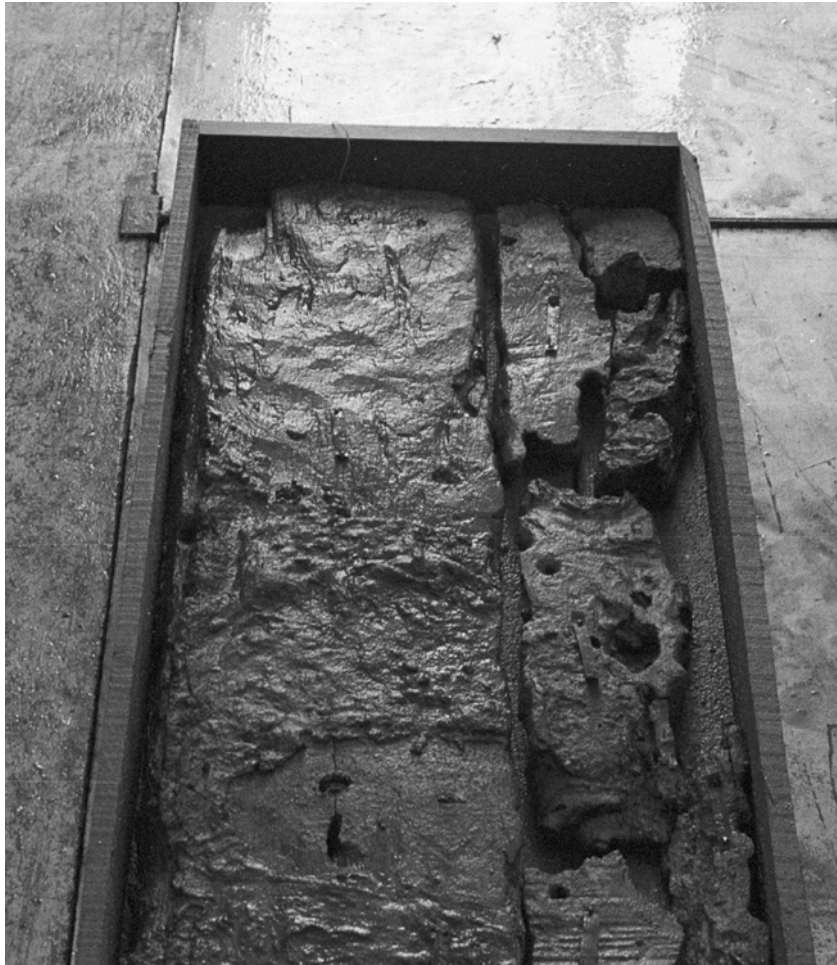
Figure 3-109: Photograph of the dubbing marks along the interior face of strake one.

Adze work, in comparison, is more prevalent on the second plank, and absent on the first. This adze work is evident between fragment SS1 2/10 and the forward end of the plank, where it is not obscured by the interior pitch. Although it is unclear what direction this dubbing proceeded, the work extends over both the width and the length of the plank, maintaining a fairly even, faceted pattern across its surface (fig. 3-109). There is no evidence to indicate that there was a nick in the edge of the blade used to dub this plank, nor are any dubbing marks evident on the plank's exterior face.

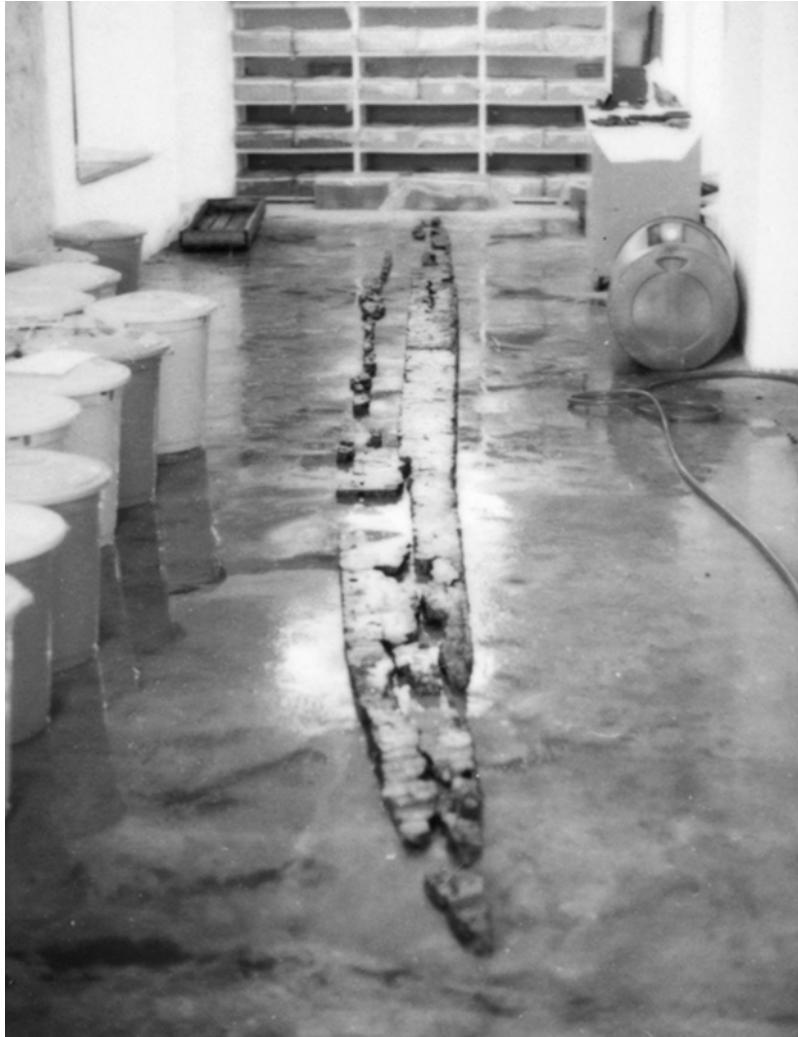
Figure 3-110: Photograph of strake two fragments laid out in the Griffis laboratory.

Starboard strake two is reconstructed as two planks, although the fragmentary and disarticulated nature of the first plank may conceal evidence indicating that the strake was originally composed of more (fig. 3-110). The first plank, with 20 associated fragments, extends forward from floor timber 12 to floor timber E, where it is butt scarfed to the second plank that extends an additional 3.32 m forward to join the rabbet. The second plank, of 10 fragments, preserves 80 cm of an originally 1.02 m-long inboard rabbet edge to the keel.

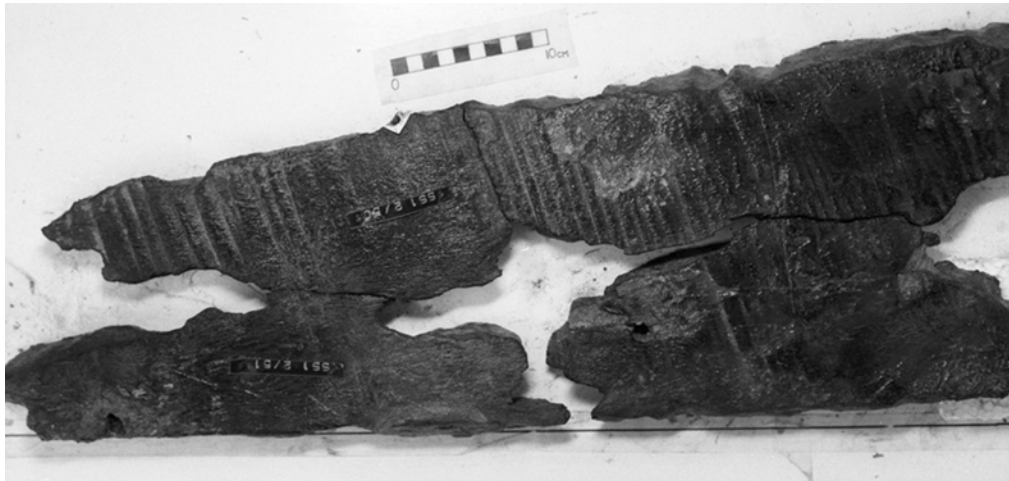
Figure 3-111: Photograph of the saw marks on strake two.

Unfortunately, the poor preservation of the first plank in strake two has left no tool marks on the preserved faces. The second plank, in comparison, preserves a large collection of saw marks; adze marks are non-existent. These distinct saw marks, which are arrayed from SS1A 2/40 to 2/49, vary between 70 and 75 degrees to the keel, and indicate the cutting proceeded from the forward to aft end of the plank (figs. 3-111, 3-112).

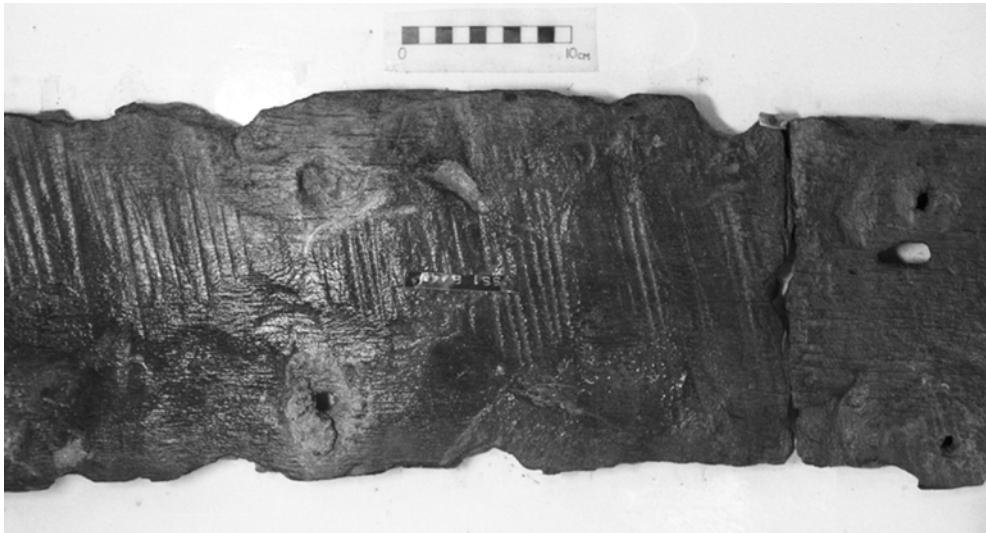
Figure 3-112: Another photograph of saw marks on strake two.

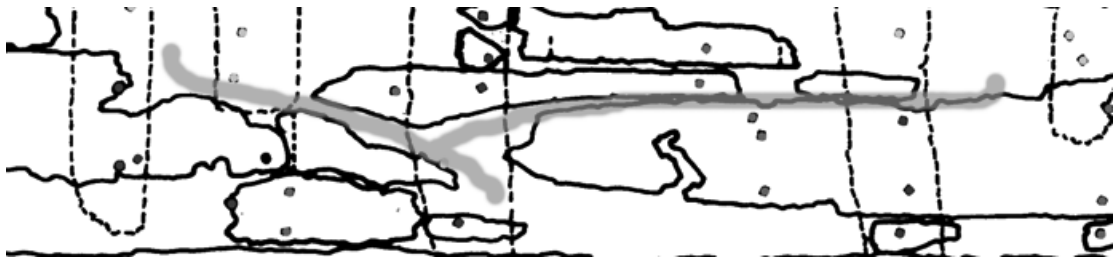
Figure 3-113: Drawing of the scarf arrangement in strake three.

Three S-scarfs are preserved along the length of the strake. Originally 39 cm long, one S-scarf near floor timber G, between planks three and four, is now represented entirely by 25 cm of a preserved edge in plank four. The two other S-scarfs represent the conjunction of three planks between floor timbers 5 and 4. One S-scarf, the longest in this strake, is between planks one and two, and intersects with the third S-scarf, which joins planks one, two and three. As plank two is scarfed only along the outboard 85 cm of plank one, and as plank two is 10 cm wide at the most, both planks one and two are also scarfed to plank three across the third S-scarf (fig. 3-113). Essentially, while one half of the scarf edge is formed by plank three, the inboard portion of the other half is formed by plank one, while the outboard portion is formed by plank two. As such, the S-scarf between planks one and two is 1.22 m long, and that between planks one, two and three is 48 cm long. No original scarf edges are preserved in plank three. Plank one, however, still retains 14 cm of its scarf face to plank three, as well as 54 cm of the inboard edge of the S-scarf to plank

two. Plank two, in turn, retains 60 cm of the long S-scarf to plank one, and 19 cm of its portion of the S-scarf to plank three. Two of these S-scarfs, that at floor timber G and that between plank three and planks one and two, are inclined in a similar manner; the outboard edge of the scarf is closer to the bow than the inboard edge. The third scarf, that between planks one and two, is inclined in the opposite manner.

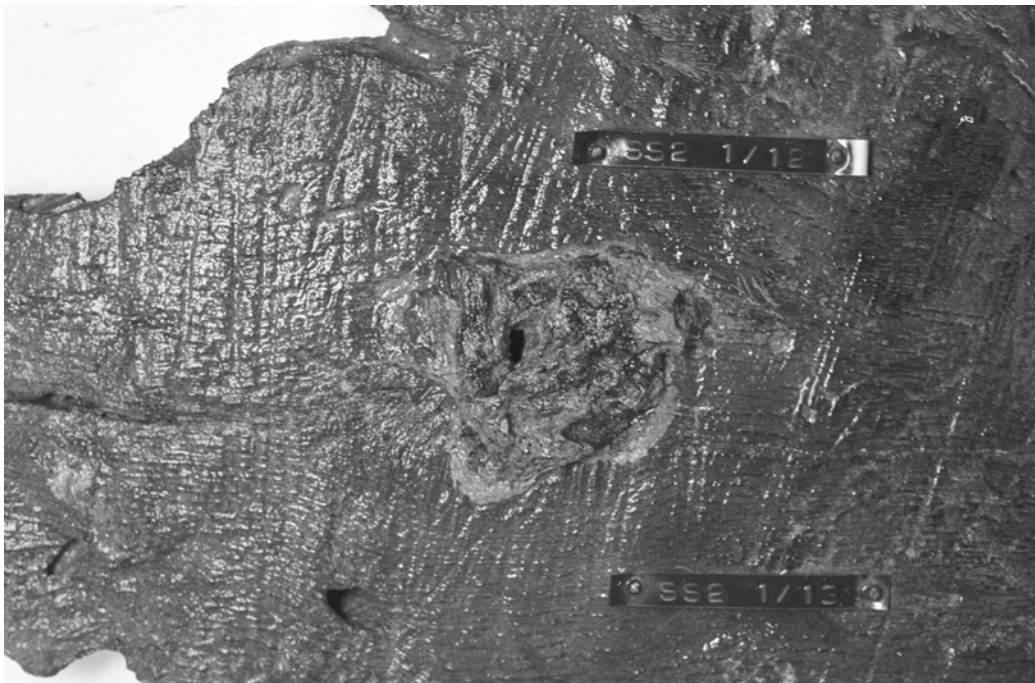
Figure 3-114: Photograph of the saw marks on strake three.

There is no preserved adze work evident on any plank of strake three, but saw marks are fairly common and evident from the very forward to the very aft preserved fragments. Although more of plank three is preserved, the saw marks are not as widespread, distinct, or diagnostic. Where they are present, on approximately 12 fragments, they tend to be fairly faint and eroded, and appear only in small preserved groups (fig. 3-114). Despite their rarity, however, they all tend to be approximately 90 degrees to the keel, and in all cases, the cutting proceeded from the forward to the aft end of the plank. The saw marks preserved on planks one and four, despite their increased incidence and quality, provide no additional characteristics. The marks on plank one tend to be more commonly inclined 110 degrees away from the bow, or fairly perpendicular to the keel, although some instances of marks 60 to 70 degrees towards the bow are preserved. Plank one was cut from the after to the forward end of the plank. Plank four retains a combination and proportion of inclined saw marks similar to those on plank one, but similar to plank three, its cutting proceeded from the forward to after end of the plank. No saw marks are preserved on plank two.

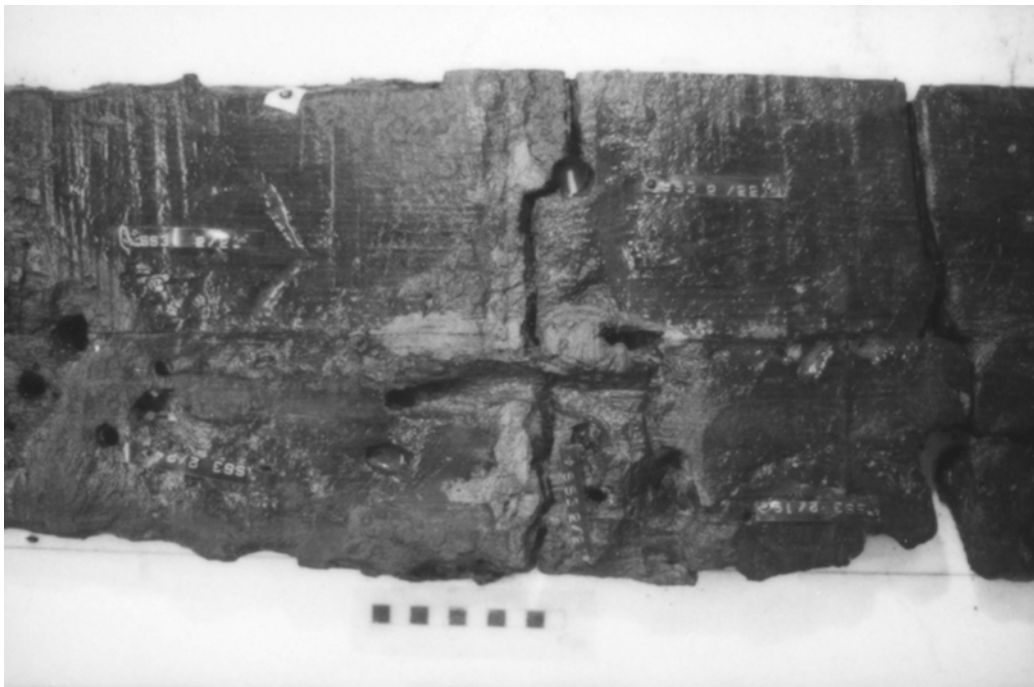
Figure 3-115: Photograph of the saw marks on strake four.

The saw marks preserved on the fragments of strake four vary less in inclination and relative preservation than those on strake three (fig. 3-115). Overall, the majority of the saw marks on strake four are approximately 90 degrees to the inboard edge of the fragment, so they tend to incline towards the bow in plank three and away from the bow in plank one, but scattered examples of saw marks between 75 and 115 degrees are evident. One fragment, SS4 2/42, appears to preserve a small collection of marks inclined approximately 45 degrees to the bow, but these are a unique example. Only in a few cases, predominantly on the fragments forward of midships, are the saw marks faint and difficult to find. More commonly the preserved marks are distinct, parallel, and straightforward to identify. The cutting of the internal faces of planks two and three proceeded from the forward to aft ends of the planks, while the cutting of plank one proceeded in the opposite direction, towards the forward end of the plank. No adze work is preserved along the length of strake three.

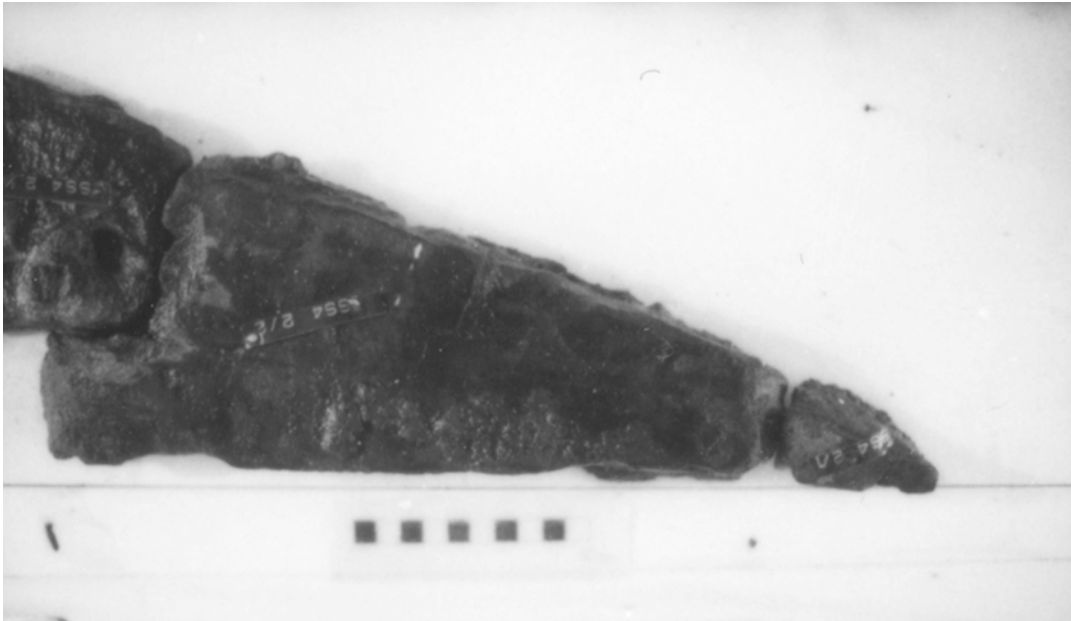
Figure 3-116: Photograph of the diagonal scarf edge of plank three in strake five.

No hood ends of this strake are preserved, so there is no evidence illustrating the joinery involved in mating this plank to the stem or stern rabbet. Moreover, although three planks make up this strake, only small sections of the two diagonal scarfs are preserved. Only 19.5 cm is preserved of the forward half of the diagonal scarf between planks three and four. This preserved scarf edge along plank four is still fragmentary, composed of four different fragments. No material preserves the aft half of this diagonal scarf edge in plank one. No portion of the scarf between planks two and three is preserved on plank two, but plank three retains 48 cm of that scarf edge, distributed along fragments SS4 2/1, 2/2, 2/3 and 2/5 (fig. 3-116). At the forward end of strake five, where it drops out and mates to strake four, only 5 cm of the aft half of that diagonal scarf is preserved on strake four. In comparison, 29 cm of the mating edge is preserved on the third plank of strake three (fig. 3-

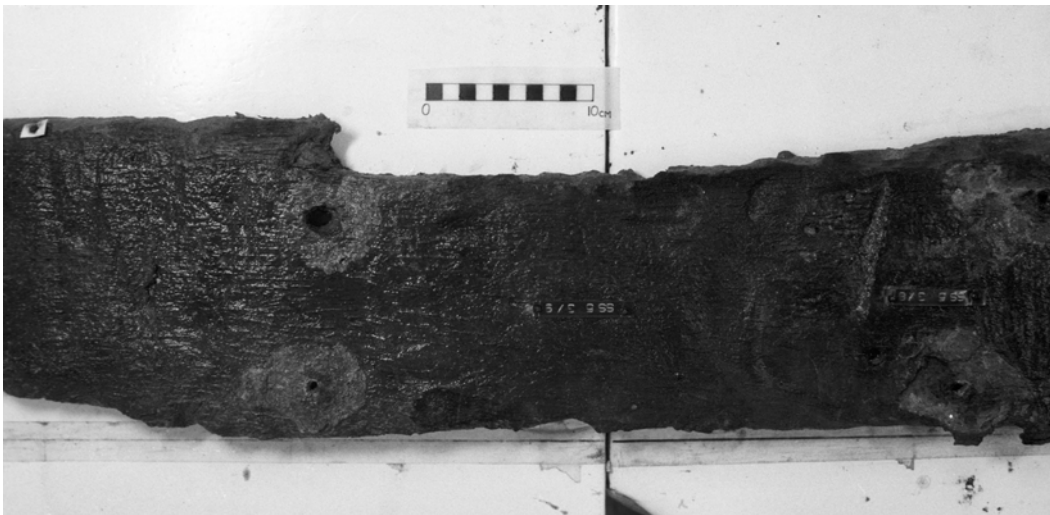
Figure 3-118: Photograph of the small joggle along the outboard edge of strake six.

The only item of joinery that distinguishes this strake from those inboard is the small joggle cut in the outboard edge of the fourth plank (fig. 3-118). This joggle is approximately 3 cm deep, and was fashioned to fit the outboard edge of strake six around the toe end of the third plank in strake seven. Clearly, this portion of strake seven was in place prior to the insertion of the fourth plank of strake six. All other items of joinery in strake six, the scarfs, treenails, and edge dowels, are similar to those in other strakes.

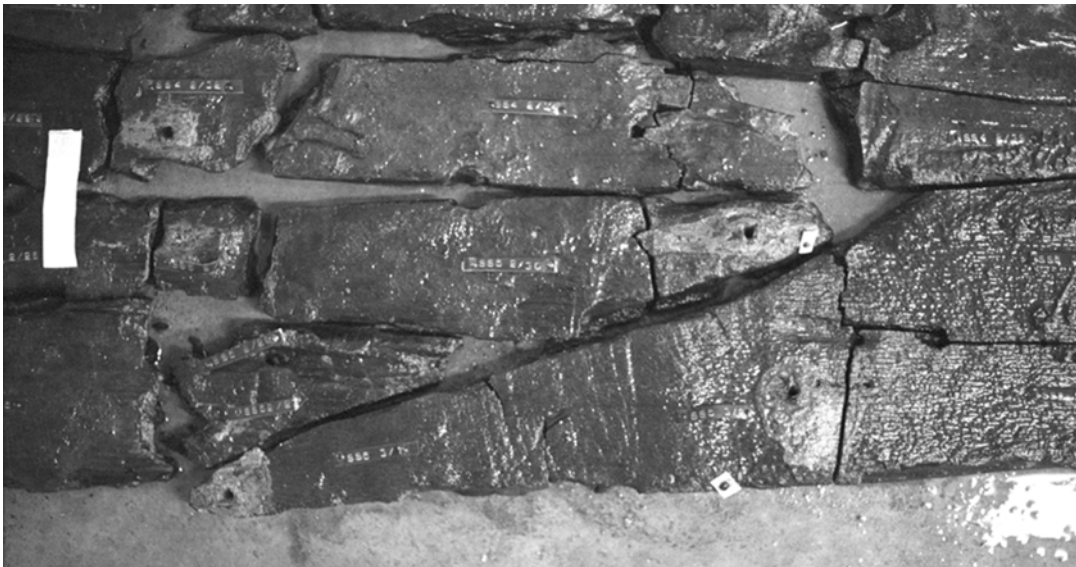
Figure 3-119: Photograph of the S-scarf between planks two and three in strake six.

Strake six is partitioned into four planks by the presence of three scarfs, an S scarf between planks three and four near floor timber H, and two diagonal scarfs dividing planks one and two and planks two and three (fig. 3-119). The first diagonal scarf, that between planks one and two near floor timber 4, was originally 42 cm long. Now, however, no original scarf edge is preserved along plank two, although the scarf's shape is still evident, and only 4.7 cm is preserved on plank one. The scarf between planks two and three, near floor timber A, originally extended 47 cm across the strake, although now only 17 cm of the scarf edge is preserved on plank two, and 23 cm is preserved in plank three (figs. 3-120, 3-121). Among these three scarfs, the S scarf and the first diagonal scarf are inclined the same way; the outboard edge of the scarf is farther from the bow than the inboard edge. The second diagonal scarf is inclined in the opposite manner.
