**A RE-ASSEMBLY AND RECONSTRUCTION OF
THE 9TH-CENTURY AD VESSEL WRECKED OFF THE COAST OF
BOZBURUN, TURKEY**

A Dissertation

MATTHEW BENJAMIN HARPSTER

A Re-Assembly and Reconstruction of
the 9th-century AD Vessel Wrecked off the Coast of
Bozburun, Turkey. (August 2005)

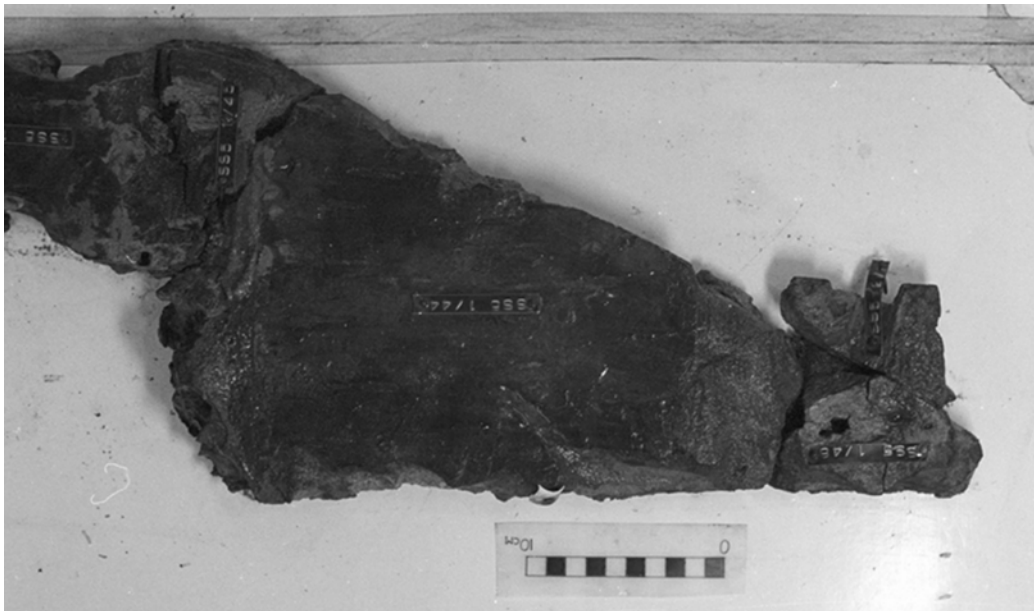
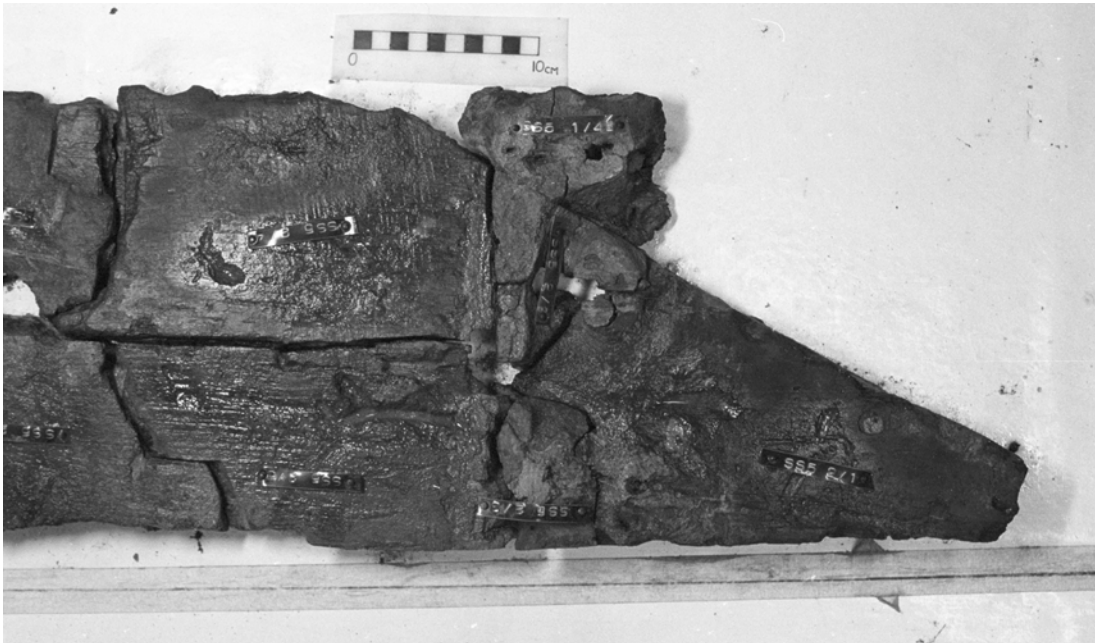
Figure 3-120: Photograph of the diagonal scarf between planks two and three in strake six.

Figure 3-121: Another photograph of the same scarf.

The majority of the 24 partial dowel joints in the edges of strake six are square, the remaining examples are round, hexagonal, ovoid and D-shaped. None of the preserved dowels or dowel holes are rectangular in cross section. Four of the dowel joints, in fragments SS5 1/21, 1/32, 1/43 – 1/45 and 2/19, are incomplete due to missing material across the strake seam in either strake four or six. Of the remaining 20 joints, eight mate to material in strake six, seven mate to material in strake four and four join together the planks of strake five across the diagonal scarfs. Plank one is joined to plank two via a dowel joint between fragments SS5 1/30 and 1/31, while plank two is joined to plank three by the ovoid dowel from fragment SS5 1/46 to 2/2. This latter join happens to be the only complete dowel joint that is still intact; the dowel has not broken and fragments SS5 1/46

and 2/2 are still joined together across the scarf seam (figs. 3-120, 3-121). In both of these cases, the dowel joint is perpendicular to the plank seam, and not the scarf seam. Moreover, no dowel joints pass across the S scarf to plank four. Extant material in fragment SS5 2/1 also indicates that a dowel joint passed from strake six to strake five at this point as well, securing the toe end of the plank to the outboard edge of strake five. Altogether, the dowel joints average 1.5 cm in cross-sectional width.

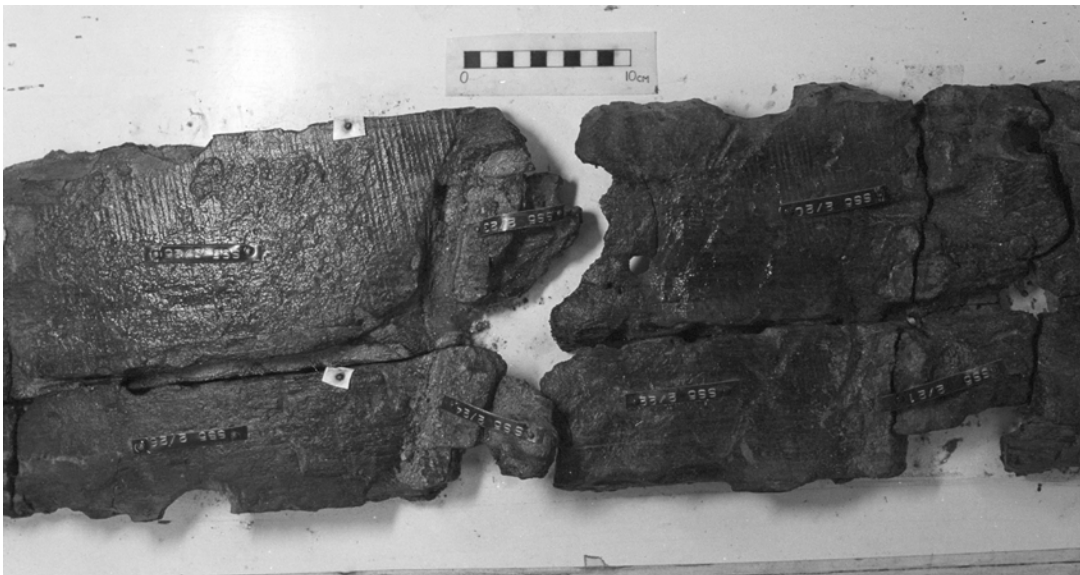
Figure 3-122: Photograph of saw marks on strake six.

Surprisingly diagnostic saw marks are preserved on the first few fragments of plank one, indicating that the cutting of the inboard face proceeded towards the forward end of the plank, and that the saw marks were generally perpendicular to the edges of the plank itself (fig. 3-122). After SS5 1/4, however, no more saw marks are preserved on plank one. The saw marks evident on planks two and three are similar as in both cases, the cutting of

the internal faces of the planks proceeded towards the aft end of the planks and the saw marks themselves are particularly parallel, distinct, and very closely set together with regular spacing. The only differences between the two sets of saw marks are their inclinations; those on plank two are 120 to 125 degrees away from the bow of the vessel, while those on plank three are inclined 80 to 85 degrees towards the bow. Saw marks are preserved on plank four as well, although these tend to be fewer in number, faint, and particularly varied in inclination. The marks on SS5 3/1 and 3/2, for example, are inclined approximately 80 degrees towards the bow, those on fragment SS5 3/15 are perpendicular to the bow, while the scattered marks evident on SS5 3/5 – 3/9 vary between 75 and 100 degrees. It is unclear which direction the cutting proceeded, but presumably, all these marks were made during the same sawing procedure.

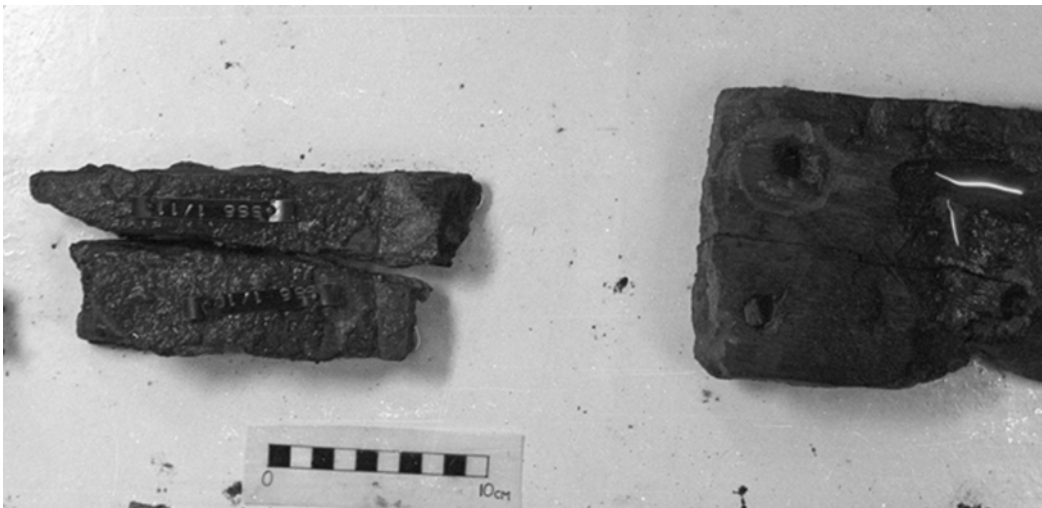
Figure 3-123: Photograph of the butt scarf in strake seven.

Although strake seven does not extend from the stem to the sternpost, it is still made up of a number of planks. Of the four planks in the strake, only planks three and four mate to each other via a diagonal scarf; planks one and two and two and three meet at butt scarfs. At the butt scarf between planks one and two, which was originally 8 cm wide, only 6.2 cm now remain along plank two on fragment SS6 1/5. The other butt scarf, originally just over 12 cm wide, is still preserved fairly intact on fragment SS6 1/8 on plank two, but no remains of the scarf are preserved on plank three (fig. 3-123). Very little remains of the diagonal scarf between planks three and four. Only 11.5 cm of the 57 cm scarf edge is preserved on plank three, along fragment SS6 1/57, while only 12 cm is preserved on plank four, along fragment SS6 1/59. This diagonal scarf is inclined similar to the nearby scarf in strake six; the inboard edge of the scarf is closer to the bow than the outboard edge.

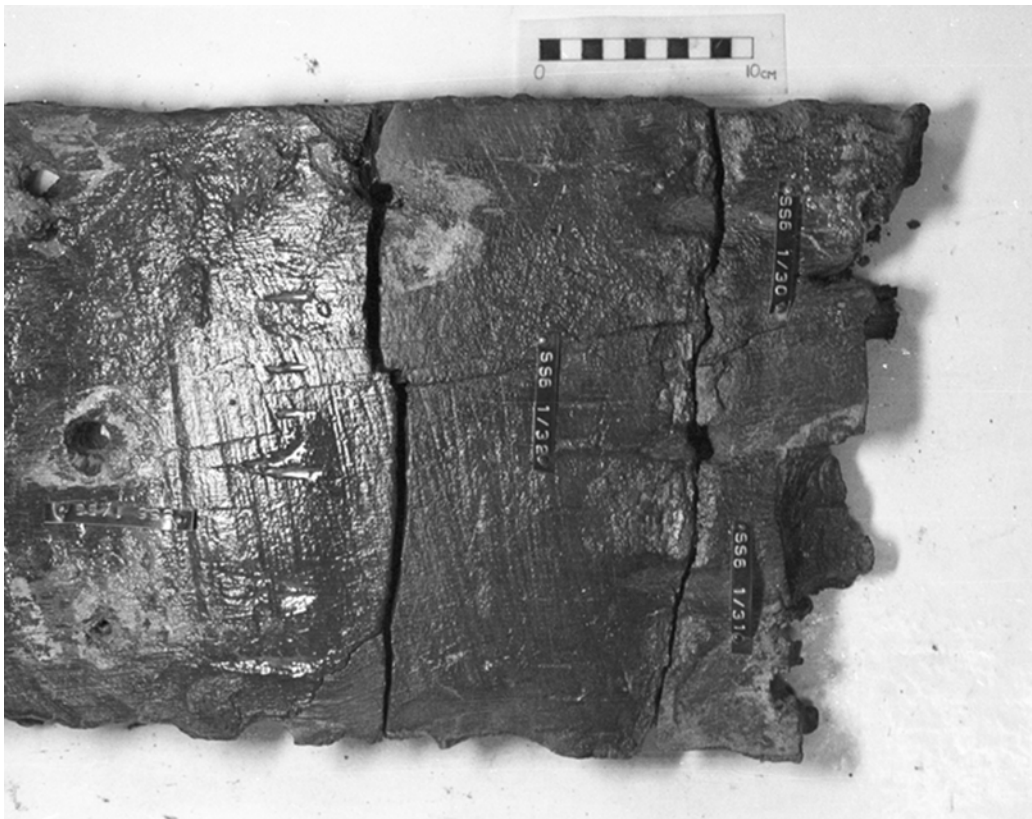
Figure 3-124: Photograph of saw marks on strake seven.

Saw marks are more prevalent along the length of the strake, although in some cases they are no more informative (figs. 3-124). No saw marks are preserved on planks one and two, although proceeding to plank three, the saw marks on fragments SS6 1/12 and 1/14, and 1/13 – 1/15 present conflicting information. The marks evident on SS6 1/12 and 1/14, and 1/16 and following fragments, are inclined between 75 and 90 degrees towards the bow, and indicate that cutting proceeded from the forward to the aft end of the fragment. The marks preserved on fragment SS6 1/13 – 1/15, which is outboard of fragments SS6 1/12 and 1/14, are inclined 120 to 125 degrees from the bow, and the cutting proceeded from the aft to the forward end of the fragment. As no other fragment in the immediate vicinity of SS6 1/13 – 1/15 has similar saw marks, it appears that SS6 1/13 – 1/15 is a small addition or repair to the outboard edge of plank three in strake six, immediately forward of the butt scarf to plank two. Although there are a few instances of saw marks inclined as low as 65 degrees towards the bow, in fragments SS6 1/34 and 1/45 – 1/47, no other saw marks along the length of plank three indicate a similar patch or repair occurred. Saw marks are similarly distinct and well preserved on plank four. Their inclination tends to vary more along the shorter length of the plank, varying between 60 and 90 degrees towards the bow, but overall, they are fairly consistent and all indicate that the cutting of this face proceeded from the forward to the aft end of the plank.

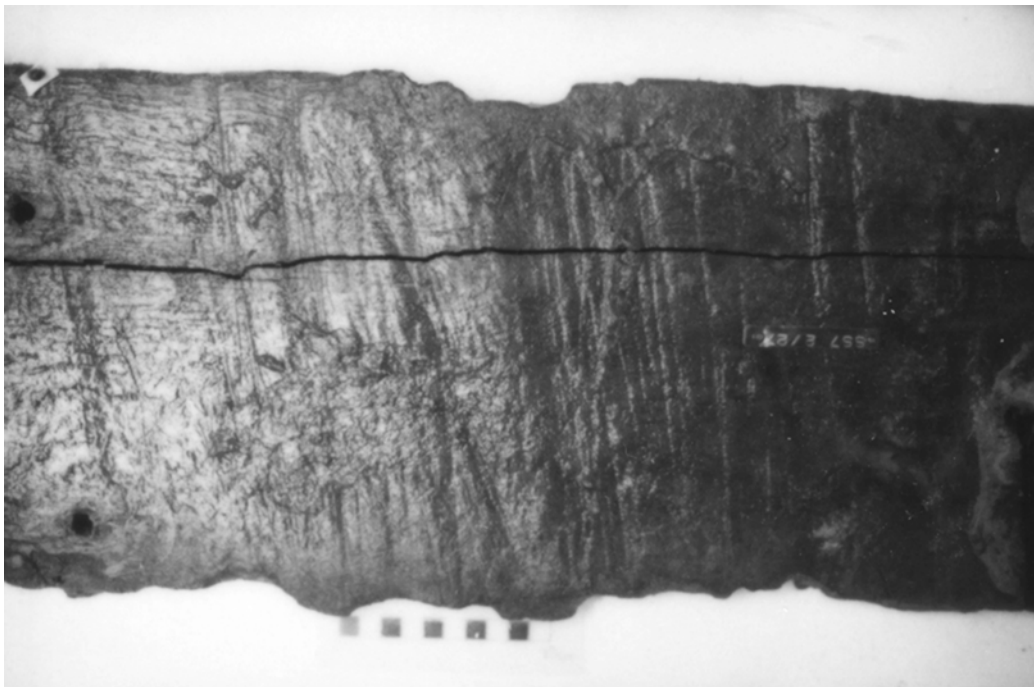
Figure 3-125: Photograph of saw marks on strake eight.

Although the general level of preservation increases towards the forward end of the strake, the number of preserved tool marks does not. No adze marks are evident anywhere along strake eight, but saw marks are prevalent on planks one through three, and absent on plank four. On plank one, all of the saw marks are similar: the cutting proceeded from the stern to the bow end of the plank and the blade was inclined towards the stern, at 60 to 80 degrees to the run of the plank (fig. 3-125). This evidence, along with the scanty preservation of an S scarf, distinguishes plank one from plank two. Approximately 90 percent of the saw marks on plank two are either perpendicular to the plank's run or inclined, at the most, 110 degrees towards the bow. The only exception are marks on fragment SS7 2/11 which are inclined towards the bow, on average, 45 degrees to the plank's run. These marks are also distinguishable as they characterize a small section of saw marks that appear to run counter to the general cutting direction. As evident on fragments SS7 2/5 and 2/19-2/22, the cutting of plank two appears to proceed from the bow to the stern end of the plank. On fragments SS7 2/9 and 2/11, the cutting appears to have proceeded in the opposite direction, while marks on SS7 2/14 appear to have been generated by cutting in both directions. The saw marks evident on plank three are very similar to the majority of those preserved on plank two, they are either perpendicular or

inclined up to 110 degrees towards the bow, and the cutting proceeded from the bow to the stern end of the plank. Only on the most forward fragment in plank three, SS7 2/33-2/35, does this inclination increase to approximately 120 degrees. Plank three also preserves a unique sawn ridge on SS7 2/23-2/26, indicating that the cutting of the plank stopped .34 m from the plank's aft end, leaving this small raised ridge on the surface. The remaining interior surface was instead cut with an axe (figs. 3-126, 3-127).

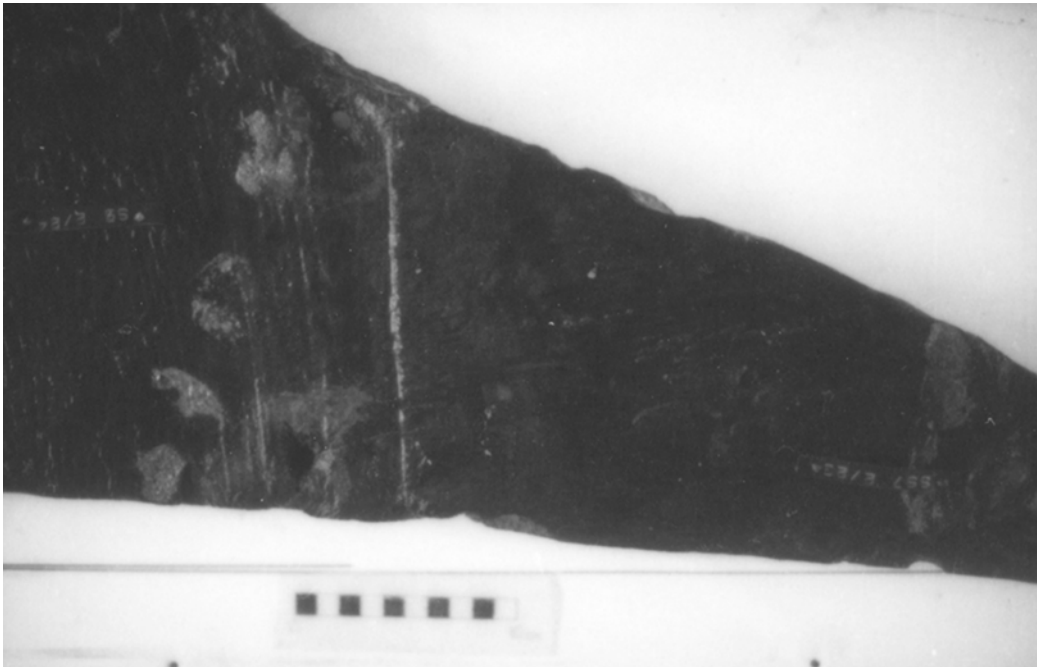
Figure 3-126: Photograph of the scarf and the tool marks at the after end of plank three in strake eight.

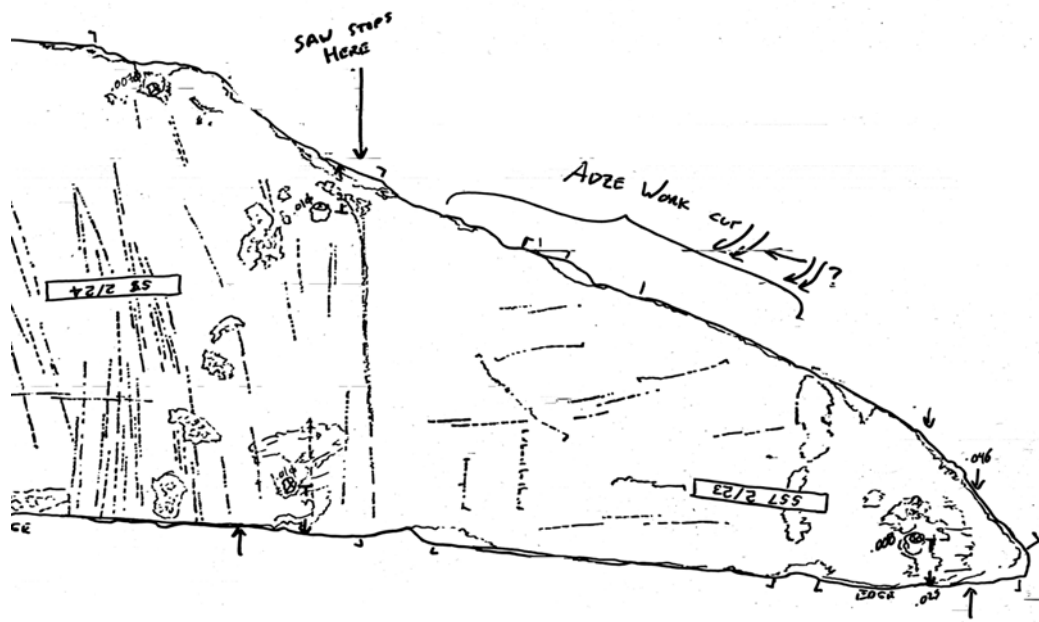
Figure 3-127: Drawing of the same area, illustrating the junction between the saw marks and axe marks.

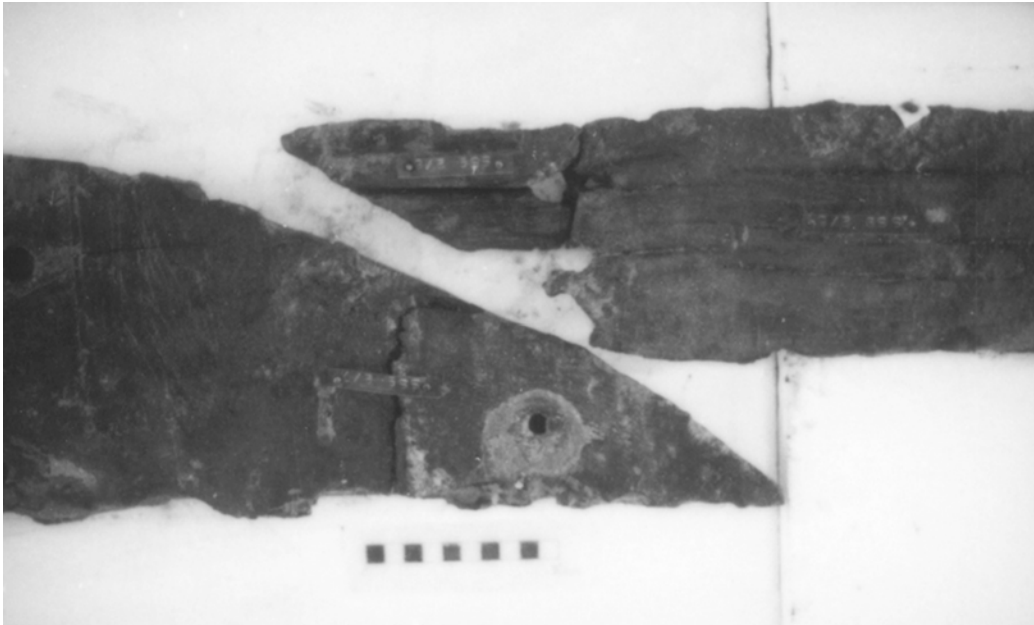
Figure 3-128: Photograph of the parabolic scarf between planks two and three in strake ten. The alignment of plank two (to the right of the photo) is too high and should be aligned with the lower edge of plank three.

Also diagnostic of strake ten and other strakes outboard is the number and variety of scarfs preserved in the planking material. Within strake ten, two scarfs are preserved between planks one and two and two and three. These three planks most likely do not represent all the planks that originally comprised strake ten but unfortunately, no scarfs are preserved at the aft or forward ends of planks one and three. The diagonal scarf between planks one and two is of a conventional design, inclined towards the stern at approximately 170 degrees and preserved for 30 cm. The scarf between planks two and three, in comparison, is the first of its kind preserved in the Bozburun material. It is essentially a curved or arcing scarf, extending forward – and inclined opposite to the first scarf – in an almost parabolic cut (fig. 3-128). Due to its length, plank two only mates to its inboard 19 cm while the remaining 18 cm outboard mates to plank eleven. Why the builders created

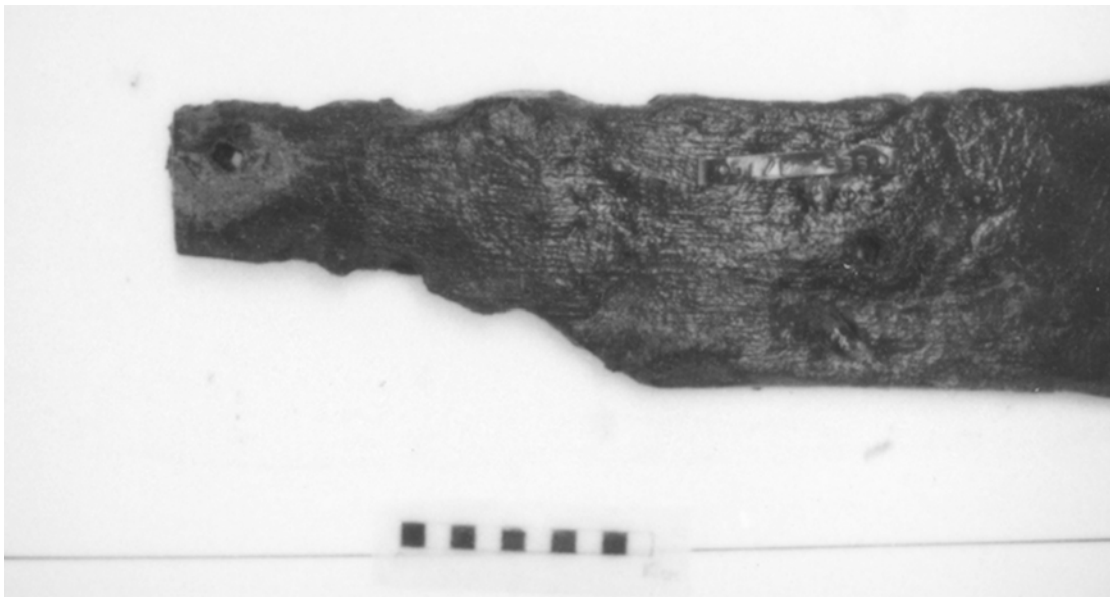
Figure 3-129: Photograph of the butt scarf in strake eleven.

The fragments of strake eleven have no edge dowels. Moreover, as the strake is so short, the only joinery of note are the two scarf edges at either end. The aft scarf edge that tucks under fragment SS10 1/9 in strake twelve is a 5.5-cm long straight edge inclined 65 degrees to the inboard edge of strake eleven. The forward scarf is composed of one curved edge that mates to strake ten, and a butt scarf face that tucks under fragment SS10 1/17 in strake twelve (fig. 3-129). This curved scarf face in strake eleven mates to the outboard 18 cm of the arcing scarf face that delineates the aft end of plank three in strake ten. The butt scarf face, which is a straight face 5.5 cm long and inclined at 90 degrees to the previous curved scarf edge and the outboard edge, mates to a similarly-sized edge in fragment SS10 1/17.

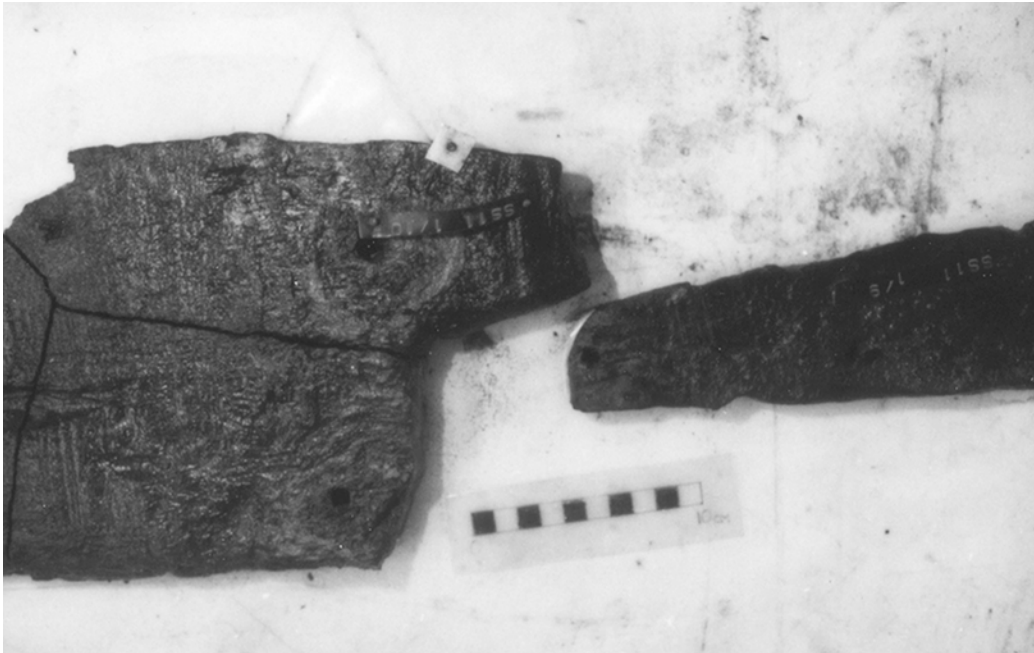
Figure 3-130: Photograph of the scarf in strake twelve that encompasses planks from strakes eleven and twelve.

Although through a reconstruction it is evident that strake eleven tucks under strake twelve at fragment SS10 1/9, no preserved scarf edges are present on SS10 1/9 itself. Of the two scarfs that are evident in strake twelve, then, only the butt scarf in fragment SS10 1/15 near midships may be discussed at this point. This 4-cm long scarf face mates to the inboard portion of a 9-cm long butt scarf face in fragment SS11 1/10 (fig. 3-130). As the scarf face in SS11 1/10 is longer than that in SS10 1/15, both strakes twelve and thirteen taper dramatically to fit to this longer face. Strake twelve near futtock 5 is approximately 19 cm wide, while approximately 1.5 m forward at the butt scarf to strake thirteen, it has tapered to approximately 5 cm wide. No labeled fragments forward of this point are a part of strake twelve.

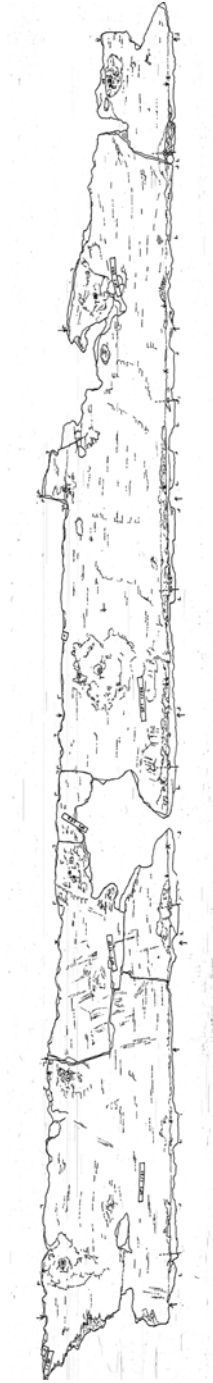
Figure 3-131: Drawing of fragments of port strake one (1:10 scale).

Among the 16 fragments of port strake one, the majority are similar to the rest of the fragments from the port side as they are disarticulated and fairly small. Five fragments from the strake, SP1 1/4 and SP1 1/20 - 1/25, are still diagnostic, solid, and representative of long stretches of strake one (fig. 3-131). Those isolated and disarticulated fragments, SP1 1/1, 1/14, 1/17-1/19, 1/28, and 1/31 - 1/38, are fairly light and friable as a whole. Their interior faces are eroded and delicate and in some cases, such as fragments SP1 1/28, 1/31,

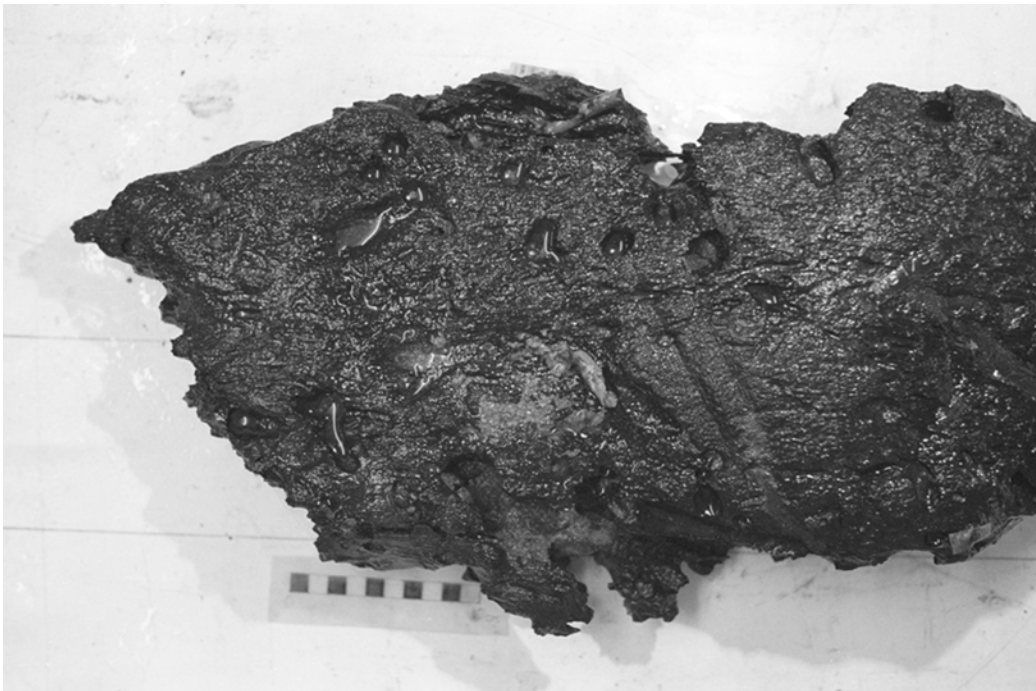
Figure 3-132: Photograph of the top of the largest fragment of the mast step.

That this fragment was labeled as the mast step in situ was a somewhat serendipitous act. While on site, and even now, it has little or no diagnostic information other than its size and location and as such, it could have been labeled with a UM label, or as part of a pump or a keelson (figs. 3-132, 3-133). Its presence, first noticed in 1996, led the excavators to the conclusion that it represented a keelson aligned with the keel. This

conclusion, due to the paucity of fastener holes and corroborating evidence, has since been discounted. It has also been argued that this fragment may be part of a pump assembly, a conclusion that seems unlikely. The fragment itself sits on top of the floor timbers instead of the keel and, despite its size, retains no evidence of the two vertical shafts needed to house the elements of a chain pump in use during this period. Without the lines plan in Chapter 5, moreover, it was also unclear until now that it aligns approximately with the hull's center of lateral resistance. In other words, it is in the ideal location for a mast step.

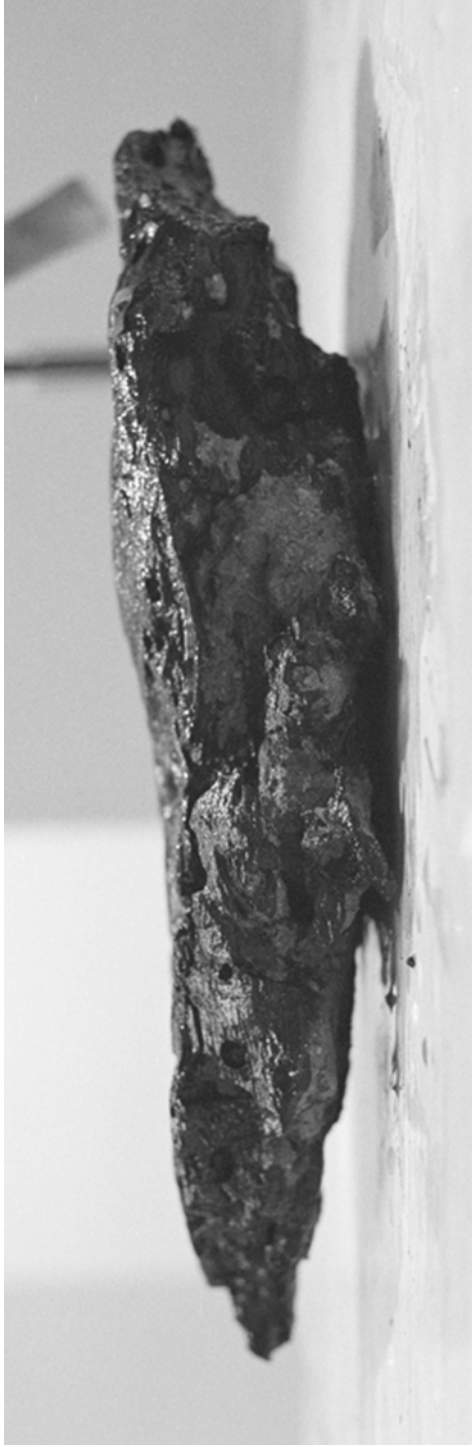
Figure 3-133: Photograph of the side of the largest fragment of the mast step.

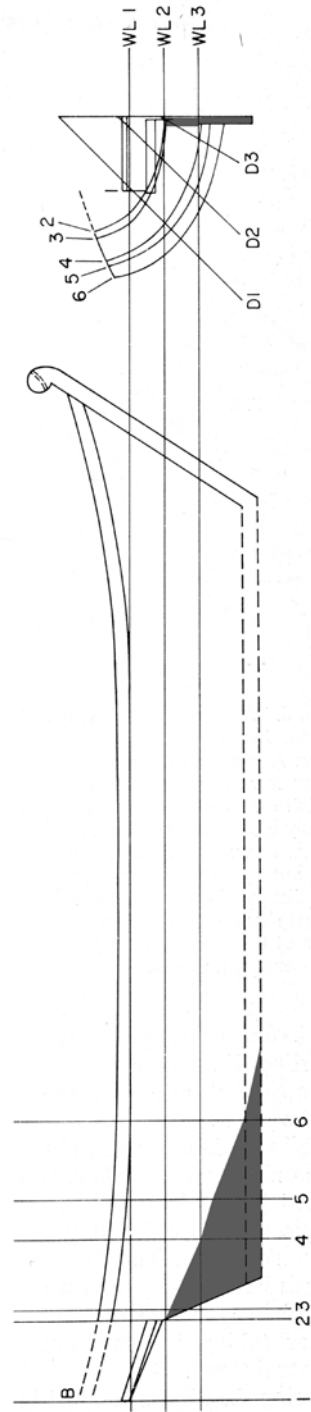
Figure 4-2: Throckmorton's lines of the Pantano Longarini vessel. The shaded area indicates the location of the skeg (After Throckmorton 1973, 258).

Primarily, the deadwood, if there was no stern rudder, served no function. From Throckmorton's re-assembly of the frame stations, it is evident that the framing material did not taper down onto the vertical faces of the deadwood, but rather crossed over almost horizontally.²⁰⁶ Secondly, the planking material too appears to meet this deadwood at a nearly 90 degree angle. This is particularly evident in the re-assembly of the framing material immediately forward of the transom construction.²⁰⁷ So if there was no deadwood, then how could the stern of the vessel have been built?

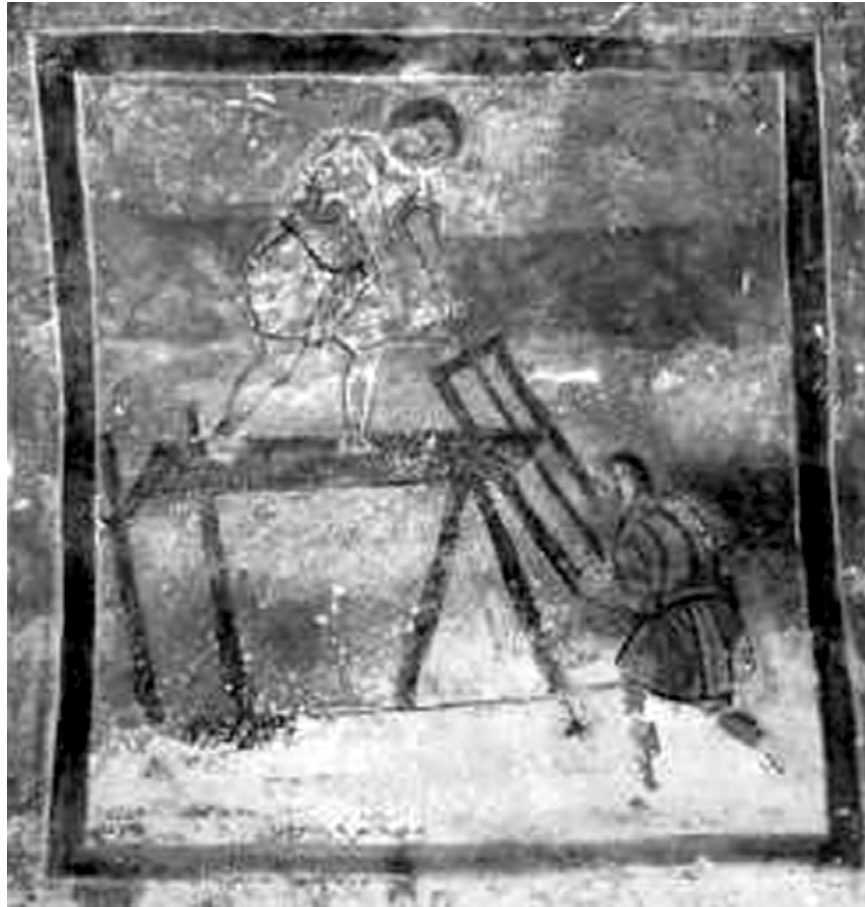
Figure 5-1: Photograph of a painting in the early-Islamic structure at Qusayr Amra, illustrating the use of a frame saw (From G. Lattanzi).

Among the tool marks preserved on the framing and planking material from Bozburun, a very large portion allude to the use of one or more saws in the vessel's construction. Some of the saws, as they cut planks approximately 30 cm wide, not only had to have been 60 cm or more in length, but also needed a frame to maintain the blade's tension and to prevent it from buckling during use.¹ This rectangular frame provided a rigid structure that the saw blade stretched across lengthwise; the use of twisted rope or sinew could adjust the tension in the frame as needed. Numerous images of their use indicate these saws were fairly common in the Roman era and, as illustrated in a painted image from Qusayr Amra, apparently known in early-Islamic Palestine as well (fig. 5-1).²

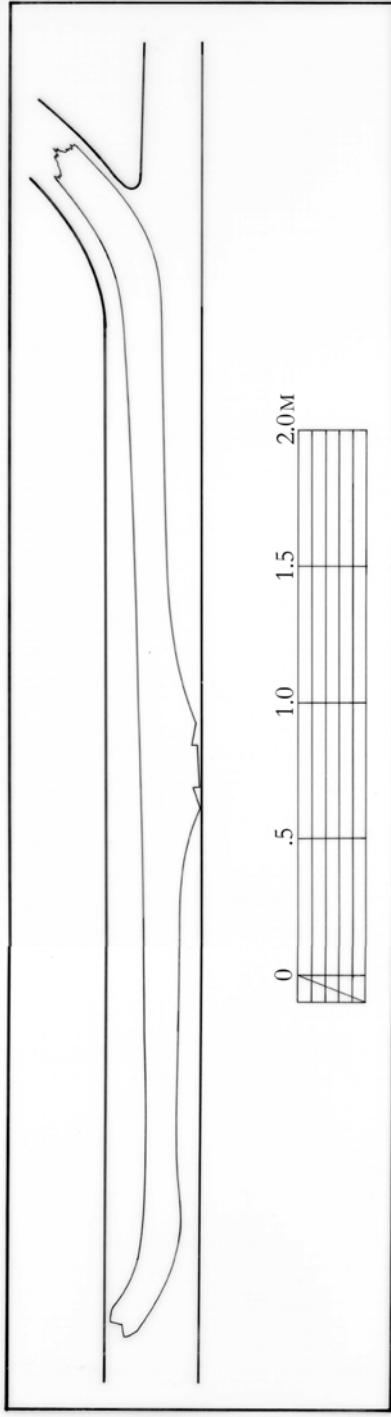
Figure 5-2: Illustration of converting an oak log into a floor timber.

Primarily important to the shipwright were the logs' shapes. Each log not only had to be at least 4 m long and 35 cm in diameter, one end of the log had to incorporate a branch at least 23 cm in diameter extending from the log at approximately 45 to 50 degrees (fig. 5-2). The lengths of the logs were dictated by the proposed beam of the ship, while the minimum diameter – and the hope for a straight pith – was governed by the shipwright's desire to incorporate various elements of the floor timber into one component. The middle of each floor timber, an area approximately 1.38 m long, encompassed its thickest part immediately over the keel, as well as the triangular limber holes and concave garboard hollows to either side. To either side of this middle section, the oak floor timbers extended another 1.035 m to the bilges. The branches on each oak log were critical because the oak floor timbers, unlike the pine floor timbers, were asymmetrical in design but identical to each other. While one end of each oak floor timber would have a short upsweep through the bilge that ended with a L-shaped scarf, the opposite end would have a longer arm that extended through and above the bilge.¹⁹ This similarity is because the oak floor timbers were fixed in place near the center of the vessel. The pine floor timbers, in comparison, varied more in shape as they were closer to the stem and sternpost.

Once five to eight logs were found, felled and dragged to the building site, each log was first cut by siding the log lengthwise. Sawing logs less than 30 cm or so in diameter, such as ones that produced floor timbers 1 and B, meant cutting away less of the log to leave a baulk wide enough for the resulting floor timber.²⁰ Other logs, such as those that produced floor timbers at midships, A, C, D and E, were sawn lengthwise to leave a similar baulk of wood, but a baulk that was approximately 24 to 25 cm wide – twice the final width of the finished oak floor timbers. In either case, after the workmen had sawn two rough faces off a log and began erecting the next log on the trestles, the shipwright laid out the molded shape of the floor timber on the log's exposed heartwood. The curves at the garboard hollows and the bilges were inscribed, the flat over the keel was marked, and the width and depth of the limber holes to either side of the keel were traced out.

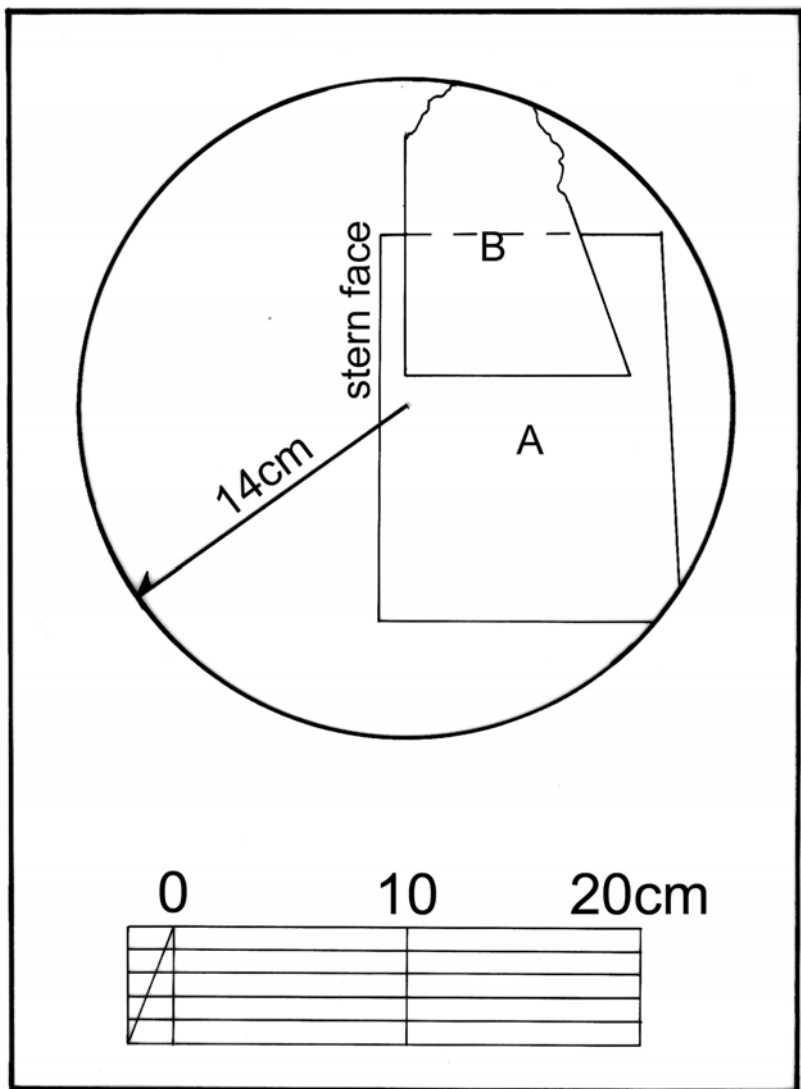
Figure 5-3: Cross section illustrating the conversion of floor timber 4.

Regardless of when a pine floor timber was fashioned, once the shipwright had chosen the appropriate log, the workmen again sawed off two vertical faces to side the log and expose the sapwood (figs. 5-3 and 5-4). At least four wood baulks initially twice as wide as the resulting floor timbers and fashioned at least seven pine floor timbers the same way they had produced five of the oak floor timbers. After fashioning the molded shapes with saws, the workmen finished the exposed faces of each floor timber with adzes. While trimming the top faces over the bilges, the workmen tended to work down and across each face, dubbing diagonally towards the bow and slowly working towards the keel as well. Over the midbody of the floor, on the other hand, they changed position and instead trimmed the face by dubbing diagonally towards the stern as well as outwards towards the bilge.²³ To produce two nearly identical floor timbers from this finished baulk, each was cut in half with two cuts proceeding from each bilge and meeting at the center of the floor timber.²⁴ Sometimes, such as floor timbers 5 and K, the finished baulk was upright when sawn in half.²⁵ The workmen cut other baulks in a slightly more complex manner. After finishing one cut to the keel, the baulk was rolled over and finished by cutting it in two, producing floor timber G and H.²⁶ After sawing their baulks in half the workmen finished floor timbers 5 and G by adzing chamfers along one of their two top edges while others were left intact.²⁷

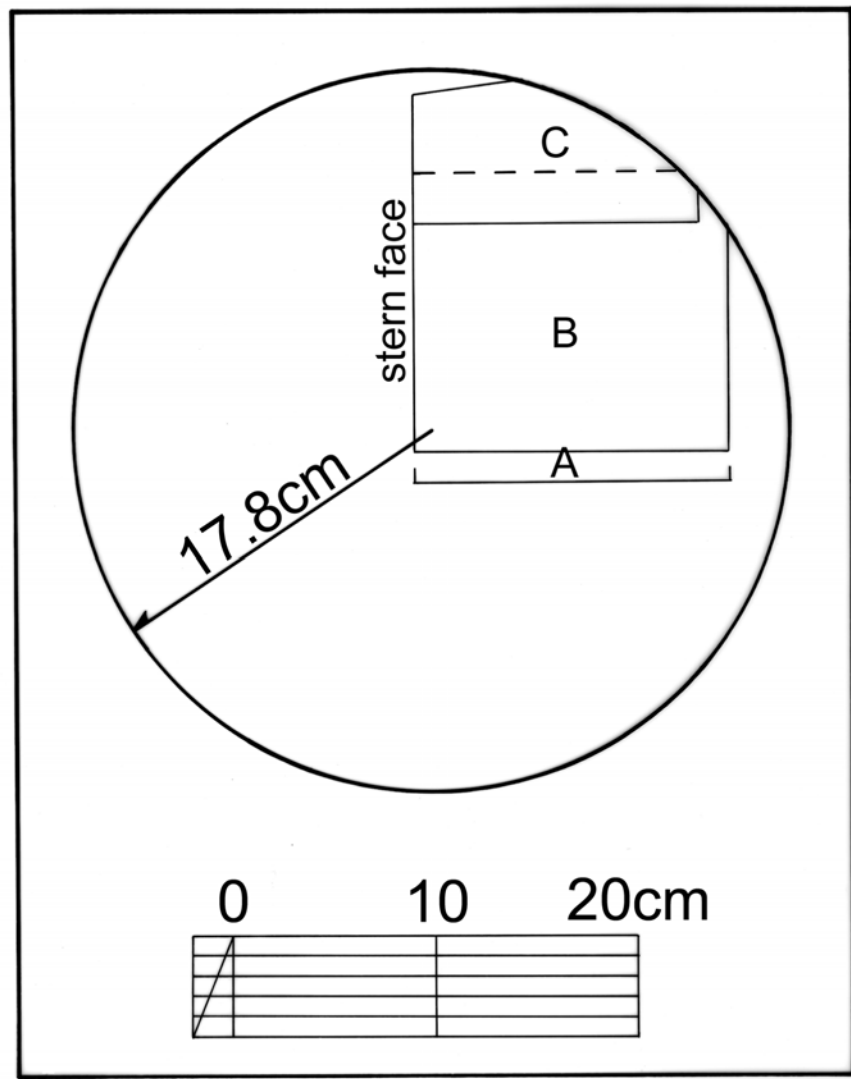
Figure 5-4: Cross section illustrating the conversion of floor timber H.

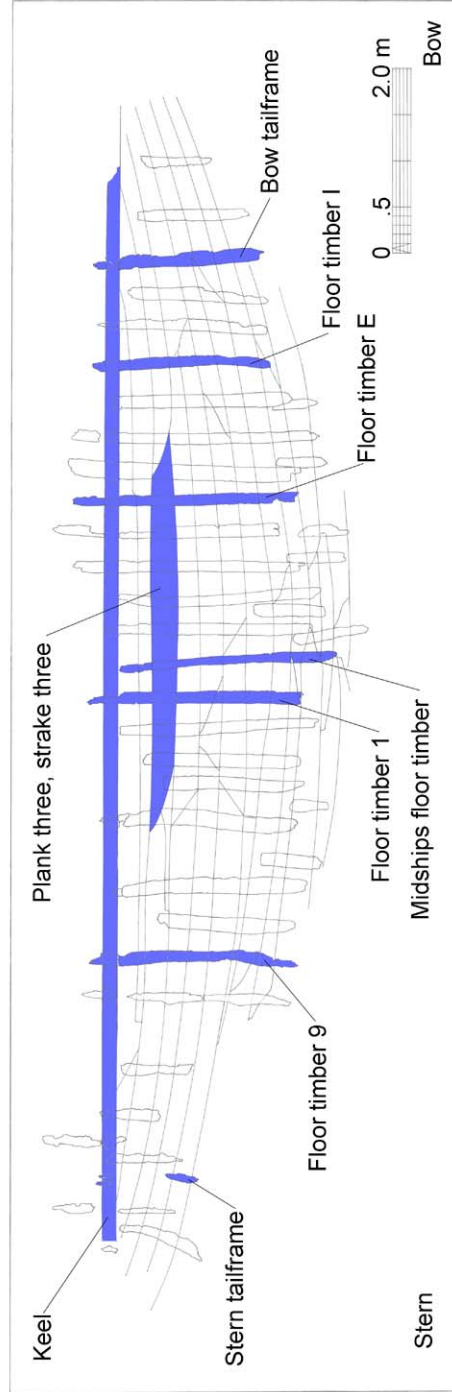
Figure 5-5: Step one in re-assembling the Bozburun hull remains. Blue timbers are newly added to the structure.

Although the shipwright partially defined the shape of this vessel with these five floor timbers and four half frames, the shapes of the remaining components incrementally designed each another. No more floor timbers were fixed in place until the workmen treenailed the third plank in strake three to the three oak floor timbers already in place (fig. 5-5). The workmen did not affix strake one in place first as that space provided a convenient place to sweep out sawdust and scraps.

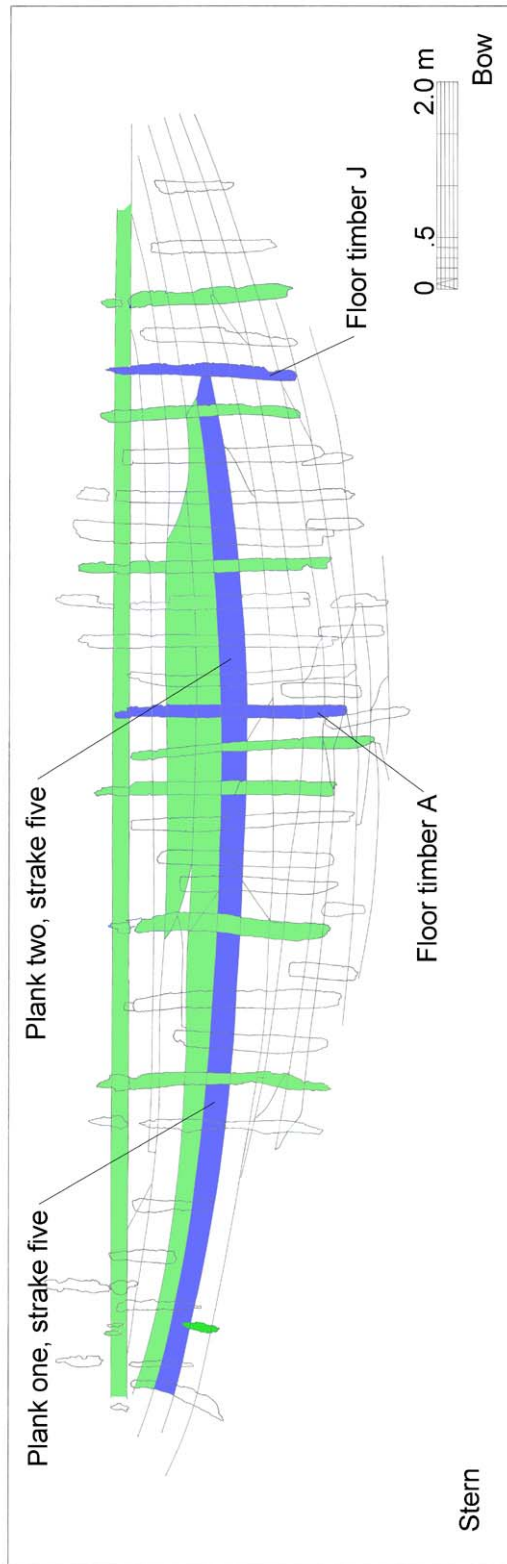
Figure 5-7: Step three in re-assembling the Bozburun remains.

dowels protruding from the outboard edge of strake four, and shored up along its outboard edge. The workmen affixed floor timber A in place at this time as it would span the diagonal scarf between planks two and three in strake six. Floor timber J, in comparison, supported the forward toe end of strake five. Once floor timbers A and J were nailed to the keel, treenail holes were drilled through the oak floor timbers, treenails were driven into place, and the strake was additionally nailed to all of the erected pine floor timbers (fig. 5-7).

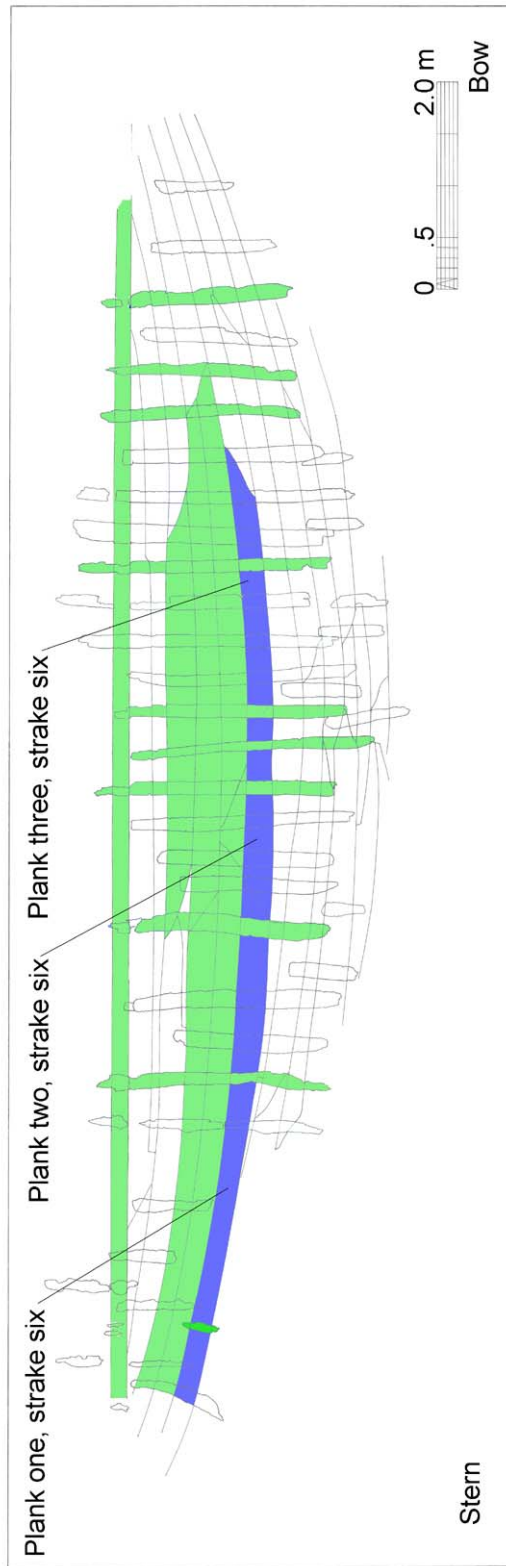
Figure 5-8: Step four in re-assembling the Bozburun remains.

The workmen attached the planks of strake six with a process similar to that of strakes four and five. Once the third plank in strake six, the to be first attached, was cut to shape, it was held up to the outer edge of strake five and the locations of the edge dowels were marked. The dowel holes along the inboard and outboard edges were drilled and, after sliding the plank onto the protruding edge dowels in strake five, the workmen shored up the plank and affixed it to the erected floor timbers. While repeating this procedure aft to attach the first plank in the strake, a workman also attached the after toe end of plank three to the outboard edge of strake five. As there was an edge dowel along the inboard edge of the third plank between floor timbers F and G, floor timber H did not yet need to be added to support the forward end of this plank. The toe end was affixed in place with an edge dowel. For possibly the first time on this vessel, however, this dowel hole was drilled with a bow drill since the hole's proximity to the midships floor timber precluded the use of an auger. Once the workmen had completed attaching the first and third planks, they installed the intervening second plank in the strake, added edge dowels across each diagonal scarf to the adjoining planks, and inboard to strake four as well (fig. 5-8).

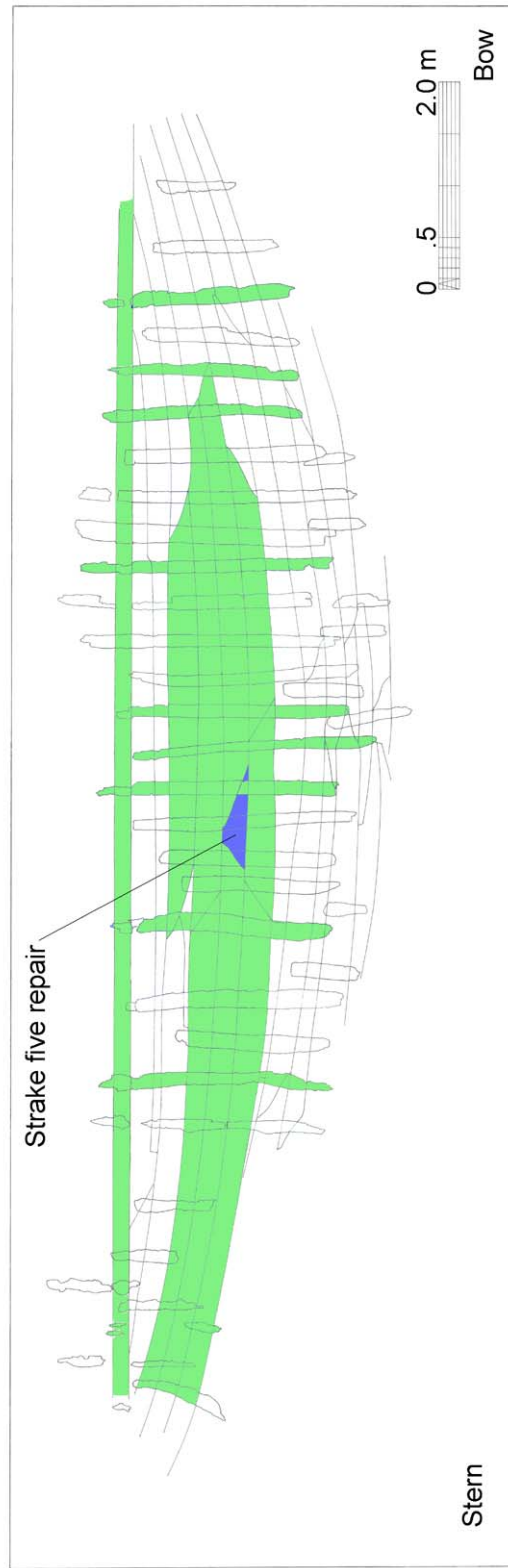
Figure 5-9: Step five in re-assembling the Bozburun remains.

Prior to adding strake seven, possibly because they were adding floor timber 4 or attempting to affix the second plank of strake six in place, the workmen found they had to repair their vessel even before it was complete. For reasons unknown, they removed the forward end of the first plank in strake five, leaving a one-meter gap next to the diagonal scarf. The two edge dowels that once joined the first plank to the second were sawn through, as were another four in the strakes surrounding the damaged section. An edge dowel in the middle of the diagonal scarf was plugged by drilling a larger hole in it and hammering a larger dowel in place. To keep the alignments of the surrounding planks tight, workmen treenailed a temporary clamp to the exterior of the ship, extending from strake
