**A RE-ASSEMBLY AND RECONSTRUCTION OF
THE 9TH-CENTURY AD VESSEL WRECKED OFF THE COAST OF
BOZBURUN, TURKEY**

A Dissertation

MATTHEW BENJAMIN HARPSTER

A Re-Assembly and Reconstruction of
the 9th-century AD Vessel Wrecked off the Coast of
Bozburun, Turkey. (August 2005)

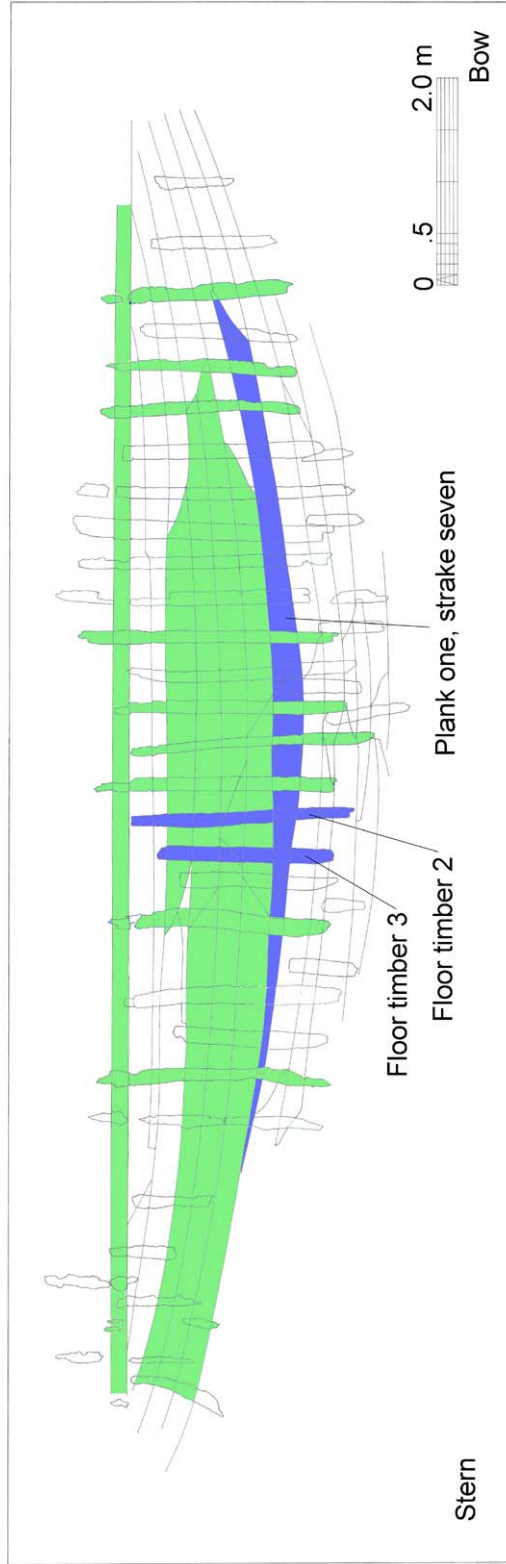
Figure 5-10: Step six in re-assembling the Bozburun remains.

three to strake six. Next, before patching the gap, they again used the bow drill to drill a new edge-dowel hole through the toe end of plank two in strake five into the outboard edge of strake four. After driving a dowel into this new hole, the patch was fitted and held in place with two additional temporary clamps nailed to the exterior of the hull (fig. 5-9). Once this repair was completed, the workmen nailed floor timber 2 in place, removed the temporary clamp treenailed in place, and added floor timber 3 as well. Next, they proceeded to attach strake seven to the increasing number of standing floor timbers (fig. 5-10).

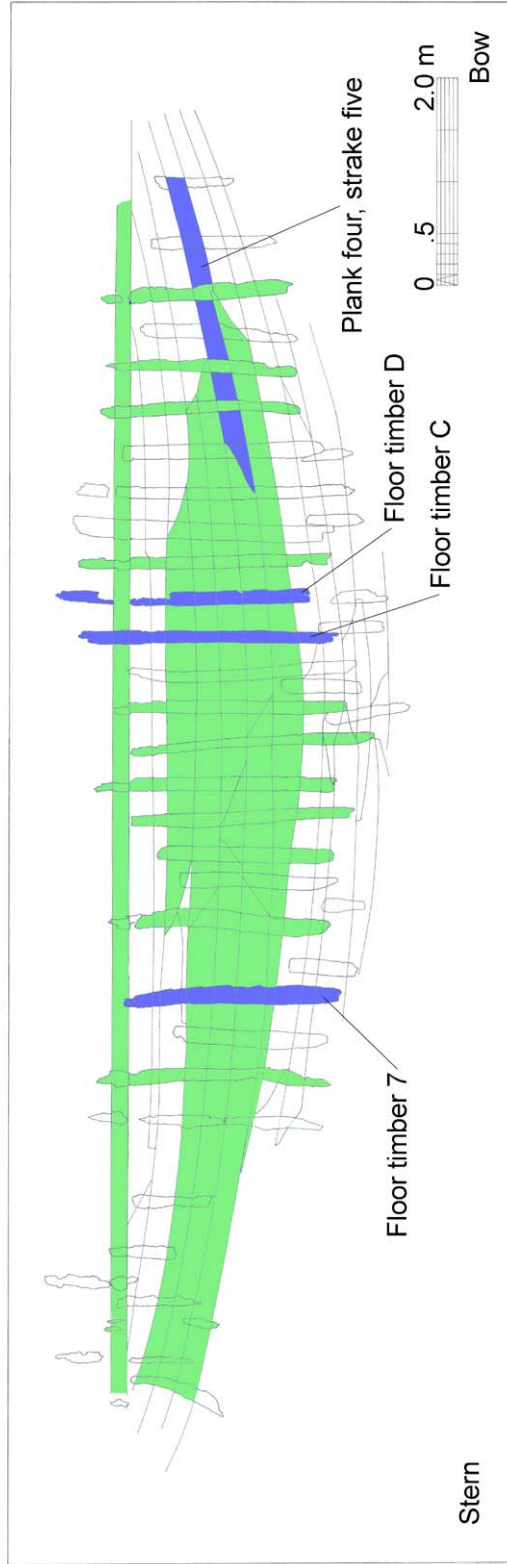
Figure 5-11: Step seven in re-assembling the Bozburun remains.

Prior to fashioning and assembling planks at the bow and stern, the workmen added another temporary clamp to the hull's exterior. Across the forward scarf of the third plank in strake six, they nailed and treenailed a short 70-cm clamp extending from strake four outboard to strake seven. The workmen could now shore up plank four in strake six against floor timbers I, J and L. Sliding it over the temporary clamp, they marked its edges to fit the scarf and adjacent planks. Having fashioned and fitted the plank in place, the workmen nailed the toe end of the first plank in strake seven to the outboard edge of this last plank in strake six (fig. 5-11).

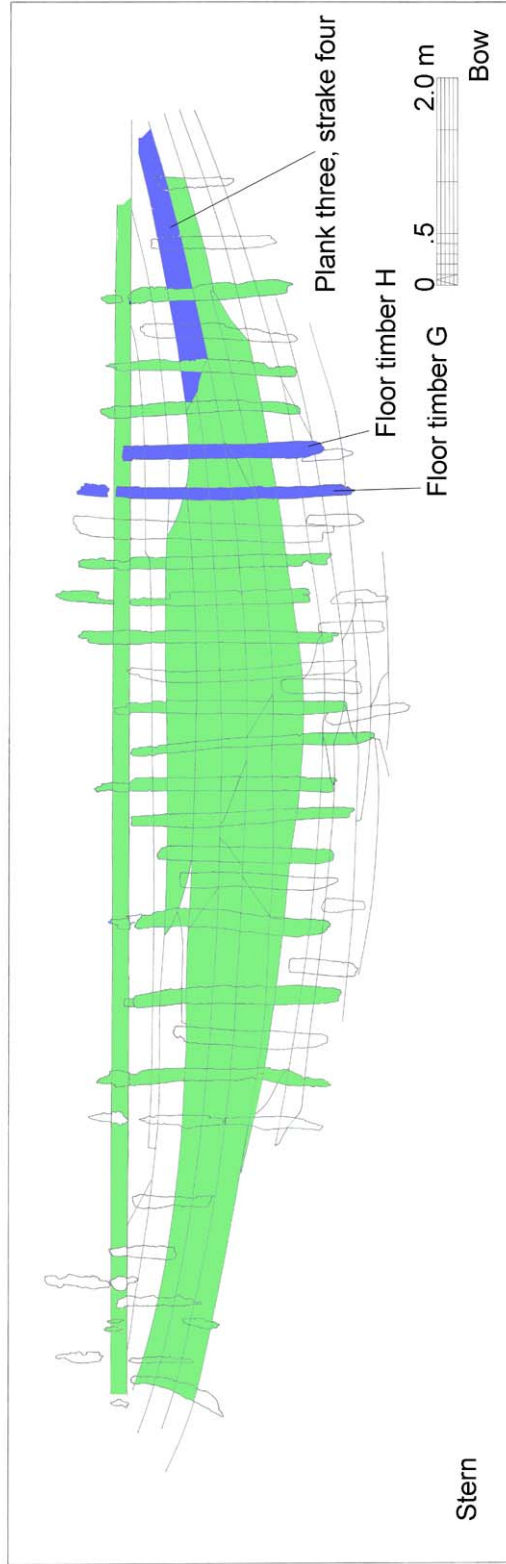
Figure 5-12: Step eight in re-assembling the Bozburun remains.

The shipwright and workmen fashioned floor timbers G and H and nailed them in place to span the diagonal scarf between planks three and four in strake six, and once the second temporary clamp was removed they followed a fairly straightforward process of fashioning the planking that fit between strake six and the stem. The workmen prepared plank three in strake four, which essentially acted as the forward-most plank in strake five as well, by carefully cutting a long diagonal scarf across its aft end and nailing it in place against floor timbers I, J and L (fig. 5-12). To support strake two and the aft end of plank four in strake three, floor timber F was fashioned and fitted in place next. It may have also been added at this time as once more planking was added, it would be increasingly difficult to move these heavy timbers into place. Planks one and four in strake three were fashioned next, fitted against the stem or sternpost and plank three, and nailed into place (fig. 5-13).

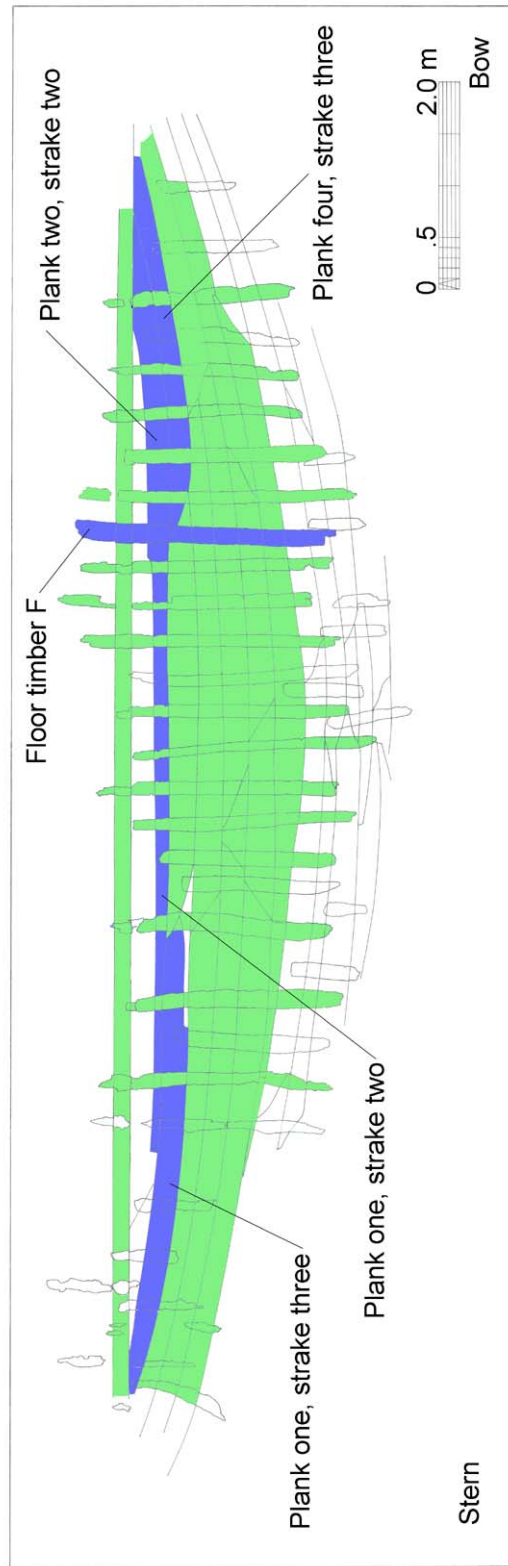
Figure 5-13: Step nine in re-assembling the Bozburun remains.

Since the first plank in strake two was relatively straight and only had two edge-dowel holes along its outboard edge, and as the garboard was still absent, the workmen could fashion and affix it in place fairly quickly (fig. 5-13). Next, the forward-most plank in strake two was nailed into place along the stem and up against floor timbers E, F, G, H, I, J and L. The workmen then fashioned floor timber K and nailed it to the keel and the assembled planking. Once the shipwright and workmen had fashioned the second plank in strake seven, affixed its forward toe end to floor timber K and added the short plank

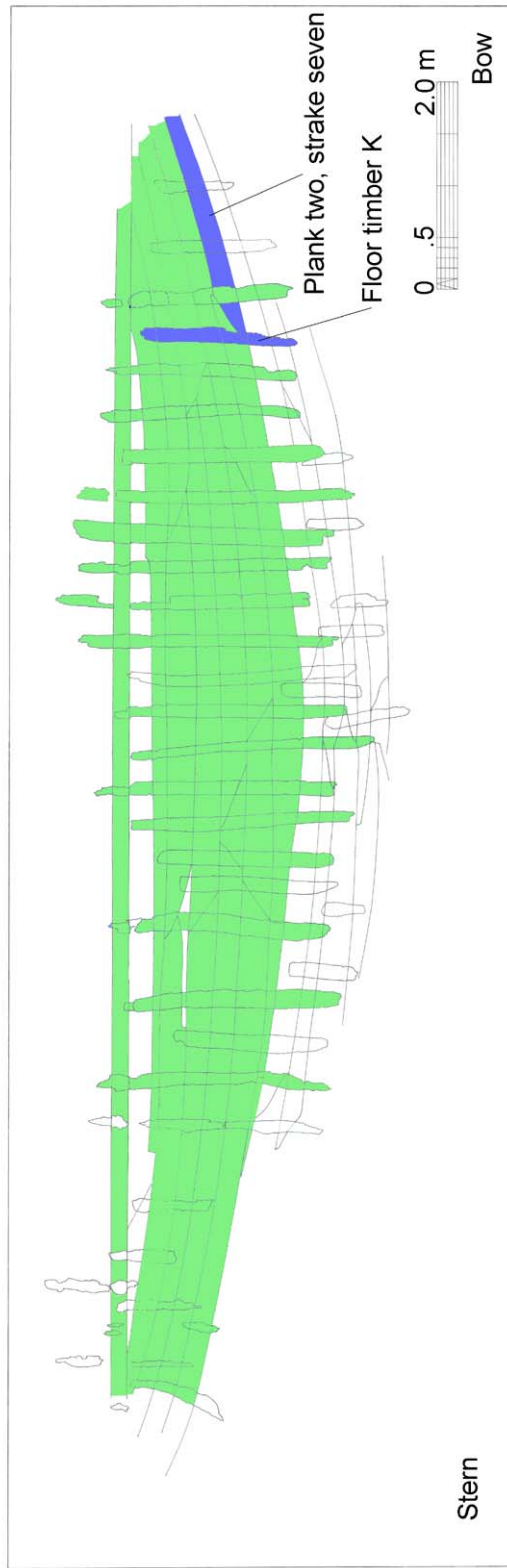
Figure 5-14: Step ten in re-assembling the Bozburun remains.

between planks one and two in strake four, all the bow and stern planking below the bilge was now complete (fig. 5-14).

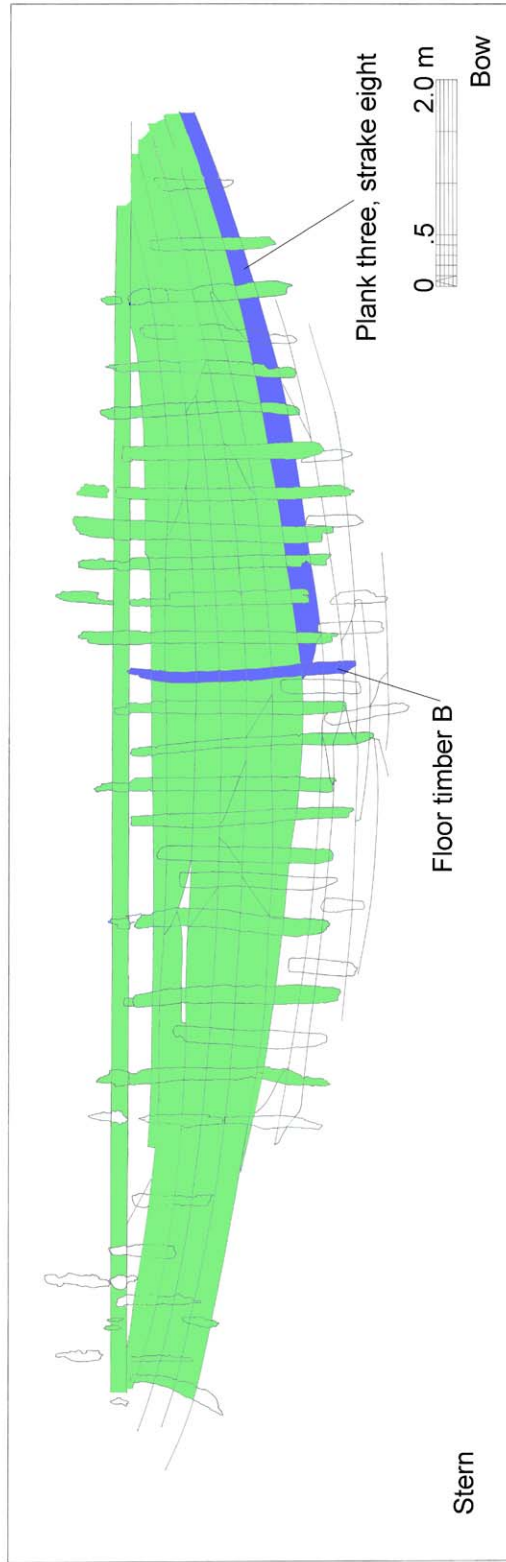
Figure 5-15: Step eleven in re-assembling the Bozburun remains.

The shipwright and workmen could maintain this pace of construction while affixing strake eight in place as well. They removed the rest of the temporary clamps beneath the repair in strake five and added floor timber B before proceeding (fig. 5-15). After fitting plank three in strake eight in place, attaching its aft toe end to floor timber B, floor timbers M and N were fashioned and nailed to the assembled structure. The workmen next attached plank two of strake eight and plank two in strake three. Similarly, once plank one in strake eight was nailed in place, finishing the strake, the workmen fitted floor timbers 8 and 6 in place, and nailed them to the keel and erected strakes (figs. 5-16 to 5-18).

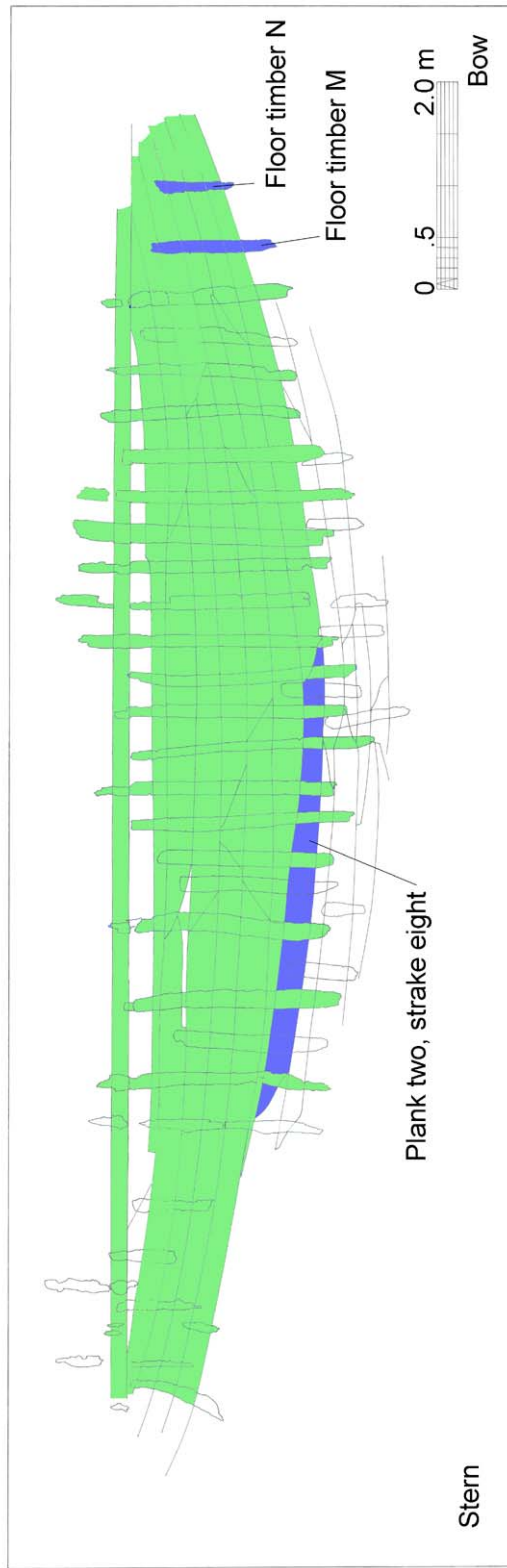
Figure 5-16: Step twelve in re-assembling the Bozburun remains.

Figure 5-17: Step thirteen in re-assembling the Bozburun remains.

Figure 5-18: Step fourteen in re-assembling the Bozburun remains.

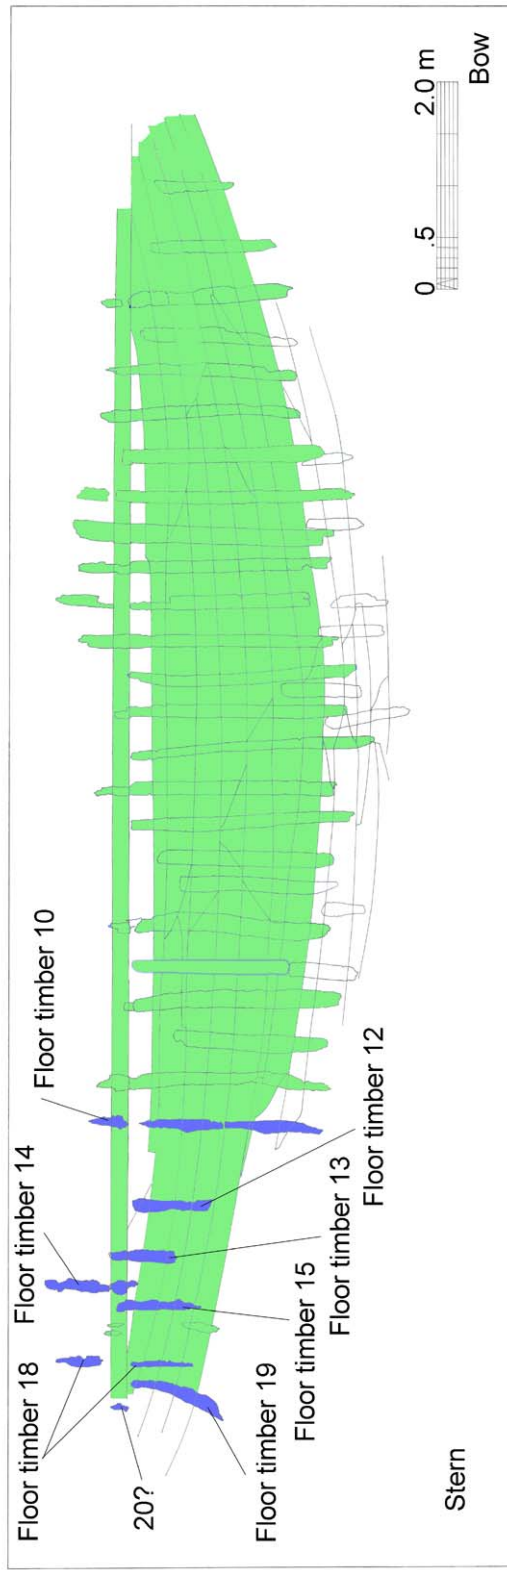
Figure 5-19: Step fifteen in re-assembling the Bozburun remains.

With much of the aft planking already attached to the sternpost, the shipwright and workmen could fashion and fit floor timber 11, and those farther aft, in place fairly easily (fig. 5-19). More importantly, they could also begin to plank the sides of the craft above the turn of the bilge. As illustrated by the slightly haphazard planking pattern evident in strakes nine, ten, eleven and twelve, these strakes were attached to the hull's structure after the adjacent plank runs were complete, not before. The discontinuous nature of their runs is exacerbated by the rising and shifting turn at the bilge, which was sharper near midships than towards the bow or stern.

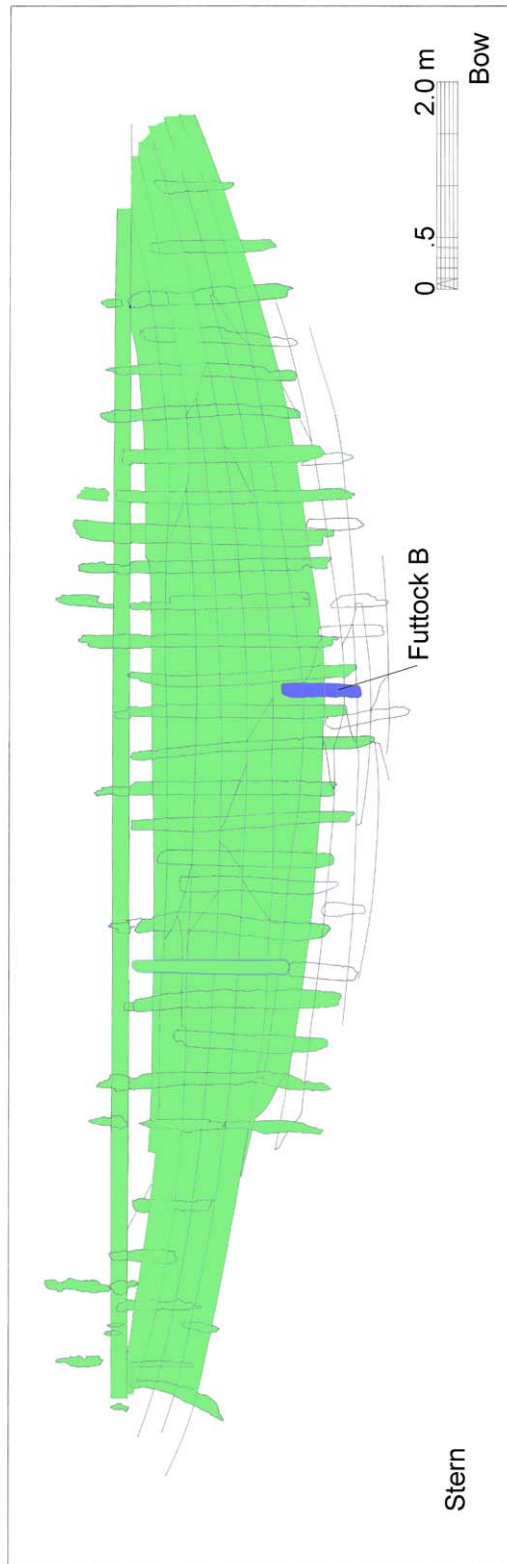
Figure 5-20: Step sixteen in re-assembling the Bozburun remains.

By this point, the midships floor timber, B, D and the majority of the pine floor timbers extended through the turn of the bilge and upwards, providing some preliminary support for strakes fourteen and higher. The shipwright and workmen most likely added the futtock immediately aft of floor timber B at this point as well, to add additional structure and perhaps to define more of the hull's shape farther above the bilge (fig. 5-20).

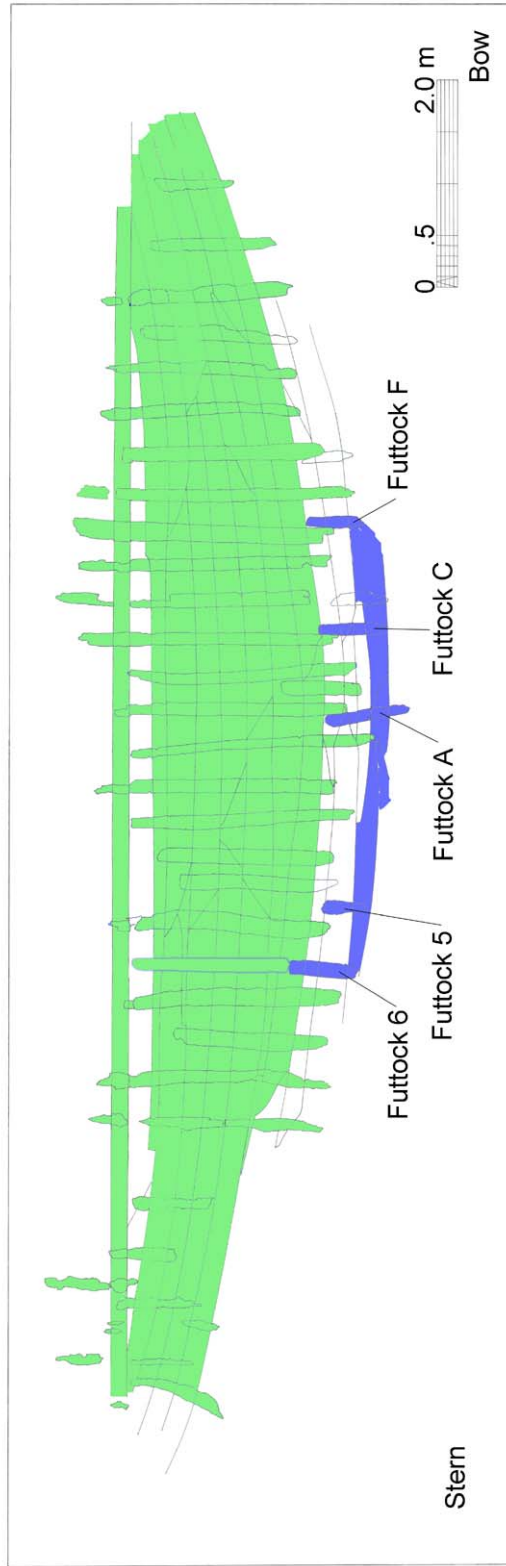
Figure 5-21: Step seventeen in re-assembling the Bozburun remains.

To fill in the gap at the turn of the bilge, it appears that the workmen first added strake thirteen and then strake twelve to close this gap. As planks in both strakes are affixed together by edge dowels, it seems likely that the workmen used the inboard edge of strake fourteen to define the run of strake thirteen, which in turn defined the run of strake twelve. Attaching the planks to each other and to the framing would have been a process of spiling the plank and drilling the edge-dowel holes, and gradually sealing the turn of the bilge. Once these two strakes were in place, the shipwright added the futtocks associated with floor timbers 6, 5, A, C, F and H (fig. 5-21). Unexpectedly, the two futtocks associated with floor timbers A and C did not fit into the exposed L-shaped scarfs at the outboard ends of these two floor timbers. Instead, these two pine futtocks each overlap floor timbers A and C by 20 cm. The futtock for floor timber H, in contrast, does not overlap its corresponding floor timber to either side, but was instead fashioned to fit partially underneath the floor timber at the bilge, apparently because the floor timber's shape did not match the turn in the bilge.

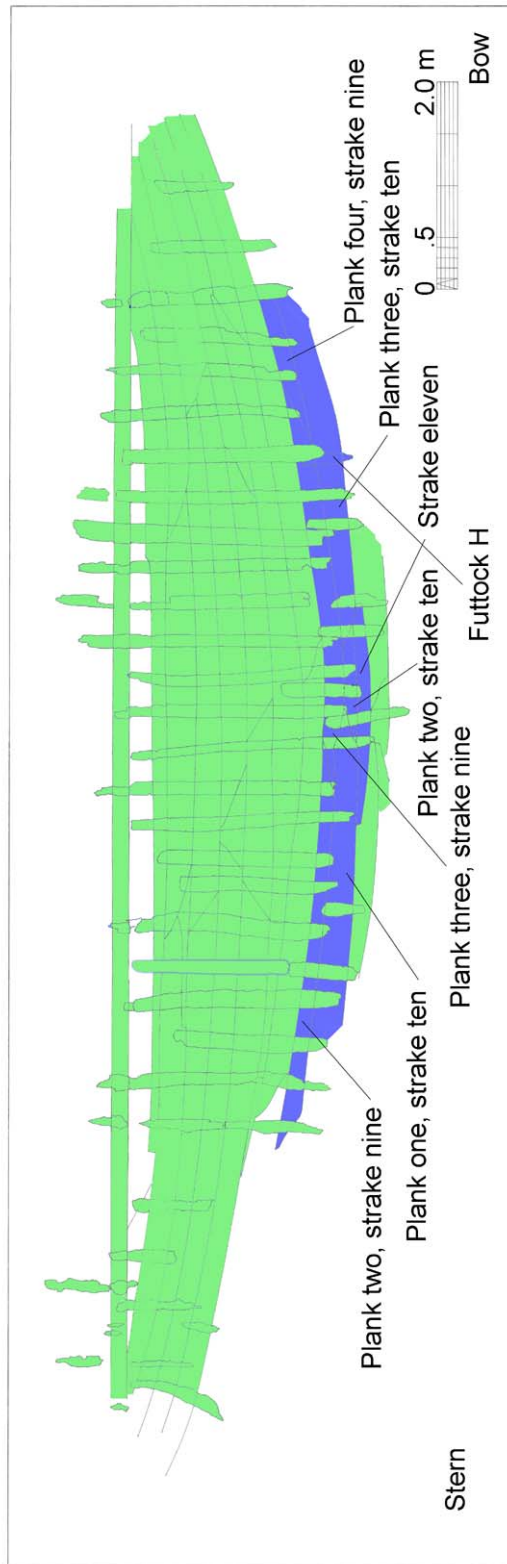
Figure 5-22: Step eighteen in re-assembling the Bozburun remains.

The four planks in strake nine were added next. Plank two in strake nine was installed first, followed by planks one and three, and the strake was completed with plank four at the bow. The nibbed and tapered planks in strake ten were added next, to seal up the turn of the bilge (fig. 5-22).

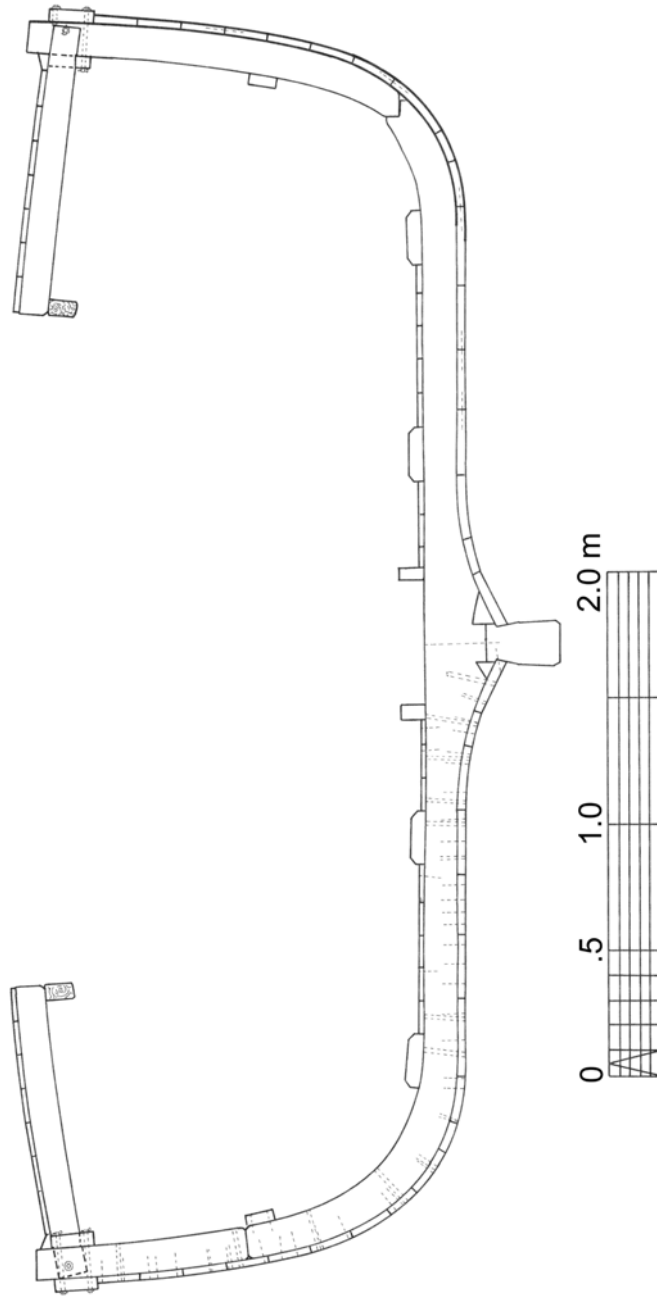
Figure 5-24: Proposed cross section of the Bozburun vessel at midships.

The ship the owner received probably looked similar to that in figures 5-24 to 5-26. With approximately 35 percent of the original hull preserved on the sea floor, the ship's structure above the turn of the port and starboard bilges is conjecture, but it may have been approximately 14.3 m long overall, 13 m along the waterline and 4.9 m in beam at the waterline. Its estimated hold was 1.55 m high and extended 10 m between the tailframes. The lateen sail and boxy cross section probably resulted in a fairly hard ride, but the deep keel and rather flat sides would resist any tendency to slip downwind.

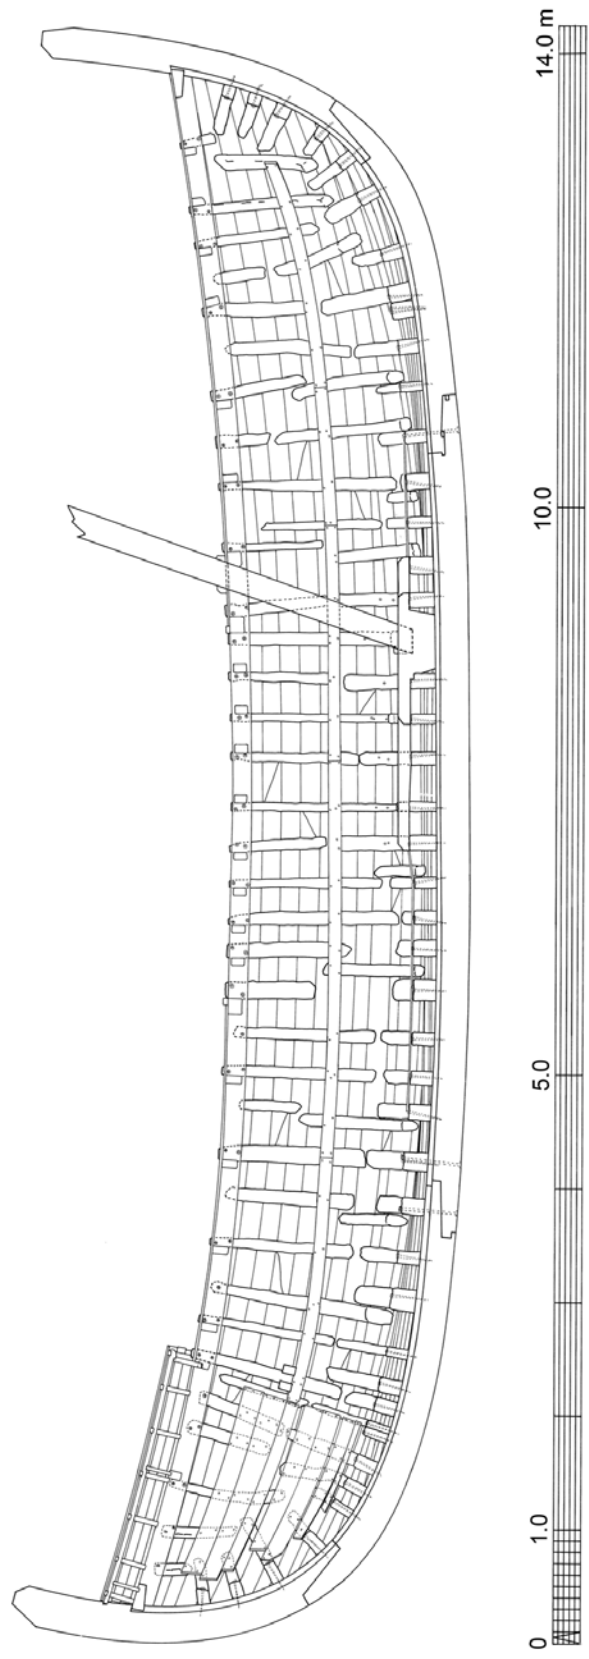
Figure 5-25: Longitudinal cross section of the reconstructed port side of the Bozburun vessel.

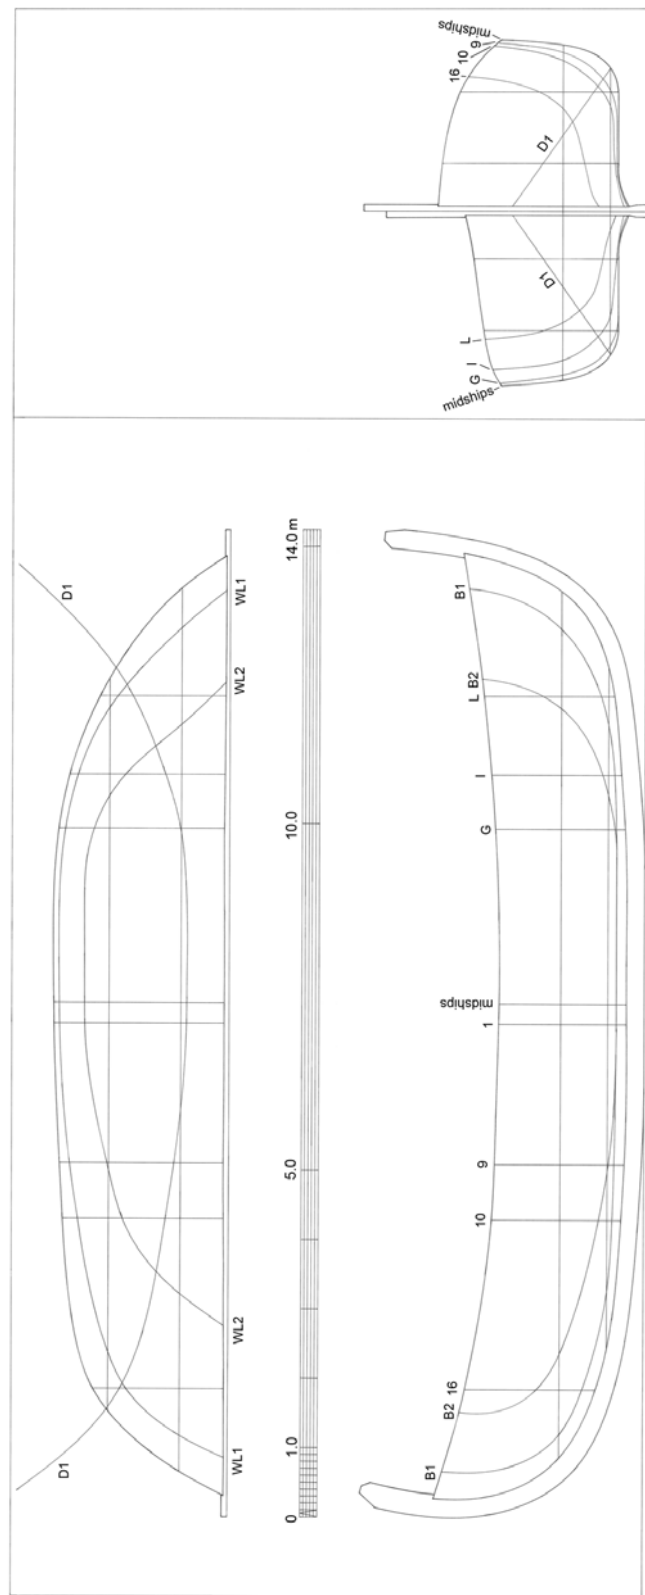
Figure 5-26: Proposed lines of the Bozburun vessel.

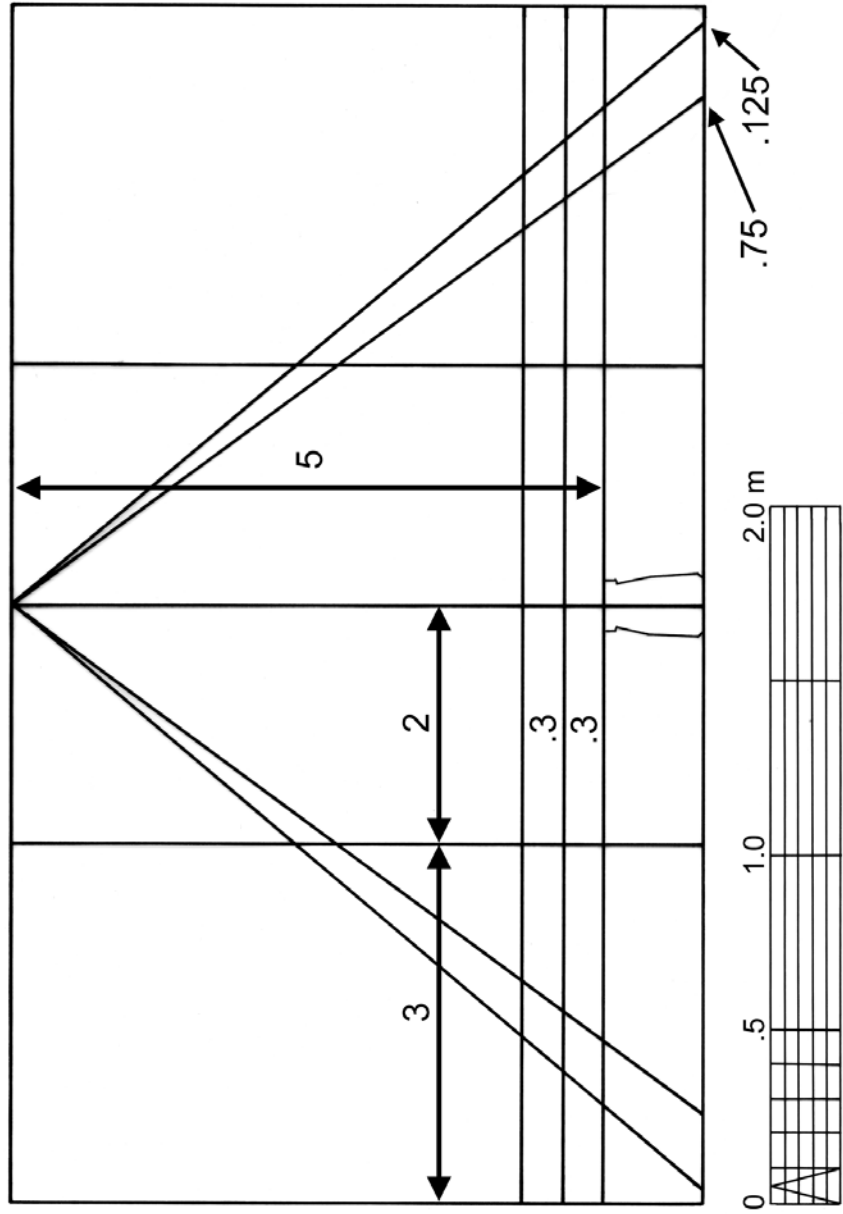
Figure 6-1: Proposed design of the conceptual framework used to design the Bozburun vessel.

either side of the centerline. The lower half of the rectangle was divided into three sections as the shipwright added two more horizontal lines across its width, at heights of 11.5 and 23 cm above the baseline. To finish, he marked two intermediate widths on the baseline, approximately 4.3 and 25.8 cm away from either vertical edge, and joined these marks to the top of the centerline with four diagonal lines. When complete, the sketch most likely looked very similar to the framework in figure 6-1.

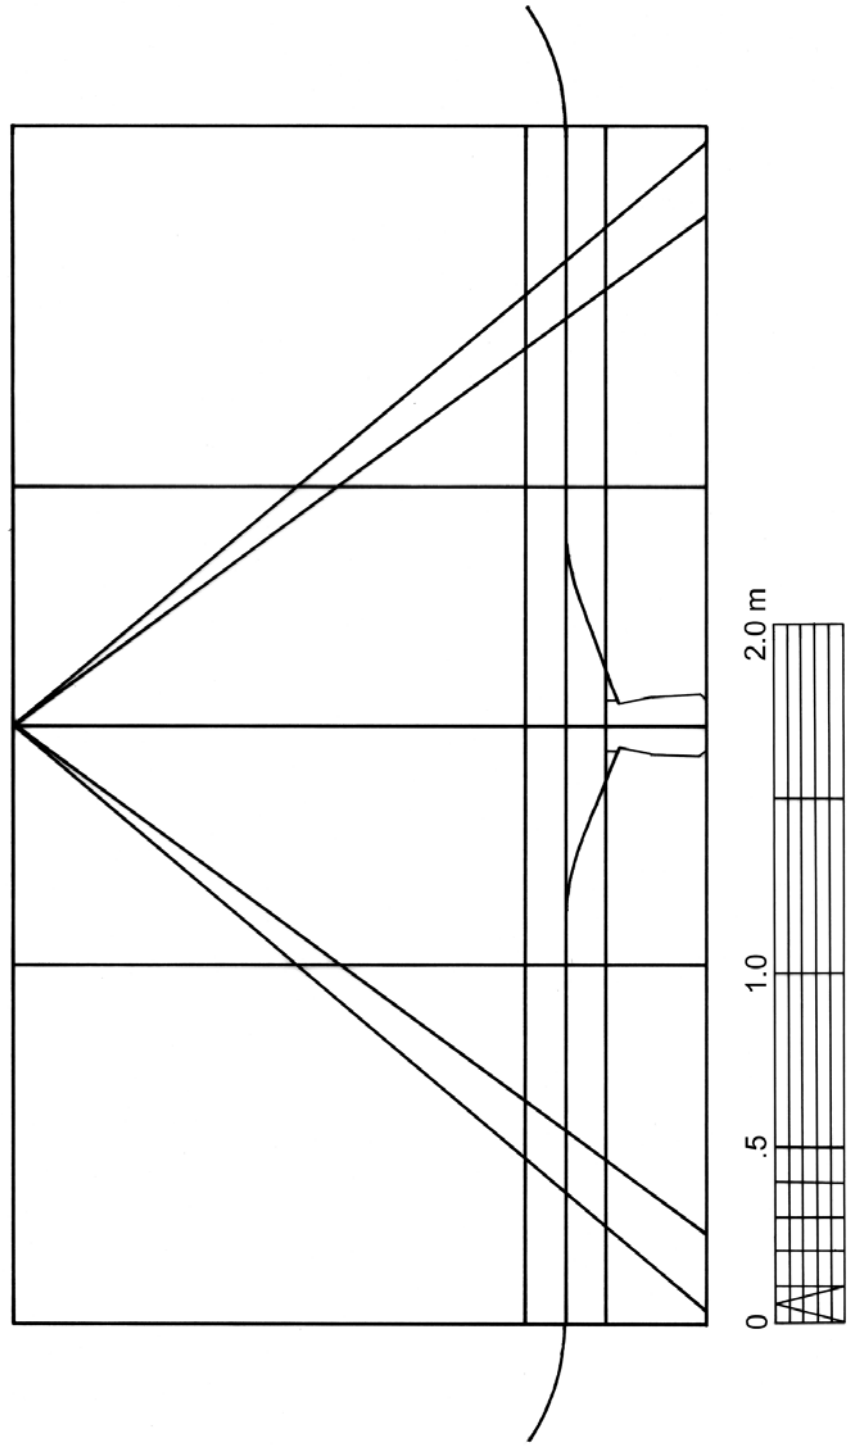
Figure 6-2: Adding curves to the conceptual framework.

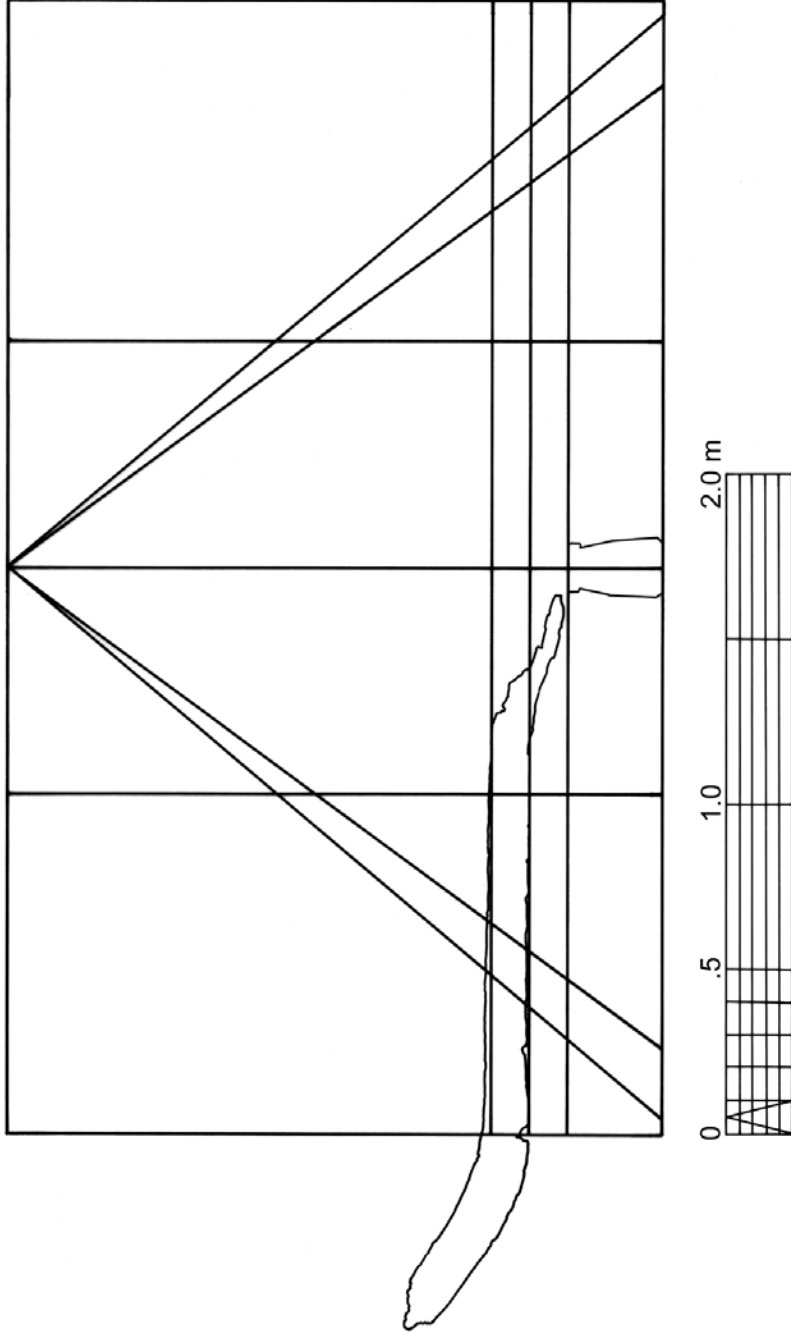
Figure 6-3: Superimposing the midships floor timber over the conceptual framework.

The midships floor timber was designed within this framework by first extending identical bilge curves from either end of the line one-third of a unit above the baseline. Second, at the intersection of the same horizontal line and each vertical line demarcating the four-unit wide center section, additional curves to the baseline and the keel's rabbet outlined the garboard hollows (fig. 6-2). The shipwright had, in this way, not only defined the molded shape of the midships floor timber, but all seven oak floor timbers as well, and had begun a process that would eventually shape the rest of the ship (fig. 6-3).

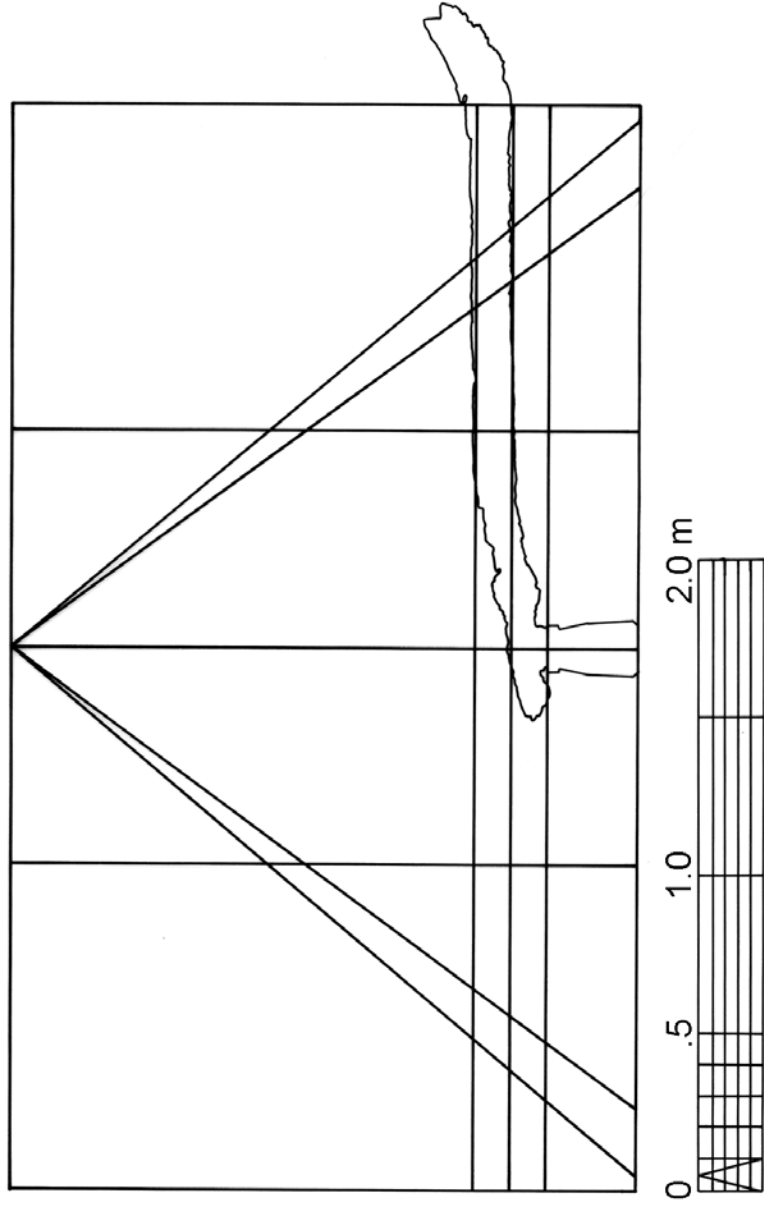
Figure 6-4: Superimposing floor timber 1 over the conceptual framework.

This compromise in the hull was embodied in the instructional guidelines sketched by the shipwright. The primary floor timbers 1 and E are distinctive because they have the same cross-sectional shape as that of the midships floor timber. Outlined on the guidelines, the bilge curves of these three floor timbers begin and end at the same points (figs. 6-4, 6-

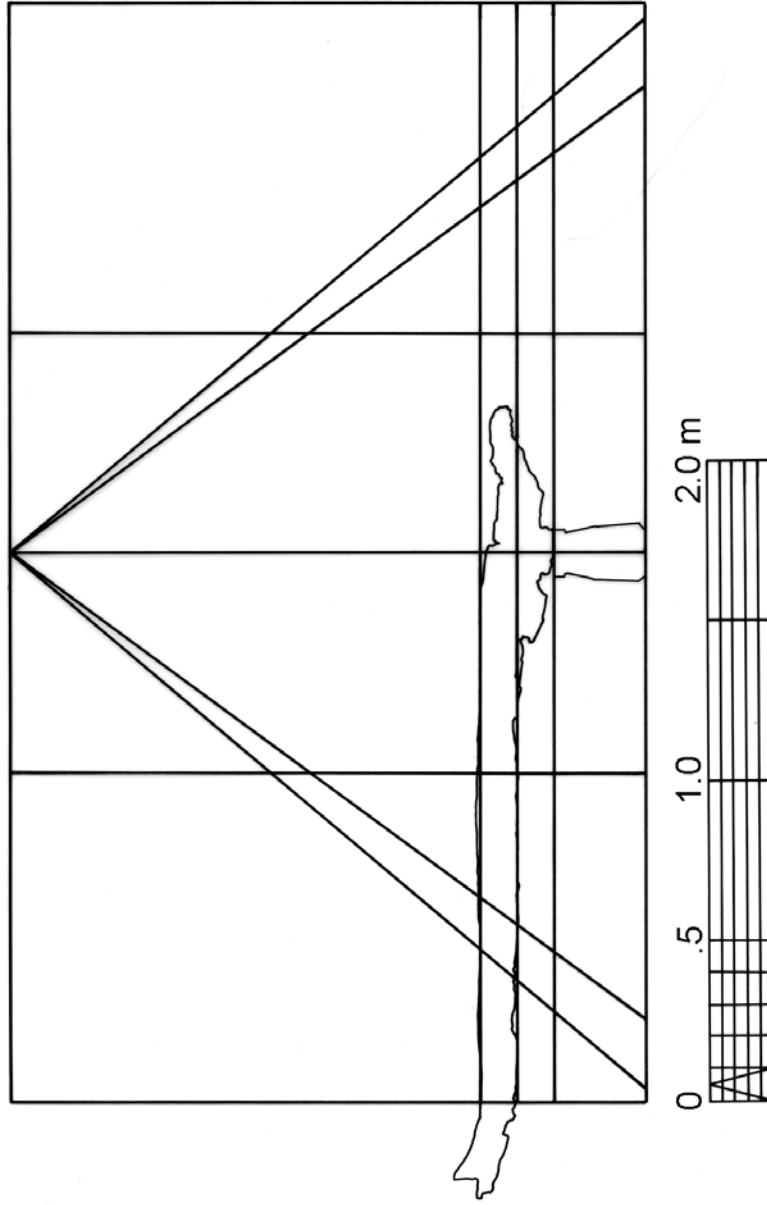
Figure 6-5: Superimposing floor timber E over the conceptual framework.

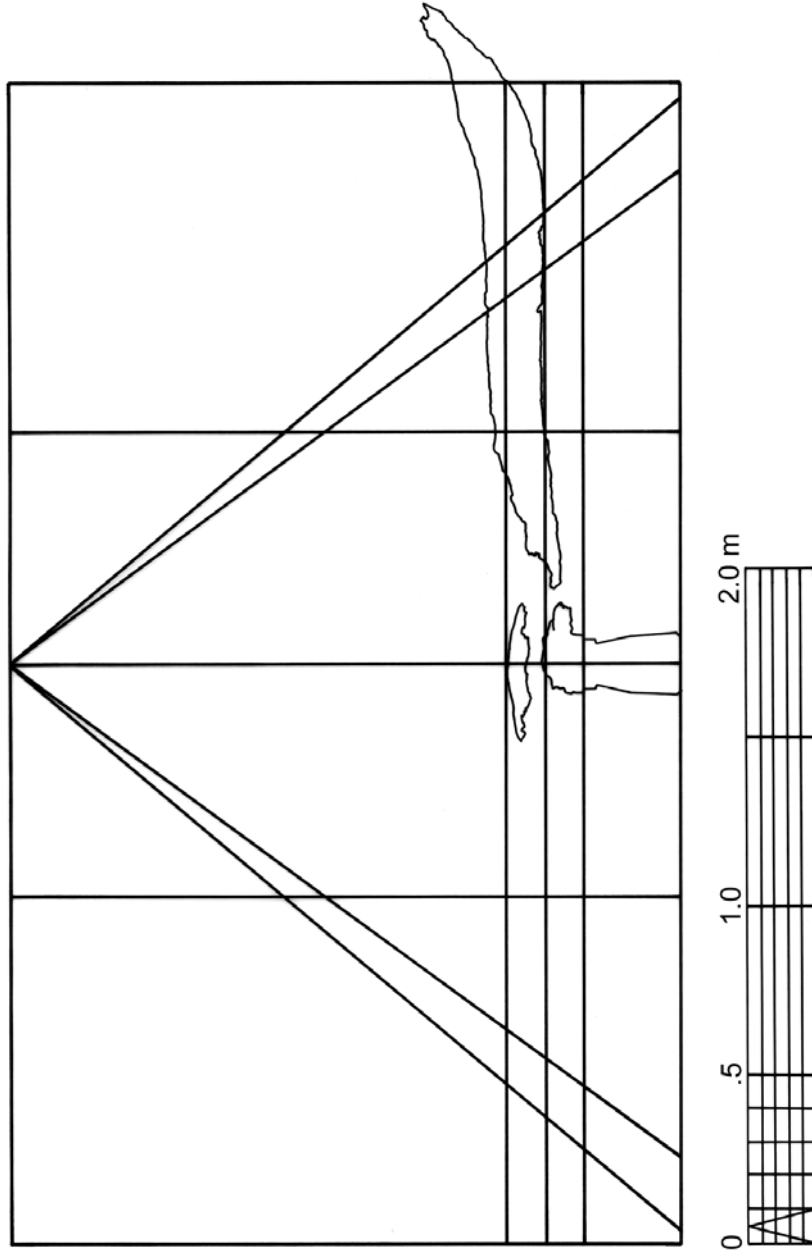
Figure 6-6: Superimposing floor timber 9 over the conceptual framework.

5). The bilge curves in floor timbers 9 and I, on the other hand, begin at a point that is both higher and closer to the keel. On the guidelines, this point is the intersection of the horizontal line one-third of a unit above the line along the keel top, and the diagonal line extending from the top of the centerline to the intermediate mark one-eighth of a unit from either vertical edge (figs. 6-6, 6-7). As the distance between these two points is approximately 77 percent the length of the baseline, it is also possible that this point represents a narrowing line that is three-quarters the length of the baseline.

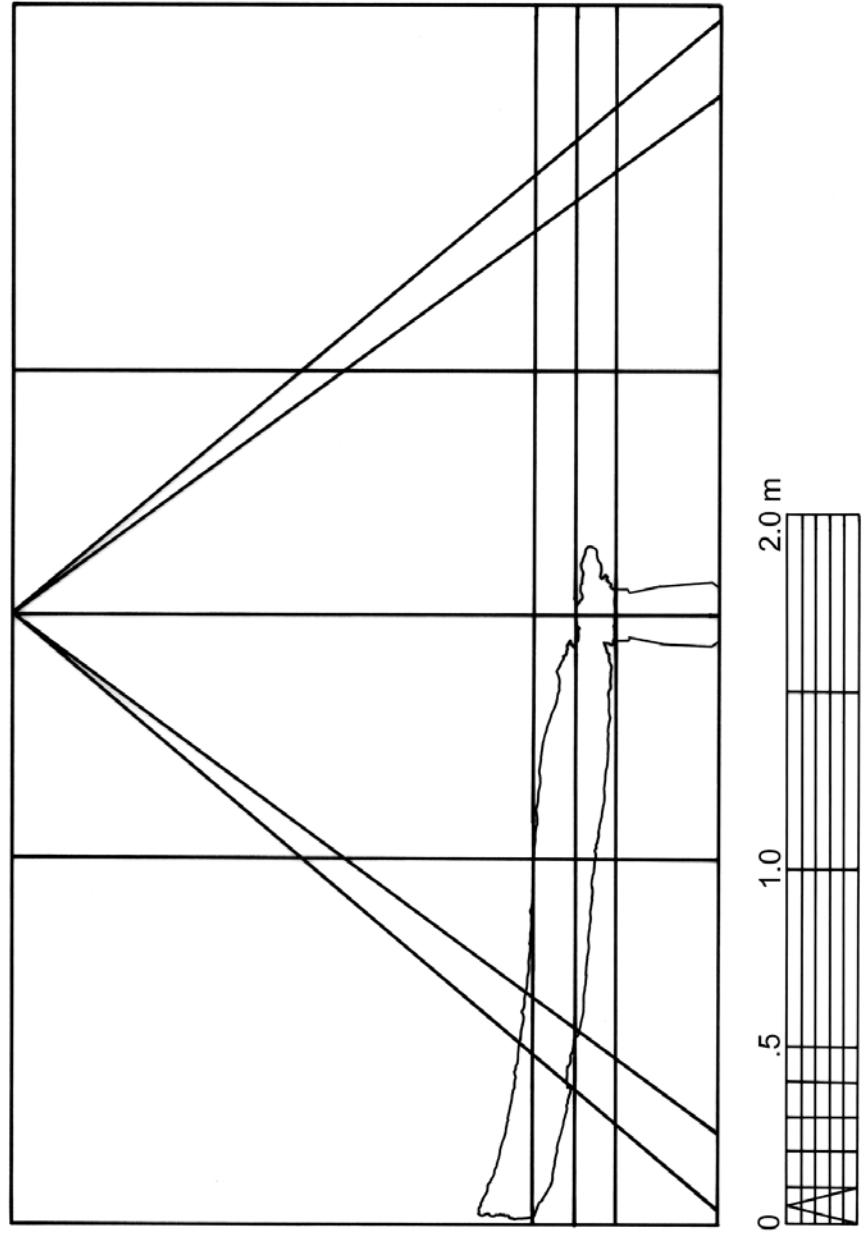
Figure 6-7: Superimposing floor timber I over the conceptual framework.
