**A RE-ASSEMBLY AND RECONSTRUCTION OF
THE 9TH-CENTURY AD VESSEL WRECKED OFF THE COAST OF
BOZBURUN, TURKEY**

A Dissertation

MATTHEW BENJAMIN HARPSTER

A Re-Assembly and Reconstruction of
the 9th-century AD Vessel Wrecked off the Coast of
Bozburun, Turkey. (August 2005)

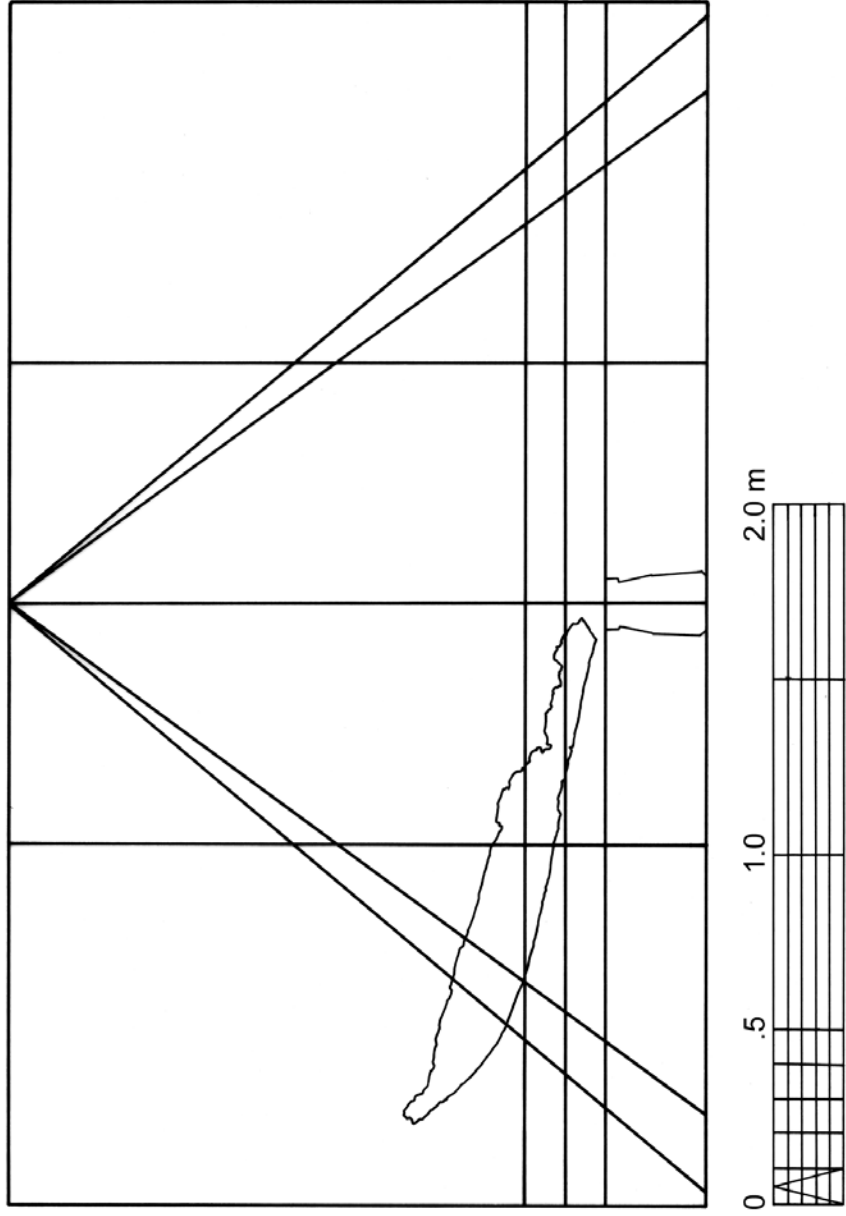
Figure 6-8: Superimposing floor timber L over the conceptual framework.

Importantly, since tailframes are erected fairly early in the construction process, they too needed to have a cross-sectional shape carefully adapted from the shape of the midships floor timber. Thus, the shipwright again used his conceptual framework to define the tailframes' shapes and locations along the keel. Similar to the primary floor timbers 9 and I, the bilge curves of each tailframe were both higher and closer to the keel than those of the floor timbers through the dead flat and, again, a similar process was used to dictate where the appropriate bilge curves began. In this case, the tailframes' bilge curves began at the point where the horizontal line two-thirds of a unit above the baseline intersected the diagonal line extending from the top of the centerline to the intermediate point six-eighths, or three-quarters, of a unit from either vertical edge (fig. 6-8). Similar to the primary frames

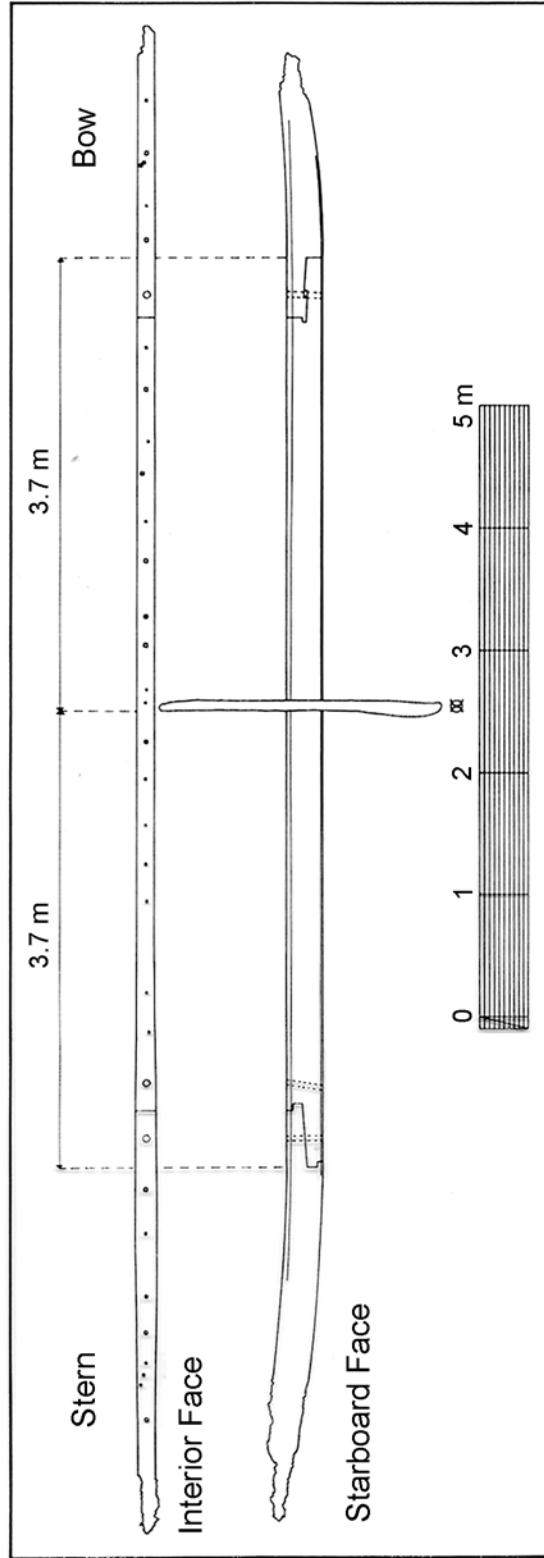
Figure 6-9: Drawing illustrating the alignment of the midships floor timber halfway along the length of the keel.

The apparent instructions for the design and construction of this merchant ship should be summarized. The shipwright used a standard unit length of ca. 34.5 cm as a basis for the conceptual framework in which the ship was designed. This conceptual framework, which is merely an intersecting collection of straight lines, dictated both the shapes and locations of eight key framing timbers in the Bozburun hull. Just as it defined the length of the center flat of the ship as ten times the standard unit, it also established a keel length that is 2.15 times the center flat, or twice the center flat plus 1.5 feet. Following the attachment of the midships floor timber to a point halfway along the keel's length, the locations of the primary floor timbers were demarcated. Floor timber 1 is one unit aft of midships, floor timber E is half the center flat length forward, while 9 and I are 1.5 times the length of their diagonal forward and aft of midships. Lastly, the forward tailframe is 1.25 times the center flat of the ship, or 12.5 feet, forward of midships, while the aft tailframe is 1.5 times the center flat, or 15 feet, aft of the aft primary floor timber (figs. 6-9, 6-10).

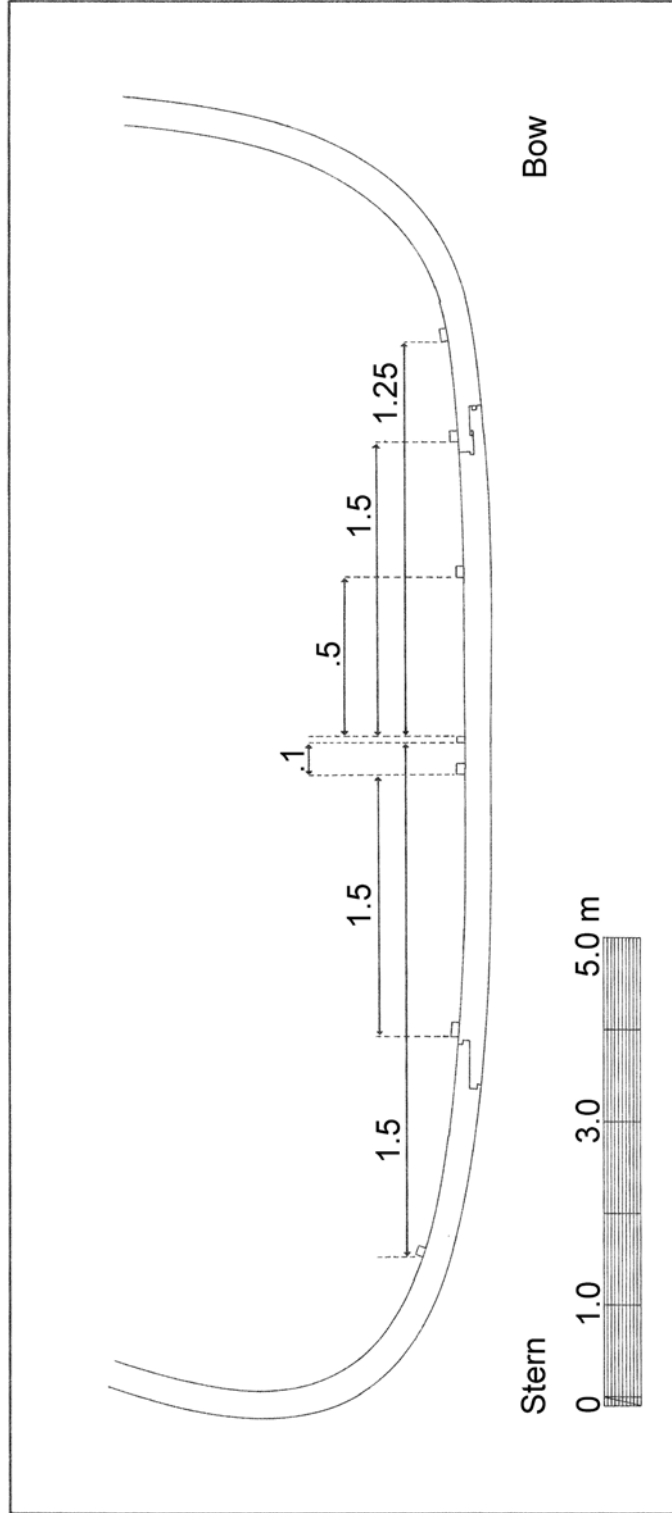
Figure 6-10: Locations of key framing timbers in the Bozburun vessel, and their proportional relationship to the vessel's center flat.

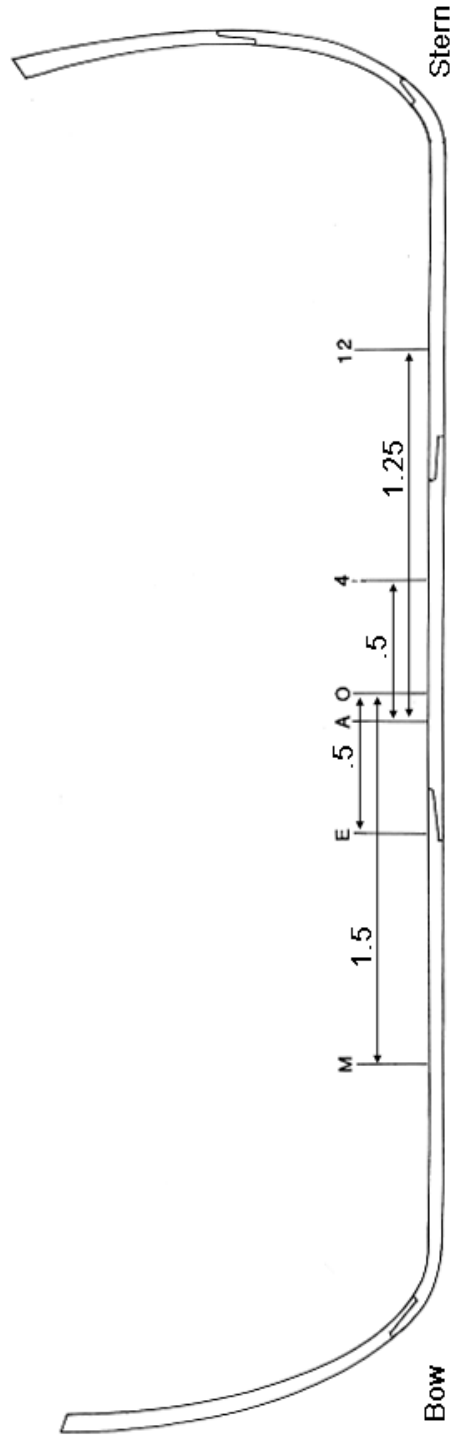
Figure 6-11: Locations of the key framing timbers in the Serçe Limanı vessel, and their proportional relationship to the vessel's center flat (After Steffy 1994, 88).

Again, similar to those in the Bozburun ship, the locations of the two tailframes on the Serçe Limanı vessel were determined by particular multiples of the center flat length between the bilges at midships. On the Bozburun vessel, the forward tailframe was 1.25 times this length forward of the midships floor timber, while the aft tailframe was 1.5 times this length from the aft primary floor timber. On the Serçe Limanı vessel the center flat length is used, as are the same multiples, but the application of the multiples is reversed. The forward tailframe P, for example, is approximately 1.5 times the center flat length forward of frame A, while the aft tailframe 12 is approximately 12.5 times the center flat length aft of midships (fig. 6-11).
