THE MICA SHIPWRECK: DEEPWATER NAUTICAL ARCHAEOLOGY
IN THE GULF OF MEXICO

A Thesis

MASTER OF ARTS

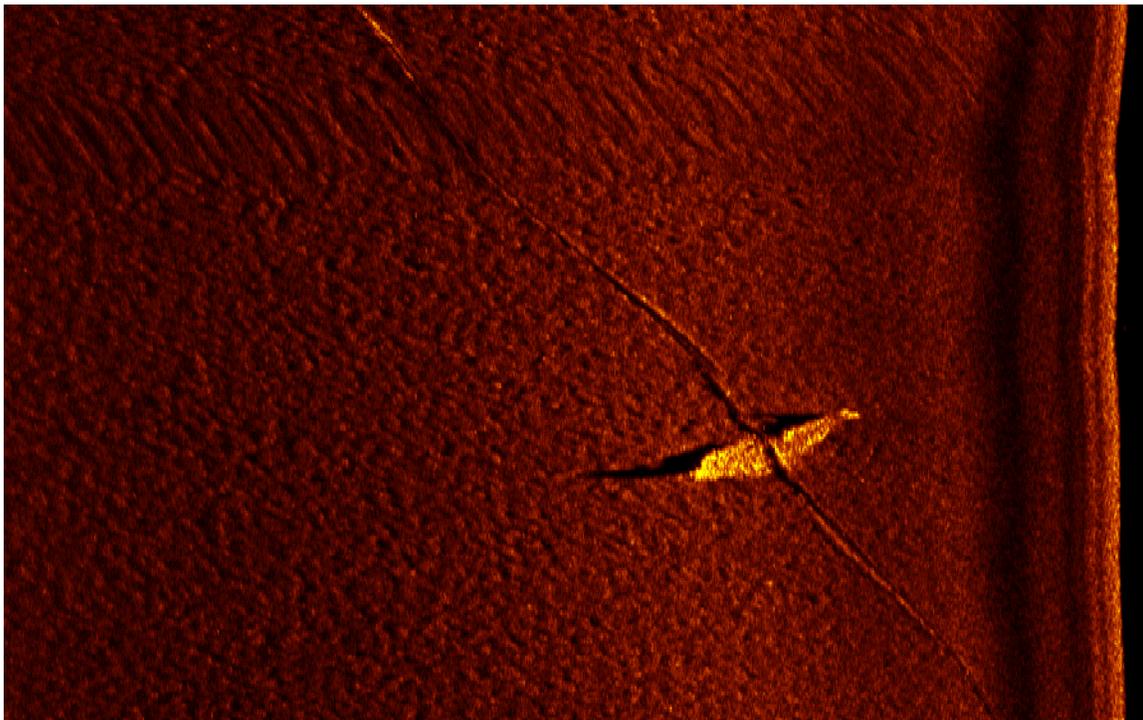
Figure 2. Side scan sonar image of Mica wreck bisected by oil pipeline (Image courtesy of the United States Navy).

A unique hazard of working in the Mica shipwreck area was the location of the oil and gas pipeline. The pipeline almost perfectly bisected the wreck near amidships. As it was being laid, the pipeline contacted the remains of the vessel, knocking down the sides of the hull in the amidships section (Figure 2). The pipeline came to rest on the keelson. It was evident that the structural integrity of the Mica vessel remained, as the force of the pipeline on the keelson and keel caused the bow and stern to lift slightly out of the sediment. The pipeline served as a sort of fence, dividing the wreck into north and south halves. The submarine *NR-1*, with its ability to land and drive on the seafloor, was restricted in its operational movement because of this obstacle.

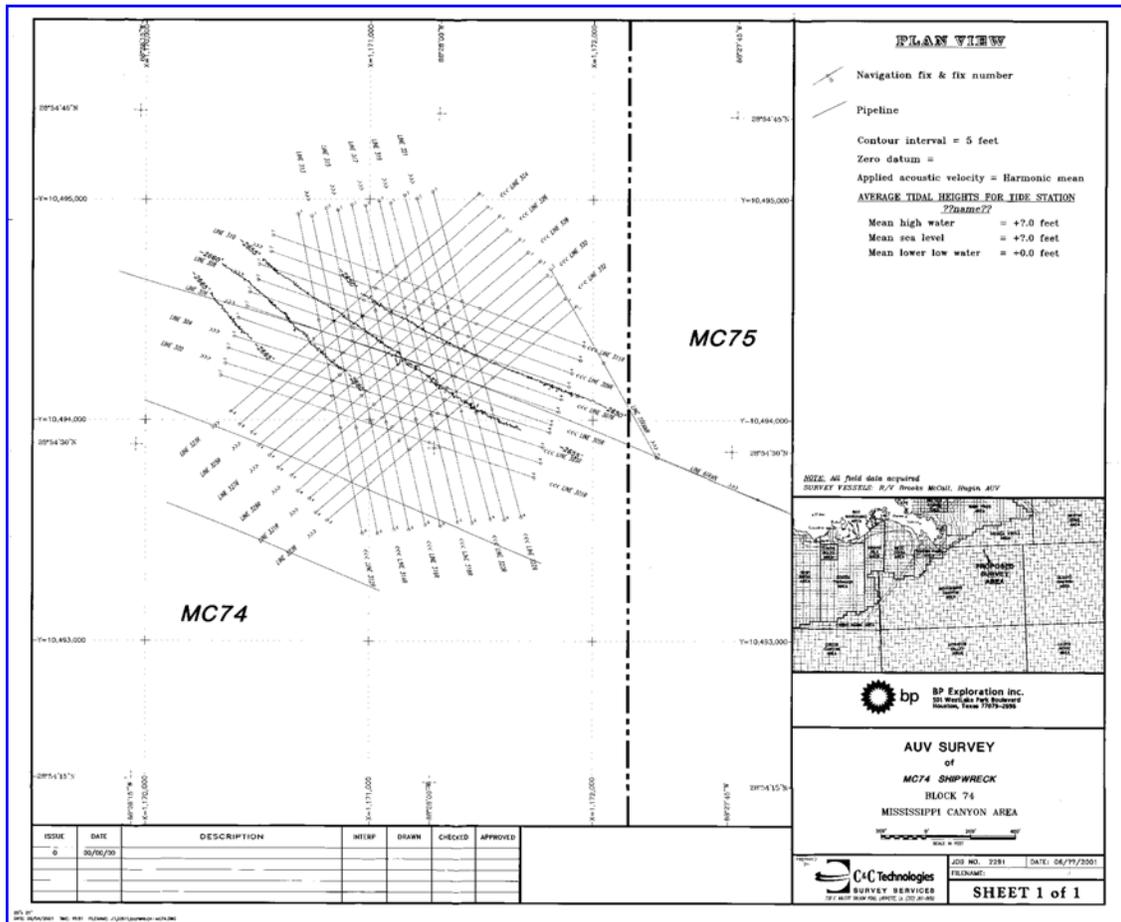
Figure 3. Survey route of the Hugin Autonomous Underwater Vehicle. The robot was equipped with multi-beam and side scan sonar systems (Image courtesy of C&C Technologies).

While archaeologists planned the excavation, C&C Technologies of Lafayette, Louisiana performed a survey of the shipwreck area using an autonomous underwater vehicle. The torpedo-shaped untethered robot flew back and forth over the wreck at regular width intervals and at a preset altitude (Figure 3). The goal of the survey was to define the extent of the wreckage and detect any geohazards that might complicate the investigation (Figure 4).

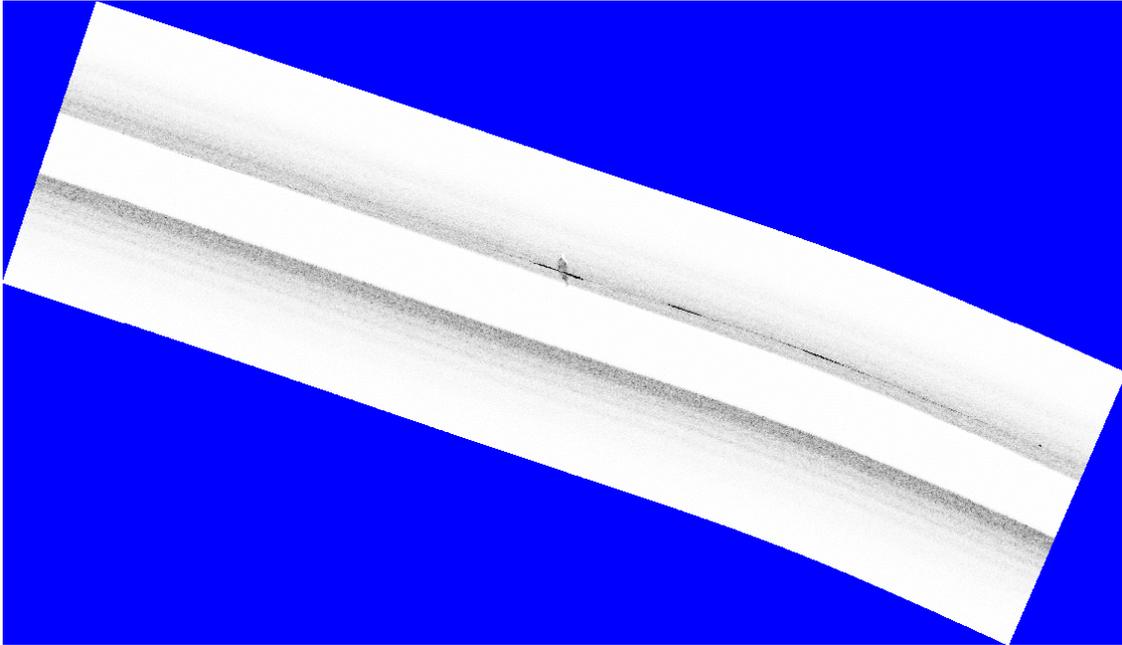
Figure 4. Side scan sonar image of the Mica shipwreck. Note the pipeline running from top left to lower right (Image courtesy of C&C Technologies).

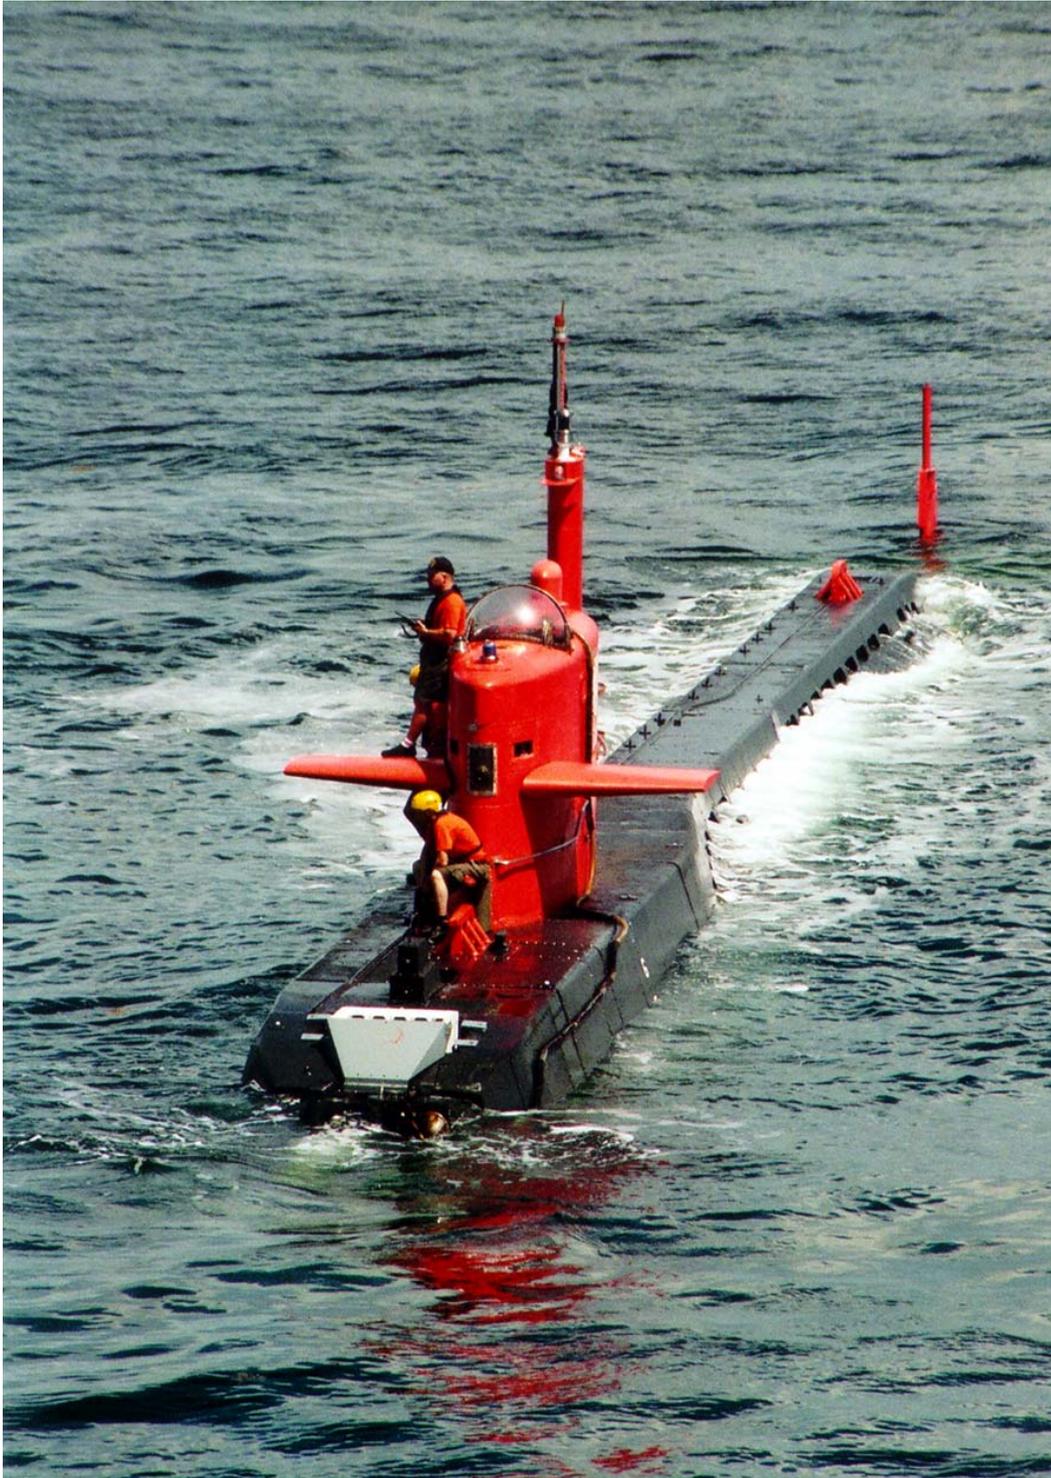
Figure 5. The United States Navy Submarine *NR-1* surfaces during the investigation (Photograph by author).

The nuclear powered submarine *NR-1* was designed, built, and operated by the United States Navy (Figure 5). The 45.72 meter (150 foot) submarine was launched in 1969 and was capable of diving to 914.4 meters (3000 feet). It has numerous unique features that made it a valuable asset to marine archaeologists and other scientists. The submarine is crewed by 12 men, including the captain, executive officer, and chief engineer. The sailors are divided into two watches consisting of six men each. This configuration allows one rider or scientist to accompany the submarine during diving operations. The rider typically sits immediately behind the pilot and navigator of the submarine, which allows for immediate and effective communication (Figure 6). *NR-1* is capable of remaining submerged for months, with the only limiting factors being food and crew morale.

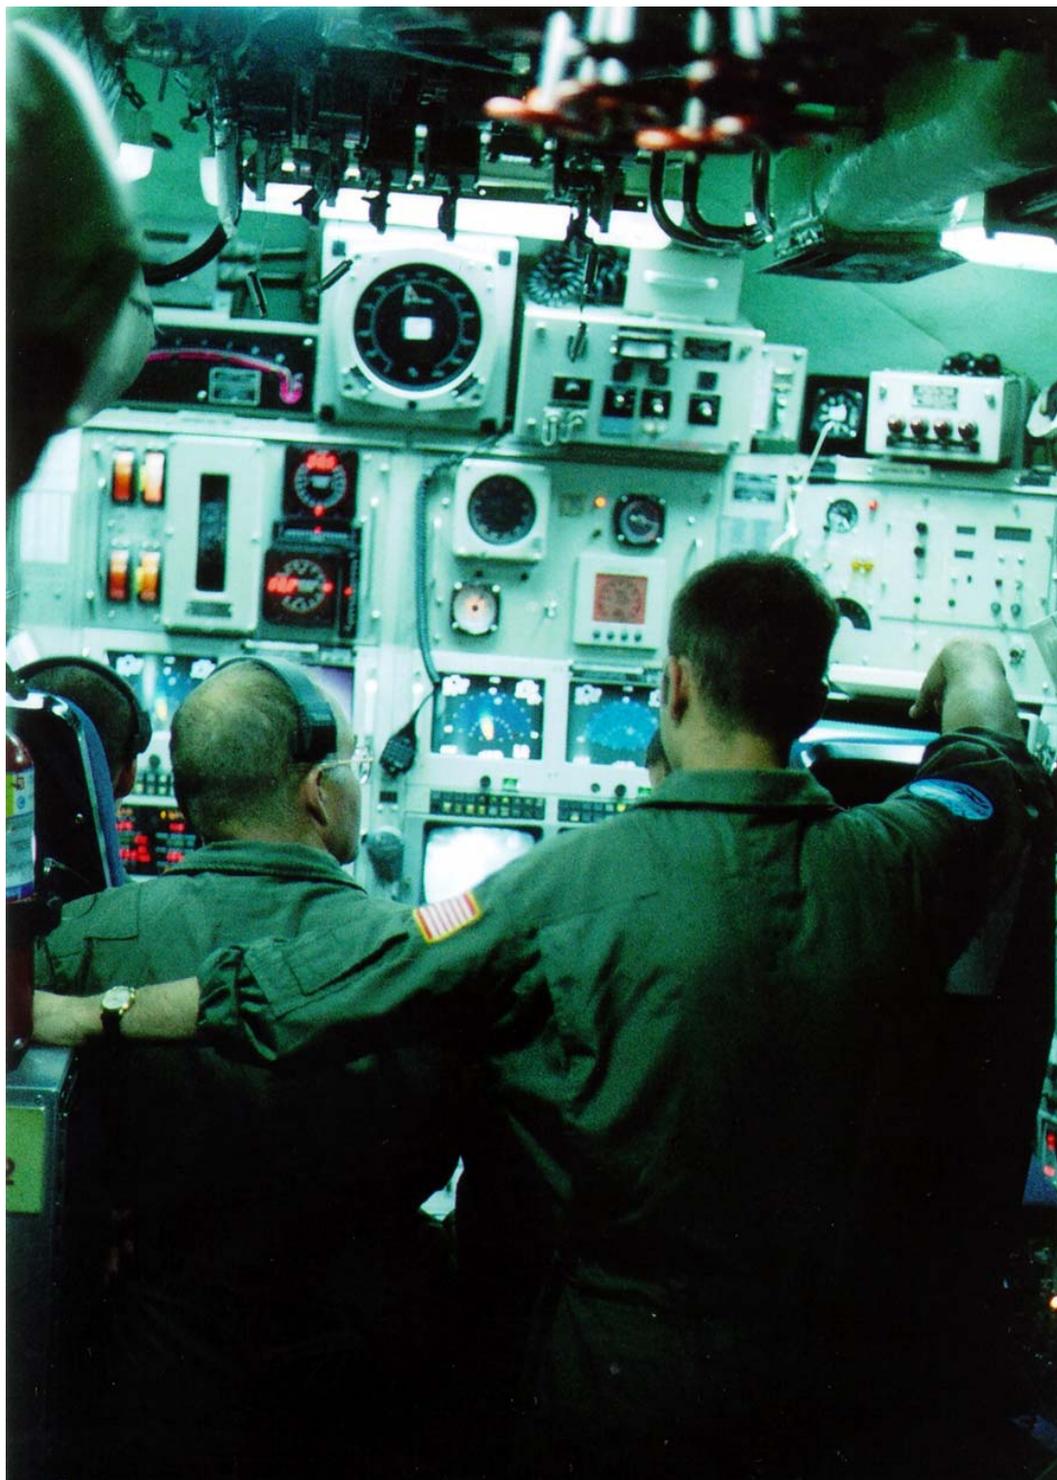
Figure 6. Control center and internal arrangement on the submarine *NR-1* (Photograph by author).

The submarine has several unique features, the most prominent of which are wheels that allow the vessel to drive on the seafloor. The maneuverability and agility of *NR-1* proved invaluable. The submarine is also equipped with a large manipulator arm and 14 digital video cameras that have zoom, pan and tilt features. Numerous lights are attached to the hull of the submarine, providing ample illumination in the otherwise pitch-black environment. There is a work module attached to the external hull of the submarine, located immediately in front of the manipulator arm, which contains various tools. These tools are used by the manipulator arm, and included soil coring devices as well as gripping and cutting devices. There are three view ports on the lower bow surface of the hull, directly behind the manipulator arm. From this vantage point it is possible to observe the actions of the manipulator arm as well as search the wreck site without the use of cameras. The submarine can communicate with vessels on the surface via radio and through-water acoustical modem.

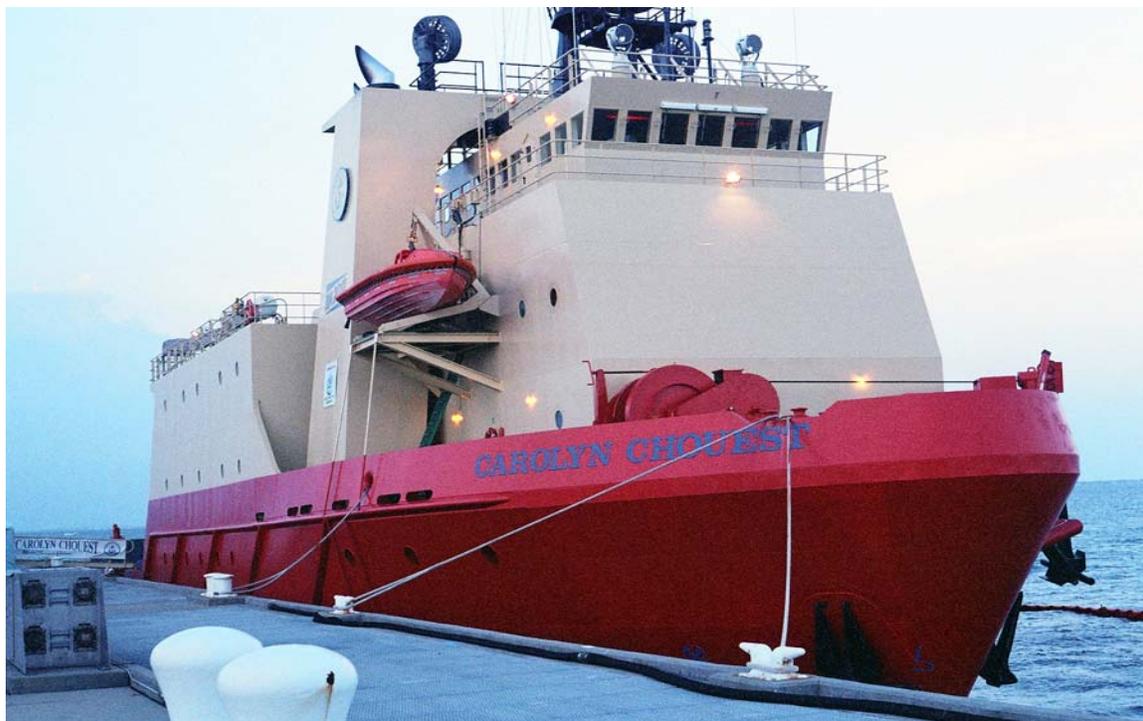
Figure 7. SSV *Carolyn Chouest*, the surface support vessel for *NR-1*. The vessel was docked at Pensacola Naval Air Station, Pensacola, Florida (Photograph by author).

SSV Carolyn Chouest is the surface support vessel for *NR-1* (Figure 7). The 72.5 meter (238 foot) vessel has a beam of 15.9 meters (52 feet) and a draft of 5.2 meters (17 feet). It had a total displacement of 1599 long tons. The surface vessel tows *NR-1* between work areas, as well as serving as a floating supply warehouse and providing quarters for the extra crewmembers. During the Mica shipwreck investigation, the scientists were housed in staterooms on the *SSV Carolyn Chouest*.

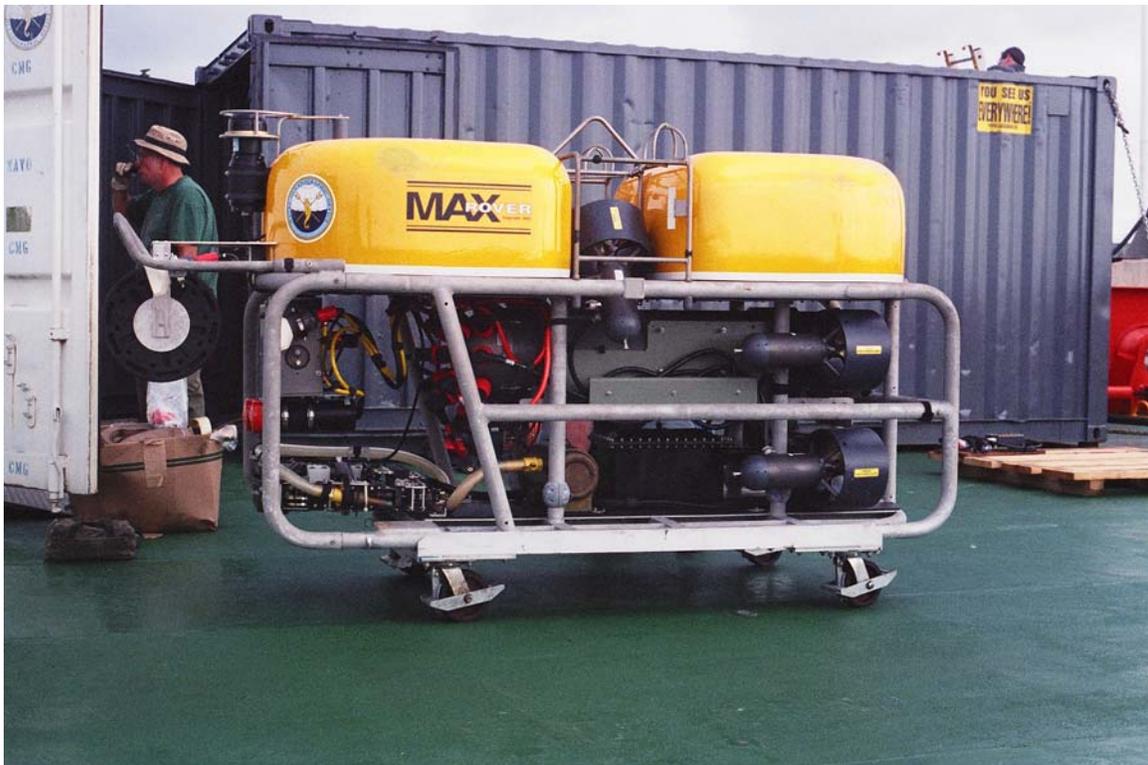
Figure 8. The Naval Oceanographic Office's *MaxRover* remotely operated vehicle. Here it is seen preparing to explore the Mica shipwreck site (Photograph by author).

In order to remove the overburden inside the wreck and retrieve larger artifacts, a work-class remotely operated vehicle was utilized. The Naval Oceanographic Office provided a Deep Sea Systems *MaxRover* work system, accompanied by three pilots (Figure 8). The large unmanned vehicle is controlled via a fiber optic tether, which is capable of sending real-time high-resolution digital imagery to the surface. The robot is equipped with a manipulator arm and six thrusters, which allow the vehicle to hold station with remarkable precision.

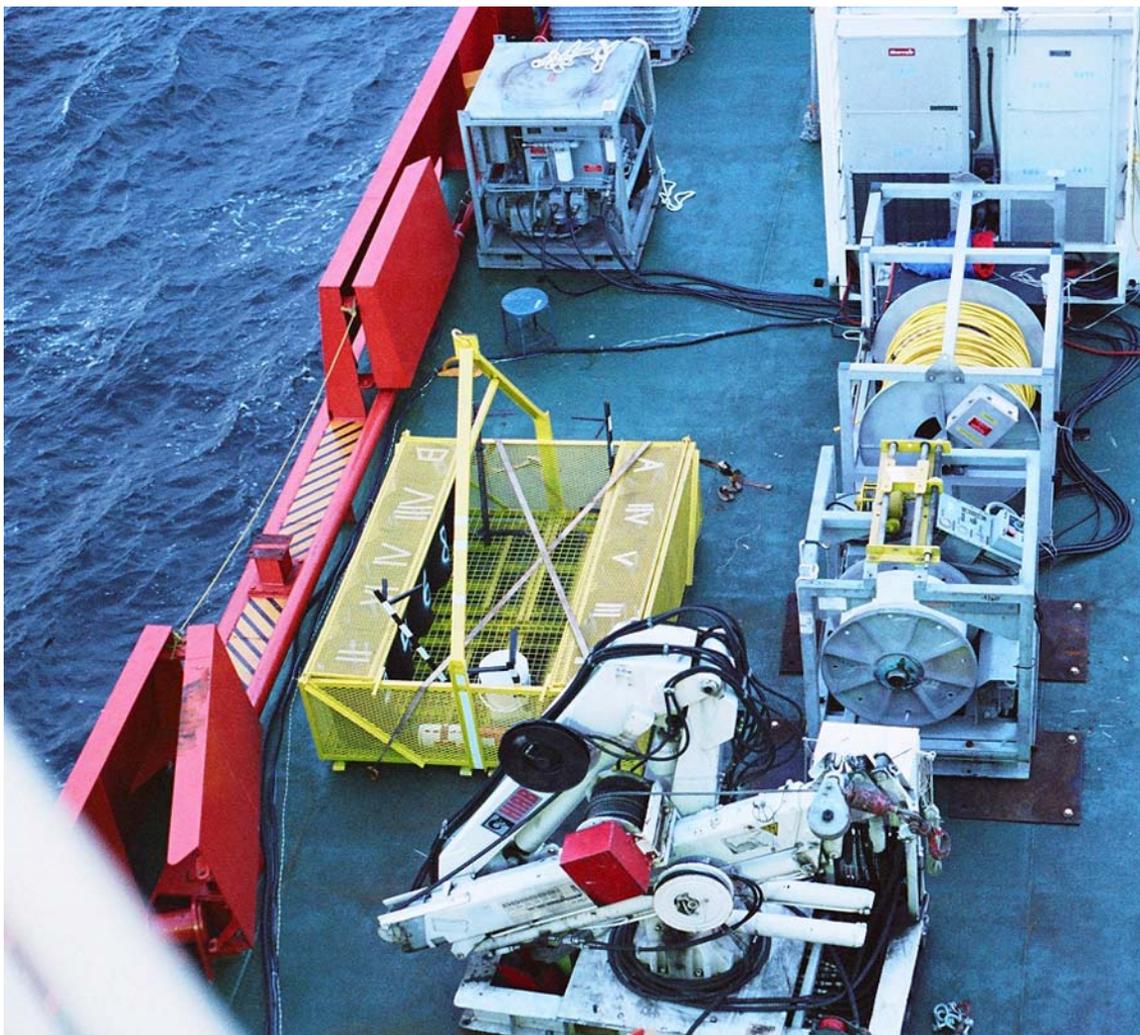
Figure 9. The Mica shipwreck investigation artifact lift. The lift, visible in the center of the photograph, was designed to securely carry artifacts from the wreck site to the surface vessel. The basket also served as a clump weight for the MaxRover vehicle (Photograph by author).

An artifact retrieval system was designed and built at the Offshore Technology Research Center at Texas A&M University (Figure 9). The system consisted of a square steel mesh-lined box containing ten individually numbered barrels with doors that prevented retrieved material from escaping. The box also contained an open area in the center, which was designed to hold large pieces of the vessel's metallic sheathing, or structural samples of the vessel, including the sternpost. This open area was also useful for carrying tools down to the site, including four one-meter (3.3 foot) scale bars. These scale bars were built like sawhorses, to allow them to sit on top of the unconsolidated sediment, both inside and around the shipwreck.

The artifact retrieval system is designed to be deployed and retrieved by a winch on the SSV *Carolyn Chouest*. When deployed on the seafloor, the artifact retrieval system serves a secondary purpose as a clump weight to which the *MaxRover* tether is attached. The basket was positioned approximately 50 meters (164.1 feet) from the wreck. This position allows both the *MaxRover* and the SeaBotix *Little Benthic Vehicle 1500* to access the artifact retrieval system. Subsequent expeditions to the Mica wreck site used similar, albeit smaller, versions of the artifact retrieval system.

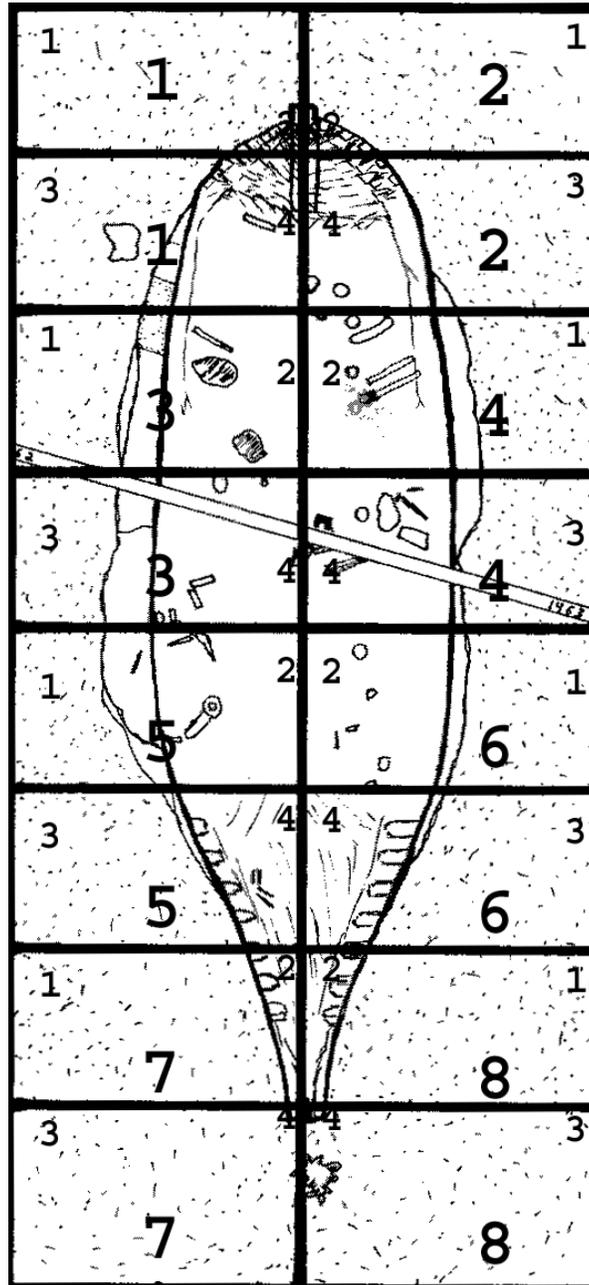
Figure 10. Mica shipwreck site grid. The site grid shows quadrants (bold numbers) and sections (smaller numbers). Even number quadrants represent areas inside of the hull, while odd number quadrants represent areas outside the hull (Drawing by author).

To aid in the organized recovery of artifacts for conservation and analysis, a site grid was developed that divided the interior of the wreck into eight sections containing four quadrants each (Figure 10). The shipwreck site was divided into port and starboard halves along the keel. Each half was divided into four sections that were five meters (16.4 feet) square. Each five meter (16.4 foot) square section would be further subdivided into quadrants measuring 2.5 meters (8.2 feet) on a side. A system of numbering the artifacts and entering them into a catalog upon retrieval was formulated. The remotely operated vehicle pilots would place retrieved artifacts in individually numbered containers on the artifact retrieval system. The entire process of artifact

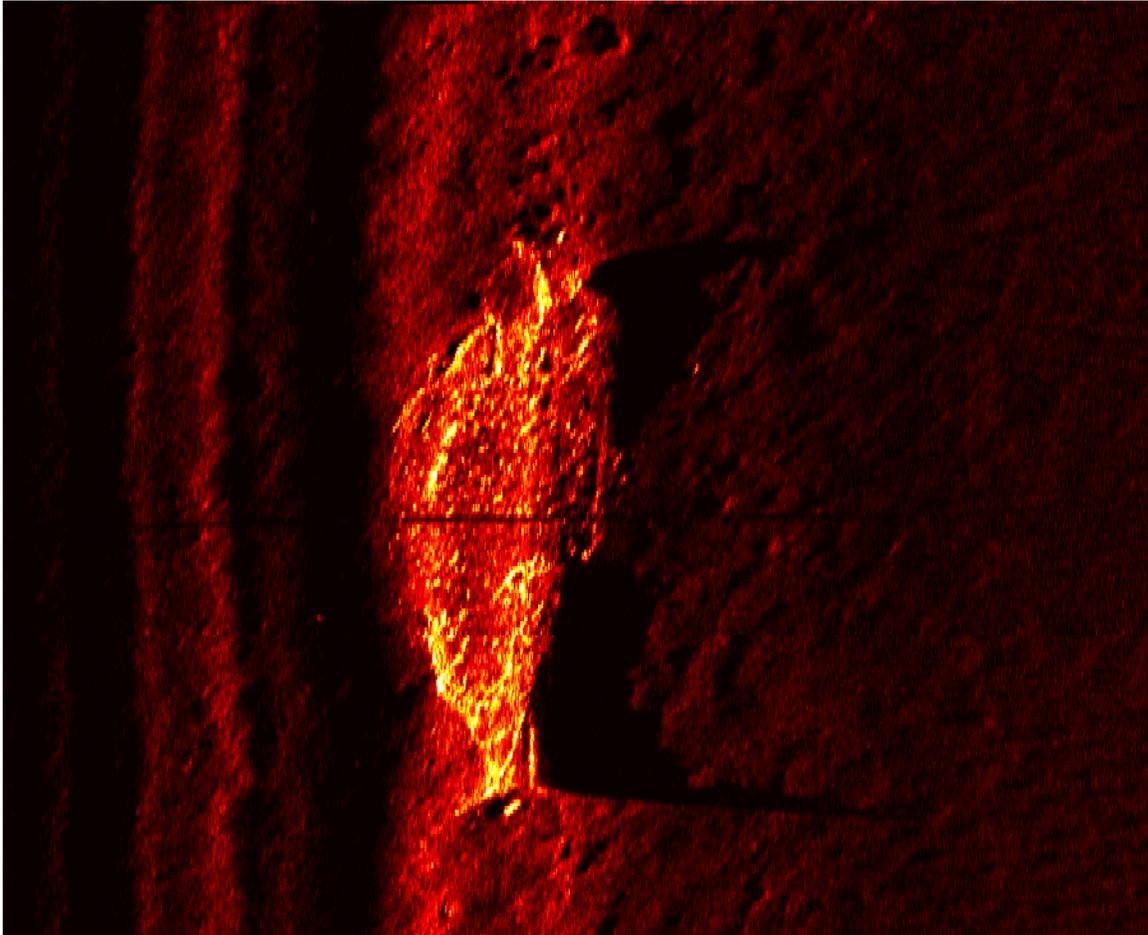
Figure 11. Detailed 600 kHz side scan sonar view of the Mica shipwreck. The stern profile can be seen in the acoustic shadow in the bottom right of the photograph (Image courtesy of the United States Navy).

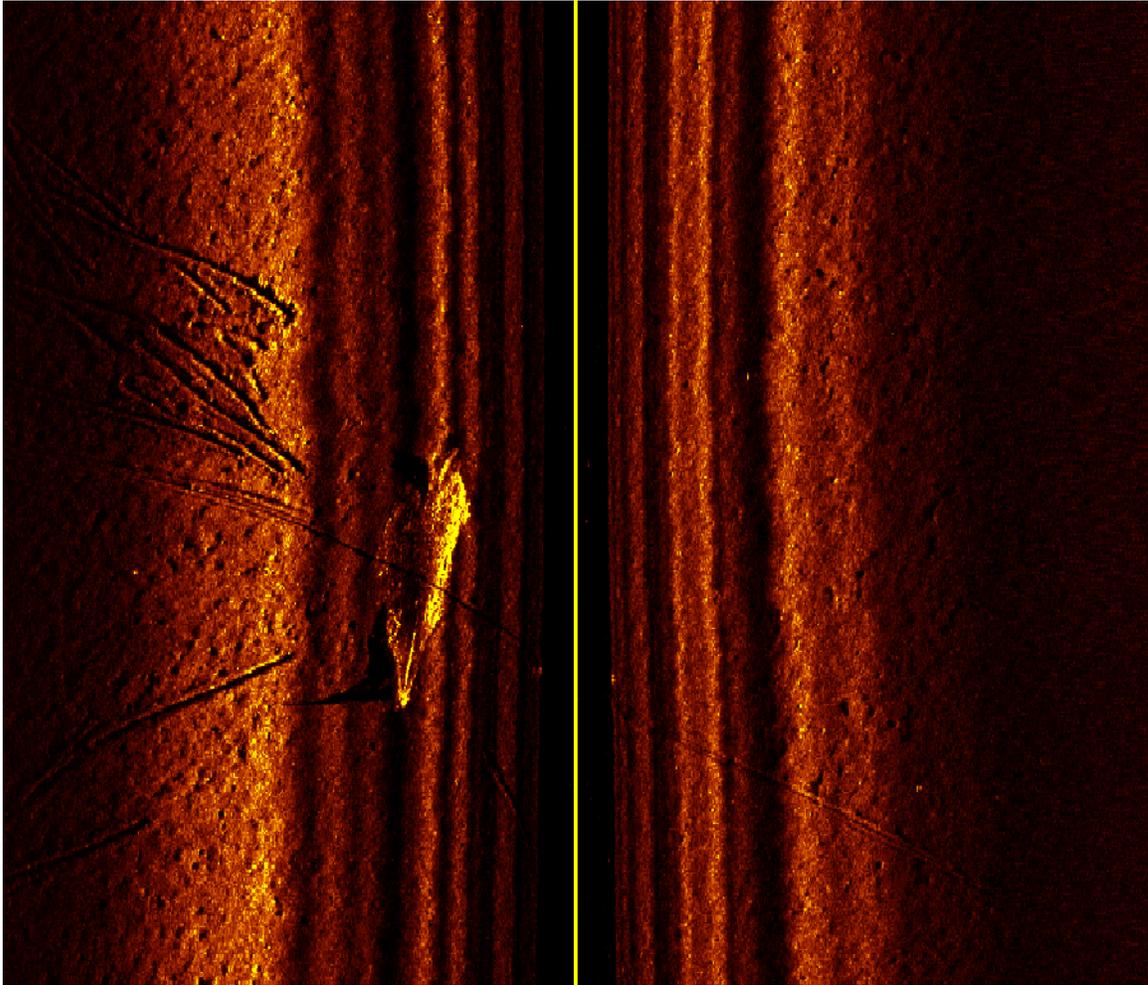
Figure 12. Side scan sonar image of Mica shipwreck. Note the numerous tire tracks (left) where the submarine drove along the seafloor. The ruts made maneuvering on the seafloor more difficult as the investigation continued (Image courtesy of the United States Navy).

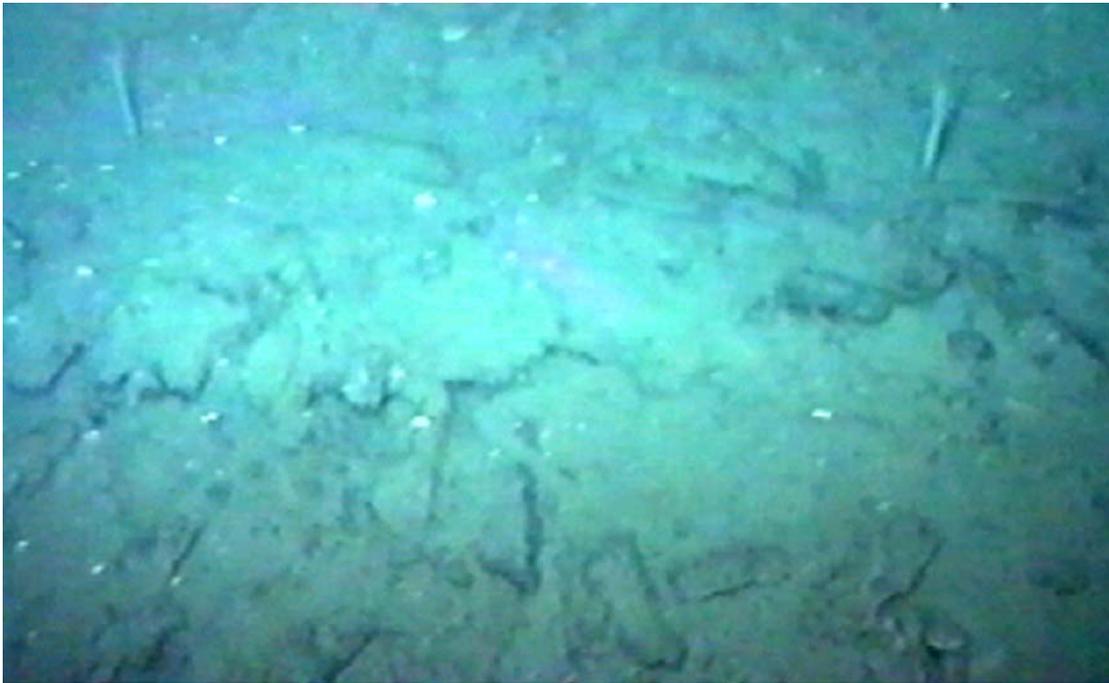
Figure 14. The keelson bolts on the Mica shipwreck. They do not appear corroded, leading to the assumption that they were made of a copper alloy, not iron (Photograph courtesy of the United States Minerals Management Service and ExxonMobil Corporation).

With the SSV *Carolyn Chouest* and *NR-1* again fully operational, the archaeologists resumed their investigation of the Mica shipwreck. Dr. Rik Anuskiewicz, the second scientist to ride on the submarine, commenced his dive at 1820 on 26 July 2002. A measuring bar, left behind during an earlier visit by a remotely operated vehicle, was leaning against the pipeline approximately 30.4 meters (100 feet) west of the wreck area. Dr. Anuskiewicz directed the crew of the *NR-1* to pick up the measuring bar and place it abaft of the pipeline, near the row of keelson bolts (Figure 14).

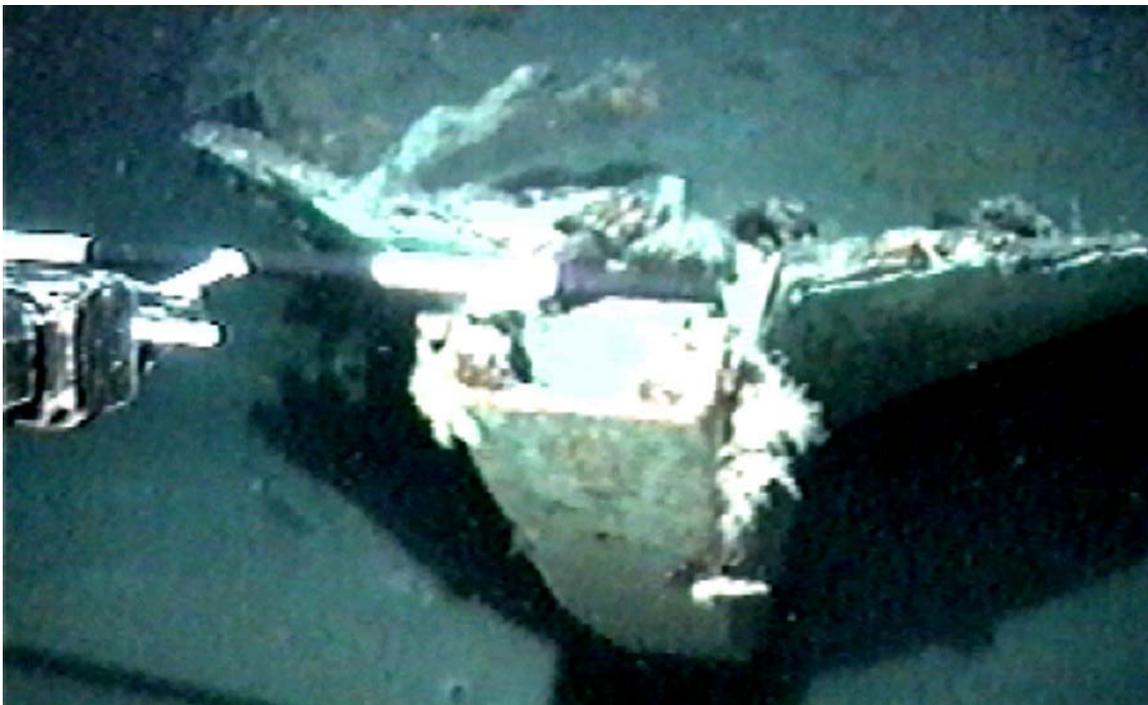
Figure 15. Bow area of the Mica shipwreck. Tips of the cant frames can be seen. The stem, along with the rest of the hull's exterior was covered with copper sheathing (Photograph courtesy of the United States Minerals Management Service and ExxonMobil Corporation).

the wreck with the manipulator arm. Working within the confines imposed by the currents, the archaeological team believed that additional areas of the wreck could be dusted off to expose structural timbers (Figure 15). With the new priority, it was time for the fourth submarine dive to the Mica wreck.

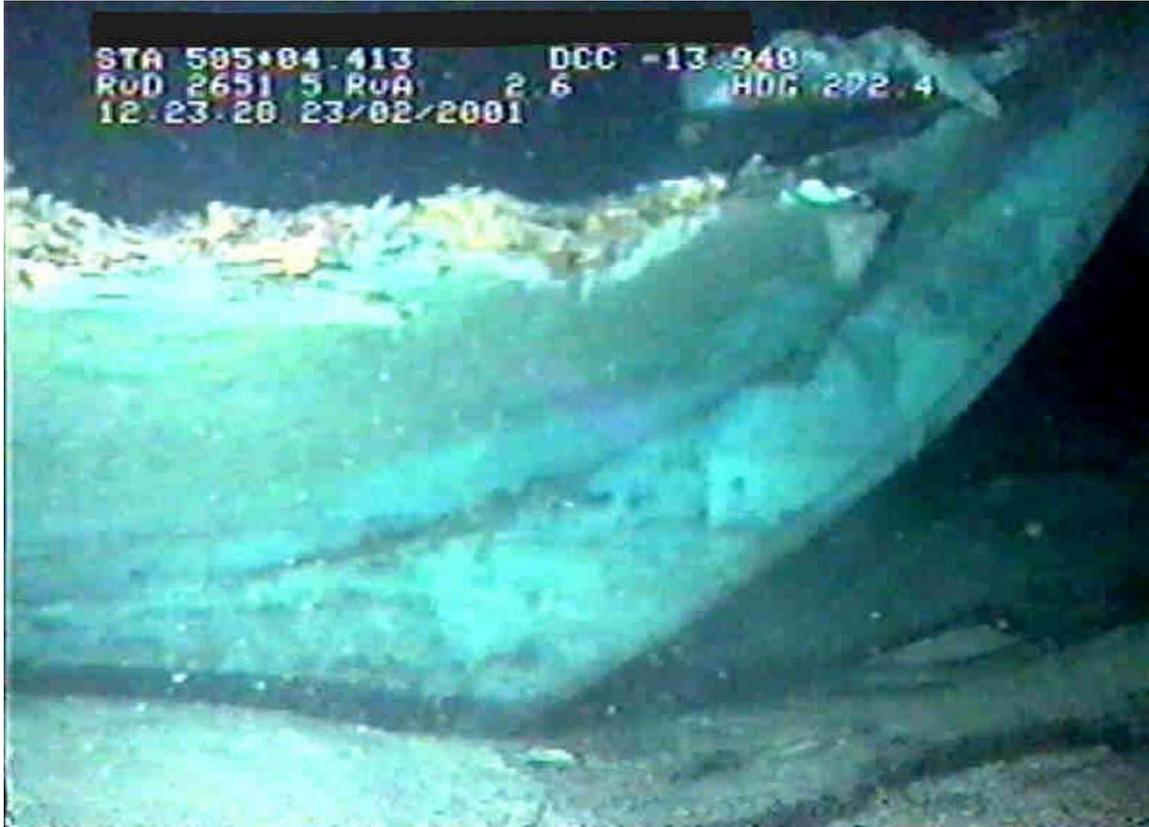
Figure 16. Starboard bow quarter of the Mica shipwreck. The edges of the sheathing and hull appear brittle and unconsolidated. Note the copper sheathing on the stem (Photograph courtesy of the United States Minerals Management Service and ExxonMobil Corporation).

After working in the center of the wreck abaft of the pipeline, the submarine moved into the port bow area. Here, two more chainplates were noted, both along the starboard side. The uppermost edges of the external hull planking and the copper sheathing appeared to be fragile and unconsolidated (Figure 16). They crumbled slightly during an attempt to remove sediment from the bow area using *NR-1*'s thrusters. This dusting was advantageous because it clearly showed that the ship was sheathed with wide thin planks, which were sandwiched between the narrower, thicker external hull planking and the metallic sheathing.

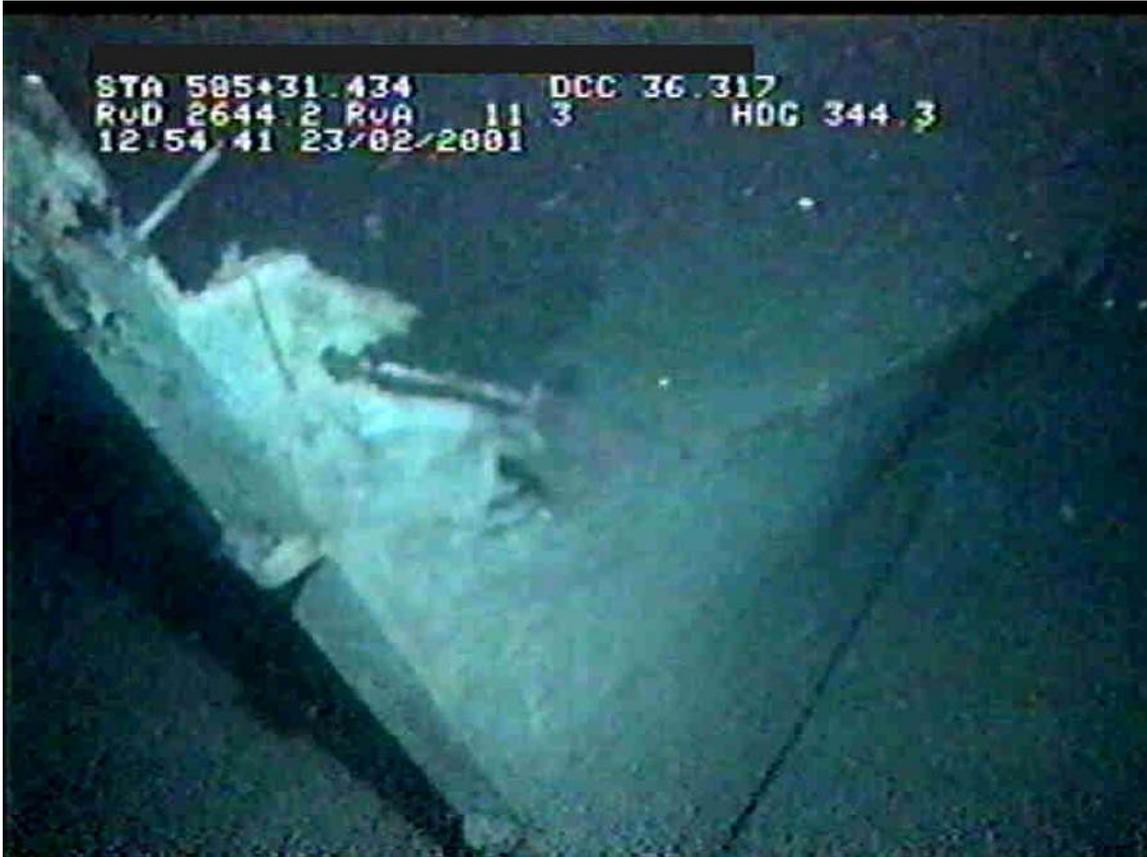
Figure 17. Perspective view of the starboard stern quarter of the Mica shipwreck. Two gudgeons are clearly visible, with the skag also still attached (Photograph courtesy of the United States Minerals Management Service and ExxonMobil Corporation).

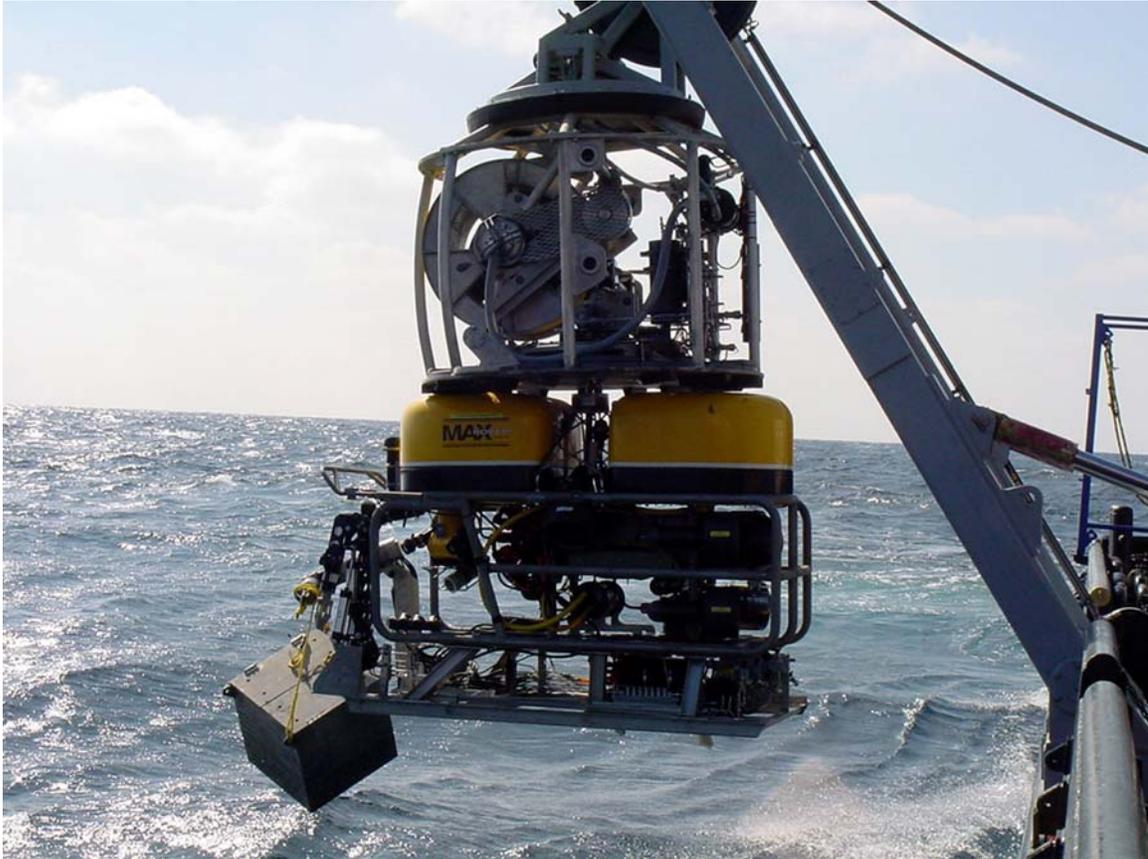
Figure 19. Deep Marine Technology's *MaxRover* being deployed over the Mica site. Note the artifact retrieval basket attached to the manipulator arm on the remotely operated vehicle (Photograph courtesy of Brett Phaneuf).

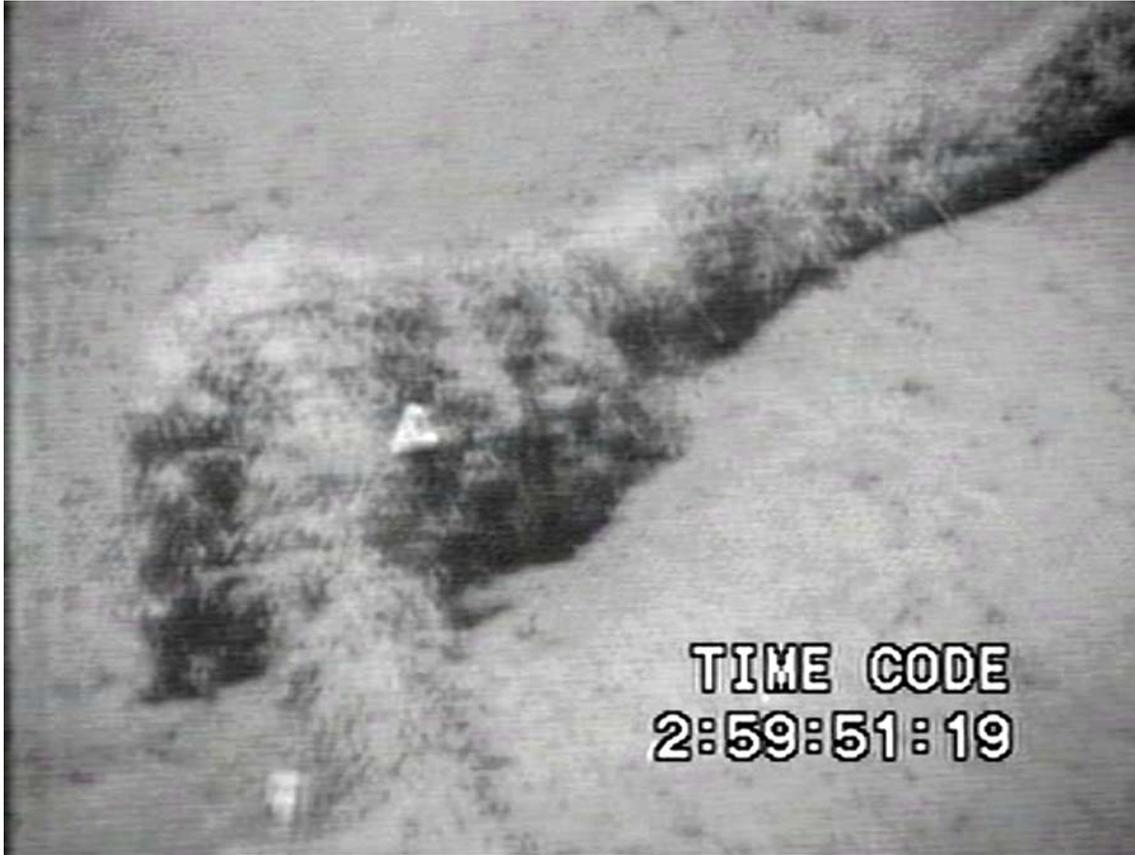
Figure 20. Possible remains of a chainplate or deadeye strap seen aft of amidships on the port side (Photograph courtesy of the United States Minerals Management Service and ExxonMobil Corporation).

The investigation did not recover any rigging elements or specific evidence of rig type or sail arrangement, however, evidence of mast placement was collected by noting the position of possible chainplates and deadeye straps. Three possible groups of chainplates and deadeye straps were found, one on the port side of the wreck just aft of amidships and one on either side of the vessel several meters aft of the bow, indicating that the vessel had at least two masts (Figures 20 and 21). The vessel could also have been a

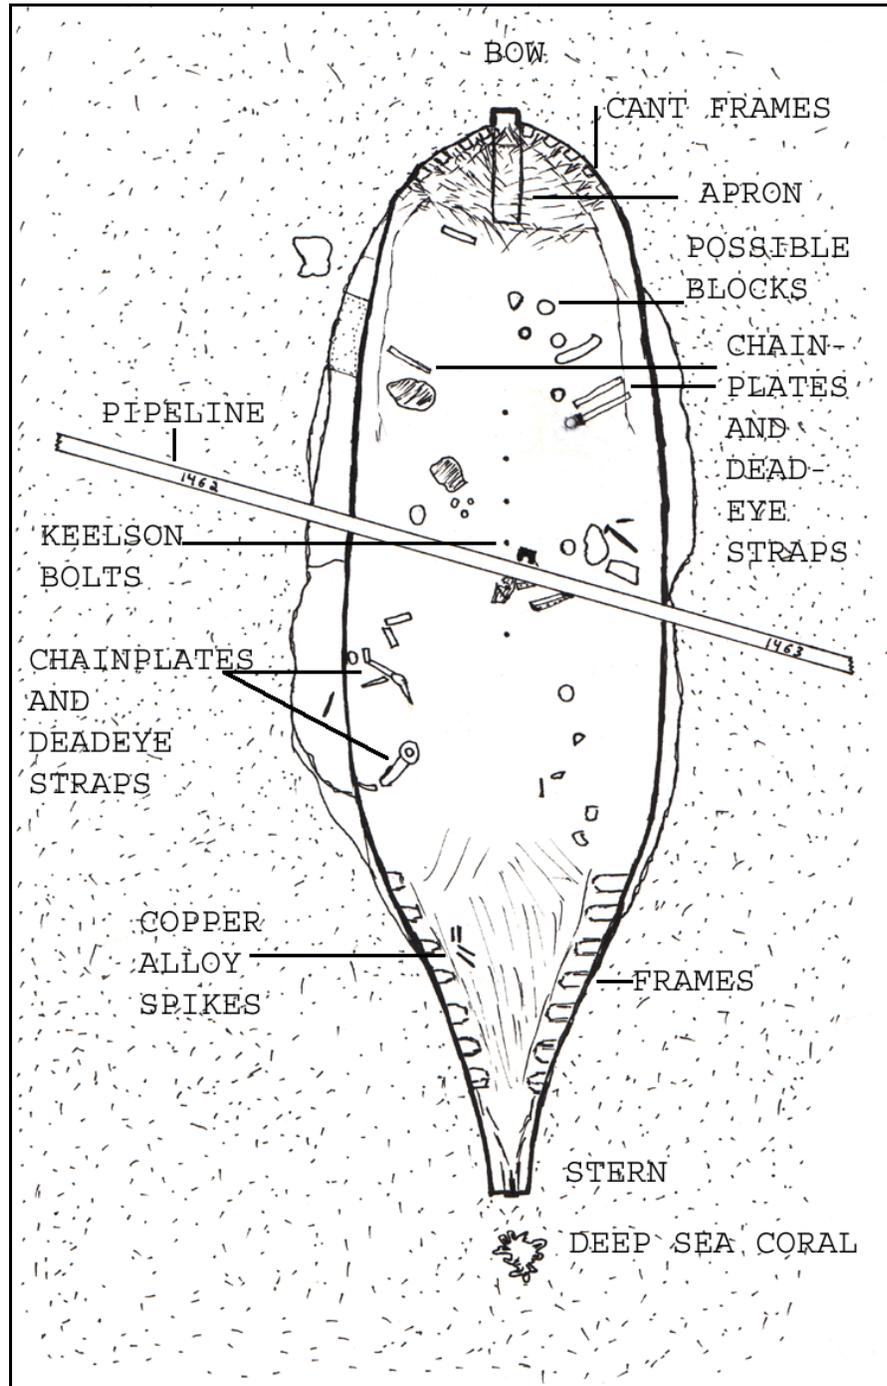
Figure 21. Site plan drawing of Mica shipwreck. It should be noted that the spatial relations of the artifacts are relative (Drawing by author).

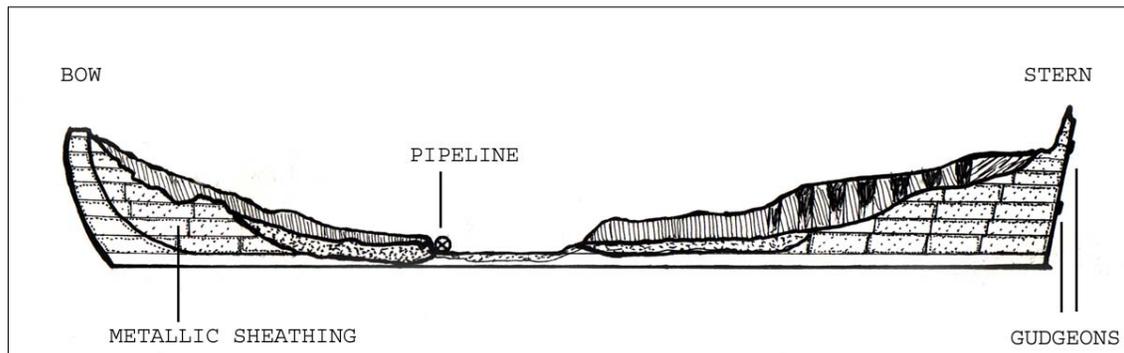
Figure 22. Profile drawing of the Mica shipwreck. Note the pipeline forward of amidships (Drawing by author).

In several areas of the bow and stern the sides of the ship had fallen away and out, but were still attached to the hull along the bottom edge (Figure 22). In these areas, the archaeologists noted that there was a layer of intermediate planking between the metallic sheathing and the hull. This layer, known as sacrificial planking, is normally found on vessels that were not sheathed with metal. It was curious that there would be two types of sheathing, one on top of the other, on the same vessel. That unique feature will be discussed more fully in Chapter IV.
