THE MICA SHIPWRECK: DEEPWATER NAUTICAL ARCHAEOLOGY
IN THE GULF OF MEXICO

A Thesis

MASTER OF ARTS

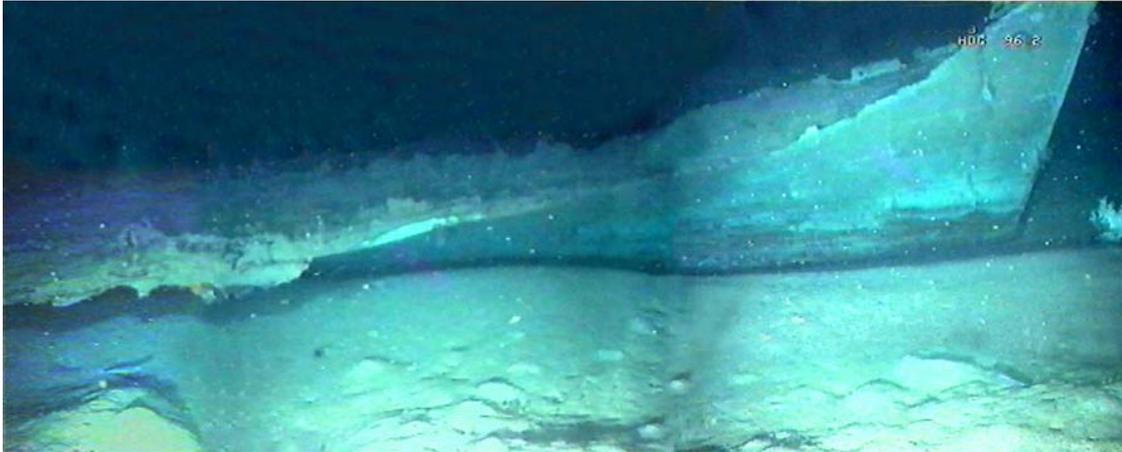
Figure 23. Profile view of the port stern quarter of the Mica shipwreck. The thin sacrificial planking can be seen attached to the copper sheathing. The laying of the pipeline caused the gunwales of the vessel to spread outward near amidships (Photograph courtesy of the United States Minerals Management Service and ExxonMobil Corporation).

Several wood samples were retrieved at the time of the wreck's discovery. They appeared to be taken from the thin layer of planking that was sandwiched between the metallic sheathing and the hull planking in the port bow quarter (Figures 23, 24 and 25). The specimens were sent out to several tree identification laboratories. While there was an insufficient amount on which to perform dendrochronological analysis, the scientists were able to determine the species and probable location where the trees were harvested. Both laboratories, the Center for Archaeological Investigations at Southern Illinois University at Carbondale, and the College of Forestry at Mississippi State University, agreed that the wood samples were *Pinus strobus*, commonly known as eastern white pine. This species grows along the seaboard of Eastern North America. It is commonly found from the North Carolina-Virginia border north into Canada. The wood has a history of use in ship construction and is mildly resistant to rot and degradation. It

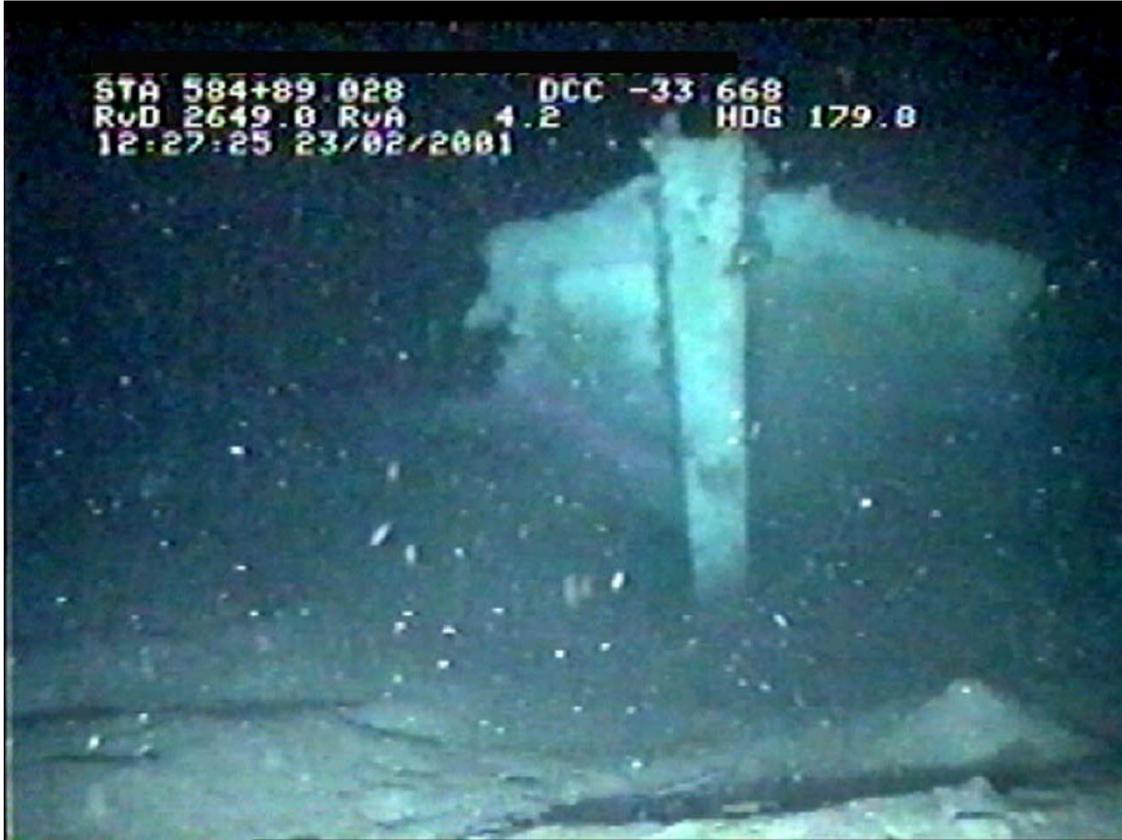
Figure 24. Photograph of stem and bow of Mica shipwreck (Photograph courtesy of the United States Minerals Management Service and ExxonMobil Corporation).

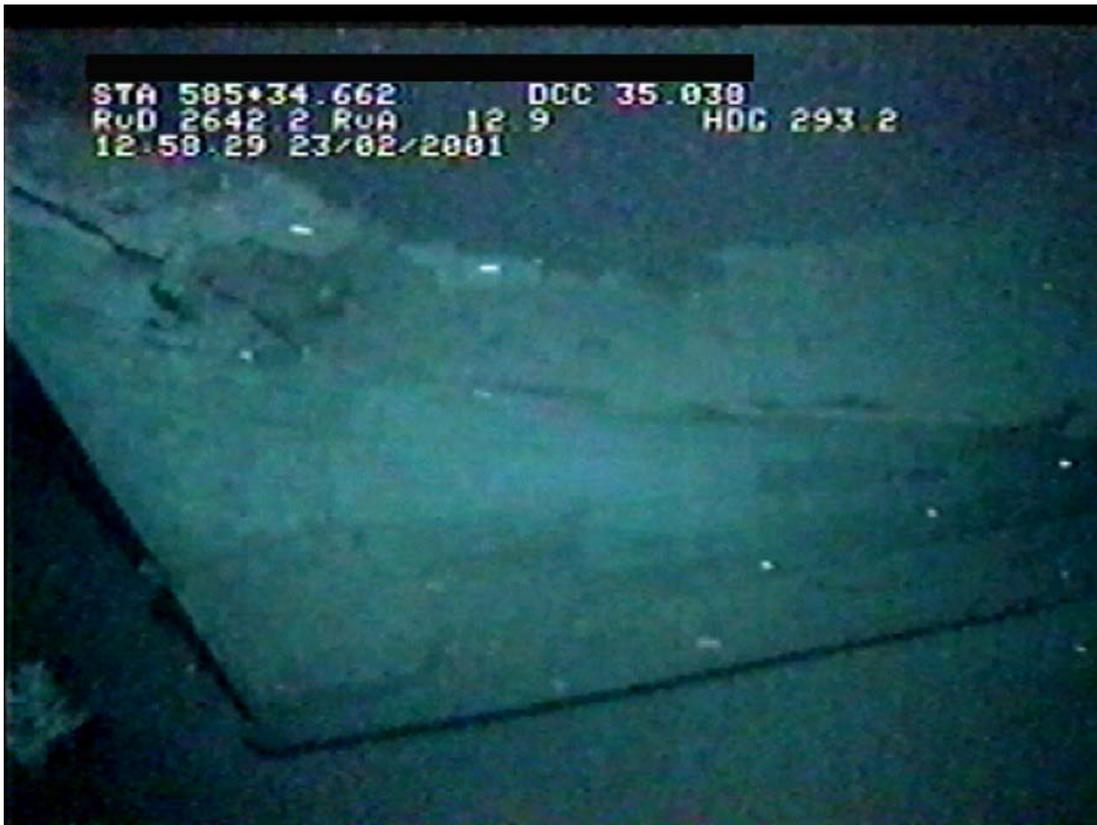
Figure 25. Photograph of starboard stern quarter of Mica shipwreck. Note the amount of sediment present inside of the wreck (Photograph courtesy of the United States Minerals Management Service and ExxonMobil Corporation).

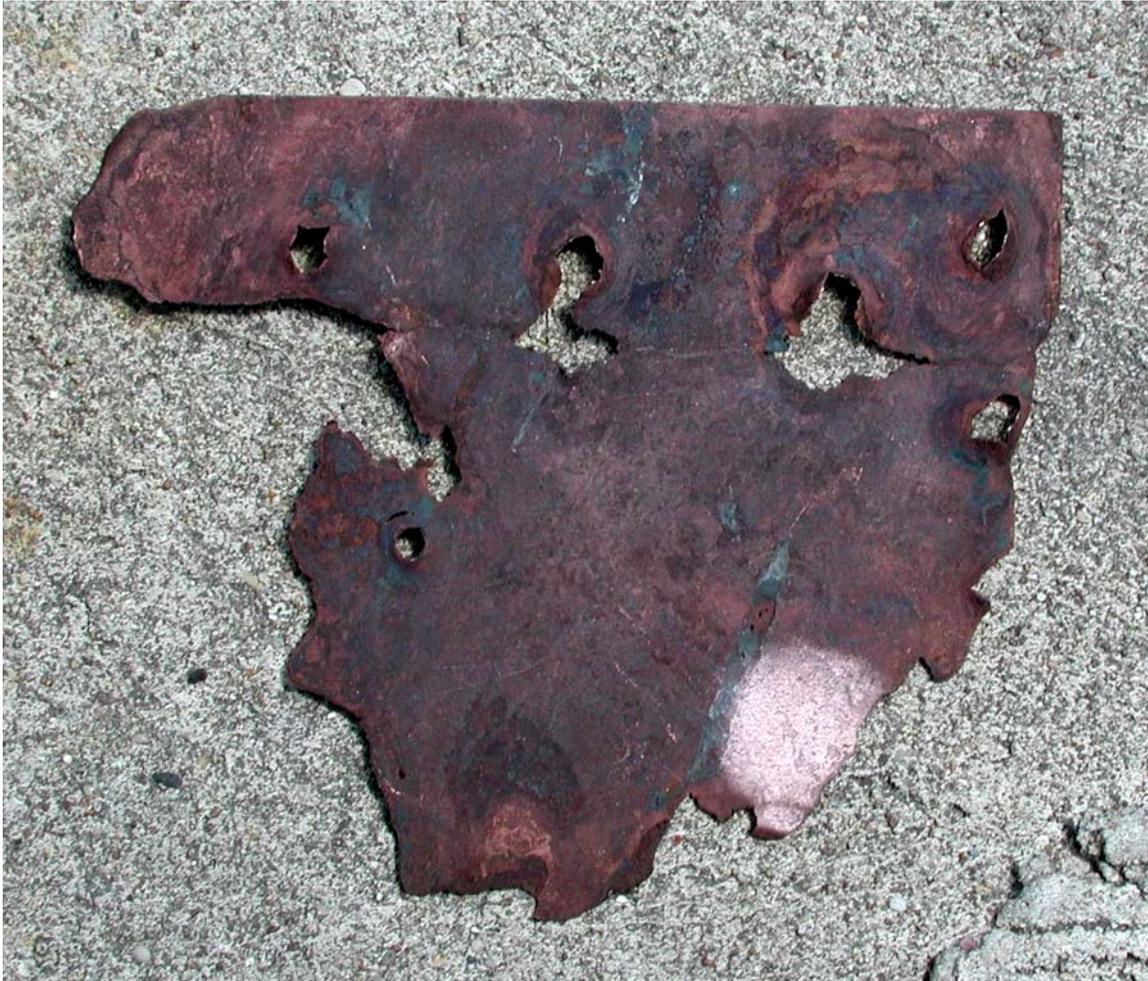
Figure 26. A fragment of the copper sheathing retrieved from the Mica shipwreck. The bright spot in the lower right corner has been mechanically cleaned with a glass bristle brush (Photograph by author).

Dave Johnson of Galvetech in New Orleans, Louisiana undertook the initial conservation of the wood and metal artifacts, including the hawse pipe. Barnacles and lead carbonate covered substantial portions of the internal and external hawse pipe. The amount of conservation carried out on the hawse pipe was unclear. The metallic sheathing fragments were treated using desalination and electrolytic reduction cleaning. None of the metallic sheathing fragments appeared to have been sealed, and were experiencing extensive tarnishing. They were retreated by the author at the Conservation Research Lab at Texas A&M University. The pieces were mechanically cleaned with glass bristle brushes and then immersed in benzotriazole and finally coated with Krylon 1301 clear matte acrylic spray (Figure 26).

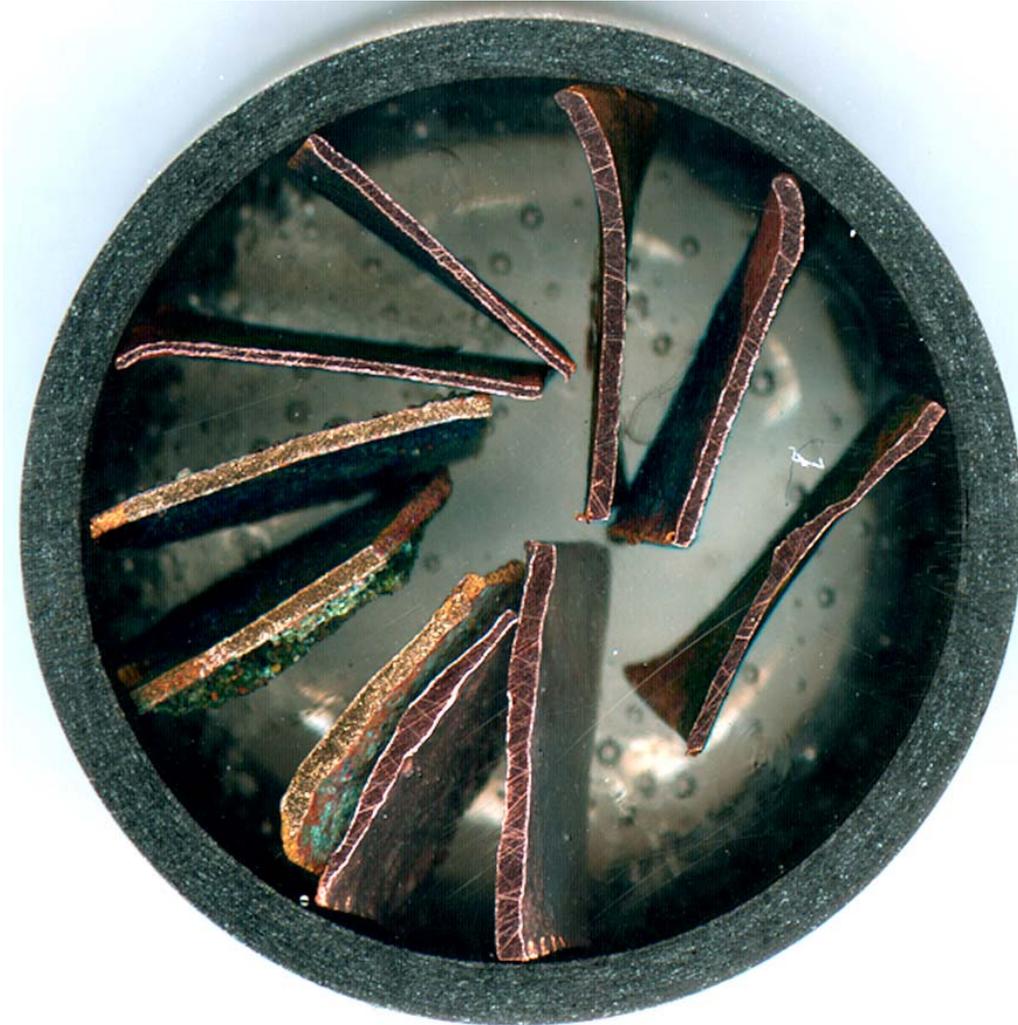
Figure 27. The refracting electron microprobe sample carrier. It contains pieces of metallic sheathing awaiting analysis (Photograph courtesy of Dr. Renald Guillemette).

In order to analyze samples on the refracting electron microprobe, small pieces of sheathing were bedded on edge in epoxy (Figure 27). The face of the block was polished to expose a fresh surface of metal, and then coated with a fine layer of pure powdered carbon. By focusing the x-rays on a freshly cut edge, the probe could avoid areas where superficial corrosion had altered the structure and composition of the metal. While the sheathing fragments were not destroyed, they remained permanently embedded in the clear epoxy carrier. The electron microprobe allowed more in-depth and varied analyses, however, it was also more labor-intensive and slightly more expensive to use when running a small number of samples.

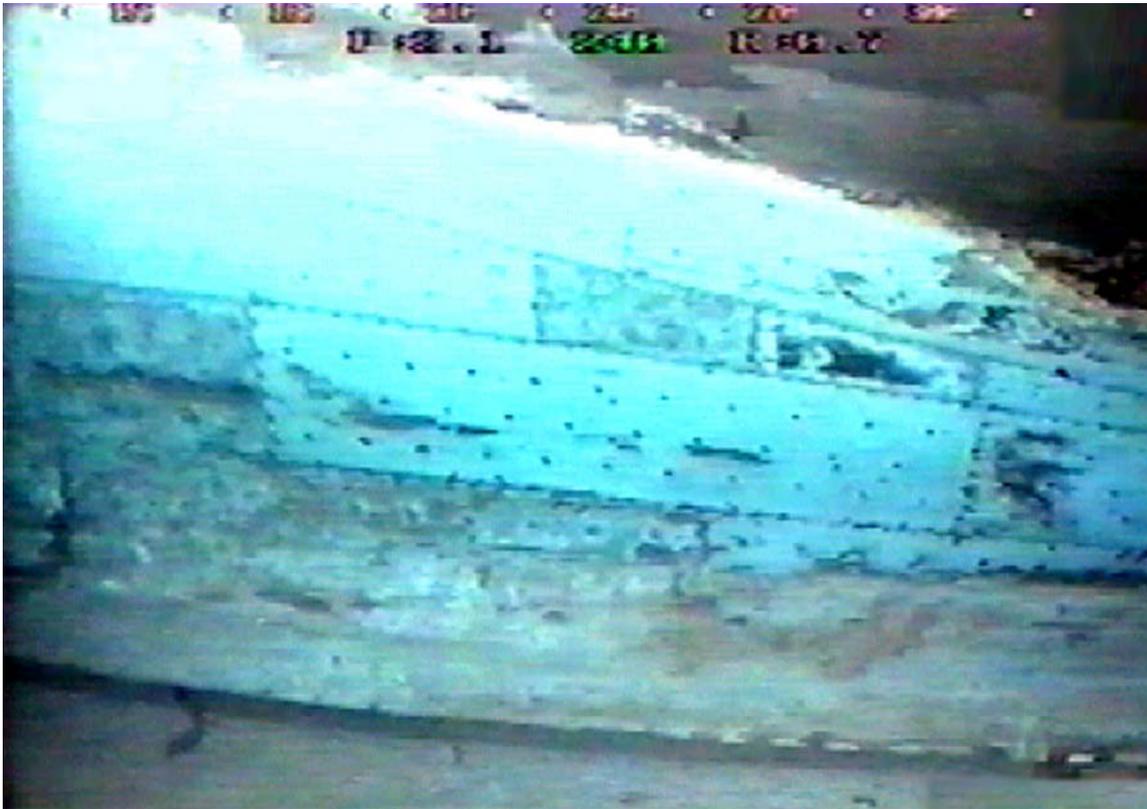
Figure 28. Detail of the starboard stern quarter of the Mica shipwreck. Note the dense nailing around the edges and the quincunx pattern in the middle of each sheet (Photograph courtesy of the United States Minerals Management Service and ExxonMobil Corporation).

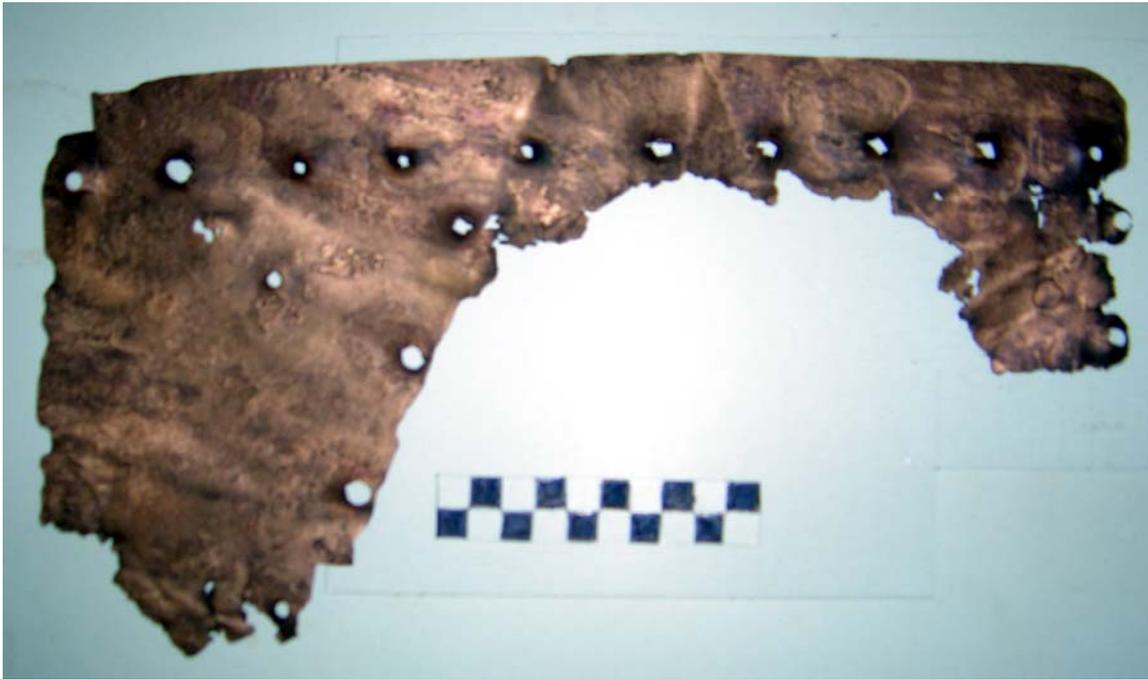
Figure 29. Largest fragment of metallic sheathing recovered from the Mica shipwreck (Photograph by author).

Several fragments of sheathing from the Mica shipwreck were from the edges of sheathing plates. The largest fragment of sheathing retrieved also contained two corners, comprising the edge of a 36 centimeter (14 inch) wide sheet (Figure 29). The amount of sheathing overlap, 4 centimeters (1.5 inches), was determined from this piece. The sheathing on the wreck appeared to overlap on the lower edge of each sheet, in the same

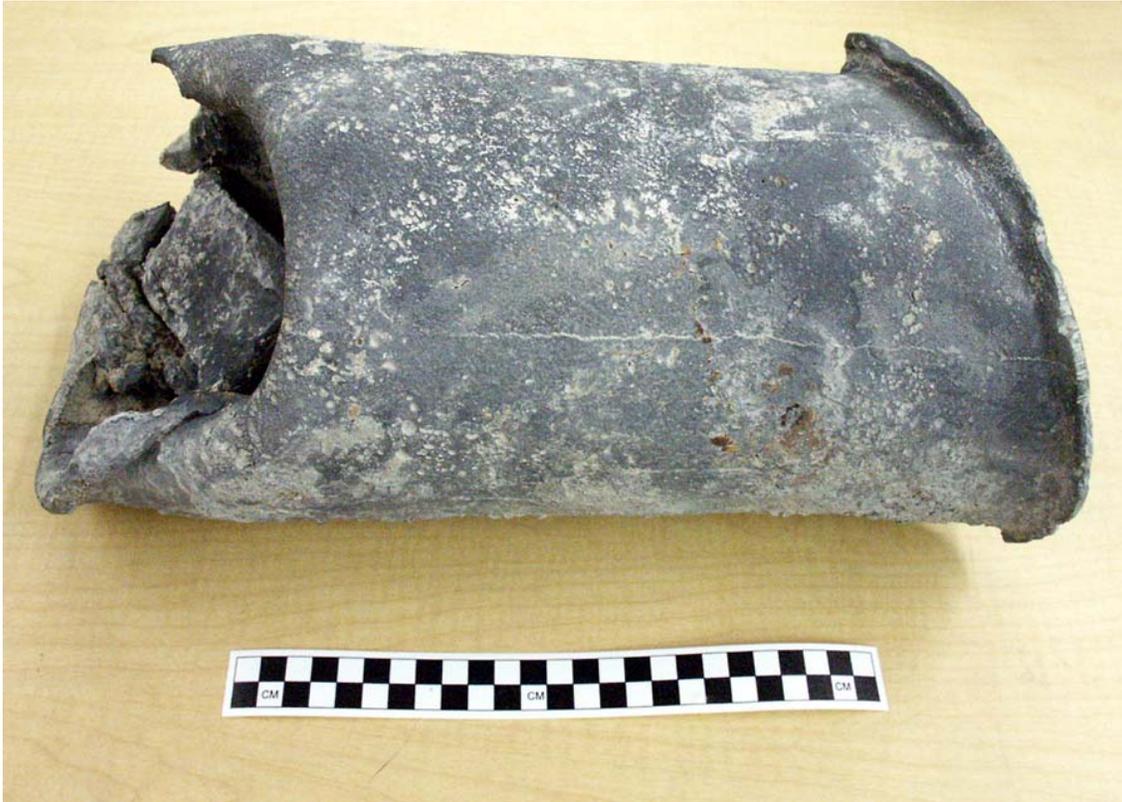
Figure 31. Forward face of lead hawse pipe from the Mica shipwreck. Casting seams are evident on the both the external (right) and internal (left) openings (Photograph by author).

The lead hawse pipe found on the Mica shipwreck was 17 centimeters (6.8 inches) in diameter and 41 centimeters (16.2 inches) long (Figures 30, 31 and 32). The thickness of the hawse pipe wall averaged 2 centimeters (0.5 inches). The hawse pipe appeared to be poured or formed with eight longitudinal seams, which were evident on both the internal and external surfaces. The average width between the seams was 7 centimeters (2.5 inches). An examination of the wear patterns on the lead artifact revealed that it was probably the starboard hawse pipe. The lower outboard lip was substantially worn, probably from the rubbing of an anchor cable or chain while the vessel was riding at anchor. There were several deep cuts near the inner end of the hawse pipe, which might indicate that the anchor line was cut in a hurried manner (Figures 33 and 34).

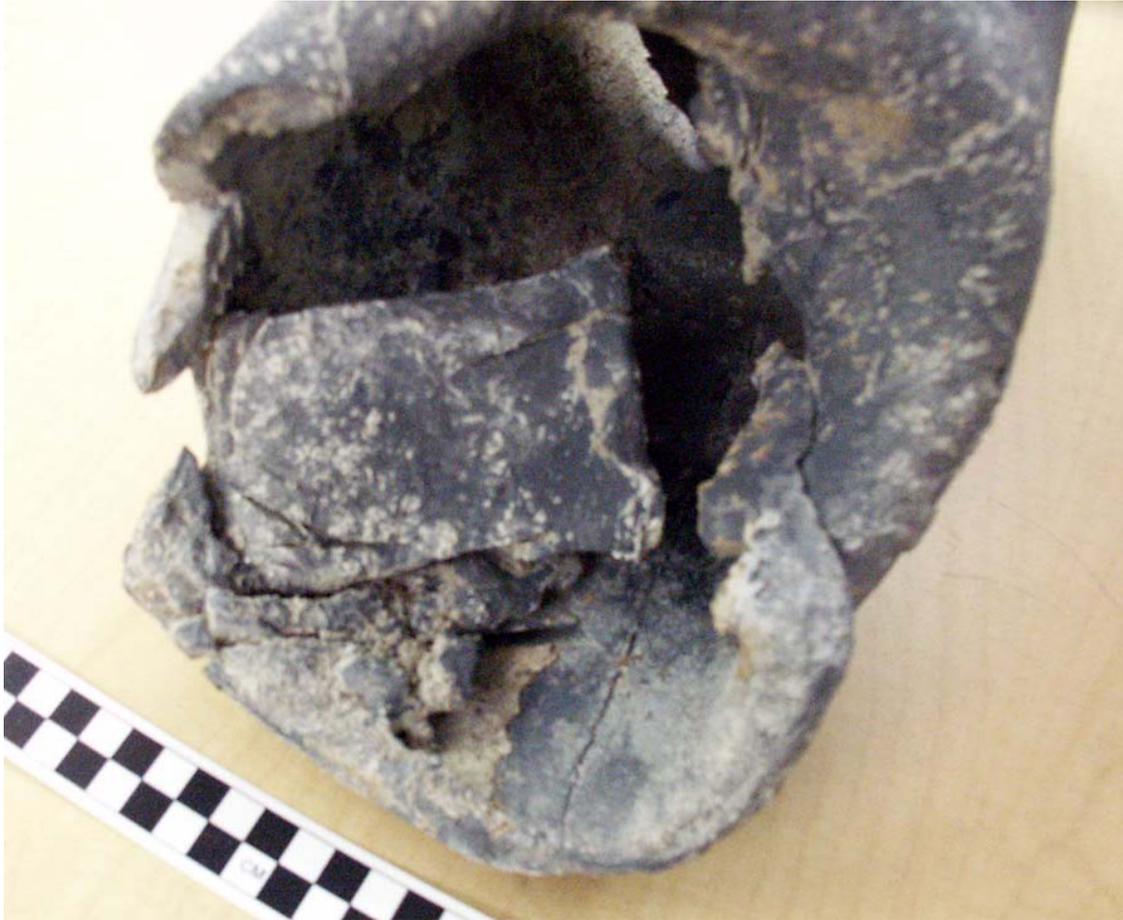
Figure 32. After face of conserved lead hawse pipe from the Mica shipwreck. Casting seams are evident on the both the external and internal surfaces (Photograph by author).

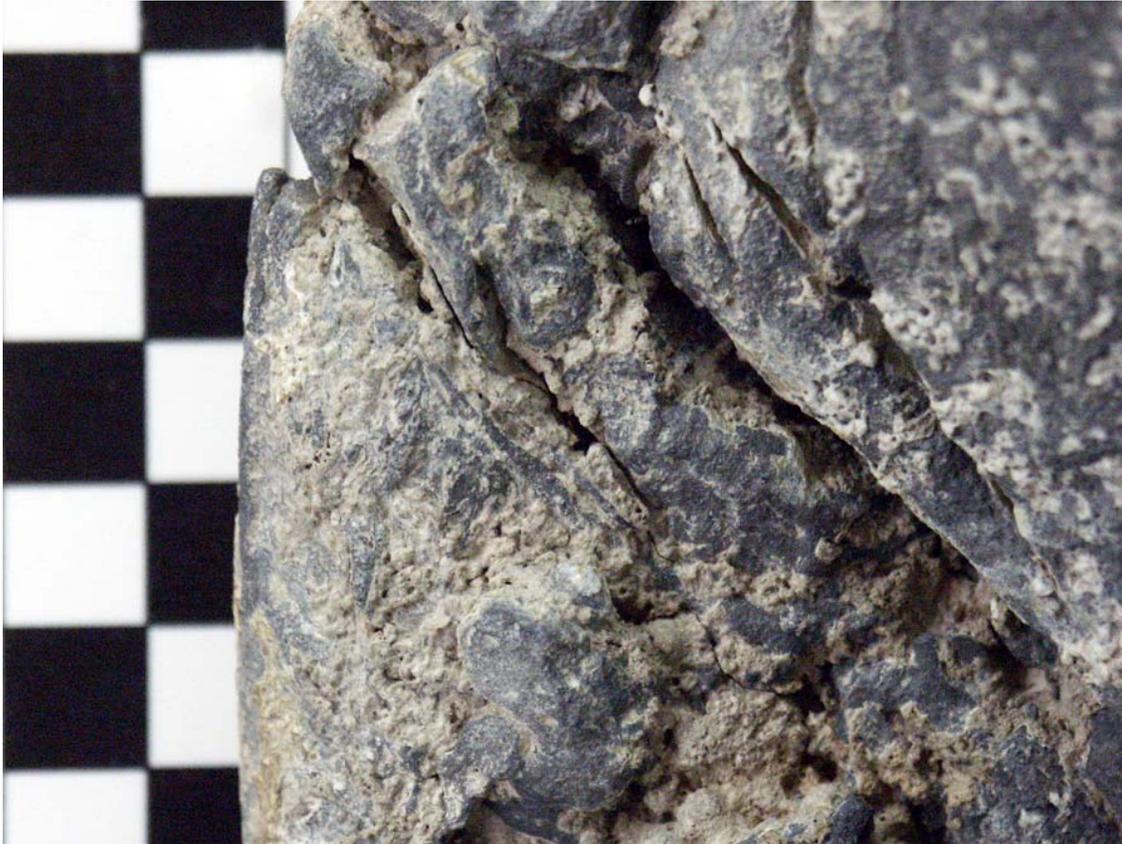
Figure 33. Interior opening of conserved lead hawse pipe from the Mica shipwreck. Note the possible cut marks on the curled-in exterior surface, visible in the lower left (Photograph by author).

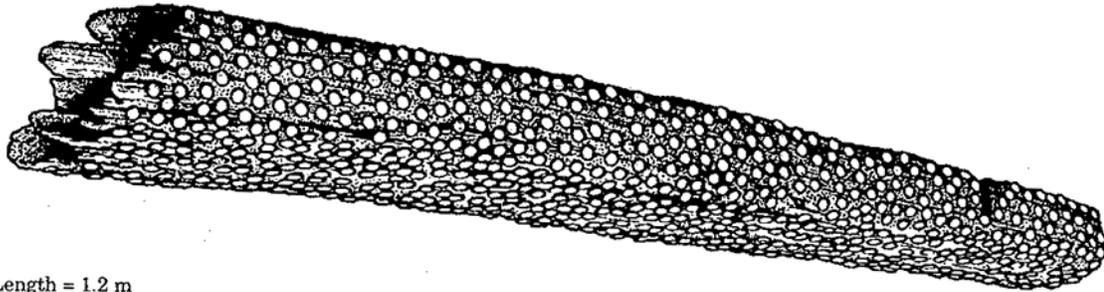
Length = 1.2 m

Figure 35. The false keel from *Invincible*, lost in 1758. Example of “filling” a false keel with nails to protect it from marine organisms. The nails and their corrosion products formed a physical barrier that prevented the *Teredo navalis* from boring through the wood (After Bingeman et al. 2000, 219, figure1)

One of these experimental methods of protecting a vessel from shipworm attack was called filling (Figure 35). Iron or copper nails with large heads were driven into a hull plank so close to each other that their heads were touching. This created a mechanical barrier of rust or corrosion product, yet the massive amount of nails needed to fill a significant portion of the hull made the treatment prohibitively expensive. This method was used sporadically through the end of the eighteenth century, and was often the only practical way to protect the false keel, where thin sheathing would be ripped off upon the slightest contact with the seafloor.⁴⁴ Wood remained the dominant method of sheathing, for the widespread acceptance and manufacture of pure copper sheathing was still a half-century away.

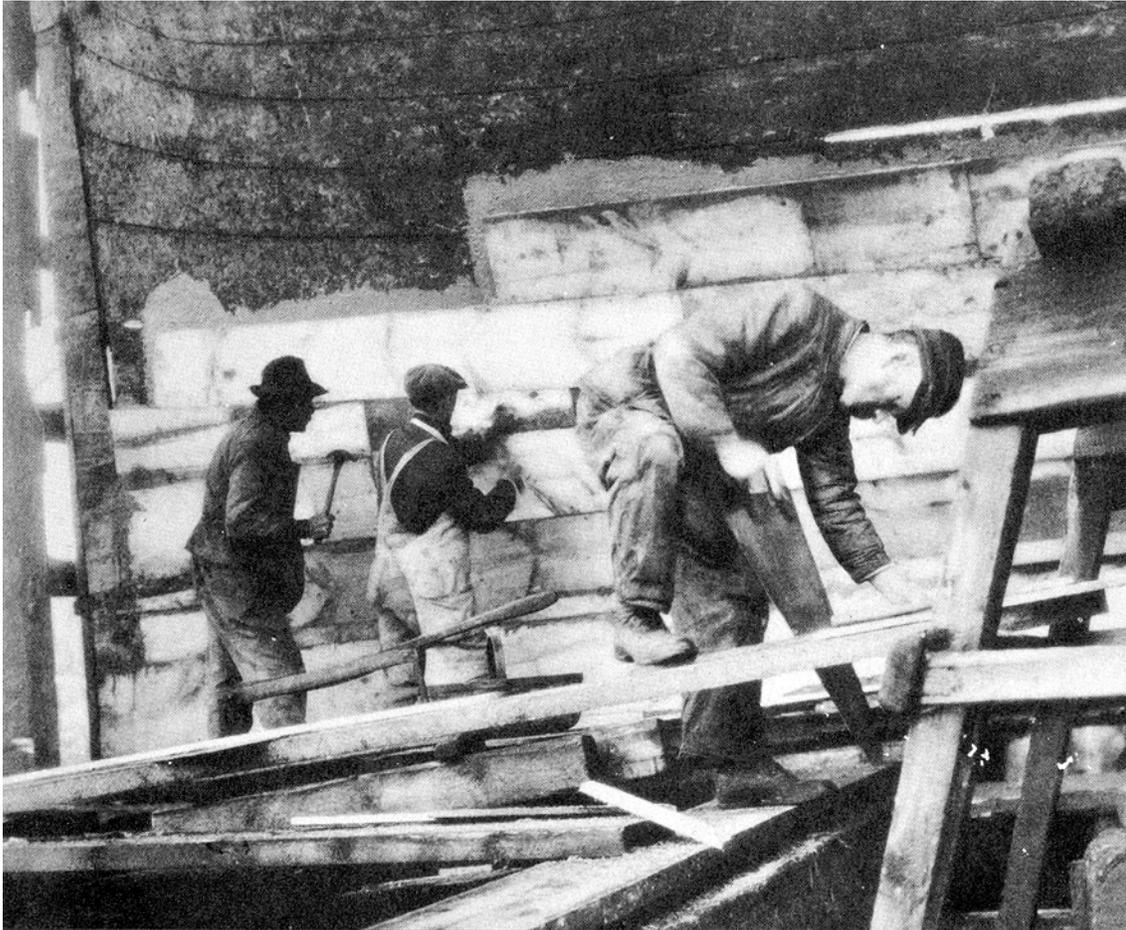
Figure 36. Carpenters applying pine sheathing before the application of metallic sheathing (From Church 1938, Figure 17).

Sacrificial planking could be used in lieu of thick paper to provide a barrier between the dissimilar fasteners. The thin wood planking, like that found on the Mica wreck, could also serve another purpose, namely as a spacer. By nailing the hull planks to the frames, then nailing the sacrificial planking to the hull planks, and finally nailing the sheathing to the sacrificial planking, there would be no nail holes that penetrated completely through all three layers. This arrangement would prevent leaks if the outer fasteners fell out, while preventing interior fasteners from working loose. The sacrificial planking may also have been placed on the vessel while it was being re-sheathed. In order to avoid driving sheathing nails through preexisting holes, the ship owner may have had sacrificial planking placed on the hull to give the nails a better hold. An example of sacrificial planking being applied can be seen in a contemporary photograph of a whaling ship being sheathed (Figure 36).

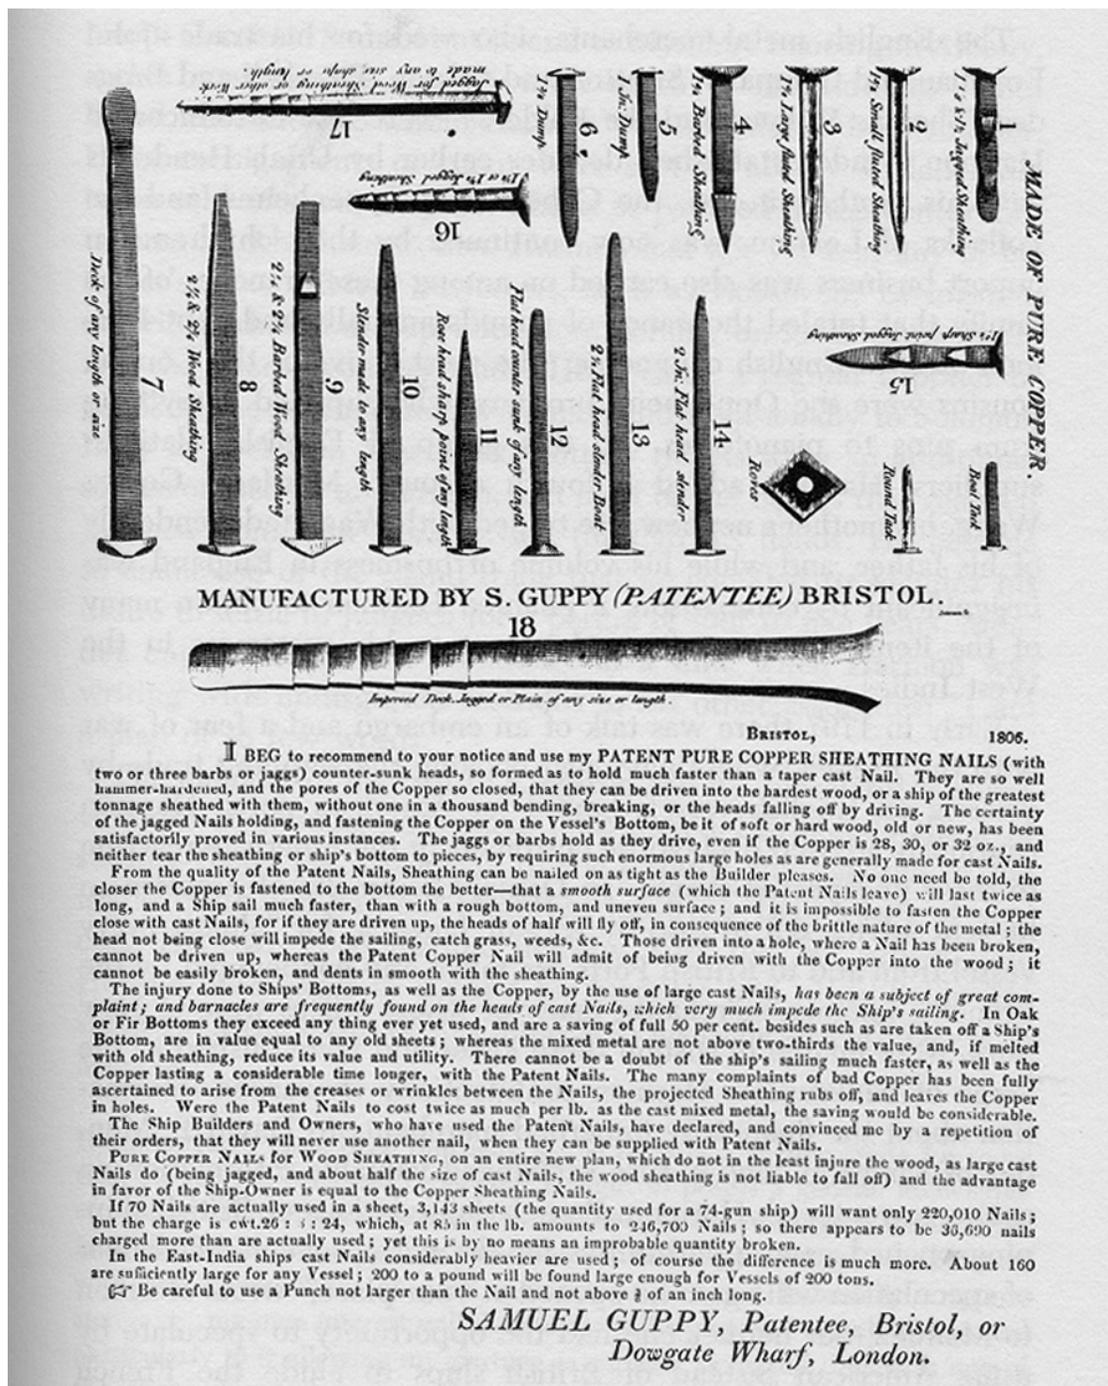
Figure 37. A sheathing nail advertisement from 1806. It revealed how inventor Samuel Guppy modified copper alloy nails to perform as well as iron fasteners (From Whiteman 1971, 39).

Besides containing details of the new sheathing nails, the Guppy advertisement listed the advantages of, and rules for, using the new hammer-hardened fasteners instead of the older, cast copper, nails. Guppy claimed that unhardened cast copper nails had an abnormally high breakage rate:

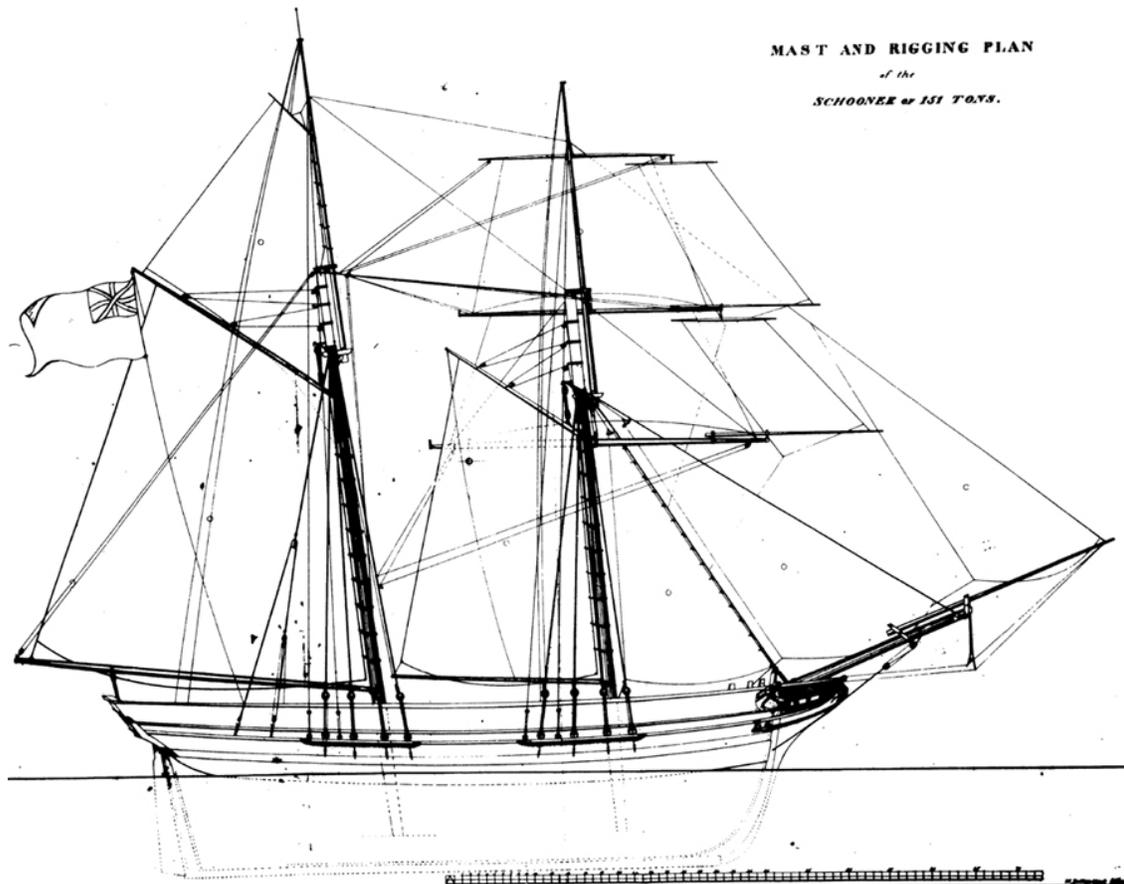
Figure 38. Peter Hedderwick's 1826 rigging plan for *Glasgow*, a schooner of 151 tons (From MacGregor 1997, 39).

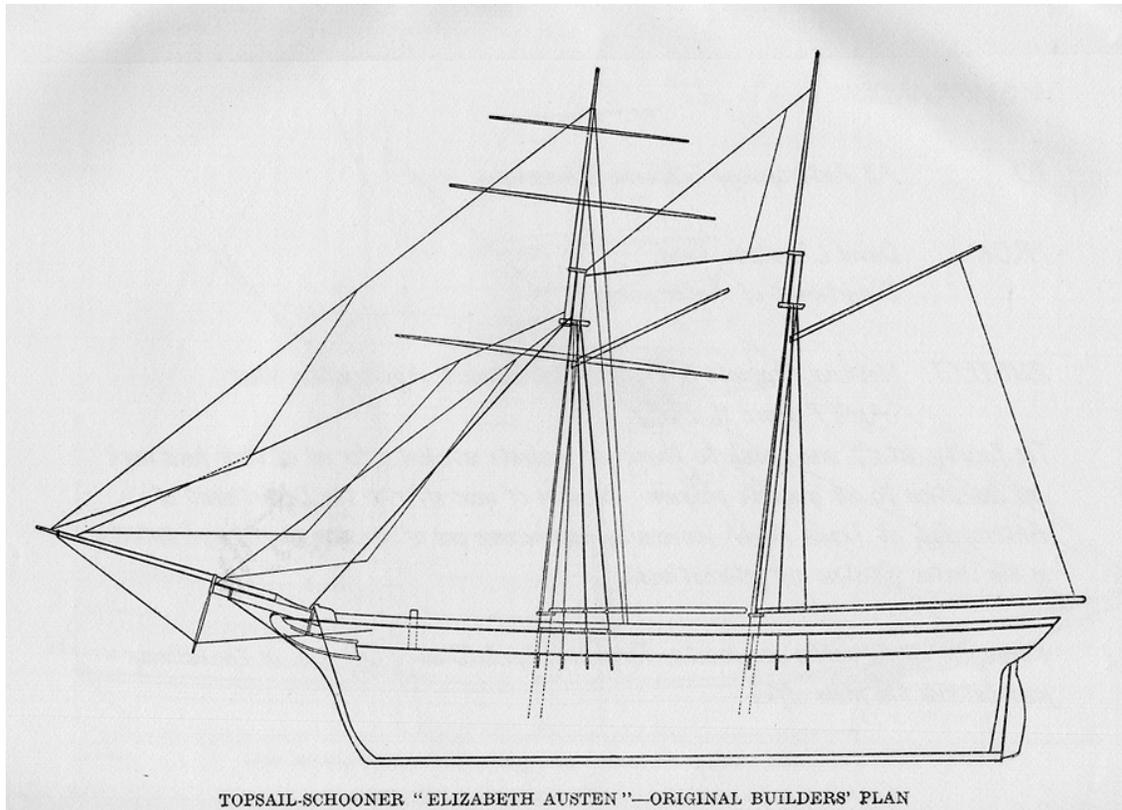
Figure 42. Original builder's plans for the topsail schooner *Elizabeth Austen*, (After Underhill 1952 Plate 18).

The photographs were compared to several building plans of merchant schooners, including Hedderwick's *Glasgow*, an original builder's plan of the schooner *Elizabeth Austen*, and a lines drawing of the HMS *Subtle*, an American-built, Danish-owned schooner captured by the British in 1808 and pressed into naval service as an armed schooner (Figures 42 and 43). *Subtle* was lost in a violent squall while pursuing an

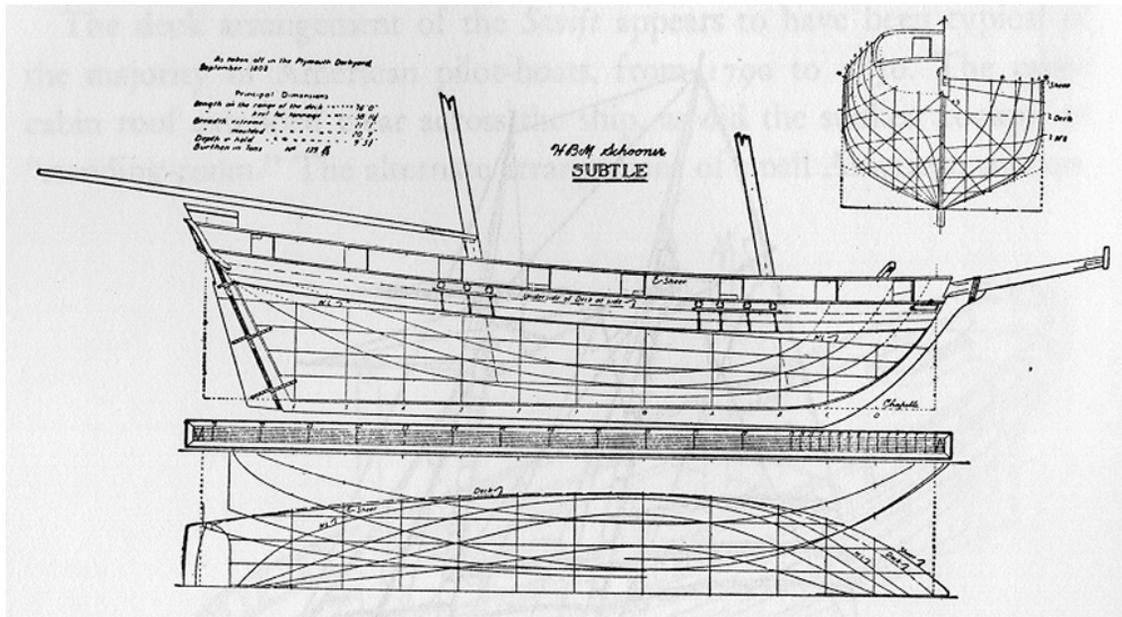
Figure 43. Lines of HMS *Subtle*, lost in a violent squall while pursuing an American privateer in the West Indies in 1812 (From Chapelle 1935, 232).

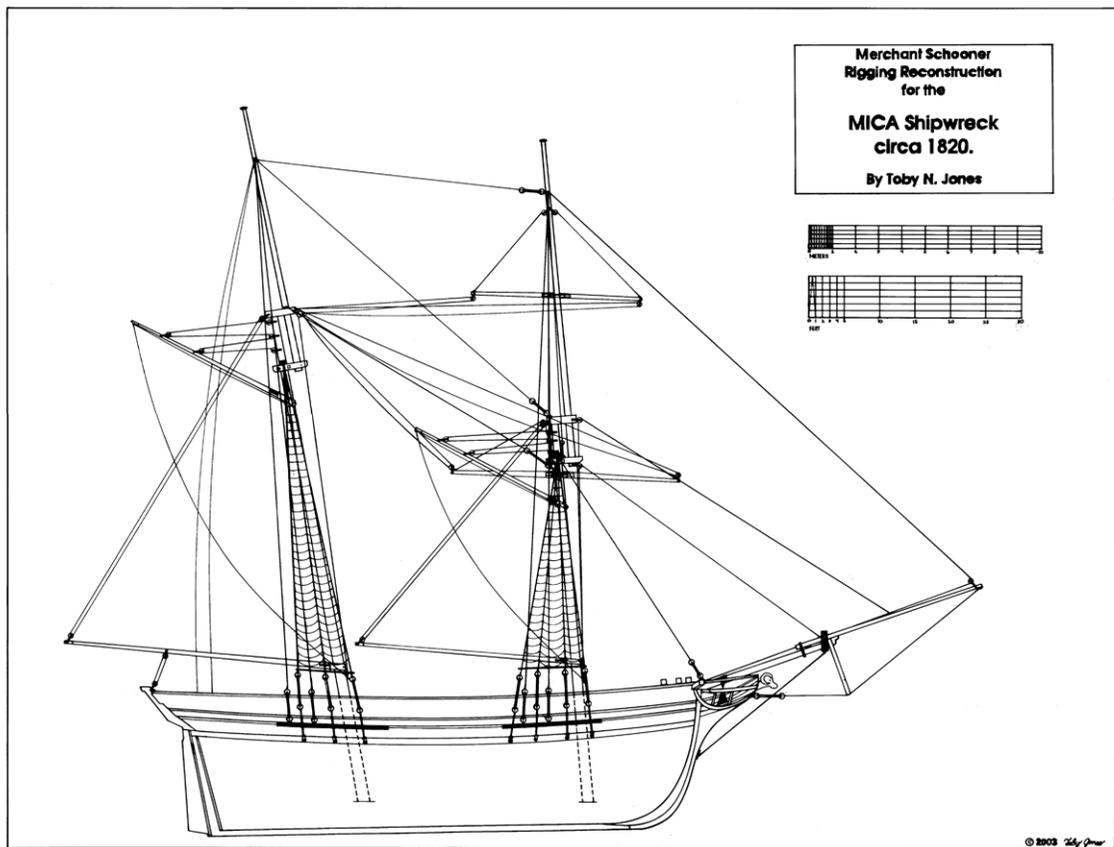
Figure 44. Hypothetical Mica shipwreck rigging reconstruction (Drawing by author).

All six representations of nineteenth-century merchant schooners were analyzed and averaged to create a plausible rigging reconstruction to place on Hedderwick's *Glasgow* hull (Figure 44). Therefore, the Mica shipwreck rigging reconstruction did not exactly resemble any single source, but rather, was a sum of its parts, a hypothetical hybrid two-masted fore-and-aft rigged schooner of the type that would have been common along the coast and in the ports of the early American republic.

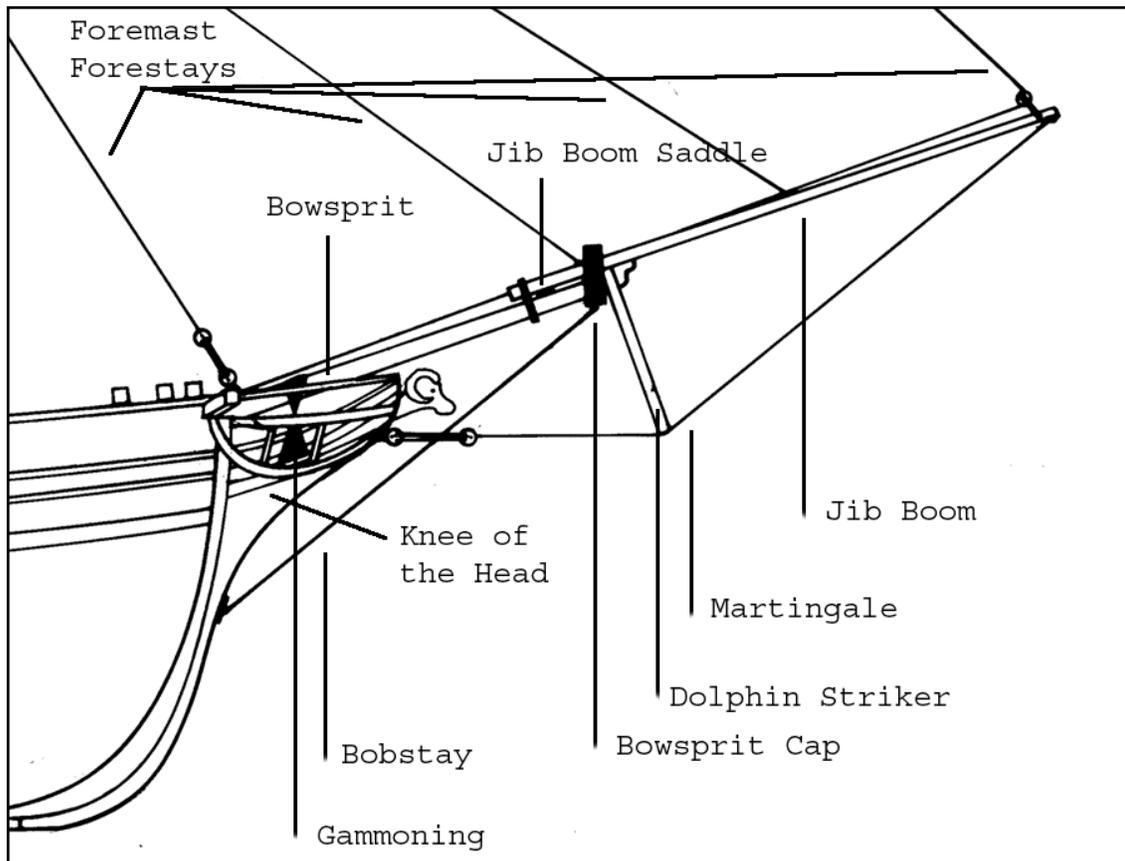
Figure 45. Selected bow area nomenclature (Drawing by author).

The dolphin striker provided a fulcrum point that allowed the martingale to pull down on the jib boom with enough force to counteract the strong upward pull of the foremast forestays. The bobstay, as well as the gammoning of the bowsprit to the knee of the head provided additional support to the bowsprit and jib boom. The jib boom was attached to the bowsprit where it ran through the bowsprit cap, and was supported by the jib boom saddle that was abaft the cap, as well as a clamp abaft the chock (Figure 45).

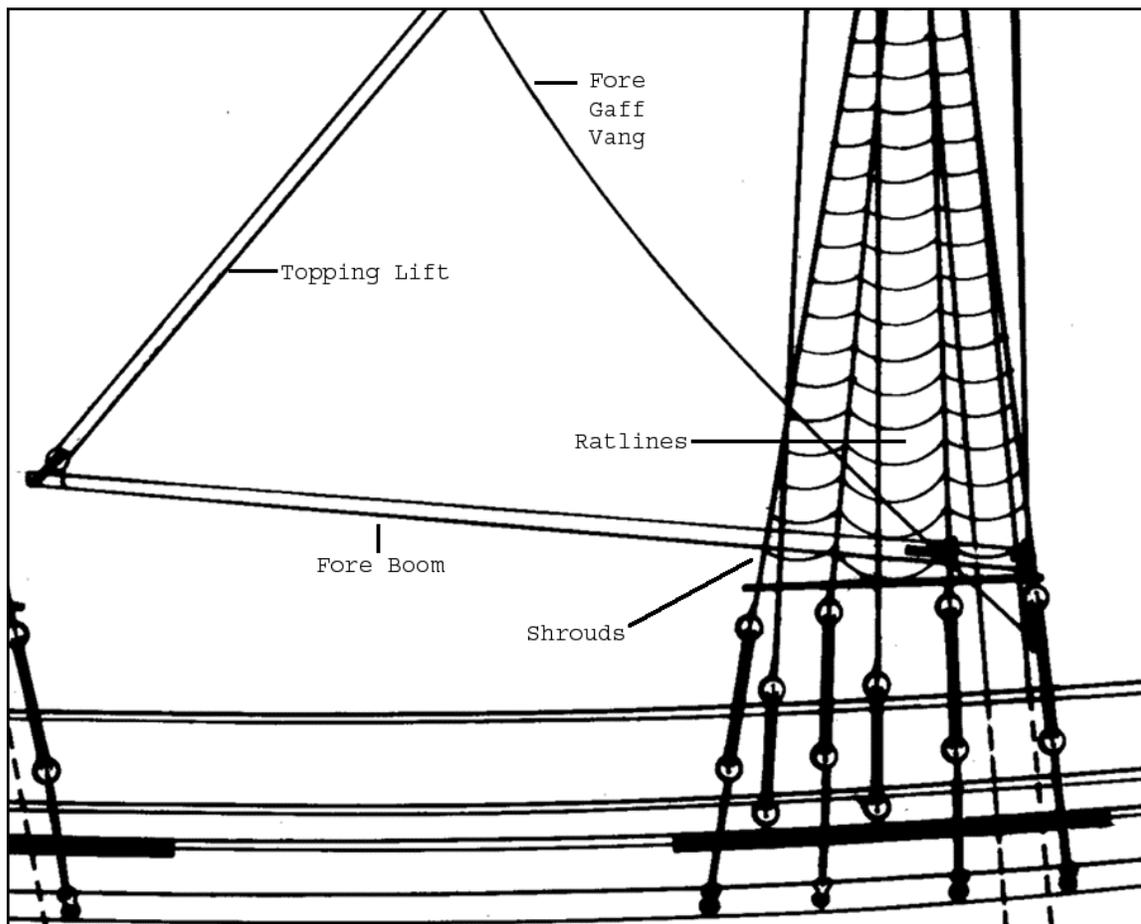
Figure 46. Lower forward rigging nomenclature (Drawing by author).

In the reconstruction, four shrouds were placed on each side of the foremast, and two shrouds on each side of the fore topmast (Figure 46). The remains of two sets of deadeyes and chainplates were seen in both the starboard bow quarter and port stern quarter of the Mica wreck. This was taken as a minimum number, with the likelihood that additional elements were missing or buried under the sediment inside the wreck. A comparison of the contemporary photographs and Hedderwick's treatise show the vessels rigged with 3-4 chainplates and deadeyes per side on the fore and main masts. The reconstructed mainmast had three shrouds on either side of the mast. Both sets of lower shrouds looped around the lower masts and were spliced to themselves, just above the crosstrees and trestletrees. According to Biddlecombe, the shrouds were 0.13 meters

(0.44 feet) in circumference.⁸⁴ All the shrouds ran from the mast down to deadeyes attached to chainwales. The deadeyes were 0.25 meters (0.83 feet) in diameter, which was half of the diameter of the mast which they were serving, a rule cited by R.C. Anderson.⁸⁵

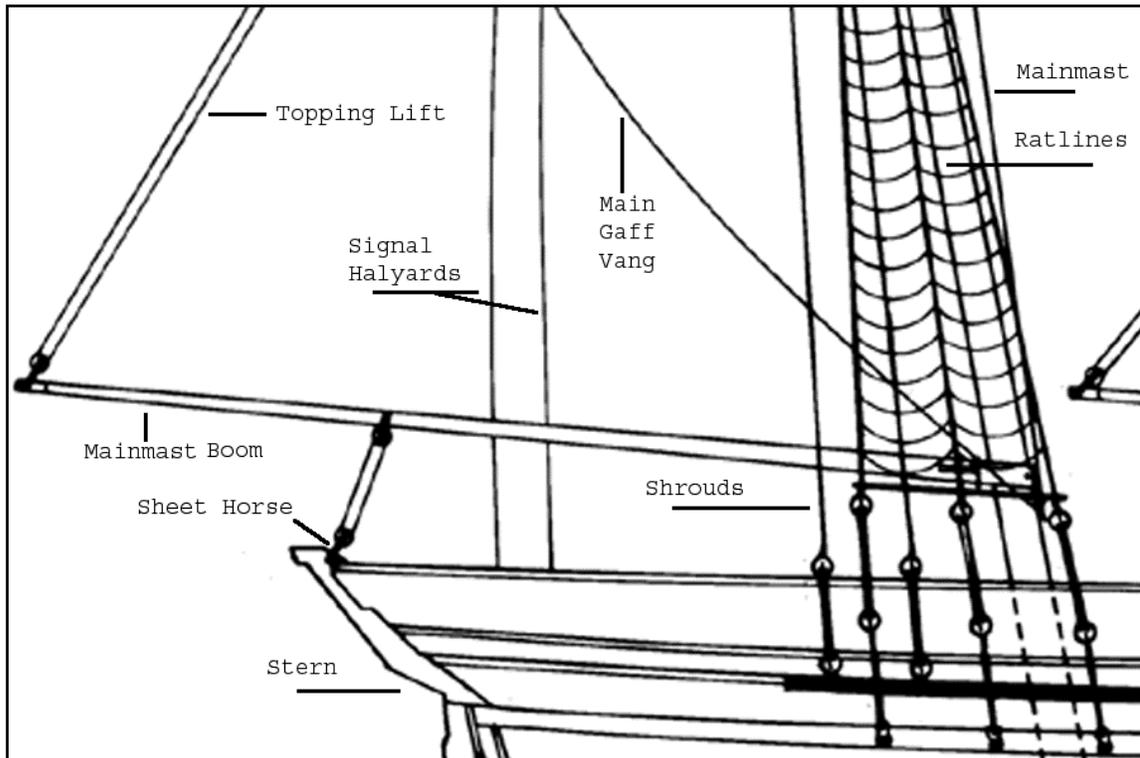
Figure 47. Lower aft rigging nomenclature (Drawing by author).

The main boom was secured downward with a main sheet and tackle to an iron staple or 'sheet horse' in the deck. Two backstays were placed on each side of the fore topmast and main topmast and ran down and aft to the aft part of the chainwales, where they were attached to deadeyes. The deadeyes were identical to those employed by the lower masts (Figure 47).

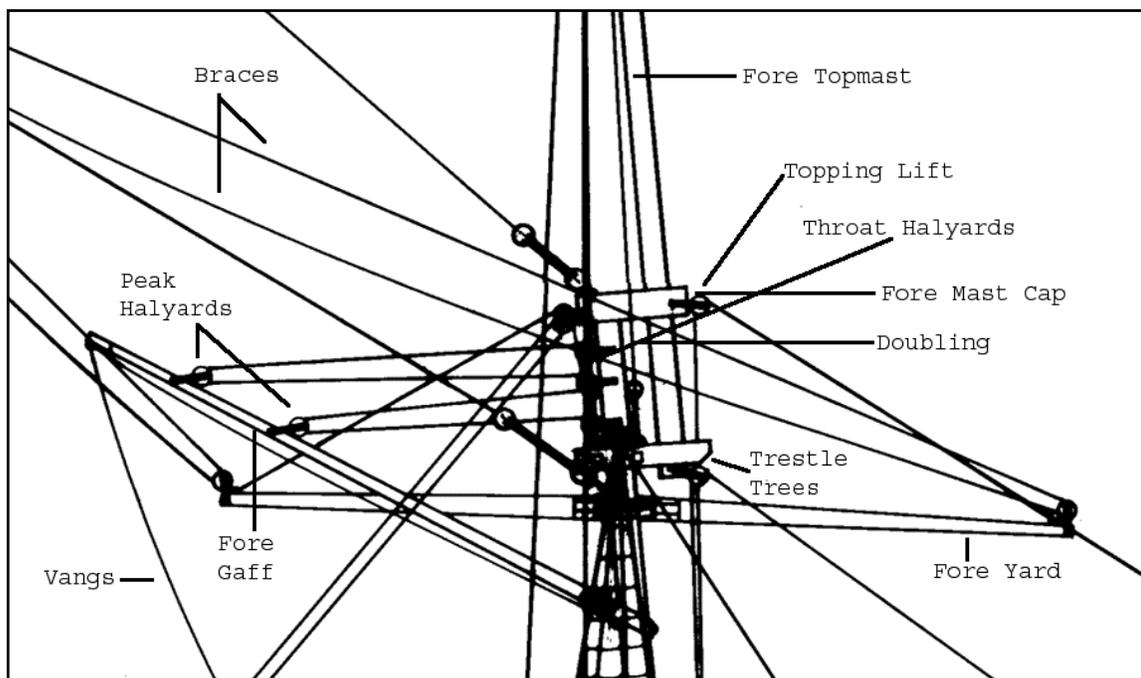
Figure 48. Upper forward rigging nomenclature (Drawing by author).

The peak and throat halyards for the fore and main gaffs were visible on *Glasgow*, *Polly*, and *Hope*. All of the halyards had similar placement and size. The *Glasgow* and the *Hope* had three blocks on the mast, while the *Polly* only showed two. Given the large size of the gaffs on the Mica reconstruction, three halyard blocks were chosen to support the gaff on both the fore and main masts. The lines running through these blocks were 0.08 meters (0.25 feet) in circumference on both gaff sails (Figure 48).⁸⁸
