THE MICA SHIPWRECK: DEEPWATER NAUTICAL ARCHAEOLOGY
IN THE GULF OF MEXICO

A Thesis

MASTER OF ARTS

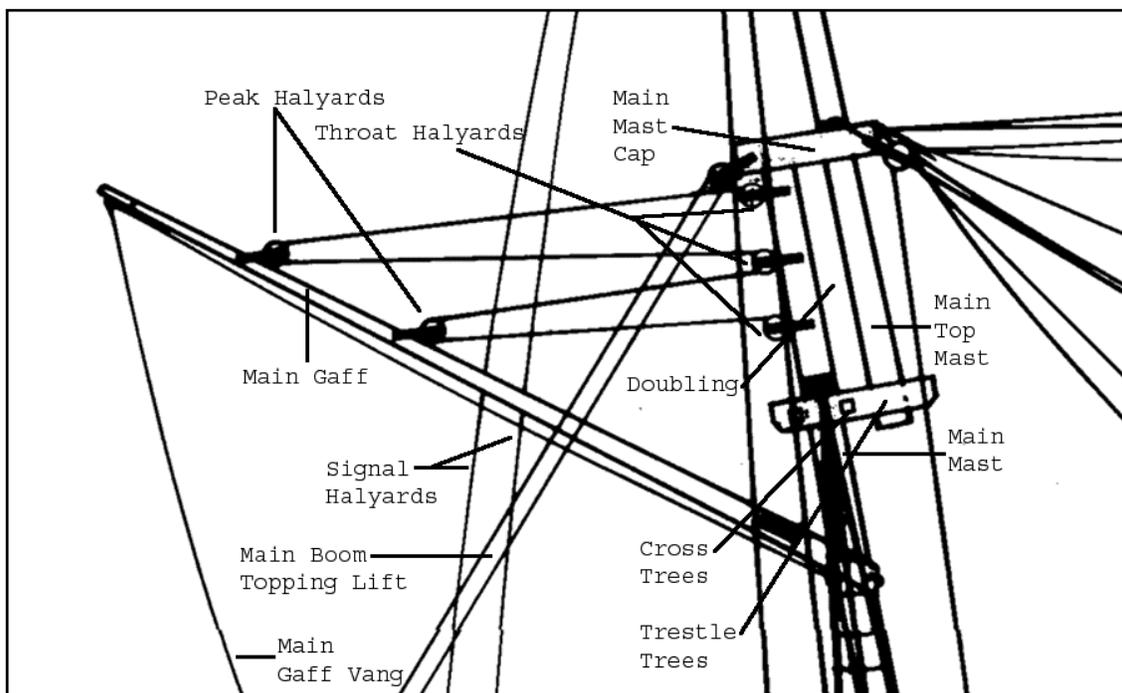
Figure 49. Upper aft rigging nomenclature (Drawing by author).

Vangs were visible on the *Glasgow*, *Hope*, *Polly*, and on an unidentified schooner moored in Havana. The vangs were used for manipulating the gaff towards the port or starboard. All of the images showed the vangs attached near the after end of the gaff on both the main gaff and fore gaff. The vangs hung slack and trail forward and down, where they are tied off to a cleat on the forward face of their respective masts. Two signal halyards were placed aft of the mainmast, and ran from the gunwale to the head of the main topmast (Figure 49).

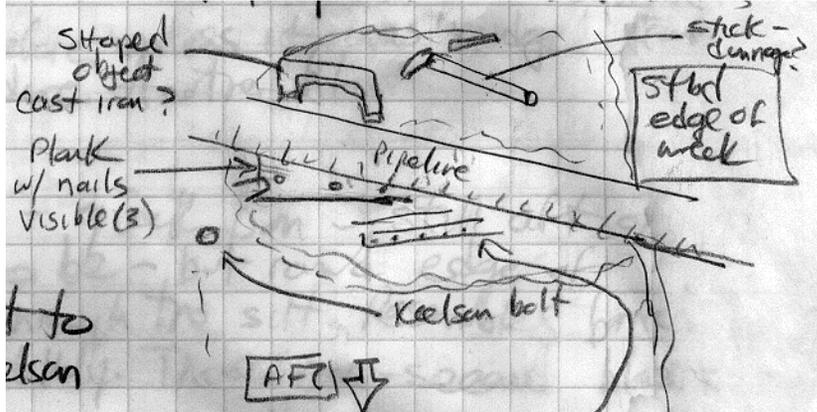
Figure A-1.

- 1515 Second squirt with duster. Lumpy-Possibly stone ballast?
- 1517 Another slightly longer blast. Small stone ballast? Forward of pipeline, starboard side.
- 1520 Fourth dust off.
- 1529 Object with straight line under pipeline.
- 1536 Silt clears, visual inspection along both sides of pipeline. Shallow U-shaped object forward of pipeline. Stick or Dunnage. Plank with nails or tacks directly adjacent to starboard side of keelson or keelson bolts. Lumps that looked like ballast are not so evident- probably just silt and not ballast. A copper strip tacked to a plank (Figure A-1).

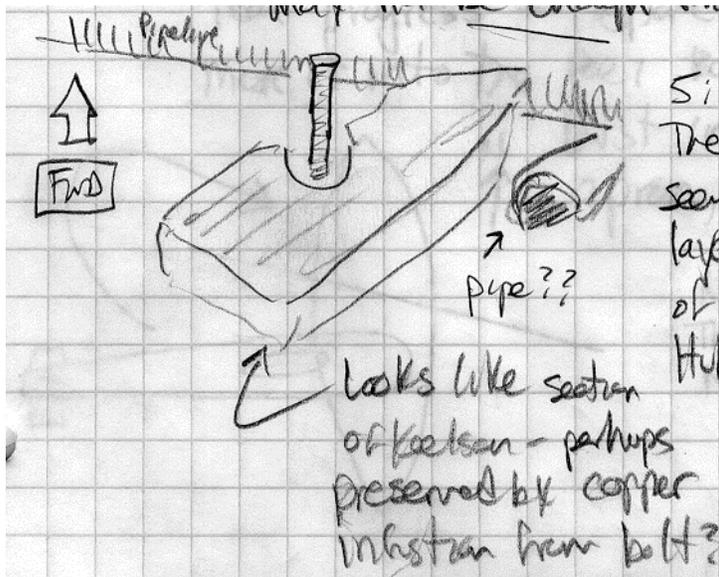
Twisted over to starboard. Out pipeline. Twisted when pipeline laid (Figure A-3).

Figure A-3. Illustration depicting part of keelson section, perhaps preserved by copper infusion from bolt.

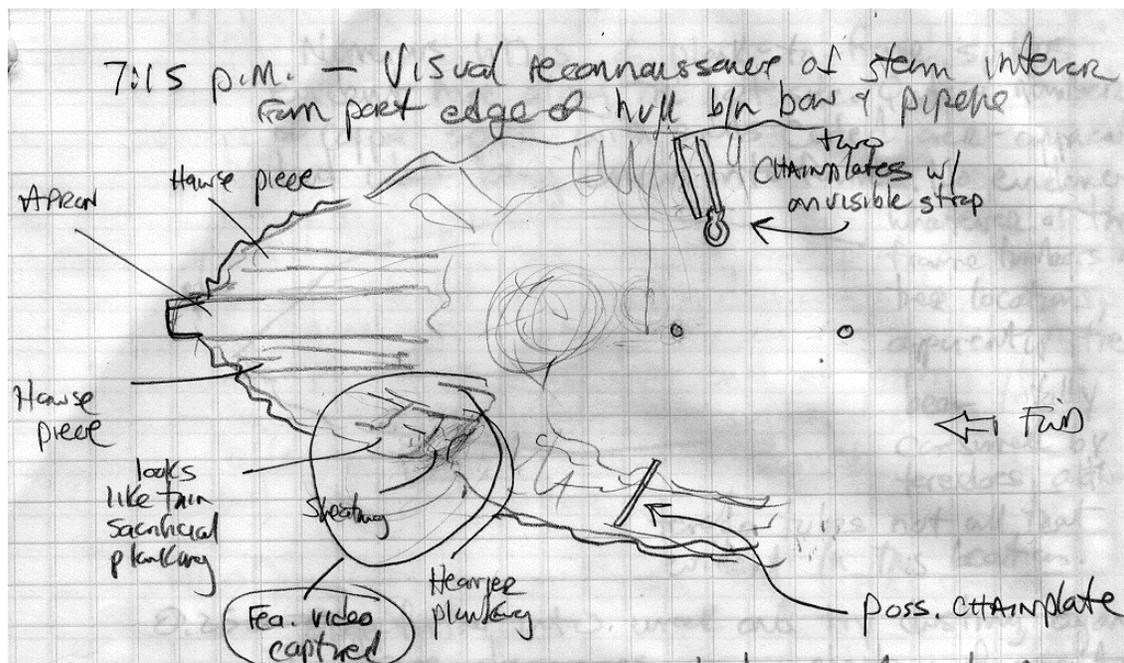
Figure A-4.

- 1915 Visual reconnaissance of stem interior from port edge of hull beneath bow and pipeline (Figure A-4).

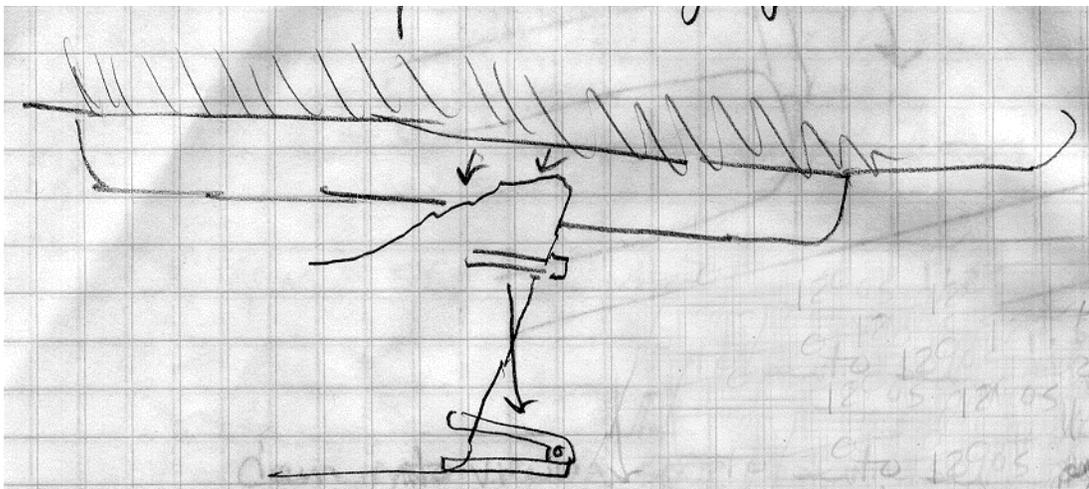
Figure A-5.

2355 pass just over post, then dropped down with hull and applied downward pressure. Gudgeon and top of post appeared to separate and fall to bottom. Back up and see gudgeon free on bottom (Figure A-5).

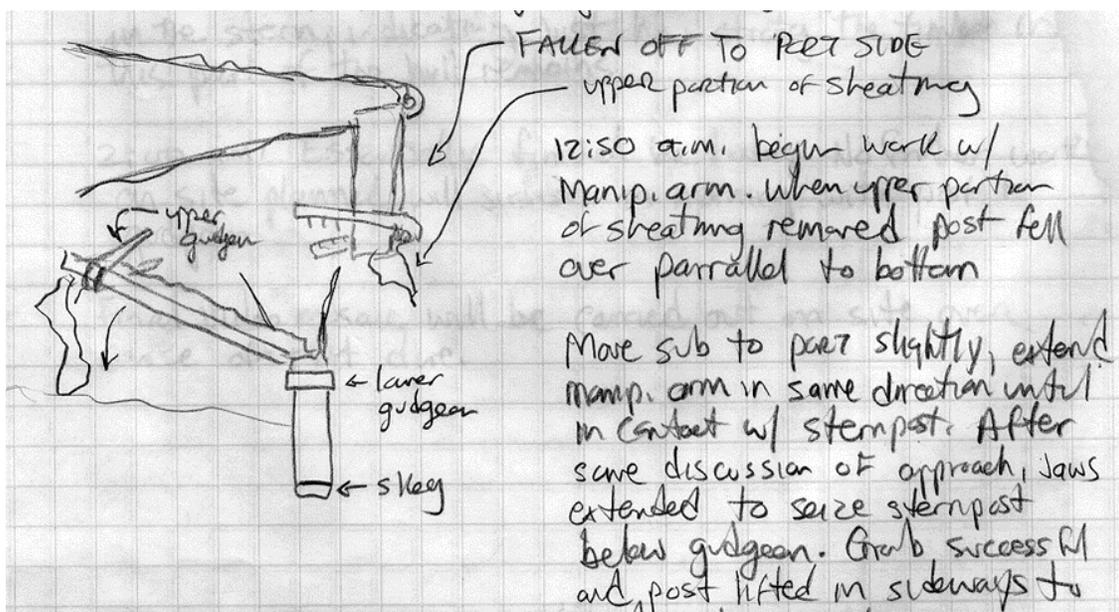
Figure A-6.

0030 Commence inspection of detached upper sternpost. Post broken just above lower gudgeon. Frame grabs made of upper, lower gudgeons, skeg (Figure A-6).

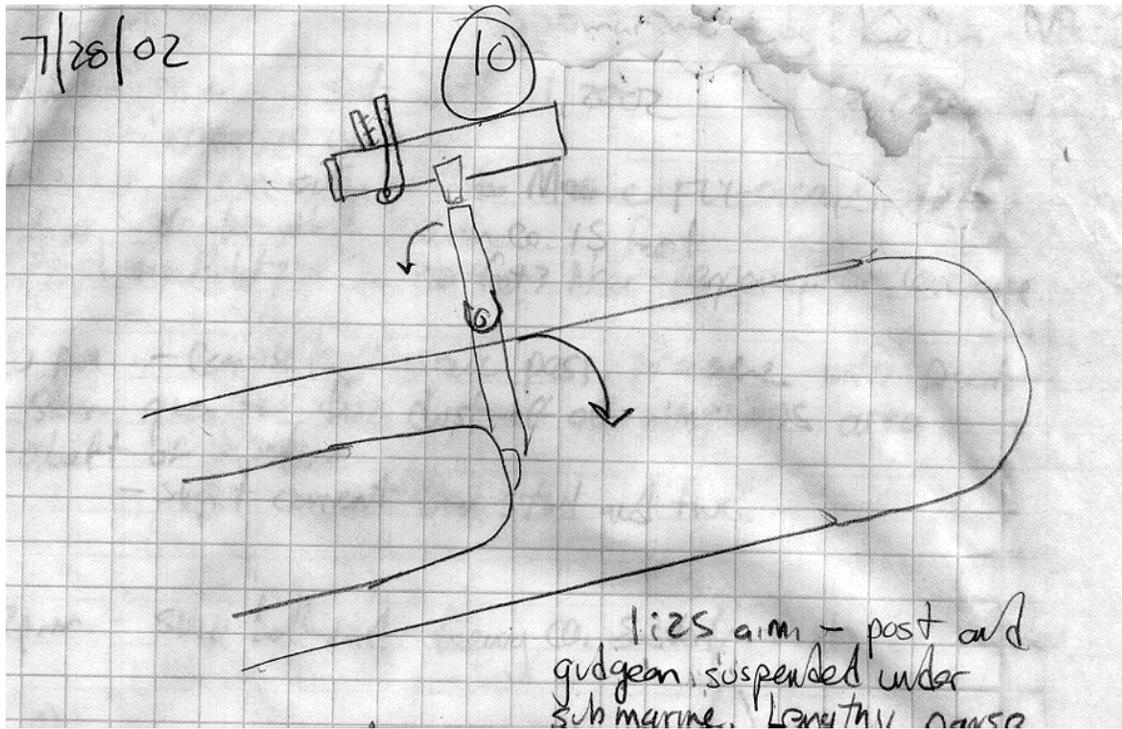
Figure A-7.

- 0050 Begin work with manipulator arm. When upper portion of sheathing removed, post fell over parallel to bottom. Move sub to port slightly, extend manipulator arm in same direction until in contact with sternpost. After some discussion of approach, jaws extended to seize sternpost below gudgeon. Grab successful and post lifted in sideways to underside of sub.
- 0125 Post and gudgeon suspended under submarine. Lengthy pause while various members of crew and KJC climb down into viewing space to see piece firsthand. Port side of stern sheathing and planking has peeled outward slightly, but otherwise minimal damage to structure is evident. Curiously, after a 150' nuclear submarine has leaned heavily upon the top of the sternpost and broken half of it off, the keel is still up off the bottom in the stern, indicating just how strong the timber in this part of the hull remains (Figure A-7).

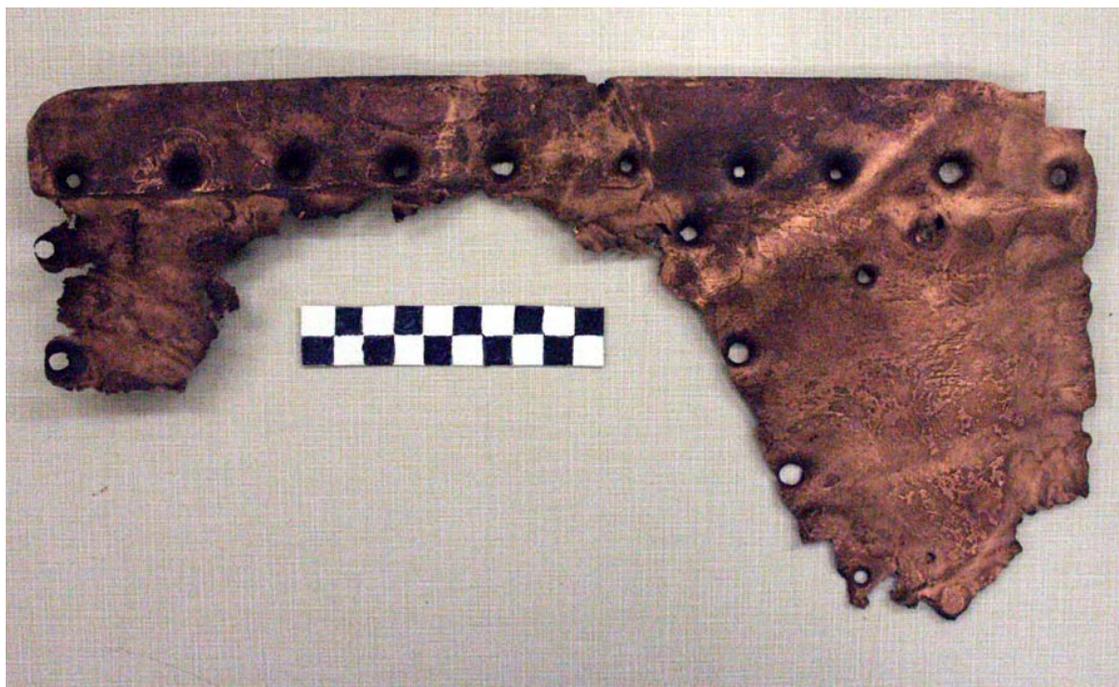
ARTIFACT 1

Description: Fragment of copper hull sheathing

Dimensions: 35.0 centimeters x 18.3 centimeters

Features: Appears to be the side edge of a sheet, as two corners are visible. 17 fastener holes visible. Sheathing overlap line is perceptible along the upper edge. Largest fragment of hull sheathing retrieved.

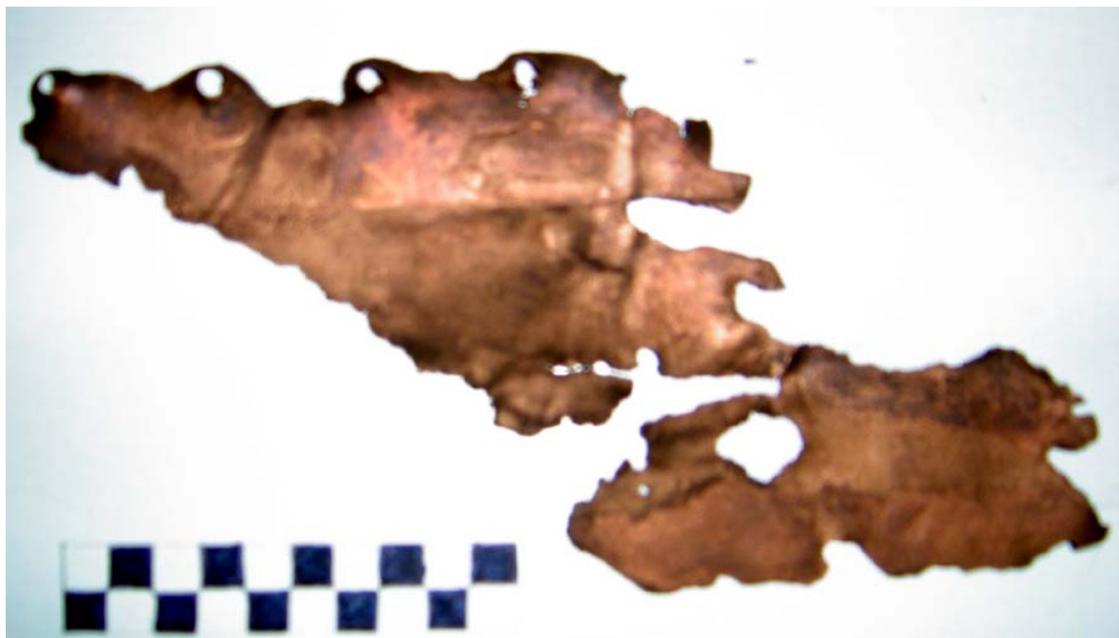
ARTIFACT 2

Description: Fragment of copper hull sheathing

Dimensions: 26.5 centimeters x 12.0 centimeters

Features: 4 fastener holes visible, no edges evident

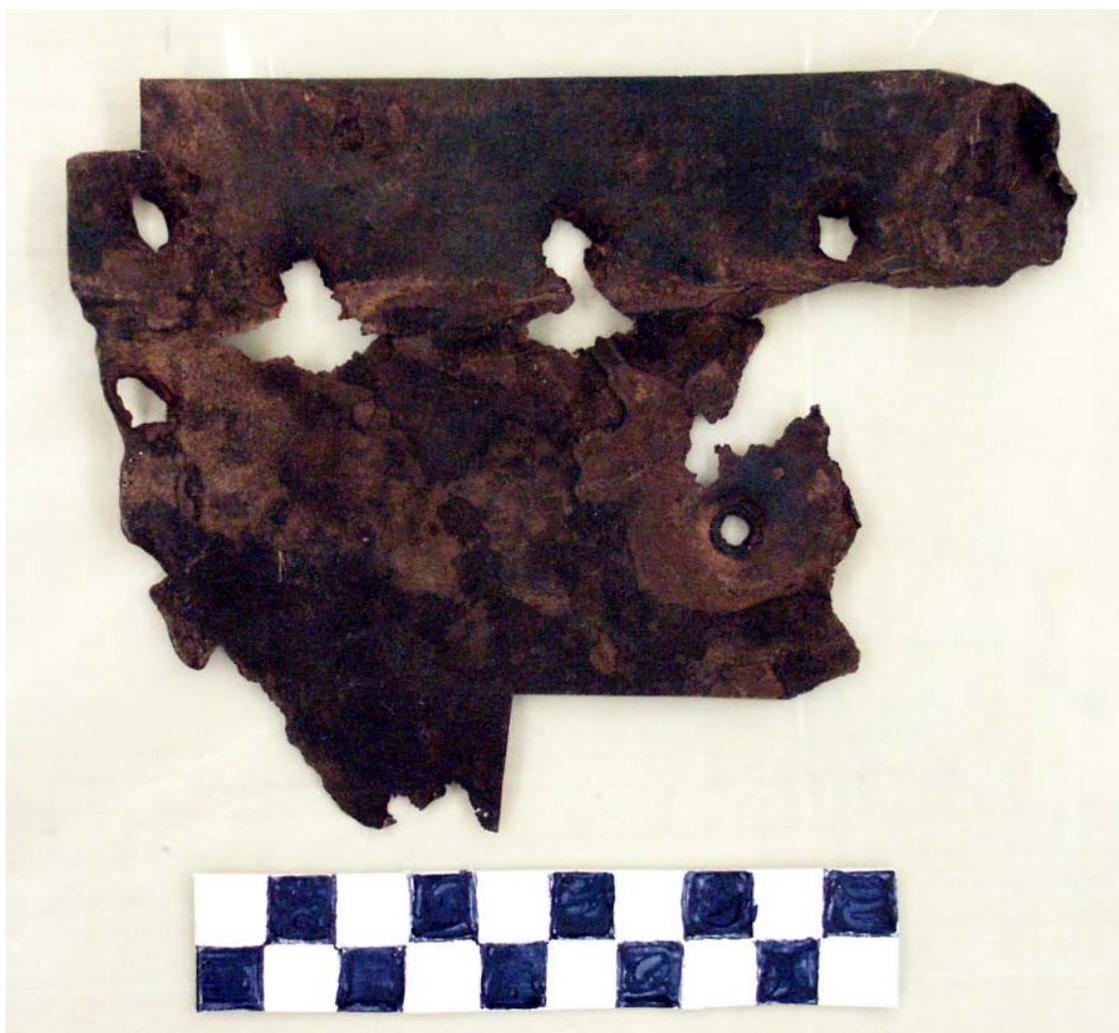
ARTIFACT 3

Description: Fragment of copper hull sheathing

Dimensions: 14.5 centimeters x 10.8 centimeters

Features: One edge visible, possibly a corner fragment. 6 fastener holes visible.

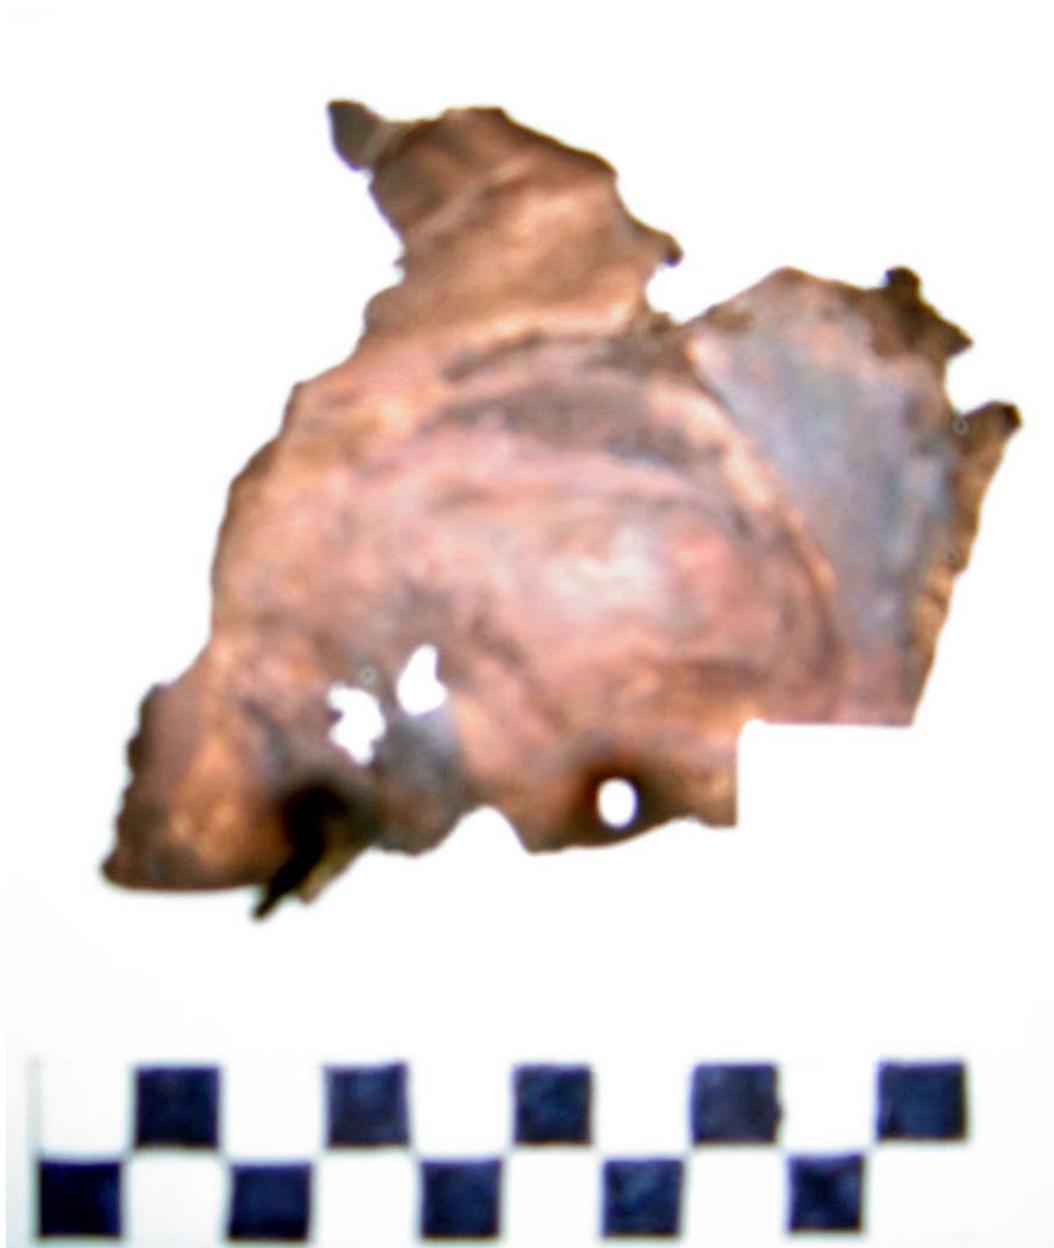
ARTIFACT 4

Description: Fragment of copper hull sheathing

Dimensions: 8.5 centimeters x 8.2 centimeters

Features: 2 fastener holes visible, 1 fastener, no edges.

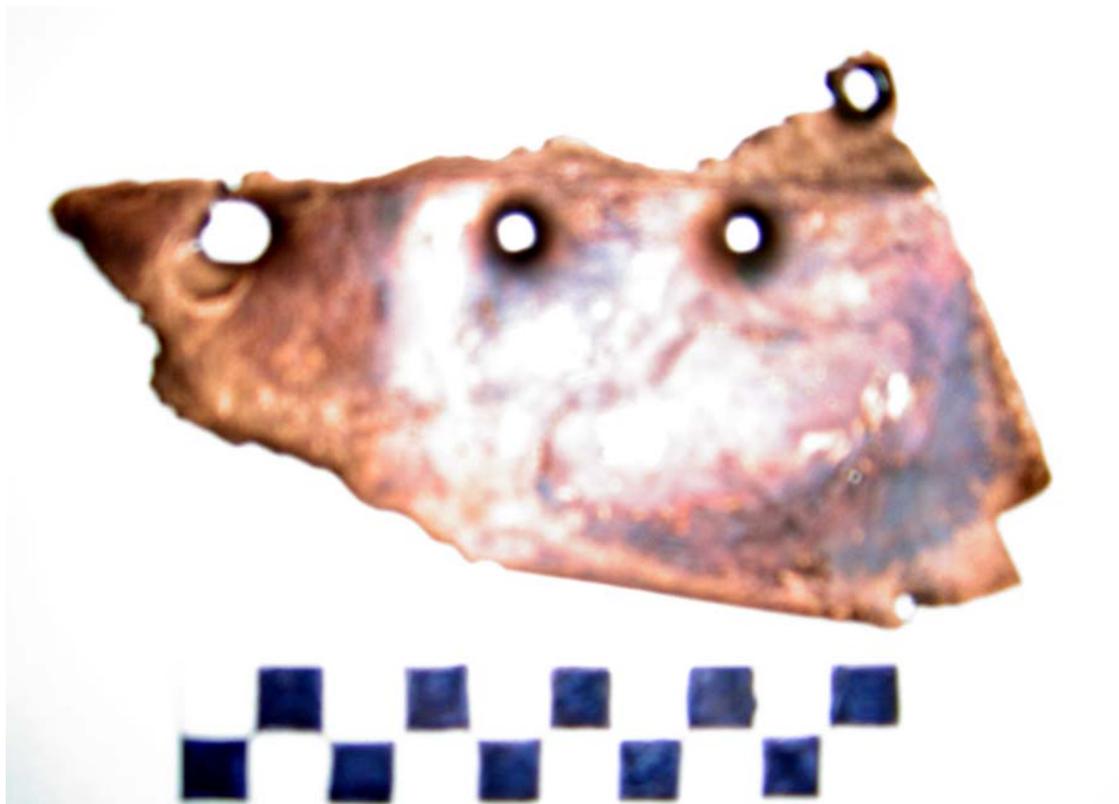
ARTIFACT 5

Description: Fragment of copper hull sheathing

Dimensions: 14.5 centimeters x 7.5 centimeters

Features: 4 nail holes, no edges.

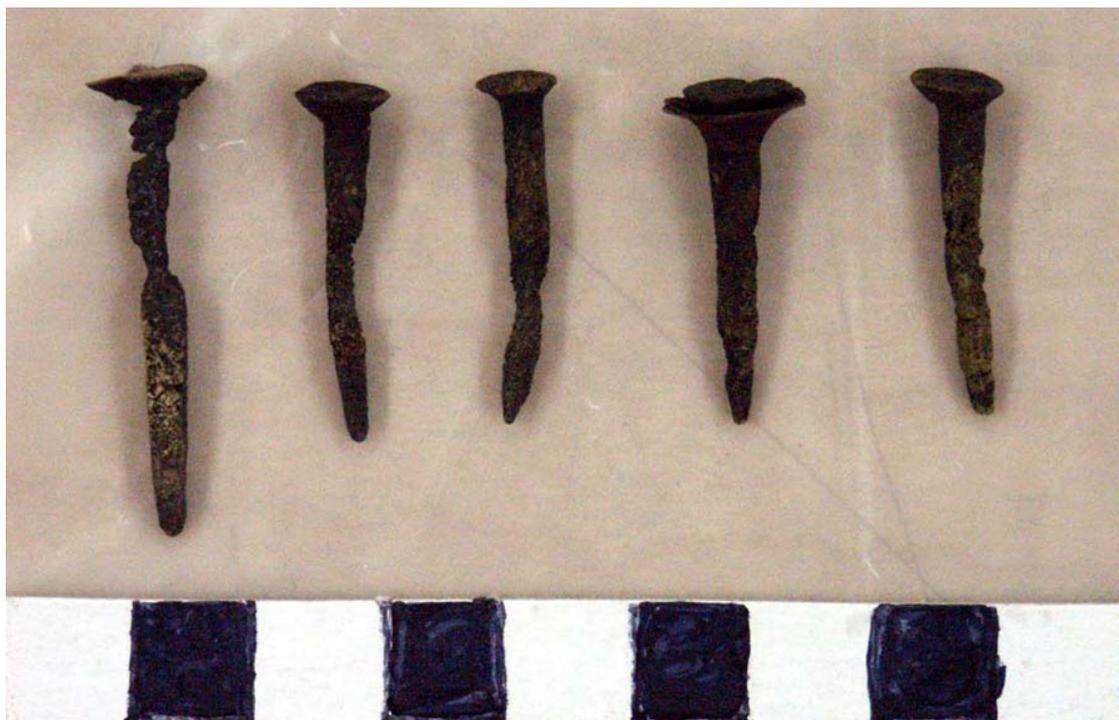
ARTIFACT 6

Description: Copper alloy sheathing fasteners

0.4 centimeter average shank diameter

Features: Flat head, tapered shank.

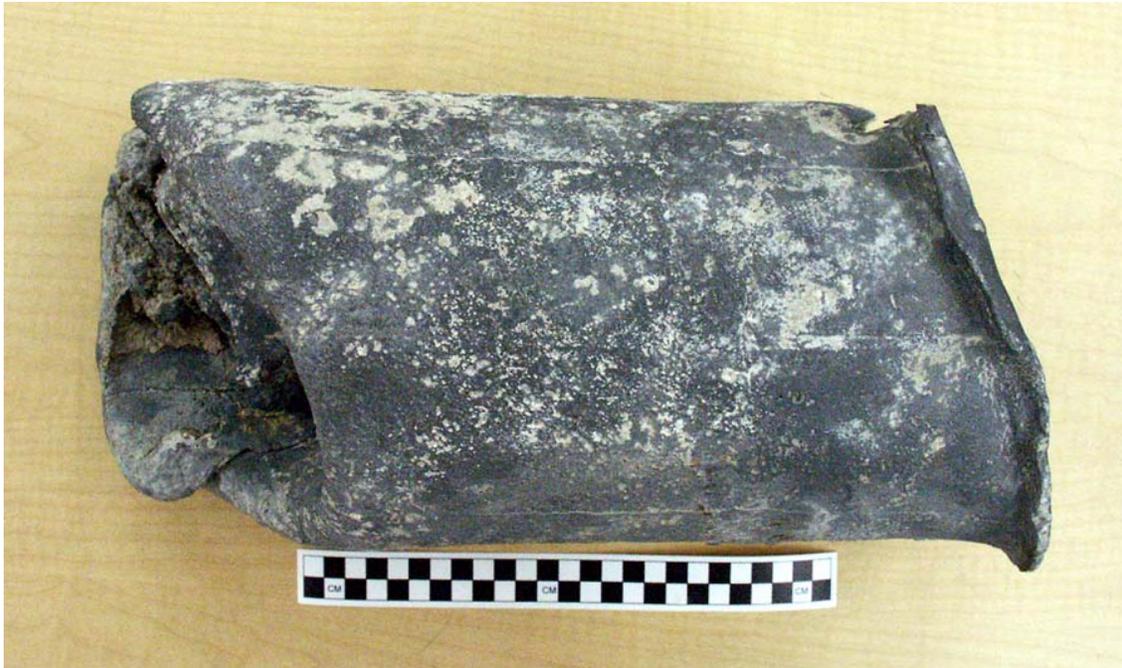
ARTIFACT 7

Description: Lead Hawse Pipe

Features: Casting seams, cut marks and internal wear are evident.
