A PRELIMINARY RECONSTRUCTION OF THE YASSIADA SIXTEENTH-  
CENTURY OTTOMAN WRECK

A Thesis

Submitted to the Office of Graduate Studies of  
Texas A&M University  
in partial fulfillment of the requirements for the degree of

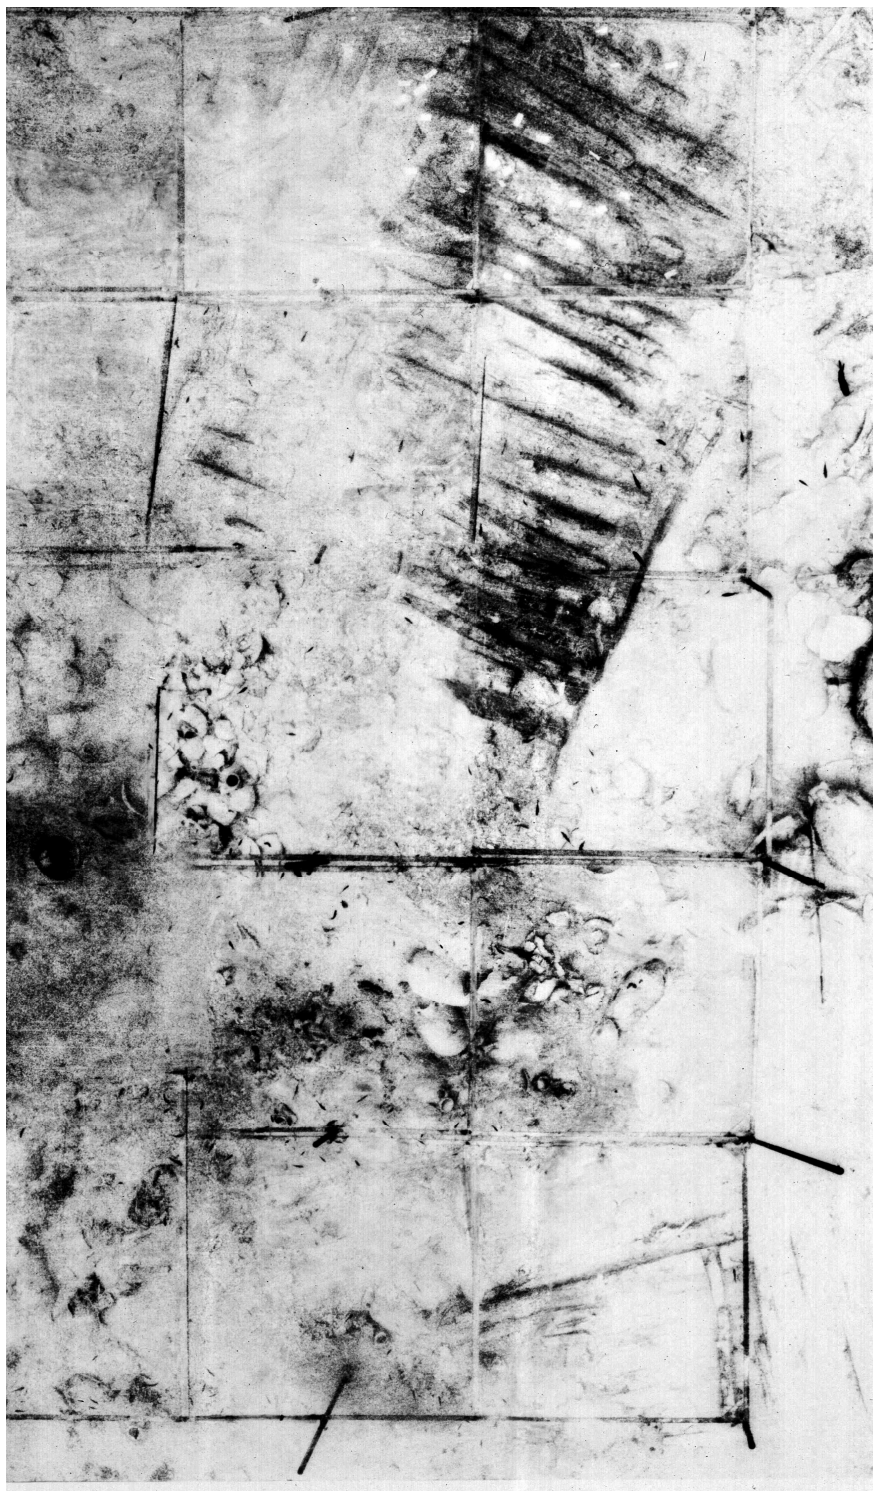
Fig. 1.3. Photo of the fourth-century wreck site. The Ottoman wreck is visible in the lower right hand corner. Photo courtesy of the Ottoman wreck project (INA).

Near the end of June, divers began discovering pieces of wood and the occasional artifact that seemed to have no obvious relationship to the fourth-century wreck and its cargo. A number of very well preserved timbers were found that ran perpendicular to the wreck. Further, much of this wood lay directly on top of fourth-century cargo, particularly crushed amphorae, indicating that it could not possibly be construction materials from the fourth-century vessel. By 24 June 1967, divers had cleared six to eight meters worth of the this "new" wood, enough to be able to say with certainty that it was, in fact, a second shipwreck<sup>7</sup> (fig. 1.3).

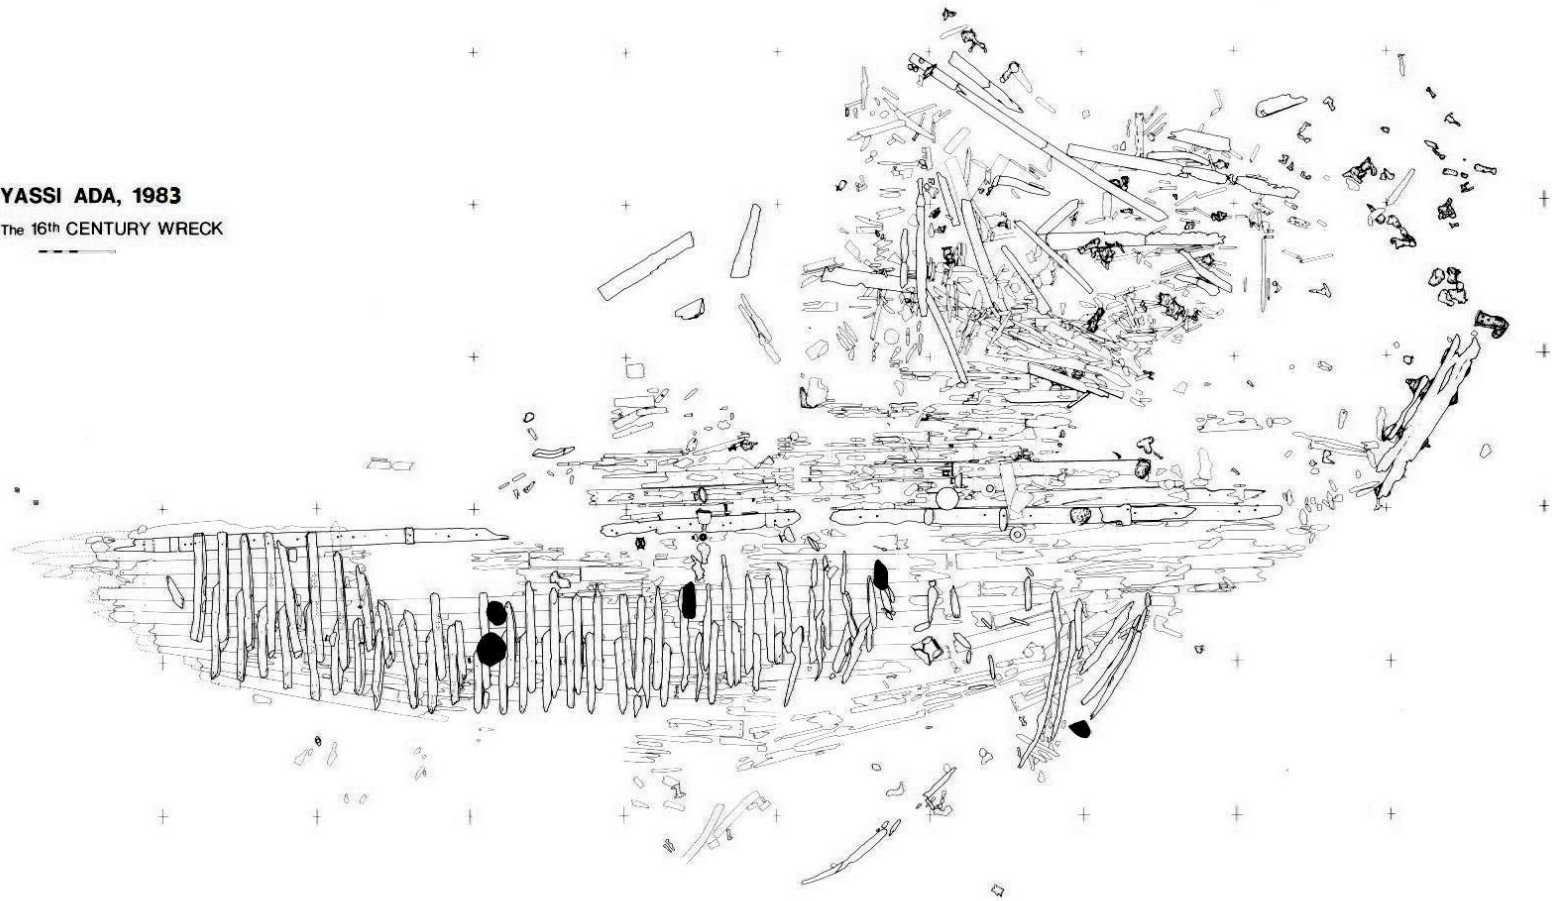
**YASSI ADA, 1983**  
The 16th CENTURY WRECK

Fig. 1.5. The wreck plan after the 1983 season. Drawing by Cemal Pulak.

During the course of the excavation, timbers from the wreck were raised after they were mapped (fig. 1.5). The timbers and artifacts to be raised were placed in wooden boxes that were raised with a lift balloon and then walked to the shallows of the island for storage. At the end of the excavation season, they were then loaded on *Virazon* for transport to the Bodrum museum.

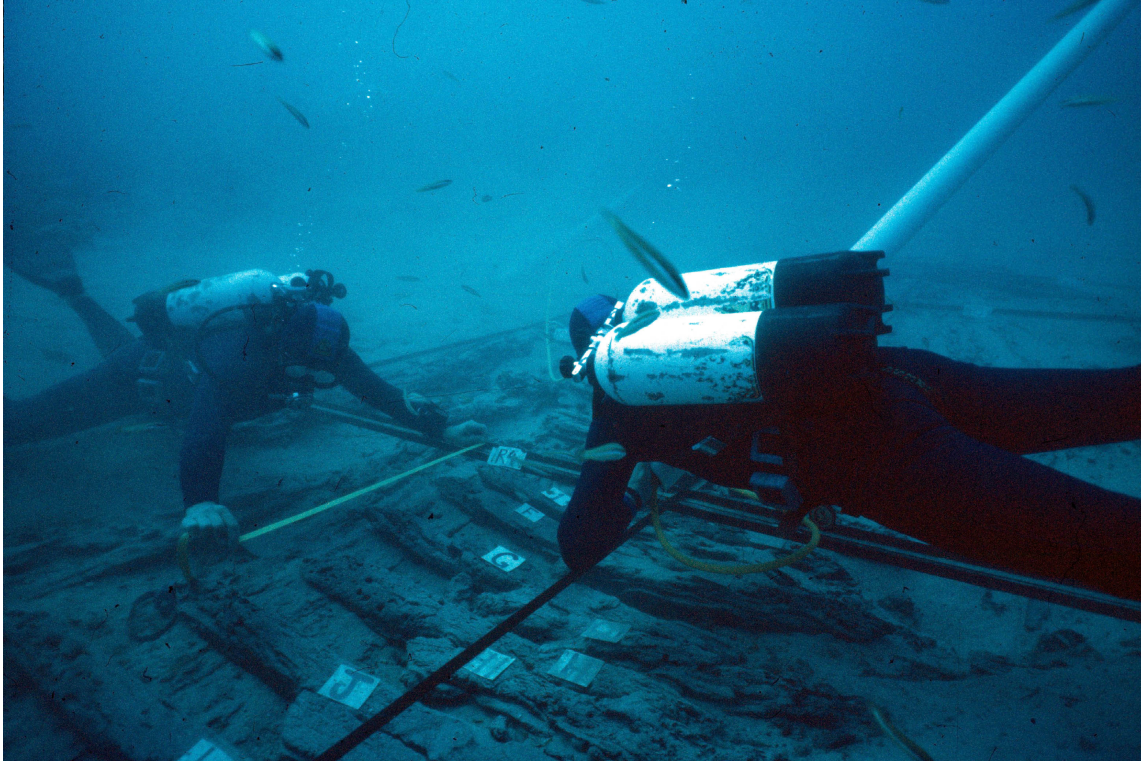
Fig. 3.1. Divers map the hull of the Ottoman wreck in 1982. Photo by Don Frey, courtesy of the Ottoman shipwreck project (INA).

The position of all of the ship's timbers was trilaterated from the corners of the two-meter wide grid squares and plotted on plastic drafting film while divers were still underwater (fig. 3.1). These maps of the individual grid square were then combined to

form a single master site plan drawn by field director Cemal Pulak. These measurements were supplemented with the application of stereophotogrammetry, which allows the general arrangement of the wreck to be captured by photographs with minimal parallax.

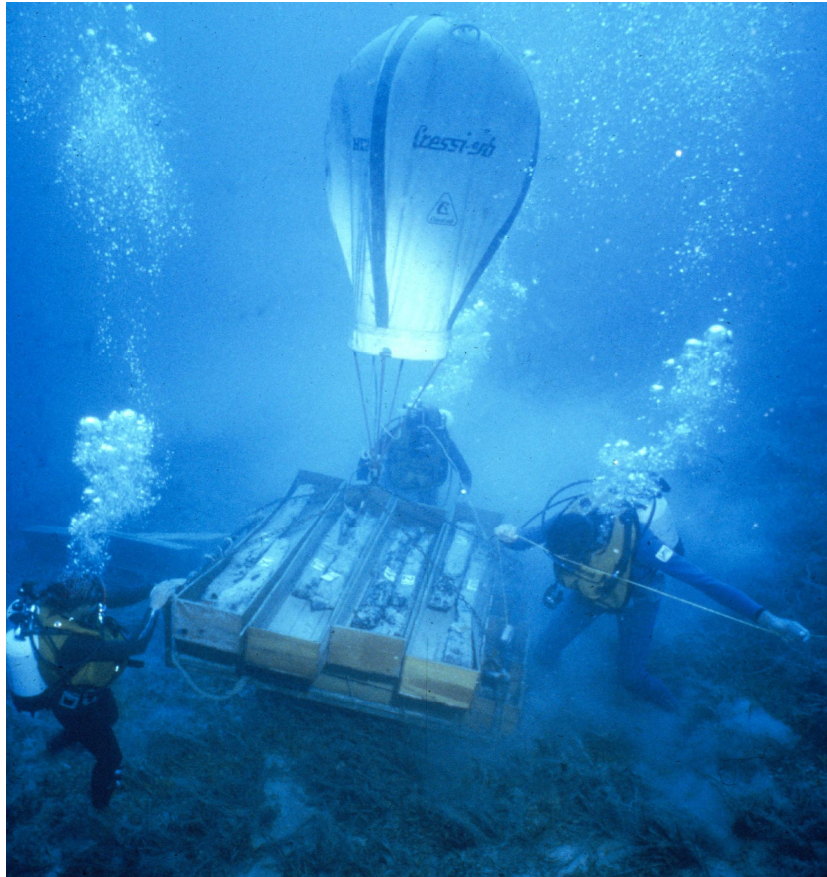
Fig. 3.2. Timbers being raised from the seabed. Photo by Don Frey, courtesy of the Ottoman wreck project (INA).

Once the site was mapped, timber removal began. The timbers were placed into custom made wooden boxes that had been sunk to the seabed. After they were loaded, they were raised by loading the boxes on a large metal framed lifting tray, which was attached to an airbag. The air bag was inflated, and the timbers walked to the surface and loaded onto *Virazon* (fig. 3.2).

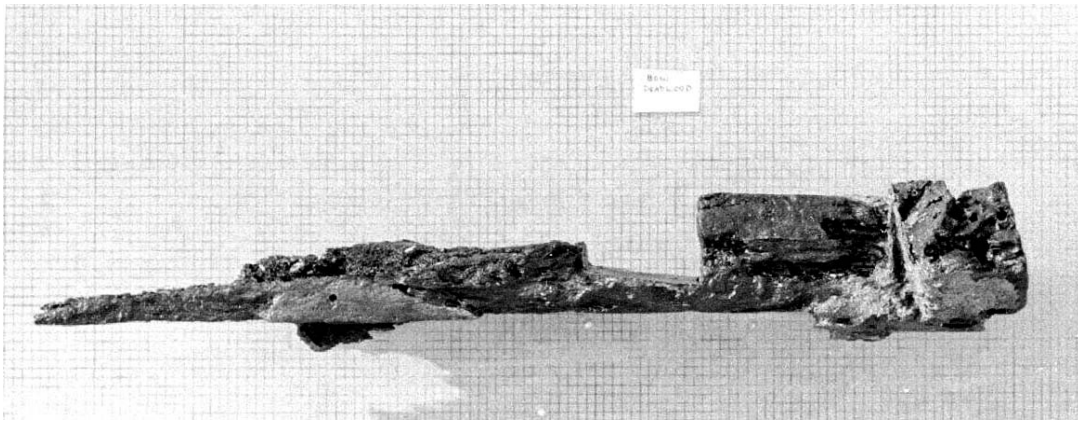
Fig. 3.4. Side view of the apron. Note the large notch for the stepping of frames. Photo by Cemal Pulak, courtesy of the Ottoman wreck project (INA).

On the inner face of the apron is a preserved notch 9 cm deep and 13 cm wide that was used to step the frames in this area (fig. 3.4). They would reduce in depth as they moved toward the bow, and eventually the frames would have sat on top of the apron with no notches. In August of 1967, divers recorded the depths of the notches preserved on the apron up to frame station DD. The measurements given were 9 cm at frame station BB; 6 cm at frame station CC; and 2.5 centimeters at frame station DD. All measurements were taken from original surfaces on the inner face of the apron. The reduction in the depths of the notches as they near the bow indicates the frames were stepped gradually to accommodate for the curving of the stem and to prevent the installation of Y-shaped frames, also known as crotch timbers.

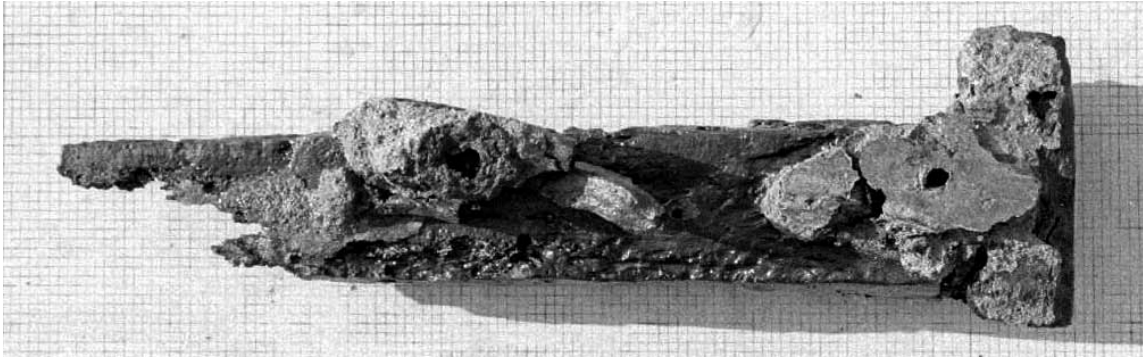
Fig. 3.5. Bottom view of the apron. The bent forelock bolt (center) is the area where the ship struck the reef. Photo by Cemal Pulak, courtesy of the Ottoman wreck project (INA).

The forward most forelock bolt on the apron is bent aft (fig. 3.5). In its concretion are preserved wood fragments that came from the keel. On the port side of the apron in approximately the same location is a nail hole that shows no evidence of concretion or oxidization, suggesting that the nail was ripped out during the sinking. These two pieces of evidence indicate that this is the area where the ship struck the reef; the keel would have broken from the impact and some of the planking ripped away from

the frames, allowing seawater to flood the ship.<sup>89</sup> The forelock bolt in this area bent aft since the ship was moving forward at the time it struck the reef.

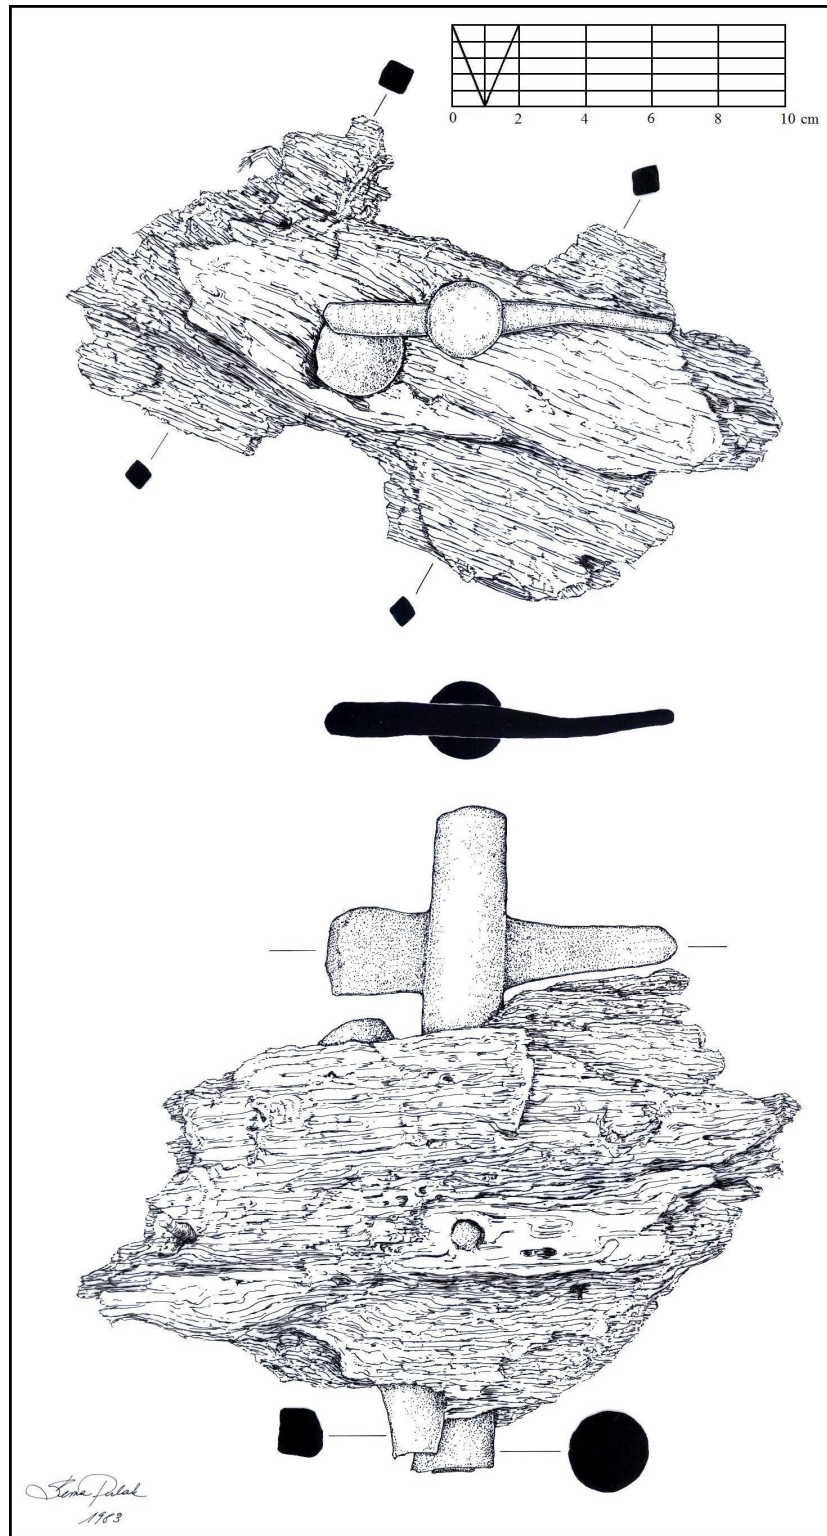
Fig. 3.7. OW81. The artifact includes a fragment of a forelock bolt and a nail embedded in a fragment of the inner sternpost. Drawing by Sema Pulak.

One of the more unusual artifacts found on the wreck was a fragment of the upper end of a forelock bolt, OW81 (fig. 3.7), found in grid L2 above the preserved

fragment of the sternpost. It is unusual because in addition to the key for the forelock bolt, it has a nail head that runs vertically through the timber, as well as nails that run through the side. The presence of a forelock bolt in this area indicates that the preserved wood attached to the bolt is a fragment of the inner sternpost, and represents some of the best evidence that the inner sternpost continued up to deck level. This is supported by the nail that runs vertically through the timber, since this type of nailing was also utilized to fasten the lower end of the inner sternpost that was attached to the aft end of Keel 5. The nails that pass through the sides of the timber may represent two possible scenarios. The first is that they are planking nails attached at this point because it was the location of a hood end. The second, but less likely, possibility is that these nails were placed here as a means to attach transom timbers. Because the sternpost is not especially well preserved, and the stem is non-existent, the apron and inner sternpost help give an indication as to the original length of the ship. We know that the frames on this ship were pre-erected because the fasteners for the hook scarves could not have been installed after the floors were erected, since they are longer than the space between the frames. The midship frame also gives an indication that the entire shape of the hull was pre-designed. This means that frame AA and frame 21, which would have butted against the stern knee, were probably the last pre-designed frames. As a result, the presence of these two components indicates that no significant section of the wreck at the ends has decomposed, and the ship could not originally have been much longer than the remains that were preserved.

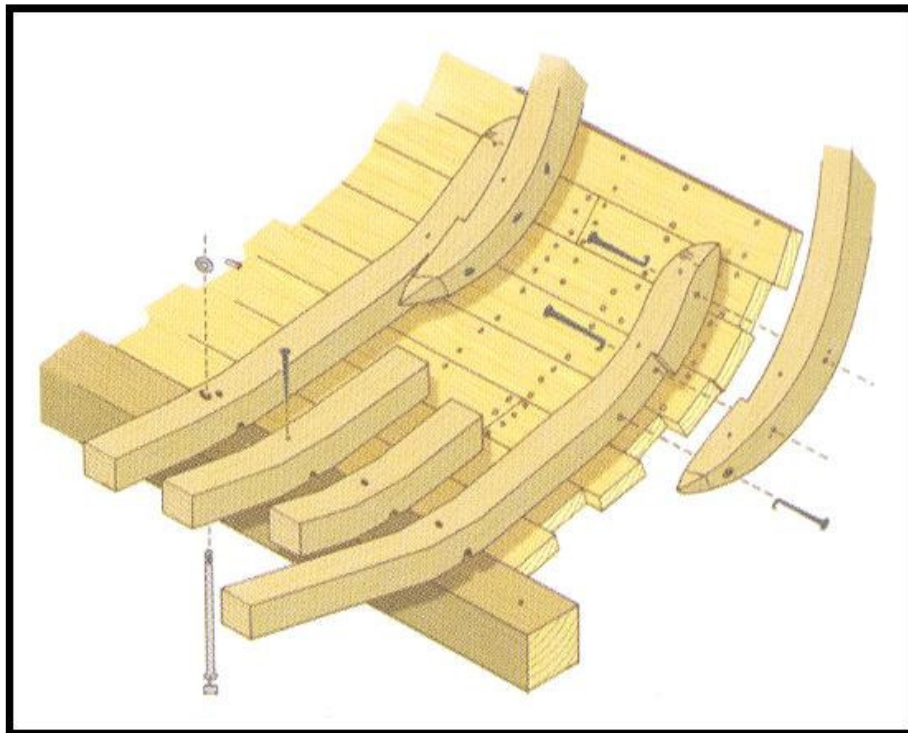
Fig. 3.8. Isometric diagram of frame assembly of the Ottoman wreck. Drawing by Jay Rosloff (from Pulak 2005, 141).

All of the frames are attached to the keel with a single spike, and were probably held in place more by the keelson rather than just these spikes. Each frame was attached to its futtock with a sawn out knuckle joint, also known as a hook scarf, and three clenched nails (fig. 3.8).

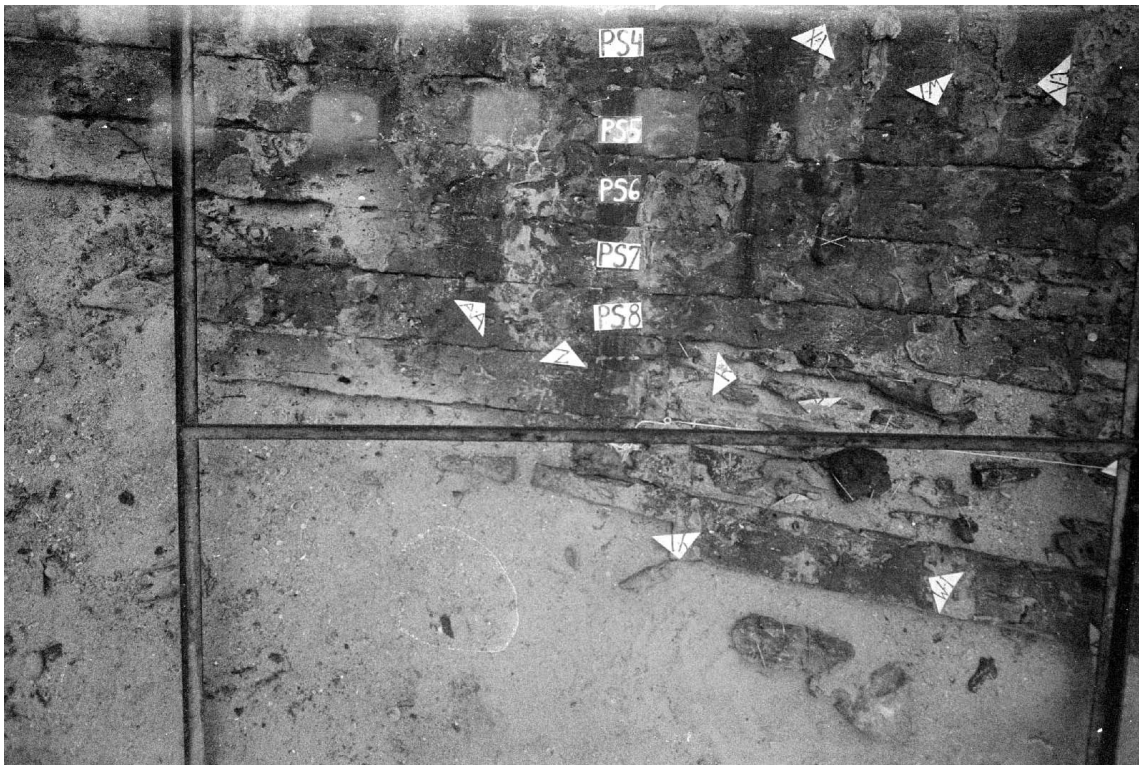
Fig. 3.10. An overhead view of the planking showing repairs to strake PS 14/2. Note the L-shaped cut in the plank near label Y-1 near the center of the photo. Photo courtesy of the Ottoman wreck project (INA).

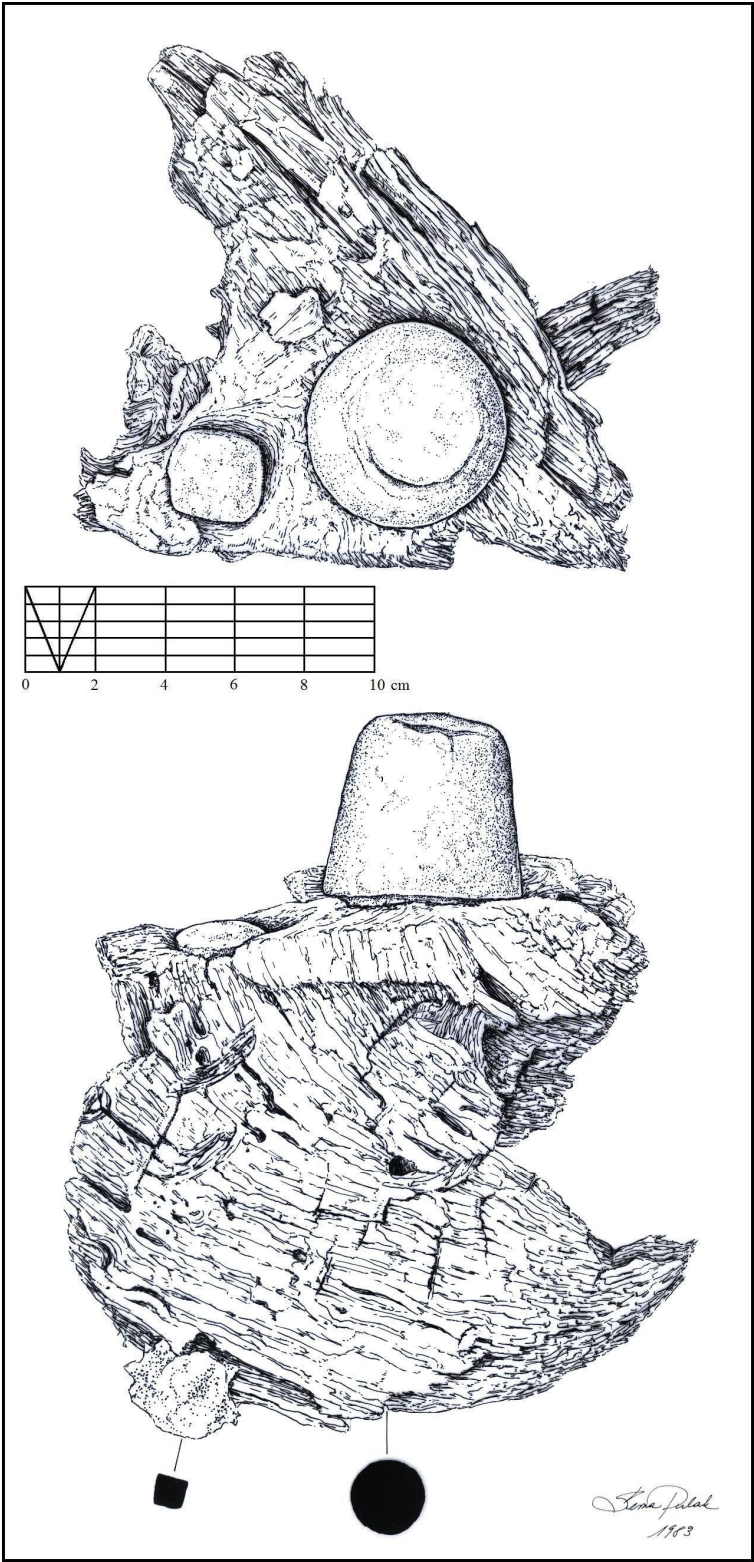
Fig. 3.11. OW113. Mushroom bolt with additional nail. Drawing by Sema Pulak.

This theory is supported by one particular mushroom bolt, OW113 (fig. 3.11), which is a preserved section of one of the ship's wales with the head of the mushroom bolt, as well as a standard nail. The presence of common planking nails indicates that they were sufficient to hold the wale in place, so the mushroom bolts must have had some secondary function, most likely that they were installed as a means to protect the hull from damage. Further, a single complete mushroom bolt (OW88) was found with fragments of a wale, frame, and a stringer (fig. 3.12). This gives us a thickness of at least 9-11 cm for the ship's wales. The fact that the mushroom bolts were anchored to the frames and stringers indicates a desire to make the wale rigid and able to absorb the force of contact between a bouncing ship and a dock.

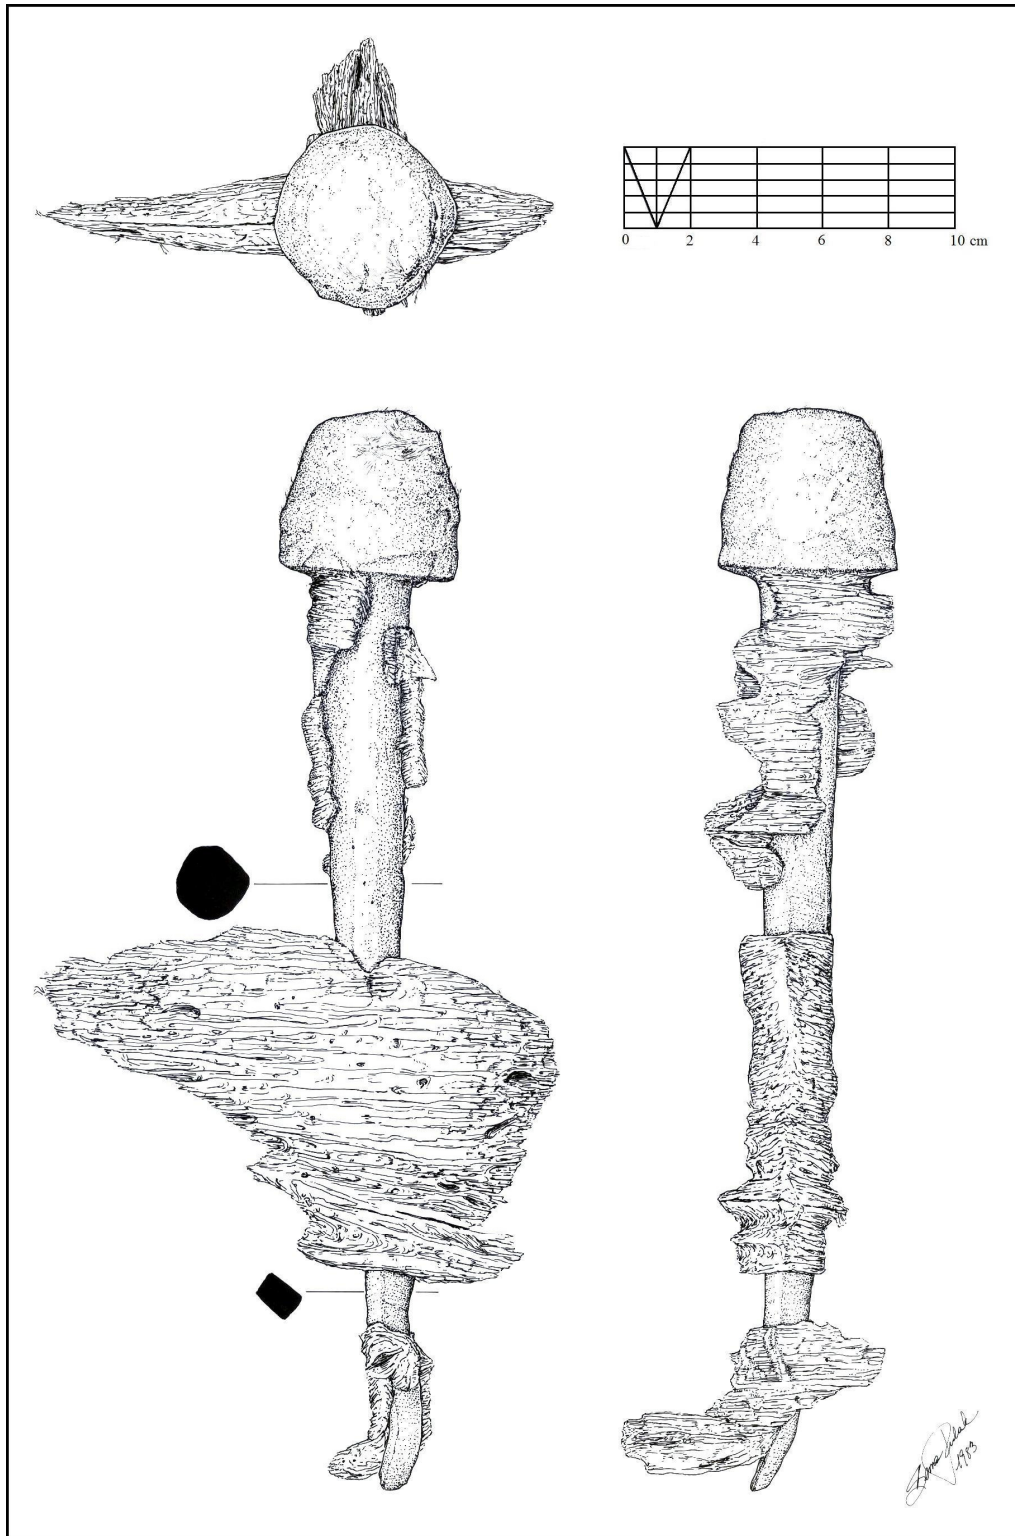
Fig. 3.12. OW88. This was the only complete mushroom bolt found on the wreck. The change in direction of the wood grain on the artifact indicates which timbers the bolt was attached to. Drawing by Sema Pulak.

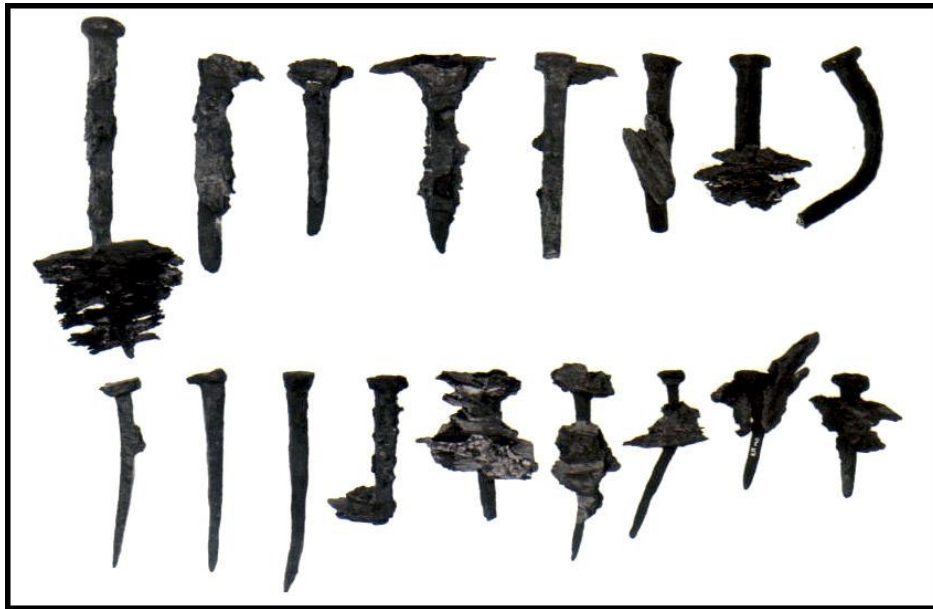
Fig. 3.13. A selection of planking nails from the Ottoman wreck. Photo by Cemal Pulak, courtesy of the Ottoman wreck project (INA).

The most common type of artifact found on the Ottoman wreck was square, wrought iron nails (Fig. 3.13). This makes sense, because common nails were used to attach all of the planking as well as the framing of the ship. There is little to no difference between the nails used on the framing and those used for planking the vessel, suggesting they were manufactured in the same place.

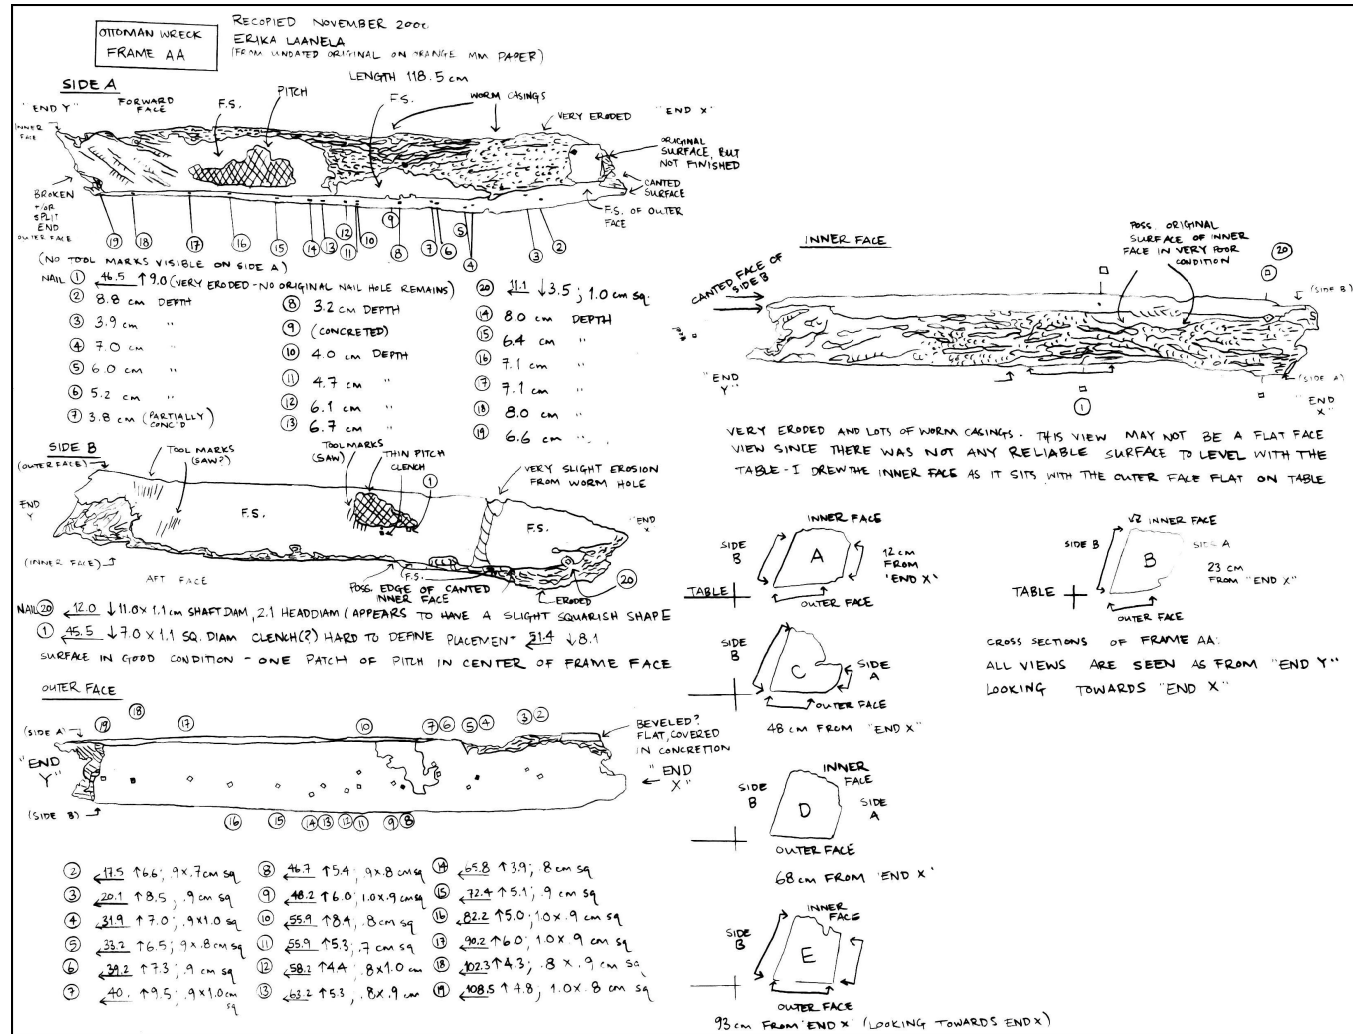
Fig. 4.1. A 1:10 scale drawing of frame AA. The drawings, which show all fasteners, tool marks, and other details, were invaluable to the reconstruction. Drawing by Cemal Pulak, recopied by Erika Laanela.

The revised site plan was a vital component of the reconstruction. With the added detail, the positions of nail holes relative to each other and those on other previously attached timbers were visible. The added detail of frame impressions and pitch made it possible to accurately place timbers in their proper location; an absolute necessity, particularly in reconstructing the original frame spacing, since a majority of the frames on the wreck had detached from the keel as the ship disintegrated.

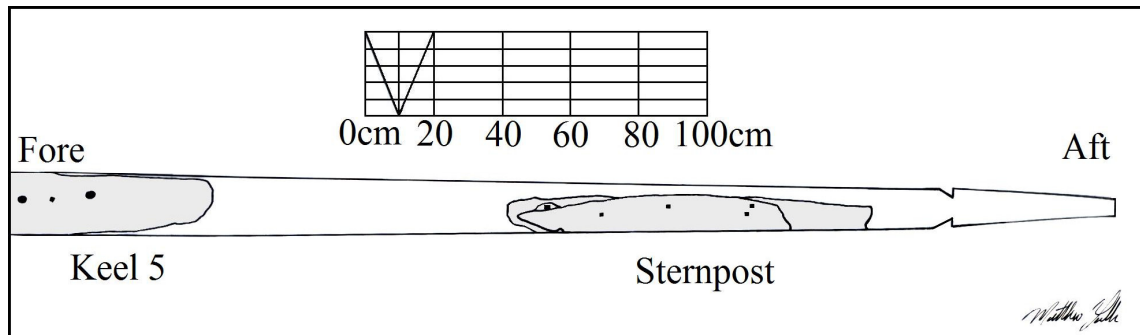
Fig. 4.3. An overhead view of the keel showing the original location of the sternpost fragment. The sternpost has been foreshortened to accommodate the curve of the post. Drawing by Matthew Labbe.

The next step was to find the distance that the preserved section of the sternpost would have sat above the keel. When the keel is viewed from the top aspect, it is seen to narrow slightly as it runs aft. The preserved fragment of the sternpost does the same. By continuing to narrow the keel beyond its after end, it was possible to position the

sternpost in such a way that its narrowing was consistent with that of the keel (fig. 4.3). This resulted in 1.28 m as the distance from the preserved end of Keel 5 to the base of the preserved section of the sternpost.

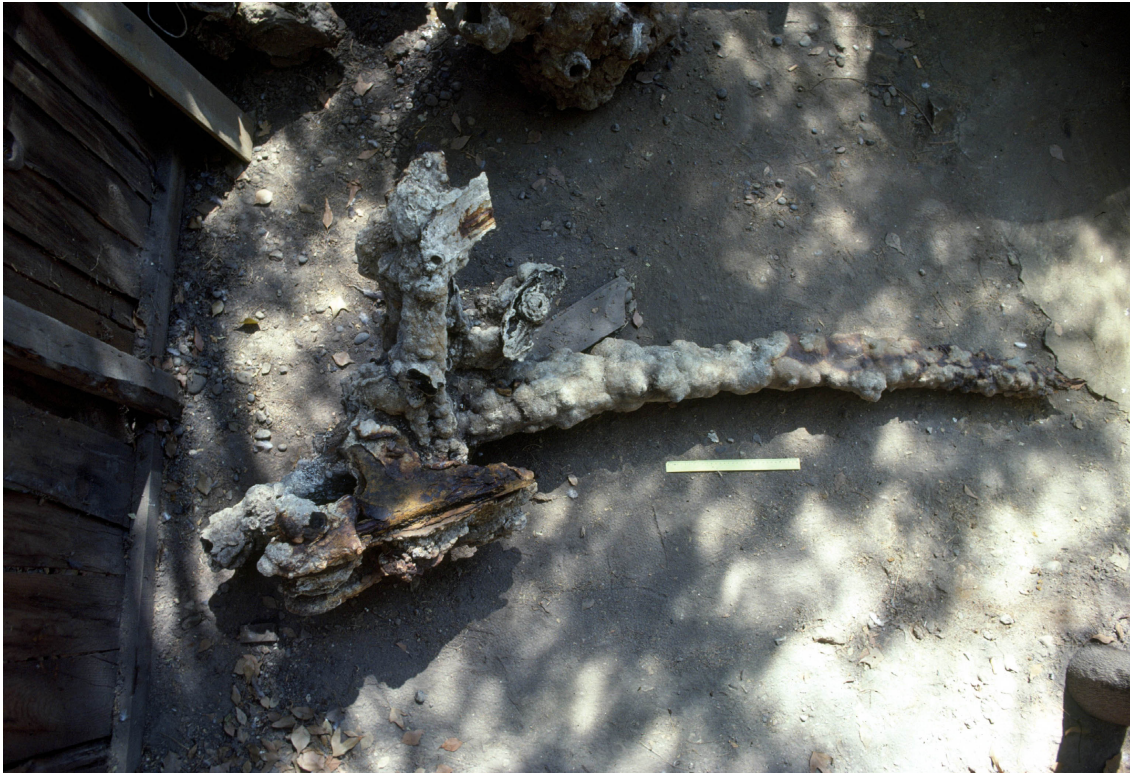
Fig. 4.4. The heavily concreted pintle awaiting conservation in 1983. Photo by Cemal Pulak, courtesy of the Ottoman wreck project (INA).

Unfortunately, this location alone was not sufficient to place the sternpost accurately. With only a single point locked in, the sternpost fragment could be rotated to produce a variety of curves that are consistent with its outer face as well as the outer face of Keel 5. Another point between these two was needed in order to assure that the run of the sternpost was plausible while remaining consistent with the preserved remains. This point was found by analyzing the shape of the 1.9 m long pintle that was found southeast of the wreck. Parts of the pintle were bent and heavily concreted (fig. 4.4). Due to the very poor preservation of the pintle, Cemal Pulak spent a significant amount of time cleaning, casting, and reconstructing the artifact before it could be accurately measured and drawn (fig. 4.5).

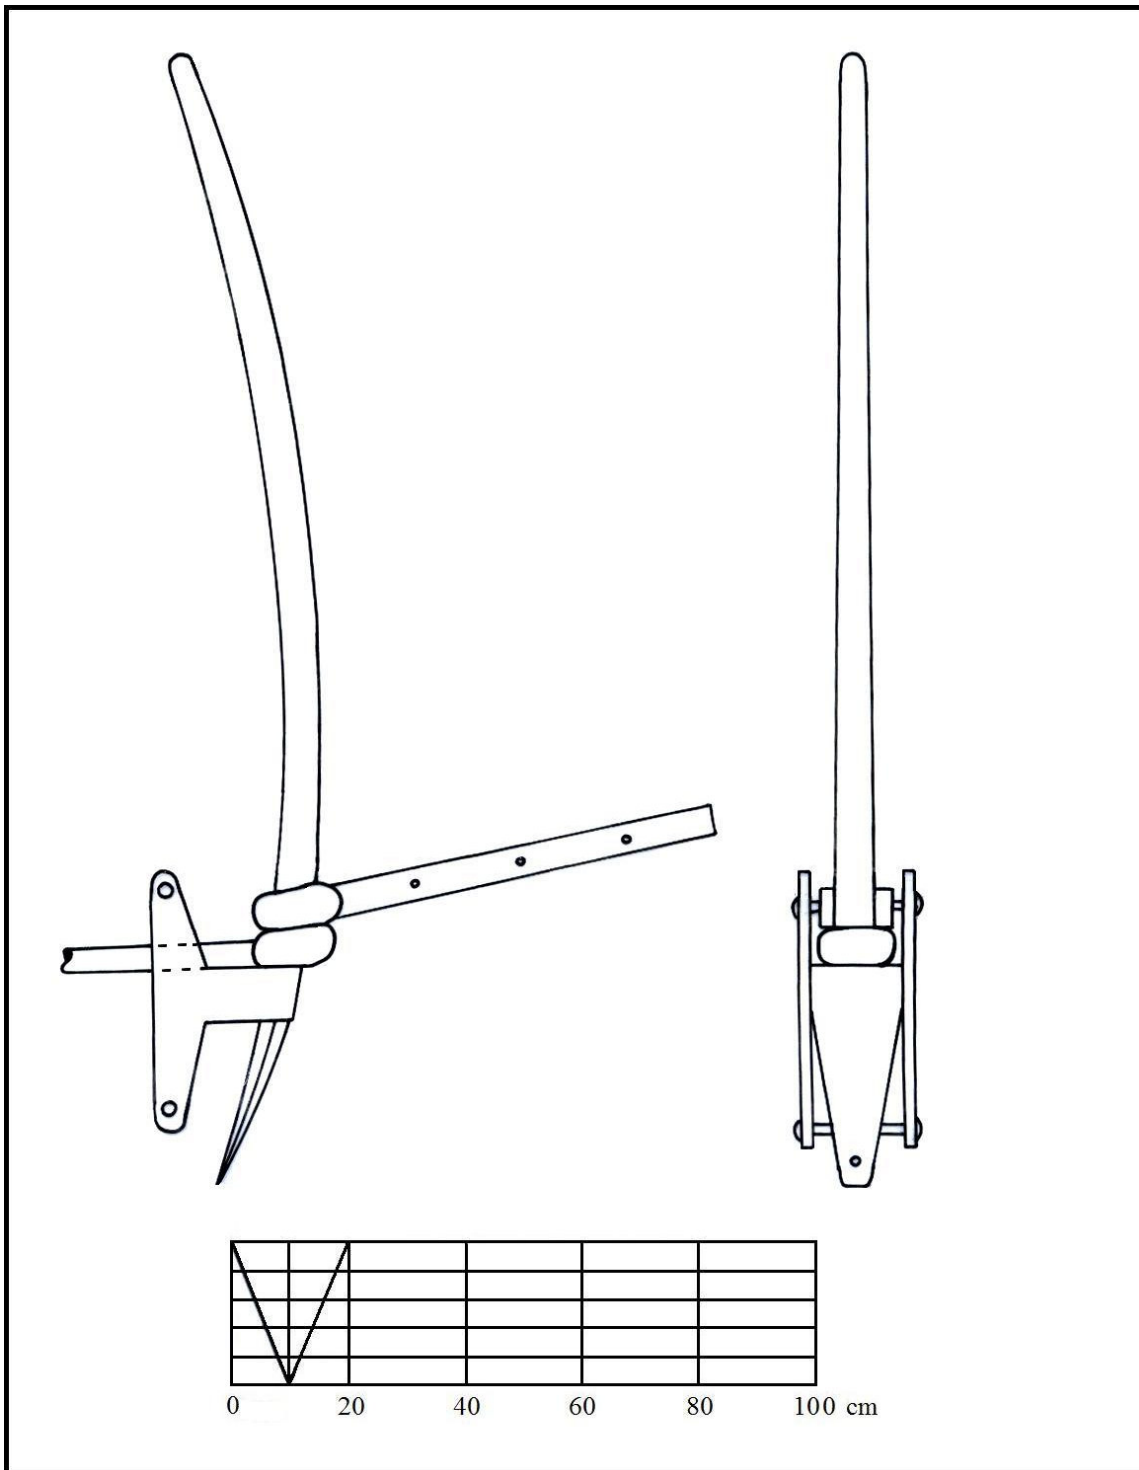
Fig. 4.5. Port and aft views of the reconstructed pintle. Drawn by Cemal Pulak, inked by Matthew Labbe.

The long arm of the pintle was mounted to the sternpost below the waterline in such a way that it would have maintained a consistent distance away from the curving sternpost so that it would not interfere with the rotation of the rudder. This meant that the curve of this arm had to be nearly identical to that of the sternpost. By placing the pintle on the sheer view drawing of the sternpost and shifting it, it was possible to see the limited number of places that the pintle could fit with the proposed reconstruction. With this information, as well as that from the keel itself, and from the sternpost fragment, it was possible to obtain a fairly accurate reconstructed curvature for the stern.

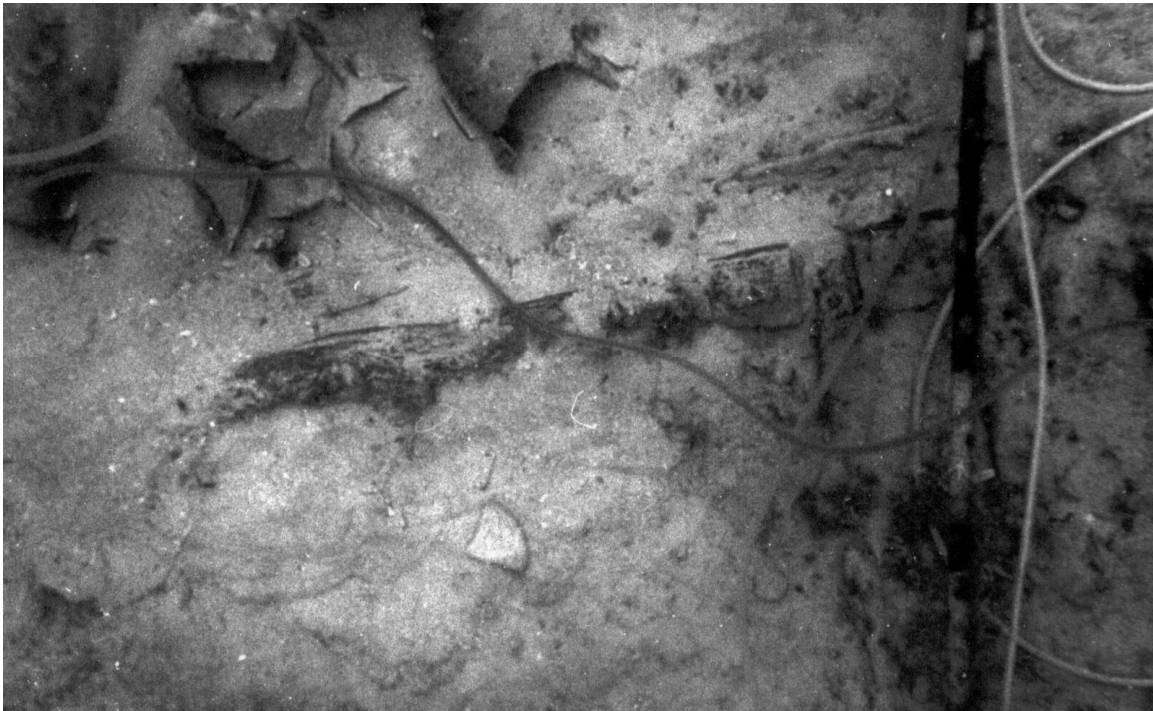
Fig. 4.6. Photo from late summer 1967 showing the broken keel. Photo courtesy of the Ottoman wreck project (INA).

The final bit of information regarding the stem came from the photographs of the excavations from the 1960s. The most useful photograph shows the forward most end of the apron, with a portion of it broken off and lying on its port face (fig. 4.6). This face shows the outer curve at the beginning of the stem, as well as the remains of a frame, likely frame EE. Because the preserved section of the apron is in the photograph, it was possible to scale this fragment to assess its dimensions with the help of Ryan Lee, a nautical archaeology program student, in the Wilder 3-Dimensional Imaging Lab at Texas A&M University.

The photograph was scanned and imported into Rhinoceros 3.0, a 3-D modeling program, where all of the wood fragments were traced. A known distance, in this case, the width of the step at frame BB, was imported as real world measurement, and the picture was scaled to fit this measurement. It was then printed out at 1:10 scale so that it could be traced onto a reconstructed stem drawing. It was necessary to find out, however, exactly where this fragment would sit on the keel. In this case, the preserved frame fragment on this newly scaled keel fragment gave a clue.

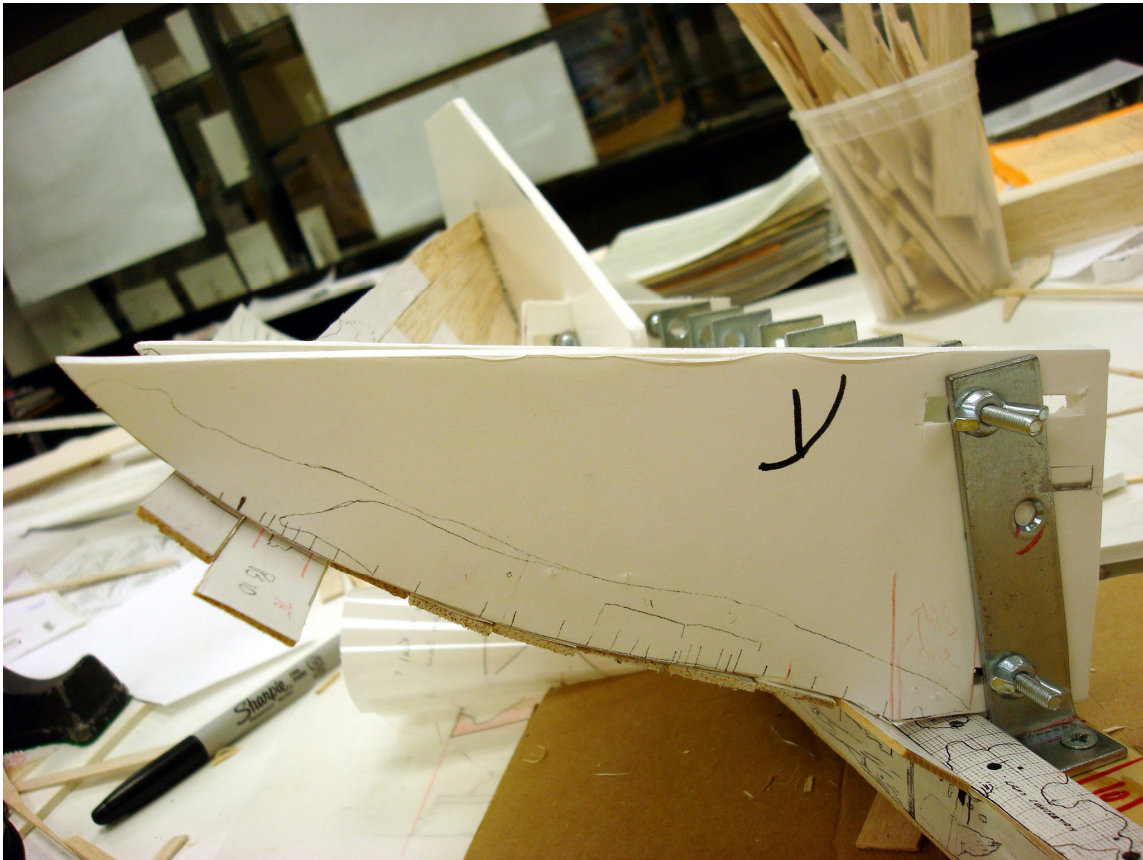
Fig. 4.7. A frame attached to the model's support structure. Photo by Matthew Labbe.

Because a large majority of the floor timbers do not cross the keel on the wreck and their exact orientation on the ship was not known, it became necessary to devise a system so that the floors could be rotated up or down, depending upon the information derived from the ship's planking. A support structure for the model was constructed to solve the problem. Two pieces of particle-board of the same length and shape of the keel were placed to the starboard side of the model keel. A series of L-shaped brackets, one for each frame (even those that were not preserved), were mounted to the particle-board pieces at distances that corresponded to the location of frames on the reconstructed framing pattern. The foam-core floor timbers could then be mounted to the brackets with one or more screws and butterfly nuts in such a way that the frame was either held in place securely by multiple bolts, or was free to move when attached with a single bolt (fig. 4.7). The other advantage of this plan was that the floor timber could also be slid back and forth across the keel by cutting a square channel in the foam-core frame equal to the diameter of the attachment screws and perpendicular to the mounting bracket. The brackets were placed in an area where no frames were preserved so that the curves of the missing frames could be reconstructed as the planking of the model progressed.

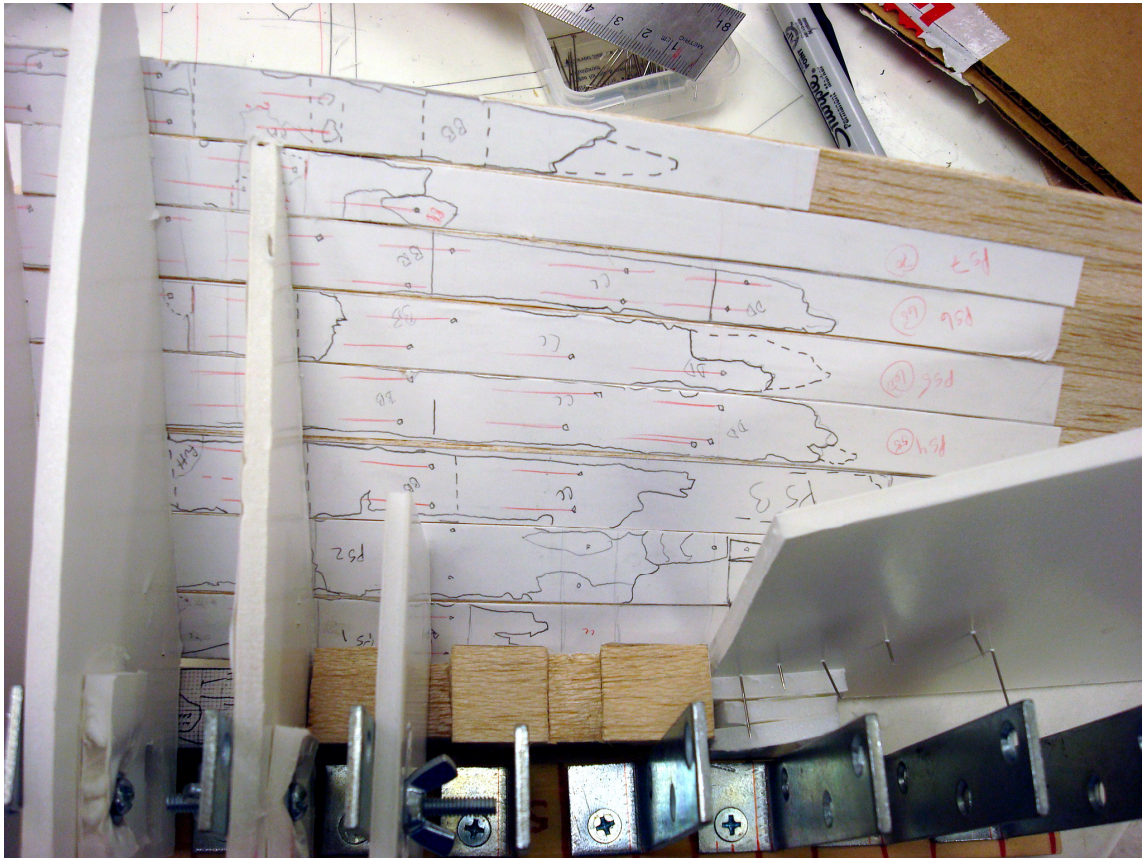
Fig. 4.8 View of the model early in the construction sequence. Note the alignments of nails on planks to which frames were attached. Photo by Matthew Labbe.

structure. Photocopies of plank remains were glued to strips of balsa wood. Multiple planking fragments were added to each piece of wood to increase the plank length in order to produce smoother, more accurate hull curves. Original locations of plank butt joints were maintained. The nails on the inner faces of the planks were marked in red and matched to their corresponding nail holes on the frames (fig. 4.8). When the two matched, the planking was pinned to that area of the frame with steel pins.
