A PRELIMINARY RECONSTRUCTION OF THE YASSIADA SIXTEENTH-  
CENTURY OTTOMAN WRECK

A Thesis

Submitted to the Office of Graduate Studies of  
Texas A&M University  
in partial fulfillment of the requirements for the degree of

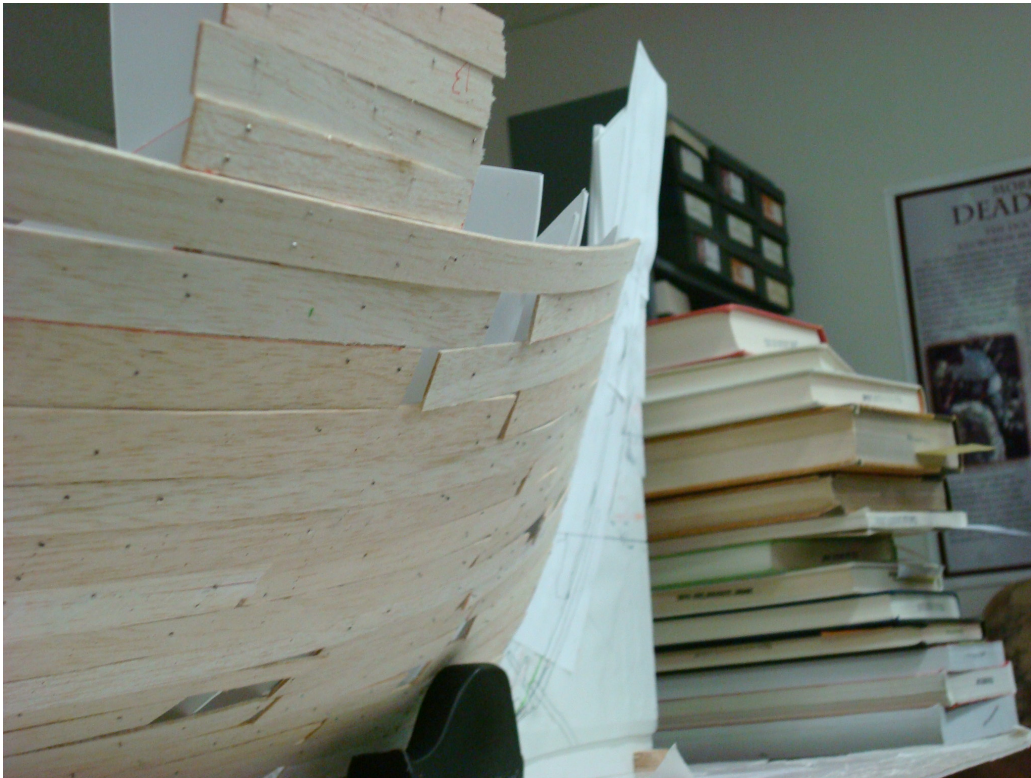
Fig. 4.9. The stern of the model showing the wale in place. The wale is the uppermost complete strake. Photo by Matthew Labbe.

There was, however, a line of mushroom-head bolts running perpendicular to the top ends of the futtocks preserved on the port side of the ship at the aft end. These bolts, used to hold the wales to the framing of the ship, were attached to the futtocks when they fell to the seabed during the disintegration sequence. By examining the distance between these bolts and known planking runs, it was possible to discern where the wale may have sat; in this case, somewhere around strake 18. A wale made of a thicker strip of balsa wood than the planking was installed on the model at this location, and additional strakes were added above it for three more strakes (fig. 4.9).

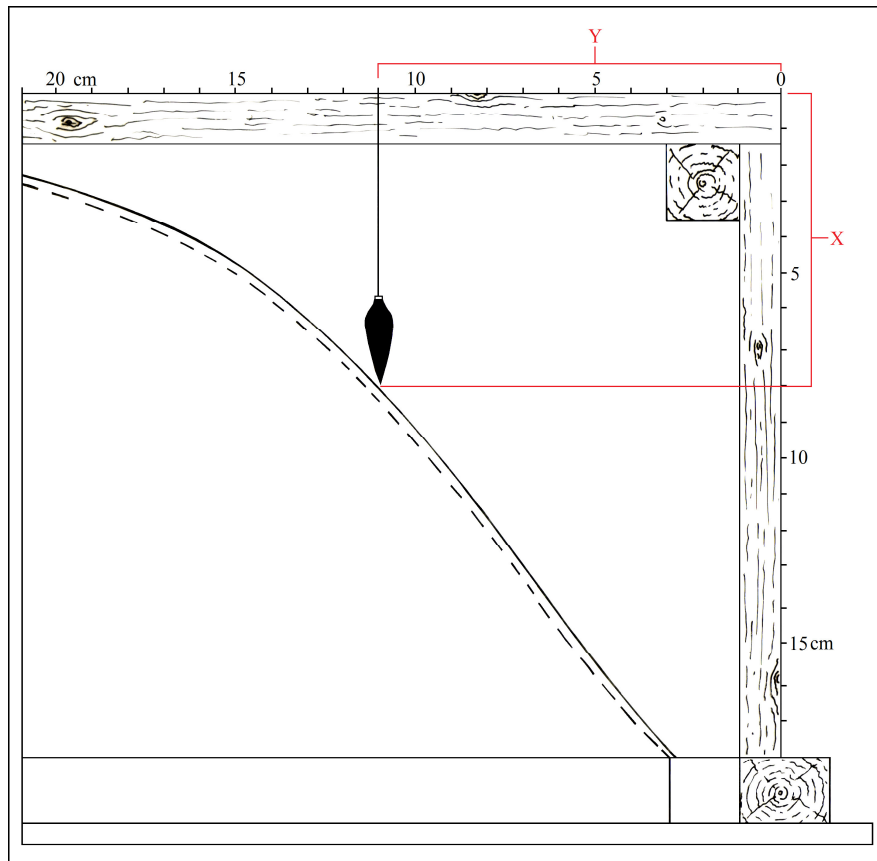
Fig. 4.10. Schematic showing the recording of hull sections from the model. The dashed line represents the framing of the hull under the planking, and the solid line, the exterior surface of the planking. Drawing by Matthew Labbe.

A new support structure had to be built around the model to ensure that the measurements taken on the model were accurate. A U-shaped frame built of pine was placed over the model corresponding to the location of the first section station. Once this U-shaped frame was leveled, measurements were taken from a ruler mounted on its upper surface, using a plumb bob. Because of the curved surfaces of the vessel, the locations of these measurements on the Y-axis were not standardized from section to section. Instead, they were taken as needed to ensure a fair curve. These measurements resulted in a series of x-y coordinates that could be plotted on a grid (fig. 4.10). These plots resulted in clean, fair sections. After all of the sections were recorded in this way, the thickness of the balsa wood planking had to be subtracted from the contour of the

sections, since drafting conventions for the lines drawings require the lines to show the contours of the vessel where the planking and frames meet, and not on the exterior surface of the planking.

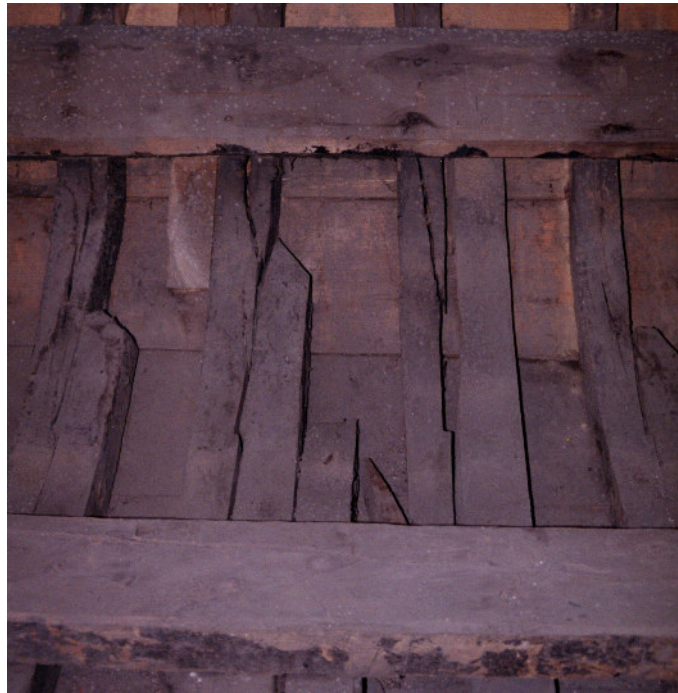
Fig. 5.1. An interior view of *Kadırga* showing some of the ship's hook scarves. Photo by Erkut Arcaç, courtesy of the *Kadırga* project (INA).

The most striking commonality is the use of hook scarves to bind the futtocks to the floors (fig. 5.1). Unfortunately, many of *Kadirga*’s frames are not original to the ship, making it difficult to make direct comparisons of dimensions like scarf overlap and fastening patterns with the Ottoman wreck. As with the Ottoman wreck, however, the futtocks sit forward of the floors at the bow and abaft the floors in the stern, and they are secured with three nails, one of which is driven from the opposite face as on the Ottoman

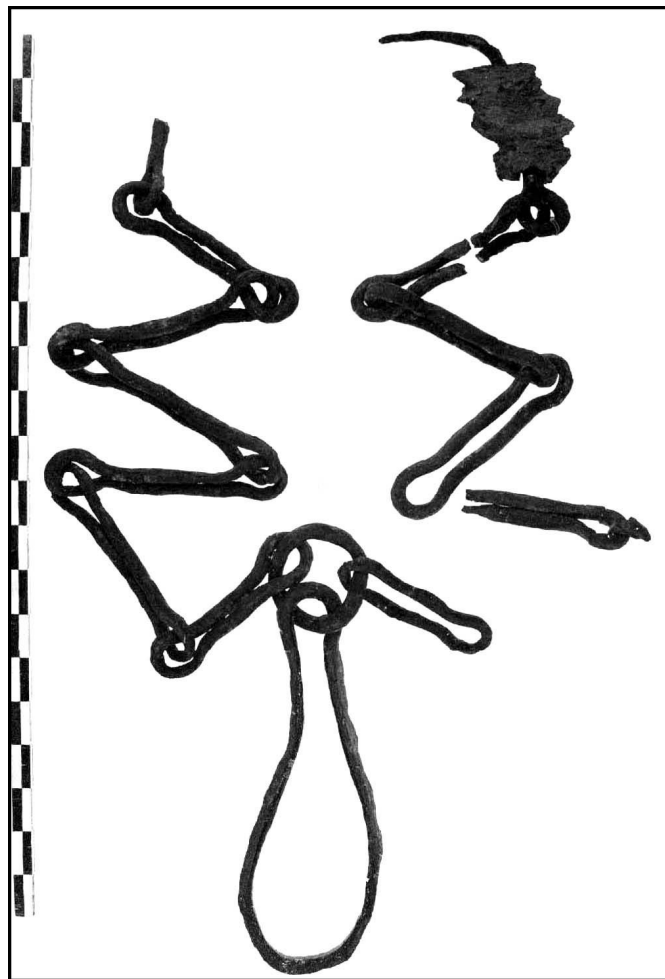
Fig. 5.2. A set of chains found near the bow of the Ottoman wreck in the 1967. Photo courtesy of the Ottoman wreck project (INA).

When the Ottoman wreck was discovered in 1967, archaeologists recovered a set of chains from the bow of the ship that were probably used as a stay to hold the main mast (fig. 5.2)<sup>122</sup>. An archaeological parallel to the chains found near the Ottoman wreck was found on a wreck near Padre Island in Texas in the 1970's.<sup>123</sup> Measuring 80 cm long, the chain consisted of six links attached to a 39 cm wide central yolk, and was probably used on the forestay of the main mast. The links splay from the central yolk in

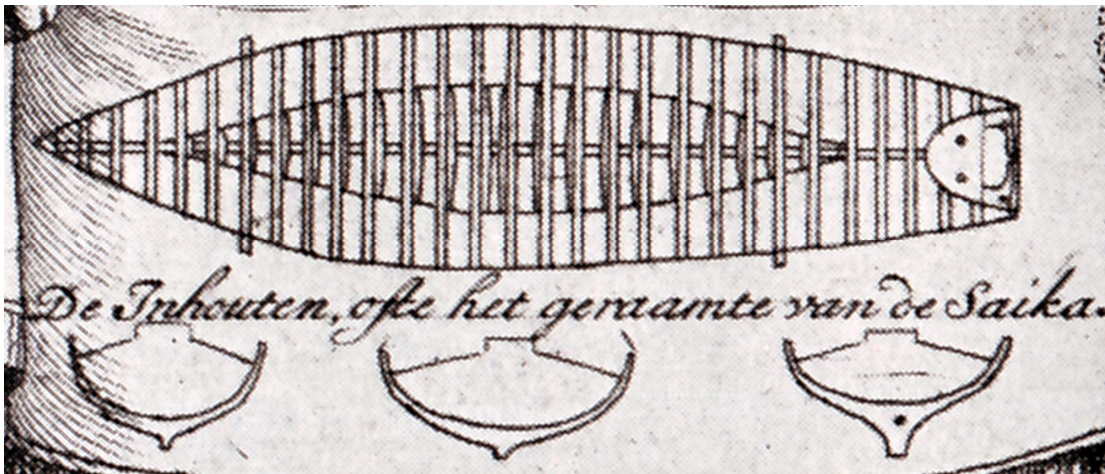
Fig. 5.7. Close up of the framing of the *saique*. (After Moore 1929, 195).

forward on the latter image. Its caption reads “*Saika of korenschip op de Swarte Zee, en omtrent de mont van den Donauw gebruikelijk,*” meaning “Saic or grain ship in use in the Black Sea and about the mouth of the Danube.”<sup>146</sup> At the top of the image is a depiction of the ship’s framing in plan view with three sections, presumably one at the bow, one at midship, and one in the stern (fig. 5.7). As with the Ottoman wreck, this ship has a narrow bow, with a relatively flat midship section.
