**REBUILDING FOR SUSTAINABILITY: SPATIAL ANALYSIS OF
BOLIVAR PENINSULA AFTER HURRICANE IKE**

A Dissertation

Submitted to the Office of Graduate Studies of
Texas A&M University
in partial fulfillment of the requirements for the degree of

Major Subject: Architecture

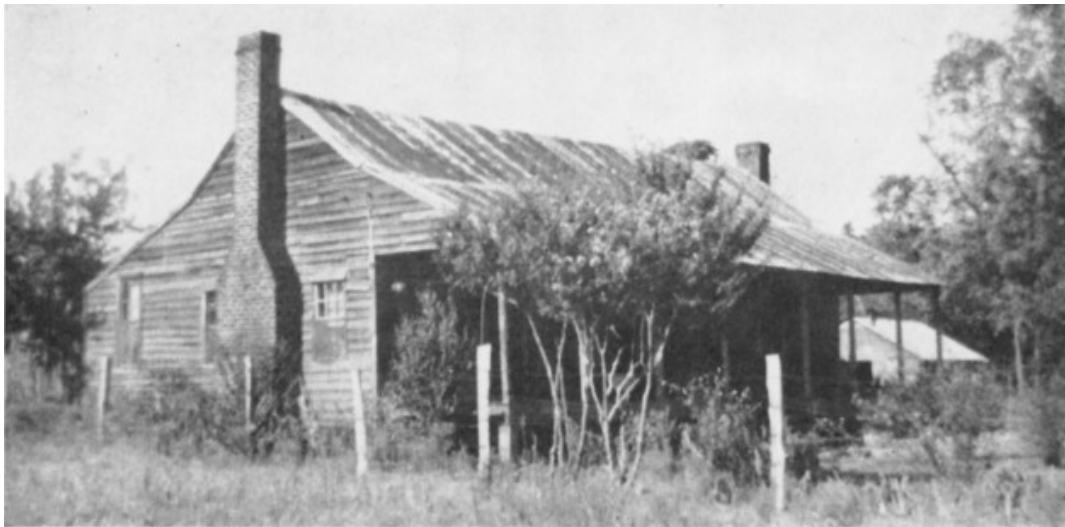
Figure 13. House inspired by Tennessee and Kentucky styles: Elliot-Robinson house (C. 1880), Center Road, Nacogdoches County. Source: Evans, 1952.

The first American settlers who followed Stephen F. Austin to Texas colonized a significant part of East Texas. They came mainly in two groups from what was recognized as the old south. A visible distinction can be identified in the architectural practice between the people who came from the Kentucky and Tennessee hills and groups from further south in Georgia, Mississippi, and Alabama. The first group was larger and typically used a simple wooded country style of building. The second group, mainly plantation owners, preferred grander homes predominantly promoting the Greek revival tradition. According to many scholars, two distinctive types of houses represent the building practices of these early settlers. What was recognized as the “East Texas House” was credited to the Tennessee and Kentucky groups in the north part of East Texas, as shown in Figure 13.

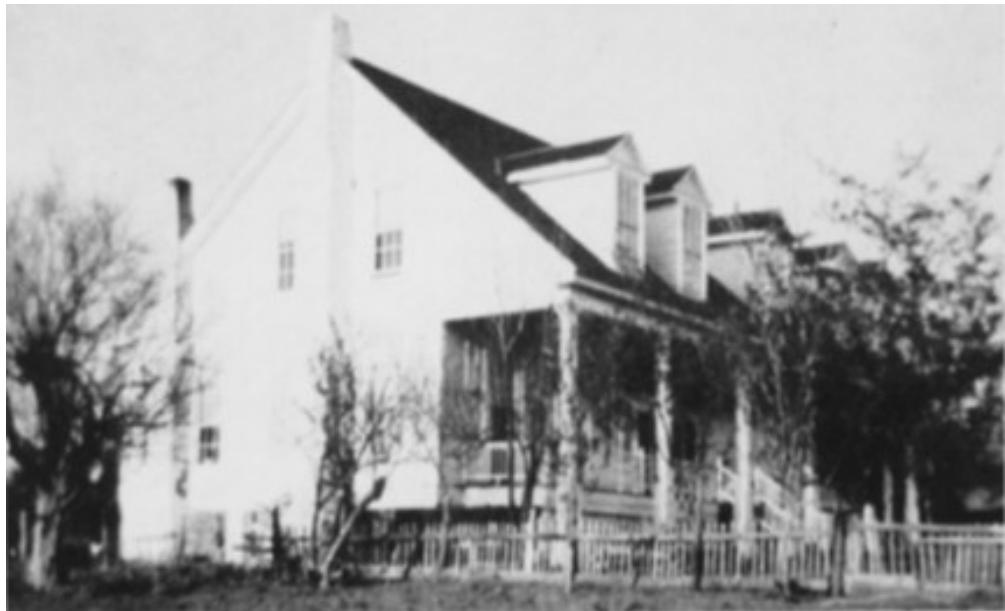
Figure 14. Louisiana type house: Garrett house (C. 1850), Parker-Dorsey house, San Augustine. Source: Evans, 1952.

The “Louisiana House” type was developed simultaneously among the houses built by the former residents of the Deep South, as shown in Figure 14. These houses were unique in many ways, especially in the adaptation of classical and Greek Revival features from prominent-urban landmarks to rural, but contemporary domestic structures. In contrast, the East Texas type followed a different development process similar to houses in Kentucky and Tennessee (Barker, 1969). The skillful artisanship of these constructions can be explained by the scarcity of power machinery during the early settlement of the area. The survival of manual cutting and dressing of lumber in some areas until the present day is a proof this phenomenon. Evans (1953) stated that the “beautiful exterior and interior detail were the result of the carpenter's tools, skill, and taste” (p. 3).

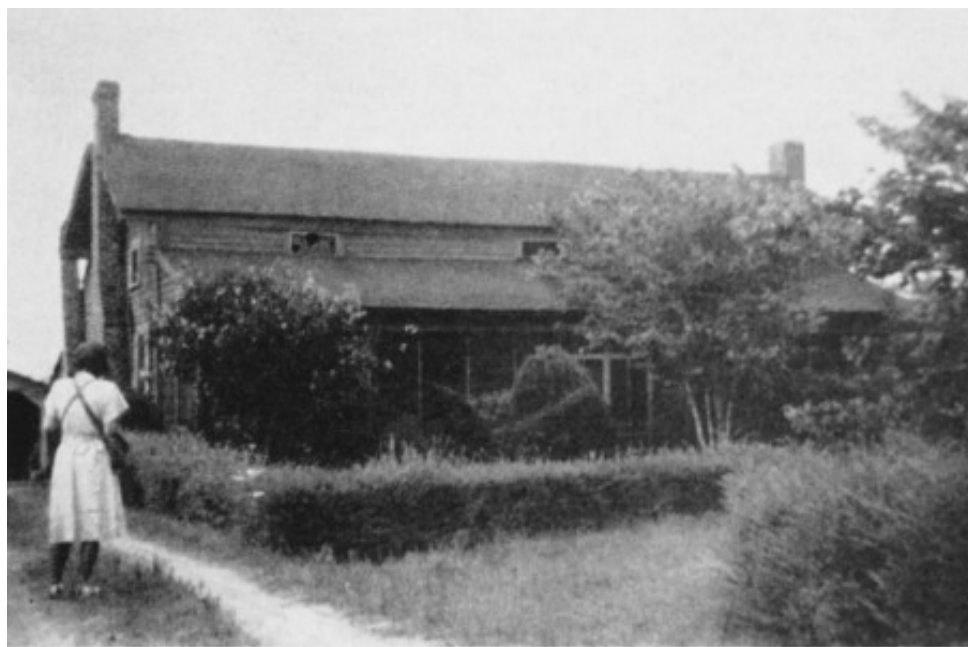
Figure 16. Forest Hill (1847), Mrs. Carl Yowell residence near Alto, Cherokee County (top), and Tucker House (c. 1840), Mrs. Granberry Residence, near Chireno, Nacogdoches County (bottom). Source: Evans, 1952.

The East Texas House in its generic form was rural in design and completely built out of wood, including its foundations and chimney (see Figures 15, 16). Quite interestingly, many houses built between 1820 and 1890 still remain in their original primary form. These houses were planned for convenience, and the simple, sound, and straightforward constructions were reflections of the East Texas life style. They were elevated on wooden pillars, some moderately high, a few low, and accommodated an air space underneath the house. They were well fitted to the land sites, and good ventilation was essential to the design.

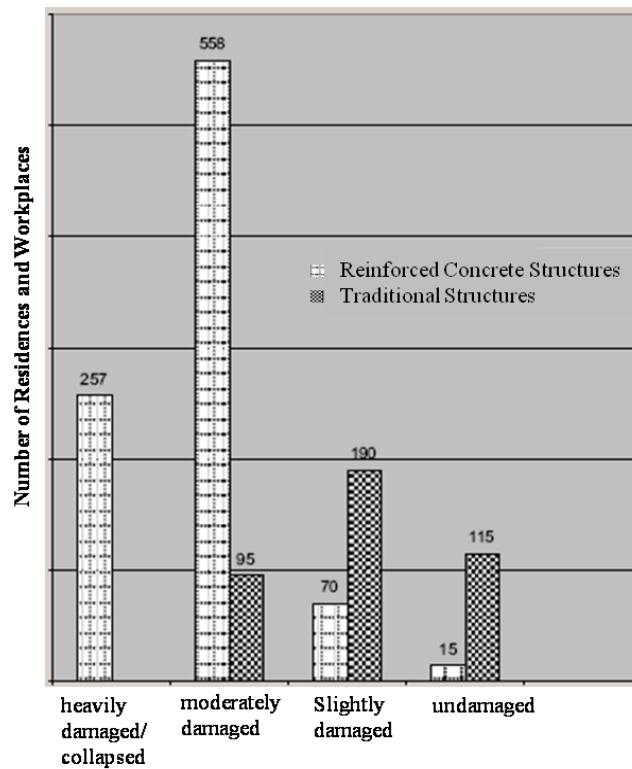
Figure 21. A comparison of earthquake damage between concrete and timber framed structures in Turkey. Source: Gülhan, & Güney, 2000.

The vernacular architectural tradition of many countries, including Turkey, features masonry work supported in a firmly braced wooden skeleton to provide a certain degree of shock absorption during seismic occurrences. Gülhan (2007) examined the locations selected for ancient settlements in Anatolia, Turkey, and found that the builders considered earthquake risk and their cities were located on sound, rocky ground. It was this fact that helped minimize damage to the houses situated in the I'zmit urban historic core (see Figure 21 and Figure 22).

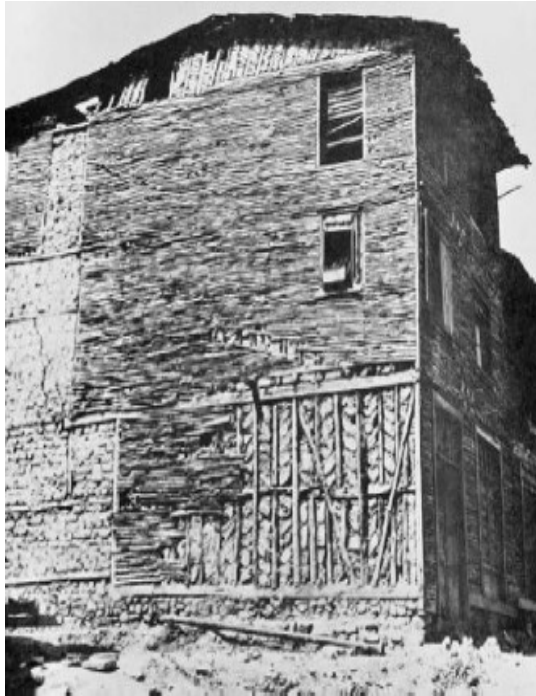
Figure 22. Timber framed ground floor of an undamaged building in Akcaalan, Turkey. Source: Gülhan, 2007.

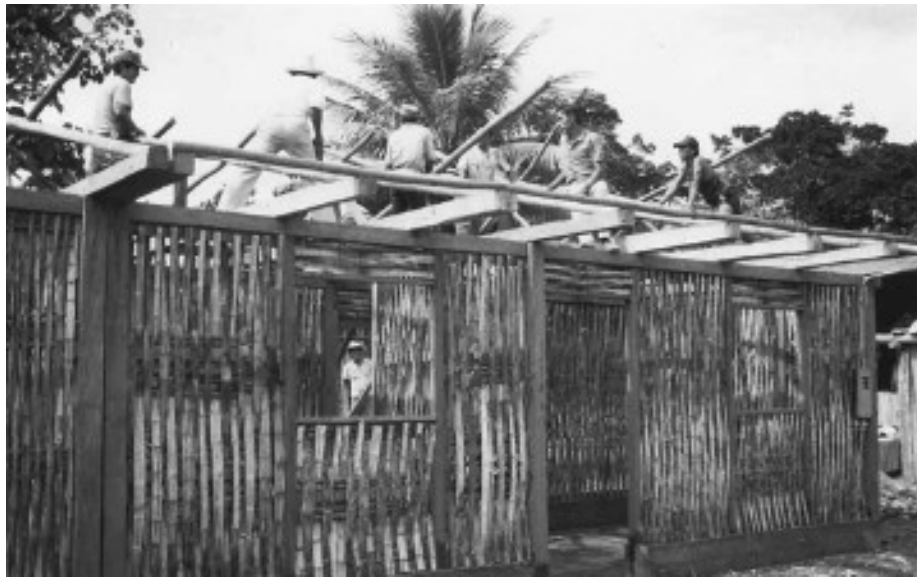
Figure 23. Quincha house under construction in Alto Mayo, Peru. Source: Schilderman, 1993.

The *quincha* houses were simple pole and cane frame structures filled in with earth and sometimes covered with plaster, all locally acquired materials. They were originally introduced by immigrants from drier zones. Post-earthquake observations proved that these quincha structures are relatively flexible during seismic actions. Because the quincha is comparatively cheap and can be constructed with local materials

It was reported by Schilderman (1993) that houses (known as *quinchas*) in Alto Mayo, Peru, were built using local technology and were able to withstand earthquakes better than some of the more recently built structures that used modern technologies (see Figure 23).

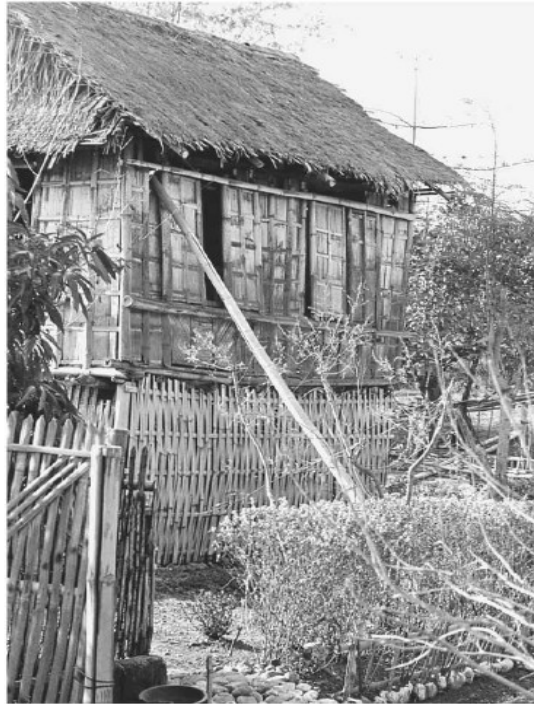
Figure 24. Use of bamboo poles to brace structures during storms in Philippines. Source: Schilderman, 2004.

Cyclone-prone villages in the Philippines also have certain coping strategies, as reported by Hall (1997). The roofs of the houses of these villagers have vertical and horizontal poles in the framework that are held together by tongue-and-groove joints and pegged together with bamboo wedges. However, it was noted that after many years of weather exposure, the bamboo shrunk and the pegs became loose, which contributed to an overall weakening of the house structure. This means that the villagers are constantly repairing the roofs and hammering in the pegs in order to make them ready for the next cyclone, which is an important and necessary job in the village. The village artisans are an important part of this cyclic event, which in turn supports their livelihood. The level of quality matters to the overall structural integrity, and the better the joints work together, the better the chances of surviving cyclones. However, people in older houses are not without their own survival strategies. Although these older houses become a bit rickety, the residents have a simple method to brace their houses: external buttresses. They erect these external supports using long, strong bamboo poles wedged under the eaves and anchored firmly to the ground (see Figure 24).

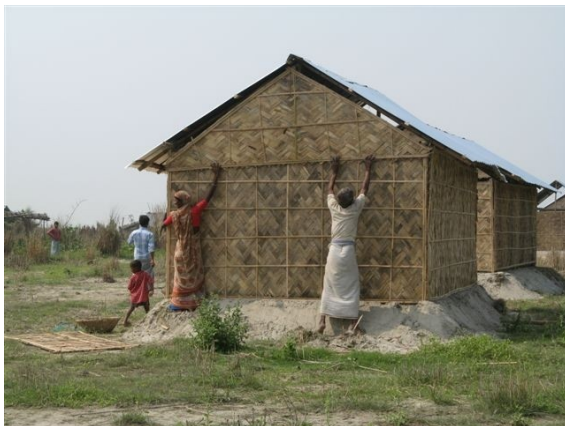
Figure 25. Raised platform flood prone house in Bangladesh. Source: Hufstader, 2008.

Schilderman (2004) also found that the flood-prone *kaatla* houses of Bangladesh were relatively cheap and affordable to maintain (see Figure 25). The use of local materials and artisans was not only cost effective, but also had value as a demonstration, which was evident because neighbors visited to observe the construction work. Part of the success of these recovery programs was due to the employment of women in the construction, which gave them a sense of ownership. However, Howell (2003) reported that the possibility of employing coastal Bangladesh villagers' traditional early warning signals of cyclones has not been investigated extensively.

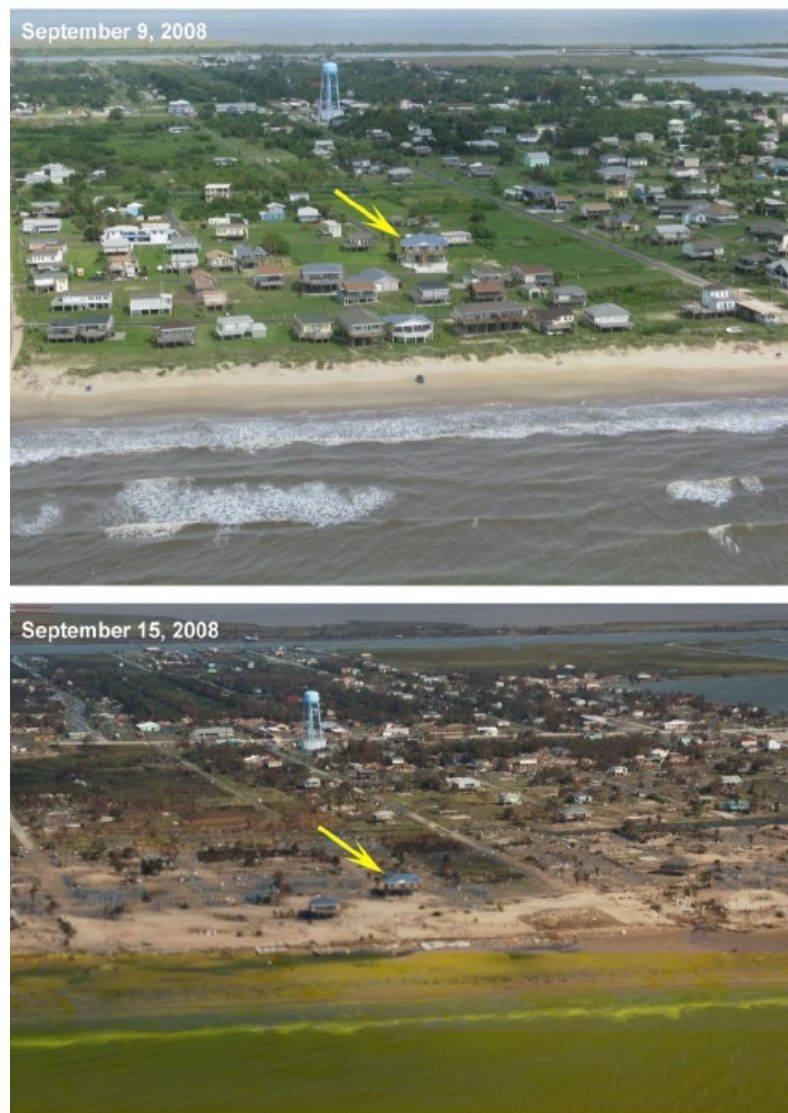
Figure 27. Before and after Ike images of one of the studied settlements on Bolivar Peninsula. Source: Doran, Plant, Stockdon, Sallenger, & Serafin, 2009.

materials, construction techniques pertaining to design, and planning of residential settlements (see Figure 27). Because the storm hit a number of highly populated areas and pushed well inland with hurricane force winds, it is not surprising that Hurricane Ike caused huge property losses. In fact, Ike ranks as the third costliest hurricane to make landfall in the United States, behind Hurricane Andrew, which caused \$23.8 billion (2008 dollars) in insured losses in 1992, and Hurricane Katrina, which caused \$45.3 billion (2008) dollars in insured losses in 2005. Property losses from Ike totaled an estimated \$12.5 billion across eight states; at least 115 deaths are linked directly to the storm (United States Geological Survey, 2009). The photos shown in Figure 26 illustrated loss of houses, eroded dune face, and landward sand deposits. Damage caused by Ike's storm surge and wave action was extensive, especially on Bolivar Peninsula where hundreds of homes were destroyed. The elevation of the first floor level above the water level and the distance from shore were critical factors in determining whether buildings survived the storm surge and wave action. Buildings with the best chance of survival during this hurricane were at or above six meters above mean sea level.

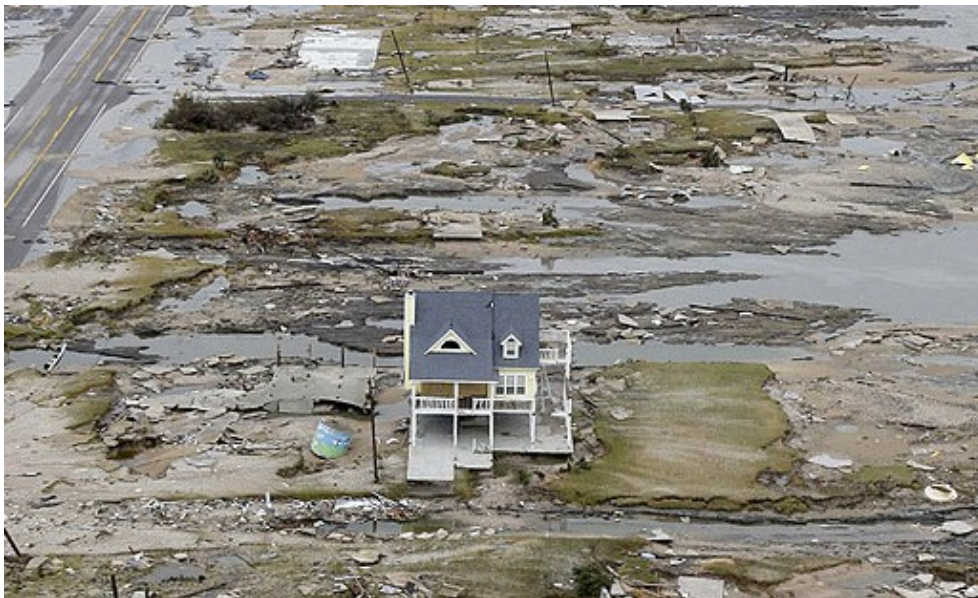
Figure 29. The structure called “Last House Standing” in Gilchrist was built by the owners after Hurricane Rita. Source: IBHS, 2009.

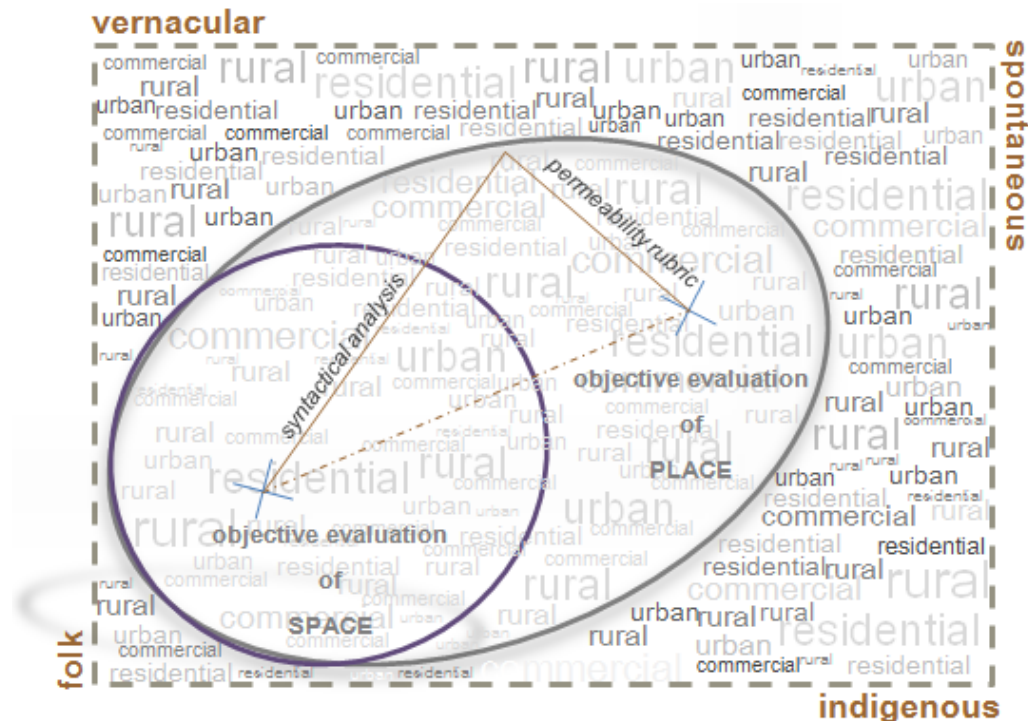
Figure 30. Research design.

(settlements) through the syntactical analysis. Third is the objective evaluation of the space (houses) within place (settlements) via the permeability rubric.

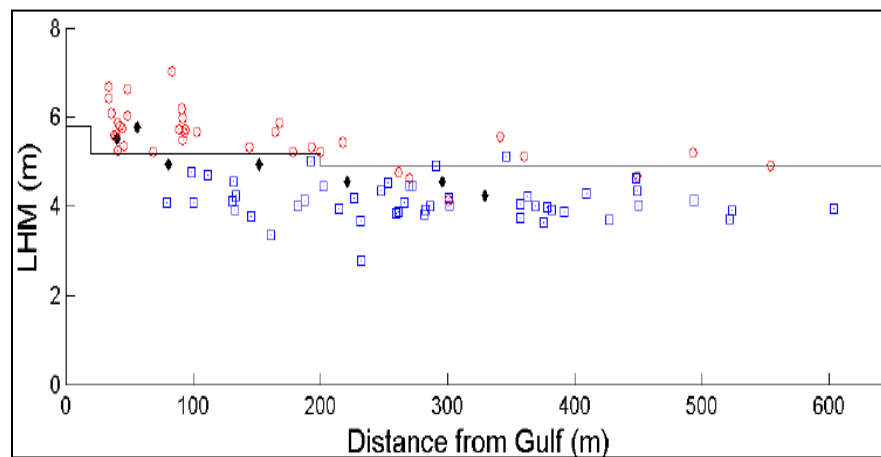
Figure 36. Survival and destruction rates based on elevation and distance from the Gulf of Mexico shoreline. Note: (□) Surviving houses. (◻) Destroyed houses. (◆) Surviving, but significant wave damage. Source: Kennedy et al., 2010.

landfall location. Actual wave-surge directions and surge damage variations along the Gulf of Mexico are shown in Figure 35 and 36. Figure 36 further demonstrates survival and destruction against increasing distance from the Gulf of Mexico shoreline. The X-axis plots the Lowest Horizontal Structural Member (LHM) elevation and the solid line approximates 1993 FEMA Base Flood Elevation (BFE) with distance inland.

The most important damage feature of surge is the very strong division in elevation between survival and destruction. This is approximately 0.5m and appears to be related to whether waves riding on top of surge did or did not reach the elevated flooring systems. Houses with lower elevations were uniformly destroyed by waves, while houses at higher elevations survived. The sheer weight and force of debris swept away by the floodwaters caused damage to properties beyond the shoreline.

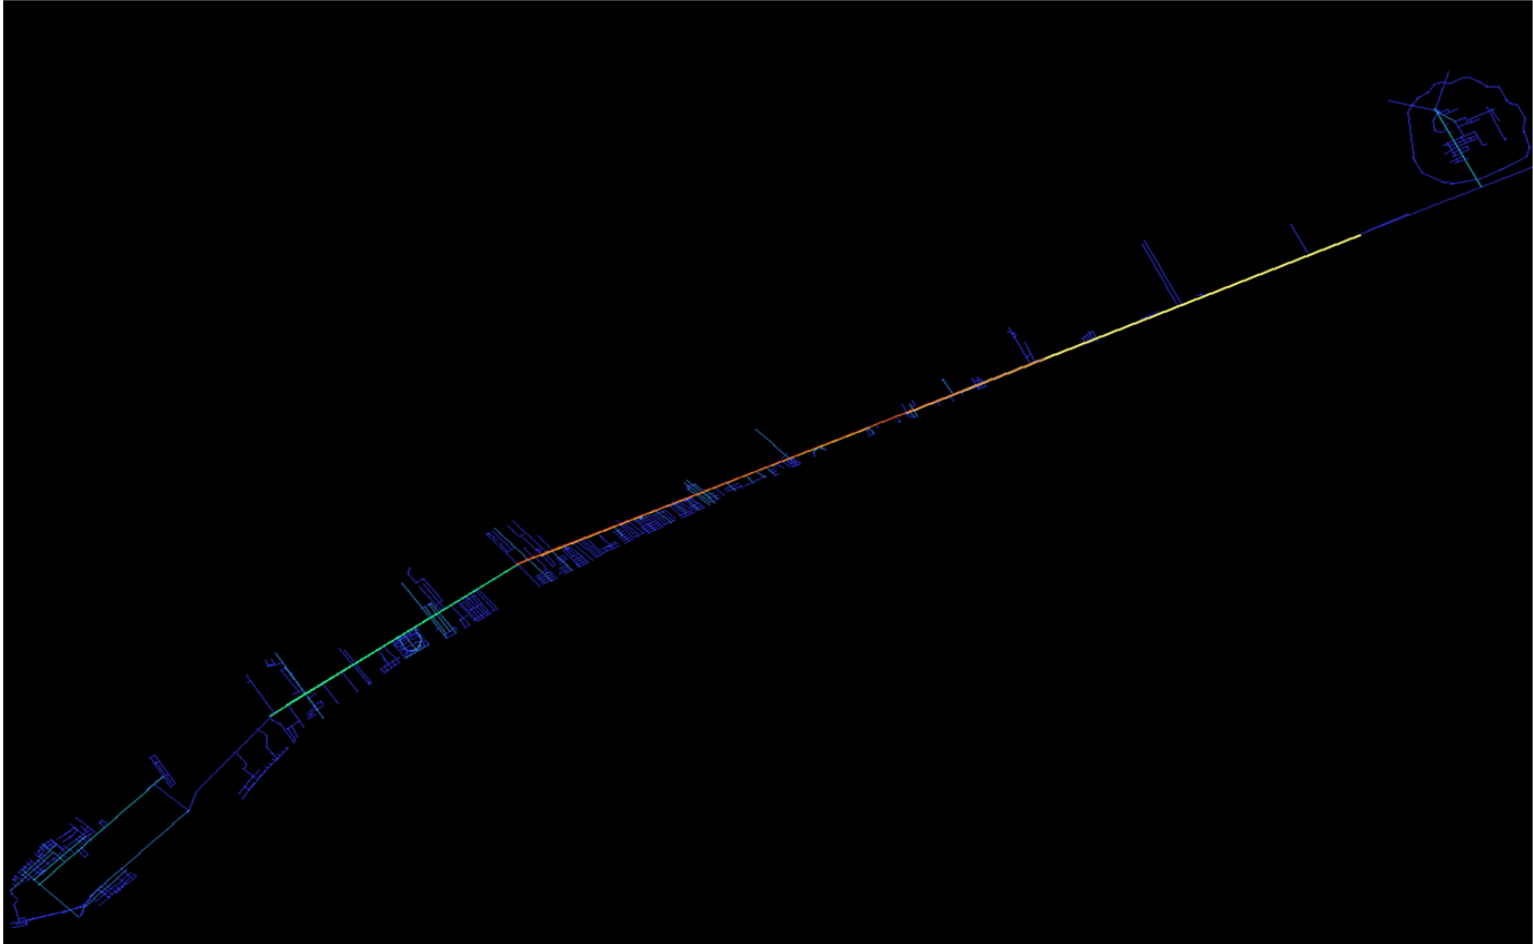
Figure 37. Syntactical representation of the open space system of Bolivar Peninsula.

As shown in the axial maps (see Figure 37), both Port Bolivar and High Island are isolated from the main residential zone along the southwestern edge of the shoreline.

Crystal Beach and Gilchrist are part of the linear belt of neighborhoods facing the Gulf of Mexico. All other coastal settlements except High Island are linear in form and very regular in their patterns of axial space. Parallel streets, linked one to another, make Port Bolivar more compact than other coastal settlements (see Figure 38). Axial maps transform the connectivity among open space network into a graph, which shows the relation between one axial segment and another.

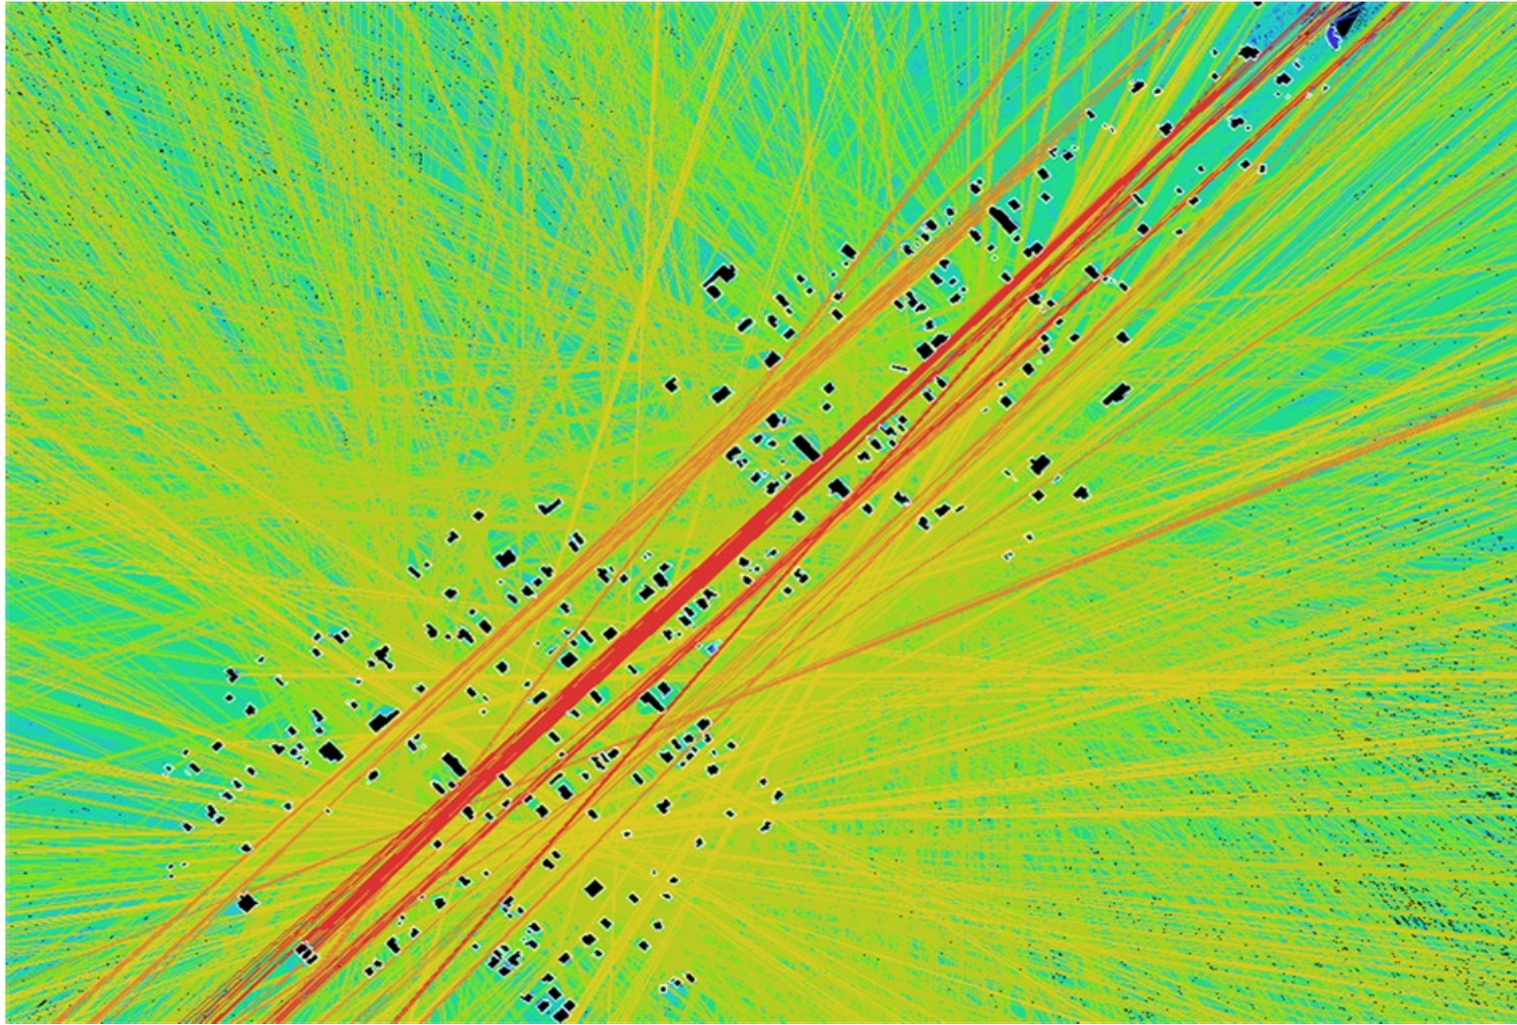
Figure 40. All lines settlement interface map for Port Bolivar neighborhoods.

Settlement interface maps more or less convey the permeability of the settlement. The interface map (see Figure 40) clarifies the fact that the system is shallow from outside the settlement. Some of the east-west open spaces represent convex spaces that are as long as axial spaces, allowing uninterrupted movement from the front of the dwelling to the shore. Thus, they not only provide the place for day-to-day occurrences or movements within the settlement, but also the direct link between the outside world and the deepest part of the system.

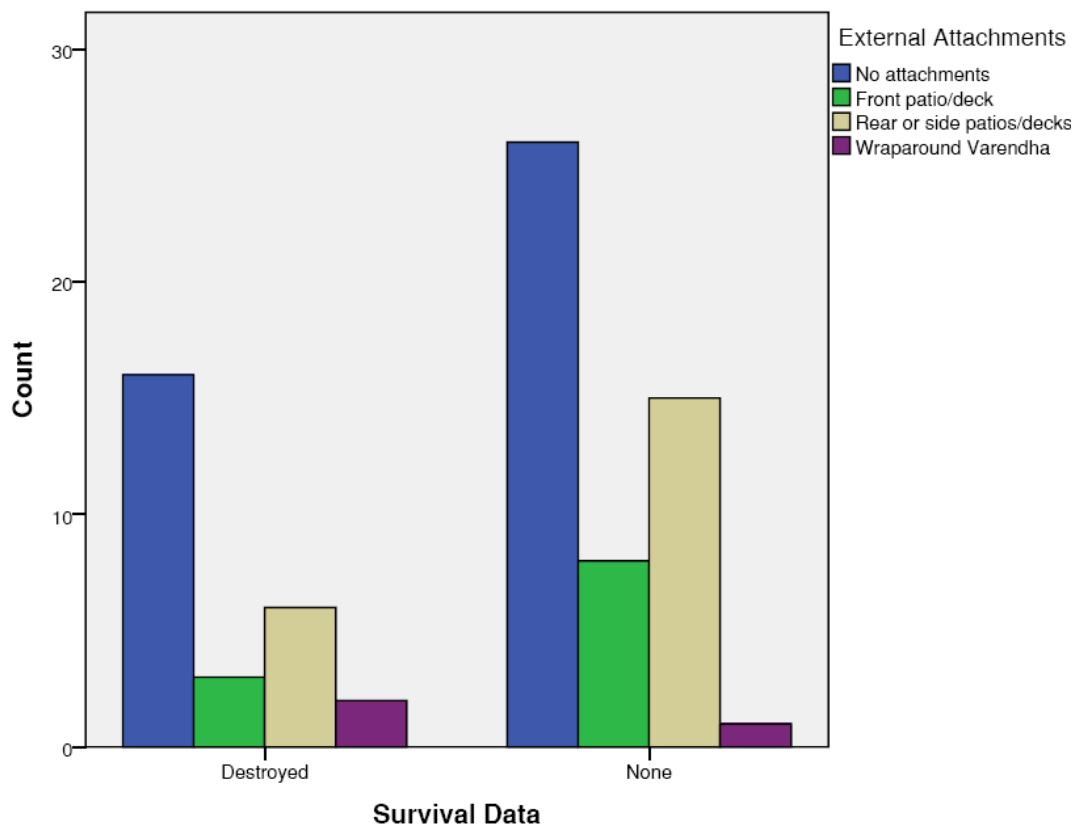
Figure 45. Bar graph showing survival binaries for *external attachment*.

In order to distill permeability characteristics to predict survival probabilities via a logistic regression, sample sizes have to be adequate for each group. However, 2x2 cross tabulations will not perform asymptotic significances values for smaller sample sizes. Therefore, in order to avoid any discrepancies due to lack of significance, a two-tailed Fisher's Exact Test for small samples has been conducted. Tables 9 through 13 summarize the Pearson Chi-Square Likelihood Ratio and Fisher's Exact Test results. Each contingency table is followed by a bar graph (Figures 41 through 45) that plot the characteristic counts for survival binaries.

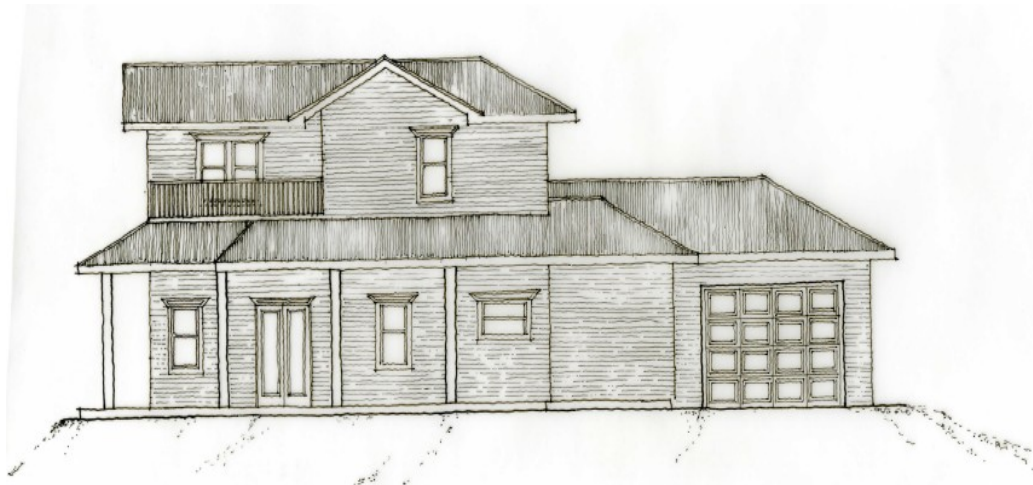
Figure 47. A “hill escape” type of dwelling.

The “hill escape” type of house is the most contemporary response to protection against hurricane-surge attacks, as well as one of the most extreme responses. This approach alters the existing topography drastically by raising the ground elevation from 10 to 16 feet above existing ground level. Few houses have this capacity, and this approach was found the least in the entire Bolivar housing block. Inherent to this typology is putting up a typical suburban house without considering the prevailing environmental conditions or addressing such conditions at an arbitrary level. This is no better than an afterthought and is a result of incomplete design and planning often found in tract housing. Most of these houses are larger than the average house found in Bolivar neighborhoods and are relatively new constructions. Both the exterior and interior finishes display professional or hired labor skills than self-built skills. Typically, these houses have an entrance lounge with wrapper-round verandas, three to five bedrooms, an open plan living-dining-kitchen arrangement, one to three garages, several restrooms, attic space, and many auxiliary rooms. Semi or full basements are not common in this category, although a very few had small underground storage units or wine cellars. Multi-tiered roof formations with several skylights or roof windows are also characteristic of these houses. Some of those roof cutouts are mere architectural features or “roof volumizers” and have no connection to interior spaces. In some cases, they are asymmetrically placed to maintain consistency of architectural façade, but still provide natural light to attic spaces. If they are operable, as in a few cases, they provide both light and ventilation. Because these houses are on artificially created hills, orientation is

usually central and clearly visible from all four sides with a statement like appearance. A ramp that runs to the main entrance creates a wide flat platform enabling convenient vehicular access and connecting the yard area in front of the main entrance with a garage. Some public buildings including the United State Postal Services building had more than one ramp to ensure an uninterrupted flow of vehicular traffic in and out of the area. Figure 47 illustrates a “hill escape” type of house.

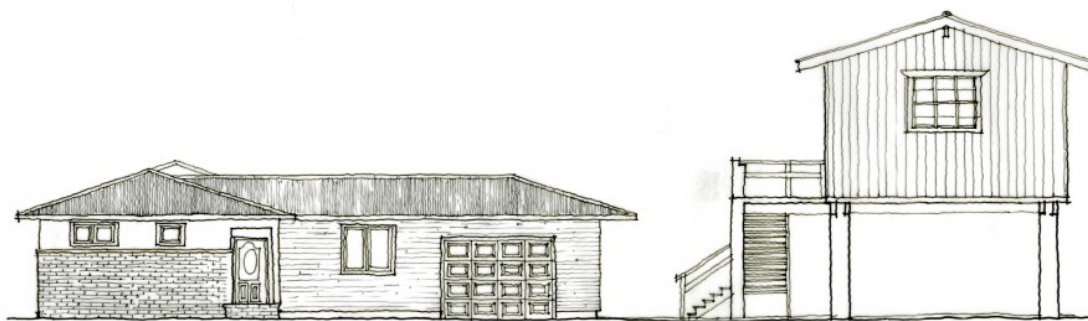
Figure 48. A “buddy system” type of dwelling.

The “buddy system” type of house is the second least prevalent, after the “high and dry” house. Two sheltering or dwelling units coexisting with different operational systems that are heavily dependent on hurricane season are characteristic of this type of house. Highly contrasting façade appearances as well as ground arrangement of the two units are striking features of this type. While the unit with the larger footprint usually

accommodates the typical residential functions, the smaller unit usually provides storage facilities during the non-hurricane period of the year. A rectangular hurricane or refuge house is often oriented at a right angle to the main house. The interface between the two units is often demarcated by an open staircase that leads to the deck or small entrance/landing of the hurricane house. The vertical circular staircase of the smaller unit always has an uninterrupted physical and visual connection to the entrance of the main house; either it is in line with the main entrance or easily accessed without in-between spaces or barriers such as fences, vegetation, or different levels. Elevation of the smaller unit or rescue house usually exceeds typical story height. Ownership of this type of house is not very clear; it may belong to a single owner, several owners, or members of the extended family. The house's intended performance and operational procedures are only fully realized during hurricane season. During the rest of the year or season, these usually served as storage units. Some of the common features of the "buddy system" house include a sound structural system, simple spatial arrangement, easy access, and strategic orientation in relation to the main house. The exposed columned-ground floor of the hurricane/refuge unit sometimes houses fishing or leisure boats. Unlike the main house, the refuge unit is relatively uncrowded; cars parked in close proximity to these units were hardly noticed. Figure 48 illustrates the "buddy system" house.

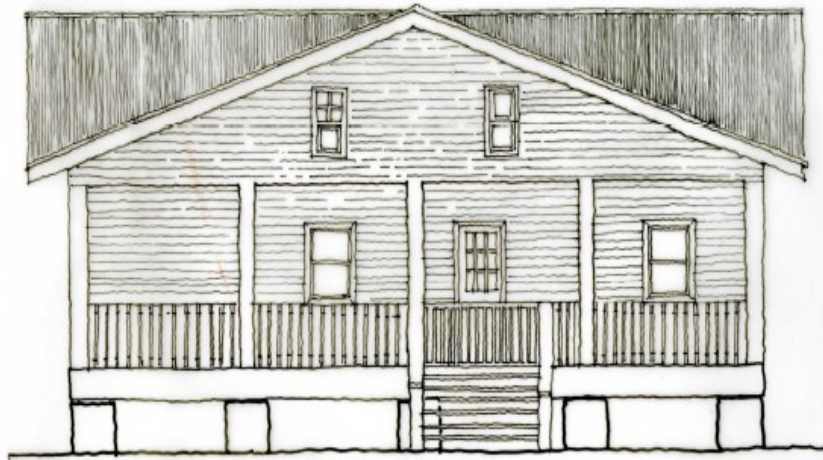
Figure 49. An “old and gold” type of dwelling.

The “old and gold” dwelling is the most common type of residence along Broadway and Madison Avenues in the Port Bolivar neighborhoods. Most of these houses are more than 75 years old and are remaining pieces of typical South East Texas houses; they also are the smallest in square footage. With few exceptions, the majority of these houses are single story buildings unspoiled by the lavishness of contemporary suburban living. These houses usually have a simple square plan layout, elevated on heavy hardwood logs two to four feet above ground, a wide front porch that runs throughout the front façade, an equally divided colonnade of four to six columns, and a

steep hipped or gable roof. Many houses that belong to this category constituted separate structures dedicated to variety of functions including storage of fishing and yard maintenance equipment, covered parking, workshop facilities, and occasional secondary accommodations. Some houses may have wooden latticework covering the heavy timber thresholds that elevate the house above surge damage and various other climatic conditions. These lattices are primarily aesthetic in nature instead of serving as safety features, but they do prevent dust and debris from entering under the ground or first floor slab. They also make the underneath space less accessible to domestic animals and strays that could die under the house or leave waste behind. The front façades of a few houses have a false two-story appearance created by windows in the concealed area between the front porch-colonnade and gable end. Most of these windows are not operable and are not associated with a mezzanine or attic level. Typically, the main door is aligned with the entrance steps and a wooden gate that also makes up a small portion of the handrail of the front veranda. Generally, road frontage is wide open with no landscaping, keeping the unobstructed yard area between the access road and street front of the house. Usually they have a considerably bigger backyard that allows the smaller front yard to merge into the access road, creating a continuous stretch of open space along the road. Figure 49 depicts the “old and gold” house.

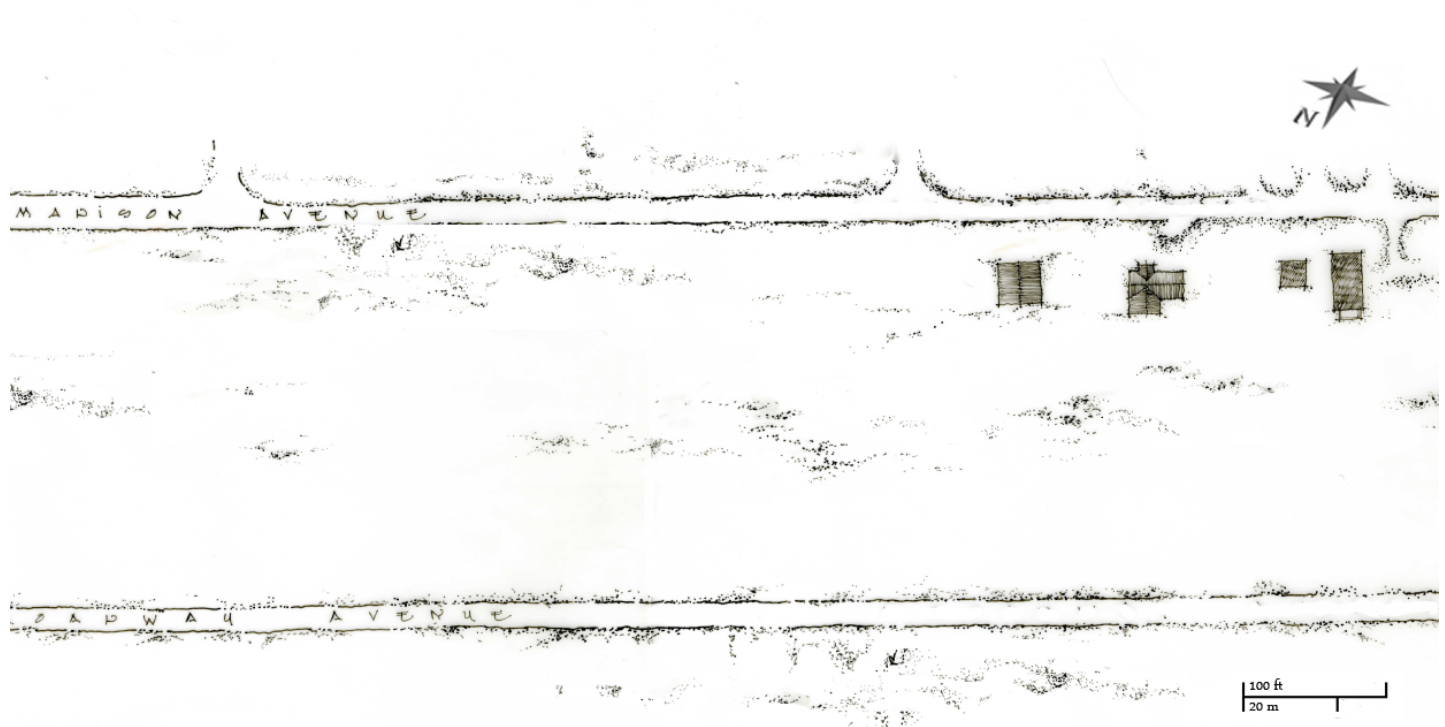
BROADWAY AVENUE DETAILED LAYOUT – E

Layout-study showing properties at (from left)

- a. 14th Street
- b. 12th Street
- c. 10th Street

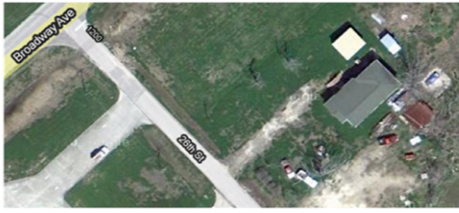
Aerial view		Street view

STREET: 26		HOUSE: 1					
Street orientation	Ground elevation	Ground enclosure	External bracings	External attachments			
Length wise from access road							
Width wise from access road	√						
Offset from access road < road width							
Offset from access road > road width	√						
	Boarded/solid plinth	√					
	Exposed plinth						
	Column height ≥ average storey height	√					
	Column height ≤ average storey height						
			Open with columns				
			Columns with a room				
			Columns with rooms				
			Enclosed with rooms	√			
				No bracings	√		
				Braced at one direction			
				Braced at opposite directions			
				Braced at multiple directions			
						No attachments	
						Front patio/deck	√
						Rear/side patio/deck	√
						Wrapping verandah

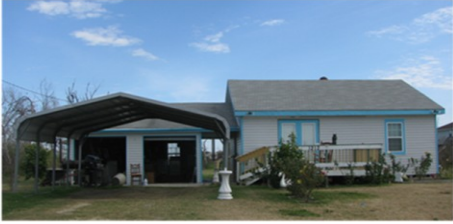
Aerial view		Street view

STREET: 26		HOUSE: 2							
Street orientation		Ground elevation		Ground enclosure		External bracings		External attachments	
Length wise from access road									
Width wise from access road	√								
Offset from access road < road width									
Offset from access road > road width	√								
		Boarded/solid plinth	√						
		Exposed plinth	√						
		Column height ≥ average storey height							
		Column height ≤ average storey height							
				Open with columns					
				Columns with a room					
				Columns with rooms					
				Enclosed with rooms	√				
						No bracings	√		
						Braced at one direction			
						Braced at opposite directions			
						Braced at multiple directions			
								No attachments	
								Front patio/deck	√
								Rear/side patio/deck	
								Wrapping verandah

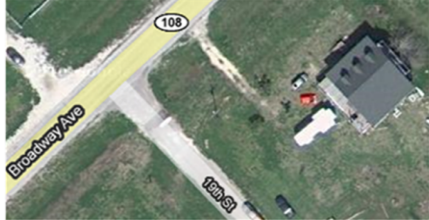
Aerial view

STREET: Broadway Avenue		HOUSE: A'				
Street orientation	Ground elevation	Ground enclosure	External bracings	External attachments		
Length wise from access road	√					
Width wise from access road						
Offset from access road < road width						
Offset from access road > road width	√					
	Boarded/solid plinth					
	Exposed plinth					
	Column height ≥ average storey height	√				
	Column height ≤ average storey height					
		Open with columns				
		Columns with a room				
		Columns with rooms	√			
		Enclosed with rooms				
			No bracings	√		
			Braced at one direction			
			Braced at opposite directions			
			Braced at multiple directions			
				No attachments	√	
				Front patio/deck		
				Rear/ side patio/deck		
				Wrapping verandah

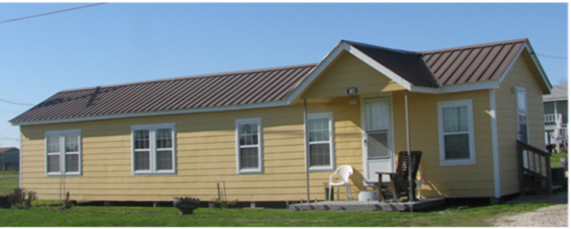
STREET: Broadway Avenue		HOUSE: 1				
Street orientation	Ground elevation	Ground enclosure	External bracings	External attachments		
Length wise from access road	√					
Width wise from access road						
Offset from access road < road width	√					
Offset from access road > road width						
	Boarded/solid plinth					
	Exposed plinth	√				
	Column height ≥ average storey height					
	Column height ≤ average storey height					
		Open with columns				
		Columns with a room	√			
		Columns with rooms				
		Enclosed with rooms				
			No bracings	√		
			Braced at one direction			
			Braced at opposite directions			
			Braced at multiple directions			
				No attachments		
				Front patio/deck	√	
				Rear/ side patio/deck	√	
				Wrapping verandah

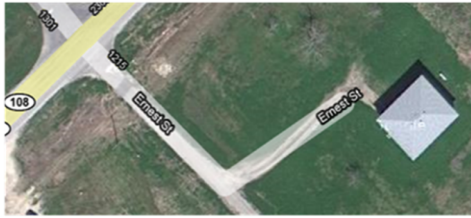
Aerial view

STREET: Ernest		HOUSE: 1							
Street orientation		Ground elevation		Ground enclosure		External bracings		External attachments	
Length wise from access road									
Width wise from access road	√								
Offset from access road < road width									
Offset from access road > road width	√								
		Boarded/solid plinth							
		Exposed plinth							
		Column height ≥ average storey height	√						
		Column height ≤ average storey height							
				Open with columns					
				Columns with a room	√				
				Columns with rooms					
				Enclosed with rooms					
						No bracings	√		
						Braced at one direction			
						Braced at opposite directions			
						Braced at multiple directions			
								No attachments	
								Front patio/deck	√
								Rear/ side patio/deck	√
								Wrapping verandah
