**THE HULL REMAINS OF THE LATE HELLENISTIC SHIPWRECK AT  
KIZILBURUN, TURKEY**

A Thesis

MASTER OF ARTS

December 2012

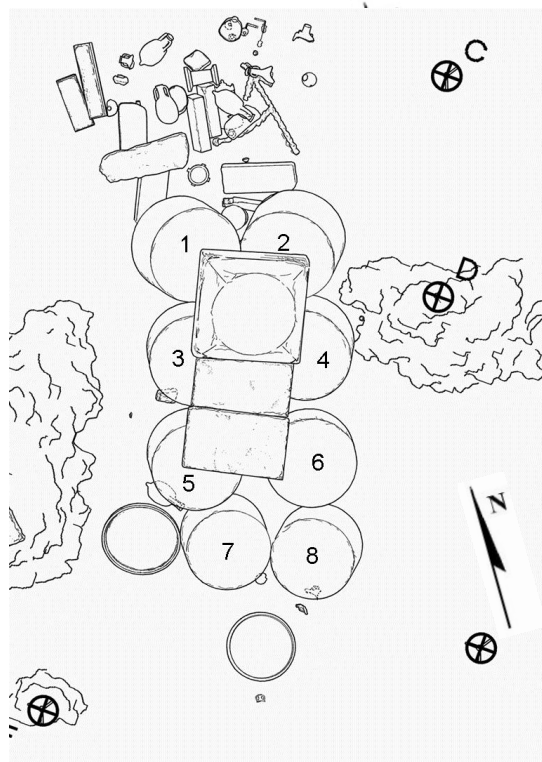
Figure 1.5. Site plan showing drum numbering system. Image by Sheila Matthews.

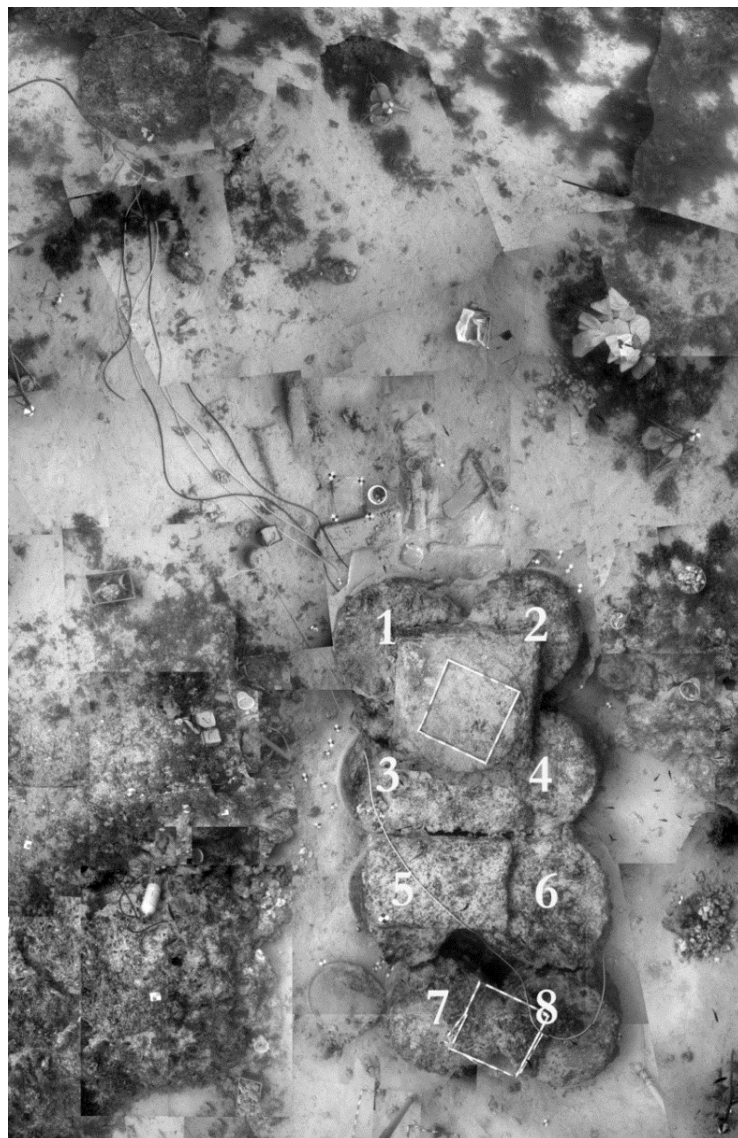
Figure 2.1. Column drum positioning as found and their assigned numbering. Photomosaic by Sheila Matthews.

After the ship sank, it came to rest on a moderately sloping, coarse-sandy seafloor at a depth of 42-45 m, grounded between outcrops of rocks (Figure 2.1).<sup>43</sup> Although site formation processes have not been formally addressed, evidence suggests the hull was not immediately buried in the seafloor sediments. Rather, the hull likely came to rest on the seabed and slowly became structurally weak by the effects of seawater saturation, bacterial

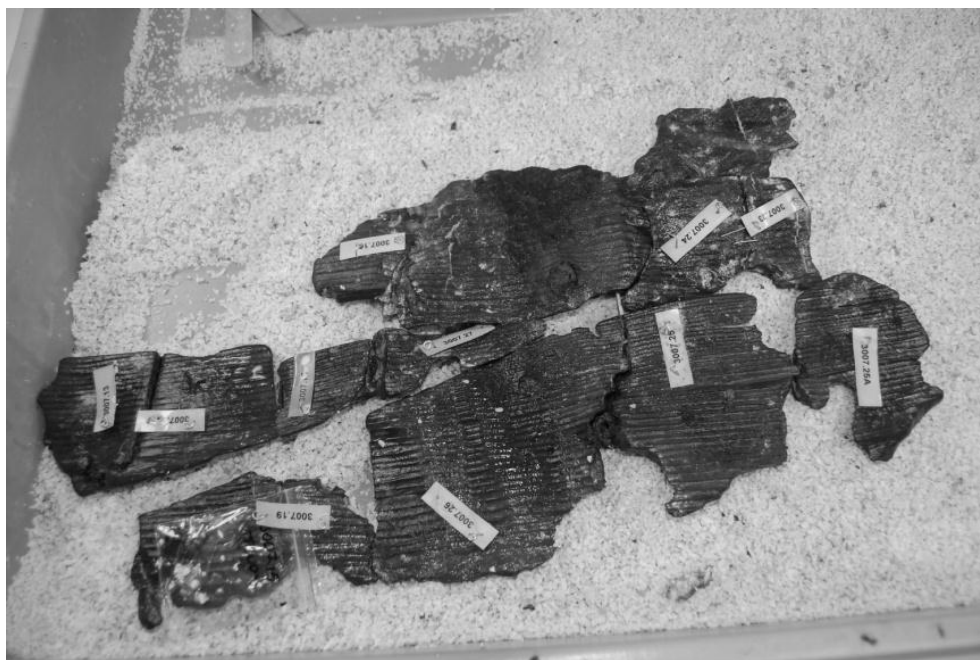
Figure 2.4. Planking section 3007 being reassembled. Photograph by the author.

Some timbers, often made up of many fragments, could be temporarily reassembled and recorded as a unit (Figure 2.4). Therefore, in addition to recording each individual fragment, a second catalog sheet was created solely for laboratory use (Figure 2.3) to record each distinct timber.

A long, shallow plastic container filled with tiny marble chips was used to support and align the timber fragments so that they could be recorded as a unit (Figure 2.4). These marble chips were chosen as they were easily form fitted under and around the fragments and offered more support than sand, which was also experimentally used. Further, the marble chips were more easily rinsed off the wood. This was a minor, albeit essential, adaptation that allowed accurate drawings and measurements to be produced. It further allowed for features such as nail spacing and mortise spacing to be measured or estimated more accurately. An illustrated catalog of reconstructed timbers follows in Appendix I.

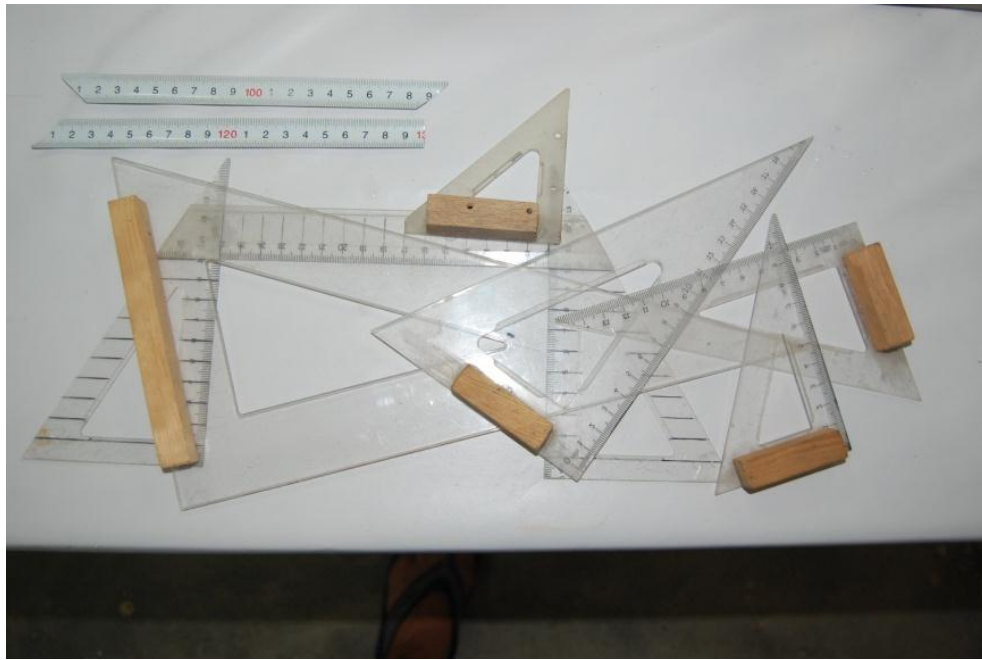
Figure 2.5. Tools adapted for recording timbers. Photograph by the author.

Steffy's method was adopted to record the wooden remains of the Kızılburun timbers and fragments. Proper alignment of the marker over the wood was maintained through the use of variously sized right-angle triangles with a small block of wood fastened to the lower edge for vertical and horizontal stability (Figure 2.5). By using the vertical edge of the triangle I was able to create a line of sight between the eye, the acetate, and the edge of the fragment, the goal being to keep the point of the marker directly over the edge of the timber being drawn in order to reduce the margin of error.<sup>57</sup>

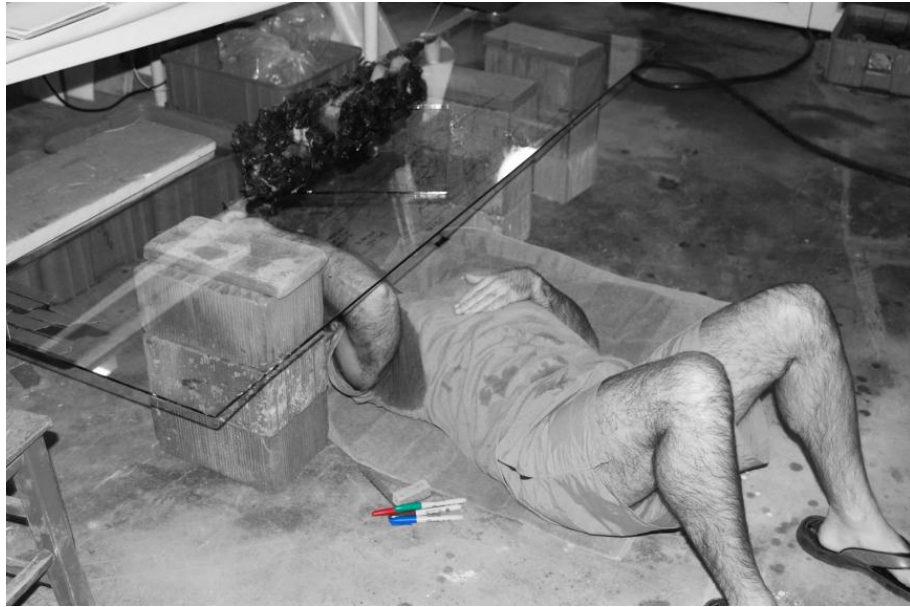
Figure 2.6. Recording the keel fragments. Photograph by Kimberly Rash.

once more by placing the timber's inner face on the glass to give the best alignment of the fragments in all three dimensions. This modification necessitated lying on the floor and recording the timber from below (Figure 2.6), while the molded face(s) was recorded by using an additional plate of glass mounted to 90° shelving brackets (Figure 2.7). In this manner the keel fragments were less susceptible to movement or misalignment, which resulted in a more accurate drawing.

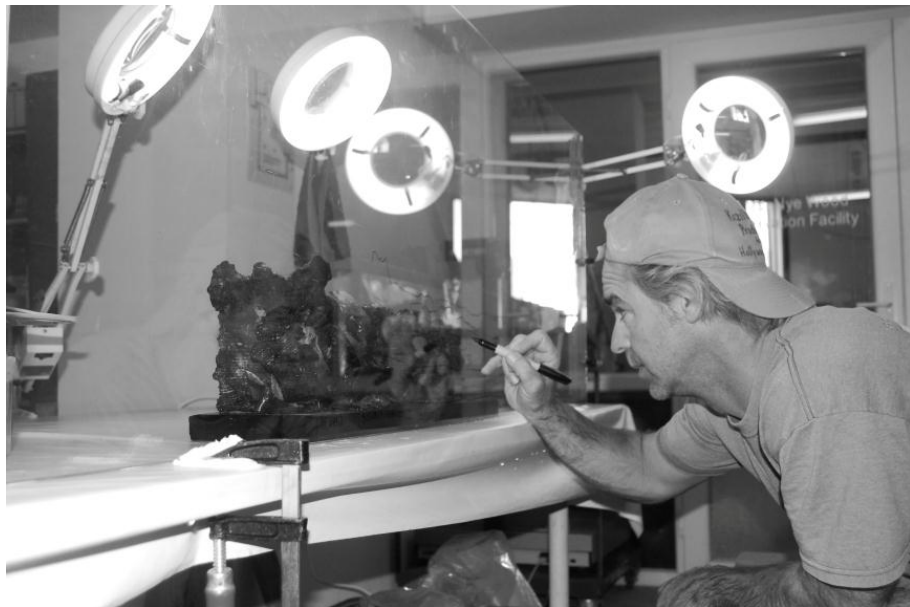
Figure 2.7. Recording keel fragments using plate glass and 90° brackets. Photograph by Kimberly Rash.

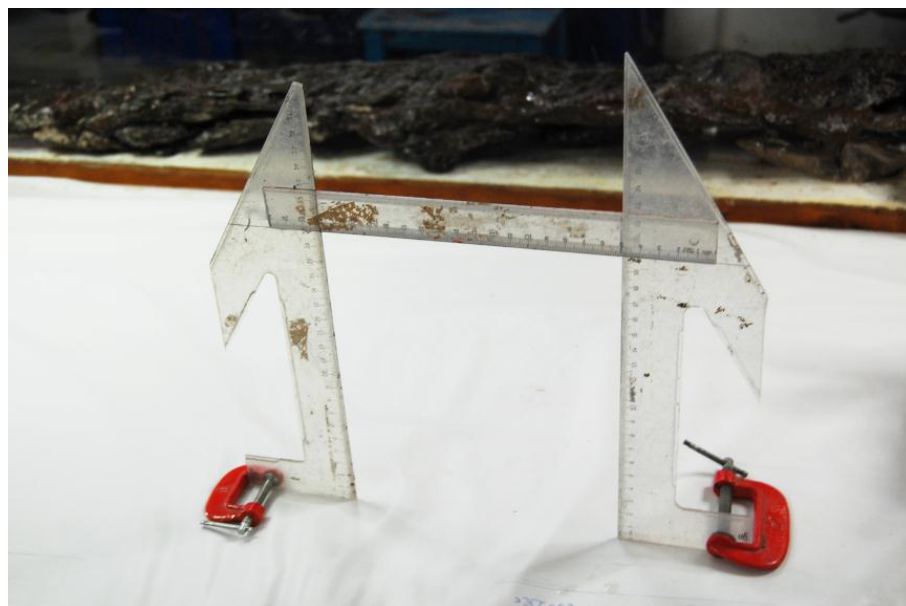
Figure 2.8. Tool for measuring timber profiles. Photograph by the author.

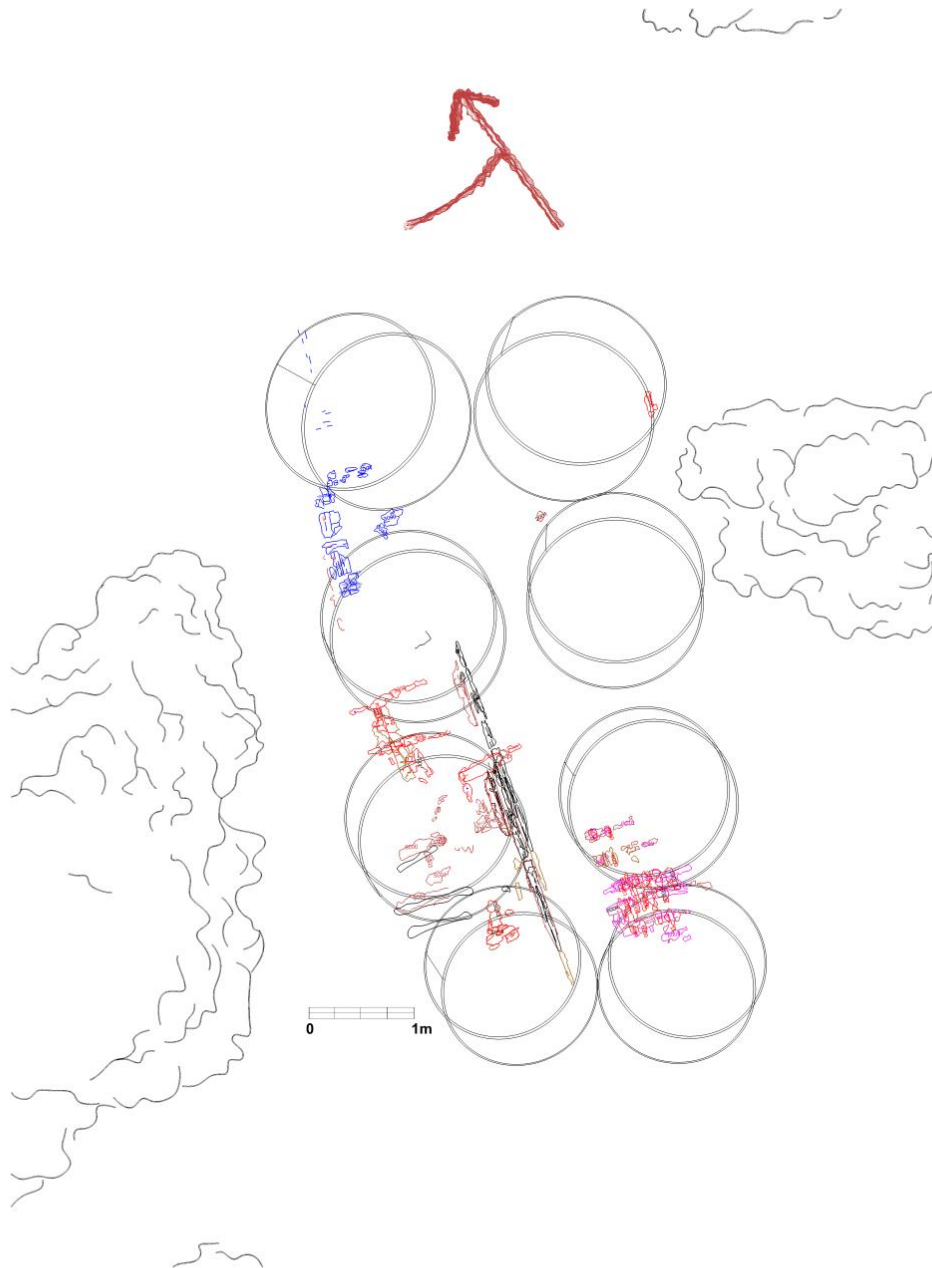
Figure 3.1. Timber fragments and iron anchor from Kızılburun with column drums superimposed. Site plan by Sheila Matthews and the author.

Almost all of the wood that survives was located under or between the eight column drums, concentrated in four areas (U1, U3, U5, and U6) with a few sporadic fragments coming from areas U7 and U8 (Figures 3.1 and 3.2) (Table 3.1). There was little continuity of individual timbers, even among those that were presumably adjoined (e.g. a floor timber that crossed the keel may have had fragments on both sides of the keel, yet had no physical connection). In instances where elements such as framing or planking were contiguous, they were still broken such that individual pieces are seldom more than 20 cm in length. The most substantial timber excavated was the keel, retrieved in three relatively large sections, with at least 30 additional smaller fragments. Often, recording the timber fragments was only feasible in two dimensions and not always in the same two dimensions, further complicating the interpretation of a constructional puzzle with most of the pieces missing.

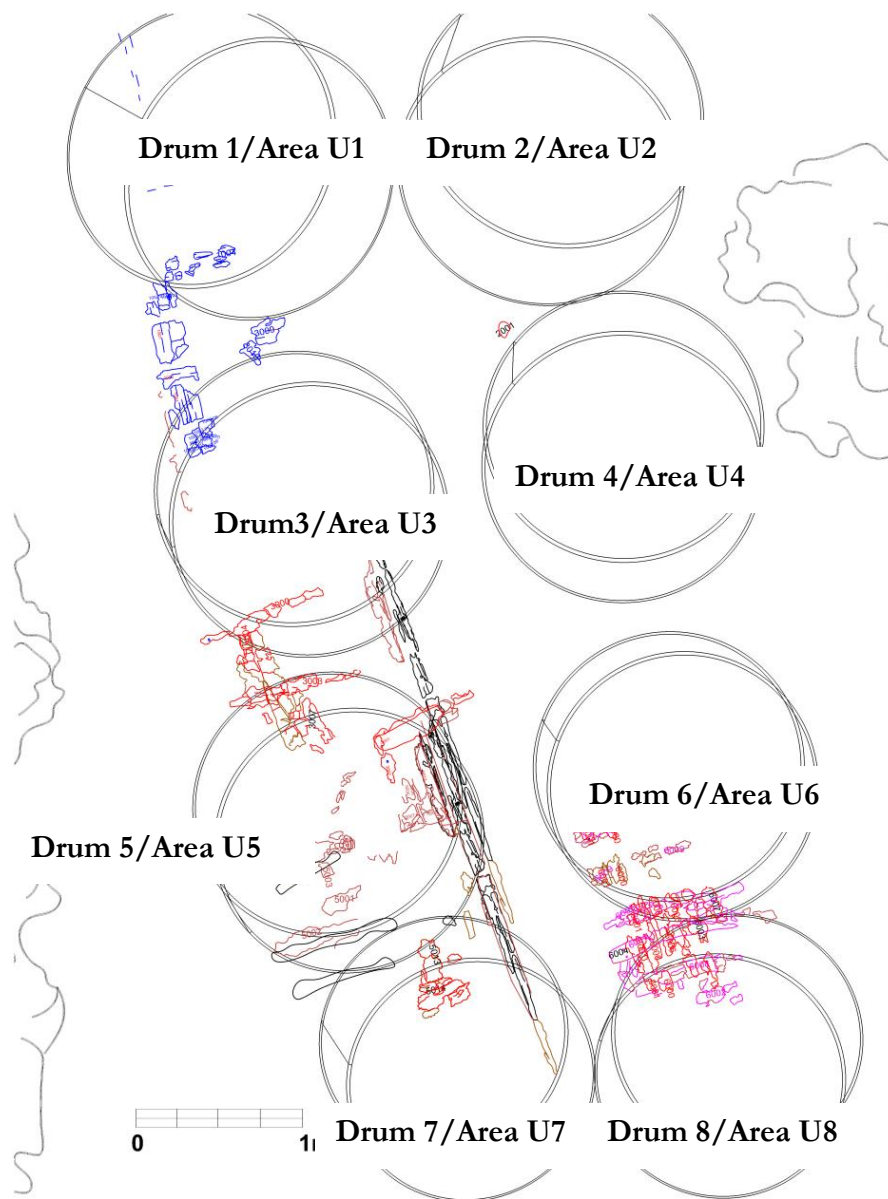
Figure 3.2. Detail of Figure 3.1. showing main concentrations of wood remains with column drums included for reference. Areas under the drums were named according to the corresponding drum after it was re-positioned off-site. Image by Sheila Matthews and the author.

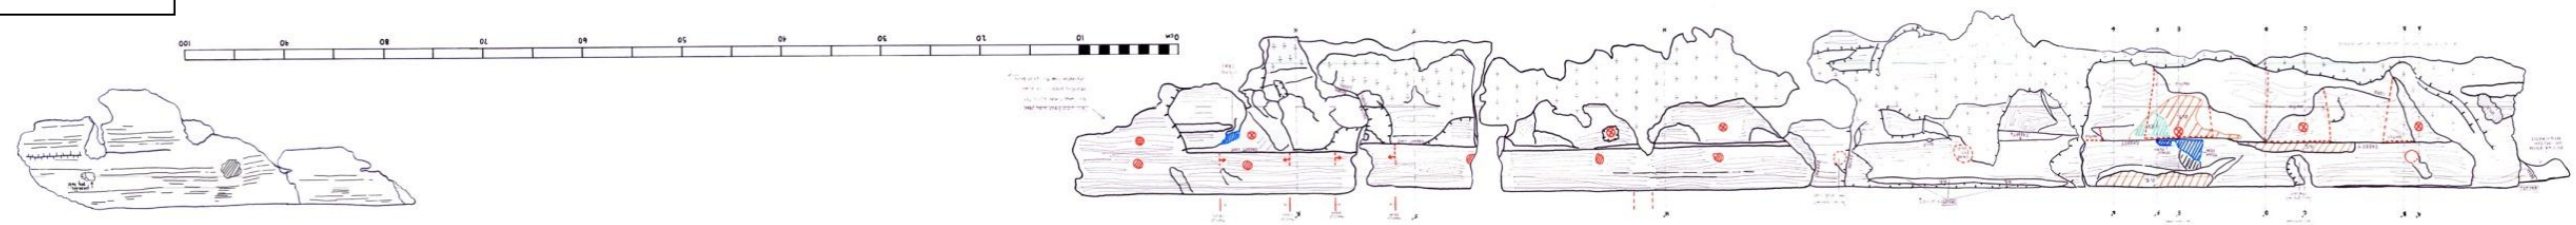
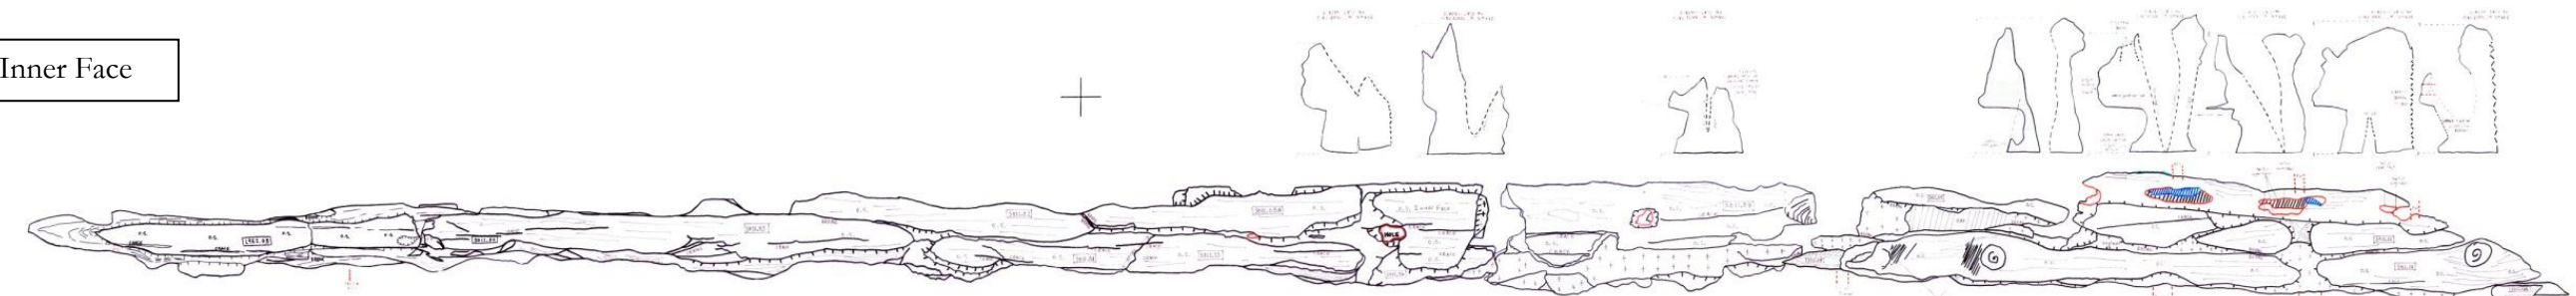
KIZILBURUN COLUMN WRECK  
TIMBER 5011-KEEL  
JOHN LITTLEFIELD - FALL 2009  
SCALE 1:1

Figure 3.3. Extant keel section. Drawing by the author.

A longitudinal timber discovered in 2006 was initially thought to be a stringer due to its small transverse dimensions. In 2009 this timber was positively identified in situ as the keel owing to the presence of a rabbet. Only a portion of the overall keel survives; less than 3 m in three fragmentary, but contiguous sections along with numerous small disarticulated fragments (Figure 3.3).<sup>64</sup> Although this surviving keel section is relatively small when the potential overall length of the ship is considered, it is the single most substantial surviving timber. There is no evidence of a scarf in the extant keel and no remains of the stem or sternpost. It is also unclear if the keel was rockered, but no rockering is present in the extant timber. Evidence, in the form of three partial nails, suggests the use of a false keel or shoe attached to the bottom of the keel, although the actual timber does not survive.<sup>65</sup> The nail fragments literally disintegrated upon lifting the timber from the seafloor and reassembly of the fasteners was impossible. Consequently, it is not possible to comment on the thickness of the false keel beyond that it was at least 1-3 centimeters thick, presuming its existence.

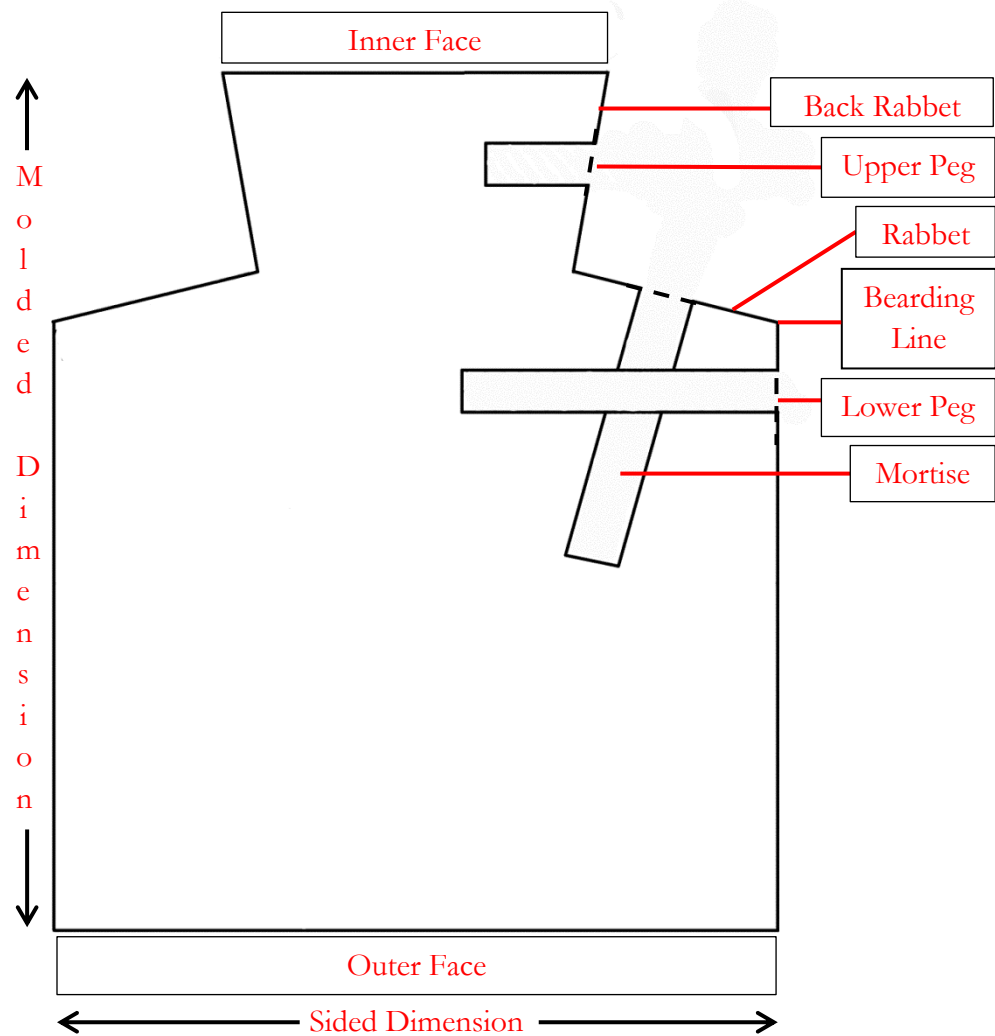
Figure 3.4. Keel features, in profile view. Image by the author.

From the aforementioned keel fragment the first cross section was taken and found to be lacking sufficient preservation to produce an accurate profile. Due to its incomplete and degraded nature, particularly below the bearding lines, a series of 21 cross sections were taken from various stations along the length of the timber and a composite profile was created (Figure 3.4). This was aided by a score mark (Figure 3.5) that was observed in the port-side rabbet of a keel fragment (5011.09) approximately 17 cm in length and protected by a small fragment of the garboard that was still in place. In order to ascertain the accuracy of the dimensions, this score mark was utilized as a point of reference to produce composite measurements where direct measurement was not possible and subsequently transposed to other sections for measurement as possible.

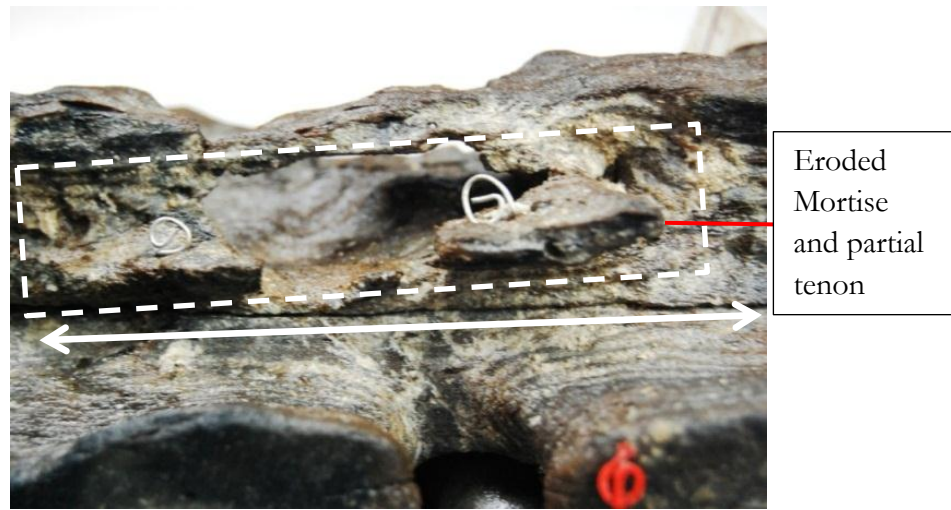
Figure 3.5. Score mark in rabbet of keel. Photograph by the author.

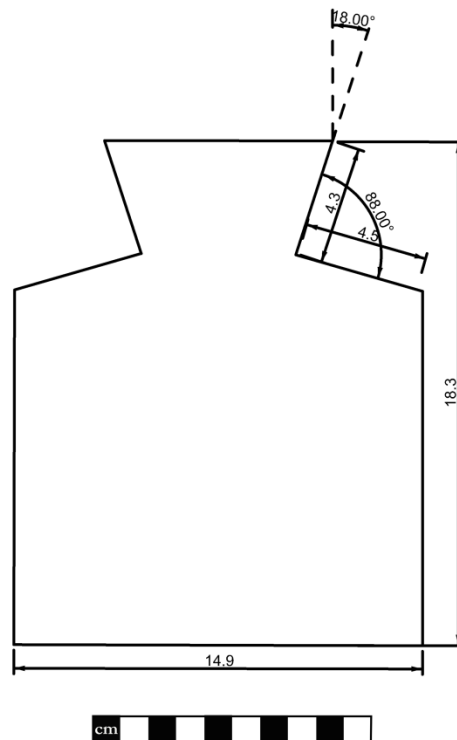
Figure 3.6. Keel profile. Image by the author.

Using the measured angles of the rabbets and back rabbets, the surviving dimensions of the flat inner face and the incised rabbet line as references, along with the maximum extant dimensions, I was able to extrapolate the minimum original sided dimension of the keel as 14.9 cm at the bearding line (the widest point of the keel) using a combination of hand-drawings and *Rhinoceros* 4.0 software. It was not possible to determine anything more than the maximum surviving molded dimension of 18.3 cm due to the lack of any existing original surface of the outer face (Figure 3.6).

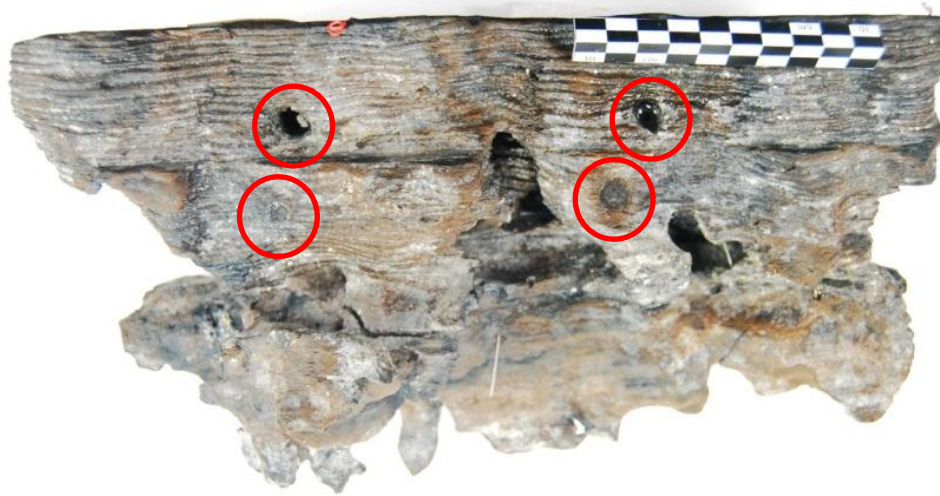
Figure 3.8. Staggered peg holes in the keel. Photograph by the author.

In all cases where pegs or peg holes were discernible in the keel, the upper pegs were driven into the back rabbets parallel to the inner face of the keel. The lower pegs were likewise driven into the keel's molded faces at an angle parallel to its inner face. An unusual and possibly unique feature is observed in the placement of the tenon pegs; they are consistently

staggered along the vertical central axis of each tenon when viewed from the molded faces. This occurs in over 90% of mortise stations that have discernible pegs or peg holes, and always in the same orientation regardless of which side of the keel is viewed. The upper peg is always placed to the right of the central axis (Figure 3.8). This feature may have been employed to prevent possible splitting of the tenon, but may simply be the habit of a particular shipwright with no functional purpose. Staggered placement of tenon pegs is seen in at least one other ship, the fifth century C.E. Dramont E wreck, yet there the pegs are staggered randomly.<sup>67</sup>

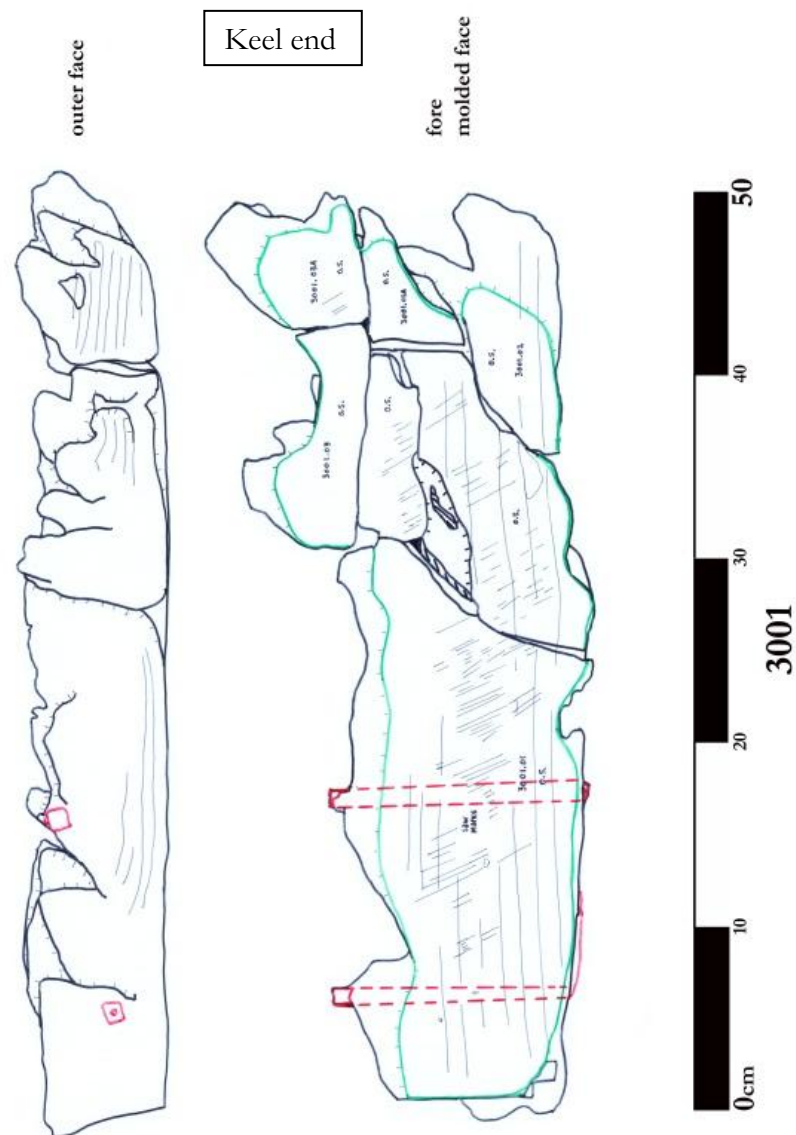
Figure 3.9. Frame 3001 showing sculpted shape. All frame drawings were made as the timber was found with the forward molded face up. Often not all pieces could be placed correctly for drawing and had to be omitted from some views. Drawing by the author.

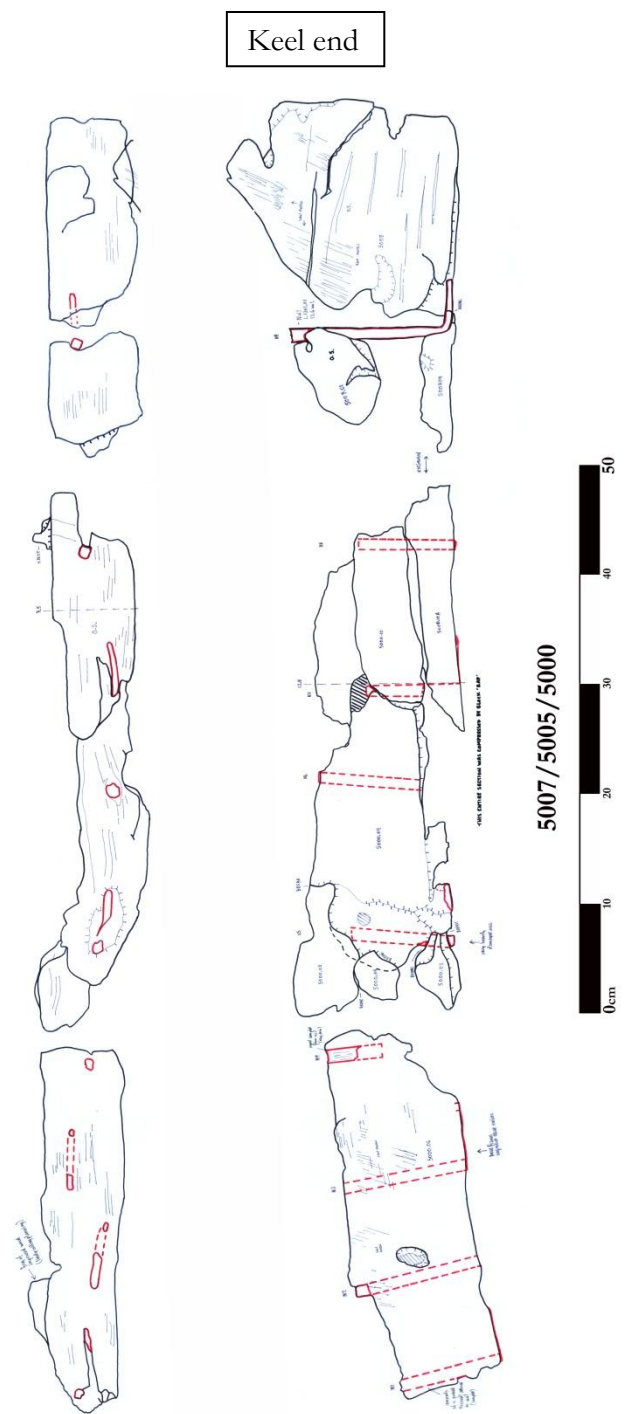
Figure 3.10. Frame 5000/5005/5007 showing sculpted shape towards the keel. Drawing by the author.

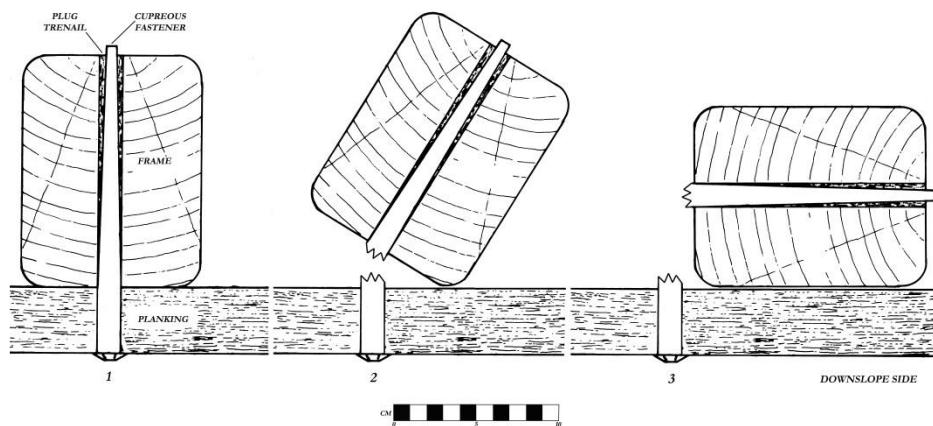
Figure 3.13. Sequence of frame/planking separation. Image by the author.

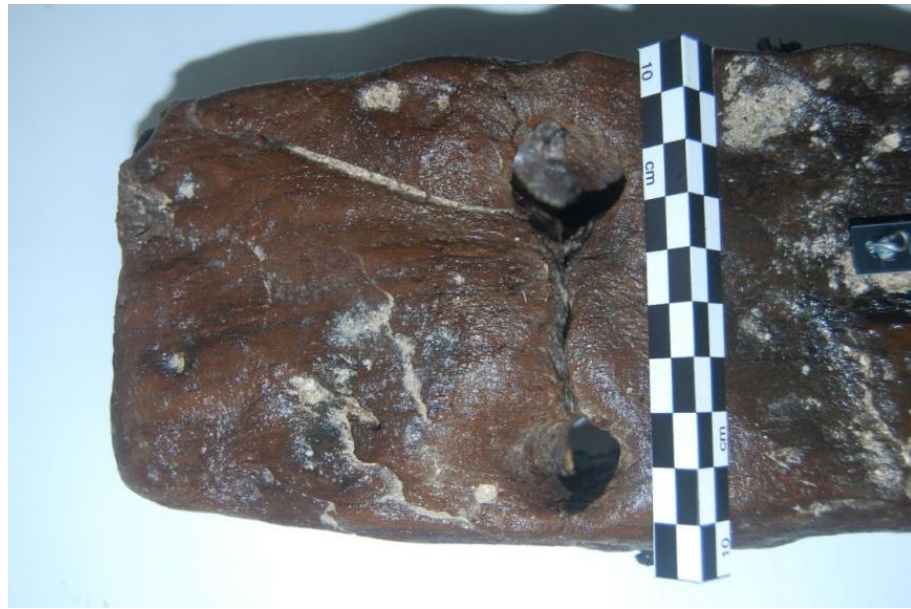
Figure 3.14. Frame 6004 showing cut end. Photograph by the author.

Molded dimensions are somewhat more difficult to define as at least some of the frames (presumably floors) were sculpted to become wider at or over the keel. Here we are forced to rely on maximum surviving dimensions. Timber 6004, which *may* represent a futtock, has a maximum width at the cut inboard end of 10.0 cm (Figure 3.14), while timbers 3000, 3001, and 5000 have maximum outboard dimensions of 10.5, 12.3 and 13.6 cm, respectively. The most telling, however, may be timber 5017, which is a disjointed outboard fragment of timber 5000 on the presumed port side of the keel. Measurements obtained from this 63 cm-long fragment are 12.6 cm on the inboard side and 13.1 cm on the outboard end. If timber 5000 is a floor, then the combination and reconstruction of 5000, joined with 5017, is a representative frame from the vessel (discussed in Chapter V).

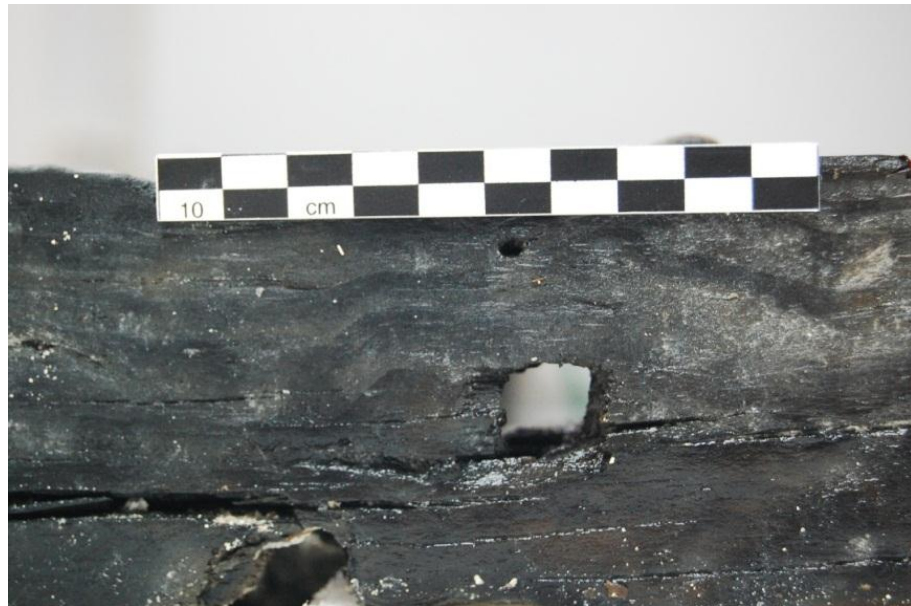
Figure 3.15. Nail hole in keel. Photograph by the author.

Floor timber 5000 has nails spaced at regular intervals as it widens approaching the keel. It is devoid of any fasteners in its widest portion, showing a break in the nailing pattern that otherwise averages 9.3 cm from center-to-center on the inner face. This suggests the lack of regularly placed fasteners between the frames and the keel. Therefore, the function of the square-sectioned nail hole, as well as several other possible nail holes in the keel, remain undefined.

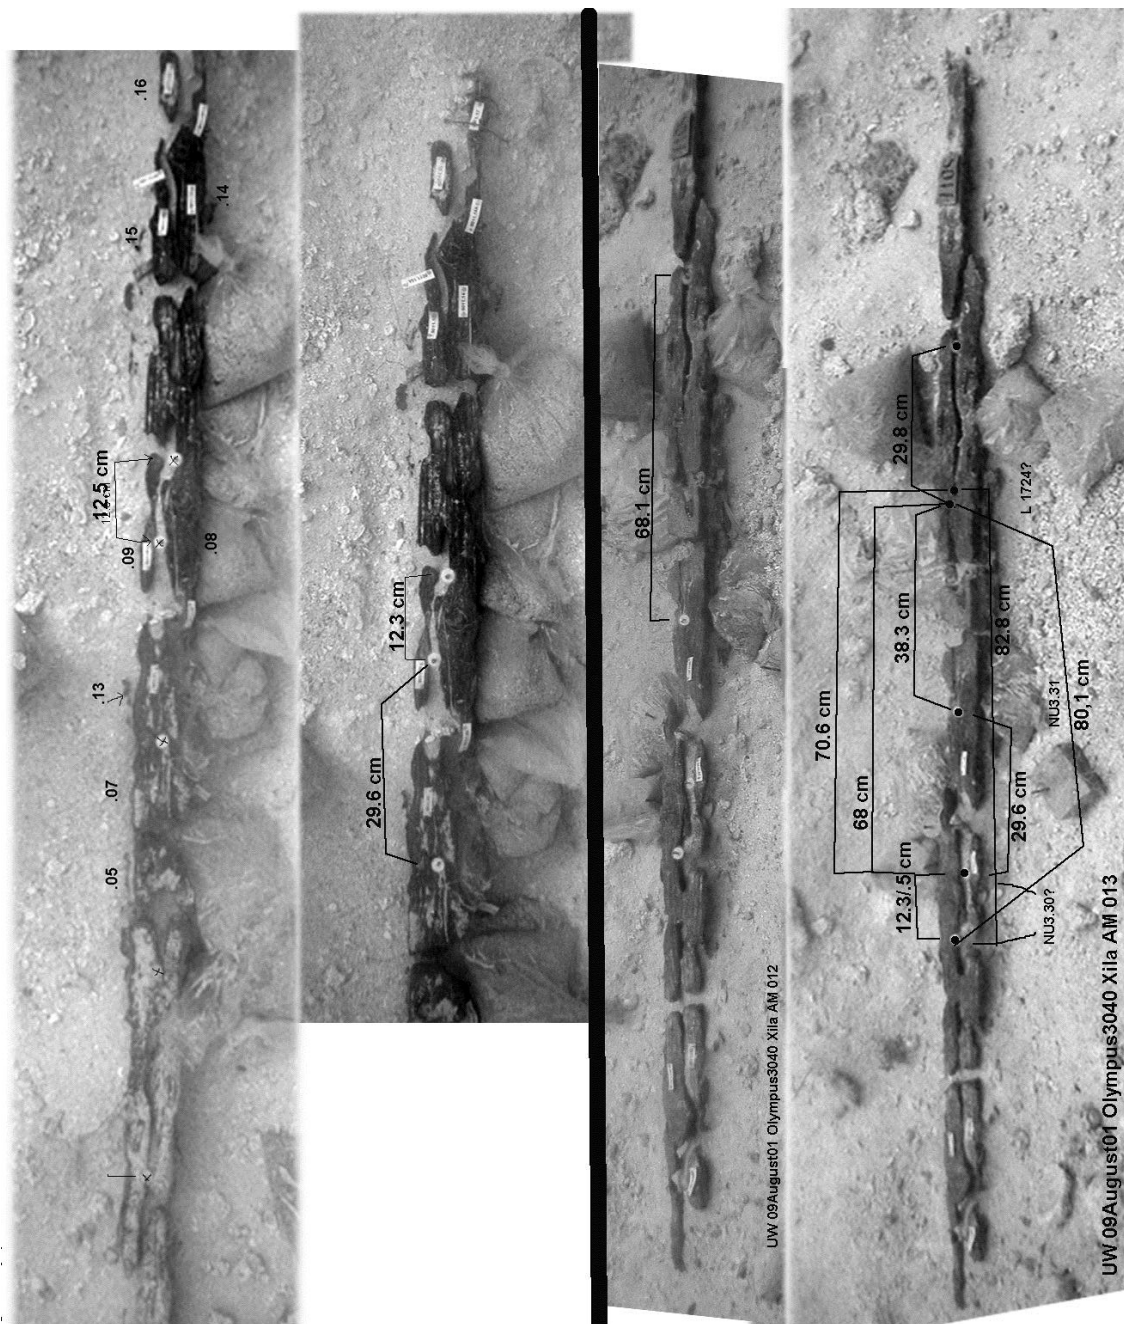
Figure 3.16. Potential nail stations for frames in the keel. Image by Sheila Matthews.

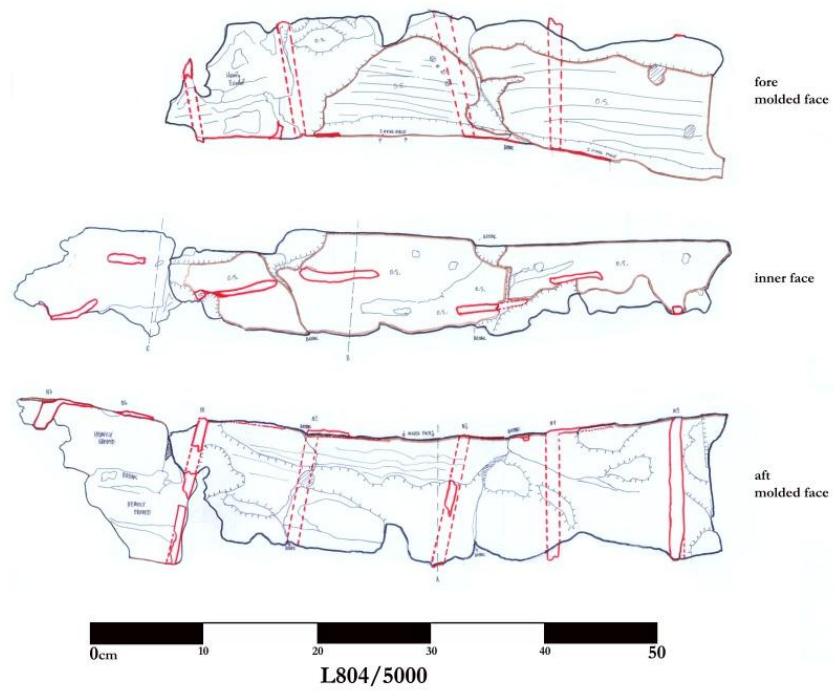
Figure 3.17. Frame fragment 5017. Drawing by the author.

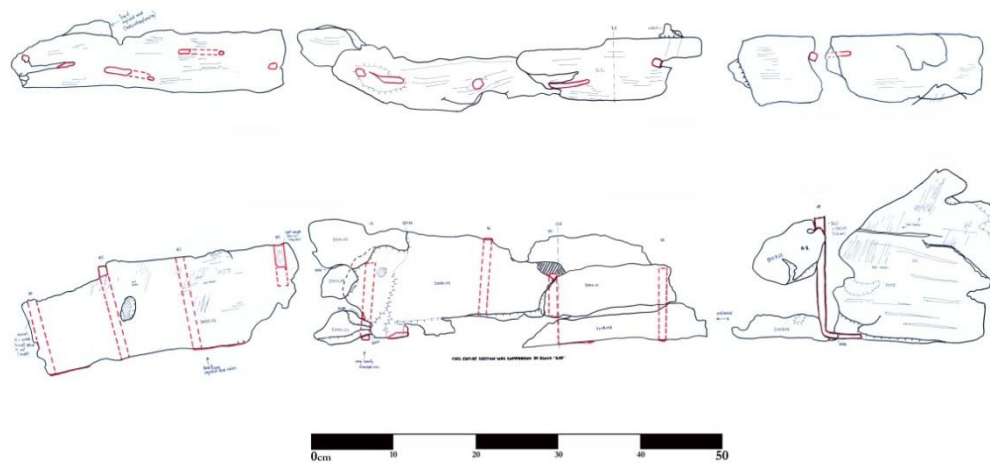
Figure 3.18. Floor fragments 5007/5005/5000. Drawing by the author.

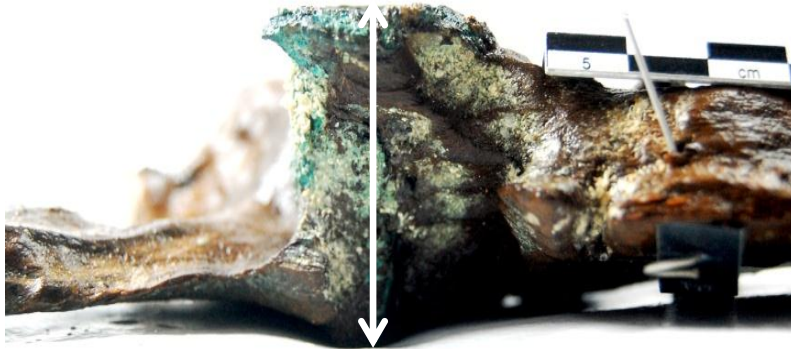
Figure 3.19. Plank fragment 3005.01 with partial nail (highlighted by the arrow) corresponding to original plank thickness. Photograph by the author.

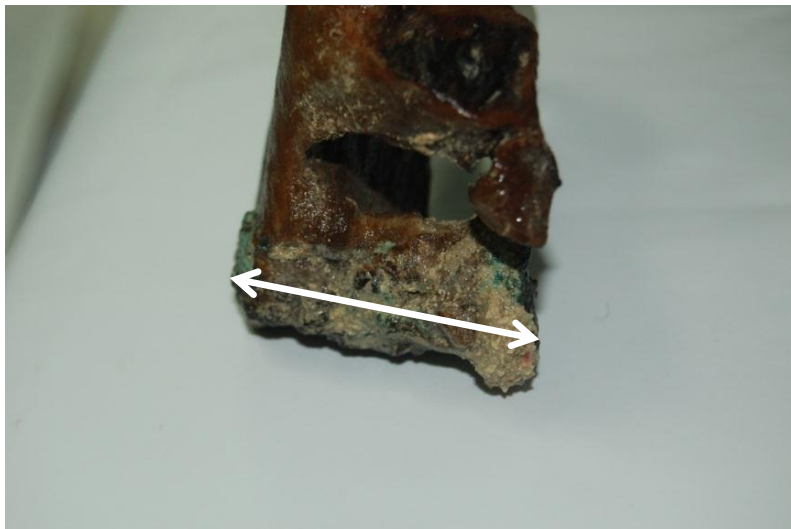
Figure 3.20. Planking fragment 6009.04 with broken nail (highlighted by the arrow) corresponding to original plank thickness. Photograph by the author.

partial nail with head, broken at 4.1 cm below the head.<sup>75</sup> It also retained small portions of original surface from the plank's outer and inner faces (Figure 3.20) This fragment was located on the seafloor over one meter away from the keel and it's thickness is representative of the planking strakes as opposed to the garboard strake that is often of greater thickness (4.8 cm in this case). These figures correspond well with those obtained from examination of the nails discussed in Chapter IV, as well as figures obtained from the examination of the keel rabbets (4.0-5.0 cm). It should be noted that some variation in planking thickness is to be expected, as thicknesses often vary depending on a plank's position on the vessel.<sup>76</sup>

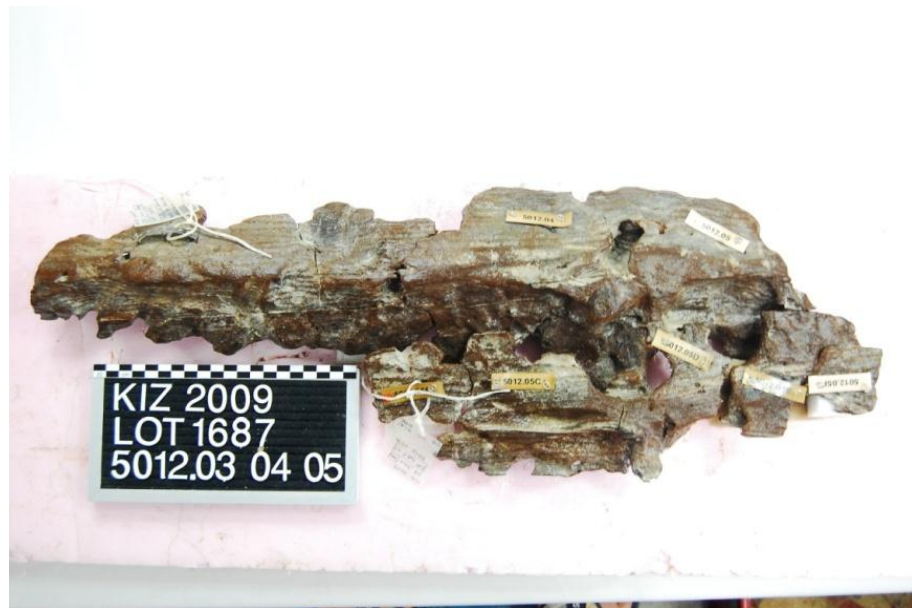
Figure 3.22. Garboard fragment- timber 5012. Photograph by the author.

A 62 cm-long section of the disarticulated port side garboard strake was excavated from under Drums 3 and 5 (areas U3 and U5) (Figure 3.22). This area corresponds to approximately the longitudinal central point of the cargo. Comparing the location of the keel, to that of the cargo's central axis, one can see some shifting toward the starboard side. This may simply be a result of the ship listing to starboard before the collapse of the hull. The downslope movement of the heavy load cannot be stated with certainty, although I do not believe the shift to have been substantial.<sup>78</sup> Regardless, the garboard fragment should be representative of its shape from, or within relatively close proximity to, amidships.

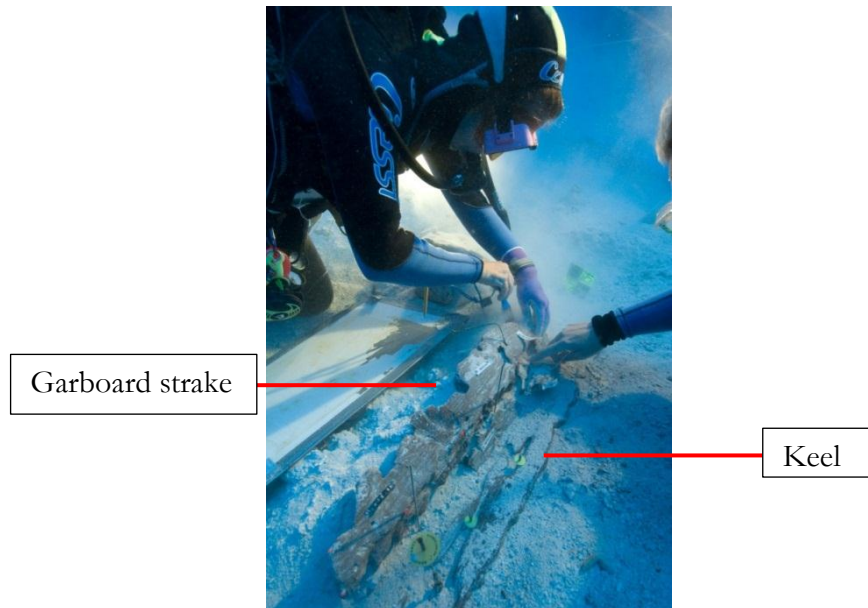
Figure 3.23. Garboard strake in situ. Photograph by Eric T. Kemp.

The lower portion of the garboard's inner face is so eroded and deteriorated that no original surface is discernible and none of the mortise-and-tenon joinery that once connected the garboard to the keel survives in the garboard fragment. Although separated completely from the keel, the garboard was only slightly removed from its rabbet (Figure 3.23).

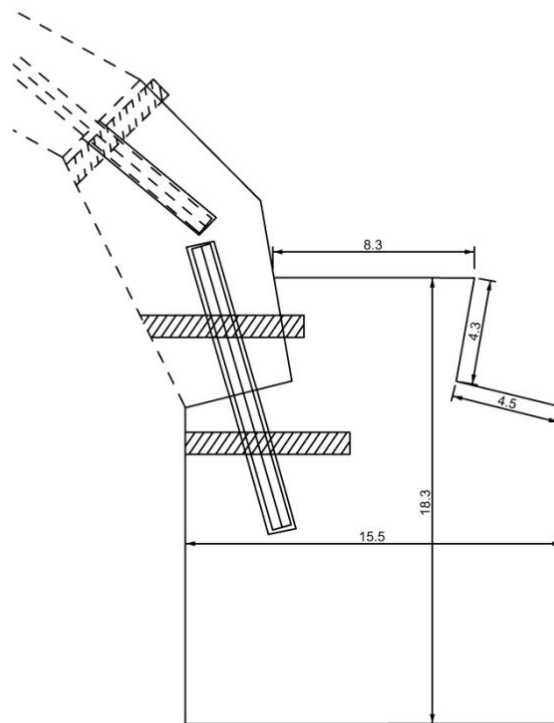
Figure 3.24. Keel profile with reconstructed garboard. Image by the author.

The garboard is not rectangular in section, but sculpted to form a two-part angled inner surface,<sup>79</sup> with the upper portion of the garboard angling away from the lower portion at an angle of approximately 35 degrees, thereby creating a five-faced or pentagonal-shaped timber (Figure 3.24). The upper portion of the garboard is just deep enough to

accommodate the plank-to-garboard mortises before the garboard angles downward towards the rabbet of the keel. Although the upper mortised face of the garboard is eroded, its width can be estimated based on the more complete surviving mortise and an empty peg hole. The average tenon peg-to-plank seam distance in the keel is 1.3 cm, and this figure can be used to estimate the original mortise depth at 6.8 cm. The width of the lower section of the garboard is unclear. However, if the lower portion of the garboard is at least equal to the upper portion in width (6.8 cm), as seems likely since it has to accommodate the garboard-to-keel tenons, then these dimensions can be used to reconstruct the original garboard size from an area near amidships. This will be discussed in detail in Chapter V.

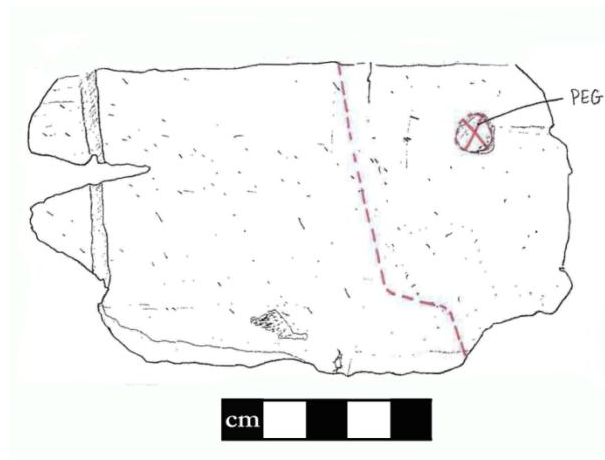
Figure 3.25. Planking fragment 3007.29 illustrating a partial tapered mortise. Drawing by the author.

Although original edges are poorly defined and often difficult to discern on both tenons and mortises, these average figures correspond well to one another and suggest they are indicative of their original dimensions. In several examples, mortise edges are better defined and clearly show distinct tapering (Figures 3.25 and 3.26), as do several tenon fragments.

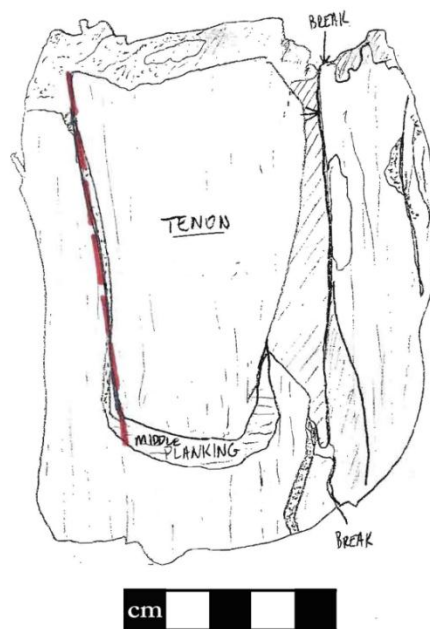
Figure 3.26. Planking fragment 3011.01 illustrating a partial, tapered mortise. Drawing by the author.
