**THE HULL REMAINS OF THE LATE HELLENISTIC SHIPWRECK AT  
KIZILBURUN, TURKEY**

A Thesis

MASTER OF ARTS

December 2012

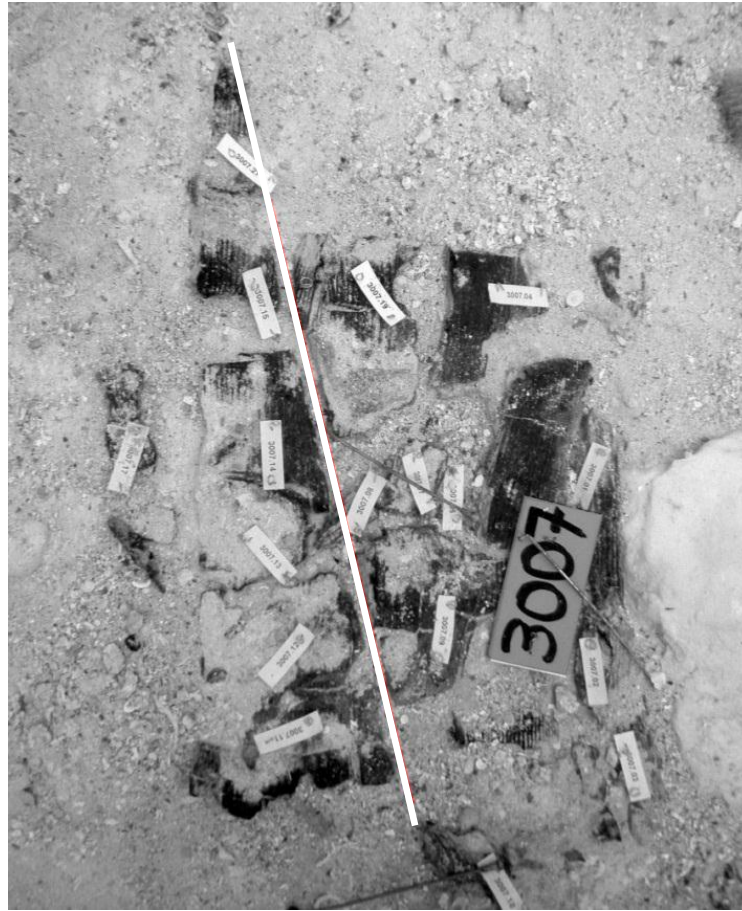
Figure 3.27. Diagonal scarf on plank section 3007 shown in situ, with the scarf marked by line. Photograph by Deborah N. Carlson. Also see Figure 3.22 for drawn version.

The single, partially extant planking scarf is of the common diagonal version.<sup>80</sup> Although its full length has not survived, it can be reconstructed as having a length of 80 cm in a strake that is estimated to have been 24 cm wide.<sup>81</sup> Pegged mortise-and-tenon joints aided by a single nail secured the two planks of the scarf. The nail, used to secure the scarf tip, was driven from the lower plank into the upper one (Figure 3.27). Strengthening scarfs with nails is a common feature of Graeco-Roman shipbuilding and lasted well into the seventh century C.E.<sup>82</sup>

Edges of the three surviving mortises are not clearly defined due to heavy compression, distortion, and the degraded nature of the wood, but it is possible to see that tenons were placed in a perpendicular orientation to the plank seam rather than perpendicularly to the scarf seam. This further supports the idea that the two planks were pre-assembled into a strake prior to securing them to the strake below.<sup>83</sup> The ship excavated at Kyrenia also exhibits diagonal scarfs. In fact, four of its scarfs have nailed tips, and there is evidence of both strake-by-strake and plank-by-plank assembly in the same ship, illustrating that these

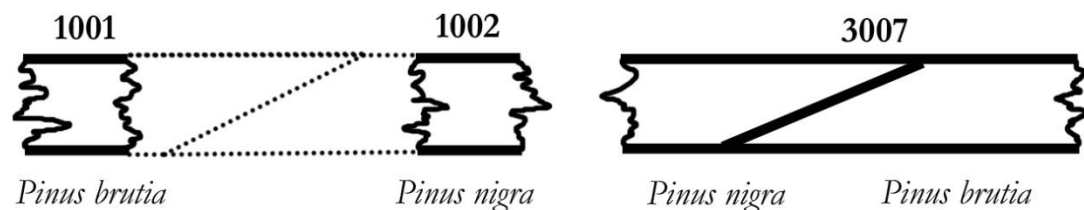
Figure 3.28. Wood identification of planks in scarf 3007 and location of possible scarf between plank fragments 1001 and 1002. Image by the author. Wood identification by Nili Liphshitz. Image not to scale.

The diagonal scarf in planking section 3007 is the only scarf that has survived among the Kızılburun planking. However, there is evidence for the presence of a second planking scarf. Plank fragments 1001 and 1002 were found in line and were presumably parts of the same strake. Both fragments have been identified as pine but of differing species; 1001 is of *Pinus brutia* and was found upslope of 1002, which is of *Pinus nigra*. These timber fragments likely represent a continuation of strake section 3007, which was also sampled on either side of the scarf for wood identification purposes. In 3007, the same situation was discovered, with the plank on the upslope side (fragment 1002) being of *Pinus nigra*, and thus matching the wood species of plank fragment 1002. The plank lying on the downslope side of the scarf in section 3007 is of *Pinus brutia*. (Figure 3.28)

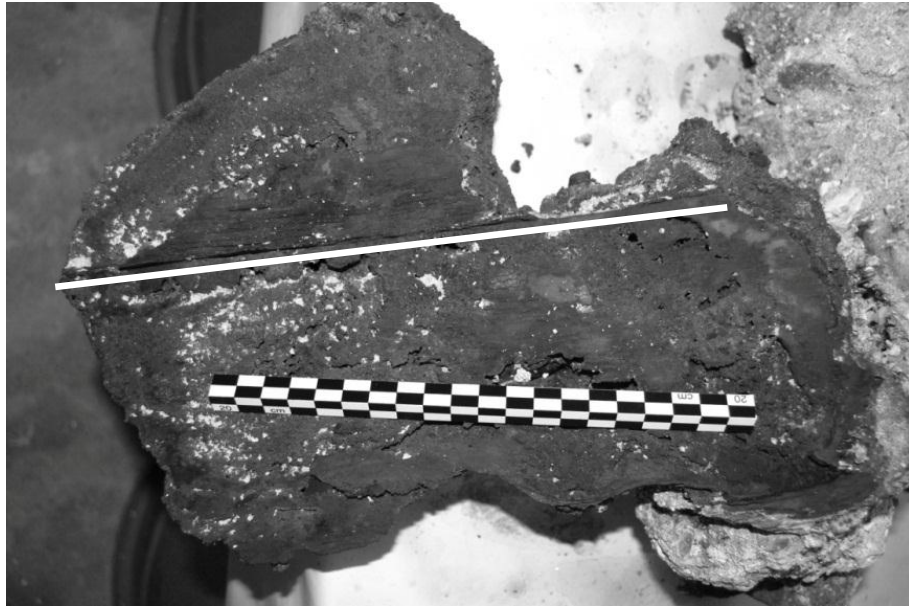
Figure 3.29. Ceiling plank seam impression preserved in iron anchor concretion. Photograph by the author.

The remains of an iron anchor, with its disassembled stock lying next to it, were located just forward of Drum 2 on the starboard side of the keel. Although the original iron anchor itself does not survive, its shape is preserved in the form of a natural concretion mold composed mostly of calcium carbonate.<sup>86</sup> The anchor shaped concretion preserved the impression of a plank that included one of its seams (Figure 3.29). Measuring perpendicularly from the seam to the widest point of the impression yielded a width of 19.2 cm. As the anchor could not have been resting directly on hull planking due to the presence of frames, the plank impression most likely represents of ceiling planking.<sup>87</sup> Although fragments of ceiling planks were identified elsewhere in the hull, the impression left on the iron anchor concretion provides the widest preserved piece from which a minimum width is obtained for the ship's ceiling planking.

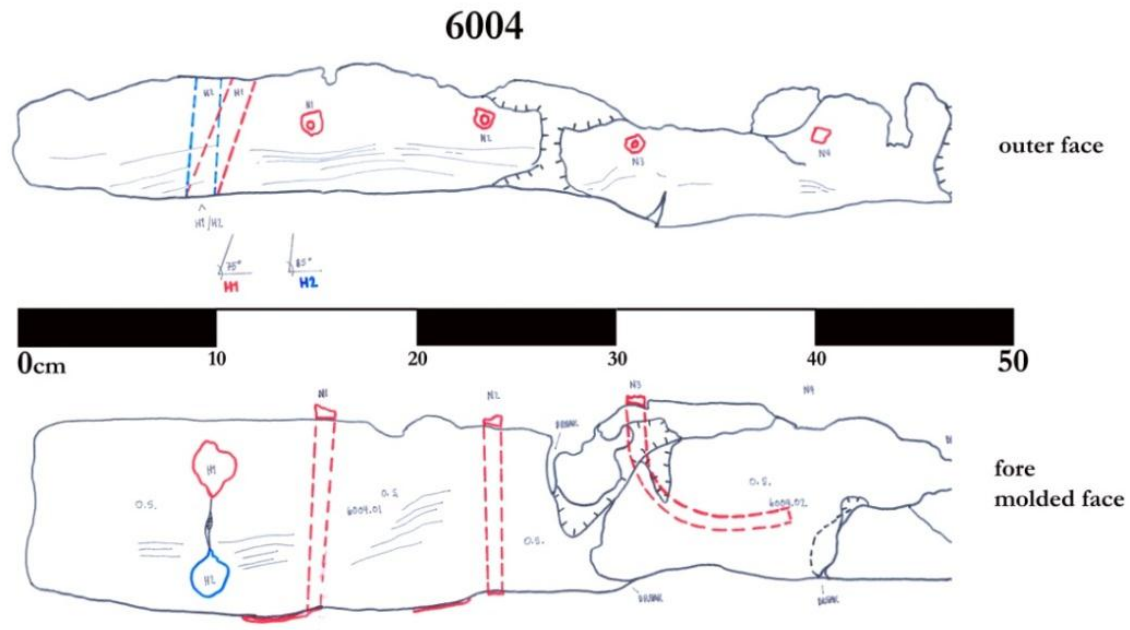
Figure 3.30. Frame fragment 6004 showing vertical holes of unknown purpose at its finished end. Drawing by the author.

Timber 6004 is a frame fragment, possibly from a futtock, and has a cut inboard end with two vertical holes of small diameter (2.0, 1.8 cm) (Figure 3.30). Given the vertical placement of the two holes in relation to each other, they were likely drilled from the foreword face as this relationship is not shared on the aft face. Each hole is drilled at slightly different angles with respect to the forward face of the timber. The upper hole is drilled at 105° while the lower hole is drilled at 95°.

One possible function of the two holes is to secure its end to a floor or other similar member. However, no extant floor survives from the area in which 6004 was excavated. Further, no dowel, nail or treenail remnants survive to suggest that the holes were in use at the time of the ship's demise. Examples of this type of joinery have eluded the author thus far and their function remains unknown.

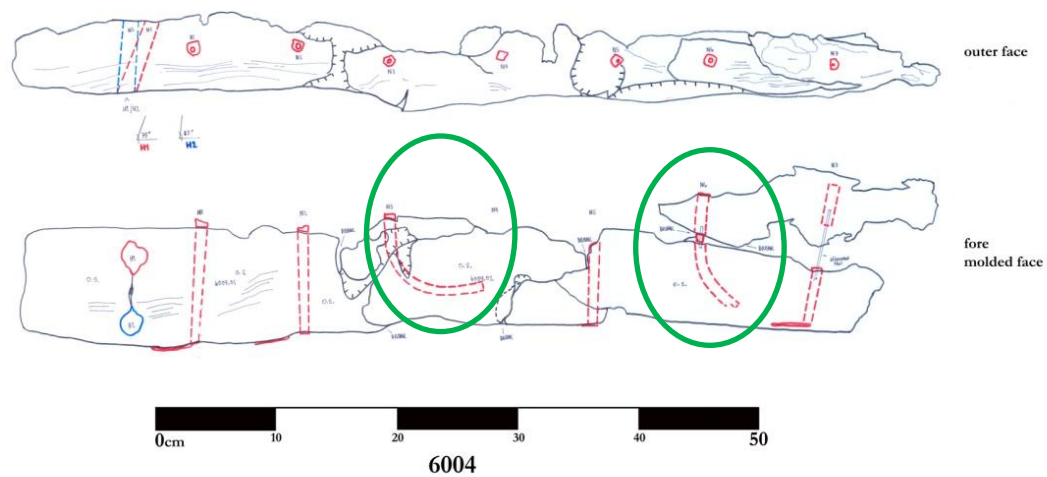
Figure 3.31. Timber 6004 with bent nails of unknown purpose. Drawing by the author.

A second possibility to explain the two holes in frame piece 6004 is that the timber was reused, either from an earlier construction or from another vessel. This idea is supported by two nails serving no apparent function (Figure 3.31). They are spaced appropriately to serve as clenched planking-to-frame nails, but instead of penetrating through the inner face of the frame for clenched, they are embedded within the timber. There are no treenails on the inner face of the timber to guide these nails through the thickness of the timber. However, it is also possible that these nails were simply mis-driven and left in place. No other instances of mis-driven nails or those of dubious purpose were observed in the other timbers.

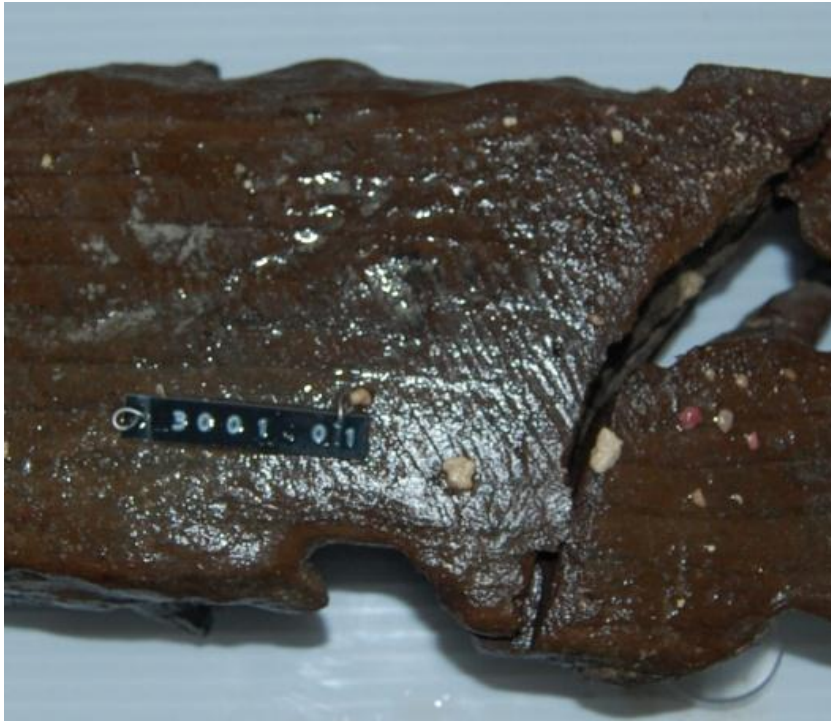
Figure 3.32. Saw marks on frame fragment 3001. Photograph by the author.

There are a limited number of tool marks preserved on the hull remains, including the already discussed score mark on the port side rabbet of the keel. A small area with saw marks has also been found on the inner face of the keel, illustrating the manner in which the keel was shaped. Saw marks were also found on other timbers from the ship. Ceiling planking fragments 3002 and 5006 also exhibit saw marks on their inner faces, but saw marks are most clearly seen on frame fragments 3001 (Figure 3.32) and 5000 (Figure 3.33). These were made by a fine-toothed finishing saw with teeth spaced approximately 1 mm apart. No clear evidence of a coarse-toothed saw was discovered, nor was there any direct evidence for the use of an adze to shape or finish the timbers. Absence of evidence does not constitute evidence of absence; therefore, it is only possible to say that the timbers of this ship were at least finely shaped with the use of finishing saws.

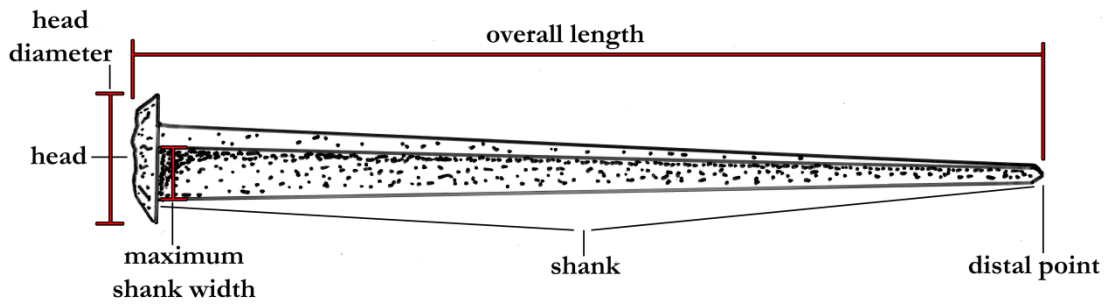
Figure 4.1. Anatomy of a nail and measurement points. Image by the author.

Attributes of existing iron fastener typologies are: head shape, head diameter, shank shape, shank width, and length (Figure 4.1). Head shape can be indicative of function,<sup>100</sup> and is therefore a diagnostic typological attribute. Head size is variable, but generally it is another good attribute to consider. Most ancient nails have a maximum shank width just below the nail head. The head is adjoined to a square-sectioned shank that tapers towards the distal end. However, cylindrically shanks are not unprecedented, so one must also distinguish shank shape for typological analysis. As ancient nails were hand-forged, variation in length is inevitable.<sup>101</sup> Therefore, length is of limited utility in categorizing fasteners.

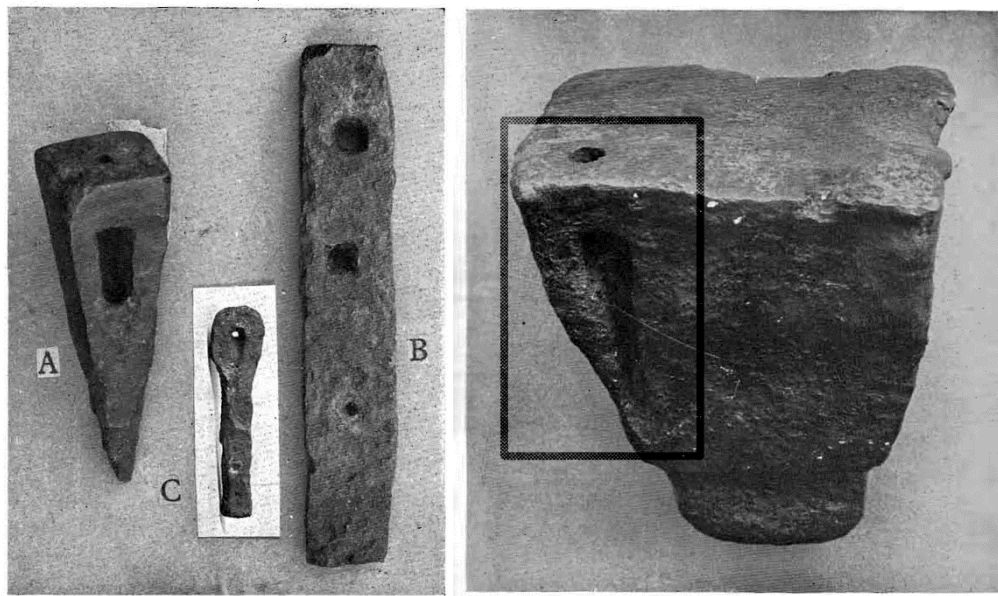
Figure 4.2. Roman nail headers and anvil. Reprinted with permission from *Ancient Carpenter's Tools*, by Mercer, Mercer Museum/Bucks County Historical Society, Doylestown, PA. 1960.

Shank width may be the most consistent attribute of a hand-forged nail, at least within individual assemblages.<sup>102</sup> With forged nails, the blacksmith forms the nail head by driving the fastener through a square hole in an anvil,<sup>103</sup> swage block,<sup>104</sup> or nail header<sup>105</sup> (Figure 4.2) until the width of the shank fits snugly in the hole and so that a short length of the nail protrudes above the anvil or swage block. The smith then hammers the remaining metal into the desired shape of a head<sup>106</sup> (Figure 4.3). As the maximum shank width of a nail is dictated by the size of the hole in the swage block/anvil/heading tool, the finished nails will have a uniform maximum width and therefore may be more easily compared and categorized, at least within a single assemblage (assuming a single source of production). However, shank widths will likely vary only slightly between independent smiths having different sized slots cut into their swage blocks, anvils, or nail headers. As there may be a correlation between nail shank width and length, these two variables are generally functions

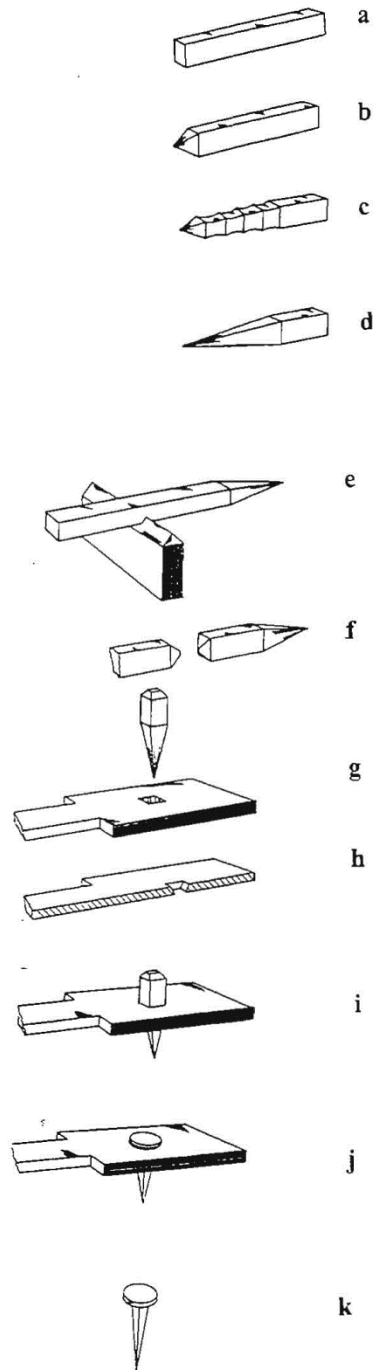
Figure 4.3. Nail production process. Reprinted with permission from *Beyond the Bloom: Bloom Refining and Iron Artifact Production in the Roman World*, by Sim, 1998.

of each other, as are nail head size and length.<sup>107</sup> Experiments in replicating Roman nails have shown that un-headed nail blanks could, and likely were, often produced by a blacksmith's apprentice(s), women, or even children. These experiments further demonstrated that considerable variation in length can exist in nail blanks produced by multiple workers, while the shank width remains more uniform.<sup>108</sup>

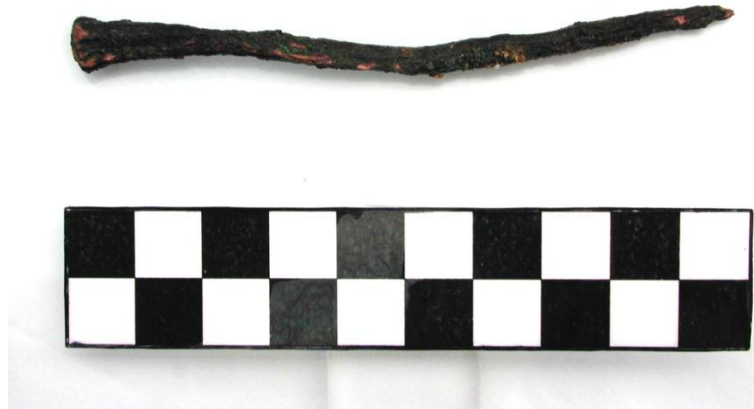
Figure 4.4. Cupreous nail (Lot 019) from Kızılburun. Photograph by the author.

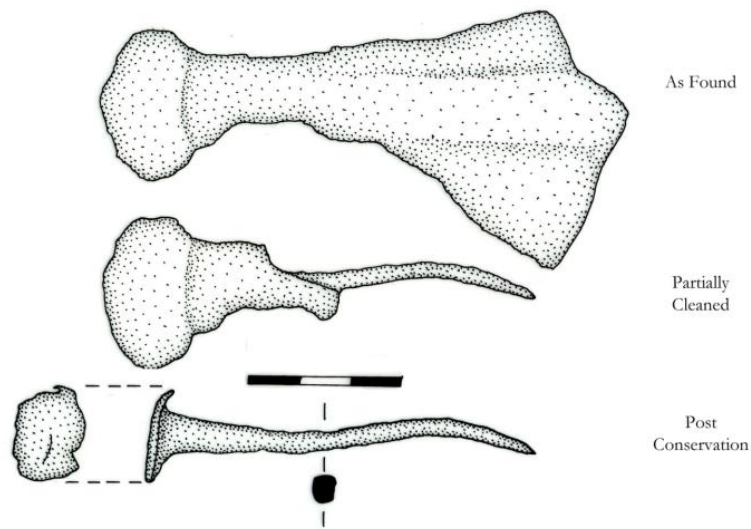
Figure 4.5. Lot 655.03- stages of concretion buildup. Drawing by Mustafa Korkmaz.

A second process that can cause copper to become concreted normally results in higher amounts of concretion. A cathodic protection, induced upon the cupreous metal by adjacent iron artifact(s), spurs an increased amount of calcareous accumulation on the cupreous fastener.<sup>140</sup> This, in turn, has two effects to help reduce, albeit not halt, corrosion of the cupreous metal. First, it reduces the amount of oxygen available to the surfaces of the metal, thus creating an reduced oxygen, if not completely anaerobic, environment. This new environment explains the black powdery surface on several of the fasteners after their removal from the concretion.<sup>141</sup> This covering is by-product of the devolution of the metal and gives the fastener an appearance much like that of iron. Second, the calcareous matrix reduces the normal pH of the seawater ( $8.0 \pm 0.2$ ) by as much as two full points.<sup>142</sup> Fresh water is the defining point for pH neutrality at 7.0. By reducing the pH to a level closer to 7.0 or a neutral pH figure, the metal fastener is provided more protection. This process can also be seen within the Kızılburun nail assemblage (Figure 4.5). One specific example of the process involves nail Lot numbers 655.03 (cupreous) and 655.04 (ferrous). These were found side by side, with the cupreous fastener having substantial amounts of concretion protecting a relatively well preserved small nail.<sup>143</sup>

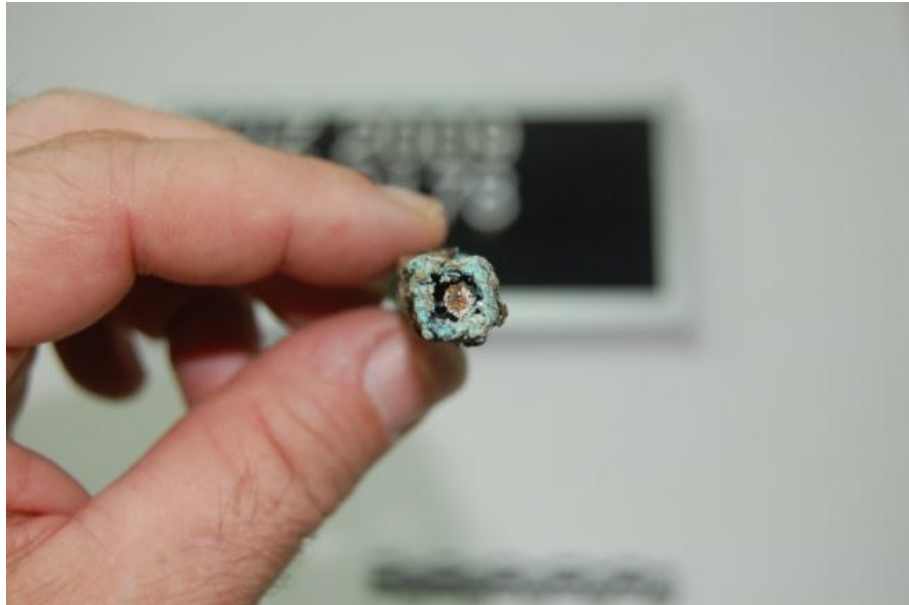
Figure 4.6. Square nail section- Photograph by the author

As observed in the assemblage of nails from Kızılburun, some nail shanks degraded from copper to copper sulfides and began to erode away. Edge definition is often lost and the shape of the shank becomes more rounded until eventually it looks as though it was a nail with a circular section. Further, during the reduction process, the wood of a treenail may adhere to the nail and absorb corrosion products of the degrading metal, giving the shank of the nail an apparent cylindrical shape. However, this is not the case. All fasteners with a discernible shape in this category have a square cross section.

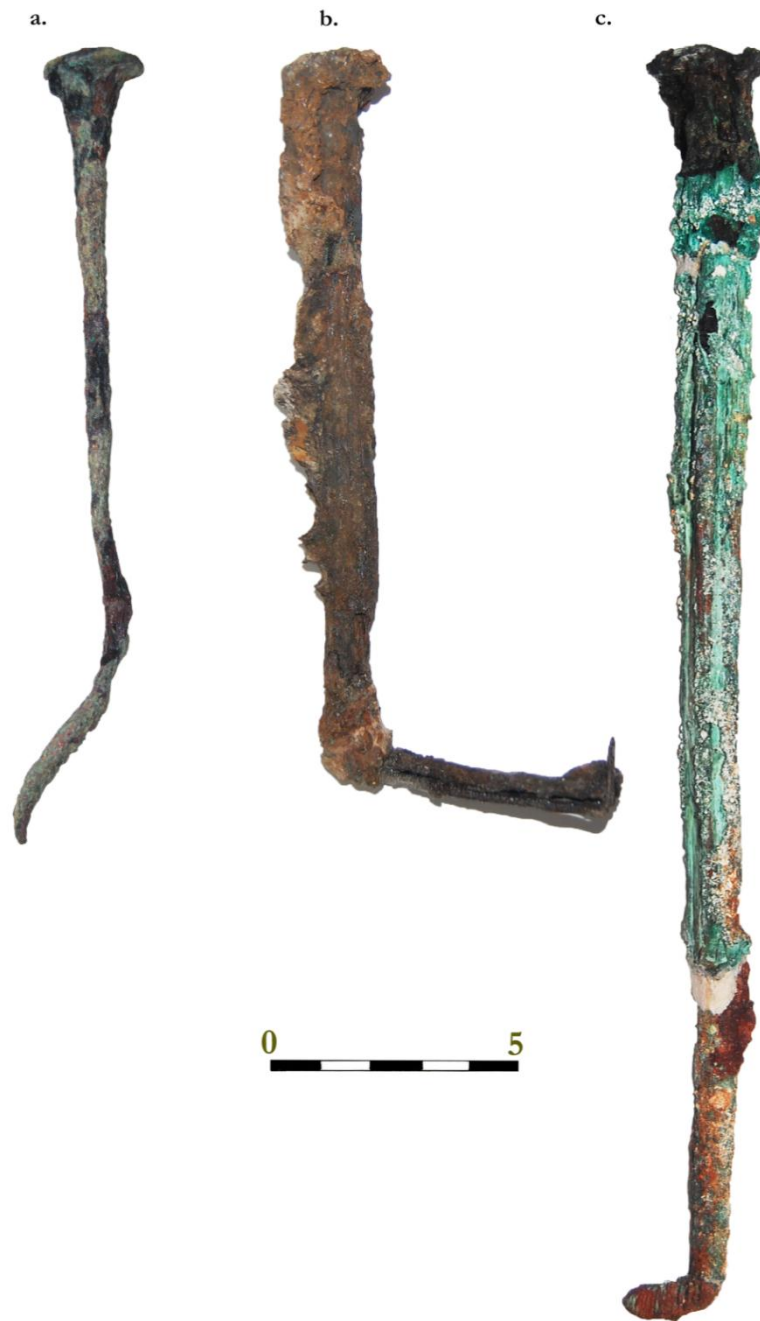
Figure 4.7. Photographs of large cupreous nails from the Kızılburun shipwreck; a. Lot 920 b. Lot 177.03 c. Lot 1329. Photographs by the author.

Nail head shape is not easily defined in the Large Fastener category, as nearly every nail head that survives is covered by concretion or has degraded to the point that the head shape is no longer discernible. The few nail heads that survive without concretion have a flattened pyramidal shape (Figures 4.7a and 4.8a). The flattening of the head is most likely the result of the force exerted on the nail to drive it into the timber as demonstrated in tests conducted by Angus and his colleagues.<sup>154</sup>

Only six large nails from Kızılburun survive sufficiently for direct measurement of length. Lengths range from 21.3 (Lot 177.03) to 25.4 cm (Lot 1329). Since most of the clenched portion of fastener Lot 1329 is missing, the actual unclenched length would be approximately 7 cm longer,<sup>157</sup> making the total length approximately 32 cm before it was clenched. Although the Kızılburun nail lengths are limited to only a few examples, the dimensions fit within the length ranges provided by both the typology of the Inchtuthil group A nails (22 - 37 cm) and that of the Brading Type I nails (19 – 31 cm).

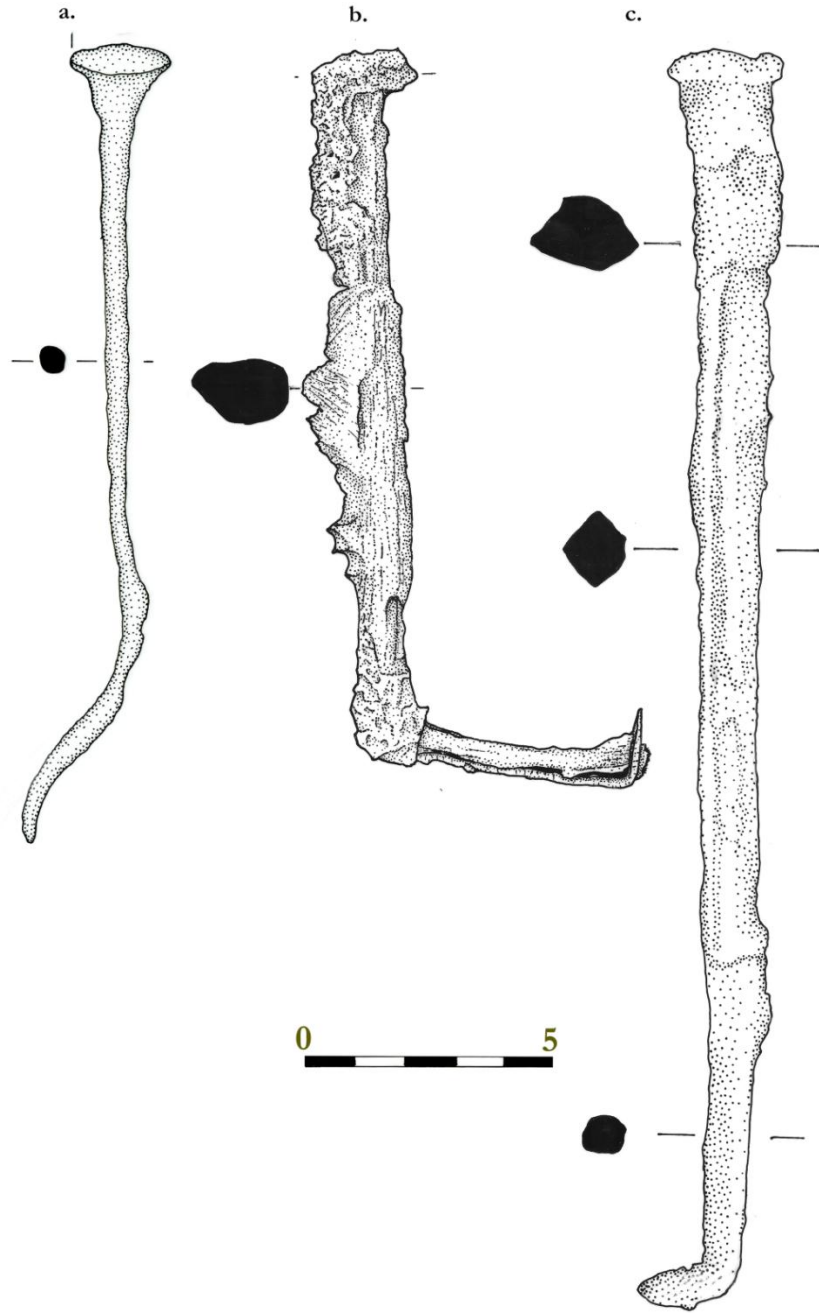
Figure 4.8. Drawings of large cupreous nails from the Kızılburun shipwreck; a. Lot 920 b. Lot 177.03 c. Lot 1329. Drawings by Mustafa Korkmaz (a and c) and Seçil Kayacık (b).

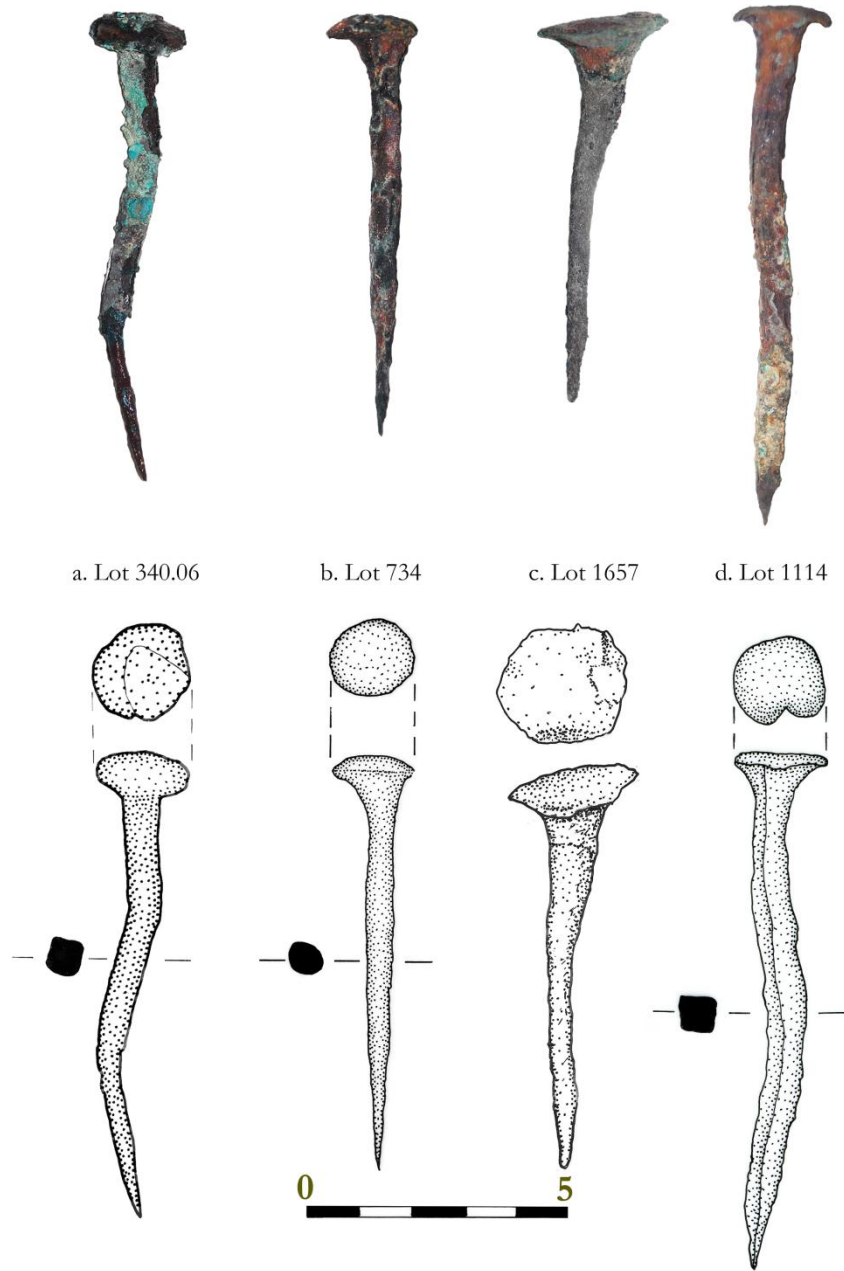
Figure 4.9. Small cupreous nails from the Kızılburun shipwreck.. Photographs by the author. Drawings by Mustafa Korkmaz (a and b) and Seçil Kayacık (c and d).

As with the large fasteners, the small nails have a square cross section and taper towards the distal end. This group consists of 12 nails having a shank width ranging between 0.6 and 1.0 cm; nine of which (75%) fall between 0.6 and 0.7 cm. Lengths range between 5.2 and 9.8 cm. Head diameters range from 1.5 to 1.9 cm, with one outlier at 2.5 cm (Lot 1657). However, small fasteners have two distinct nail head shapes; a pyramidal shape that is often flattened in the center, presumably from the force of driving the nail into a timber (Figure 4.9a,b), and a flat shape (Figure 4.9c,d). The distinct shapes of the nail heads suggest the nails served different purposes, although those specific purposes are not known. It is reasonable to presume that one of the two types was used to secure the ceiling planking to frames, as a square nail hole of small dimensions (0.55 x 0.64 cm) was located in a section of ceiling planking (6023) (Figure 4.10). The nail hole dimensions are consistent with shank widths in the small nail category.

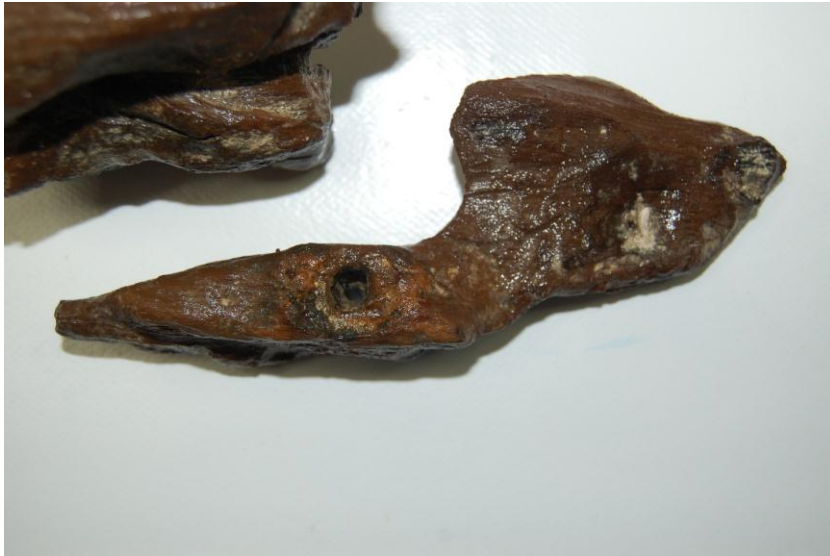
Figure 4.10. Ceiling planking fragment (6023) with small nail hole and nail head impression. Photograph by the author.

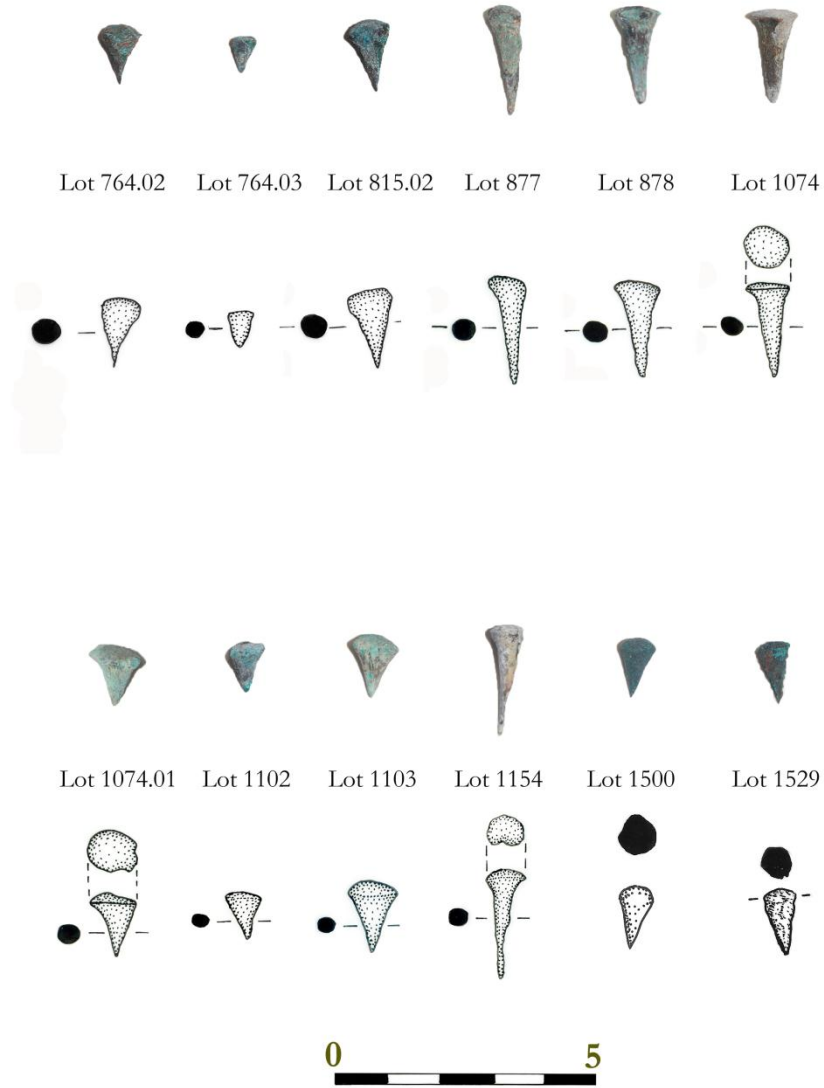
Figure 4.11. Other cupreous fasteners from the Kızılburun shipwreck.. Photographs by the author. Drawings by Mustafa Korkmaz.

Forty eight fasteners have been assigned to this category of which 46 have an overall diamond or conical shape with no distinct shank and are generally of very small size, with lengths ranging from 0.7 - 3.7 cm and head diameters ranging from 0.4 - 1.7 cm (Figure 4.11- Other Fasteners).

These were measured for length and maximum diameter, which is always at the top of the nail unless it exhibited a diamond-shaped profile (e.g. Lot 1103). As demonstrated in the analysis of the copper nails from the fifth-century B.C.E. shipwreck at Tektaş Burnu, these fasteners consist primarily of deteriorated nail heads, the original dimensions of which cannot be determined with any certainty.<sup>158</sup>

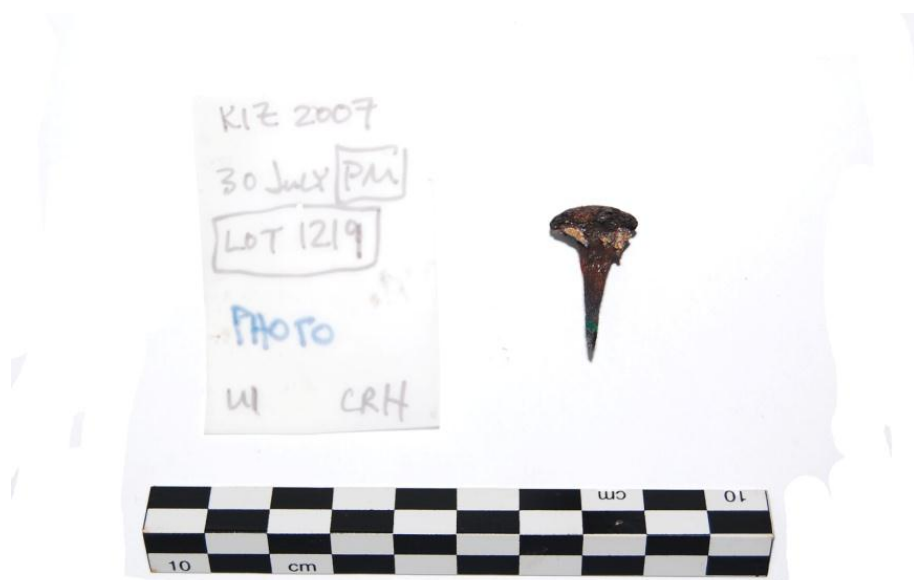
Figure 4.12. Fastener Lot 1219. Photograph by the author.

One fastener, clearly of a different type than the rest (Lot 1219) (Figure 4.12), has a maximum length of 2.4 cm, a maximum shank width of 0.5 cm along clearly defined edges, and head diameter of 1.5 cm. As with many of the nails in the Small Fastener category, the head of this tack has a flattened, pyramidal shape. It is possible that many of the degraded, indefinable nails originally had this form and similar dimensions. Similar objects have been described as tacks used for securing lead sheathing to hulls, albeit there is no evidence of lead sheathing from the Kızılburun site.<sup>159</sup>

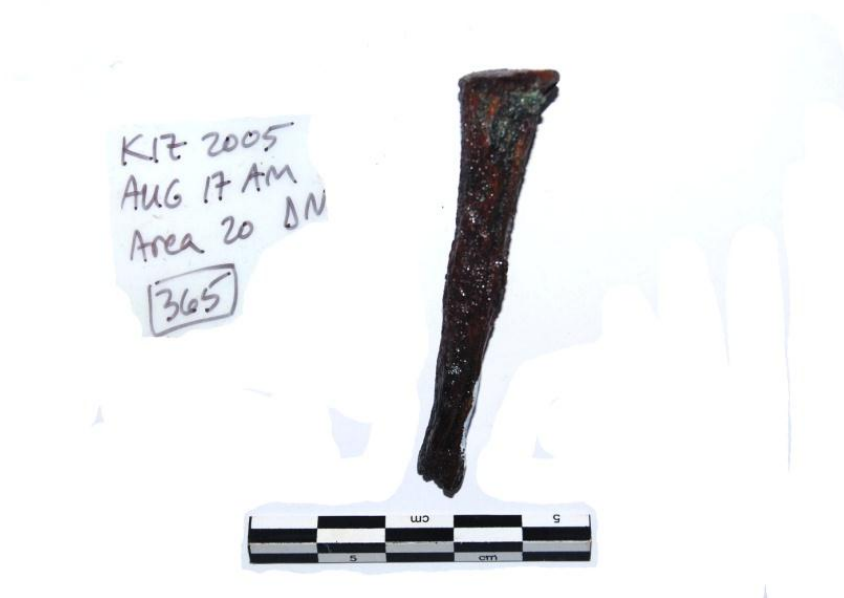
Figure 4.13. Fastener Lot 365. Photograph by the author.

One final nail type (Lot 365) has a large shank with a very flat, poorly defined head, if it can be considered a head (Figure 4.13). The fastener is incomplete, so it is not possible to comment on its overall length, but given the shank width (1.1 cm), it was likely a rather long nail. Its head is vaguely defined, being only slightly wider than the shank. It is possible that this is a broken nail that had been reused in another capacity, although this remains speculative.

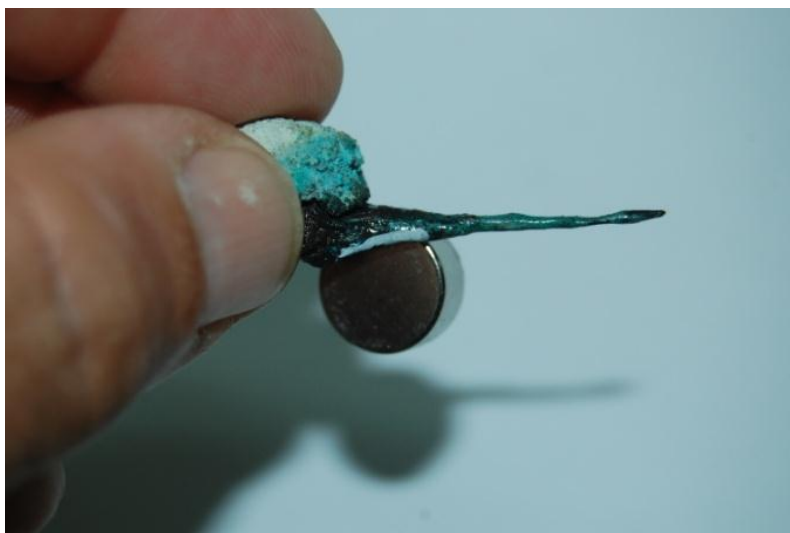
Figure 4.14. Ferro-magnetic cupreous nail (Lot 181.04). Photograph by the author.

All fasteners and fastener fragments were tested using a small, simple rare-earth magnet in order to discern possible ferro-magnetism in the seemingly cupreous nails (Figure 4.14).<sup>162</sup> Six specimens (Table 4.1), of the 1062 inventoried items in the assemblage were found to be ferro-magnetic. Through close examination and removal of all corrosion products and concretion deposits, where such existed, these fasteners were determined to have been made of cupreous materials.

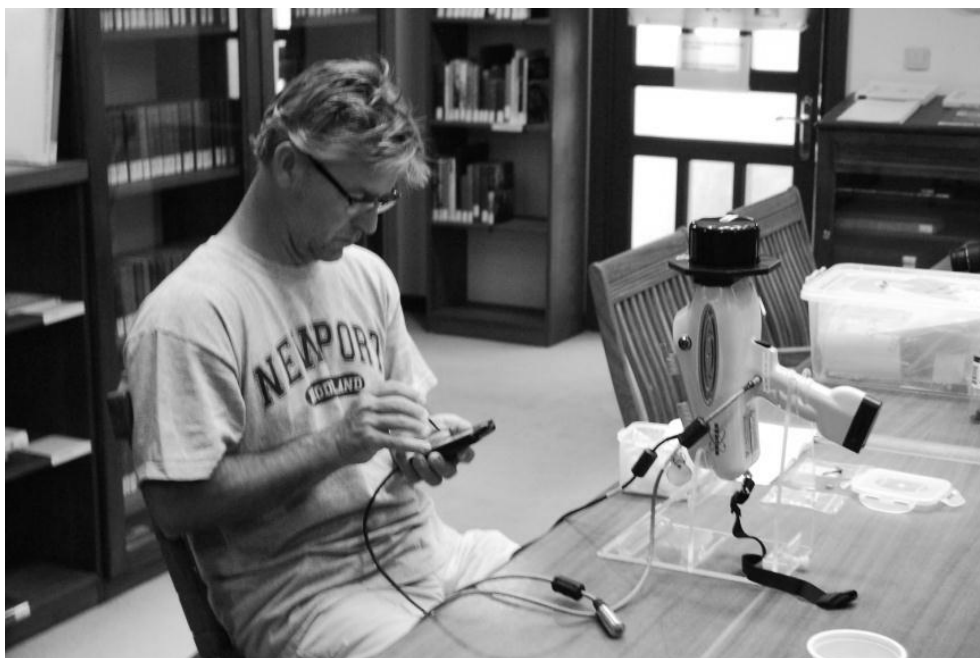
Figure 4.15. The author analyzing nails using the Bruker pXRF. Photograph by Ryan C. Lee.

Elemental analysis of some of the fasteners, including two nails from the ferro-magnetic group (Lot 308.01 and Lot 1219), was performed by the author using a Bruker Tracer III-V portable XRF (pXRF) (Figure 4.15) in order to determine the primary and secondary metals of manufacture, as well as to determine the source of the ferro-magnetic characteristics of the six nails listed above.<sup>163</sup> Once the pXRF is set up the analysis is very simple. The apparatus is designed to be a point-and-shoot analyzer, but may also be utilized on a tabletop stand for best results. Two key aspects for obtaining proper analysis results are exposing a clear and clean surface for the examination, and isolating that surface from the surrounding surfaces. Isolation of the surface is best accomplished by setting the apparatus on a tabletop stand and placing the artifact to be analyzed directly in front of the laser, under a small metal cover.<sup>164</sup>

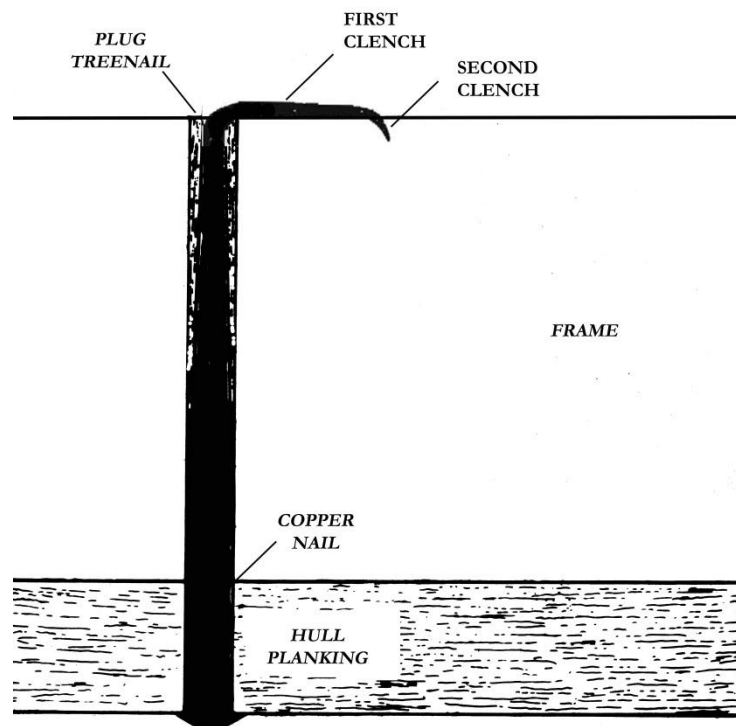
Figure 4.16. Nail double clenched to inner face of a frame (profile view). Drawing by the author.

Plug-treenails prevent splitting of the timbers through which nails are driven.<sup>171</sup> This is accomplished by pre-drilling holes from the interior of the vessel, through the frames and through the hull planking. A cylindrical wooden dowel or treenail is then driven through the hole and cut flush with each surface. Next a nail with a maximum width close to that of the diameter of the treenail is driven from the exterior, through the wooden treenail and double clenched to the inner face of the framing element (Figure 4.16).<sup>172</sup>

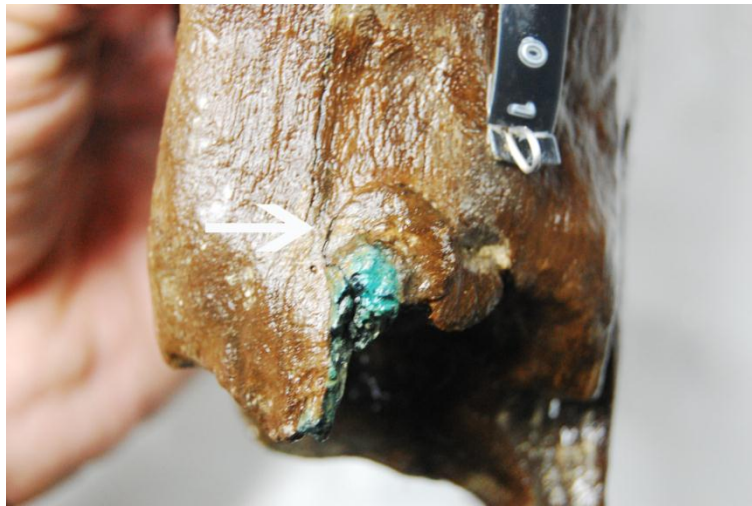
Figure 4.17. Plug-treenail. Photograph by the author

During initial examination of the ship's timbers, no treenails were observed. In degraded wood, plug-treenails can be especially difficult to see with the naked eye,<sup>173</sup> particularly on the outer face of a frame, as the treenail and the nail are of such similar sizes. However, during analysis of the copper nails, it was noted that many retained fragments of wood along their shanks, which suggested the use of plug-treenails. Closer examination of the wood fragments confirmed their use in the vessel (Figure 4.17). Treenails that survive (16 clear examples) are cylindrical in shape and have diameters ranging between 1.1 and 1.7 cm, with an average of 1.3 cm and a mode of 1.2 cm occurring five times. One would presume the treenails to be of the same or approximately the same diameter if a single auger was used to drill the holes into which these treenails were driven, but there is some variation in their diameters. This variation may be due to preservation processes, to augers of different diameters used in drilling the holes, or the roughly shaped treenails were of slightly different sizes, which, when driven into the uniformly drills holes, fit snugly into some and more tightly in others, expanding the diameter of the hole.

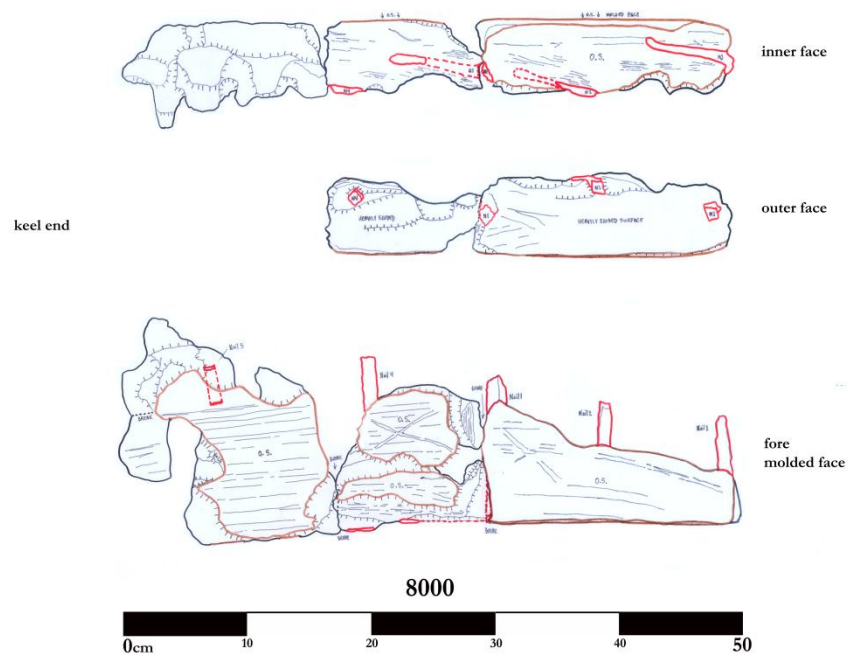
Figure 4.18. Frame 8000 showing nail staggering. Drawing by the author.

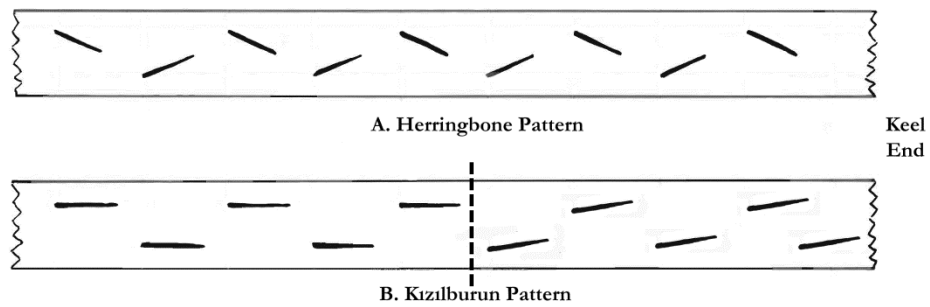
Figure 4.19. Frame nail patterns. Image by the author.

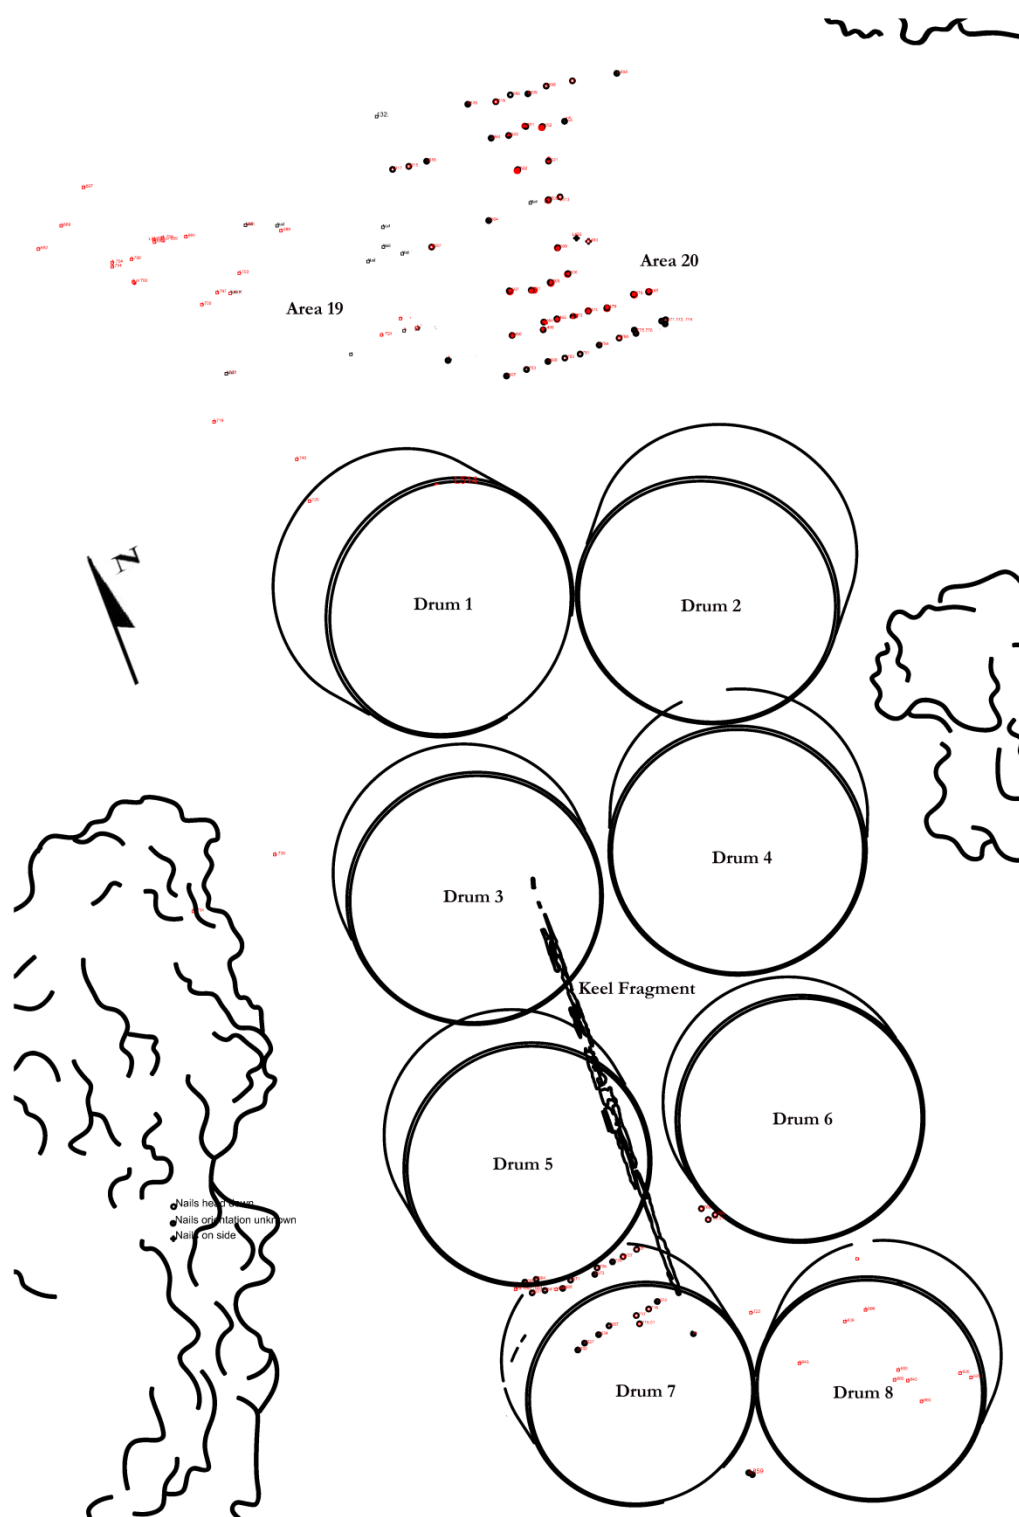
Figure 4.20. Site plan with nails found heads down. Image by Sheila Matthews and the author.

While cataloging nails from the wreck, a pattern of breakage was noted on nail fragments that retained their heads, suggesting a common weak point. Of the 1062 non-ferrous nail fragments, 396 retained heads. Of these 396, 178 (approximately 45%) were broken between 3.9 and 5.1 cm length along the length of the preserved nail shank (Figure 4.22). An additional 31 fragments (totaling 53%) with heads were broken between 3.7 and 5.3 cm. These figures might have been higher if the heavily degraded nail fragments could have been conclusively identified as either small nails or large frame nails. However, even without the ability to eliminate the non-descript nails, there still appears to be a clear correlation between this nail breakage pattern and planking thickness. This deduction is supported by post-excavation examination of the planking fragments (discussed in Chapter III). In the laboratory, the original planking thickness was determined by the discovery of a fully preserved knot in a planking fragment as well as by a nail fragment (Lot 1145.03) embedded in a planking section, which was broken at 3.9 cm below the nail head. To further support this idea, the rows of plank-to-frame nails found in Areas 19 and 20 were examined with the result that of 46 distinct framing nails, 21 were broken between 3.9 and 5.1 cm (46%), and another 25 were broken between 3.7 and 5.3 cm (54%). These figures

correlate well with the overall nail breakage pattern figures and are likely higher had some fasteners not been eroded beyond recognition and thought to be tacks. A further verification of the original plank thickness became apparent later when documenting and modeling the keel, which had a rabbet width is 4.0- 4-5 cm.

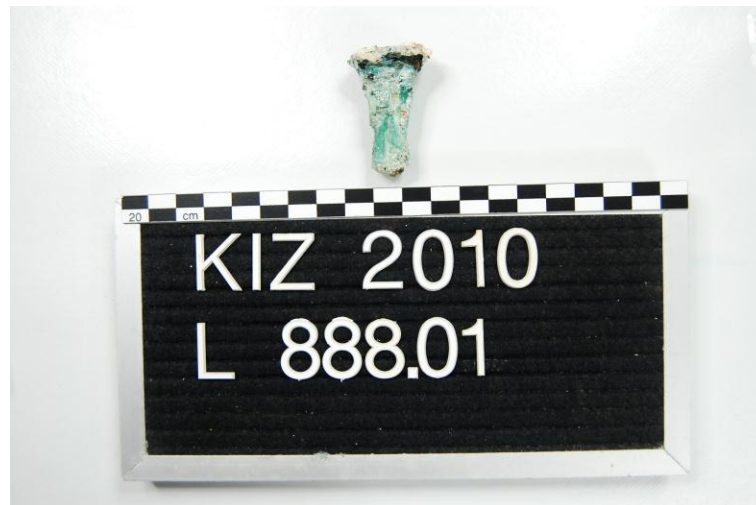
Figure 4.22. Nail Lot 888.01 with head. Photograph by the author.
