**THE HULL REMAINS OF THE LATE HELLENISTIC SHIPWRECK AT  
KIZILBURUN, TURKEY**

A Thesis

MASTER OF ARTS

December 2012

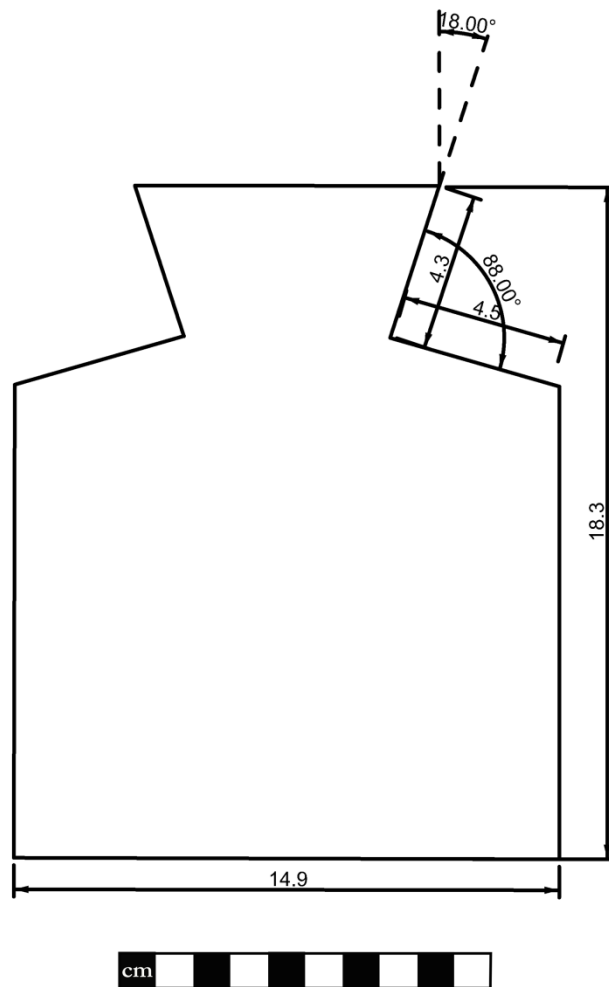
Figure 5.1. Cross-section of the Kızılburun keel. Image by the author.

The maximum *surviving* dimensions of the keel (8.3 cm wide on the inner face, 11.5 cm sided, and 18.3 cm molded) may give the impression of a keel with gracile dimensions. To understand the original dimensions of the keel, these data, coupled with measurements from 21 cross-sections, were used to project the minimum original size of the keel that was at least slightly greater than the surviving dimensions as shown in Figure 5.1. This projected profile was used to create a 3-D model of a section of the Kızılburun ship’s keel in Rhinoceros 4.0 software (Figures 5.2 and 5.3).

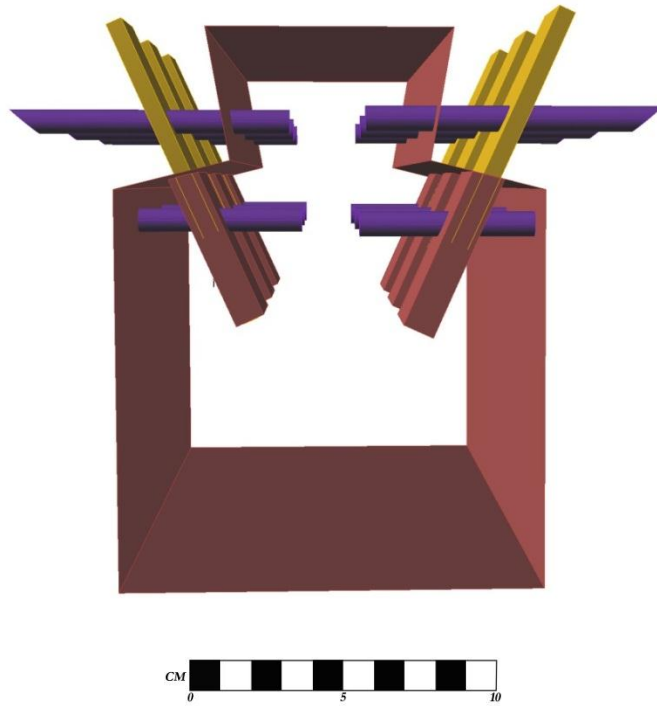
Figure 5.2. 3-D model of the Kızılburun keel cross-section. Image by Sheila Matthews and the author.

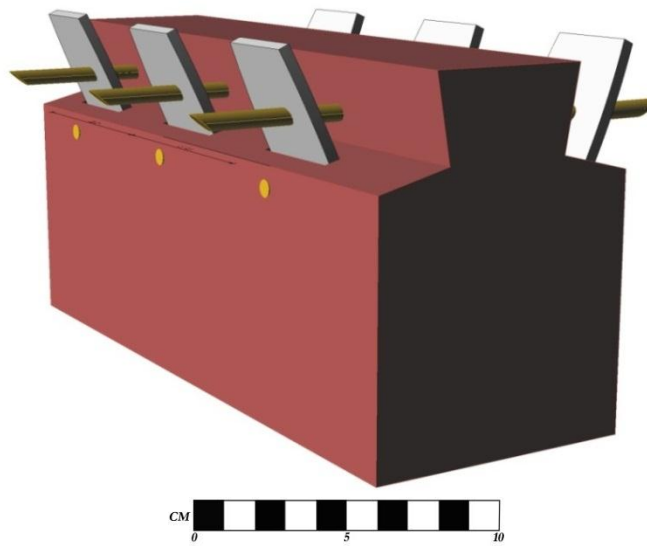
Figure 5.3. 3-D model of the Kızılburun keel. Image by Sheila Matthews and the author.

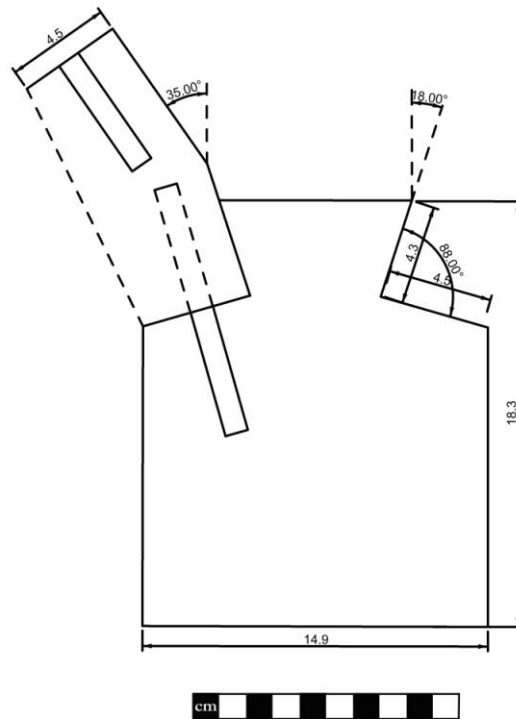
Figure 5.4. Garboard strake and keel in profile. Image by the author.

In my examination of the keel, the sharp deadrise (75-80°) of the garboard was clear and this became even more prominent in the model. This initially suggested a wine-glass hull shape, like that of the ship excavated at Kyrenia, Cyprus. Since the garboard had been disarticulated from the keel, it was necessary to fit the two together in order to understand their relationship to each other and gain a better understanding of the shape of the lower portion of the hull. However, due to the highly degraded nature and fragility of both timbers, this was not physically possible. As an alternative, information gleaned from its 3-D keel profile was coupled with information from the garboard fragment in order to make a drawing of the keel and garboard junction (Figure 5.4)

The upper portion of the port side garboard strake is shaped to form an angle of approximately  $-35^{\circ}$  ( $145^{\circ}$ ) from vertical. There is no extant original outer surface; it has been entirely destroyed by biological activity and degradation processes. However, knowing the rabbet width in which the garboard was seated (4.5 cm) and using the planking thickness of 4.5 cm, the outer face could be reconstructed. The hypothesized reconstruction gives the garboard a robust five-faceted section.<sup>187</sup> This is a conjectural shape, as the outer face may have been a sculpted surface like the inner face. However, the five-faceted (pentagonal) shape would have afforded more strength to the garboard and appears to be a common and therefore perfectly feasible shape to consider for modeling purposes. Whichever shape the original garboard employed does not change its function in this discussion.

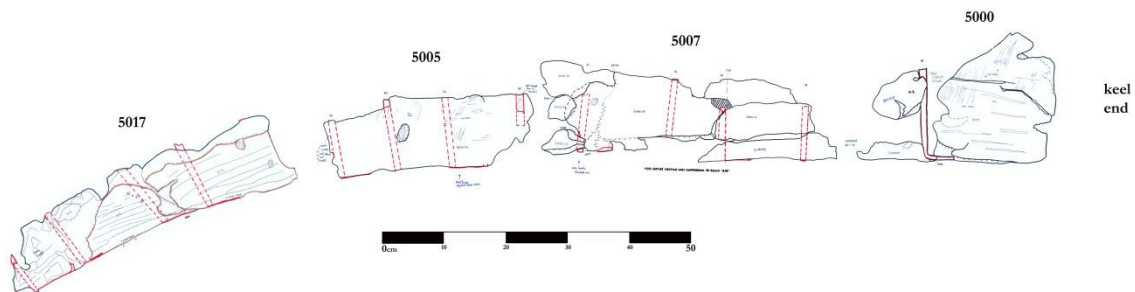
Figure 5.5. Frame fragment 5017 joined with floor fragments 5007/5005/5000 (forward molded face up as found). Image by the author.

As noted by McGee, “sweet wooden curves follow mathematical rules and the spline is the analogue for these rules.”<sup>189</sup> By using the curvature of the fragments and average nail spacing of 9.3 cm on the outer surface, seen not only fragments of this floor, but among many of the other Kızılburun frame fragments as well, fragment 5017 can be approximately positioned in relation to the other pieces of the floor timber by extending its natural curvature with a spline, thus allowing for a reconstruction of the port side of a floor timber (Figure 5.5). The timber is drawn as found with the molded forward face up (i.e. toppled 90° downslope).

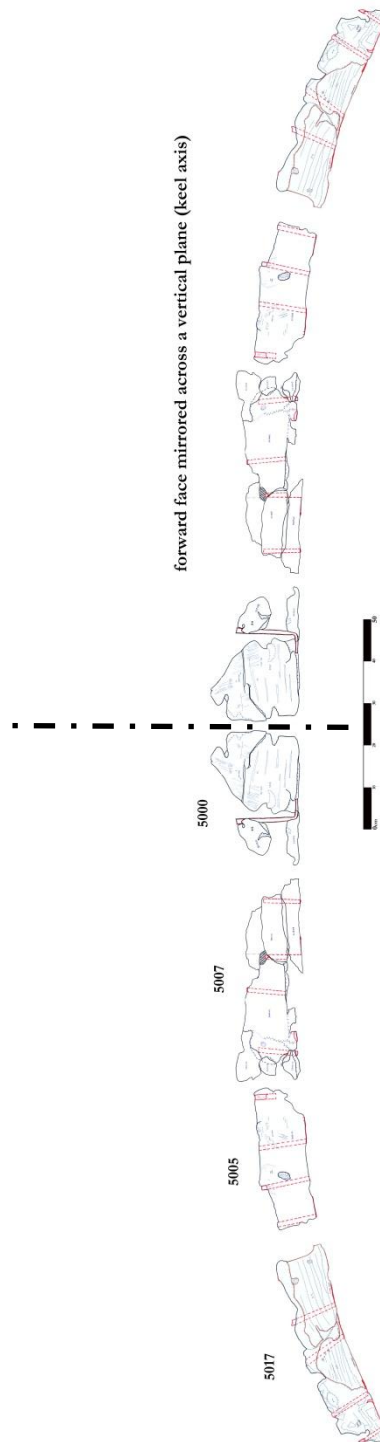
Figure 5.6. Floor fragments 5017/5007/5005/5000 mirrored across a vertical plane. Image by the author.

Presuming a fair amount of symmetry, the reconstructed portion of the floor timber can be mirrored across a vertical plane (the keel) to simulate a full or nearly full floor timber as it would have been originally under Drums 5 and 6 (Figure 5.6).<sup>190</sup> Expanding on this idea, the reconstructed floor timber can be superimposed upon the garboard/keel reconstruction

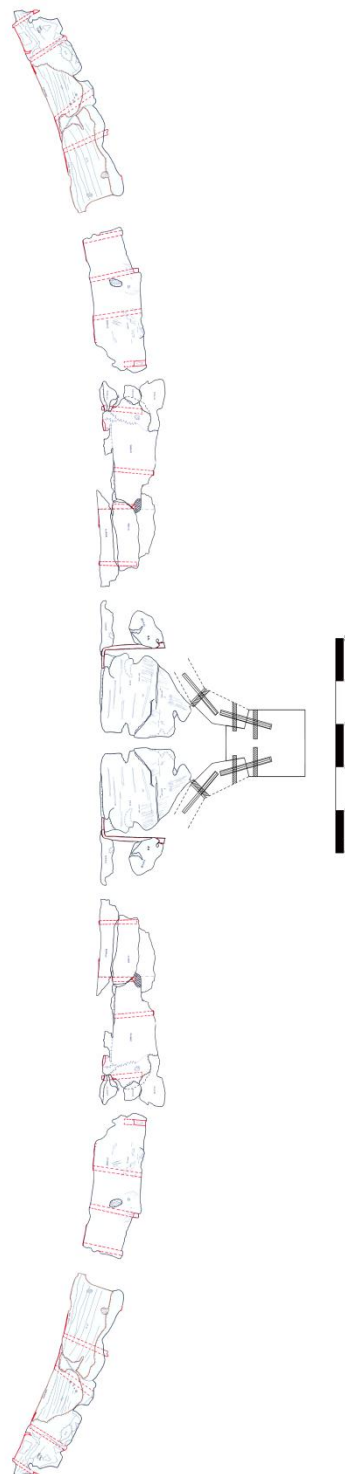
Figure 5.7. Reconstructed floor rotated and superimposed onto the garboard and keel.  
Image by the author.

presented earlier. In this manner, one reconstruction is used to support or refute the other and informs the reconstruction's viability (Figure 5.7). The resulting combined reconstruction hints at the bottom shape of the vessel, but this is still less than conclusive. Therefore, one more element may be added to the model to further test its feasibility.

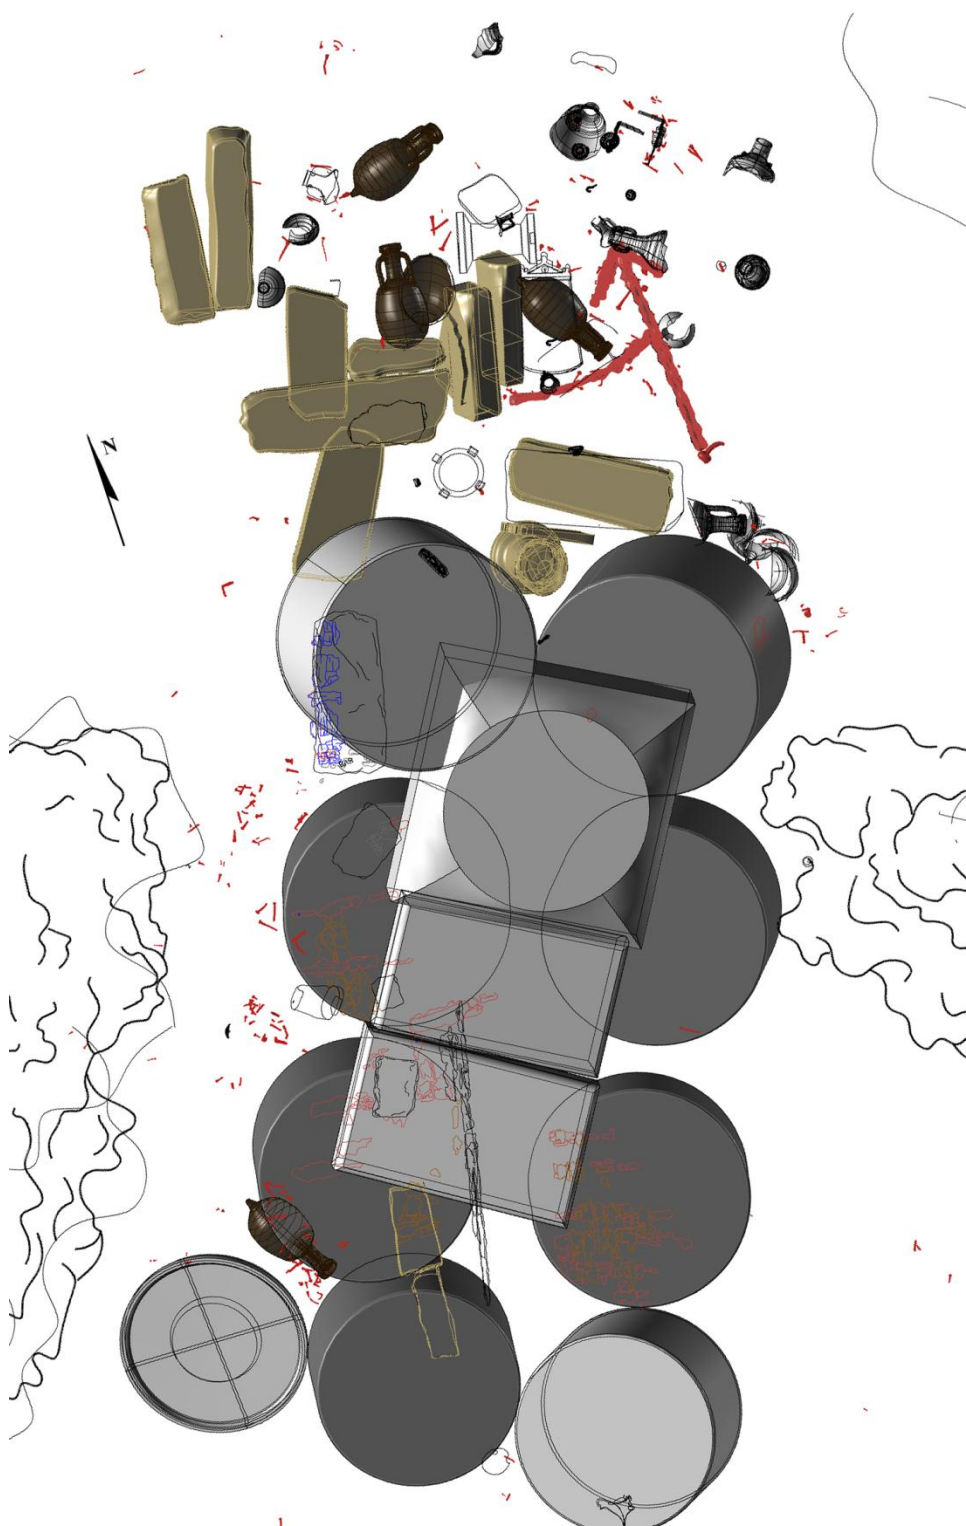
Figure 5.9. Lading of the Kızılburun cargo. Image by Sheila Matthews.

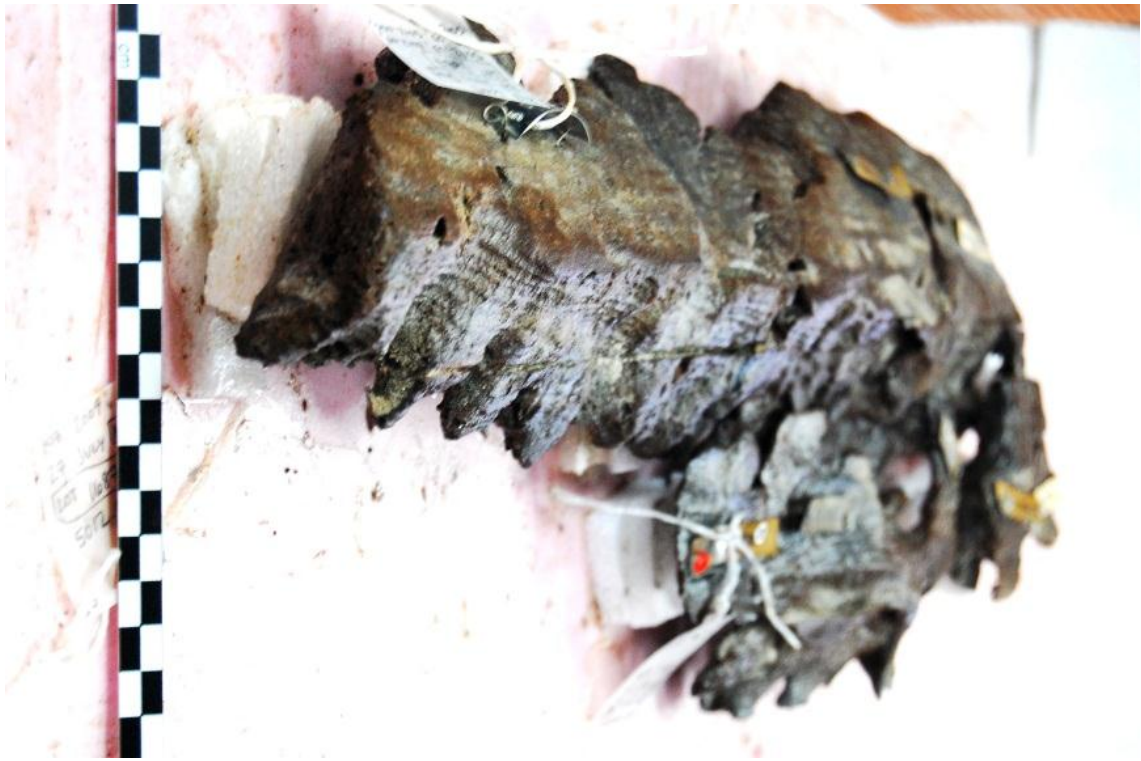
**HP 6003**

Heavily deteriorated planking section. One framing nail hole. Residual iron stain from unknown source.

Recon. l. 46.9; w. 15.8; th. 3.8. Nail hole w. 0.9.

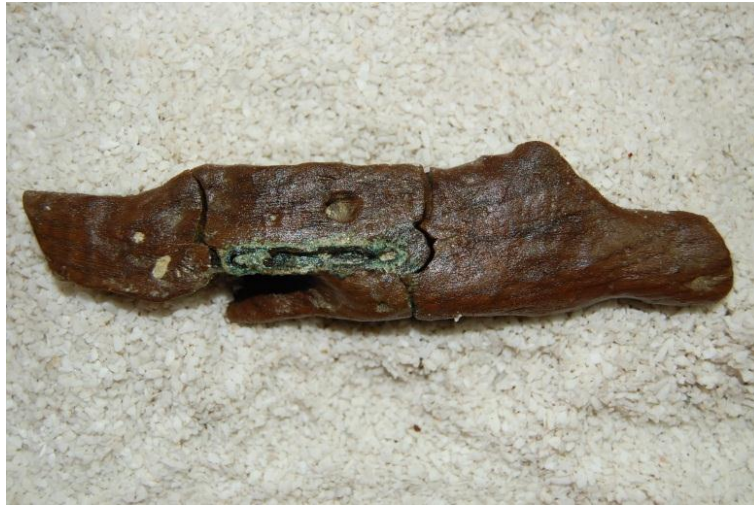
Lot Numbers 594/680/680.01

Heavily deteriorated frame fragment in three fragments, broken along a treenail. One embedded clenched nail.

Pres. l. 19.8; s. 4.3; m. 5.1. Distinct treenail diam. 1.1. Nail clench l. 4.9.

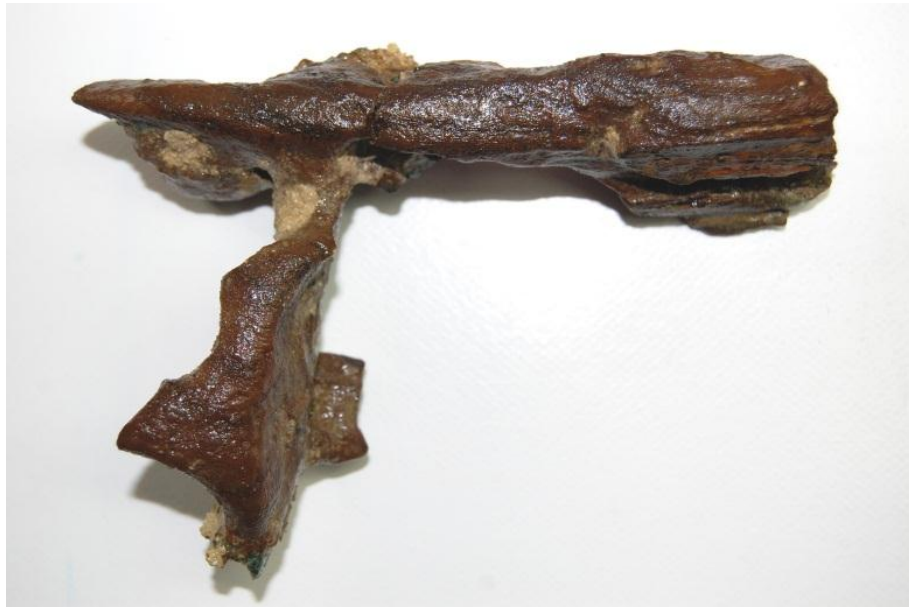
Lot Number 792

Mostly deteriorated frame fragment with one partial clenched nail demonstrating minimum molded dimension.

Pres. l. 13.6; s. 3.9; m. 9.7. One partial clenched nail: l. 9.7; diam. 1.2.

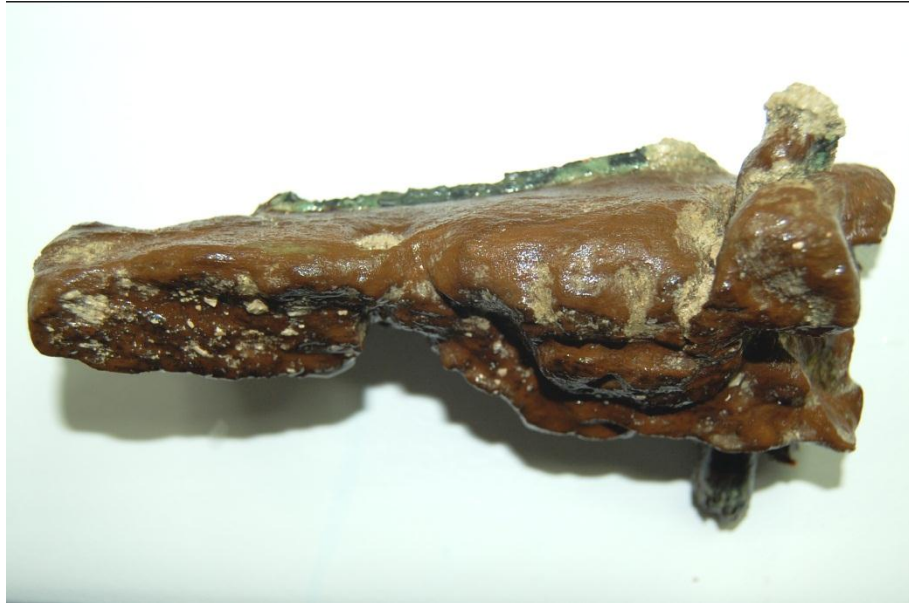
Lot Number 903

Lot Number: 903      Wood Number: 5018      Frame      *Fraxinus excelsior*

Heavily deteriorated frame fragment. Two partial nails embedded.

Pres. l. 17.7; s. 8.1; m. 10.0. Two partial nails: l. 3.6, 11.0; w. 1.1, 1.3. Nail spacing: N1-N2  
10.0. Nail clench: 9.0.

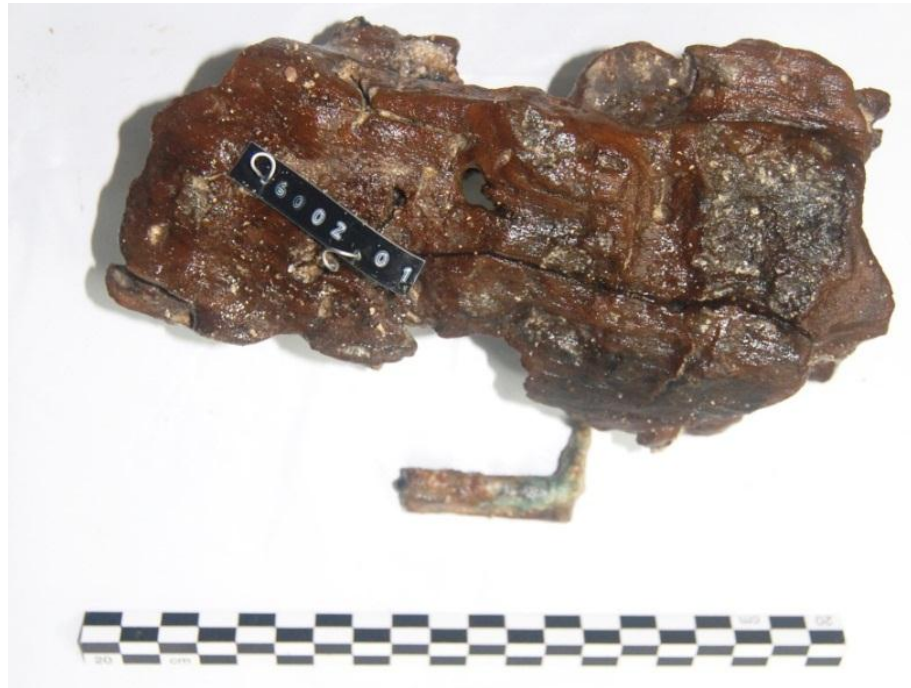
Lot Number 1259

Lot Number: 1259      Wood Number: 6002.01      Frame      *Fraxinus excelsior*

Heavily deteriorated frame fragment. Two partial nails embedded.

Pres. l. 17.7; s. 6.7; m. 10.2. Two nails: l. 10.6, 9.8; w. 1.0, 1.1. Nail spacing: N1-N2 7.1 inner, 9.6 outer. Nail clench: l. 2.7 (broken).

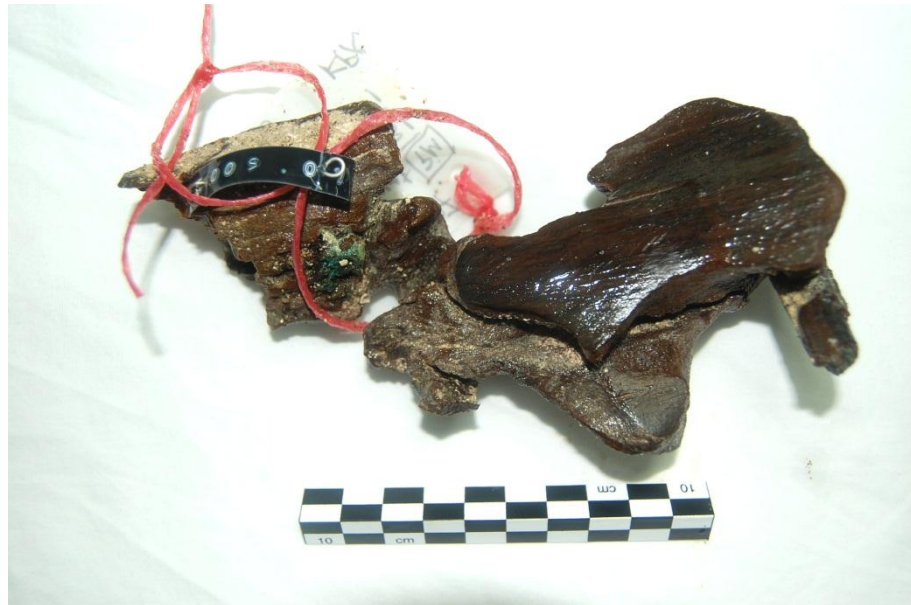
Lot Number 1303

Lot Number: 1303      Wood Number: 5009.01      Frame      *Fraxinus excelsior*

Heavily deteriorated frame fragment with two partial nails. One clear plug-treenail.

Pres. l. 15.5; s. 4.8; m. 8.6. Two partial nails: dist. 10.2 inner. Plug-treenail: diam. 1.6.

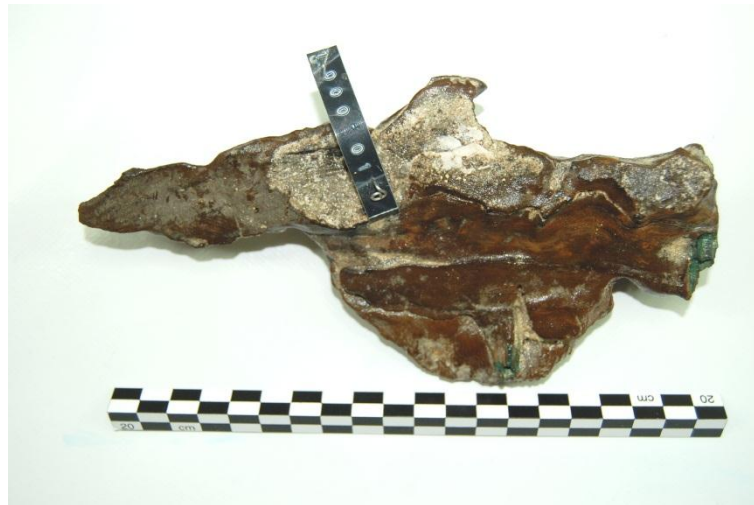
Lot Number 1347

Lot Number: 1347      Wood Number: 1000.01      Frame      *Fraxinus* sp.

Heavily deteriorated frame fragment with small compressed planking section attached including partial tenon. Two partial nails embedded. Minimum mortise depth taken from partial tenon (5.8). Planking section *Pinus brutia*. Tenon fragment *Quercus cerris*.

Pres. l. 19.3; s. 3.8; m. 9.9. Two partial nails: N1 l. 8.0, w. 1.0; N2 l. 3.4, w. 0.8. One attached partial tenon: l. 5.8; w. 3.9; th. 0.3. Nail spacing: N1-N2 6.0 inner, 7.3 outer.

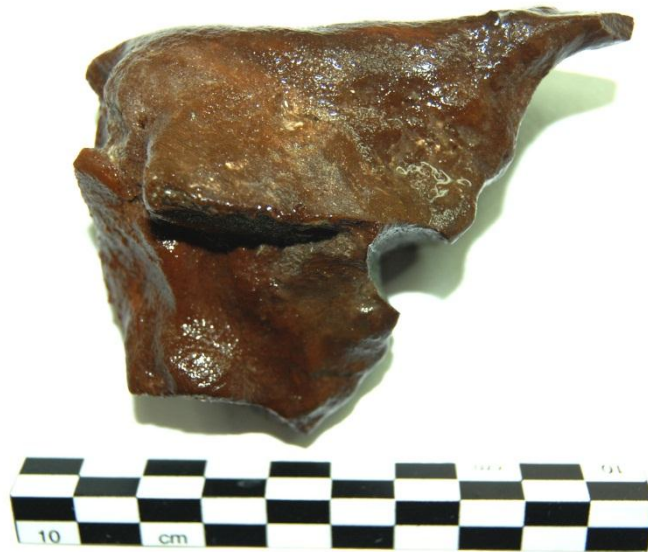
Lot Number 1562

Demonstrates planking thickness.

Pres. l. 16.3; w. 11.6; th. 4.1.

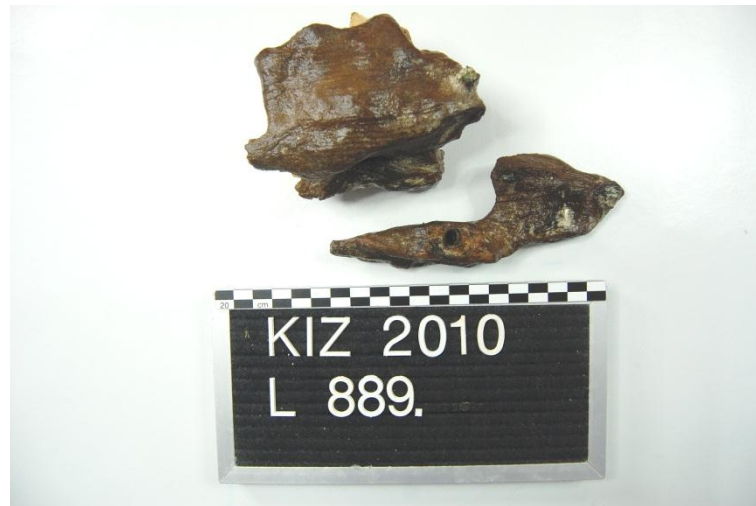
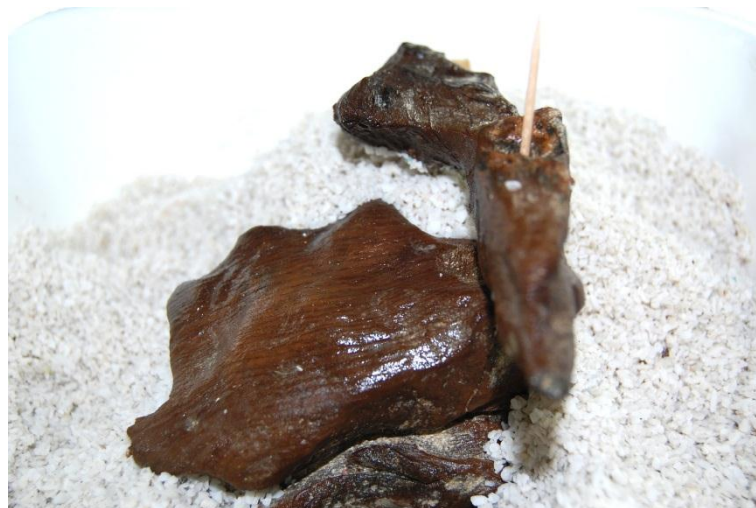
Lot Number 889

Lot Number: 889      Wood Number: n/a      Ceiling planking      not sampled  
Frame fragment and ceiling planking fragment with nail hole. The only frame fragment with  
definitive ceiling planking attachment.

Pres. l. 15.4; w. 7.0; th. 2.9. One nail hole: w. 0.6.

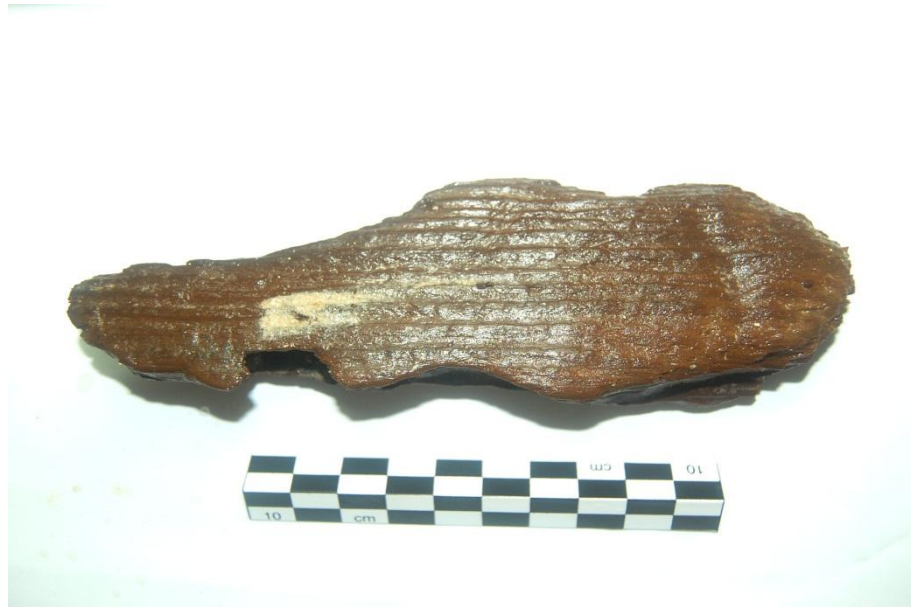
Lot Number 1210.01

Lot Number: 1210.01 Wood Number: 5006.02 Ceiling planking *Pinus nigra*

Featureless ceiling planking fragment demonstrating thickness of timber.

Pres. l. 9.5; w. 3.0; th. 4.1.

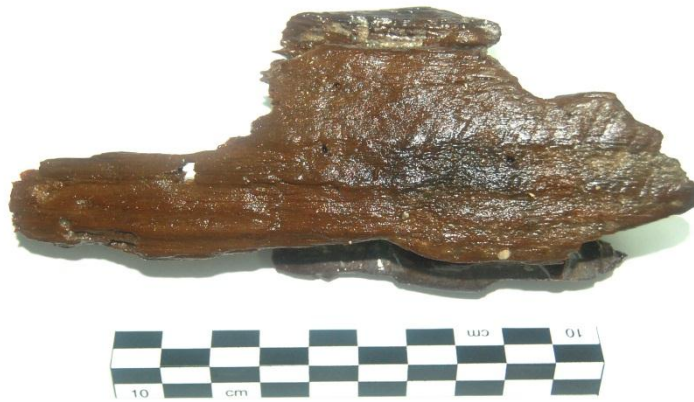
Lot Number 1210.02

Lot Number: 1210.02 Wood Number: 5006.03 Ceiling planking *Pinus nigra*  
Original inner face surface with saw marks. One nail hole. See Lot Number 1210.01 for thickness.

Pres. l. 13.4; w. 5.6; th. 2.9. Nail hole: diam. 0.4.

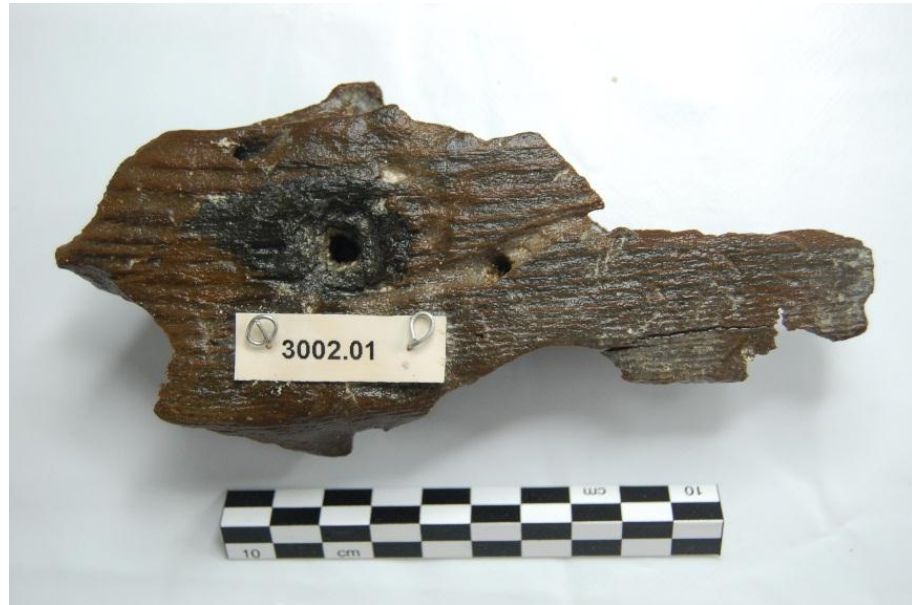
Lot Number 1339

Lot Number: 1339      Wood Number: 3002.01      Ceiling planking      *Pinus brutia*  
Heavily deteriorated ceiling planking fragment with one nail hole. Original surface on inner  
and outer face.

Pres. l. 15.5; w. 7.4; th. 3.5. One nail hole: w. 0.5.

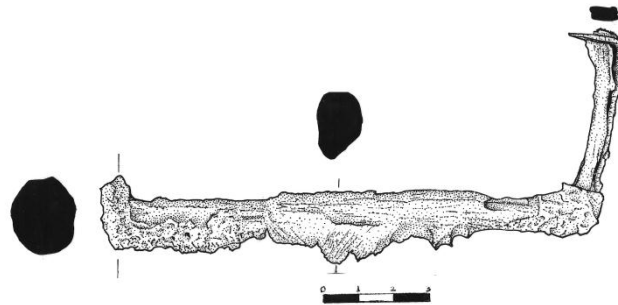
L. 21.3; max. w. 1.3; diam. head. 2.0; 1 clench 7.4 cm. Complete in length degraded width. Square section shank. Retains some of the treenail and 3.3 cm of planking wood below the head. Shank length to first clench 12.7 cm preserving the width (molded dimension) of the frame it secured. First clench is formed by an angle of 98° with length 5.8 cm. Second clench 1.6 cm in length.

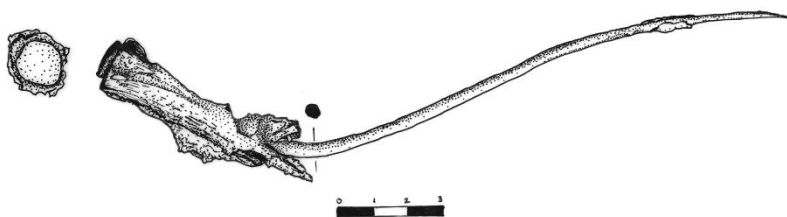
Pres. l 20.2; max w n/a; diam head 1.5; clench length n/a. Flattened pyramidal head. Indeterminate shank shape and width. Remnants of treenail to 5.1 cm below head. Central portion is ferro-magnetic, but not the extremities.

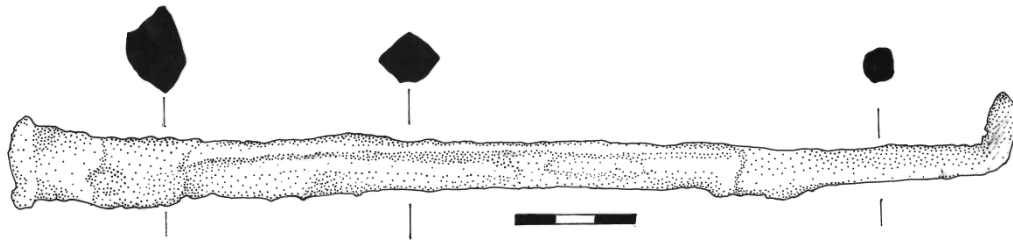
Pres. l. 26.9 cm; max. w. 1.5; diam. head 2.4; clenched length n/a. Restored from four fragments with clearly defined breaks. Indeterminate head shape. Square shank. Shank length to partial first clenched 24.1 cm preserving the molded dimension of the floor it secured. First clenched is formed by an angle of 104°. Second clenched is missing.

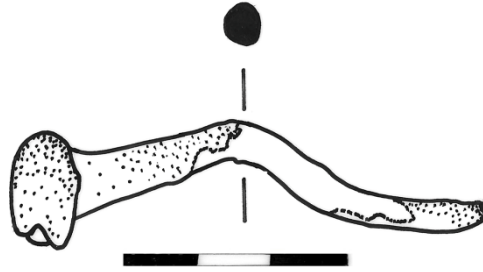
L. 7.0; max. w. 0.7; diam. head 1.6. Flattened pyramidal head. Square shank..

Compound curve starting at 2.8 cm below the bottom of head which is canted 104 degrees to the shank.

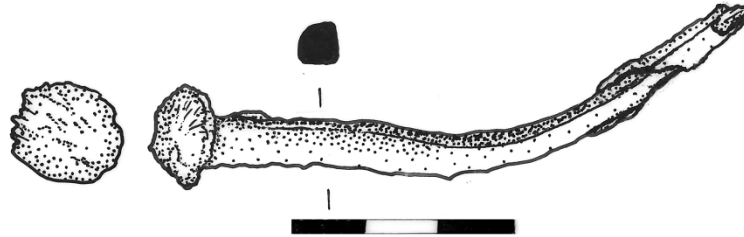
L. 8.4; max. w. 0.7; diam. head 1.5. Flattened pyramidal head. Square shank with a compound curve starting at 4.4 cm.

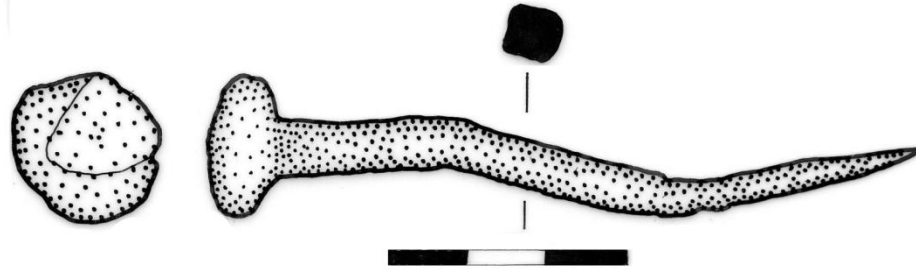
L. 9.2; max. w. 0.7; diam. head 1.9. Flattened pyramidal head. Square shank.  
with bend starting at 4.5 cm below head.

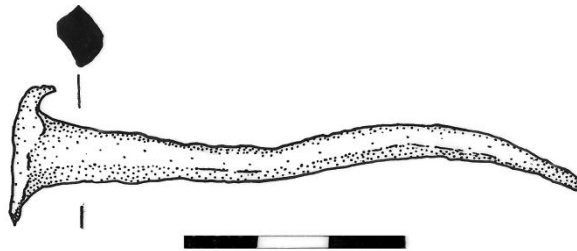
L. 8.0; max. w. 0.6; diam. head 2.0. Flat head. Square shank.

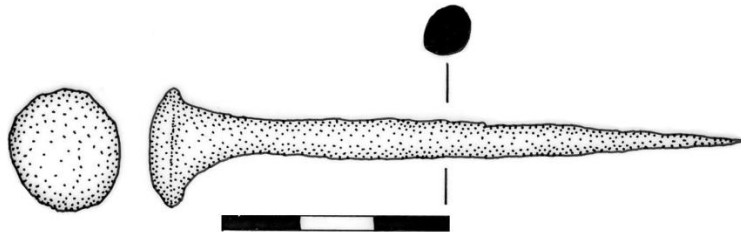
L. 7.6; max. w. 0.7; diam. head 1.7. Flattened pyramidal head. Square shank.

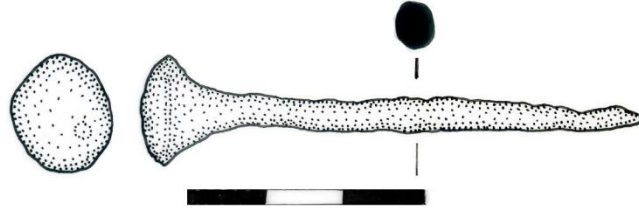
L. 6.5; max. w. 0.6; diam. head 1.5. Flattened pyramidal head. Square shank with degraded edges.

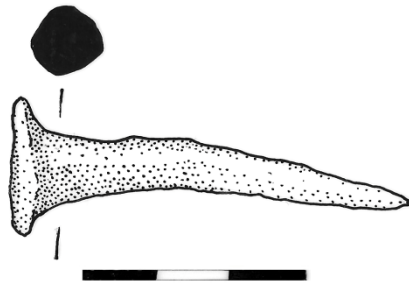
L. 5.4; max. w. 0.9; diam. head 1.9. Flat head. Square shank rapidly tapers toward distal end with slight curvature.

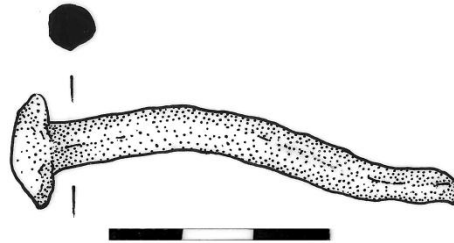
Pres. l. 6.0; max. w. 0.6; diam. head 1.5. Flattened pyramidal head. Square shank, with compound curved shape. Distal end is broken.

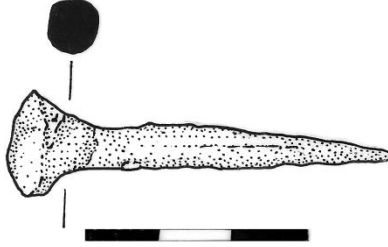
L. 5.2; max. w. 0.6; diam. head 1.5. Flattened pyramidal head. Square shank.

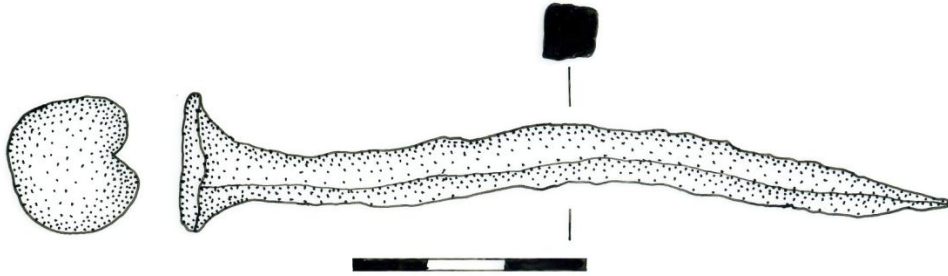
L. 9.8; max. w. 0.6; diam. head 1.7. Flat head split on one side, likely due to impact of heavy hammering. Square shank with broken distal end.

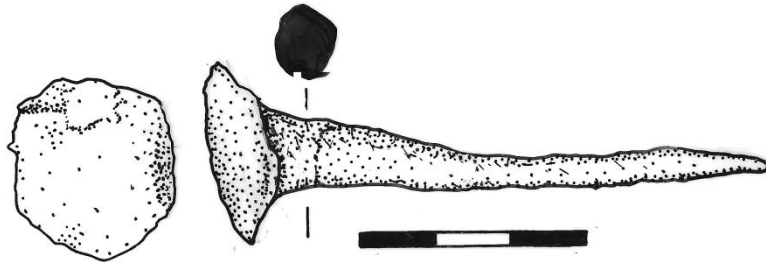
L. 7.4; max. w. 1.0; diam. head 2.5. Flat head canted at an angle of 104 degrees to the shank. Square shank tapers rapidly toward distal point.

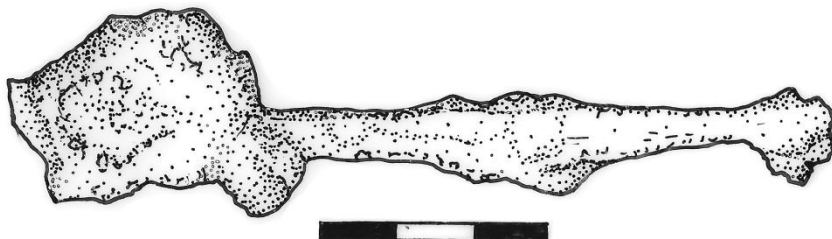
Pres. l. 8.8; max. w. 0.65; diam. head n/a. Incomplete. No head. Square-sectioned shank tapering to 0.45 cm at distal end.

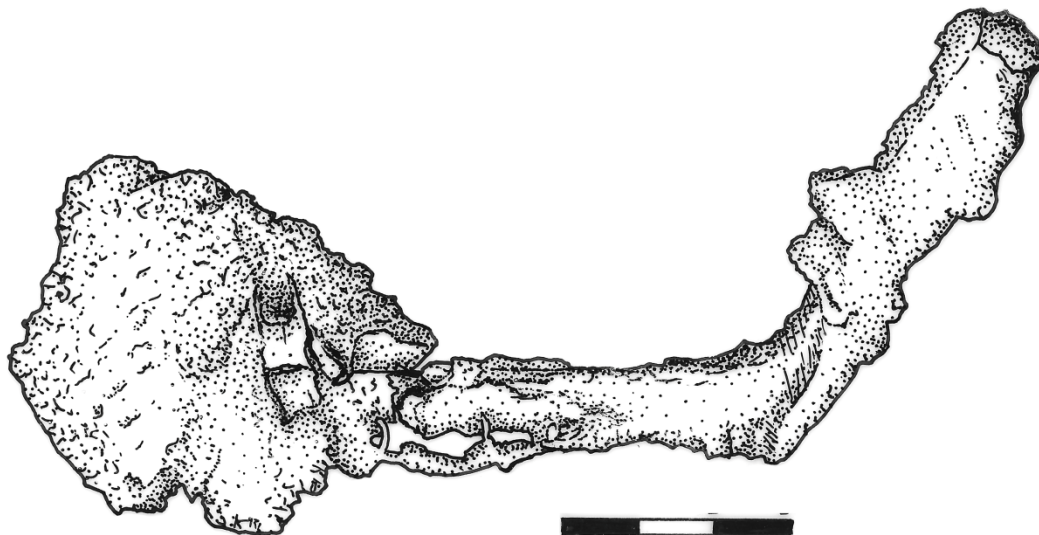
Pres. l. 12.1; max. w. 0.91; diam. head n/a. Incomplete. Head survives under iron bleed but is indeterminate. Iron impregnated wood encases approximately 6.5 cm of the shank. Square-sectioned shank tapers toward missing distal tip (0.91 cm to 0.76 cm).

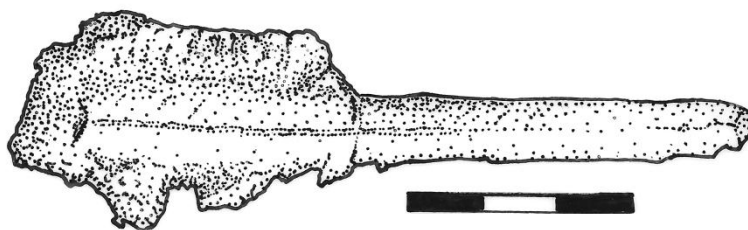
L. 8.4; max. w. 0.64; diam. head n/a. Incomplete. No head, may be broken off. Square shank tapering toward broken distal tip (0.64 cm tapering to 0.44 cm).
