FRAMING THE DEBATE:  
A STUDY OF THE DEVELOPMENT OF SHIP FRAMING IN THE MEDITERRANEAN  
FROM THE 5<sup>TH</sup> CENTURY B.C.E. TO THE 9<sup>TH</sup> CENTURY C.E.

A Thesis

Submitted to the Office of Graduate and Professional Studies of  
Texas A&M University  
in partial fulfillment of the requirements for the degree of

December 2016

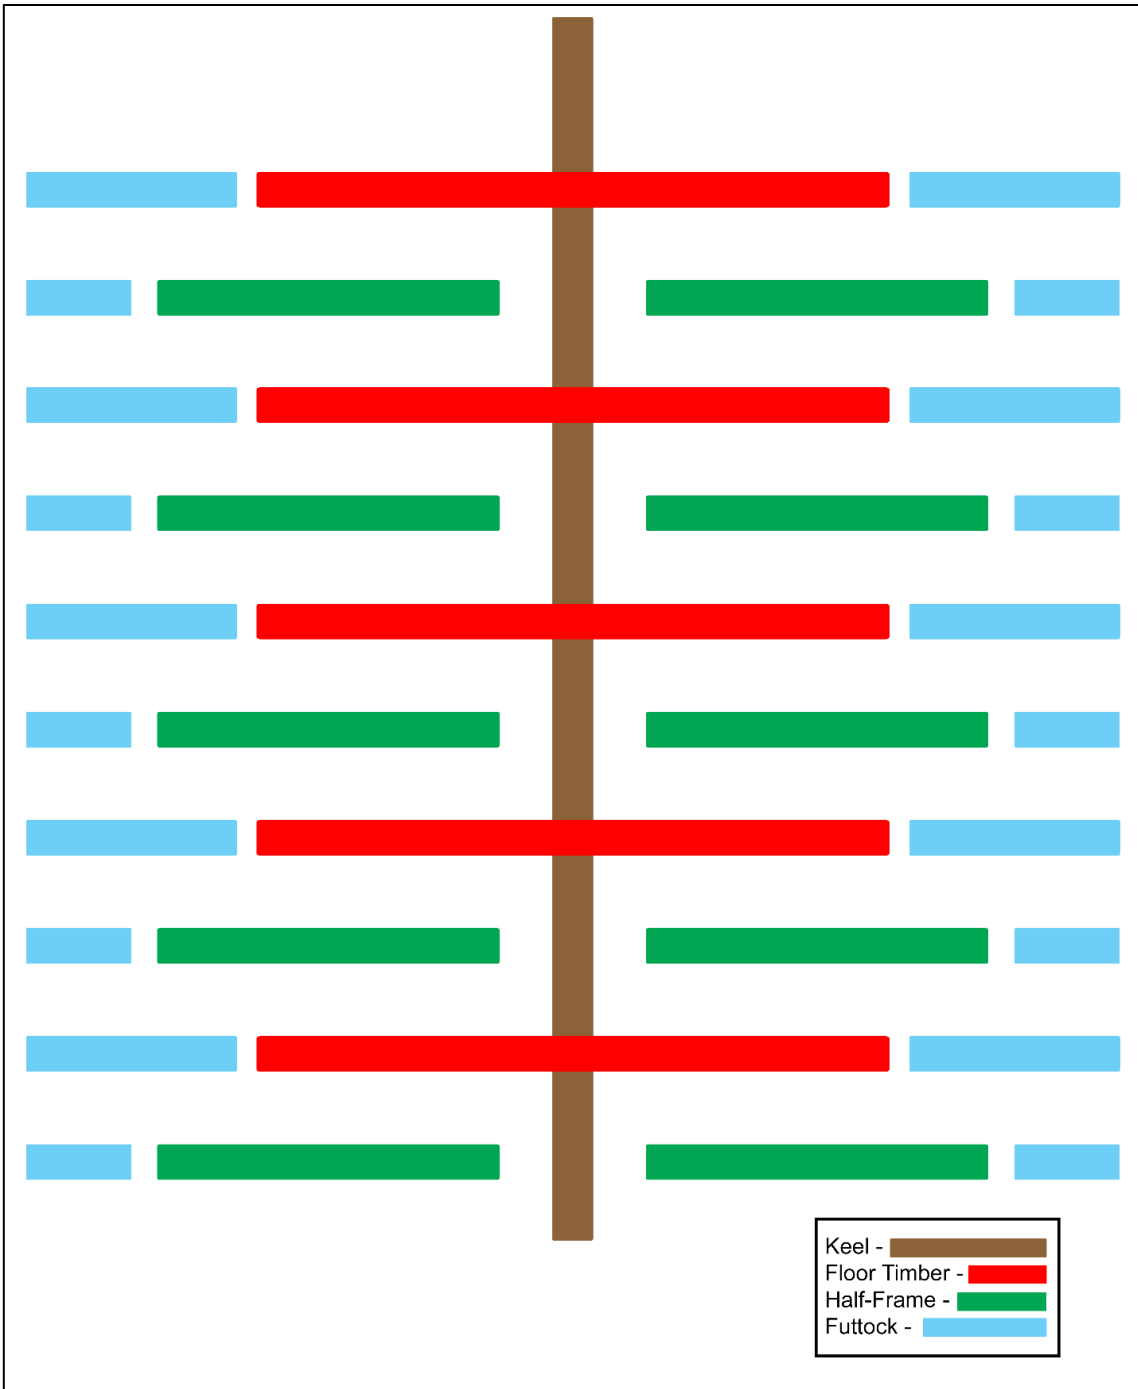
**Figure 1.** Traditional arrangement of floor timbers alternating with paired half-frames.

the frame itself. The general rule was two nails per frame for each plank that was less than 0.20 m in width, and three nails per frame when the plank was wider. It is estimated that of the more than 3,000 copper nails used in the ship's construction, 75% attached the framing to the planking.<sup>51</sup>
