TURBINE OVERSPEED TRIP PROTECTION

Charles R. Rutan

Lyondell/Equistar Chemicals, LP

ABSTRACT

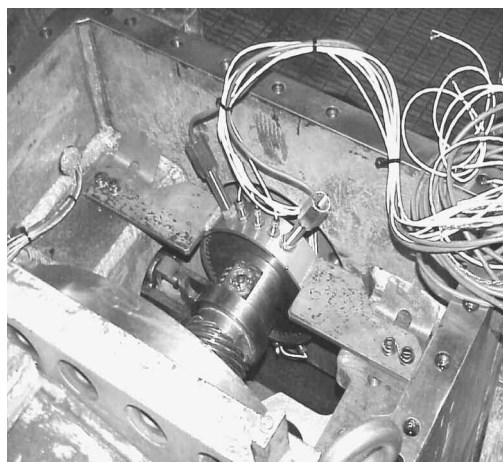
Figure 4. Top Half of Bracket with Sensors Installed.

Since the speed sensors are critical to the operation of the turbine, at least one spare speed sensor is normally installed. If an electronic fault tolerant governor is used, then three additional speed sensors and one spare are installed. A separate speed sensor is installed for the vibration monitoring system. All the speed sensors are reading one multitooth “speed pickup wheel” that is being held in position by a nonferrous mounting bracket (Figures 3 and 4). In addition to the speed sensors, two radial vibration probes, two thrust (axial position probes), thrust bearing temperature indicators, and radial bearing temperature indicators are normally installed. As is readily apparent to the most casual observer, the thrust end of the turbine is now taking on the appearance of the Starship Enterprise.

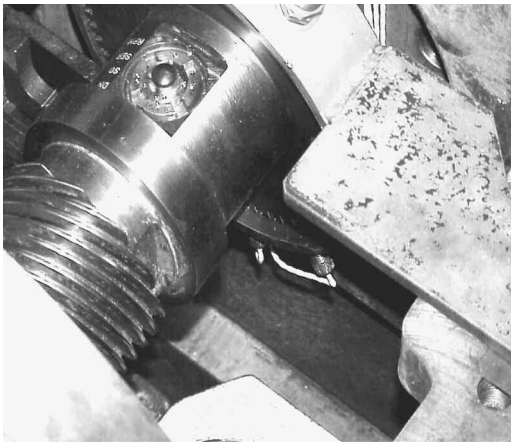
Figure 6. Mechanical Overspeed Mechanism Installed in Turbine Rotor.

Inside a mechanical overspeed trip mechanism there are four basic components. The internal components consist of two bushings, a plunger, and a spring as shown in Figures 5, 6, 7, 8, and 9.

One of the bushings is screwed completely into the overspeed trip body at a set depth. This controls the position when the turbine is not rotating. Then a bushing is installed over the plunger and spring, and then tightened down. The spring pushes against the plunger “stopper disk” and the adjustable bushing where the plunger extrudes from the body (Figure 5). Now the spring is in compression holding the plunger inside the mechanism body. The overspeed trip is then attached, typically bolted, to the outboard end of the rotor.

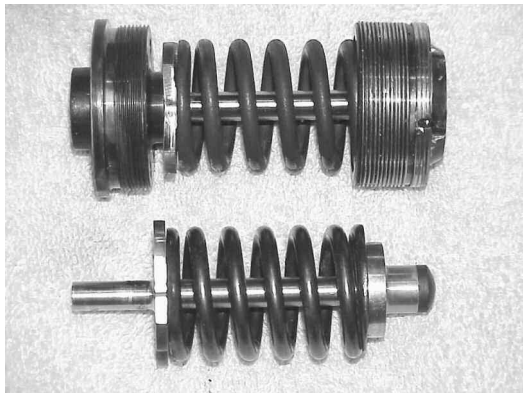
Figure 7. Mechanical Overspeed Mechanism.

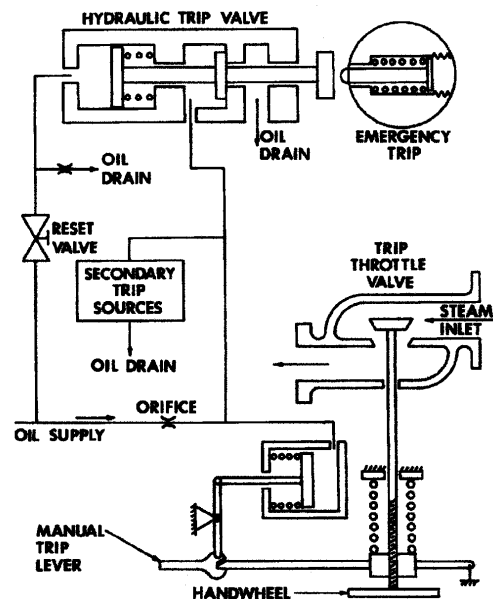
Figure 10. Overspeed Trip System.

How fast the turbine accelerates determines how fast the overspeed trip system must respond (refer to Figure 10). If the turbine valves change their position instantaneously, this measurement of time is now as the time constant, T_C . The speed is a first order function of torque, and then the mathematical equation is:

From Equation (1), when $t = T_C$, then $n = 1 - 1/e$ or $n = 0.63$.

Then, the rotor time constant gives the length of time that it takes the rotor to reach 63 percent of its total speed change due to an instantaneous change in the turbine valve position.
