SPECIAL PURPOSE GEARING—A USER'S APPROACH TO SOUND APPLICATION ENGINEERING

J. Hans Arndt

ABSTRACT

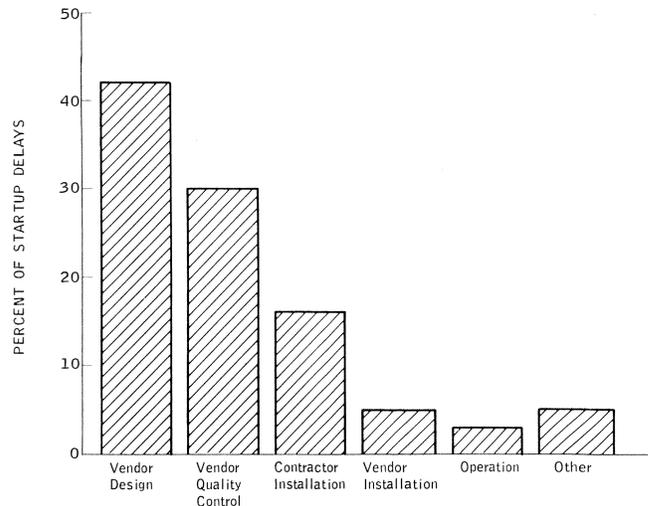
Figure 1. Machinery Startup Problem Distribution—1964-1973.

This generalization applies to special purpose gearing as well as other high speed rotating equipment such as steam and gas turbines, and centrifugal and axial compressors. Figure 1 shows a general breakdown of machinery startup delays into individual problem categories. The two major areas, design and quality control, total over 70 percent of all potential delays, i.e., delays that were attributed to machinery only and not "camouflaged" by other startup difficulties. The remaining 30 percent of delay is made up of field installation errors, maloperation and miscellaneous other causes.

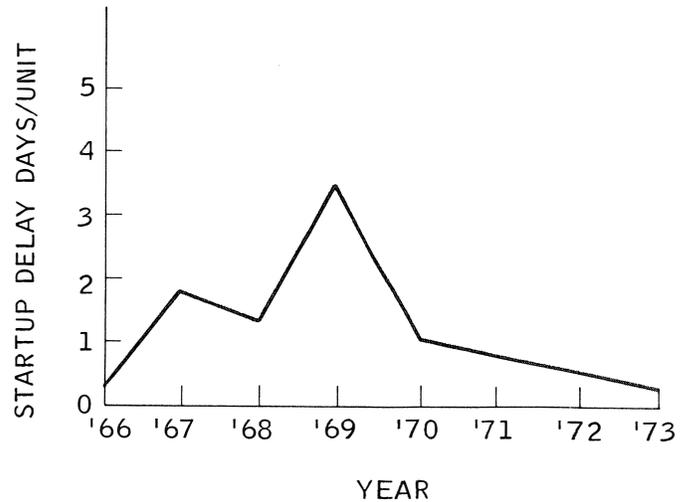
Figure 3. Gear Startup Delays.

Returning to the startup problem study for a moment, the average project downtime due to startup problems on special purpose gears is shown in Figure 3. As can be seen, startup delays gradually increased in the late sixties to a peak of 3-1/2 days in 1969. At that time, the intensified followup procedures went into effect, and project delays have been reduced to less than 1 day per unit. This may appear to be a low order-of-magnitude change; however, it must be borne in mind that daily downtime losses on major process units can be quite high and usually more than enough to compensate for the cost of the additional engineering followup.
