### A REFINED METHOD TO CHECK TOOTH CONTACT PATTERNS OF GEARS GUARANTEES FACTORY QUALITY TOOTH CONTACT, BUT WITH LESS EFFORT AND LESS RISK

**Dietmar Sterns** Head of Engineering, High Speed Gears RENK Aktiengesellschaft Augsburg, Germany

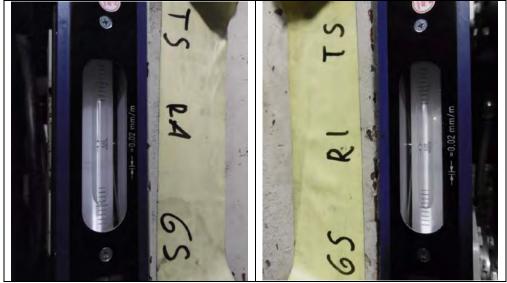
Figure 12. Spirit Level check on site

On site, the gear set was installed during a major overhaul. Before the gear unit was opened, the levels on the casing were checked. The check with precision levels indicated that the casing alignment was very good, with the two level readings having a deviation of 0.01 mm/m (see

Figure 12) between each other, while the specified limit was 0.02 mm/m.

Figure 12. Altogether, these checks confirmed once more that the level check is a reliable representation of the tooth contact in the gear mesh.
