THE CONSTRUCTION OF THE CITYPLACE SCHOONER

A Thesis

Major Subject: Maritime Archaeology and Conservation

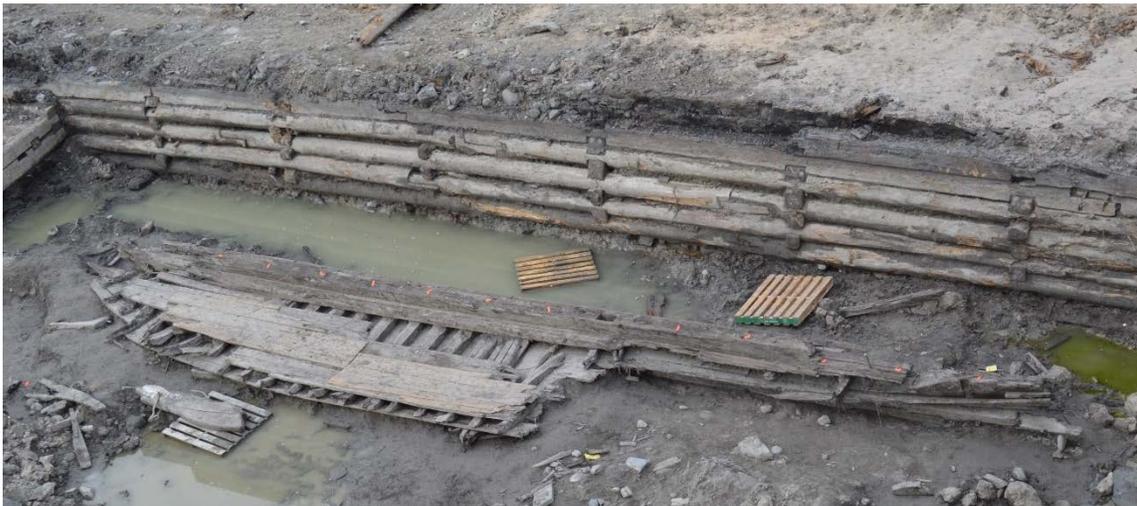
FIG. III.2 CityPlace schooner wreck in situ alongside the remains of the Queen's Wharf (photograph by Archaeological Services, Inc.).

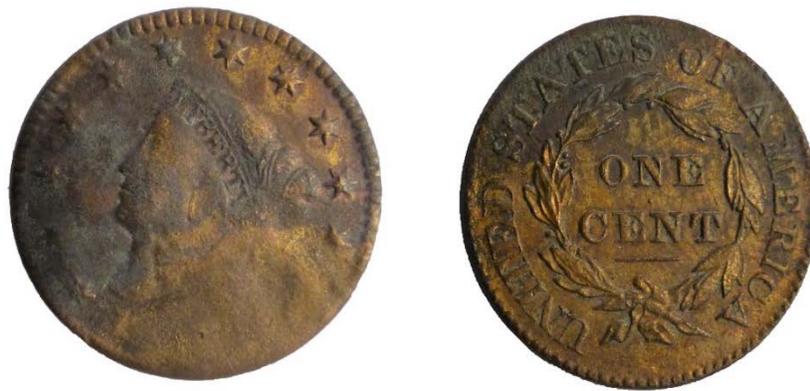
FIG. III.3 U.S. Coronet Head cent found in main mast step (photographs by R. Galloso).

waterfront. This was determined by the wreck's location and artifacts recovered by ASI, including a United States Coronet Head cent found in the main mast step (fig. III.3). The coin appeared to have been deliberately placed under the mast (following a centuries old tradition for bringing the vessel good luck). The coin usefully provides a *terminus post quem* for the vessel's construction. The date on this coin is illegible due to wear, however, Coronet Head cents were produced between the years of 1816 and 1839 and, based on an analysis of its design, ASI dated the recovered coin to 1828.⁷¹

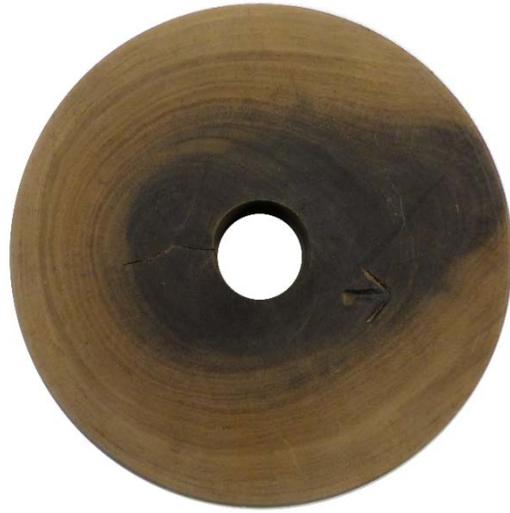
FIG. III.4 Sheave incised with a broad arrow indicating that it was once considered British Government property (photograph by R. Galloso).

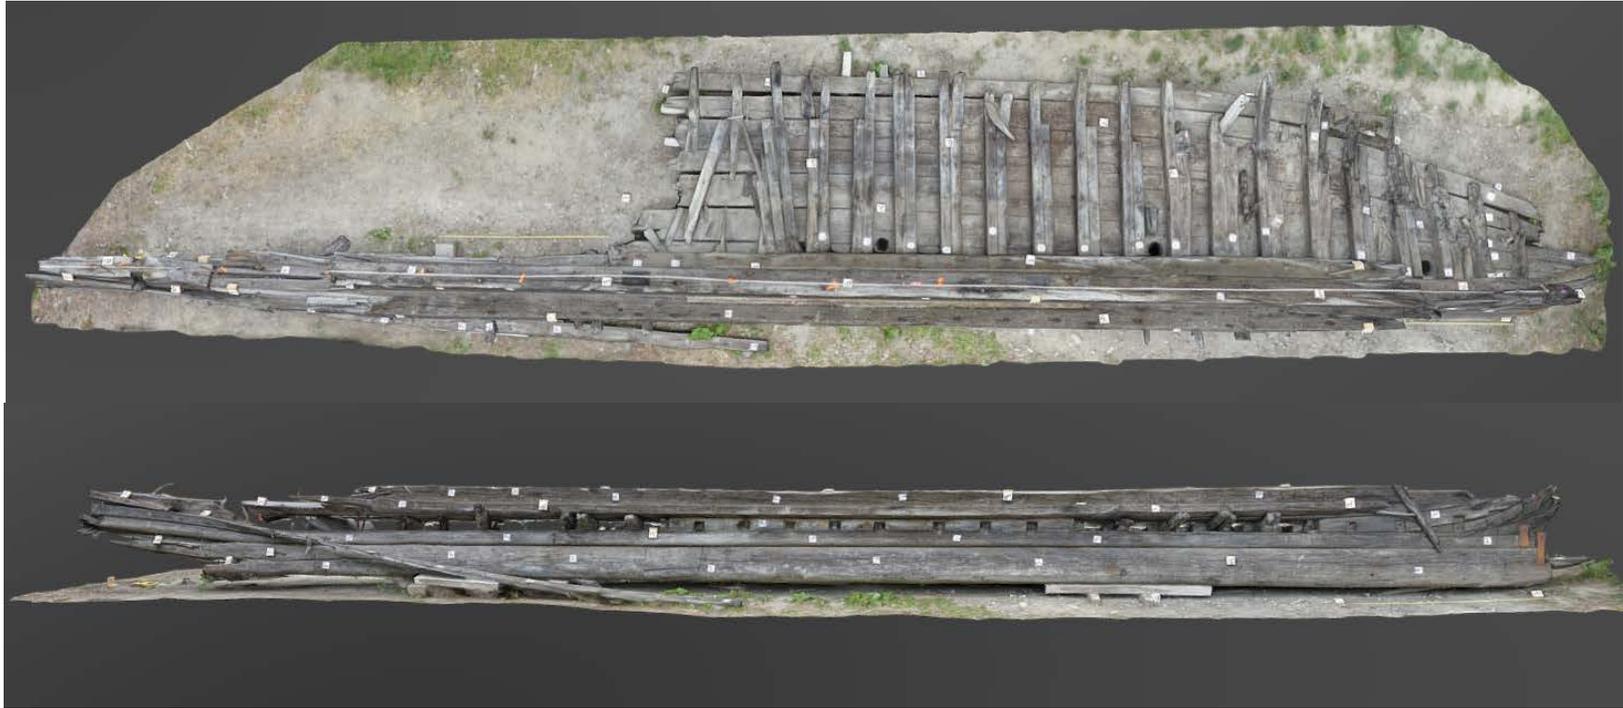
FIG. IV.5 Photogrammetric model of the CityPlace schooner wreck (model prepared by J. Herbst).

In addition to direct measurements, I also documented the wreck using photogrammetry, which is a process by which multiple photographs of an object, taken from all different angles, are used to derive measurements and produce three-

dimensional models. Prior to removing the ceiling planking, I took hundreds of photos of the hull using a Panasonic Lumix DMC-FZ200 camera (on loan from TAMU's Analytical Archaeology Lab) (fig. IV.4). I did this as quickly as possible in an effort to maintain uniform lighting in all of the photographs. To minimize gaps in the model, I made sure that each photo had approximately 80 percent overlap and to improve the alignment process, I laid a number of photo-reference targets on the hull prior to taking the photographs.

I sent the resulting images to Dr. Christopher Dostal, who used the computing power of TAMU's Analytical Archaeology Lab to process the model with Agisoft Photoscan (now Agisoft Metashape). Once completed, he uploaded the model to Sketchfab, an online three-dimensional model-sharing platform. Thanks to his assistance, we were able to use social media to share this model with the public while we were still in the field.

Once we removed the ceiling planking from the hull and cleared all of the sediment trapped beneath it, I took a second set of photographs to prepare another photogrammetric model of the wreck. Throughout our time on site, I also photographed disarticulated hull timbers, including the remains of the stem, sternpost, and two knees. Additionally, Robin Galloso photographed a piece of the lower keel that had broken off of the stern end of the vessel. Upon returning to TAMU, I processed these photos with Agisoft Photoscan to produce photogrammetric models (fig. IV.5). I then uploaded the models to Sketchfab and shared them using social media. The models increased public accessibility to the wreck and served as valuable references in finalizing the scaled drawings of the remains.⁷⁵

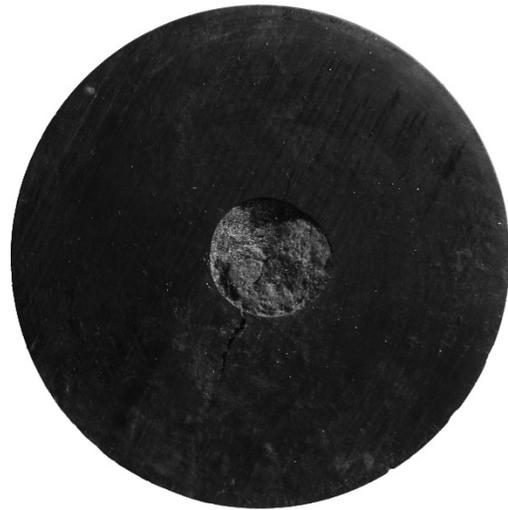
FIG. IV.7 Sheave recovered during the 2018 field season (photograph by R. Galloso).

Because ASI had already excavated the remains, we were not expecting to find any artifacts during our field work. As noted above, however, upon removal of the vessel's ceiling planking, a significant amount of sediment remained between the frames. This needed to be removed in order to record the structure. Team member Robin Galloso dedicated a substantial amount of her time on site to removing the sediment with trowels and brushes, screening it, and documenting the finds. She recovered a number of small artifacts during this process, many of which were used in the construction of the vessel, including iron fasteners, caulking material, and small, shaped pieces of wood that were likely used as wedges. She also recovered ceramic sherds (similar in style to those recovered during the 2015 excavation), charcoal, and one piece of coal. Her most exciting find was an intact sheave from a rigging block, which was located between frames D and E. It is 1 inch (2.54 cm) thick and 6 inches (15.2 cm) in diameter and appears to be made of a dense tropical hardwood known as *lignum vitae* (figs. IV.6 and IV. 7). Unlike the sheave recovered by ASI, this example did not have a British Government broad arrow.

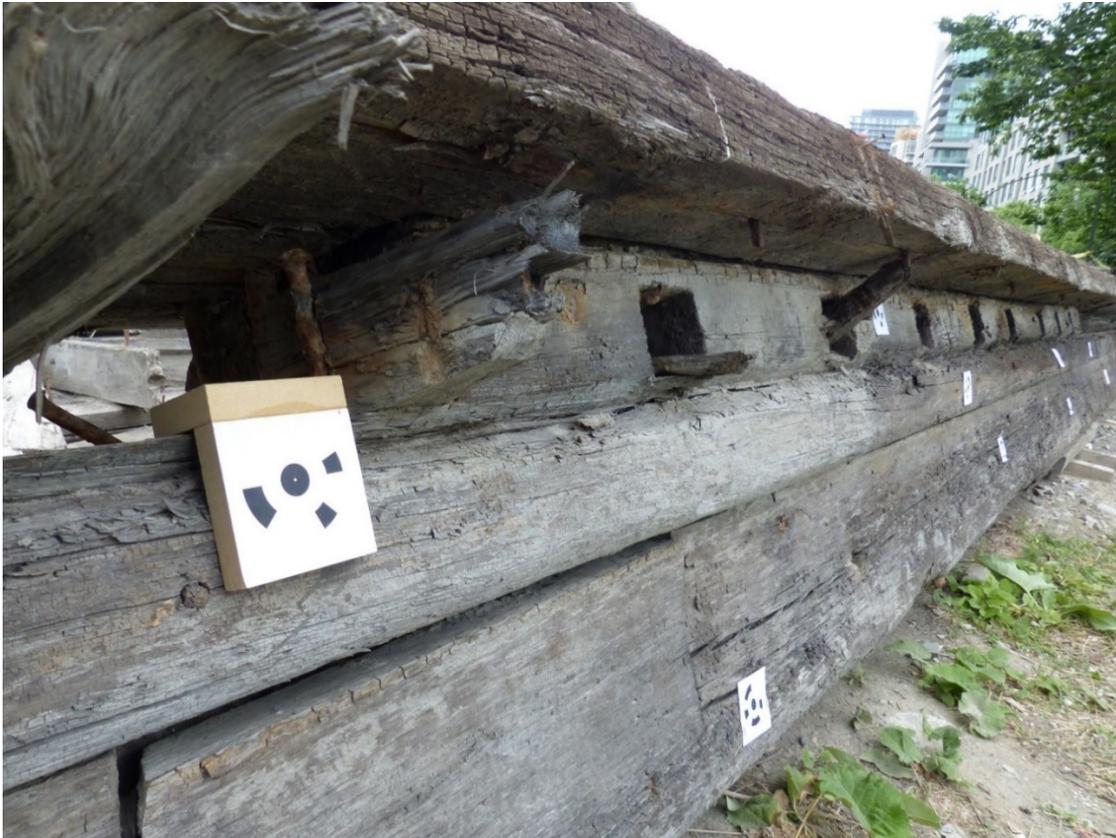
FIG. V.3 After end of trunk from the starboard side (photograph by J. Herbst).

The upper keel had a sided dimension ranging from 5 inches (12.7 cm) in the bow, to 16.5 inches (39.37 cm) at frame \otimes , and to 7 inches (17.78 cm) in the stern. It had a molded dimension of 6 inches (15.24 cm) for much of its length. This increased to 11 inches (27.94 cm) just aft of frame C to form the base of the centerboard trunk, which served as the watertight compartment that housed the centerboard or daggerboard during the earlier part of the vessel's career (fig. V.3). The trunk base was 13 feet, 4 inches (4.06 m) long and terminated just forward of frame 6. Over the entirety of its length, floor timbers were fitted to mortises cut into the sides of the trunk base instead of crossing over the keel. The molded dimension of the upper keel also increased in the stern to form the lower part of the deadwood structure (fig. V.4). Starting at a point 42 feet, 3 inches (12.88 m) aft of its forward end, its upper edge rose at a 20 degree angle before leveling off at a molded dimension of 11 inches (27.94 cm). The upper keel continued at this height for another 6 feet, 4 inches (1.93 m) before the molded

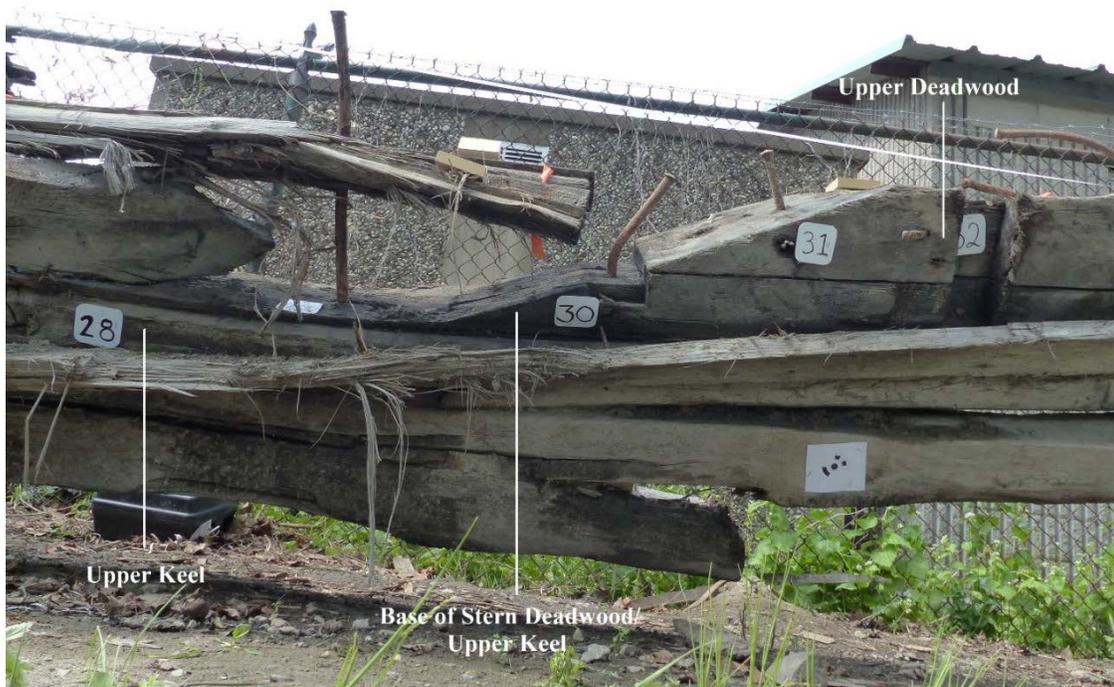
FIG. V.4 Forward end of the stern deadwood (photograph by J. Herbst).

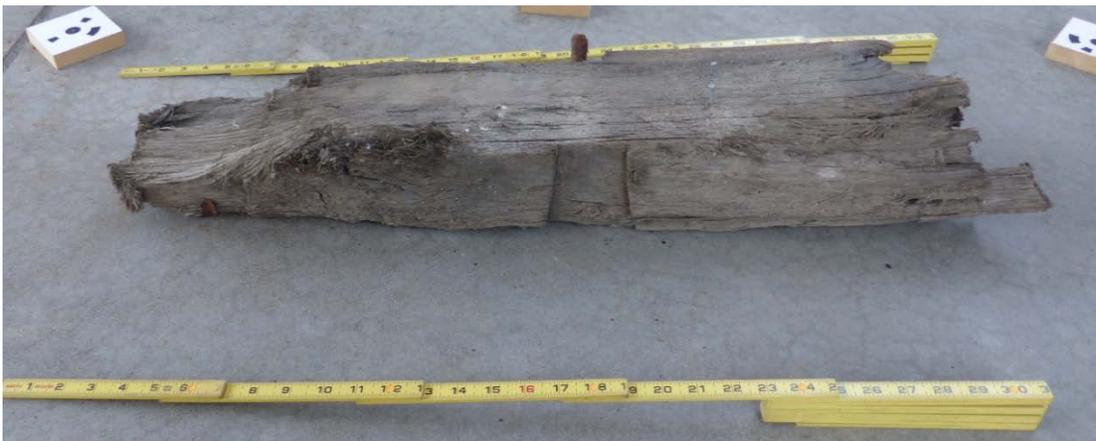
FIG. V.5 Disarticulated lower keel piece (photograph by R. Galloso).

In the stern, the bottom half of the lower keel appeared to have been purposely cut. It is likely that this was done at the time the vessel was abandoned, rather than as part of its construction or as an in-service modification. The upper half of the timber continued for another 3 feet, 10 inches (1.17 m) beyond the break. A 2 feet, 9 inch (83.82 cm) long portion of the lower keel was found disarticulated from the wreck. It was originally attached to the after end of the upper half of the timber and included partial mortices for a pair of fish plates (one on each side of the piece), which fastened the lower keel to the upper keel (fig. V.5).

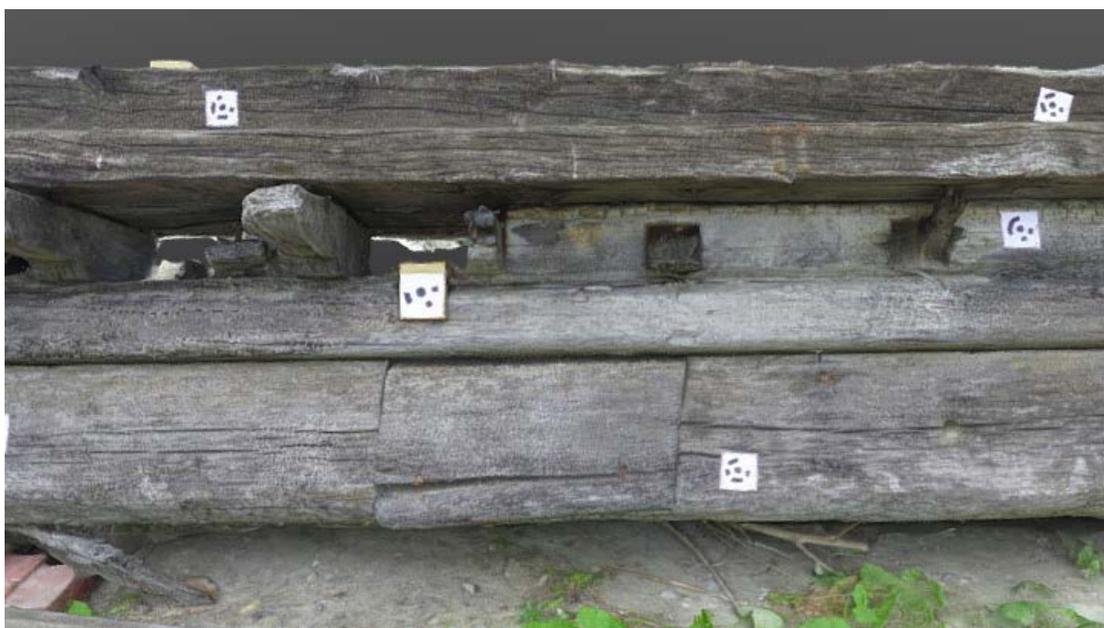
FIG. V.6 Graving piece in lower keel (photograph by J. Herbst).

The lower keel was also fastened to the upper keel with 17 iron bolts (averaging 1 inch [2.54 cm] in diameter) driven through the upper keelson, frames, and other centerline timbers, with eight terminating out the bottom or side of the lower keel. Evidence of a repair in the form of a patch (also known as a dutchman or graving piece) was found on the starboard side of the lower keel, located 27 feet, 4 inches (8.33 m) aft of the timber's forward end. The patch was 1 foot, 10 inches (55.88 cm) long, approximately 1 inch (2.54 cm) thick, covered almost the entire molded dimension of the lower keel, and was secured in place with two iron spikes (fig. V.6). It may have repaired impact damage, an area of rot, or an inherent weakness such as a knot in the lower keel timber. Like the upper keel, the bottom corners of the lower keel were rounded from wear.

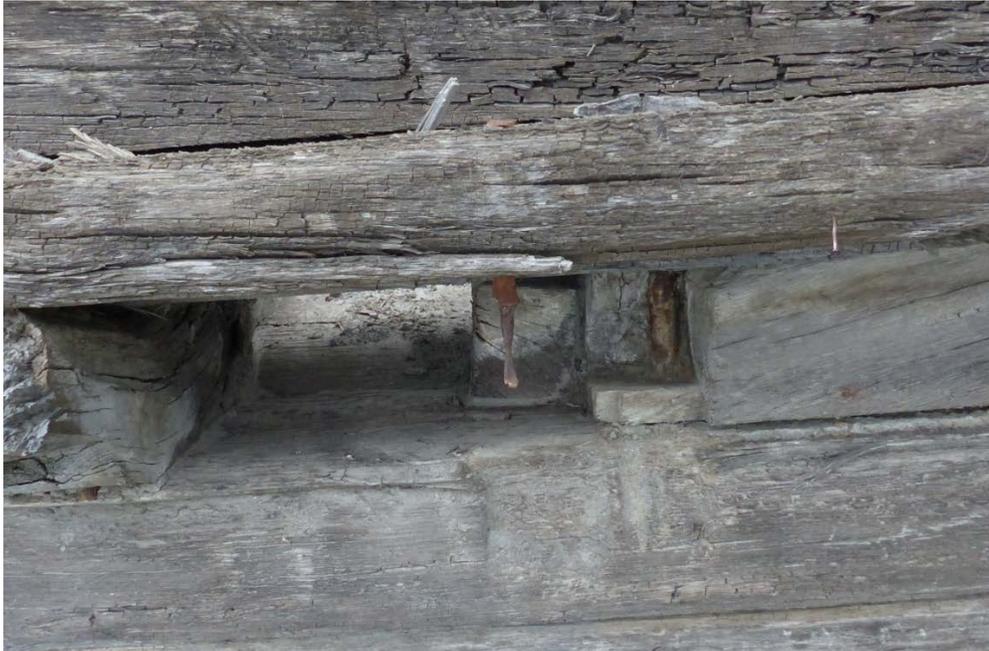
FIG. V.8 Lip at after end of apron for floor H (photograph by J. Herbst).

The apron was bolted atop the main stem and upper keel (fig. V.2). Its forward end was broken off and eroded. The extant remains measured 6 feet, 6 inches (1.98 m) long and had an average molded dimension of 6 inches (15.24 cm). As noted earlier, notches for two cant frames carved into the main stem continued upwards onto each side of the apron. Aft of the stem, two additional notches (averaging 3.5 inches [8.89 cm] wide and 5.25 inches [13.34 cm] high) were carved into both sides of the apron. Each of these additional notches contained a shallow, circular hole drilled into the wood with an auger, which may have been used to determine how deep to carve them. The after end of the apron terminated in a 1.75 inch (4.44 cm) tall, 4 inch (10.16 cm) long lip, upon

which the floor of frame H (the first frame to cross the keel) sat (fig. V.8). None of the wreck's other floors were arranged in a similar manner.

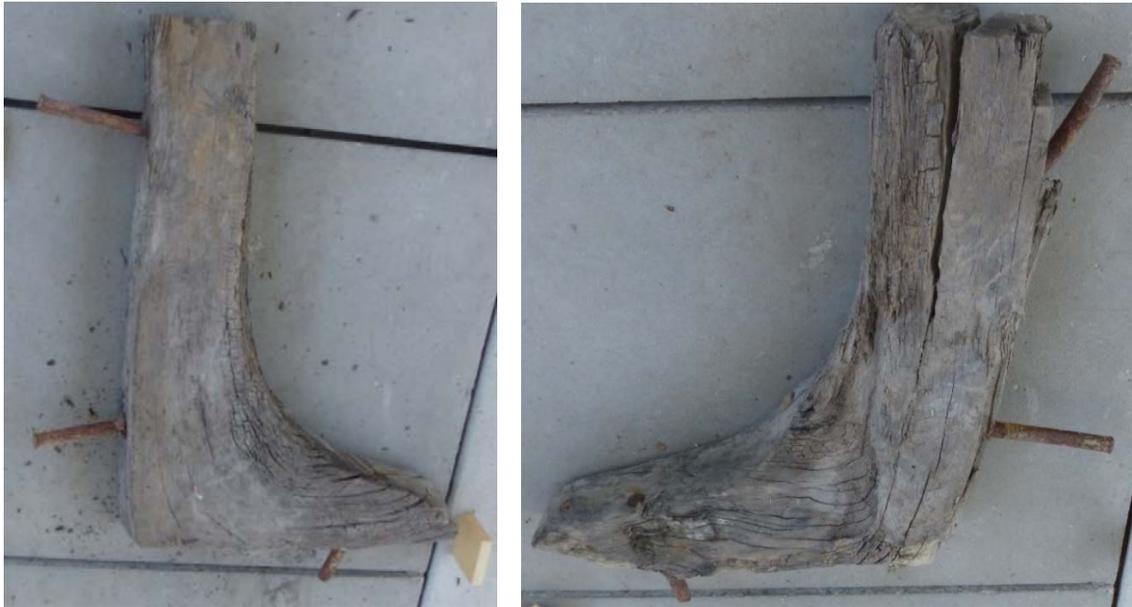
FIG. V.19 Knee 1 (left) and Knee 2 (right) (photographs by J. Herbst).

Two knees were recovered disarticulated from the wreck (fig. V.17). The first had a base of 1 foot, 9.5 inches (54.61 cm), a vertical extension of 2 feet, 7.5 inches (80 cm), and was 3.5 inches (8.89 cm) thick. The second had a base of 1 foot, 10 inches (55.88 cm), a vertical extension of 2 feet, 4.5 inches (72 cm), and a thickness of 4.75 inches (12.07 cm). These knees appeared slightly too large to have been used to support the schooner's deck beams and, as noted earlier, many Great Lakes vessels used clamps instead of knees to support their beams.⁷⁸ Consequently, they may have instead been used for another purpose, such as to support a bitt for the schooner's windlass.

As mentioned in Chapter V, two disarticulated knees were found on the wreck. It is possible that these knees were used to support the deck beams, but they seem too large for this purpose. Additionally, few Great Lakes vessels had hanging knees to support their decks, as these timbers added significant weight above the waterline and were generally considered unnecessary due to the moderate conditions on the lake (as opposed to more extreme waves encountered on the open ocean).⁹³ Consequently, it is likely that the knees were used for other purposes (possibly to support a bitt for the windlass). For this reason, they were not included in the reconstruction of the midships section of the vessel. Instead, the deck was supported with light clamps in a manner similar to that seen on *Tecumseth* (fig. VI.8). The deck structure was completed by adding in 1.5 inch (3.81 cm) thick deck planking, which was assumed to be no thicker than the lower layer of ceiling planking. These planks are relatively narrow (averaging 6 inches [15.24 cm] wide), as this would have been more economical and less prone to leaking than wider planks.
