ANALYSIS AND RECONSTRUCTION OF SHIPWRECK YK 11  
(C. SEVENTH CENTURY A.D.) FROM THE THEODOSIAN HARBOR  
AT YENİKAPI IN ISTANBUL, TURKEY

A Dissertation

Submitted to the Office of Graduate Studies of  
Texas A&M University  
in partial fulfillment of the requirements for the degree of

DOCTOR OF PHILOSOPHY

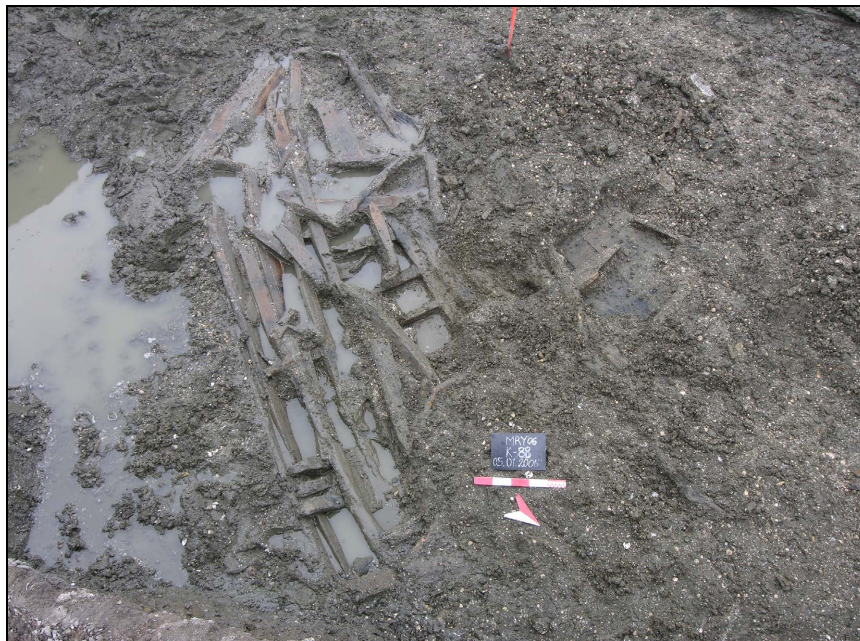
**Figure 3.2.** Shipwreck YK 11 shortly after discovery. January 5, 2006. Photo by Bekir Köşker (used with permission.)

<sup>1</sup> In the early photo shown in figure 3.2, the wreck was labeled MRY 06.

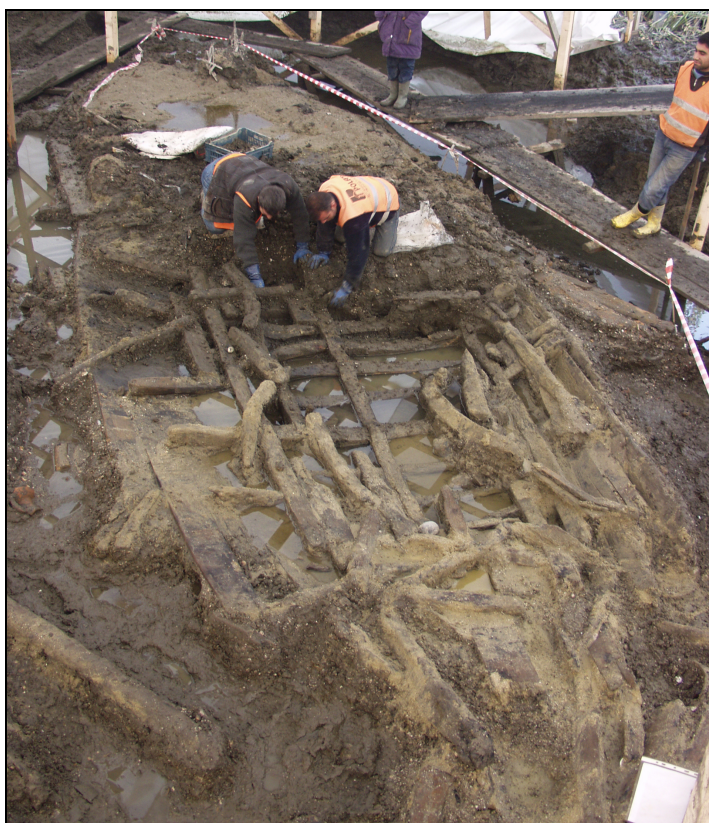
**Figure 3.3. Final removal of overburden from YK 11 by Istanbul Archaeological Museums' staff; looking northeast (toward the stern). January 16, 2008. Photo by M. Jones/INA.**

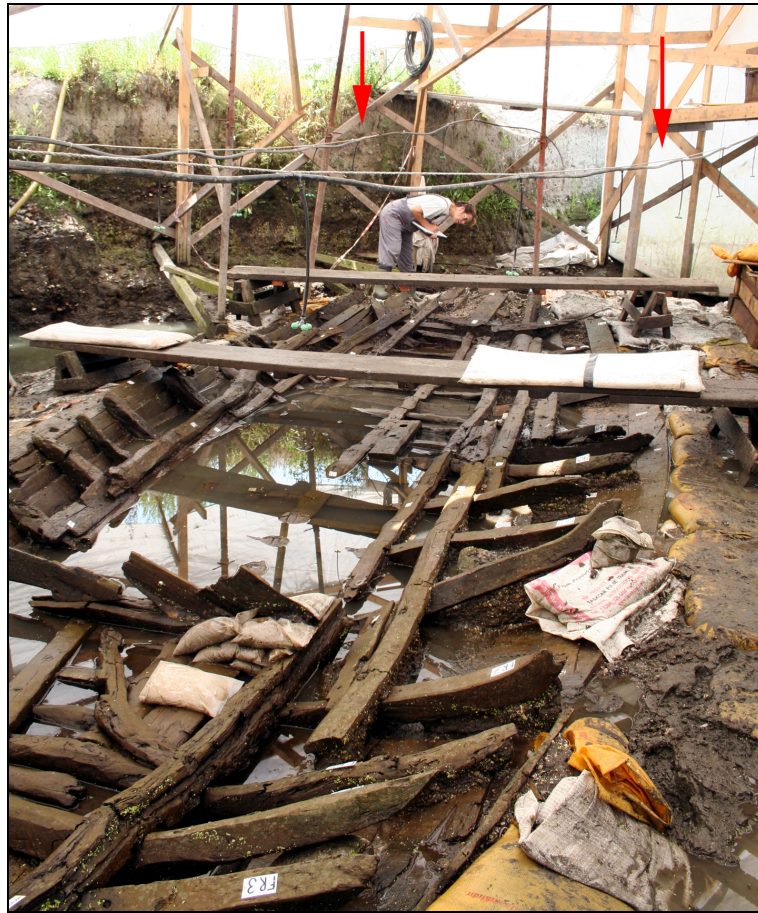
**Figure 3.4. Shipwreck YK 11 during in-situ documentation. Two sprinkler lines (marked with red arrows) were installed above the wreck after it was uncovered. Long pallets, laid across sawhorses, provided access to the central part of the ship. June 21, 2008. Photo by R. Ingram/INA.**

interior area of the shipwreck, sawhorses were placed on either side of the ship with a long pallet laid over the top (fig. 3.4). The nature of the sediment on this site, combined with the depth of the excavation pit in relation to its surroundings, led to frequent flooding. This was exacerbated by a poorly-functioning sump pump and electricity problems; as a result, the pit was flooded and the shipwreck became inaccessible approximately 15% of the time during the course of INA's work on the wreck.<sup>9</sup>

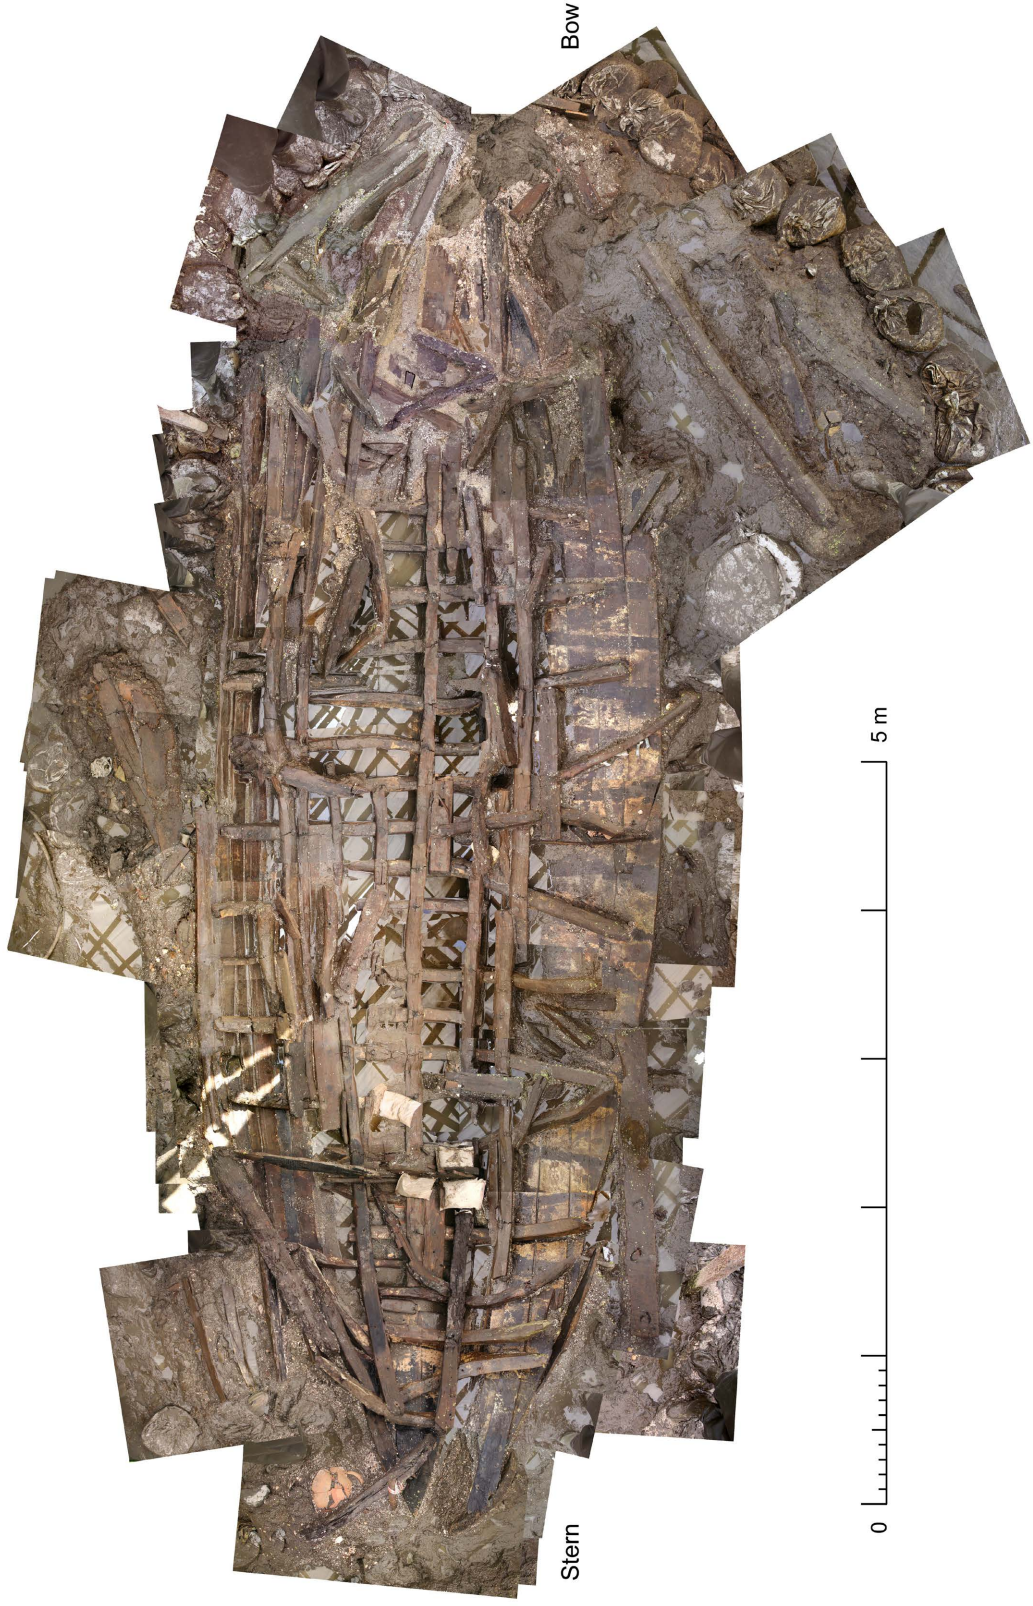
Figure 3.5. Initial (upper-most layer) photomosaic of wreck YK 11, including all timbers. Photos by O. Köyagaşioğlu, mosaic by S. Matthews. May 3, 2008.

with the aid of the photomosaic of the upper-most layer created by Sheila Matthews and Orkan Köyağasıoğlu (fig. 3.5). Once each timber was labeled and its approximate position indicated on a sketch plan based on the photomosaic, the wreck was scanned using a Total Station (May 23-24, 2008) by a team from İmge Harita under the direction of Sadık Demir. Matthews used the resultant data to create a precise, three-dimensional map of the wreck using Rhinoceros modeling software (fig. 3.6).

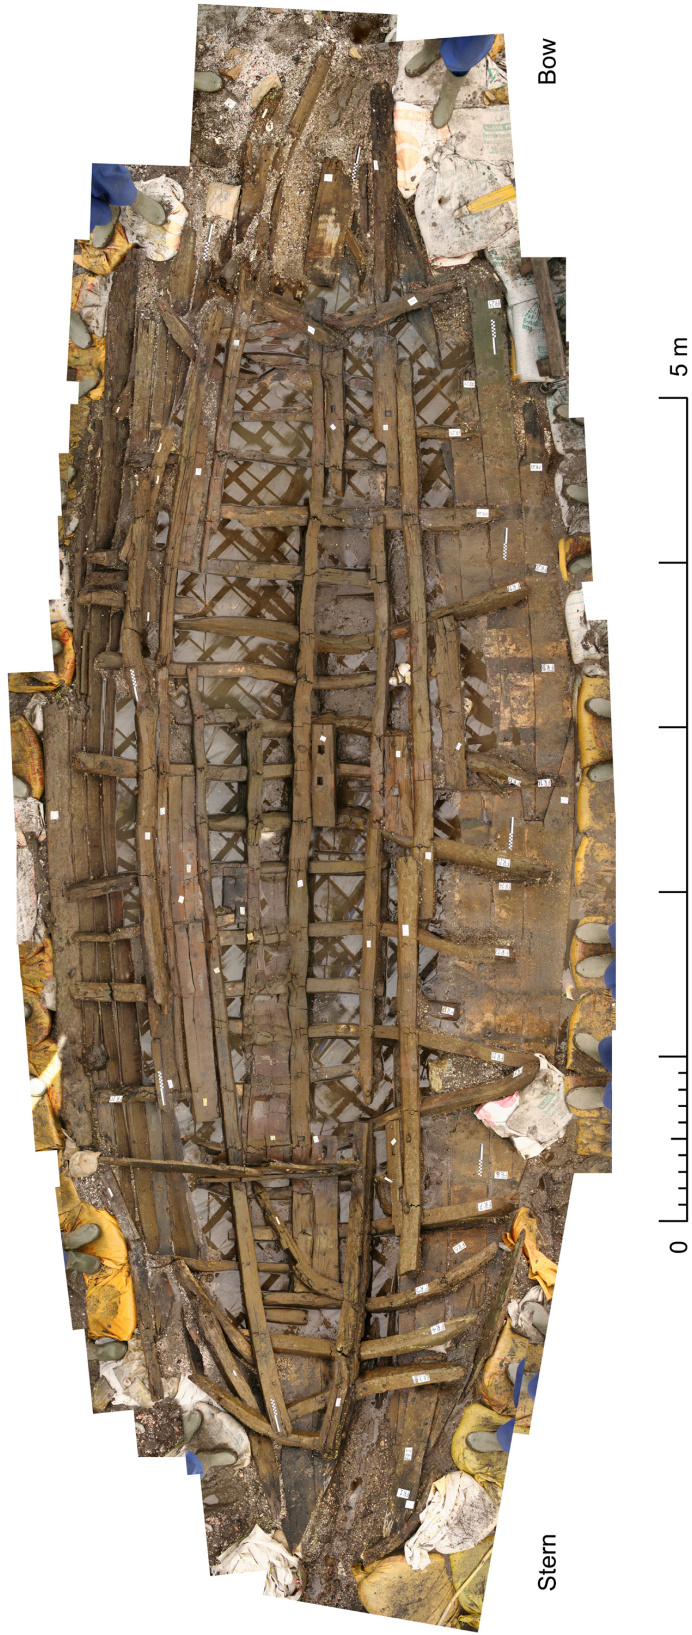
Figure 3.7. Photomosaic of wreck YK 11 with all in-situ timbers, after removal of upper-level UM fragments. June 8, 2008. Photos and mosaic by R. Ingram.

The well-preserved ceiling of YK 11 was mapped, documented and removed June 24-July 21, 2008. This layer included the stringers, common ceiling, stemson, sternson, stanchion blocks, and the bulkhead partition, located near the ship's stern (fig. 3.7). At this time, several artifacts were found and removed from the ship's bilges, including a folded lead seal, a bronze lamp hanger, and small wooden objects associated with the ship's rig; the seal and lamp hanger are discussed below when considering the date of the vessel.

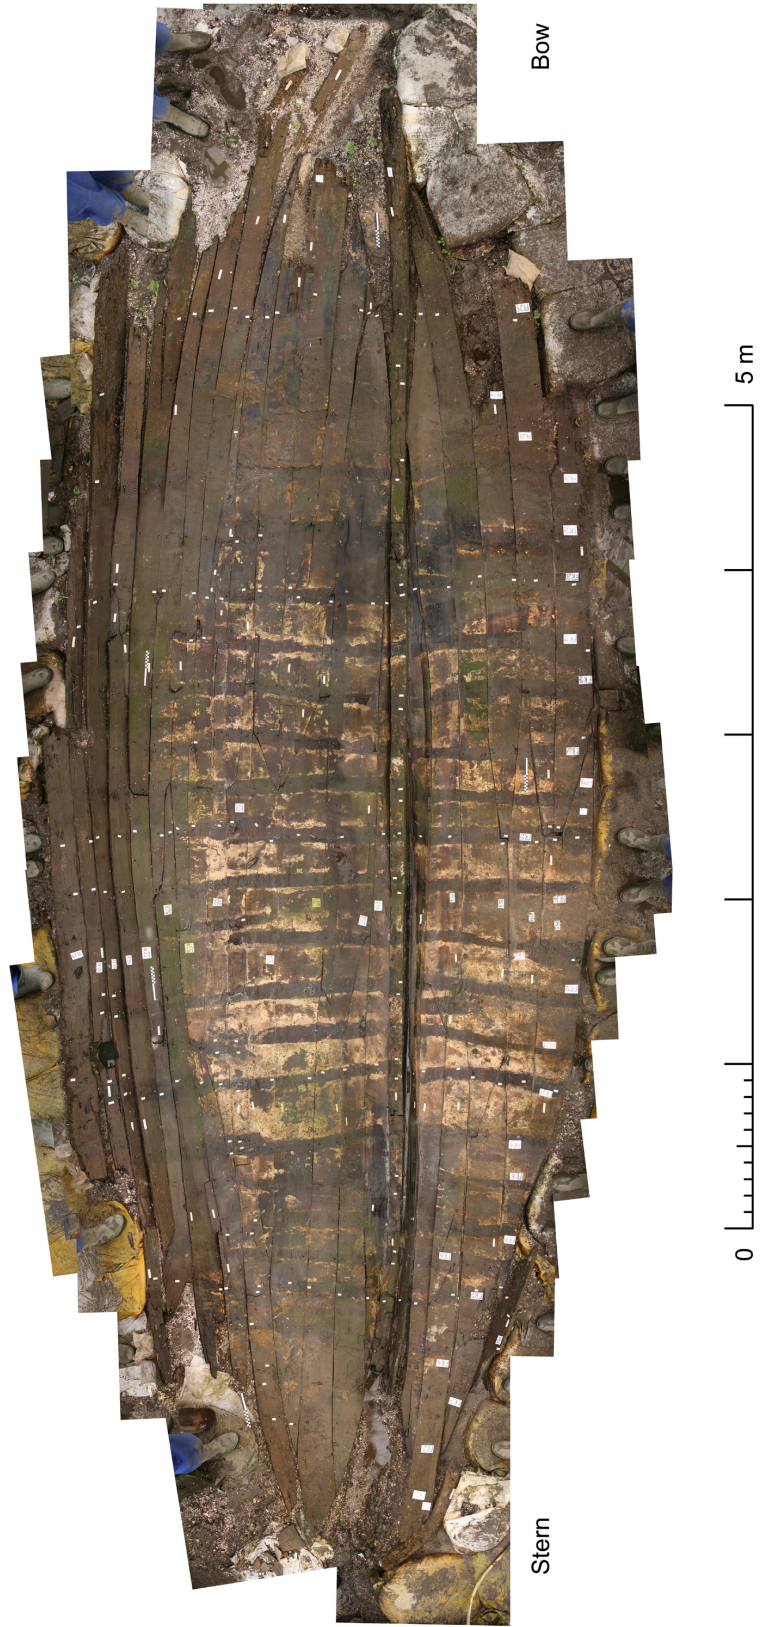
Figure 3.9. Photomosaic of wreck YK 11 keel and planking, after removal of frames and ceiling. August 23, 2008. Photos and mosaic by R. Ingram.

The ship's planking and keel timbers were mapped, documented and removed August 25-November 17, 2008 (fig. 3.9). In addition to the usual sequence of documentation, these timbers were traced on clear plastic film prior to their removal

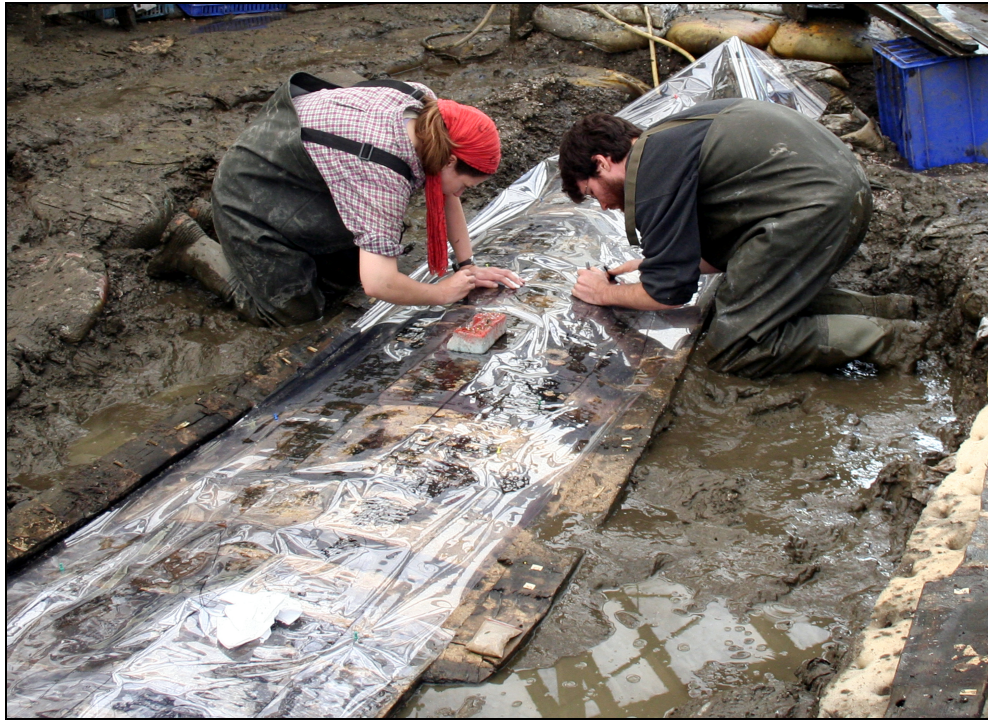
**Figure 3.10. R. Ingram (L) and M. Jones tracing YK 11 planking on clear plastic film. Oct. 23, 2008. Photo by S. Matthews/INA.**

from the wreck (fig. 3.10). This additional documentation was required in order to preserve surface detail which might not be discernible once planks are disassembled. To facilitate the eventual digitization of the drawings, the plastic film was no more than 90 cm in width and 6 m in length. Each drawing covered multiple strakes of planking and overlapped adjacent drawings by one strake to allow the drawings to be joined later.

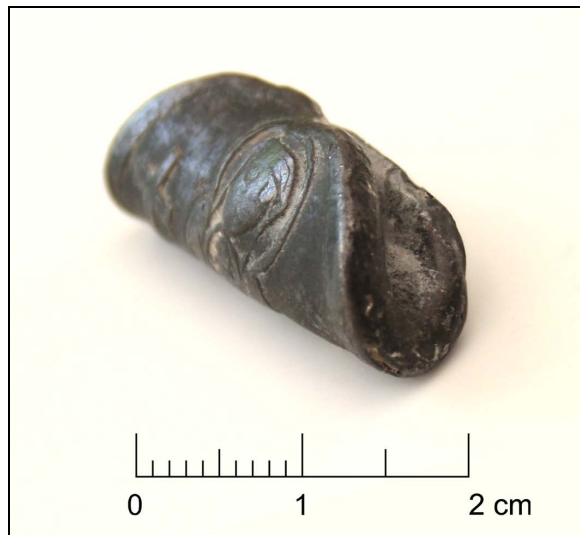
**Figure 3.11. Folded lead seal MRY5/19, found within the ship.**

Although most of the scattered ceramics and other artifacts are not associated with the shipwreck and are thus of limited value in dating the vessel, two objects were found within the ship that corroborate the late sixth- or early seventh-century date indicated by details of the ship's construction. Lead seal MRY5/19 was found between frames just above the level of planking, in the port turn of the bilge forward of amidships. Only one face of the lead seal is visible due to its having been rolled or

folded in half (fig. 3.11). The visible face of the seal shows the Theotokos, standing to front, wearing a chiton and maphorion; Christ, framed in an oval mandorla, is held before her (fig. 3.12). There is a cross potent to left and right. This particular design was used in imperial seals from the reign of Maurice to the end of the first reign of Justinian II (A.D. 582-695).<sup>19</sup> This seal appears to show the more naturalistic position of the Theotokos first seen during the reign of Heraclius; thus, the date of the seal could be slightly narrowed to A.D. 610-695.<sup>20</sup> Based on its find location, the seal was either in the ship when it was abandoned or was deposited very soon thereafter, before sediment filled the submerged hull. As a result, this seal provides a *terminus post quem* of ca. A.D. 610 for the abandonment of the vessel.<sup>21</sup> Based on other artifacts in the excavation pit, the seal had likely been rolled or folded over for use as a net weight for fishing.<sup>22</sup>

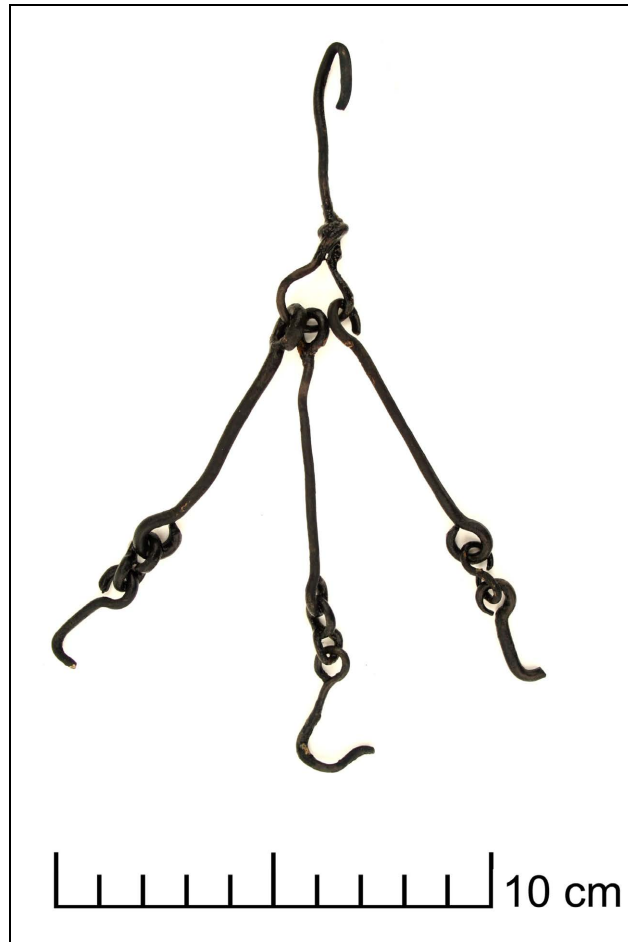
**Figure 3.13. Bronze lamp hanger MRY5/16, found within the ship.**

The bronze lamp hanger or incense burner (*thymiaterion*) hanger shown in figure 3.13, while less securely dated than the lead seal, was almost certainly part of the ship's equipment during its lifetime. This nearly perfectly-preserved lamp hanger, complete and intact with the exception of the tips of two hooks, was found under the bulkhead partition frame. This object had probably been stored with other valuables in the stern cabin and had fallen into the bilges and under the ceiling level, thus escaping notice.

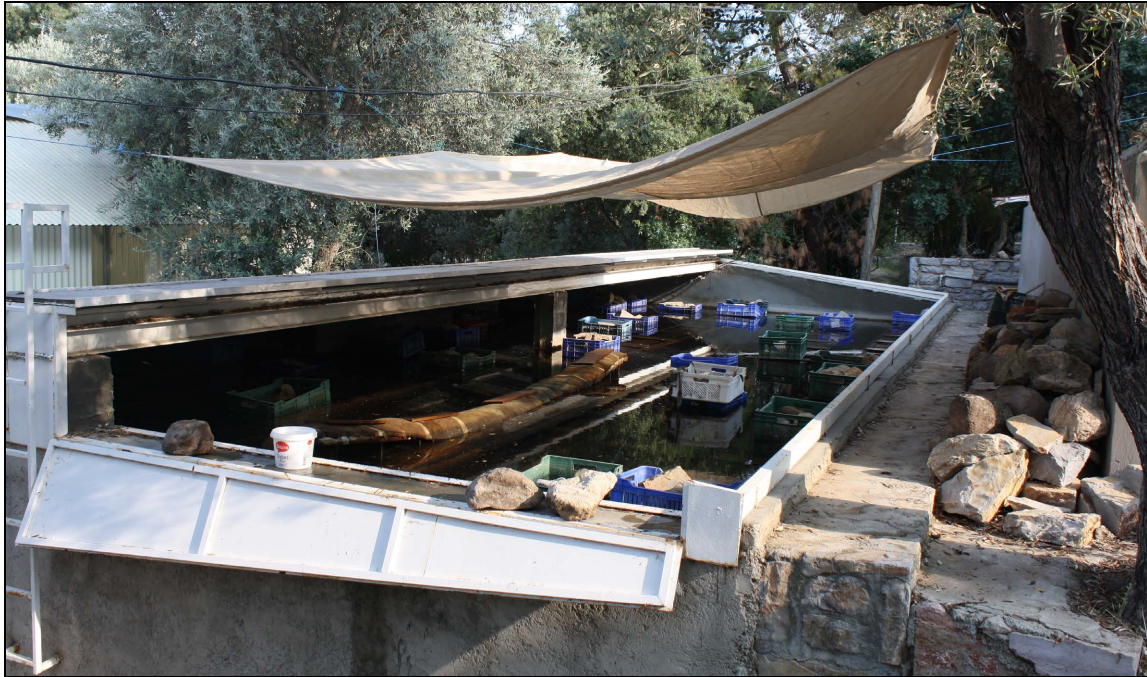
**Figure 3.14.** The large timbers of shipwreck YK 11 were stored in this 90 m<sup>3</sup> freshwater tank at INA's Bodrum Research Center. July 31, 2010.

Upon arrival in Bodrum, the crates holding the YK 11 timbers were moved into an outdoor freshwater storage tank, 90 m<sup>3</sup> in volume (fig. 3.14). This tank housed the timbers from YK 11 as well as those of the late eighth-century Yenikapı shipwreck YK 23. An adjacent storage tank held the timbers of YK 14 and YK 24. The water in the timber storage tanks was treated with a 0.02% solution of borax and boric acid as a pesticide and fungicide. Per local municipality regulations, guppies were also added to the tanks to reduce the mosquito population.

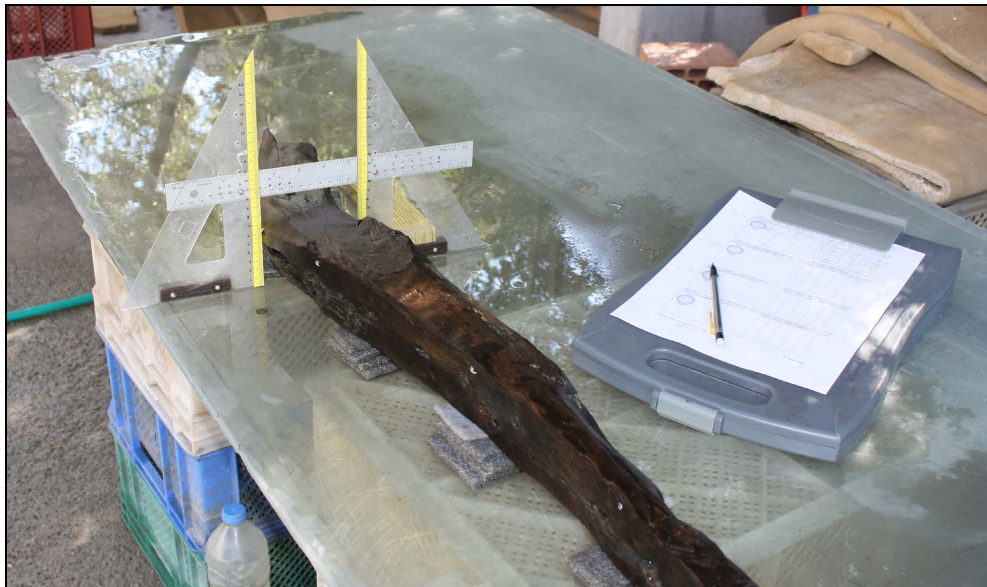
Sections of each timber were recorded at one or more locations with the aid of a homemade adjustable tool (fig. 3.15). This tool consisted of two plastic triangles joined across the top by an aluminum rule; holes drilled into all components at precise locations

allowed the height and the width of the tool to be adjusted. Offsets measured from the framework formed by the tool provided an accurate sectional form of the timber.

**Figure 3.15.** Sections were created with the aid of an adjustable, custom-made tool.

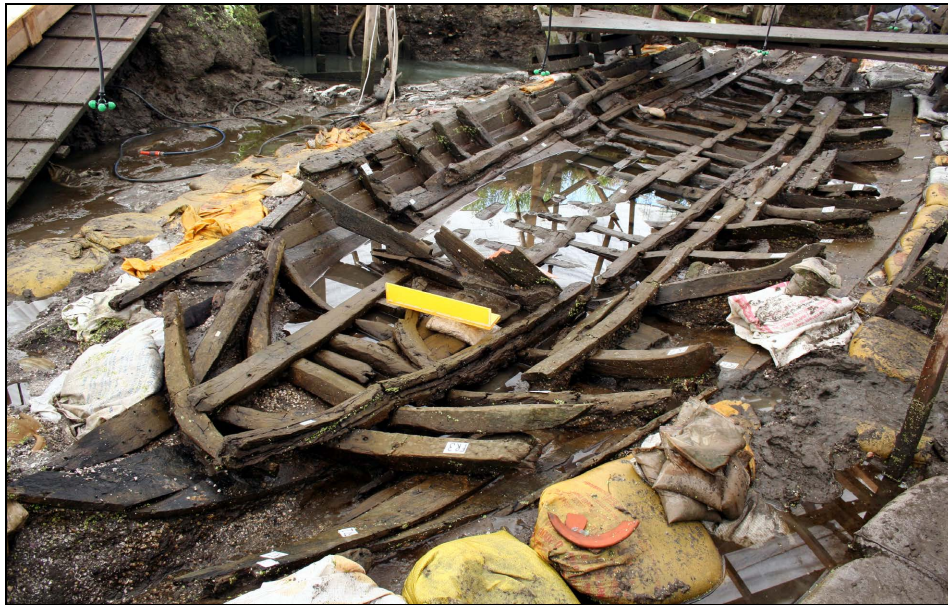
Approximately 40% of the wooden hull of YK 11 was preserved, most of it in very good condition. The wineglass-shaped bottom had settled on the floor of the harbor with a slight list to port. As a result, the port side exhibited excellent preservation up to the second wale, just above the first level of through-beams. This includes most of the planking, parts of two wales, and elements of framing (some of which are complete) at 26 frame stations (fig. 4.1). The planking had opened up slightly, with parts of the upper strakes, above strake nine, slipping downward behind lower strakes. The preservation of the starboard side was far less extensive, with planking preserved to the turn of the bilge and only one extant half-frame. A significant portion of the ceiling and other internal timbers, including a stemson, a sternson, stringers, common ceiling, sills, stanchion blocks, and part of a bulkhead partition, were also preserved on the port side of the vessel and on the starboard side near the ship's centerline.

**Figure 4.1. Hull of YK 11 in situ. July 2008. Photo by O. Köyağasıoğlu/INA.**

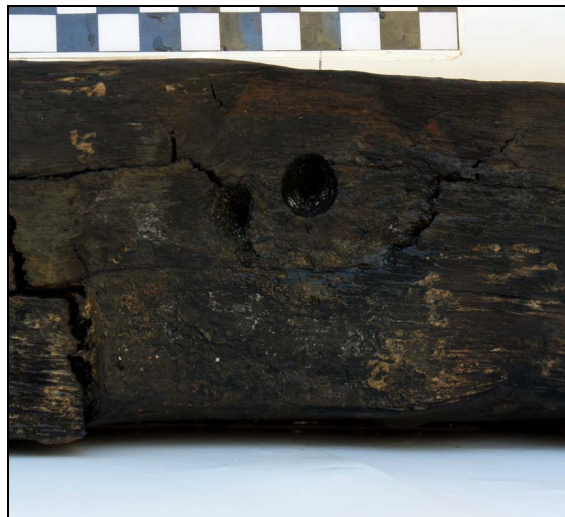
**Figure 4.6. Square nail hole next to a nail in a pilot hole on Keel 1 inner face at FR 7.**

Frames were attached to the keel primarily with long nails that did not extend to the keel's outer face. Holes from these square nails are usually 0.5-0.9 cm in sided dimension. The nails at every floor, and a few of the half-floors, were driven into a drilled pilot hole, 0.9-1.4 cm in diameter. Pilot hole depths are often unclear, but the drilled holes at FR 7 on Keel 1 and at FR 22P on Keel 3 are only 1.2-1.3 cm in depth (fig. 4.6). Corrosion within these pilot holes reveals that the holes were left empty and served to prevent the nail from bending before it was fully driven into the keel. Every frame that crossed or contacted the keel was attached to it with at least one iron nail (or, at scarf joints, with a bolt). In many cases, there is more than one nail at a frame location on the keel, either because the frame had been replaced, or because, as at FR 23, additional nails were added to correct damage or to reinforce the keel-frame joint. Whether the presence of multiple nails is due to replacement or reinforcement of framing is only clear at extant frames.

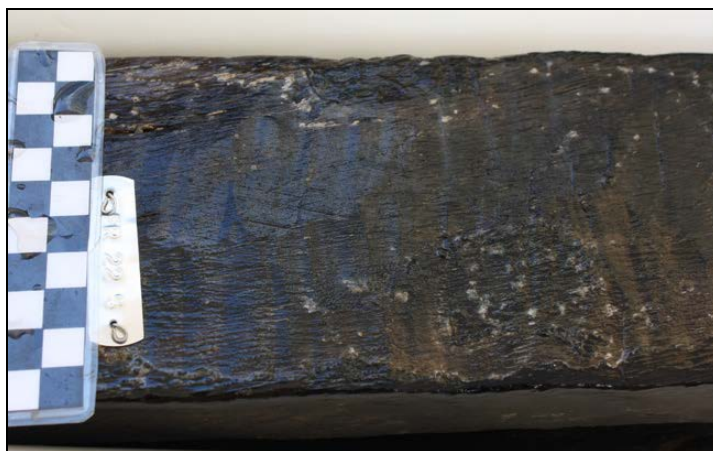
**Figure 4.9. Adze marks on the inner face of Keel 3 at FR 21-FR 22.**

Inner faces were dubbed flat through a series of short adze blows, from an adze blade 3.5-4.0 cm in width (fig. 4.9). These are usually spaced approximately 1 cm and are approximately perpendicular to the length of the keel. The inner face may have been trimmed down slightly at some frame locations, noted on Keel 2 at FR 11, FR 13, FR 14, FR 16S, and FR 20; it is noteworthy that all of these frames, with the exception of FR 20, were replaced during the life of the ship.

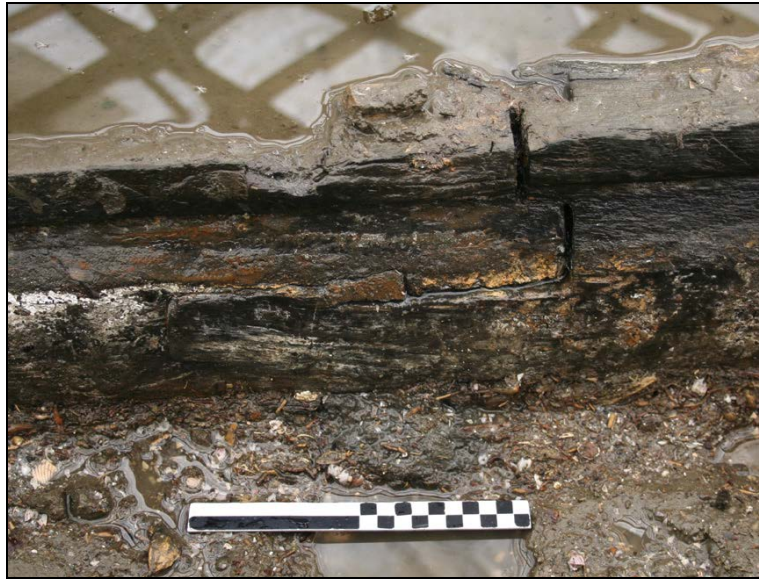
**Figure 4.11. Starboard face of Keel 1-Keel 2 scarf, in situ.**

Each keel timber terminated in a keyed hook scarf similar to those observed on the seventh-century shipwreck at Yassiada;<sup>7</sup> two such scarf ends were preserved on each keel timber with the exception of Keel 3, which was broken and eroded at its forward end. These hook scarfs locked the three keel timbers and the sternpost together; the joints were held in place by means of a small, rectangular scarf key placed within the scarf table, pressed up against the vertical step in the scarf table (figs. 4.11-4.13).

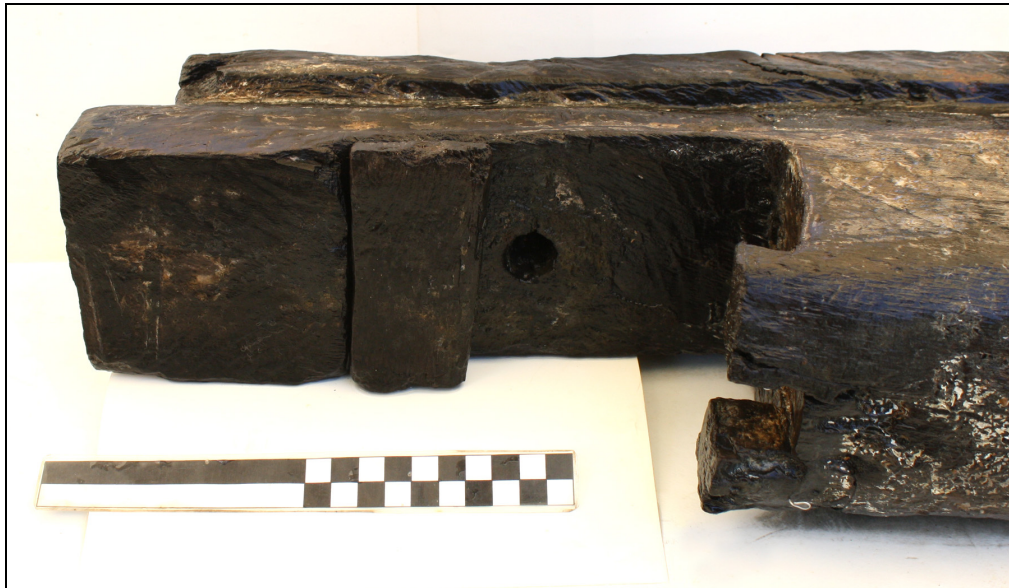
**Figure 4.12. Aft scarf of Keel 3 with scarf key in place, as seen from starboard-outer.**

The two preserved scarf keys were 10.5 cm in length, 4.5-5.1 cm in width, and 1.5-2.0 cm in thickness. The Keel 2-Keel 3 key was very well preserved (figs. 4.4, 4.12). The Keel 1-Keel 2 key, through which the bolt was inserted, necessarily endured some surface damage during removal, but remains largely intact. Splintered fragments of *Pinus nigra* removed from the aft scarf on Keel 1 may be part of that scarf's key.

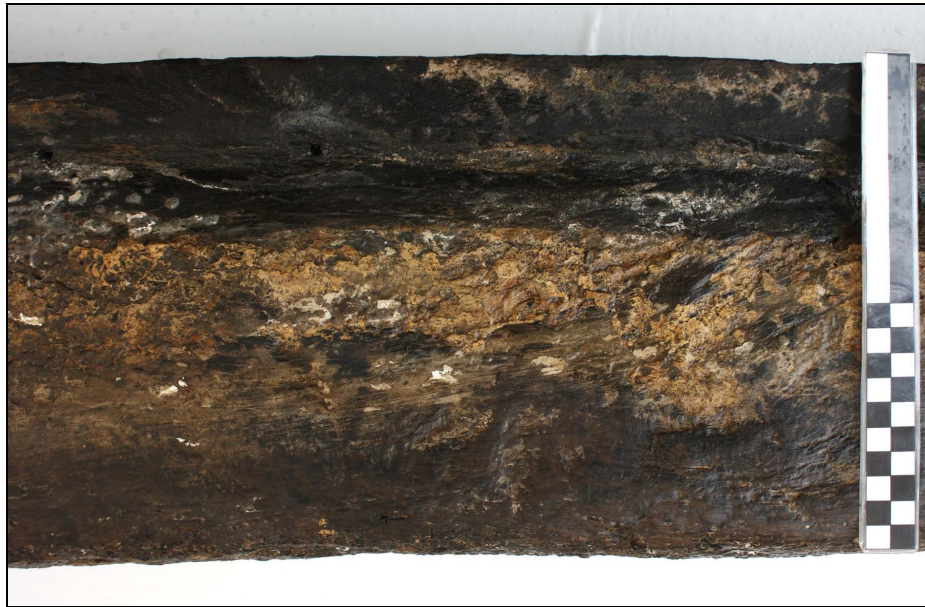
**Figure 4.14. Pitch on Keel 2 port face, below rabbet.**

similar to that observed elsewhere on the ship's planking. In some areas, the layer of pitch on the sides of the keel was up to 0.5 cm in thickness; it was also used to fill in small knot holes or other wood abnormalities. A distinct pitch line along the bearding line indicates multiple pitch applications after the garboard was installed (fig. 4.14). This is confirmed by the presence of pitched-over barnacles below the bearding line. Above the rabbet, pitch seems to have pooled in the deep crevices between the garboards and keel, forming thick lumps in these areas.

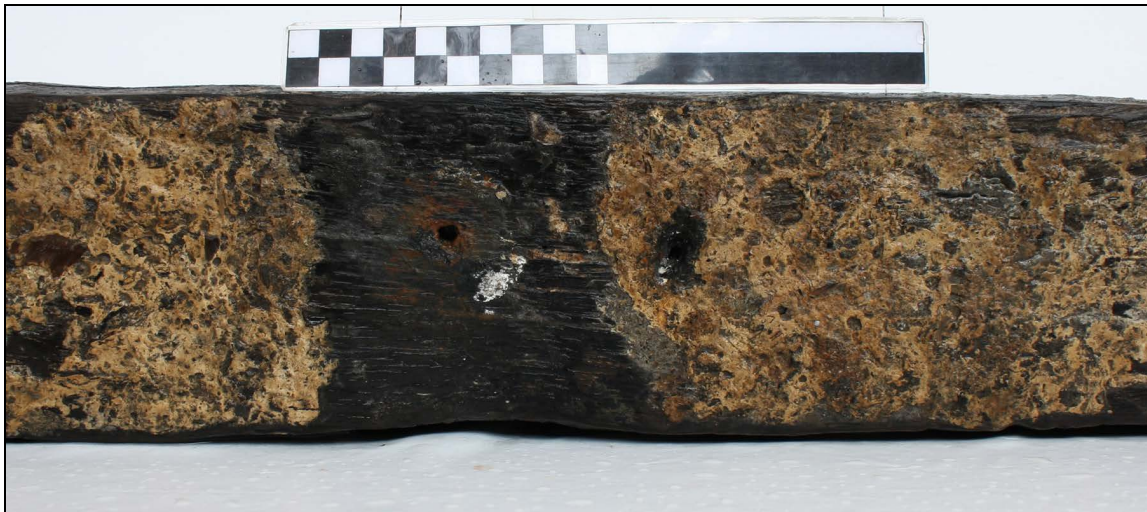
**Figure 4.15. Thick pitch between frames on the Keel 2 inner face, with sparse patches under FR 19.**

Dark yellow pitch, 0.2-0.4 cm in thickness, was prominent between frame locations on the keel timbers' inner surfaces (fig. 4.15). Tiny stones and various organics, especially olive pits, pine-cone scales, and wood chips, were found embedded in the inner face pitch; this inclusion was especially heavy between FR 10 and FR 13,

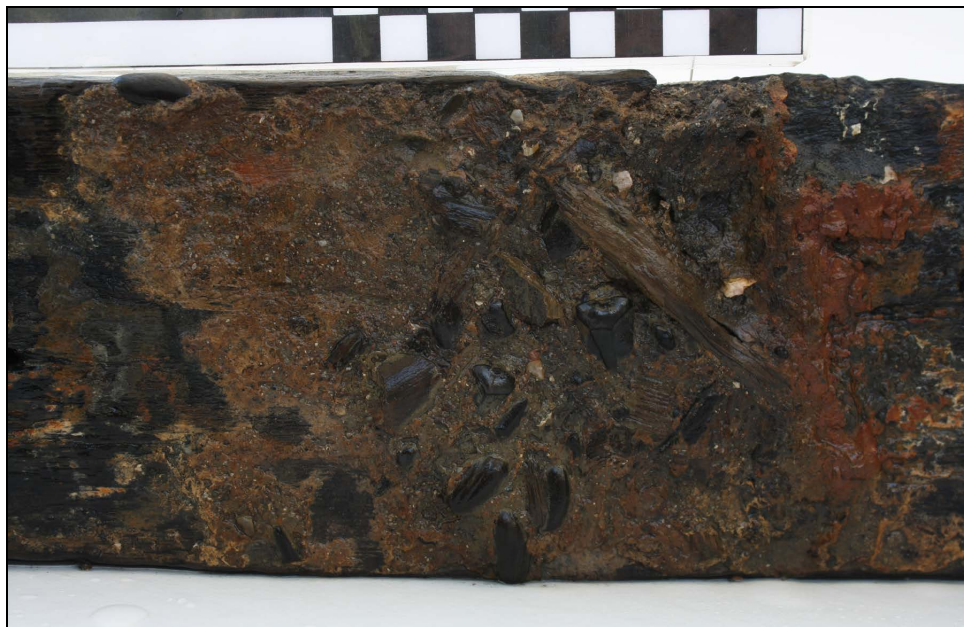
**Figure 4.16. Organics in Keel 2 inner face pitch between FR 10 and FR 11.**

just forward of the bulkhead and in the open portion of the hull (fig. 4.16). Small hairs and plant fibers were observed in the pitch but were uncommon. Between FR 10 and FR 11, inner face pitch was exceptionally thick (up to 1 cm).

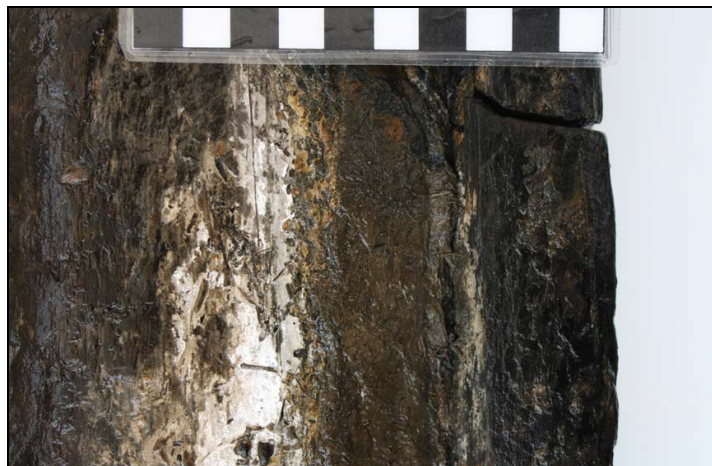
**Figure 4.17. White pitch(?), yellow pitch, and caulk on the starboard face of Keel 1.**

Faint traces of pitch under some frames probably indicates that the outer face of the ship's frames were pitched prior to their installation in the hull; application of pitch to the entire inner face of the keel timbers before the addition of framing would not have been conducive to the construction process. The traces of pitch at frame locations is much more common on the keel than on the ship's planking, which could indicate that the frames and keel were not in such close contact as were the frames and planking. A white substance, presumably degraded pitch, was also noted on each keel timber, and it was often found below a layer of yellow pitch. The white substance varied in color from bright white to a sandy or grayish white (fig. 4.17).

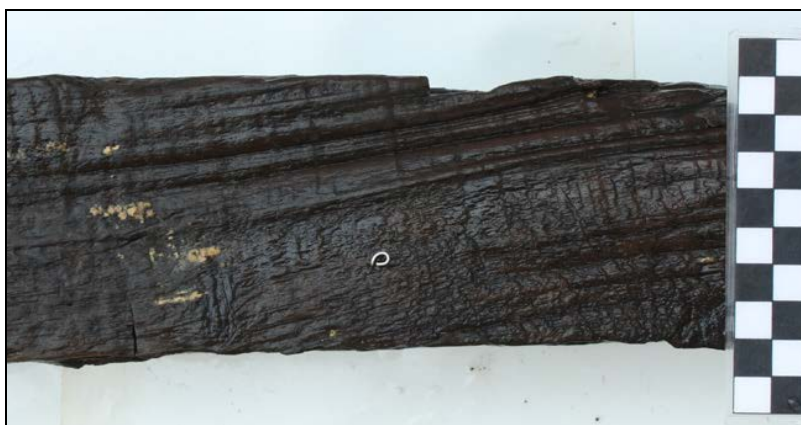
**Figure 4.19. Compression damage to the forward face of FR 10, causing a wrinkled appearance to the frame surface.**

more faces to appear wrinkled or wavy (fig. 4.19); a similar phenomenon was noted on other ships at Yenikapı.

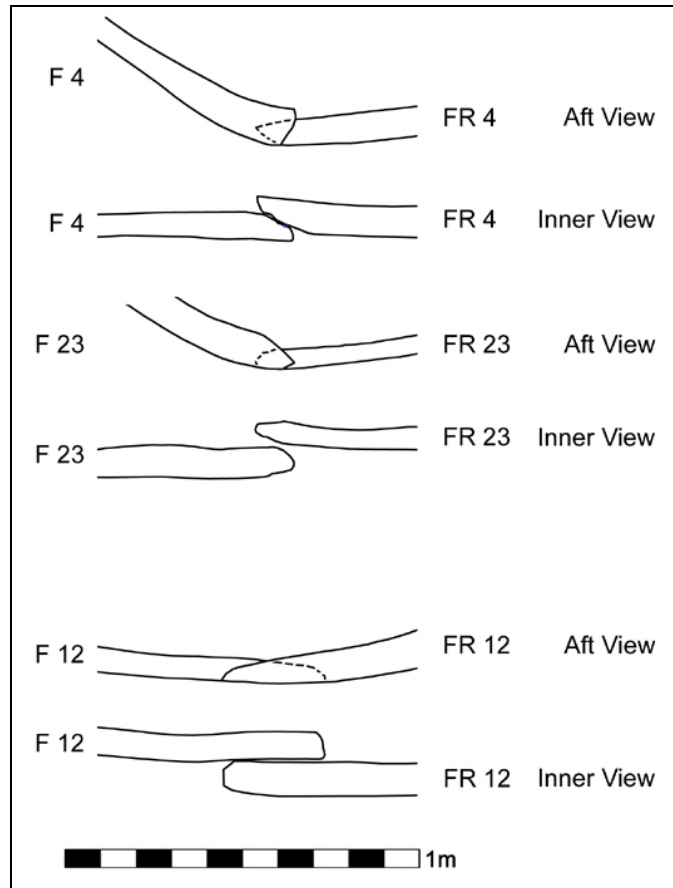
**Fig. 4.20. Overlap between floors or half-frames and futtocks.**

Neither type of futtock was attached to its associated floor or half-frame. The area of planking covered by each floor or half-frame and corresponding futtock overlapped by one or more plank widths, and some frames appear to have been trimmed down on one face in order to accommodate the placement of its associated futtock (fig. 4.20). FR 4 and F 4 were both trimmed to fit closely together, and a nail was unintentionally driven between the two. Only one frame, replacement floor FR 21, was notched at either end to accommodate futtocks, neither of which were preserved.

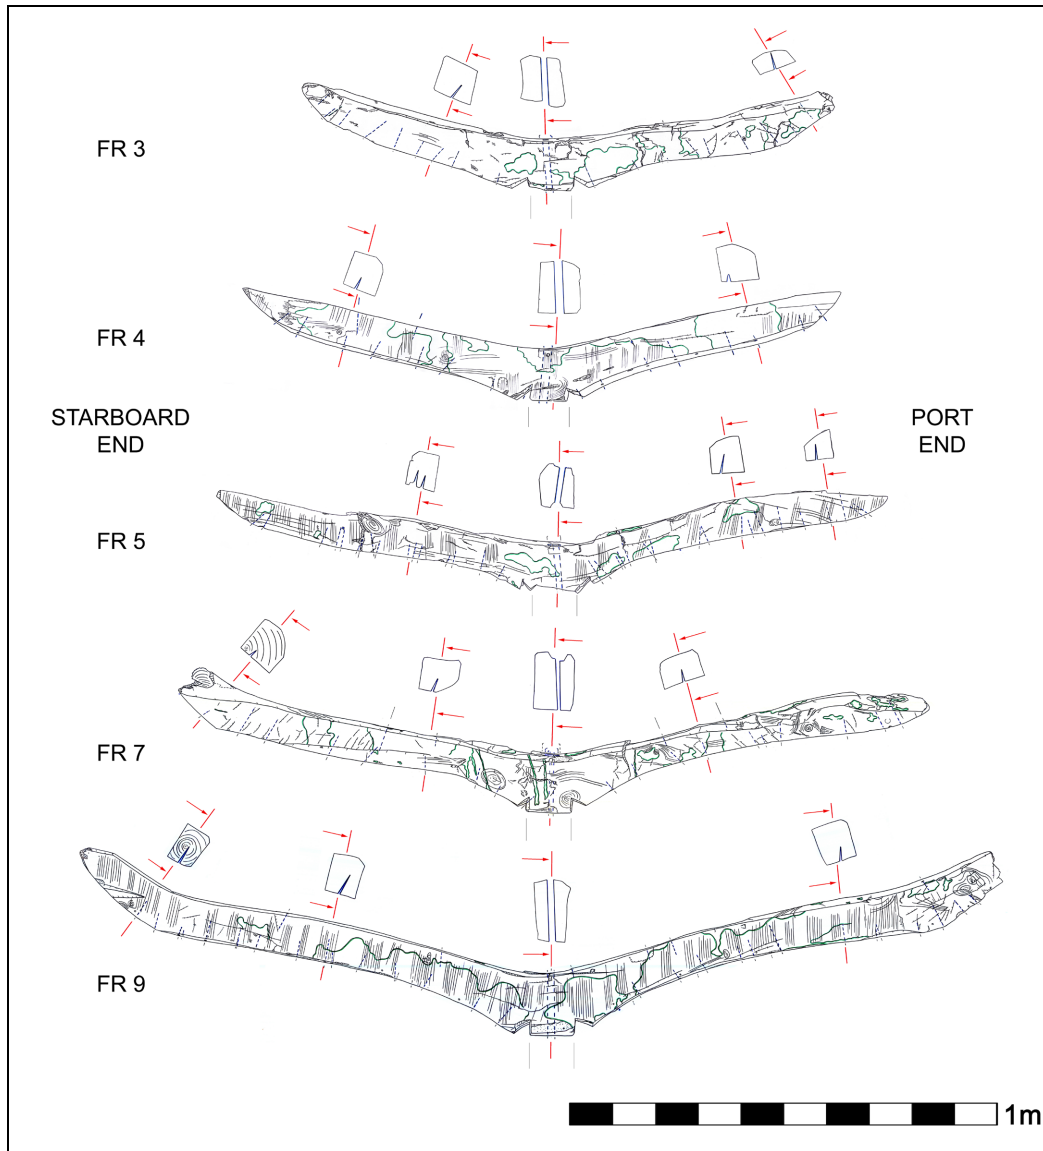
**Figure 4.23. YK 11 floors FR 3 through FR 9, forward face.**

Thirteen floors were preserved on YK 11 (figs. 4.23-4.25); of these, only four (31%) are original floors, while nine (69%) are replacement pieces. All floors were attached to the keel with one or more nails or, in the case of FR 4 and FR 9, an iron bolt. Twelve of the thirteen floors are complete or nearly so, and range in length from 1.24 to

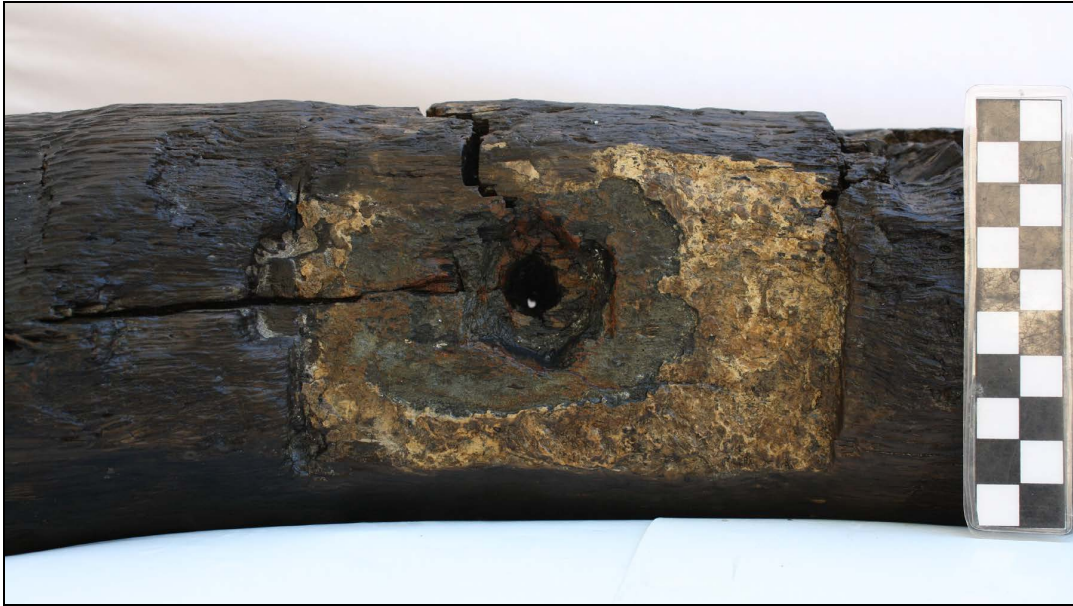
**Figure 4.26. FR 15 inner face, cut down to accommodate the mast step.**

There are three areas on these floors which were notched or trimmed to accommodate other timbers. On FR 15, part of the inner face along the ship’s centerline was notched to accommodate the mast step, which was not preserved (fig. 4.26). This indicates a mast step at least 13.4 cm in width. Also on FR 15, the port end of the floor is adzed down along its forward face for a length of 37.5 cm, presumably to accommodate futtock F 15 (which was not preserved). FR 5 is the only original floor with an outer face

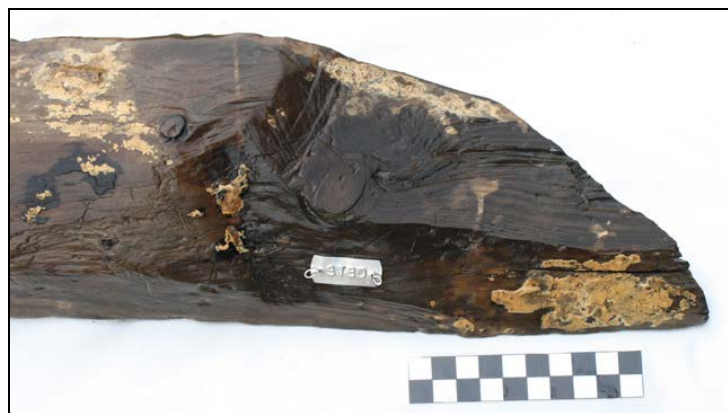
**Figure 4.27. Aft face of FR 4, adzed down for futtock F 4 at the port end.**

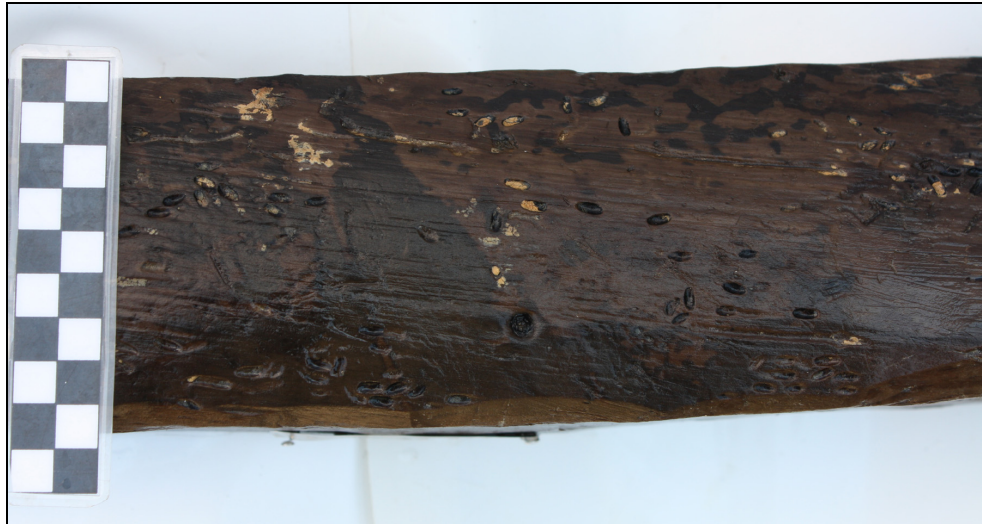
**Figure 4.28. Natural surface of the FR 11 forward face. Note pitched holes from wood-boring insects.**

faces. Much of FR 11's forward face, especially along the starboard arm, is a minimally-worked surface riddled with small holes from wood-boring insects; many of these holes had been filled in with pitch (fig. 4.28).

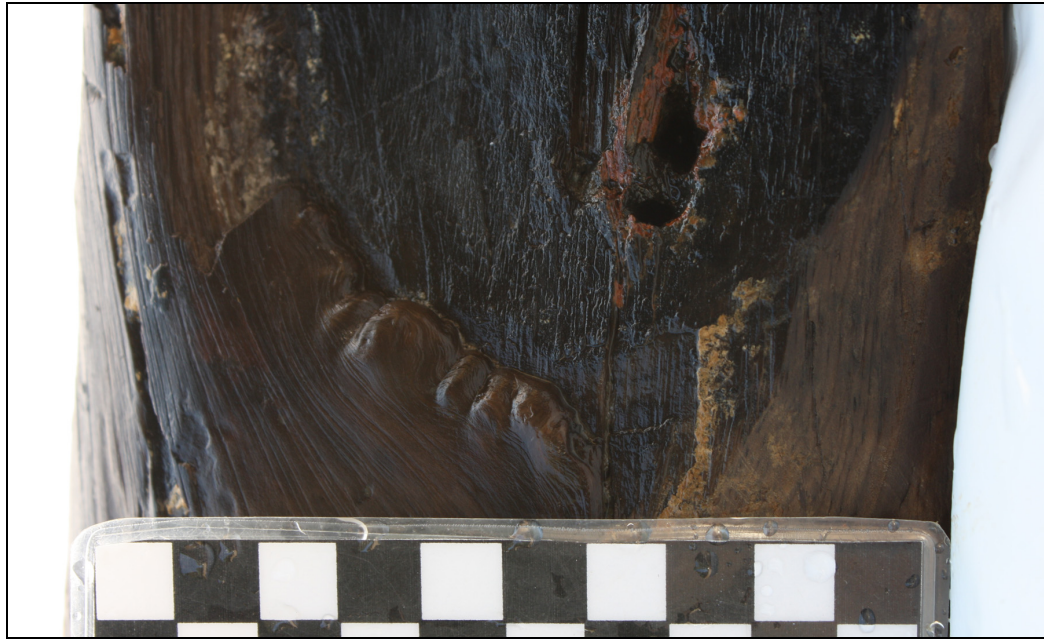
**Figure 4.29. Fire scarring on the outer face of FR 11.**

Four of the longest replacement floors, FR 11, FR 13, FR 17, and FR 19, were cut from fire-scarred Turkish pine. This appears in areas of original surface as a smoother lower layer surmounted by a thick, uneven border (fig. 4.29). Three deep, rough cuts to the forward face of FR 17 may represent an attempt to remove the scarred timber (fig. 4.30).

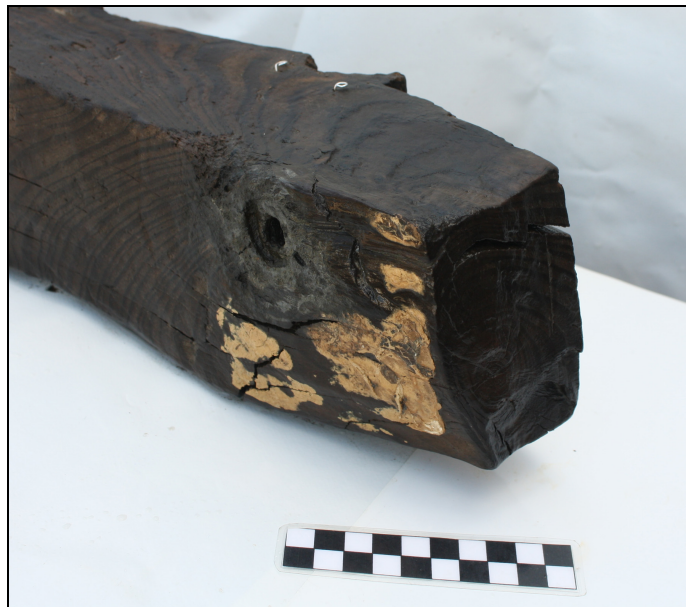
**Figure 4.34. FR 20 keel end. The tip was blunt-cut, likely with an adze.**

Where undamaged, the keel ends of original half-frames were blunt-cut (fig. 4.34). The keel end of FR 22 is exceptionally small, seemingly cut down on the aft and inner faces, possibly in association with the replacement of FR 22P (not preserved). The presence of pitch and multiple nails indicate that the keel ends of FR 6 and FR 8 were both badly damaged during the ship's lifetime.
