ANALYSIS AND RECONSTRUCTION OF SHIPWRECK YK 11  
(C. SEVENTH CENTURY A.D.) FROM THE THEODOSIAN HARBOR  
AT YENİKAPI IN ISTANBUL, TURKEY

A Dissertation

Submitted to the Office of Graduate Studies of  
Texas A&M University  
in partial fulfillment of the requirements for the degree of

DOCTOR OF PHILOSOPHY

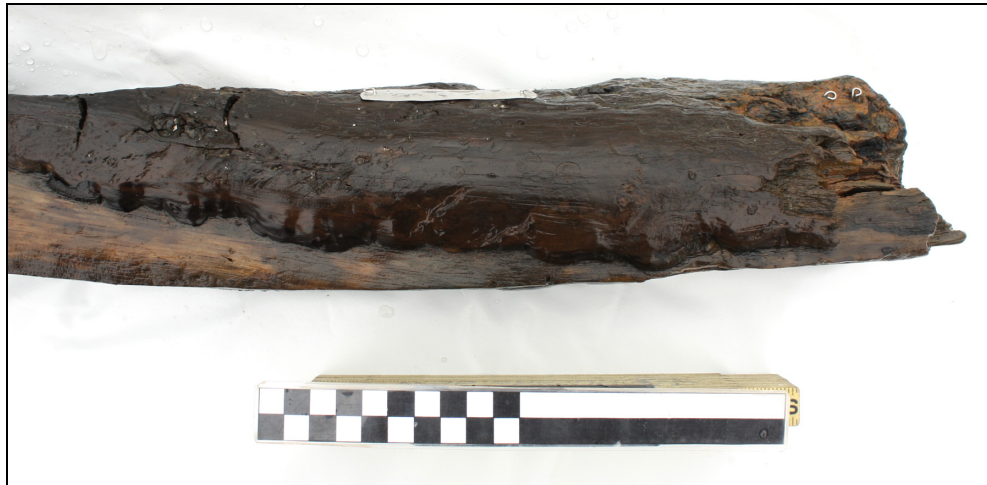
**Figure 4.35. Fire scarring on the forward face of FR 22.**

Wood species used for original half-frames is relatively consistent: seven of the eight are *Pinus brutia* (88%), while only one of them is *Quercus cerris*. There is evidence of fire-scarring on three of the original pine half-frames (fig. 4.35).

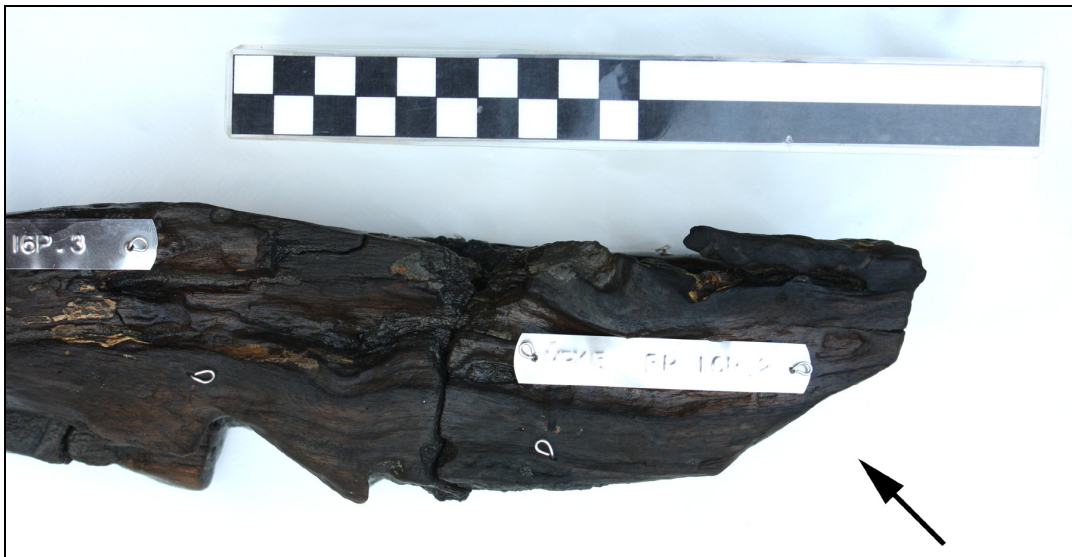
**Figure 4.36. Type B limber hole on FR 16P, forward face. Note angling of outer face near keel end (at arrow), which might have acted as a second limber hole.**

Each original half-frame possesses one limber hole, with an average width of 4.0 cm and depth of 2.6 cm. Five of the limber holes correspond to Type A, the triangular limber hole lacking a keel notch. Two of the limber holes are Type B and exhibit a clear keel notch. FR 16P is unique in that the keel end extends beyond the port edge of the keel, after which the outer face angles up sharply, much like the edge of a second limber hole (fig. 4.36). FR 26 has a Type C limber hole, appropriate for its location in the bow. The limber holes were adzed or chiseled; edges are usually not chamfered. The two keel notches, on FR 16P and FR 20, both appear to have been saw-cut.

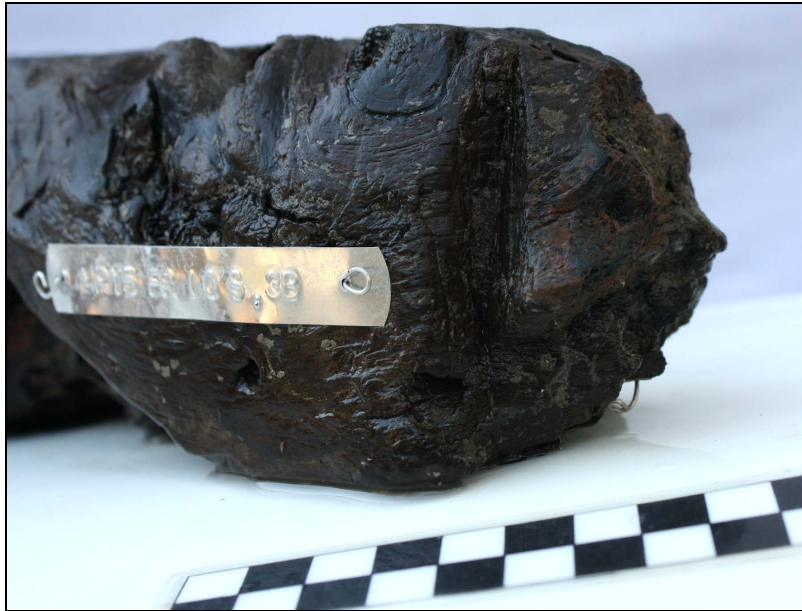
**Figure 4.37. Notch on the inner face of FR 10, near the broken top end.**

The only other possible notch on the original half-frames is near the top (broken) end of FR 10. This notch runs across the inner face of the frame and is 1.4 cm in depth; it seems to have been cut with an adze or chisel with a 3 cm blade (fig. 4.37). The function of this notch is unclear, but would have been located at approximately the same level as the top of a through-beam; perhaps part of the stern deck fit into this notch.

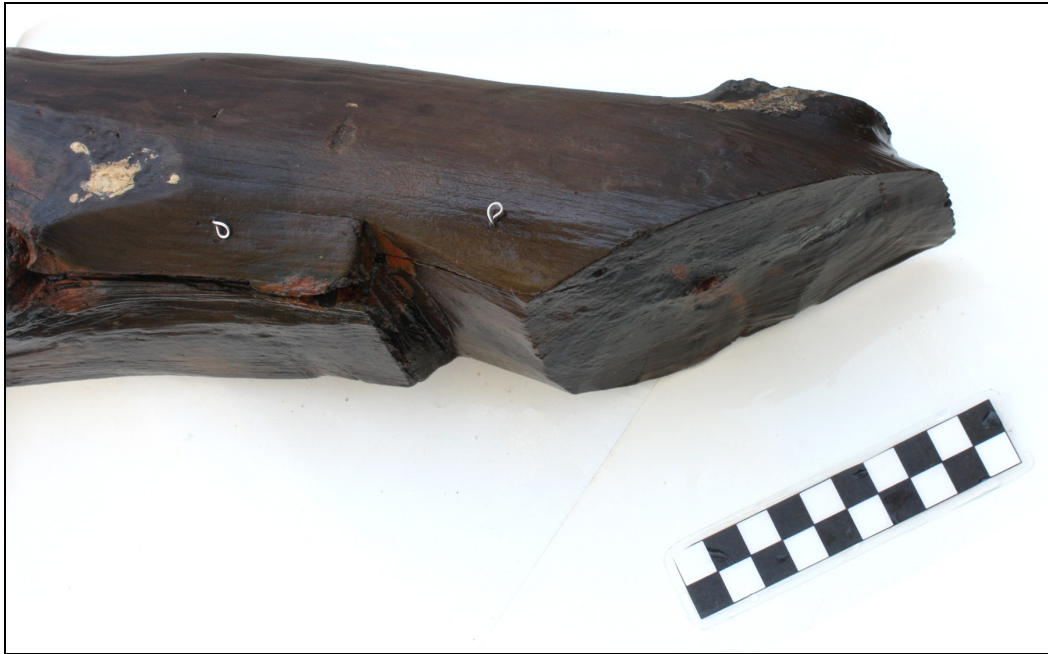
**Figure 4.38. Tapering, minimally-worked keel end of FR 18.**

As on all other frames, the replacement half-frames tend to taper toward original ends, either through the natural form of the timber used (best exemplified by FR 18, fig. 4.38), or through the cutting down of one or more faces. Keel ends that do not taper to a point (as do FR 1 and FR 18) were blunt cut, perhaps with a chisel or adze (FR 2, FR 12, FR 14, FR 16).

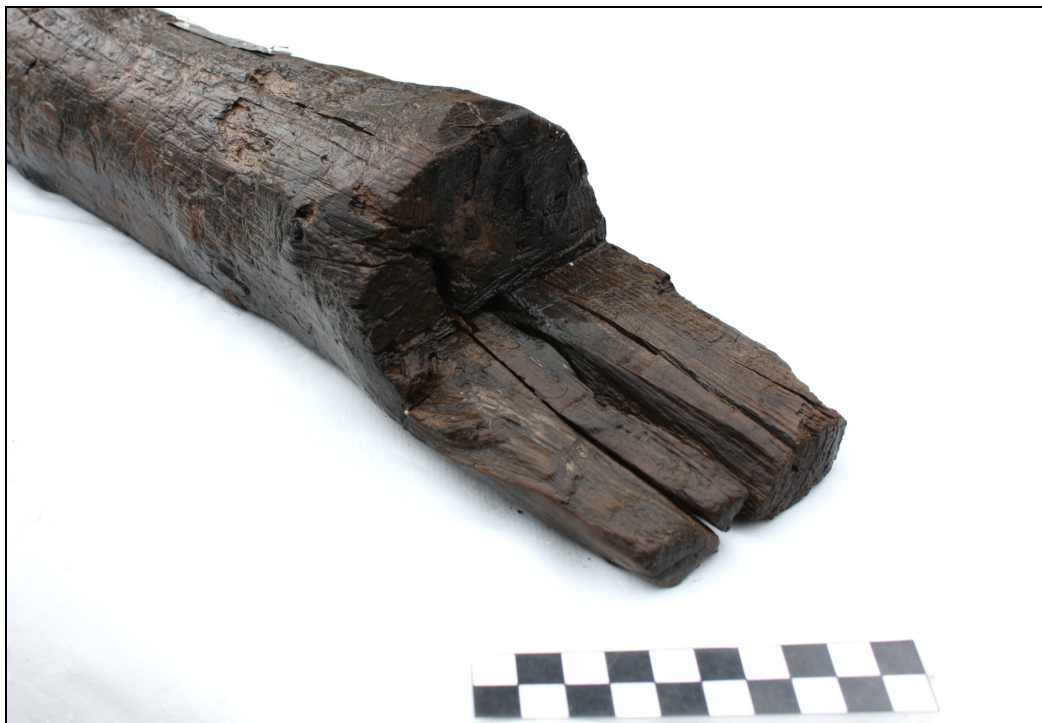
**Figure 4.43. Original notched end of UM 53. Possible top timber?**

with a rounded section very similar to F 12 and F 18. There is a deep notch cut into the original (top?) end of this timber (fig. 4.43), reminiscent of futtocks from the Port-Berteau II ship.<sup>20</sup>

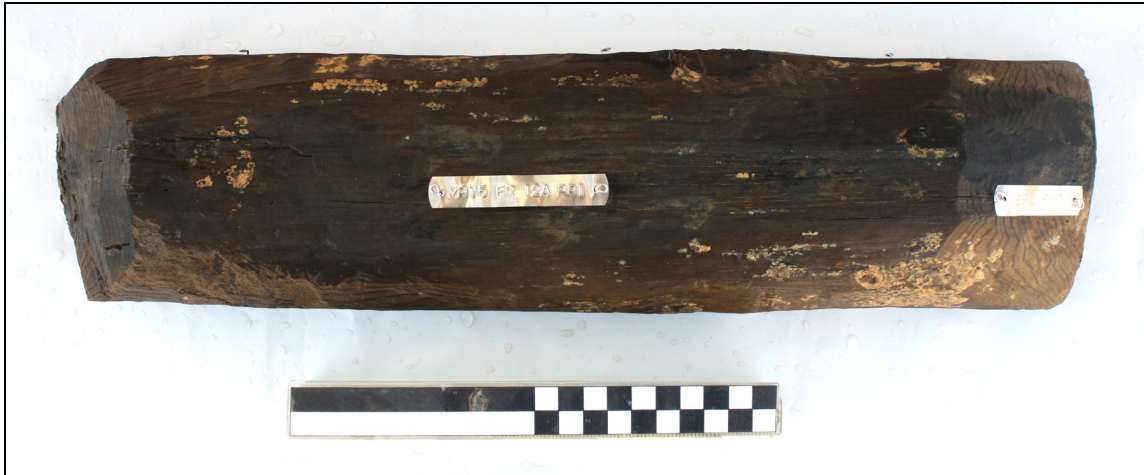
**Figure 4.44. Reinforcement piece FR 12A.**

One other framing element was found on the ship in situ. FR 12A is a short, low-profile timber that was attached to the starboard planking in order to provide a surface onto which the damaged forward end of PS 2-2 could be fastened (fig. 4.44). This timber was located aft of FR 12P (not preserved). This short timber of *Pinus brutia* was 45 cm long, 10.3-11.2 cm sided, and 5.3-6.0 cm molded. It was fastened to five separate pieces of planking with one iron nail each; none of the nails extended through the inner face of the timber, and none was driven through a pilot hole.

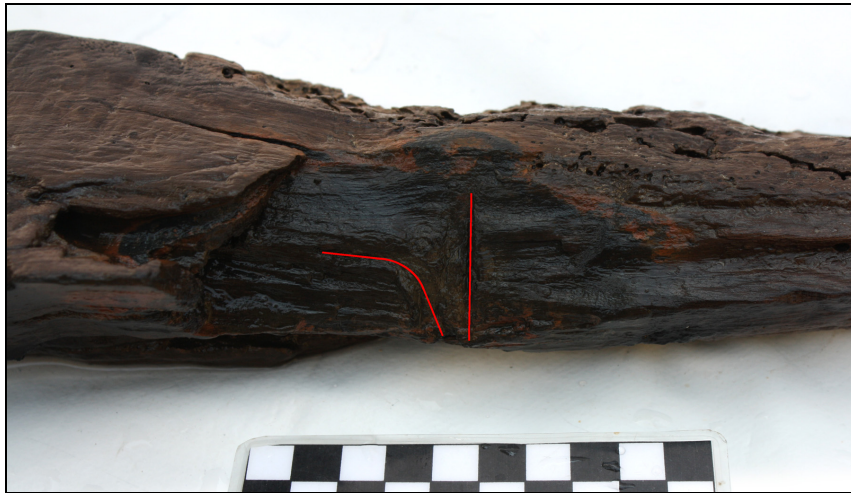
**Figure 4.45. Traces of iron nails on the broken aft face of FR 25. Note straight nail next to a nail which bent upon insertion (red line added for clarification.)**

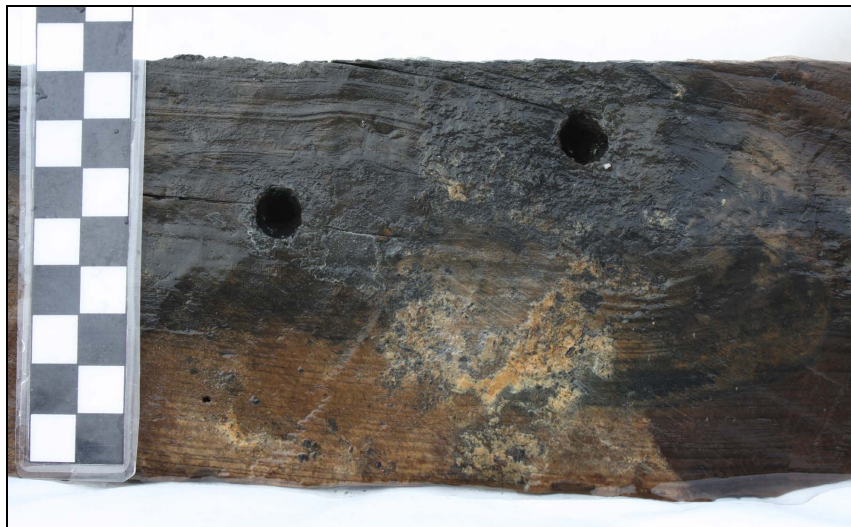
**Figure 4.46. Pilot holes on the outer face of FR 4.**

Pilot holes, while relatively uncommon on outer face nails, were recorded at one or more fasteners on approximately 1/3 of the frames (fig. 4.46); there are usually not more than one or two per frame. These pilot holes are usually 0.8-0.9 cm in diameter and

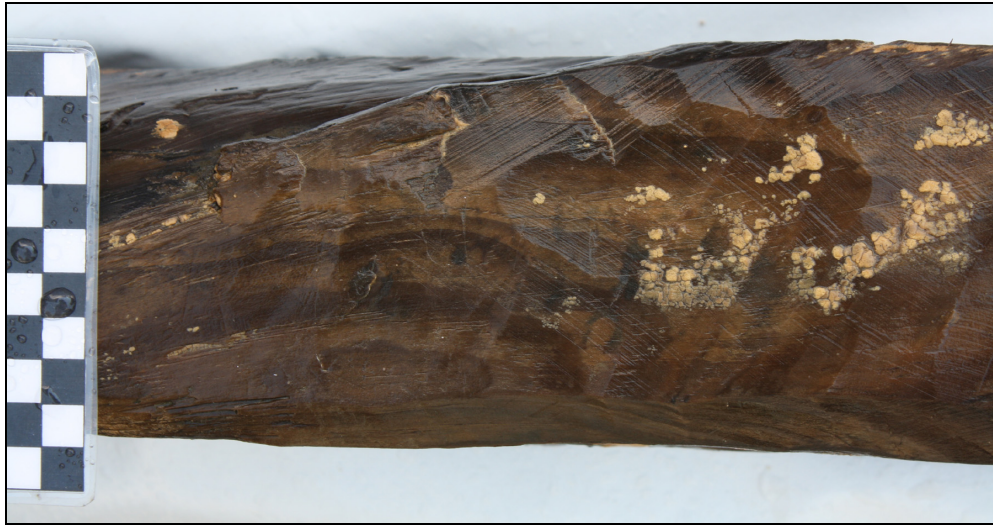
**Figure 4.47. Adze marks on the forward face of FR 11. Overlapping tool marks obscure the original blade width. Note striations due to the use of a chipped adze blade.**

Adzing is prevalent on the framing, with three or four faces of each frame finished with an adze. Tool marks indicate use of a chipped blade 3.5-5.1 cm in width (fig. 4.47). The chips in the blade result in light striations visible within the tool marks, at times more distinct than the start and end of an adze blow. Overlapping tool marks may obscure original blade width. Adze marks are surprisingly well preserved on the outer faces of some frames. Adzing is usually the only tool mark observed on minimally worked surfaces, where small branches or knots were trimmed with a chipped adze. Edge chamfers, where present, were dubbed with an adze, and an adze was also used to trim down areas of some sawn surfaces. The roughly-cut area on the outer-aft edge of FR 21, just over the keel, was probably dubbed with an adze up to 5 cm in width (fig. 4.48).

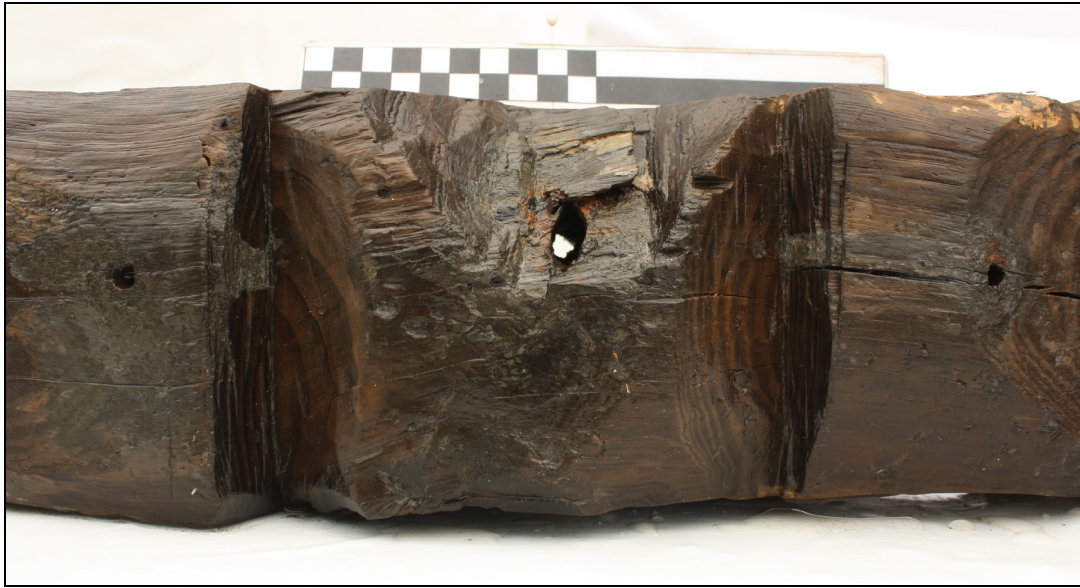
**Figure 4.48. Outer face of FR 21 at the keel. The outer-aft edge was roughly cut down.**

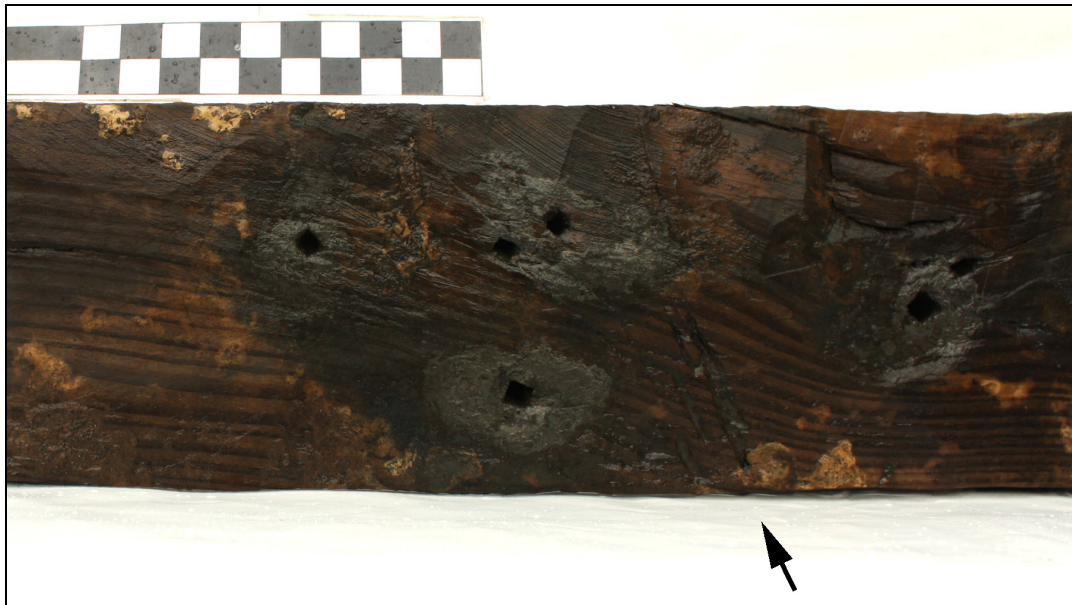
**Figure 4.49. Cut marks on the outer face of FR 20.**

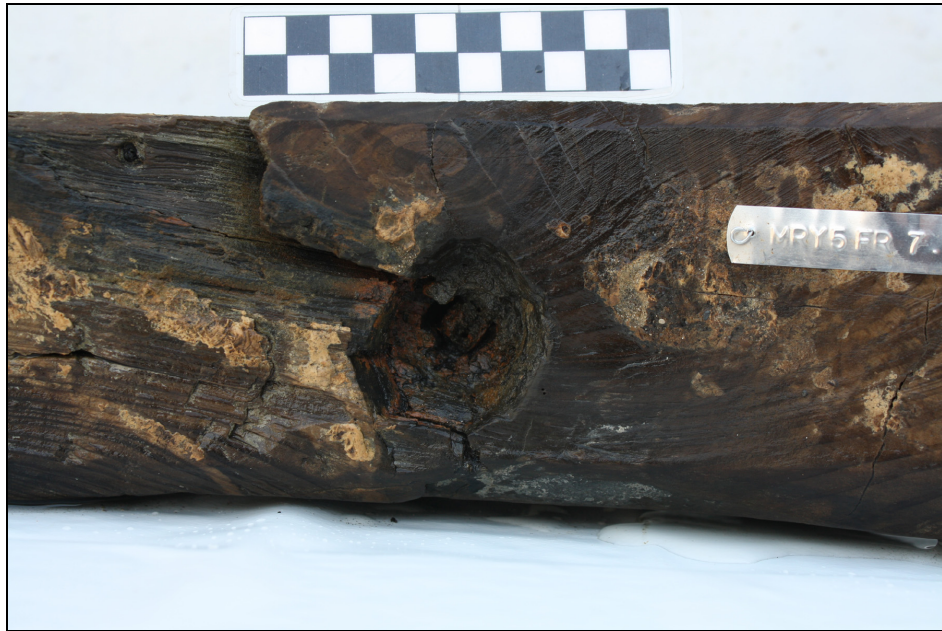
**Figure 4.50. Countersunk nail head on the inner face of FR 7.**

Some tool marks are more difficult to interpret and may indicate the use of either a flat-bladed adze or a chisel in the forming of limber holes, cutting of notches, and trimming of surfaces. Well-preserved tool marks indicate that limber holes were primarily cut with a blade 2-3 cm in width, although wider tool marks, up to 4.7 cm in width, were observed. Some of the limber holes, as on FR 4 and FR 17, may have first been started with a saw prior to adzing or chiseling. The FR 21 futtock notches may have been cut with a combination of adzing and chiseling. Cut marks on the outer face of frames at plank seam locations, likely from an adze or chisel, are not uncommon and indicate where planks were cut down for repair (fig. 4.49); other marks at plank seam locations might have resulted from the cutting of tenons prior to the recaulking of the ship. A narrow chisel, 1.5-2.0 cm in width, was used to countersink nail heads on FR 7, FR 15, and FR 17 (fig. 4.50).

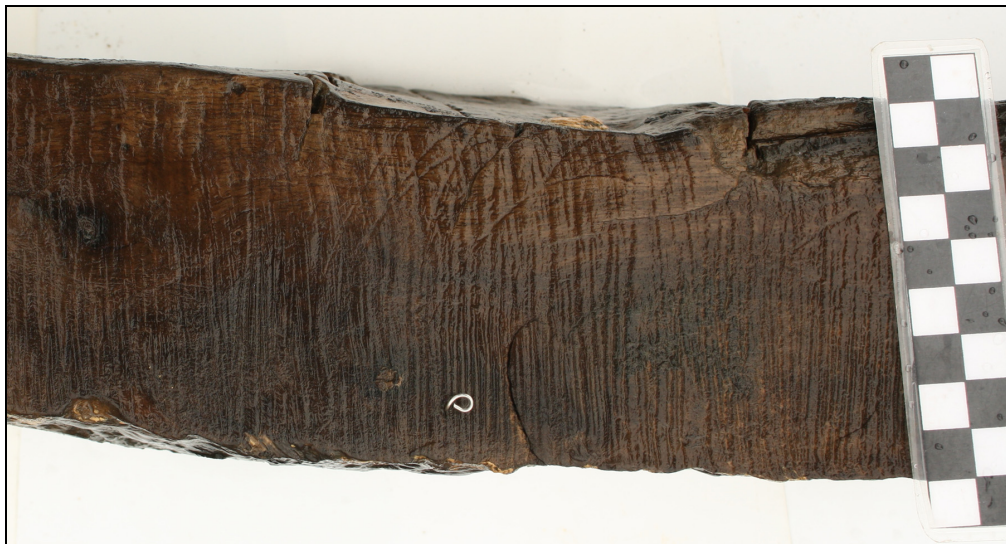
**Figure 4.51. Forward face of F 13, with saw marks and saw return marks.**

Sawn surfaces exhibit closely-spaced parallel lines that vary slightly in orientation along the length of the timber. Curved scratch-like marks on the sawn faces are probably saw return marks (fig. 4.51).<sup>21</sup> FR 5 is the only large frame that is partly sawn on its outer face; saw marks are present to either side of the FR 5 limber holes for a short distance (approx. 5 cm), while the remainder of the outer face was adzed. On FR 17 and FR 19, the floor was saw-cut for most of the aft face, then roughly split toward the end. Sawing appears to have been done in two different directions on FR 6, FR 8, and FR 16, with the keel end sawn from the keel toward the top end, and the top end

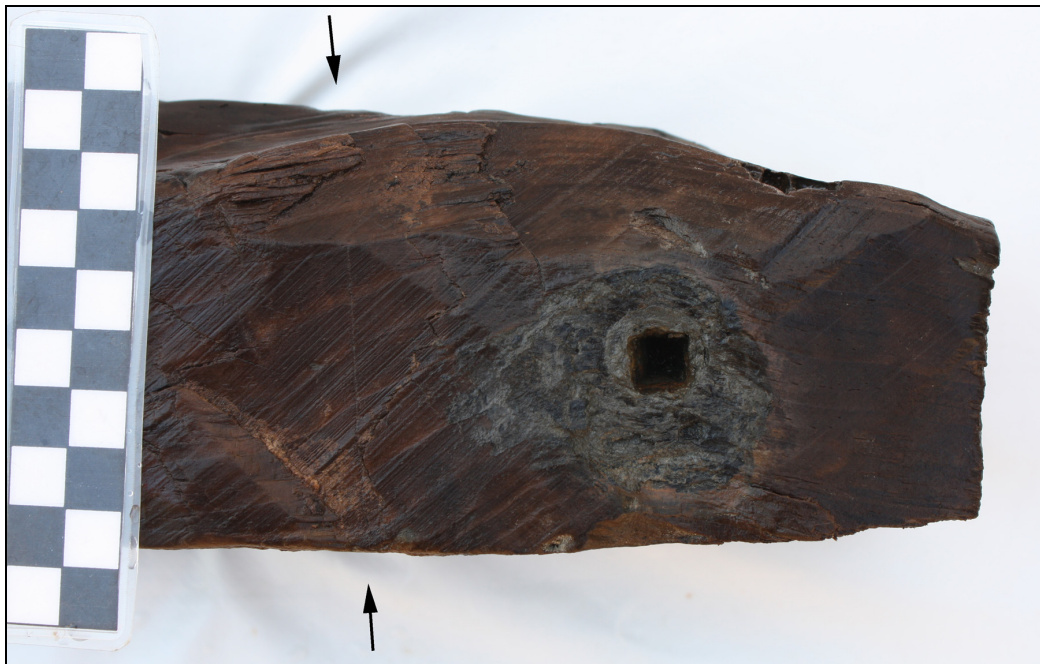
**Figure 4.52. Thin score mark on the inner face of FR 24, near keel end.**

Finally, score marks were noted on the inner face of replacement half-frame FR 14 and original half-frame FR 24 (fig. 4.52); these marked the location of stringers and other internal timbers that would have been temporarily removed during repairs. Other occasional knife cuts on frames' inner faces are of unknown function.

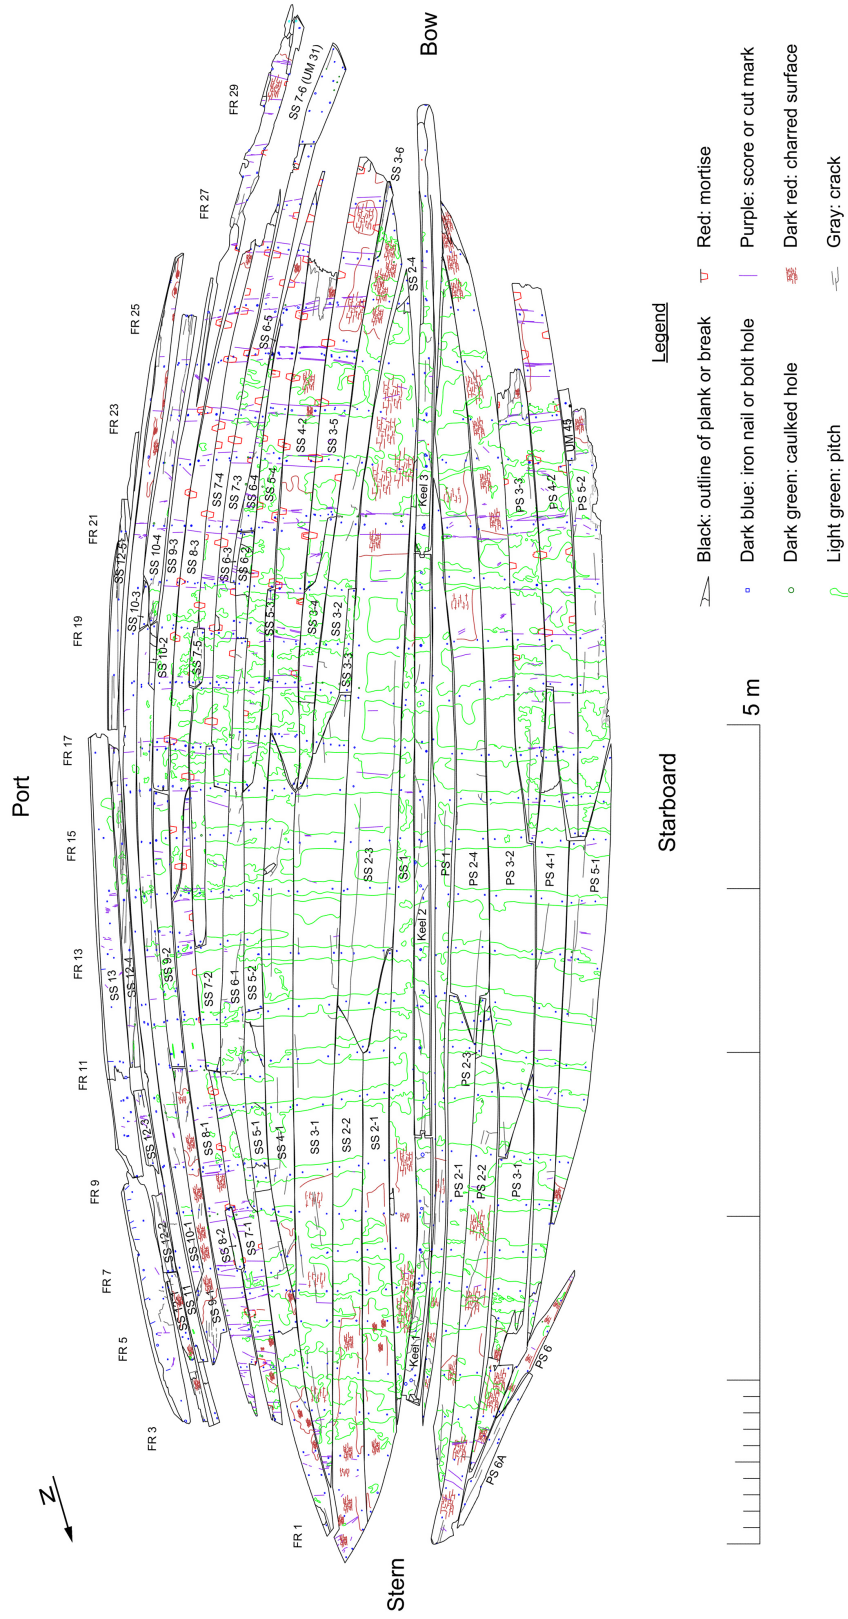
Figure 4.54. YK 11 planking, with surface detail shown.

The planking of YK 11 is in a very good state of preservation. Approximately 50% of the hull planking was preserved, comprising 58 distinct planks in 17 strakes (table 4.5, fig. 4.54). Planking was preserved to the turn of the bilge on the starboard side and to the second wale on the port side. The majority of the planks are complete, and more than half of the extant planks and small replacement or graving pieces are both complete and intact (32 of 58, 55%). The overall condition of these planks is excellent, most exhibiting original surfaces and surface treatment, well-preserved tool marks, and caulking along plank edges. Several planks also retain their original curvature,

system.<sup>26</sup> For example, the aftermost, furthest inboard plank on strake SS 2 was labeled SS 2-1, while the plank outboard of this was SS 2-2 and the wide forward plank SS 2-3 (see fig. 4.54). Graving pieces which spanned a strake seam, such as SS 7-5 and SS 8-2 (both along the SS 7-SS 8 seam), were grouped with one of the strakes along that seam.

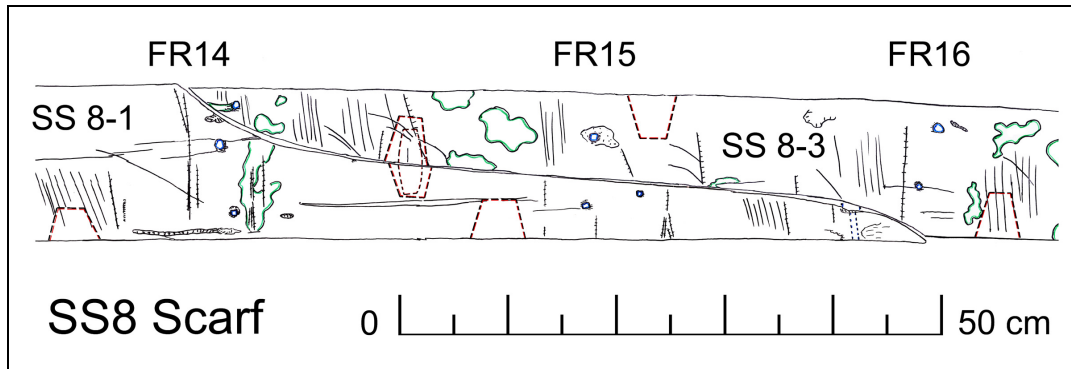
Figure 4.55. S-scarf on SS 8.

Only one original scarf has been preserved in the edge-fastened planking, the gently-curving S-scarf between SS 8-1 and SS 8-3, located around amidships (FR 14-FR 16); it is 69 cm in length (fig. 4.55). The SS 8-3 tip was nailed to FR 14, while the SS 8-1 tip was just slightly shy of FR 16 for fastening; instead, this tip was fastened to SS 7-4 with a transverse iron nail. SS 8-1 and SS 8-3 were also joined along the scarf edge by a mortise-and-tenon joint along the central (flat) portion of the scarf. SS 4-2 also terminates in a slightly-curving S-scarf at its aft end; however, rough cutting, a lack of

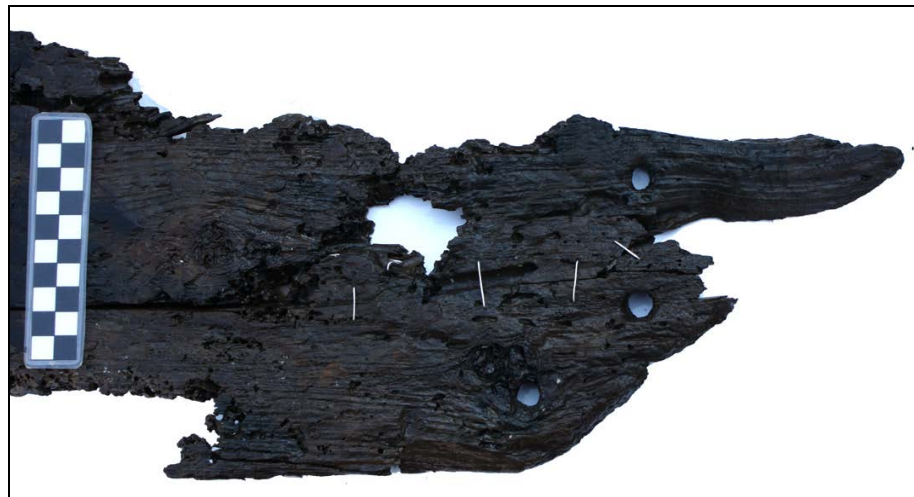
**Figure 4.56. Forward hood end of original plank SS 9-3.**

There is only one hood end preserved on the original, edge-joined planking, SS 9-3 (fig. 4.56).<sup>29</sup> The hood end is cut with a slight bevel (110°), and the forward end is at an angle of 142° to the lower edge. There are two drilled holes for nails near the edge, and a damaged area that probably held a third iron nail.

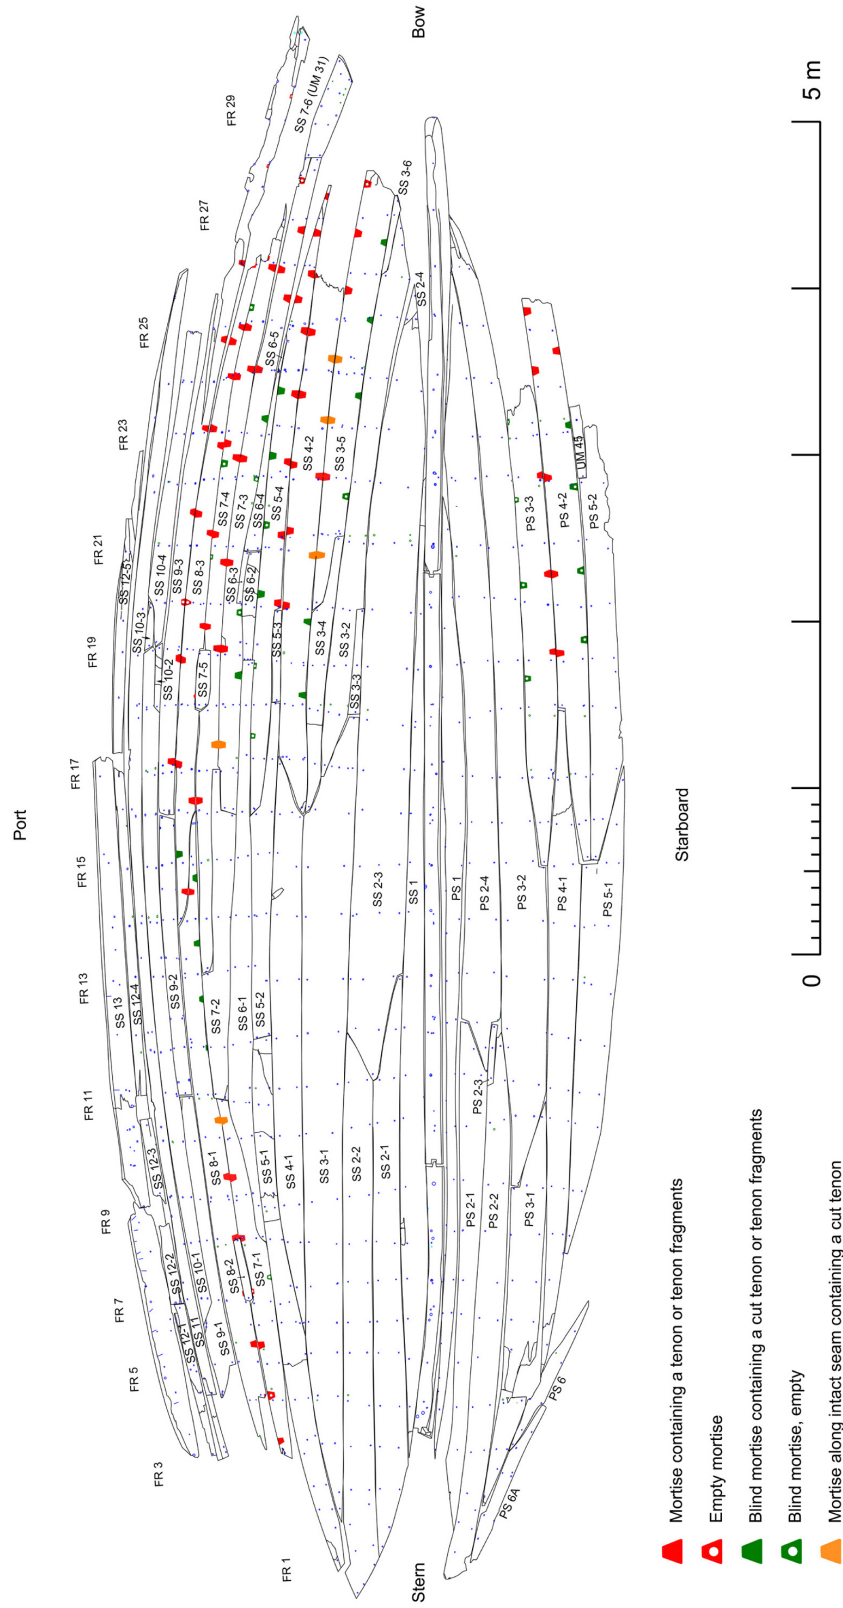
Figure 4.57. YK 11 mortise-and-tenon joints.

The 11 extant edge-fastened planks retained evidence of 87 mortise-and-tenon joints (table 4.6, fig. 4.57). Mortises are chisel-cut and 3.3-6.1 cm in width, with an average width of 4.7 cm.<sup>30</sup> Mortises are 0.35-0.6 cm thick, with an average thickness of 0.47 cm.<sup>31</sup> A typical mortise-and-tenon joint is shown in figure 4.58. Depths of mortises vary significantly due to both rough cutting of the mortise as well as the relatively common trimming of plank edges to accommodate repairs; recorded depths range from

fragments of a tenon, or having been filled in with pitch, with or without caulking fibers. Of the 87 mortises identified on YK 11, 32 (37%) were blind, lacking a corresponding mortise on the facing plank (table 4.6, fig. 4.57). Even on seams for which both original planks are preserved, damage, often from *Teredo navalis*, had led to the cutting out of some mortise-and-tenon joints, subsequently replaced with wads of caulking (fig. 4.61) or a graving piece. Mortises were also cut down on the edges of original planks in order to accommodate replacement planks; this has led to some unrepresentative variation in mortise width and depth, noted above. Damage to mortises due to coincidental placement of nails is not uncommon; such damage was also noted in the hull planking of the seventh-century Yassiada ship.<sup>33</sup>

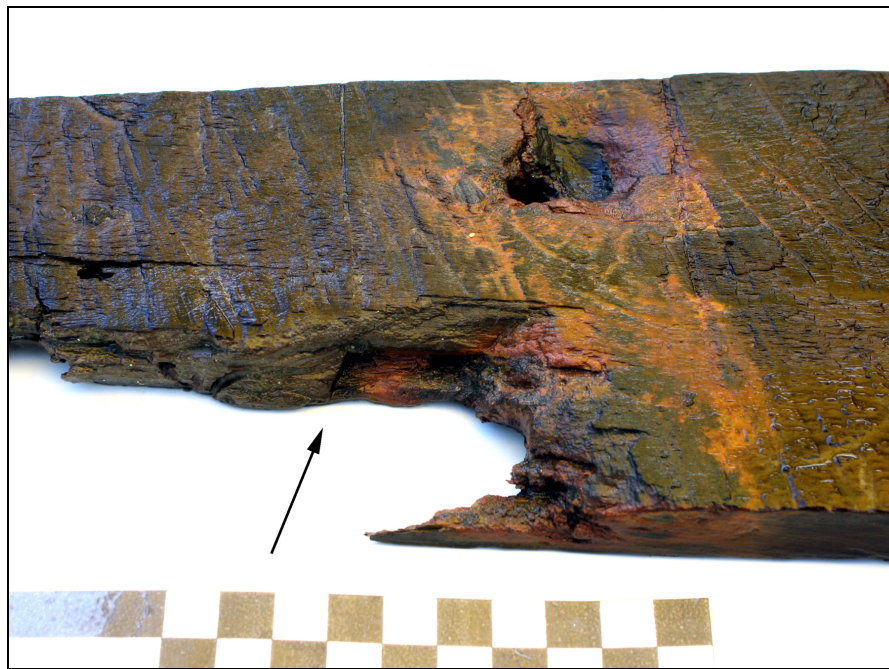
**Figure 4.59. Exposed mortise along the top edge of SS 7-4. Note angled cuts to edges (arrow).**

Although uncommon, broken plank surfaces reveal that the mortises of YK 11 were cut at an angle (fig. 4.59), such that the back wall of the mortise was narrower than the opening along the plank edge. An exposed back wall of a mortise on PS 3-3 further reveals that the mortises were relatively roughly cut, with jagged, irregular back walls. Tool marks at this exposed mortise, combined with what appears to be the profile of a

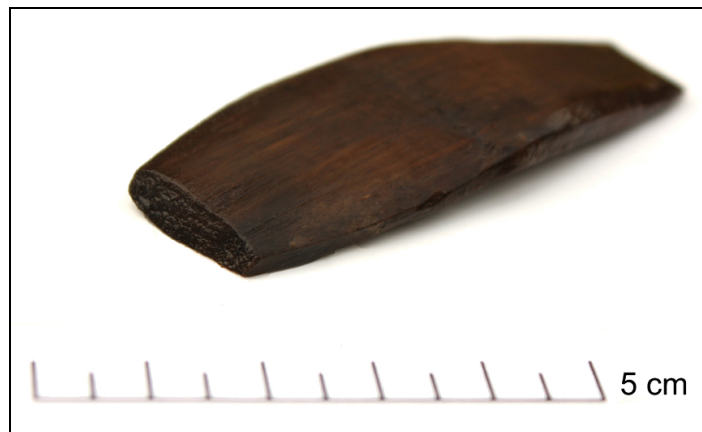
**Figure 4.63.** Oblique view of intact tenon at SS 7-3-SS 7-4 seam at FR 20-FR 21. Note beveled tip and narrowing of tenon toward ends.

Tenons are widest around the plank seam and taper toward the ends (average width at ends is 1.5 cm.) They taper slightly in thickness as well, to an average of 0.33 cm near the end; from this slightly diminished thickness, the tenon is then beveled down to a thin tip (fig. 4.63), with bevels on average 0.3 cm in length. In very few cases, this end bevel is omitted and the tenon terminates in a blunt end. On six of the seven complete tenons, the bevels are on the same face.

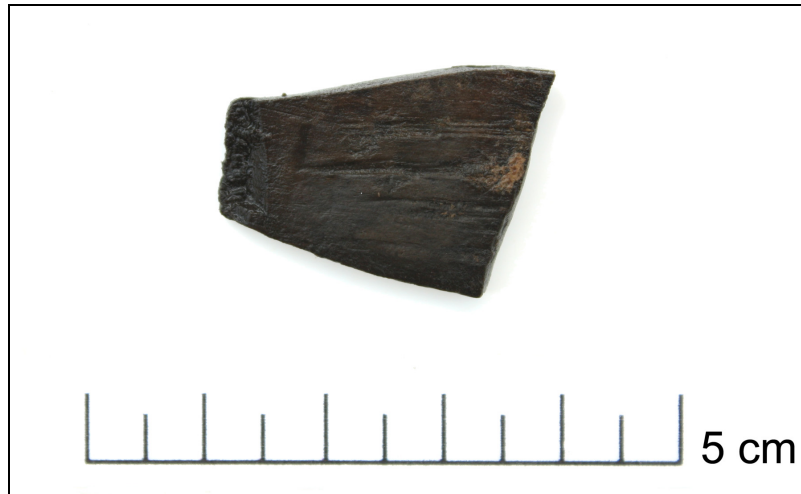
**Figure 4.64. Tenon cut at an oblique angle. From SS 5-4 top edge at FR 20. Note pitch near plank seam edge, bevel at tip, and pressure marks from the plank.**

Tool marks are very rarely preserved on the tenons; preserved tool marks and the tapered form of the tenon both suggest whittling with a sharp knife. Pitch is present in patches on several tenons, usually along the plank seam, but sometimes as sparse patches

elsewhere (fig. 4.64). A sharp pressure line or pitch ridge denotes the location of the plank seam on all of the intact tenons. As illustrated in figure 4.62, three of the five intact tenons were bent or distorted along the plank seam.

Of the 87 extant mortise-and-tenon joints, 18 (21%) held a tenon (or fragments thereof) that had been cut through along the plank seam. Ten of these were found in blind mortises, indicating that the tenons were cut to facilitate a repair, but five of the cut tenons are located along original, intact seams.<sup>37</sup> It is unclear why such tenons would have been cut, but this may have been associated with recaulking the vessel: the tenons were likely first cut through with a knife before a caulking iron was used to drive waterproofing material into the plank seam. Four of the cut tenons were at an angle within the mortise when cut, as evidenced by their oblique cut line (figs. 4.62, 4.64). The

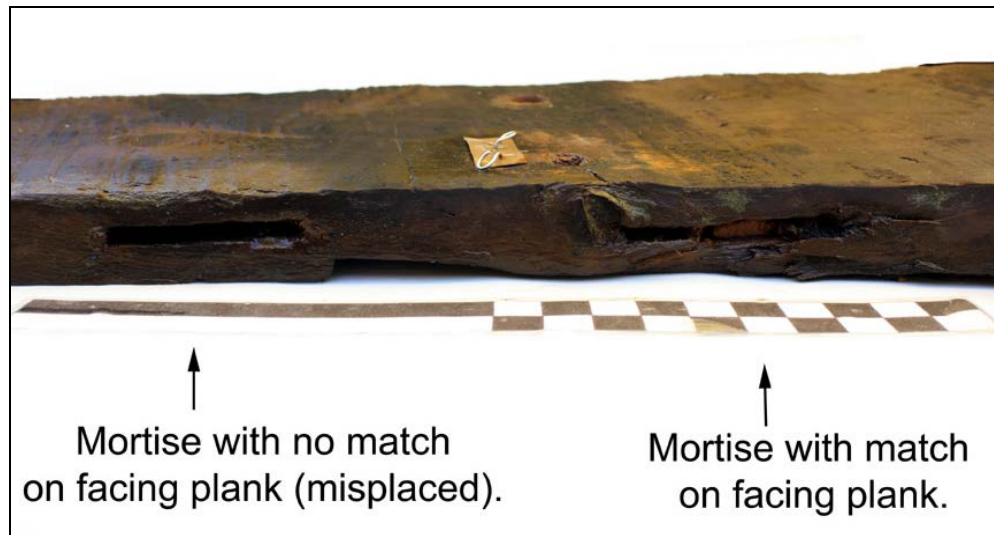
**Figure 4.65. Mortises on the top edge of SS 7-4 near F 25.**

There are two places in the edge-fastened planking where the mortise-and-tenon joints do not align as expected, both on SS 7-4. On the upper edge of SS 7-4, there are three empty mortises with no match on the facing plank, SS 8-3. These appear to be mistakes, cut either just forward (F 25) or just aft (FR 21-FR 22, FR 22-FR 23) of the functioning mortise (fig. 4.65). Spacing between these blind, misplaced mortises and the functional mortise is 8-12 cm. While the widths and thicknesses of the misplaced mortises are commensurate with those of other mortises, the depths of two of them are much shallower, suggesting the shipwright realized his mistake before completing the mortise to its usual depth. This is not surprising in the mortise at FR 21-FR 22, which may have been re-cut after it was cut too close to the plank's outer face.<sup>38</sup> It is less than half the depth of the functioning mortise (1.6 and 3.5 cm, respectively.) The blind, misplaced mortise at F 25 was only 2.8 cm in depth, while the functioning mortise was about 50% deeper (4.3 cm). The deepest of the misplaced mortises, that at FR 22-FR 23, was filled in with pitch.

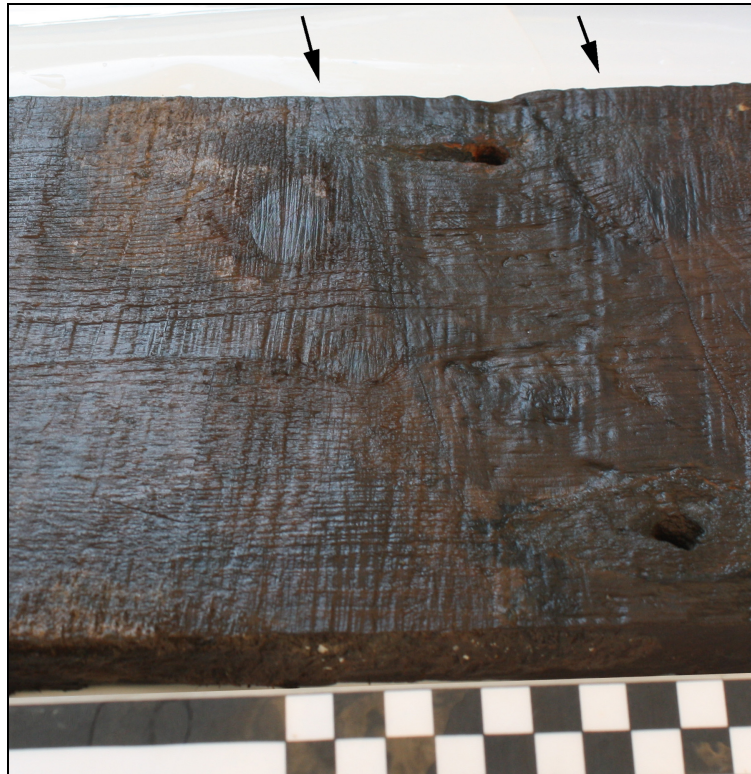
**Figure 4.67. Score marks on PS 3-3 at FR 21. Differentiating between saw marks and score or other cut marks was facilitated through the use of raking light. Score marks here are denoted by arrows.**

especially if saw marks run in a similar orientation (fig. 4.67). Some score marks, especially those at charred areas near the ship's extremities, are wider and deeper, possibly cut with a different tool than the thinner score marks (fig. 4.68). Perhaps a different tool was needed on the harder, charred surfaces, or perhaps the nature of the charred wood caused the marks to be better preserved.

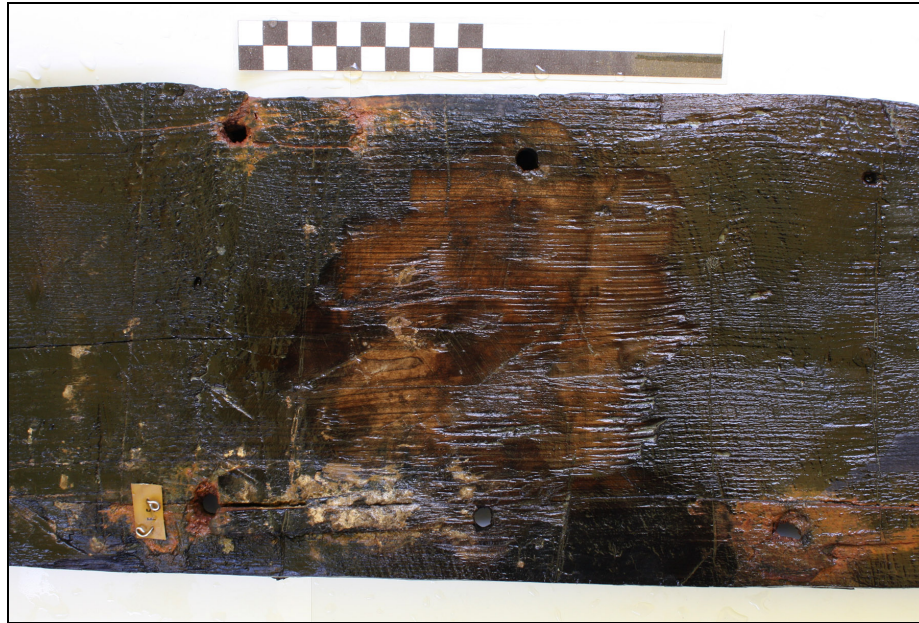
**Figure 4.69. SS 8-1 at FR 5-FR 7. The charred inner face of the plank is adzed down at the original location of futtock F 5; note lighter color at adzed area.**

There are several areas where multiple score marks have been cut along one frame edge. These score marks may highlight a discrepancy in placement between an original and a replacement frame. On SS 7-1 and SS 8-1, score marks at an original futtock location are partly obliterated by later adzing, while score marks at the replacement for that futtock, aft rather than forward of the floor, cut across any previously adzed area (fig. 4.69). Comparison of score marks may also indicate whether a framing element had been replaced or not, even though the frame itself is not

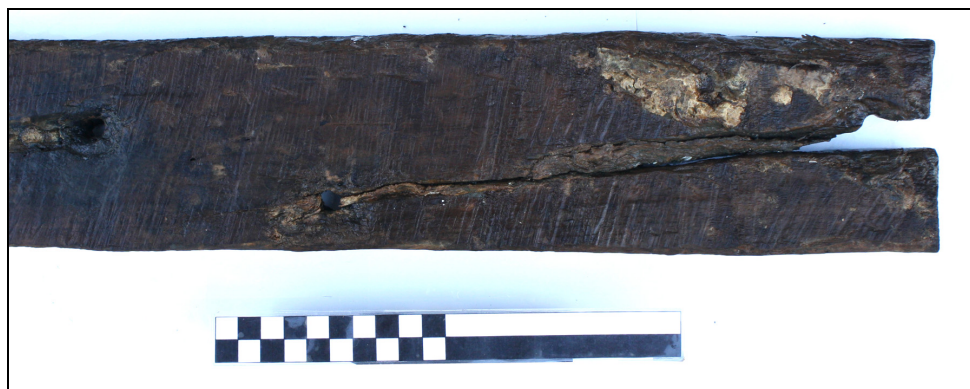
**Figure 4.70.** Caulk wad stuffed in split at aft end of SS 12-4, outer face.

Most of the other planks of this type are relatively solid; cracking is usually associated with nails, and damage from teredo or gribble may be present in areas that were exposed after sinking. Both SS 10-4 and SS 12-4 have areas of old damage that were either filled in with pitch or stuffed with caulking fibers (fig. 4.70). Splits or cracks that emanate from the blunt-cut ends, often running through a nail hole, are present on each plank in SS 12. Wear or damage on several of the plank ends in this strake seems to be associated with their abutting a through-beam (fig. 4.71).

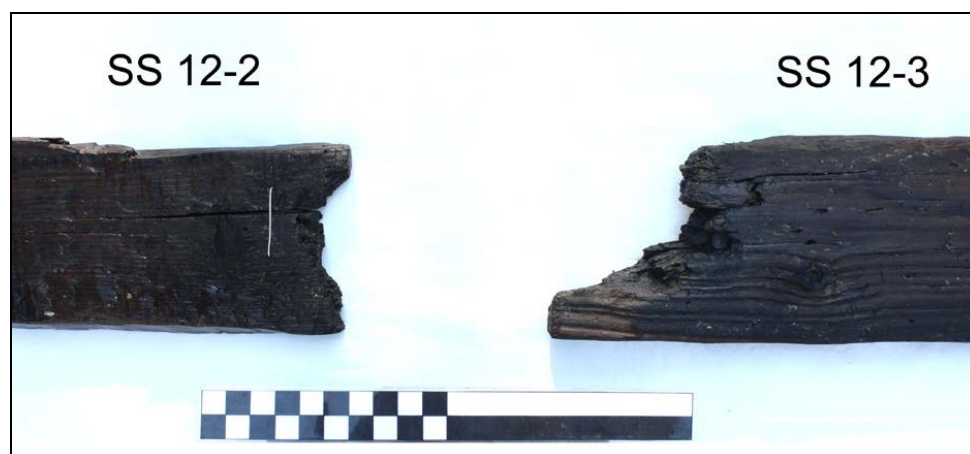
**Figure 4.71.** Gap between SS 12-2 and SS 12-3 for FR 8-FR 9 through-beam; inner face shown.

The planks that comprise SS 12, including UM 110, terminate in butt joints in varying degrees of preservation. SS 12-1 joins SS 12-2 in a butt joint at a very slight angle, while the remaining original ends butted up against through-beams.<sup>45</sup> Based on the one extant fragment of a through-beam, these were recessed to receive the blunt-cut ends of strake twelve, and pressure marks or discoloration on the outer or inner faces of these ends reflect the form of the through-beam (fig. 4.72). Damage at these ends is also relatively common (fig. 4.71).

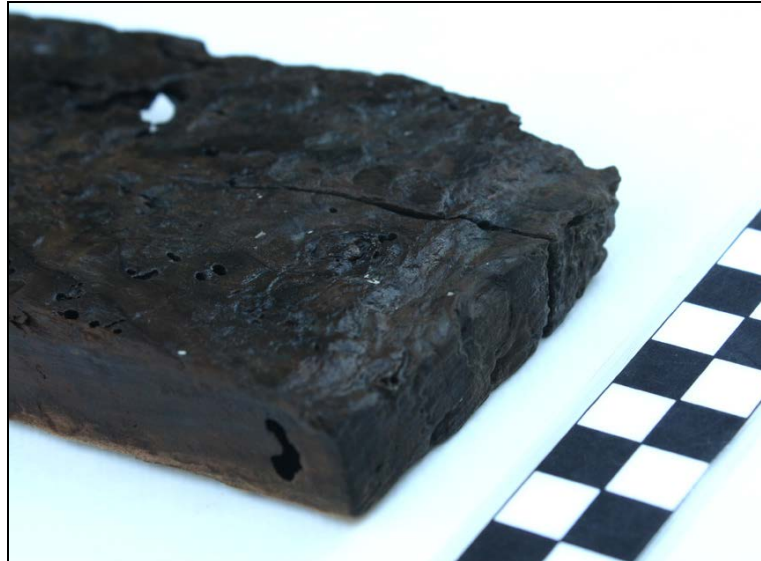
**Figure 4.72. Outer face of UM 110 at preserved (aft?) end. Pressure mark likely reflects the outline of the through-beam, recessed to receive the plank end.**

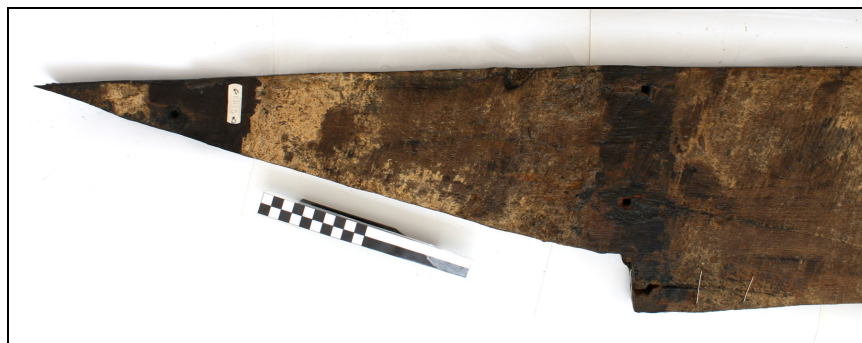
**Figure 4.74. PS 3-1 forward scarf.**

SS 6-1) were recorded. The narrow forward tip of PS 3-1 was fastened to the plank below with a transverse iron nail.

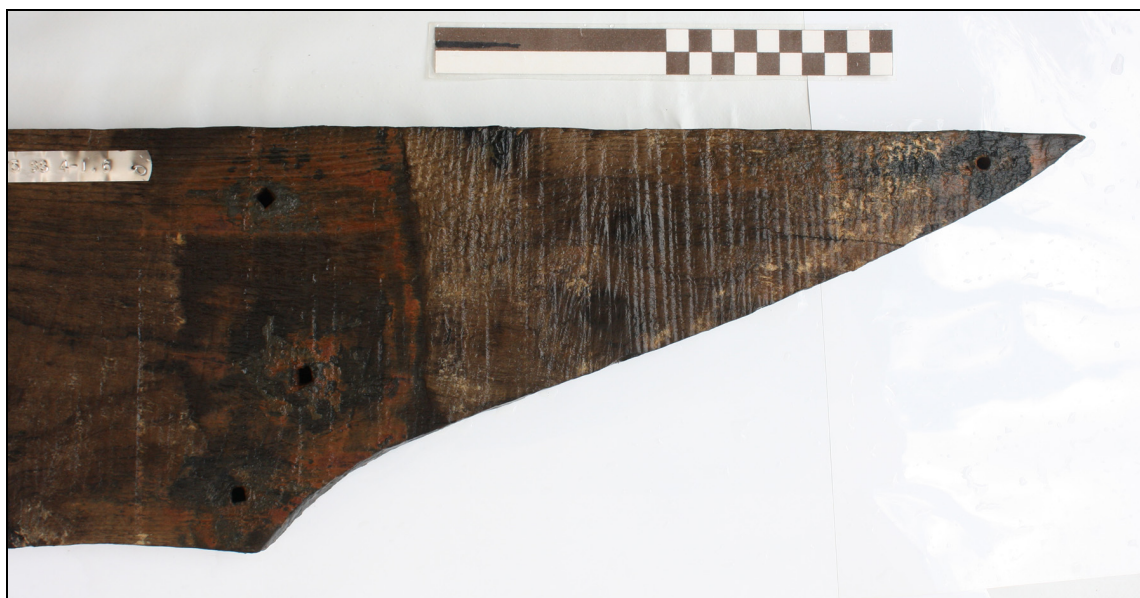
**Figure 4.75. SS 4-1 forward scarf.**

scarf (fig. 4.75).<sup>54</sup> In contrast to the scarf on original planks SS 8-1 to SS 8-3, the curved scarfs of replacement planking are shorter (29-35 cm), only covering two frame locations, again with scarf tips at frames. Diagonal scarfs were only recorded on two of the replacement planks, although neither resembles a typical diagonal scarf.<sup>55</sup> The narrow aft end of SS 3-4 (fig. 4.73, to left) is only 22 cm in length; only one end of this approximately diagonal scarf falls at a frame location. The aft end of SS 3-2, 40 cm in length, more closely resembles a typical diagonal scarf; however, this was originally probably a two-planed scarf whose vertical portion was later cut off and replaced with graving piece SS 3-3.

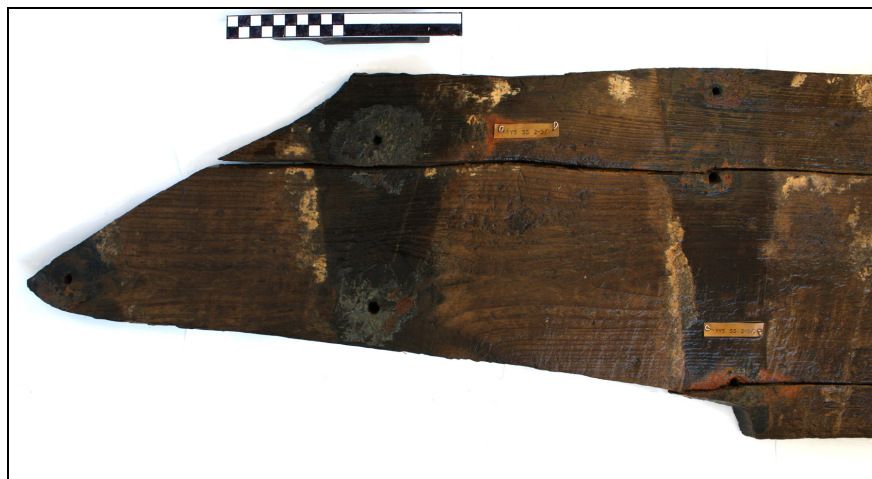
**Figure 4.76. SS 2-3 aft scarf. “Double” scarf for both SS 2-1 and SS 2-2.**

Finally, there are five plank ends at which a scarf is cut out of both the top and the lower plank edges, forming a double scarf, which accommodated two separate planks.<sup>56</sup> The clearest example is on the aft end of SS 2-3 (fig. 4.76), in which the plank's top and lower edges form an unbroken, approximately straight seam with the lower edge of SS 2-1 and the top edge of SS 2-2. The double-scarfed planks on the starboard side tend to be less clear-cut; as exemplified by PS 2-2, these usually have one clearly-delineated edge, while the opposite edge is trimmed down to create a subtle, ill-defined diagonal scarf (fig. 4.77). Because these planks are narrower than SS 2-3, and the adjoining planks wider, the smooth seam lines of the port side are not present on much of the bottom on the starboard side. The double scarfs are 33-92.5 cm in length and cover between two and four frames, with scarf ends at frame locations.
