ANALYSIS AND RECONSTRUCTION OF SHIPWRECK YK 11  
(C. SEVENTH CENTURY A.D.) FROM THE THEODOSIAN HARBOR  
AT YENİKAPI IN ISTANBUL, TURKEY

A Dissertation

Submitted to the Office of Graduate Studies of  
Texas A&M University  
in partial fulfillment of the requirements for the degree of

DOCTOR OF PHILOSOPHY

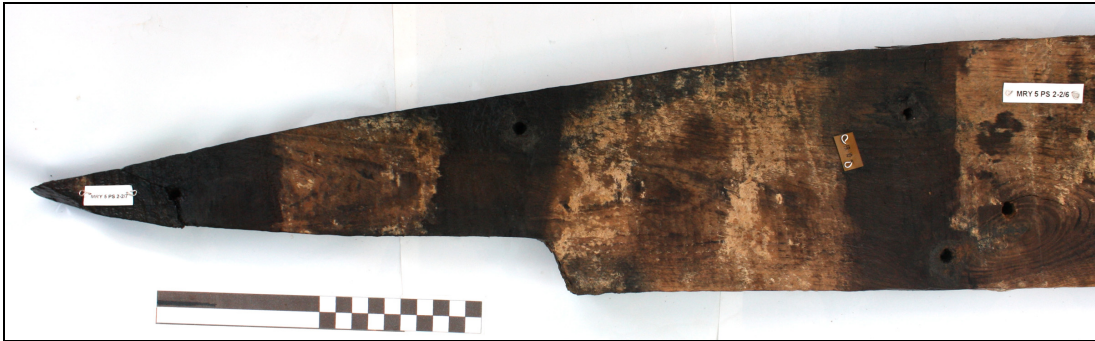
**Figure 4.77. “Double” scarf at forward end of PS 2-2.**

<sup>56</sup> PS 2-2 (forward end), PS 2-4 (aft end), PS 3-2 (aft end), PS 4-1 (forward end), and SS 2-3 (aft end). Technically, the forward end of SS 3-1 also accommodated two planks and one graving piece; however, in form, it closely resembles a two-planed scarf and was therefore included in that category.

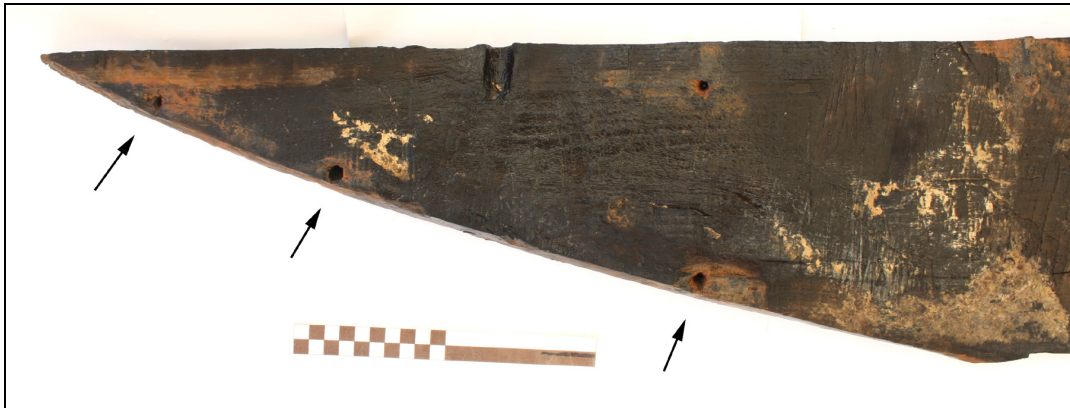
**Figure 4.78. SS 2-1 inner face at hood end. Rabbit nails are indicated with arrows.**

Nine of the replacement planks terminate in a hood end, where the plank was fastened to the ship’s keel, stem, or sternpost with nails driven from the outer face of the plank (fig. 4.78).<sup>57</sup> The end is cut at a diagonal, either long and shallow for planks lower in the hull (up to 1.08 m in length on the forward end of PS 2-4), or shorter and steeper for planks higher up in the hull (15 cm in length on the forward end of SS 7-6). The

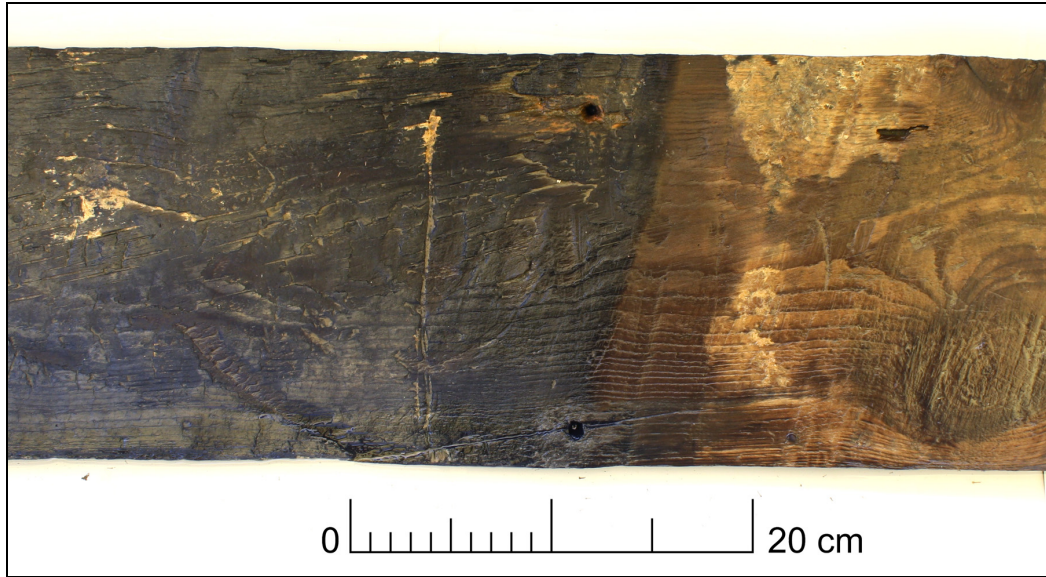
**Figure 4.79.** PS 3-2 inner face at FR 21. Note clearly-delineated charring and score marks at FR 21.

As expected, score marks were far less common on the replacement planks than the original planking, and they are also more poorly preserved, perhaps simply not cut as deeply. Score marks at charred areas are generally better preserved. Score or cut marks along some frame edges were recorded on approximately half of the replacement planks. They were observed at several replacement frames and are best preserved at FR 21, a very late repair (fig. 4.79). Score or cut marks in several areas on both the port and starboard sides at the stern indicate the replacement of multiple frames in this difficult area. A score mark just forward of original FR 20 on SS 2-3 could have been used by the shipwrights to mark where the plank should be char-bent. Score marks on SS 6-4 and SS 9-2 do not match those of neighboring planks, instead flanking the location of disused fastener holes; these score marks are thus further proof that these planks are recycled.

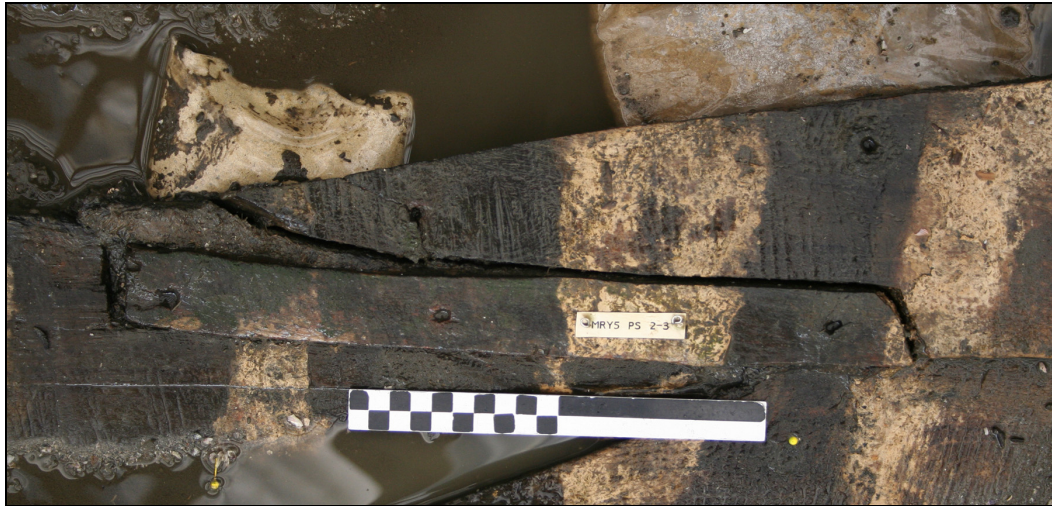
**Figure 4.80.** Graving piece PS 2-3 in situ. Note large wad of caulking at the gap between PS 2-3 and the forward end of PS 2-2.

The graving pieces are those small repairs that did not span the entire width of a strake; twelve such pieces were identified.<sup>58</sup> These pieces were installed to repair damaged areas along the edges of planks, both original and replacement planks (fig. 4.80). SS 7-5 and SS 8-2 repaired areas of damage along both edges of a seam between two original planks. With the exception of SS 3-6, *Cupressus sempervirens*, all of the graving pieces are *Pinus brutia*.

Pitch or pitch stain usually covers the inner plank surfaces between frames, and it is therefore a good indication of frame location (figs. 4.80). Where well preserved, it is

In addition to the use of applied caulking along edge-fastened plank seams, there is also ample evidence for the use of driven caulking throughout much of the hull. Where well preserved, caulk fibers were generally oriented perpendicular to the plank seam (fig. 4.91), indicating driven caulking. This orientation of fibers was inconsistent, however, with some caulk patches exhibiting no clear orientation. It seems likely that thick caulking (or wads of caulk fibers) was driven into seam gaps during the addition of graving pieces or replacement planks, or during routine maintenance. Caulk fibers were also used to fill in knot holes, damaged areas, and other irregularities along plank edges, some of which were surprisingly large. A wad of caulking between PS 2-2 and PS 2-3 was 2 cm thick (fig. 4.80), and similar, albeit slightly thinner, lumps were found in several areas.

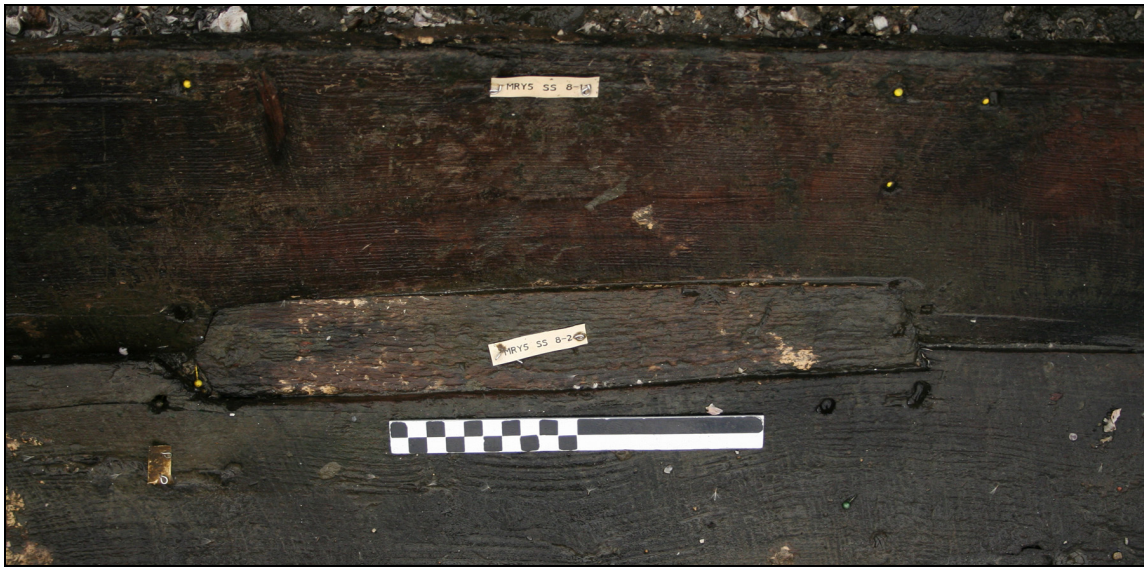
**Figure 4.81. Graving piece SS 8-2 in situ.**

Most of the graving pieces terminate in a butt-joint, either straight or at a slight diagonal, depending on the form of the plank to be repaired. These have either no bevel or, more often, a slight inward bevel that would facilitate repairing a plank from the ship's exterior. The aft ends of SS 2-4 and SS 10-3 form a short diagonal scarf with the adjoining plank; the forward end of SS 10-3 is cut in the form of the curving tip of an S-scarf. The forward end of SS 6-5 tapers to a thin tip that is fastened to the plank below it with a transverse iron nail. Both SS 7-5 and, to a less notable extent, SS 8-2 terminate in a kind of two-planed scarf, custom-cut to fit recesses on two planks each (fig. 4.81).

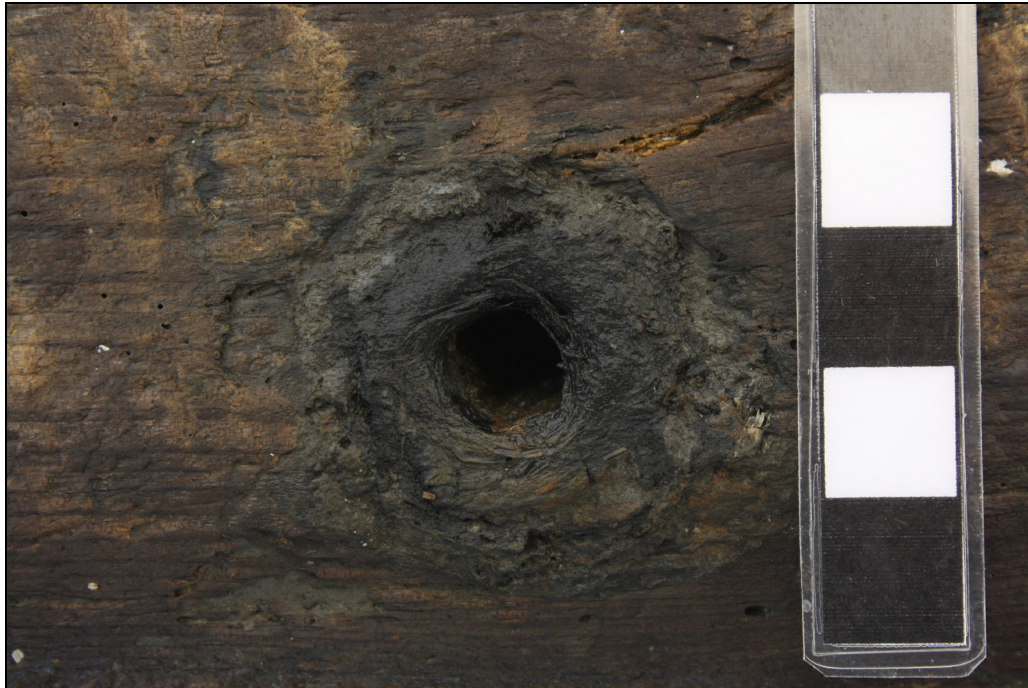
**Figure 4.82. Nail on PS 5-1 outer face at FR 15. Note fibers that had been wrapped around the base of the nail shank.**

Pressure marks or concretion outlines on the outer face of planking indicate rounded or slightly angular nail heads, usually 1.8-2.3 cm in diameter. These may be impressed into the plank surface up to 0.1-0.2 cm. Only two nail head concretions were preserved on the outer face of replacement planking; these indicate domed nail heads 0.6-1.1 cm thick. Although easily washed away, grass-like fibers were found surrounding the hole on many of the planks' outer face nails, on both original planks and repairs (fig. 4.82). The frequency of this phenomenon, and the ease with which it could

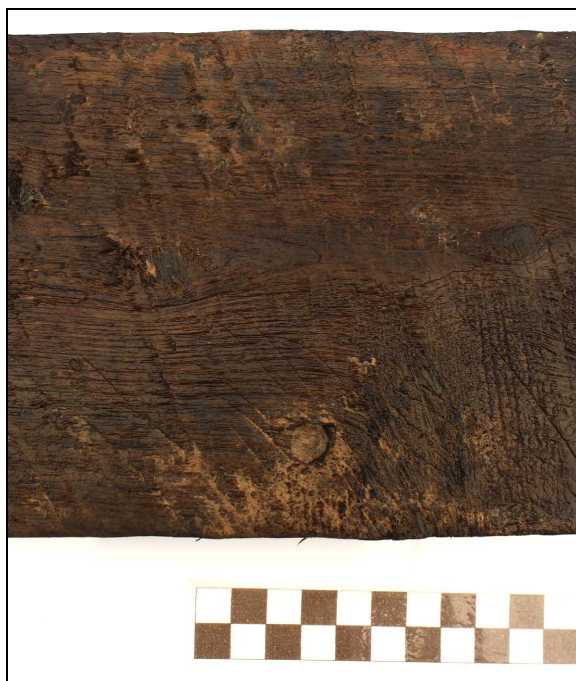
**Figure 4.83.** Caulked- and pitched-over hole on SS 5-4 between FR 21 and FR 22.

When a hole on the plank was abandoned or otherwise disused, it was filled in, either with caulk-like fibers (fig. 4.83) or, in one instance, with a small wood plug (fig. 4.62, lower right) and sealed with pitch. Many such holes could only be identified after nearly all pitch had been removed from the inner face of the planking. Although initially misinterpreted as the location of cleats used in the initial construction of the ship, it is now clear that these filled holes, in most cases, indicate where a frame had been replaced. Abandoned holes were found on nearly all of the original planking and several of the other planks, reflecting multiple significant repairs to the ship.

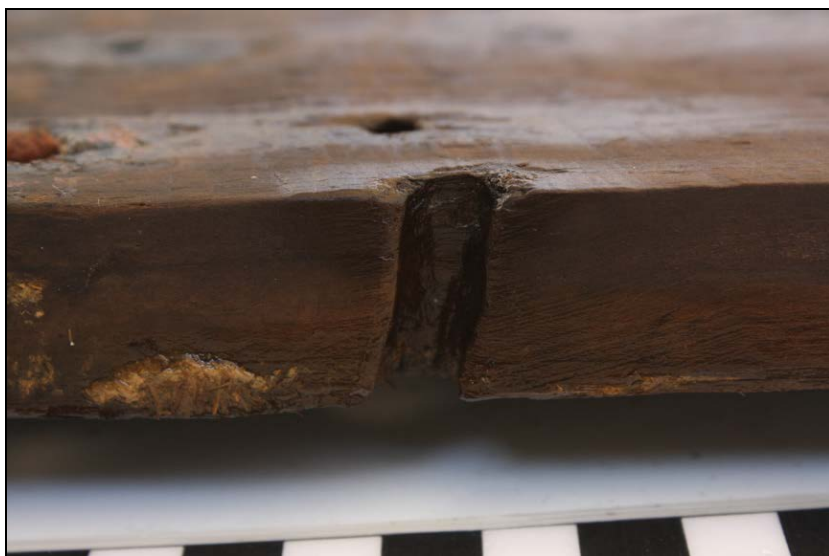
**Figure 4.84.** Abandoned fastener (?) hole, cut through, along the lower edge of SS 3-5 at FR 24. Note striations within adze marks on plank edge.

Abandoned holes are usually at the same location as the replaced frame, but some are located just forward or just aft of the replaced frame. Several of the abandoned nail holes are located along plank edges (fig. 4.84), where the plank had been trimmed down for repairs; this was observed even on replacement planks.

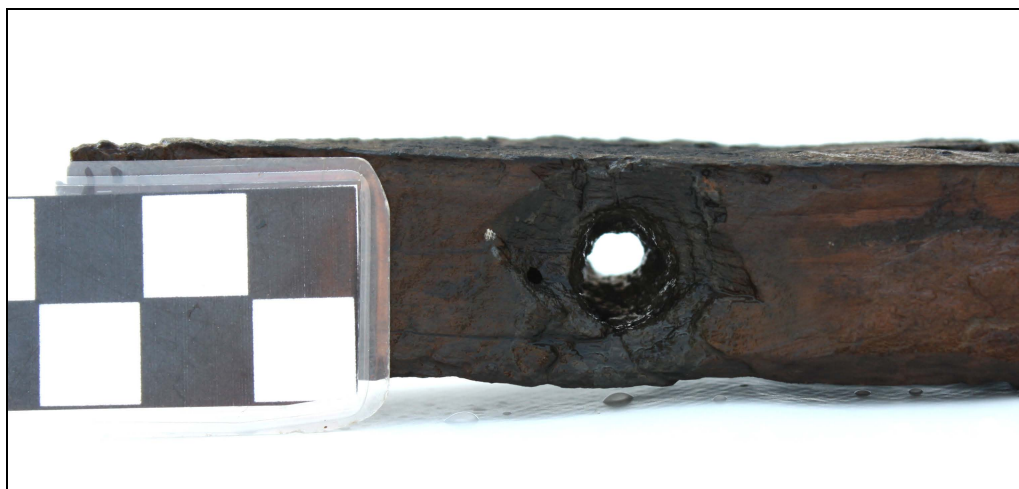
**Figure 4.85. Transverse iron nail at the tip of edge-fastened plank fragment UM 100. Note countersinking for nail head.**

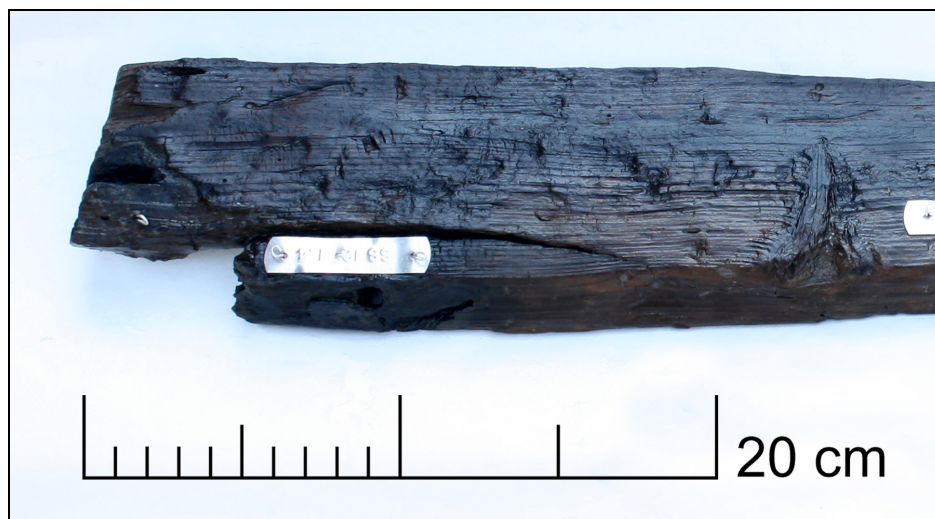
**Figure 4.86. Top edge of SS 12-1 at forward end. An iron nail was driven through the top edge of SS 12-1 into SS 13 to repair damage.**

Finally, there is an odd nail that is driven from the outer face of SS 12-1 up through the top edge and into the lower edge of SS 13 between FR 6 and FR 7 (fig. 4.86). This seems to have been done to repair damage to the plank near this edge.

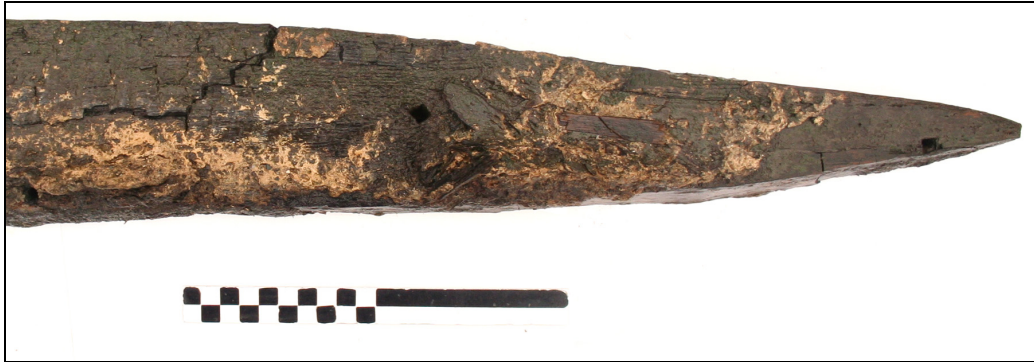
**Figure 4.87.** Aft end of PS 1, inner face. Very thick pitch formed a 3 cm-high ridge, sealing the space between PS 1 and the keel. Note wood chips in pitch.

Pitch was generally not well preserved on the garboards, although at the garboard extremities, pitch had pooled in the narrow space between plank and keel, forming a tight seal between the two (fig. 4.87). A pitch line also seems to indicate the location of the keel on some of the hood ends. On SS 2-3, there is less pitch at the location of SST 1, which likely protected part of the plank from a later application of pitch (fig. 4.88). Although faint, pitch stains were preserved at old frame locations on recycled plank SS 9-2.

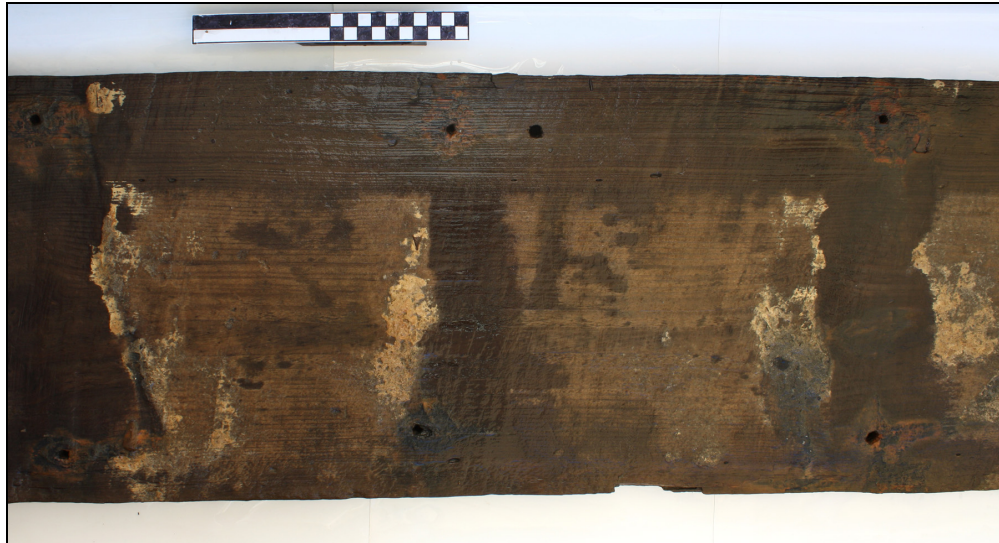
**Figure 4.88.** SS 2-3 inner face at FR 17-FR 19. Note pitch stain between frame stations and lack of pitch stain at SST 1 location (near upper edge).

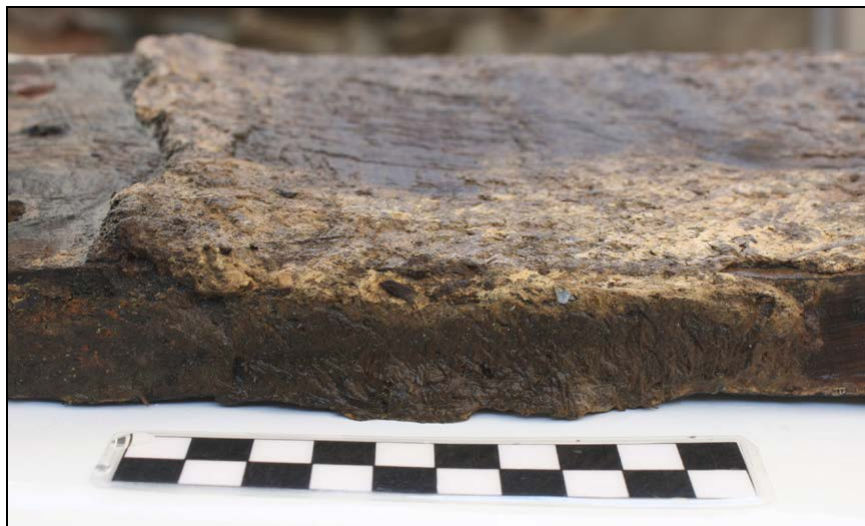
**Figure 4.89.** Caulk on lower edge of SS 3-5 at FR 22-FR 23.

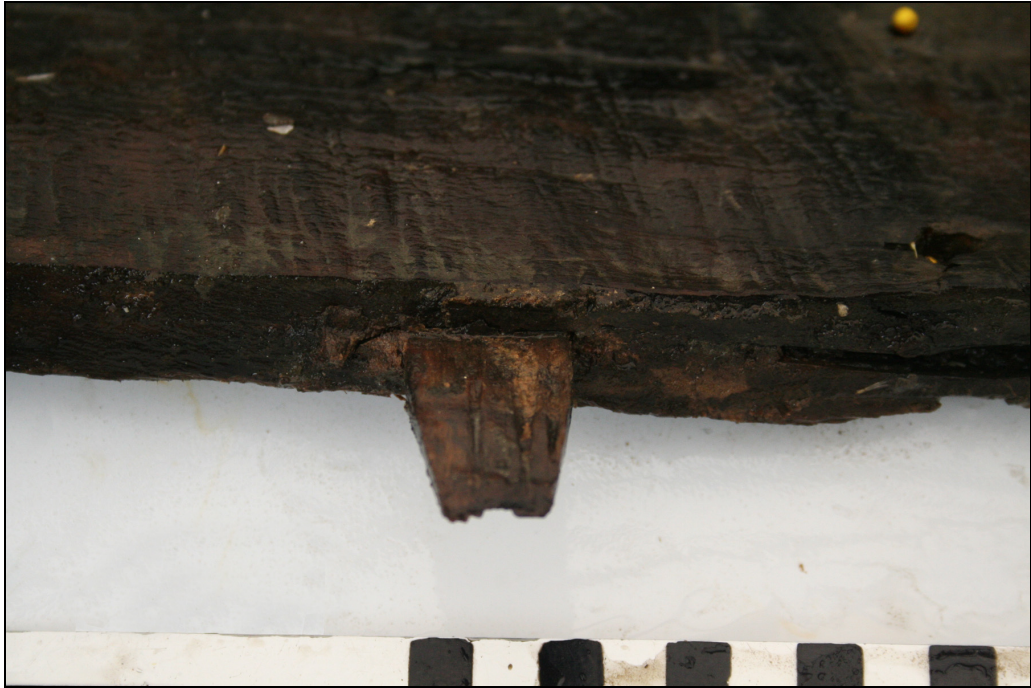
**Fig. 4.90. Intact tenon on top edge of SS 7-4 at F 21. Note caulk along plank edge, inboard of tenon.**

The presence of caulk fibers along edge-fastened seams challenges the conventional belief that caulking was not used in association with mortise-and-tenon edge joinery. That caulking was found to inboard of intact tenons proves that, during the initial construction of the vessel, caulking was applied to edge-fastened plank seams during assembly (fig. 4.90). Pitch was found on several tenons, usually at the plank seam but also in spots throughout, and many of the mortises had pitch and caulking fibers filling the cavity around the tenon. Damaged areas along mortise edges were also filled in with caulk fibers.

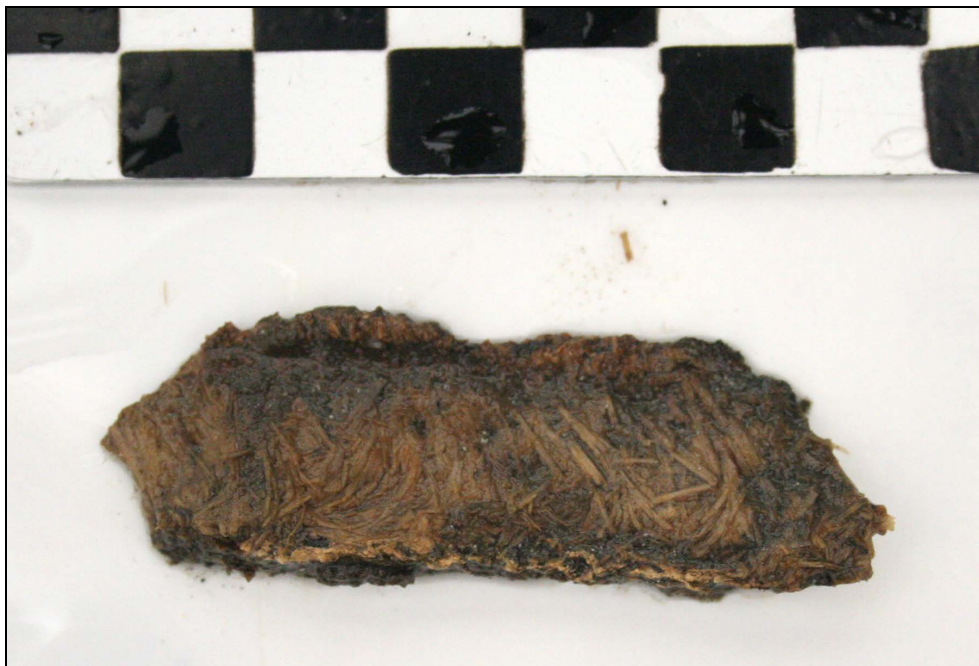
**Figure 4.91. Caulk removed from top edge of PS 2-4 at FR 20-FR 21.**

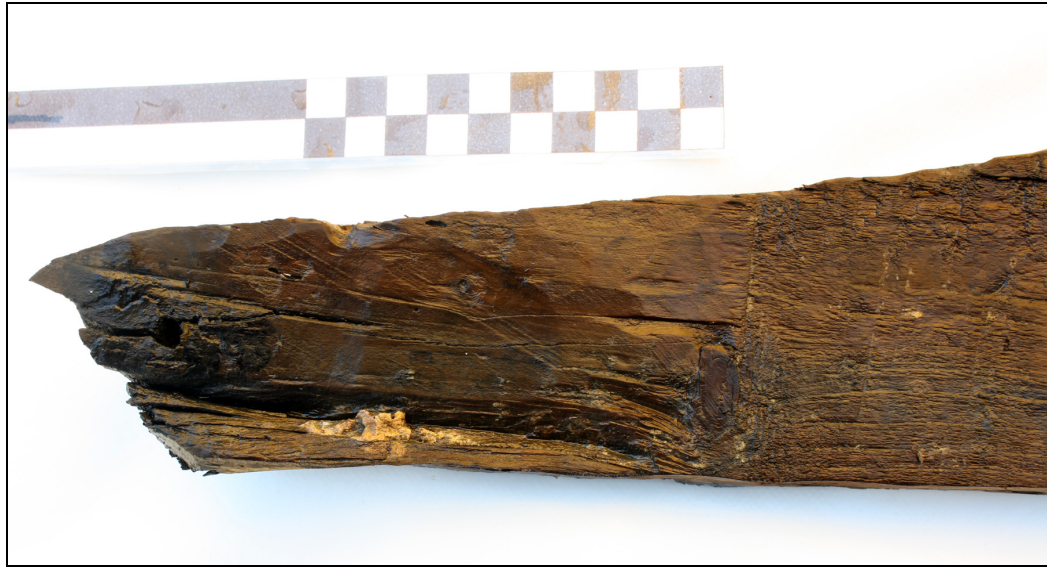
**Figure 4.93. Aft tip of SS 10-4. Note abrupt end to sawing, followed by adzing of the inner face. The plank tip was roughly cut for a repair.**

Most of the planking consists of plainsawn boards with edges trimmed to form with an adze. Saw marks are quite clear and are usually angled, varying slightly in orientation. They are usually 0.1-0.4 cm apart and are especially deep and more closely spaced at knots. On several planks, deep, arcing scratches probably represent saw return marks, not unlike those observed on the framing (fig. 4.83). Based on the size of the planks, they must have been cut with a large frame saw. The direction of sawing on the planks' inner faces was usually oriented against the direction of growth. More often than not, the plank was oriented such that the growth of the tree was from aft to forward. However, inconsistency here is enough to suggest that this may be merely coincidental. On SS 10-4, the plank was sawn toward the aft end then split along the last 16 cm. This split surface was later trimmed with an adze, but damage due to splitting remained and was filled in with pitch (fig. 4.93).

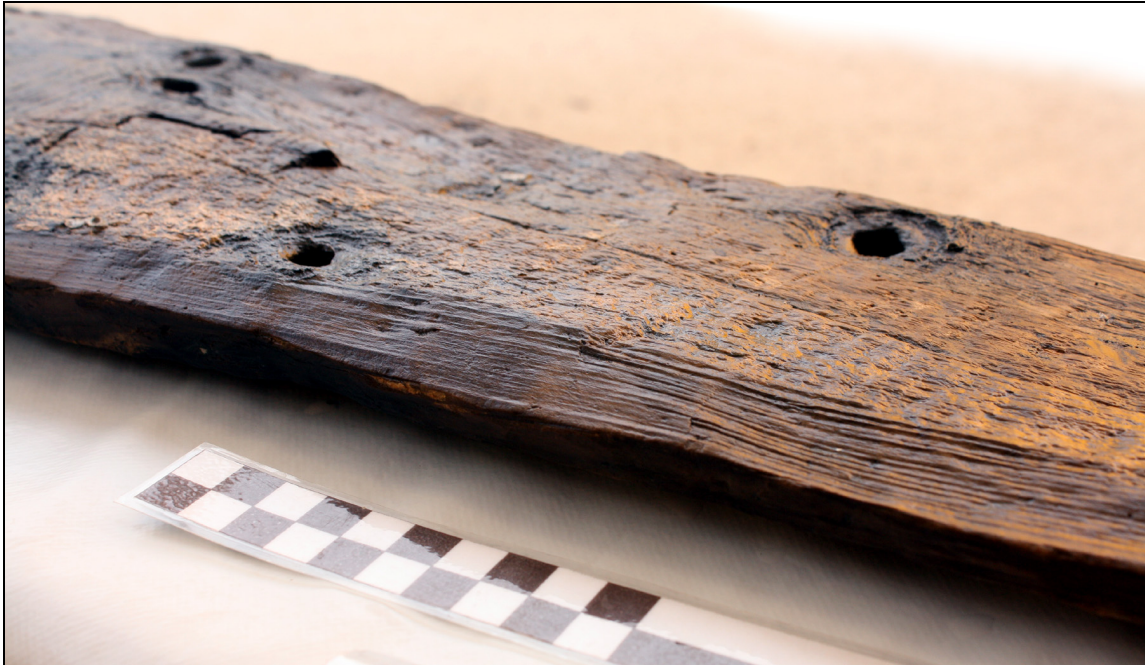
**Figure 4.95. SS 5-1 outer face at FR 6-FR 7. Note adzed area near top edge.**

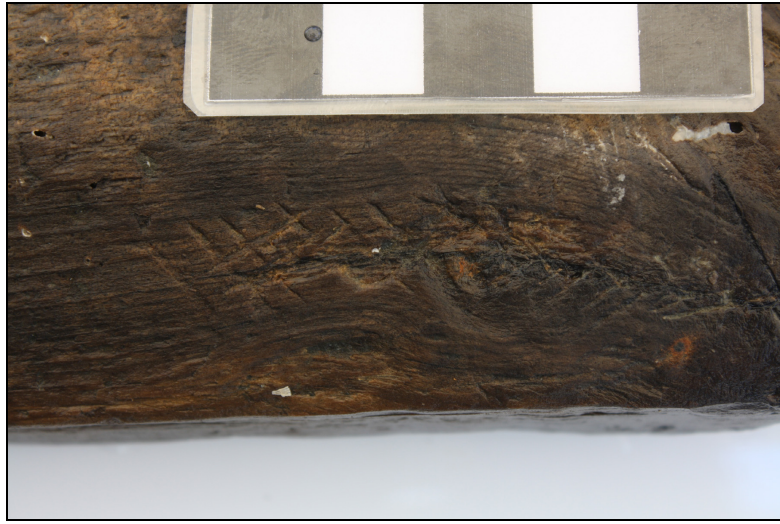
**Figure 4.96. Small cuts across a grain defect on the outer face of PS 5-1 at FR 14.**

series of short cuts across the outlines of knots and along natural fissures in the wood (fig. 4.96). The function of these cuts is unclear, but they appear to be associated with natural defects in the wood grain; plank PS 3-1 broke along one such grain defect.

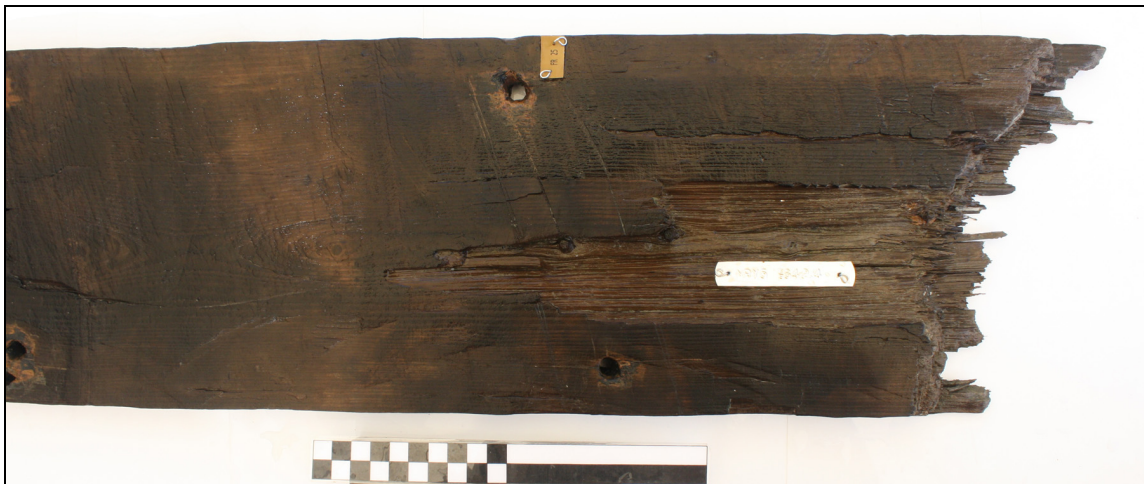
**Figure 4.97. Charred areas on the inner face of SS 4-2 at FR 25.**

(fig. 4.97). The charring of replacement planks seems to have been much more severe than that seen on the original planking, with charred and crazed surfaces very common (fig. 4.98). Distinct charring was sometimes later trimmed with an adze, perhaps to create a smoother surface; similar adzing was noted on the Kyrenia ship.<sup>73</sup> The charred areas are usually somewhat poorly delineated; in some cases, however, the char-bent area ends in a very distinct line, as on PS 1, PS 2-4, PS 3-2, SS 2-3, and SS 3-1 (fig 4.79). As noted above, a score mark on the inner face of SS 2-3 may have been cut to indicate where the char-bending should commence.

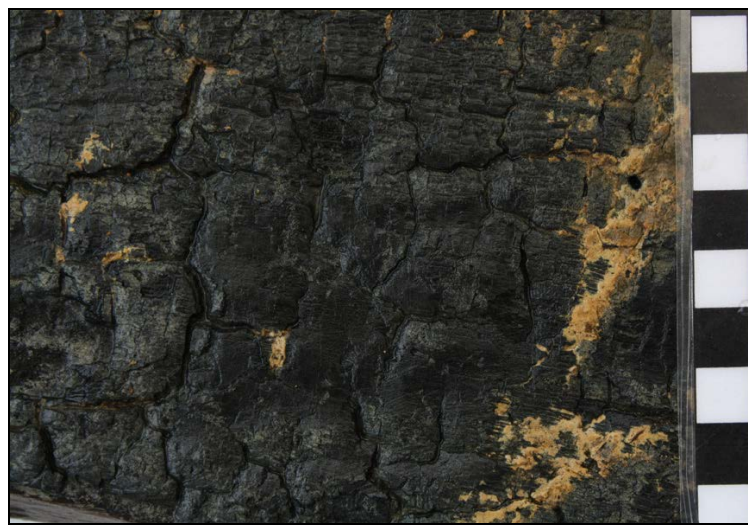
**Figure 4.98.** Charred inner face of PS 3-1 at FR 3-FR 4.

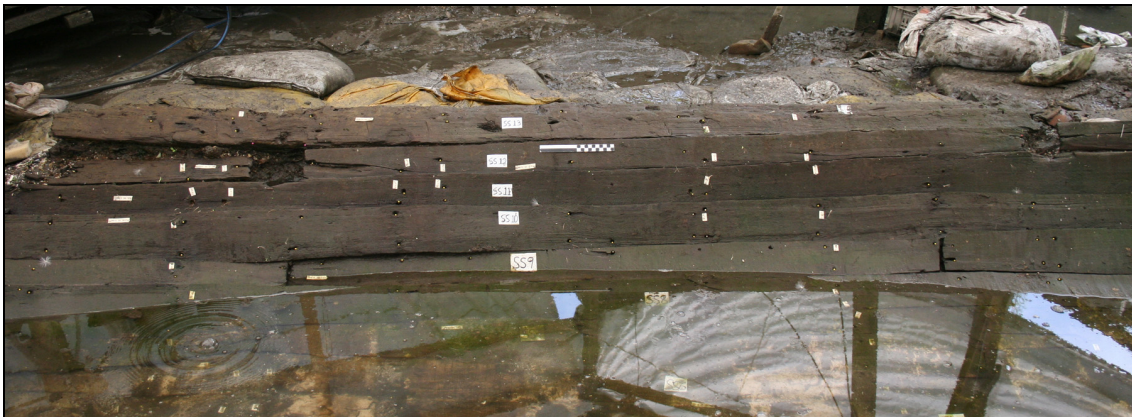
**Figure 4.100. Part of SS 11 and SS 13 in situ. Holes for through-beams at FR 10-FR 11 and FR 17-FR 18 are clearly visible.**

The clearest evidence for the presence of through-beams may be found along strake SS 12 on the port side, where gaps in the planking accommodated the through-beams. Well-defined gaps are clearly visible at FR 10-FR 11 and FR 17-FR 18 (fig. 4.100). Based on the finished (albeit damaged) forward end of SS 12-2 and aft end of SS 12-3, there was another gap between FR 8 and FR 9. A fourth through-beam was postulated between the broken forward end of SS 12-5 and the aft end of the proposed original location of displaced timber UM 110, although this remains uncertain; however, evidence from SS 11 seems to confirm a through-beam in this location.

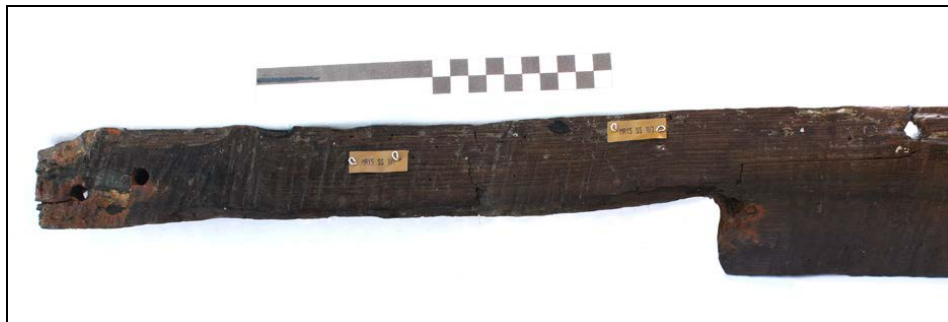
**Figure 4.101. Scarf at aft end of wale SS 11.**

The aft end of SS 11 terminates in a flat scarf, 38 cm in length, between F 3 and F 4 (fig. 4.101); the timber to which it was scarfed was not preserved. A similar scarf was observed on the wale of the Serçe Limanı hull, although this was nailed together;<sup>74</sup> there are no nails on the SS 11 scarf that would have edge-fastened it to another part of

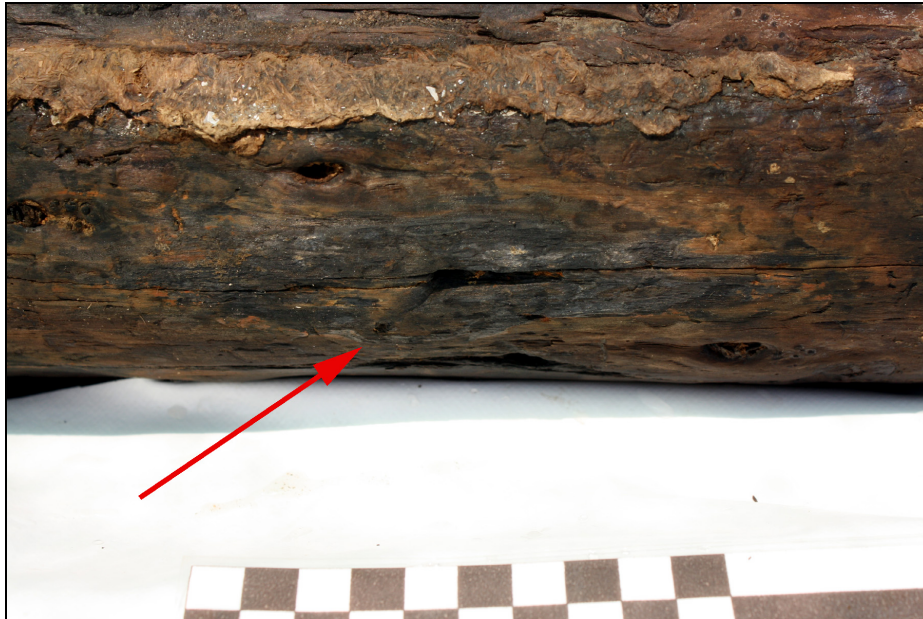
**Figure 4.102. Outer face of SS 11 at FR 12. Note clenched nail tip (at arrow) and thick pitch and caulk near top edge.**

Wale edges were caulked in a manner similar to the planking (fig. 4.102), although much of the pitch and caulk had washed away due to exposure. Where well

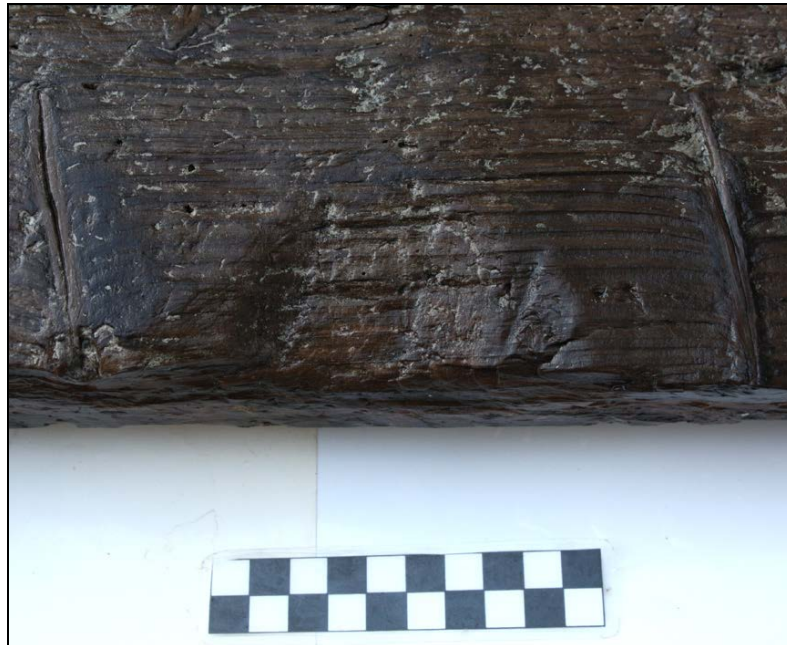
**Figure 4.103. Inner face of SS 13 near lower edge, trimmed down for FR 12 top end.**

All of the extant half-frames, with the exception of FR 6, were attached to SS 11; FR 6 does not seem to have extended up to this level, but the top end is damaged.<sup>75</sup> Most of the half-frames do not extend to SS 13; FR 8 terminates over SS 13 and was attached to it. FR 10 and FR 14 seem to have been either cut down or damaged below SS 13. Replacement frame FR 12 extended just to SS 13; while it is not attached to the wale, a shallow recess trimmed out of the wale's inner face accommodated the frame (fig. 4.103).

There are several areas on SS 13 where the surface was notched or recessed. This includes the inner face at the top end of FR 12, which was cut with a 1.4 cm deep recess to accommodate the frame; this was likely dubbed with a 4.4 cm-wide adze (fig. 4.103). There is also a shallow (0.9 cm deep) notch cut out of the lower edge of SS 13 at the FR 10-FR 11 through-beam; this notch is 17.6 cm along the length of the wale, although the gap for the through-beam in SS 12 is only 14.7 cm wide. The countersinking for outer face nail heads, at two through-beam locations and for a nail driven from the outer face at F 10, was created with a chisel; tool marks suggest blade widths of 1.3 cm and 1.9 cm (fig. 4.107). An area of pitched damage just forward of the through-beam nail on SS 13 at FR 10-FR 11 (around the middle of the outer face) may be a botched attempt at countersinking; if so, the countersinking was done too close to the edge of the through-

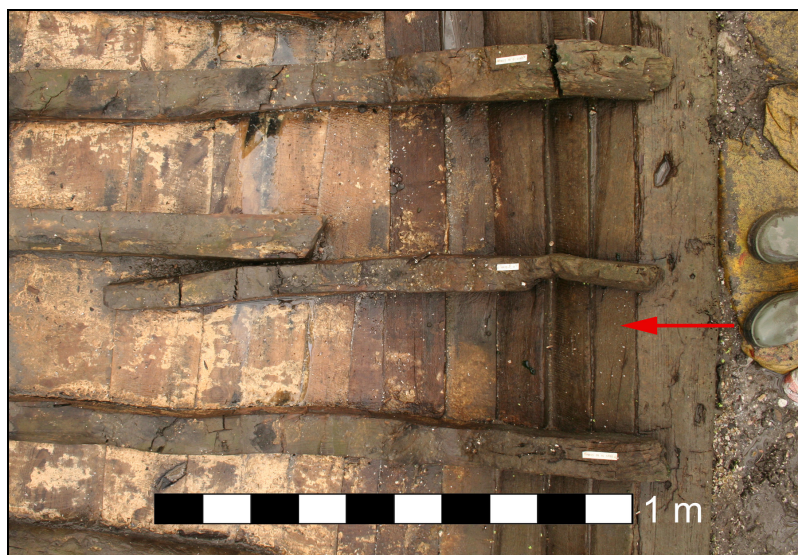
**Figure 4.104.** Line of nail holes and pitch outline around a possible reinforcement futtock forward of F 13 on the port side.

There are several other nails on the wales that do not appear to match the pattern of the ship's framing. A nail forward of F 13 on SS 11 matches a line of fasteners on SS 8, SS 9, and SS 10; this deviates from the typical framing pattern and could be a reinforcement frame timber, not unlike FR 12A on the starboard side (fig. 4.104). Unexplained nail or fastener holes are much more common on SS 13 and may represent top timbers at F 3-F 4, F 6-F 7, F 8-F 9, and F 9-F 10. Multiple nail holes at the F 9-F 10 location on SS 13 suggest that whatever timber was here may have been replaced at some point. None of these nails appears to have been driven from the outer face; nail holes are 0.4-0.6 cm in sided dimension and do not always extend to the outer face of the wale.

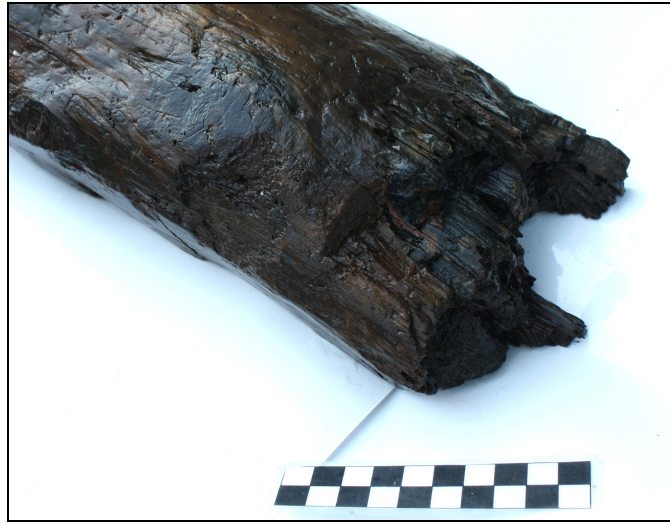
**Figure 4.105.** Countersunk nail head at a through-beam nail. SS 13 at FR 17-FR 18.

The diagonal edge nails were 0.6-1.2 cm in sided dimension and seem to have been driven through pilot holes, 1.1-1.4 cm in diameter. Based on the depth of the nail in through-beam fragment UM 81, these nails were approximately 8-13 cm in length; the SS 13 nail at the FR 10-FR 11 through-beam was bent within the wale. All of the diagonal edge nails were driven from the outer face; nail-head impressions are 2.0-2.6 cm in diameter and are often associated with damage. The nail heads on SS 13 at the FR 10-FR 11 and FR 17-FR 18 through-beams, and perhaps also on SS 11 at the FR 17-FR 18 through-beam, are partly countersunk (fig. 4.105) to offset the odd angling of the nail head against the curved face of the wale.

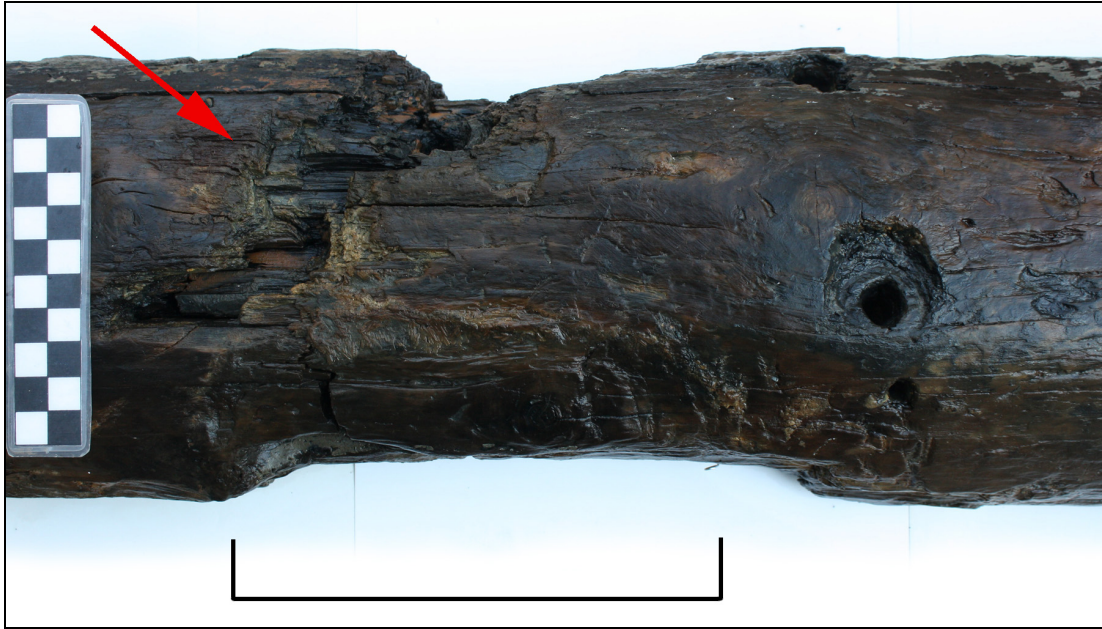
**Figure 4.107. SS 13 outer face at FR 10-FR 11. Red arrow indicates rough tool marks that had been pitched over. Note pressure mark and caulk outline at through-beam location (indicated in black).**

beam, which could be why the effort was abandoned (fig. 4.107). Cut marks here, at least 1.8 cm in width, seem to have been made with a chisel.

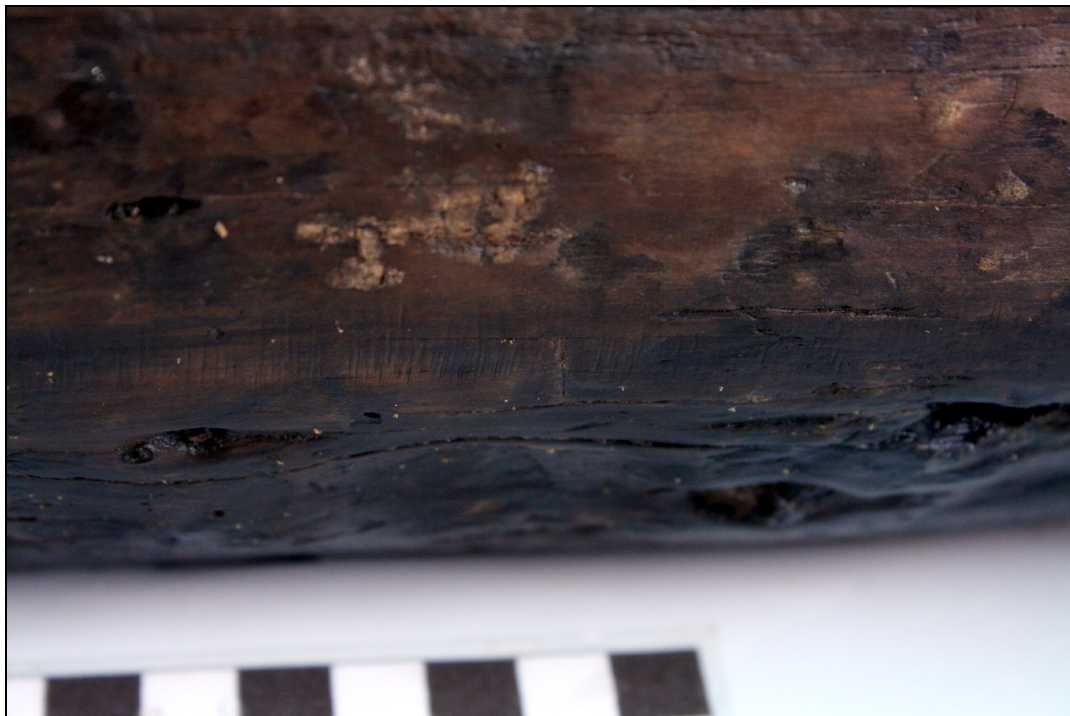
**Figure 4.108. Fine wear marks on the outer face of SS 11 between FR 14 and FR 15.**

Finally, there are fine, vertical wear marks on the outer face of SS 11 at its thickest area between FR 14 and FR 15 (fig. 4.108). The location and orientation of these marks strongly suggest rubbing damage, perhaps against some part of a dock, although it is noteworthy that this was not observed on SS 13.

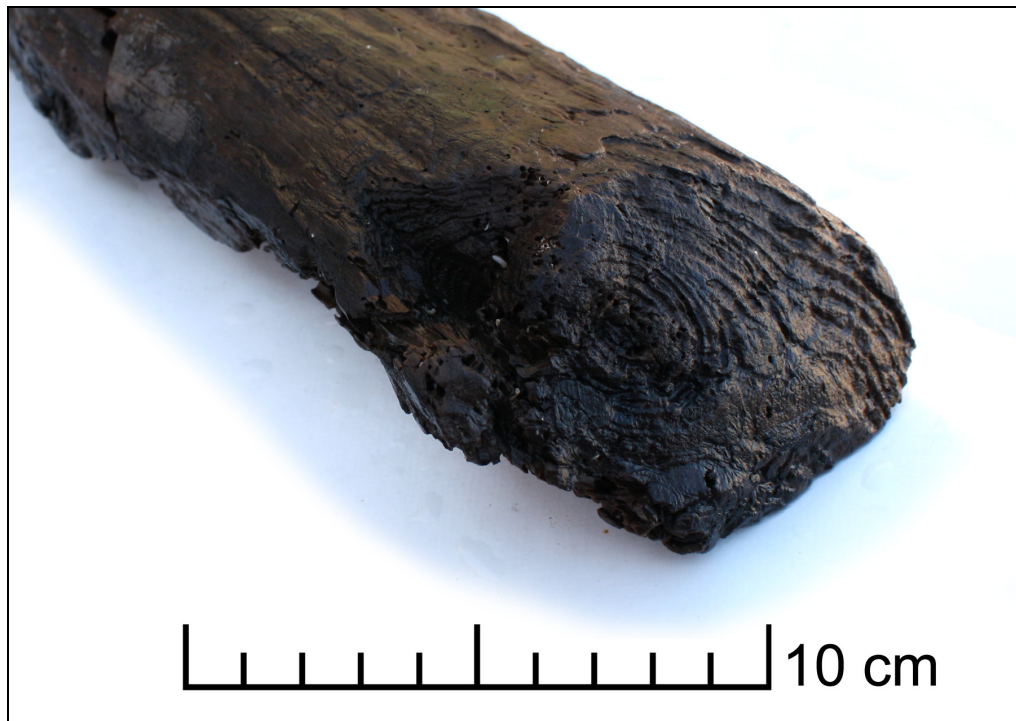
**Figure 4.110. Original end of wale(?) UM 121.**

Although much shorter and of unknown provenience within the excavation pit, UM 121 provides an example of an original wale end. This wale was part of a longer half-log of Turkish pine; only 57.5 cm of its length was preserved, and in width and thickness it is similar to the slightly smaller aft end of SS 11, just before the scarf. A diagonal edge nail and a pressure mark along one edge indicate the location of a through-beam. At this wale fragment's original end, the timber is beveled along the outer face over a length of 4 cm to a thin tip (fig. 4.110). A nail was driven into the wale just before the start of the bevel to fasten the timber to the stem or sternpost. A triangular notch, approximately 4 cm per side and 1.5 cm in depth, accommodated the nail head, of which no trace was found. The nail was driven through a 0.9 cm-diameter pilot hole. It is interesting that this wale end was located just 30 cm from a through-beam, which perhaps supported one of the decks.

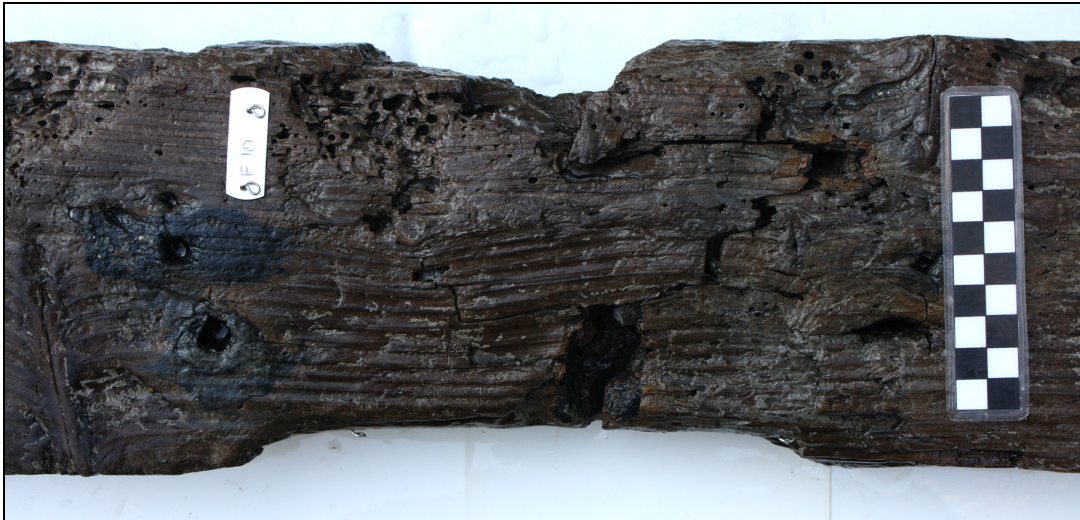
**Figure 4.111. Wale SS 13 inner face at FR 10-FR 11 through-beam. Note nail hole near lower edge and shallow notch along edge.**

There was a shallow notch, 0.9 cm in depth, cut out of the lower edge of SS 13 at the FR 10-FR 11 through-beam (fig. 4.111).<sup>80</sup> Otherwise, the wale edges are usually worn or damaged at the location of through-beams. Pressure marks along the outer face were caused by some through-beam edges. A well-preserved line of pitch and caulking fibers along the wale's outer face denotes the original chamfered form of the through-beam at the lower edge of SS 13 at FR 10-FR 11 (fig. 4.107). Although this is above the waterline, the caulking of this seam indicates the shipwright's desire to waterproof the area. Traces of similar pitch and pressure lines are also seen on the top edge of SS 13 at FR 7-FR 8, the lower edge of SS 13 at FR 17-FR 18, and the top edge of SS 11 at FR 17-FR 18. The pitch line and iron fastener on the top edge of SS 13 at FR 7-FR 8 are the

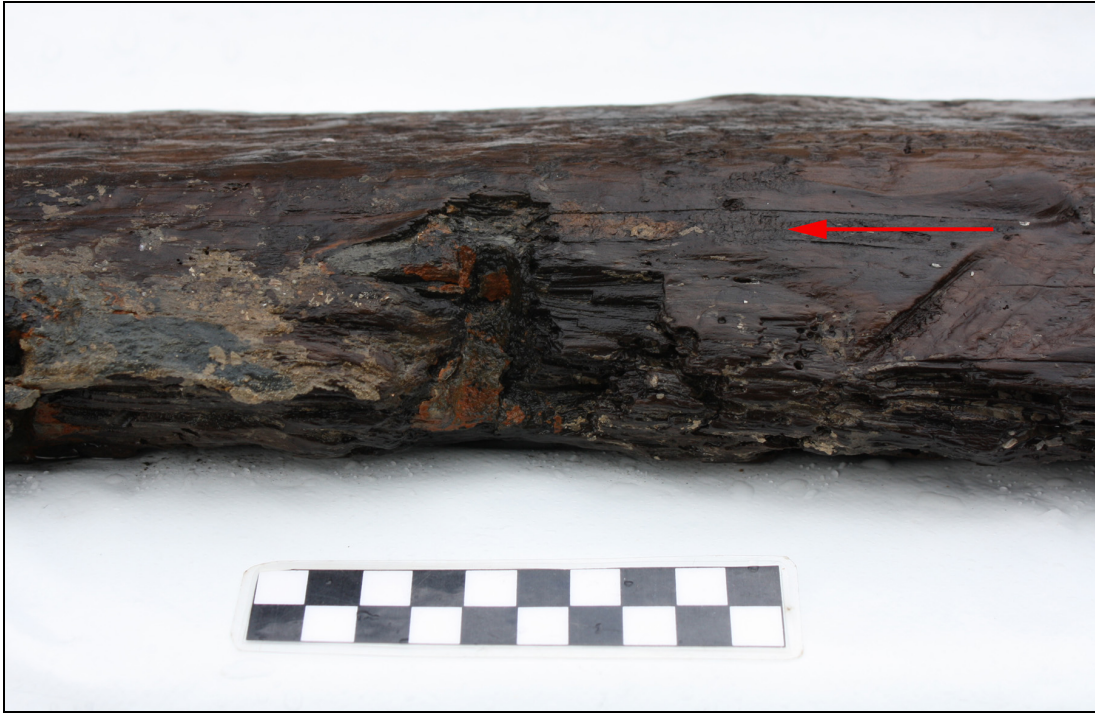
**Figure 4.112. Wale SS 13 top edge at FR 7-FR 8. Iron nail hole and pitch outline (red arrow) indicate a through-beam at this location.**

only indications of a second level of through-beams, between the second and unpreserved third wales (fig. 4.112).

of SS 13 at each of these locations. It may have been the through-beam above SS 13, where upper edge pressure and wear marks 9.5 cm in width (fig. 4.112) fit the sided dimension of UM 81. However, without the third wale preserved, it is impossible to say for sure.
