ANALYSIS AND RECONSTRUCTION OF SHIPWRECK YK 11  
(C. SEVENTH CENTURY A.D.) FROM THE THEODOSIAN HARBOR  
AT YENİKAPI IN ISTANBUL, TURKEY

A Dissertation

Submitted to the Office of Graduate Studies of  
Texas A&M University  
in partial fulfillment of the requirements for the degree of

DOCTOR OF PHILOSOPHY

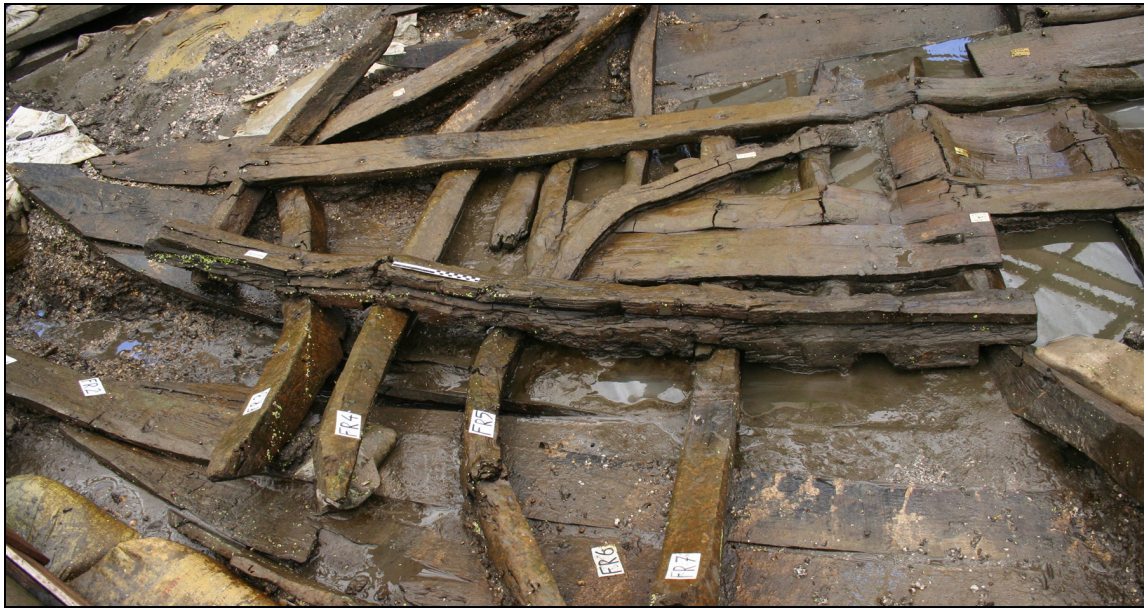
**Figure 4.116. Sternson KS 1 in situ. Note compression over frames.**

KS 1 is in a relatively good state of preservation; its most significant damage is breakage, cracking and distortion resulting from compression of the timber over the framing. It is broken into three pieces and has additional cracking, often at YK 11 frame locations. Compression damage is worst at the unsupported aft end, aft of FR 2. The keel timber that was modified to form KS 1 was already extensively damaged by teredo and gribble along its outer face. Although much of this damaged portion had been cut off, traces remain on KS 1 (fig. 4.118). Despite the distortion and ancient damage, surfaces were usually very well preserved, especially along the outer face. There is more wear along the inner face, both due to its previous use as keel, as well as its exposure within the hull both during use and after abandonment.

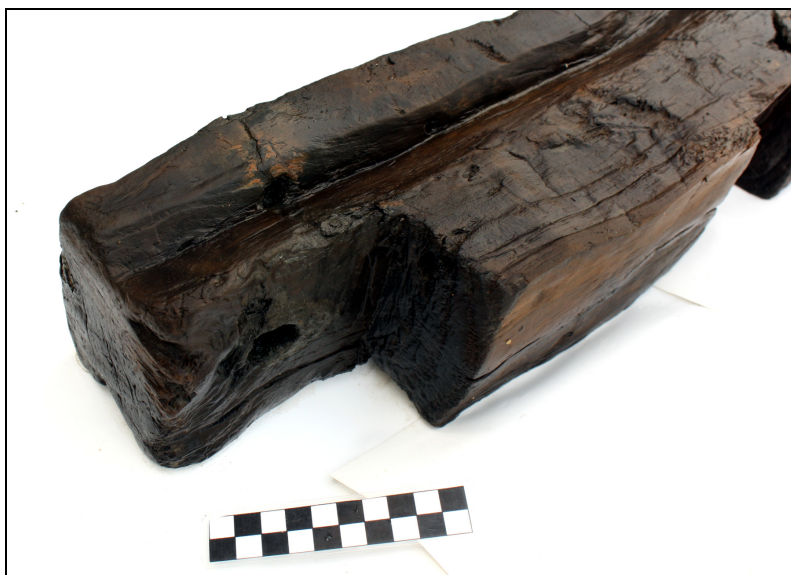
**Figure 4.117. Forward end of sternson KS 1. Note rabbet from former use as a keel.**

Perhaps the most notable feature of KS 1 is that it was fashioned from a recycled, worm-damaged keel timber from another ship, albeit one with similar construction features as YK 11. As such, it has rabbets cut along the sides (fig. 4.117), nails within the rabbets that fastened the garboards to the keel, and nails and faint pressure marks

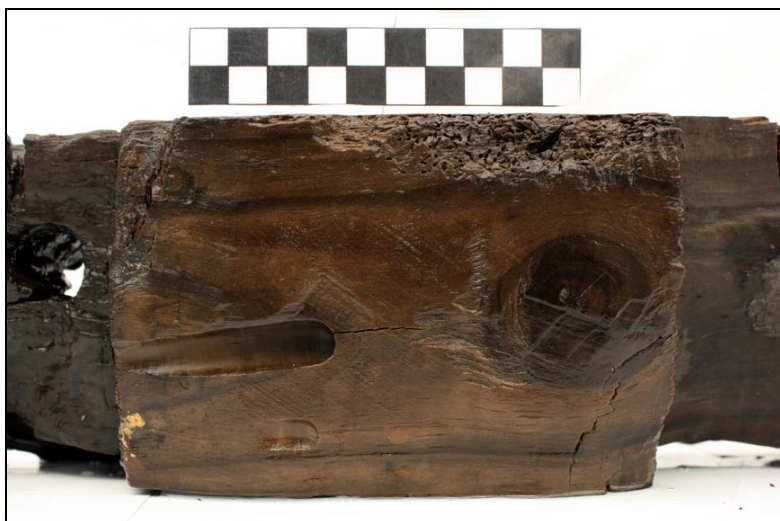
**Figure 4.118. Sternson KS 1 outer face at FR 3-FR 4. Note teredo and gribble damage from its previous use as a keel.**

KS 1 was cut from a relatively young trunk of Turkish pine, seemingly curved along its length. Surfaces appear to have been dubbed with an adze; this is best preserved on the outer face, where tool marks indicate a blade up to 5 cm in width (fig. 4.118). The outer face notches were first sawn along the edges then trimmed to form with an adze or chisel, although some notches appear to be entirely cut by adze or chisel.

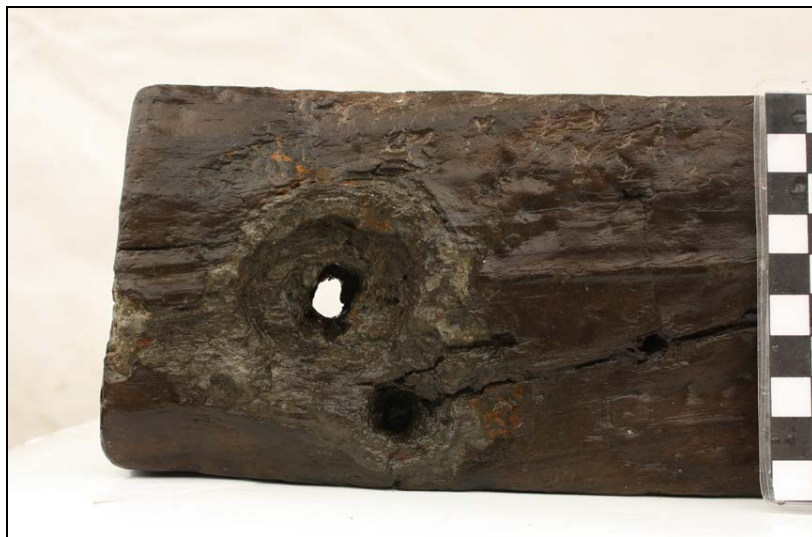
**Figure 4.119. Sternson KS 1 inner face at forward end. Note bolt hole and secondary nail hole.**

comparable in size to washers found on the seventh-century Yassiada ship (fig. 4.119). There is no indication of washer size on the FR 4 bolt. No evidence remains of the key or of the tip of either bolt. The reliance on bolts as the principal means of attachment greatly facilitated the framing repair process, since the bolts could be removed and replaced fairly easily, and the drilled holes reused.

Two additional nails were added to secure KS 1 to the inner face of FR 3 and FR 9, perhaps to tighten a loosened fit (fig. 4.119). The inner face was chiseled out around the FR 3 nail head, allowing the nail head to be countersunk into the surface. Only one other nail was used on KS 1, and this fastened the bulkhead frame to KS 1's inner face; it did not extend to the outer face. Several other nail holes on the inner face of KS 1 were disused and probably represent nails from the timber's original function as a keel as well as nails that had been extracted when the sternson was, out of necessity, removed in order to replace framing. The nails used were of the same type as those seen elsewhere on YK 11, short nails, approximately 8 cm in length, with square, 0.45-0.6 cm shanks and 2.4-2.8 cm-diameter heads. Some of the nails were driven through pilot holes, 1.1-1.5 cm in diameter. Large drilled holes near FR 3 and FR 7 may represent the location of bolts from this timber's previous use.

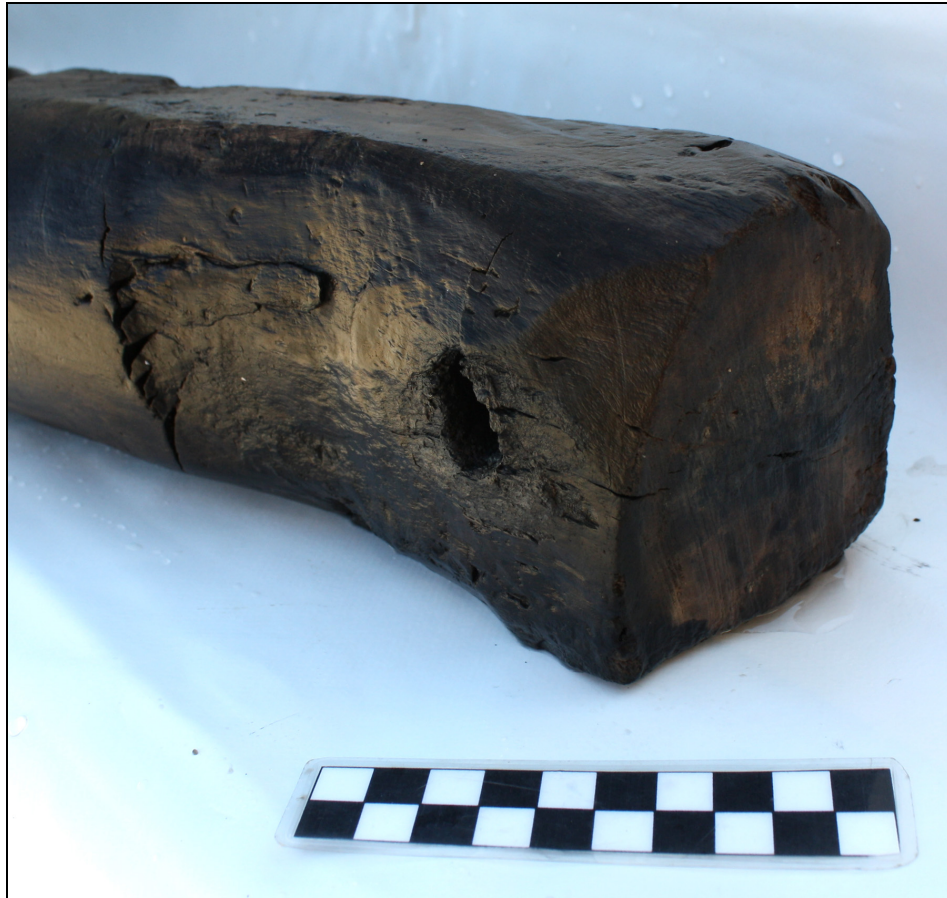
**Figure 4.121. Aft end of stemson UM 47, from outer/aft. At FR 21.**

Rather than a worn, recycled pine keel, UM 47 is a pristine, custom-made timber cut from *Ulmus campestris*. Although broken at the FR 22 notch, it is otherwise in excellent condition, with solid wood structure and well-preserved surfaces. There is some pressure damage at the FR 21 location (fig. 4.121). The timber is complete and is 80 cm in length. It is 8.2-9.5 cm in sided dimension and 3.7-9.3 cm molded, tapering toward its forward end. Much of the inner and outer faces are naturally rounded surfaces with bark removed. It was cut from the center of a large elm branch with 12 tree rings visible. Where not naturally rounded, inner face edges were chamfered with an adze to remove sharp edges.

The forward end is adzed down along its inner face to a thin tip. The aft end, in contrast, is sawn flat to form a blunt end that was fit into notches on the central stringers; the fine, closely-spaced saw marks (fig. 4.121) suggest a different saw than that used for the planks, perhaps a much smaller hand saw. Both ends were located at frames which aided its preservation. Other than the sawn aft end, all other surfaces and chamfers, where not natural, were trimmed with an adze (blade width 3.0 cm). The notch on the outer face for FR 22, up to 4.6 cm in depth, was 19.5 cm in length and was cut with an adze or chisel at least 2.5 cm in width.

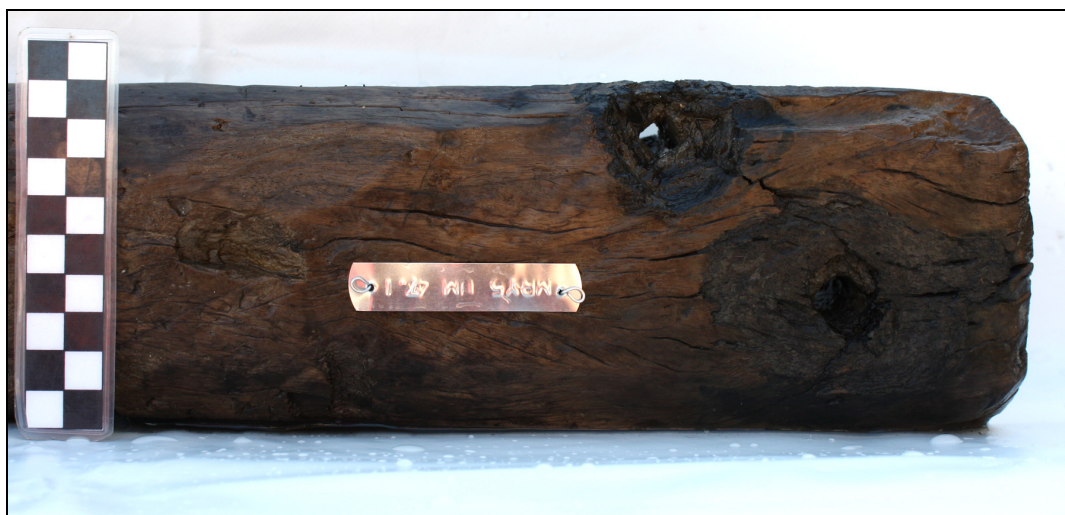
Figure 4.122. Aft end of stemson UM 47, from inner. At FR 21.

The large drilled hole at the primary FR 21 fastener seems to indicate that UM 47 was attached to the original FR 21 and Keel 2-Keel 3 scarf with a bolt. Once the frame was replaced and the bolt no longer fastened the frame to the keel, but merely served to bolt the two keel timbers together (see section on frames, above), UM 47 was fastened to the replacement frame and the keel with a long iron nail driven through the predrilled hole that previously held a bolt. This was obviously too loose a connection and a secondary nail was added accordingly (fig. 4.122).

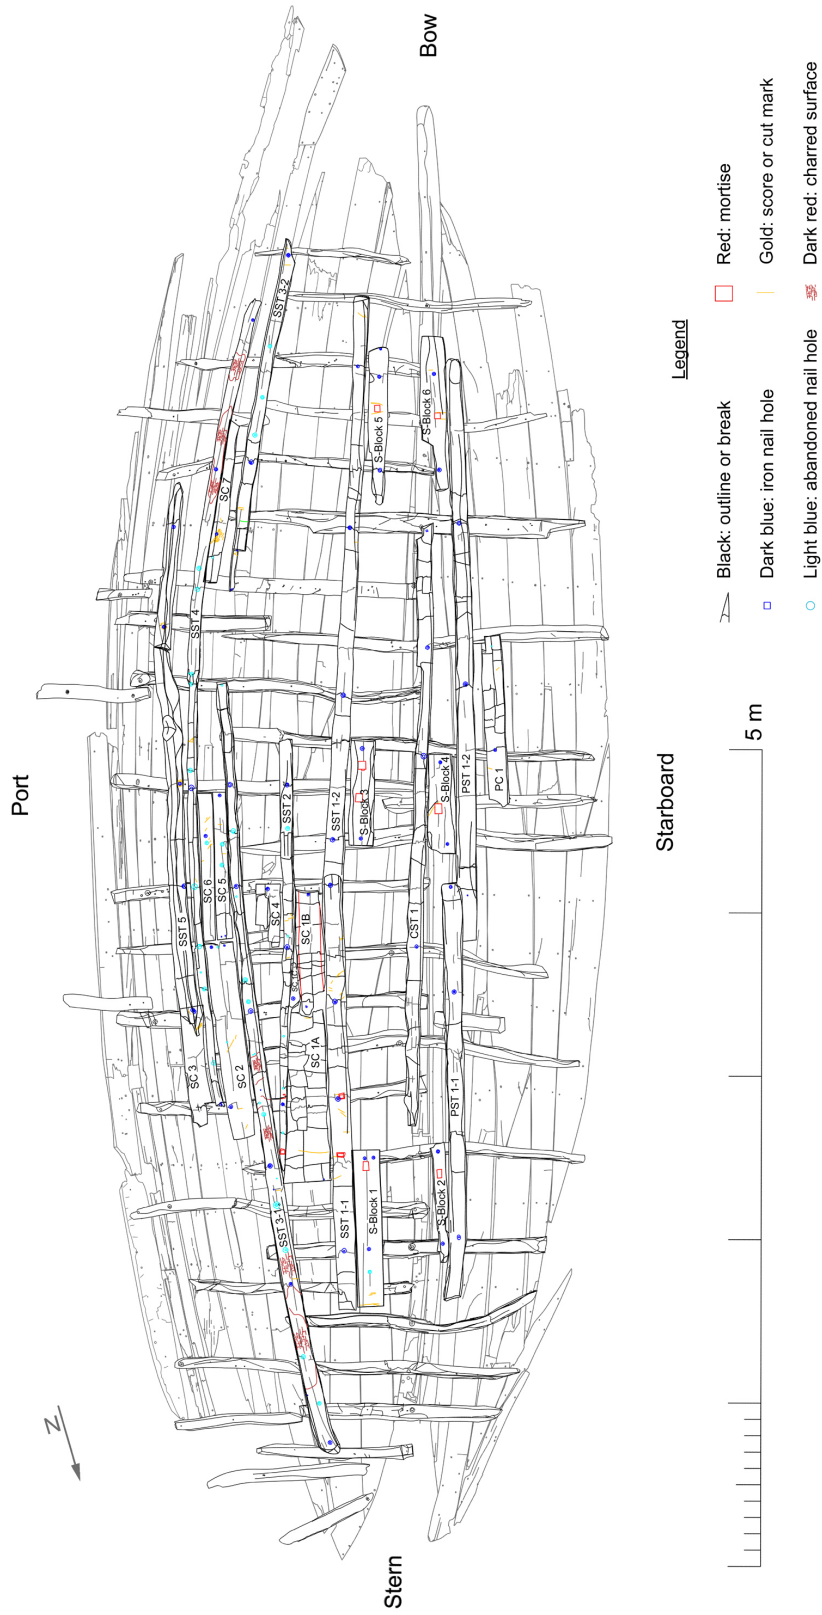
Figure 4.123. YK 11 in-situ stringers, common ceiling, and stanchion blocks. Plank and frame outlines are also indicated.

Ten stringers were preserved on YK 11, most of them in their original locations (fig. 4.123, table 4.14).<sup>89</sup> One central stringer, CST 1, was located just to starboard of the keel and inboard of the stanchion blocks; as such, it may be considered a limber strake. Unmatched nails on the framing indicate the location of a similar stringer just to port of the keel, although this was not preserved. Outboard of the keel area, five strakes of stringers were preserved on the port side, each strake composed of one or two stringers. The topmost of these, SST 5, is a clamp, that is, a slightly thicker stringer located approximately opposite the wale SS 11. Due to poorer preservation along the ship's starboard side, only one strake of stringers, consisting of two stringers scarfed together, was preserved.

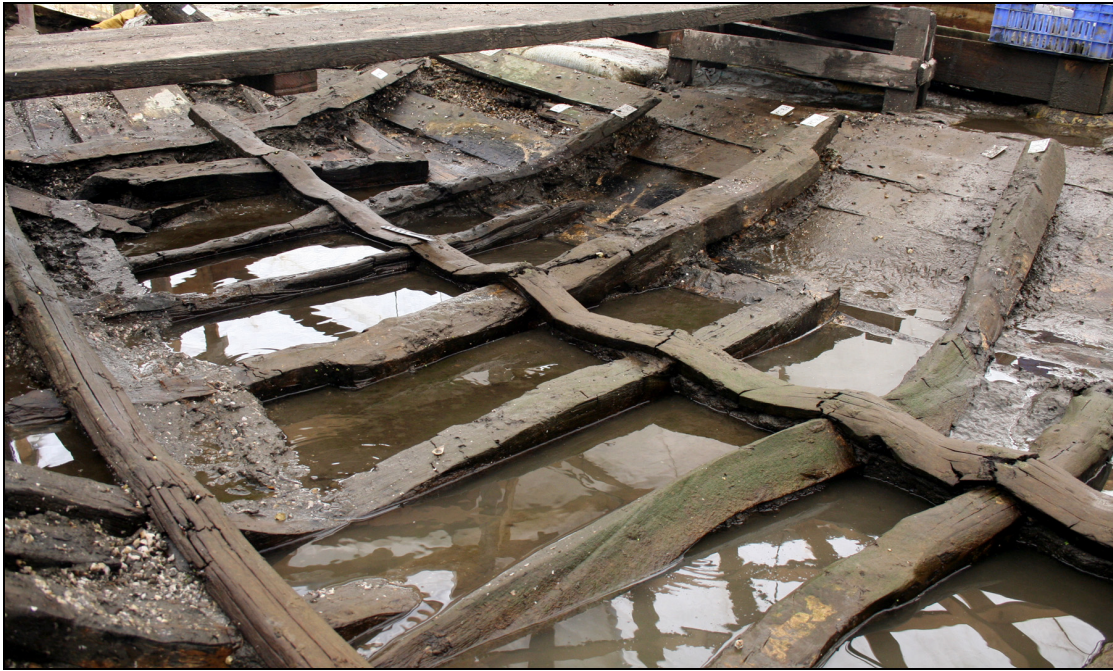
**Figure 4.124. Forward portion of SST 1-2 in situ. Note distortion and cracking at frame locations.**

Like the exterior planking, the stringers were fashioned from flexible softwoods, both Turkish pine (6) and Mediterranean cypress (4) (table 4.14). Although very well preserved in most aspects, several of the stringers are heavily distorted in form, having suffered significantly from compression damage. The stringers were pressed down over the frames, resulting in cracks, breaks, and an undulating form along the length of the stringer (fig. 4.124). In addition to the breaks and cracks, deep pressure marks, some sharply delineated, indicate some frame locations on the stringers' outer face. Although most of this damage was likely incurred after sinking, there is evidence that similar pressure damage, although far less intense, was incurred during the ship's working life: a crack on the inner face of SST 3-2 at FR 21 is similar to those caused by pressure damage, but had been filled in with pitch (fig. 4.125).

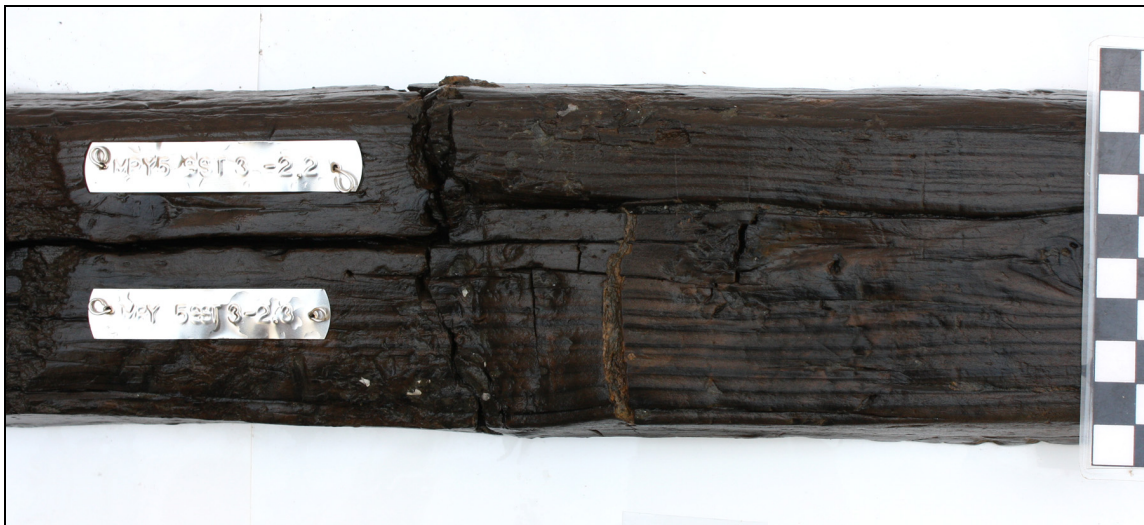
**Figure 4.125. Pitched crack on the inner face of SST 3-2 at FR 21.**

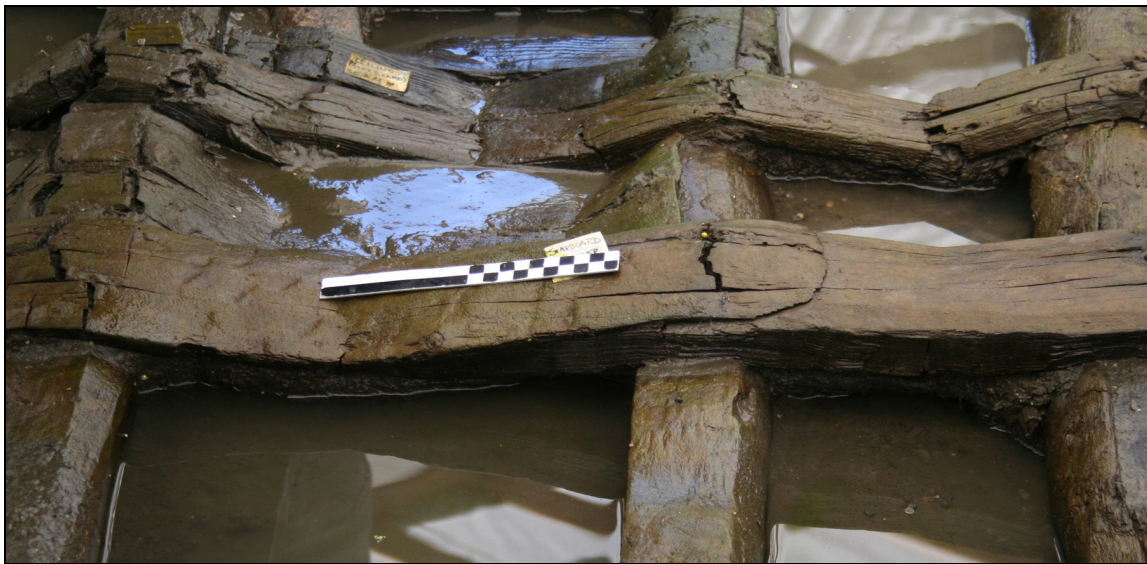
**Figure 4.126. SST 1 scarf in situ, at FR 14.**

Strakes PST 1 and SST 1 both consist of two stringers that are scarfed together with a carefully-crafted, flat vertical scarf 29-33 cm in length (which could correspond roughly to either one Roman or Byzantine foot); a single nail is driven through each scarf, fastening the stringers to FR 14 (figs. 4.126-4.127). In each scarf, the aft stringer (1-1) overlaps the forward stringer (1-2). Other than for PST 1 and SST 1, there is no evidence of scarfing on any of the stringers. Although SST 3 consists of two separate stringers, the ends of SST 3-2 are broken, and there is a gap between the broken aft end of SST 3-2 and the original forward end of SST 3-1, which is roughly cut.

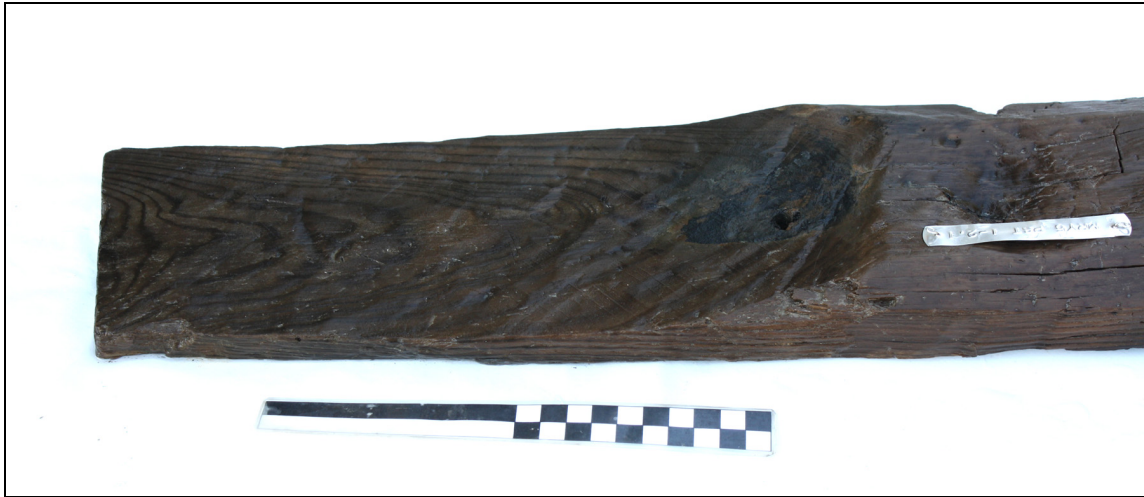
**Figure 4.127. Inner face of PST 1-2 scarf end.**

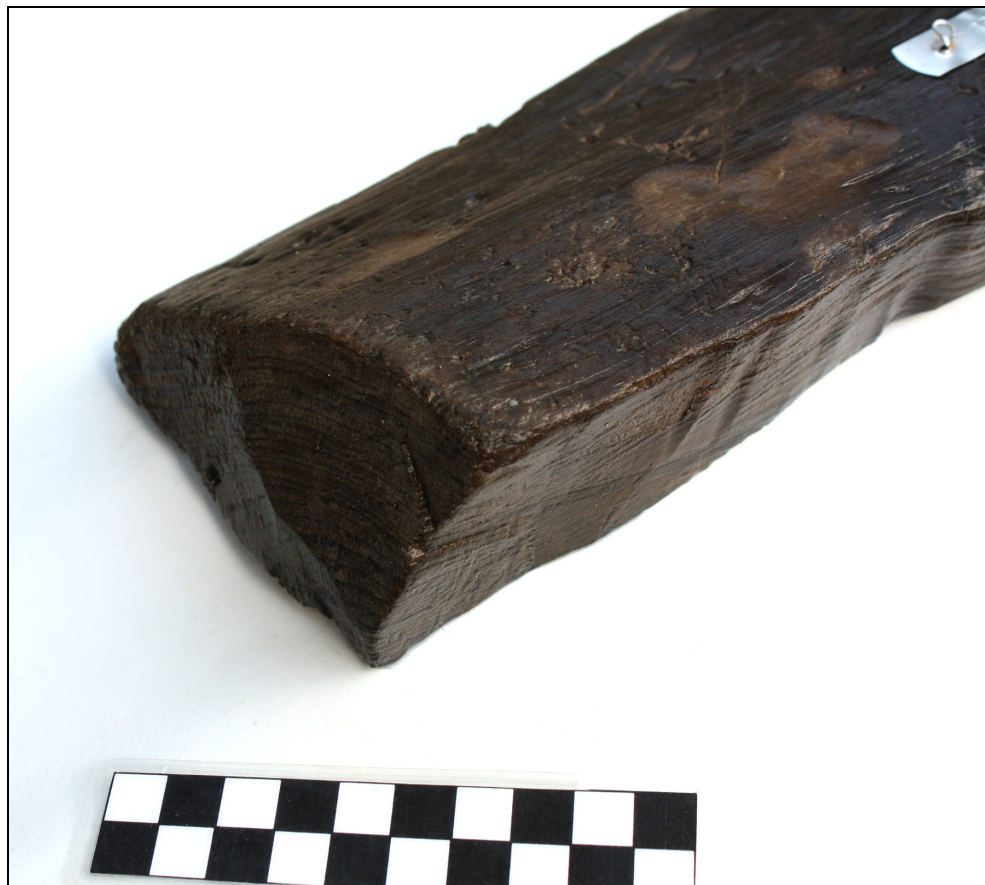
**Figure 4.128. Forward end of SST 1-2. Note naturally rounded inner face and adzed edge.**

Original ends of stringers that did not terminate in a scarf were cut in a variety of forms. The forward ends of PST 1-2 and SST 1-2 increase significantly in thickness toward the tips which are adzed to a blunt finish (fig. 4.128); this may have been influenced by the natural form of the timber. The aft end of SST 2, in contrast, tapers to

In many areas, the natural, rounded surface of the timber was preserved along the stringer's inner face, the bark having been removed with an adze. Where cut, inner faces and edges were shaped with an adze (figs. 4.128, 4.137); blade widths of 3.2-4.3 cm, most often approximately 4.0 cm, were recorded. Striations within blade marks reflect cutting with a chipped blade. Recesses or mortises were cut with chisels of varying size, approximately 2.0-2.2 cm for mortises in the inner face of SST 1-1 and SST 2. A larger blade, probably an adze, up to 3.1 cm in width, was used to cut the recesses along the edges of CST 1. The countersinking on the inner face of SST 5 was created with a

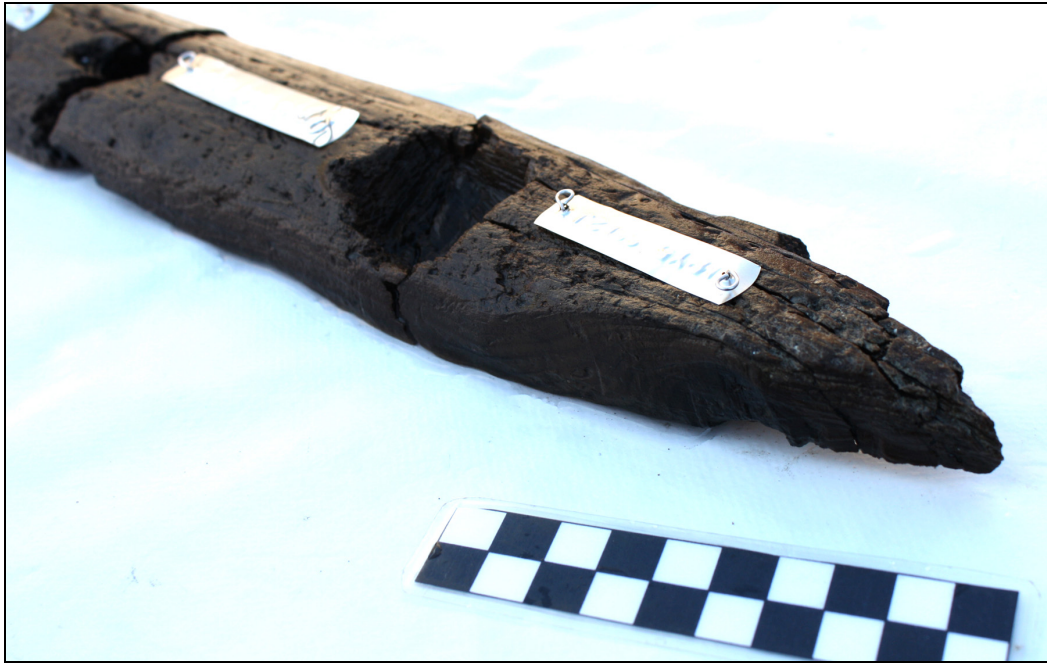
**Figure 4.129. Tapered aft end of SST 2. Note mortise on inner face.**

a thin, narrow tip, further weakened by the presence of a deep mortise on the inner face (fig. 4.129). Both the aft end of SST 3-1 and the forward end of SST 4 are of average thickness, cut at a slight diagonal and beveled toward the inner face. All of these original ends fall at frame locations, which would have prevented damage to the stringer tips from cargo or foot traffic.

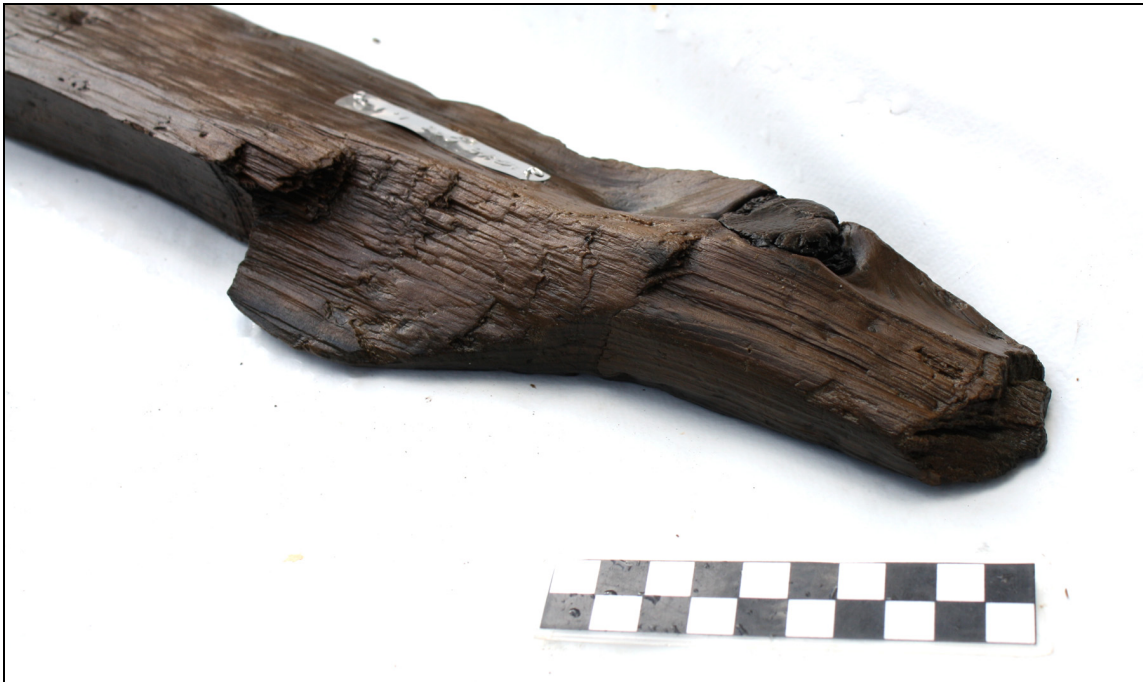
**Figure 4.130. Recessed aft end of CST 1.**

In contrast, the original ends of CST 1, the limber strake, did not terminate at frames. Both ends are curiously cut with recesses along the lower (inboard) edge at the aft end (fig. 4.130) and along both edges at the forward end. The lower edge recess at the forward end accommodated stemson UM 47. The other recesses at CST 1 ends are of unknown function.

CST 1, SST 3-2, and SST 5 all have recesses or notches cut out of one or more edges. These are most pronounced at CST 1, which has four deep recesses along the inboard edge (figs. 4.130-4.131) and one along the outboard edge. These recesses appear to have accommodated other timbers, only one of which, UM 47, was preserved. The inboard edge recess at FR 19 may have accommodated the end of the ship's mast step,

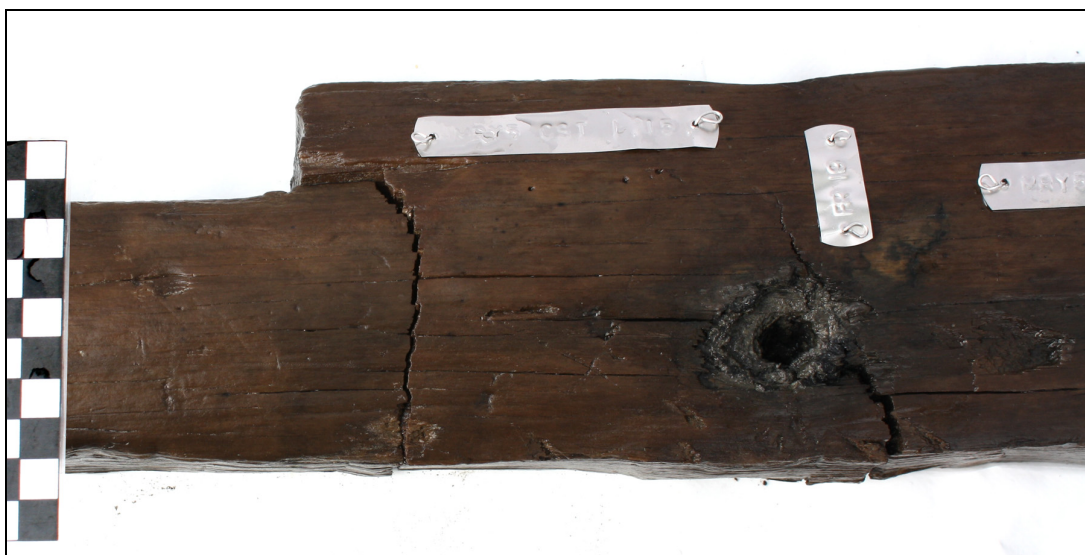
**Figure 4.131. CST 1 inner face at FR 19. Note recess along inboard edge and deep pressure mark from nail head.**

The square holes left by the nail shanks are 0.5-1.2 cm in sided dimension on the inner face and slightly smaller, only 0.4-1.0 cm, on the outer face. The nails were driven through pilot holes, usually 1.0-1.2 cm in diameter, in some cases up to 1.5 cm; in most cases, these pilot holes did not extend to the outer face of the stringer. Pressure marks from nail heads that were hammered into the inner face are usually 2.0-2.5 cm in diameter; these pressure marks can be quite deep (fig. 4.131). On SST 5's inner face, a chisel was used to countersink two of the nail heads (fig. 4.132).

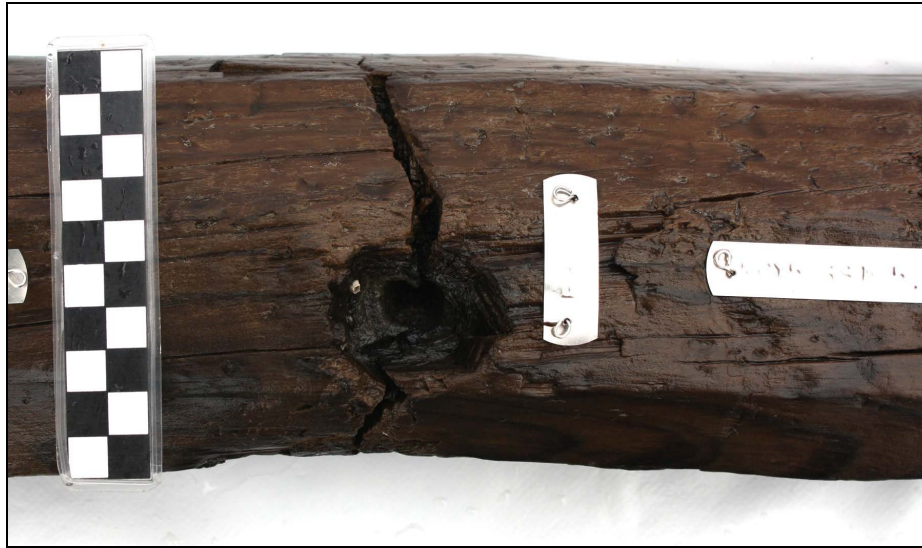
**Figure 4.132. Countersinking around nail at FR 16 on SST 5. Note small barnacle in countersunk area.**

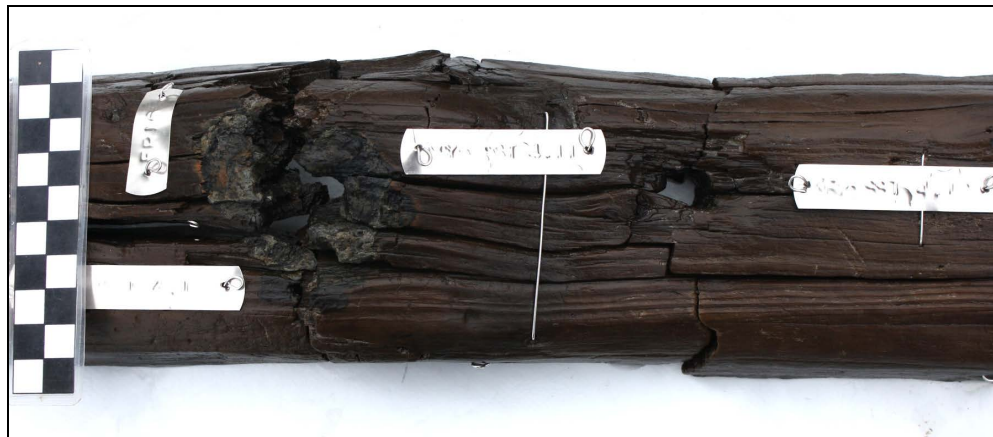
**Figure 4.133. Inner face of SST 4 at FR 16. Note difference between used (to left) and disused (to right) nail holes.**

a matching concreted nail hole on the respective frame (fig. 4.133). On SST 4, there are more than twice as many empty or disused nail holes as used nail holes. The presence of these abandoned nail holes offers proof that these stringers were pried out of place, without doubt to permit the extensive repairs to the ship's framing, then later reattached.<sup>90</sup> That many such abandoned holes were found between frame locations shows that the stringers were not always reattached in precisely the same position; such was the case on SST 2, SST 3-1, SST 3-2, and SST 4.<sup>91</sup> The great number of disused holes on SST 4, combined with two disused nail holes at FR 10 at this location, indicates that SST 4 was pried out of place then reinstalled on at least two occasions.

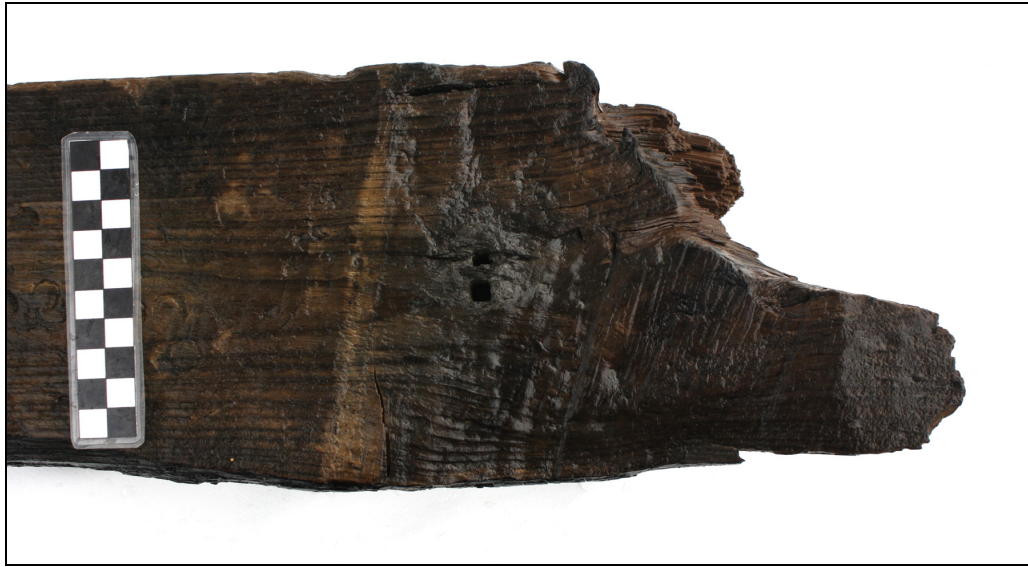
**Figure 4.134. Outer face of SST 5 at FR 12, with broken aft end. Both nail holes were started from the same hole on the stringer's inner face. One of the nail holes is disused.**

Does the lack of disused holes on PST 1, CST 1, and SST 1 mean that these stringers had not been removed and were, therefore, replacements for earlier stringers? Not necessarily; there were only two disused nails on SST 5, and both had been driven through the same inner face pilot hole as a used nail when the stringer was replaced. They are only identifiable as disused nails since, in each pair, one of the nails bent slightly upon insertion, creating two nail holes on the stringer's outer face at each of the frames in question (fig. 4.134). If indeed SST 5 is a shelf clamp, as seems to be indicated by both its location and the cut recess near the mast-partner through-beam, its position in the hull could not be altered. It appears, then, that stringers for which a position was delineated by one or more other timbers were replaced in their exact original location, and the old pilot holes were reused. CST 1, with its multiple recesses, would have had a prescribed position and, theoretically, may have been removed and replaced without any

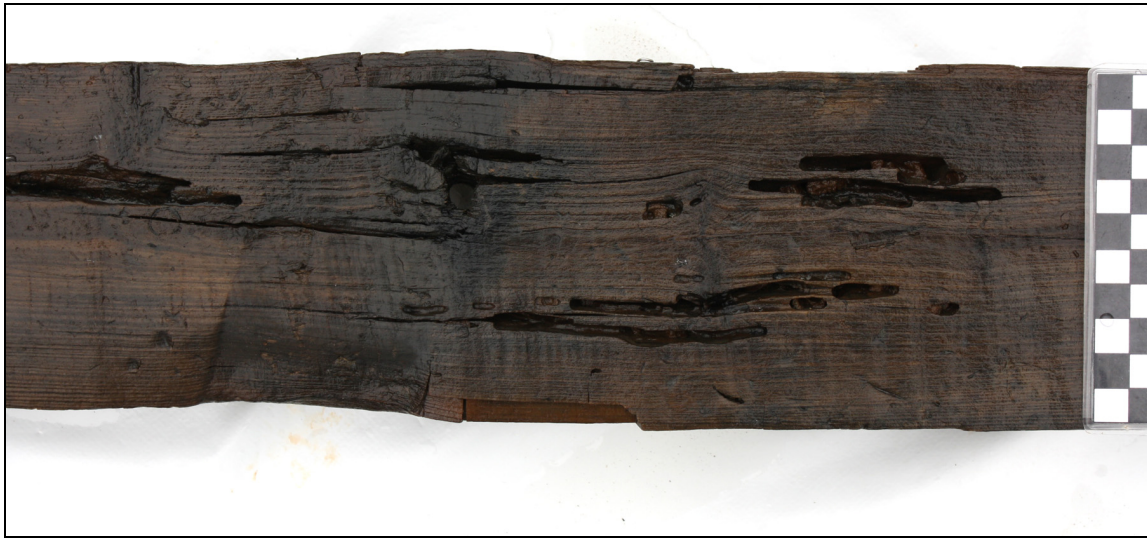
**Fig. 4.135. Wood borer damage on the outer face of SST 4. Note saw marks and, at frame location, pressure damage.**

All of the stringers were sawn along their outer face, most likely with a frame saw (fig. 4.135). In eight of the ten stringers, sawing was oriented against the direction of growth on the tree. On SST 1-2, the outer face was sawn to a point near the aft end, after which the wood was roughly split (fig. 4.136). The outer faces of PST 1-1 and SST 1-1 were both sawn from aft to forward, after which the forward portion (approx. 30 cm) was trimmed with an adze to form a flat vertical scarf. On SST 3-1, SST 4, and SST 5, the outer face was sawn, but an area at the end of the sawn portion was trimmed with an adze. This adzed area on SST 3-1 and SST 4, 31 and 24.5 cm, respectively, is substantial, but, probably due to breakage, only 5.5 cm of the adzed portion is preserved on SST 5. That such adzed areas were only preserved at stringer extremities seems to indicate that the broken aft end of SST 5 was relatively close to the original end of the stringer.<sup>92</sup>

Shells from barnacles and oysters and other marine growth were noted on many of the stringers. That such growth was present on the outer face of some of the lowest stringers in the hull (fig. 4.141) indicates that the hull sat abandoned for some time, filling slowly with water, before it had become fully inundated and choked with mud which would have prevented such growth. This again confirms the slow but steady demise of this abandoned vessel. Evidence of char-bending was found on SST 3-1 and SST 4. On each, the blackened portion of the inner face (fig. 4.142) appears to have facilitated a twist in the stringer toward the ship's extremities (near the stern on SST 3-1 and near the bow on SST 4). A charred portion of SST 5 was found along the stringer's lower (inboard) edge (fig. 4.143); both the location and intensity of the charring suggest that this may have been an area that had been burned in a forest fire or otherwise unintentionally. Pre-felling damage to the wood is also visible on SST 4, on which some areas of the outer face are riddled with damage from wood-boring insects (fig. 4.135).

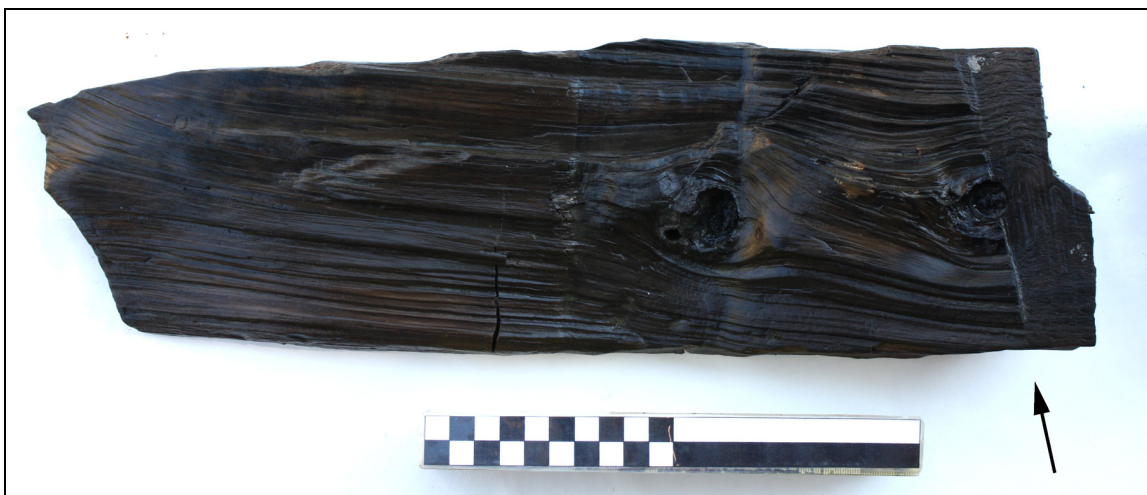
**Figure 4.136. Split aft end of SST 1-2, outer face. Arrow indicates end of sawing.**

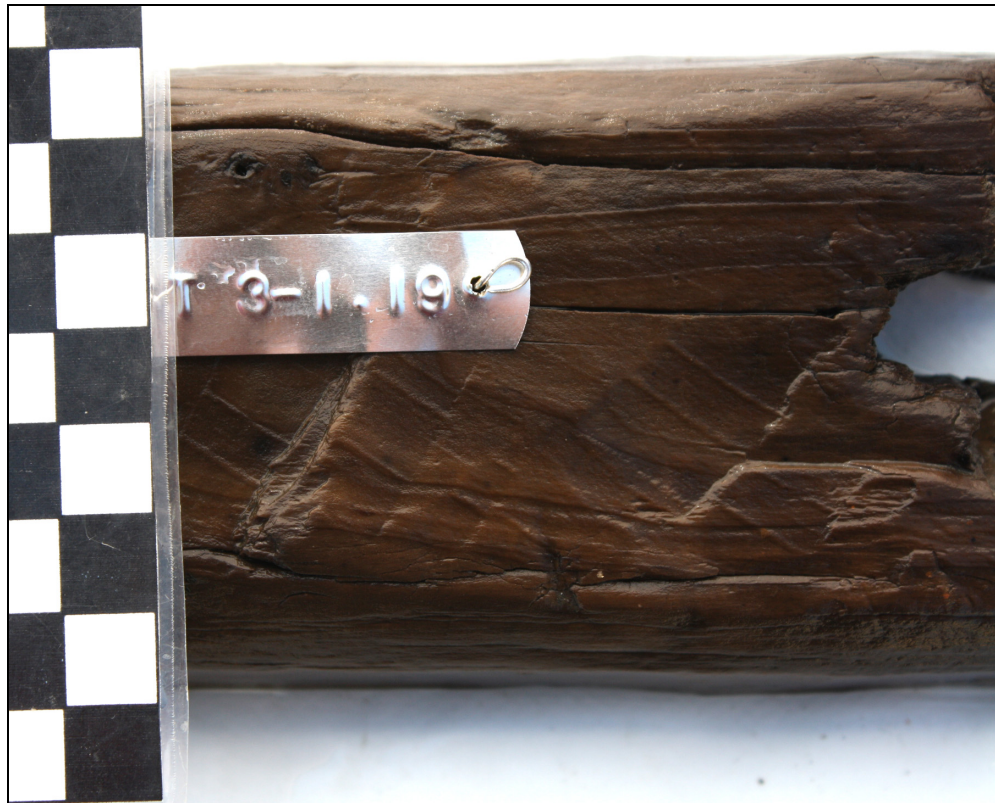
**Fig. 4.137. Tool marks from a chipped adze on the inner face of SST 3-1. Near forward end.**

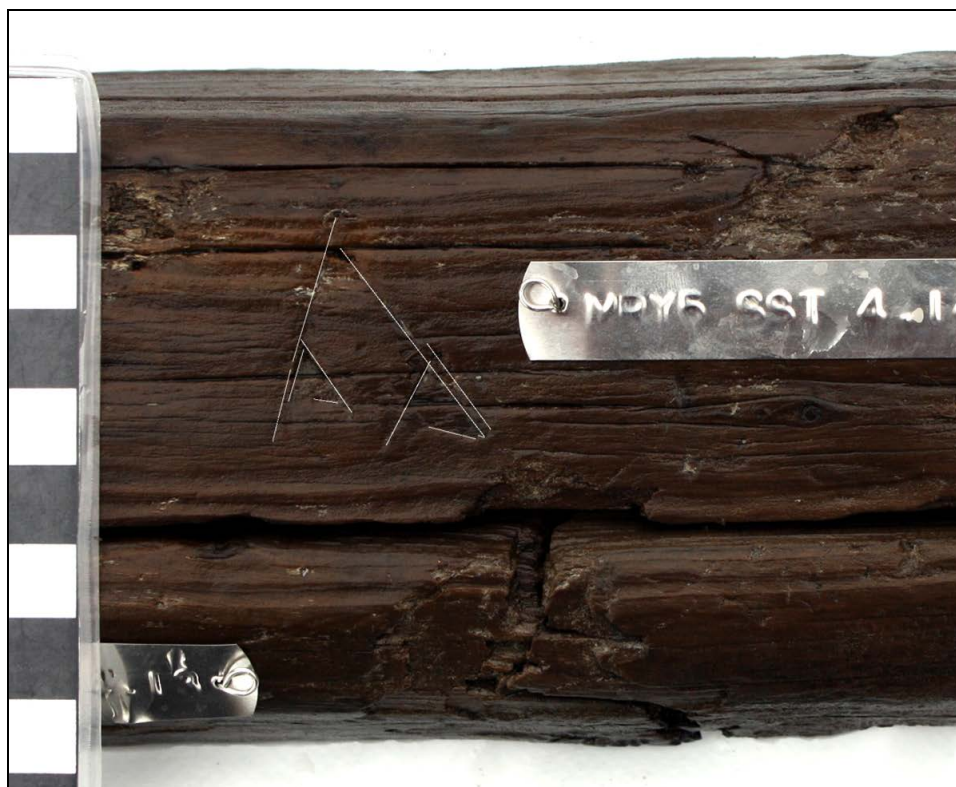
**Figure 4.138. Graffito cut into the inner face of SST 4 at F 17. White outline added for emphasis.**

Knife cuts or score marks are rare on the stringers, although a score mark indicates the edge of one (possibly both) of the mortises on SST 1-1. A sharp tool, perhaps a scribe, was used to carve a graffito into the inner face of SST 4 near F 17, below the location of the mast-partner through-beam (fig. 4.138). This graffito might represent the word *ἄλα*, a variant of the word *ἄλας*, which means “salt” or, by extension, “seawater,” the latter meaning appearing more likely in view of the inscription’s context.<sup>93</sup> Upon reconstruction of the ship, the graffito was found to be located approximately halfway between the calculated waterline of the empty hull and the

estimated load waterline. The graffito thus seems to have served as an indicator of the ship's waterline; as such, it may have aided the crew in the lading of the vessel.

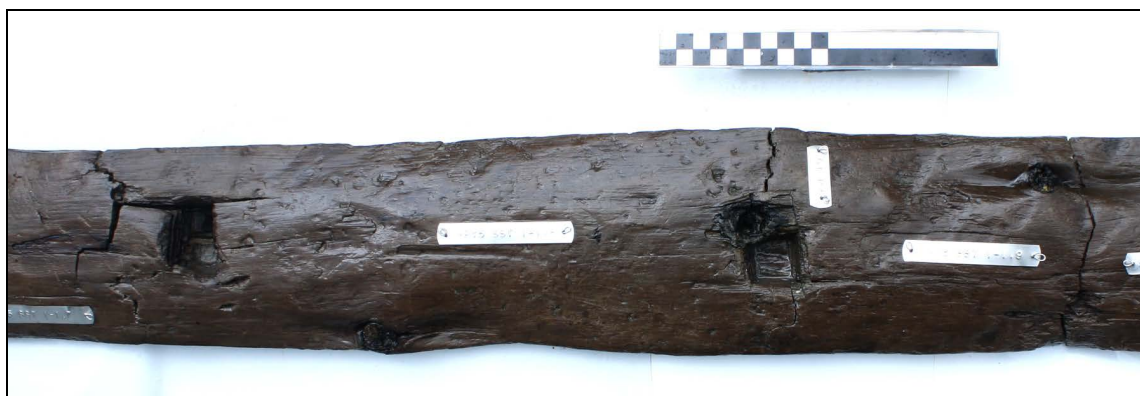
**Figure 4.139. Mortises on the inner face of stringer SST 1-1 at FR 9-FR 10.**

Two quadrilateral mortises were chiseled out of the inner (top) faces of both SST 1-1 and SST 2, both at approximately the same location, near FR 9 and FR 10. On SST 1-1, the mortises are 2.2-3.0 cm in depth and 2.8-4.7 in sided dimension (fig. 4.139). The mortises on SST 2 are slightly shallower, just above 1 cm in depth, and smaller as well, just 2.7-3.0 cm in sided dimension. The edges of the mortises are worn, and SST 2 is broken at each mortise. There is no pressure damage on the inner face indicating that a timber might have been seated here.

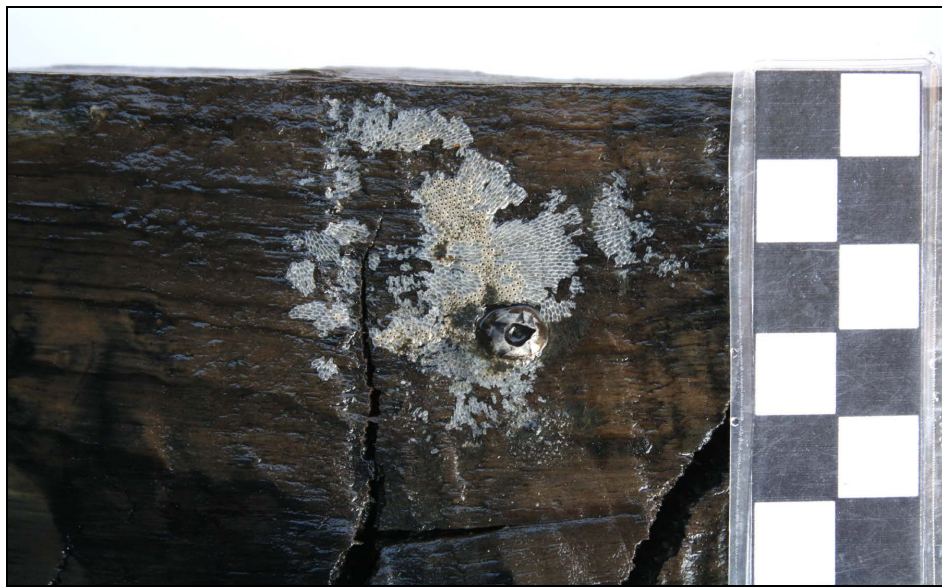
**Figure 4.141. Marine growth and barnacle on the outer face of SST 1-2 at FR 14-FR 15.**

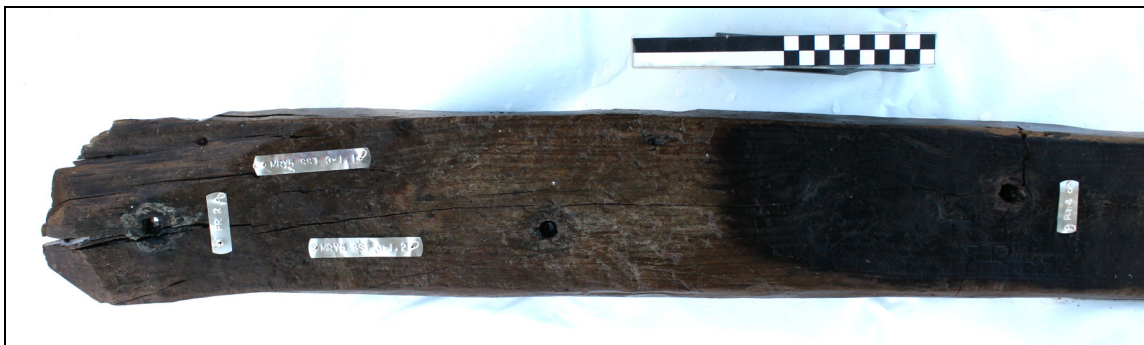
**Figure 4.142. Inner face of SST 3-1 at aft end. Note charring of inner face.**

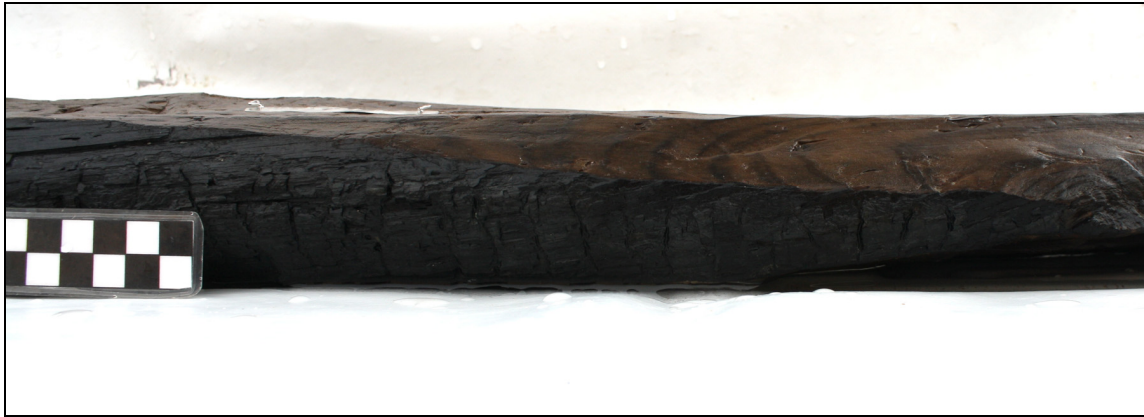
Figure 4.143. Charred lower edge of SST 5.

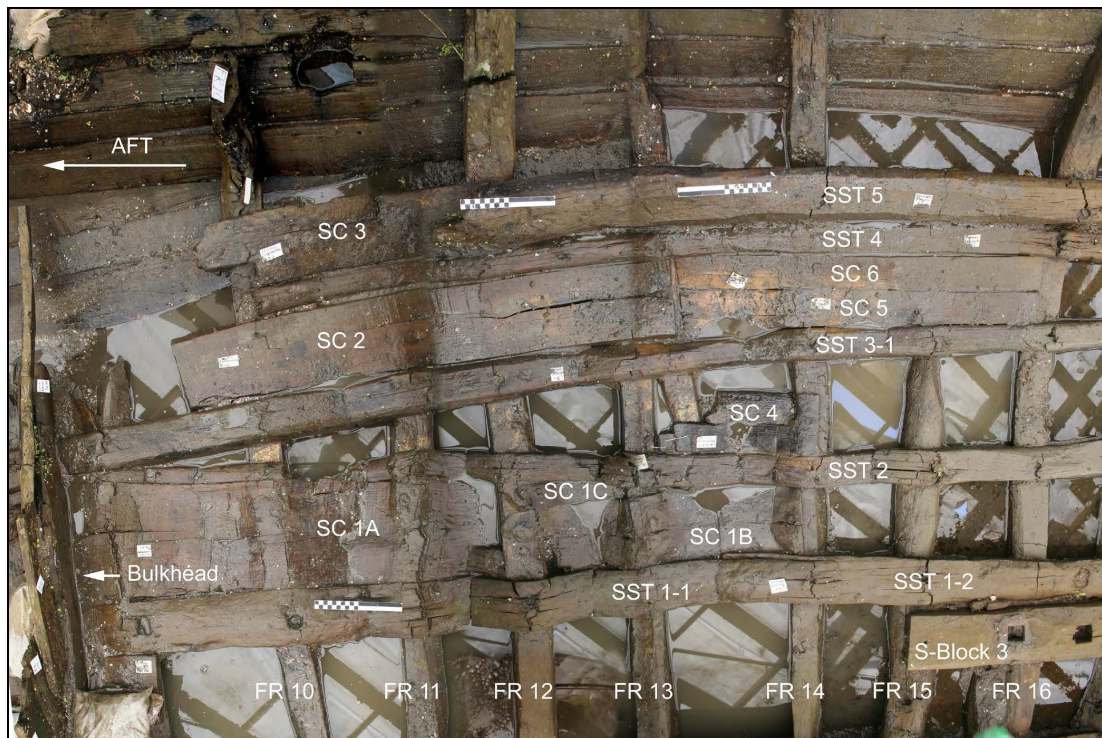
**Figure 4.144. Photomosaic of port-side ceiling, forward of the bulkhead. SST 5 has slipped downward. Scale shown is 20 cm.**

Ten planks of common ceiling were preserved on YK 11 (table 4.16). Most of these were located on the port side between FR 9 and FR 16, just forward of the bulkhead, where they alternated with stringers (figs. 4.123, 4.144). The orientation of the ceiling ran parallel to the centerline of the ship; there is no evidence of transverse ceiling. Only one ceiling plank, PC 1, was preserved on the starboard side, outboard of PST 1, and one, SC 7, on the port side toward the bow, between SST 3 and SST 4. The planks were numbered PC (for starboard ceiling) and SC (for port ceiling), with consecutive numbers starting in the stern and moving up and forward in the hull. SC 1, a

poorly preserved area of ceiling, was found to be three separate planks, later labeled SC 1A, SC 1B, and SC 1C. Like the stringers, the common ceiling rested atop frames, to which the ceiling was very lightly nailed. As illustrated in figure 4.144, the boards were carefully cut to fill gaps between stringers.
