ANALYSIS AND RECONSTRUCTION OF SHIPWRECK YK 11  
(C. SEVENTH CENTURY A.D.) FROM THE THEODOSIAN HARBOR  
AT YENİKAPI IN ISTANBUL, TURKEY

A Dissertation

Submitted to the Office of Graduate Studies of  
Texas A&M University  
in partial fulfillment of the requirements for the degree of

DOCTOR OF PHILOSOPHY

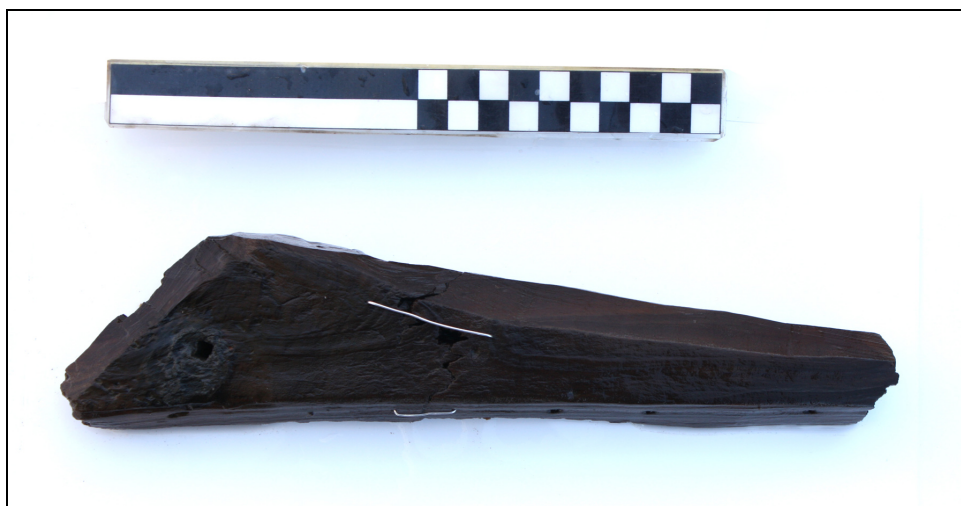
**Figure 4.146. SC 1C outer face. Edges are beveled to fit with SC 1A and SC 1B.**

Despite the damage, seven of the ten ceiling planks were either complete or nearly so, and two of these are both complete and intact (table 4.16). The complete planks range in length from 0.76 to 1.22 m, 96 cm on average. SC 1C is a small, nearly complete piece (with a broken tip) that is just 27 cm in length; this approximately triangular piece was custom-cut to fill a gap between SC 1B and SST 2 (fig. 4.146).

In section, the bar-like pieces of ceiling, SC 5, SC 6, SC 7, and UM 19, are slightly trapezoidal, with edges beveled so that the inner face is slightly wider than the outer face. Alternately, the edges of SC 2 are significantly beveled so that the inner face is 2-3 cm narrower than the outer face (fig. 4.149). However, other evidence reveals that some of these ceiling planks were removed and replaced upside down, which suggests these bevels are merely incidental. The only evidence of an edge intentionally cut at an angle to fit the edge of another plank is in the SC 1 transition, where SC 1A and SC 1C were both cut with a chamfer to ensure a better fit, and the inboard edge of SC 1C was also cut with a chamfer to better match the edges of SC 1B (fig. 4.146). Most other common ceiling had a section that was either approximately rectangular or too badly

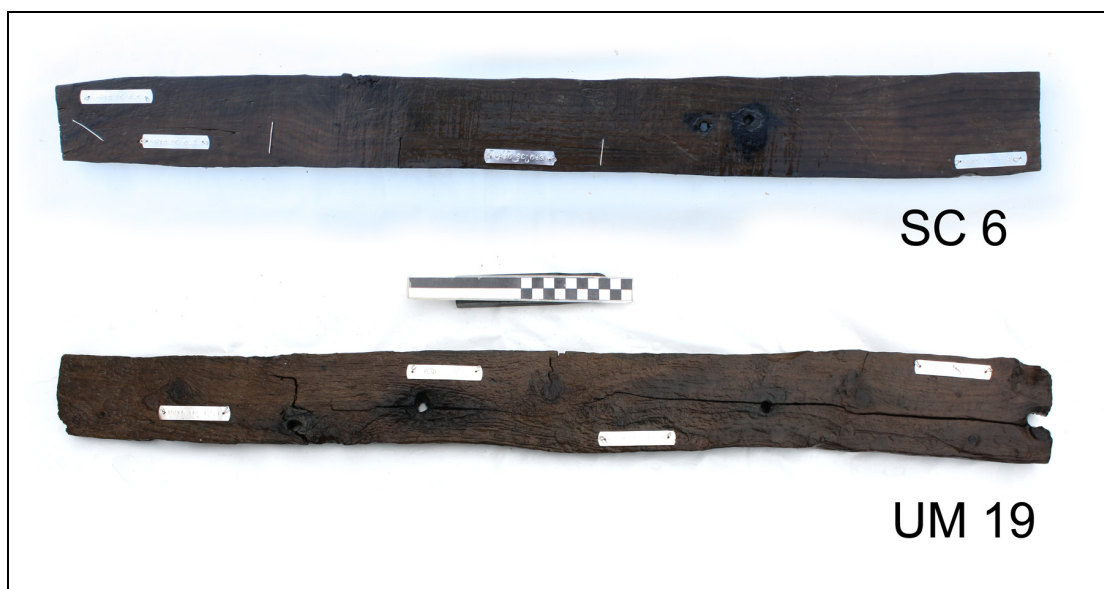
**Figure 4.147. Narrow ceiling planks SC 6 and UM 19, inner face.**

original widths of 2.1-28 cm were recorded, with an average maximum width of approximately 15 cm. SC 5, SC 6, and SC 7, all cypress, appear to be more standardized; these narrow, rectangular planks have a maximum width of 8.8-11.2 cm and a length of 91-101 cm. UM 19, a similarly-shaped pine plank found wedged under SST 5, is probably also a ceiling plank of the same type (fig. 4.147).

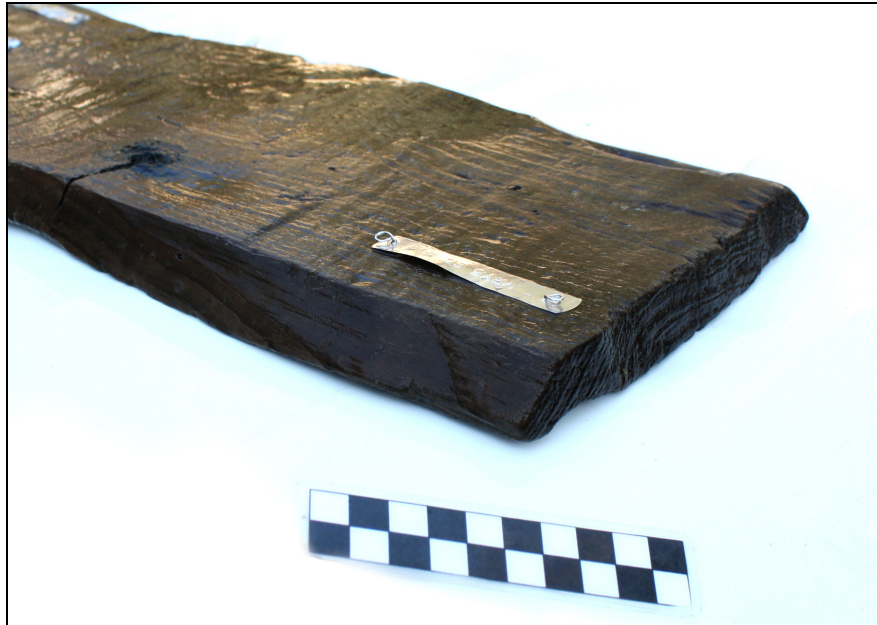
**Figure 4.149. Aft end of SC 2. Note inward bevel to edges.**

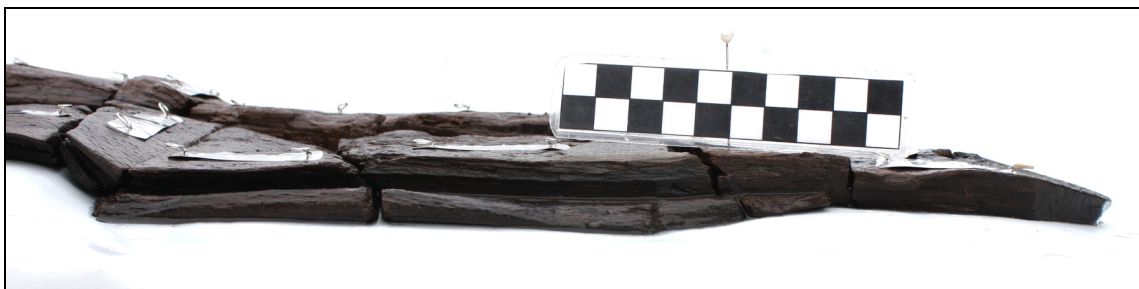
**Figure 4.150. Groove cut along top (outboard) edge of SC 1B.**

SC 1B, a recycled piece, has a unique section. A deep, narrow groove, 2.0-2.5 cm in depth and 0.5-0.6 cm in width, was cut along both the upper and lower edges (fig. 4.150).<sup>94</sup> Although the form is now badly damaged and compressed, with many of the edge fragments broken away along one or both edges (fig. 4.151), it was originally a fine piece of craftsmanship. It is much more delicate than anything seen on YK 11, and it may have been recycled from another ship or, more likely, from the *opus intestinum*, the interior woodwork, of some structure in Constantinople. A tongue-and-groove joint such as this was observed on the carbonized planks of a shuttered shop door at Herculaneum.<sup>95</sup>

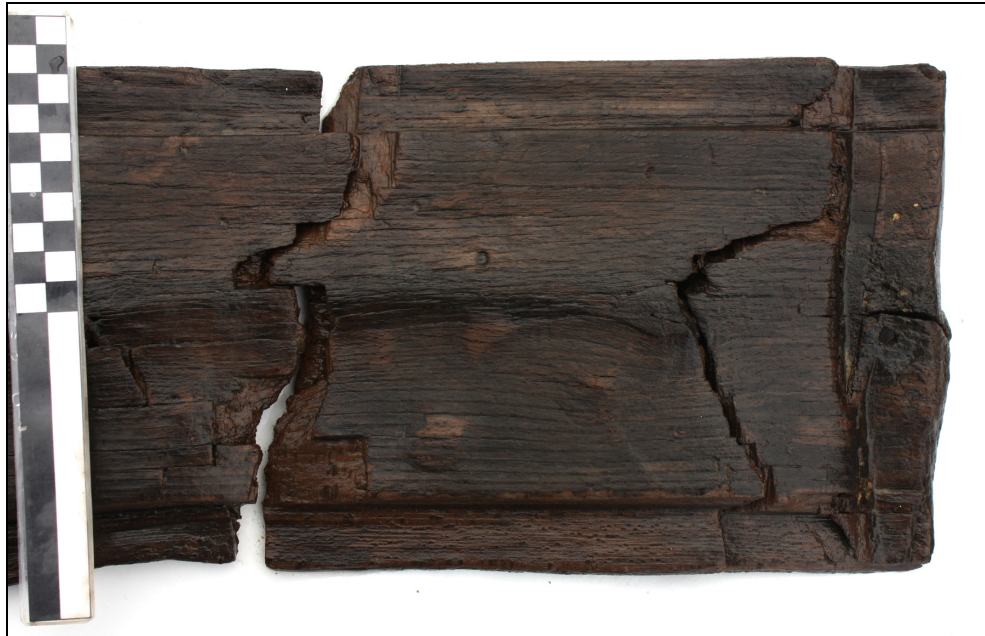
**Figure 4.151. Outer face of recycled ceiling plank SC 1B, forward end. Note deep groove along damaged edges and compression damage at end.**

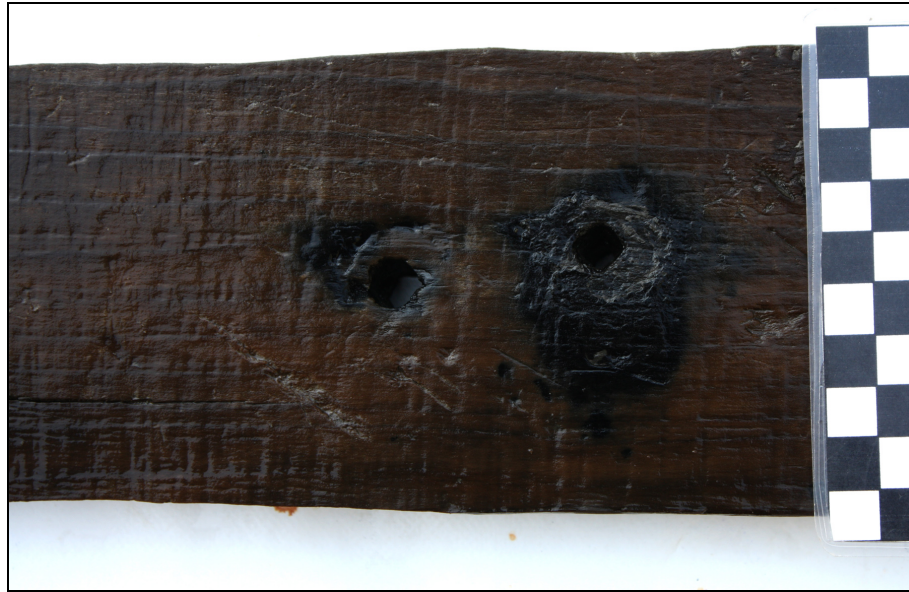
**Figure 4.152. Nail holes in SC 6 inner face. The nail hole on the left is disused.**

The common ceiling was very lightly fastened to the ship's framing with small nails, similar to those used for the planking, framing, and stringers. Nails were driven from the inner face, and the square holes left by the nail shanks are 0.5-0.9 cm, usually 0.7 cm, sided on the inner face, and slightly smaller on the outer face, usually 0.5-0.6 cm. Nail heads often left a pressure mark or an outline in concretion on the inner face and range from 1.7 to 2.3 cm in diameter, although nail-head impressions up to 2.5 cm in diameter were observed. Most, but not all, of the nails were driven into pilot holes drilled from the ship's interior. These usually do not extend to the outer face of the ceiling and show some variation in size, from 0.7 to 1.2 cm, although 0.9 to 1.1 cm is most common.

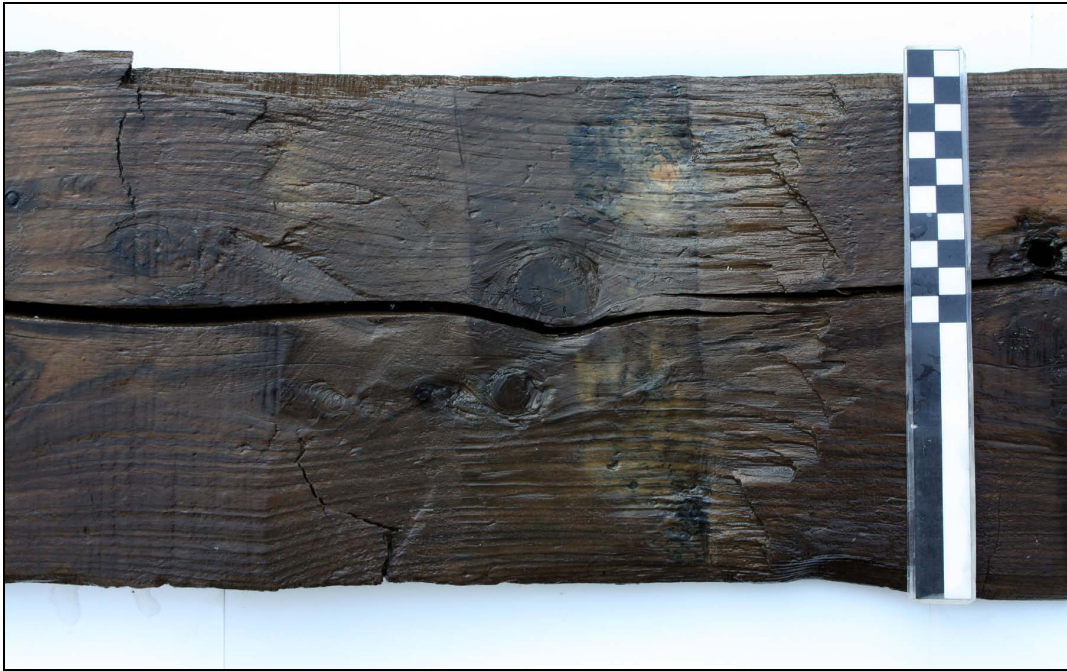
**Figure 4.153.** Roughly-adzed area on outer face of SC 2 at FR 12. Note pressure mark and pitch stain at frame location.

On SC 2 and SC 5, parts of the outer face were trimmed with an adze, presumably to provide a better fit against the framing (fig. 4.153). On SC 2, this area helped accommodate the replacement FR 12, which was slightly larger than the average frame in molded dimension. The adze used in this area was notably wide, 5.5 cm, while other adze-trimmed areas suggest use of an adze closer to 4 cm in width. Recesses or notches along ceiling edges and at the carefully crafted SC 1 transition were likely adzed, with blade widths up to 2.1 cm recorded (fig. 4.154). No score marks were recorded on the common ceiling, but a series of thin, deep, knife-like cuts or sharp abrasions were noted on the inner face of SC 7, around F 21; the cause of this is unclear but could be associated with movement of cargo (fig. 4.155).

Pitch was generally not well preserved on the common ceiling. When present, it was usually found on the outer face in small patches or as a vague, yellowish stain (fig. 4.153). Some areas of pitch on the outer face had been transferred from the inner face of framing. There are some small patches of pitch on the edges and, more rarely, the inner face; there is an extensive area of pitch on the inner face of SC 3 (fig. 4.156), but it is unclear whether all of the common ceiling was pitched on the inner face, or if this area, above the turn of the bilge, was pitched for a certain reason. The former seems more likely, although perhaps the pitch was tempered with some other material to prevent it from being too sticky on the interior of the cargo hold.

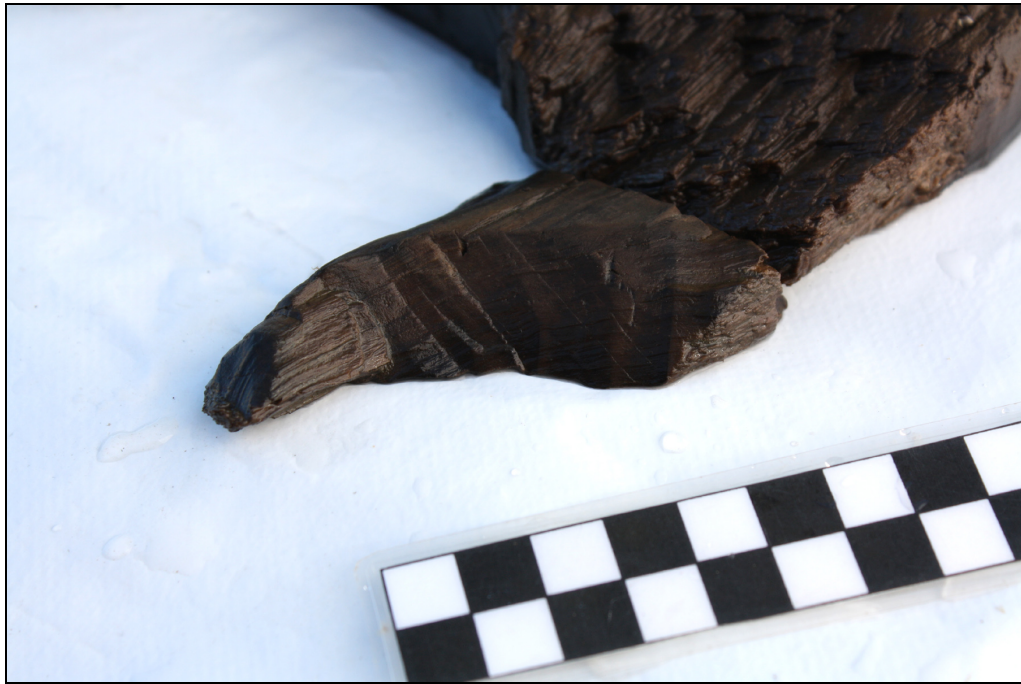
**Figure 4.154.** Adzed forward end of SC 1A.

Flat-cut ends are usually sawn, and the fine, closely-spaced striations on the forward end of SC 6 suggest cutting with a finer saw than the larger frame saws that were used to create the wide, flat inner and outer faces. On both faces, SC 1A was sawn to a point near the forward end, then split for the remaining distance; this split surface was then trimmed with an adze along the outer face, while the inner face remained untrimmed.

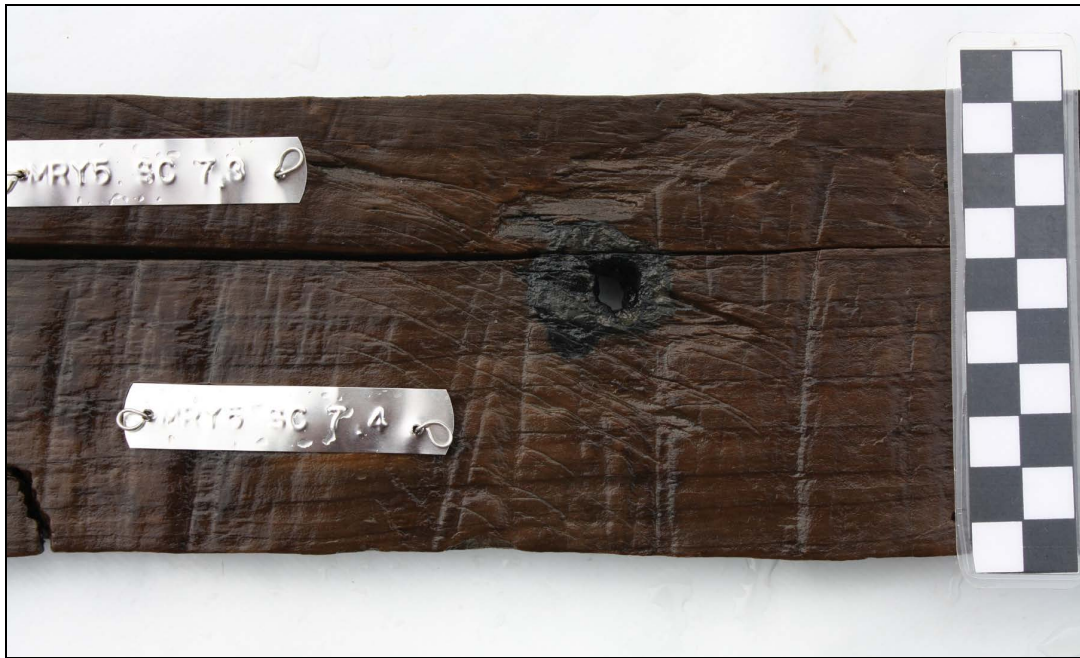
Figure 4.155. Cut marks or deep abrasion to SC 7 inner face at F 21.

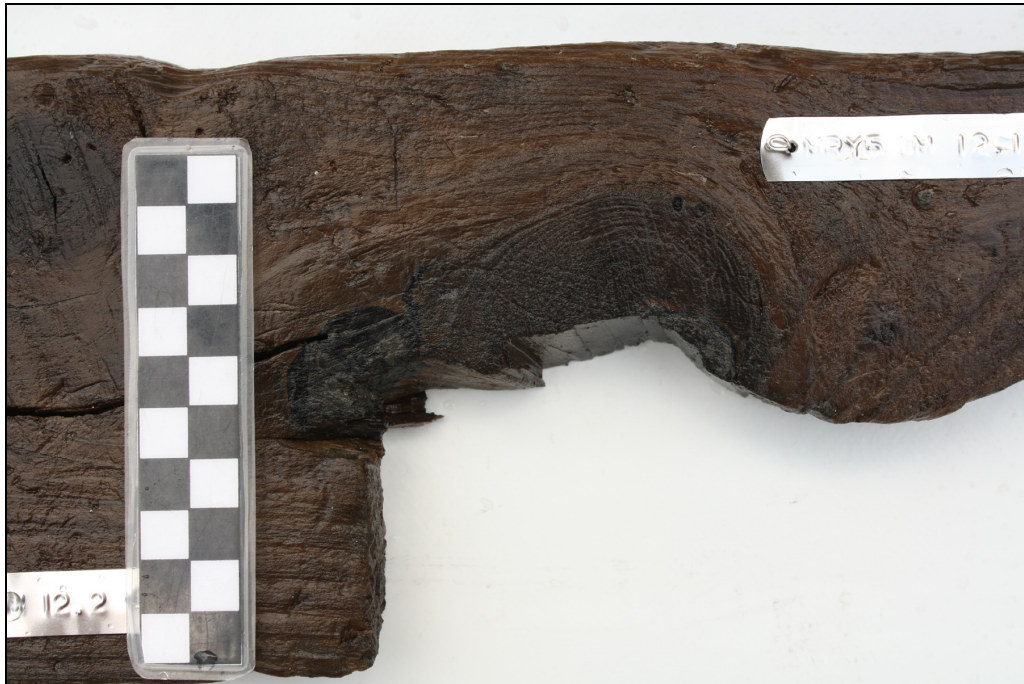
**Figure 4.158. Upper face of UM 12, showing roughly chiseled recess at timber forward of F 13.**

The deep recesses along the outboard edges were adzed or chiseled. On UM 6, angled tool marks reflect use of a sharp blade at least 2.0 cm in width. On UM 12, the FR 14 recess is carefully cut, while the recess at F 13 and an unpreserved timber just forward of this is very roughly cut at a knot with a 1.3 cm-wide chisel (fig. 4.158). Part of this edge also seems to have been split along the wood grain.

forward of F 13 (fig. 4.158). There were also traces of a third nail at the FR 12 recess on UM 6; this may be what remains of a nail that attached the sill to the original frame FR 12. There is also a fourth nail hole on UM 6, disused and located between FR 12 and FR 13. Due to its proximity to the outboard edge, it was probably never used to attach this sill to any timber, and it may be evidence that this sill was fashioned from an old, recycled piece of common ceiling or exterior planking.

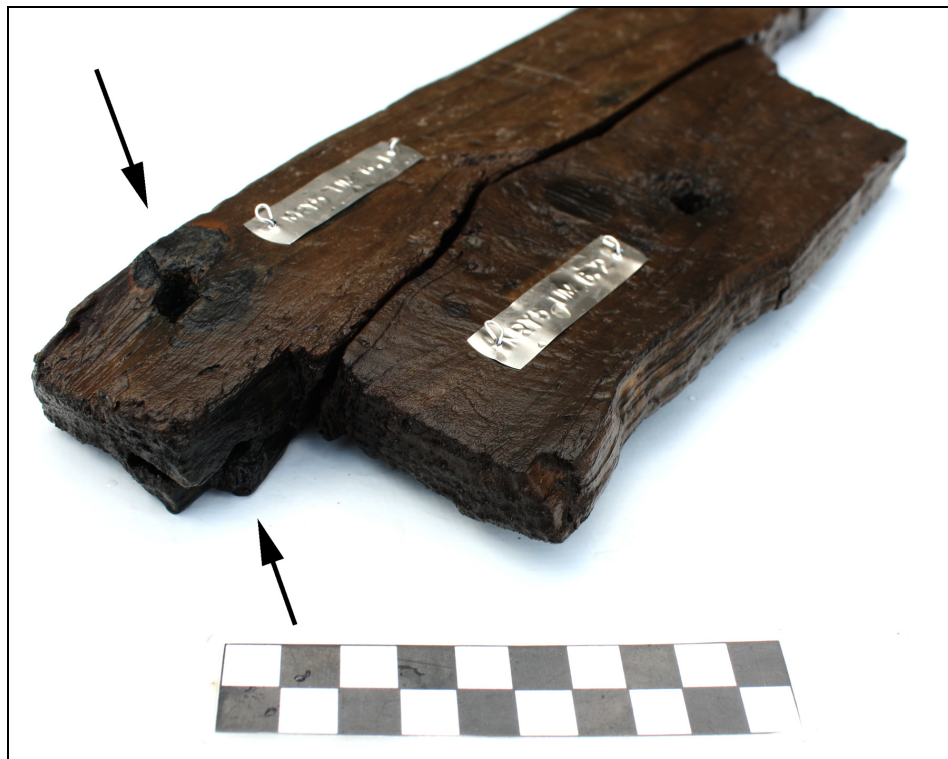
**Figure 4.159. Diagonal nail (at arrows) at forward end of UM 6, at F 13.**

UM 12 was attached with one nail only; the nail was driven diagonally through the top face of the sill, exiting through the edge between the bottom and outboard surface, into the inner face of FR 14. UM 6 was attached in a similar fashion to F 13 (fig. 4.159) and also had a nail driven straight through the sill near the aft end, presumably into the top edge of stringer SST 5, which was not preserved here. In addition to the diagonal nail, UM 12 retained traces of two other nails along the roughly-cut recess

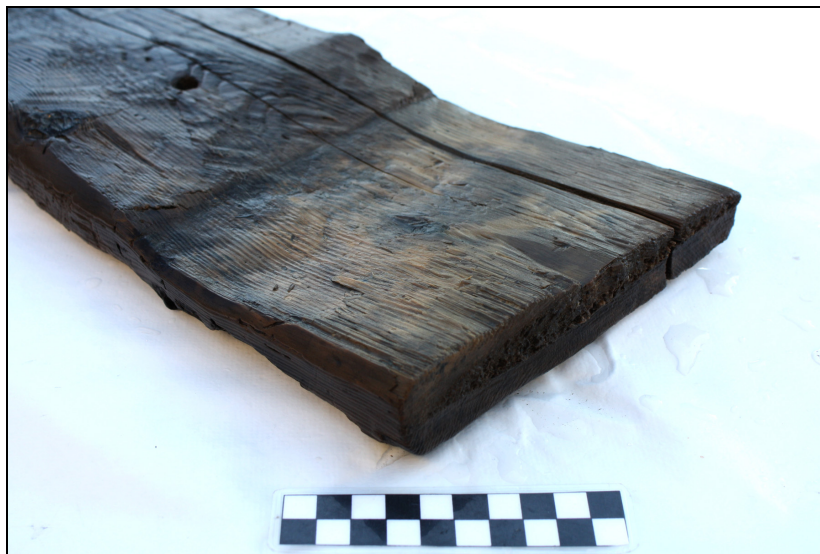
**Figure 4.161.** Aft end of S-Block 1, outer face. Note trimming of outer face for frame, compression at frame location, and saw marks and splitting at end.

original, relatively undamaged surfaces. Cracking is usually minor and does not threaten the integrity of the timbers, except on badly split S-Block 1; surface damage is usually shallow. Compression damage is rare, although it is notable on S-Blocks 1 and 4 (fig. 4.161). On S-Block 4, pressure damage has caused significant distortion to the aft end, although the timber remains intact (fig. 4.162). Part of the pith has dropped out of the inner face here as well; a deep diagonal cut across the inner face near the mortise could have caused this.

Most of the stanchion block ends have been sawn flat; in at least three cases, the ends were sawn first from one direction, then from another direction, with the small area between the two saw cuts snapped off (figs. 4.161, 4.163). While most ends are blunt-cut, the aft ends of both S-Block 2 and S-Block 5 have wide chamfers to transition from the inner face to the flat-cut end (fig. 4.166). Likewise, the aft end of S-Block 6 is cut flat with an adze, with a wide chamfer cut to one of its corners. The outer face of S-Block 6 is also trimmed with an adze, gradually decreasing the timber in molded dimension toward its forward end; this does not, however, seem to be associated with a

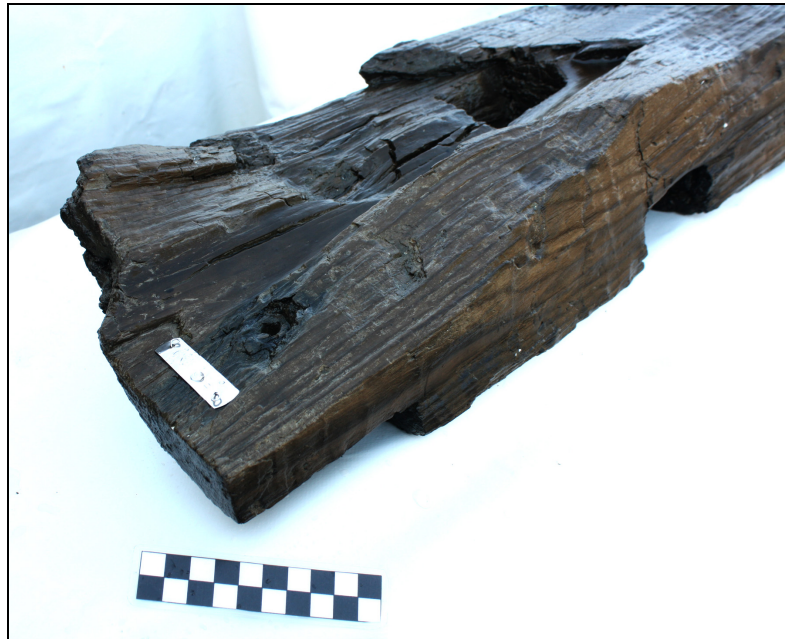
**Figure 4.162. Distorted aft end of S-Block 4.**

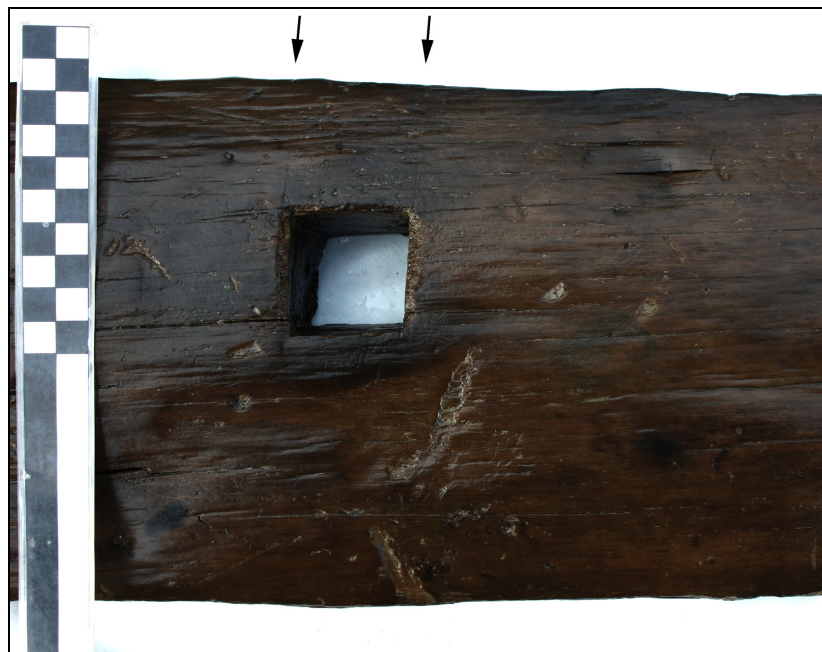
**Figure 4.164.** Mortise at S-Block 6 inner face. Note naturally rounded surface, score marks at mortise edges (arrows).

In form, S-Blocks 5 and 6 are quite similar; both are stringer-like in section, with a naturally rounded inner face (fig. 4.164) and a flat outer face, and both narrow toward the aft end through bevels cut along the edges (see below). They were cut from the outer portion of a sawn log, with only 15-25 annual rings visible, the pith oriented toward the exterior of the hull. Areas of the outer face of both timbers were trimmed with an adze to accommodate one or more frames. In section, the edges are beveled such that the outer face is slightly narrower than the inner face.

All of the mortises were cut with a chisel, at times roughly, with blade widths of 1.5 and 2.0-2.3 cm reflected in cut marks (fig. 4.169). The outer face is usually more roughly cut than the inner face. Score marks along both the forward and aft edges of the mortises on S-Blocks 5 and 6 (fig. 4.164) reveal the significance of the longitudinal location; these mortises align with the probable location of a forward through-beam. Faint score marks were also noted near the edges of the mortise on S-Block 2, but were not preserved on any of the other stanchion blocks. Perhaps the longitudinal position of the mortises was less important on the central pair of stanchion blocks, or perhaps the score marks were simply not preserved on these timbers.

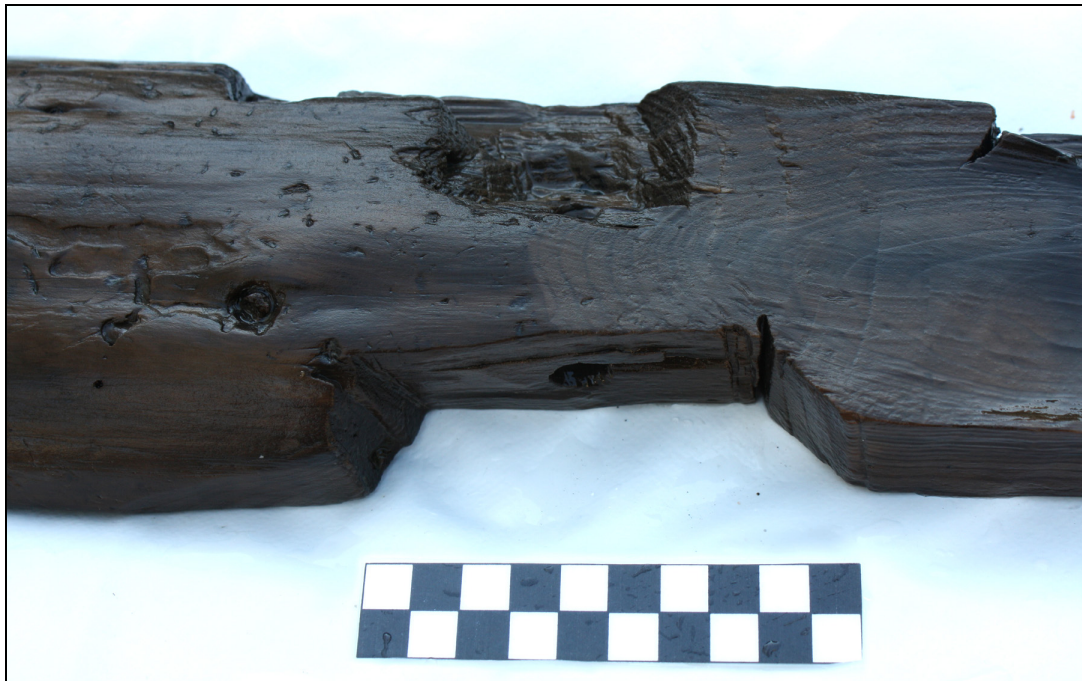
**Figure 4.165. Notches on recycled timber S-Block 2.**

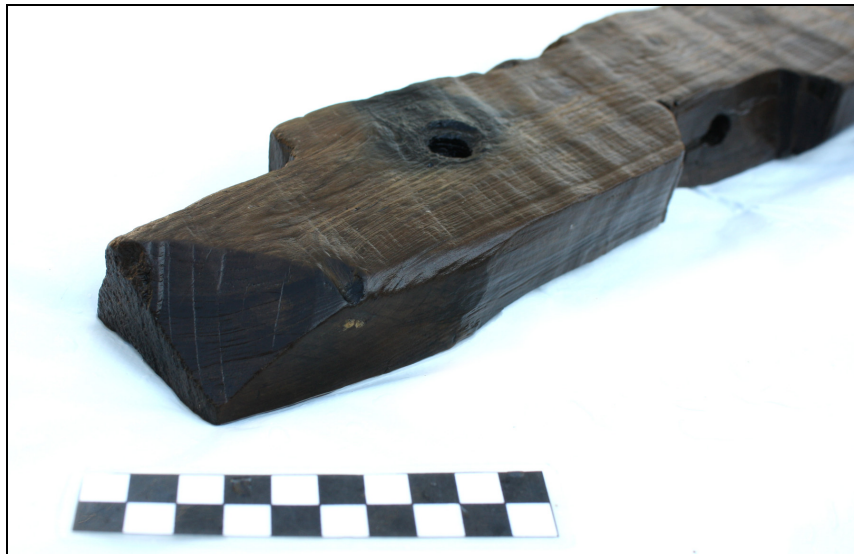
**Figure 4.166. Aft end of S-Block 2, showing inner face.**

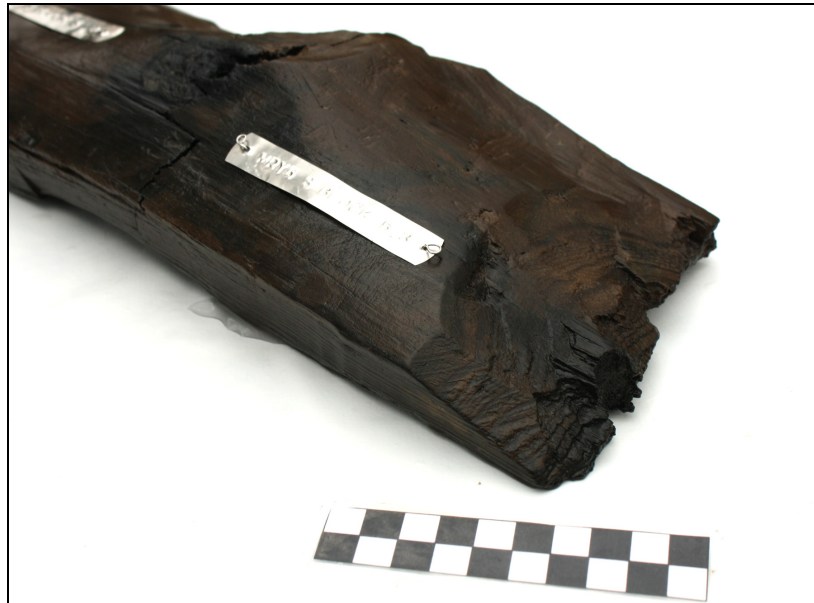
**Figure 4.167.** Forward end of S-Block 5. Note rough adzing and cut-through nail hole.

frame, and the reason for this trimming is unclear. The forward end of S-Block 5 is the only end which is not cut flat; rather, this end is roughly adzed down to a thin, ragged edge (fig. 4.167). This edge cuts through a nail hole of unclear function, located between frames.

Four of the six timbers have one disused fastener hole, varying in size, shape, and location. The disused fastener hole on S-Block 1 is an empty drilled hole, 1.0 cm in diameter, between frame locations. The disused fastener hole on recycled S-Block 2 is a diagonally drilled hole that served some unknown function in the timber's original use (fig. 4.165). The small abandoned nail hole on the outer face of S-Block 4 looks like an old, square nail that had been extracted. The large, black-stained nail hole, cut through on the ragged forward end of S-Block 5, was noted above (fig. 4.167).

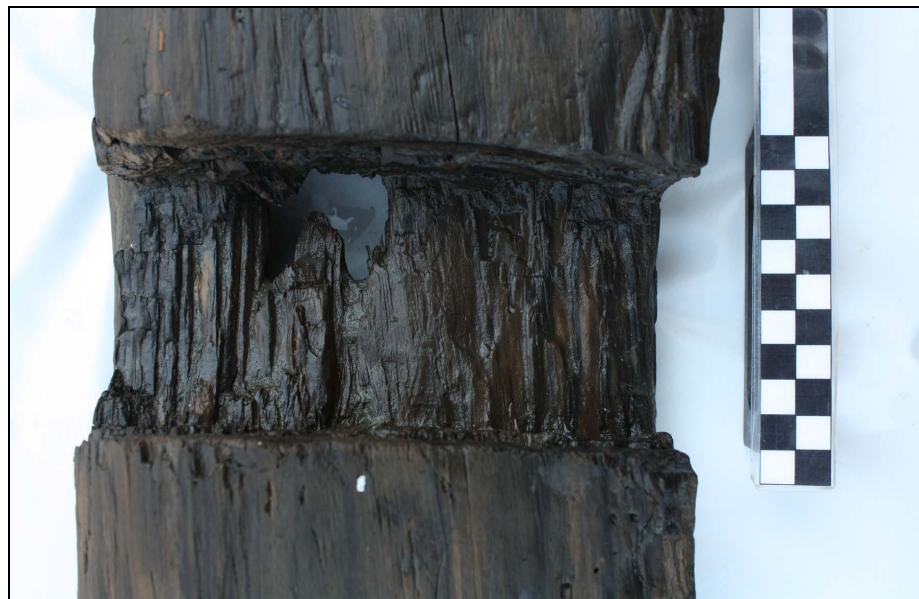
**Figure 4.168. Rough edges of mortise on outer face of S-Block 4.**

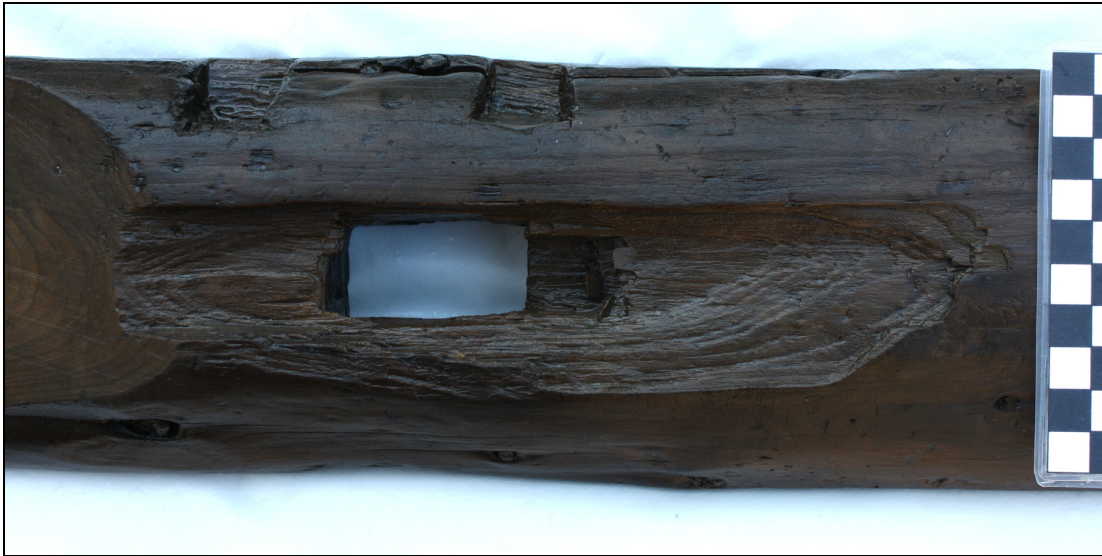
**Figure 4.169. Outer face of S-Block 2 at mortise.**

The most characteristic feature of the stanchion blocks is their mortise. Each stanchion block, with the exception of S-Block 3, possesses one mortise that extends to the outer face. On S-Block 3, there are two mortises; the forward mortise does not extend to the outer face and may have been cut in the wrong location, while the aft mortise does extend to the outer face and aligns with the mortise on S-Block 4. On S-Block 4, the broken and irregular outlines of the mortise on the outer face suggest it was cut from the inner (upper) face and merely broke through the outer face incidentally (fig. 4.168). Other mortises appear to have been cut from both the inner and outer faces, and chisel marks to one side of the mortise reveal that the mortises on S-Blocks 2, 3, and 5 were started off-center on the outer face (fig. 4.169).

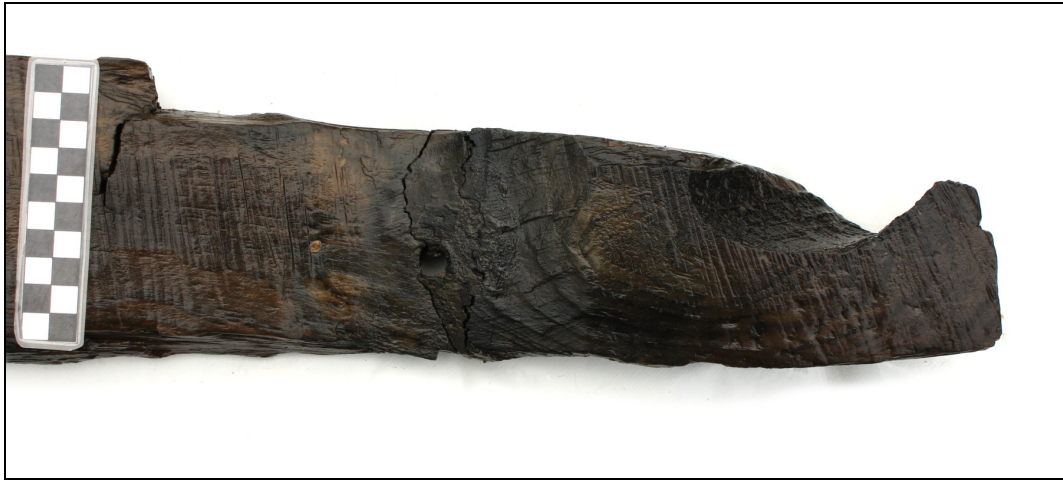
**Figure 4.170.** Sawn outer face of S-Block 5. This face is adzed down at FR 22. Note large knot hole near end.

The stanchion blocks were fashioned with the use of an adze, saw, several chisels, and a drill. The inner face of S-Blocks 1, 2, and 4, and the outer face of S-Blocks 5 and 6, were sawn; most of the blunt-cut ends were also sawn. Remaining surfaces and any chamfers were either naturally rounded, with bark removed (figs. 4.164, 4.165, 4.167, 4.169), or were trimmed with an adze. Tool marks suggest the use of one or more chipped blades with widths of 3.5-4.5 cm. The outer face of S-Block 2 was roughly split near its aft end. The sawn outer faces of both S-Blocks 5 and 6 were adzed down at some frame locations (fig. 4.170).

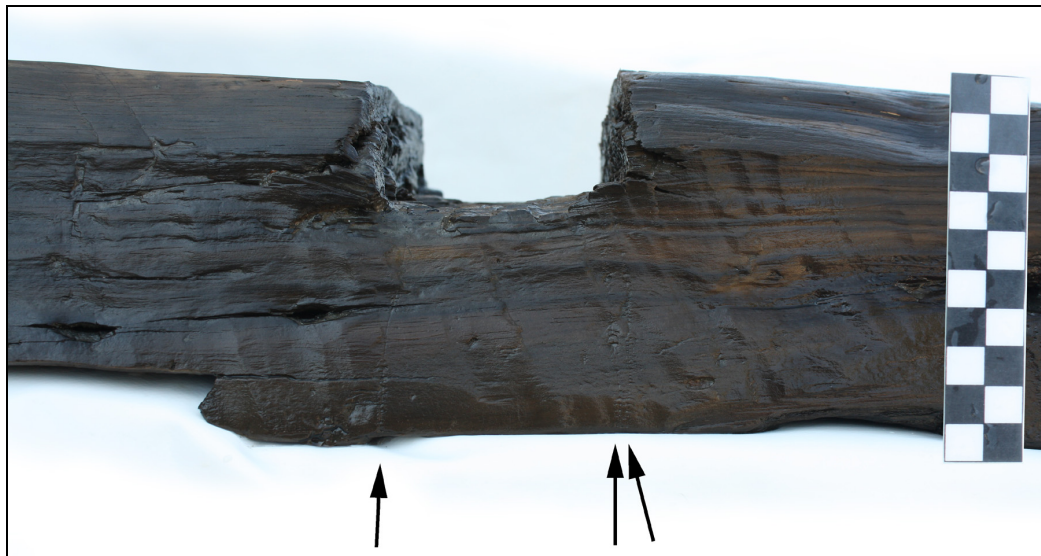
**Figure 4.171. Score marks on the inboard edge of S-Block 4.**

Score marks were used both to designate the longitudinal position of the mortises on S-Blocks 5-6 and to indicate the location of the outer face notches for framing on S-Blocks 3 and 4. Their precise placement on S-Block 4 (fig. 4.171) indicates the importance of fitting these timbers over framing, locking them in place longitudinally;

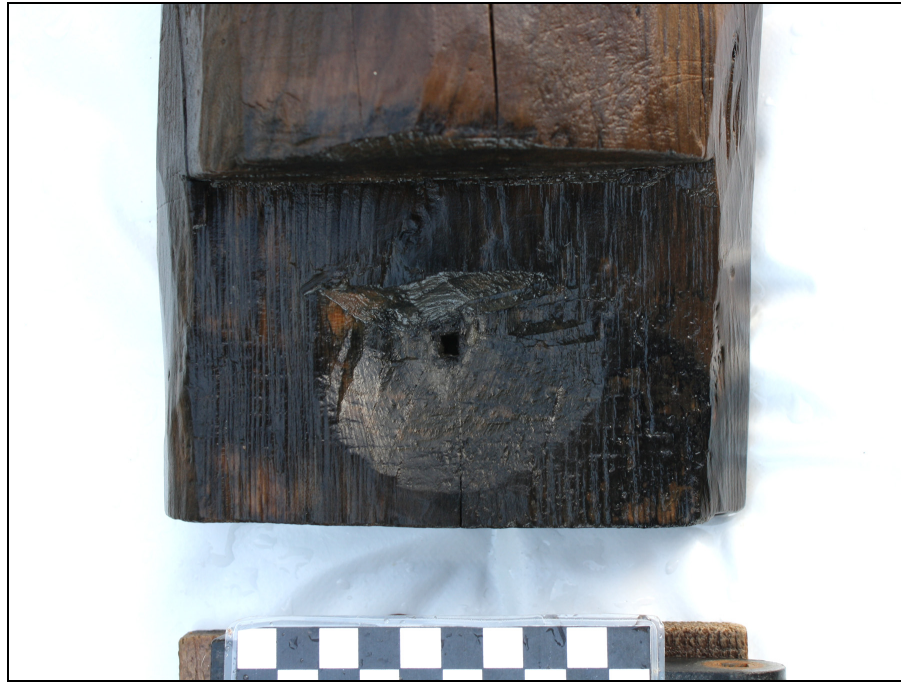
**Figure 4.172. Outer face of S-Block 3 at aft end (FR 15). Note cut-down area around nail.**

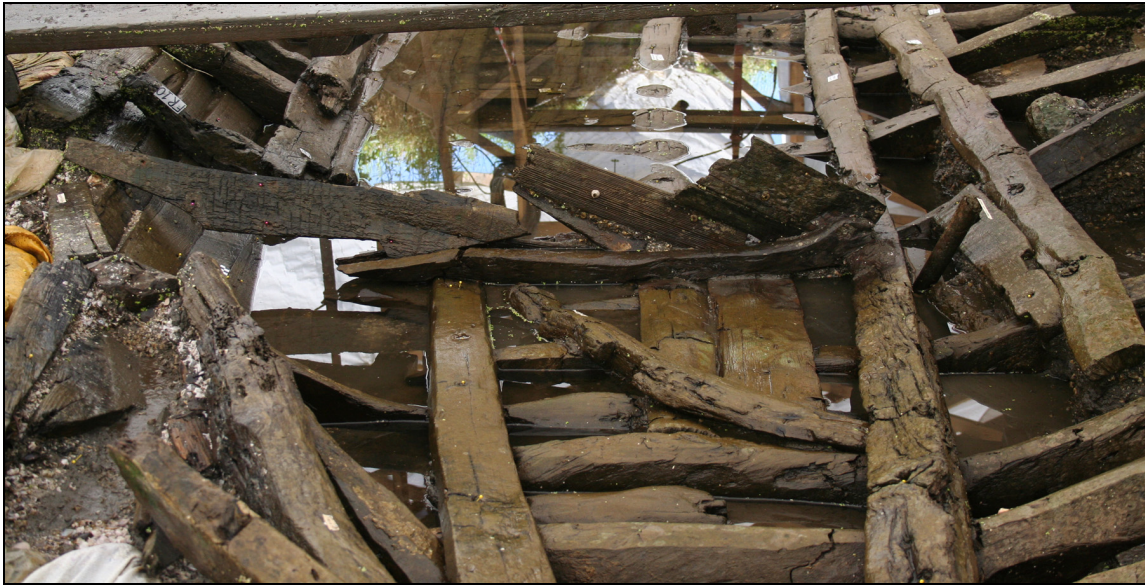
**Figure 4.173. Bulkhead components in situ, viewed from stern. Plank PS 6A, to left of bulkhead planks, was erroneously placed in the bulkhead frame by workers. UM 157 is on its side, aft of the bulkhead (toward foreground), between FR 5 and FR 8.**

Five planks were found resting in the BH FR 1 inner face slot; these were numbered BH Plank 1-BH Plank 5 (from outboard/port to inboard/keel) (figs. 4.173-4.174). BH Plank 1 was later found to be part of the ship's planking, mistakenly placed in the bulkhead frame by workers during excavation; the other planks were in their original location, slotted into the bulkhead frame. Measurements for each plank are provided in table 4.19. Planks 2 through 4, like the bulkhead frame, are of Turkish pine; BH Plank 5 is of European ash. The planks are of relatively consistent thickness, usually 1.8-2.1 cm, which would fit well within the BH FR 1 slot. Widths vary, from a maximum of 5.9 cm (Plank 4) to a maximum of 17.2 cm (Plank 5). Lengths vary as well and are not original; only the planks' inboard ends are preserved. Preserved lengths are 29-47.2 cm, approximately 35 cm on average.

Plank 5 is the only bulkhead plank that was broken. This is the only bulkhead plank not of pine, and the wood type used might have affected the structural integrity of the piece. As found, the top edge of Plank 5 extended beyond the keel end of the bulkhead frame (fig. 4.173).

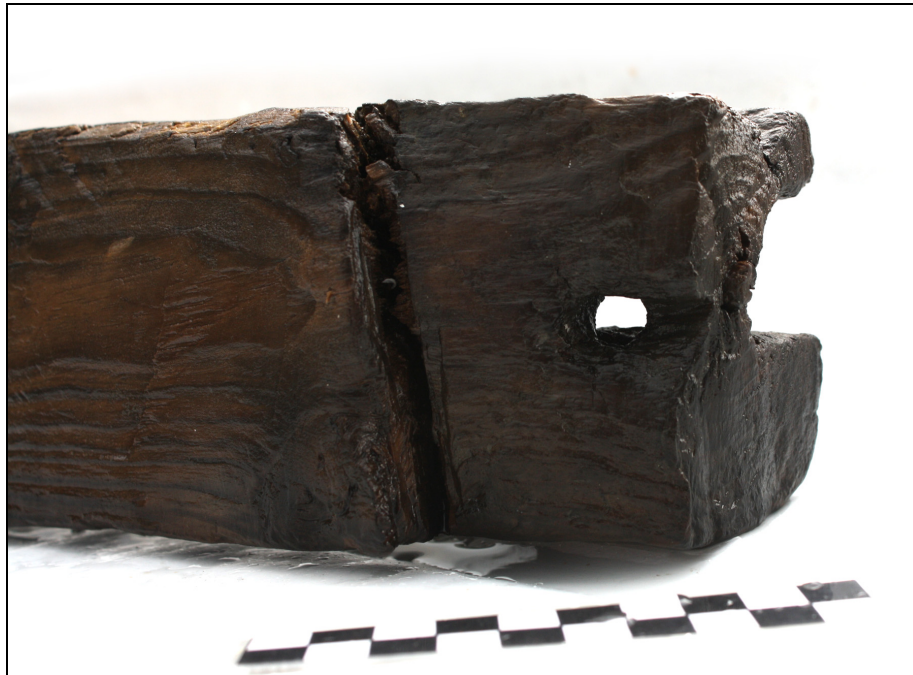
**Figure 4.175. Notched outer face of BH FR 1 at sternson KS 1.**

3-1 and in pressure cracking and damage at KS 1. Such pressure damage occurred despite the outer face of BH FR 1 being cut down to accommodate these timbers. The outer face has an adzed or chiseled recess at the location of KS 1; this recess is up to 1.3 cm in depth (fig. 4.175). At SST 3-1, a 14.5 cm-long area on BH FR 1's outer face (more than wide enough for SST 3-1) is trimmed down with an adze; this recess is approximately 1 cm in depth, but is less distinct than the KS 1 recess. The outer face also seems to have been trimmed down lightly with an adze at the location of SST 1-1.

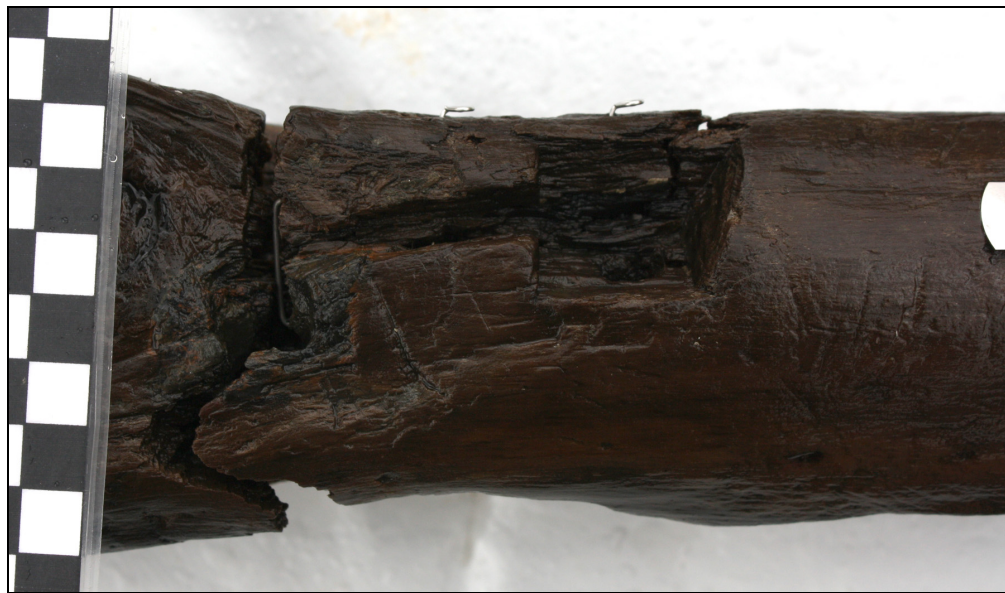
**Figure 4.176. Nails N2 and N3 on BH FR 1. N3, a disused nail, is in a chiseled recess.**

down into the inner face of stringer SST 3-1 (fig. 4.176). The timber broke at this nail. The original second nail on the bulkhead frame was much more carefully driven, through a drilled hole set in a chiseled recess. This chiseled recess, cut with a chisel not more than 2.5 cm wide, is set into the naturally-rounded, inner-forward edge of BH FR 1. The recess is 2.5 cm in length and 2.1 cm in height, with a depth of 2.2 cm. It suggests an original nail head not more than 2.5 cm in diameter. The original nail here seems to have corresponded to an abandoned nail hole on the inner face of stringer SST 3-1, suggesting that the original position of the bulkhead partition was very close to its replaced position, assuming of course that the stringer SST 3-1, which was also removed and repositioned, did not change location significantly. Traces of pitch found within the 0.9 cm-in-diameter pilot hole of this abandoned fastener hole on the bulkhead frame are the only remains of pitch on the timber.

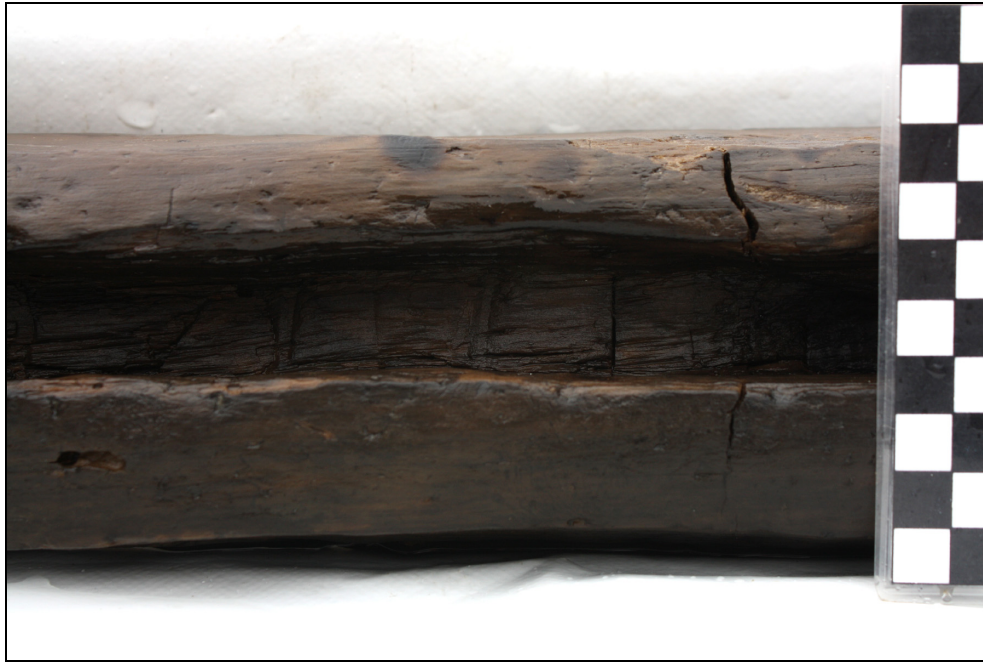
**Figure 4.177. Chiseled slot on inner face of BH FR 1.**

The most significant characteristic of BH FR 1 is the chiseled slot running the entire length of the timber (fig. 4.177). This slot is cut into the inner face of BH FR 1 and served as a base for the planks that comprise the bulkhead wall. The slot is usually 2.0-2.1 cm in width at its base (or deepest area). The depth of the slot is variable, from 2.0 to 3.0 cm depending on the depth of some of the chisel cuts, but is usually approximately 2.5 cm deep. The depth increases to 3.7 cm near the keel end. The slot was cut with a chisel, fairly smoothly along the walls, but roughly at the base of the slot, where the wood between the walls seems to have been roughly chopped out with a chisel probably 2.0 cm in width. That the slot runs along the entire length of the timber lends some support to the theory that the bulkhead partition continued on to the starboard side of the ship.

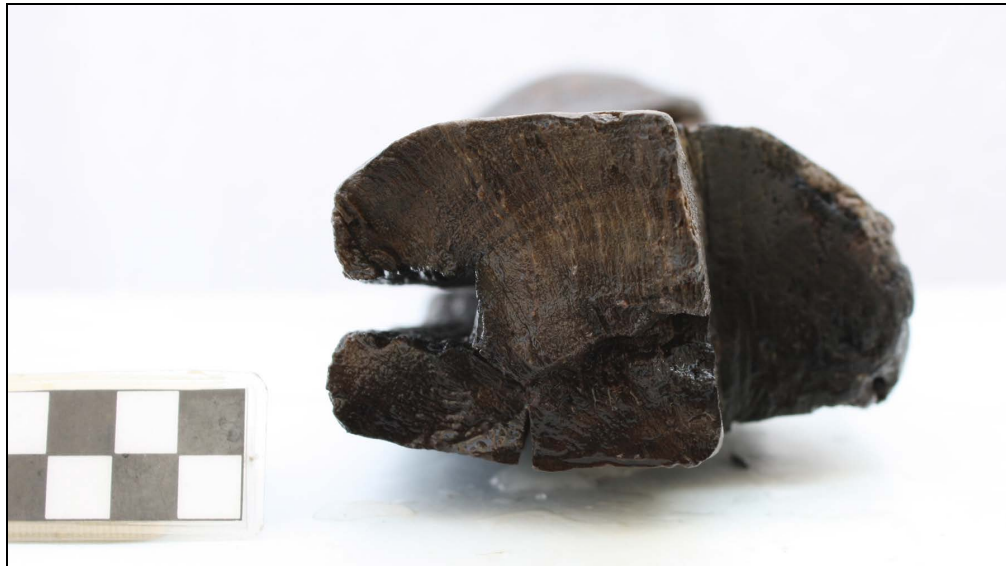
**Figure 4.178. Sectional view of bulkhead frame UM 157, at a break. Note slot on inner face and recess on outer face. Inner face to left.**

The main feature by which UM 157 may be identified as part of a bulkhead frame is the deep slot along the inner face (figs. 4.174, 4.178). This slot is heavily

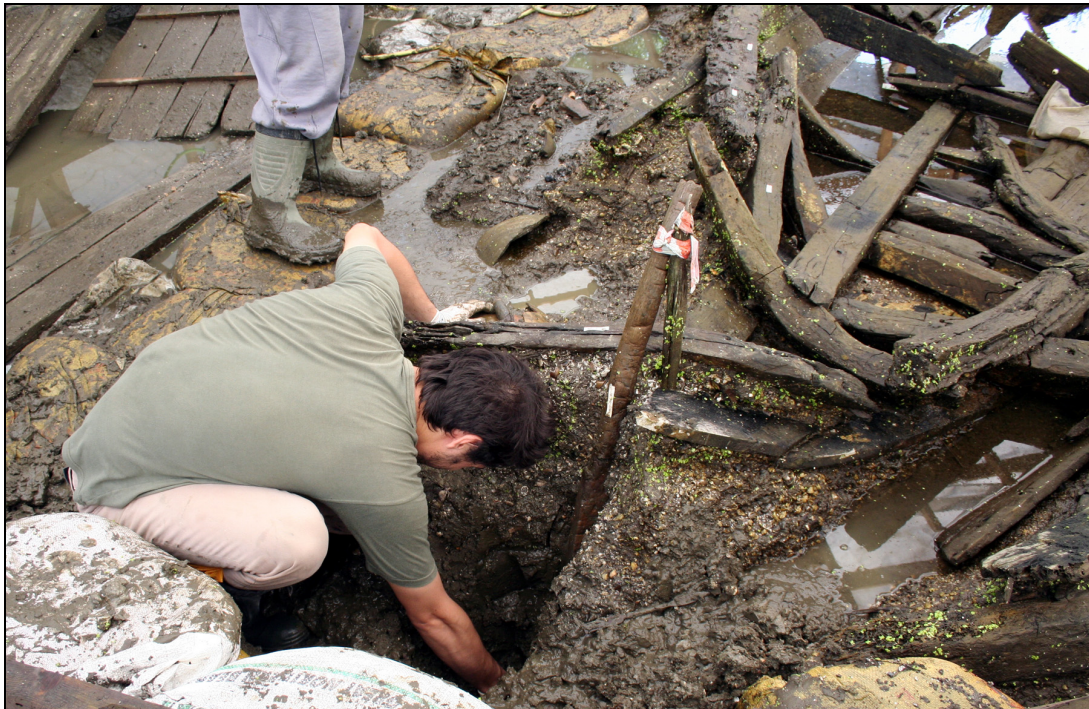
**Figure 4.179.** Ívgin excavating oar UM 30, found upright just aft of YK 11. May 27, 2008.

from which the bark had been removed. Nearly half of these objects were found upright in the viscous mud surrounding the shipwreck (fig. 4.179). This orientation confirms the shallow nature of the area as well as its continued use by smaller vessels, most likely fishing boats.

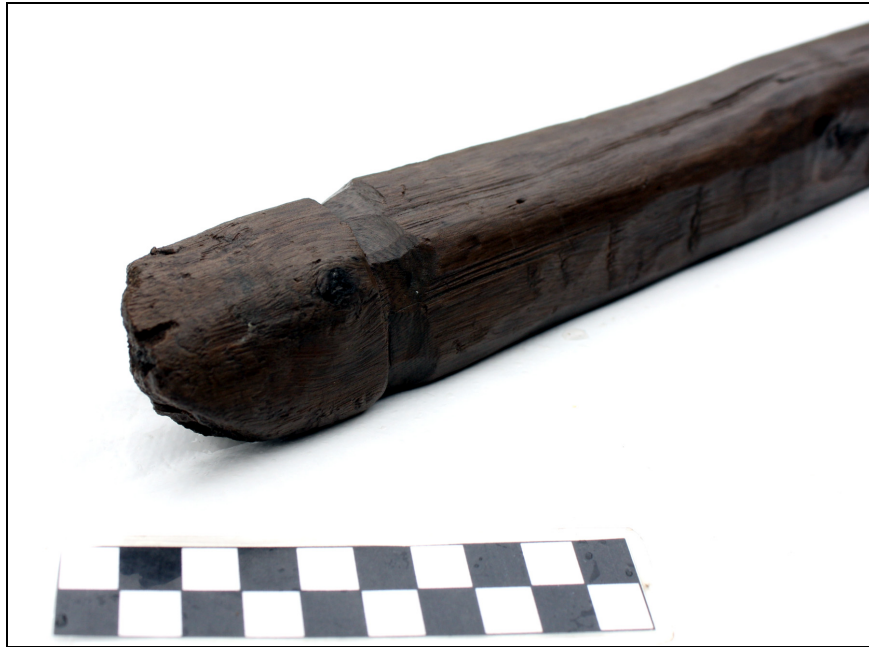
Figure 4.180. Whittled collar near broken end of UM 21.

Only one of these fragments, UM 49, is complete and may therefore represent a tool handle rather than a punting pole; it is 1.12 m in length. UM 21, found within the ship toward the bow, has a squared section and a whittled collar near its broken end (fig. 4.180). Due to its form, this fragment may more likely be a stanchion; however, there is no preserved evidence of a flange as would have been necessary for its use with the YK 11 stanchion blocks.
