ANALYSIS AND RECONSTRUCTION OF SHIPWRECK YK 11  
(C. SEVENTH CENTURY A.D.) FROM THE THEODOSIAN HARBOR  
AT YENİKAPI IN ISTANBUL, TURKEY

A Dissertation

Submitted to the Office of Graduate Studies of  
Texas A&M University  
in partial fulfillment of the requirements for the degree of

DOCTOR OF PHILOSOPHY

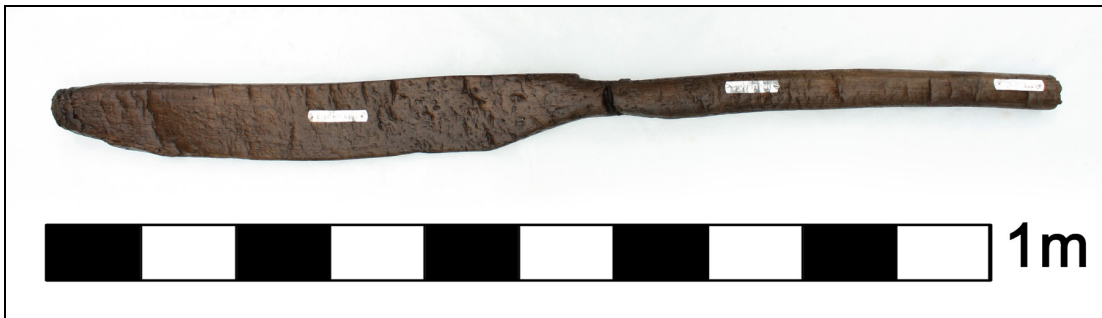
Figure 4.181. Oar UM 30, found upright in mud aft of YK 11.

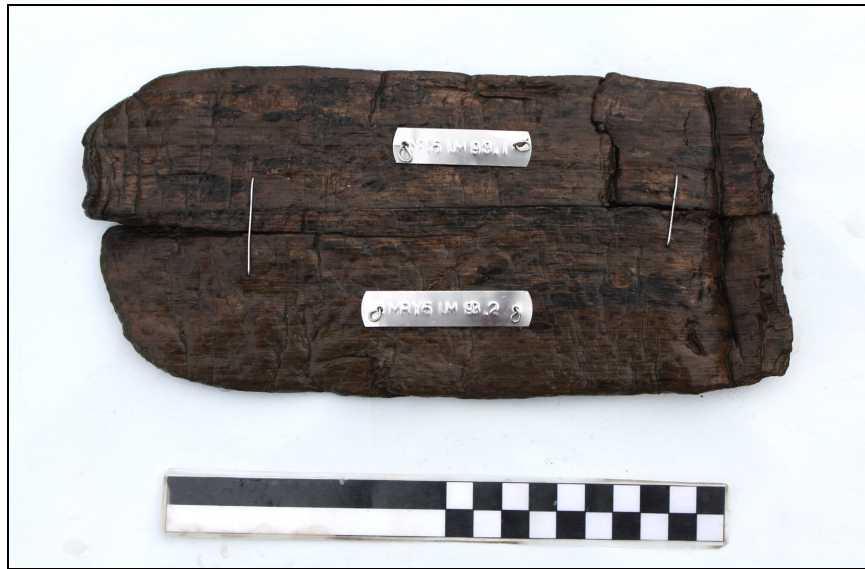
Figure 4.182. Oar blade UM 93.

Finally, five of these fragments appear to represent part of an oar, including oar blades, a counterweight near the handle, and a transitional fragment between the oval shaft and the blade or counterweight. All five are *Fagus orientalis* (Oriental beech), which Theophrastus notes does not decay in water;<sup>107</sup> however, the beech timbers found around YK 11 were somewhat poorly preserved and frequently compressed. The most extensively-preserved oar is UM 30, on which the entire oar blade and a large part of the shaft is preserved (fig. 4.181). The UM 30 oar blade is triangular in section, up to 4.8 cm thick along the thicker edge and up to 2.5 cm along the thinner edge. Based on its form, perhaps UM 30 was the quarter rudder used by a small boat when sailing. In contrast, compressed oar blade UM 93 seems to have had a more uniform section, although it is now not more than 1.1 cm in thickness due to severe compression (fig. 4.182).

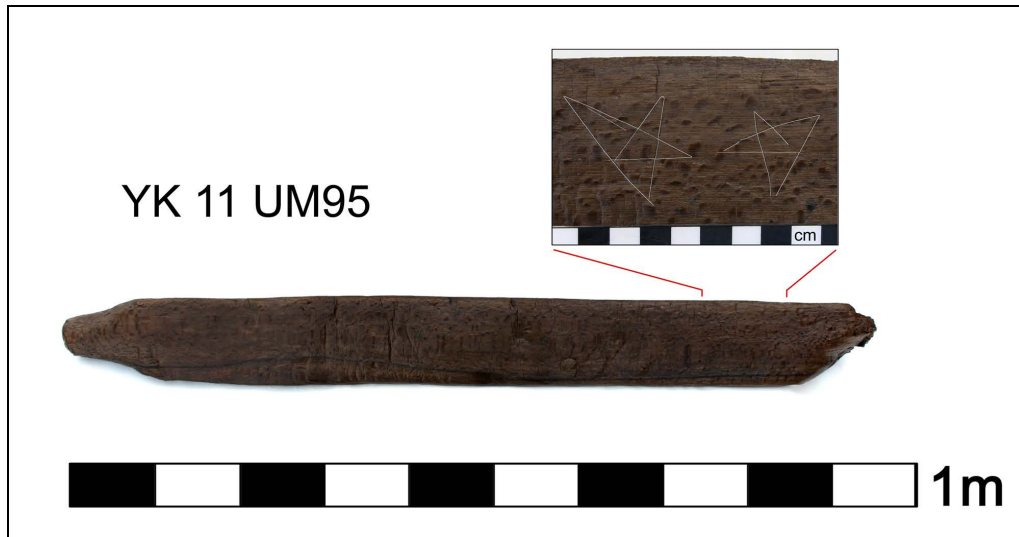
Figure 4.183. UM 95, part of an oar (near handle?). Pentagrams are highlighted for emphasis.

UM 95 may be the counterweight of an oar near the handle (fig. 4.183). It also has a triangular section but differs from the section of UM 30 and does not seem well-

suited to an oar blade. The UM 95 section reaches 6.7 cm in thickness and 10.2 cm in width. If this is the handle rather than the blade of an oar, it was being used upside down in order to push or punt the ship through a shallow, marshy area, perhaps in order to preserve the more delicate blade at the opposite end. Two nearly complete pentagrams and two lines of a third were inscribed on this piece near its broken end (fig. 4.183, detail).

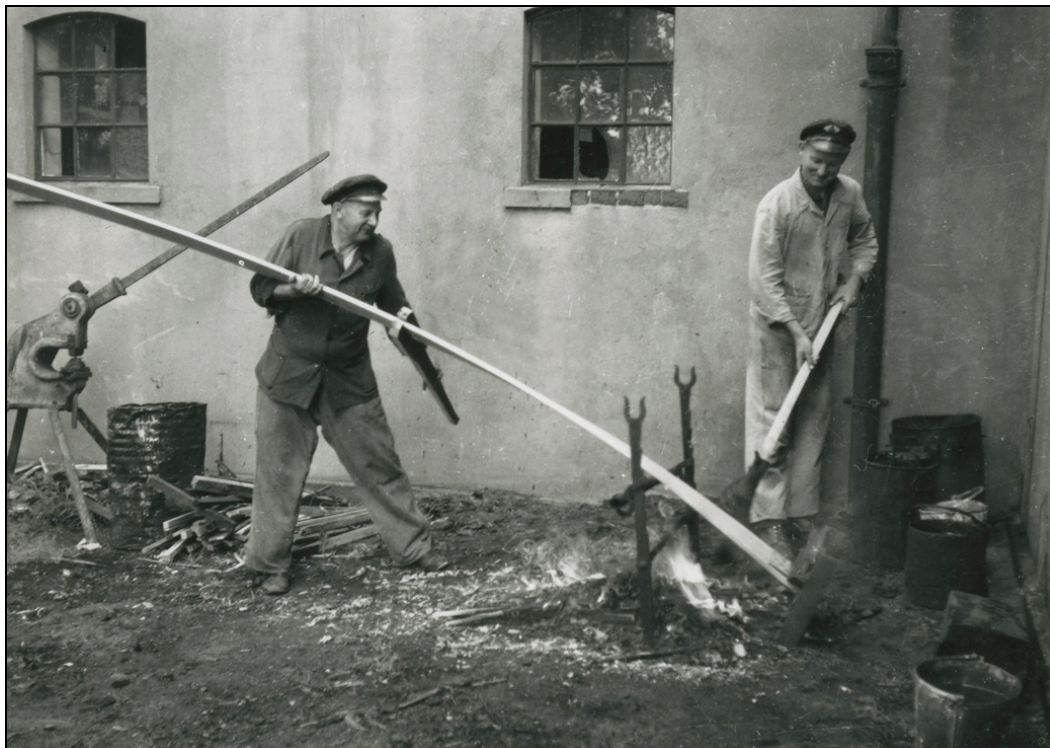
**Figure 5.1.** Workers char-bending a plank in an early 20<sup>th</sup>-century shipyard along the Weser River in northern Germany. Photo Deutsches Schiffahrtsmuseum; used with permission.

In char-bending, the wood is plasticized and allowed to bend through an application of both water and heat, facilitating the formation of complex curvatures without cracking or breaking.<sup>136</sup> The simplicity of this technique is well-illustrated in figure 5.1, which shows workers bending and twisting a plank in an early 20<sup>th</sup>-century shipyard along the Weser River in northern Germany. In the photograph, a weight clamped to the end of the plank pulls the end downward over a metal rack, which acts as a fulcrum. On the other side of the metal rack, a worker grasps the plank with one arm,

and with the other gently twists the plank by means of a hand-held lever clamped to the plank. A second worker maintains sufficient moisture throughout the process with a wet rag or sponge on a stick. Many of the YK 11 planks retained some of their original twist and curvature; these complex curves have been preserved in storage by means of custom-built molds designed by Sheila Matthews. The curve, twist, charred or blackened surface, and, on some planks, sharply-delineated char line, could perhaps have resulted from the simple method illustrated in figure 5.1.

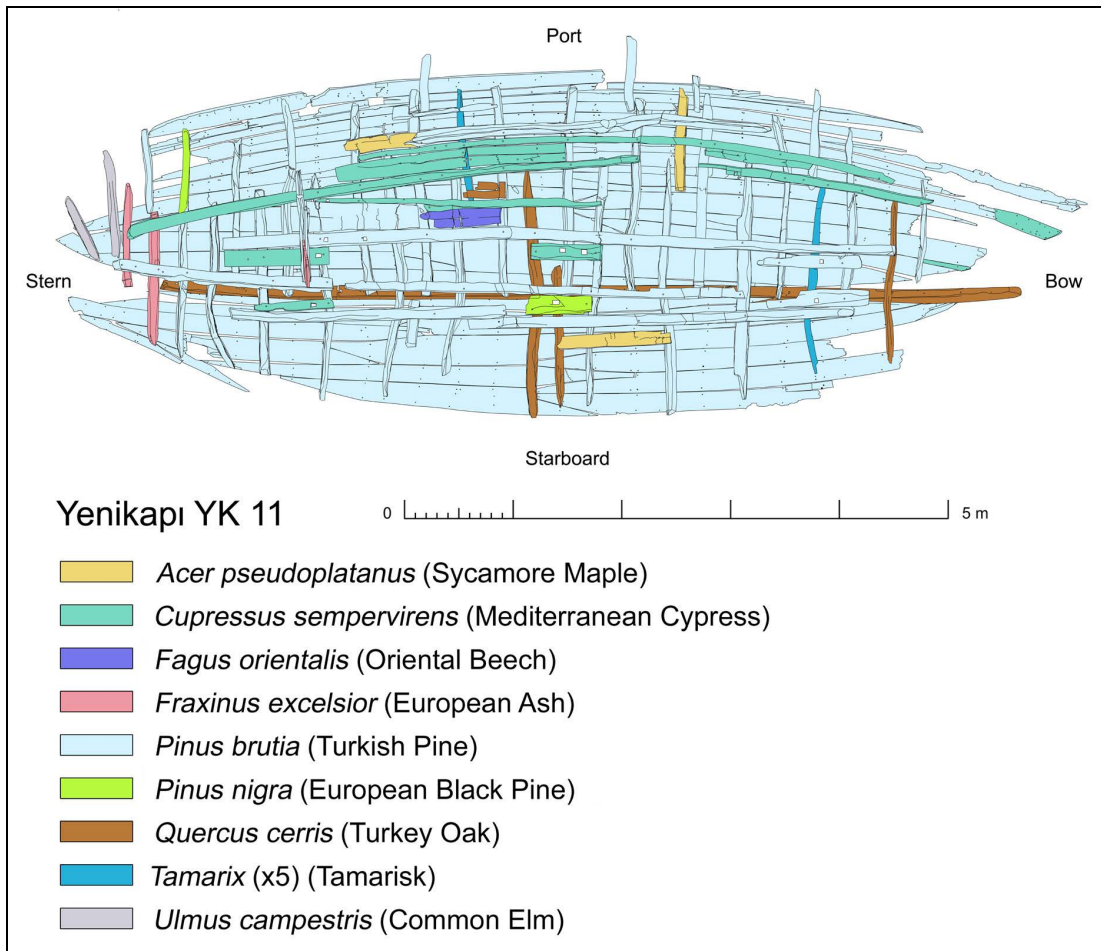
Figure 5.2. Overview of wood species used in YK 11 (identifications by Nili Liphshitz).

The framing of YK 11 showed some variation in wood species. During the initial construction, the shipwrights crafted floors and half-frames of oak, pine, and tamarisk. Original futtocks included those of sycamore maple, pine (both *Pinus brutia* and *Pinus nigra*), tamarisk, and elm. During later repairs, however, shipwrights overwhelmingly preferred Turkish pine, with only two other woods, ash and elm, represented in just three timbers, these being shorter timbers near the ship's stern (FR 1, FR 2, and FR 3).

Finally, most of the ship's interior structure over the frames, including the stringers, stanchion blocks, and sternson, consists of softwoods: Turkish pine, black pine, and cypress. Pine and cypress stringers were also noted on the Saint-Gervais 2 and Yassiada 1 ships.<sup>199</sup> While small cypress timbers, such as graving pieces or common ceiling, may have been cut from scraps of wood in the shipyard, it is interesting that four of the long stringers—up to 5.09 m in length—were also cut from this wood which, in Constantinople, may have been imported.<sup>200</sup> The importation of cypress is unsurprising, as cypress was prized for several of its qualities.<sup>201</sup> However, the use of an imported wood for sizable timbers is incongruous on a ship otherwise characterized by economizing measures. Perhaps the shipwrights were utilizing lengths of cypress that were leftover from the construction of another ship, or perhaps cypress was indeed locally grown in Constantinople during the sixth and seventh centuries. Altogether,

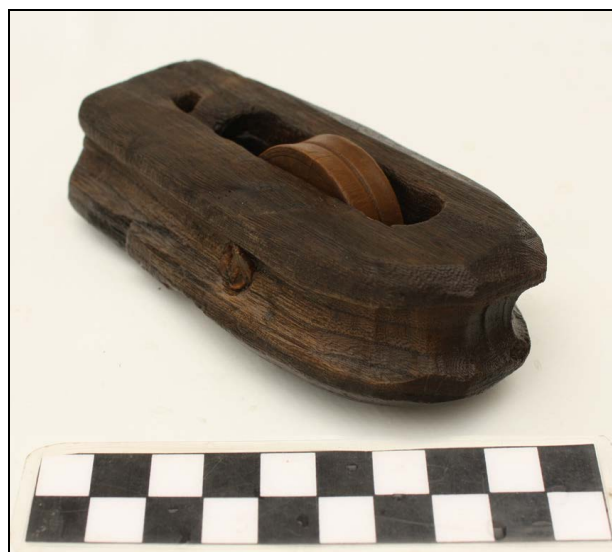
**Fig. 6.2. Photograph of pulley block UM 151. Note tool marks within the groove along the shell perimeter and the pin fixing the sheave in place.**

The sheave was lathe-turned; a deep groove runs along the narrow center of the sheave's circumference. The shell itself was whittled, with tool marks especially well preserved in the curved groove that runs along the shell's perimeter, meant to accommodate the strap (fig. 6.2). Shell edges were chamfered to remove sharp edges. A small, 0.5 cm-diameter hole was cut through the shell near its flat end, in line with

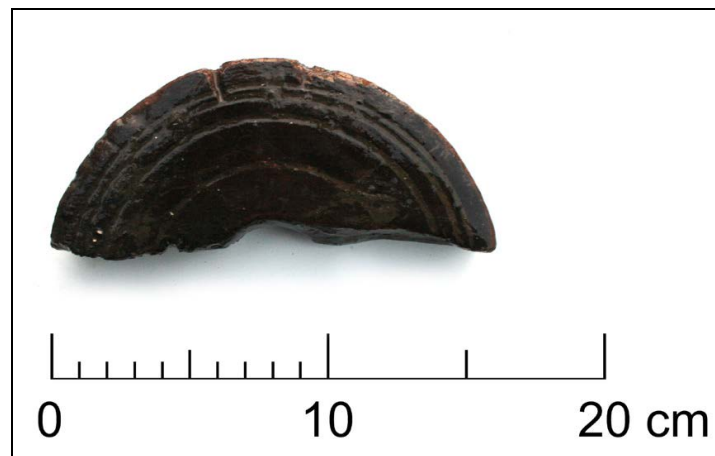
**Fig. 6.4. Unnumbered sheave fragment from YK 11. Diameter approximately 16 cm.**

A Byzantine hook-shaped masthead has not yet been found in the archaeological record, although there have been some attempts to reconstruct it.<sup>50</sup> For YK 11, the hook-shaped masthead was reconstructed as a double block with a shell that curves over into a hook-like projection. The block is closed above the sheaves to maintain the halyards in their proper location, preventing them from becoming displaced during tacking in rough weather. The function of the hook-like projection remains unclear, but iconography suggests that the halyard ran under the hook rather than over it.<sup>51</sup> That mastheads of this type had two sheaves rather than one is suggested by the graffito at Corinth, where Lucien Basch interprets the two circles on the masthead as the artist's attempt to show detail in perspective.<sup>52</sup> The Corinth graffito also clearly shows that the masthead had a tenon at its base that fit into a mortise at the top of the mast.<sup>53</sup> The mortise at the top of the mast of Black Sea wreck D suggests a similar arrangement.<sup>54</sup> The size of the masthead is based on the diameter of the mast at its top (15 cm) and the fragment of a large sheave found near YK 11 (fig. 6.4), 16 cm in diameter.

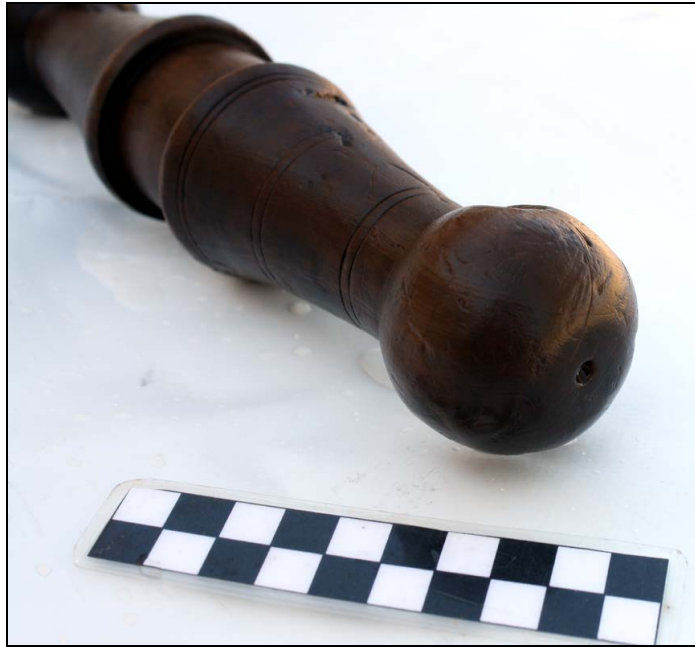
**Fig. 6.6. Lathe-turned toggle UM 189. Note decorative incised lines on the arm and at knob.**

Only two of the toggles, UM 189 (sycamore maple) and UM 190 (boxwood), are lathe-turned; both carefully-fashioned pieces terminate in spheroid knobs. On both pieces, the arms and end knobs are decorated with fine incised lines (fig. 6.6). The remaining toggles were whittled from sycamore maple, oak, or boxwood (fig. 6.7).

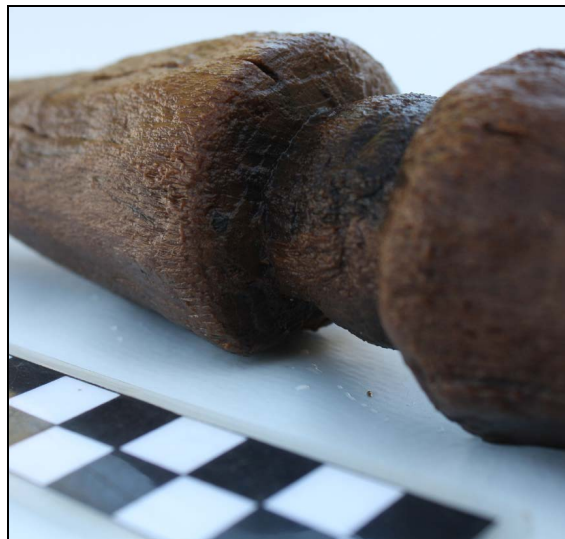
**Fig. 6.7. Cut marks at the neck of toggle UM 175.**

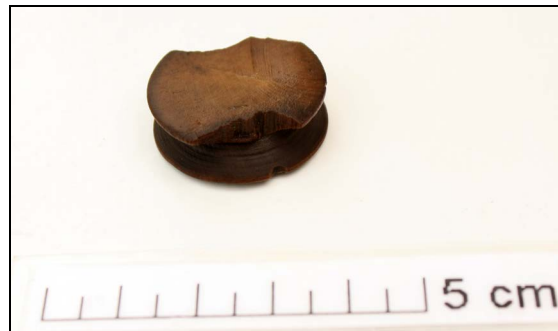
**Fig. 6.9.** Spool toggle UM 181. Note lathe striations within groove and damage to thin edges.

All of the spool toggles were lathe-turned. UM 176, UM 181, and UM 182 are very similar in form; all three have flat faces and thin edges (fig. 6.9). UM 181 and UM 182 are nearly identical to each other and to Yassiada MF 50, with dimensions differing by no more than one millimeter. UM 180 and UM 184 differ slightly from the other numbered spools. These possess the V-shaped groove along their circumference but also

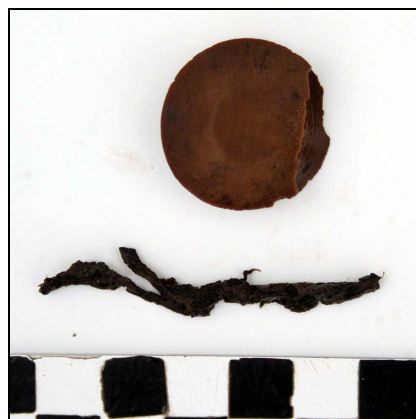
**Fig. 6.10.** Spool toggle UM 182 and the twine wrapped around it.

fishing line.<sup>5</sup> A thin line of grass-like fibers was found within the groove of spool toggle UM 182 (fig. 6.10). The shallow depth of the groove on UM 182 (0.45 cm) and the size of the twine in the groove (0.3 cm) seem to indicate that these objects did not serve as spools, as twine of this size could only have been wrapped around the spool two or three times. These objects may more likely have served as a kind of small, button-like toggle. The concentration of these spool toggles near toggle UM 179 may indicate that a small store of ship's equipment was kept between FR 9 and FR 10; this is just forward of the bulkhead compartment, which itself may have been used to store goods or equipment of higher value.

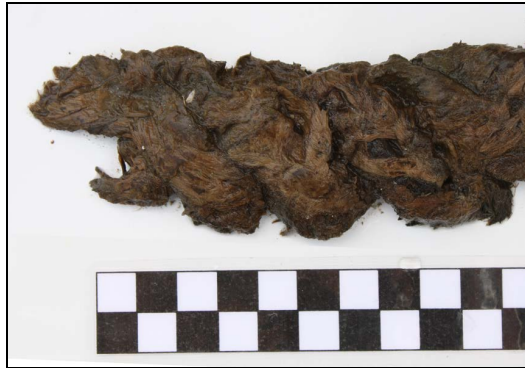
**Figure 6.11. Detail from rope found forward of the location of the mast step.**

Seven short lengths of rope were found scattered around and under shipwreck YK 11. Although poorly preserved and with sediment and shell inclusions, two general types of fibers and approximate diameters may be identified. Four of the samples consist of wide, soft fibers that are easily damaged; one of these samples has been identified by Liphshitz as *Graminae*. All four examples of this type are fragments of three-strand Z-twist rope (fig. 6.11).<sup>6</sup> Due to the nature of the fibers, all are distorted and compressed; the flattened pieces, up to 4.7 cm in width, indicate an original diameter of 3-4 cm. Two fragments of this type were found within the ship, one near where the base of the mast would have been located and the other just forward of where the mast step would have been located.

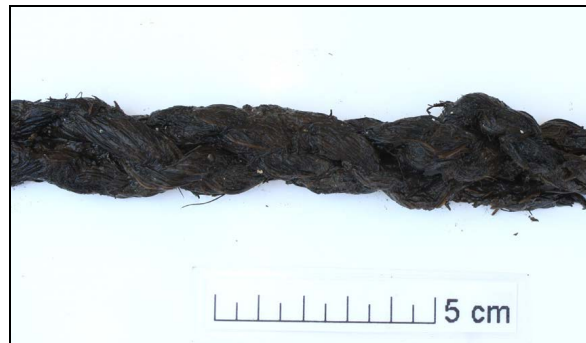
**Fig. 6.12. Detail from rope found under PS 2-PS 4 at FR 14-FR 15.**

The second type of rope consists of coarse, wiry fibers that are less easily damaged than the previous type; the fibers of this type have not yet been analyzed. Three examples of this type were found around the ship. Each example of this type was fashioned from yarns consisting of approximately 30 individual fibers twisted together in a Z-twist. One of the examples was poorly preserved, and another example is a three-strand Z-twist rope, 1.5-2.0 cm in diameter, found under the ship's hull planking (fig. 6.12). A third example of this type is a Z-twisted cable of three ropes, each consisting of three S-twisted strands; its diameter is approximately 3.0 cm.

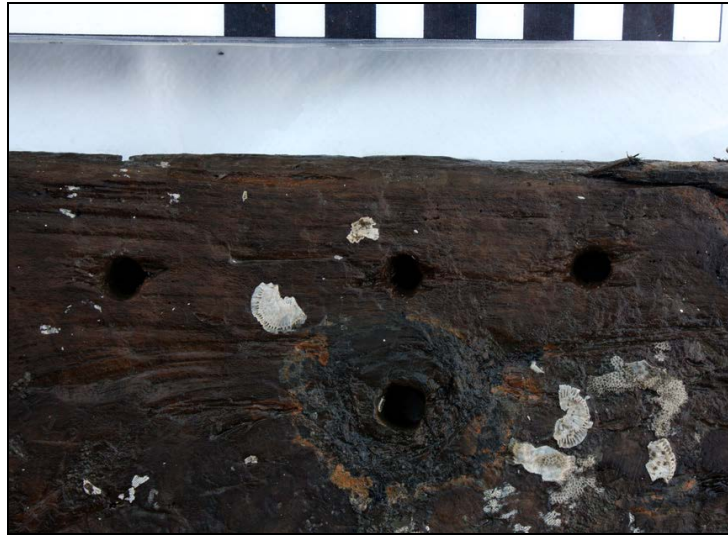
**Figure A.2. Evidence for the use of a claw for the extraction of nails. Note sharp tool marks to either side of three disused nail holes, near edge; SS 7-6 (UM 31), outer face.**
