TESTING AND EVALUATION OF LARGE SIGNS SLIPBASE SUPPORT ON
SLOPE AT MASH TEST LEVEL 3 IMPACT CONDITIONS

A Thesis

Major Subject: Civil Engineering

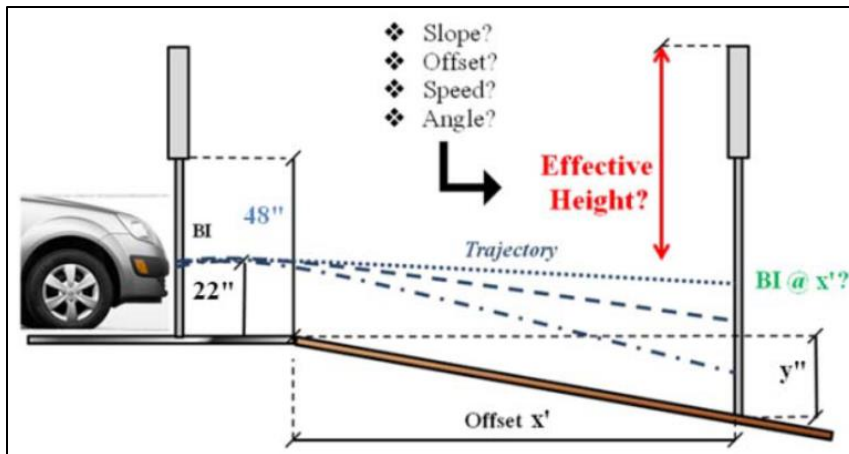
Once a sign support system is installed on a slope, the local mounting height of the sign (calculated from ground level at the location of installation) will be greater than that for the same system installed on flat level ground. For a general installation of a sign support system on a slope at an offset distance “x” from the slope breakpoint, the depth “y” of the slope at the particular installation location contributes to an increase in the length of the support post and local mounting height of the sign (Figure 1).

Figure 1. Effective Pole Height Variation for Sign Support Installation on Slope (Reprinted from Silvestri et al., 2013)

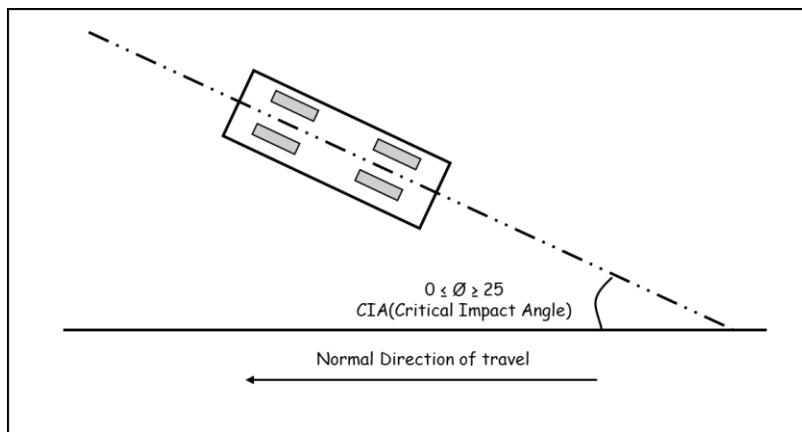
Figure 3. Impact Angle for Support Structures

As shown in Table 1 three full-scale crash tests are recommended for support structures. Two of these tests include high-speed tests with car and pickup truck to identify the prospective of support structure intrusion into vehicle. The slow speed test is conducted to evaluate the support structure's activation energy. The impact conditions for support structures are shown in Figure 3. The different evaluation guidelines are shown in Table 2.

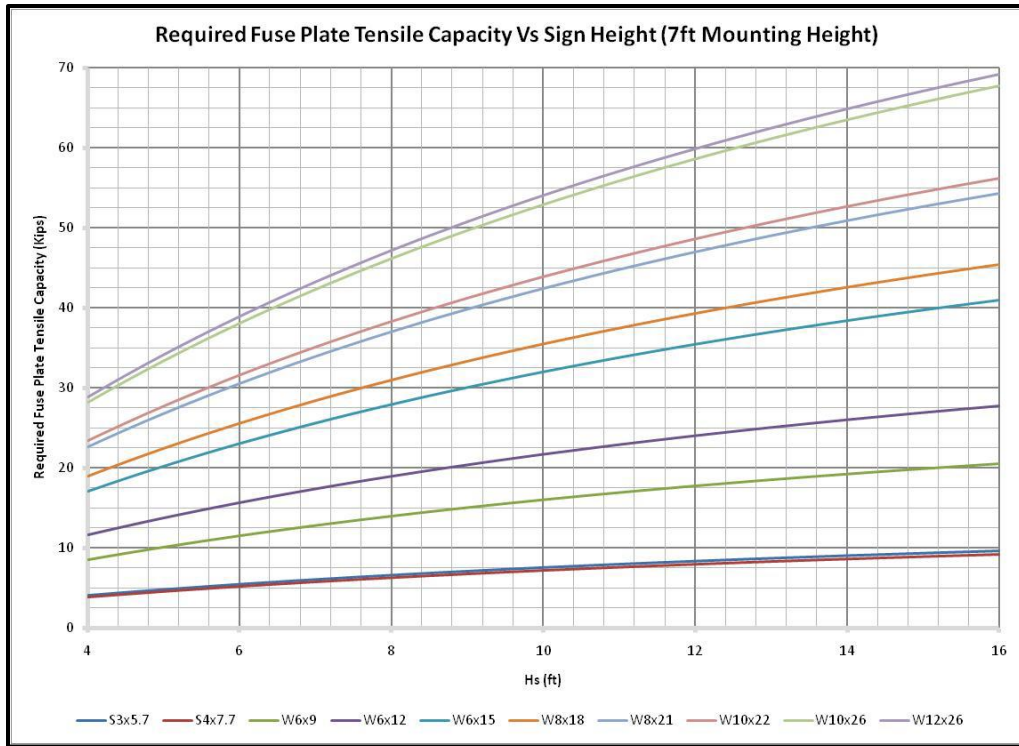
Figure 10. Minimum Fuse Plate Capacity (Reprinted from Silvestri et al., 2011)

Researchers performed an in-depth study to optimize the fuse plate capacities for large guide signs. The team recommended that the design of fuse may be optimized further to allow more effective use of standard support sections. To facilitate the recommendation, the fuse plate capacity for wind loading was plotted (Figure 10) for the mounting height of 7 ft. for different post sections. The system will be designated as inefficient if the fuse plate will control the maximum sign area instead of the post section. To overcome this issue, maximum fuse plate capacity was calculated based on the graph and according to that, the most optimum fuse plate was selected. The testing procedure performed was confirmed with the testing procedure according to MASH. A different test installation was

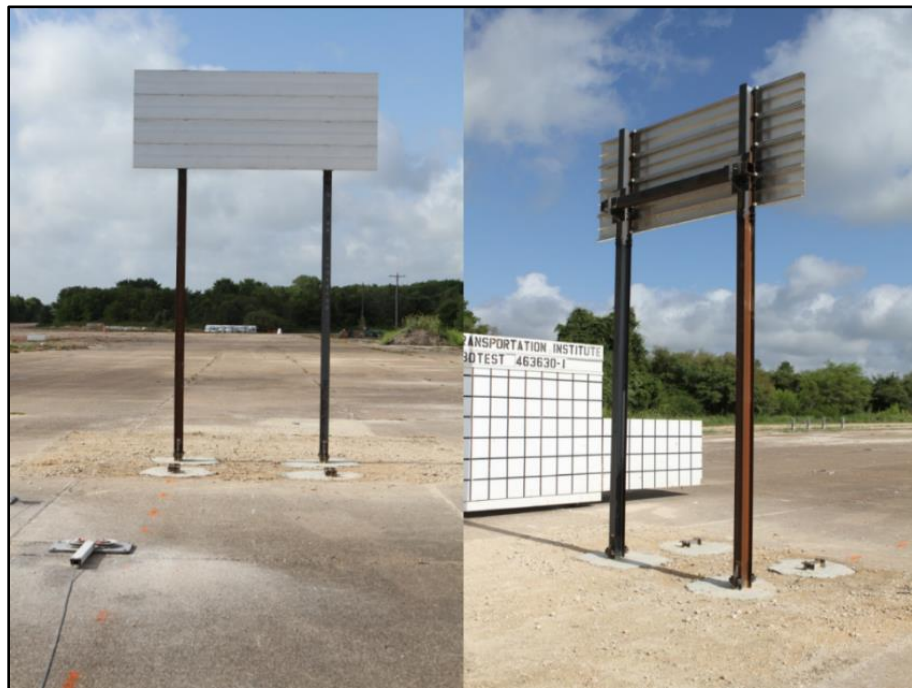
selected for fabrication and testing. The small cars were more critical than pickup if the fuse plates fail as it was designed. Two impact conditions were selected for crash testing. The first system (Figure 11) provided high stiffness to a 10-ft wide panel and the second system (Figure 12) was selected to provide the weak system so that the fuse plate can fail before the post starts to yield or buckle.

Figure 11. TxDOT W6x9 – 4-ft x 10ft Large Sign Support System (Reprinted from Silvestri et al., 2011)

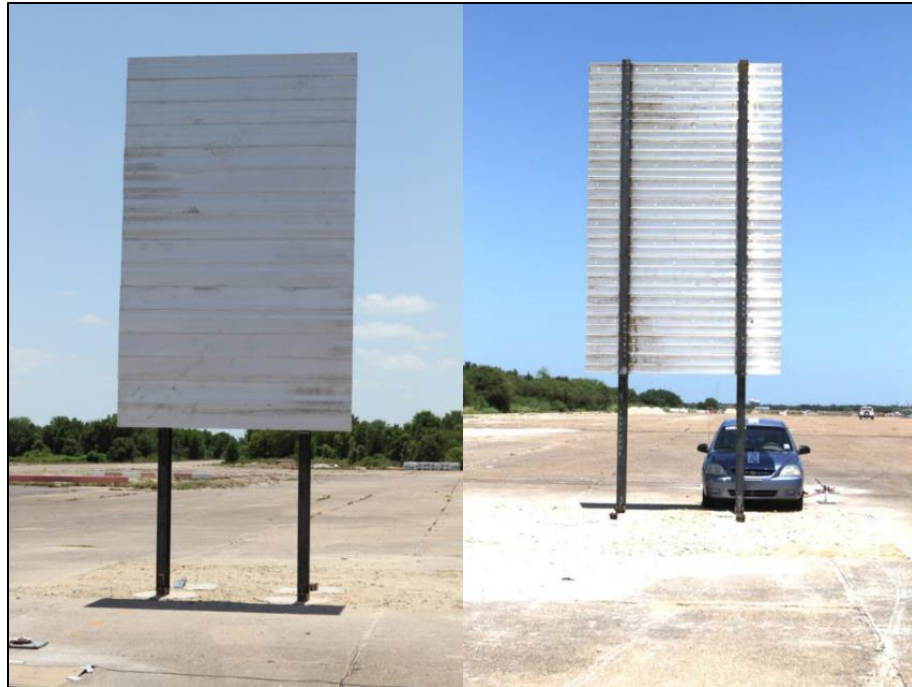
Figure 12. TxDOT W8x18 – 16-ft x 10-ft Large Sign Support System (Reprinted from Silvestri et al., 2011)

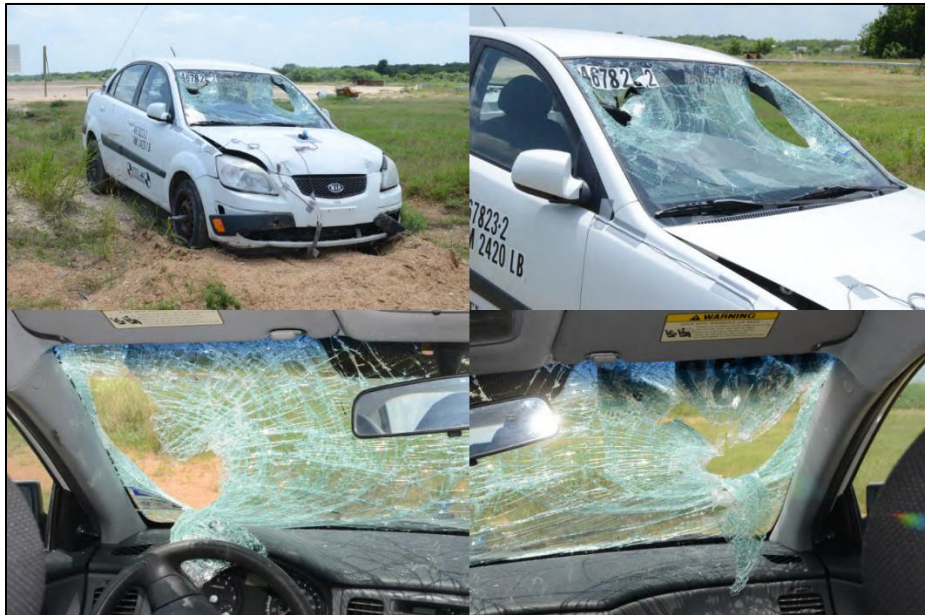
the fractured section of the post. Figure 15 illustrates the damage sustained by the impact vehicle. The test article fails the evaluation according to MASH criteria. Modified versions were developed by TTI researchers to overcome this problem. The modified test article consisted of two tests: a high-speed small car test and a high-speed pickup test. Both the tests passed the MASH evaluation criteria.

Figure 15. Vehicle After the Test at High Speed (Reprinted from Bligh et al., 2013)

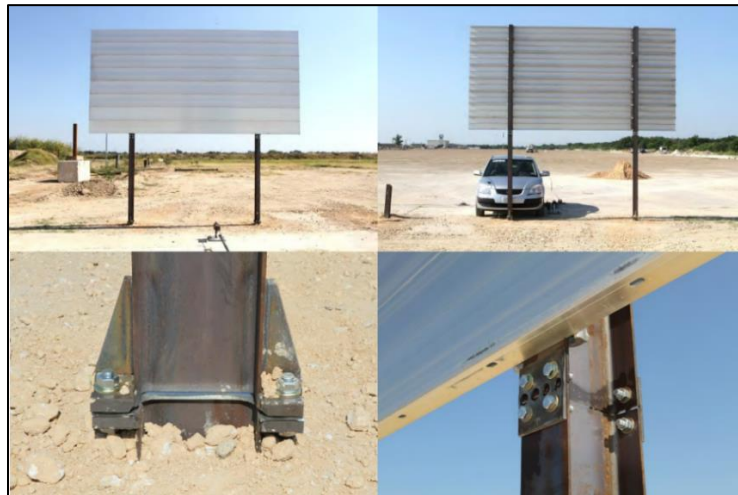
For steel embedded design, 8 ft. x 16 ft. aluminum sign panel supported by two W6X9 posts at a 7 ft. mounting height was tested. The foundation of the system was like the size of support and was embedded at 3.5 ft. below ground. The detailed test article is shown in Figure 16. The car was traveling at the speed of 19 mph and the right support was impacted at 0 degrees. It was seen that the lower connection in the right support was slipped away and the upper connection was still hinged. In the left support, the lower

Figure 16. Direct Embedded Steel Support System (Reprinted from Bligh et al., 2013)

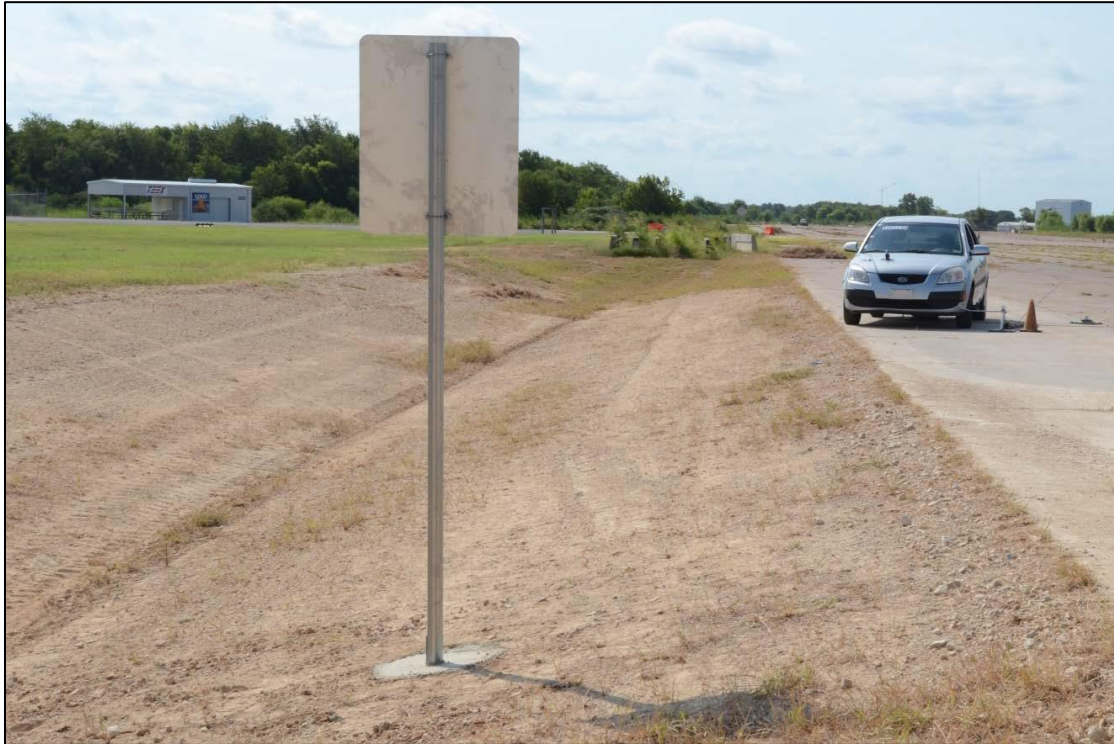
Figure 18. Vehicle and Test Article for Slope Test (Reprinted from Silvestri et al., 2013)

Figure 18 shows the test article and Figure 19 shows the damage sustained by the vehicle during the impact test. There was no deformation in the windshield and the occupant compartment. Only hood, front bumper, and headlight got damaged. The chevron sign performed according to MASH criteria (Table 8).

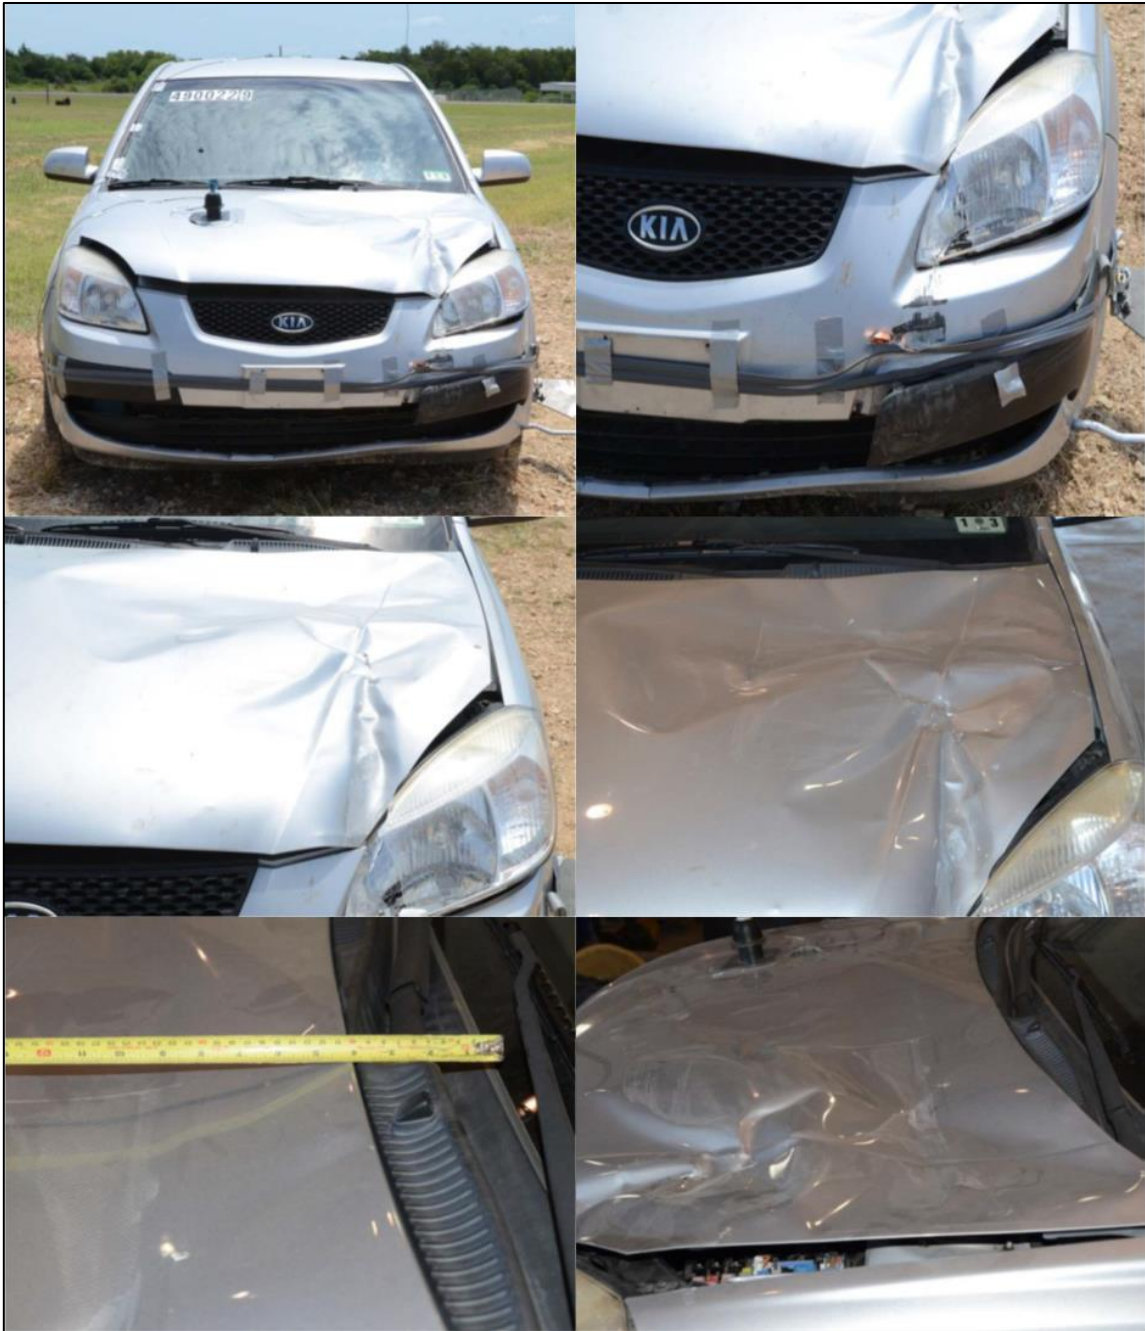
Figure 19. Vehicle After the MASH 3-61 Test (Reprinted from Silvestri et al., 2013)

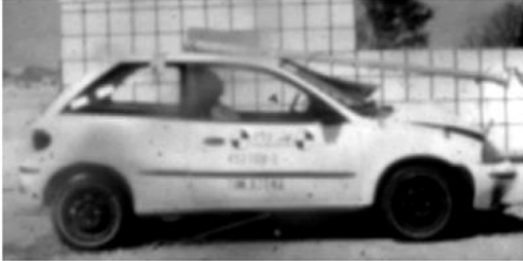
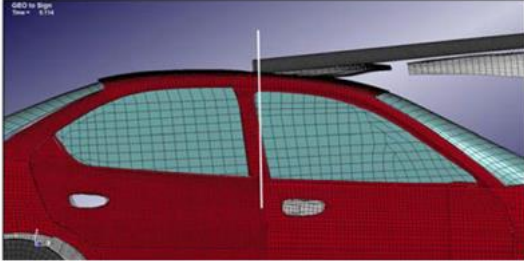
Burn Ban Test No. 452108-3	FE Model Simulation

(a) Test Roof Impact Location	(b) FE Model Roof Impact Location

In the second phase of the study, different FE simulation was performed to replicate the impact of the vehicle on sign support connected to the slip base system. As shown in Figure 24 the top casting of the system was modeled using solid elements with rigid material properties. The bolts used in the slip base system was also modeled explicitly using spring elements. The report shows the correlation achieved between the actual crash test and the validation model. The FE simulation predicted roof deformation of 8 in. whereas the actual deformation was 5.1 in. A similar simulation was conducted to

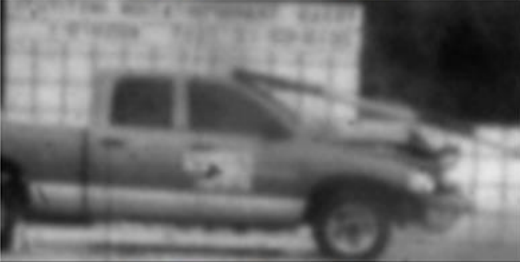
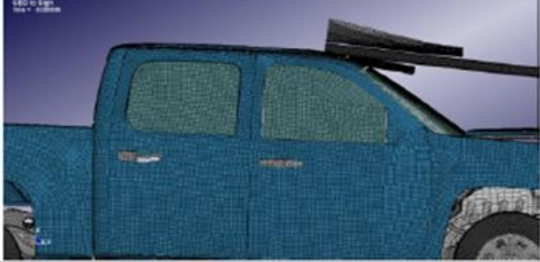
(a) Test Roof Impact Location	(b) FE Model Roof Impact Location

<p data-bbox="1198 1497 1382 1524">Roof Crush: 6.3"</p>
(c) Post-impact Test Vehicle Damage	(d) Post-impact FE Model Damage
Pickup Truck Comparison

validate the results of a pickup with existing full-scale crash tests performed under TxDOT projects (No. 455266 and 405872). In this simulation, FE predicted deformation in the roof of 6.3 in. whereas the actual deformation was 6.5 in. A detailed comparison between finite element and actual crash tests is shown in Figure 25. It was seen that the FEM was able to predict the location of the sign after the release of the slipbase up to a good extent. The main reasons for over or underprediction of the roof deformation can be due to the vehicles. Because the vehicles used in the FE was not exactly similar to the actual crash test ones. There can be also some minor differences in the measurements of the test articles used in the finite element and the actual crash test. After all these considerations, researchers decided to use the FEM for further simulations, keeping in mind that the model over predicts certain values.

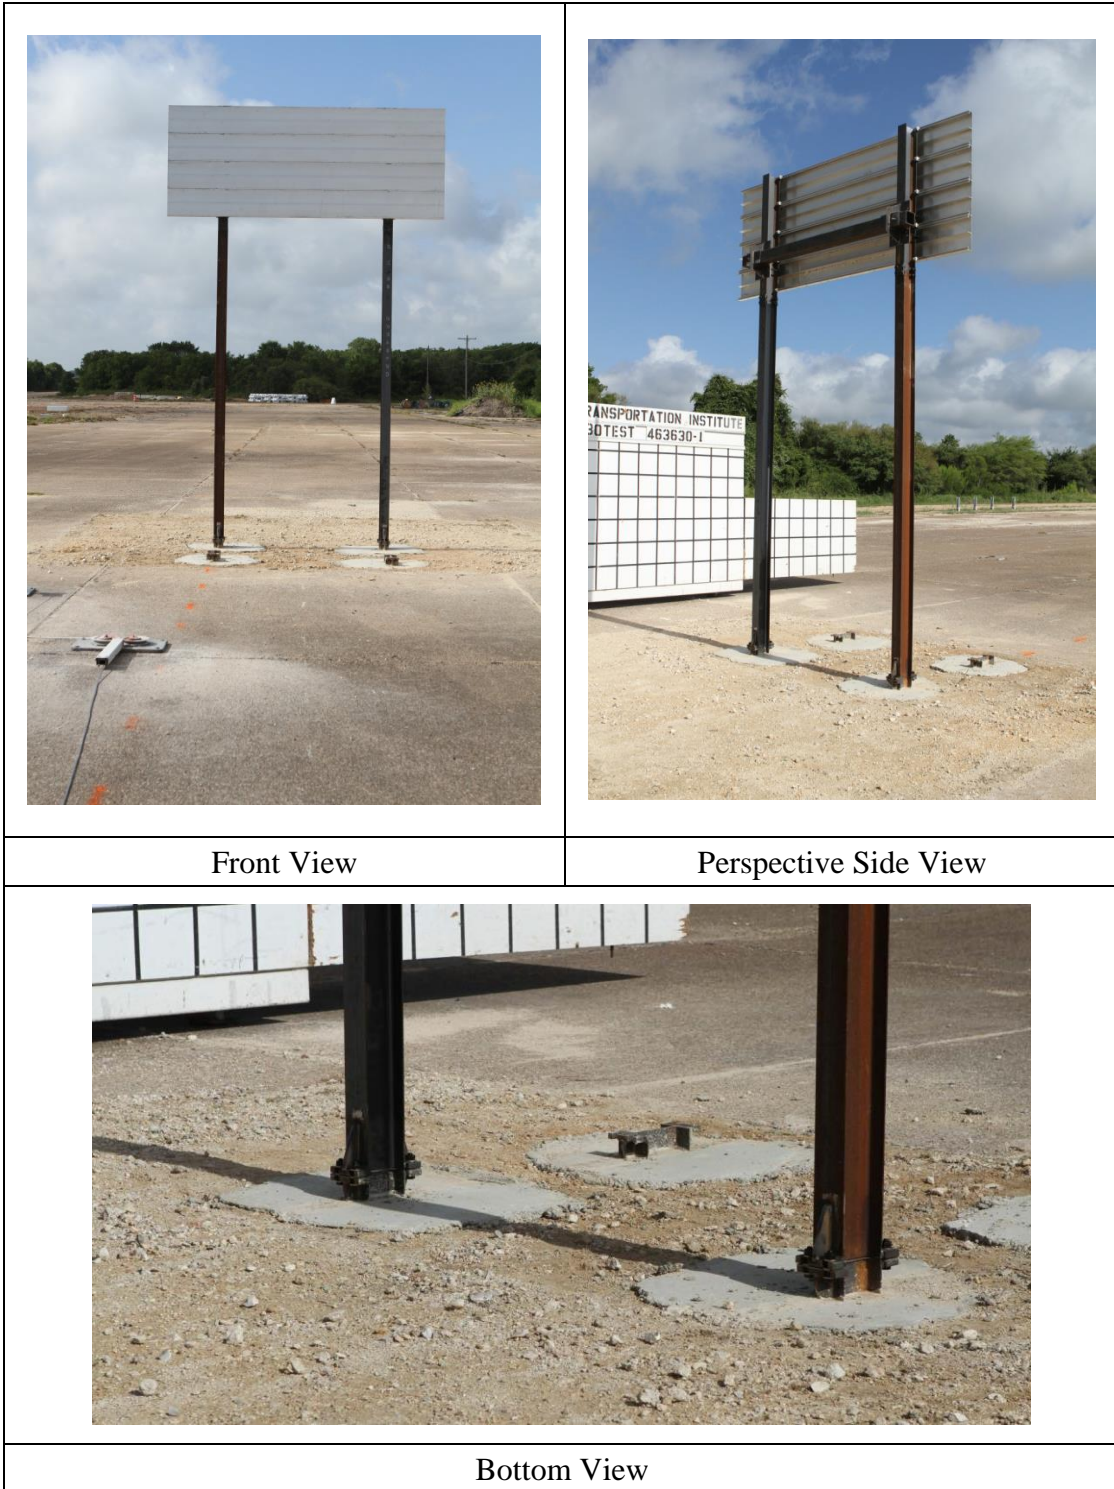
The 2004 Kia Rio passenger car was used in the test. The actual impact speed and angle were 62 mph and 0 degrees, respectively. Figure 42 illustrates the actual constructed large sign system from different views.

Figure 42. LS-DYNA Sign Post System Model without Vehicle (Silvestri et al., 2011)

The test installation was constructed to support a 10-ft × 4-ft tall sign at a mounting height of 12 ft. The sign assembly was constructed using four 1-ft × 10-ft long extruded aluminum panels. Panels were fastened together using 3/8-in. × 3/4-in. bolts and washers spaced every 24 in. along the length of the panels. Each panel was fastened to the support post using a cast sign clip and aluminum bolt that locked into slots incorporated into the design of the extruded panels.

The middle section was fabricated from an 11-ft. 5 in. long piece of the W6×9 section. This section again had the same hole pattern that was found in the top section at one end. The hole pattern allowed for the splicing of the top and middle sections using a milled fuse plate. The other end of the middle section had two slipbase feet, meeting TxDOT's W6×9 specifications, welded to each flange. These plates were made from 2×5×3/4-in. plates. The two slots were cut into each plate at a spacing of 2 3/4-in. Each slot was fabricated to receive a 5/8-in. slipbase connecting bolt. Then, a 2×5×1/2-in. gusset plate supported the slipbase feet. The slipbase foot assembly was centered on each of the external flanges of the W6×9 beam support section.

The ground stub was installed in a 48-in. deep 24-in. diameter concrete foundation. The foundation was reinforced with eight 42-in. #5 vertical rebars. The foundations were shear reinforced using a single #2 spiral rebars with a 6-in. pitch with three flat turns at the top and one flat turn at the bottom. The foundations were spaced 72 in. on center. Each ground stub protruded 3 in. out of the foundation.

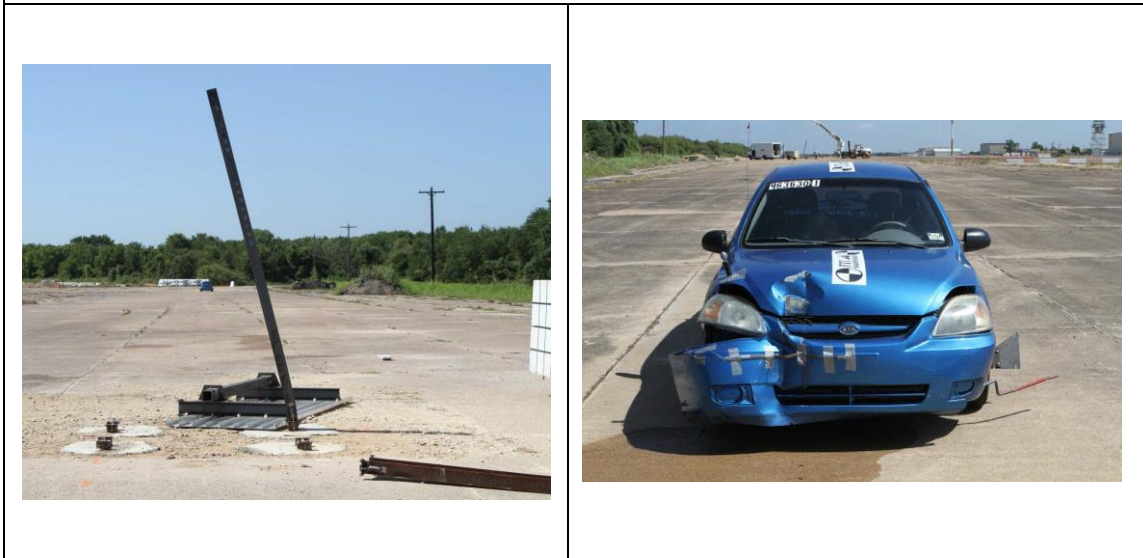
Figure 44. TxDOT Large Sign Support System Before and After Crash Test (Silvestri et al., 2011)

Test Article and Vehicle Before the Test.

Test Article and Vehicle After the Test.

All hot rolled W-sections conform to A992 material specifications. Every tube section conforms to A500 grade B specification. All bolts and nuts meet A325 material specifications. The State of Texas Prison System supplied all extruded sign panels and post clamps, which meet AASHTO and TxDOT material specifications. All other steel sections and plates meet A36 specifications. The concrete used in the foundation has a compression strength of over 3000 psi. Figure 44 illustrates the test article and the impacting vehicle before and after the test. Figure 45 shows the summary of the test results for the TxDOT large sign support system.

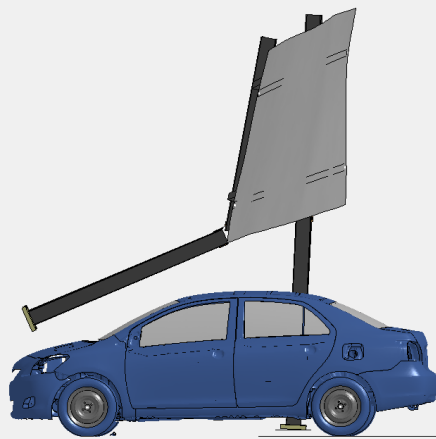
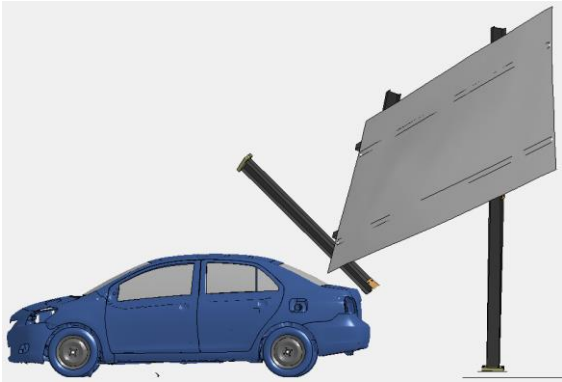
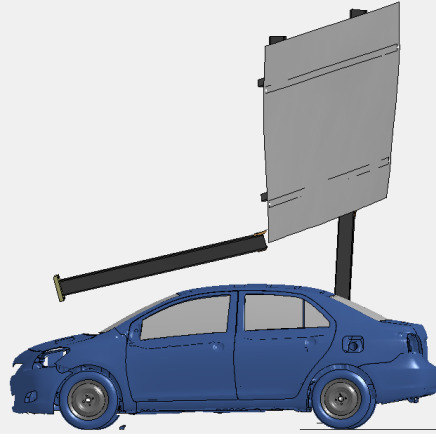
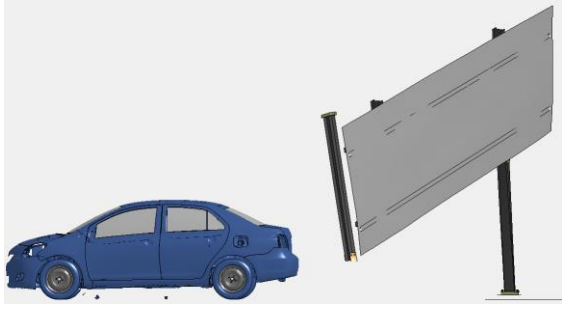
By 0.36 s, the upper fuse and hinge plate connection on the left support leg was completely ruptured. After the complete rupture of connection plates of the left leg, the support began to move in the direction of the vehicle. At the same time sign panel started rotating in the direction of the vehicle with the right leg still intact. Support and sign panel did not come in contact with the vehicle. At 0.7 s the vehicle safely crossed the signpost assembly. Table 14 shows the complete sequential photographs of the simulations.

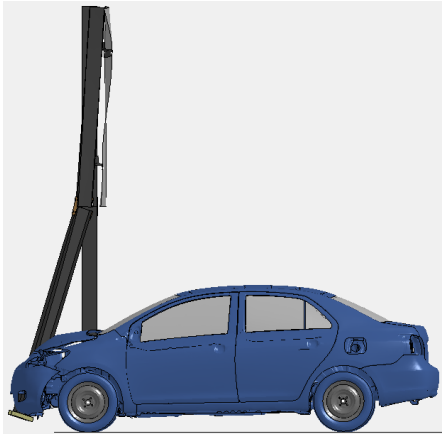
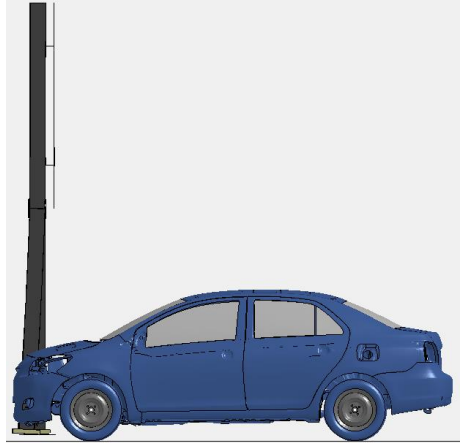
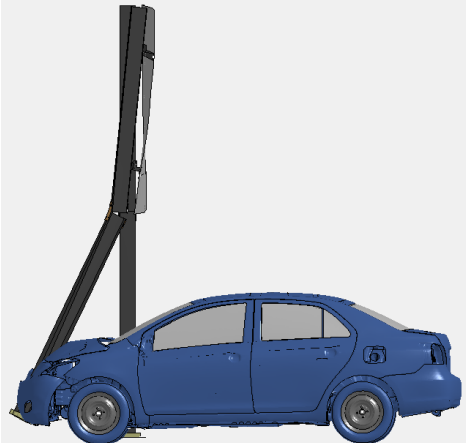
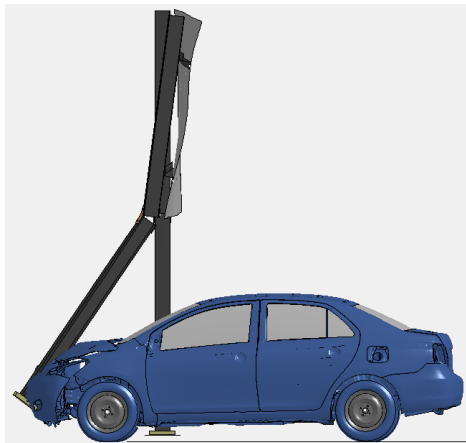
Table 15. Sequential Images of the FE Simulations for Car at High Speed

By 0.134 s, the upper fuse and hinge plate connection on the left support leg was completely ruptured. After the complete rupture of left leg connection plates, the support began to move in the direction of the vehicle. At the same time, the sign panel started tilting towards the vehicle with the right leg still in position. The hinge plate on the right leg was activated at 0.158 s. Support and sign panel did not come in contact with the vehicle. At 0.25 s the vehicle safely crossed the signpost assembly. Table 28 shows the complete sequential photographs of the simulations.

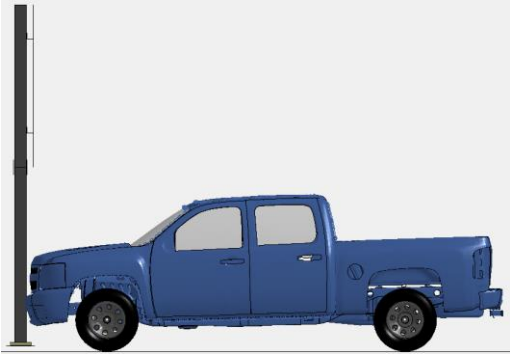
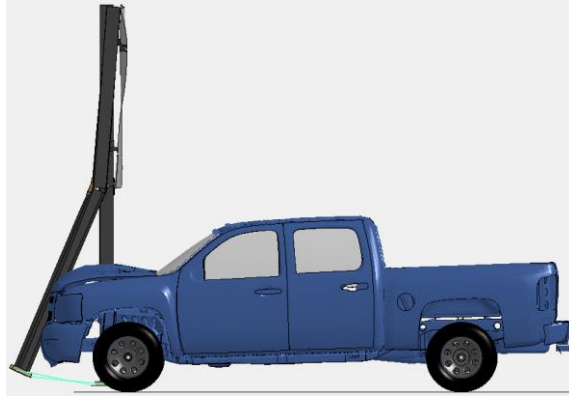
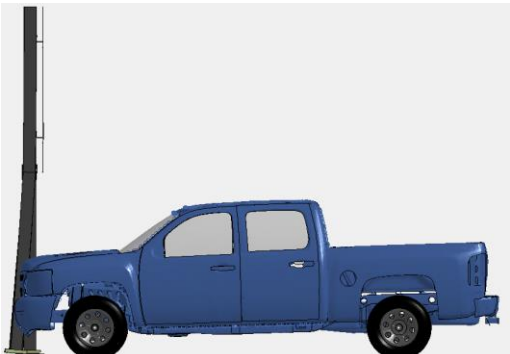
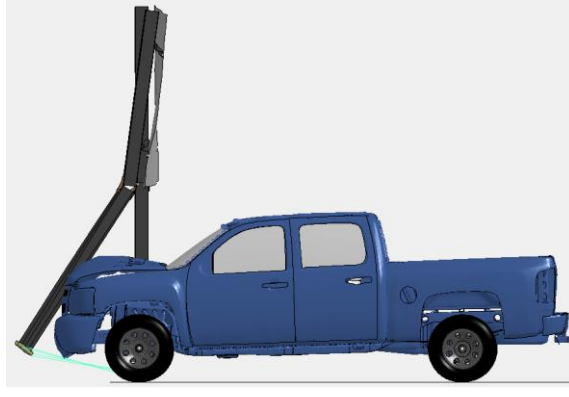
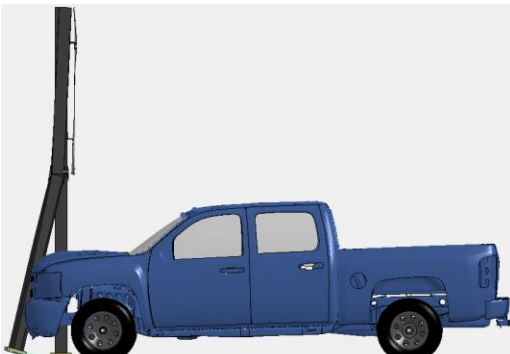
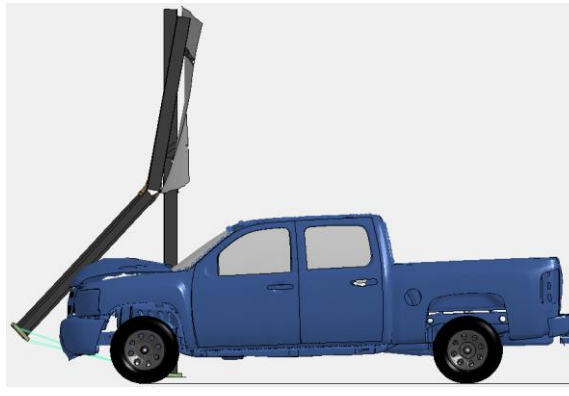
Table 16. Sequential Images of the FE Simulations for Pickup Truck at High Speed

The hinge on the right leg got activated at 0.118 s. By 0.13 s, the upper fuse and hinge plate connection on the left support leg was completely ruptured. After the complete rupture of left leg connection plates, the support began to move in the direction of the vehicle. The right leg also started rotating about its axis. Support and sign panel both came in contact with the roof of the vehicle. The maximum deformation of 2.708 in. was seen in the roof. At 0.224 s the vehicle safely crossed the signpost assembly. Table 16 shows the complete sequential photographs of the simulations.

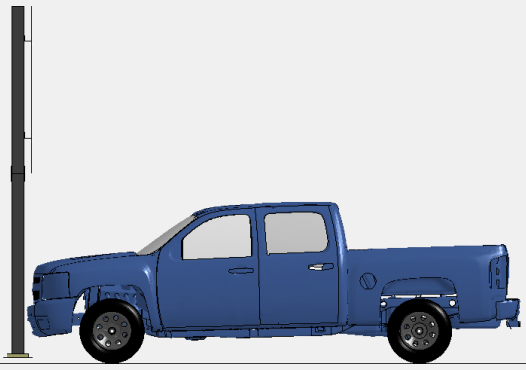
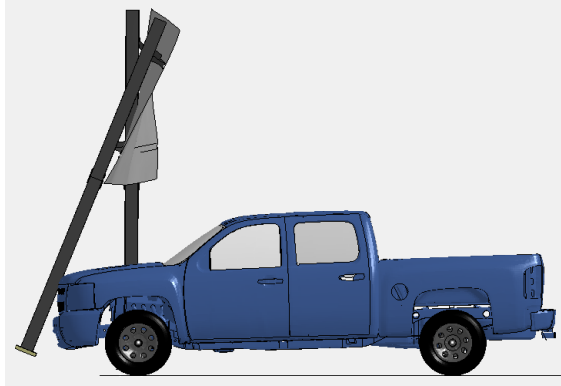
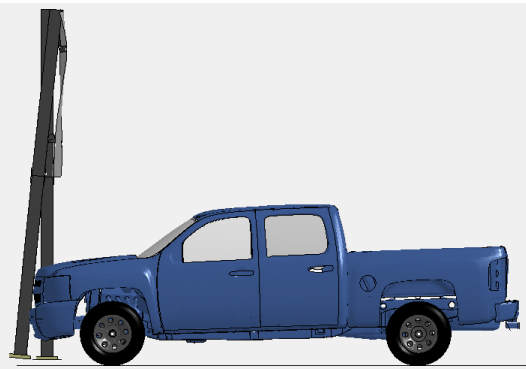
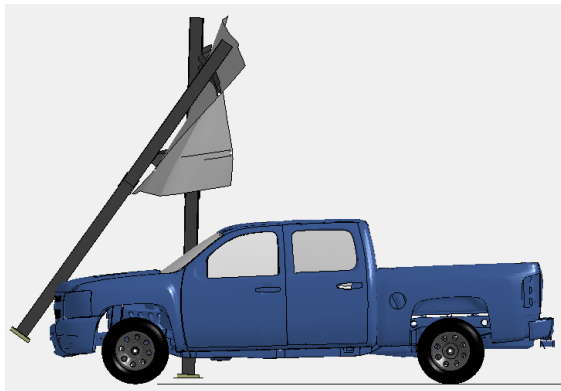
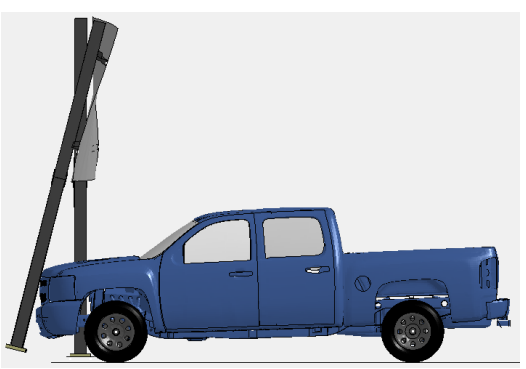
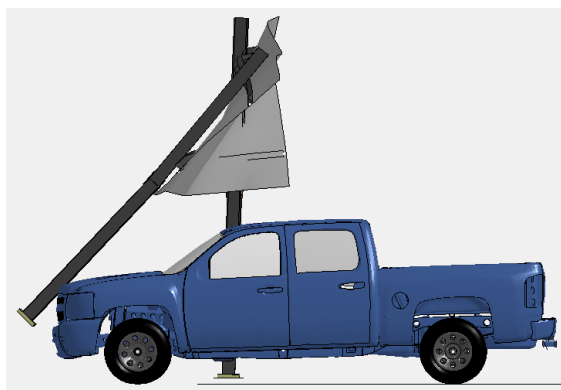
Table 17. Sequential Images of the FE Simulations for Pickup Truck at Low Speed

By 0.37 s, the upper fuse and hinge plate connection on the left support leg was completely ruptured. After the complete rupture of left leg connection plates, the support began to move in the direction of the vehicle. At the same time sign panel started rotating in the longitudinal direction and the right leg was still in position. The hinge plate on the right leg was activated at 0.53 s and was completely ruptured by 0.64 s. The right leg also started rotating about its axis. Support and sign panel both came in contact with the roof of the vehicle. The maximum deformation of 3.574 in. was seen in the roof. At 0.83 s the vehicle safely crossed the signpost assembly. Table 17 shows the complete sequential photographs of the simulations.

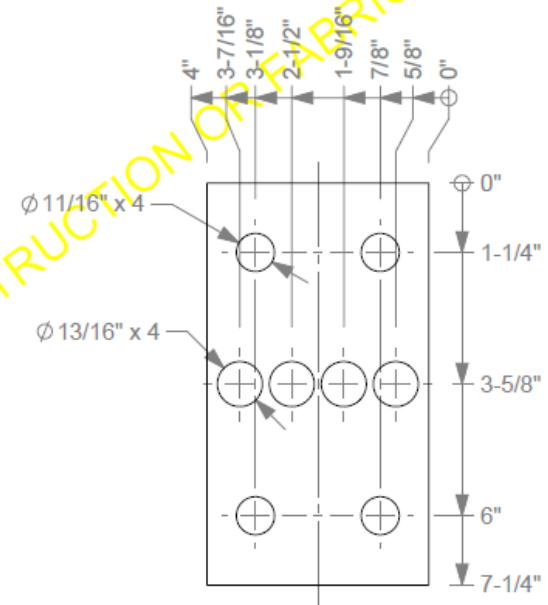
Fuse Plate
Plate, 4" x 3/8" x 7 1/4"
ASTM A36

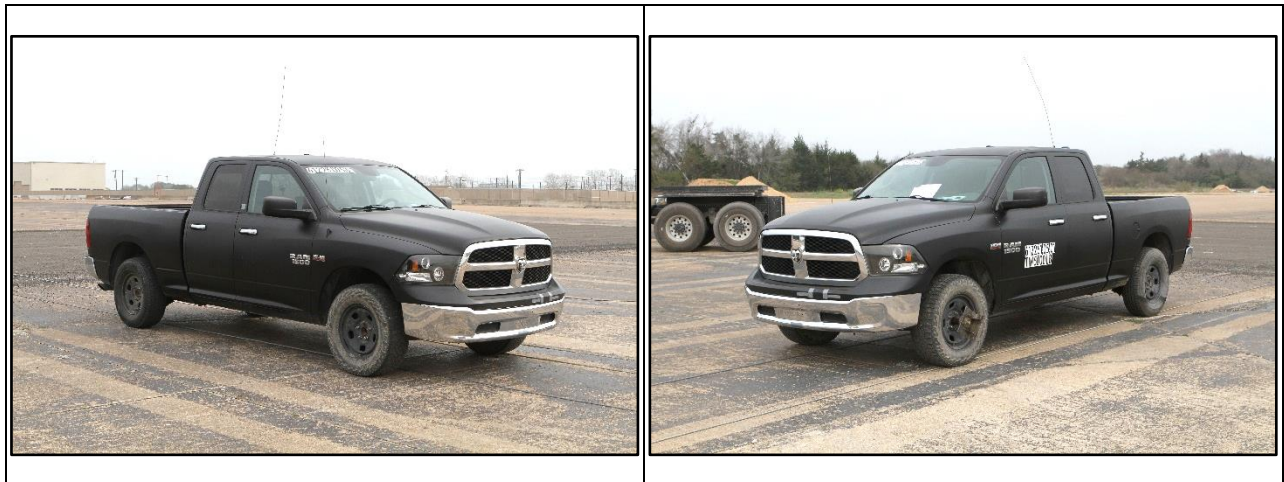
Figure 75. Test Vehicle before Testing

Figure 5.2 shows the 2014 RAM 1500 pickup truck used for the crash test. The vehicle's test inertia weight was 5040 lb, and its gross static weight was 5040 lb. The height to the lower edge of the vehicle bumper was 11.75 inches, and height to the upper edge of the bumper was 27.0 inches. The height of the vehicle's center of gravity was 29.25 inches. Appendix B gives additional dimensions and information on the vehicle. The vehicle was directed into the installation using a cable reverse tow and guidance system and was released to be freewheeling and unrestrained just before impact.

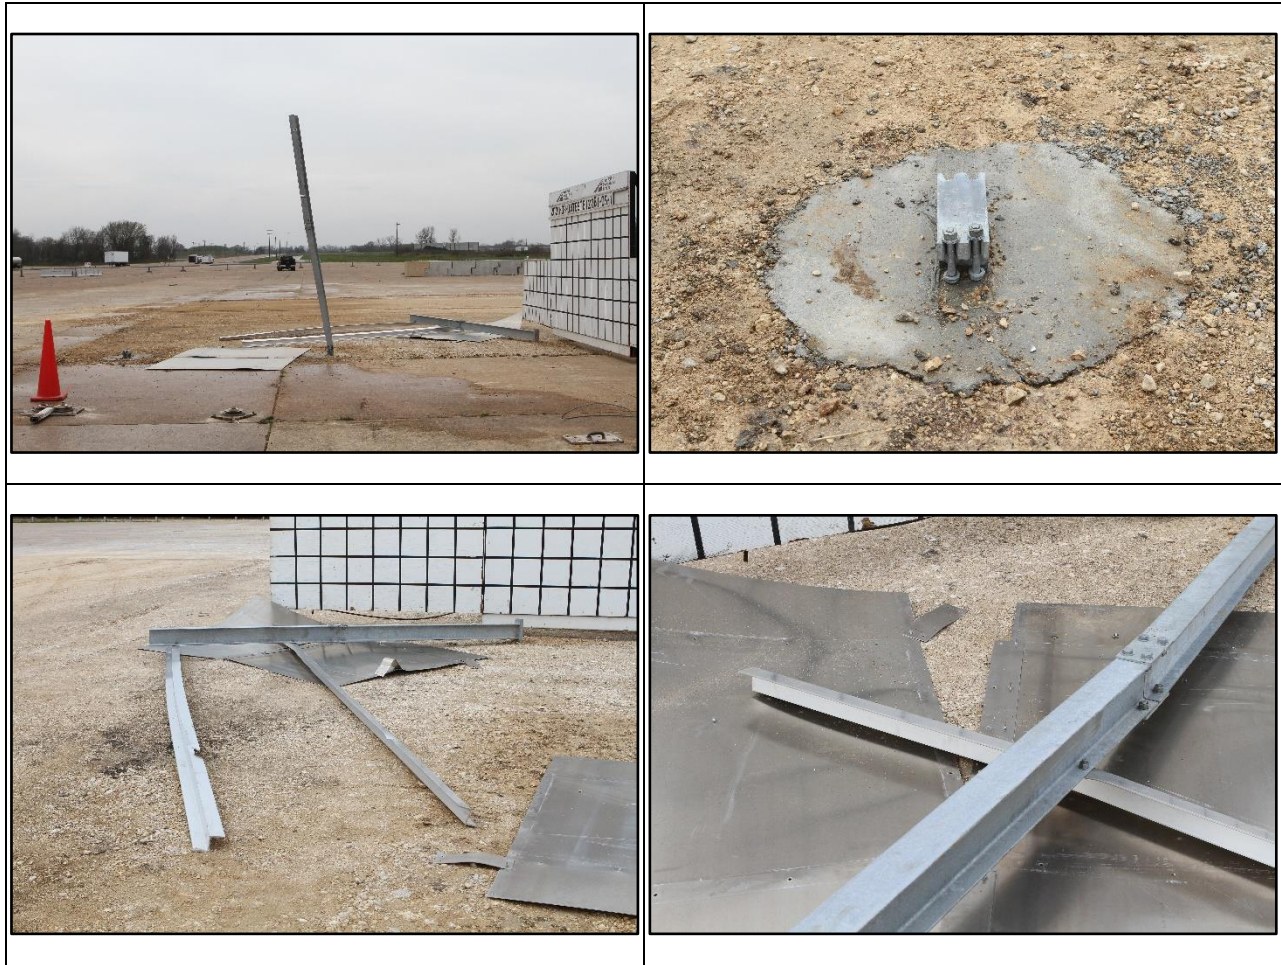
Figure 76. Test Article after Test

Figure 76 shows the damage to the test article. The left slip base activated upon impact. The hinge plates did not activate for either post. The panel connected to the right-side post was removed and landed 6 feet to the right of impact. The left support post and a partial sign panel landed 22 ft to the right and 11 ft downstream. The right support base did not activate and leaned to the left at 10 degrees to the left from vertical with a slight clockwise twist.

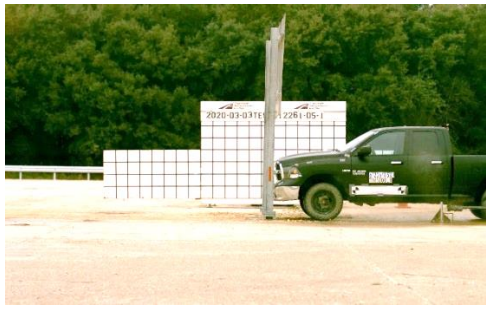
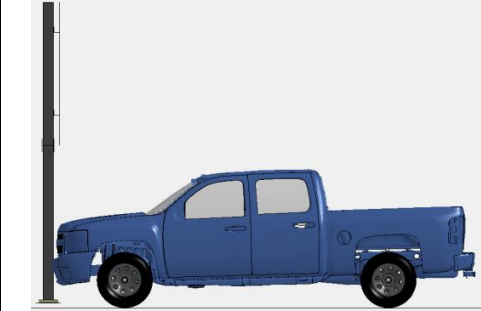
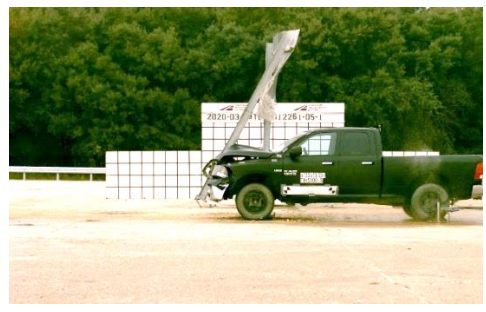
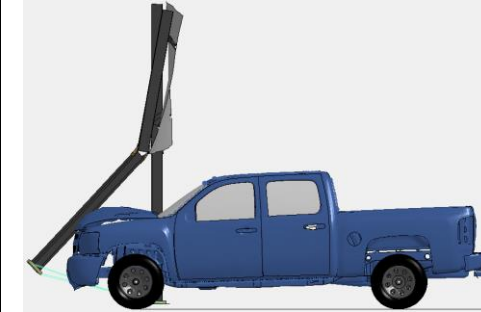
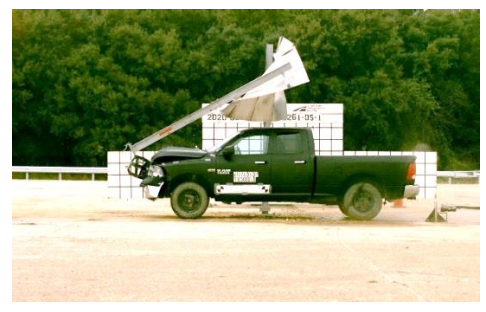
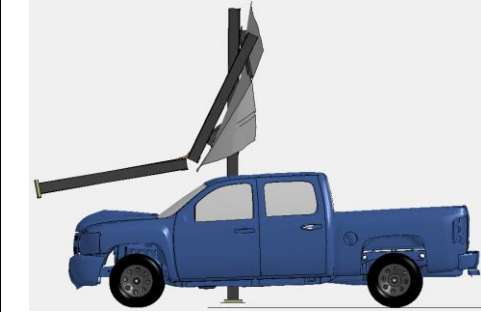
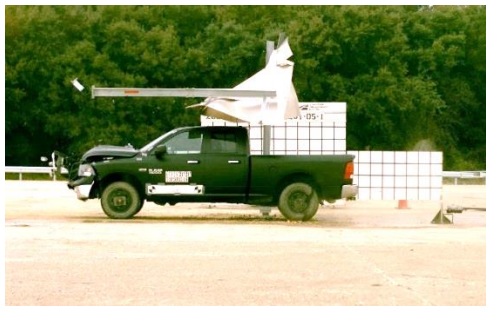
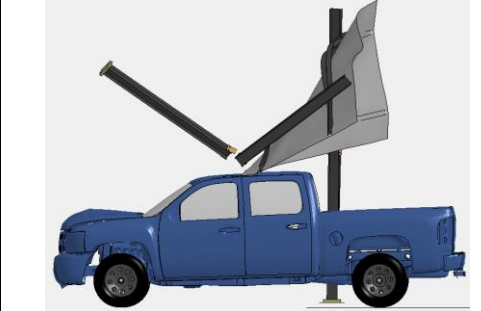
Table 23. Sequential Frame Comparison between Original FEA and Full-Scale Test

In FEA simulation, both hinge and fuse plates got activated after 0.1 s and got completely fractured by 0.3 s. Whereas, in the full-scale crash test the hinge and fuse plates did not activate. Further modifications were performed in the FEA simulation for achieving the results similar to the full-scale crash test.

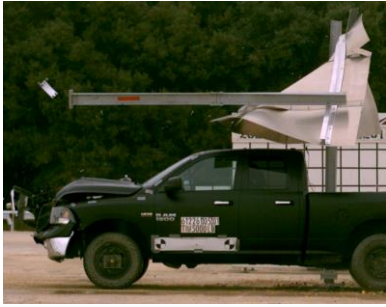
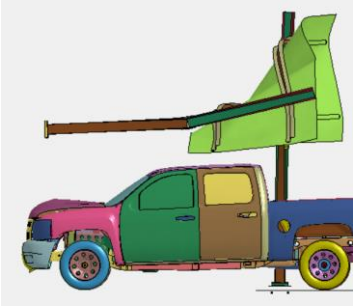
0.1 s

0.15 s

To achieve the results like the performed full-scale crash test, the FEM model was re-validated. Multiple trial and error methods were performed. By increasing the erosion values (MAT_ADD_EROSION) of fuse and hinge plate to very high values (1.0 e+04 MPa), similar results were obtained. Different frames observed during the analysis and actual crash test are shown in Table 24. All other properties of the large sign system and the vehicle were kept the same as earlier.

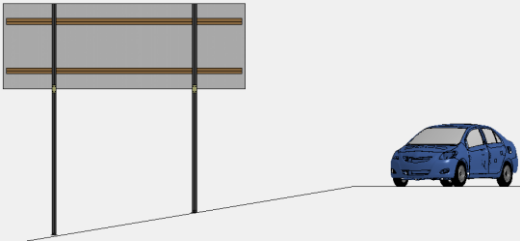
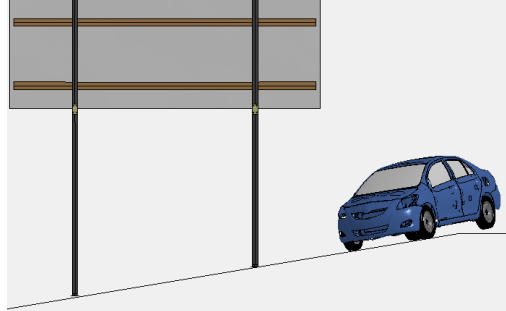
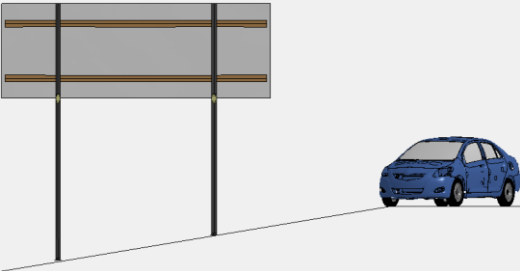
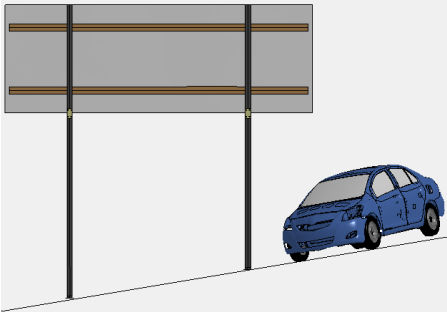
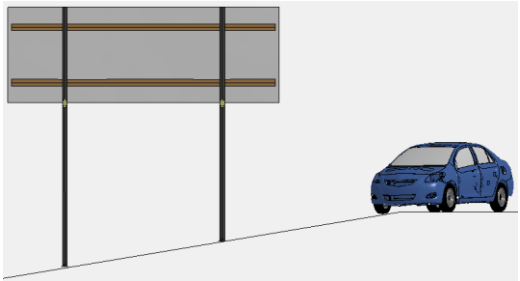
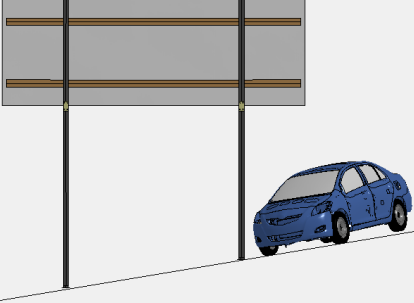
Table 37. Sequential Images of FE Simulations for Car at Low Speed.

By 1.7 s, the upper fuse and hinge plate connection on the left support leg was completely ruptured. After the complete rupture of connection plates of the left leg, the support began to move in the direction of the vehicle. At the same time, the sign panel started tilting towards the vehicle with the right leg still intact. Support and sign panel didn't come in contact with the vehicle. At 2.0 s the vehicle safely crossed the signpost assembly. Table 37 shows the complete sequential photographs of the simulations.

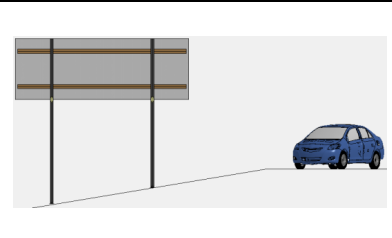
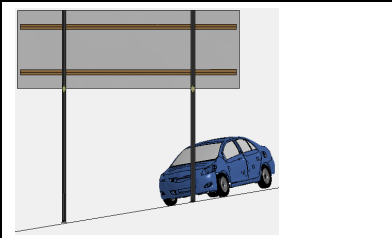
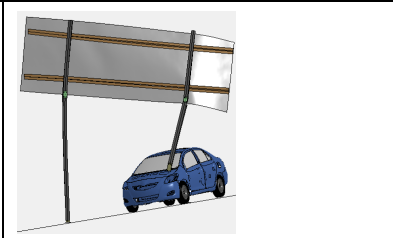
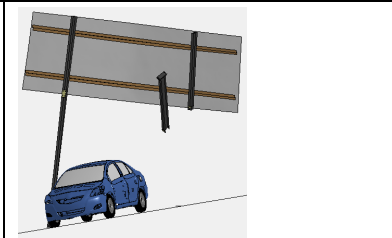
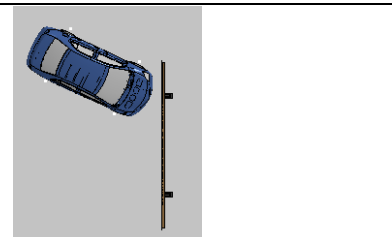
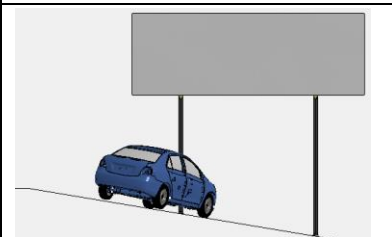
Top View	Front View	Back View	Side View		
<p>General Information Test Agency: Texas A&M Transportation Institute Test Standard: Sloped Terrain; Car (1100C); Low Speed</p> <p>Test Article Type: Sign Support System Name: MASH TL-3 Sign Support System Material or Key Elements: Steel Soil Type: Concrete Pavement</p> <p>Test Vehicle Type/Designation: 1100C Make and Model: Finite Element Yaris Curb: 2420 lb. Dummy: No Dummy</p>		<p>Impact Conditions Speed: 19 mph Angle: 25 degrees Location/Orientation: Left Leg</p> <p>Occupant Risk Values Longitudinal OIV: -7.21 ft./s Lateral OIV: 3.28 ft./s Longitudinal Ridedown: -9.3 G Lateral Ridedown: 3.4 G</p> <p>Max. 0.050-s Average Longitudinal: -2.6 G Lateral: -1.7 G Vertical: -1.9 G</p>		<p>Post-Impact Trajectory Stopping Distance: N/A</p> <p>Vehicle Stability Maximum Roll Angle: 9.8 degrees Maximum Pitch Angle: 5.4 degrees Maximum Yaw Angle: -6.4 degrees</p> <p>Vehicle Roof Deformation: Yes Max Deformation: Nil</p>

Figure 83. Summary of Finite Element Simulation for 1100C Vehicle at Low Speed.

Data from the accelerometer, located in the vehicle at the center of gravity was used to compute occupant risk factors based on MASH safety criteria for flat-level ground. The TRAP program was used to digitize the values obtained from the finite element model. In the longitudinal direction, the occupant impact velocity was 7.21 ft/s at 1.24 seconds, the highest 10-ms occupant ridedown acceleration was -9.3 G from 1.353 to 1.363 seconds, and the maximum 50-ms average acceleration was -2.6 G between 1.346 and 1.396 seconds. In the lateral direction, the occupant impact velocity was 3.28 ft/s at 1.24 seconds, the highest 10-ms occupant ridedown acceleration was 3.4 G from 1.357 to 1.367 seconds, and the maximum 50-ms average was -1.7 G between 1.198 and 1.248 seconds. The maximum roll, pitch, and yaw angles were 9.8, 5.4, and -6.4 degrees respectively (See Figure 82). Figure 83 summarizes the above data and other important information from the test.
